2012

Annual Inspection Report

ORLANDO - ORANGE COUNTY
EXPRESSWAY AUTHORITY

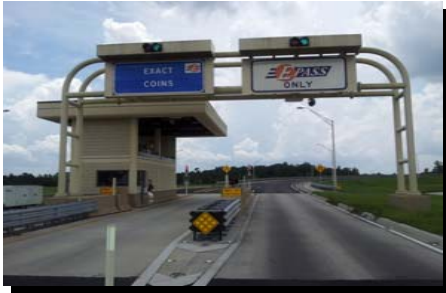
Facility Feature	Rating	Comments
Sign Structure	3	Algae growth present needs power wash.
Traffic Red / Green Lighting	1	No deficiencies noted
Sign Lighting	1	No deficiencies noted
Canopy Underside	1	No deficiencies noted
Canopy Fascia	1	No deficiencies noted
Canopy lighting	1	No deficiencies noted
Variable Message Signs	1	No deficiencies noted
Canopy Columns	1	No deficiencies noted
Signs	1	No deficiencies noted

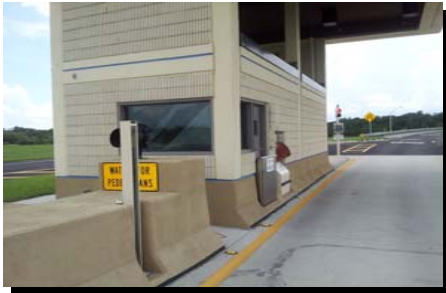
Facility Feature	Rating	Comments
ACM	3	ACM screen does not display anything.
Windows and Storefronts	3	Algae growth on window frames
Generator	2	No deficiencies noted
Paint - Interior and Exterior	1	No deficiencies noted
Condensing Units	1	No deficiencies noted
Doors / Frames (Interior and Exterior)	1	No deficiencies noted
Receptacle	1	No deficiencies noted
Ductwork and Insulation	1	No deficiencies noted
Exhaust Fans	1	No deficiencies noted
Concrete Pavement	1	No deficiencies noted
Nose Flashers	1	No deficiencies noted
Signs	1	No deficiencies noted
Walls (Concrete Block, Brick, Stucco or EIFS)	1	No deficiencies noted
Lighting (Exterior)	1	No deficiencies noted
Site Grounds	1	No deficiencies noted
Joint Sealants	1	No deficiencies noted

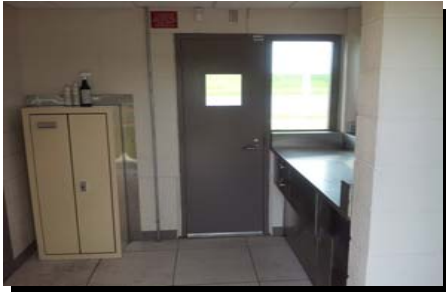
Facility Feature	Rating	Comments
Flooring (Interior and Accessories)	3	Floors are dirty.
Switchboards and Breakers	1	No deficiencies noted
ACM	1	No deficiencies noted
Ceilings and Ceiling Grids	1	No deficiencies noted
Counters/Cabinets and Drawers	1	No deficiencies noted
Ductwork and Insulation	1	No deficiencies noted
HVAC Control Systems	1	No deficiencies noted
Joint Sealants	1	No deficiencies noted
Lighting (Interior)	1	No deficiencies noted
Paint - Interior and Exterior	1	No deficiencies noted
Fire Extinguisher	1	No deficiencies noted
Receptacle	1	No deficiencies noted
Security	1	No deficiencies noted
Telephone System	1	No deficiencies noted
Ventilation Outlets	1	No deficiencies noted
Walls (Concrete Block, Brick, Stucco or EIFS)	1	No deficiencies noted
Walls (Interior)	1	No deficiencies noted
Windows and Storefronts	1	No deficiencies noted
Wiring	1	No deficiencies noted
Air Conditioners	1	No deficiencies noted

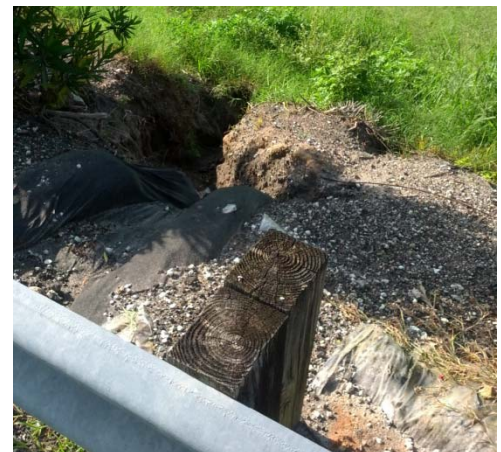
Picture 1 – EB SR 408 near MP 2

Roadside features are in good condition with soil shoulder deficiencies being the most common. Most of the deficiencies are located along eastbound SR 408 west of Kirkman Road

and on westbound SR 408 near Dean Road.

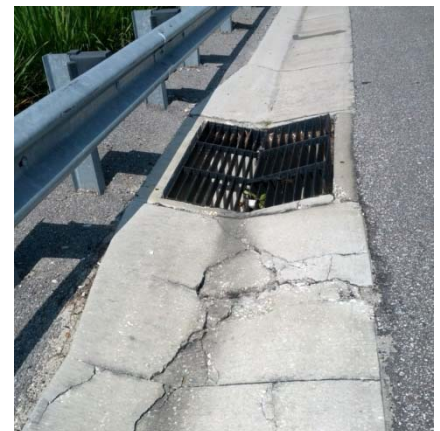
Picture 2 – EB SR 408 near MP 7

Other deficiencies were related to roadside ditches, curb inlets and cross drains.

Fifteen of the 976 inspected Drainage features on SR 408 received a rating of 4. No Drainage features received a rating of 5.

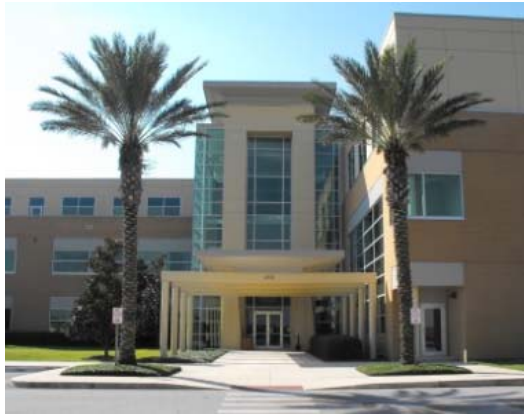
**Picture 3 – OOCEA
Headquarters Building**

The Authority's headquarters building (shown in Picture 3) is located along SR 408 near the Conway Westbound Mainline Toll Plaza. The building is in good condition. Only two features related to cabinets in the break room and the backflow preventer received a rating of 4. No features received a rating of 5. These deficiencies can be addressed through routine maintenance.

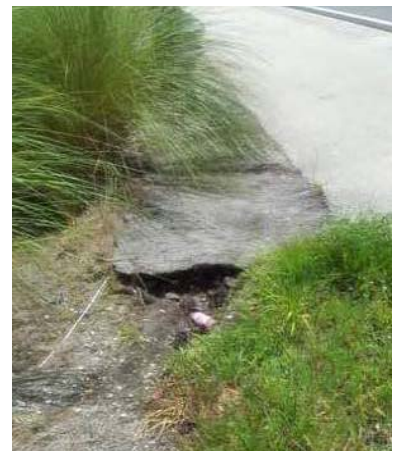
**Picture 5 – SB SR 417
near MP 17**

Roadside features are in generally good condition. The most common deficiencies were related to soil shoulder and front slope. While soil shoulder erosion occurred at some isolated locations (as shown on Picture 5), most of the soil shoulder erosion deficiencies were concentrated on or near the Lake Nona Boulevard and University Boulevard interchanges. Front slope erosion occurred

at various locations throughout SR 417, with the area near University Boulevard needing special attention.
