2013 Annual Inspection Report

ORLANDO - ORANGE COUNTY
EXPRESSWAY AUTHORITY

The 2013 inspection of the Orlando-Orange County Expressway Authority's (Authority) system, performed by Atkins, the Authority's General Engineering Consultant, included a visual inspection of the roadways, buildings and bridges under Authority jurisdiction.

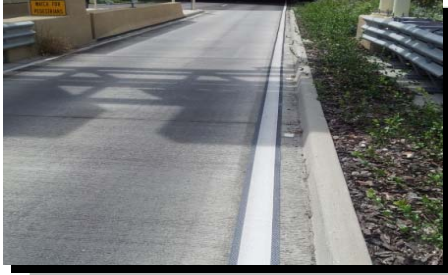
Keene Rd - EB On ramp

Feature	Rating	Comment
Apron Sweep	8	No deficiencies noted
Cracking	9	No deficiencies noted
Joints	6	Vegetation growing thru deteriorated joint material adjacent gator head.
Pavement Voids	9	No deficiencies noted
Striping	9	No deficiencies noted

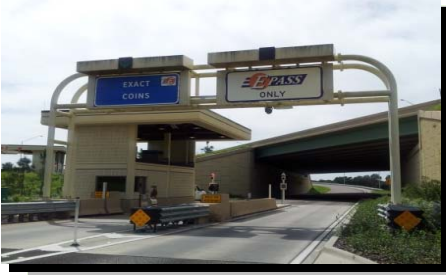
Keene Rd - EB On ramp

Feature	Rating	Comment
Canopy Columns	9	No deficiencies noted
Canopy Fascia	9	No deficiencies noted
Canopy lighting	8	No deficiencies noted
Canopy Underside	9	No deficiencies noted
Sign Lighting	6	Both Sign lights are out over lane EPASS Lane.
Sign Structure	9	No deficiencies noted
Signs	9	No deficiencies noted
Traffic Red / Green Lighting	9	No deficiencies noted
Variable Message Signs	9	No deficiencies noted

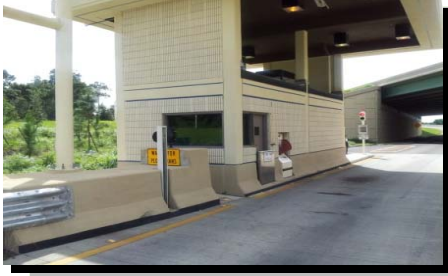
Keene Rd - EB On ramp

Feature	Rating	Comment
Bollards	6	Paint is chipping off bollards
Concrete	6	Needs paint behind sign (Watch for pedestrians).
Concrete Pavement	6	Cracked pavement or sidewalk.
Condensing Units	9	No deficiencies noted
Doors / Frames (Interior and Exterior)	9	No deficiencies noted
Irrigation System	9	No deficiencies noted
Joint Sealants	9	No deficiencies noted
Lighting (Exterior)	9	No deficiencies noted
Lightning Protection	9	No deficiencies noted
Nose Flashers	9	No deficiencies noted
Paint - Interior and Exterior	9	No deficiencies noted
Receptacle	9	No deficiencies noted
Signs	9	No deficiencies noted
Site Grounds	6	Landscape need trimming.
Stand-By Generator	6	Generator pad not sealed around conduit.
Walls (Concrete Block, Brick, Stucco or EIFS)	8	No deficiencies noted
Windows and Storefronts	9	No deficiencies noted
Wiring	6	Junction Box is above grade (mowing hazard).
Wiring	6	Pull box bolts above grade (tripping hazard).

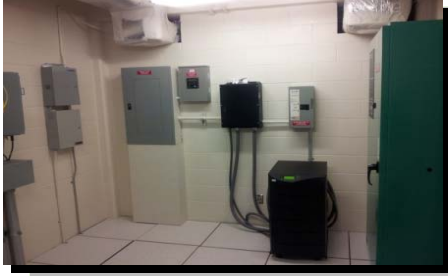
Keene Rd - EB On ramp

Feature	Rating	Comment
Ceiling	8	No deficiencies noted
Doors / Frames (Interior and Exterior)	9	No deficiencies noted
Ductwork and Insulation	9	No deficiencies noted
Fire Extinguisher	9	No deficiencies noted
Flooring (Interior and Accessories)	6	Access flooring tile/s are loose. Tiles stained.
HVAC Control Systems	9	No deficiencies noted
Lighting (Interior)	3	Emergency lighting is not working.
Paint - Interior and Exterior	9	No deficiencies noted
Panelboards	9	No deficiencies noted
Receptacle	9	No deficiencies noted
Switchboards and Breakers	6	Circuit breakers, switches are missing identification in both panels. Missing numbers on breakers
TVSS (Transient Voltage Surge Suppressor)	9	No deficiencies noted
UPS (Uninterrupted Power Supply)	9	No deficiencies noted
Ventilation Outlets	9	No deficiencies noted
Walls (Interior)	6	Walls not sealed around duct work.
Wiring	9	No deficiencies noted

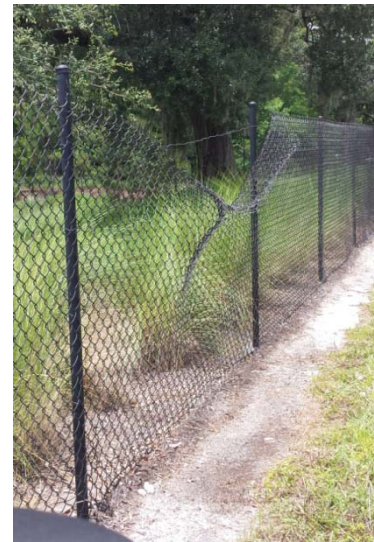
**Picture 1 – Fence along
SR 408 WB Off Ramp to
Mills Avenue**

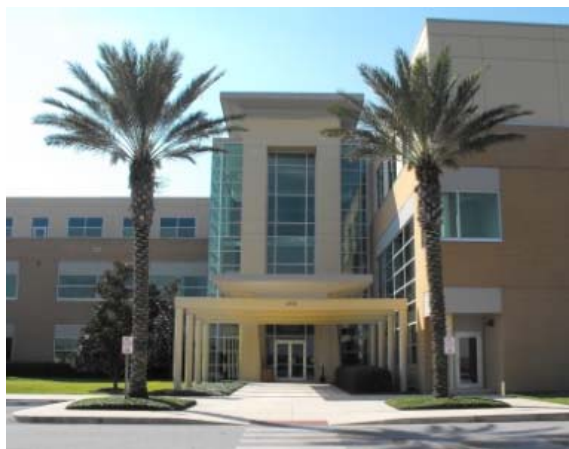
**Picture 2 – OOCEA
Headquarters Building**

The Authority's headquarters building, shown in Picture 2, is located along SR 408 near the Conway Westbound Mainline Toll Plaza. The building is in good condition with no deficiencies identified. Maintenance is suggested for two features related to deteriorated restroom tile grout and auditorium walls which received a rating of 5, and two features related to cabinets in the break room and cracked hallway floor tiles which received a rating of 4. No features received a rating lower than 4.

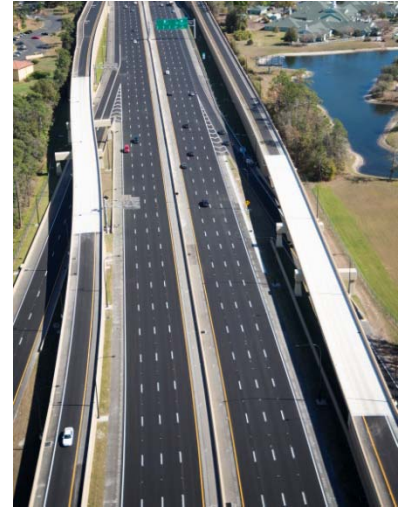
The latest bridge inspection reports for the bridges along SR 408 are available for review upon request to the Authority. No significant deficiencies were reported. Minor deficiencies reported are being addressed by the Authority. Picture 3 shows the newly constructed bridges at the SR 408 Chickasaw Trail on and off ramps.

**Picture 3 – SR 408 Bridges at
Chickasaw Trail On and Off
Ramps**

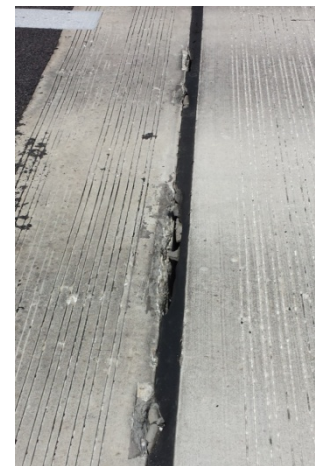
**Picture 4 – Joint
at EB SR 414 near
MP 5.2**

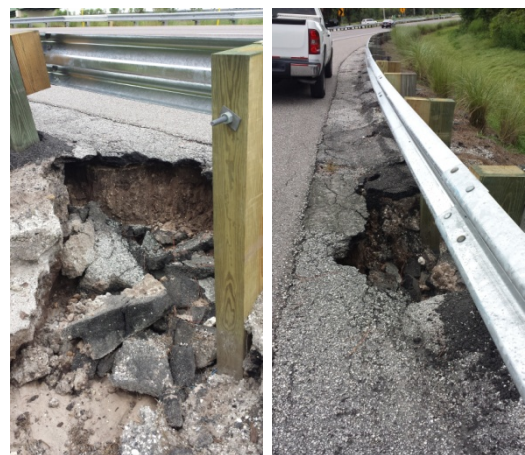
Picture 5– Paved Shoulder Erosion on SR 417 SB Off Ramp to WB SR 528

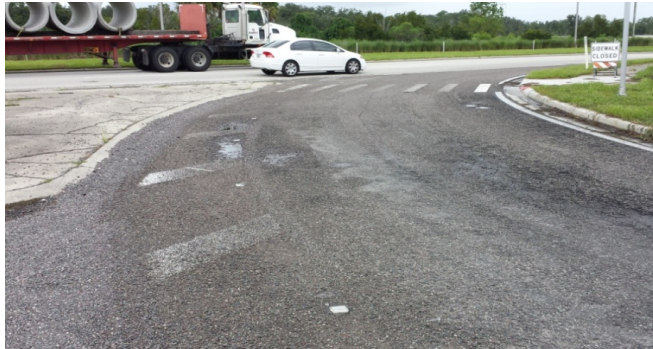
**Picture 6 – Stripping on SR 417 SB
Off Ramp to Boggy Creek Road**

Maintenance is also suggested at various locations along SR 417 for features that were rated 4 and 5 related to paved shoulders, stripping, edge ravel, joints and pavement voids, rutting, shoving, bridges, and potholes. Picture 6 portrays the SR 417 southbound off ramp to Boggy Creek Road, one of the locations where stripping was identified.

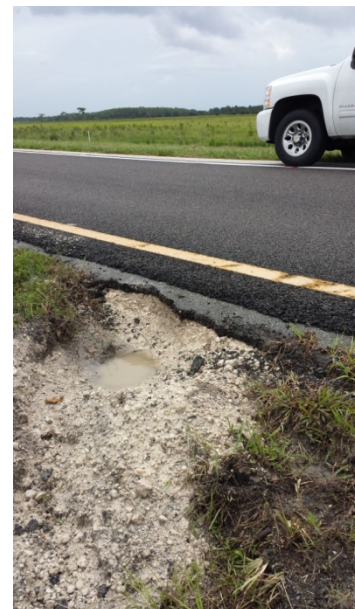
**Picture 7 – Soil Shoulder
Erosion at SR 417 Boggy
Creek NB On Ramp**

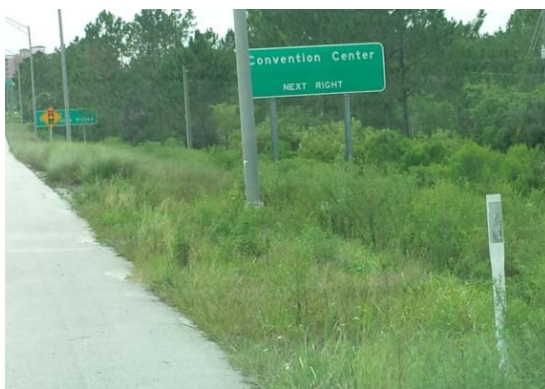
Picture 8 – Slope Mowing suggested along SR 417 International Drive SB Off Ramp

Maintenance is also recommended for the following features which received ratings of 4 or 5: slope mowing (as shown in Picture 8), roadway sweep, turf condition, litter removal, roadway mowing and landscape.

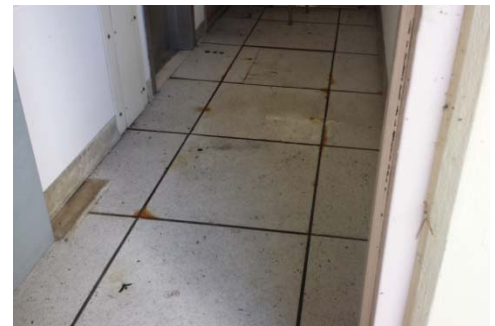
Picture 9 – Floor at Narcoossee SB Off Ramp Toll Plaza Booth

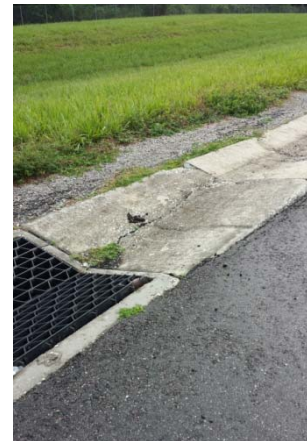
Maintenance is recommended for storm drains throughout SR 429 that received ratings of 4 and 5. As shown in Picture 10, most of the locations where storm drain maintenance is suggested exhibit cracked and depressed shoulder gutters. A few isolated locations also received ratings of 4 and 5 for median ditch erosion and overgrown roadside ditches.

Picture 10 – Storm Drain Deficiency on SR 429 West Road NB Off Ramp

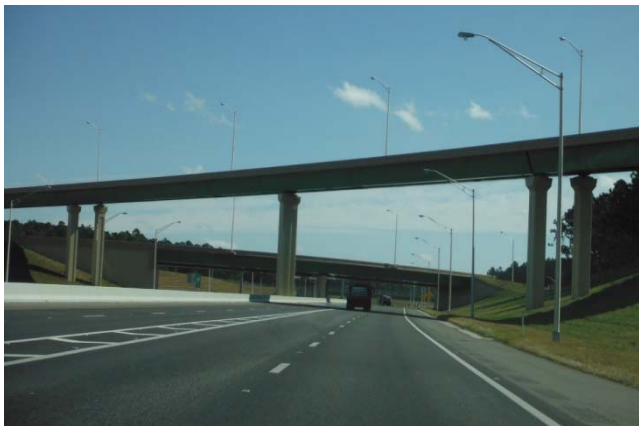
Picture 11 shows the SR 451 northbound bridge over SR 414. The latest bridge inspection reports for the bridges along SR 451 are available for review upon request to the Authority. No significant deficiencies were reported. Minor deficiencies reported are being addressed by the Authority.

Picture 11 – SR 451 NB bridge over SR 414
