Annual Inspection Report

2014

CENTRAL FLORIDA EXPRESSWAY AUTHORITY

The 2014 inspection of the Central Florida Expressway Authority's (Expressway Authority) system, performed by Atkins, the Authority's General Engineering Consultant, included a visual inspection of the roadways, buildings and bridges under Expressway Authority jurisdiction.

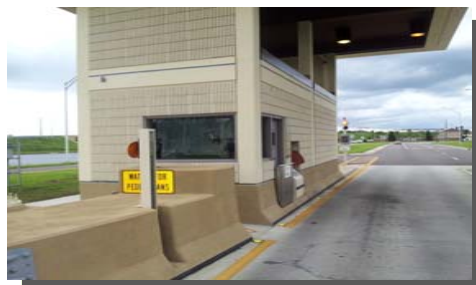
Feature	Rating	Comments
Joint Sealants	6	Vegetation growing through deteriorated joint sealant.
Windows and Storefronts	6	Frame finish exhibits peeling paint algae growth.
Site Grounds	8	No deficiencies noted
Concrete Pavement	9	No deficiencies noted
Condensing Units	9	No deficiencies noted
Doors / Frames (Interior and Exterior)	9	No deficiencies noted
Lighting (Exterior)	9	No deficiencies noted
Lightning Protection	9	No deficiencies noted
Nose Flashers	9	No deficiencies noted
Paint - Interior and Exterior	9	No deficiencies noted
Receptacle	9	No deficiencies noted
Security	9	No deficiencies noted
Signs	9	No deficiencies noted
Site Drainage	9	No deficiencies noted
Stand-By Generator	9	No deficiencies noted
Toll Indicator	9	No deficiencies noted
Transformers	9	No deficiencies noted
Walls (Concrete Block, Brick, Stucco or EIFS)	9	No deficiencies noted
Wiring	9	No deficiencies noted

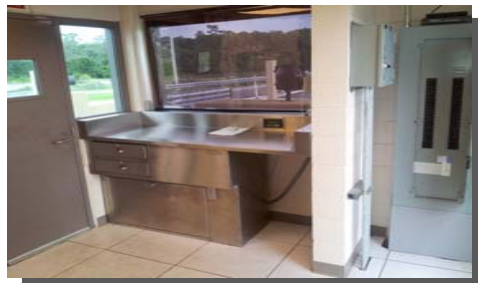
Feature	Rating	Comments
Flooring (Interior and Accessories)	5	Tiles are scuffed near ACM machine. Money laying on the floor.
Fire Extinguisher	8	No deficiencies noted
ACM	9	No deficiencies noted
Air Conditioners	9	No deficiencies noted
Ceilings and Ceiling Grids	9	No deficiencies noted
Counters/Cabinets and Drawers	9	No deficiencies noted
Doors / Frames (Interior and Exterior)	9	No deficiencies noted
Ductwork and Insulation	9	No deficiencies noted
HVAC Control Systems	9	No deficiencies noted
Joint Sealants	9	No deficiencies noted
Lighting (Interior)	9	No deficiencies noted
Paint - Interior and Exterior	9	No deficiencies noted
Panelboards	9	No deficiencies noted
Receptacle	9	No deficiencies noted
Security	9	No deficiencies noted
Switchboards and Breakers	9	No deficiencies noted
Telephone System	9	No deficiencies noted
TVSS (Transient Voltage Surge Suppressor)	9	No deficiencies noted
Ventilation Outlets	9	No deficiencies noted

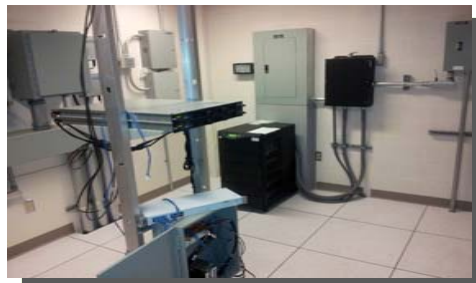
Feature	Rating	Comments
Switchboards and Breakers	3	Labeling / directory is incorrect in panel EDR
Lighting (Interior)	4	Emergency lighting is not working.
Air Conditioners	8	No deficiencies noted
Fire Extinguisher	8	No deficiencies noted
Ceiling	9	No deficiencies noted
Doors / Frames (Interior and Exterior)	9	No deficiencies noted
Ductwork and Insulation	9	No deficiencies noted
Flooring (Interior and Accessories)	9	No deficiencies noted
HVAC Control Systems	9	No deficiencies noted
Paint - Interior and Exterior	9	No deficiencies noted
Panelboards	9	No deficiencies noted
Receptacle	9	No deficiencies noted
UPS (Uninterrupted Power Supply)	9	No deficiencies noted
Ventilation Outlets	9	No deficiencies noted
Walls (Interior)	9	No deficiencies noted
Wiring	9	No deficiencies noted

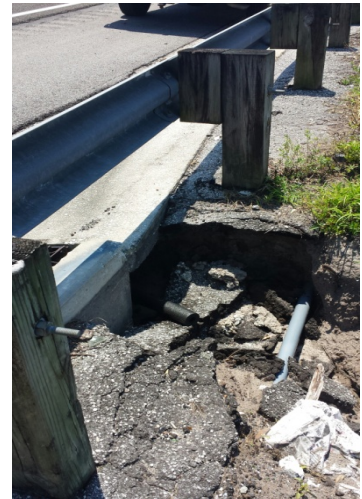
Picture 4 – SR 417 Soil Shoulder Erosion

Out of the 559 inspected Roadside features on SR 417, 33 received a rating of 4. 10 features were considered deficient, as follows:

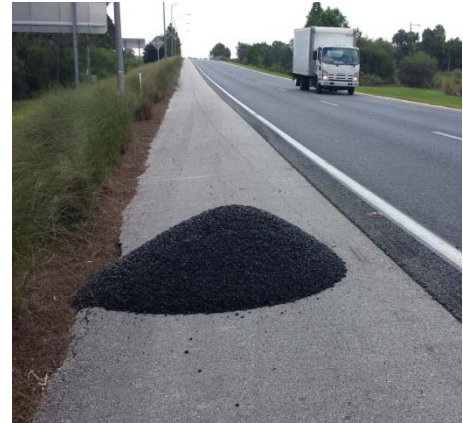
Picture 5 – Asphalt Pile on SR 417 International Drive SB Off Ramp

Vegetation/Aesthetics features along SR 417 are in good condition with only one litter removal deficiency reported at the SR 417 International Drive southbound off ramp where, as seen on Picture 5, a pile of asphalt was dumped on the paved shoulder. This deficiency received a rating of 1 and was reported to the Expressway Authority as a critical item. The Expressway Authority's maintenance staff has already removed the asphalt from the site.

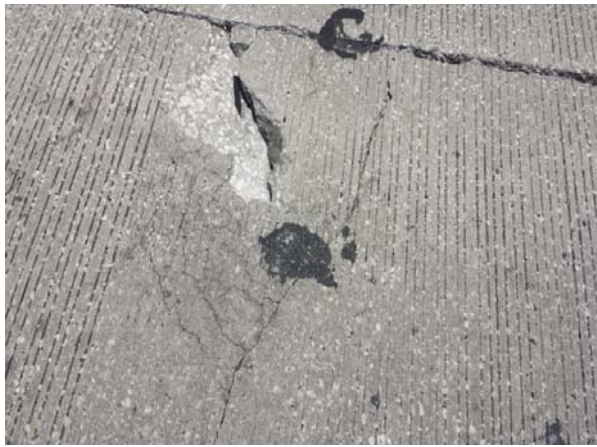
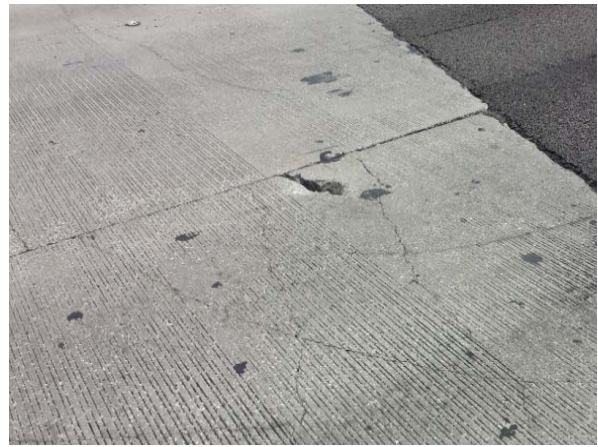
Photos 1 & 2 Critical Item Condition - Lee Vista Bridge Deck Spall

Description: 12" X 8" Spall in south approach slab of Lee Vista Bridge no 750735. MP 27.565

Date Repaired: Aug 12, 2014
CFX Contact: Steve Geiss
Inspector: Steve Franklin

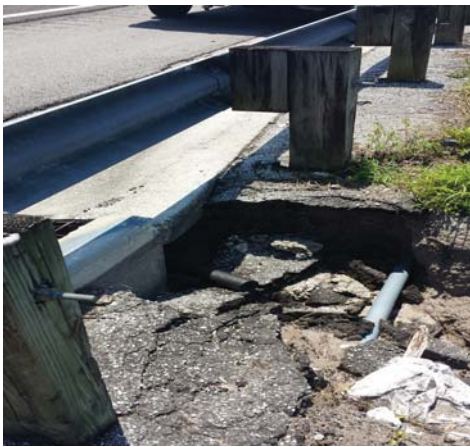
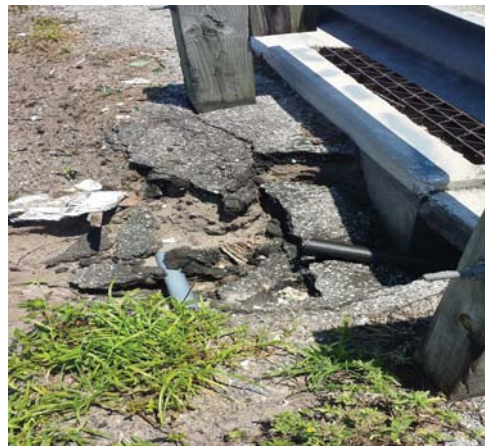
Photos 1 & 2 Critical Item Condition – Soil Shoulder Erosion

Description: Soil shoulder erosion > 30" adjacent paved shoulder. Shoulder gutter and paved shoulder have been undermined

Date Repaired: Aug 12, 2014
CFX Contact: Steve Geiss
Inspector: Steve Franklin

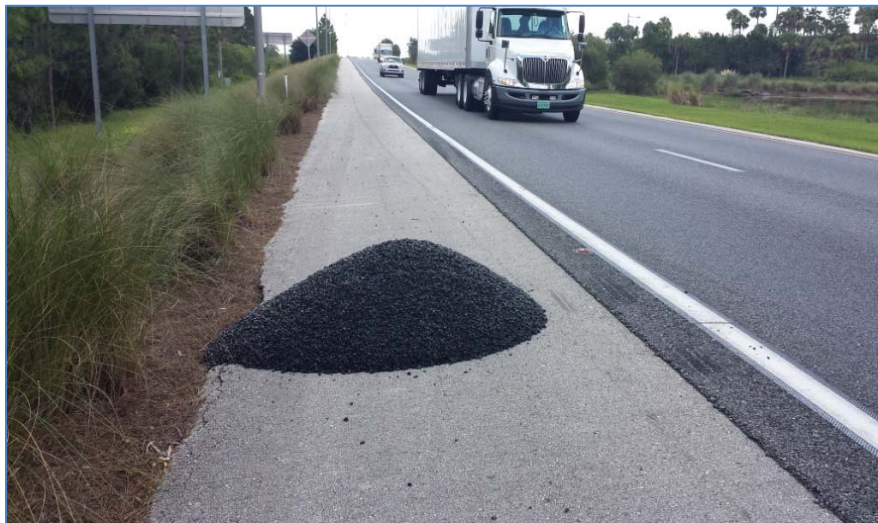
Photo 1 - Critical Item Condition

Description: 6' x 5' x 2' pile of asphalt has been dumped onto paved shoulder approx 2' from edge of travel lane.

Date Repaired: Aug 13, 2014
CFX Contact: Steve Geiss
Inspector: Steve Franklin

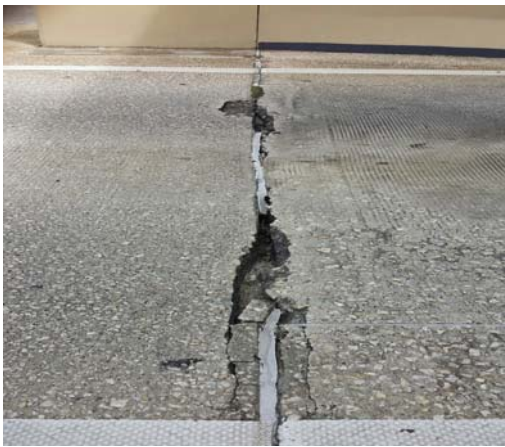
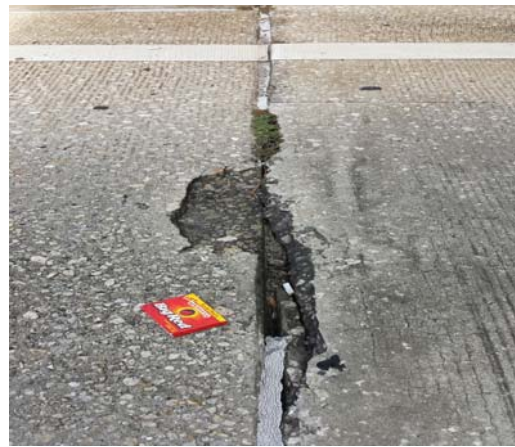
Photos 1 & 2 Critical Item Condition – Pavement Void at Plaza Apron

Description: Lane 11 exhibits two significant spalls at joint on south side of SB Canopy. Both spalls extend full depth of slab.

Date Repaired: Dec 15, 2014
CFX Contact: Robert Glasemann
Inspector: Steve Franklin
