2016

Annual Inspection Report

**CENTRAL
FLORIDA**
EXPRESSWAY
AUTHORITY

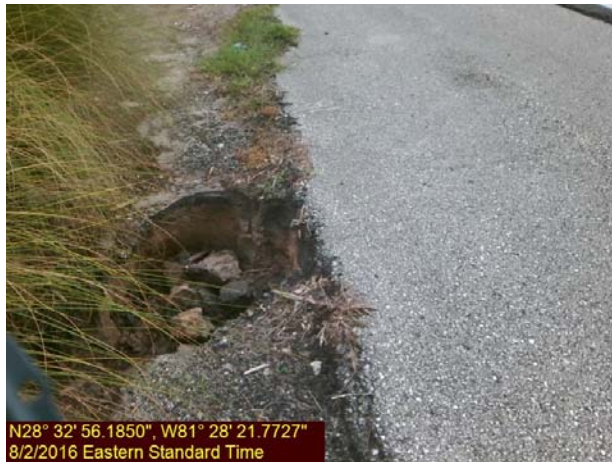
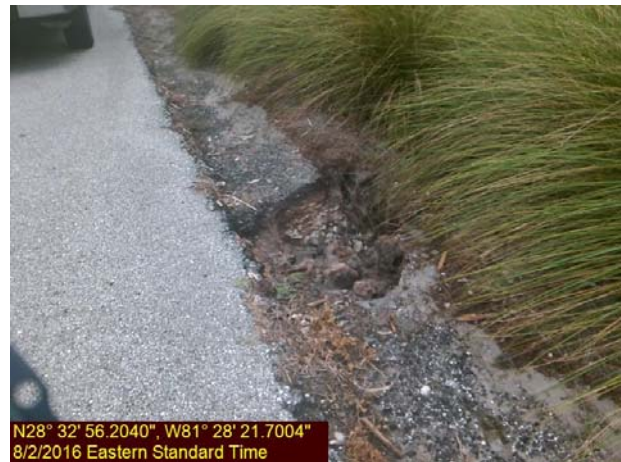
Description: Soil shoulder exhibits 18"- 24" erosion adjacent paved shoulder.

Photo 1 & 2 – Soil Shoulder erosion 18"-24 adjacent paved shoulder

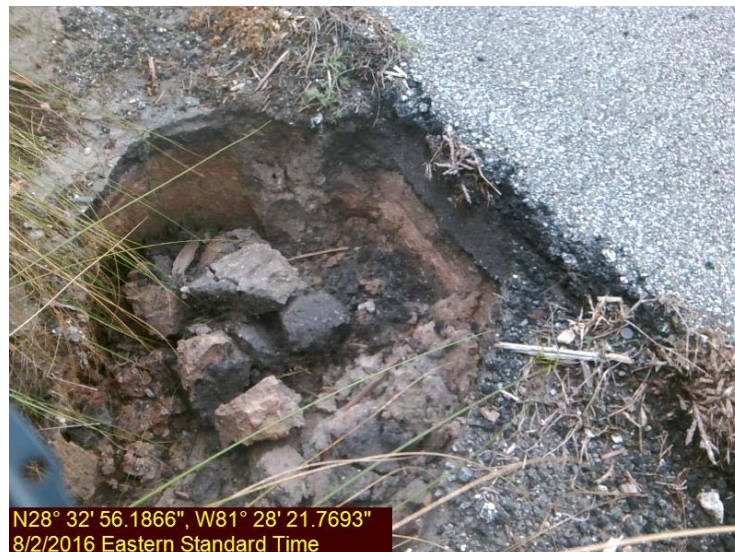
Photo 3 – Soil Shoulder erosion 18"-24 adjacent paved shoulder

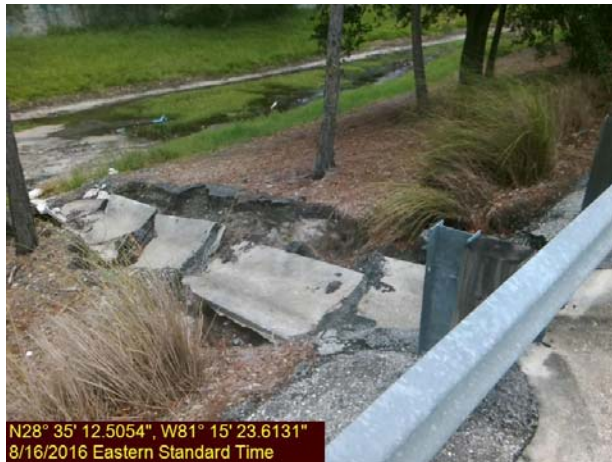
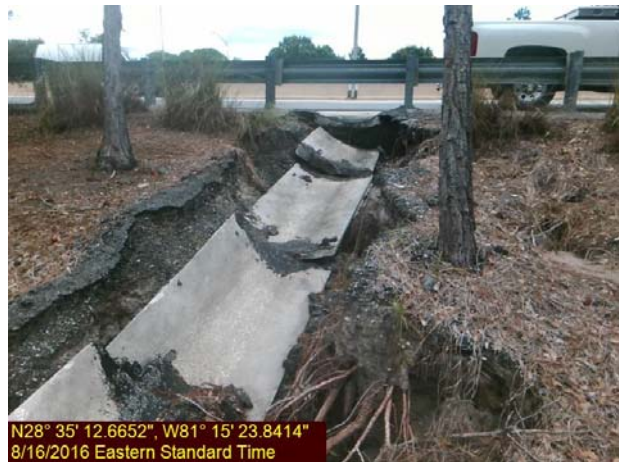
Description: 36" deep erosion of soil shoulder and front slope. Conc. flume has collapsed and broken apart. Shoulder gutter and paved shoulder has been undermined..

Photo 1 & 2 –36" deep erosion of Soil Shoulder and Front Slope. Conc. Flume collapsed and broken apart

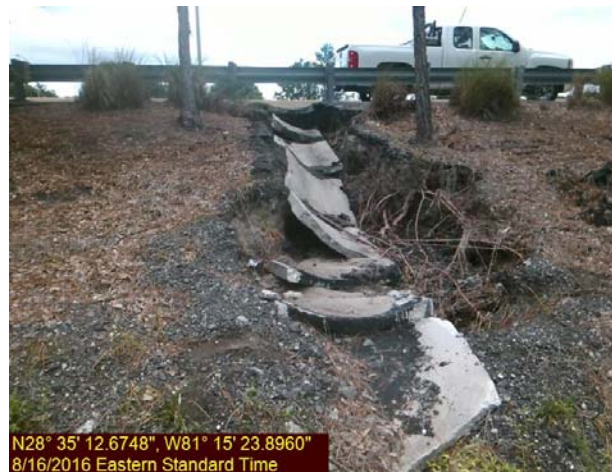
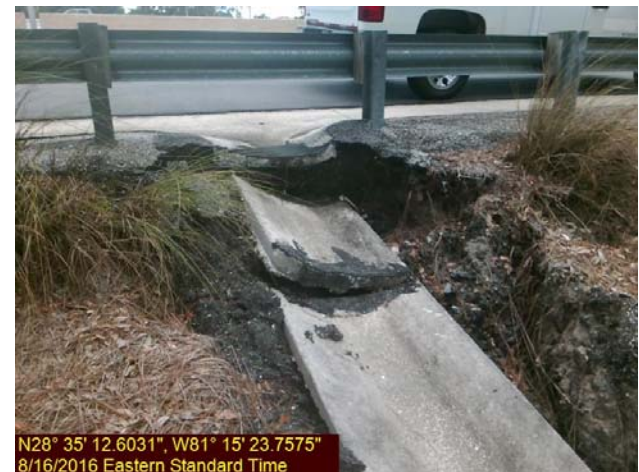
Photo 3 & 4 –36" deep erosion.

Conc. Flume collapsed and broken apart. Shoulder gutter and paved shoulder has been undermined.

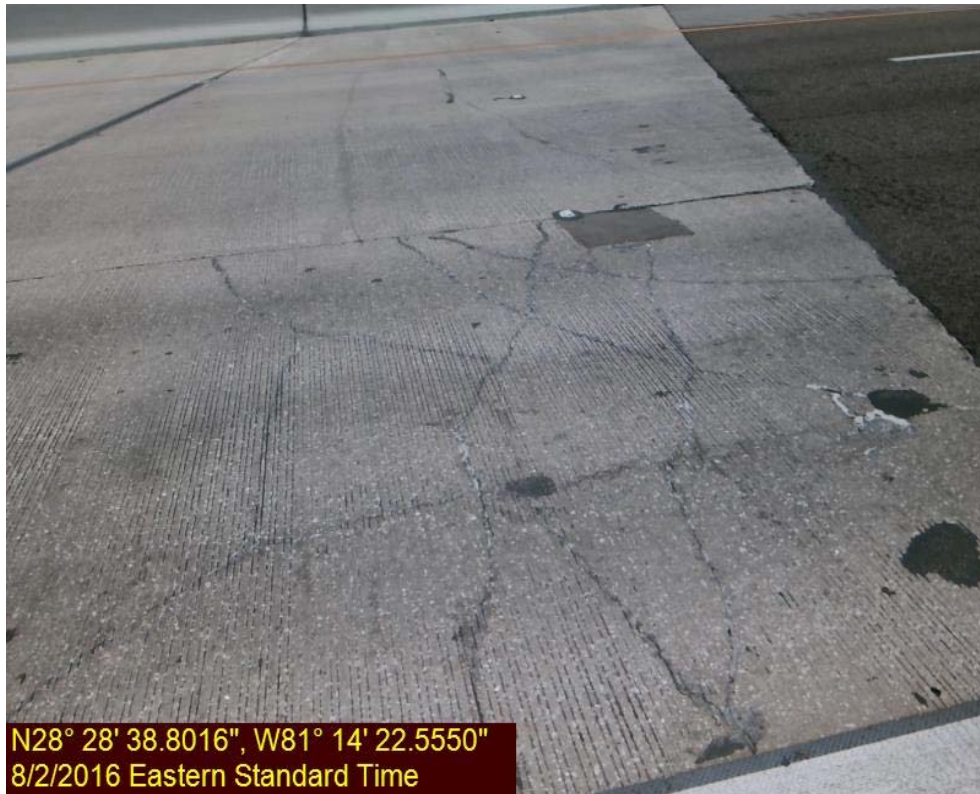
Description: 1/16 - 1/8 cracks in south approach slab (Lee Vista bridge no. 750375). Crack cells have formed.

Photo 1 - 1/16 - 1/8 cracks in south approach slab (Lee Vista bridge no. 750375).

Crack cells have formed. Slab is depressed 1" adjacent middle lane.

Sikadur® Crack Fix

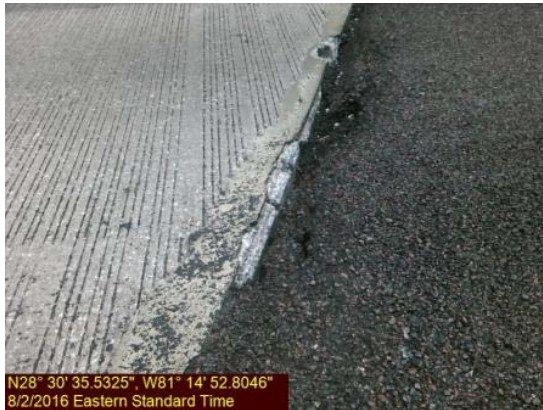
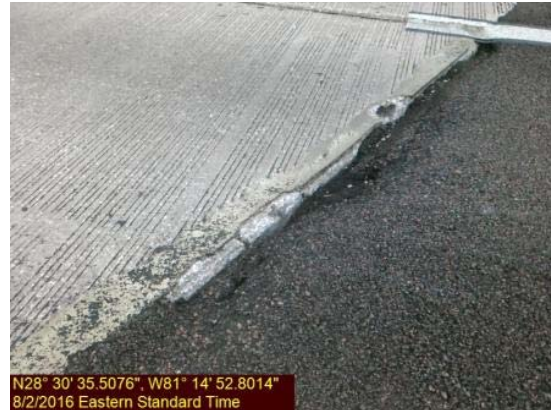
Description: 60" x 6" x 6" Asphalt void in wheel path of right lane. Up to 6" of bridge deck exposed.

Photo 1 – 2 Pothole / Asphalt void adjacent south approach Curry Ford Bridge.

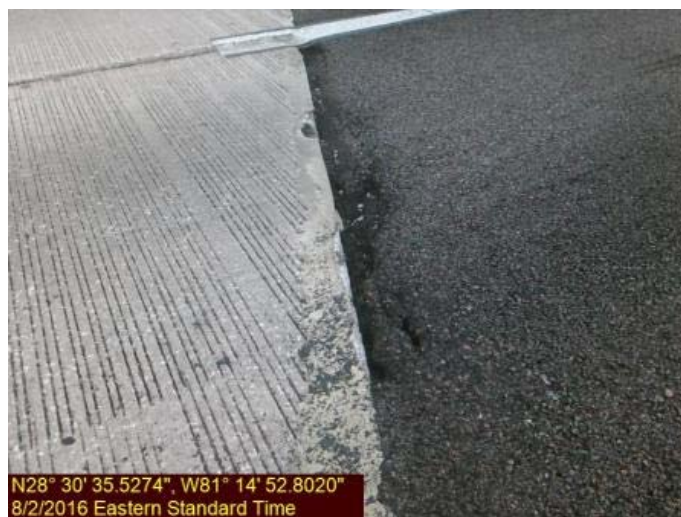
Photo 3 – Pothole / Asphalt void adjacent south approach Curry Ford Bridge

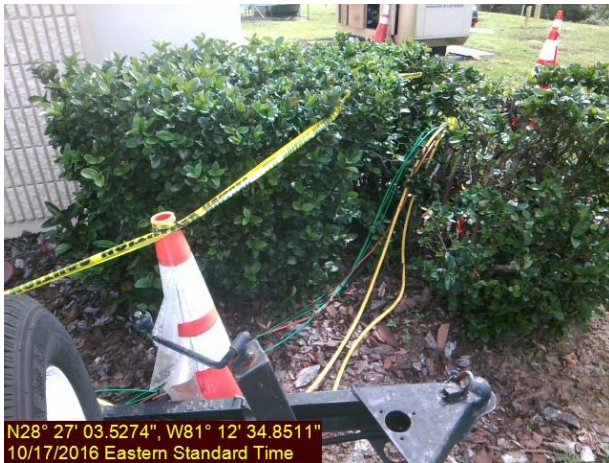
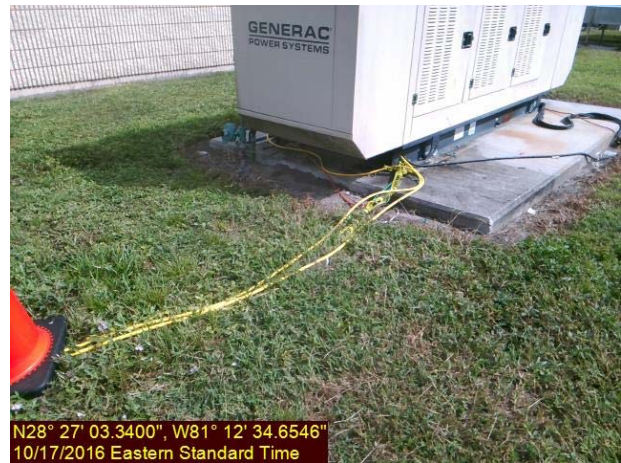
Description: Standby generator is not operational. Unit has damaged fan and broken fan belt. 2 portable generators are being utilized. Wires are laying on the ground unprotected and no electrical disconnect in place. Hazardous condition exist. (See photos below)

Photo 1 & 2 –Electrical wires laying on the ground unprotected.

Solution / Repairs: At the time of this report, the wires have been addressed. The generators are a work in progress.

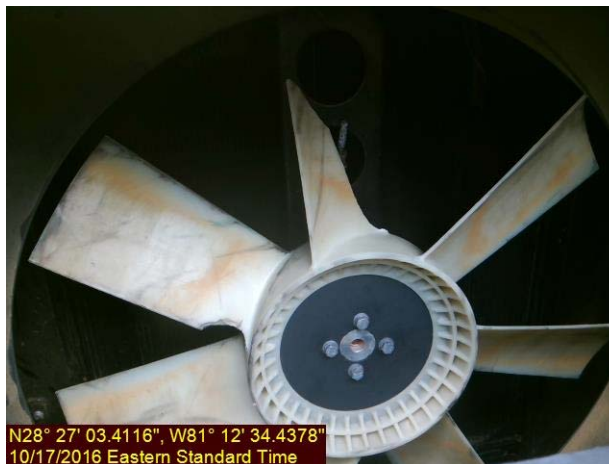
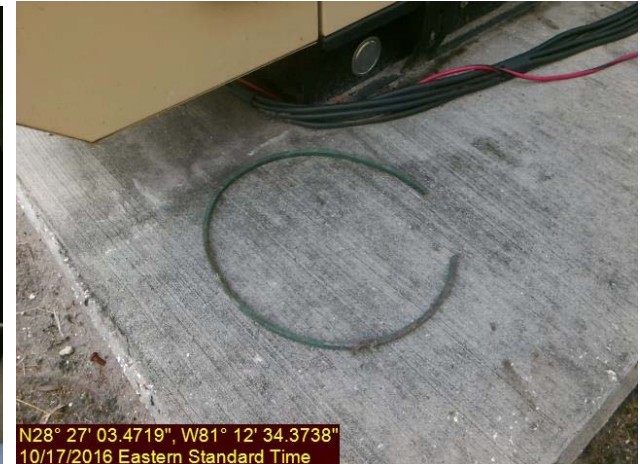
Photo 3 & 4 – Damaged fan and broken belt.
