2017 Annual Inspection Report

Mr. Joseph A. Berenis, P.E.
Deputy Executive Director
Central Florida Expressway Authority
4974 ORL Tower Road
Orlando, Florida 32807

Re: 2017 Annual Inspection Report

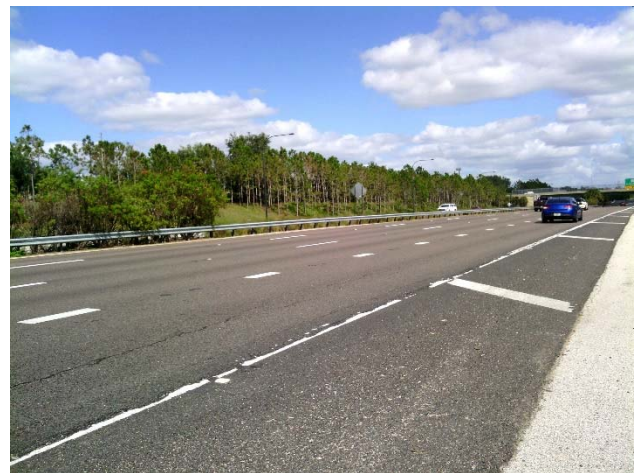
Notable pavement marking and striping observations throughout thy corridor included missing striping and faded markings.

Figure 3 Pavement marking peeling SR 408 near Pine Hills Mainline Plaza

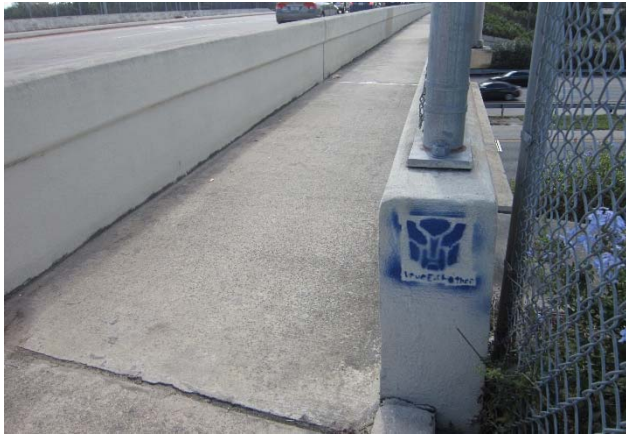
Approach slab header damage was observed at Good Homes Road. Graffiti was observed on parapets and barrier wall at both Powers Drive and Good Homes Road.

Figure 4 Graffiti on SR 408 Good Homes Road Bridge

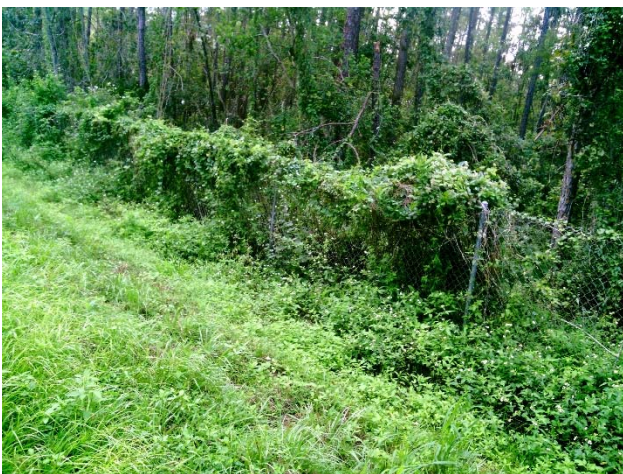
Notable wall and fence observations include coping damage, color fade, vegetation overgrown fence lines, and damaged or downed right of way fences.

Figure 5 Overgrown ROW fence line SR 408 near Alafaya Trail

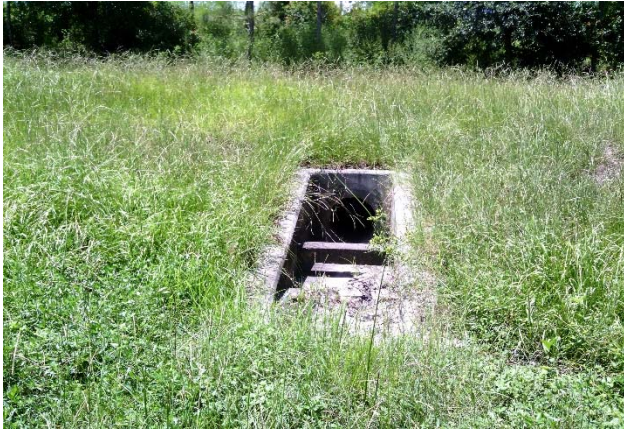
Various drainage structures with varying degrees of obstruction were observed along SR 414 including the pond behind the Coral Hills Mainline Toll Plaza and on the viaduct over Overland/CSX Railroad.

Figure 6 Drainage structure with vegetative obstruction at SR 414 Keene Road Pond

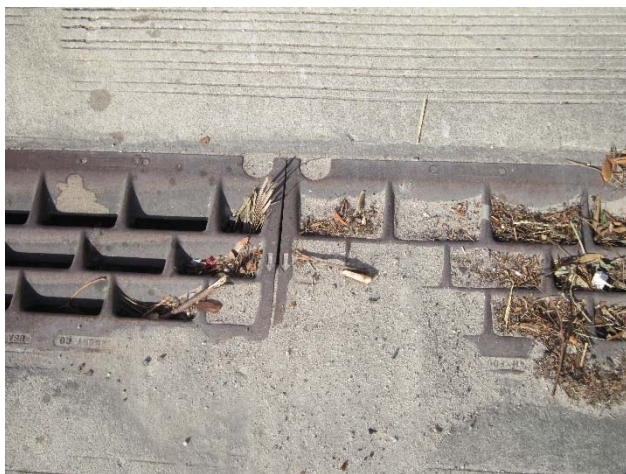
Bridge observations included spalled delaminated abutment joints, undermining at adjacent sidewalks, clogged drainage inlets, and missing/ disconnected pier downspouts

Figure 7 Obstructed bridge deck inlet SR 414 viaduct

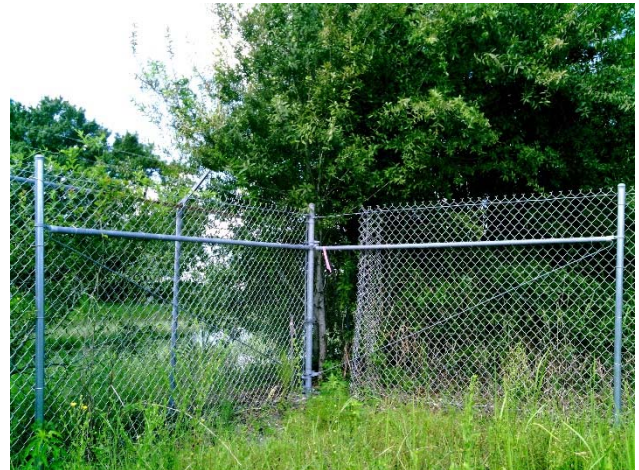
Notable fence observations included inoperable gates under the Viaduct, damaged and or

vegetation covered ROW fence along the corridor.

Figure 8 Damaged ROW fence SR 414 viaduct pond

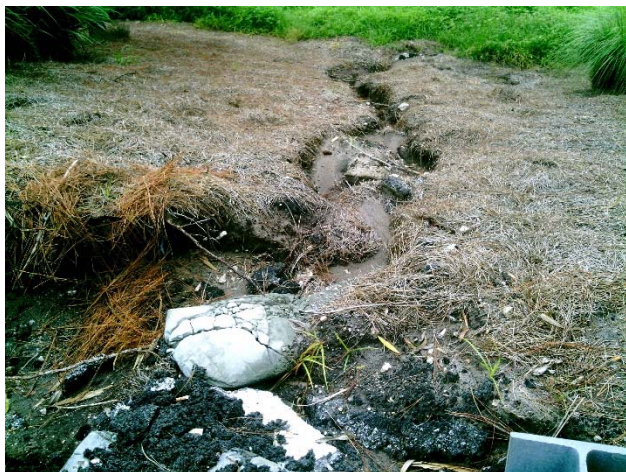
Drainage structure obstructions and roadside erosion were observed at various locations throughout the roadway without any concentration in any specific area.

Figure 10 SR 417/John Young Parkway roadside erosion

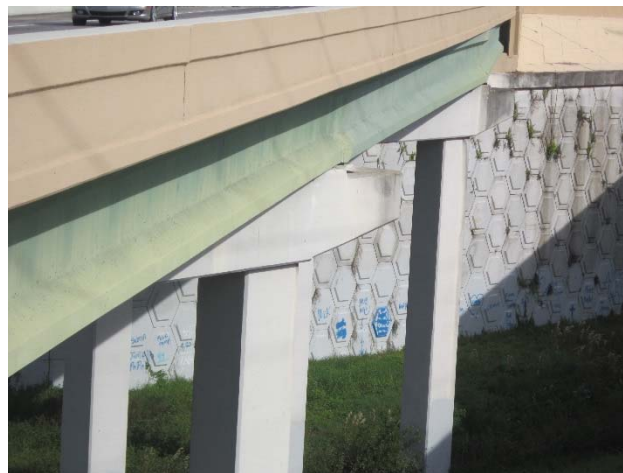
Graffiti and intermittent spalling was identified on the wall and deck of the bridge over the railroad.

Figure 11 Graffiti at SR 417 bridge over railroad

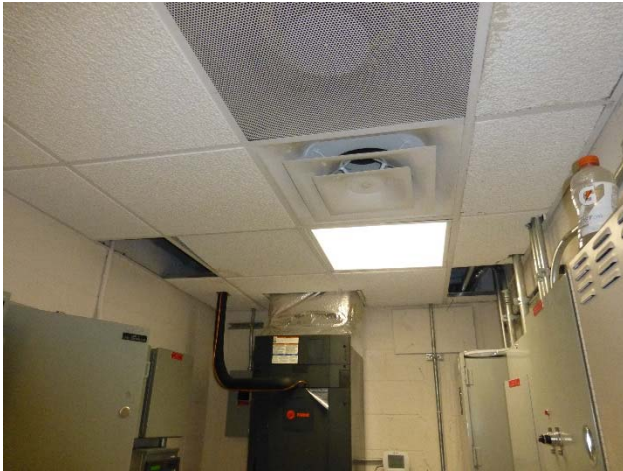
Figure 12 Missing ceiling tiles SR 417 University Ramp Plaza

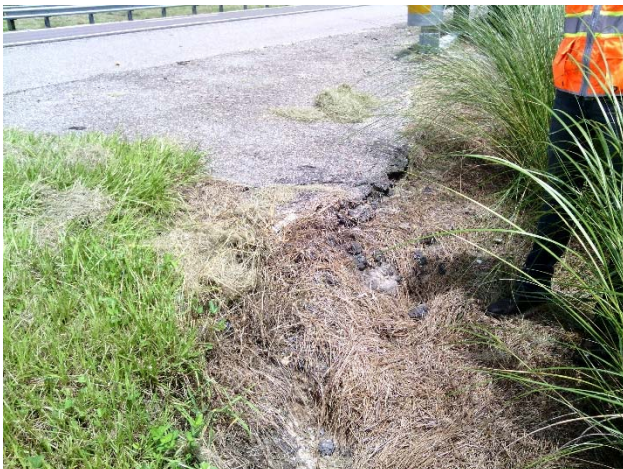
Roadside erosion was observed on slopes and swales in various locations on the roadway with the heaviest concentration from Schofield to Tiny Road.

Figure 13 Roadside erosion northbound SR 429 at Franklin Street

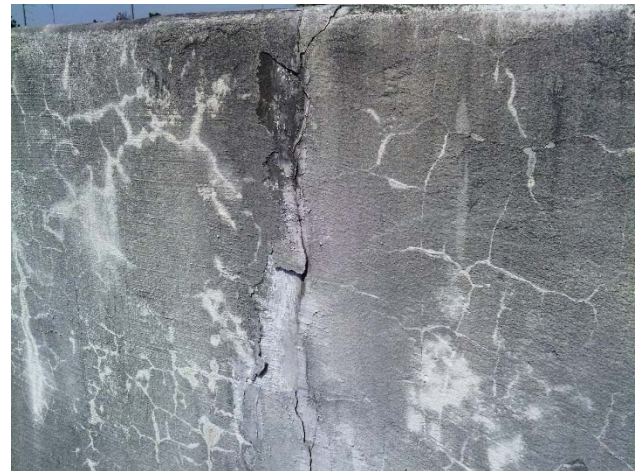
Barrier wall spalling and minor cracking was observed on the median barrier walls at the Forest Lake Mainline Plaza.

Figure 14 Barrier wall spalling SR 429 Forest Lake Mainline Plaza median

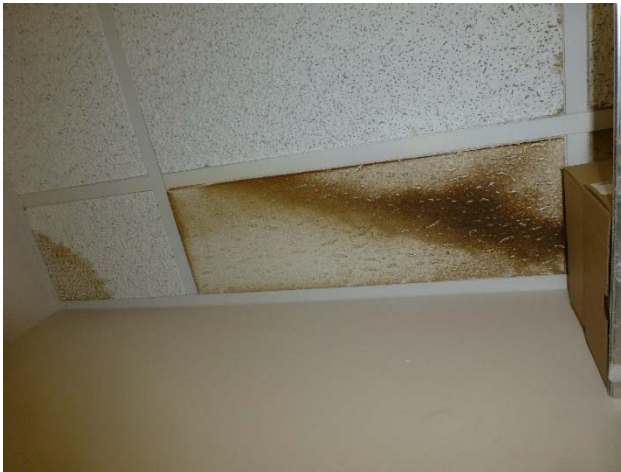
Observations for various features in the facilities along SR 429 were typically for wiring, switchboards and breakers, receptacles, duct work, ceiling tiles, vents, and flooring.

Figure 15 Damaged ceiling tiles SR 429 Forest Lake Mainline Plaza

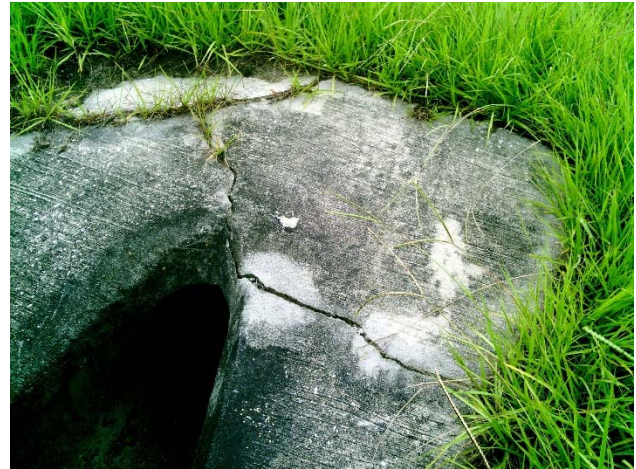
SR 451 roadway observations consisted of drainage structure with moderate spalling and minor cracking.

Figure 16 Cracked drainage structure at SR 429 Pond

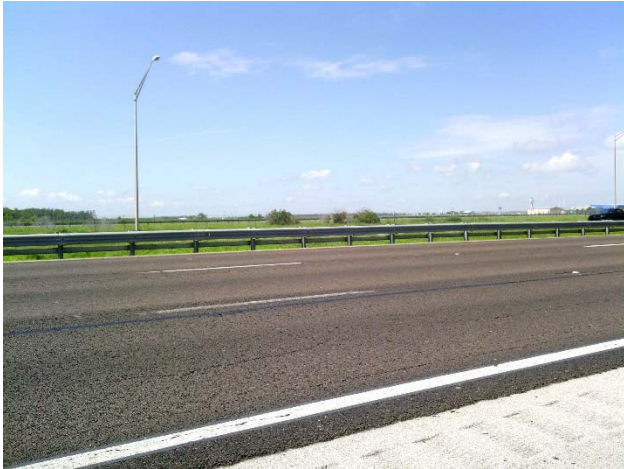
Faded pavement markings were observed throughout the 528 with the most concentrated area at SR 520 to Dallas Boulevard.

Figure 17 Faded pavement markings SR 528 adjacent to the airport

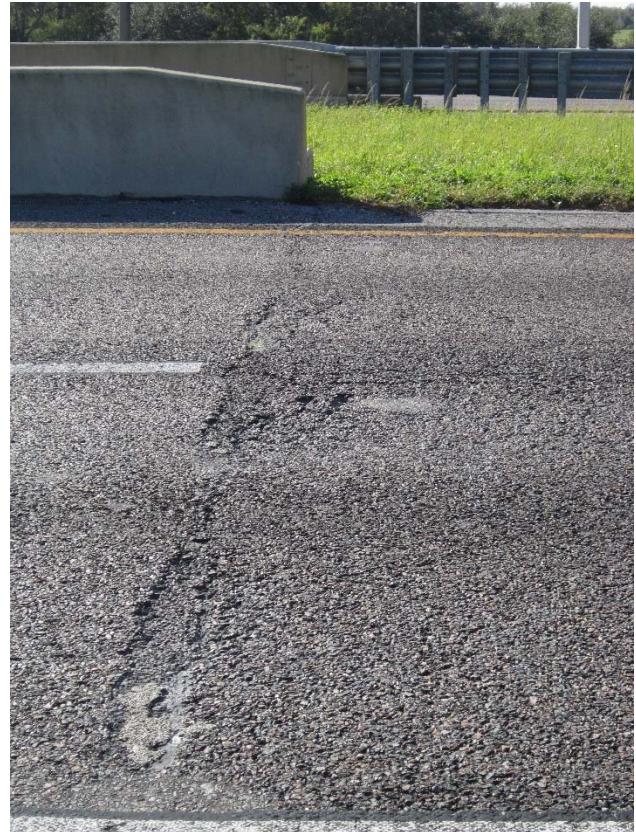
Raveling asphalt and unsealed transvers cracks were observed on the Dallas Road bridge, with the raveling asphalt occurring in lanes one and two.

Figure 18 Raveling asphalt SR 528 Dallas Road Bridge

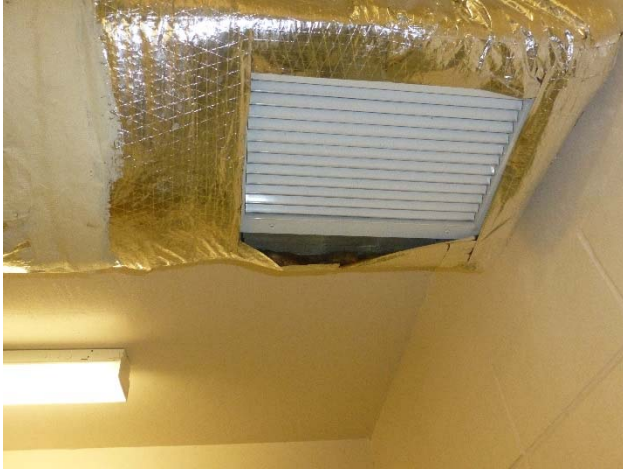
Figure 19 Minor duct repair needed SR 528 Dallas Boulevard On-Ramp Plaza

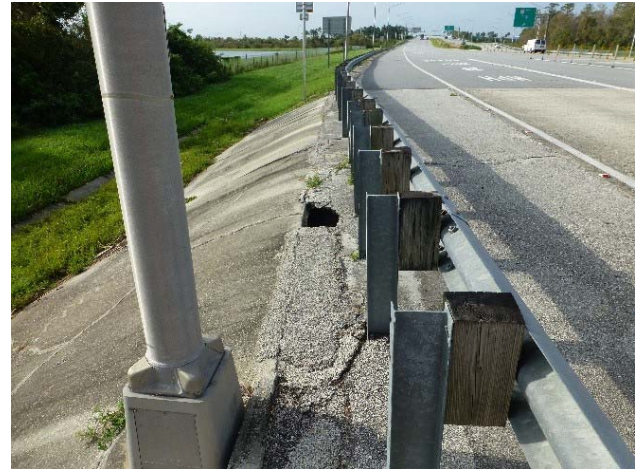
A large depression/hole was observed in the miscellaneous asphalt against the guardrail along slope pavement just northbound, just south of the Goldenrod Mainline Plaza.

Figure 20 Depression along slope pavement at Goldenrod Mainline Plaza

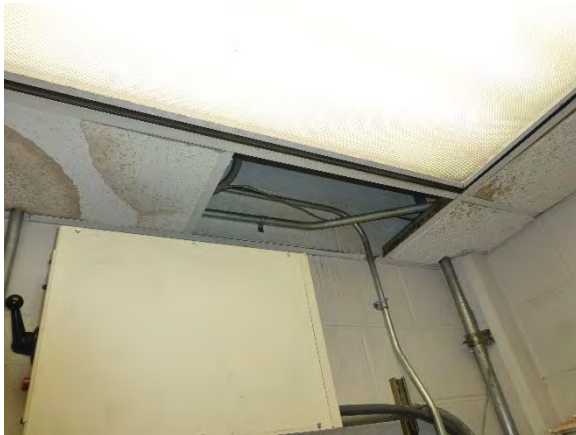
Figure 9 John Young Parkway Ramp On Missing Ceiling Tile
