2018

# Annual Inspection Report

Re: 2018 Annual Inspection Report

2018 Annual Inspection Report  
CENTRAL FLORIDA EXPRESSWAY AUTHORITY

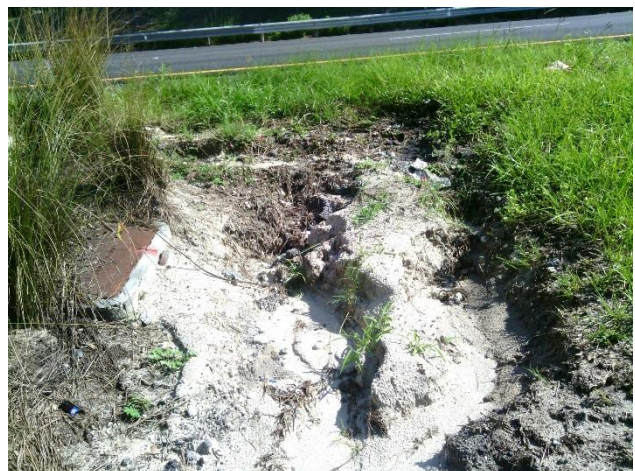
**Figure 3** Roadside erosion east of Pine Hills Road.

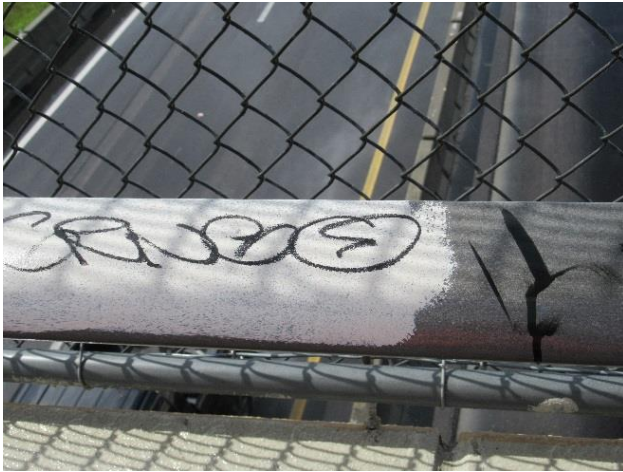
Expansion joints exhibiting spalls and adhesion loss were present at Kirkman Road. Graffiti was observed on the pedestrian railing at Dean Road. Rusting connections for fencing and screening were observed at Dean Road.

**Figure 4** Graffiti on SR 408 Dean Road Bridge

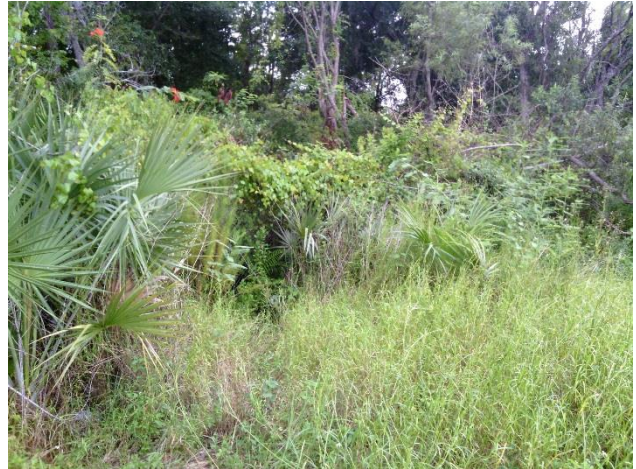
Overgrown fence observations for both ROW and retaining wall were noted at various locations including, SR 50 / Colonial and Woodbury Road.

**Figure 5** Overgrown ROW fence line SR 408 near Woodbury Road.

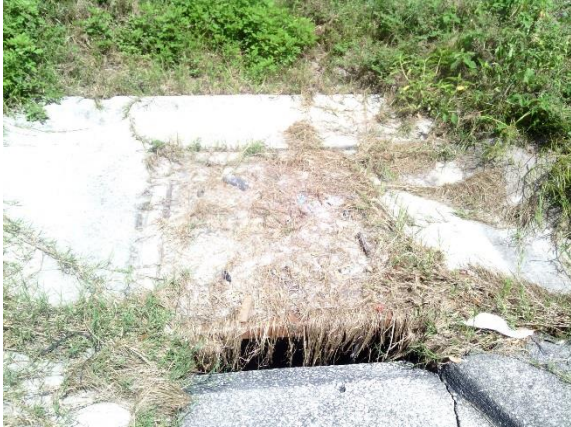
Various drainage structures with varying degrees of obstruction and washout were observed along SR 414 including the pond

behind the Coral Hills Mainline Toll Plaza and the concrete flume west of Lakeville Road.

**Figure 6** Obstructed drainage / flume structure at SR 414 south of Lakeville Road.

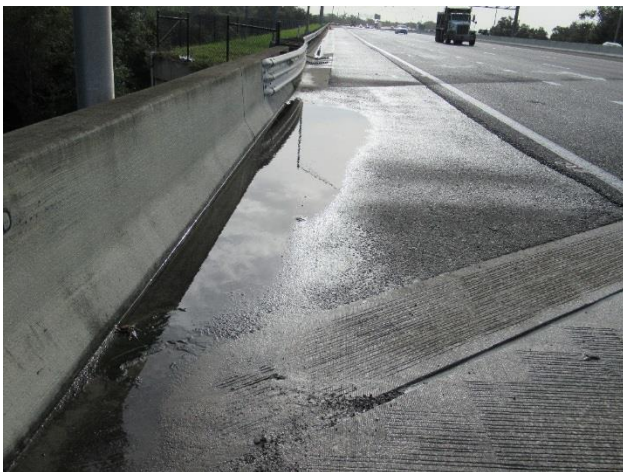
Ponding water was observed on the south side of the SR 414 bridge over CR 435. Ponding water was limited to the area adjacent to the traffic railing.

**Figure 7** Ponding water on SR 414 Bridge over CR 435.

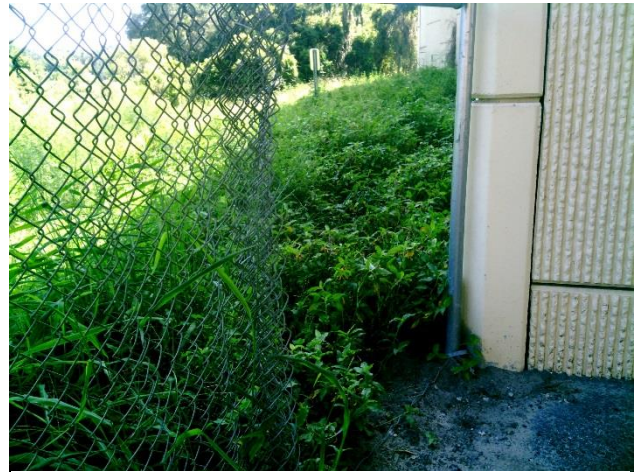
Notable fence observations included inoperable or missing gate locks at SR 441, damaged and or vegetation covered ROW fence along the corridor.

**Figure 8** Damaged ROW fence SR 414 bridge abutment (later repaired).

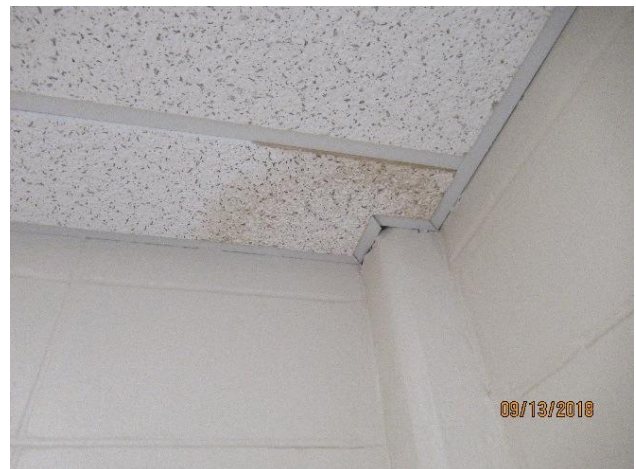
**Figure 9** Damaged ceiling tile Coral Hills Mainline IT room.

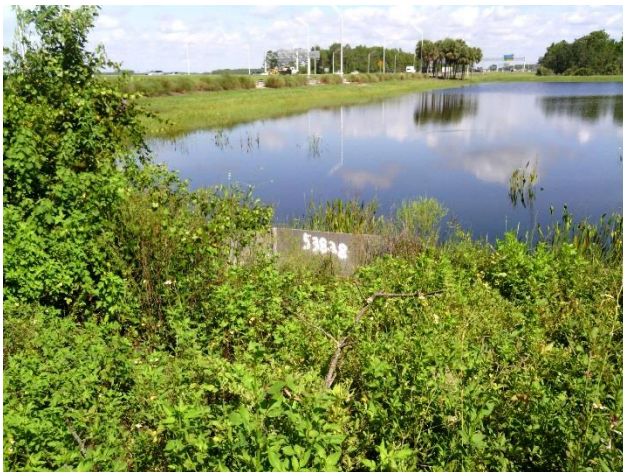
**Figure 10** Overgrown structure in pond east of SR 528.

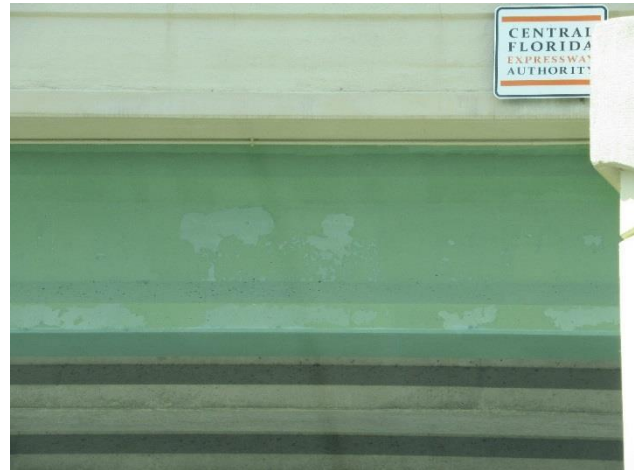
Bridge observations included overgrown vegetation in and along drainage flumes and slope pavement, bridge coatings that were peeling and fading on walls and beams and intermittent asphalt spalling and expansion joint tearing.

**Figure 11** Peeling beam coating Lee Vista Boulevard.

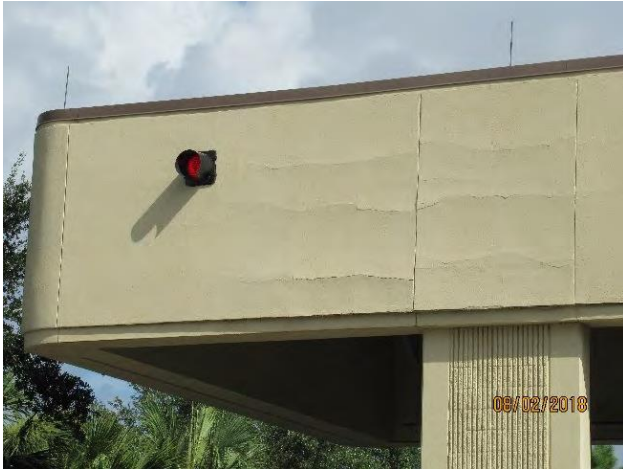
**Figure 12** Building façade damage SR 417 Lee Vista on ramp (isolated occurrence).

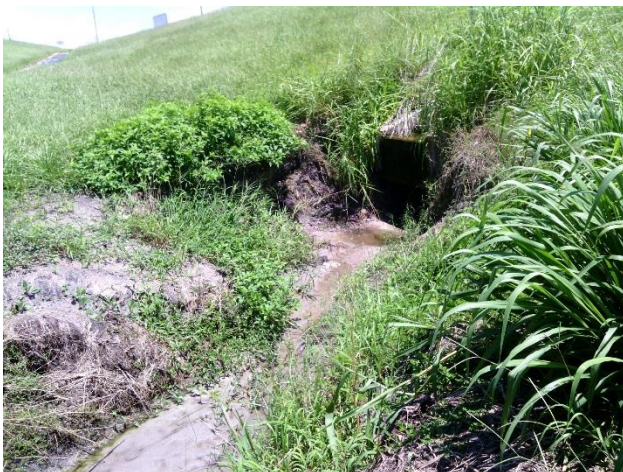
**Figure 13** Drainage structure erosion southbound SR 429 at Franklin Street

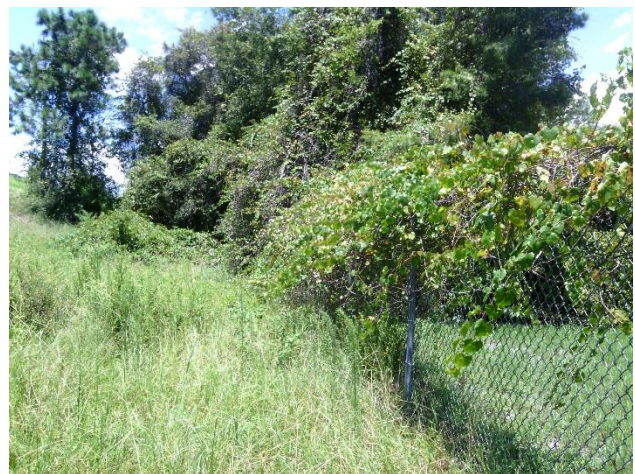
**Figure 14** Overgrown ROW fence line SR 429 south of Forest Lake Mainline Plaza.

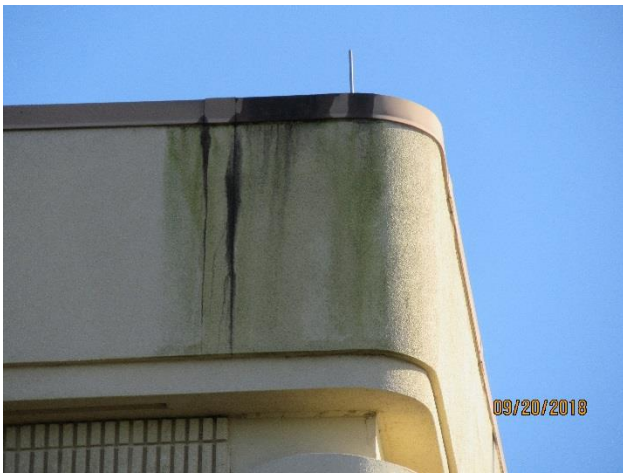
**Figure 15** Mold growing on parapet of SR 429 New Independence Plaza.

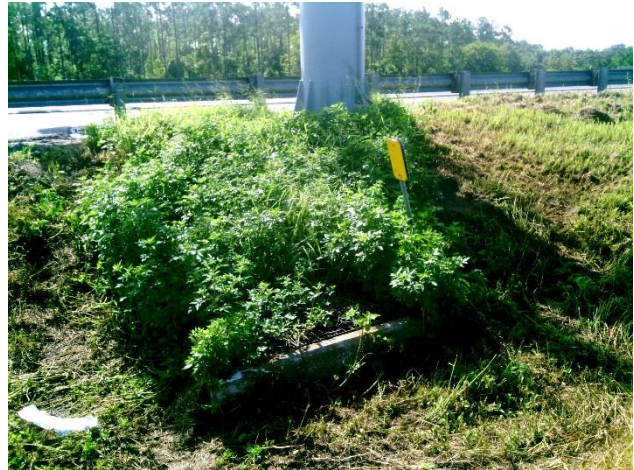
Drainage structure observations were concentrated from SR 414 to Johns Road.

**Figure 16** Overgrown drainage structure south of Johns Road.

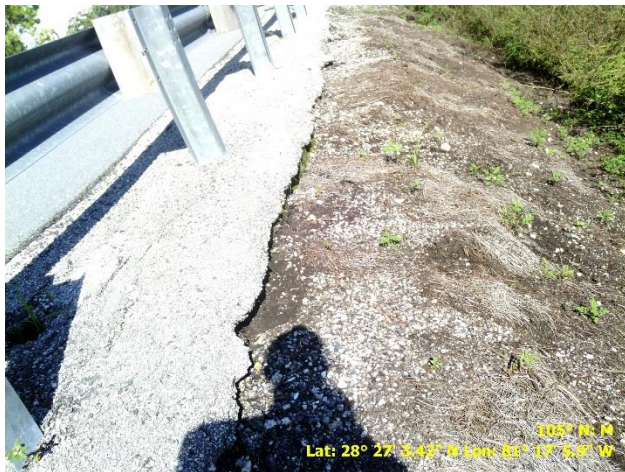
**Figure 17** Roadside erosion adjacent to SR 528 east of Beachline Main.

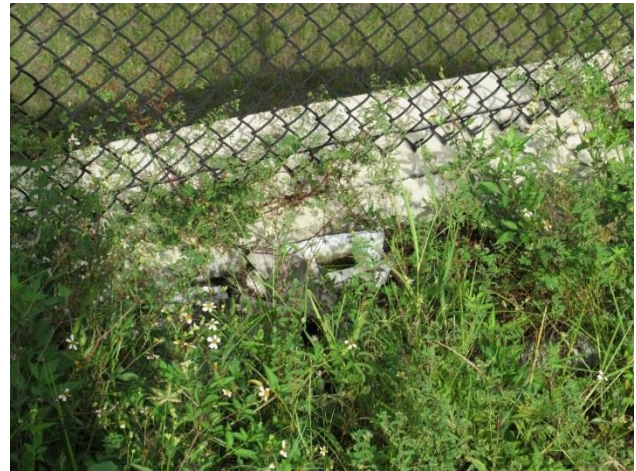
Overgrown wall gutters were observed at Daetwyler Road.

**Figure 18** Overgrown wall gutter at SR 528 and Daetwyler Road.

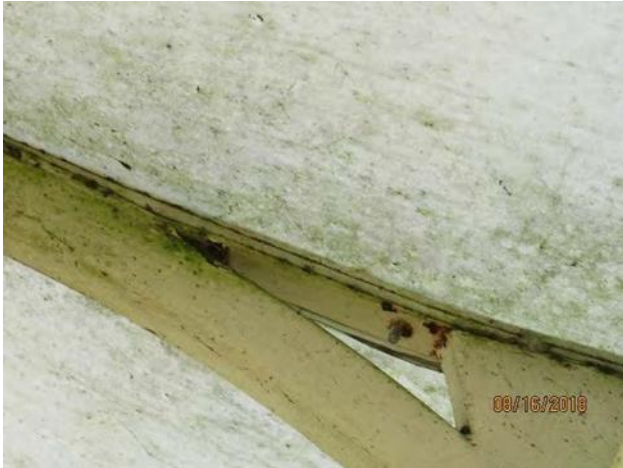
**Figure 19** Mold and mildew on canopy of Dallas Mainline Plaza pedestrian bridge.

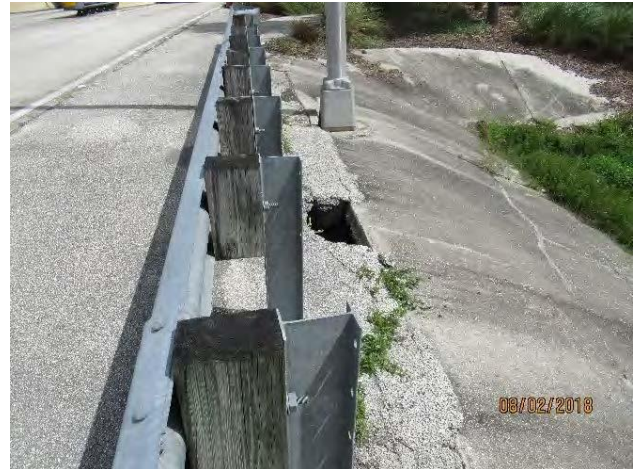
A large depression / hole was observed in the miscellaneous asphalt against the guardrail along slope pavement just northbound, just south of the Goldenrod Mainline Plaza.

**Figure 20** Depression along slope pavement at Goldenrod Mainline Plaza.
