# 2019

# Annual Inspection Report

Mr. Glenn Pressimone, P.E.  
Chief of Infrastructure  
Central Florida Expressway Authority  
4974 ORL Tower Road  
Orlando, Florida 32807

Re: 2019 Annual Inspection Report

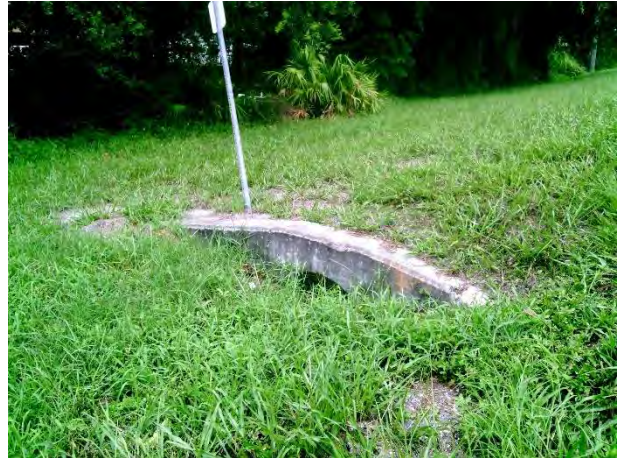
Figure 3: Drainage Structure west of John Young Parkway.

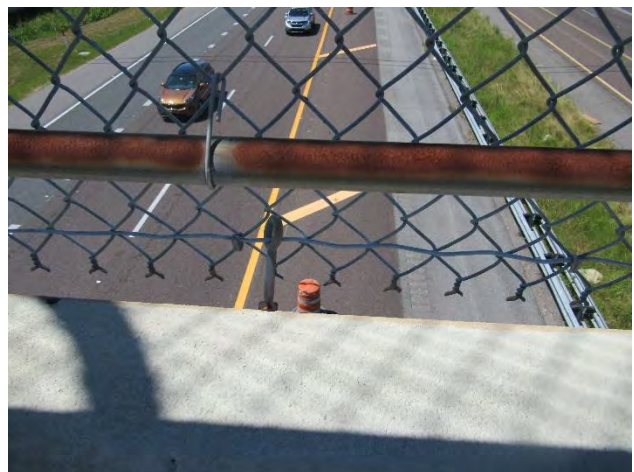
Asphalt cracking at an approach slab was present at Powers Drive. Graffiti was observed on the pedestrian railing at Econlockhatchee Trail. Rusting connections for fencing and screening were also observed at Econlockhatchee Trail.

Figure 4: Fence corrosion Econlockhatchee Trail Bridge.

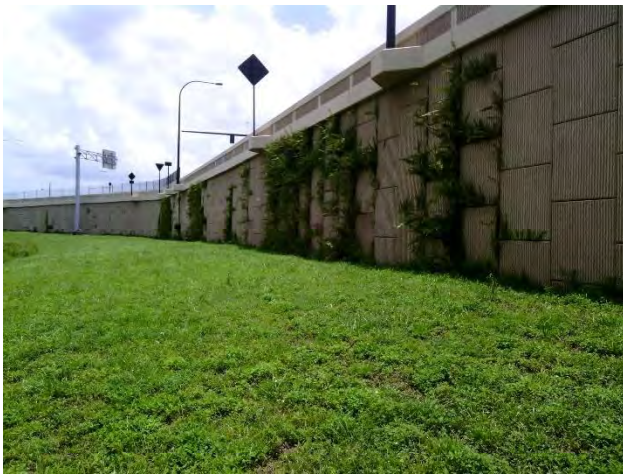
**Figure 5:** MSE Vegetation Westbound on Ramp Chickasaw Trail.

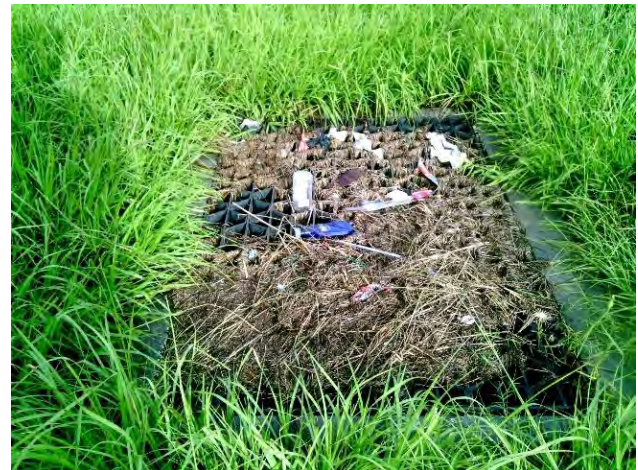
Obstructed and overgrown drainage structures were observed throughout the roadway without a concentration in any specific area.

**Figure 6:** Obstructed drainage structure at SR 414 east of Ocoee Apopka Road.

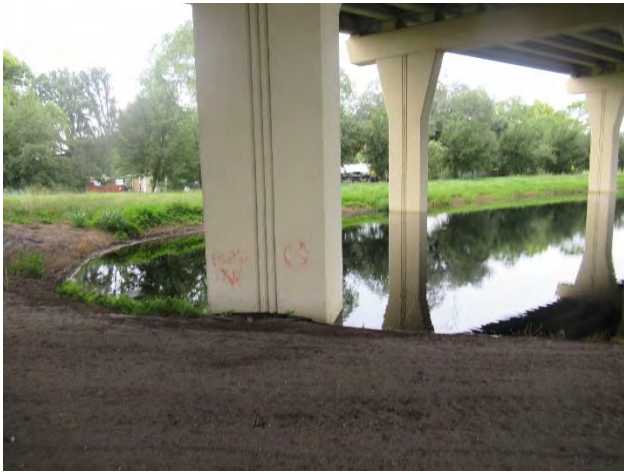
Observations of adhesion loss in joints, graffiti, and corroded junction box covers were present on the bridge over Overland Road.

**Figure 7:** Bridge pier graffiti over Overland Road.

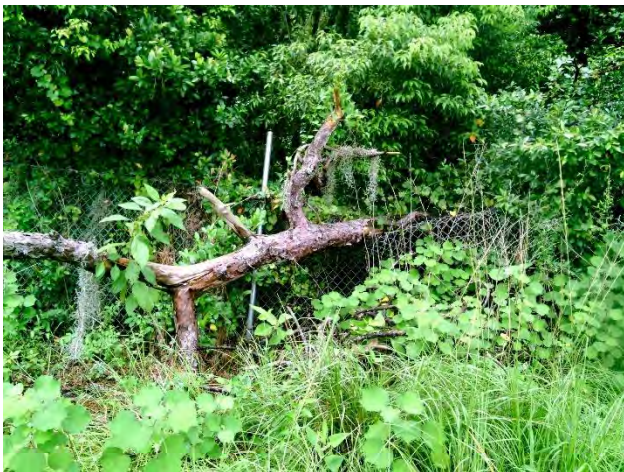
**Figure 8:** Damaged ROW fence on SR 414 dry pond at Hiawassee Road.

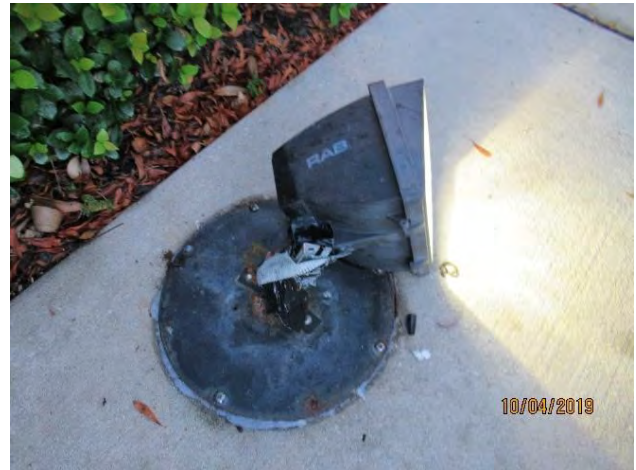
**Figure 9:** Broken flag pole luminaire at Coral Hills Mainline Plaza.

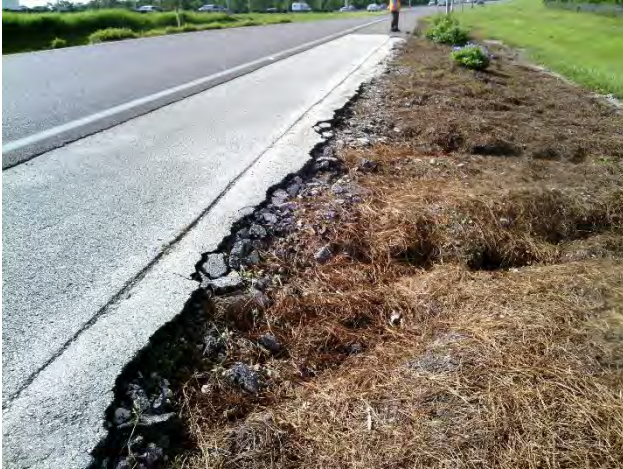
Erosion adjacent to the miscellaneous asphalt behind guardrail was observed from Lee Vista Boulevard to the SR 528 Interchange.

**Figure 10:** SR 417 Erosion along lane edge (Lee Vista Boulevard Southbound on Ramp).

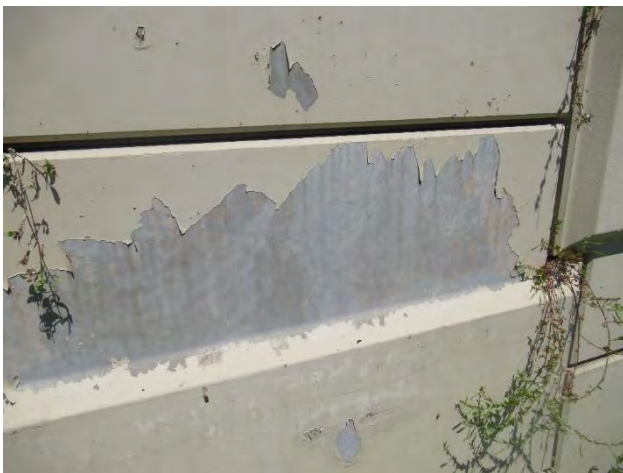
Vegetation in and along drainage flumes and MSE wall coating peeling was observed at SR 417 and SR 50. Vegetation growing from MSE wall coping was observed at SR 417 and John Young Parkway.

**Figure 11:** SR 417 over SR 50 MSE wall coating failing.

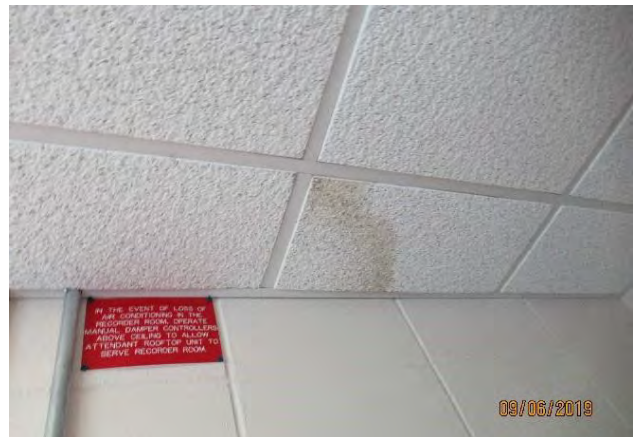
**Figure 12:** SR 417 Moss Park on Ramp damaged sealing tile.

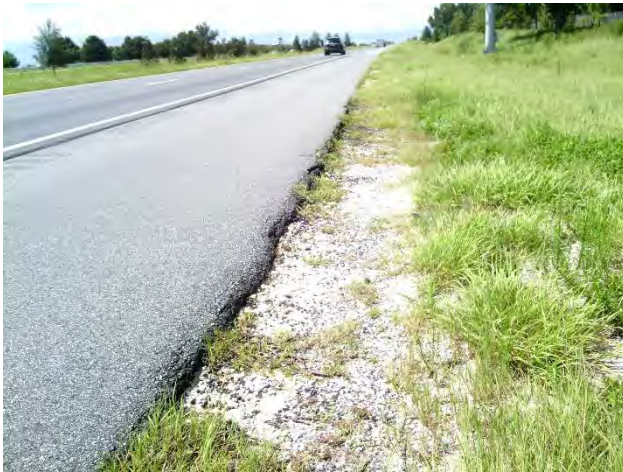
**Figure 13:** SR 429 minor erosion northbound east of Kelly Park Road.

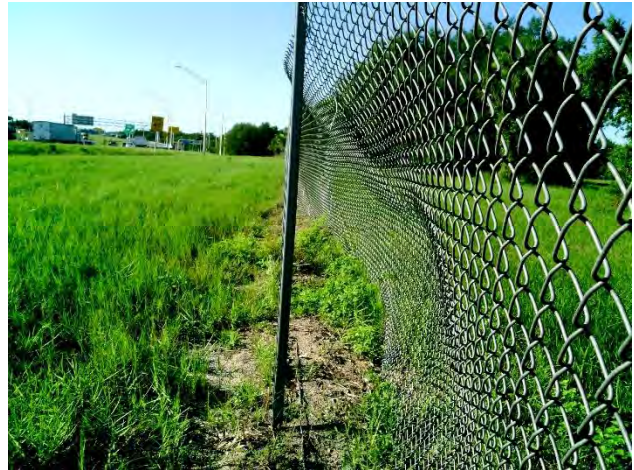
**Figure 14:** SR 429 fence fabric missing ties.

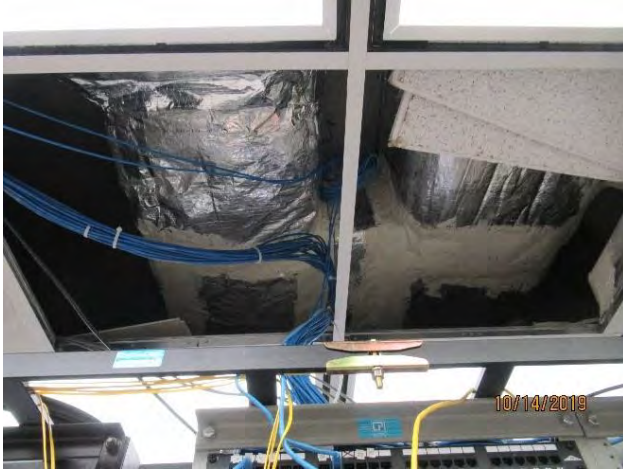
**Figure 15:** Independence Mainline IT room missing ceiling tiles.

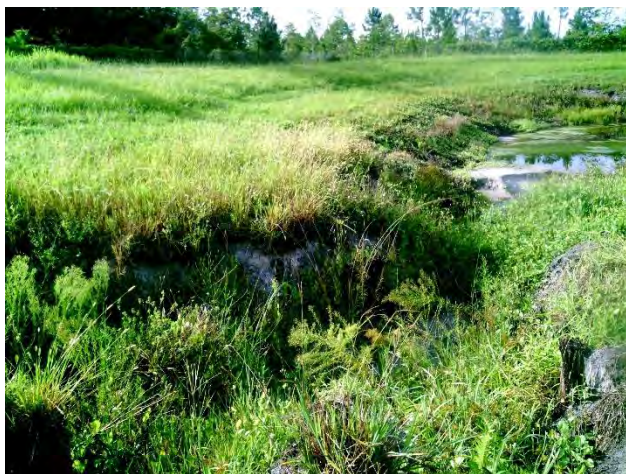
**Figure 17:** SR 528 slope erosion at pond east of SR 417.

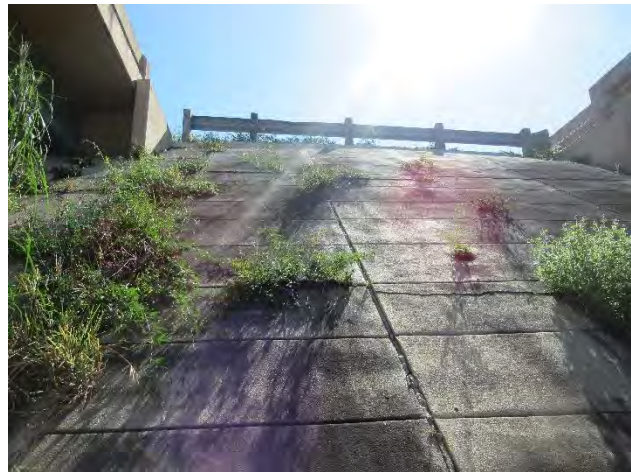
Ponding on shoulder and vegetation in concrete slope pavement was observed at the Dallas Boulevard Bridge.

**Figure 18:** SR 528 over Dallas Boulevard overgrown slope pavement.

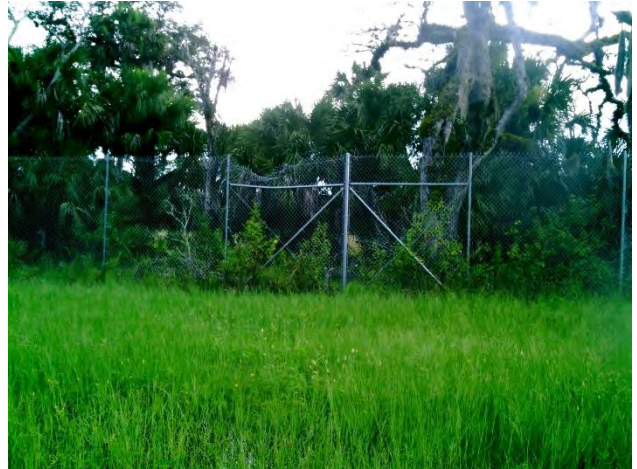
Minor fence damage from fallen trees was observed in one place along the corridor.

**Figure 21:** SR 538 (Poinciana Parkway) damaged fence.

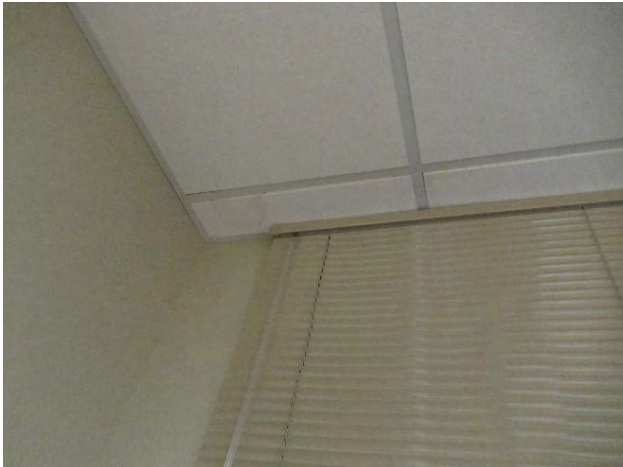
Minor interior deficiencies included areas of damaged drywall, window caulking degradation, and isolated appearances of leaking above the ceiling tiles.

**Figure 22:** CFX Headquarters Second Floor Room 211 damaged ceiling tile.

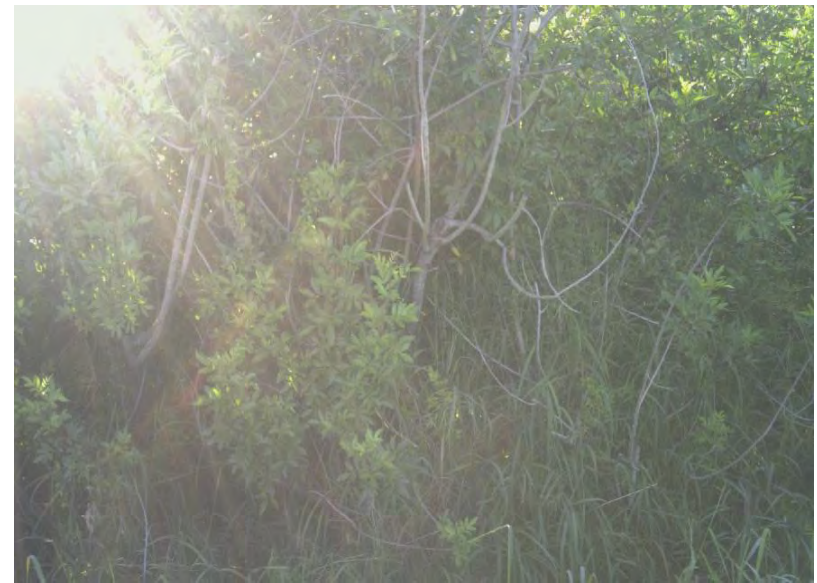
- Left Structure heavy vegetation. Right Structure beyond fence line
- Could not inspect Right structure
- Damage to fence

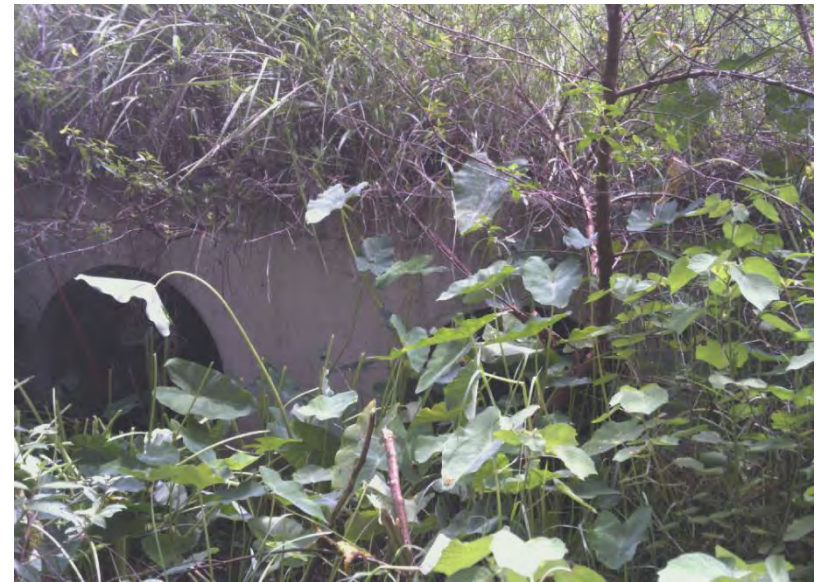
- Heavy vegetation surrounding structures
- 24" of sediment observed in 42" pipes

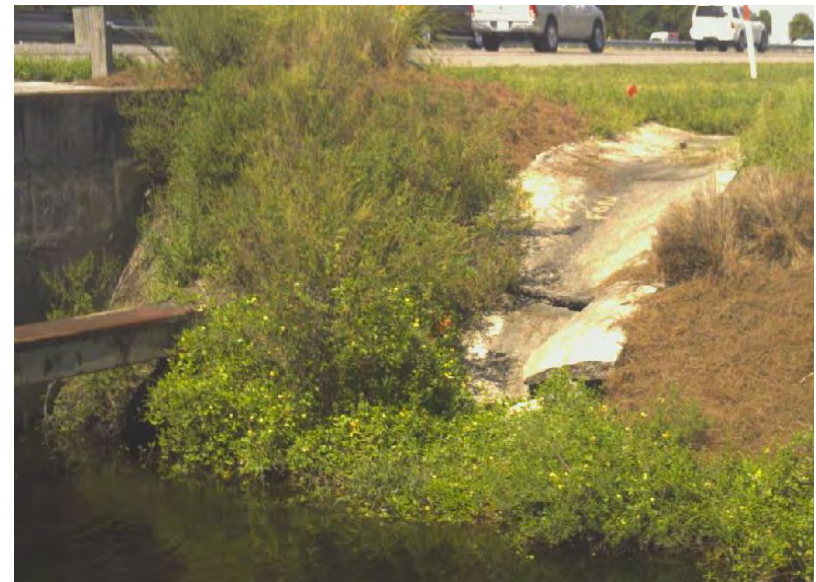
- Concrete flume near Right end damaged
- 6" of scour on Right structure

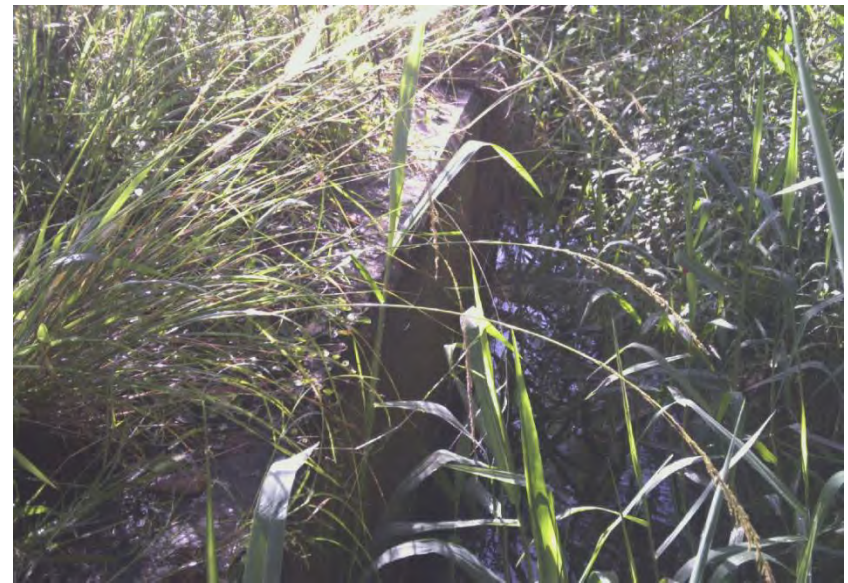
- Right structure covered in heavy vegetation, structure not observed

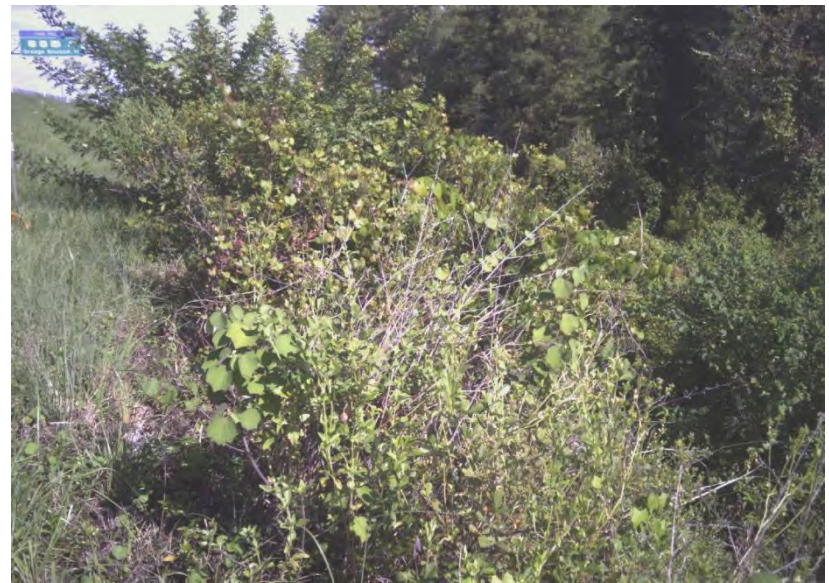
- Left structure covered in heavy vegetation, structure not observed
- Left structure: 13" of sediment observed in 84" pipe

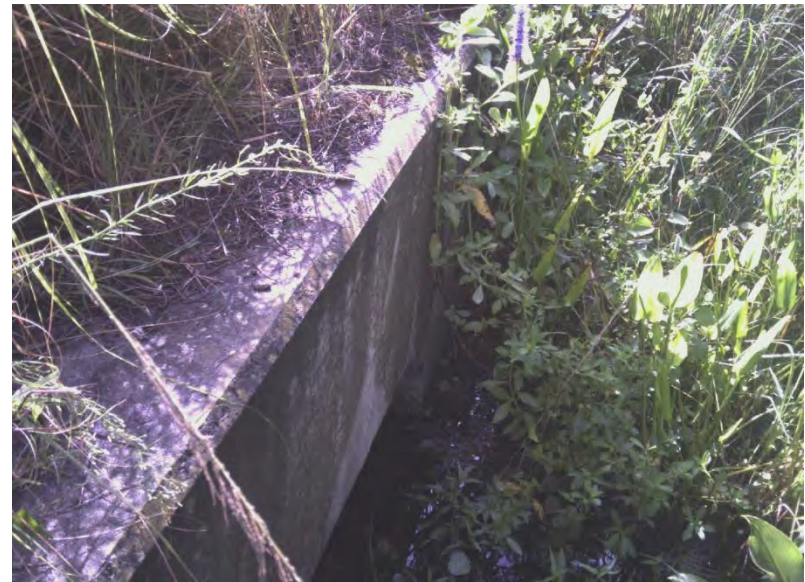
- Up to 16" of sediment observed in 8' x 3' CBC
- Moderate vegetation around culvert openings

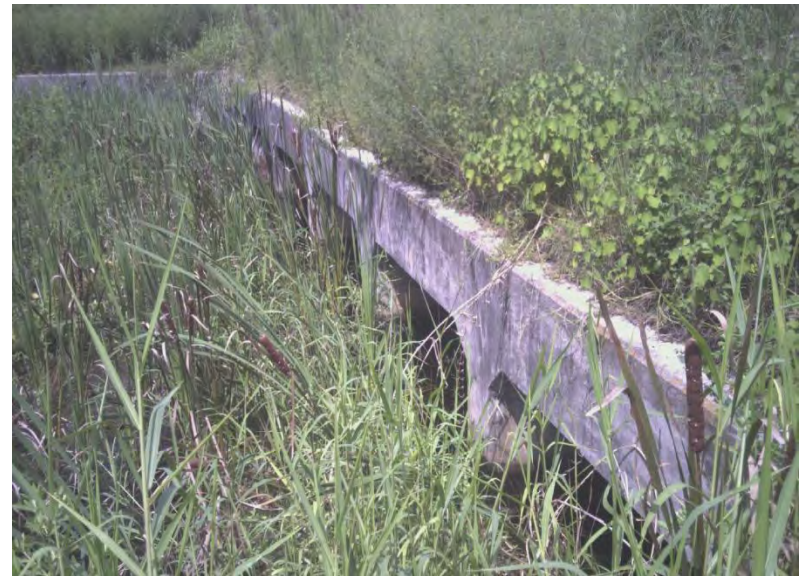
- 6" Sediment observed end of Right structure

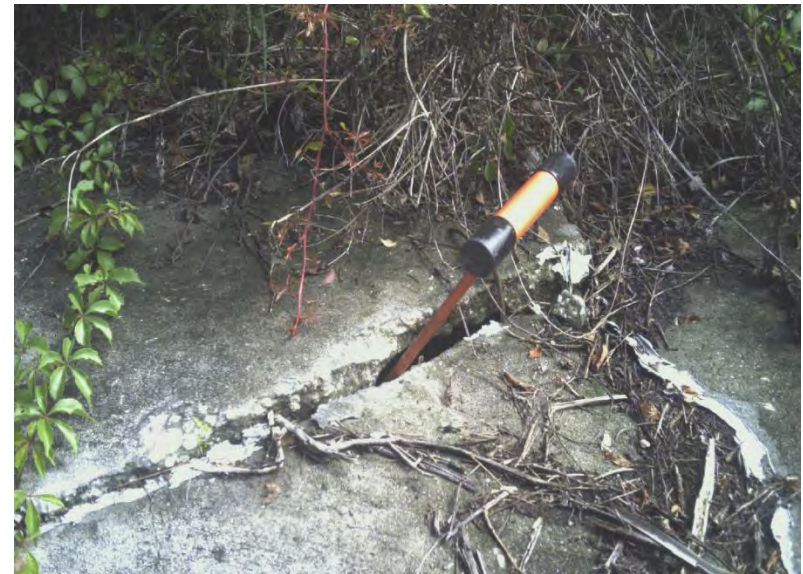
- Piles of sediment up to 8" in depth
- Cracking in concrete around opening- 36" deep
