2020

Annual Inspection Report

Appendix 3: SR 408

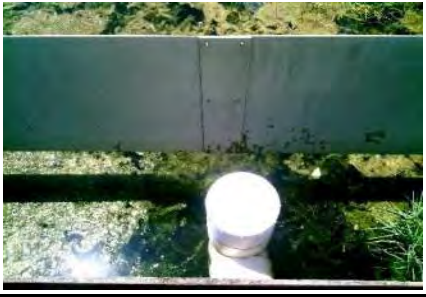
Drainage	Drainage Structure	2	no orifice - pond not draining	21
31

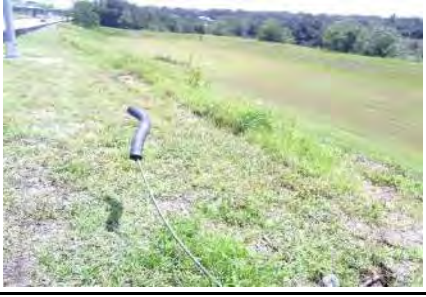
Drainage	Rip Rap	3	fabric rip rap damaged	27
33

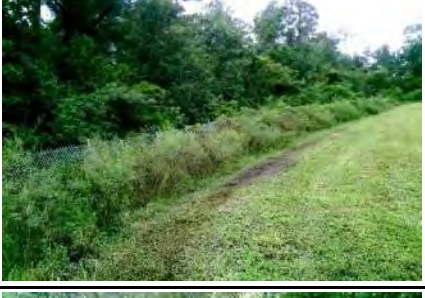
Roadside	Fence	3	fence damaged	23
51

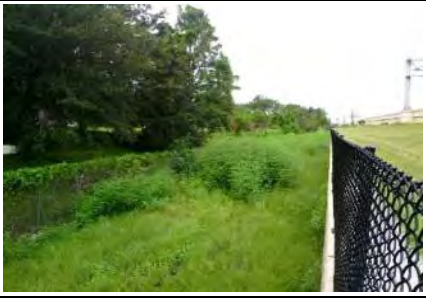
Roadside	Fence	3	overgrown vegetation	27
55

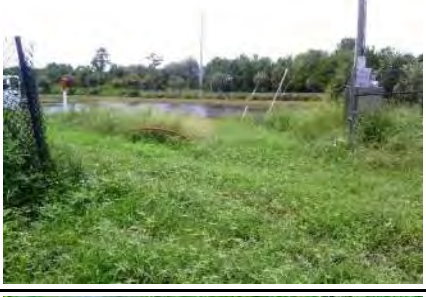
Roadside	Fence	1	fence gap leading to road/post damaged	31
57

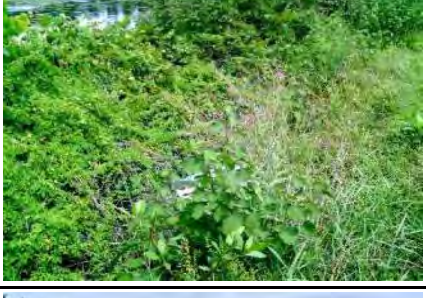
Roadside	Fence	2	fence leaning / overgrown vegetation on fence	29
58

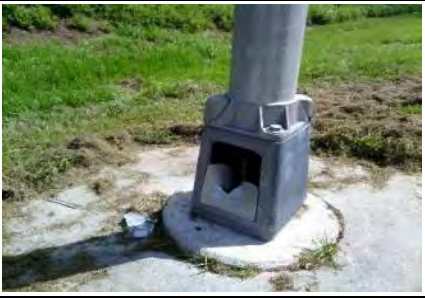
Roadside	Lighting	2	hand hole cover broken	3
85	 	Roadside	Erosion	3	erosion around light pole apron	2
86

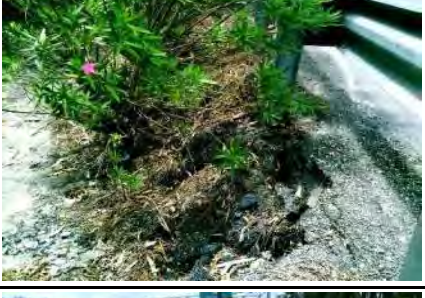
Roadside	Erosion	1	miscellaneous asphalt undermined	3
88

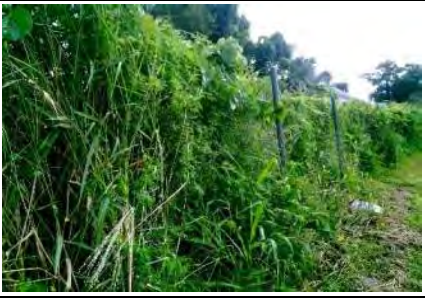
Roadside	Fence	2	overgrown vegetation on fence / posts damaged	9
91

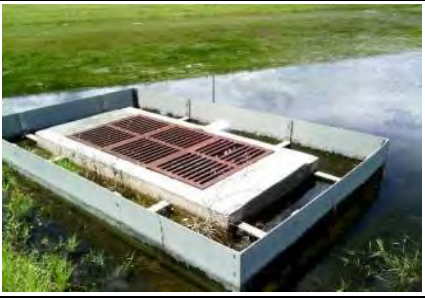
Drainage	Drainage Structure	3	grate damaged	24
49

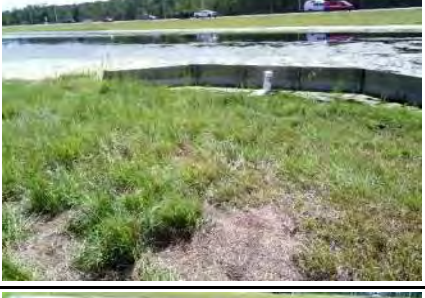
Drainage	Drainage Structure	3	not draining pond	26
52

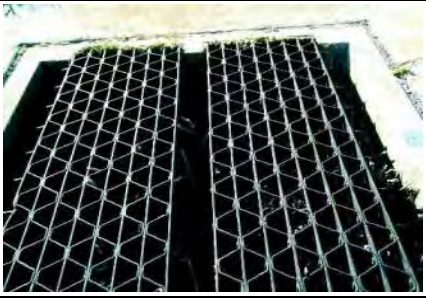
Drainage	Drainage Structure	3	dbi filled with debris	24
55

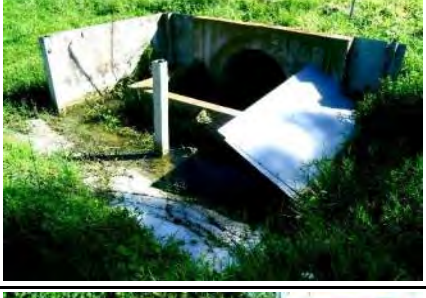
Drainage	Drainage Structure	2	skimmer broken / control structure non functional	28
58

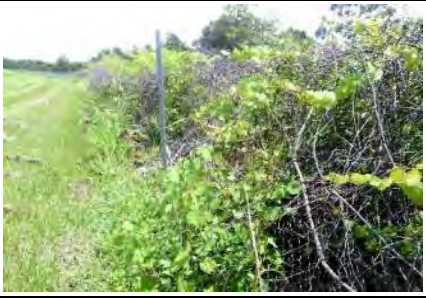
Roadside	Fence	2	fence posts damaged at multiple areas	20
127	 	Roadside	Fence	3	fence leaning due to overgrown vegetation	21
128

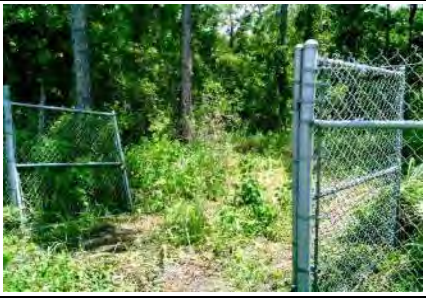
Other Issue	Other	2	gate in row fence post damaged	21
223

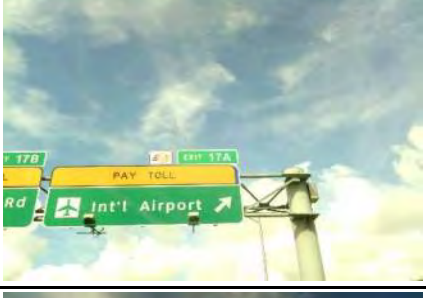
Other Issue	Other	3	sign panel - yellow reflector missing all along pay toll message	17
226

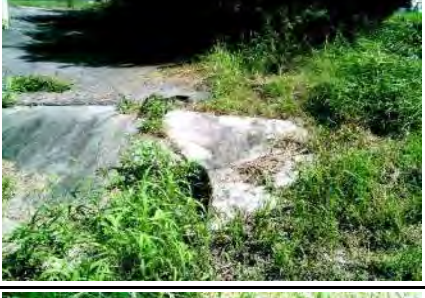
Drainage	Drainage Structure	3	cracking /maintenance	25
D161

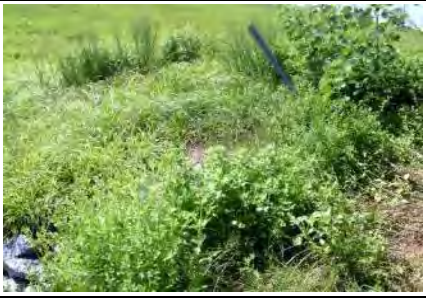
Drainage	Drainage Structure	3	maintenance around mes / marker damaged	32
D164

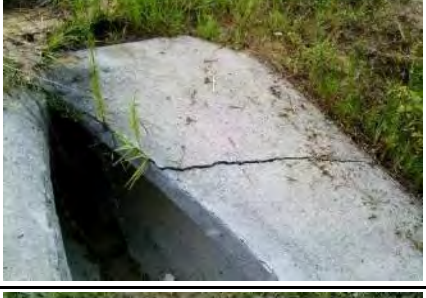
Drainage	Drainage Structure	3	mes damaged	35
D167

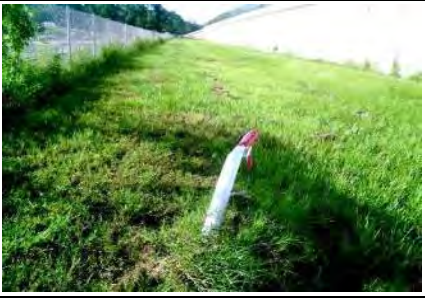
Other Issue		3	marker hit	28
OI29

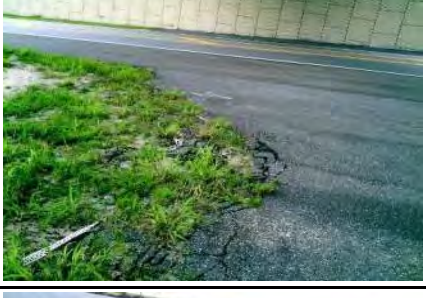
Pavement	Other	2	eroded away	4
P7

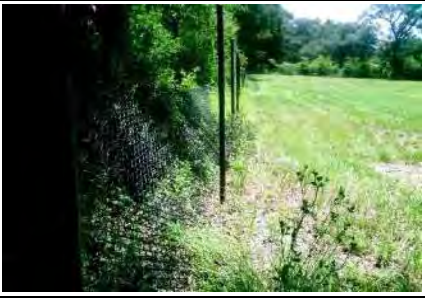
Roadway	Fence	1	fence downed / missing	37
R16

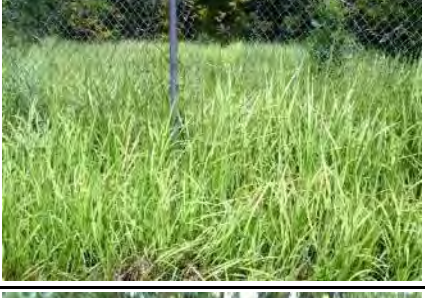
Roadway	Fence	1	fence cut open	20
R19

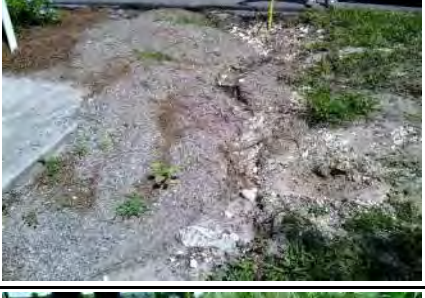
Roadway	Erosion	2	erosion by the shoulder / 9 inch dropoff	9
R55

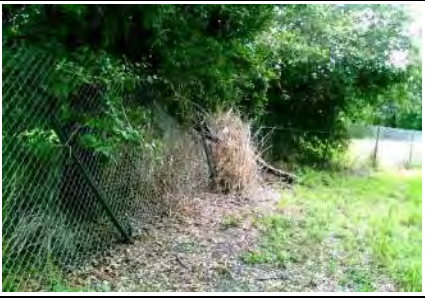
Roadway	Fence	2	damaged	14
R64

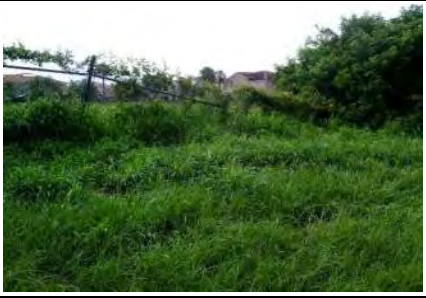
Roadway	Fence	2	fence damaged vegetation overgrown	12
R70

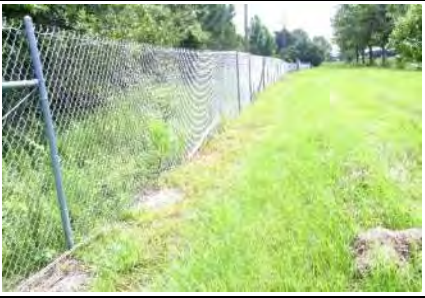
Roadway	Fence	3	fence posts damaged	13
R172

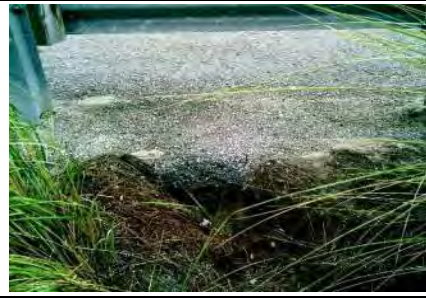
Roadway	Erosion	3	erosion	15
R178

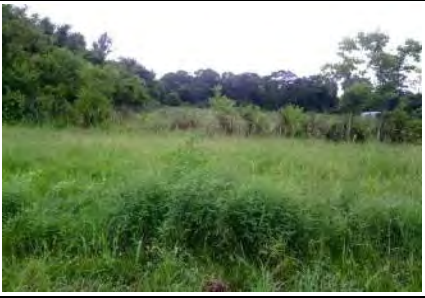
Roadway	Fence	3	fence post missing	21
R196
