2020

Annual Inspection Report

Re: 2020 Annual Inspection Report

2020 Annual Inspection Report
CENTRAL FLORIDA EXPRESSWAY AUTHORITY

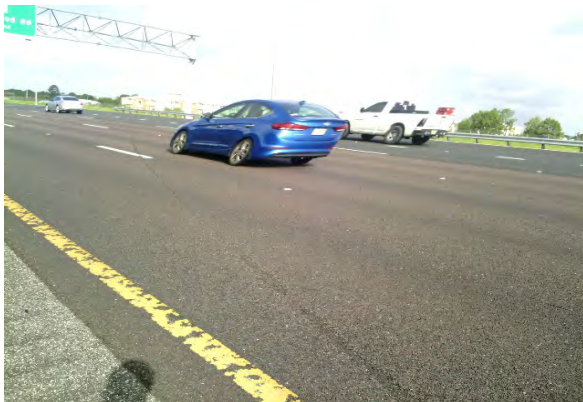
Clusters of observations were located along SR 408 at Kirkman Road, just east of Chickasaw Trail, and at the east SR 50 interchange. The observations included erosion and obstructed or overgrown drainage structures, and pavement marking degradation. Pavement marking degradation was prevalent along the mainline just east of Chickasaw Trail.

Figure 3: Pavement Marking Degradation east of Chickasaw Trail.

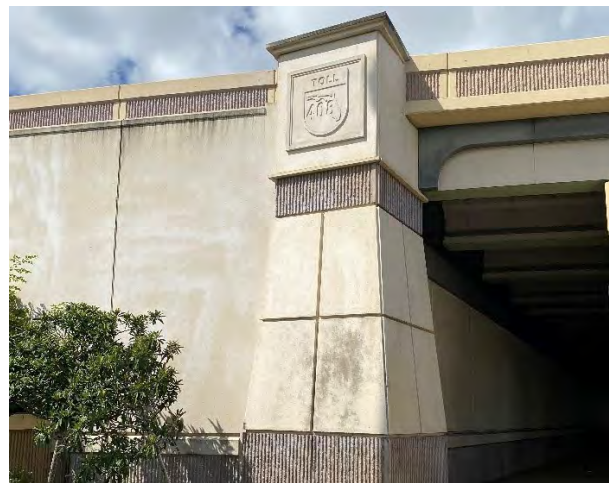
Discoloration of architectural columns and bridge features were observed at the SR 408 overpass of Goldenrod Road.

Figure 4: Discoloration on Architectural Column.

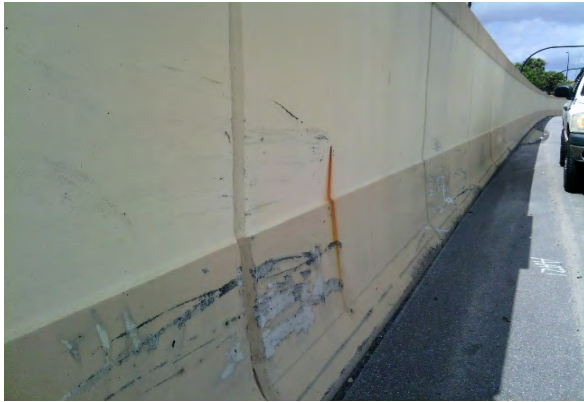
Figure 5: Barrier Wall damage east of Andes Road.

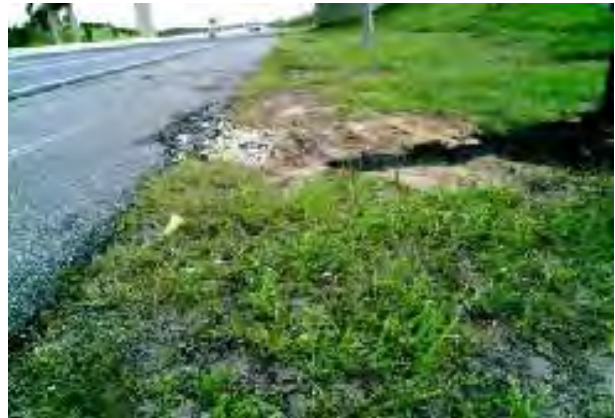
Roadside erosion was observed at the Hiawassee Road and Marden Road interchanges.

Figure 6: Roadside erosion SR 414.

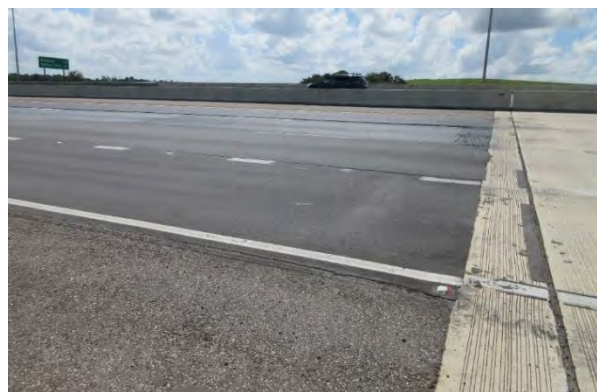
Observations of spalling adjacent to expansion joints was observed at the bridge over the Landfill Service Road.

Figure 7: Spalling at expansion joint SR 414 over Landfill Service Road

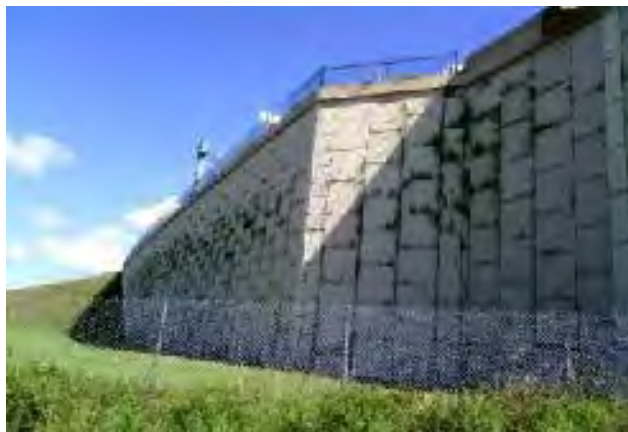
Notable fence observations included damaged and/or vegetation covered ROW fence along the corridor. MSE wall vegetation was observed at the bridge over FGT Gas Service Road.

Figure 8: MSE wall vegetation FGT Gas Access Road.

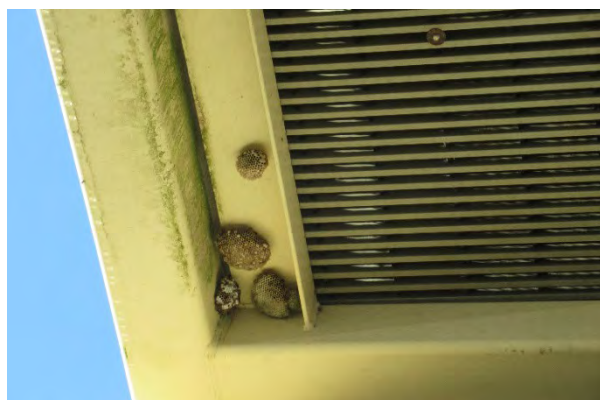
Figure 9: Algae growth and wasp nest at Coral Hills Mainline Plaza.

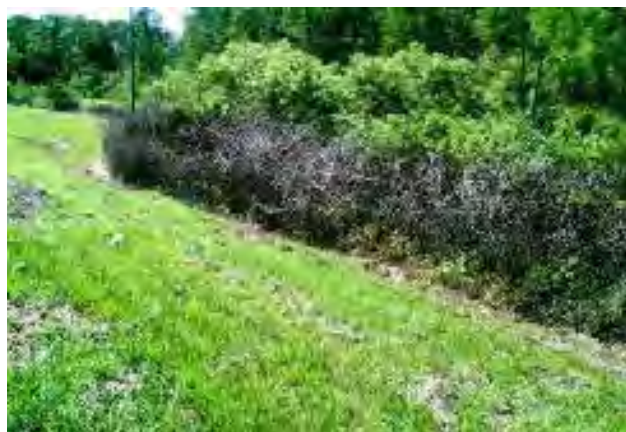
Figure 10: Overgrown fence SR 417 north of I-Drive

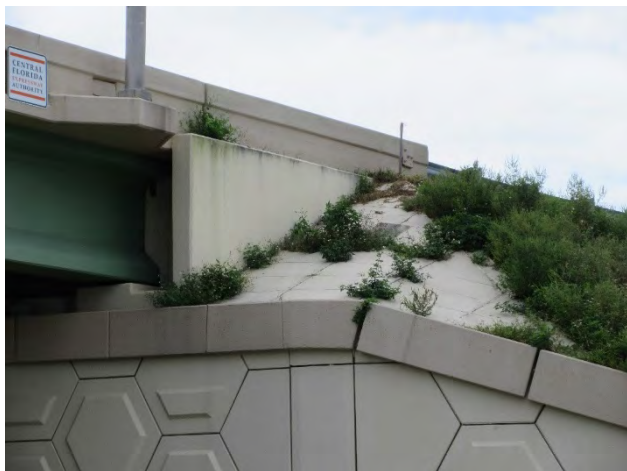
Vegetation on MSE walls and graffiti was observed at the SR 417 bridge over the OUC rail line, while vegetation growing from the slope

pavement was observed at SR 417 and Wyndham Lakes Boulevard.

Figure 11: SR 417 over Wyndham Lakes slope pavement vegetation.

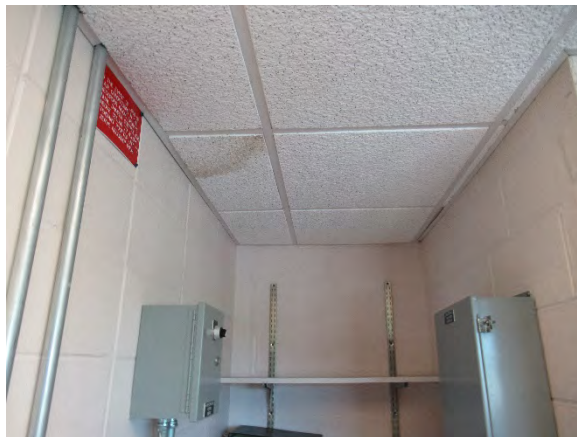
Figure 12: SR 417 Moss Park on ramp stained ceiling tile.

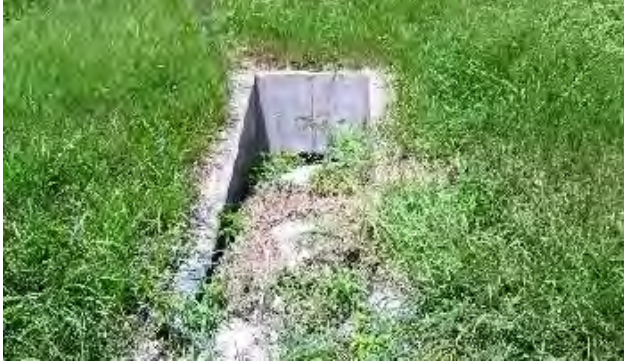
A heavy concentration of drainage structure obstructions was observed at the Franklin Street Interchange.

Figure 13: SR 429 obstructed drainage structure at Franklin Street.

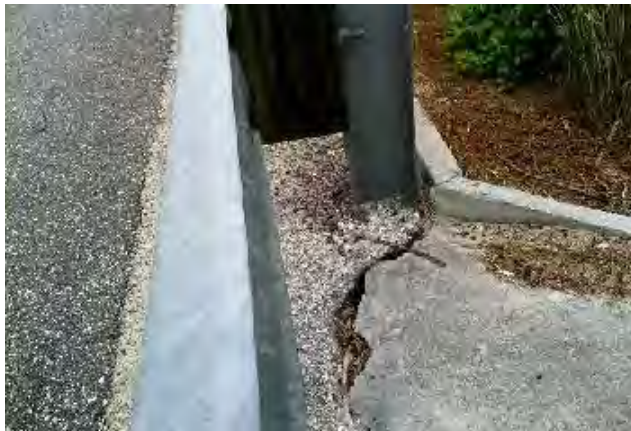
Fencing observations for both ROW and retaining wall were noted at various locations including vegetation overgrown fence lines, open gates along Wekiva Parkway. Damaged wall gutter was noted at the Schofield Road interchange.

Figure 14: SR 429 wall gutter cracking Schofield Road

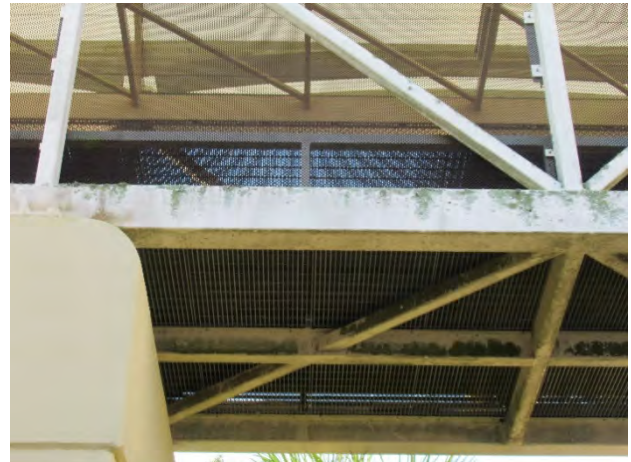
Figure 15: SR 429 Forest Lake Mainline Plaza mold growth on pedestrian bridge.

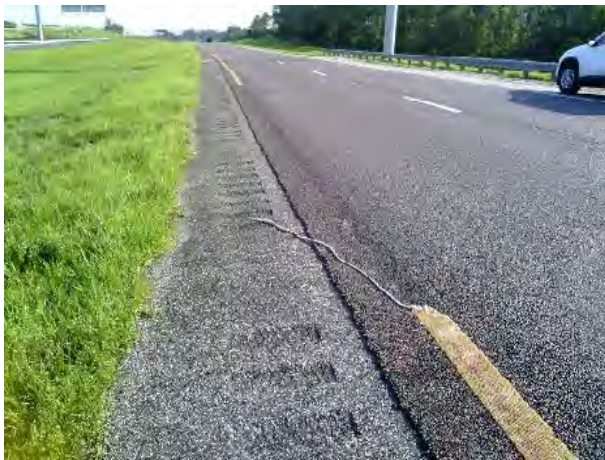
Roadside erosion was prevalent along SR 451 just south of SR 441, while pavement marking damage was observed just north the systems interchange.

Figure 16: SR 451 damaged striping.

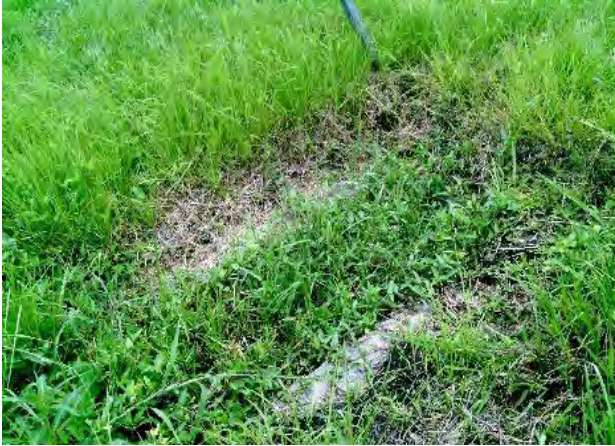
Drainage structure obstructions and erosion were observed at various locations throughout the roadway with concentrated areas east of ICP Boulevard.

Figure 17: SR 528 overgrown drainage structure east of ICP Boulevard.

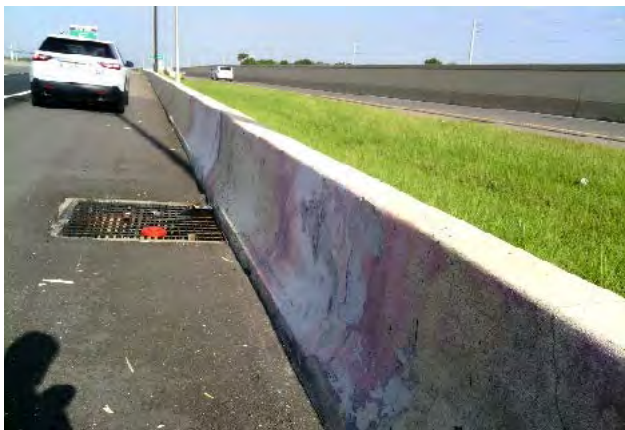
No observations were noted on SR 528 fence minor barrier wall damage was observed east of Boggy Creek Road.

Figure 18: SR 528 barrier wall coating damage east of Boggy Creek Road.

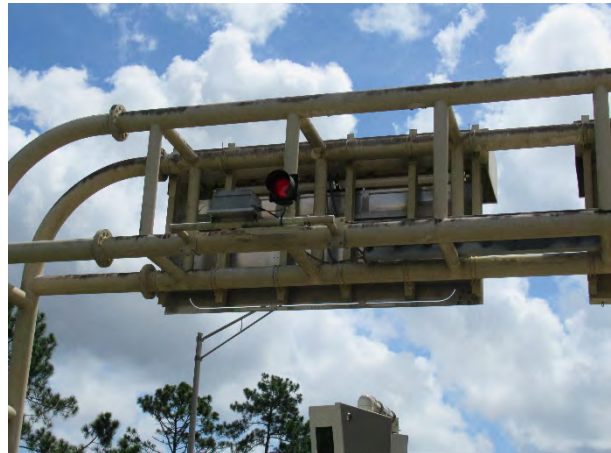
Figure 19: Toll Gantry with mold growth SR 528 Dallas Boulevard on ramp

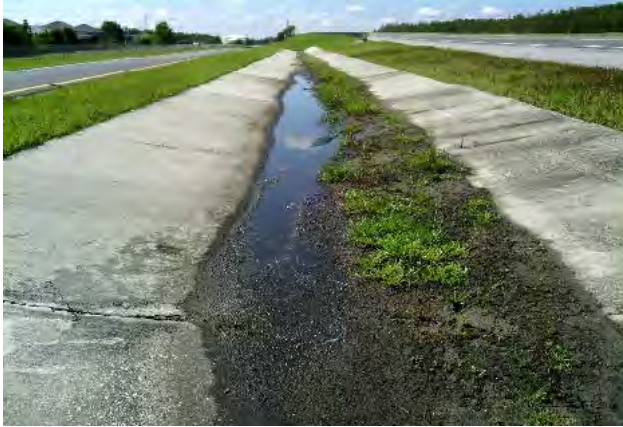
Figure 20: SR 538 sediment in ditch pavement west of KOA Street.

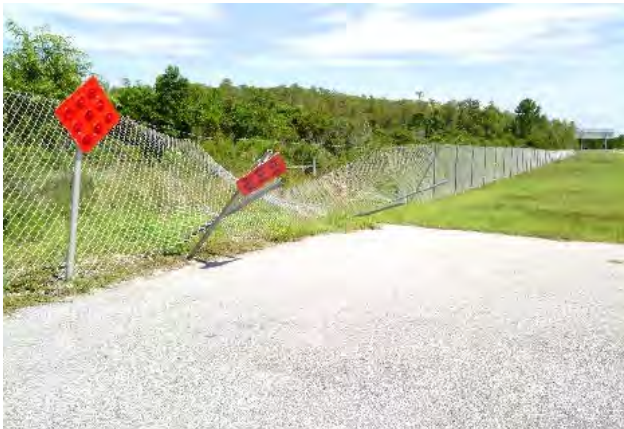
Figure 21: Damaged leaning fence on KOA Street.

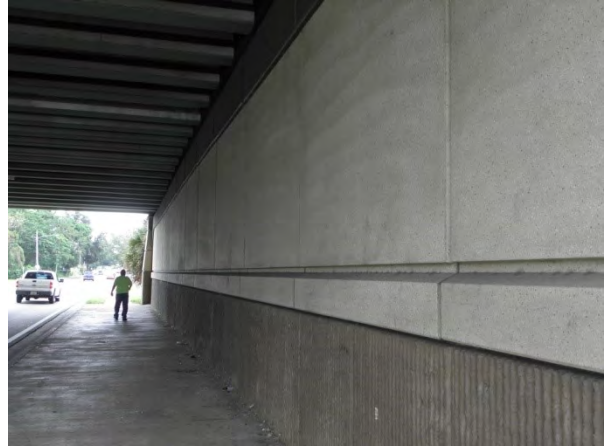
Figure 22: Cladding wall coating degradation SR 408.

- 408-763 SR 408 Milling and Resurfacing Yucatan Drive to SR 417
- 408-764 SR 408 Milling and Resurfacing Woodbury Road to SR 50
- 599-756 SR 408 Coatings I-4 to Chickasaw Trail

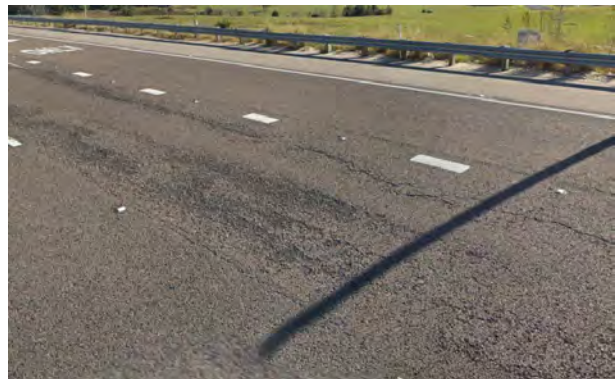
Figure 23: Asphalt Raveling and Cracking SR 414.

- 414-754 SR 414 Milling and Resurfacing SR 451 to Keene Road
- 414-755 SR 414 Milling and Resurfacing Keene Road to US 441

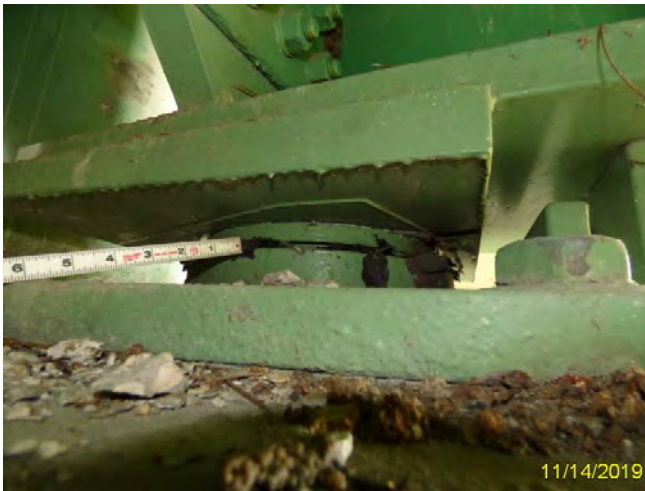
Figure 24: Extruded elastomer at Abutment bearings SR 417 over SR 528 bridge.

- 417-751 SR 417 Bridge Over SR 528 Preservation
