2021

Annual Inspection Report

Re: 2021 Annual Inspection Report

2021 Annual Inspection Report
CENTRAL FLORIDA EXPRESSWAY AUTHORITY

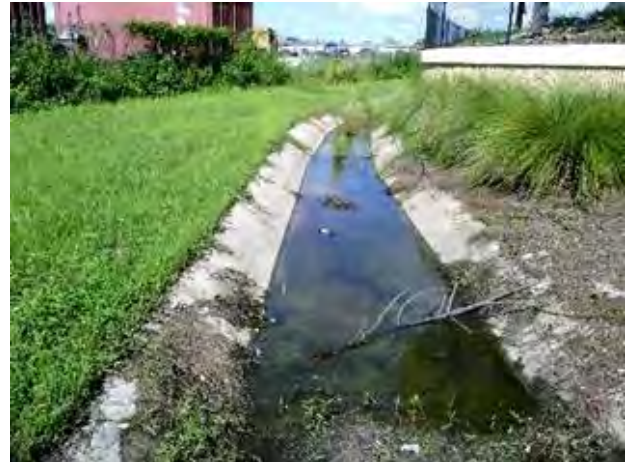
Figure 3: Flume drainage structure needs vegetation cleared.

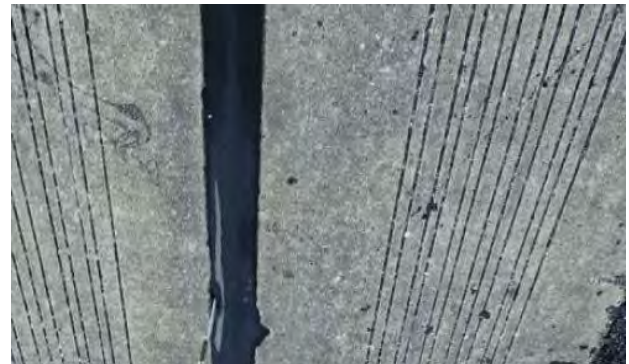
Degradation of joint sealant was observed at the SR 408 overpass of Andes Avenue.

Figure 4: Joint sealant degradation SR 408 over Andes Road.

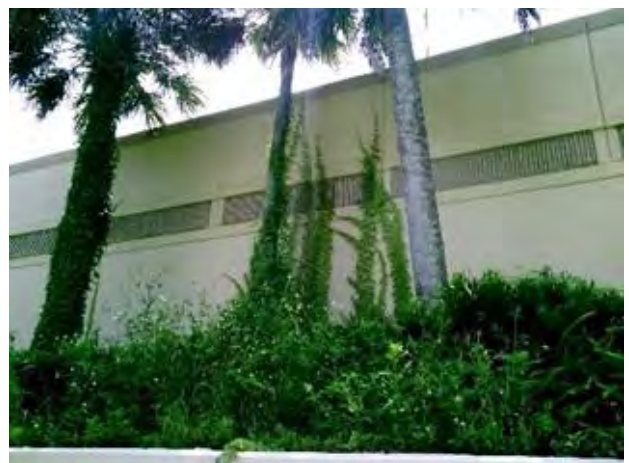
Graffiti and vegetation growth on walls were periodically observed along SR 408.

Figure 5: Vegetation of Noise Wall at SR 408 and Mills

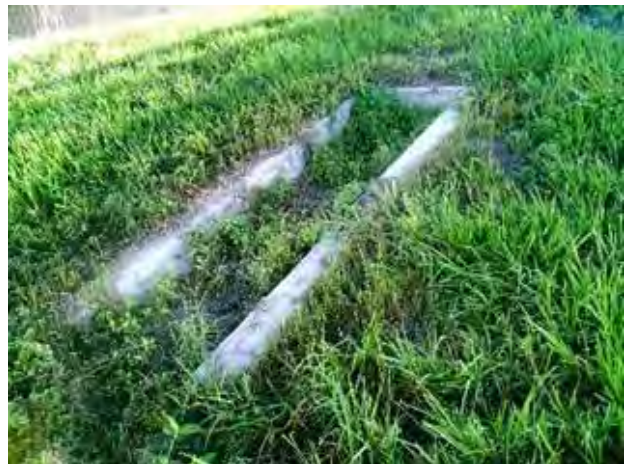
Obstructed and overgrown drainage structures were observed throughout the roadway with a concentration at the pond north of Coral Hills Mainline Plaza.

Figure 6: Overgrown mitered end section Coral Hills Mainline Plaza Pond.

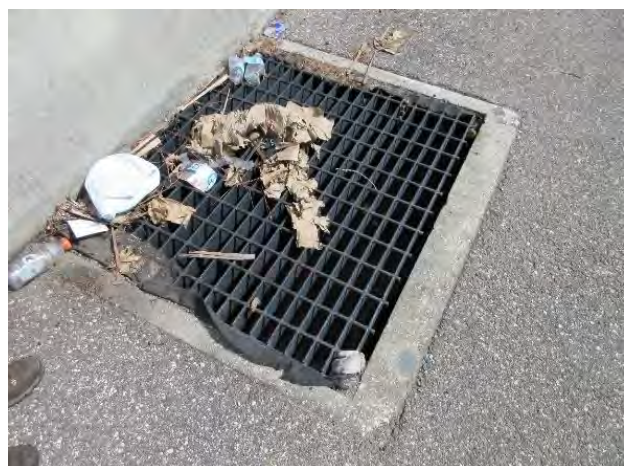
Dirt and debris on the shoulder were observed at the bridge over the Landfill Service Road.

Figure 7: Shoulder debris Landfill Service Road.

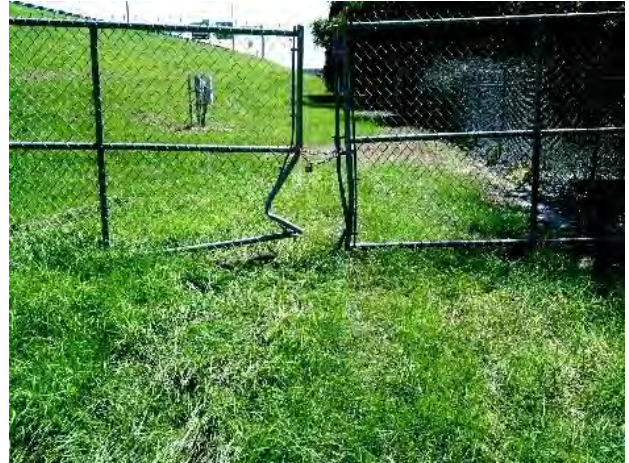
Figure 8: Damaged fence gate at SR 414 and Hawthorne Avenue.

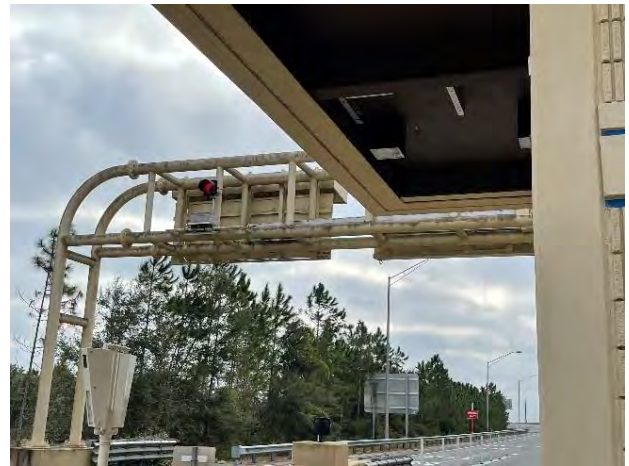
Figure 9: Algae growth Keene Road off ramp.

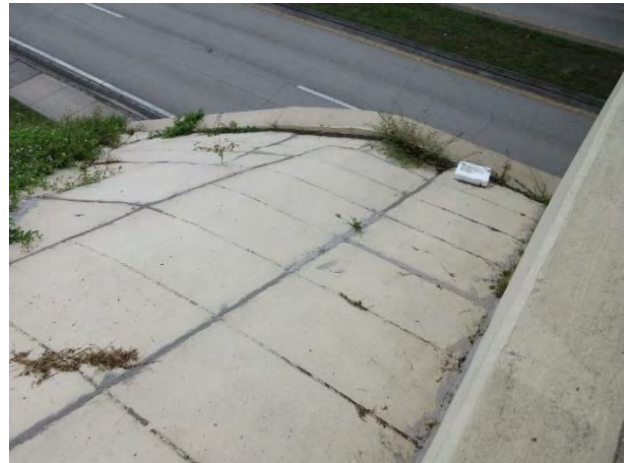
Debris filled expansion joints were observed at the SR 417 bridge over the OUC rail line, while vegetation growing from the slope pavement was observed at SR 417 and Wyndham Lakes Boulevard.

Figure 11: Slope pavement vegetation at Wyndham Lake Boulevard.

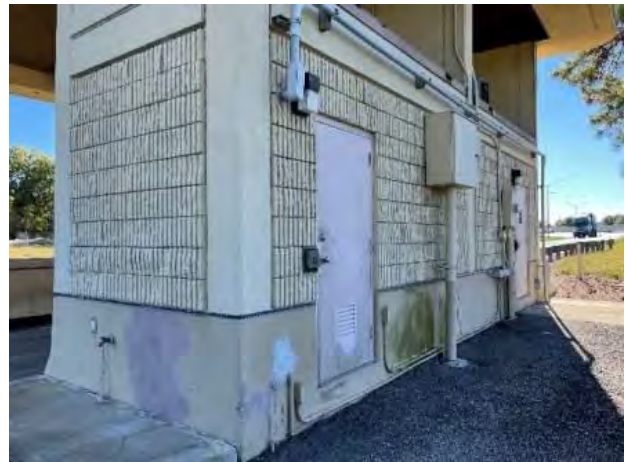
Figure 12: SR 417 Colonial off ramp coatings degradation.

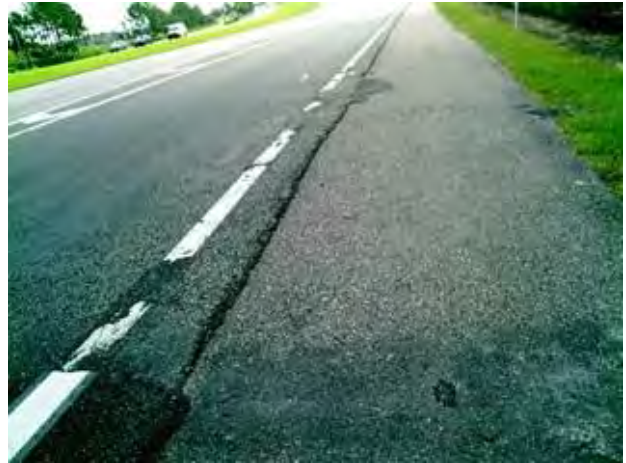
Figure 13: SR 429 pavement marking degradation CR 535 off ramp.

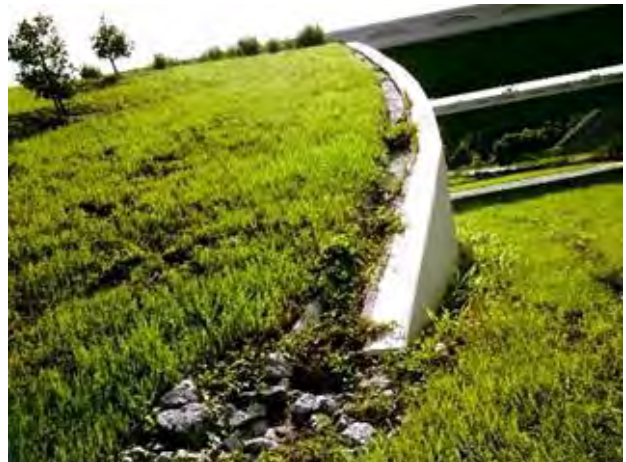
Fencing observations for both ROW and retaining wall were noted at various locations along the corridor. Vegetation on MSE walls was observed south of Connector Road. Debris filled wall gutter was recorded at various locations along the corridor.

Figure 14: SR 429 wall gutter full of debris at Ponkan Road.

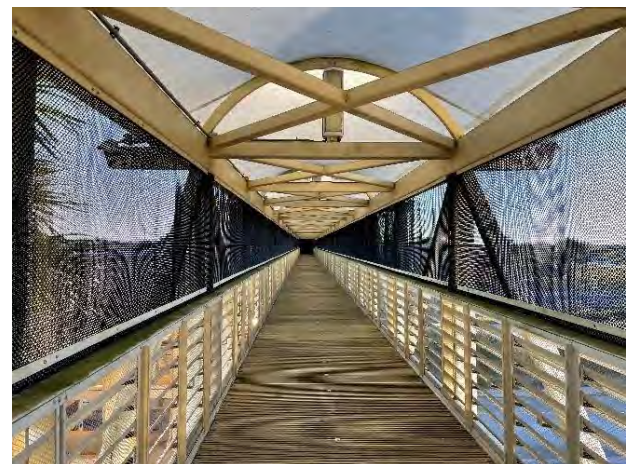
Figure 15: Mold build up on New Independence Mainline Plaza pedestrian bridge.

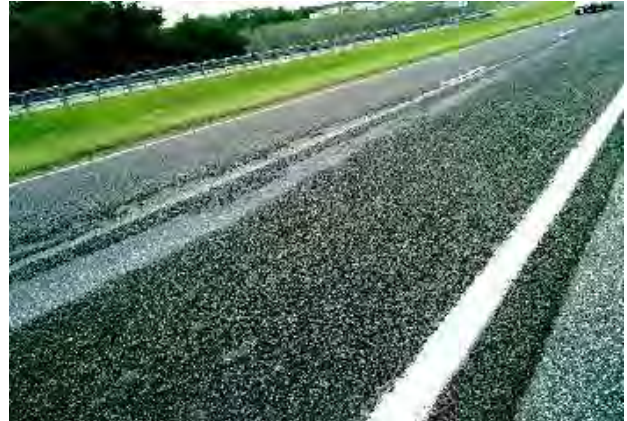
Roadside erosion and drainage deficiencies were observed along SR 451 just south of SR 441, while pavement degradation was prevalent just north of Ocoee Apopka Road.

Figure 16: SR 451 pavement degradation.

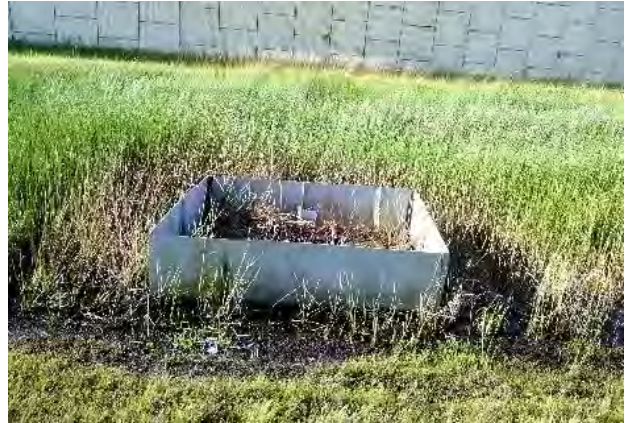
Figure 17: Overgrown weir structure SR 528 and Narcoossee Road.

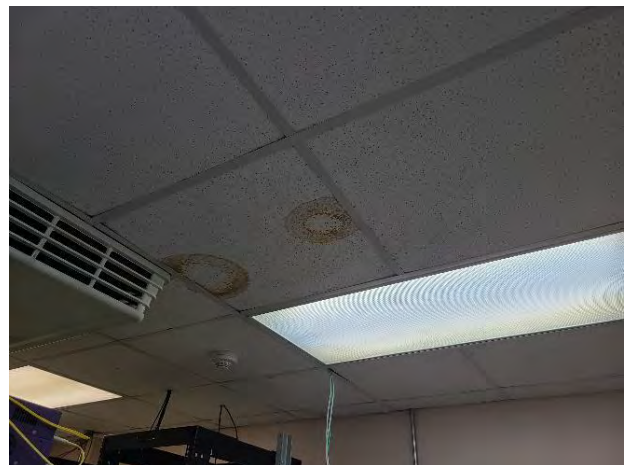
Figure 19: Water damaged ceiling tile Beachline Main Plaza.

Observations for various features in the facilities along SR 528 were leaks along tunnel walls, ceiling tiles, and exterior coatings systems with mold growth.

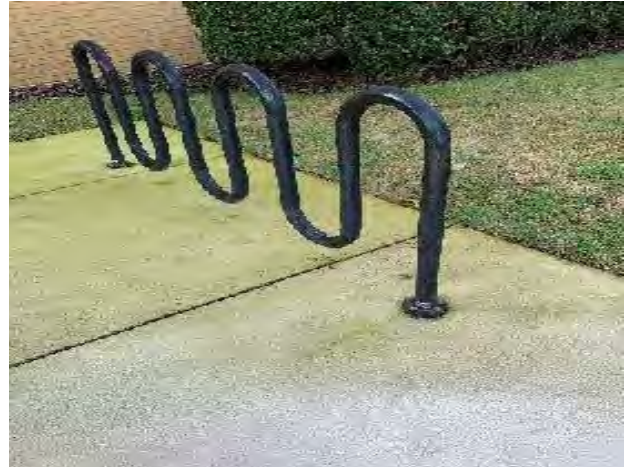
Figure 20: CFX Administration and Operations Building sidewalk with dirt and algae growth.
