FY **2023** Annual Inspection Report

Mr. Glenn Pressimone, P.E.
Chief of Infrastructure
Central Florida Expressway Authority
4974 ORL Tower Road
Orlando, Florida 32807

Re: FY 2023 Annual Inspection Report

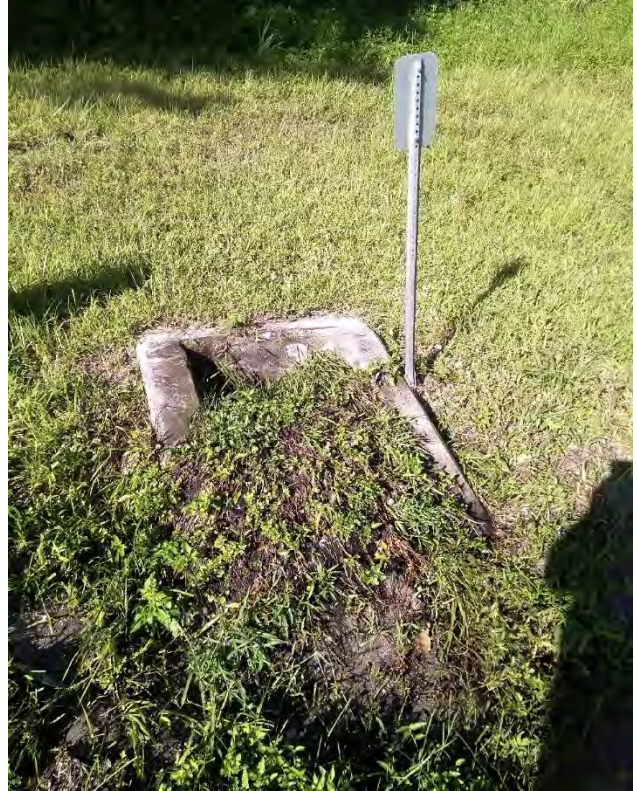
Figure 3: Mitered end structure needs vegetation and sediment cleared.

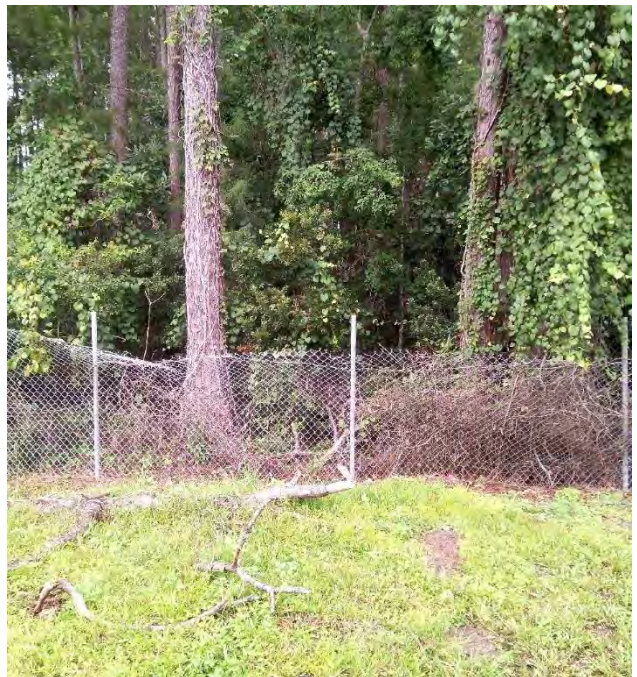
Figure 4: Damaged right-of-way fence - SR 408 and Dean Road

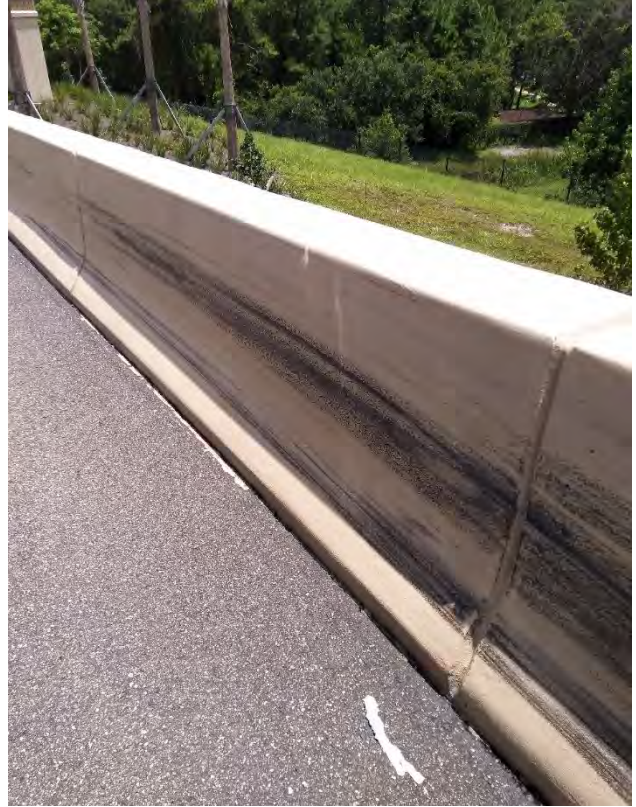
Figure 5: Scuffed barrier wall - SR 408 and Alafaya Trail

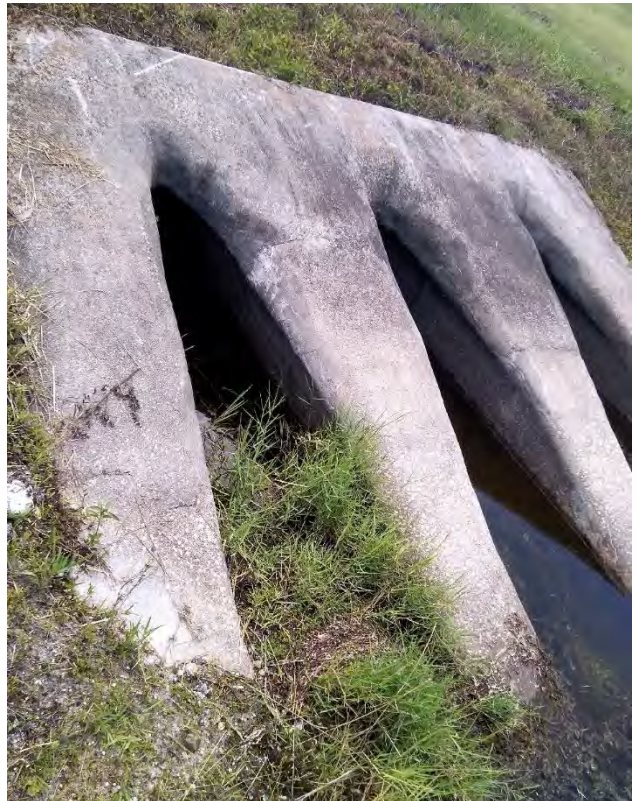
Figure 6: Sediment filled drainage structure - SR 414 pond

Obstructed and overgrown drainage structures were observed throughout the roadway with a concentration at the pond north of Coral Hills Mainline Plaza.

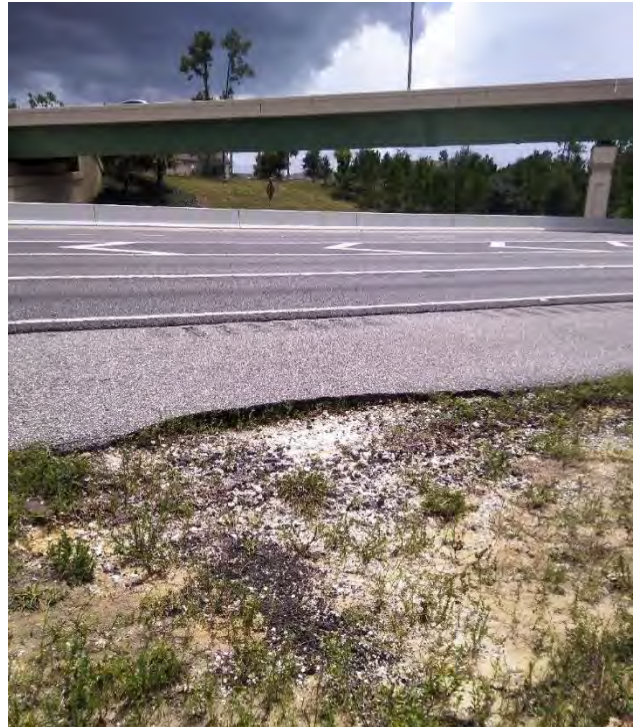
Asphalt shoulder edge ravel with slight drop offs were observed on the mainline around the Marden Road interchange.

Figure 7: Shoulder edge ravel slight drop off conditions - SR 414 and Marden Road.

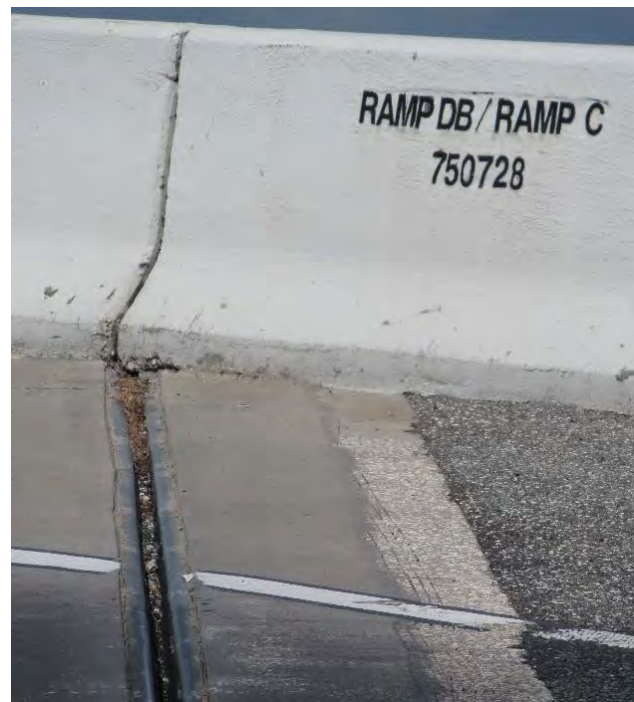
Dirt and debris in the abutment and along the shoulder was observed on the westbound SR 414 to southbound SR 429 ramp.

Figure 8: Debris at bridge abutment and shoulder - SR 414.

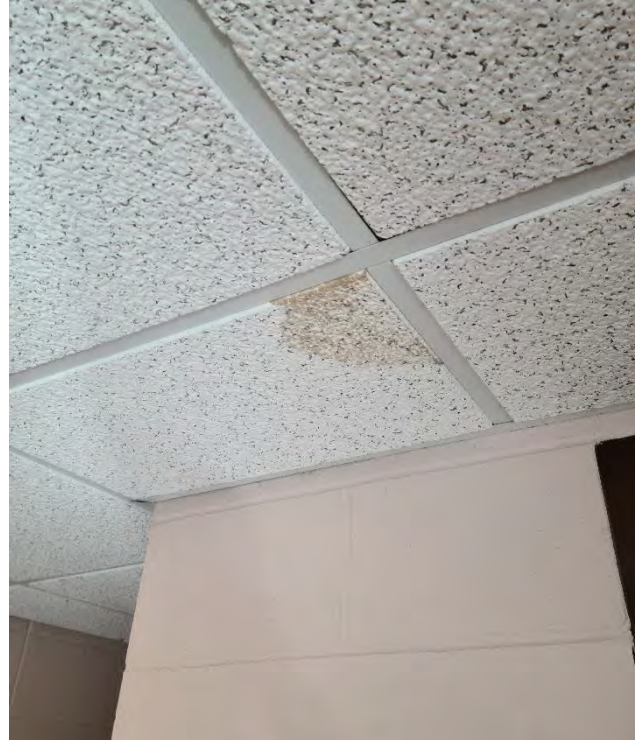
Figure 9: Damaged ceiling tile - SR 414 Keene Road off ramp.

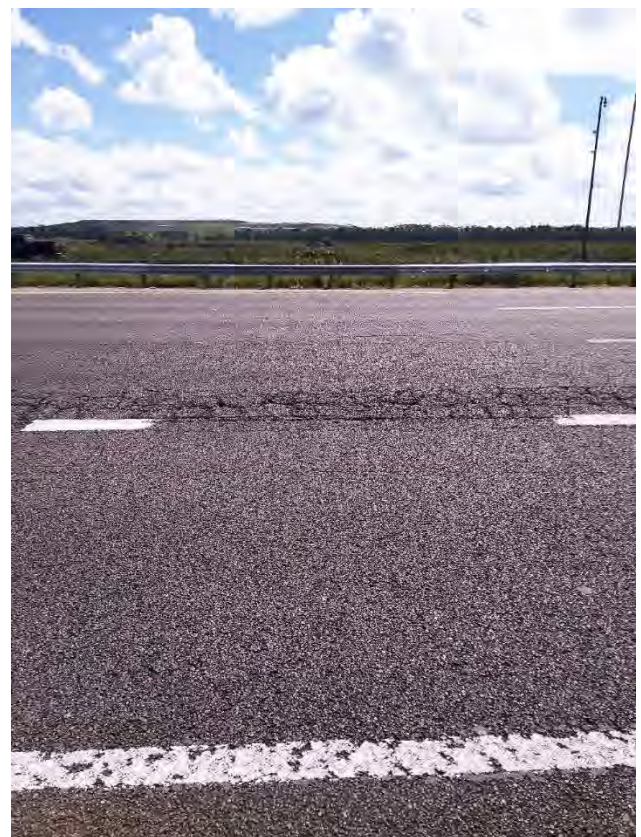
Figure 10: Pavement and pavement markings

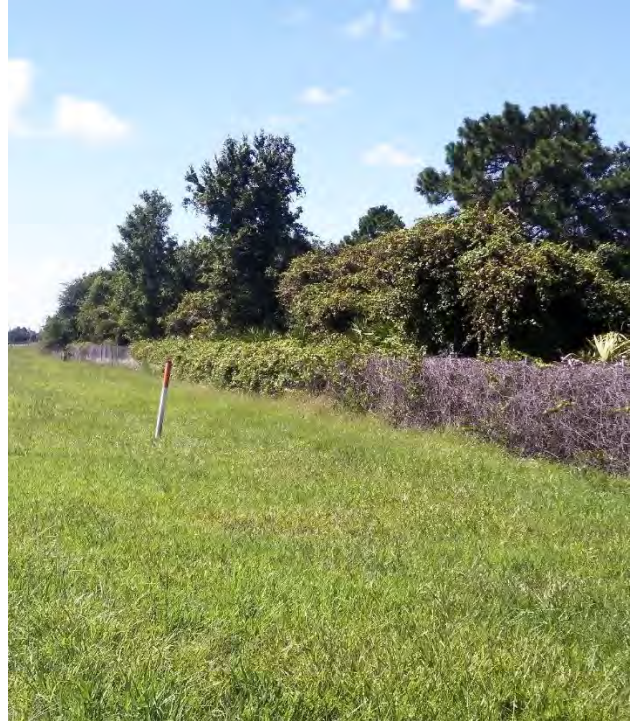
Fencing observations included minor fence damage and pockets of overgrown fence lines north of Curry Ford Road.

Figure 11: Overgrown fence - SR 417

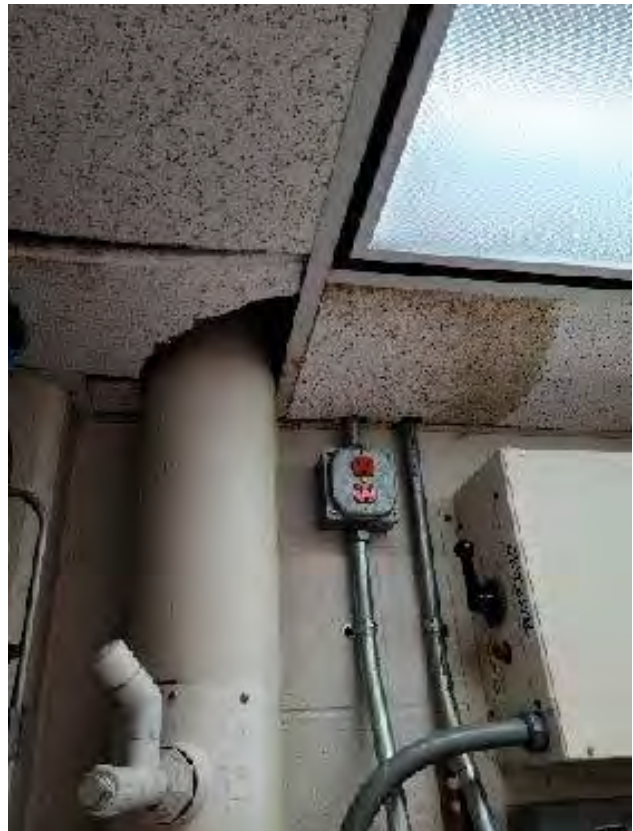
Figure 12: Damaged ceiling tile - Landstar off ramp

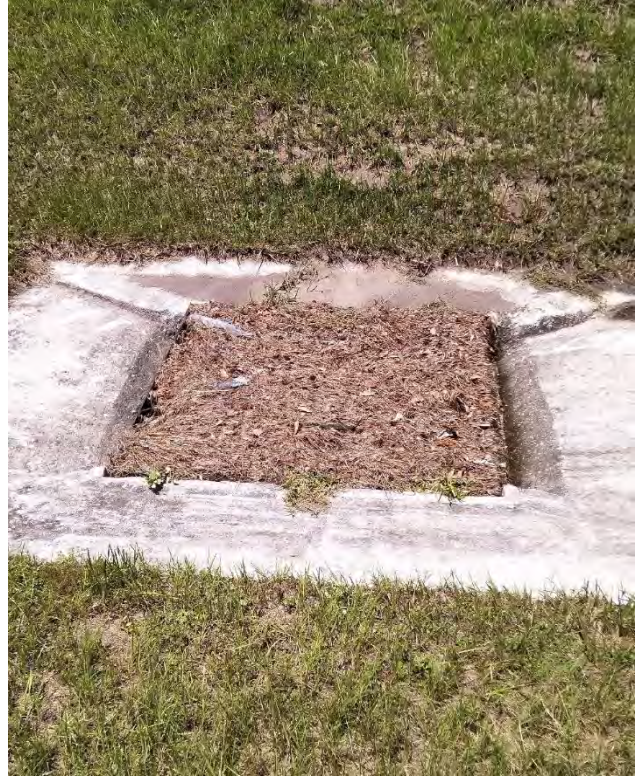
Figure 13: Debris covering drainage structure grate - south of Yothers Road.

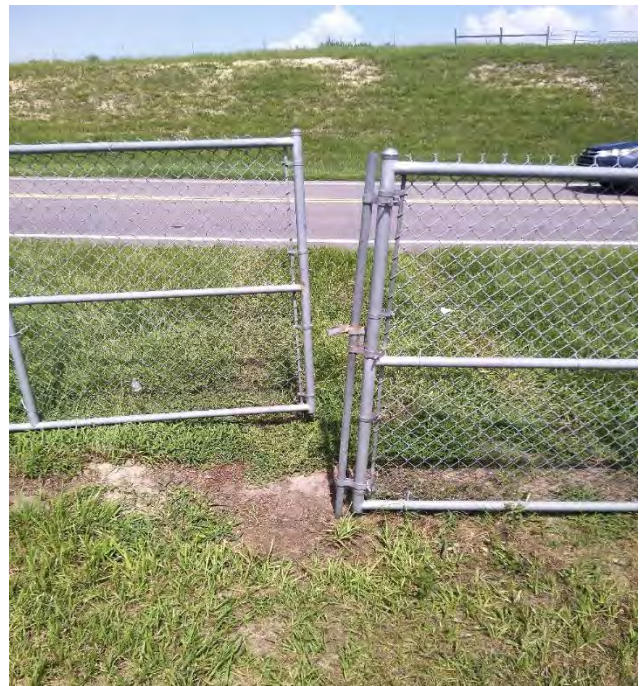
Figure 14: Damaged fence gate Plymouth Sorrento Road- Plymouth Sorrento Road.

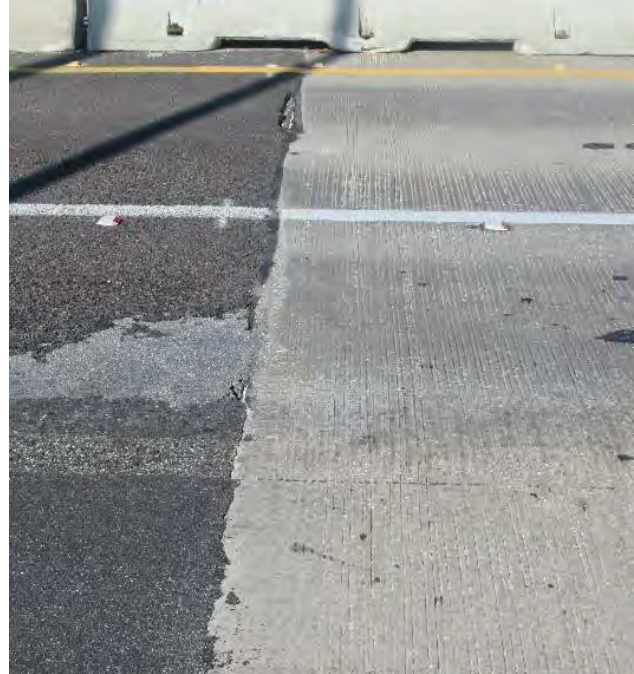
Figure 15: Damaged asphalt at south approach lanes 1 and 2 - SR 429 over Plant Street.

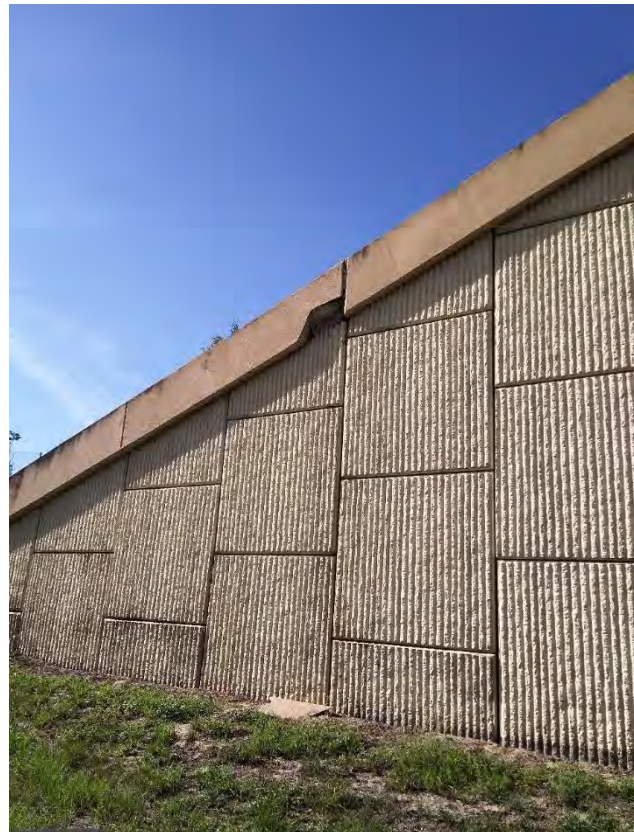
Figure 16: Damaged MSE wall coping - Ocoee Apopka Road

No observations were noted on SR 451 fences; however, a damaged MSE wall coping was seen at Ocoee Apopka Road.

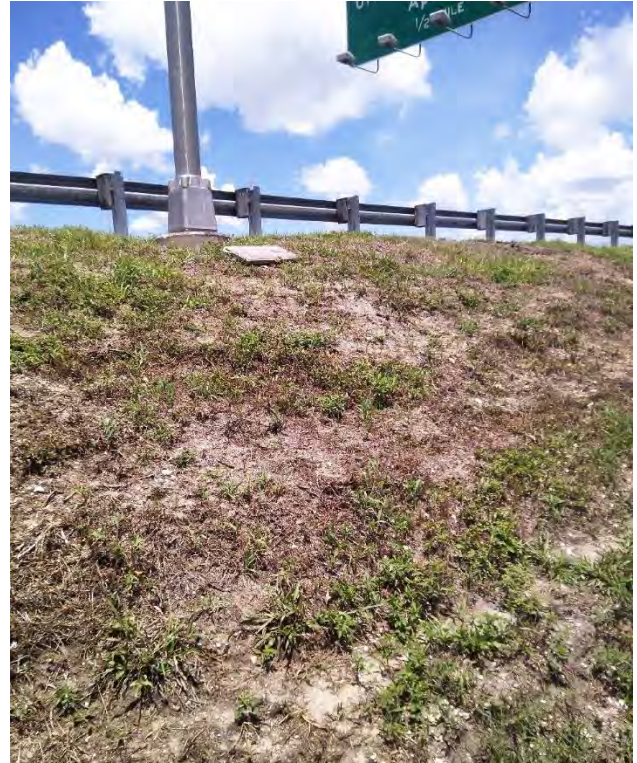
Figure 17: Minor slope erosion – SR 451.

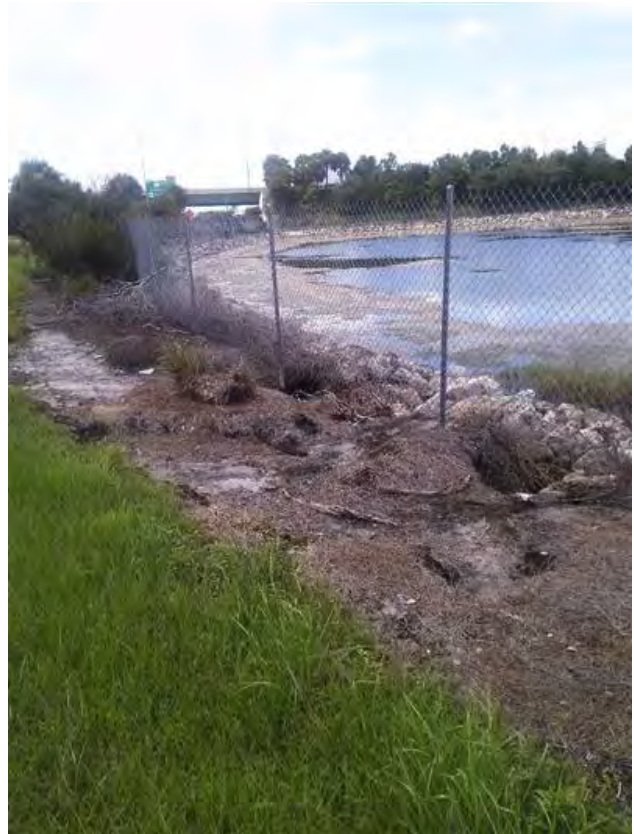
Drainage structure obstructions and erosion were observed at various locations throughout the roadway with concentrated areas at the Goldenrod Interchange.

Figure 18: Minor erosion – Goldenrod Road Interchange.

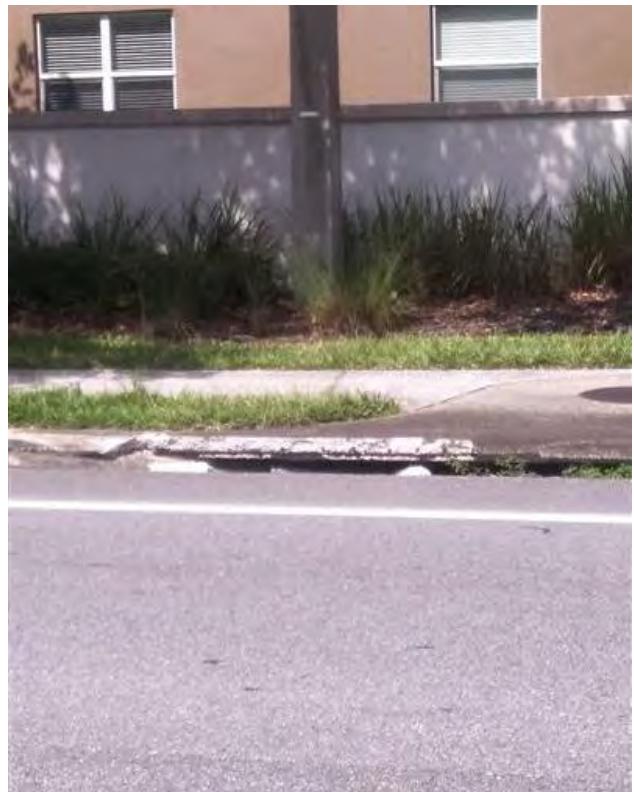
Figure 19: Damaged Inlet – SR 551 Goldenrod Road.
