Central Florida Expressway Authority

ANNUAL INSPECTION REPORT

FY 2024

Re: Fiscal Year 2024 Annual Inspection Report

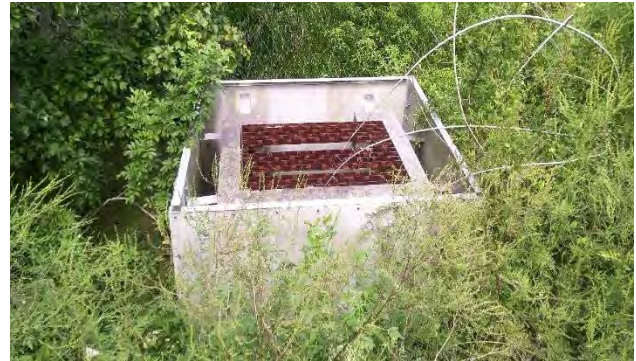
Concentrated areas of observation were located at and around the Rouse Road interchange as well as at the SR 408 east jurisdictional limit. Observations included minor roadside erosion, overgrown / damaged drainage structures. Pavement marking degradation was moderate and limited to small portions of ramps.

Figure 3: Damaged pond structure SR 408 and Rouse Road

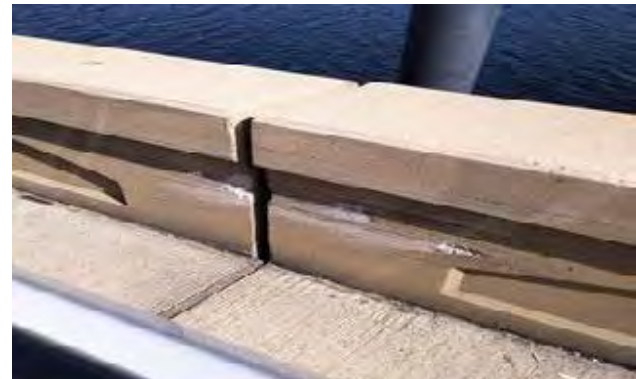
Bridge observations along SR 408 were minimal with no points observed outside of routine maintenance. Bridge observations included damaged wall coatings, minor adhesion loss at bridge joints, and damaged junction box covers.

Figure 4: Damaged bridge traffic railing coating over Lake Underhill

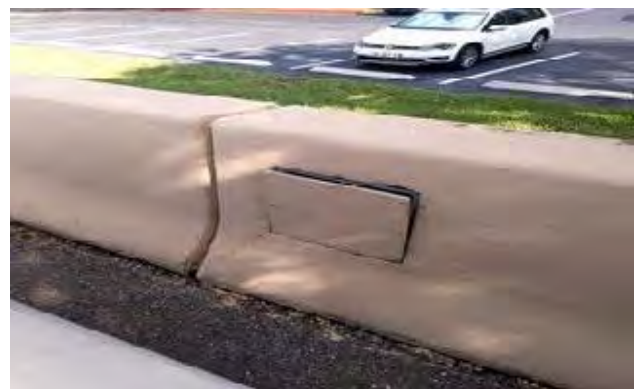
Figure 5: Damaged junction box cover Rosalind off ramp

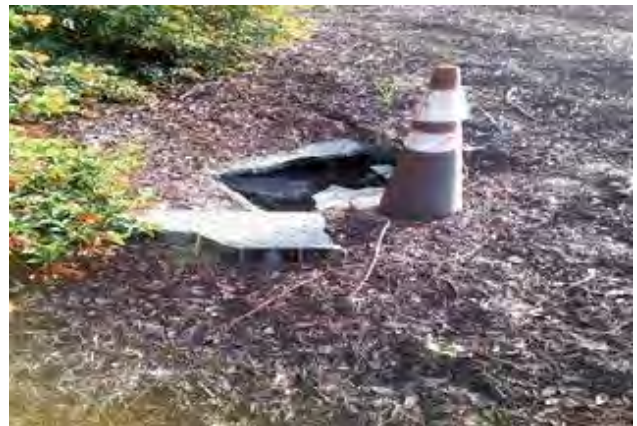
Figure 6: Damaged splice box Keene Road exit Ramp

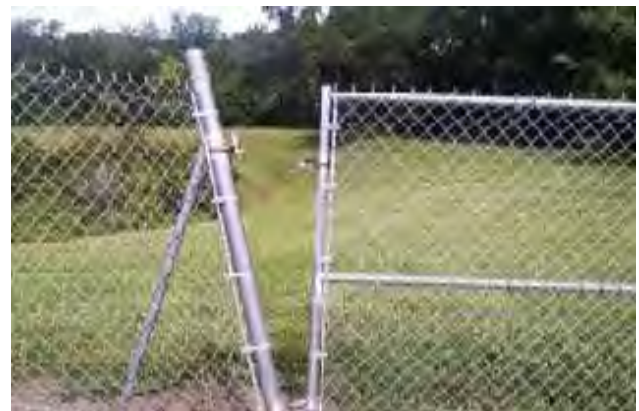
There were limited wall and fence observations during this year's inspection. Typical fence observations included damaged fence fabric and gates along the corridor.

Figure 7: Leaning fence gate Hiawassee Road pond.

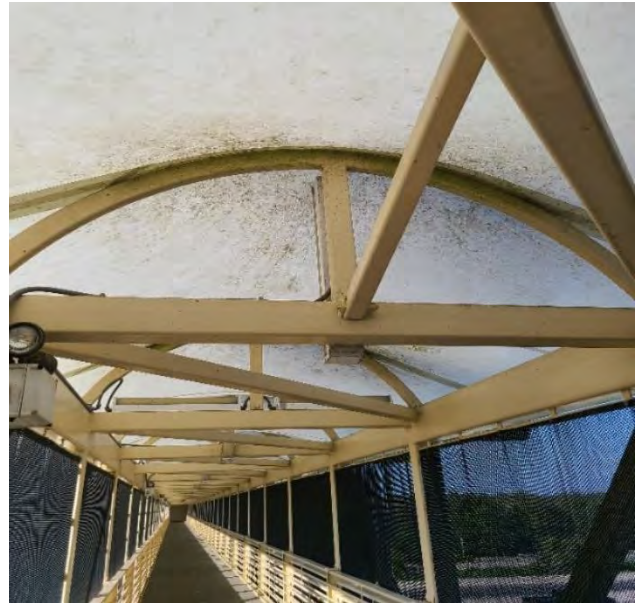
Figure 8: Mold present on canopy Coral Hills Mainline Plaza pedestrian bridge.

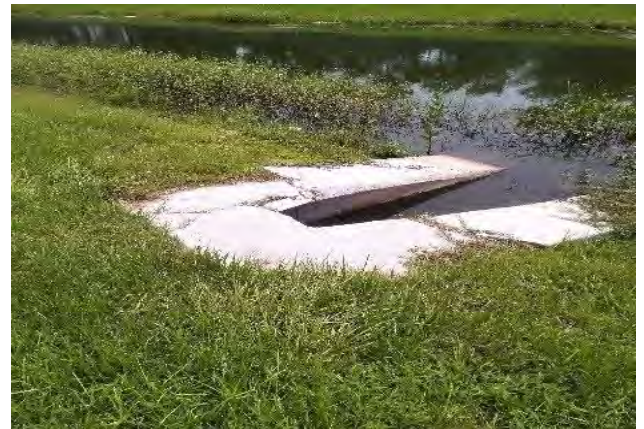
Figure 9: Overgrown drainage structure SR 417 north of Berry Dease Road

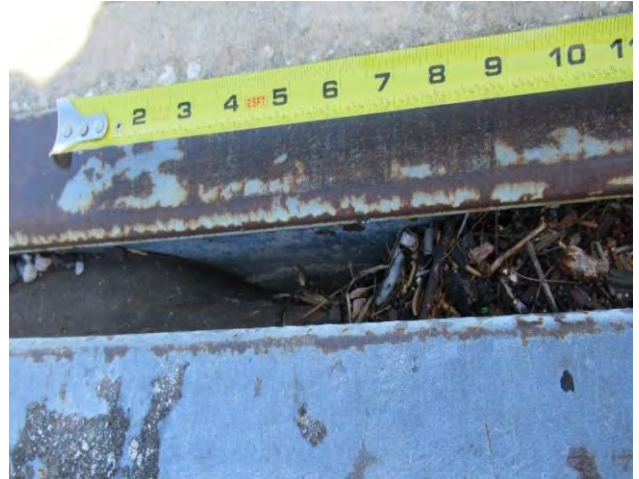
Missing joint sealant and reflectors was observed at the SR 417 bridge over Rhode Island Woods Boulevard.

Figure 10: Joint sealant at abutment missing SR 417 over Rhode Island Woods Boulevard.

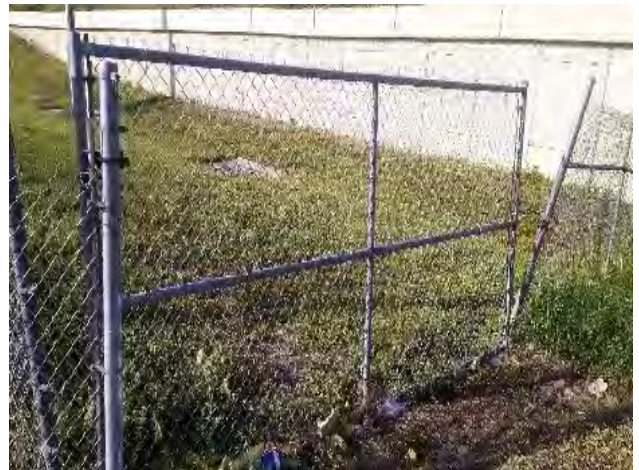
Figure 11: Fence gate damaged at Valencia College Lane.

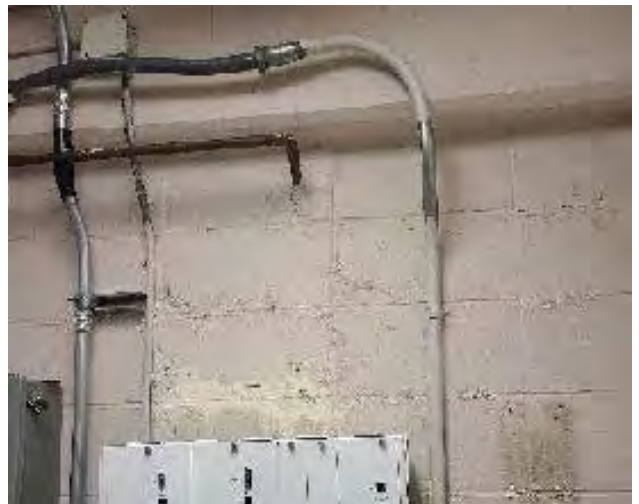
Figure 12: Curry Ford on ramp interior coatings in poor condition.

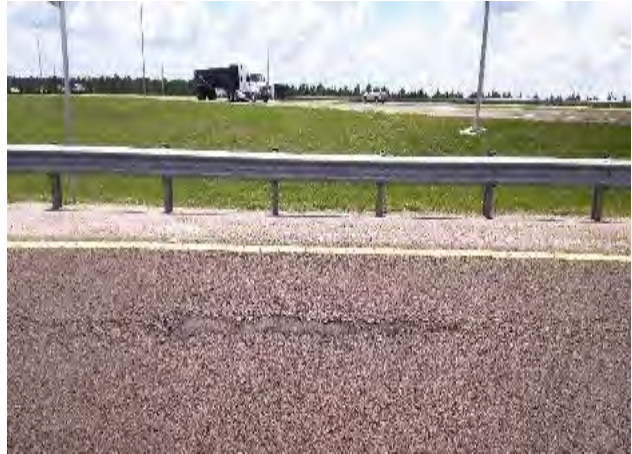
Minor pavement degradation was seen along the mainline south of Schofield Road.

Figure 13: Pavement raveling Schofield Road ramp.

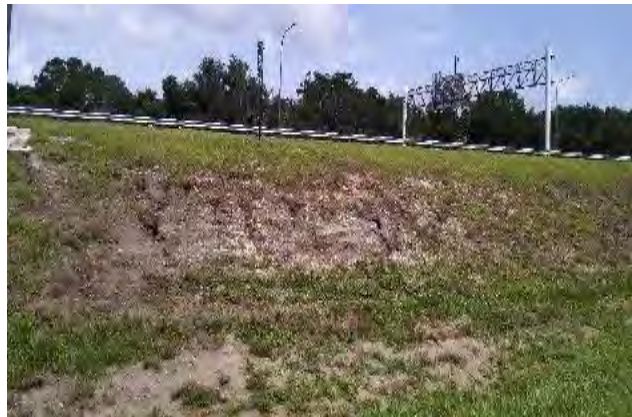
Roadside erosion was observed in medians, front slopes, and swales in various locations of the roadway. Front slope erosion was observed along SR 429 north of Kelly Park Road, and median erosion was observed north of Plymouth Sorrento Road.

Figure 14: Front slope erosion SR 429 and Kelly Park Road.

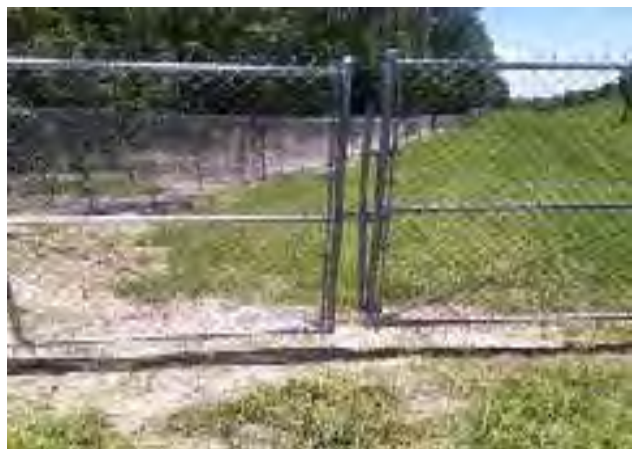
Figure 15: Gate missing lock and chain SR 429 south of Mt. Plymouth Road.

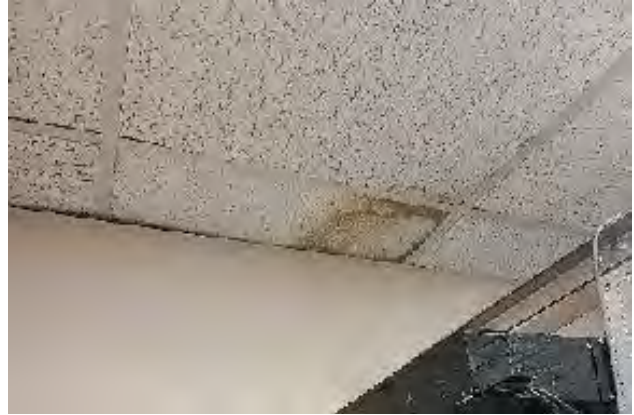
Figure 16: Water stained ceiling tile Data Room Forest Lake Mainline Plaza

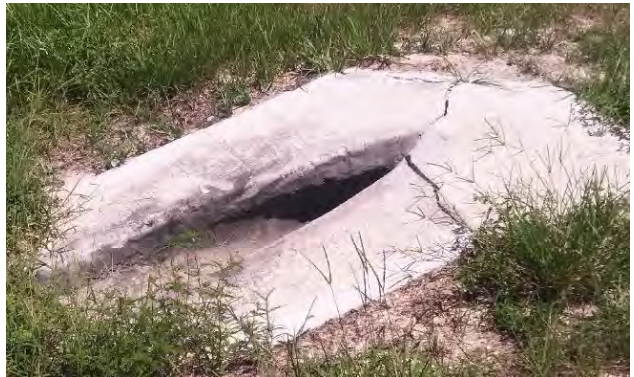
Figure 17: Damaged drainage structure SR 451.

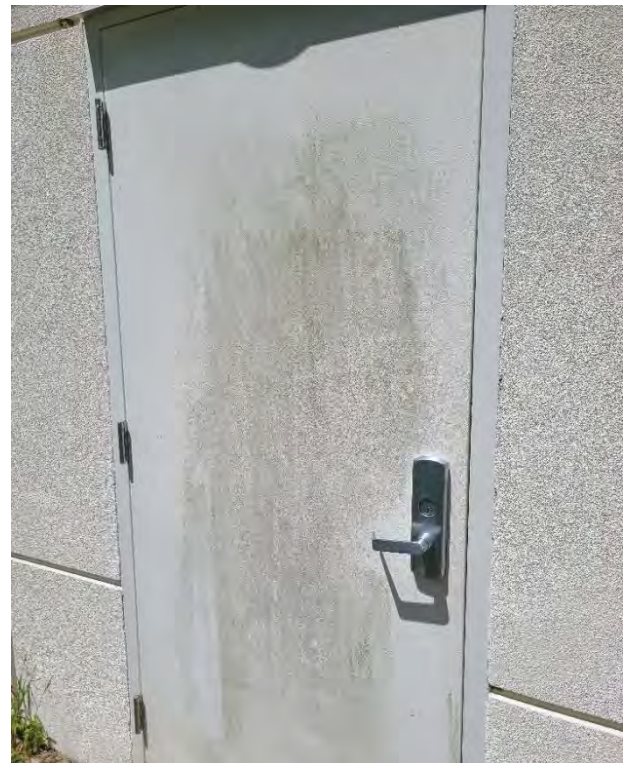
Figure 18: Mold growth on exterior of Marigold gantry building.

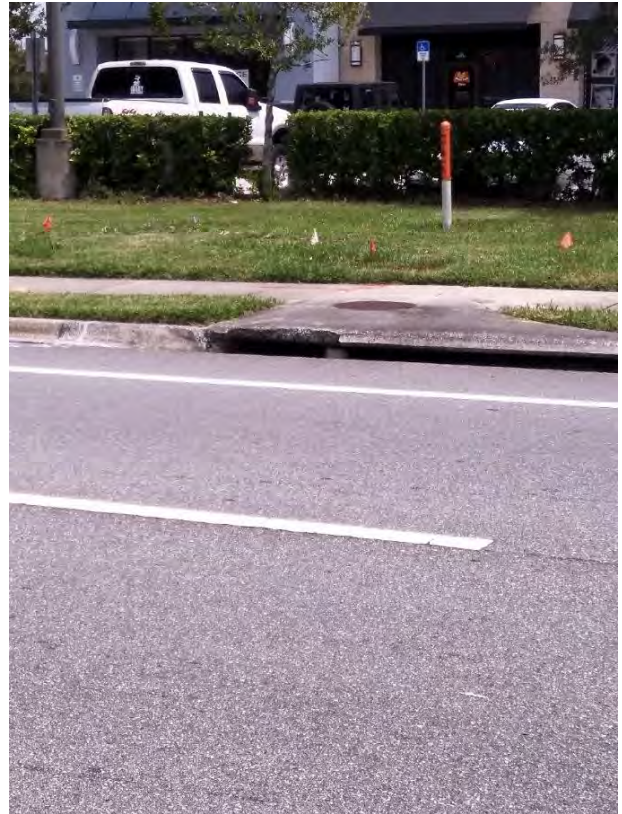
Figure 19: Damaged Inlet – SR 551 Goldenrod Road.
