Central Florida Expressway Authority

ANNUAL INSPECTION REPORT

FY 2025

Re: FY 2025 Annual Inspection Report

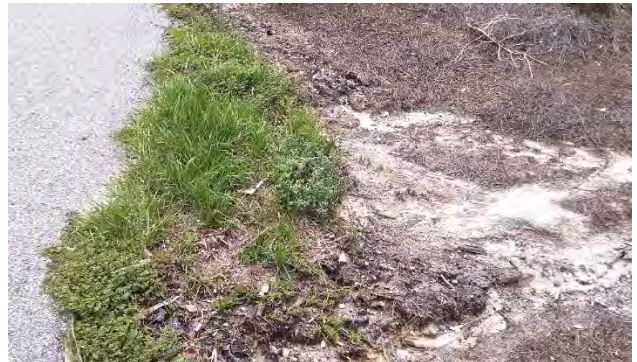
FIGURE 3: Erosion west of Citrus Oaks Avenue

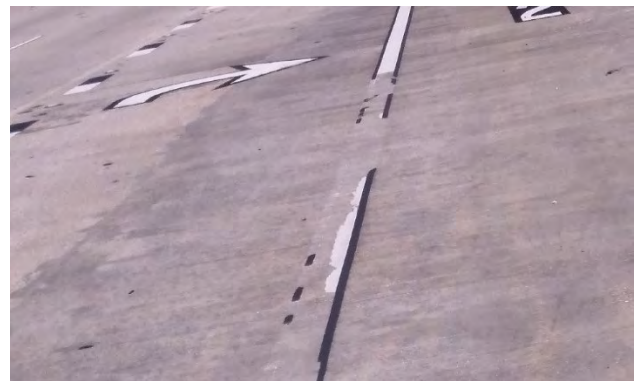
The evaluation of bridges along SR 408 indicated that there were few concerns, primarily limited to standard maintenance observations. Specific issues identified included deterioration of wall coatings, minor loss of adhesion at the joints, and pavement marking degradation.

FIGURE 4: Pavement marking deterioration bridge over Lake Sherwood

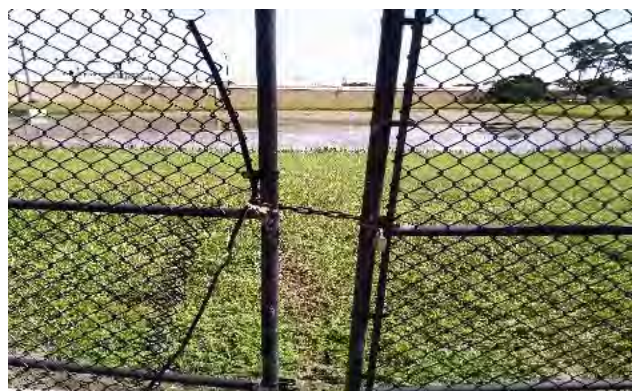
FIGURE 5: Damaged fence gate at Chickasaw Trail

compromised fence gates, and leaning or damaged right-of-way (ROW) fencing. Additionally, the walls exhibited signs of coating degradation and minor mildew accumulation on their surfaces.

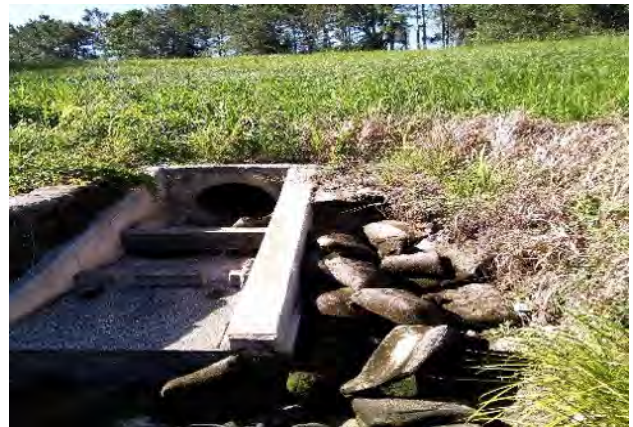
Throughout the corridor, drainage structures were noted to be obstructed and overgrown, with the area between the mainline plaza and Keene Road exhibiting a higher degree of concentration.

FIGURE 6: Erosion around drainage structure in pond at Keene Road

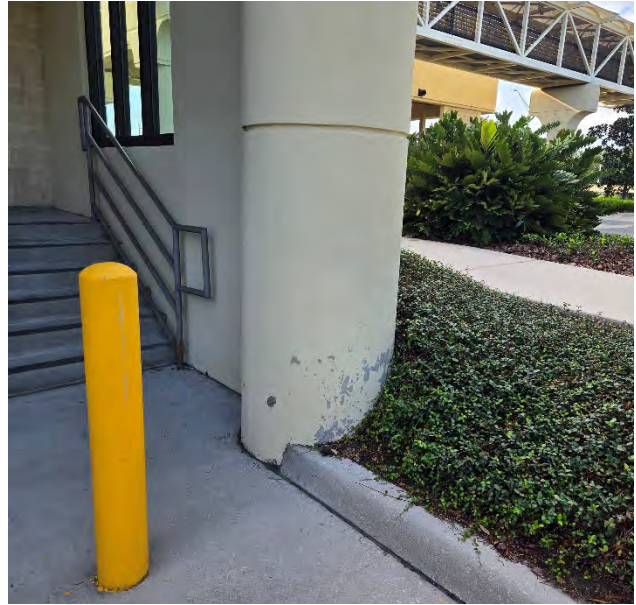
FIGURE 8: Damaged coatings Coral Hills Mainline Plaza

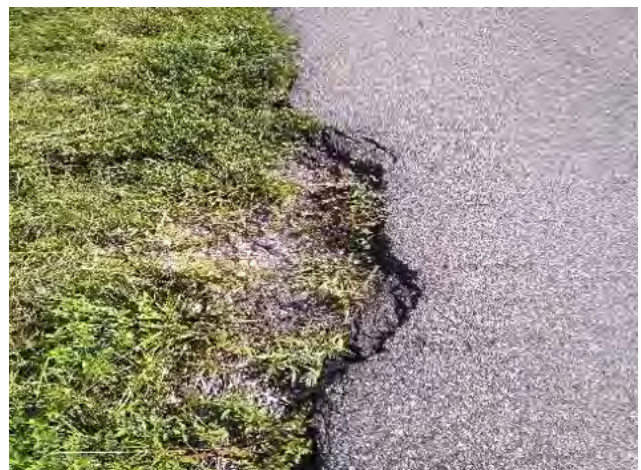
FIGURE 9: Pavement edge ravel SR 408 and SR 417 Interchange

Edge ravel as well as minor shoulder erosion was observed in various locations throughout the corridor with moderate concentration at University Boulevard.

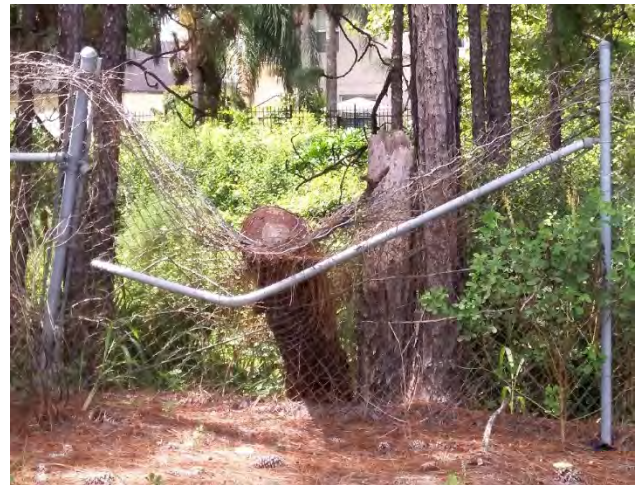
Observations related to fencing revealed slight damage caused by tree debris, as well as areas where the fence lines have become overgrown along the corridor.

FIGURE 10: Fence damage Curry Ford Mainline Plaza Pond

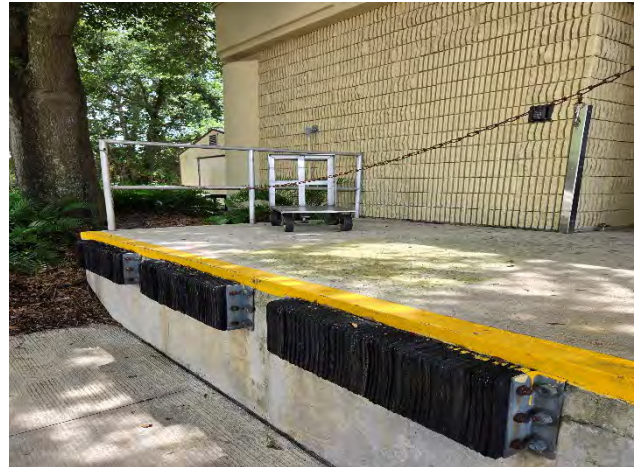
FIGURE 11: Mildew growth on loading bay surface
University Mainline Plaza

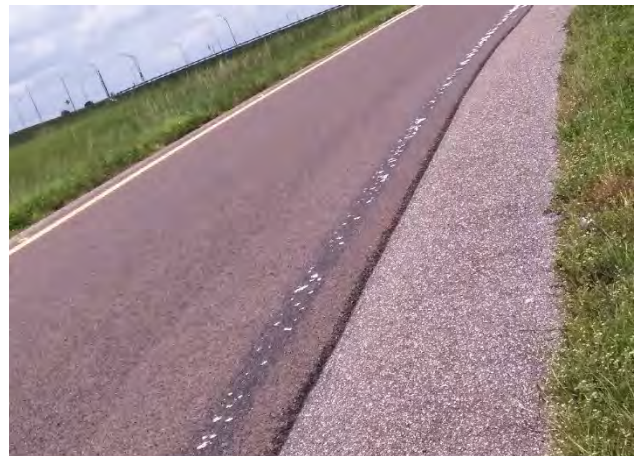
FIGURE 12: Lane striping degradation Schofield Road on ramp

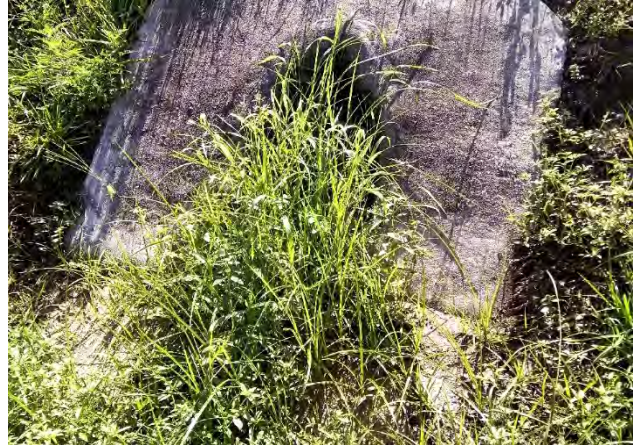
FIGURE 13: Overgrown drainage structure New Independence Parkway Interchange

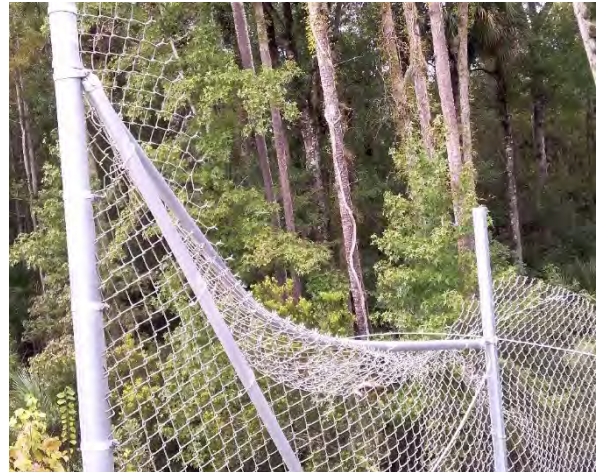
FIGURE 15: SR 538 damaged fence east end of the viaduct

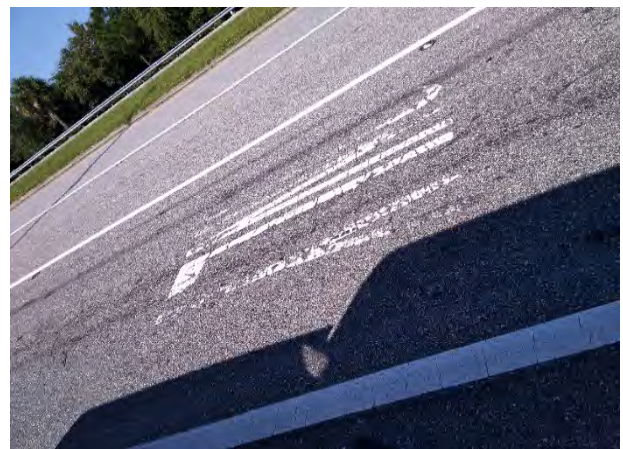
FIGURE 16: Pavement degradation SR 551 Goldenrod Road north of SR 528
