2015

Annual Inspection Report

**CENTRAL
FLORIDA
EXPRESSWAY
AUTHORITY**

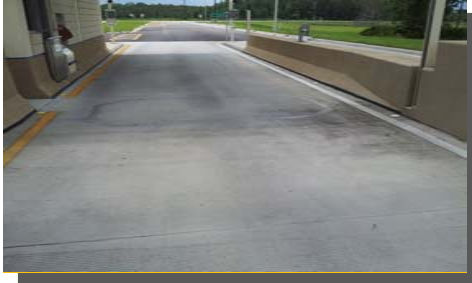
Feature	Rating	Comments
Joints	4	Vegetation growing in deteriorated joint material.
Apron Sweep	8	No deficiencies noted
Cracking	8	No deficiencies noted
Pavement Voids	8	No deficiencies noted
Striping	8	No deficiencies noted

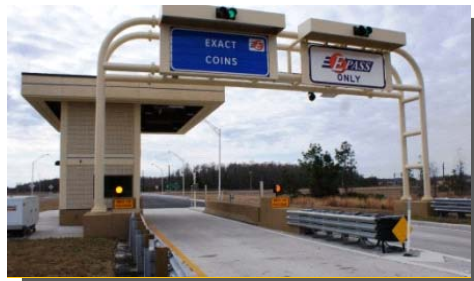
Feature	Rating	Comments
Sign Structure	6	Algae growth present, needs power wash.
Canopy Columns	8	No deficiencies noted
Canopy Fascia	8	No deficiencies noted
Canopy lighting	8	No deficiencies noted
Canopy Underside	8	No deficiencies noted
Paint - Interior and Exterior	8	No deficiencies noted
Sign Lighting	8	No deficiencies noted
Signs	8	No deficiencies noted
Traffic Red / Green Lighting	8	No deficiencies noted
Variable Message Signs	8	No deficiencies noted

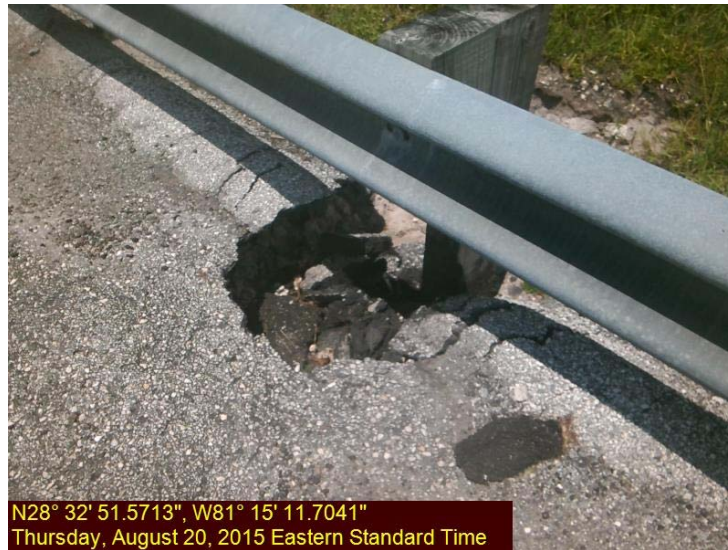
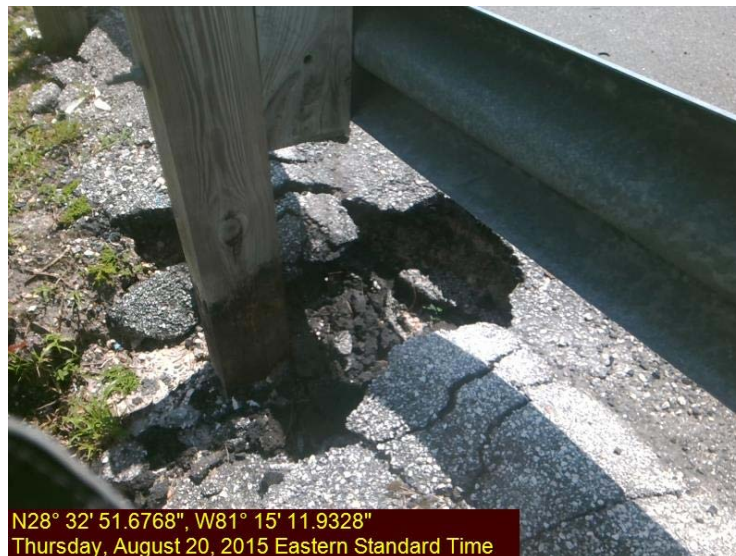
Description: Soil shoulder erosion 30" deep has undermined guardrail asphalt and encroaching into paved shoulder. 12" of paved shoulder has been undermined

Photo 1 – Soil & Paved Shoulder

Photo 2 – Soil & Paved Shoulder

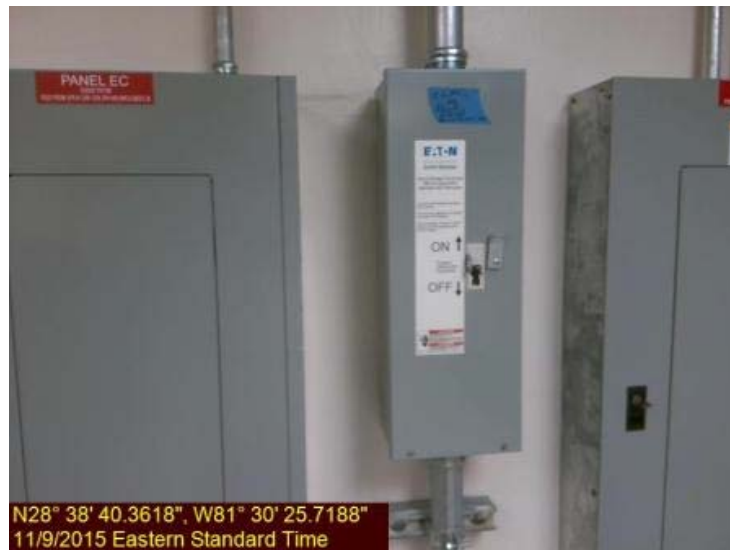
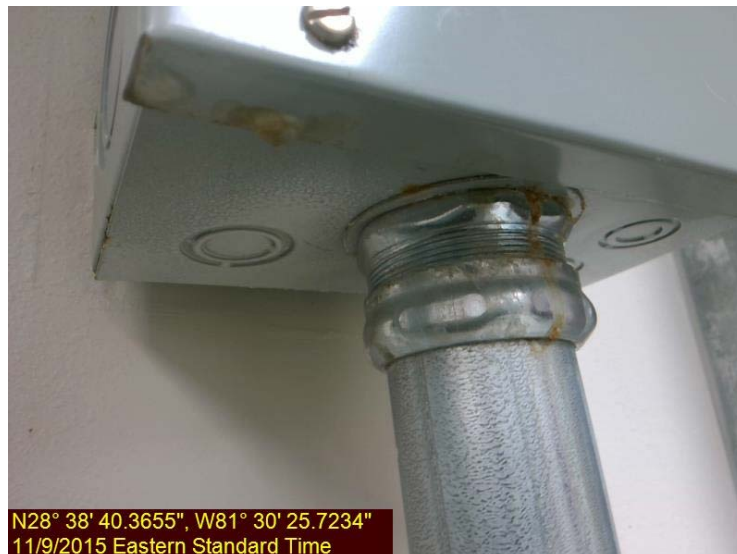
Description: Water dripping from UPS Shutoff switch n Recorder Room.

Photo 1 – UPS Shut off switch

Photo 2 – Water dripping off UPS Shut off switch.

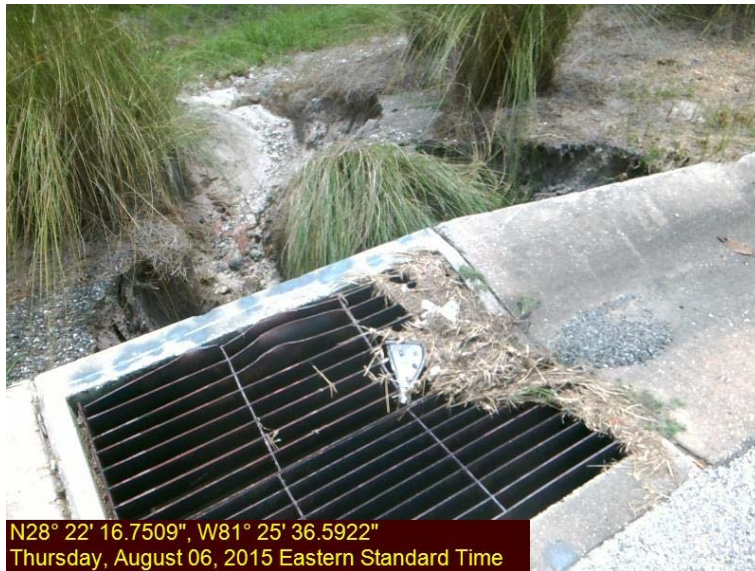
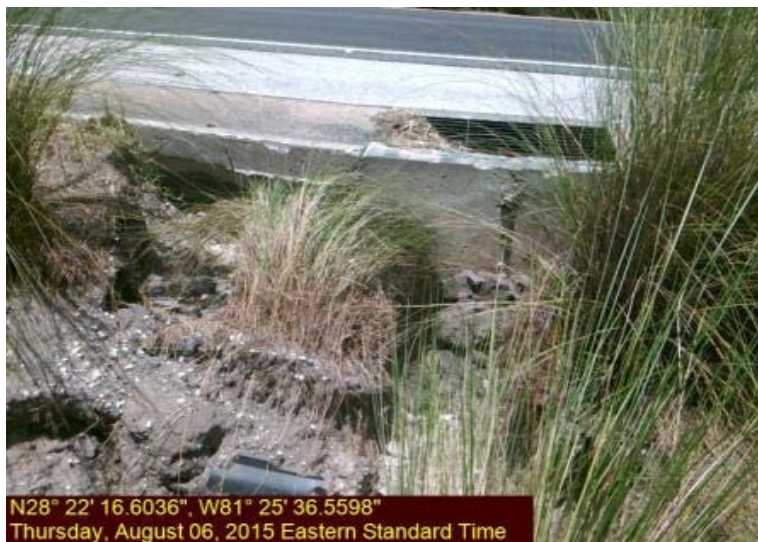
Description: 10' x 15' x 48" Erosion hole and loss of soil shoulder adjacent type S shoulder inlet. Gutter has been undermined.

Photo 1 – Soil Shoulder Erosion

Photo 2 - Soil Shoulder Erosion

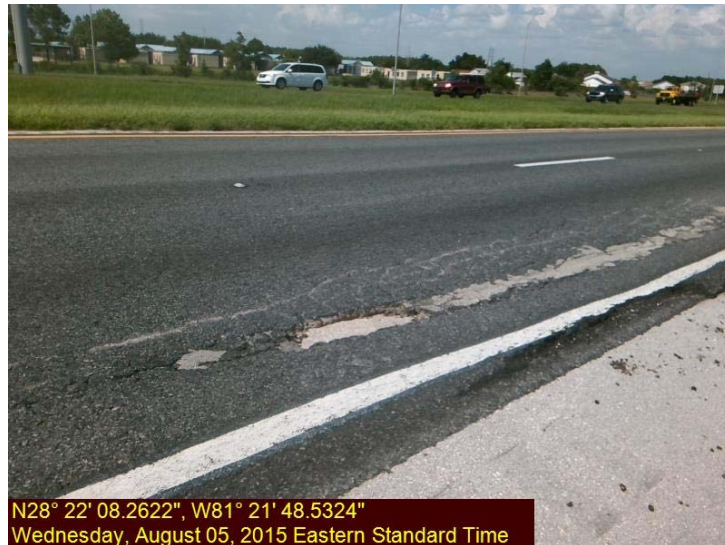
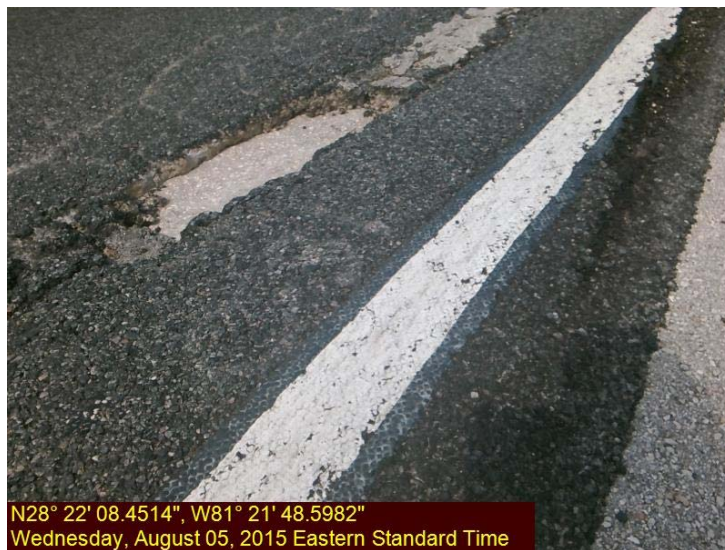
Description: 30" x 6" x 2" Pothole in wheel path of right lane. Friction course missing sub base exposed.

Photo 1 – Pothole

Photo 2 – Pothole - Subbase exposed

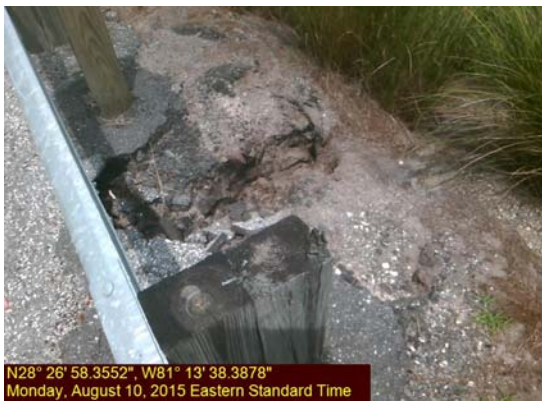
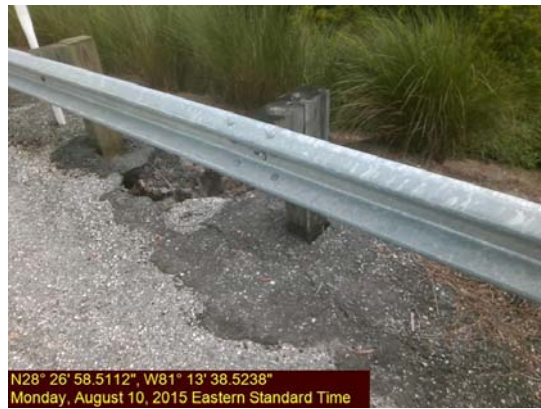
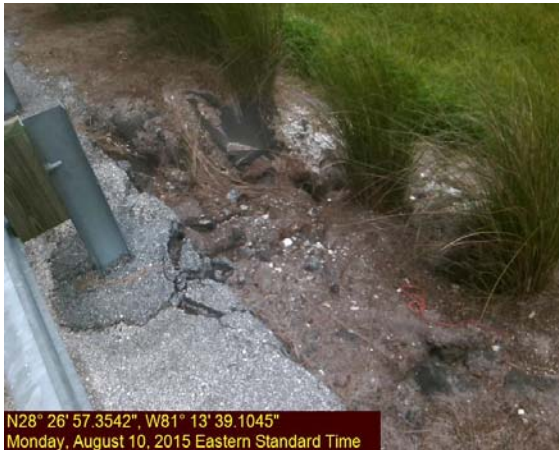
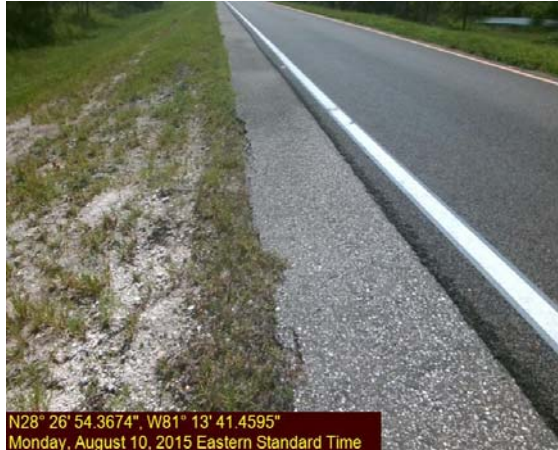
Description: Soil shoulder erosion > 36" in several locations (loss of guardrail asphalt and side slopes)

Photo 1 & 2– Soil Shoulder Erosion

Photo 3 & 4 - Soil Shoulder Erosion

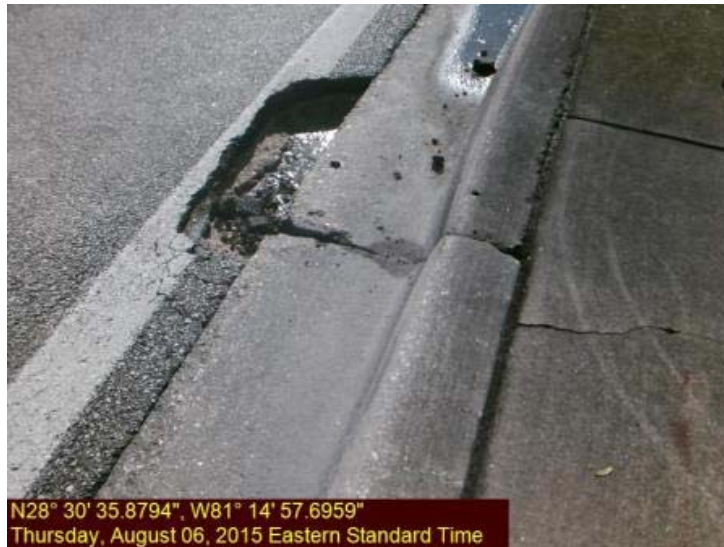
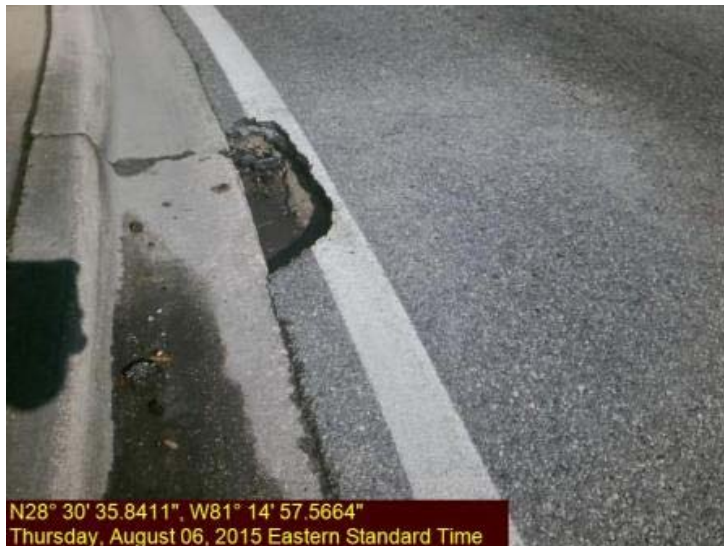
Description: 36" x 12" x 4" Pothole at edge line at beginning of ramp.

Photo 1 – Pothole

Photo 2 – Pothole

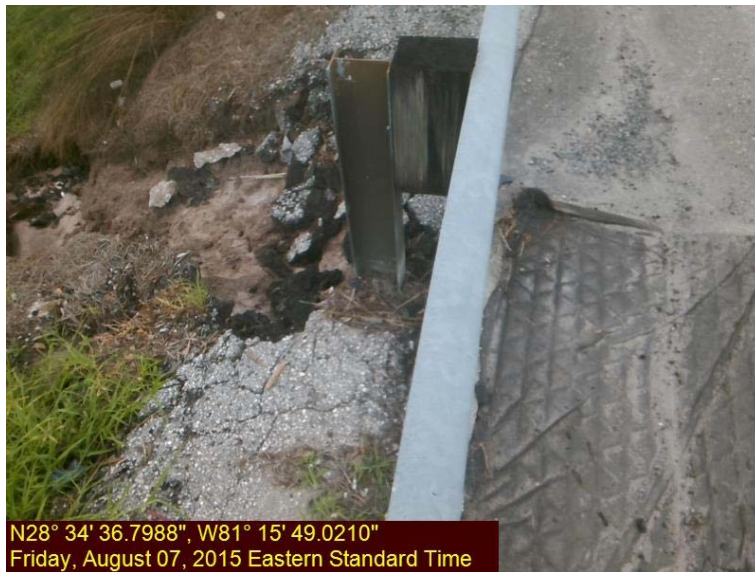
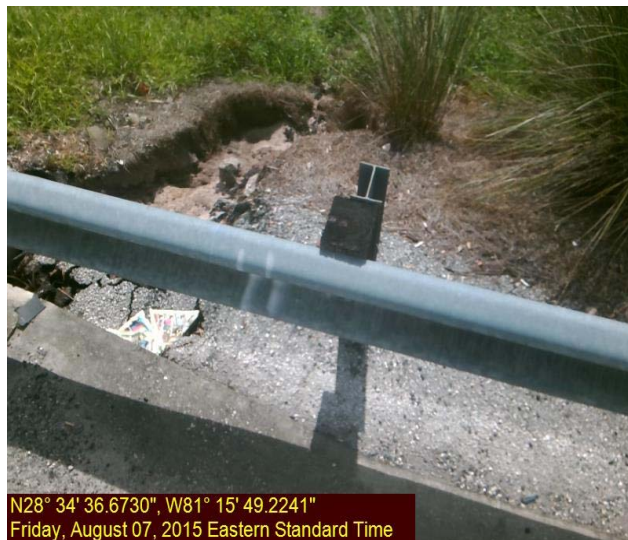
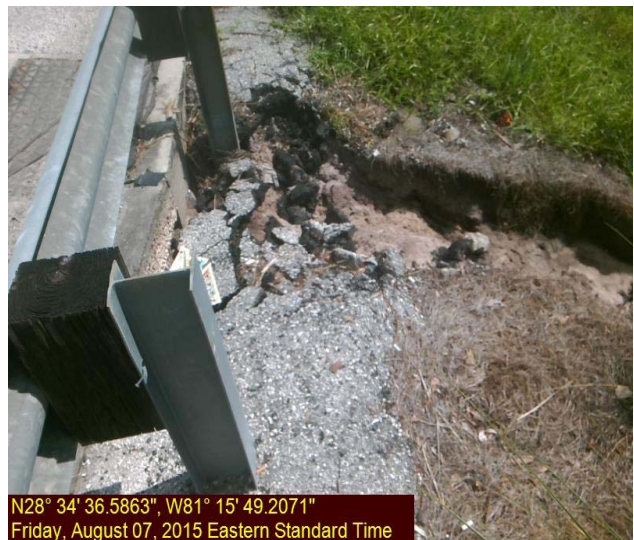
Description: 4' x 15' x 36" Erosion hole and loss of soil shoulder adjacent type S shoulder inlet.

Photo 1 – Soil Shoulder Erosion

Photo 2 & 3 -Soil Shoulder Erosion

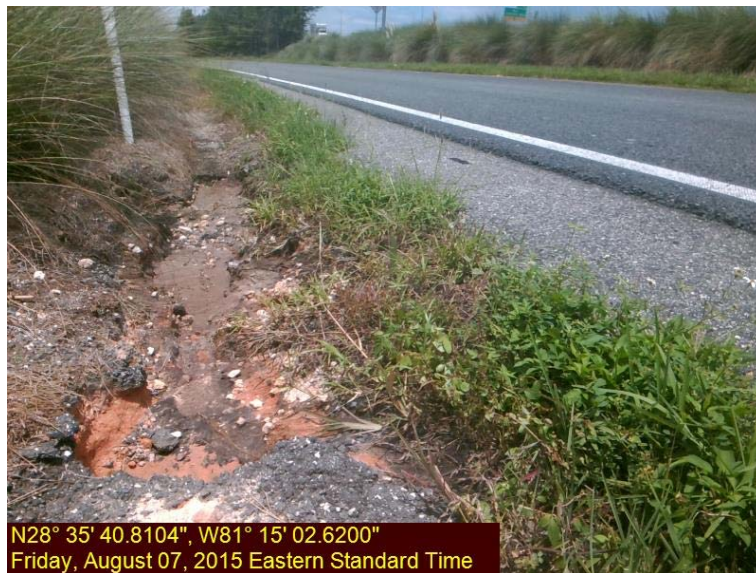
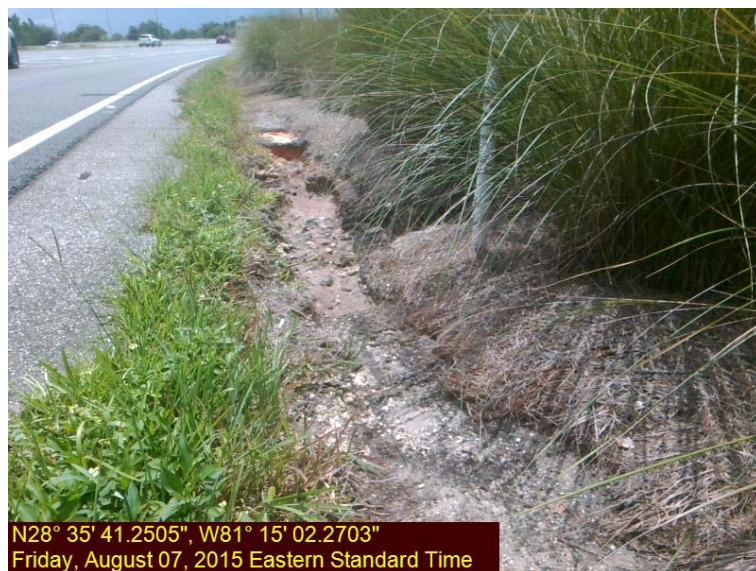
Description: Soil shoulder erosion adjacent travel lane of ramp presents a 24"- 30" drop from edge of pavement.

Photo 1 – Soil Shoulder Erosion

Photo 2 - Soil Shoulder Erosion

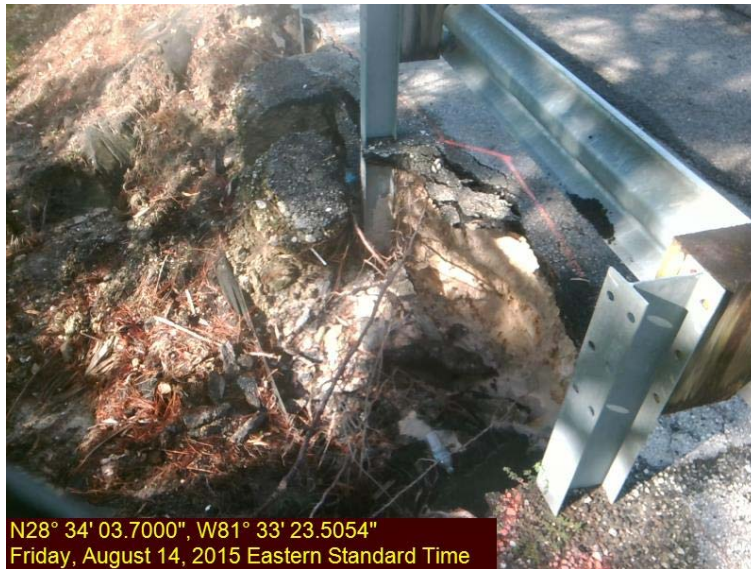
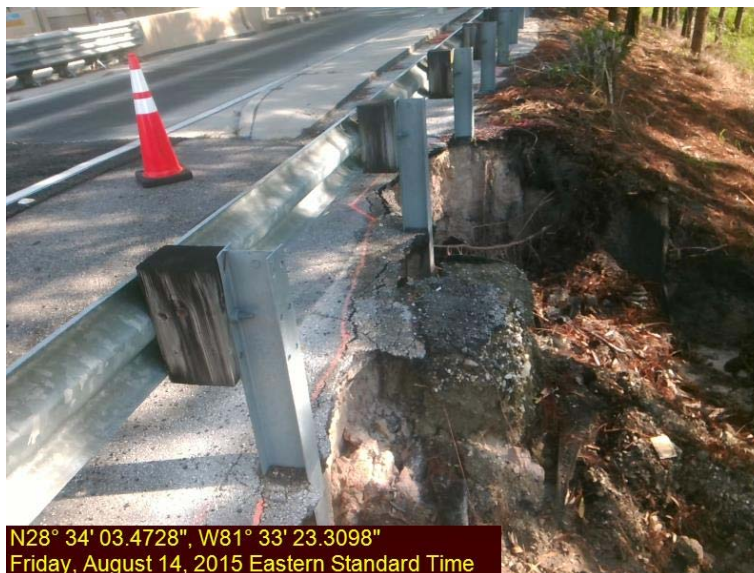
Description: Severe Soil shoulder erosion > 48" Paved shoulder has been undermined.

Photo 1 – Soil Shoulder Erosion

Photo 2 - Soil Shoulder Erosion

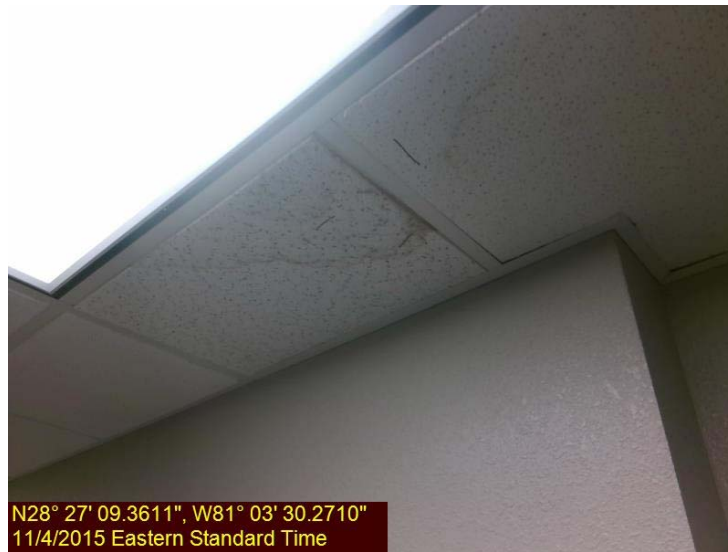
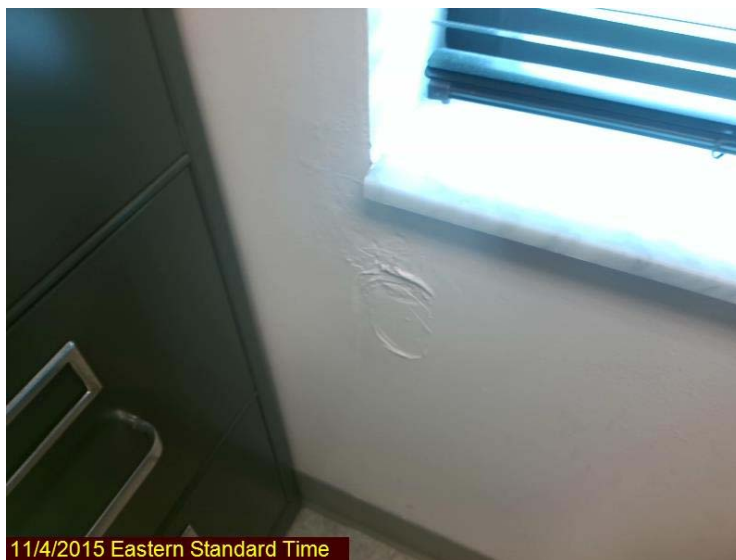
Description: Water intrusion coming from roof in hallway adjacent Storage Room 118. Also, intrusion occurs during periods of heavy rain under all windows on south face of bldg (supervisor's office, manager's office and break room). Water puddles on window sills and overflows onto drywall surface.

Photo 1 – Water intrusion in Hallway

Photo 2 – Drywall damage from water intrusion (Supervisors office)

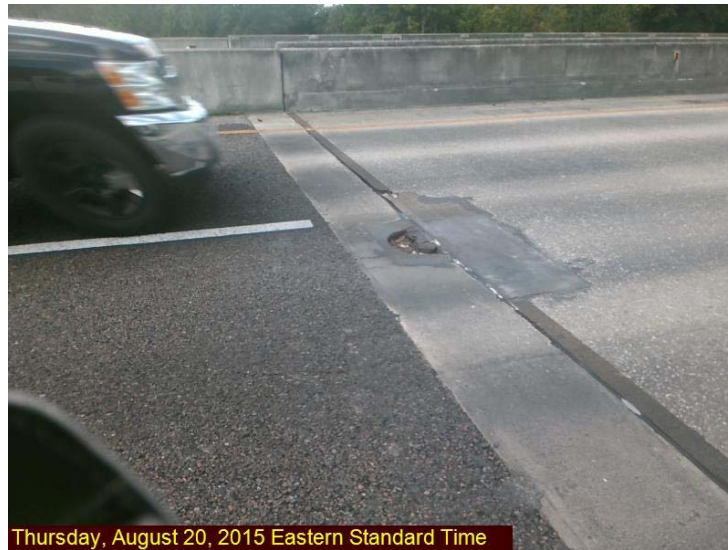
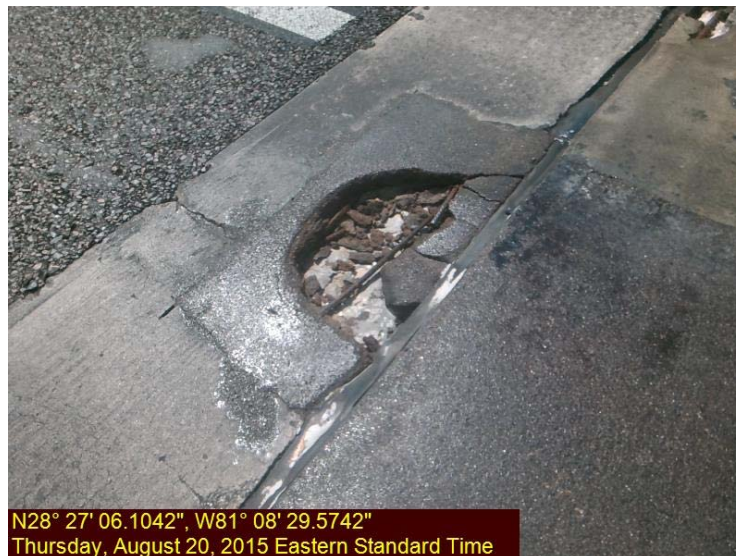
Description: Pothole repair has reopened (rebar exposed). 14" x 12" x 3" pothole in wheel path adjacent east approach ribbon to bridge no. 750056.

Photo 1 – Pothole

Photo 2 – Pothole
