**CULTURAL RESOURCE ASSESSMENT SURVEY FOR THE  
CFX LAKE/ORANGE COUNTY CONNECTOR (US 27 TO STATE ROAD 429)  
FEASIBILITY/PROJECT DEVELOPMENT & ENVIRONMENT STUDY,  
LAKE AND ORANGE COUNTIES, FLORIDA**

**CFX CONTRACT No. 001344, PROJECT No. 599-225  
METRIC ENGINEERING, INC. PROJECT NO. 1.2383  
SEARCH PROJECT No. 180086**

**METRIC ENGINEERING, INC.  
AND  
CENTRAL FLORIDA EXPRESSWAY AUTHORITY**

**MAY 2019**

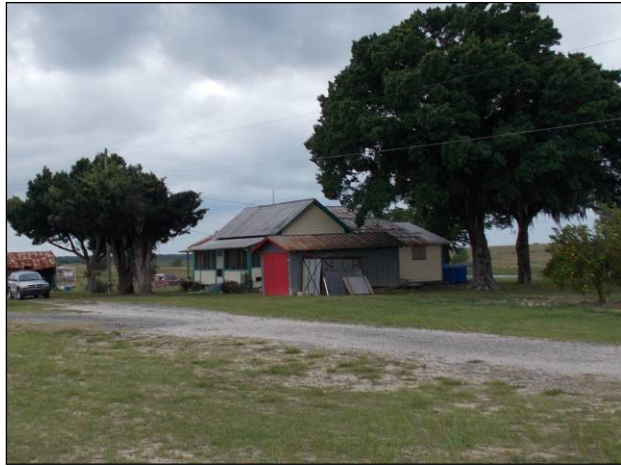
**Figure 25.** Resource 8LA02814 provides an example of the Frame Vernacular style within the Lake-Orange County Connector APE. Photograph facing southwest.

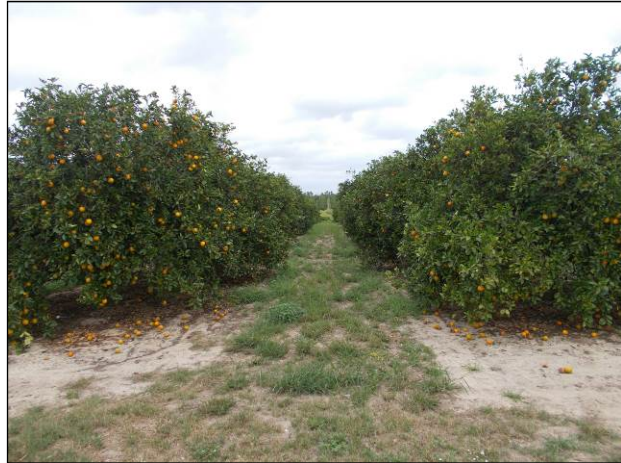
shape and incorporates approximately 94.4 acres of land. 8LA04717 consists of regularly spaced rows of low-headed, central leader style orange trees (**Figure 26**). The rows are primarily oriented east/west with some plots oriented north/south at the northeast and southwest portions of the resource group. Based on review of historic aerials, it appears at least part of the citrus grove was planted, or the land was cleared, by 1947, and trees had grown by 1958. Much of the surrounding area contained groves with discernible trees by 1958 (**Figure 27**). Now the 8LA04717 grove extends to encompass an approximately 227-acre plot of land. However, it is not surrounded by groves as it once was, and is a more isolated occurrence.

**Figure 26. 8LA04717, facing north.**

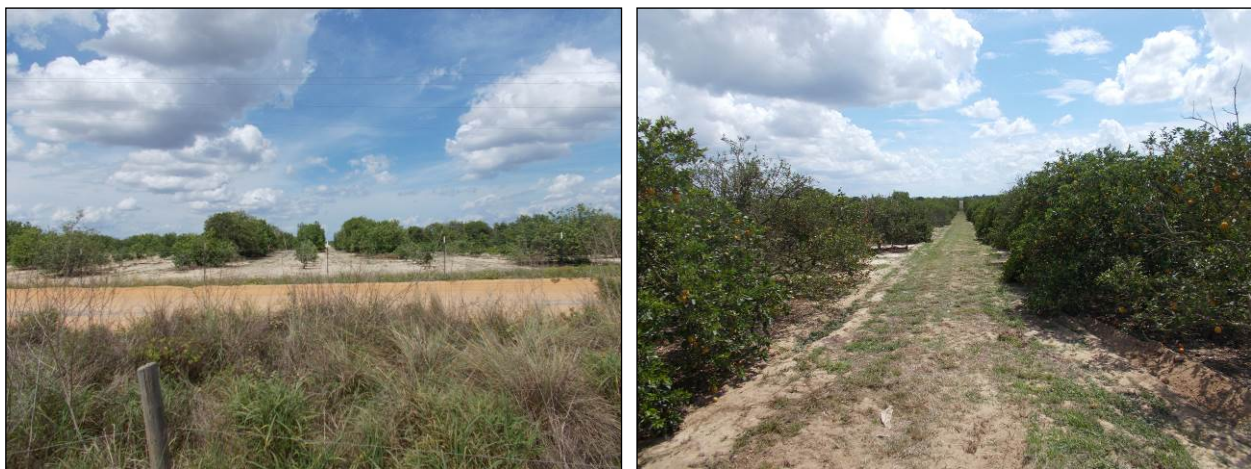
**Figure 28. Representative views of 8LA04727. Left, facing north; right, facing south.**

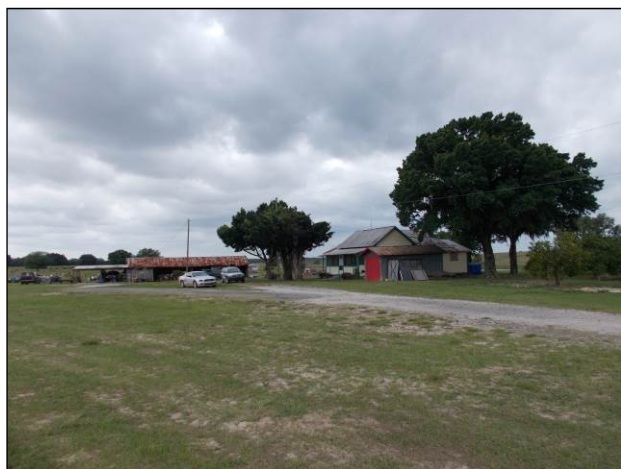
**Figure 30. Representative view of 8LA04731, facing southwest.**

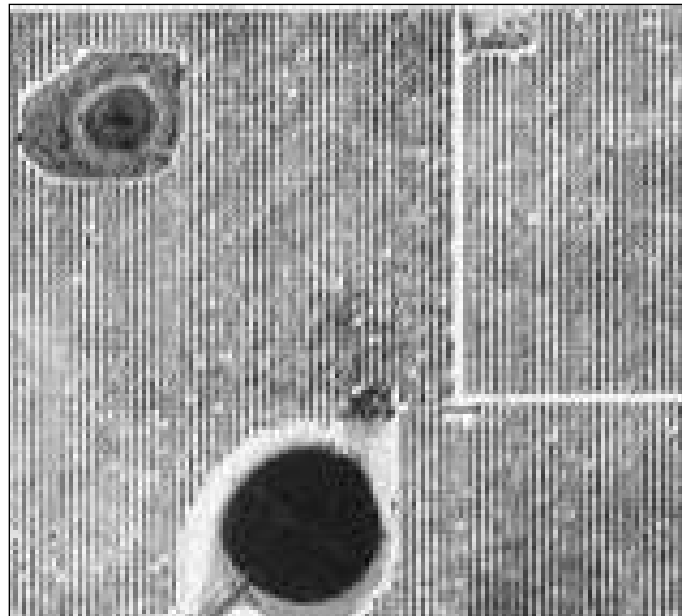
A review of aerial photography revealed a potential inconsistency with Lake County Property Appraiser information. Although property appraiser states that the Frame Vernacular residence (8LA02814) was constructed in 1925, a building is not visible in its current location until approximately 1969. The structure is not visible on aerials from 1958 within the area where it is currently located, and a search of the larger parcel was not fruitful (Figure 31). It appears that 8LA02814 was either moved to its current location in the 1960s or it was not constructed until the 1960s, as it is not seen until a 1969 aerial (Figure 32). Additional details gleaned from the 1969 aerial (see Figure 32) include: a set of buildings southwest of

Figure 31. Close up of the 1320 Schofield Road parcel where 8LA02814 should be located in 1958 (USDA 1958b).

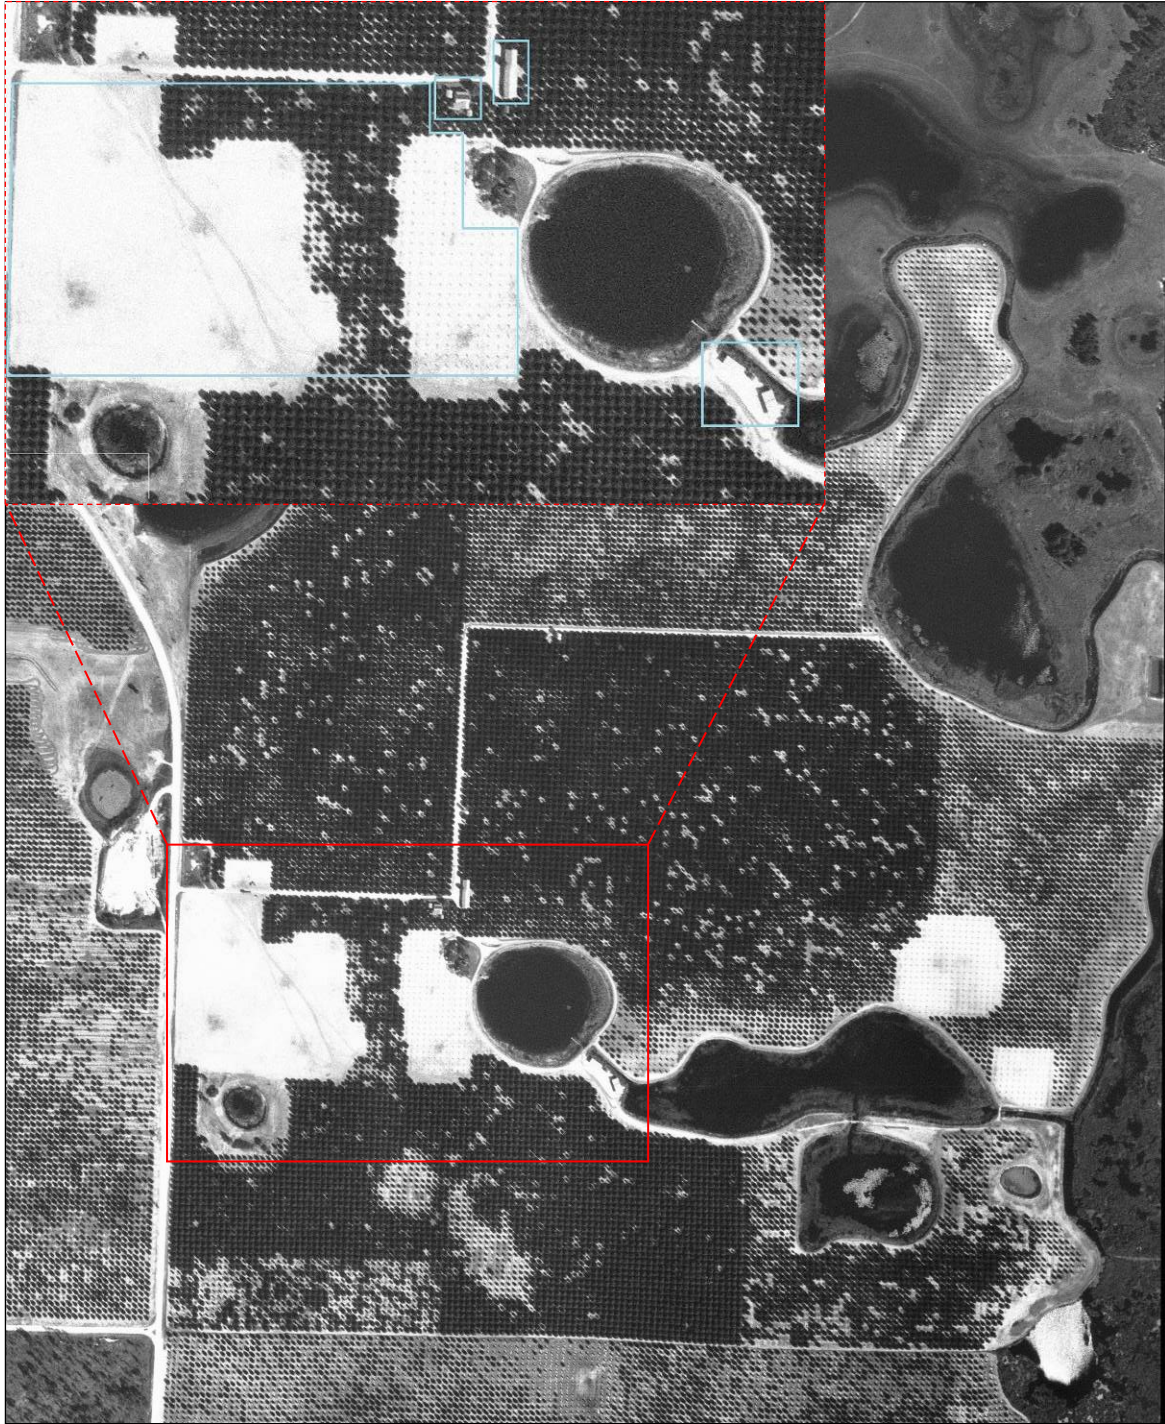
the lake below 8LA02814 which are no longer extant; roadways through the parcel providing access routes through the citrus groves; and a larger portion of the parcel used for citrus cultivation. It is unknown what specific use the demolished buildings provided, as there is no record available detailing their purpose and no artifacts related to their use were found in the area. The extant barn (8LA04795) appears to now be used for storage rather than any particular citrus grove related use. By 1974, it appears the buildings southwest of the lake were connected. Another now-demolished building appears to be present to the east of the intersection of Schofield Road and the 17320 Schofield Road driveway (Figure 33). Present-day aerials indicate that those two building are no longer extant. Furthermore, present-day aerials detail the degradation of the 17320 Schofield Road Barn (8LA04795), where part of the

Figure 32. 1969 FDOT aerial of 17320 Schofield Road Resource Group (8LA04731). Blue borders highlight relevant buildings or resources. Buildings to the southwest of the lake are no longer extant (FDOT 1969).

The 8LA04731 resource group has undergone a loss of integrity. Changes to the overall resource group include: demolition of buildings present in the 1960s and 1970s; loss of land used for citrus groves since 1958; loss of access roads; natural changes to lake boundaries; and alterations and additions to contributing resources.

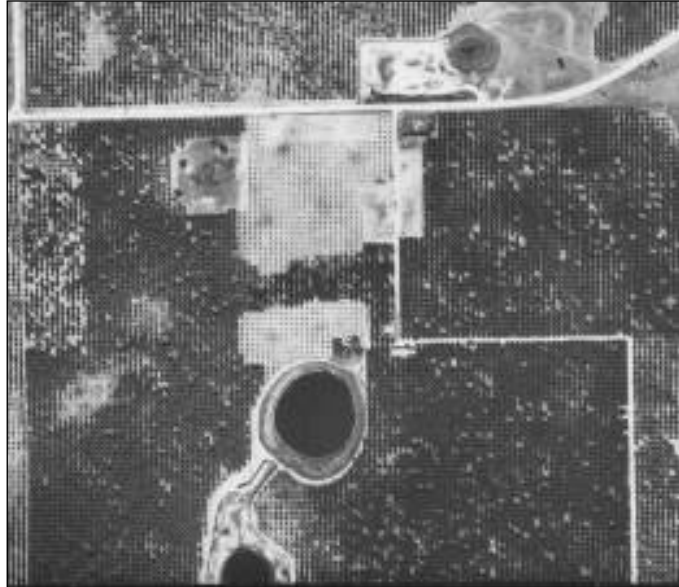
Figure 33. 8LA04731 in 1974 (USDA 1974).

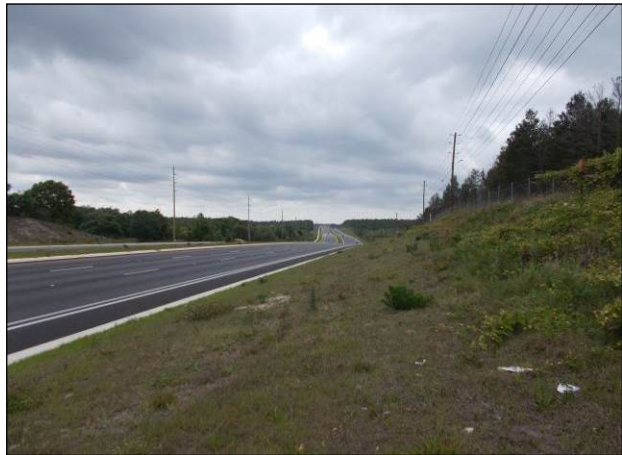
US Highway 27 (8LA04779) is a newly recorded historic road located in Lake County (see **Figure 24; Appendix E**). The resource is situated in Section 33 of Township 23 South, Range 26 East and Sections 3, 4, and 10 of Township 24 South, Range 26 East, as shown on the 2018 *Lake Louisa, Fla.* USGS quadrangle map. Within the APE, the road runs northwest to southeast for about 2.15 miles (3.45 kilometers), beginning from about 0.32 miles (0.5 kilometers) north of South Bradshaw Road and continuing to a point about 207.8 feet (63.3 meters) south of Riddick Grove. The segment of 8LA04779 within the APE is a six-lane modern asphalt-paved highway with turning lanes, concrete and grassy medians, bike lanes, and U-turn ramps (**Figure 34**).

**Figure 34. Representative view of 8LA04779, facing south.**

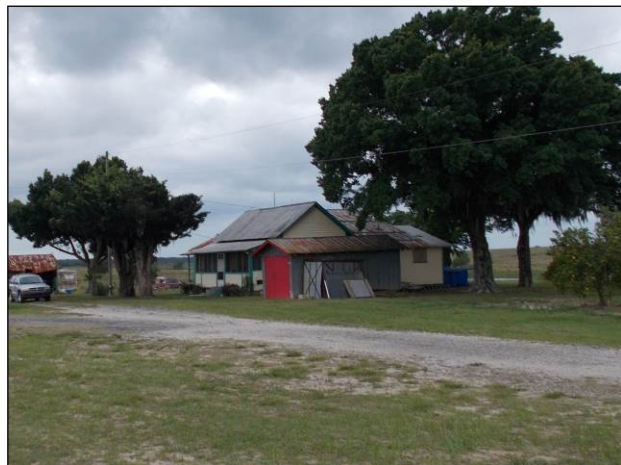
17320 Schofield Road (8LA02814) is a previously recorded structure in Lake County (see **Figure 24; Appendix E**). The resource was determined ineligible for the NRHP by SHPO on March 26, 2006 (ESI 2005b). 8LA02814 is situated in Section 36 of Township 23 South, Range 26 East, as shown on the 2018 *Lake Louisa, Fla* USGS quadrangle map. The structure is located on a large, irregularly shaped parcel bounded by Schofield Road to the north, the Orange County/Lake County line to the east, and private parcels to the south and west. The ca. 1925 (year taken from Lake County Property Appraiser) building is a one story, irregular plan Frame Vernacular residence set on a concrete pier foundation (**Figure 35**). The gable roof is clad with corrugated sheet metal and exposed rafter tails can be seen in some places along the roofline. The exterior material consists of drop siding and wood board. The only window visible from the right-of-way is boarded over. An enclosed raised porch addition is located on the east façade. It is covered by a shed roof and is accessed by concrete stairs leading to a screened storm door. It appears that the main entrance is located within the enclosed porch.

**Figure 35. Resource 8LA02814, facing southwest.**

A review of aerial photography revealed a potential inconsistency with Lake County Property Appraiser information. Although property appraiser states that the Frame Vernacular residence (8LA02814) was constructed in 1925, a building is not visible in its current location until approximately 1969. The structure is not visible on aerials from 1958 within the area where it is currently located, and a search of the larger parcel was not fruitful (see **Figure 32**). It appears that 8LA02814 was either moved to its current location in the 1960s or it was not constructed until the 1960s (see **Figure 33**).

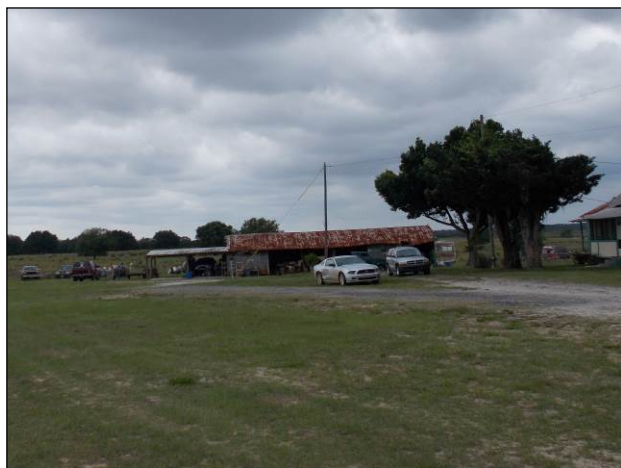
17320 Schofield Road Barn (8LA04795) is a newly recorded structure in Lake County (see **Figure 24; Appendix E**). 8LA04795 is situated in Section 36 of Township 23 South, Range 26 East, as shown on the 2018 *Lake Louisa, Fla* USGS quadrangle map. The structure is located on a large, irregularly shaped parcel bounded by Schofield Road to the north, the Orange County/Lake County line to the east, and private parcels to the south and west. The ca. 1925 building is a one-story, rectangular-plan Frame Vernacular barn set on a foundation obscured from view from the right-of-way (**Figure 36**). The gable roof is clad with corrugated sheet metal. Exterior

**Figure 36. Resource 8LA04795, facing southwest.**

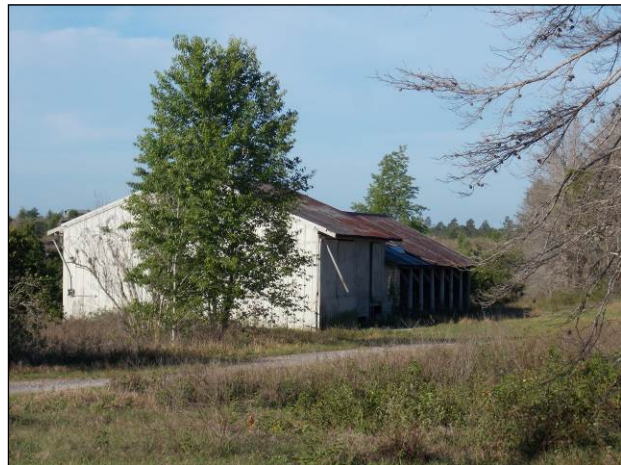
5005 US 27 Barn (8LA04796) is a newly recorded structure in Lake County (see **Figure 24; Appendix E**). 8LA04796 is situated in Section 4 of Township 24 South, Range 26 East as shown on 2018 *Lake Louisa, Fla* USGS quadrangle map. The structure is located on a large, irregularly shaped parcel bounded by US 27 to the east, and private parcels to the north, south, and west. The ca. 1945 building is a one-story, rectangular plan Frame Vernacular barn set on a foundation obscured from view from the right of way (**Figure 37**). The gable roof is clad with corrugated sheet metal. The exterior material consists of board and batten, vertical plank, and drop siding. Windows consist of one over one, double hung sash wood windows and two over two, single hung sash aluminum windows. The western end of the north façade is open and features straight, unornamented columns. It appears there might be a sliding wood door on the north façade. Based on the Lake County Property Appraiser database and field observation, the western segment appears to have been a ca. 1950s addition.

Figure 37. Resource 8LA04796, facing west.

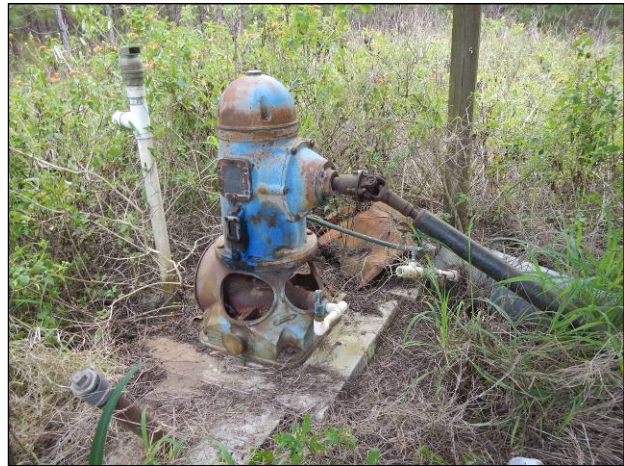
The Amarillo/Jacuzzi Bros. Water Pump (8OR11171) is a newly recorded object in Orange County (**Figure 24; Appendix E**). 8OR11171 is situated in Section 31 of Township 23 South, Range 27 East, as shown on the 2018 *Lake Louisa, Fla* USGS quadrangle map. The object is located on a large, irregularly shaped parcel with the address of 17000 Schofield Road. 8OR11171 features a Jacuzzi Bros, Inc. pump and an Amarillo Welding and Machine Works right angle pump drive (**Figure 38**). 8OR11171 is covered by a nonhistoric open shed and is surrounded by pine trees planted around 2011. The object is

**Figure 38. Resource 8OR11171, facing northeast.**

adjacent to the intersection of Irene Tilden Road and C.G. Tilden Road. Although 8OR11171 is difficult to date to an exact year, Amarillo Welding and Machine Works changed its name in 1964 to the Amarillo Gear Company, after it was purchased by the Marmon group (Amarillo Gear Company 2018). The use of the Amarillo Welding and Machine Works name on the pump drive implies, then, that 8OR11171 was constructed before 1964. This area is now planted with pine trees; however, aerial photographs indicate that this area contained citrus groves as early as 1941 (USDA 1941). There appear to have been groves in this area until approximately 2011, when the land was cleared. This places the pump in association with the history of citrus in the Clermont area, described above.

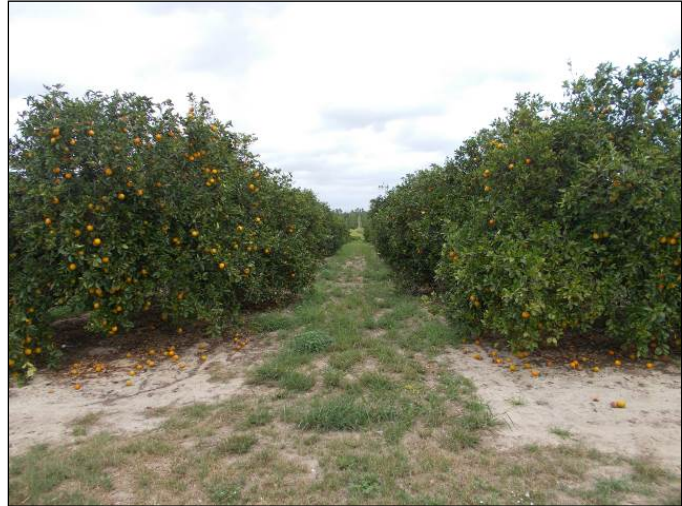
**Figure 15. Resource 8LA04717, facing north.**

(**Figure 15**). The rows within the Lake/Orange County Connector Ponds APE are primarily oriented north/south with some plots oriented east/west at the portion of this section of the resource group. Based on review of historic aerials, it appears at least part of the citrus grove was planted, or the land was cleared, by 1947, and trees had grown by 1958. Much of the surrounding area contained groves with discernible trees by 1958 (**Figure 16**). At present, the 8LA04727 grove extends to encompass an approximately 227-acre (92-hectare) plot of land. However, it is not surrounded by groves as it once was and is a more isolated occurrence.

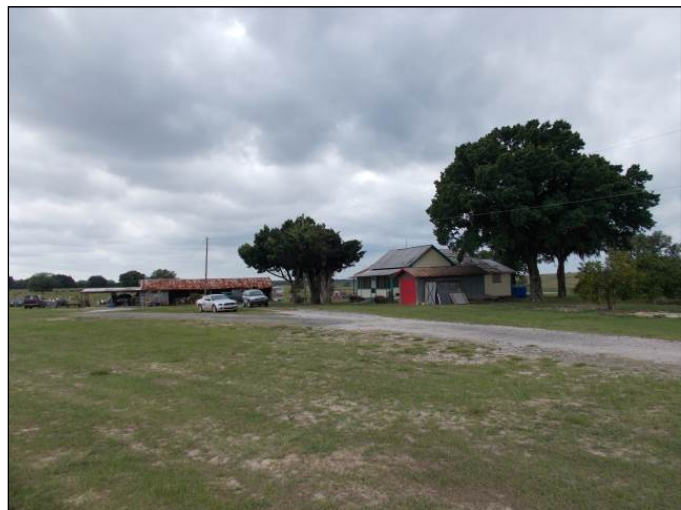
The 17320 Schofield Road Resource Group (8LA04731) is a newly recorded resource group within Lake County (see **Figures 12-13**). The resource group is situated in Section 36 of Township 23 South, Range 26 East, as shown on the 2018 *Lake Louisa, Fla.* USGS quadrangle map. Resource 8LA04731 is an irregularly-shaped resource group with boundaries matching those of tax parcel 36-23-26-0002-000-00100. It is bounded to the north by Schofield Road and to the east by the Lake County line. The resource group consists of three historic resources (8LA02814, 8LA04727, and 8LA04795) (**Figure 17**). None of the three historic resources within this resource group fall within the Lake/Orange County Connector Ponds APE. The particular section of 8LA04731 intersected by the Lake/Orange County Connector Ponds APE is comprised of unplanted land, ponds, and occasional trees. The ponds proposed within this resource group, collectively, occupy approximately 99.3 acres (40.2 hectares).

**Figure 17. Representative view of 8LA04731, facing southwest.**

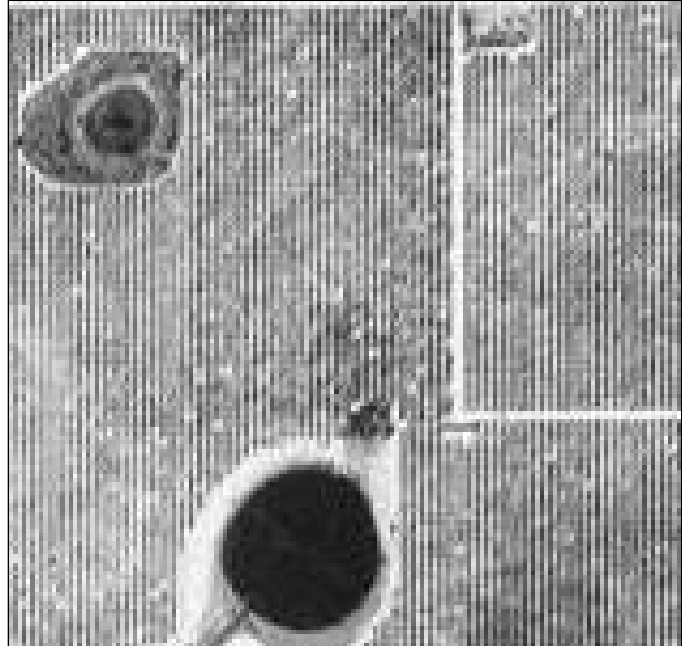
A review of aerial photography revealed a potential inconsistency with Lake County Property Appraiser information. Although property appraiser states that the Frame Vernacular residence (8LA02814) was constructed in 1925, a building is not visible in its current location until approximately 1969. The structure is not visible on aerials from 1958 within the area where it is currently located, and a search of the larger parcel was not fruitful (**Figure 18**). It appears that 8LA02814 was either moved to its current location in the 1960s or it was not constructed until the 1960s (**Figure 19**). Additional details gleaned from the 1969 aerial (see **Figure 19**) include a set of buildings southwest of the lake below 8LA02814, which are no longer extant; roadways

**Figure 18. Close up of the 17320 Schofield Road parcel where 8LA02814 should be located (Source: USDA 1958b).**

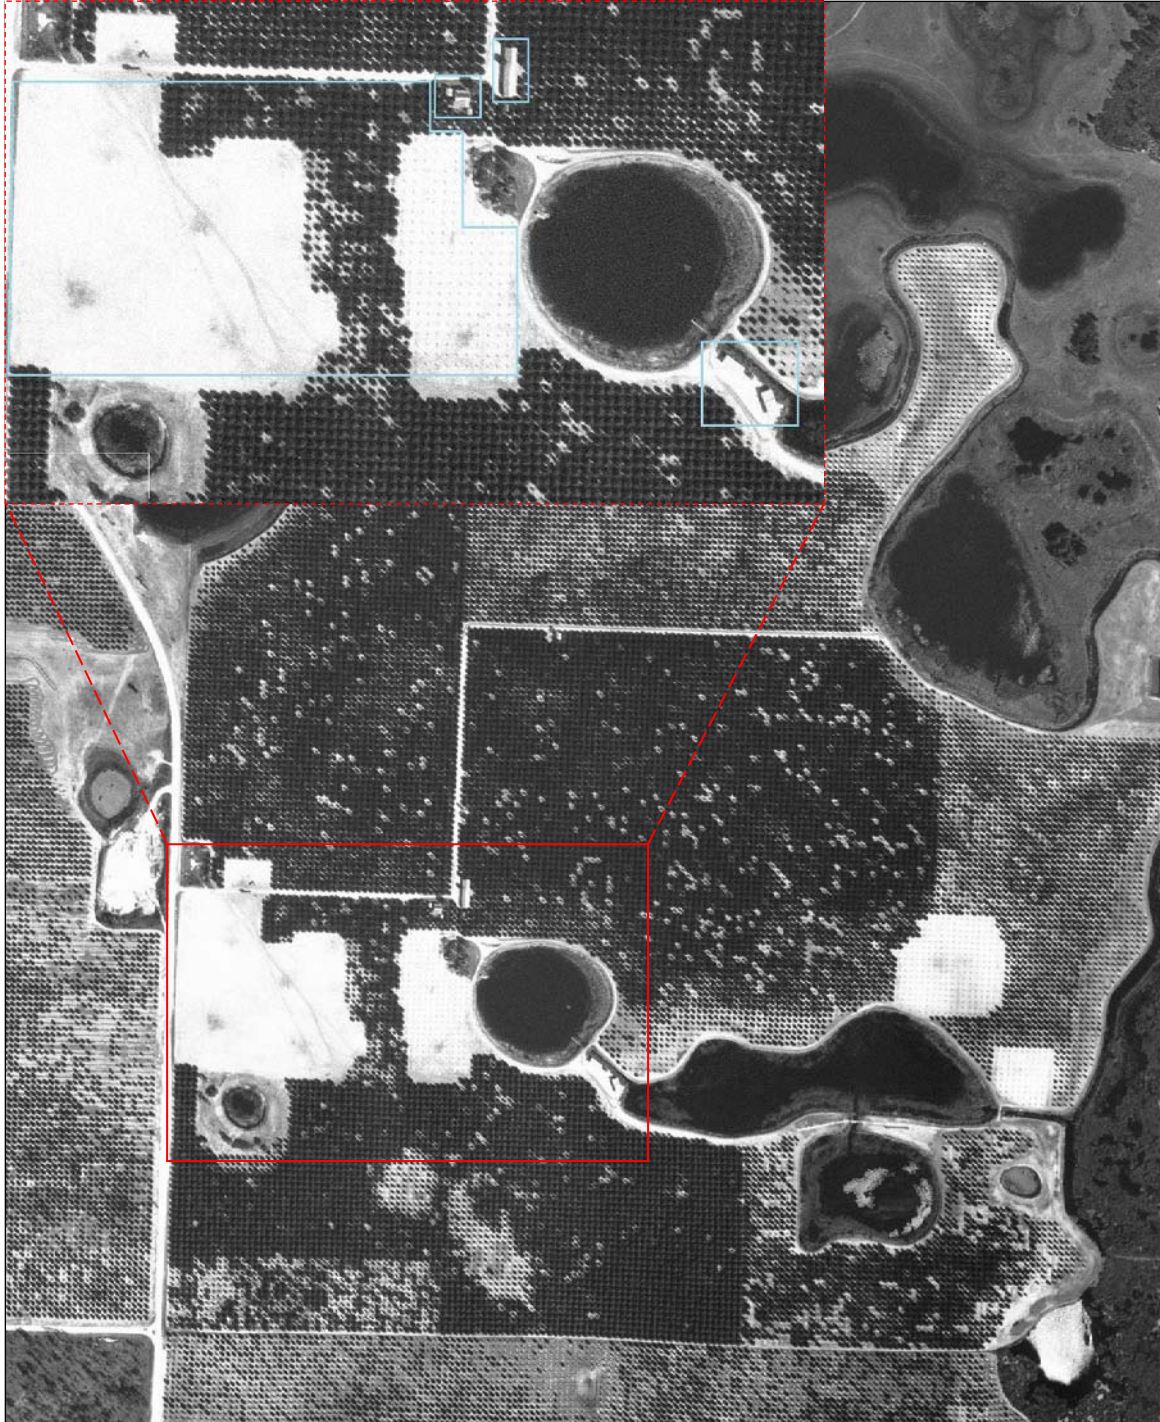
The surrounding Clermont area was known for its citrus production from the 1920s through to the 1980s, when freezes and development began its decline. No particular associations regarding the 17320 Schofield Road Resource Group (8LA04731) were found during background research.

Figure 19. 1969 FDOT aerial of 17320 Schofield Road Resource Group (8LA04731). Blue borders highlight relevant buildings or resources. Buildings to the southwest of the lake are no longer extant (FDOT 1969).

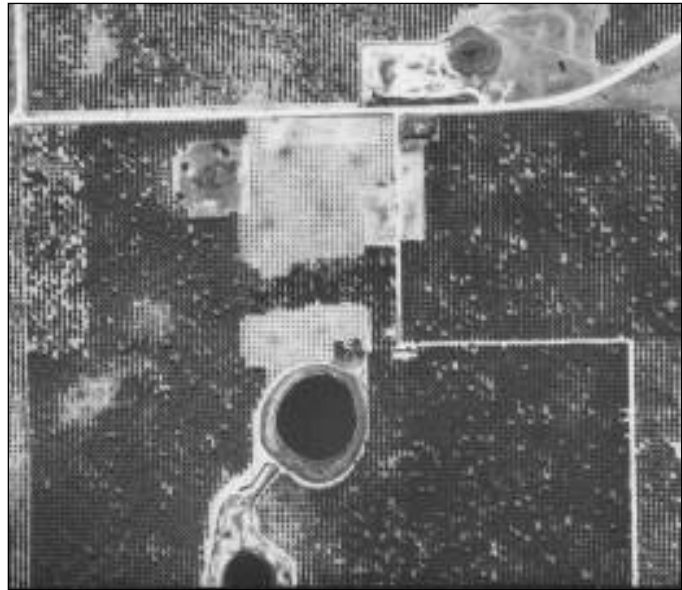
The house (8LA02814) has undergone alterations and additions, as seen in the enclosed porch on the east façade, the rectangular addition to the west façade, the metal roofing, and the boarded windows. Groves no longer abut the resource. Based on property appraiser

Figure 20. Resource 8LA04731 in 1974 (Source: USDA 1974).

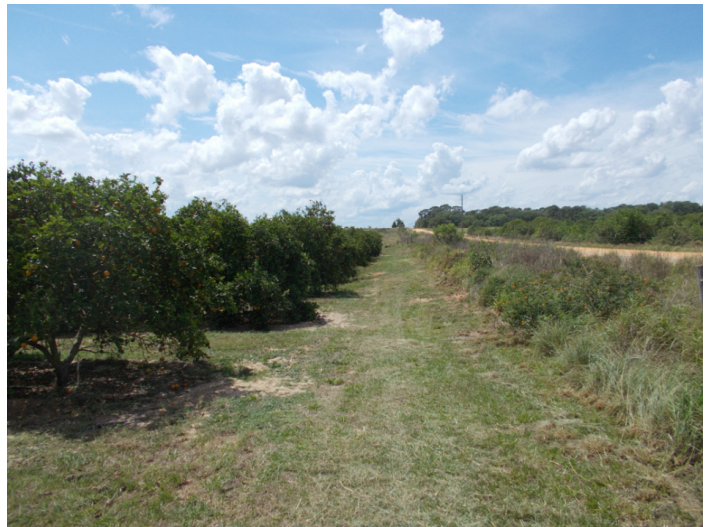
**8LA04727\_d Facing West**

2) Name USGS Date
Plat, Aerial, or Other Map (map's name, originating office with location)
Landgrant
Verbal Description of Boundaries (description does not replace required map) 8LA04727 is a roughly rectangular citrus grove beginning at Shell Pond Rd and running S for about 0.24 mi (0.38 km). It is bounded to the E by the 17320 Schofield Rd driveway and runs W for a maximum of 701.3 ft (213.8 m).

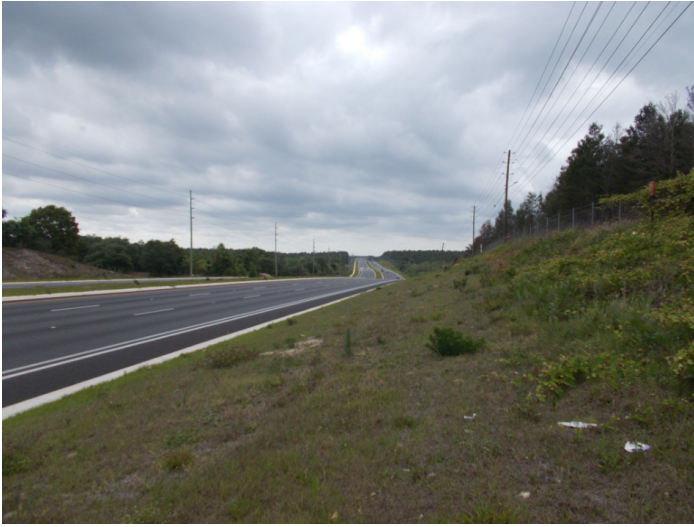
**8LA04779\_a Facing South**

2) Name \_\_\_\_\_ USGS Date \_\_\_\_\_  
 Plat, Aerial, or Other Map (map's name, originating office with location) \_\_\_\_\_  
 Landgrant \_\_\_\_\_  
 Verbal Description of Boundaries (description does not replace required map) Within the APE, 8LA04779 runs roughly NW-SE for about 2.15 mi (3.45 km), beginning from about 0.32 mi (0.52 km) N of S Bradshaw Rd and ending about 207.8 ft (63.3 m) S of Riddick Grove Rd.

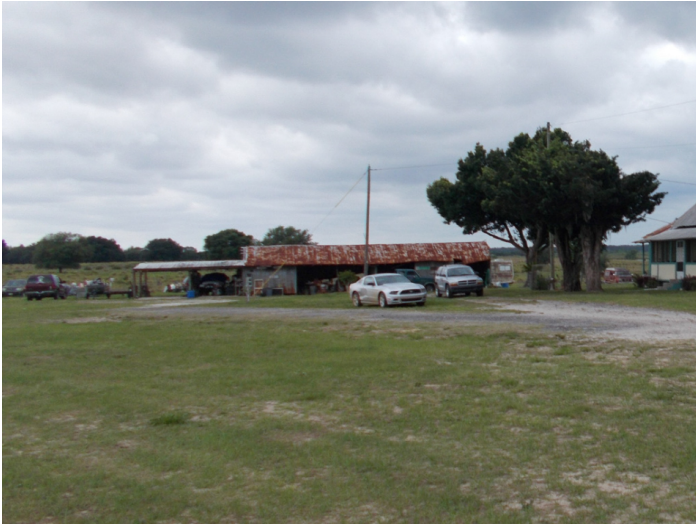
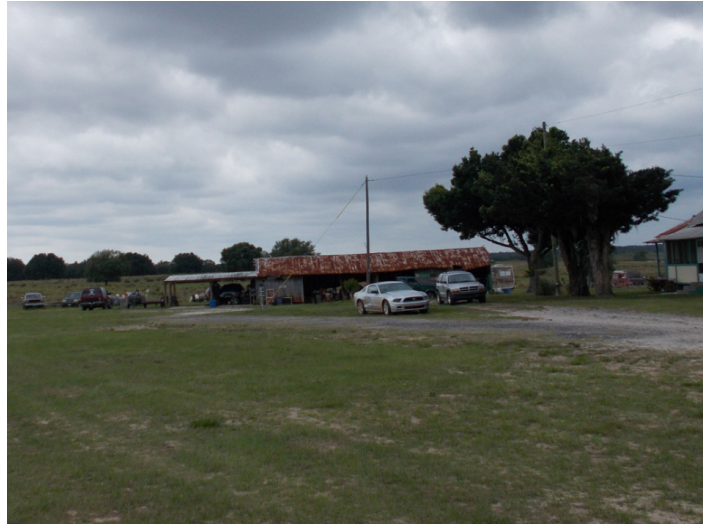
8LA04795\_a Facing Southwest

Chimney: No. \_\_\_\_ Chimney Material(s): 1. \_\_\_\_\_ 2. \_\_\_\_\_  
 Structural System(s): 1. Wood frame 2. \_\_\_\_\_ 3. \_\_\_\_\_  
 Foundation Type(s): 1. Unknown 2. \_\_\_\_\_  
 Foundation Material(s): 1. Other 2. \_\_\_\_\_  
 Main Entrance (stylistic details) Open sided N facade

Narrative Description of Resource Resource 8LA04795 is a single-story wood frame barn on an obscured foundation. It is part of the 17320 Schofield Road resource group (8LA04731).

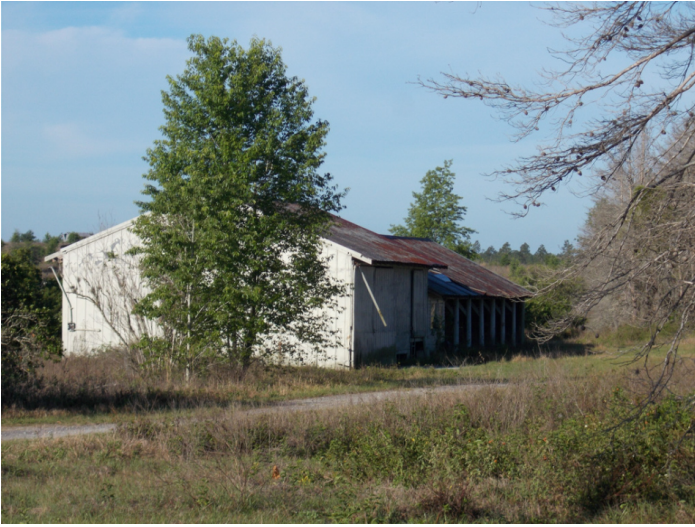
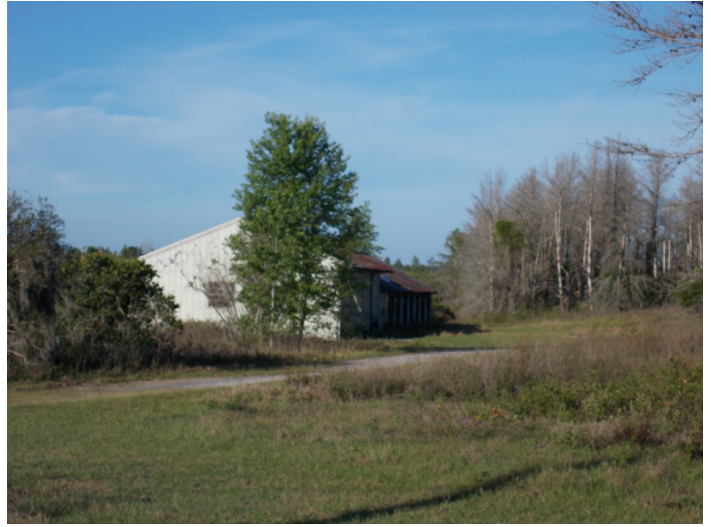
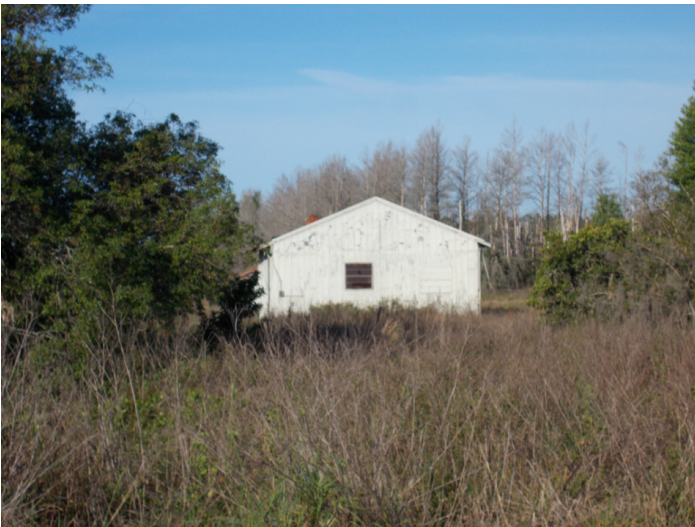
**8LA04796\_a Facing West**

Chimney: No. \_\_\_\_ Chimney Material(s): 1. \_\_\_\_\_ 2. \_\_\_\_\_  
 Structural System(s): 1. Wood frame 2. \_\_\_\_\_ 3. \_\_\_\_\_  
 Foundation Type(s): 1. Unknown 2. \_\_\_\_\_  
 Foundation Material(s): 1. Other 2. \_\_\_\_\_  
 Main Entrance (stylistic details) Potential sliding wood door along N facade; N facade, W end open

Narrative Description of Resource Resource 8LA04796 is a single-story rectangular plan Frame Vernacular barn on a foundation obscured from view from the right of way.

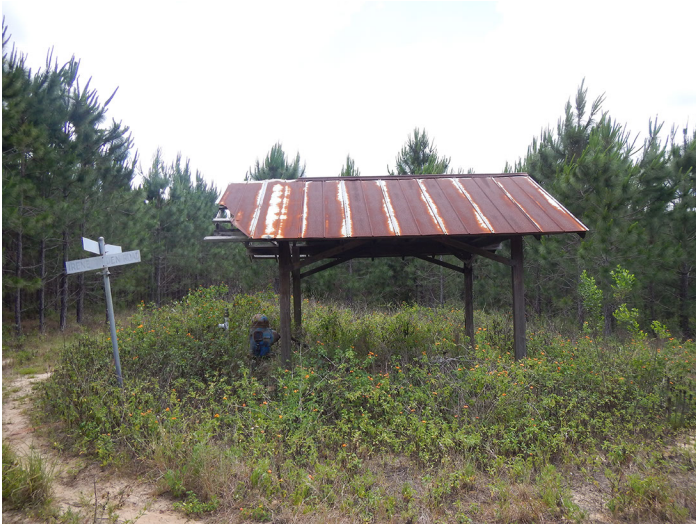
8OR11171\_a Facing South

Ancillary Features / Outbuildings (record outbuildings, major landscape features; use continuation sheet if needed.)  
An open, non historic shed covers 8OR11171. Citrus groves have been replaced w/pine trees, and the parcel now flanks Florida Toll 429.

Although associated w/history of citrus in Clermont and tangentially associated w/Jacuzzi Bros, Inc, inventions, 8OR11171 lacks the historic integrity necessary and is recommended ineligible for the NRHP.
