**APPENDIX D:**  
***National Register of Historic Places* Request for Determination of Eligibility: Strite  
House (8OR9844)**

**NATIONAL REGISTER OF HISTORIC PLACES  
REGISTRATION FORM**

historic name Strite House

street & number 6229 Plymouth-Sorrento Road ☐ not for publication

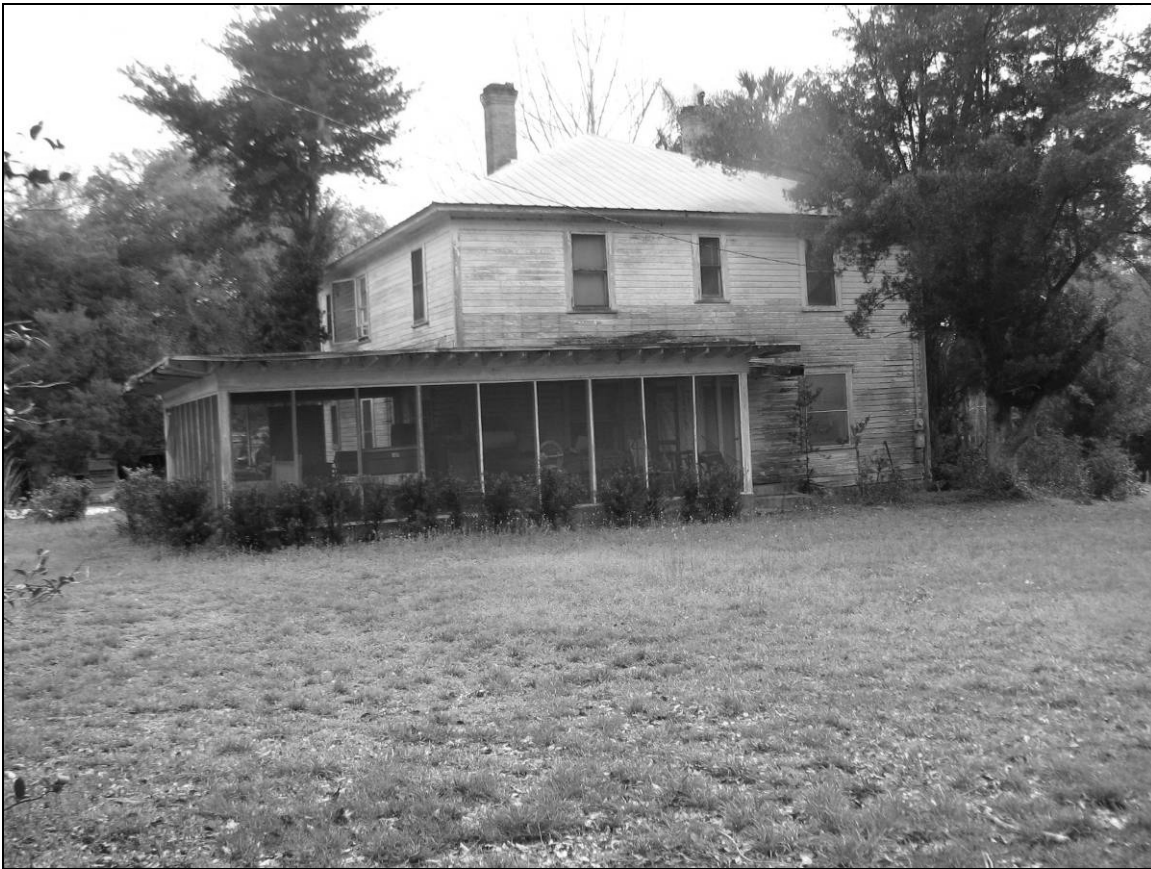
1. Strite House Front and Side Facades
2. Orange County, Florida
3. February 2008
4. Janus Research
5. Amy Streelman
6. Facing Southeast
7. Photograph 1 of 13

The Strite House is two stories tall and has a symmetrical front facade; in keeping with its Georgian form (Photograph 1). The façade is divided into three bays with the entrance centrally located and a single window on each side. The second floor fenestration matches that of the first floor with a central window in place of the door. The building is topped by a pyramidal roof clad in 5-V sheet metal. A one-story kitchen ell extends off the rear and is topped by a hipped roof clad in 5-V sheet metal. A small second story sleeping porch also extends off the rear and is set on top of the kitchen ell. This room is covered with a hipped roof clad in 5-V sheet metal as well (Photograph 2). The wood frame structural system is clad with drop siding and rests on a continuous

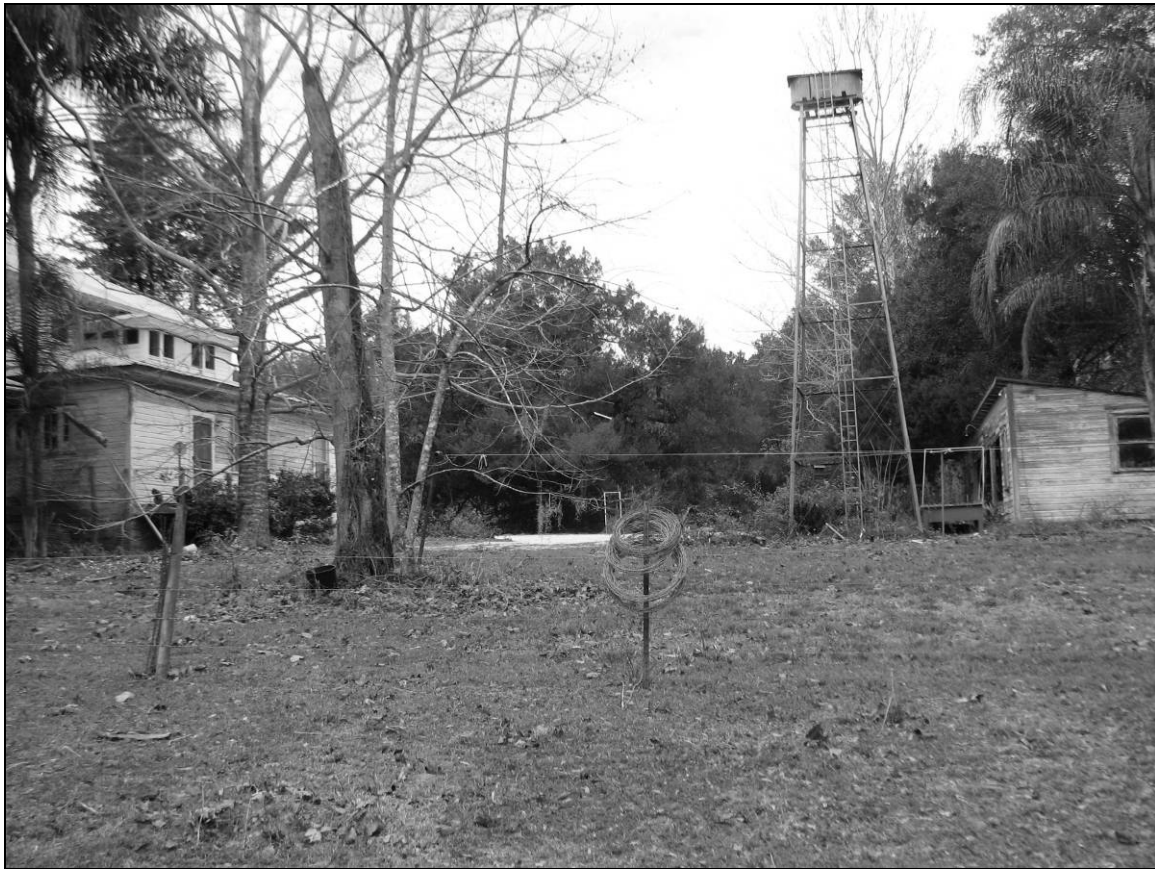
1. Strite House Rear with Historic Garage and Water Tower
6. Facing North
7. Photograph 6 of 13

A historic garage building and water tower structure are located behind the main house (Photograph 6). The garage has a wood frame structural system covered in drop siding. It is topped by a rear-sloping shed roof clad in 5-V sheet metal. The front facade of the building faces west, and is five bays wide, including three centrally located open garage bays, flanked by enclosed storage areas (Photograph 7). The open bays are divided and supported by square wood posts, with diagonal braces in the upper corner of each. The storage bay on the south end is accessed through an interior doorway located in the open garage area. The storage bay on the north end is accessed through a doorway on rear of the building. This building is likely contemporary to the construction of the house, circa 1910 (Holder 2008). Located adjacent to the garage, is a historic water tower structure (Photograph 8). The tank has been removed and replaced with what appears to be a galvanized tub. The steel support tower structure remains in tact, and is approximately 30 feet tall. It has four steel legs braced by a system of purlins and diagonal tension rods. A ladder is located on one side and extends to the top of the structure.

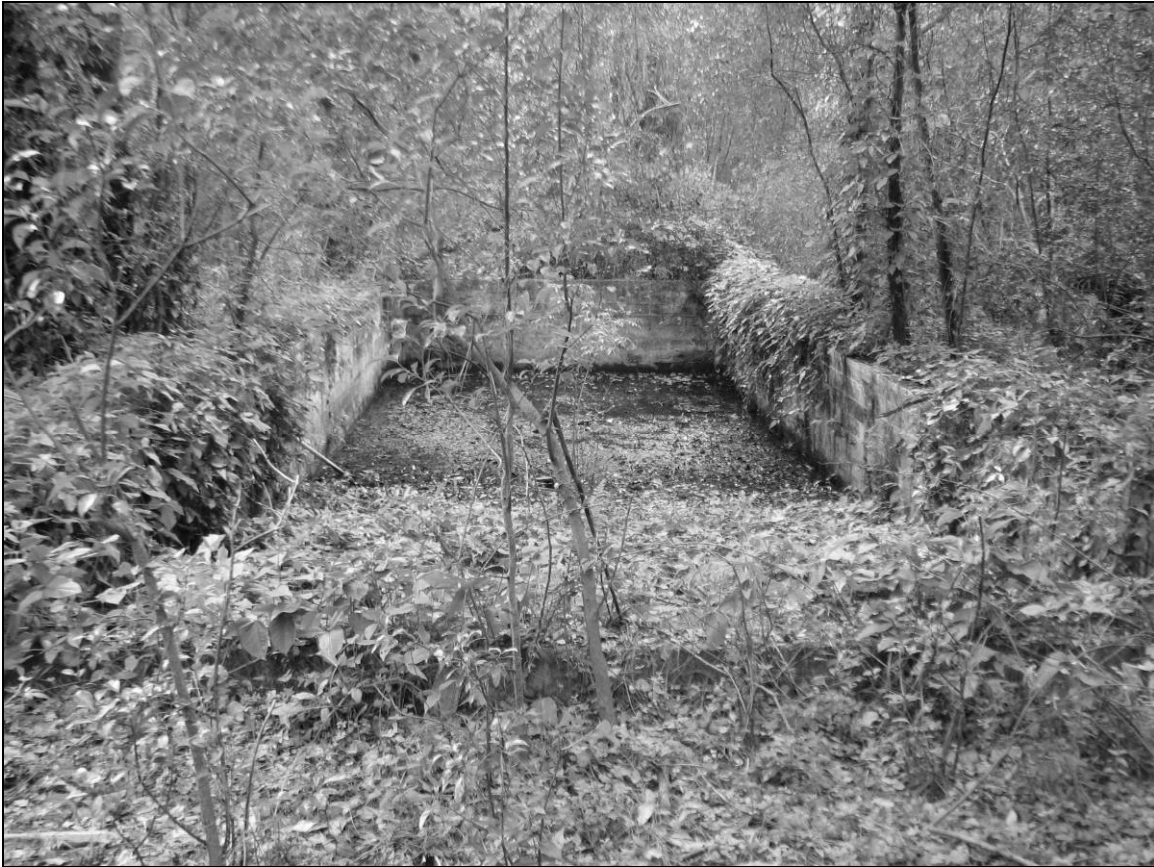
1. Historic Swimming Pool

A historic swimming pool, constructed circa 1930s is also located on the property (Holder 2008). This pool is located approximately 400 feet to the south of the house near a natural spring. The pool is rectangular in shape and consists of concrete block walls and floor (Photograph 9). It is about three feet deep at the shallow end, and slopes to a depth of seven feet at the other end. The pool is fed by the nearby spring through a pipe that flows into the pool; overflow is then directed through a pipe that allows the spring water to continue flowing through its natural path (Holder 2008). The pool ceased being used in the 1960s and has since been partially silted in, although the actual structure remains in good condition.

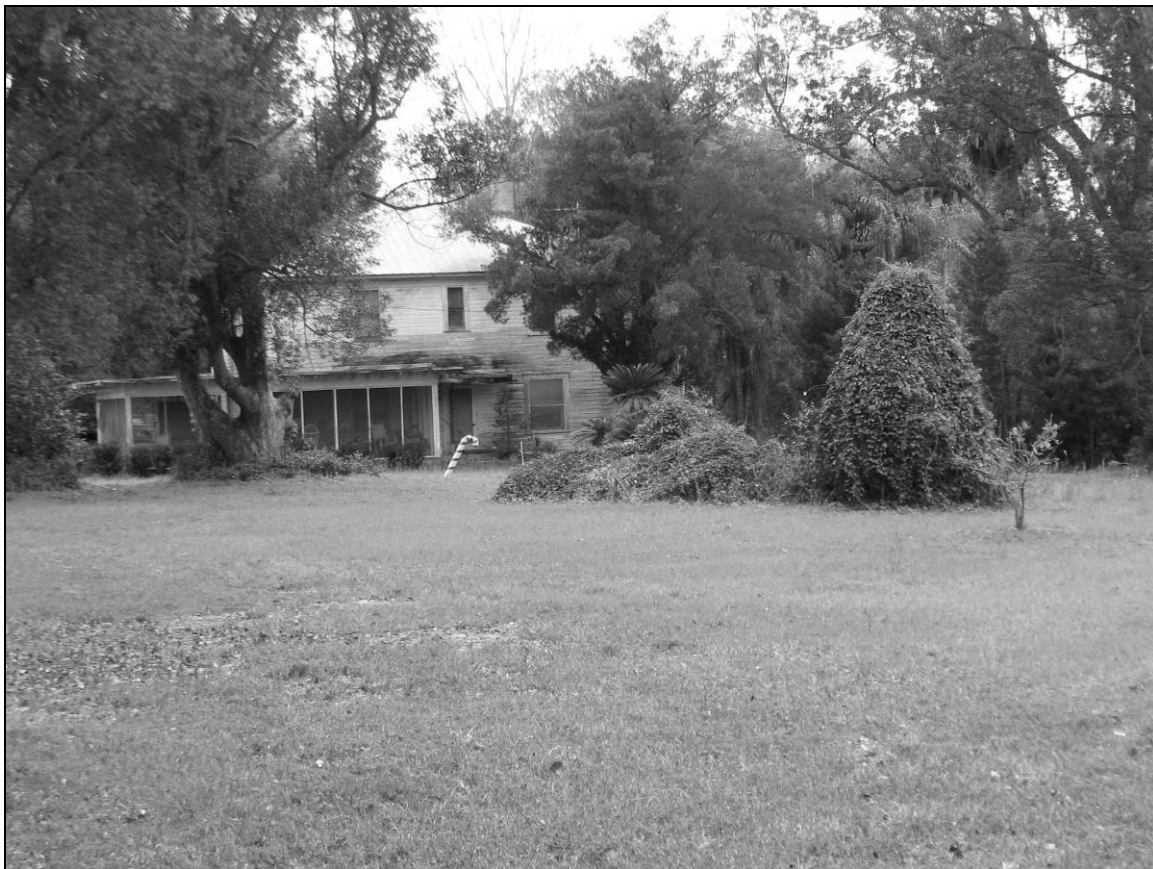
7. Photograph 11 of 13

The historic setting and landscape of the house also remains intact (Photograph 11). The house is set far back from the road, and the surrounding property is still used for agriculture (Photograph 12). Few non-historic buildings or developments are present in vicinity of the property, and overall the area appears much as it did historically. Although the citrus groves that surrounded the house in the early to mid-twentieth century are now gone, the land is now used for growing hay. The historic ancillary structures such as the garage, water tower, and swimming pool are still present on the property with few alterations. Much of the designed historic landscape on the property such as the circular drive, front lawn, and planted Camphor trees, are also still present.

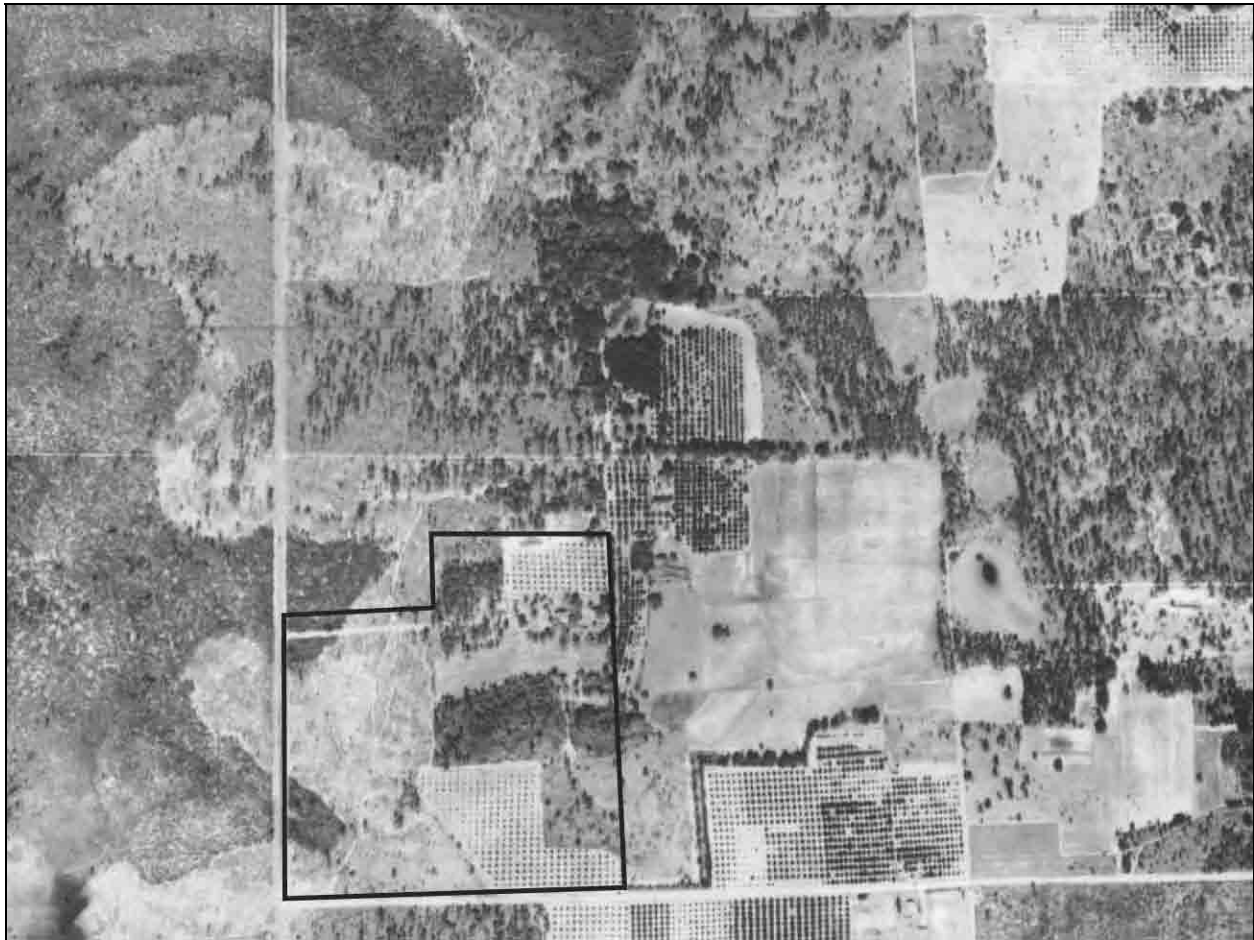
12 of 13

The boundary includes the entire land parcel currently associated with 6229 Plymouth-Sorrento Road. This is approximately 48 acres on the northeast corner of Plymouth-Sorrento Road and Haas Road; as shown in Photographs 12 and 13, and Figure 1.

**Historic Aerial Photograph from 1941,  
Showing Boundary of Strite House Property**
