TECHNICAL MEMORANDUM
CULTURAL RESOURCE ASSESSMENT SURVEY IN SUPPORT OF THE
NORTHEAST CONNECTOR EXPRESSWAY—PHASE 1 PONDS,
OSCEOLA COUNTY, FLORIDA

| CLIENT: | RS&H and the Central Florida Expressway Authority |
| DATE: | July 2021 |

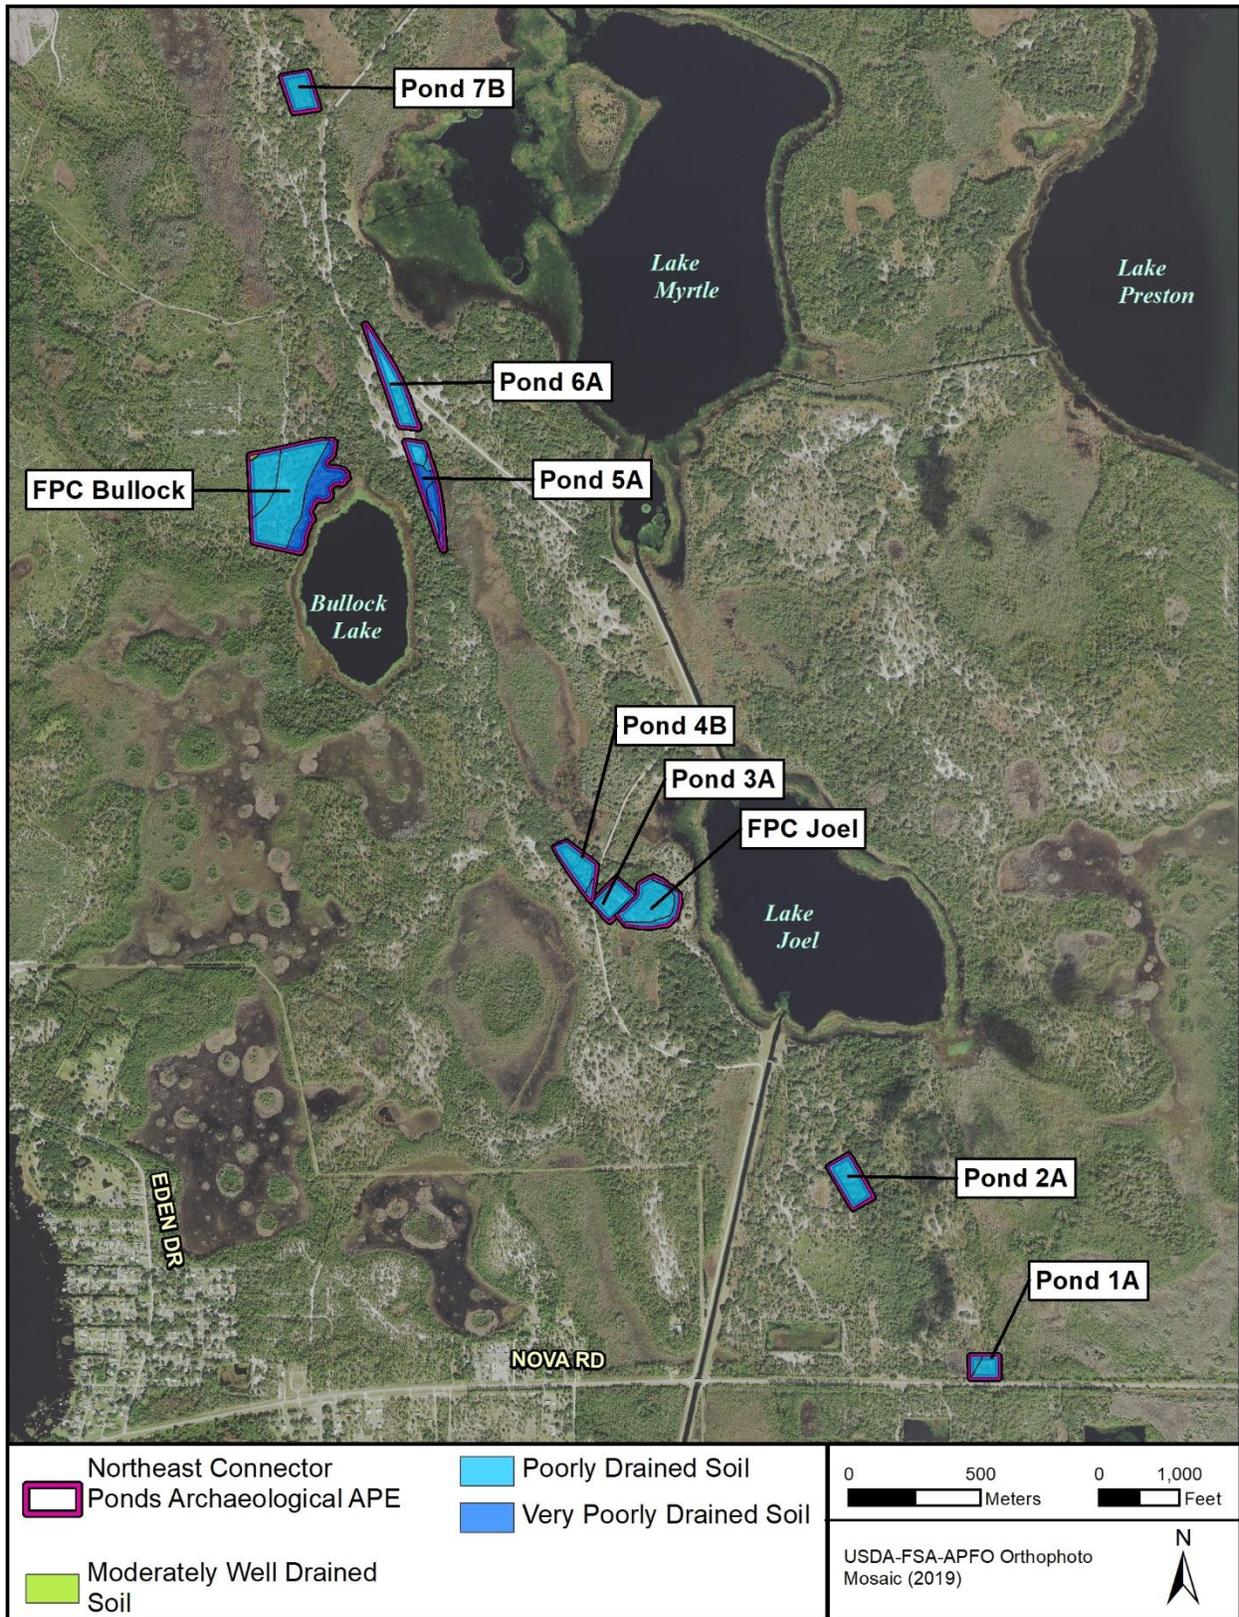
Figure 3. Soil drainage in the Northeast Connector Ponds APE.

The Northeast Connector Ponds APE is located in an undeveloped, forested area of Osceola County between Lake Joel and Lake Bullock, east of the community of Narcoossee. The project falls within the Holopaw-Indian Town Ridges and Swales physiographic province, as described by Brooks (1981). Soils primarily consist of clastic sediments and fine sand and are typically poorly or very poorly drained (**Figure 3**). Cypress strands are common and elevations generally range from 65 to 120 feet (19.8 to 36.6 meters) above mean sea level (amsl). **Table 1** provides a summary of environmental conditions in each pond.

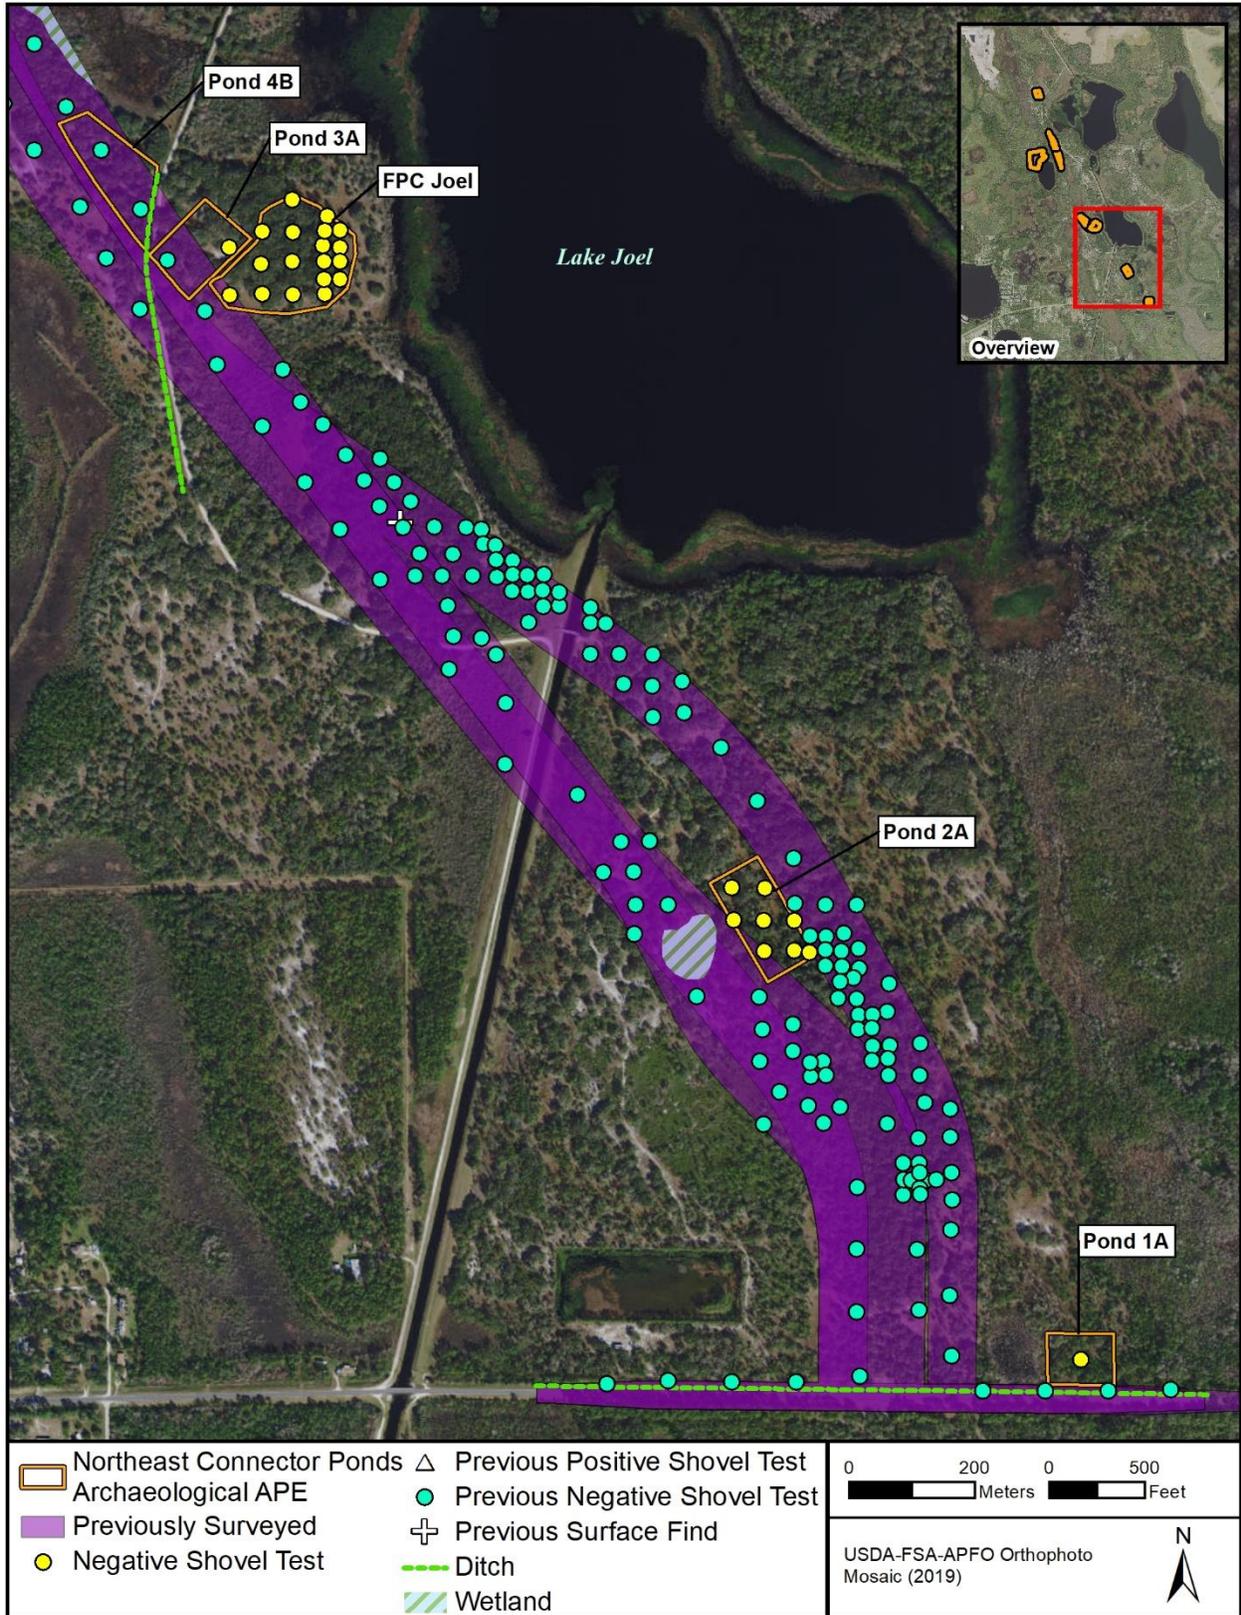
Figure 5. Results of archaeological testing in the Northeast Connector Ponds archaeological APE, map 1 of 2.

One shovel test was excavated within the Pond 1A footprint, which was negative for cultural material (see **Figure 5**). Soils in this shovel test consisted of black (10YR 2/1) sandy loam from 0 to 10 cmbs (0 to 3.9 inches, Stratum I), white (10YR 8/1) sandy loam from 10 to 50 cmbs (3.9 to 19.7 inches, Stratum II), very dark brown (10YR 2/2) sand from 50 to 70 cmbs (19.7 to 27.6 inches, Stratum III), and dark brown (10YR 3/3) sand from 70 to 100 cmbs (27.6 to 39.4 inches, Stratum IV) (**Figure 8**). The shovel test was inundated at 100 cmbs (39.4 inches) when the water table was encountered. No further archaeological work is recommended for Pond 1A.

A total of eight shovel tests were excavated within the pond footprint, all of which were negative for cultural material (see **Figure 5**). Soils were natural, with some disturbance noted in the upper stratum due to root disturbance (**Figure 10**). Soils consisted of gray (10YR 5/1) loamy sand from 0 to 20 cmbs (0 to 7.9 inches, Stratum I), white (10YR 8/1) sand from 20 to 40 cmbs (7.9 to

eastern edge of the FPC and moderate-probability (50-meter) intervals farther west. A total of 18 shovel tests were excavated, all of which were negative for cultural materials (see **Figure 5**).

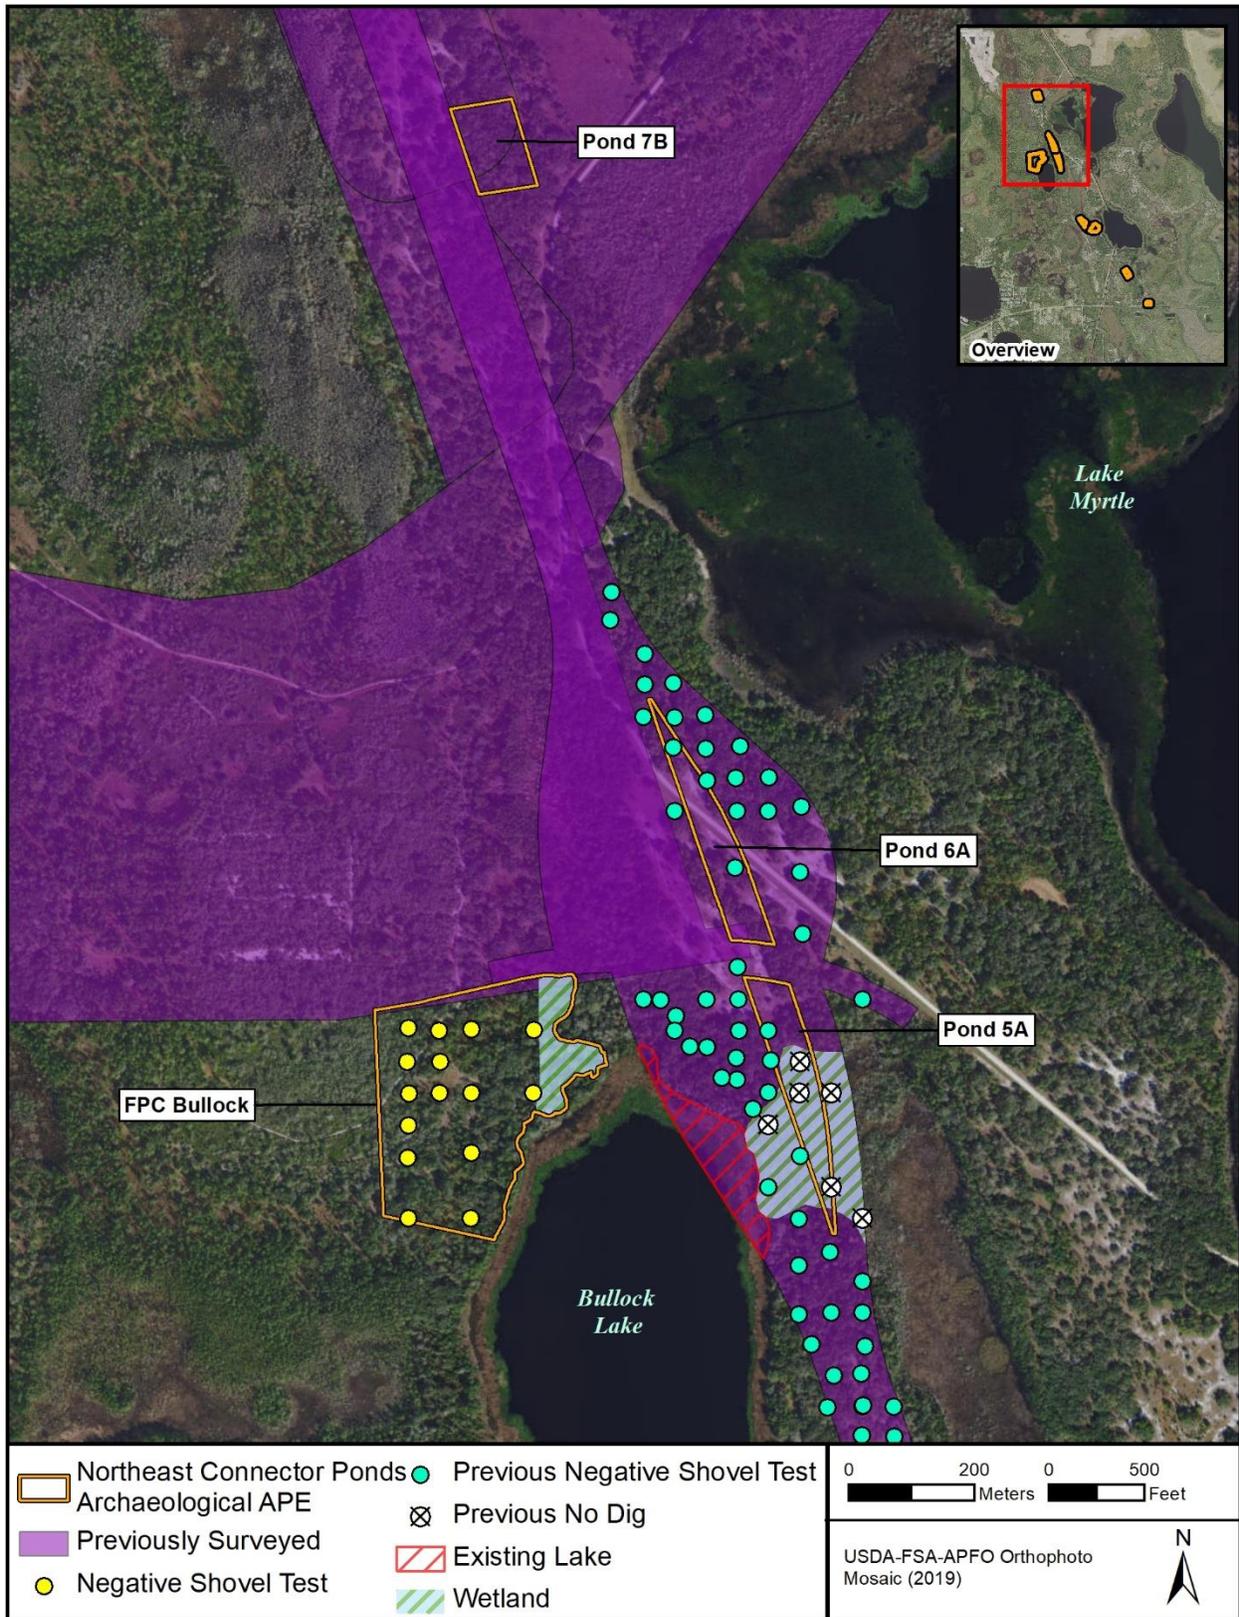
Figure 6. Results of archaeological testing in the Northeast Connector Ponds archaeological APE, map 2 of 2.

Pond 5A is an irregular, triangle-shaped pond located south of Sungrove Lane and east of Bullock Lake. The pond encompasses 4.85 acres and contains very poorly drained soils (see **Figure 6**). This pond was previously tested as part of the 2021 SEARCH survey (FMSF Survey No. TBD) for the Northeast Connector corridor. A large wetland was noted in the southern half of this pond, and all testing in the northern half was negative. No further archaeological work is recommended for Pond 5A.

A total of 15 shovel tests were excavated within FPC Bullock, all of which were negative for cultural material (see **Figure 6**). Soils varied within the APE as a result of proximity to Lake Bullock. Shovel tests excavated along the eastern edge of the FPC contained black (10YR 2/1) clay loam or clay from 0 to 40 cmbs (0 to 15.7 inches, Stratum I), light gray (10YR 7/2) or gray (10YR 6/1) sand from 40 to 70 cmbs (15.7 to 27.6 inches, Stratum II), and terminated in wet black (10YR 2/1) sand or standing water at approximately 100 cmbs (27.6 to 39.4 inches, Stratum III) (**Figure 16**). Soils in the western half of the FPC exhibited drier, but more disturbed, conditions due to root intrusion and construction of hunting trails. Natural soils typically consisted of dark gray (10YR 4/1) sand from 0 to 30 cmbs (0 to 11.8 inches, Stratum I), gray (10YR 6/1) sand from 30 to 40 cmbs (11.8 to 15.7 inches, Stratum II), black (10YR 2/1) compact, loamy spodic sand from 40 to 60 cmbs (15.7 to 23.6 inches, Stratum III), dark yellowish-brown (10Y 4/4) sand from 60 to 80 cmbs (23.6 to 31.5 inches, Stratum IV), and pale brown (10YR 6/3) sand from 80 to at least 100 cmbs (31.5 to 39.4 inches, Stratum V) (see **Figure 16**). No further archaeological work is recommended for FPC Bullock.

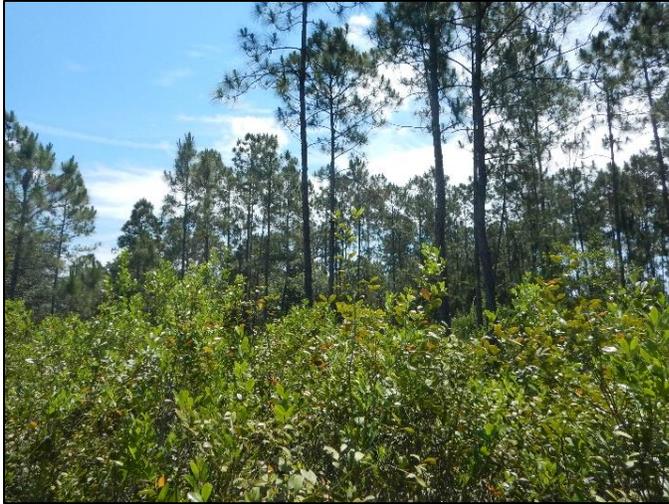
Figure 7. Overview of Pond 1A, view east.

Pond 1A is a 2.17-acre pond situated along the north side of Nova Road in an area vegetated by inkberry shrub and long leaf pine (**Figure 7**). Field crews noted that the area appears to be seasonally inundated, with standing water at the southern end of the pond. This pond was assessed with low probability for archaeological deposits.

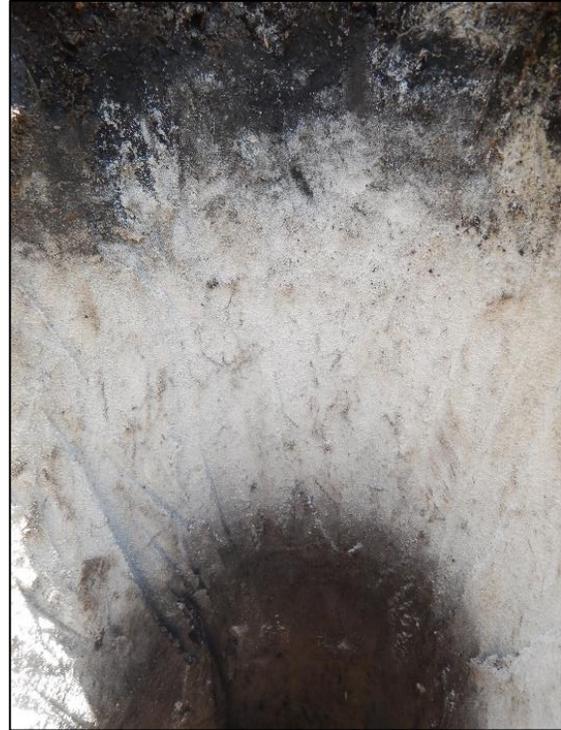
Figure 8. Typical soil profile in Pond 1A.

very dark brown (10YR 2/2) sand from 50 to 70 cmbs (19.7 to 27.6 inches, Stratum III), and dark brown (10YR 3/3) sand from 70 to 100 cmbs (27.6 to 39.4 inches, Stratum IV) (**Figure 8**). The shovel test was inundated at 100 cmbs (39.4 inches) when the water table was encountered. No further archaeological work is recommended for Pond 1A.

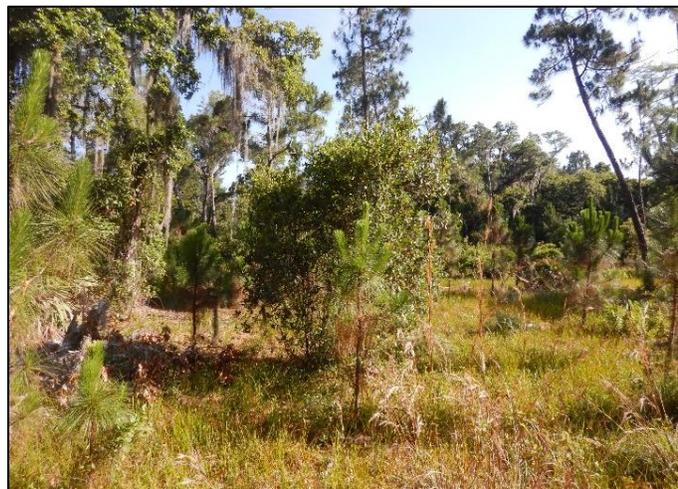
Figure 9. Overview of Pond 2A, view north.

Pond 2A encompasses a total of 3.92 acres and is north of Pond 1A, between two alternatives proposed for the Northeast Connector. Vegetation consisted of scattered oak and pine saplings with saw palmetto (**Figure 9**). The terrain was largely flat with a lower delineated wetland area near the middle of the pond.

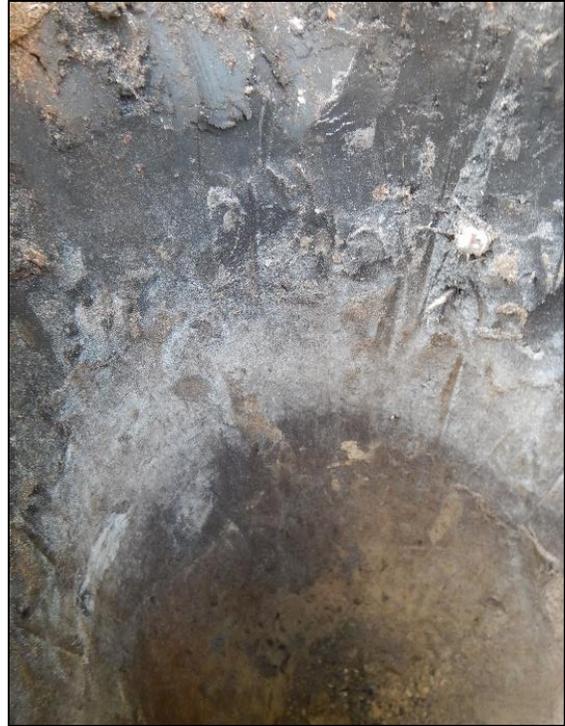
Figure 10. Typical soil profile in Pond 2A.

gray (10YR 5/1) loamy sand from 0 to 20 cmbs (0 to 7.9 inches, Stratum I), white (10YR 8/1) sand from 20 to 40 cmbs (7.9 to

15.7 inches, Stratum II), dark brown (10YR 3/3) sand from 40 to 70 cmbs (15.7 to 27.6 inches, Stratum IV), and brownish-yellow (10YR 6/6) sand from 70 to at least 100 cmbs (27.6 to 39.4 inches, Stratum V). No further archaeological work is recommended for Pond 2A.

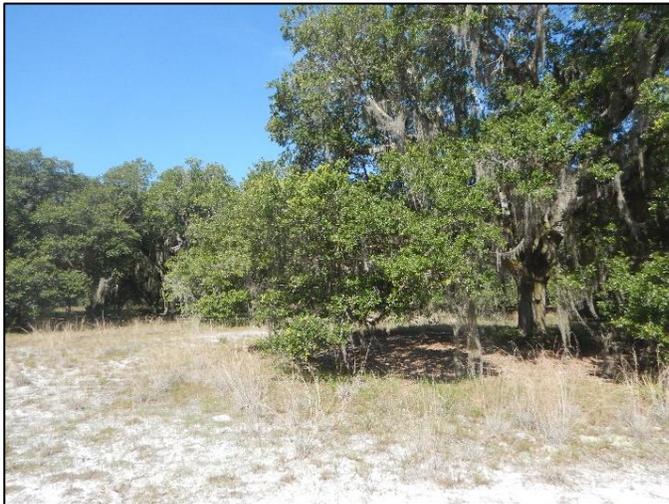
Figure 11. Overview of Pond 3A, view west.

Pond 3A is a rectangular pond situated east of Lake Joel between FPC Joel and Sungrove Lane (see **Figure 5**), encompassing 3.13 acres. The eastern corner of the pond is bisected by an unofficial trail running along the edge of a small rise. Pine and oak were the primary vegetation within this pond footprint (**Figure 11**). Soil drainage is generally poor. As shown in **Figure 5**, the western half of this pond was previously tested by the 2021 SEARCH CRAS (FMSF Survey No. TBD) conducted for the Northeast Connector corridor. As such, one shovel test was excavated in the eastern half of the pond, which was negative for cultural material.

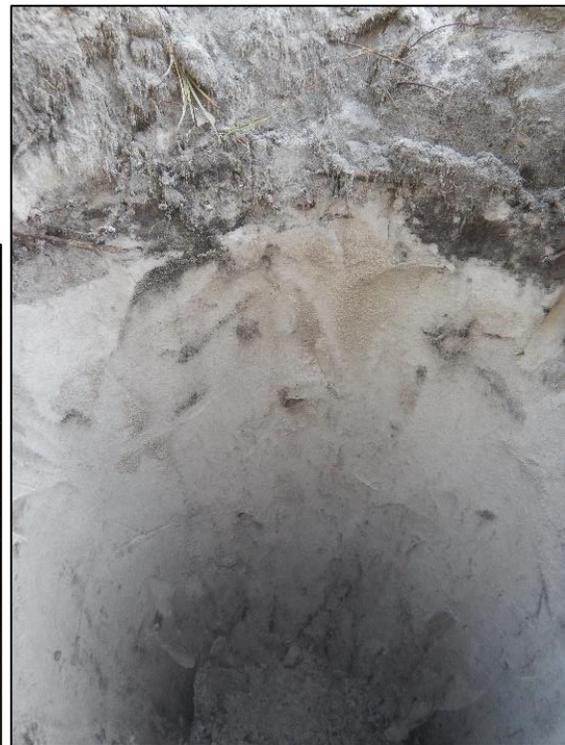
Figure 12. Typical soil profile in Pond 3A.

Soils in this shovel test consisted of gray (10YR 6/1) loamy sand from 0 to 15 cmbs (0 to 5.9 inches, Stratum I) and very pale brown (10YR 8/2) sand from 15 to at least 100 cmbs (5.9 to 39.4 inches, Stratum II) (**Figure 12**). No further archaeological work is recommended for Pond 3A.

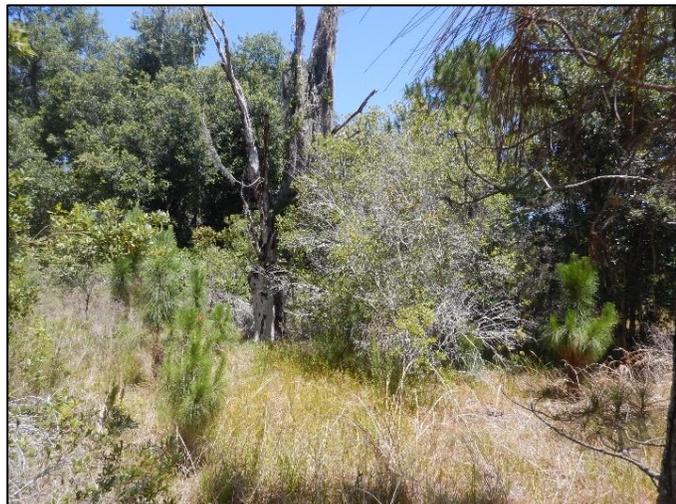
Figure 13. Overview of FPC Joel, view north.

FPC Joel is an irregular floodplain compensation area located approximately 60 meters (196 feet) west of the shore of Lake Joel. Vegetation consisted of oak and pine, and a small trail was noted skirting the edge of a small rise in the northern half of the pond. The FPC encompasses approximately 7.04 acres and is forested, with soils generally poorly drained (**Figure 13**). Due to the proximity to Lake Joel, shovel tests were excavated at high-probability (25-meter) intervals along the

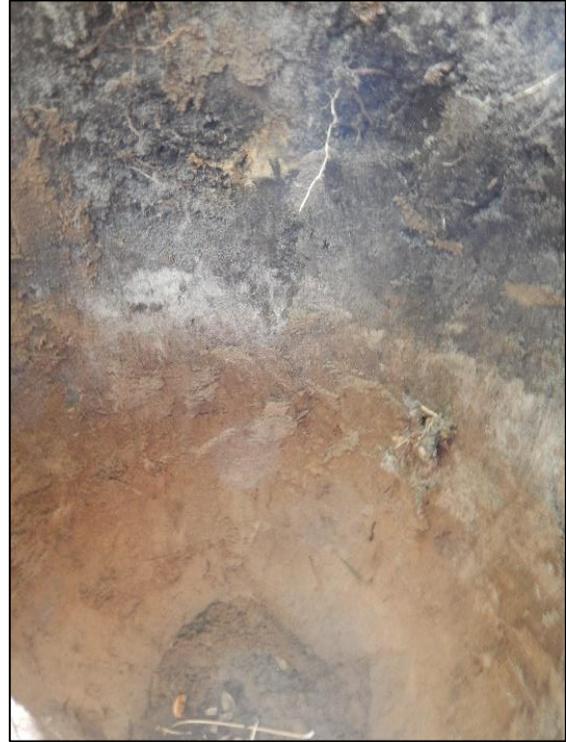
Figure 14. Typical soil profile in FPC Joel.

Soil stratigraphy was relatively uniform across the FPC, with minor fluctuations in the depth and thickness of strata, likely related to the water table and proximity to Lake Joel. Soils typically consisted of very dark gray (10YR 3/1) sand from 0 to 20 cmbs (0 to 7.9 inches, Stratum I), white (10YR 8/1) sand from 20 to 40 cmbs (7.9 to 15.7 inches, Stratum II), dark brown (10YR 3/3) sand from 40 to 60 cmbs (15.7 to 23.6 inches, Stratum III), and brownish-yellow (10YR 6/6) sand from 60 to at least 100 cmbs (23.6 to 39.4 inches, Stratum IV) (**Figure 14**). No further archaeological work is recommended for FPC Joel.

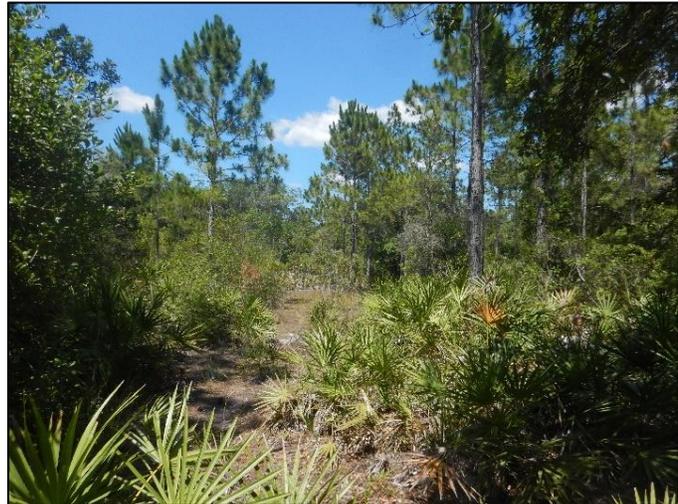
Figure 15. Overview of FPC Bullock, view east.

FPC Bullock encompasses a total of 25.11 acres and is located along the northwestern edge of Lake Bullock. This FPC is heavily forested with pine and oak, and several small trails bisect the northwest corner of the footprint (**Figure 15**). A small wetland was noted along the eastern edge of the FPC. Soils within the pond range from very poorly drained muck near Lake Bullock to poorly drained sand near the center of the FPC to moderately well drained sand in the northwestern corner of the FPC footprint. Elevations also rise from east to west. Given the presence of muck along the eastern edge of the pond, this area was assessed with moderate probability for archaeological resources. Previous archaeological testing associated within the Northeast Connector corridor (SEARCH 2021, FMSF Survey TBD) indicated that the potential for intact archaeological deposits is better in areas of more well drained soils located on elevated landforms; as such, the northwest corner of FPC Bullock was tested at moderate probability due to the elevated landform, better soils, and distance from freshwater resources.
