Level I Contamination Screening Evaluation Report
NORTHEAST CONNECTOR EXPRESSWAY PHASE 1
PROJECT DEVELOPMENT AND ENVIRONMENT (PD&E) STUDY

Cyrils Drive to Nova Road

Osceola County, Florida

CFX Project No. 599-228

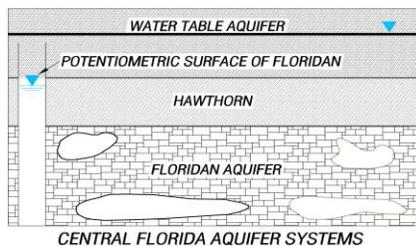
The water table aquifer is comprised of Recent and Pleistocene sands and is separated from the Eocene limestone of the Floridan aquifer by the Miocene sands, clays and limestone of the Hawthorn. Since the thickness and consistency of the Hawthorn is variable across Central Florida, the likelihood of groundwater flow from the upper to the lower aquifer (known as aquifer recharge) will also vary by geographical location.

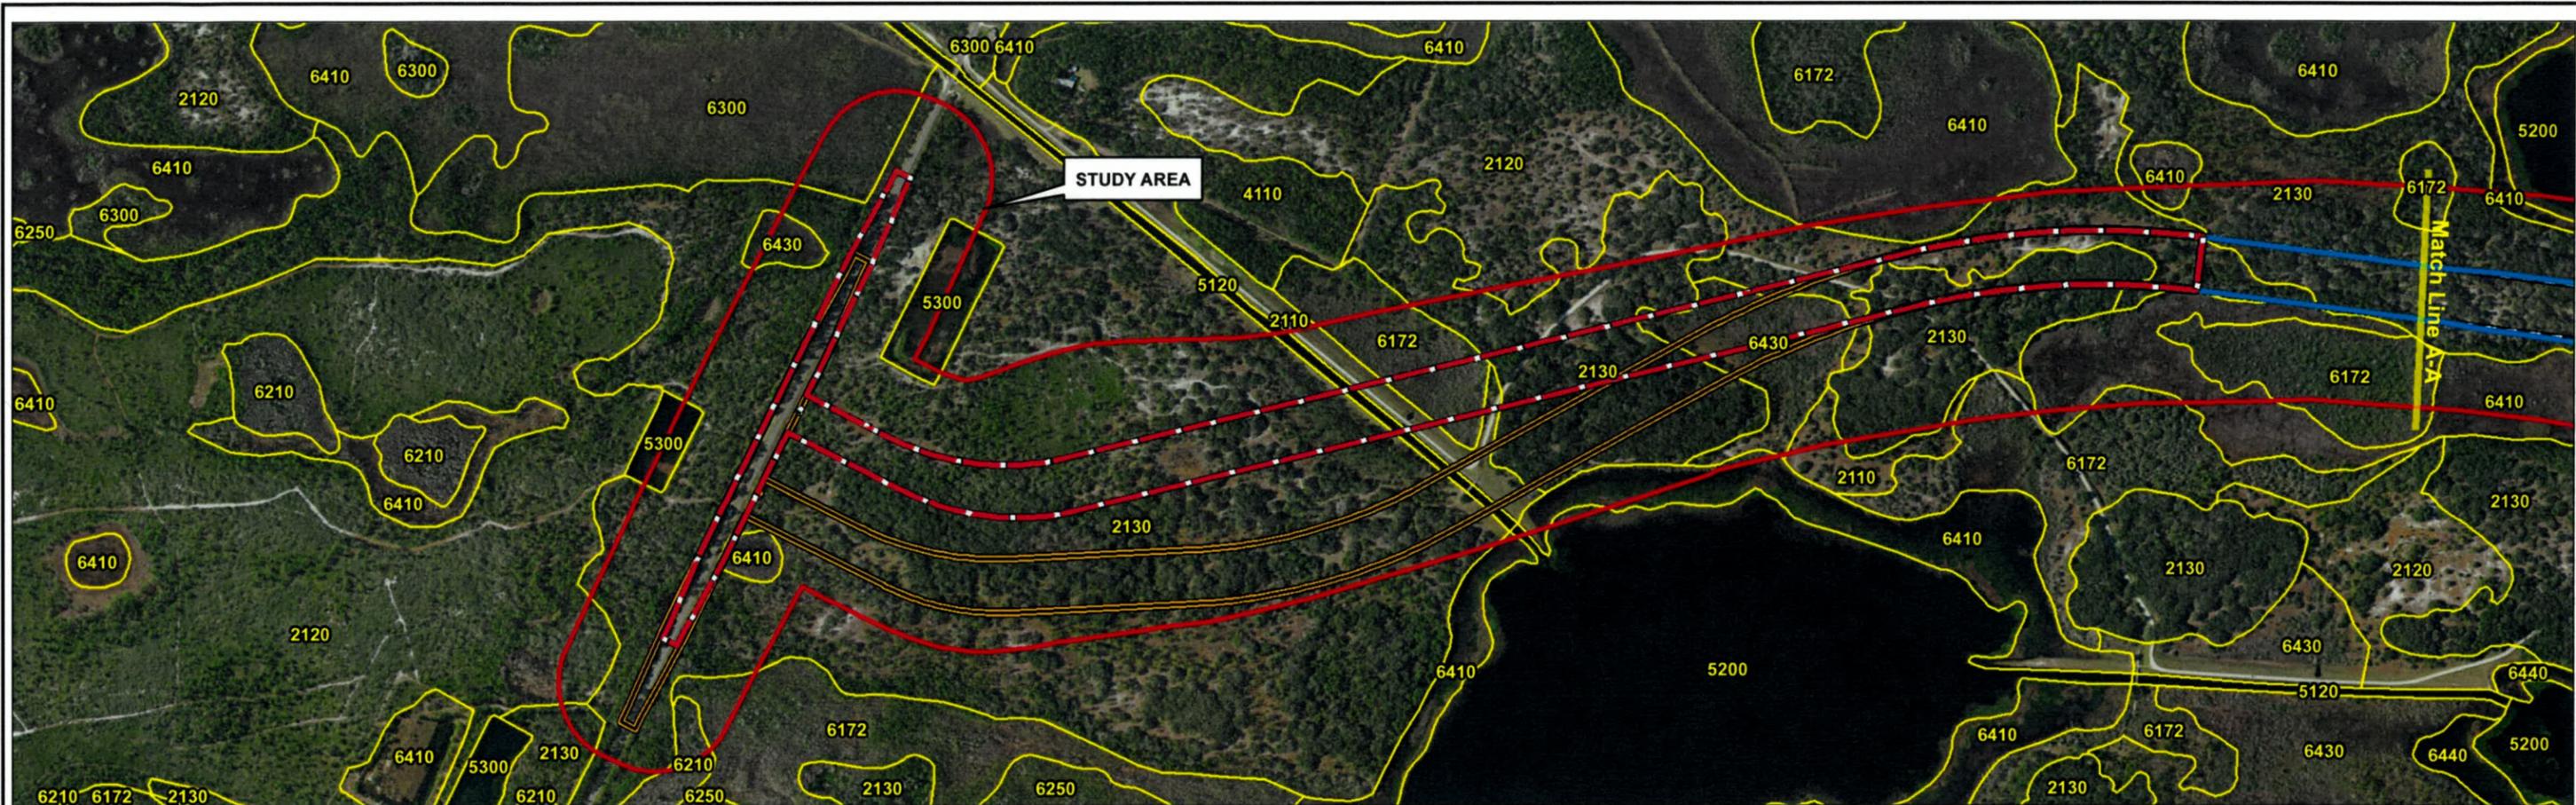
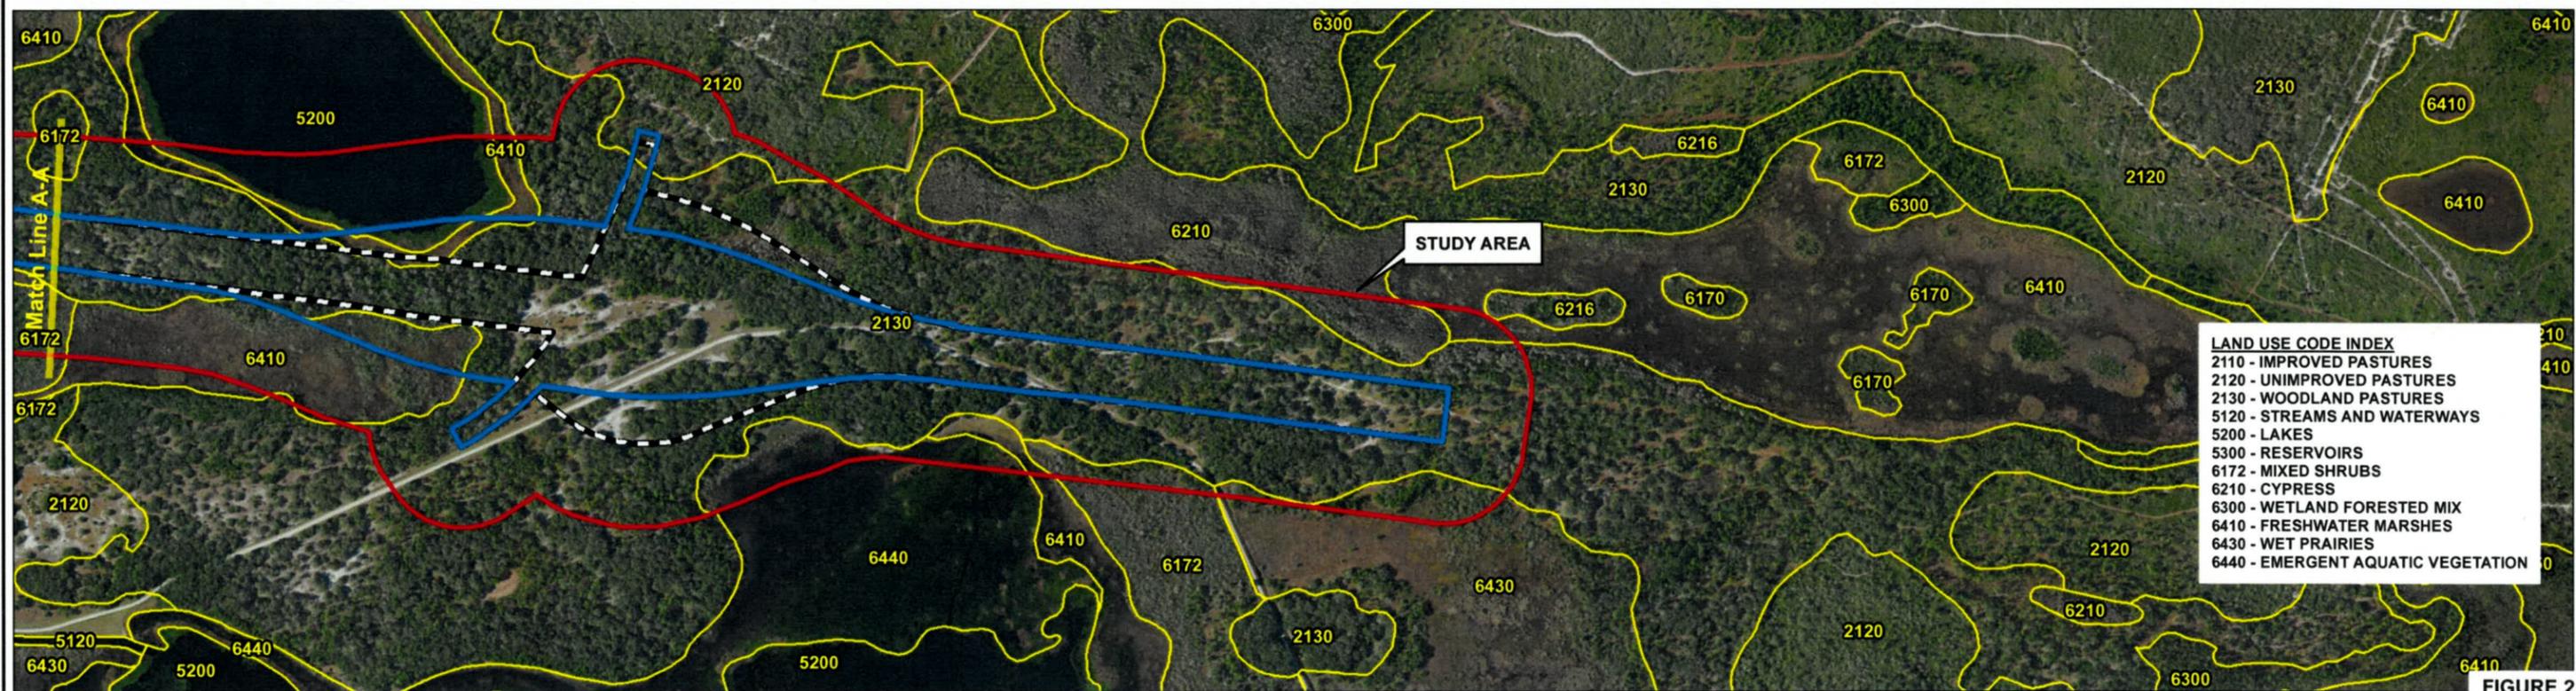
FIGURE 2

- 2110 - IMPROVED PASTURES
- 2120 - UNIMPROVED PASTURES
- 2130 - WOODLAND PASTURES
- 5120 - STREAMS AND WATERWAYS
- 5200 - LAKES
- 5300 - RESERVOIRS
- 6172 - MIXED SHRUBS
- 6210 - CYPRESS
- 6300 - WETLAND FORESTED MIX
- 6410 - FRESHWATER MARSHES
- 6430 - WET PRAIRIES
- 6440 - EMERGENT AQUATIC VEGETATION

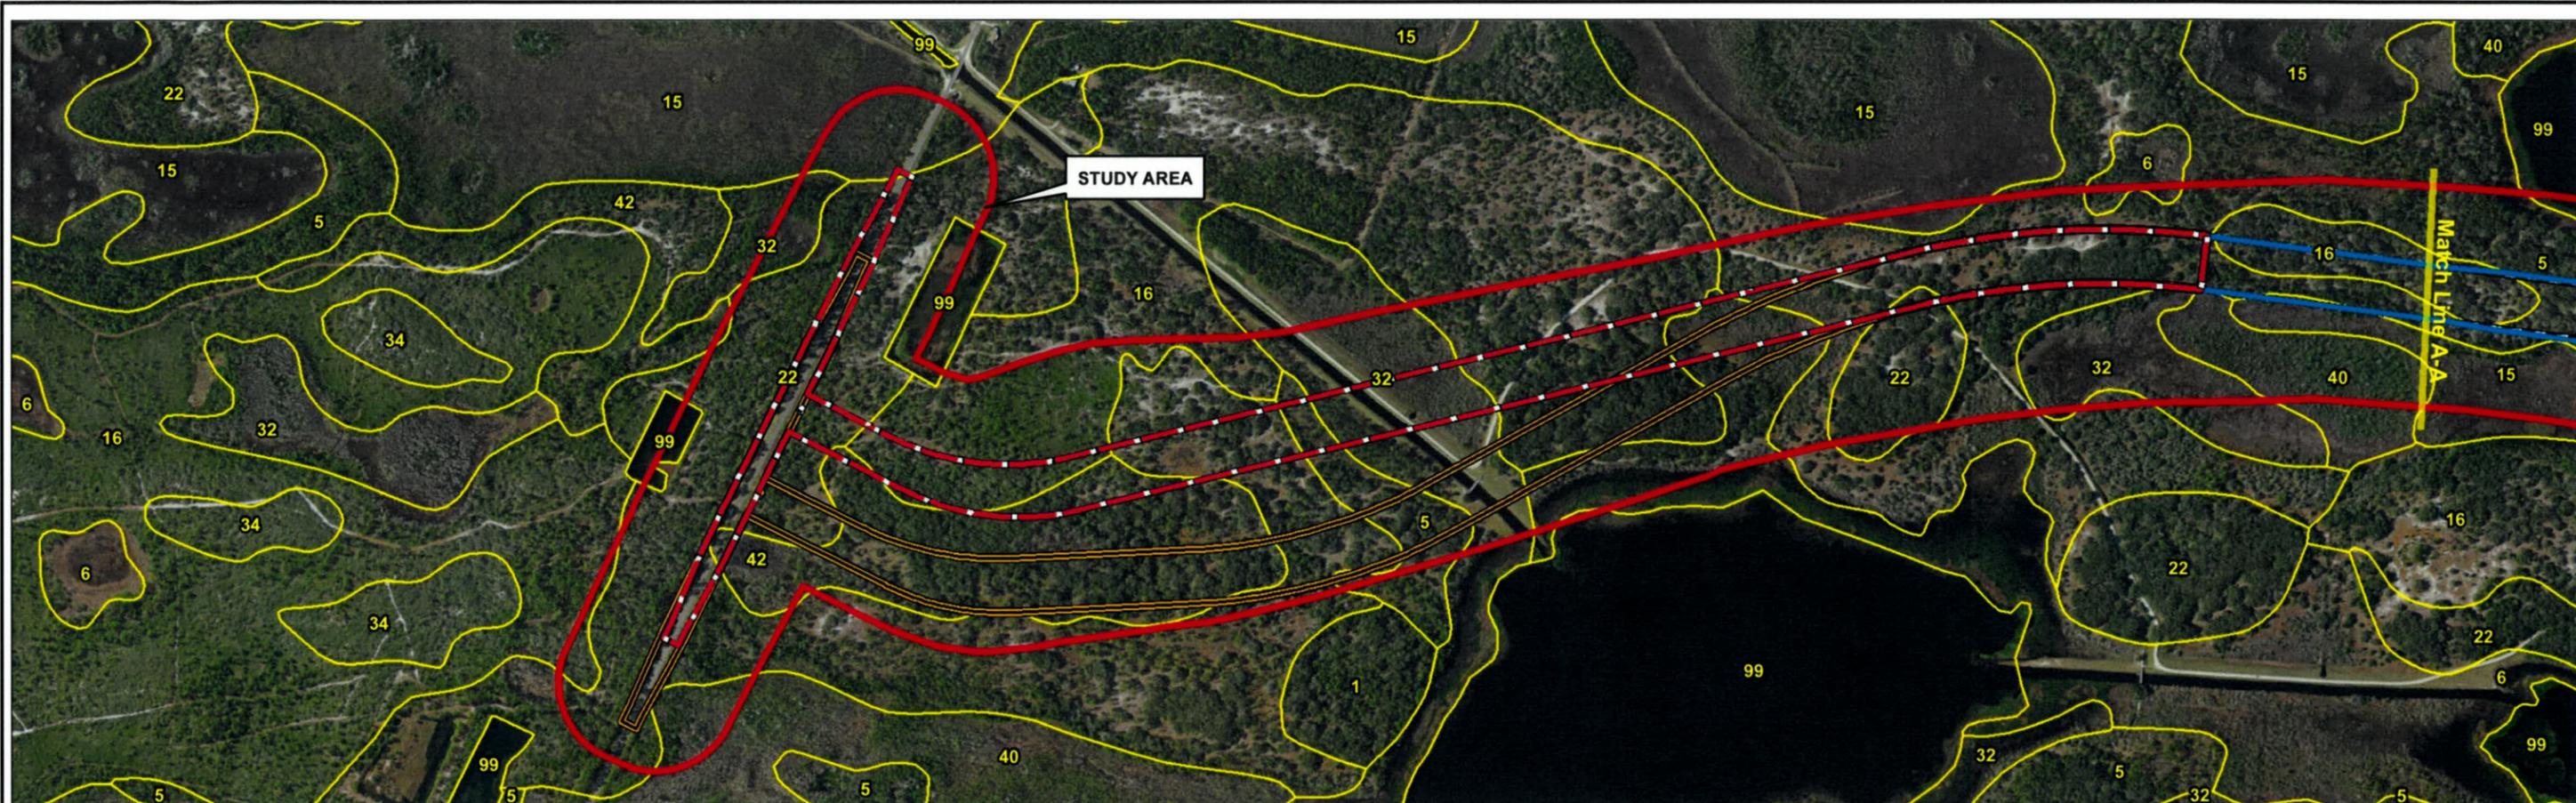
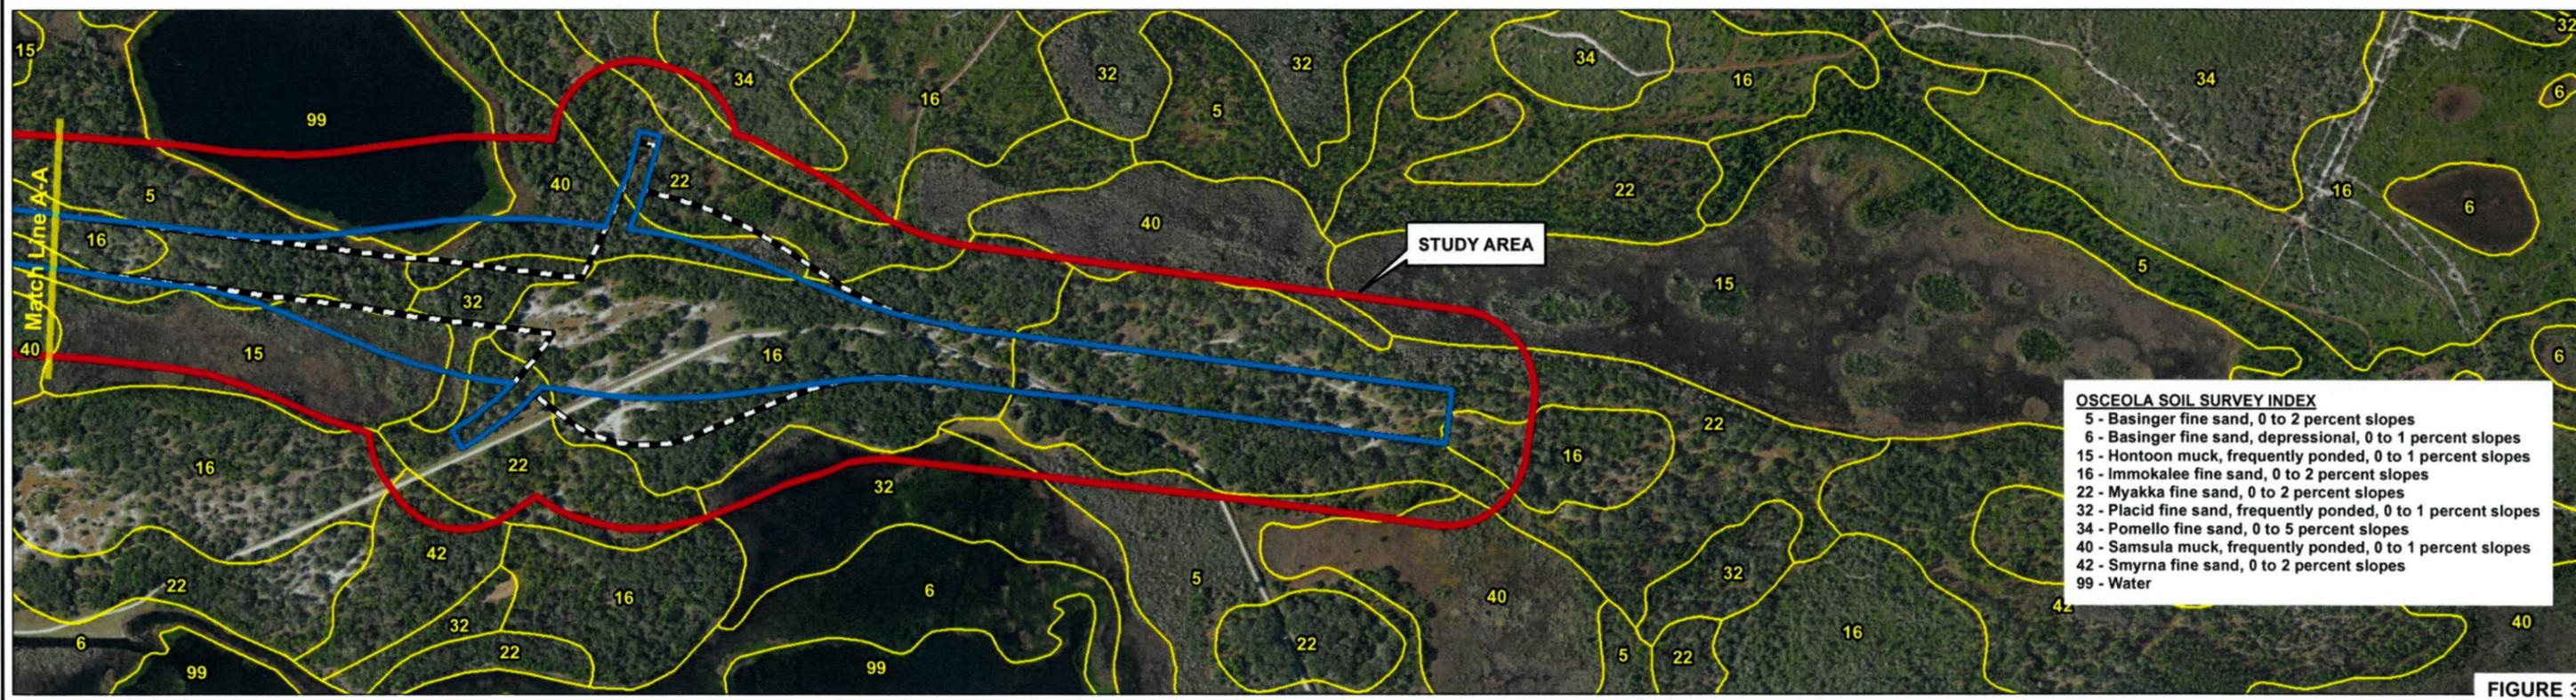
FIGURE 3

The Natural Resources Conservation Service (NRCS) Soil Survey of Osceola County, Florida was reviewed for information regarding near-surface soil conditions within the project limits, as shown on **Figure 3**. The following soil types were identified within the study area:

- 5 - Basinger fine sand, 0 to 2 percent slopes
- 6 - Basinger fine sand, depressional, 0 to 1 percent slopes
- 15 - Hontoon muck, frequently ponded, 0 to 1 percent slopes
- 16 - Immokalee fine sand, 0 to 2 percent slopes
- 22 - Myakka fine sand, 0 to 2 percent slopes
- 32 - Placid fine sand, frequently ponded, 0 to 1 percent slopes
- 34 - Pomello fine sand, 0 to 5 percent slopes
- 40 - Samsula muck, frequently ponded, 0 to 1 percent slopes
- 42 - Smyrna fine sand, 0 to 2 percent slopes
- 99 - Water

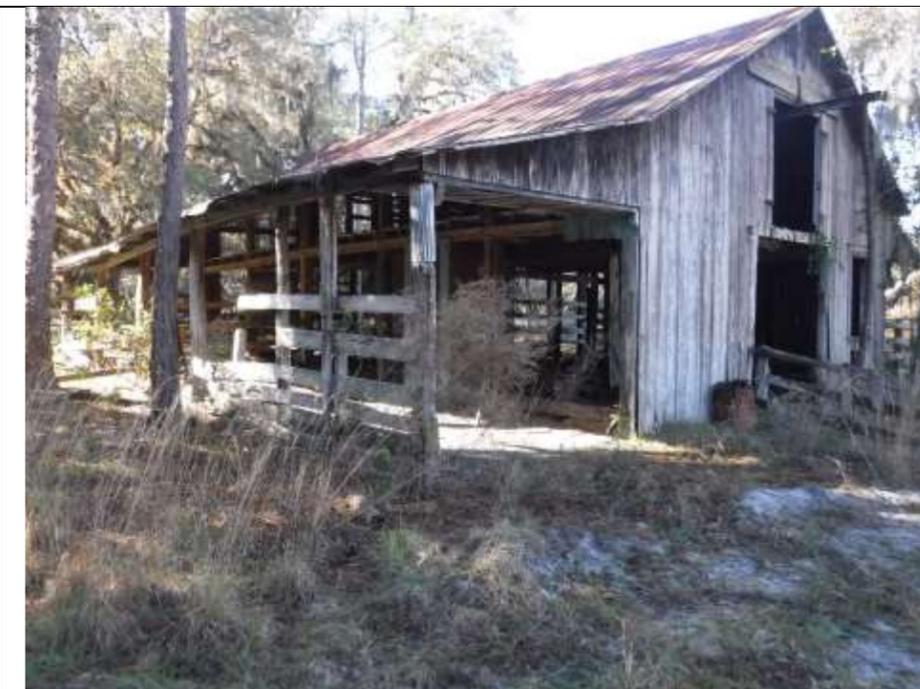
Photo taken from north of the site facing south. A historical barn is visible.

CONCLUSIONS: Based on the historical agricultural use of the property and the observations from the site reconnaissance, this site has been assigned a **Medium Risk** rating.

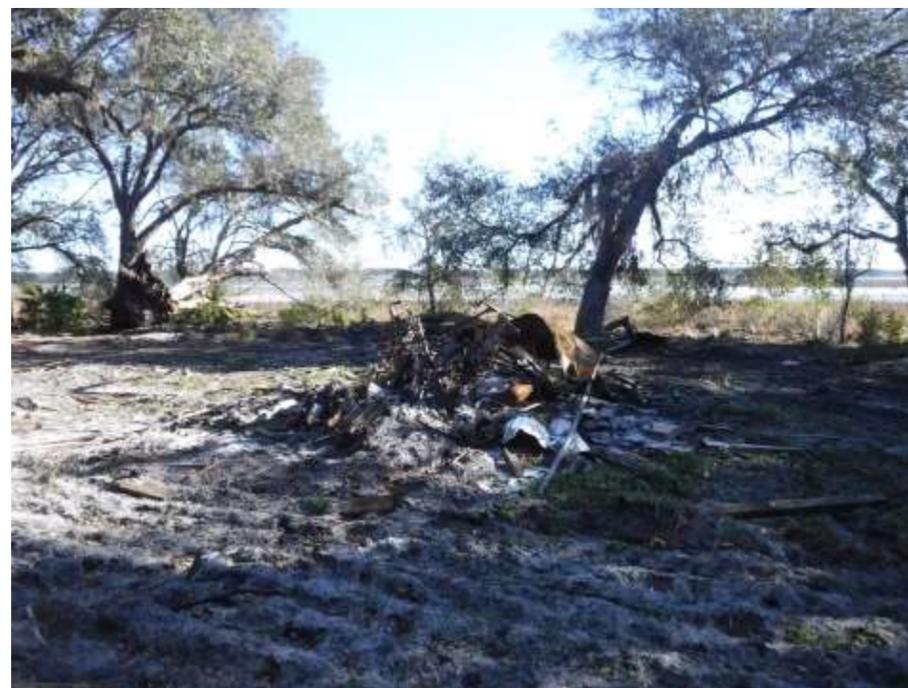
Photo taken from west of the property facing east. A burn pile is visible.

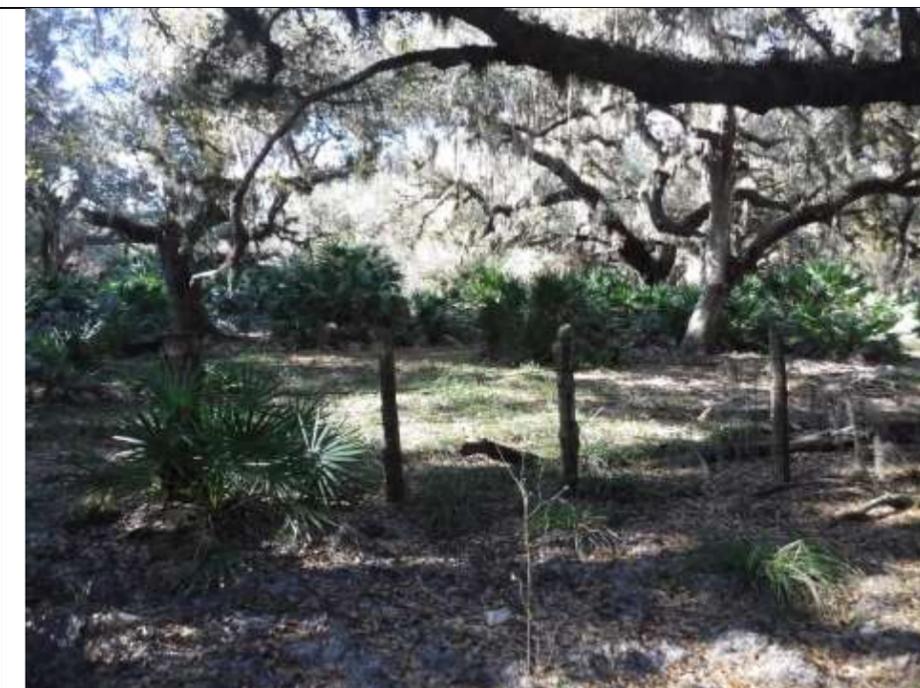
Photo taken from north of the site facing south. A historical cattle pen is visible.

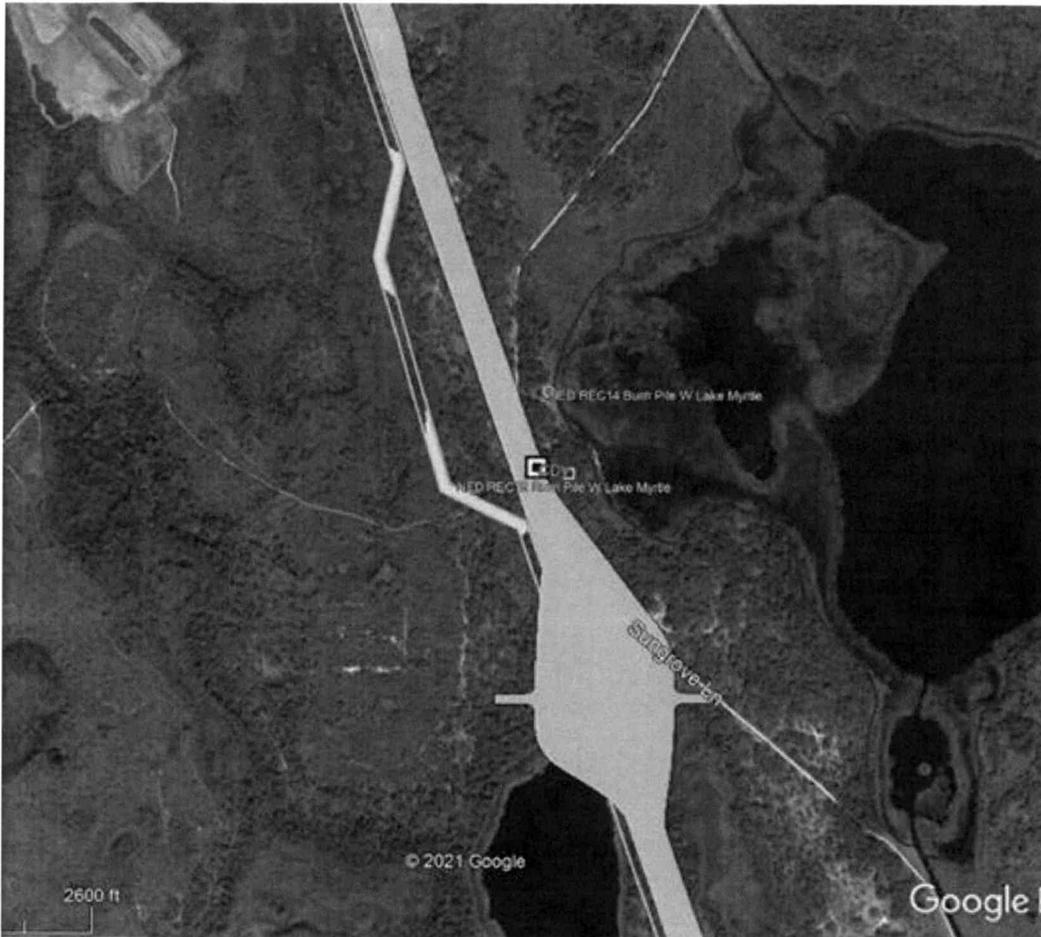
Across from the utility plant and west of Lake Myrtle there are two former burn piles and one cattle dipping vat shown on the map below. There are no other known issues along the rest of the alignment.
