Level 1 Contamination Screening Evaluation Report

State Road 414 Expressway Extension
Project Development and Environment Study
From US 441 to SR 434
Orange County and Seminole County, Florida

CFX Project Number: 414-227

Jacobs Engineering Group Inc.
200 S. Orange Ave., Suite 900
Orlando, FL 32801

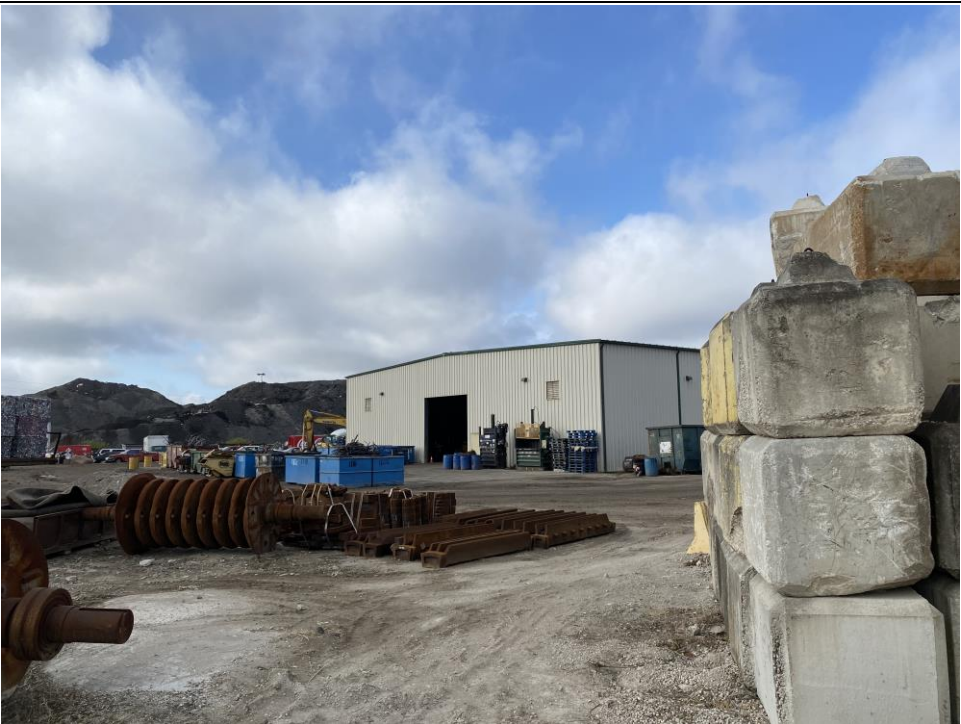
CONCLUSIONS: Based on the site being an active salvage yard, this site has been assigned a Contamination Risk Rating (CRR) of **Medium**.

View of one of the structures on the 3070 Apopka Boulevard property, near the entrance to the facility at the northeast corner of the property.

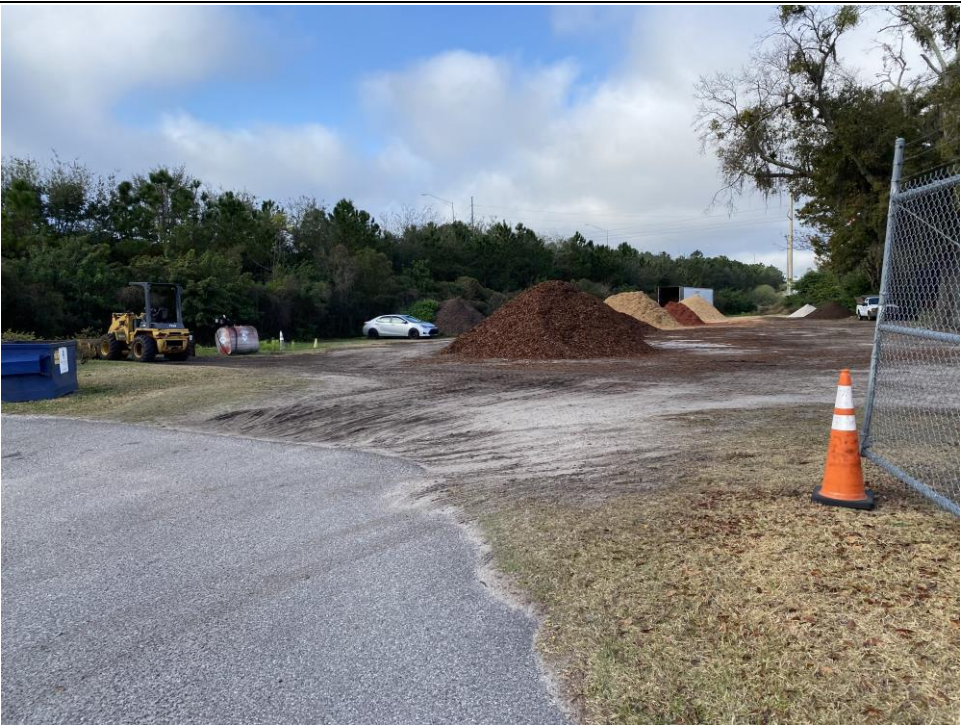
CONCLUSIONS: Based on the lack of documented contamination at the facility and only a limited amount of the facility property being located within 500 feet of the Study Area, this site has been assigned a CRR of **Low**.

View of the mulch material at the former Martinez Auto Salvage property, currently occupied by Sunrise Landscaping (Site No. 8).

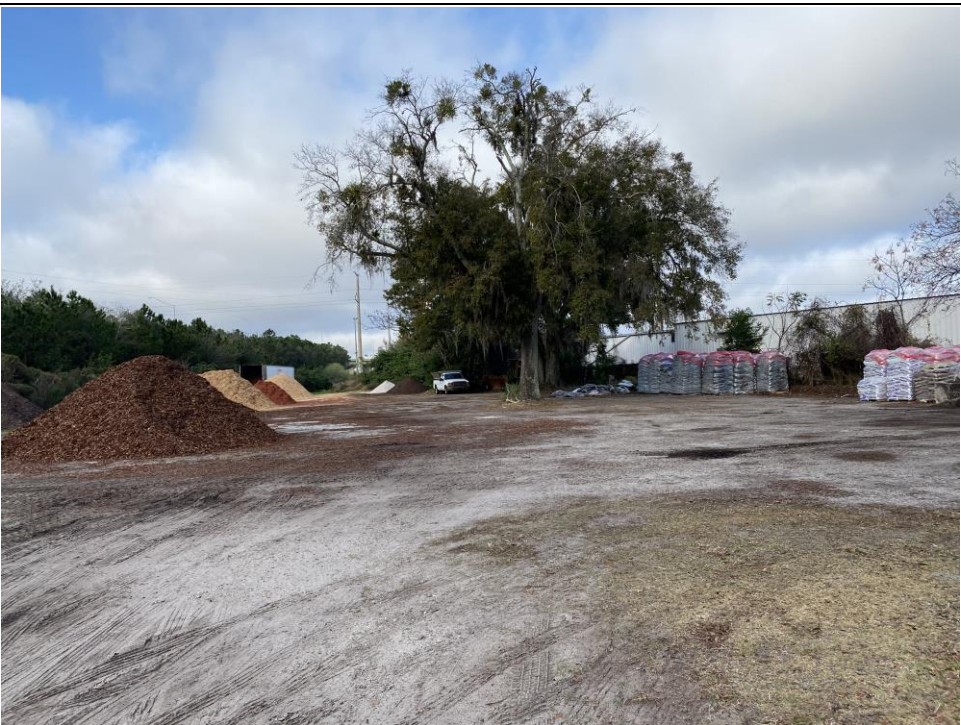
CONCLUSIONS: Based on the lack of documented contamination at the facility and only a limited amount of the facility property being located within 500 feet of the Study Area, this site has been assigned a CRR of **Low**.

View of the mulch material at the former RJ Salvage property, currently occupied by Sunrise Landscaping (Site No. 8).

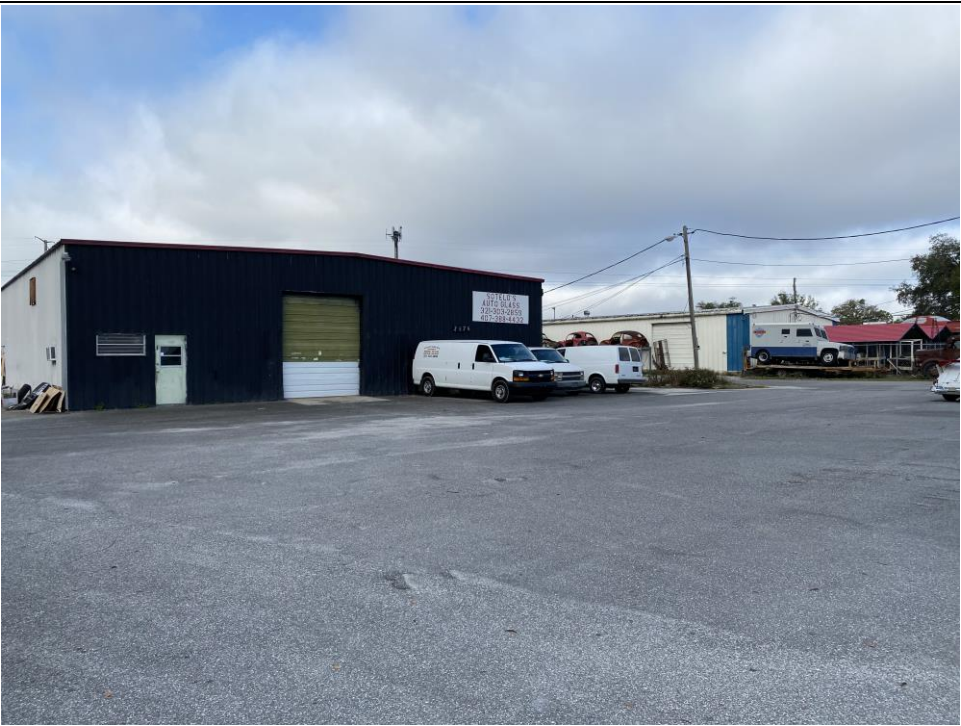
CONCLUSIONS: Based on the lack of documented contamination impacts, this site has been assigned a CRR of **Low**.

View of the former AAG Imports and Southern Outboards property from the gated entrance off Apopka Boulevard, facing west.

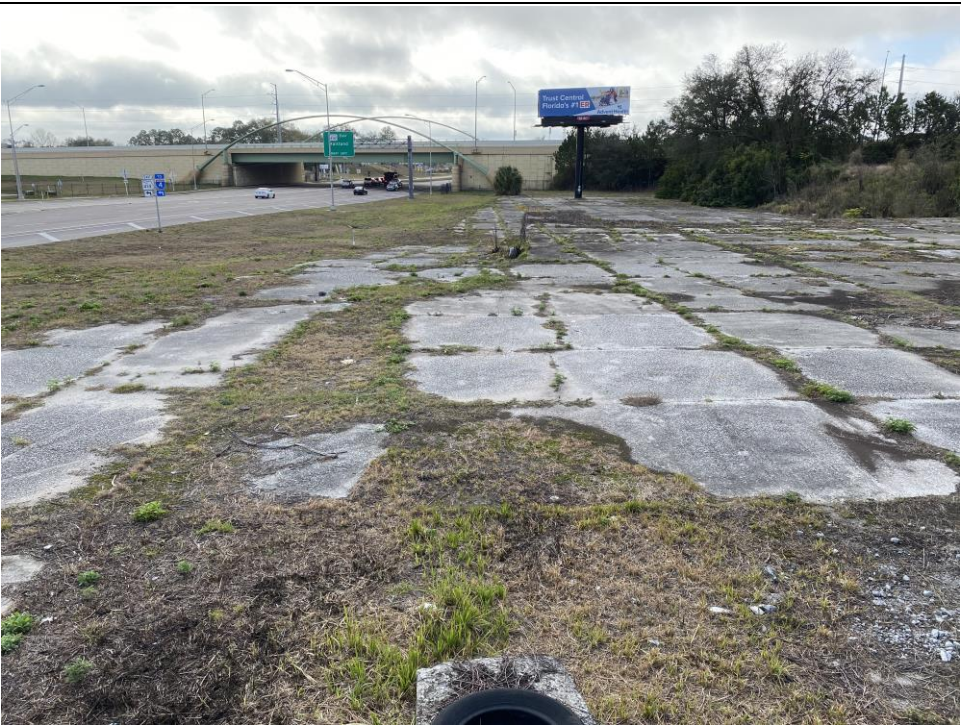
CONCLUSIONS: Based on the lack of documented contamination impacts and the redevelopment of the facility with the current roadway, this site has been assigned a CRR of **Low**.

View facing south from the northern end of the property. The site consists of concrete slabs and is terraced to the south with approximately 10 to 12 feet of drop between terraces.

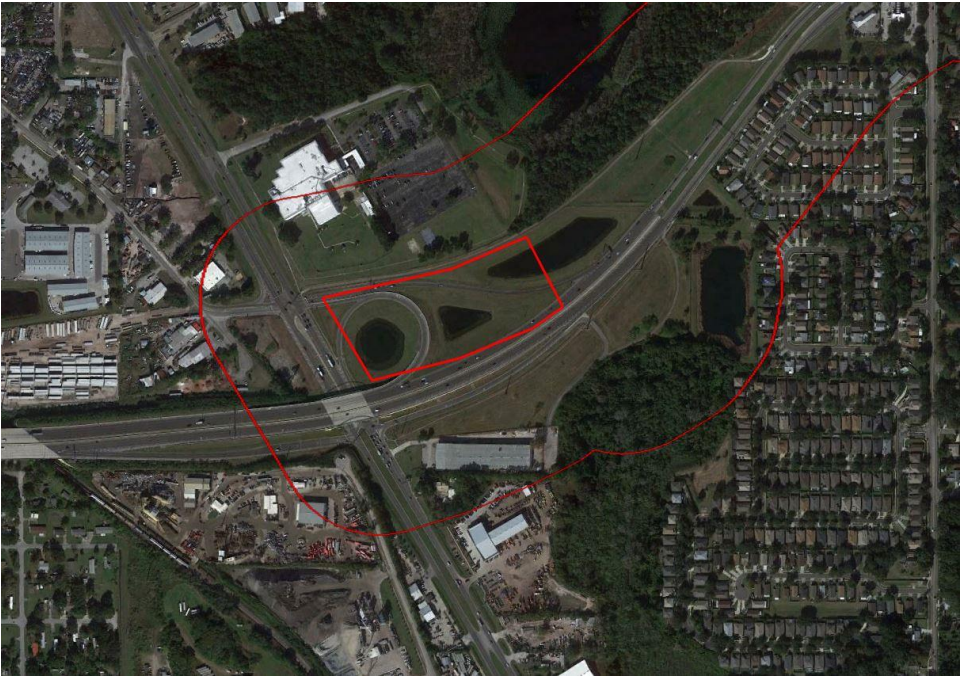
SITE OBSERVATIONS: The former facility is currently developed with several retention ponds within the SR 414 entrance and exit ramps at SR 500.

Location of the former facility outlined on a 2019 aerial photograph obtained from Google Earth.

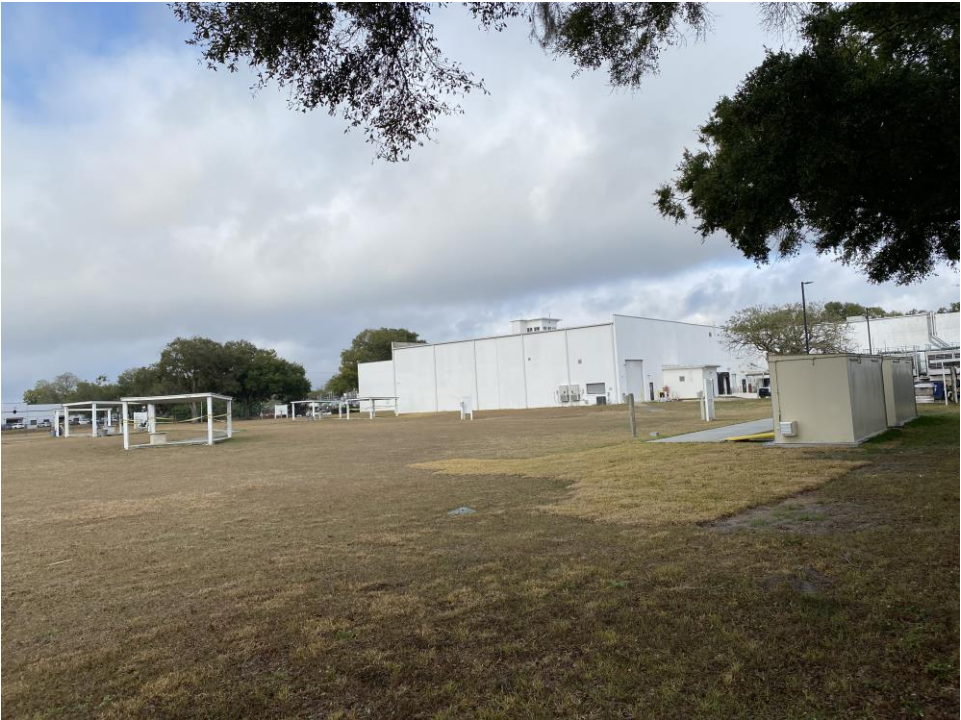
CONCLUSIONS: Based on the lack of remaining contamination impacts and the distance of the former discharge location from the SR 414 alignment, this site has been assigned a CRR of **Low**.

View of the southern portion of the Northrop Grumman facility facing west.

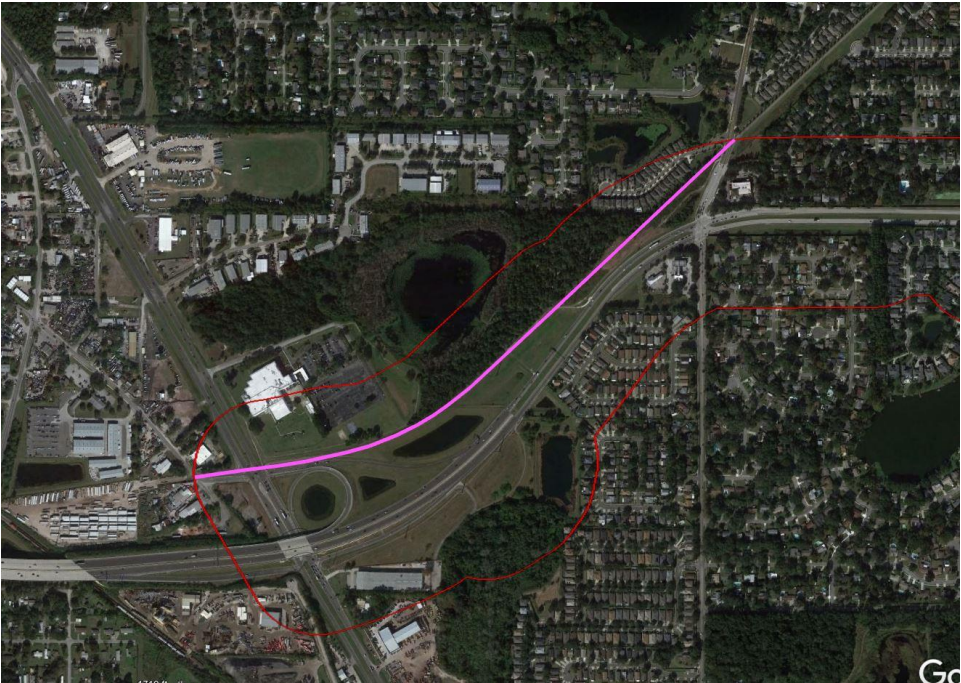
SITE OBSERVATIONS: Most of the former rail line which is located within the Study Area has been converted to an asphalt-paved recreational trail.

CONCLUSIONS: There is an elevated potential for chemical impacts along historical rail lines; therefore, this site has been assigned a CRR of **Medium**.

View of the former rail line location (pink line) through the Study Area (red outline), overlaid on a 2019 Google Earth aerial photograph.

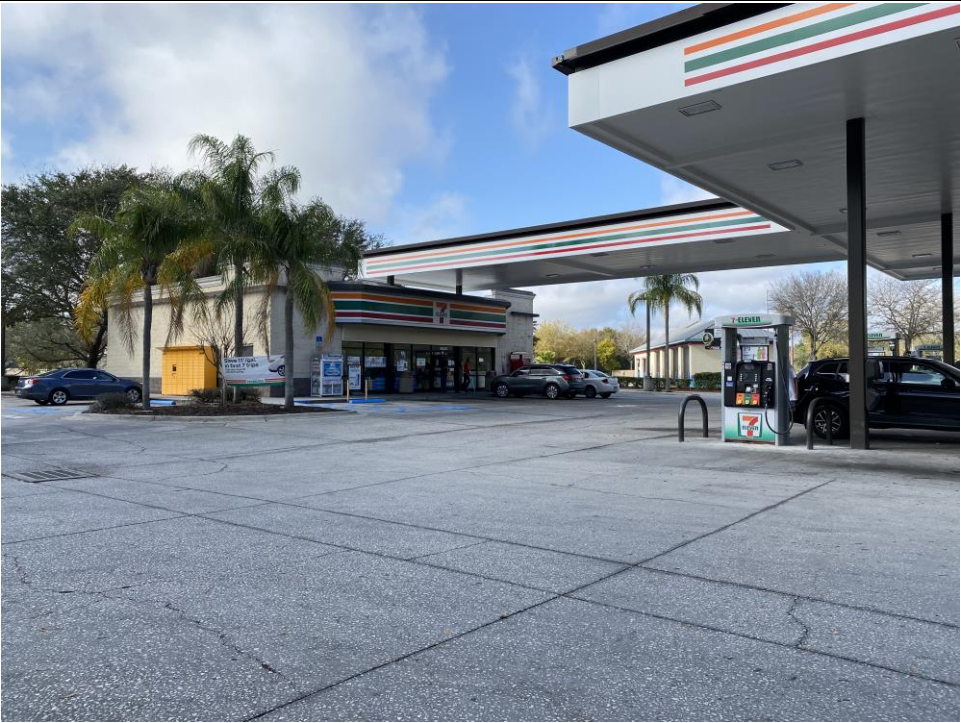
CONCLUSIONS: Based on the site actively operating as a gas station, this facility has been assigned a CRR of **Medium**.

View of the operating 7-Eleven gas station and convenience store from the northeast side, facing southwest. The fuel tanks are located on the north side of the dispenser islands and canopy.

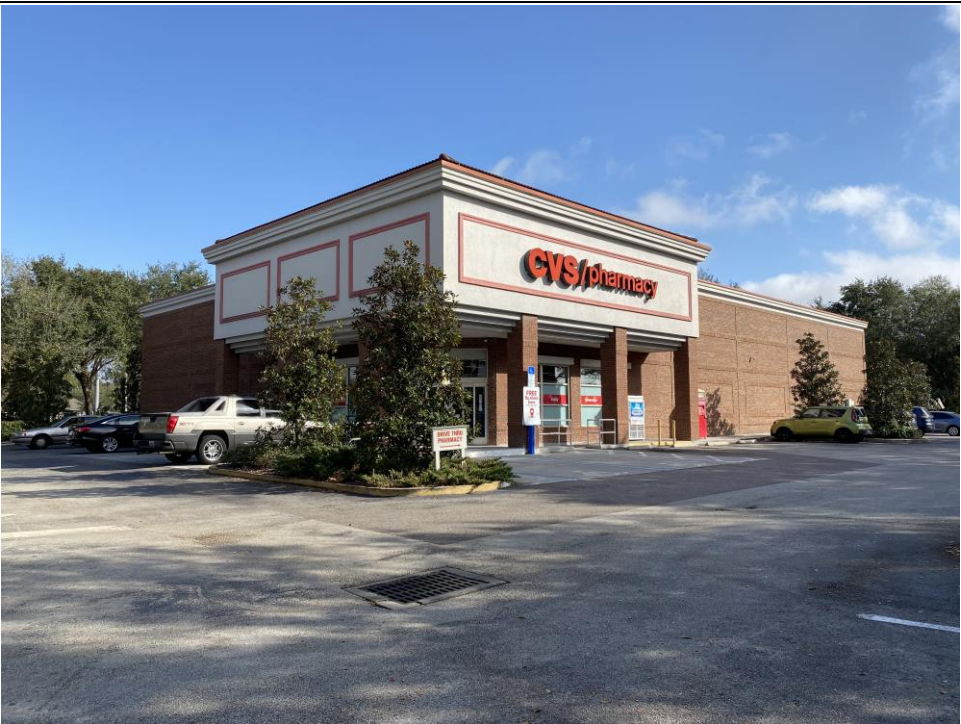
CONCLUSIONS: Based on the lack of documented contamination impacts, this site has been assigned a CRR of **Low**.

View of the CVS store from the southwest corner facing northeast.

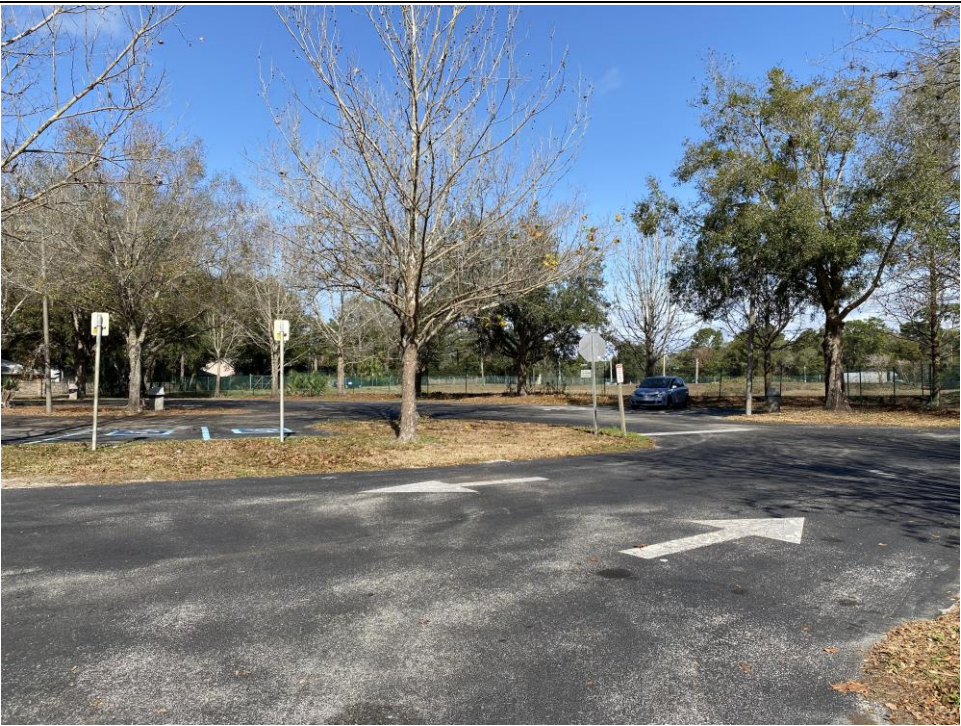
CONCLUSIONS: Based on the lack of documented contamination impacts, this site has been assigned a CRR of **Low**.

View of a portion of the parking lot at the Lake Lotus Park overflow parking lot, facing generally north toward SR 434.

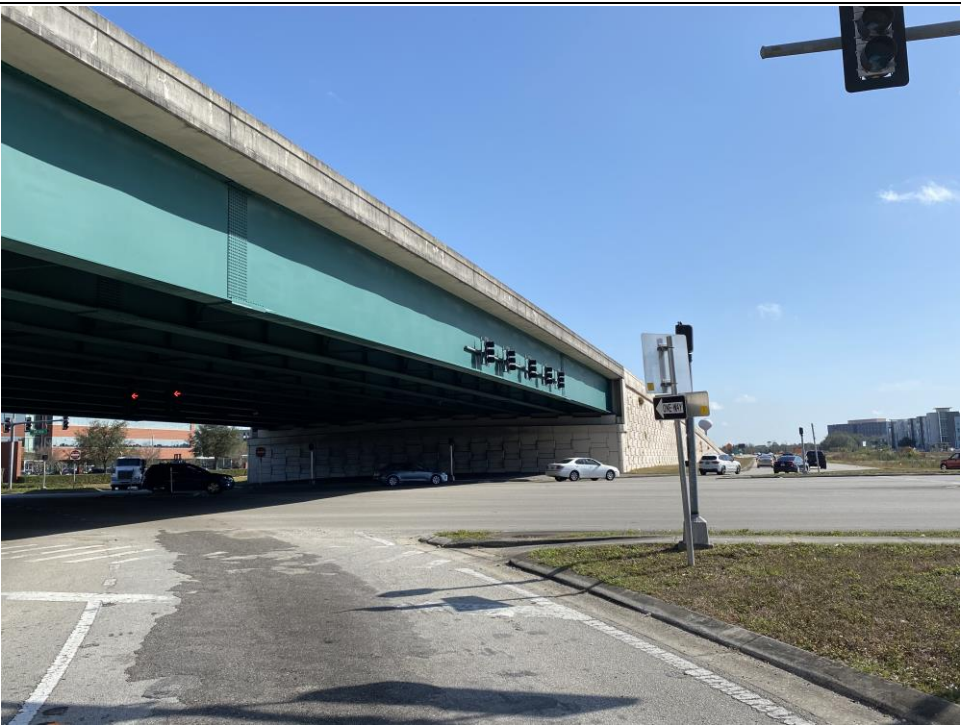
CONCLUSIONS: Based on the lack of documented contamination impacts and the former facility having been redeveloped with the current SR 414 / SR 434 interchange, this site has been assigned a CRR of **Low**.

View facing east towards the location of the former service station, from the eastbound SR 414 exit ramp onto northbound SR 434.

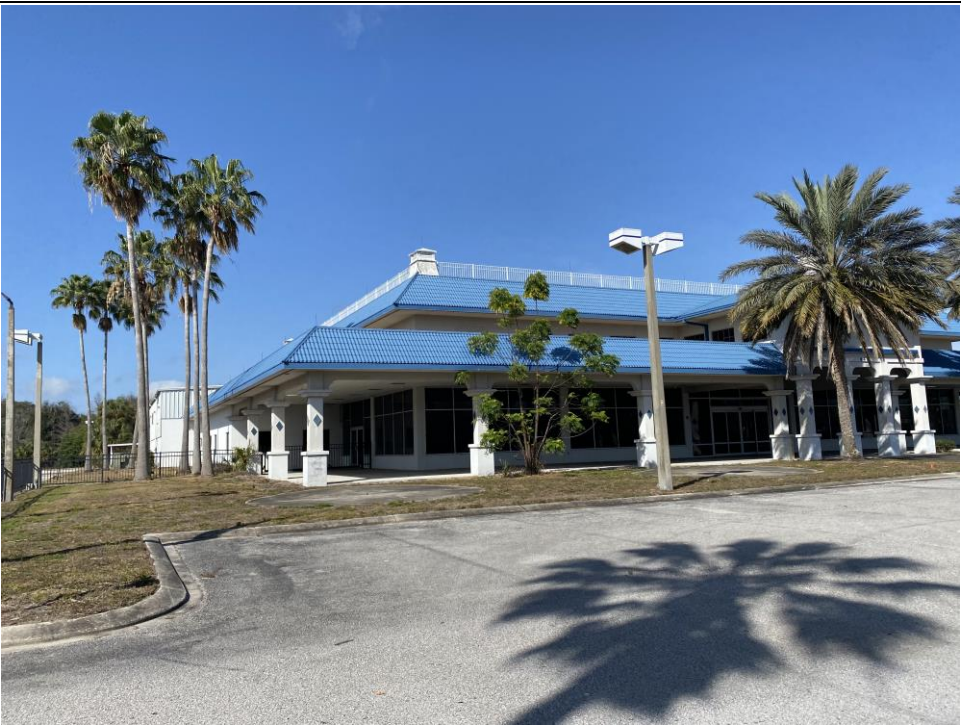
CONCLUSIONS: Based on the lack of documented contamination impacts, this site has been assigned a CRR of **Low**.

View of the vacant former automotive sales office from the east, facing west.

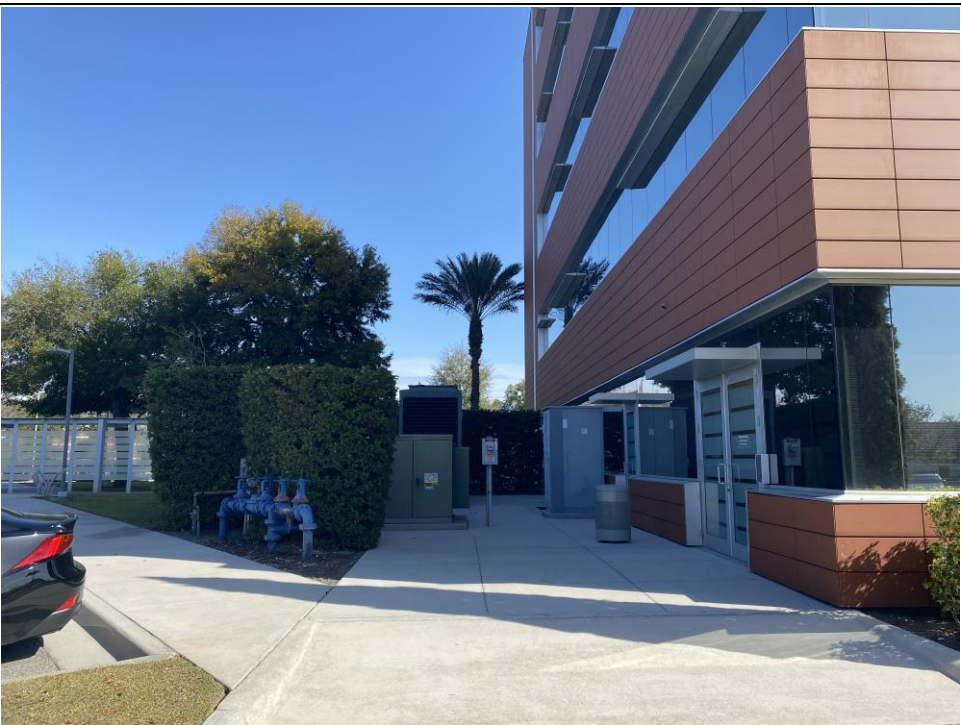
CONCLUSIONS: Based on the lack of documented contamination impacts, this site has been assigned a CRR of **Low**.

View of the emergency generator, belly tank, and pad-mounted electrical transformer, located on the northwest corner of the office building.

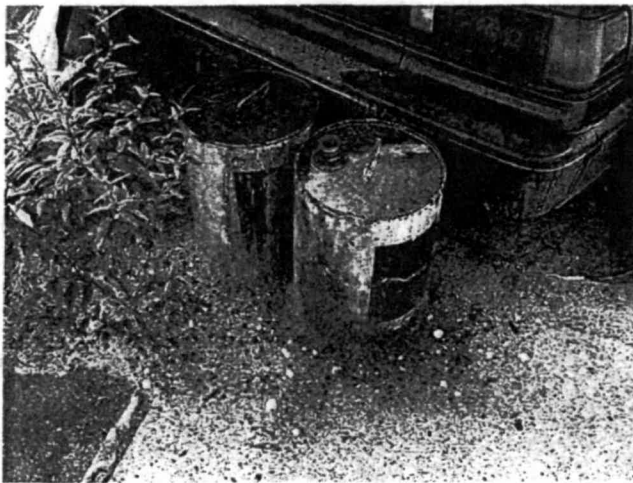
Figure 3: Two 5-gallon containers w/ unknown contents overflowing to soil

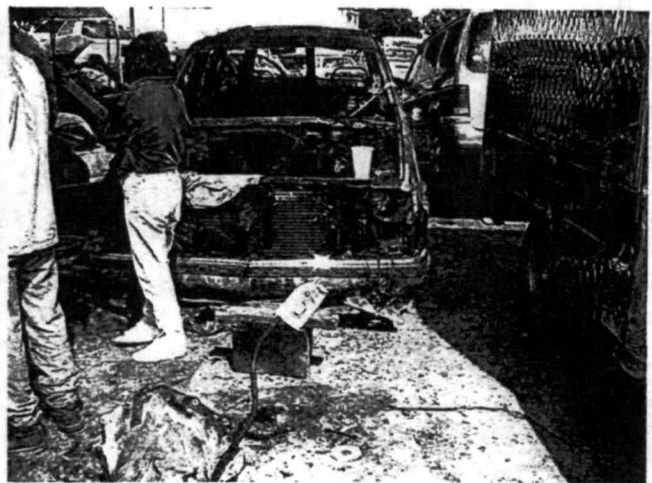
Figure 4: Burned out Explorer to be used for parts

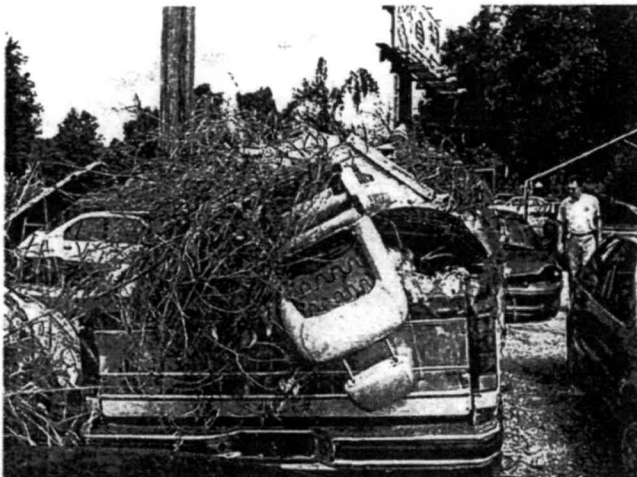
Figure 5: Solid waste

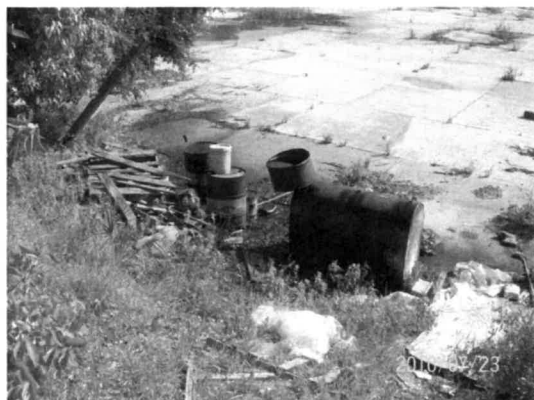
Figure 1. Tank & Containers

The property is bounded on the east by North Orange Blossom Trail, on the south by State Road 414, and on the north and west sides by Apopka Boulevard. The roadway adjacent to the west side of the property is raised and ends in a cul-de-sac. Access to the tank and containers (Figure 1) was from the cul-de-sac.

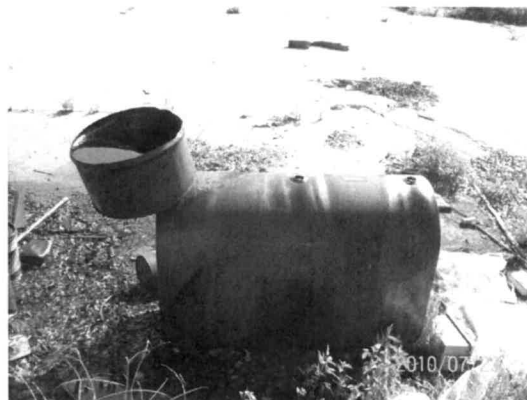
Figure 2. Tank

On the property, which appears to be a large concrete pad, was an estimated 150-gallon aboveground storage tank with one-third of a 55-gallon drum serving as a funnel (Figure 2). What appeared to be used oil was visible in the funnel and on the ground around the tank. The tank, which was full, was not labeled as to the contents.

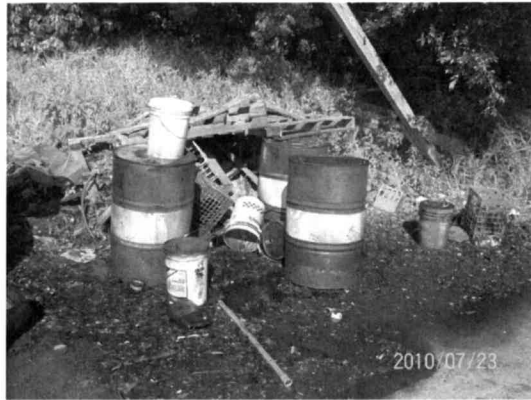
Figure 3. Drums

Adjacent to the tank were three 55-gallon drums (Figure 3). All three drums were colored blue, white, and blue. No labels were visible on the drums and all were full of unknown contents.

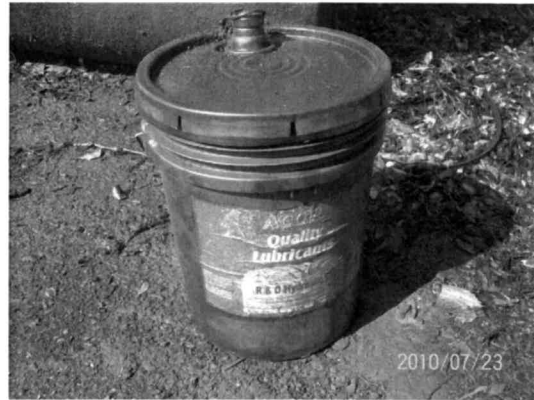
Figure 4. Black Pail

Hydraulic Oil", was one-fifth full of an unknown liquid (Figure 4). A black and white pail, labeled "Gold Ban Hydraulic Oil", was full of an unknown liquid (Figure 5). A white pail with no label was full of an unknown liquid (Figure 6). A green pail, labeled "Coastal Multi Trac Tractor Fluid", was full of an unknown liquid (Figure 7). A white pail with a red lid (Figure 8) was empty as was a white pail with a black and white checkerboard pattern (Figure 9).

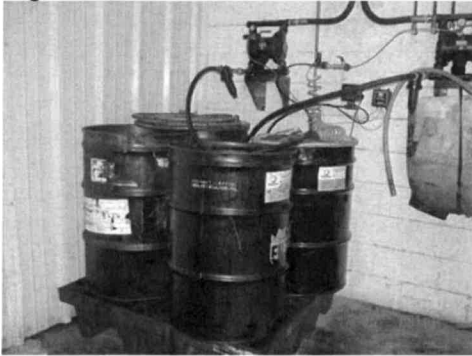
Figure 1: Drums for used oil filters and fuel

Outside the main building was the hazardous waste and used oil storage area. There was one 500-gallon above ground storage tank (Figure 3), labeled correctly and in proper containment, storing used oil. A 300-gallon above ground storage tank (Figure 4), labeled correctly, storing waste antifreeze. Two 55-gallon drums (Figures 1-2), labeled correctly, were storing used oil filters.
