2012

Annual Inspection Report

ORLANDO - ORANGE COUNTY
EXPRESSWAY AUTHORITY

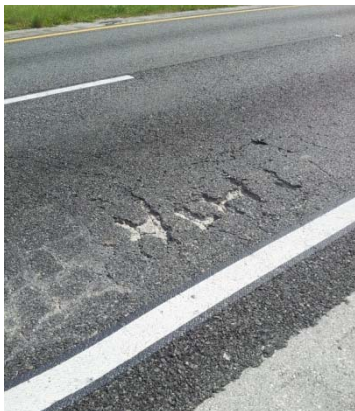
**Picture 4 – NB SR 417
near MP 15**

Roadway/Pavement features are in good condition. Pavement cracking deficiencies were the most commonly noted. In addition to a few isolated locations (as shown in Picture 4), most of the Class III cracking was observed on SR 417 between Curry Ford Road and Lake Underhill Road. A widening project for this section (which will include milling and resurfacing of existing lanes) is currently under design, and, based on the Five Year Work Plan, is scheduled to start construction in late 2013.
