2013 Annual Inspection Report

ORLANDO - ORANGE COUNTY
EXPRESSWAY AUTHORITY

The 2013 inspection of the Orlando-Orange County Expressway Authority's (Authority) system, performed by Atkins, the Authority's General Engineering Consultant, included a visual inspection of the roadways, buildings and bridges under Authority jurisdiction.

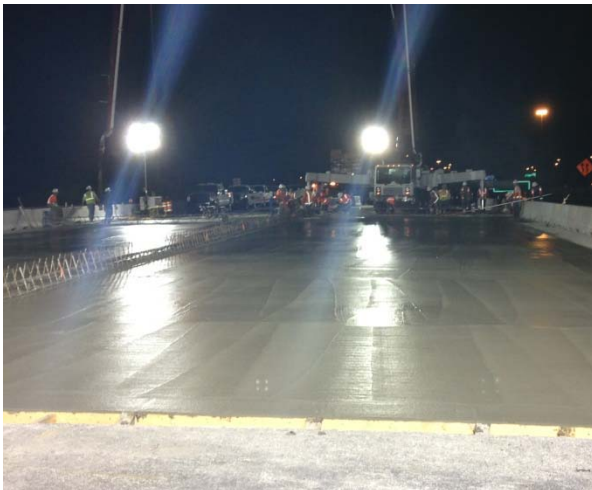
**Picture 12 – SR 528 Bridge over
Daetwyler Drive**

- Bridge # 750315, SR 436 southbound over Ramp M on SR 528
- Bridge # 750316, SR 436 southbound over SR 528
- Bridge # 750319, SR 528 over Daetwyler Drive

These reported deficiencies are currently being addressed by the Authority. The SR 528/SR 436 interchange bridges are currently in the SR 528/SR 436 Bridge Deck Replacement project in the Draft Five Year Work Plan for FY 14-18. As shown in Picture 12, the Daetwyler Drive bridge is currently under construction as part of project 528-405B, SR 528 Bridge Deck Replacements.
