Annual Inspection Report

2014

CENTRAL FLORIDA EXPRESSWAY AUTHORITY

The 2014 inspection of the Central Florida Expressway Authority's (Expressway Authority) system, performed by Atkins, the Authority's General Engineering Consultant, included a visual inspection of the roadways, buildings and bridges under Expressway Authority jurisdiction.

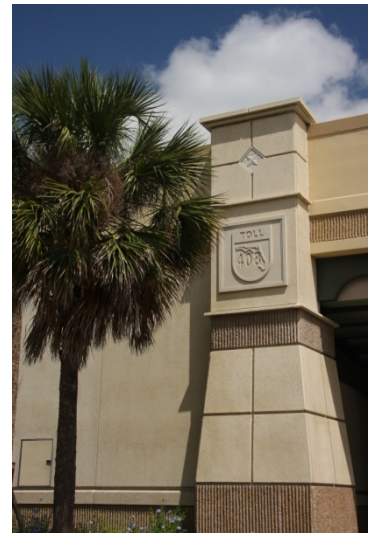
**Picture 1 –
SR 408 Aesthetics**

Vegetation/Aesthetics features along SR 408 (see Picture 1) are in generally good condition with no deficiencies identified.

Out of the total 828 Vegetation/Aesthetics features that were inspected on SR 408, maintenance is proposed for the 36 that received a rating of 4. No Vegetation/Aesthetic features received a rating lower than 4.

Tree trimming is proposed at various locations throughout SR 408 to prevent tree limbs from encroaching into travel lanes, fences and other areas. Roadway mowing is recommended where vegetation height needs to be controlled. Maintenance is also suggested for some litter removal, roadway sweep and landscape features that were rated as 4.

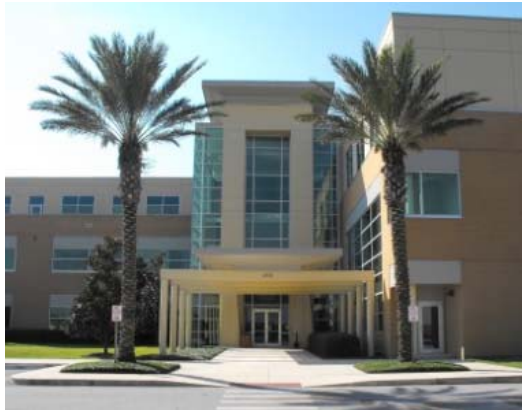
**Picture 2 – CFX
Headquarters Building**

The Expressway Authority's headquarters building, shown in Picture 2, is located along SR 408 near the Conway Westbound Mainline Toll Plaza. The building is in good condition with no deficiencies identified. No features received a rating of 4 or lower.

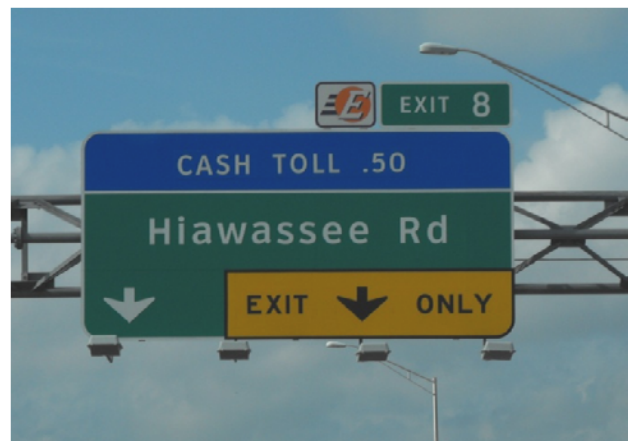
Picture 3 – SR 414 Overhead Sign

Traffic Services features for SR 414 (refer to Picture 3) are in good condition, identifying no deficiencies.

One object marker feature received a rating of 4. It is suggested that the missing milepost sign be installed. Only one feature out of a total of 310 inspected Traffic Services features received a rating of 4. No Traffic Services features were rated lower than 4.

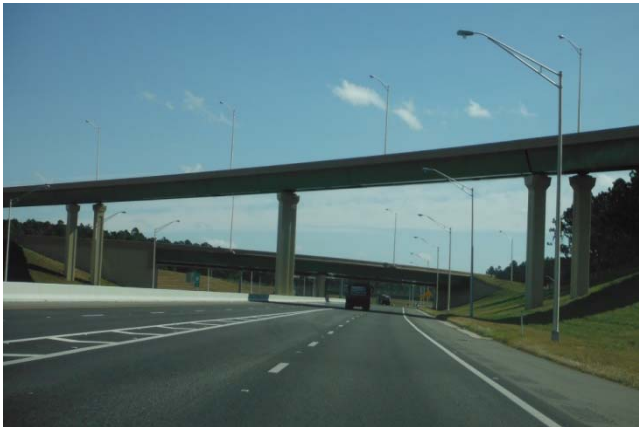
Picture 6 – SR 451 NB bridge over SR 414

Picture 6 shows the SR 451 northbound bridge over SR 414. The latest bridge inspection reports for the bridges along SR 451 are available for review upon request to the Expressway Authority. No significant deficiencies were reported. Minor deficiencies reported are being addressed by the Expressway Authority.

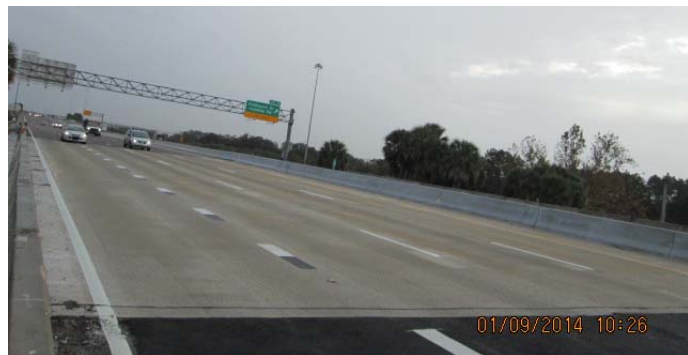
Picture 7 – SR 417 Bridge over Daetwyler Drive

The latest bridge inspection reports for the bridges along SR 528 are available for review upon request to the Expressway Authority. Picture 7 shows the completed SR 528 bridge over Daetwyler Drive. The bridge deck replacement project addressed a work order recommendation that was included in last year's bridge inspection reports.
