2015

Annual Inspection Report

**CENTRAL
FLORIDA
EXPRESSWAY
AUTHORITY**

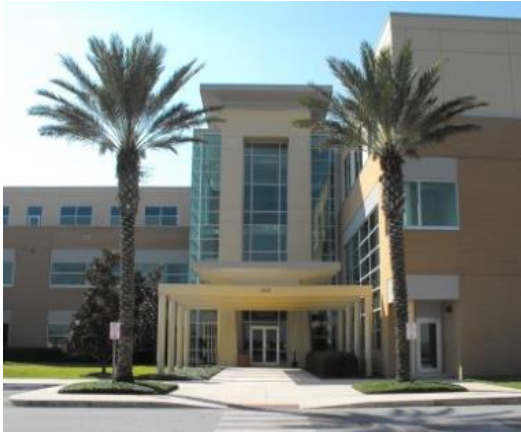
**Picture 1 – CFX
Headquarters Building**

CFX's headquarters building, shown in Picture 1, is located along SR 408 near the Conway Westbound Mainline Toll Plaza. The building is in good condition with no deficiencies identified. No features received a rating lower than 4.

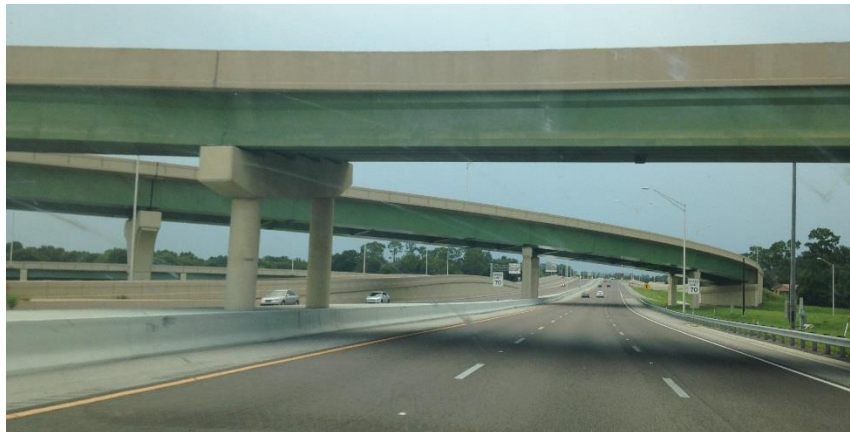
Picture 2 – SR 408 Bridges Over SR 417

Picture 2 shows the bridges of SR 408 over SR 417. The latest bridge inspection reports for the bridges along SR 408 are available for review upon request to CFX. No significant deficiencies were reported. No load limits or weight restrictions have been imposed that would constrain the use of any bridge on SR 408.

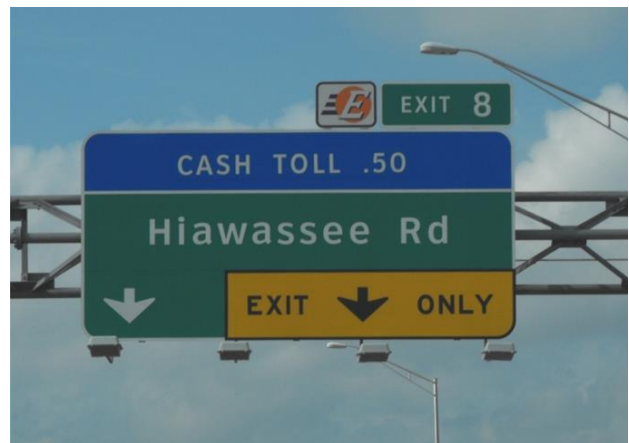
Picture 3 – SR 414 Overhead Sign

Traffic Services features for SR 414 (refer to Picture 3) are in good condition, identifying no deficiencies.

Only one feature out of a total of 304 inspected Traffic Services features received a rating of 4. It is suggested that maintenance be performed on the regulatory sign that is damaged. No Traffic Services features were rated lower than 4.

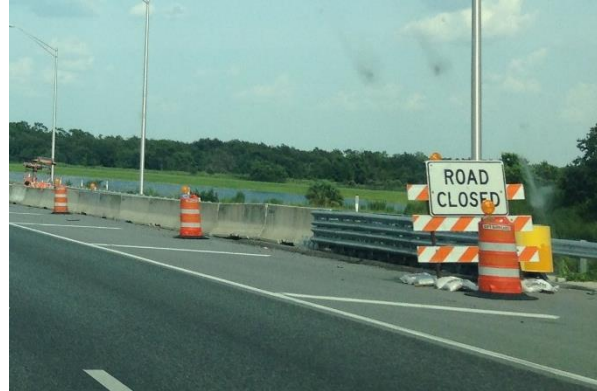
The inspection of the roadway and its appurtenances for SR 417 starts around MP 6 and extends north past MP 37 to the Orange/Seminole County Line. Figures 3-3 and 3-4 show SR 417 and its mile posts. It should be noted that at the time the 2015 inspection was performed, the following portions of SR 417 were under construction (see Picture 4):

The portions under construction were not inspected and are shown on the Inspection Worksheets with a rating of 0.

Picture 4 – Road Closed Sign on SR 417 near Boggy Creek Road
