2016

Annual Inspection Report

**CENTRAL
FLORIDA**
EXPRESSWAY
AUTHORITY

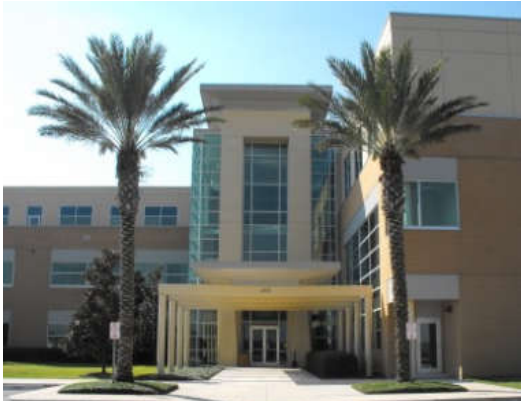
**Picture 1 – CFX
Headquarters Building**

CFX's headquarters building, shown in Picture 1, is located along SR 408 near the Conway Westbound Mainline Toll Plaza. The building is in good condition with no deficiencies identified. No features received a rating lower than 4.

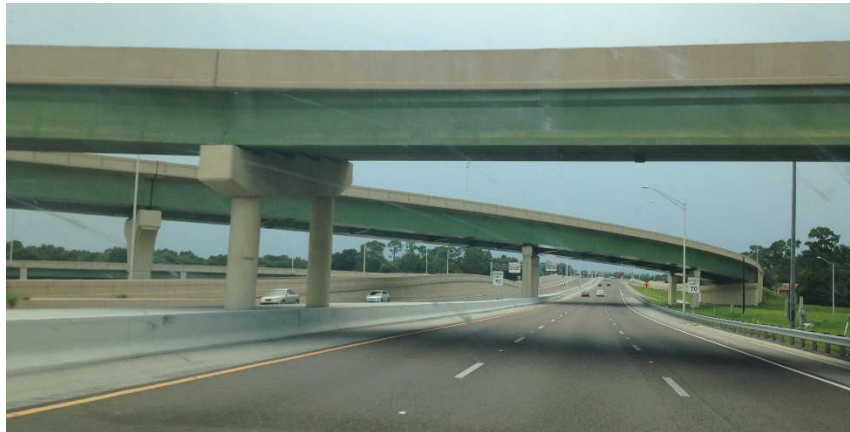
Picture 2 – SR 408 Bridges Over SR 417

Picture 2 shows the bridges of SR 408 over SR 417. The latest bridge inspection reports for the bridges along SR 408 are available for review upon request to CFX. No significant deficiencies were reported. No load limits or weight restrictions have been imposed that would constrain the use of any bridge on SR 408.

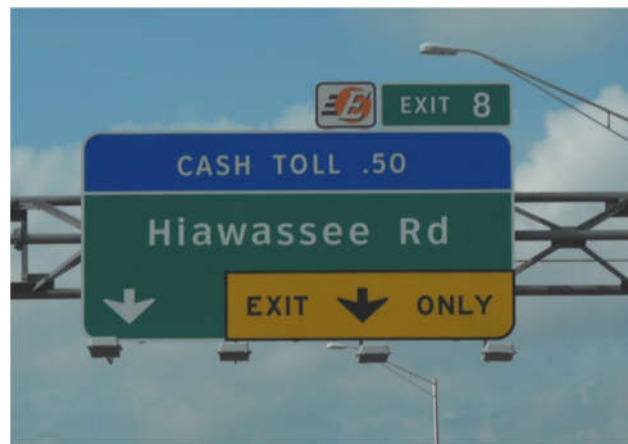
Picture 3 – SR 414 Overhead Sign

Traffic Services features for SR 414 (refer to Picture 3) are in good condition, identifying no deficiencies and no needed maintenance.

Highway and sign lighting was inspected at night and is in good condition with no deficiencies noted. The isolated sign lights that were out at the time of the inspection are identified on the Night Inspection Worksheets on the CD attached to the back of this report.

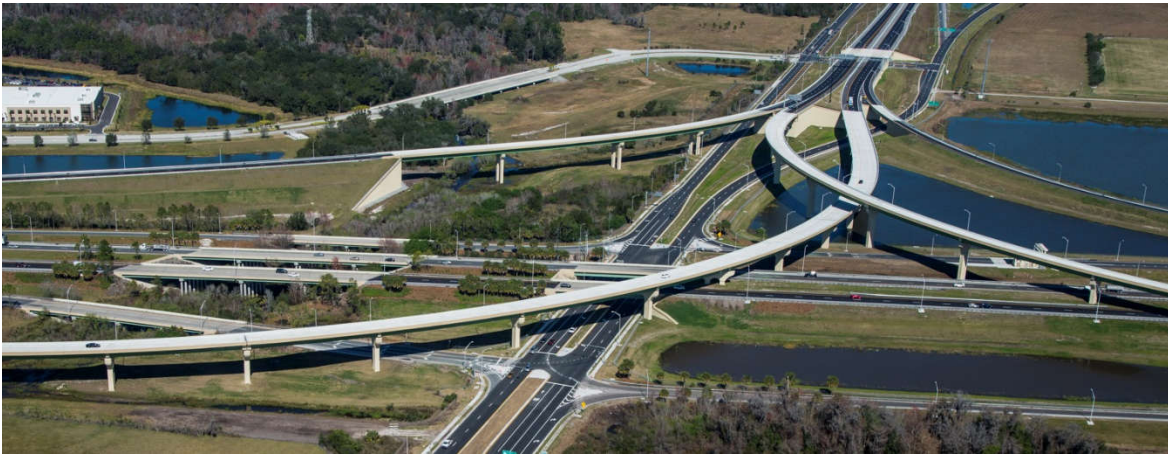
Picture 4 – SR 417 / Boggy Creek Interchange

Picture 4 shows the recently constructed bridges at the SR 417 / Boggy Creek Road interchange. The latest bridge inspection reports for the bridges along SR 417 are available for review upon request to CFX. No significant deficiencies were reported. No load limits or weight restrictions have been imposed that would constrain the use of any bridge on SR 417.
