2017 Annual Inspection Report

Mr. Joseph A. Berenis, P.E.
Deputy Executive Director
Central Florida Expressway Authority
4974 ORL Tower Road
Orlando, Florida 32807

Re: 2017 Annual Inspection Report

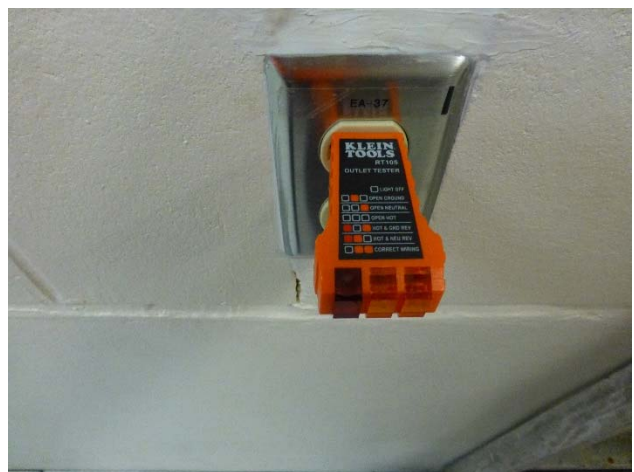
Figure 9 In-operable receptacle Coral Hill Mainline Plaza

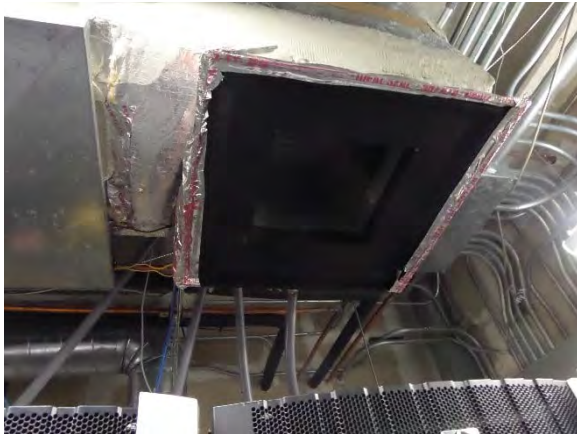
Figure 1 Hiawassee Mainline

- Main Plaza computer room needs maintenance to replace missing HVAC vent. (Figure 1)
- Main Plaza computer room needs maintenance on the door latch to ensure it is fixed properly to the wall. (Figure 2)
- Main Plaza computer room needs electrical contractor to attach unistrut, conduit and electrical box to wall with drywall screws. (Figure 3 & Figure 4)
- Main Plaza HVAC room need to be cleared of storage boxes and debris. (Figure 5)

- Recommend HVAC contractor to replace vents in computer room.
- Recommend maintenance on door latch in computer room.
- Recommend electrical contractor check the wiring in the toll booths and fix the electrical box, conduit & unistrut in the computer room.
- Recommend removal of any storage materials in electrical and HVAC closets.

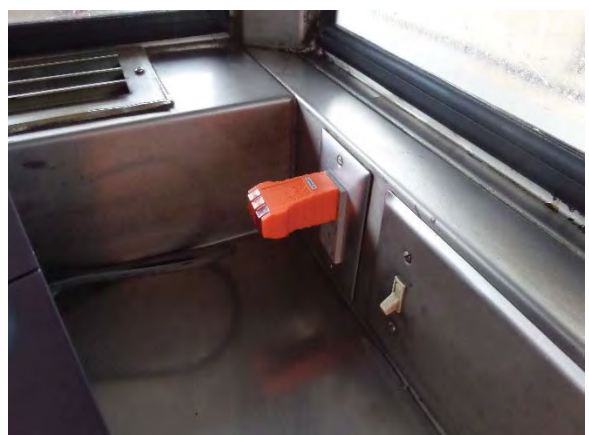
Figure 6 Hiawassee Mainline

- The above referenced tunnel is in good condition overall with the exception of some electrical outlets not working in the toll booths. (Figure 6)

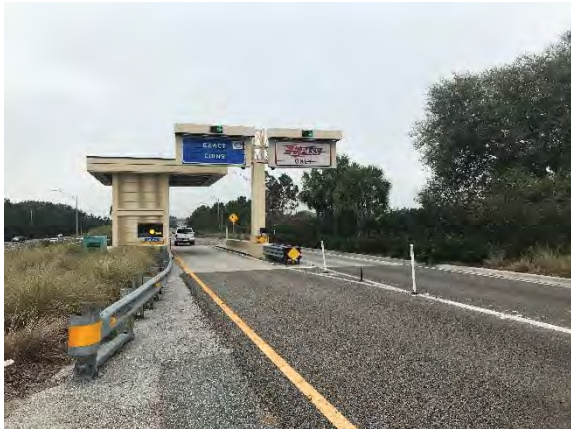
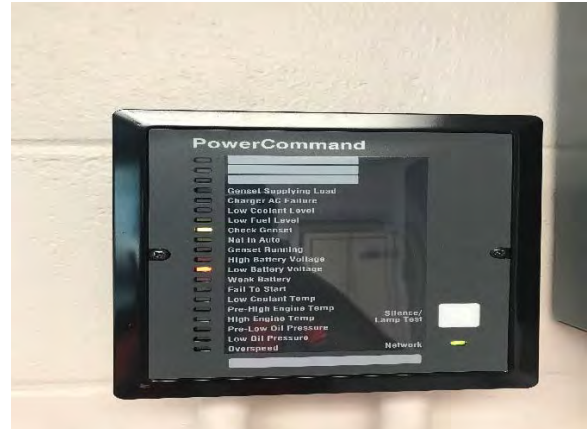
The above referenced on ramp is in good condition overall. Maintenance is recommended on the generator annunciator panel. (Figure 7 & Figure 8)

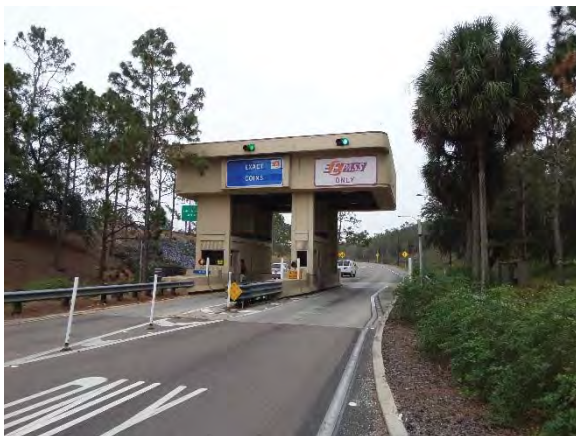
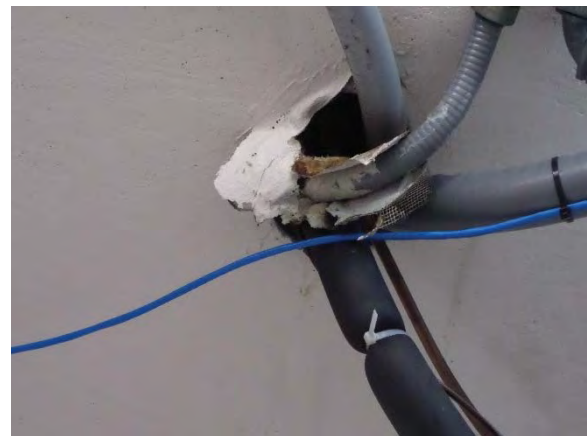
The above referenced on ramp is in good condition overall. Verification of the roof penetrations and fireproofing is recommended. (Figure 11 & Figure 12)

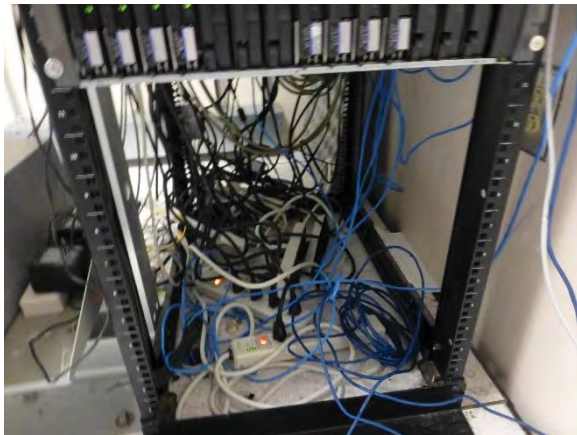
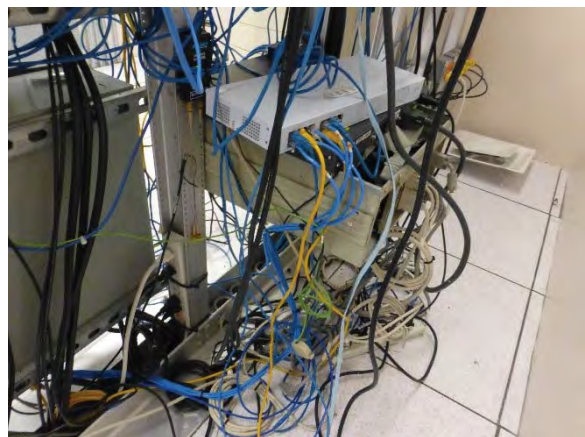
- Main Plaza has isolated wiring bundles with multiple power strips on floor below equipment racks. (Figure 1 & Figure 4)
- Main Plaza ceiling tile has possible leak above ceiling in computer room. (Figure 2)
- Main Plaza is missing HVAC vent covers. (Figure 3)

- Recommend isolated wiring in computer room be cleaned up.
- Recommend maintenance determine the source of any leaks above the ceiling grid.
- Recommend HVAC contractor to ensure that all vents have covers installed.

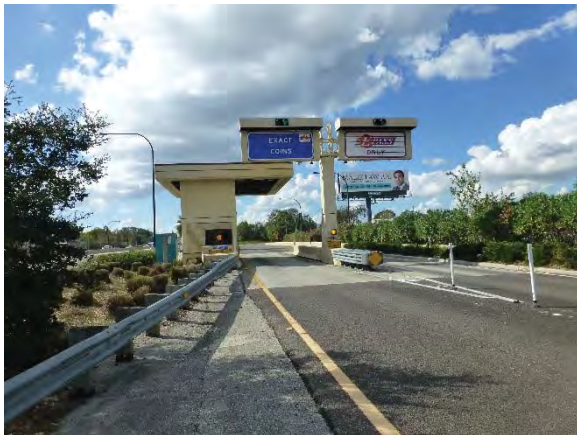
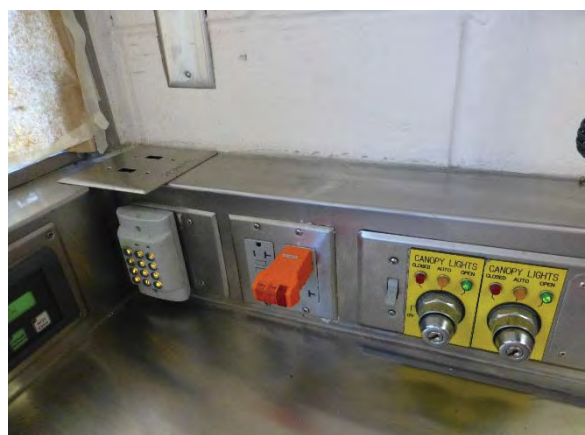
The above referenced on ramp is in good condition overall. Some maintenance of isolated wiring for the outlet missing power is recommended (Figure 5 & Figure 6)

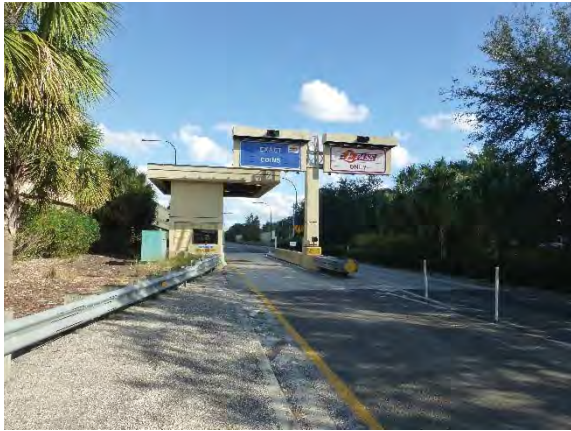
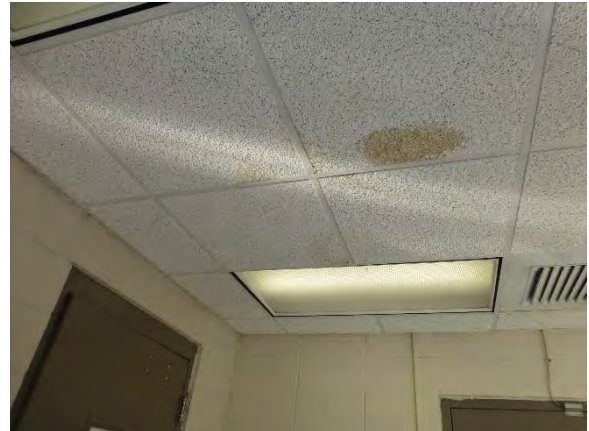
The above referenced on ramp is in good condition overall. Maintenance is recommended on some ceiling tiles and potential leaks need to be addressed. (Figure 7 & Figure 8)

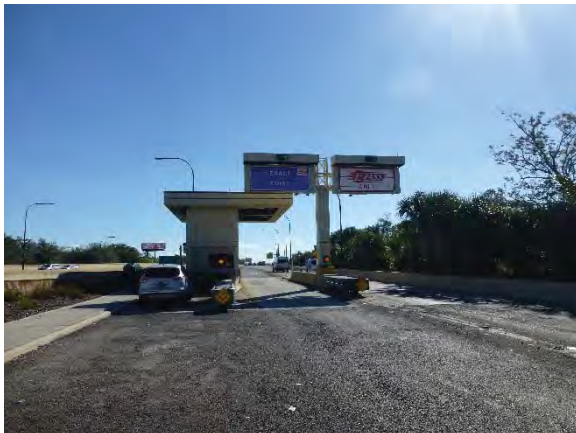
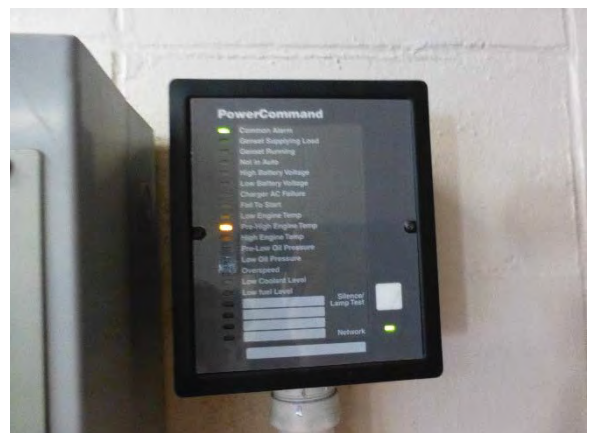
The above referenced on ramp is in good condition overall. General maintenance is recommended on the generator annunciator panel. (Figure 11 & Figure 12)

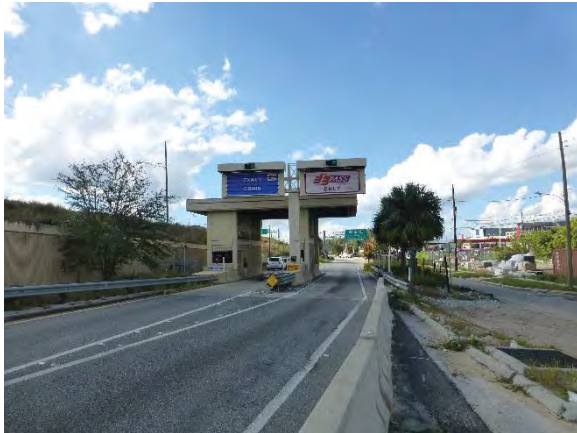
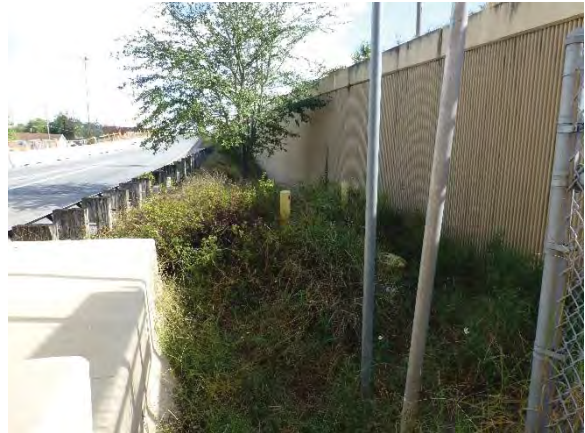
The above referenced on ramp is in good condition overall. Some landscaping around the bollards and propane tank is recommended (Figure 13 & Figure 14)

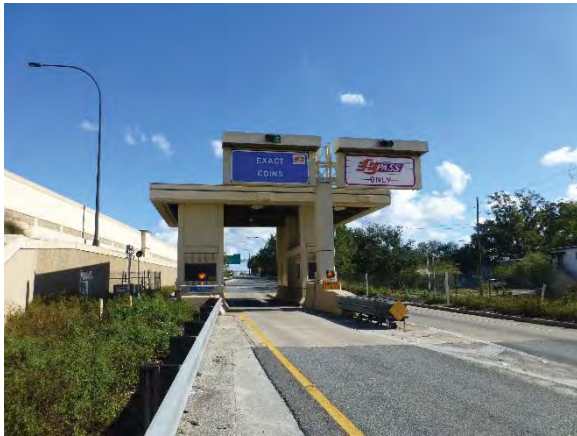
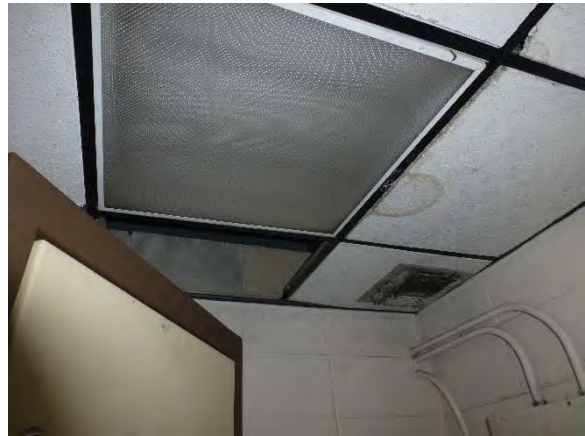
The above referenced on ramp is in good condition overall. Maintenance is recommended on some ceiling tiles and potential leaks need to be addressed. (Figure 15 & Figure 16)

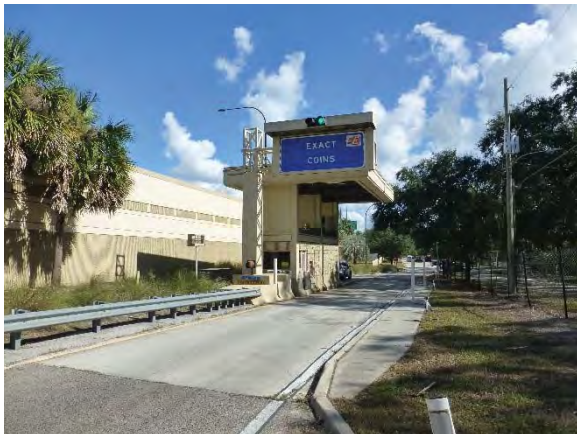
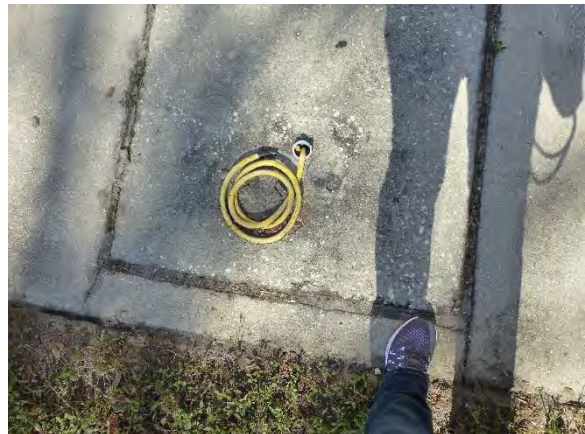
The above referenced on ramp is in good condition overall. Maintenance is recommended to properly cap off communication wiring at grade. (Figure 17 & Figure 18)

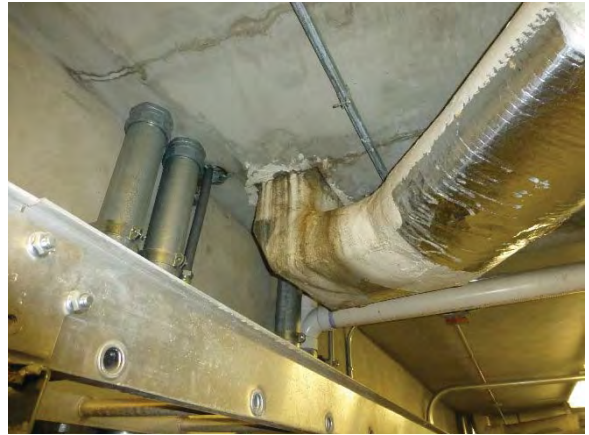
Figure 2 Conway EB Mainline

- EB Tunnel - Main Plaza tunnel HVAC duct work appears to have a leak at the ceiling point of entry. (Figure 2)
- WB Tunnel – Main Plaza tunnel has tears in duct work at ceiling. (Figure 3)

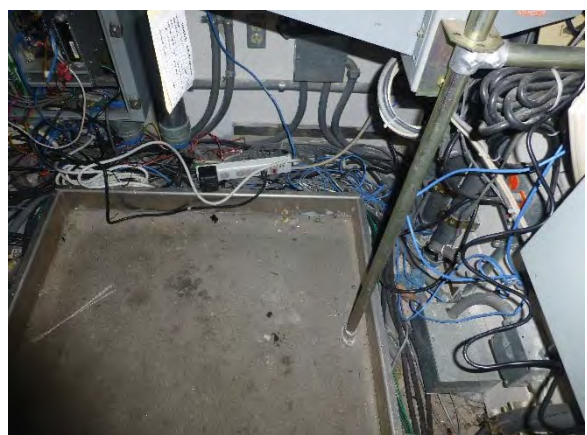
Figure 12 Bumby Ramp Off

The above referenced on ramp is in good condition overall. Recommend maintenance of isolated wiring for electrical trough. (Figure 11 & Figure 12)

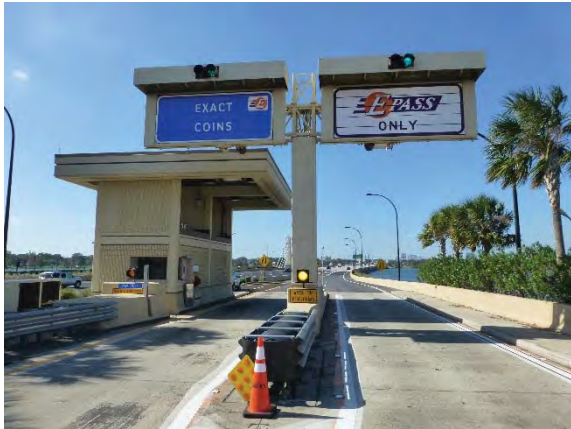
Figure 13 Conway Ramp On

The above referenced on ramp is in good condition overall. Some general maintenance of the exterior debris is also recommended. (Figure 13 & Figure 14)

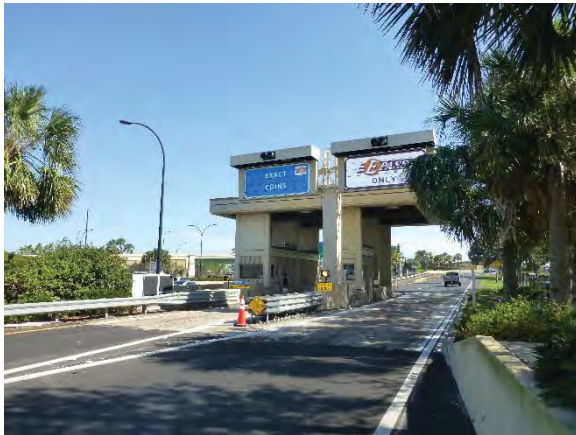
Figure 15 Conway Ramp Off

The above referenced on ramp is in good condition overall. Some maintenance on the UPS is recommended. (Figure 15 & Figure 16)

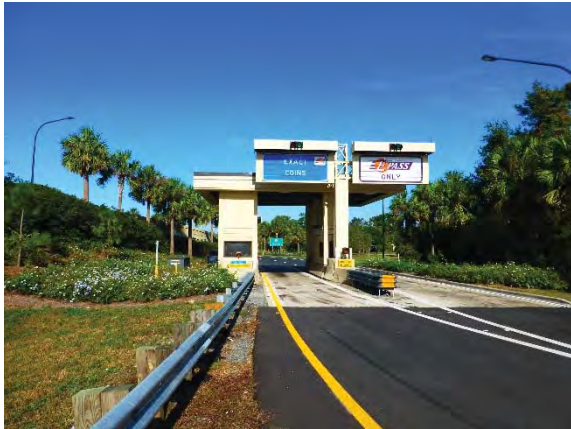
Figure 19 Semoran Ramp Off

The above referenced on ramp is in good condition overall. Some maintenance to replace missing HVAC vent covers, locate leaks above ceiling tile and close off the hole exposed to outside is recommended. (Figure 19, Figure 20, Figure 21 & Figure 22)

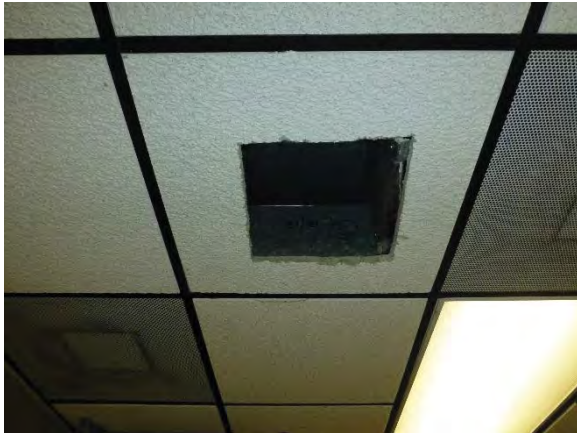
Figure 1 Dean Mainline

- Main Plaza computer room HVAC vents missing covers. (Figure 1 & Figure 3)
- Main Plaza computer room ceiling tile has potential leaks. (Figure 2)
- Main Plaza computer room equipment rack power cables. (Figure 4)

- Recommend HVAC contractor to replace vents in computer room.
- Recommend general maintenance to locate/address leaks in ceiling tile.
- Recommend electrical contractor check the wiring in the tunnel and find a closer power source for extension cord and replace the Tunnel CMS control panel Lane 1 & Lane 2 NEMA enclosures.
- Recommend general maintenance to fix ceiling seam in tunnel.

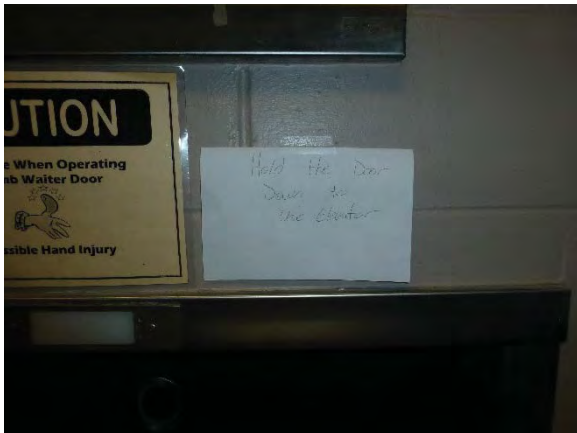
Figure 5 Dean Mainline Dumb Waiter

- Main Plaza Tunnel stairwell dumb waiter requires maintenance. (Figure 5)
- Main Plaza Tunnel power cord stretching across tunnel to power equipment. (Figure 6)
- Main Plaza Tunnel CMS control panel Lane 1 & Lane 2 NEMA enclosures rusted out. (Figure 7, Figure 8, Figure 9 & Figure 10)
- Main Plaza Tunnel ceiling seam appears to be rotting. (Figure 11)

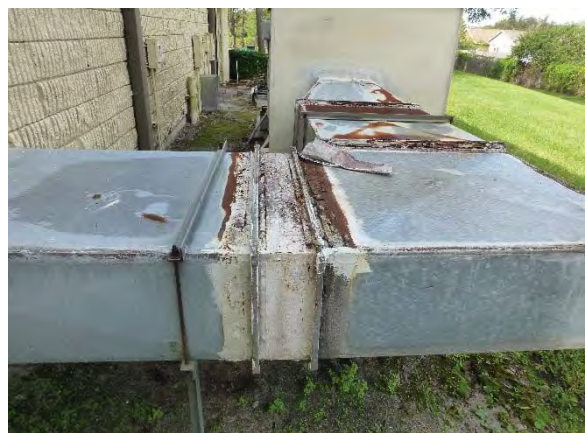
Figure 12 Dean Mainline Exterior

- Exterior Building has rusted duct work located behind building exterior. (Figure 12)

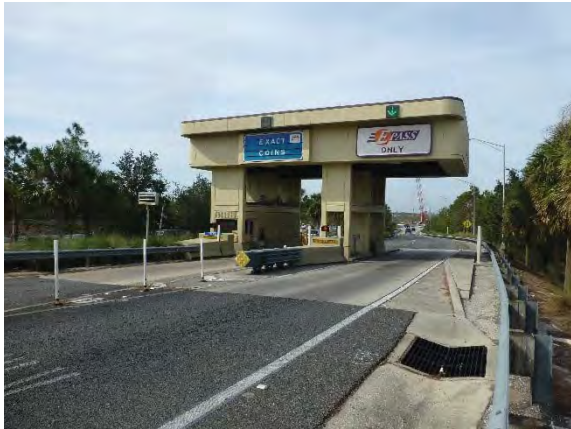
Figure 13 Dean Road Ramp On

The above referenced on ramp is in good condition overall. Some maintenance is recommended on the CCTV wiring and needs to be addressed. (Figure 13 & Figure 14)

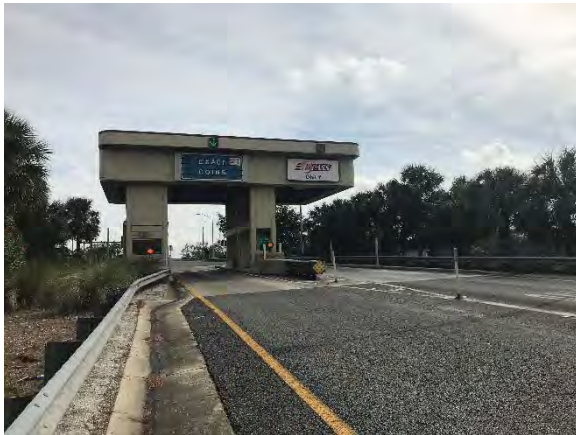
Figure 15 Dean Road Ramp Off

The above referenced on ramp is in good condition overall. Some maintenance is recommended on the electrical wiring trough. (Figure 15 & Figure 16)

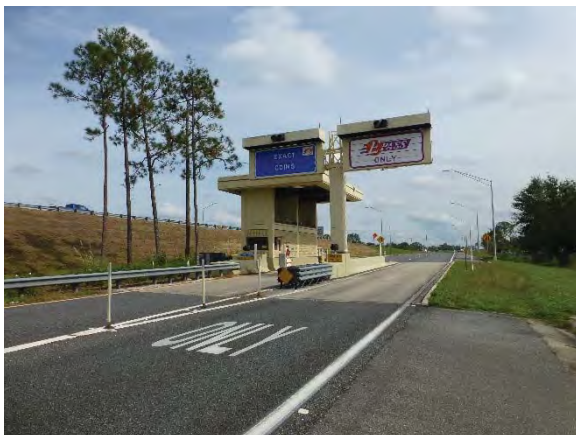
Figure 17 Rouse Road Ramp On

The above referenced on ramp is in good condition overall. Some maintenance is recommended on the existing HVAC and duct work. (Figure 17 & Figure 18)

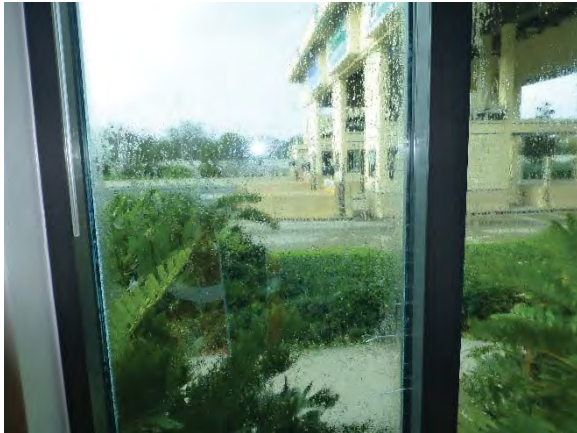
Figure 1 Coral Hills Mainline

- Main Plaza has cracks in the glass windows in the manager's office and break room. (Figure 1)
- Main Plaza doors to janitor closet and ladies restroom are sticking.
- Main Plaza HVAC in computer room missing vent cover. (Figure 2)
- Main Plaza HVAC vent has potential mold in ceiling tile near break room. (Figure 3)
- Main Plaza HVAC vent in ceiling is filled with debris. (Figure 4)

- Recommend HVAC contractor provide general maintenance.
- Recommend pressure wash on exterior walkway.
- Recommend general maintenance to repair the janitor and ladies restroom doors.
- Recommend electrical contractor provide maintenance on the electrical outlets missing power.

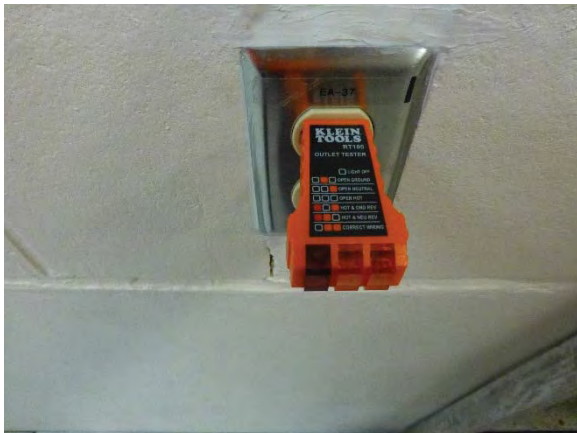
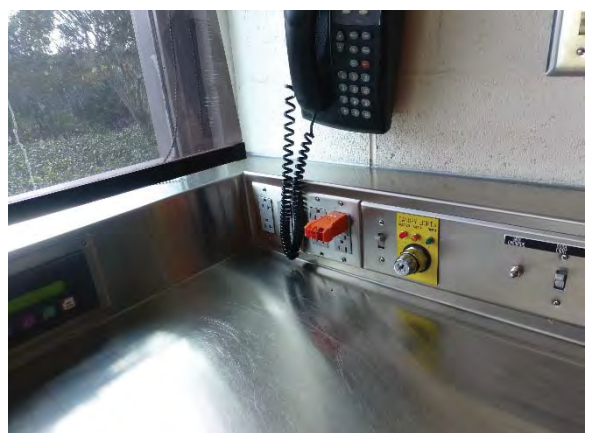
- Some electrical outlets in the toll plazas are missing power. (Figure 5 & Figure 6)

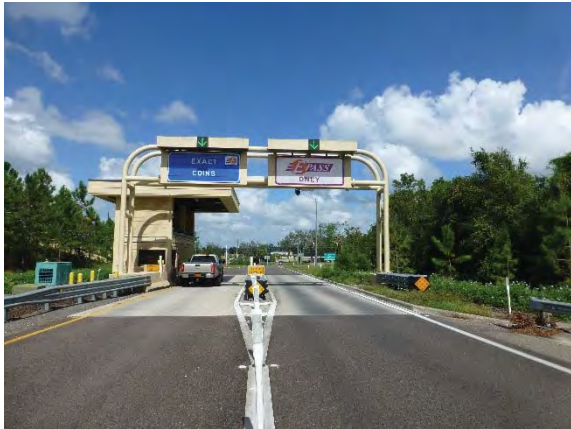
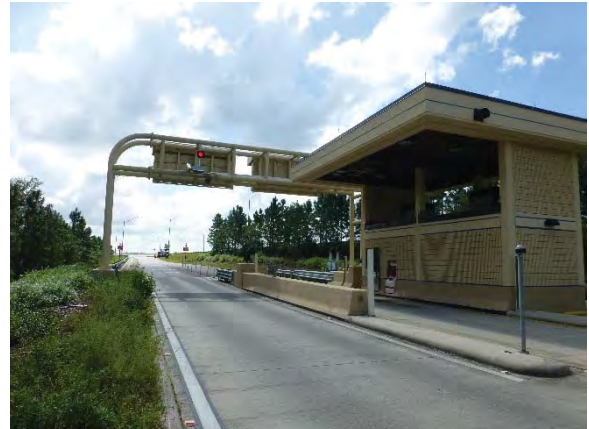
The above referenced on ramp is in good condition overall. (Figure 7 & Figure 8)

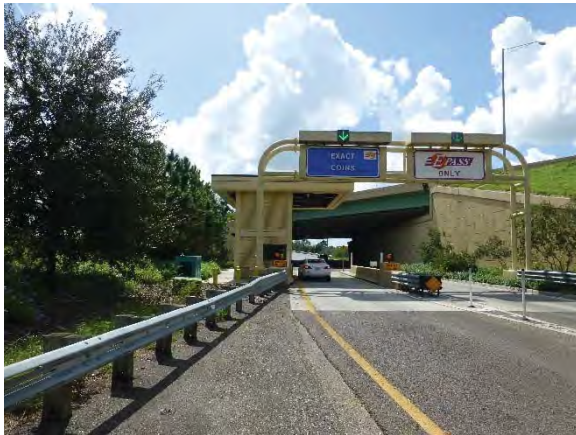
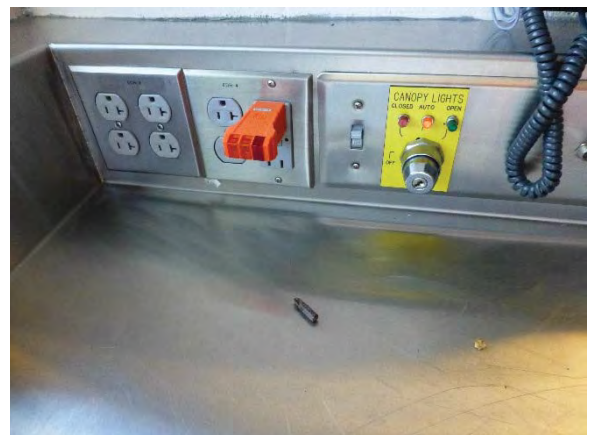
The above referenced on ramp is in good condition overall. Some maintenance on the electrical wiring for the circuits without power is recommended. (Figure 9 & Figure 10)

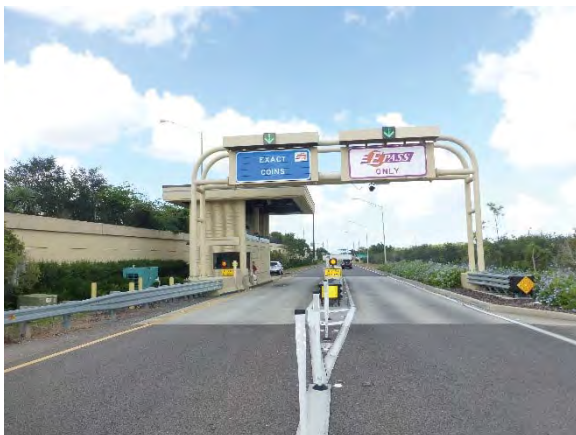
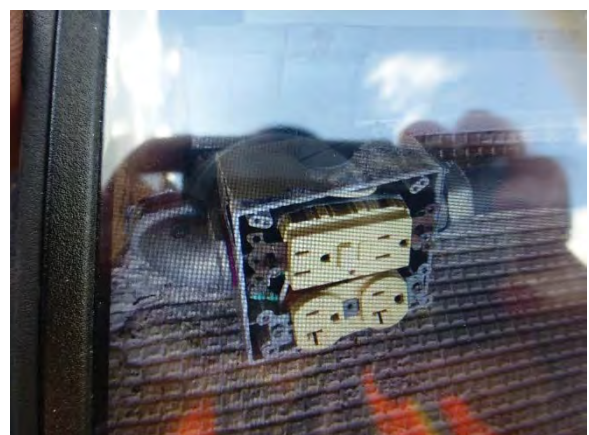
The above referenced on ramp is in good condition overall. Electrical outlet covers for the condenser units on the roof are recommended. (Figure 11 & Figure 12)

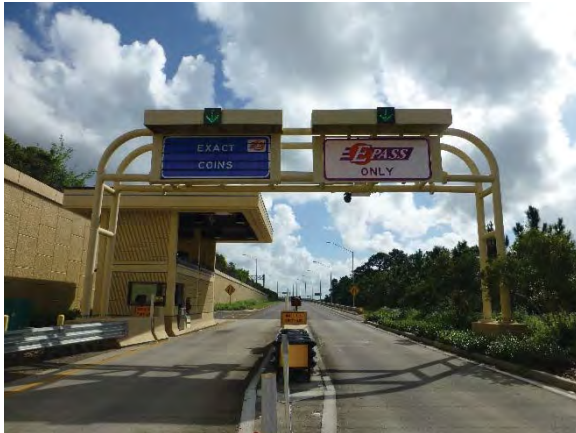
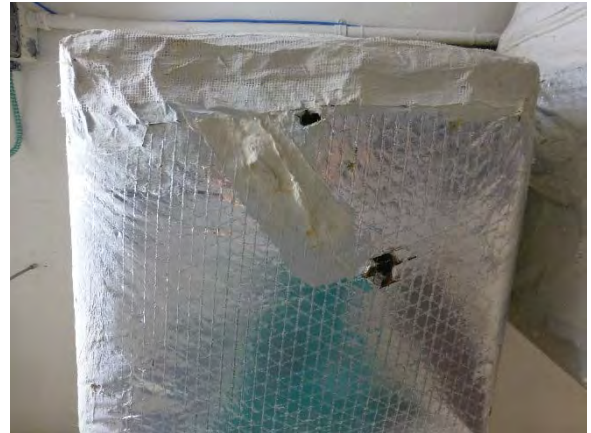
The above referenced on ramp is in good condition overall. Recommend some maintenance to repair tears in duct work. (Figure 13 & Figure 14)

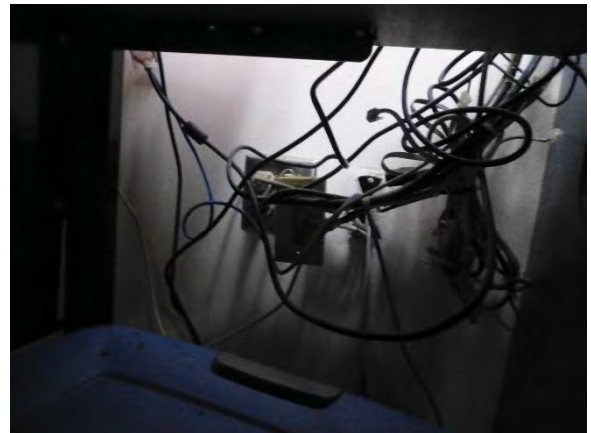
Figure 2 John Young Pkwy Mainline Counting Room Wires

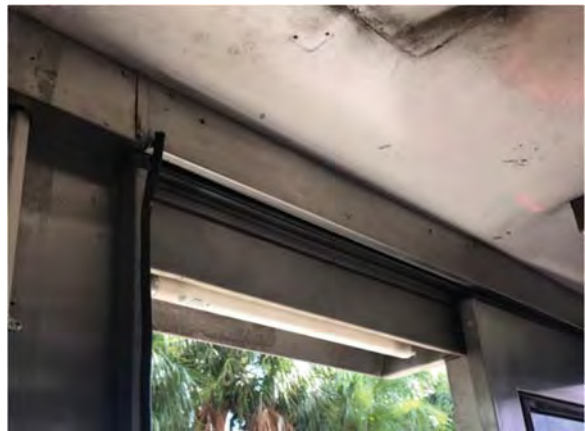
Figure 4 Boggy Creek Mainline Toll Booth

- Toll Booths have missing exterior light covers. (Figure 4)
- Possible mold overhead vent inside manned toll booth. (Figure 5)
- Some toll booths need exterior light covers. (Figure 6)
- Mechanical Room Door Covered in Wasp Nests. (Figure 7)

- Recommend HVAC contractor test the vent inside manned booth for mold.
- Recommend removal of wasp nest in exterior mechanical room.
- Recommend electrical contractor rework wiring in counting room and mechanical room.
- Recommend IT attach the panel board properly in light controller #11 enclosure.
- Recommend maintenance replace missing toll booth light covers.

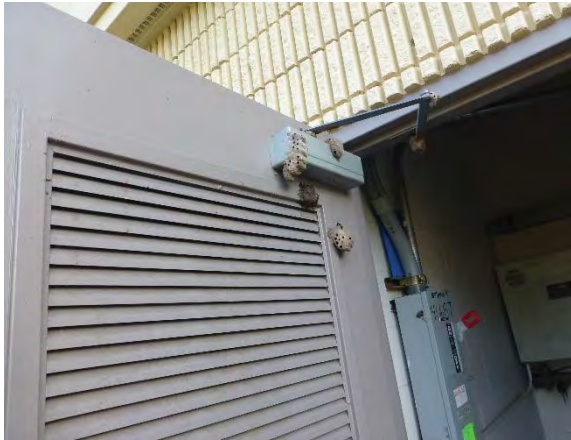
Figure 7 Boggy Creek Mainline Exterior Mech. Wasp Nests

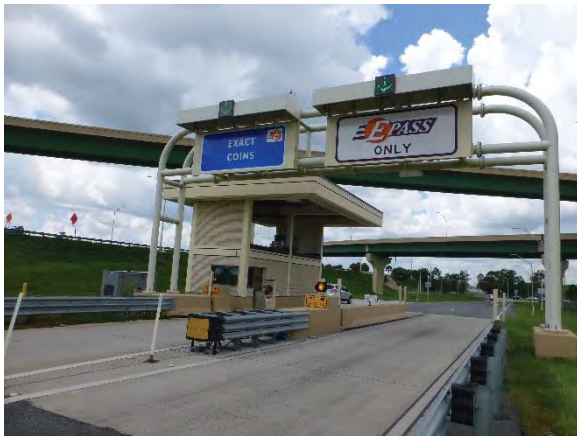
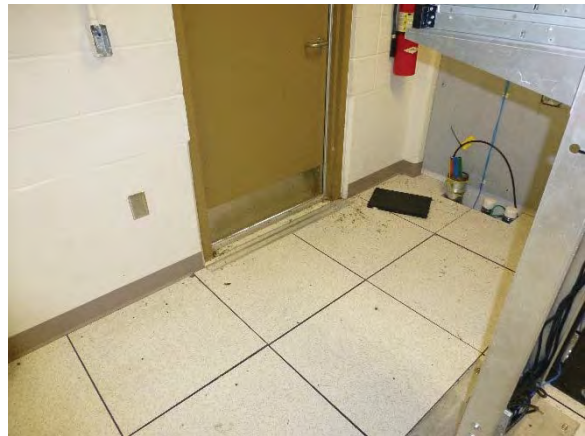
Figure 9 Boggy Creek Ramp Off

The above referenced on ramp is in good condition overall. Some pest control is recommended. (Figure 9 & Figure 10)

Figure 10 Boggy Creek Ramp Off Pest Control

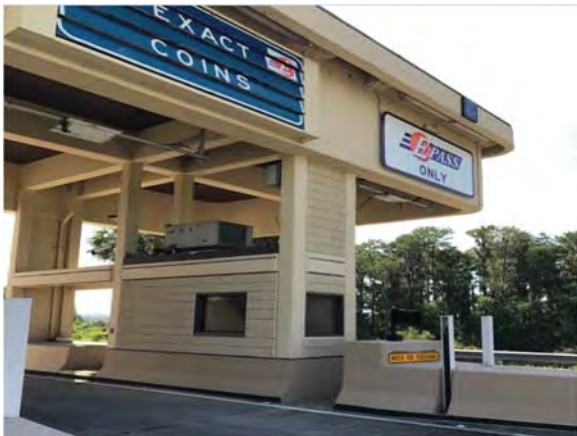
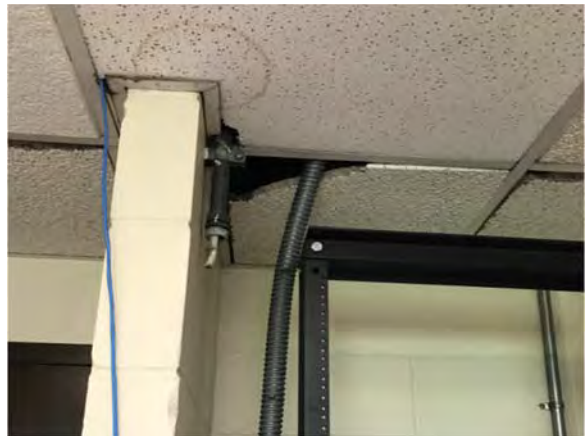
Figure 11 Boggy Creek Ramp On

The above referenced on ramp is in good condition overall. Maintenance is recommended on some ceiling tiles and potential leaks need to be addressed. (Figure 11 & Figure 12)

Figure 12 Boggy Creek Ramp On Ceiling Over Equip. Rack

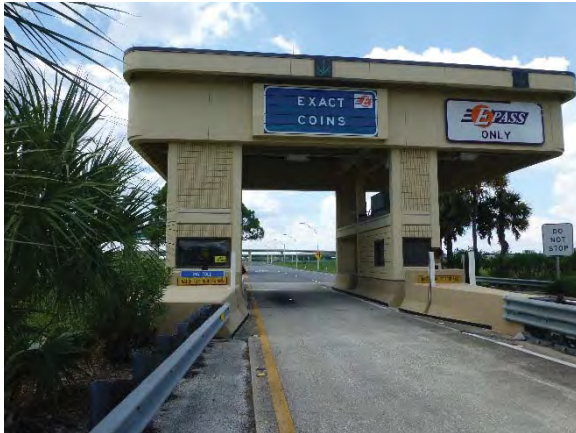
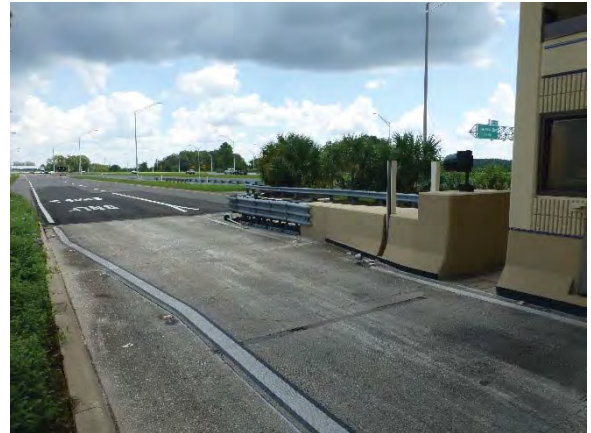
Figure 13 South Access Ramp Off

The above referenced on ramp is in good condition overall. Maintenance of the roadway safety reflectors is recommended. (Figure 13 & Figure 14)

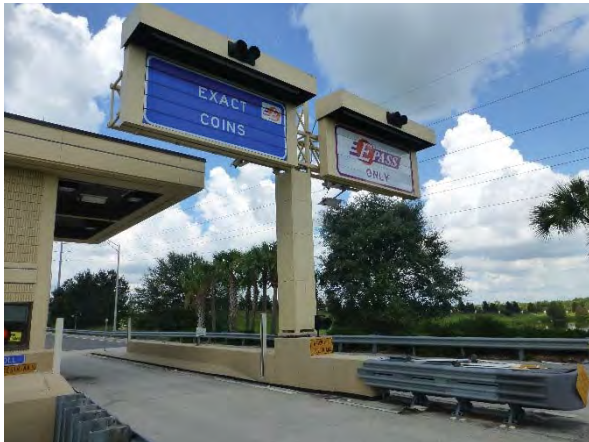
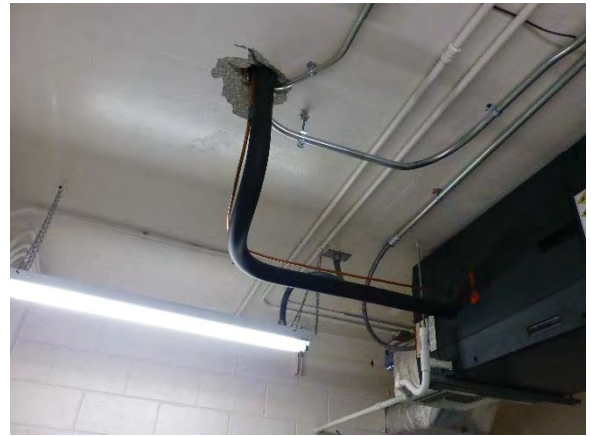
Figure 15 Lake Nona Ramp Off

The above referenced on ramp is in good condition overall. Verification the fireproofing is properly installed is recommended. (Figure 15 & Figure 16)

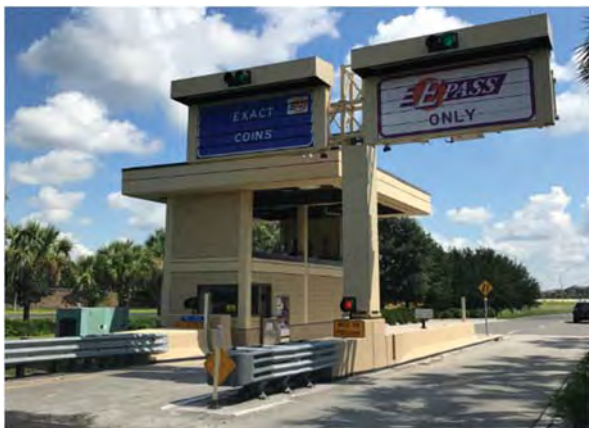
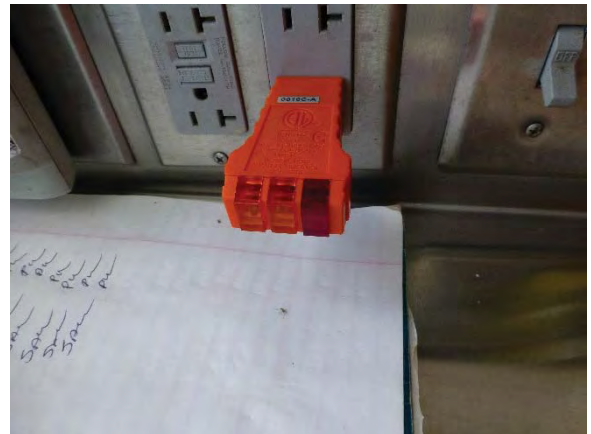
Figure 17 Lake Nona Ramp On

The above referenced on ramp is in good condition overall. Some maintenance of isolated wiring on the outlet missing power is recommended. (Figure 17 & Figure 18)

Figure 18 Lake Nona Ramp On Outlet

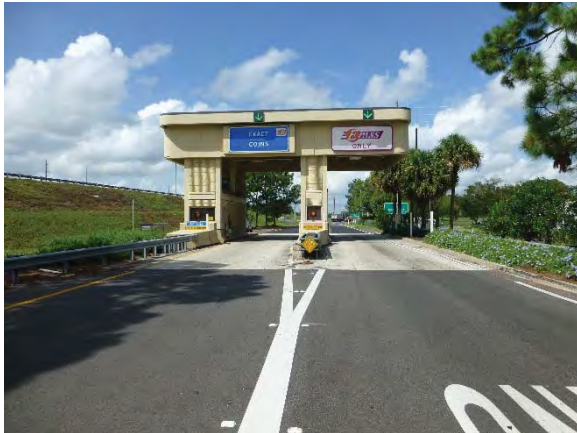
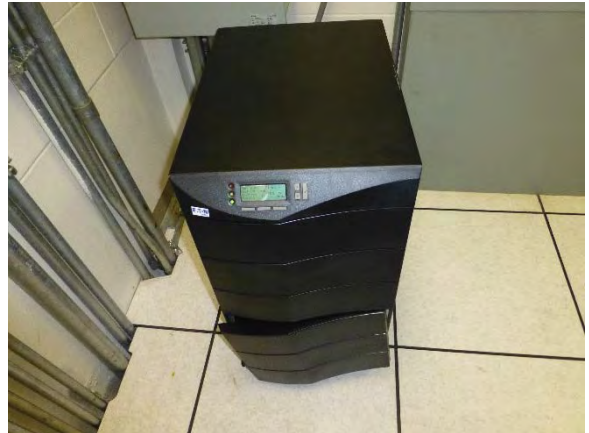
Figure 19 Narcoossee Ramp Off

The above referenced on ramp is in good condition overall. Minor maintenance to attach the loose UPS cover is recommended. (Figure 19 & Figure 20)

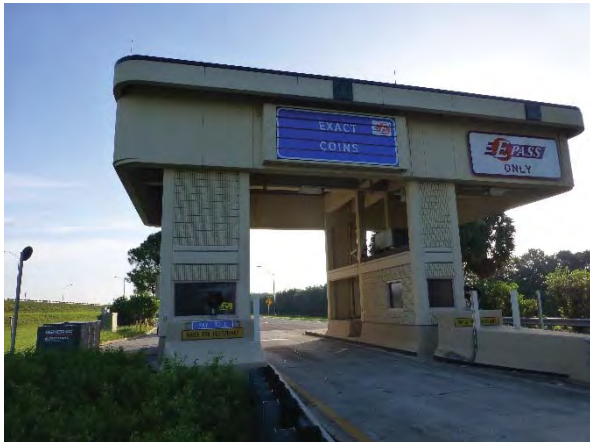
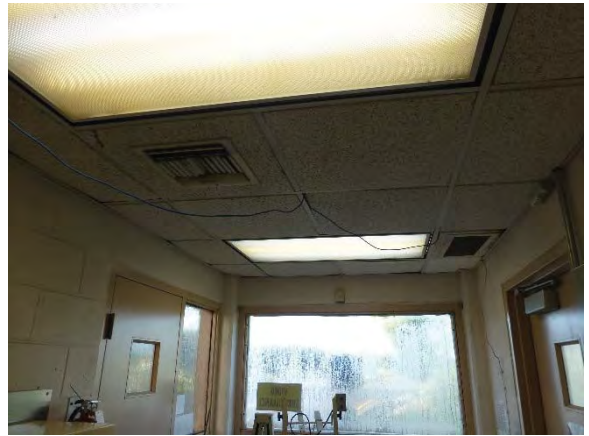
Figure 21 Narcoossee Ramp On

The above referenced on ramp is in good condition overall. Some maintenance of the installation of the wiring across ceiling tiles to the equipment rack is recommended. (Figure 21 & Figure 22)

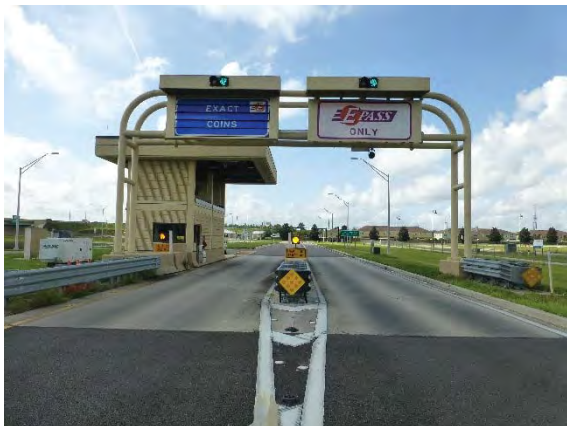
Figure 23 Moss Park Ramp Off

The above referenced on ramp is in good condition overall. Some maintenance to patch the tears in the ductwork is recommended. (Figure 23 & Figure 24)

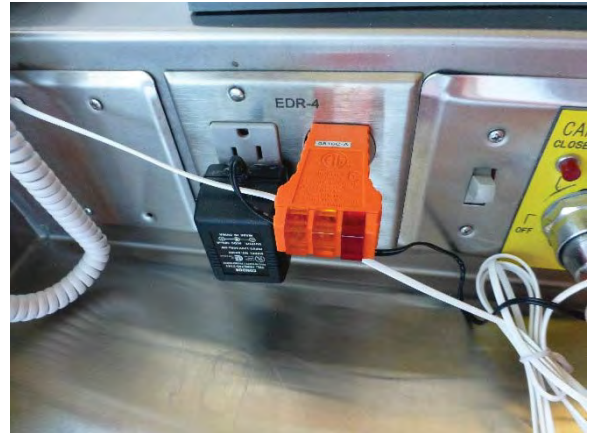
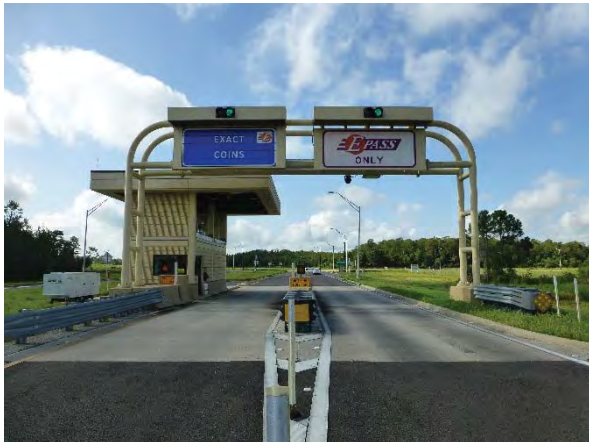
The above referenced on ramp is in good condition overall. Some maintenance of isolated wiring on the outlet missing power is recommended. (Figure 25 & Figure 26)

Figure 25 Moss Park On

Figure 26 Moss Park On

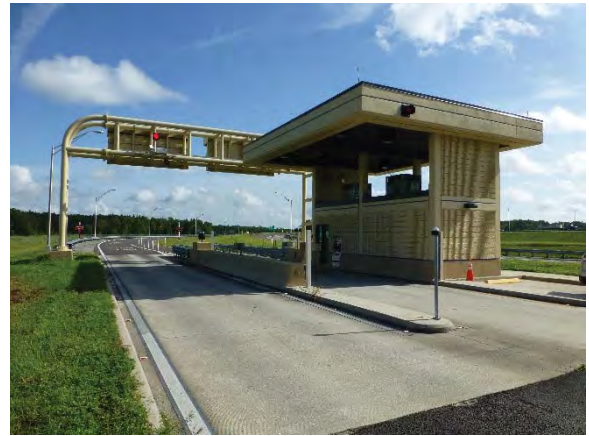
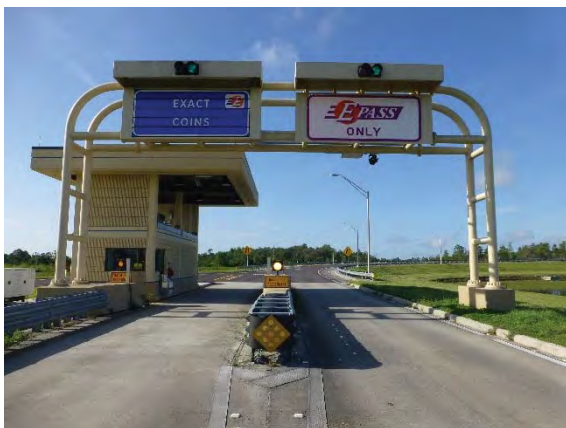
The above referenced on ramp is in good condition overall. (Figure 27 & Figure 28)

Figure 27 Innovation Way Ramp On

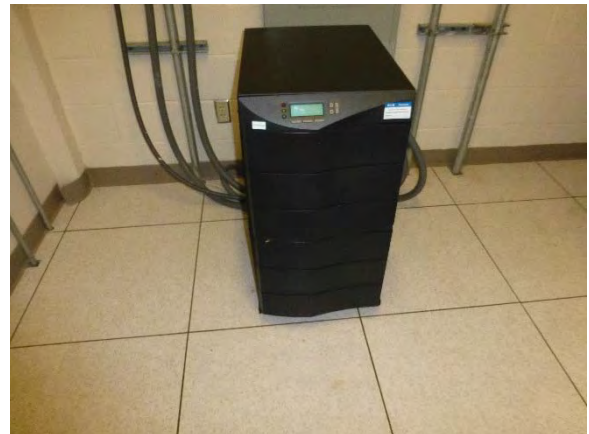
Figure 29 Innovation Way Ramp On

The above referenced on ramp is in good condition overall. Some maintenance to ensure the UPS is connected and powered on is recommended. (Figure 29 & Figure 30)

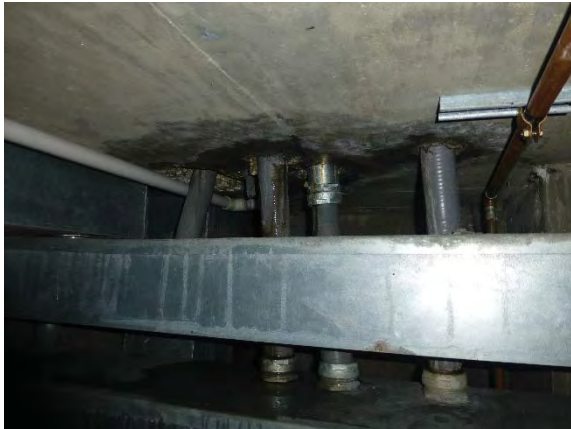
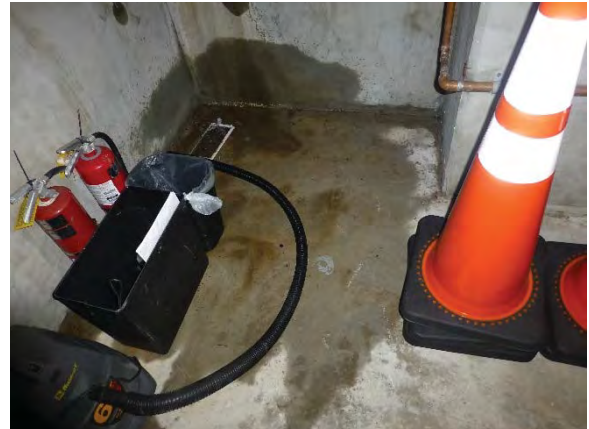
- Main Plaza tunnel ceiling seam separation from ceiling. (Figure 6)
- Main Plaza tunnel has significant water leaking through the conduit system at the rear of the tunnel. (Figure 7 & Figure 8)

Figure 7 Curry Ford Mainline Tunnel

Figure 8 Curry Ford Mainline Tunnel

- Recommend general maintenance in tunnel to repair noted deficiencies.
- Recommend HVAC contractor to ensure all vents are clear and have vent covers.
- Recommend electrical contractor check the wiring issues and repair as required.

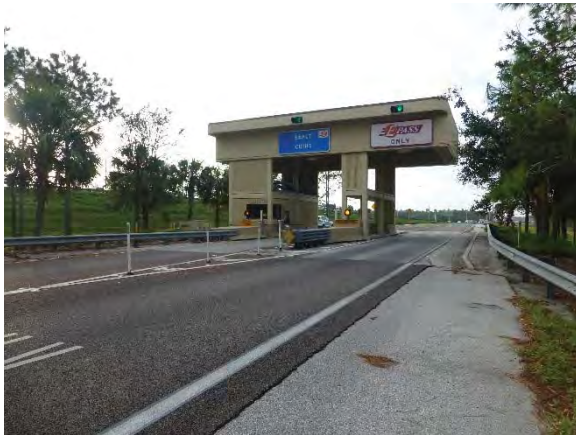
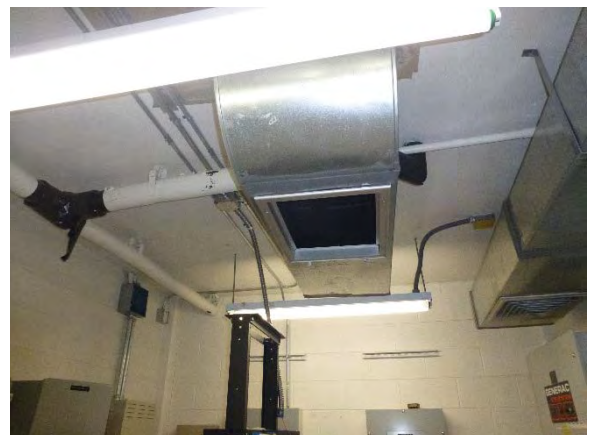
The above referenced on ramp is in good condition overall. General maintenance is recommended to ensure missing HVAC vents are installed. (Figure 9 & Figure 10)

Figure 9 Lee Vista Ramp On

Figure 10 Lee Vista Ramp On

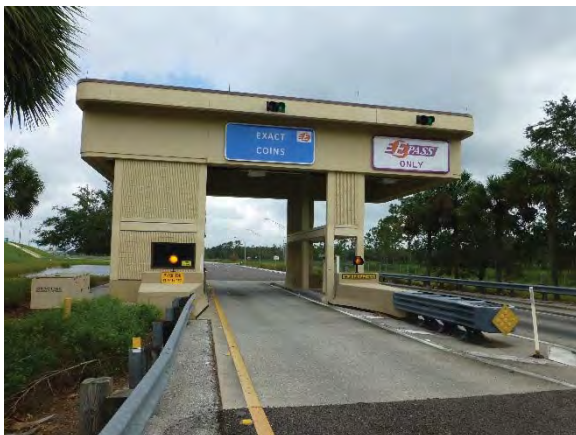
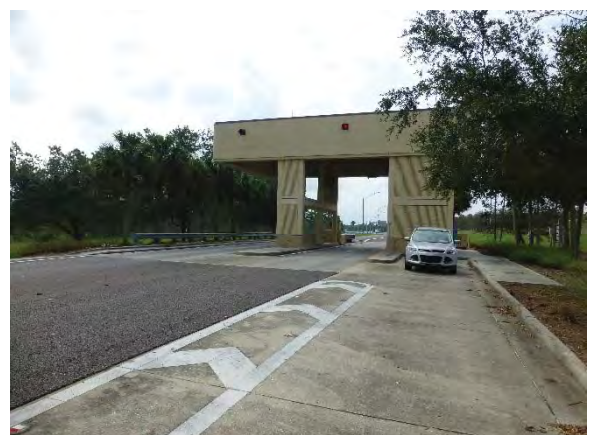
The above referenced on ramp is in good condition overall. (Figure 11 & Figure 12)

Figure 11 Lee Vista Ramp Off

Figure 12 Lee Vista Ramp Off

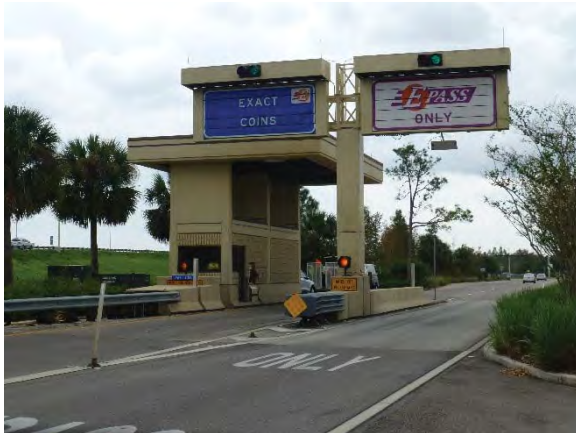
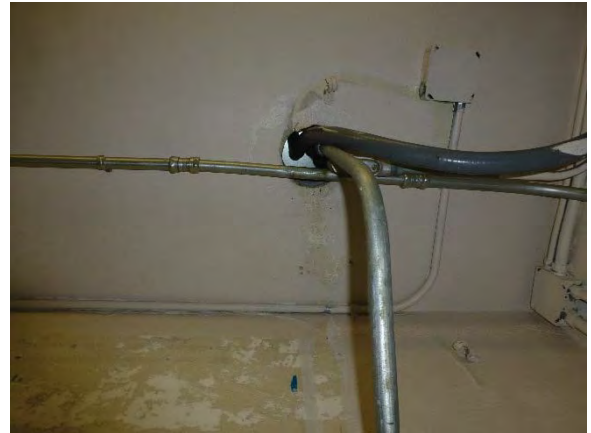
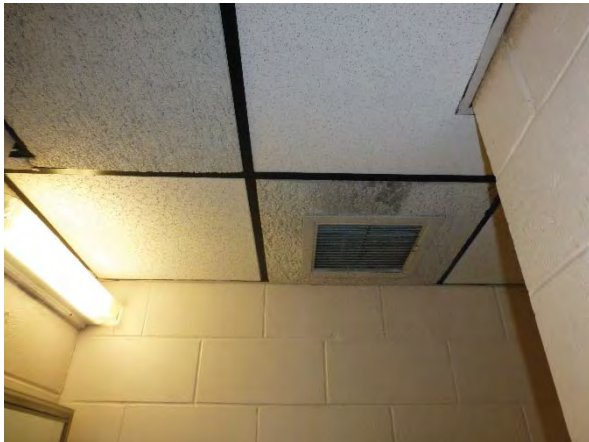
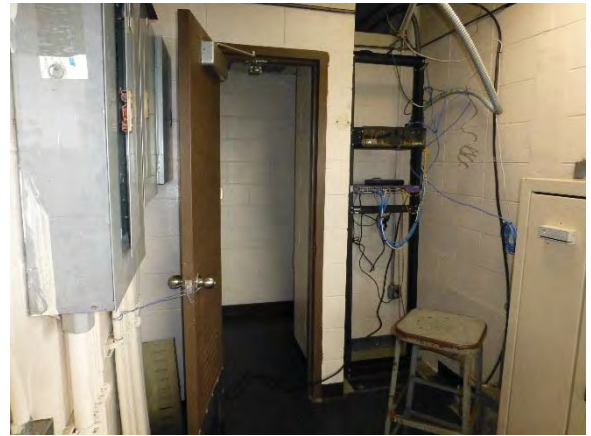
The above referenced on ramp is in good condition overall. Some maintenance to ensure that all ceiling penetrations have fireproofing material installed and is recommended. It is also recommended to check the ceiling tiles for leaks. (Figure 13, Figure 14, Figure 15 & Figure 16)

Figure 13 Curry Ford Ramp Off

Figure 14 Curry Ford Ramp Off

Figure 15 Curry Ford Ramp Off

Figure 16 Curry Ford Ramp Off

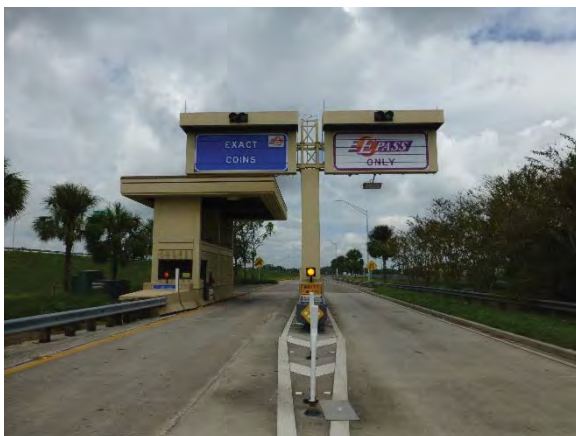
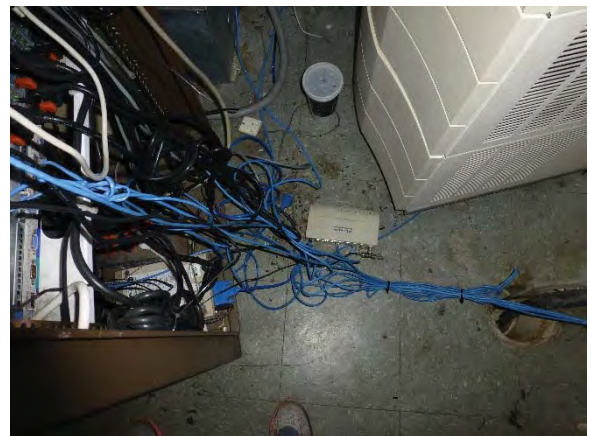
The above referenced on ramp is in good condition overall. General maintenance on wiring and equipment left on the floor of the computer room is recommended. (Figure 17 & Figure 18)

Figure 17 Curry Ford Ramp On

Figure 18 Curry Ford Ramp On
