2017 Annual Inspection Report

Mr. Joseph A. Berenis, P.E.
Deputy Executive Director
Central Florida Expressway Authority
4974 ORL Tower Road
Orlando, Florida 32807

Re: 2017 Annual Inspection Report

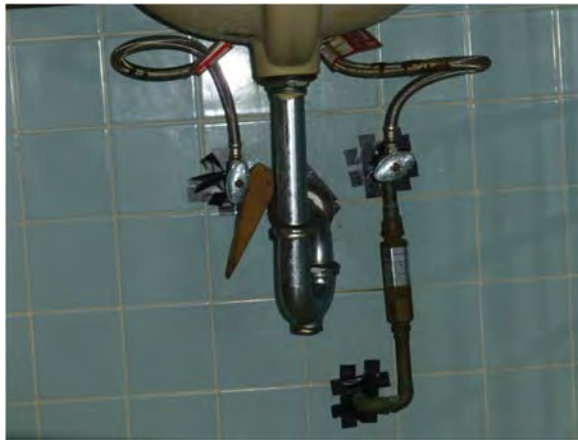
Figure 1 University Mainline Men's Restroom plumbing

- Recommend plumbing contractor fix the pipe connection to the wall properly.
- Recommend maintenance to locate/address leaks in ceiling tile.

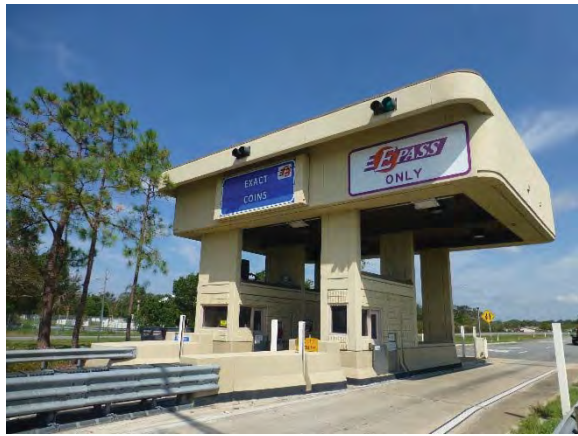
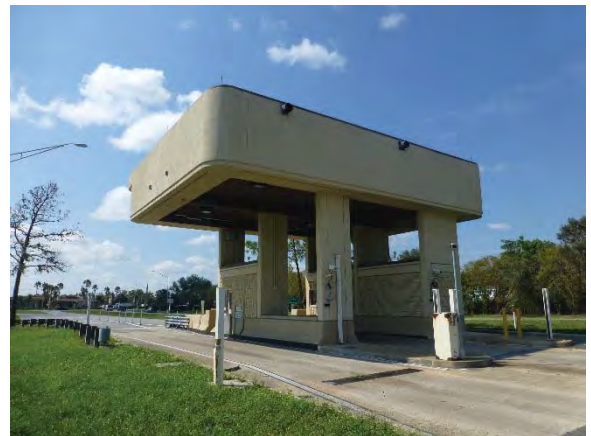
The above referenced on ramp is in good condition overall. (Figure 3 & Figure 4)

Figure 3 Colonial Ramp On

Figure 4 Colonial Ramp On

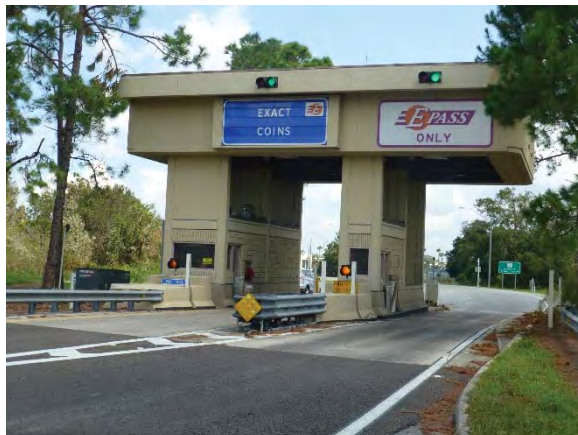
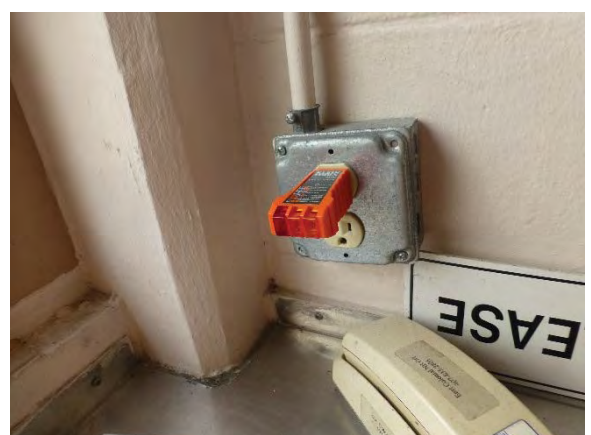
The above referenced on ramp is in good condition overall. Some maintenance of isolated wiring on the outlet missing power is recommended. (Figure 5 & Figure 6)

Figure 5 Colonial Ramp Off

Figure 6 Colonial Ramp Off

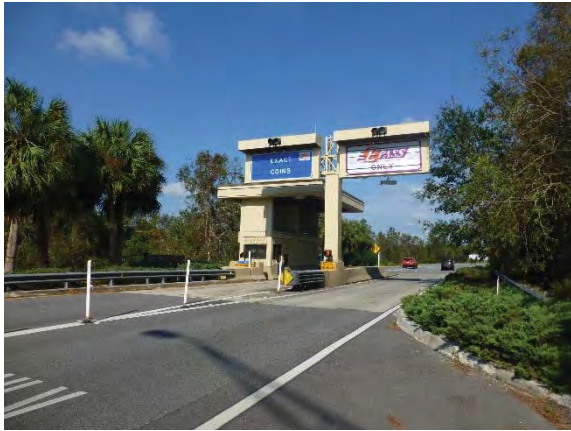
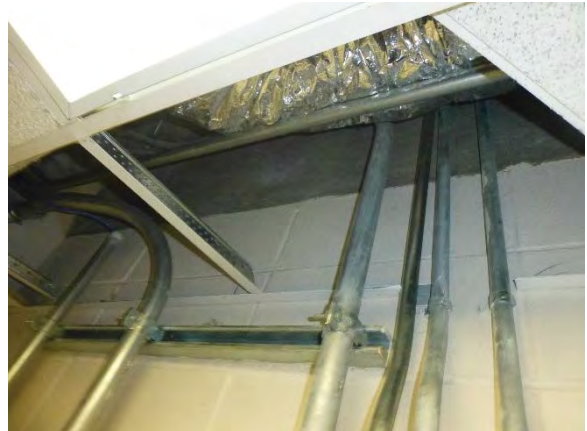
The above referenced on ramp is in good condition overall. Some maintenance to install missing ceiling tiles is recommended. (Figure 7 & Figure 8)

Figure 7 University Ramp On

Figure 8 University Ramp On

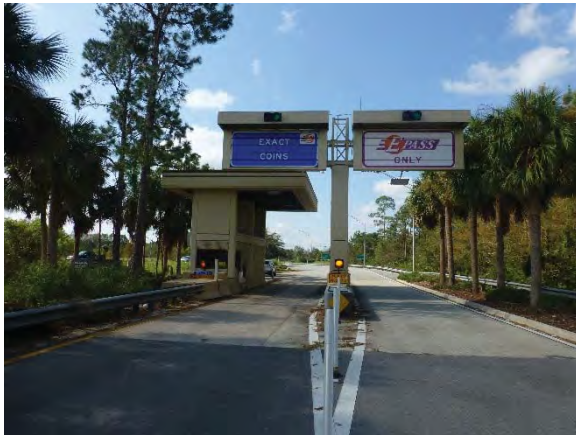
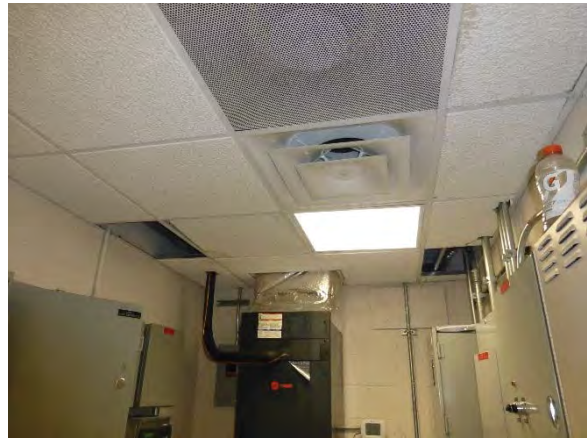
The above referenced on ramp is in good condition overall. Some maintenance to install missing ceiling tiles is recommended. (Figure 9 & Figure 10)

Figure 9 University Ramp Off

Figure 10 University Ramp Off

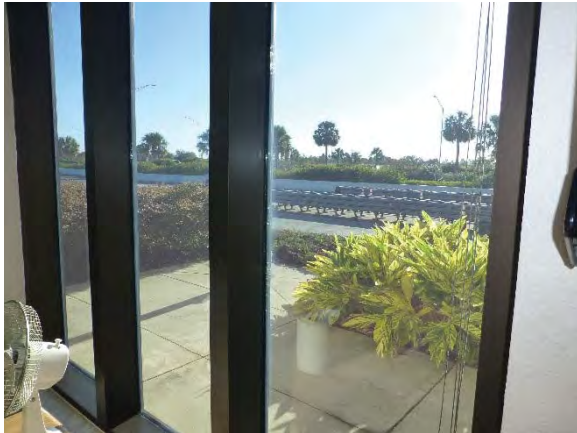
Figure 1 Independence Mainline

- Main Plaza break room area has cracks in the window glass. (Figure 1)
- Main Plaza computer room is missing HVAC vent. (Figure 2)

- Recommend pressure wash overpass area.
- Recommend HVAC contractor visit the plaza to ensure all vents have covers.
- Recommend general maintenance on the cracked window glass in the break room.

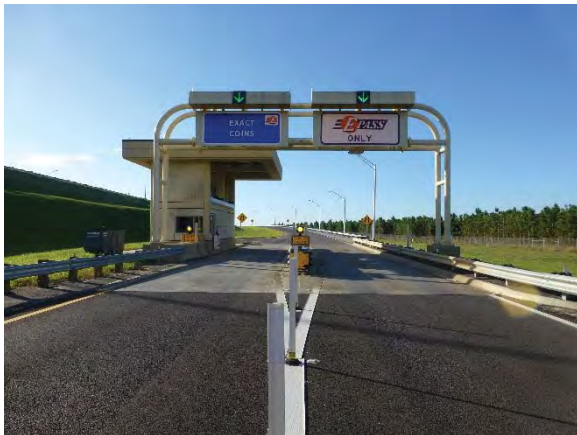
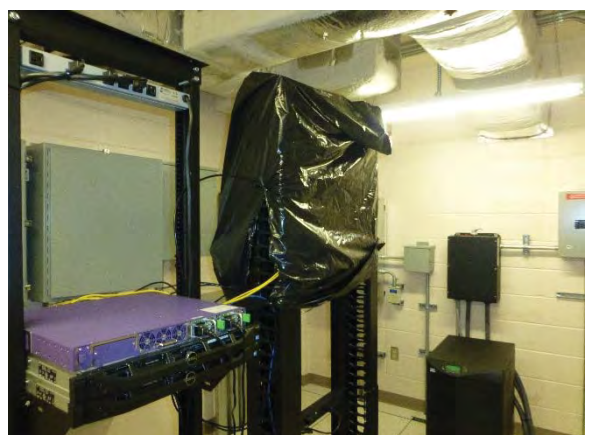
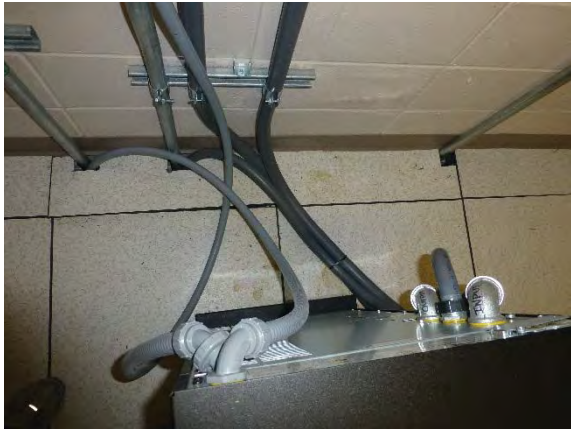
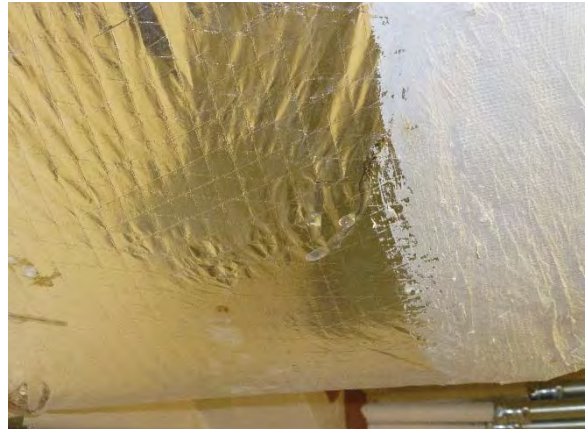
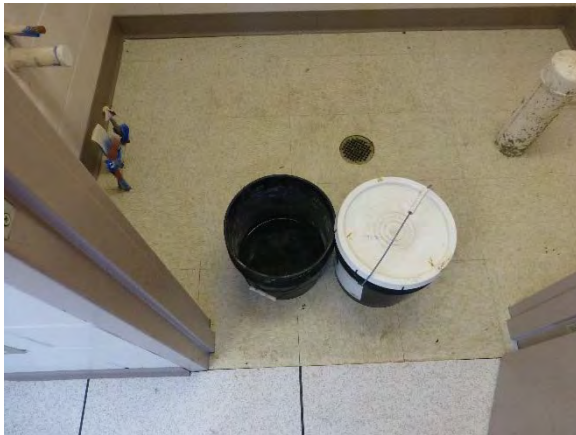
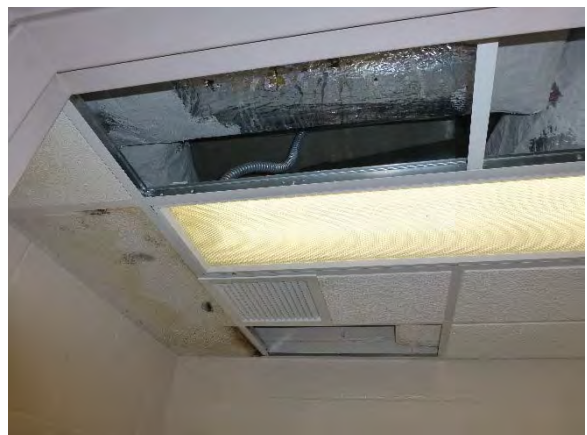
The above referenced on ramp is in good condition overall. Maintenance is recommended on some ceiling tiles and all leaks associated with the HVAC issues need to be addressed. (Figure 5, Figure 6, Figure 7, Figure 8, Figure 9 & Figure 10)

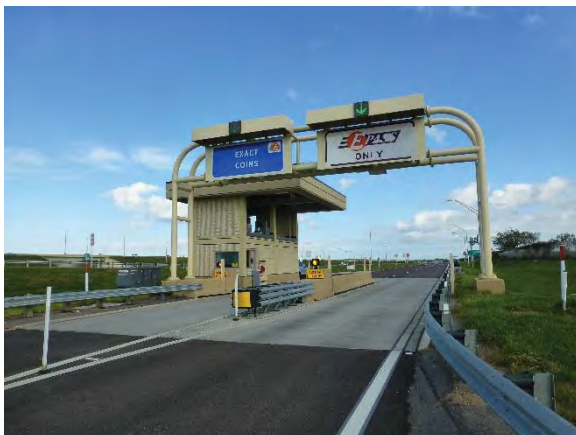
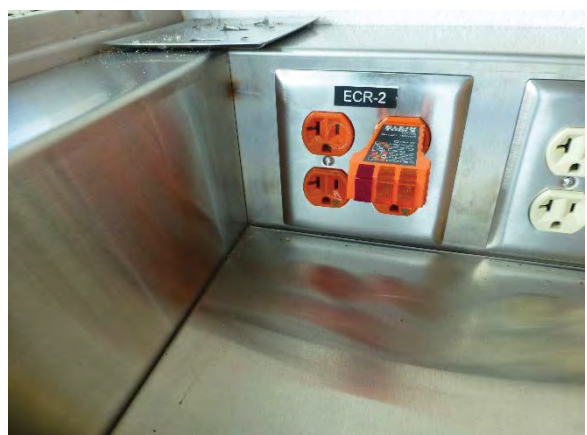
The above referenced on ramp is in good condition overall. Some maintenance on the electrical wiring missing power is recommended along with patching the tears in the HVAC duct work. (Figure 11, Figure 12 Figure 13 & Figure 14)

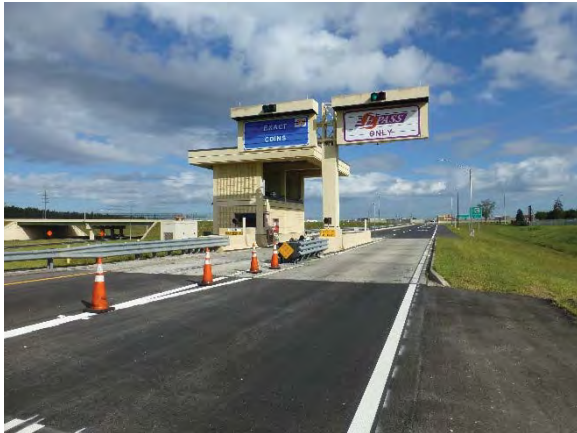
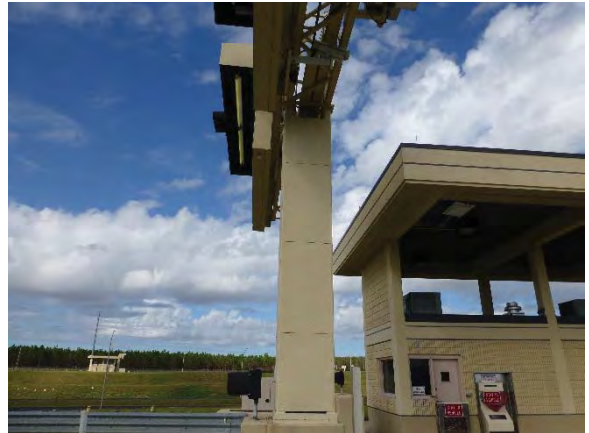
The above referenced on ramp is in good condition overall. Some maintenance is recommended to address the peeling paint on the signage post. (Figure 19 & Figure 20)

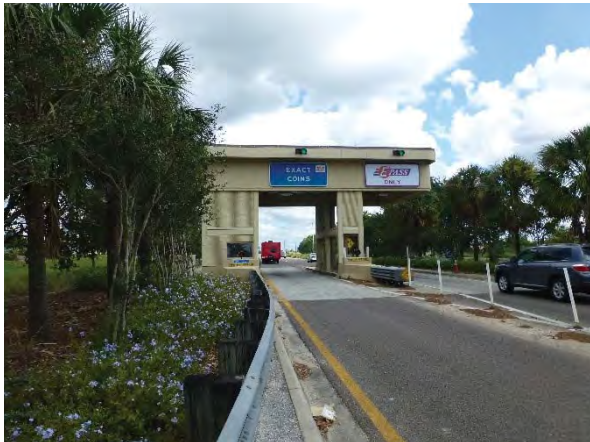
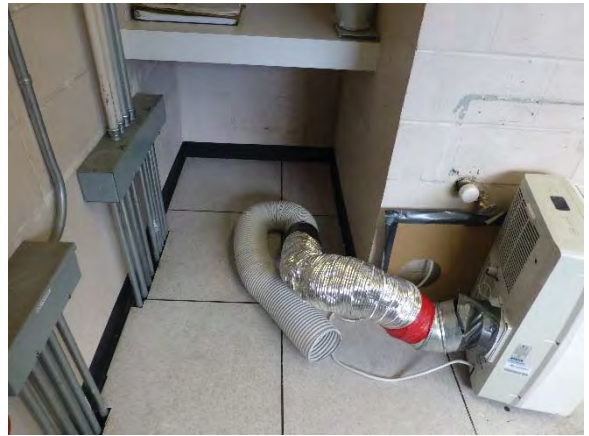
The above referenced on ramp is in good condition overall. Removal of abandoned equipment is recommended. (Figure 21 & Figure 22)

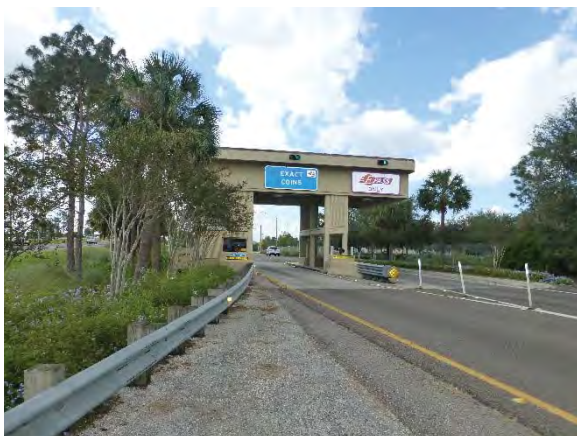
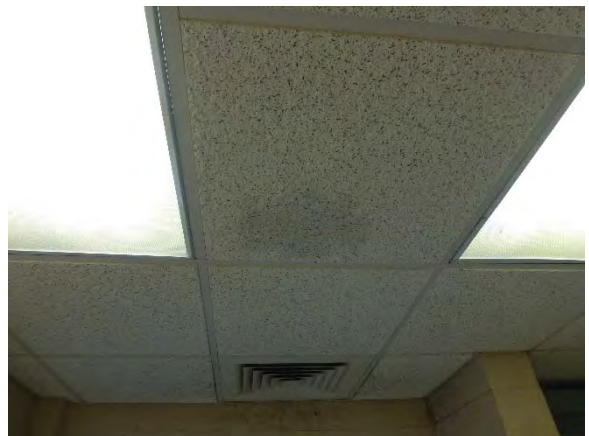
The above referenced on ramp is in good condition overall. Investigation into the leak in the ceiling tile is recommended. (Figure 23 & Figure 24)

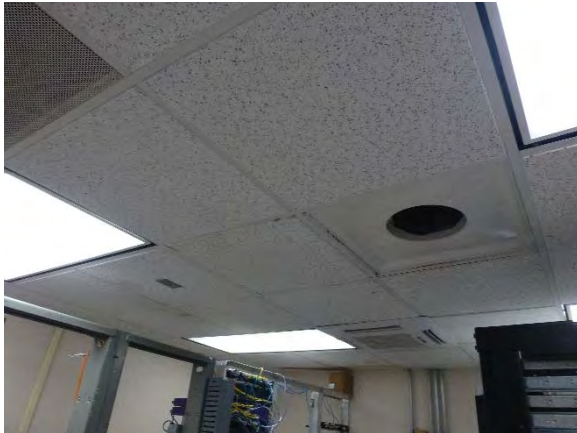
Figure 1 Forest Lake Mainline

- Main Plaza computer room is missing HVAC vent cover above equipment racks. (Figure 1)
- Main Plaza ceiling tile above equipment room has identified leaks. (Figure 2)

- Recommend electrical contractor visit plaza to resolve some isolated wiring issues.
- Recommend HVAC contractor visit the plaza to replace missing vent covers.
- Recommend maintenance on overpass to restore and repaint identified area in need of repair.
- Recommend maintenance to determine the cause of the leaks in the ceiling tiles.

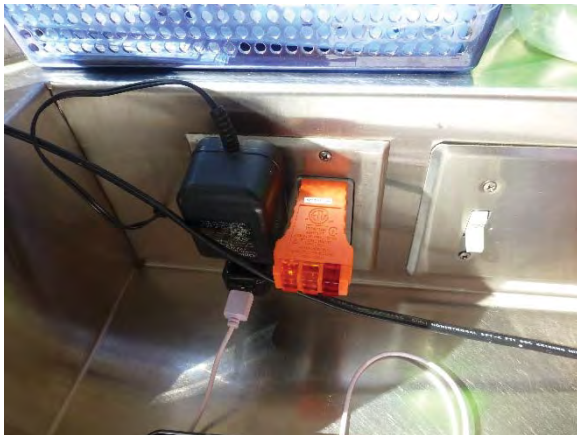
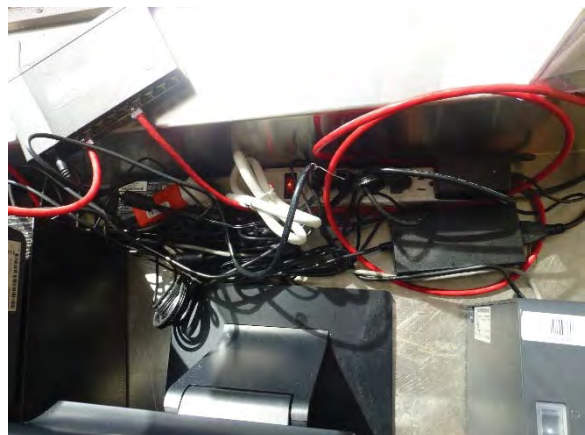
- Exterior toll booths have some isolated wiring issued identified and missing power outlets. (Figure 3 & Figure 4)

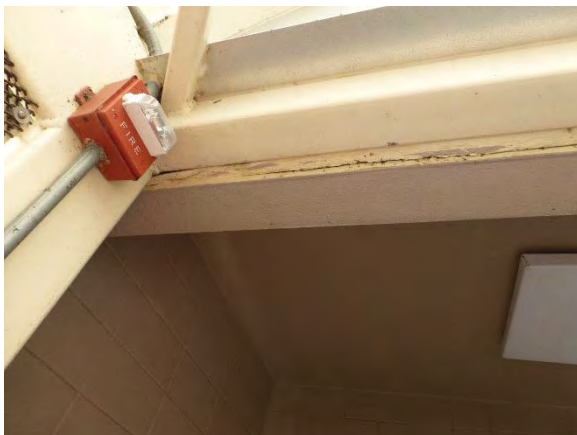
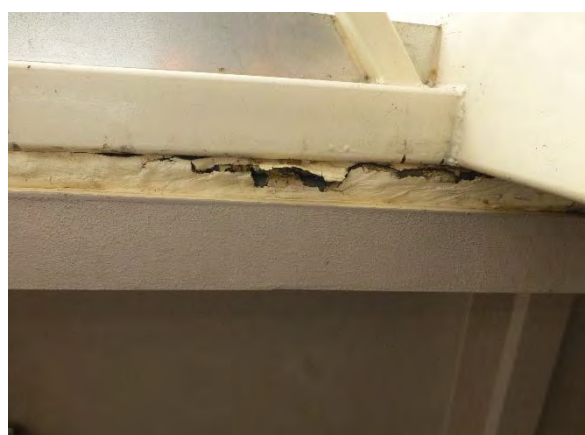
- Overpass has some recommended areas of repair as shown in inspection photos. (Figure 5 & Figure 6)

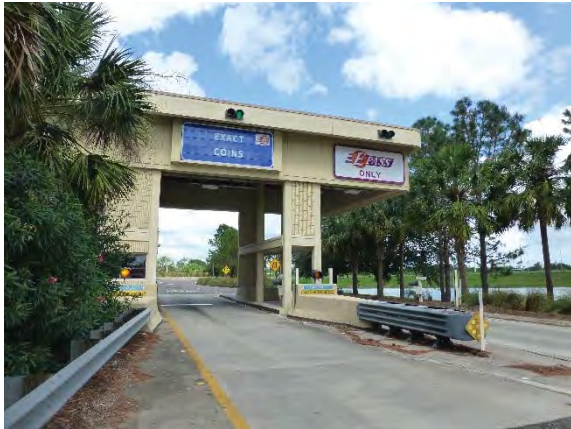
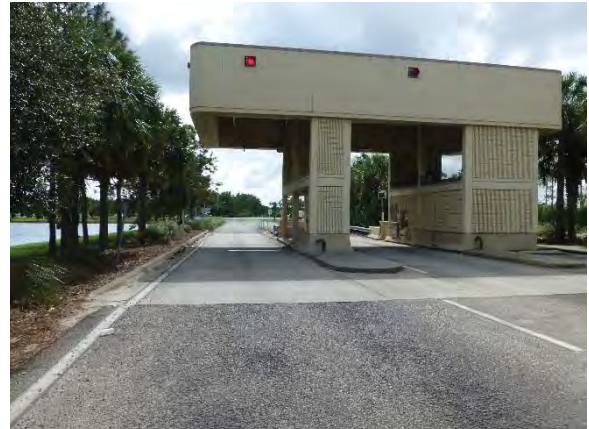
The above referenced on ramp is in good condition overall. (Figure 7 & Figure 8)

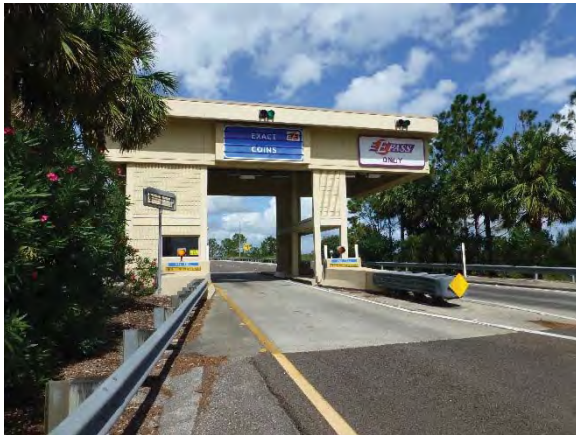
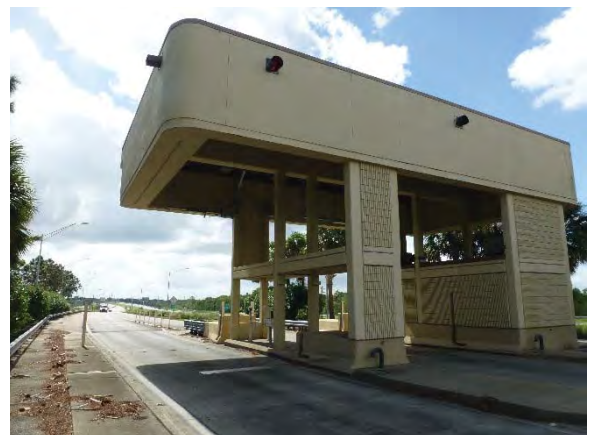
The above referenced on ramp is in good condition overall. Some maintenance and pest control of the unmanned booth is also recommended. (Figure 9 & Figure 10)

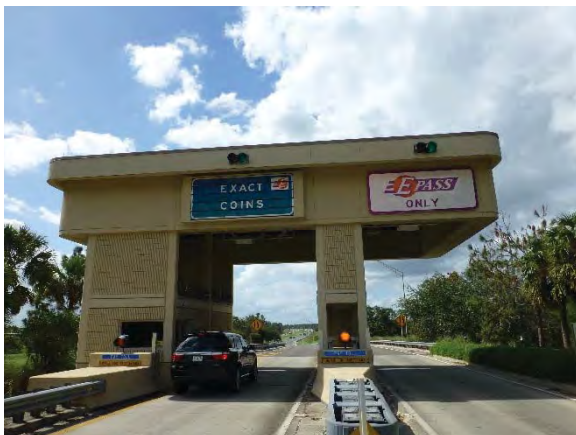
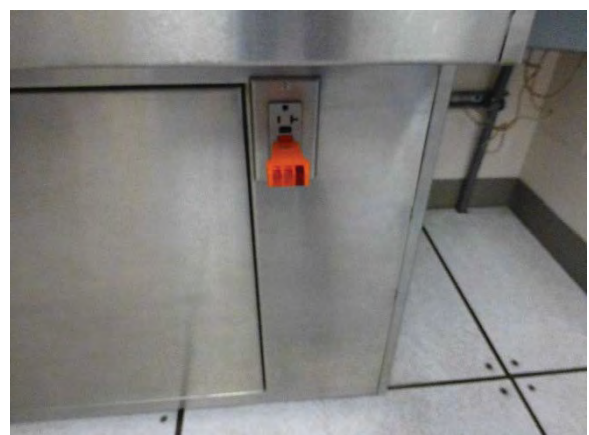
The above referenced on ramp is in good condition overall. Some isolated wiring to outlets without power needs to be addressed. (Figure 11 & Figure 12)

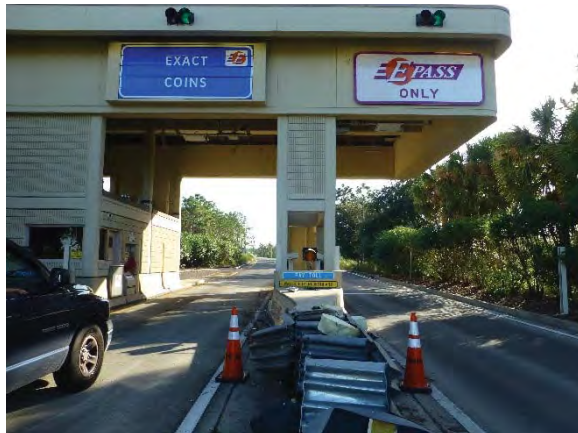
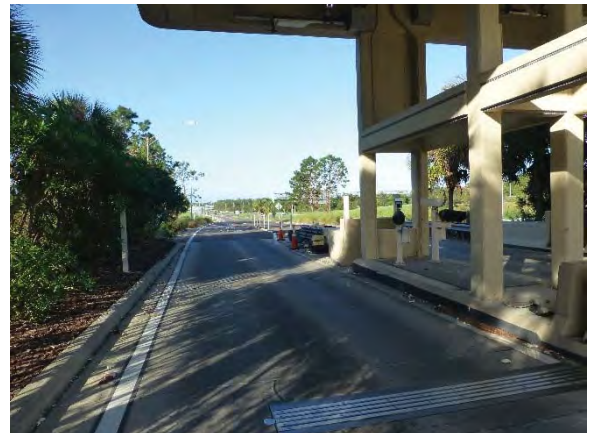
The above referenced on ramp is in good condition overall. (Accident scene).
(Figure 13 & Figure 14)

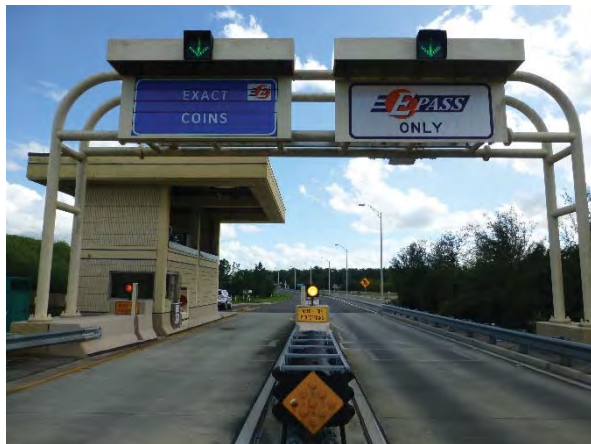
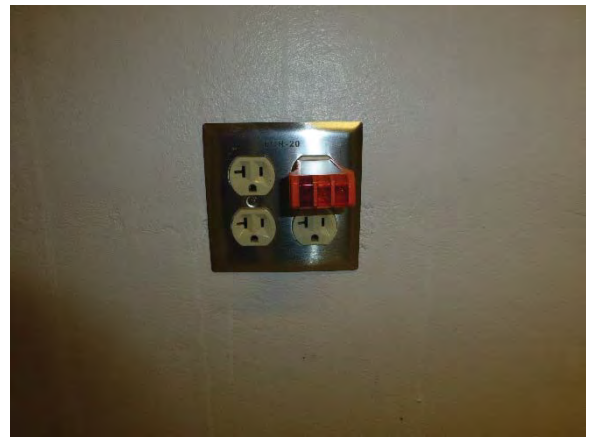
The above referenced on ramp is in good condition overall. Some isolated wiring to outlets without power needs to be addressed. (Figure 15 & Figure 16)

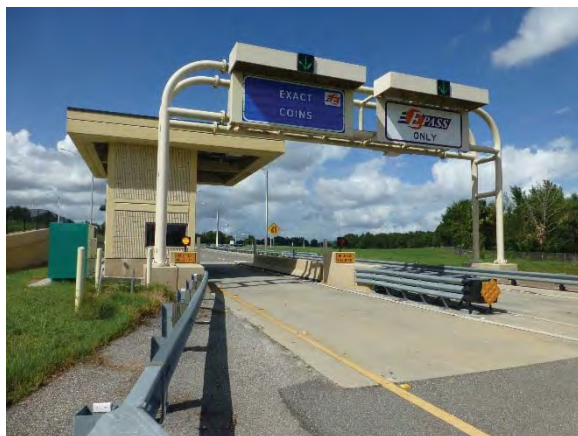
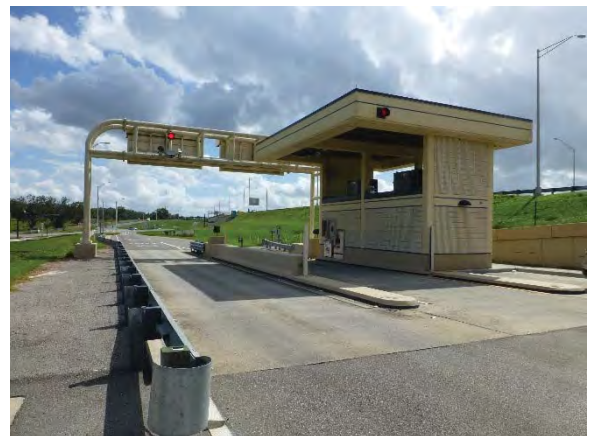
The above referenced on ramp is in good condition overall. (Figure 17 & Figure 18)

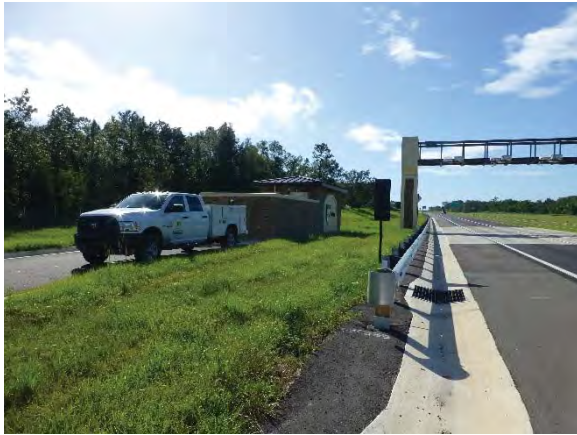
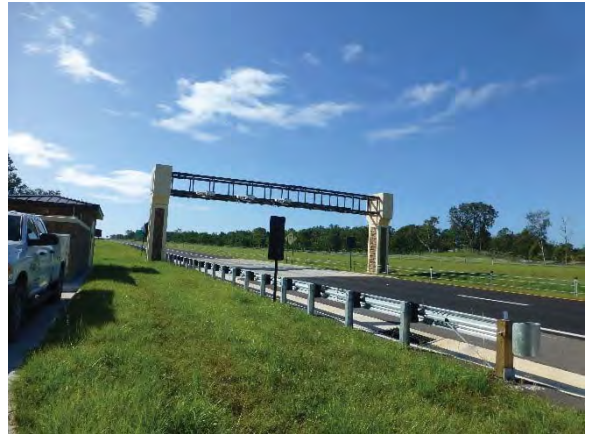
The above referenced on ramp is in good condition overall. (Figure 19 & Figure 20)

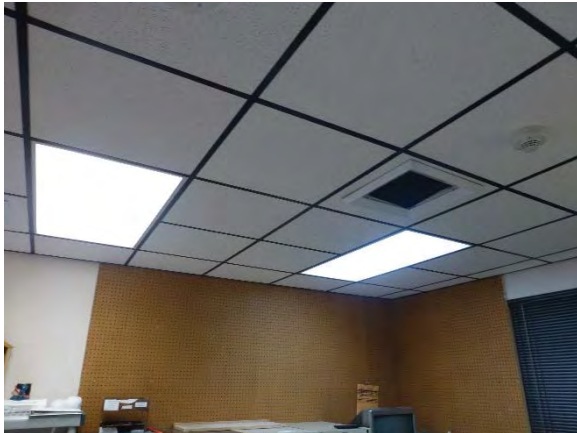
Figure 1 Beachline Mainline

- Main Plaza maintenance room is missing HVAC vent cover. (Figure 1)
- Main Plaza computer room wiring and power strips under equipment racks need attention. (Figure 2)
- Employee break room outlet is without power. (Figure 3)

- Recommend maintenance to locate above ceiling leaks.
- Recommend HVAC contractor to ensure all vents have vent covers.
- Recommend electrical contractor determine computer room wiring can be addressed.
- Recommend electrical contractor check the toll booth outlets and fix wiring in toll booth ceiling.

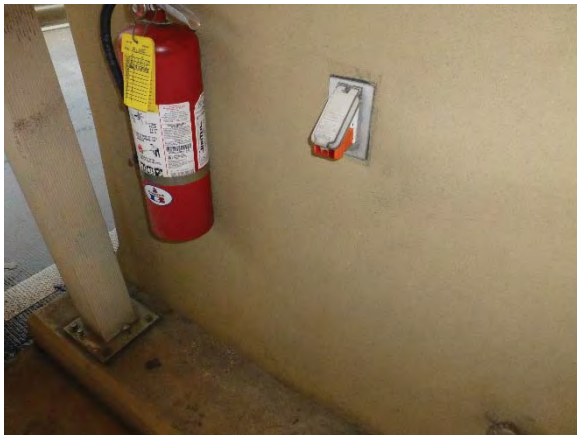
Figure 5 Beachline Mainline

- Exterior building is in good condition overall.
- Exterior outlets outside toll booth has no power. (Figure 5)
- Wiring inside manned toll booth has wiring hanging from ceiling. (Figure 6)

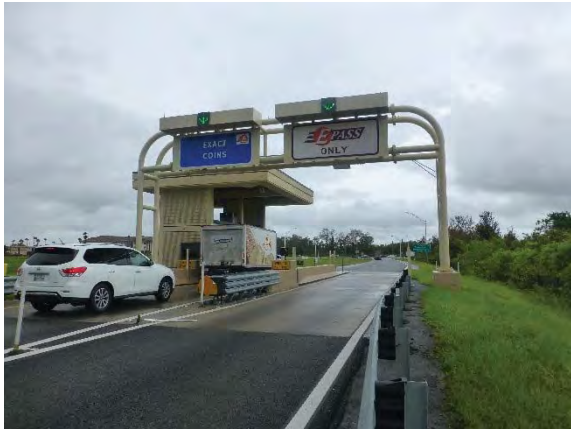
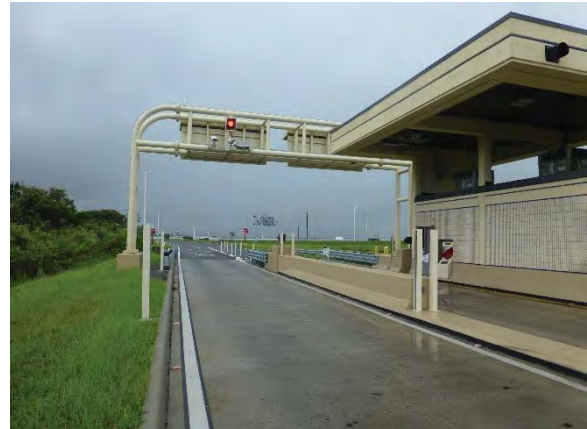
Figure 7 McCoy Ramp Off

The above referenced off ramp is in good condition overall. (Figure 7 & Figure 8)

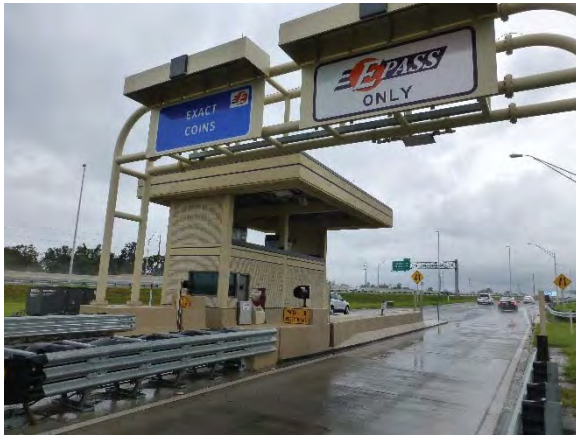
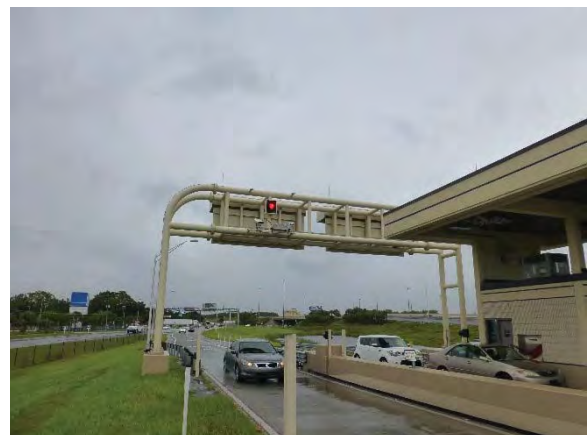
Figure 9 Jetport Ramp On

The above referenced on ramp is in good condition overall. (Figure 9 & Figure 10)

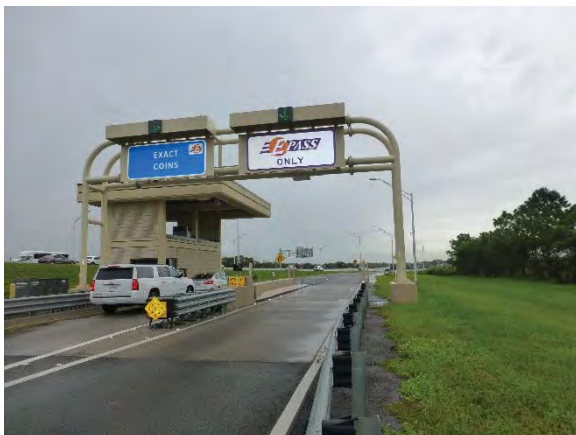
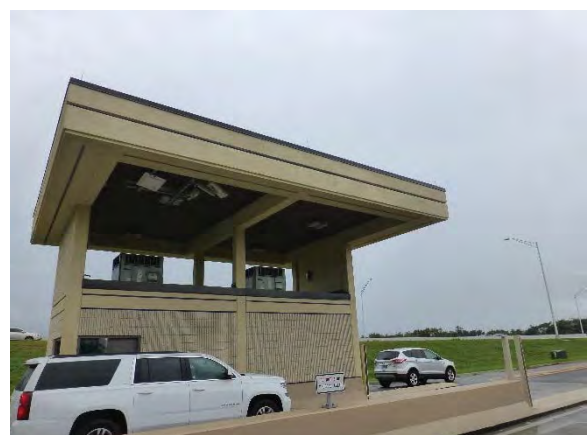
Figure 11 Conway Ramp Off

The above referenced off ramp is in good condition overall. (Figure 11 & Figure 12)

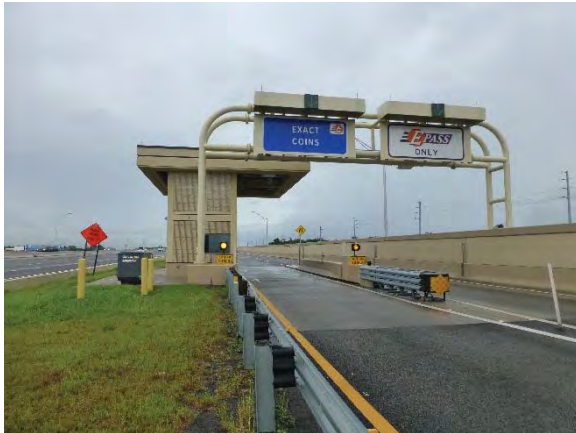
Figure 13 Tradeport Ramp On

The above referenced on ramp is in good condition overall. Maintenance is recommended on ceiling tiles and potential leaks need to be addressed. (Figure 13 & Figure 14)

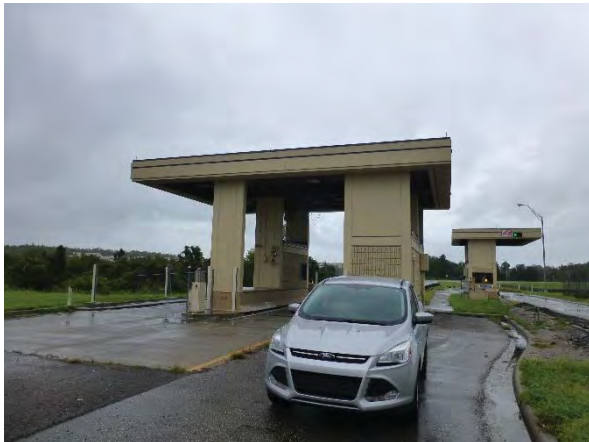
Figure 15 ICP Ramp On

The above referenced on ramp is in good condition overall. Some landscaping to fill in holes left from recent demo is recommended. It is recommended to completely close off doorway to outside elements and maintenance is recommended on ceiling tiles to locate potential leaks. (Figure 15, Figure 16, Figure 17, Figure 18, Figure 19 & Figure 20)

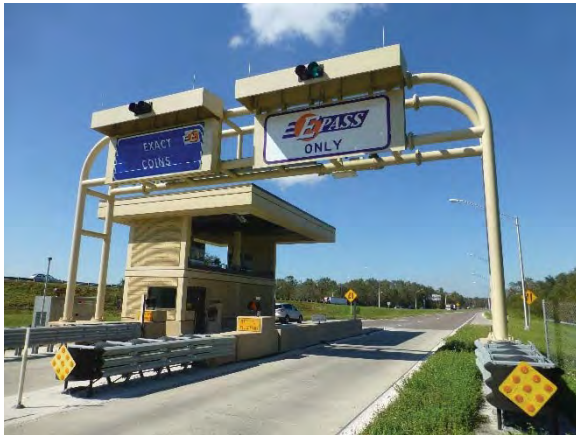
Figure 9 Dallas Ramp On

The above referenced on ramp is in good condition overall. Some maintenance on landscaping and to patch HVAC duct is recommended. (Figure 9, Figure 10, Figure 11 & Figure 12)

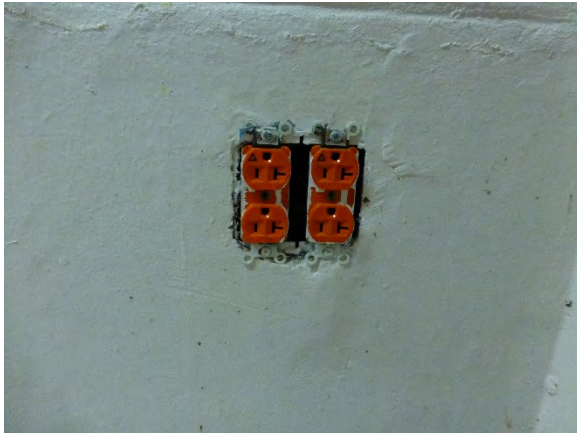
- Main Plaza computer room has electrical outlet missing cover (Figure 1)

Figure 1 Goldenrod Main Plaza Computer Room

- Recommend general landscaping (Result of the hurricane and identified at time of inspection).
- Recommend repair of depression in road (Recommended at time of the inspection).
- Recommend electrical contractor provide general repair and replace missing outlet cover.
