2018

# Annual Inspection Report

Re: 2018 Annual Inspection Report

2018 Annual Inspection Report  
CENTRAL FLORIDA EXPRESSWAY AUTHORITY

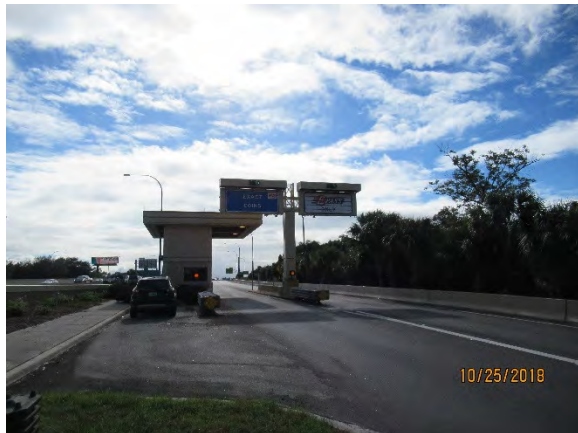
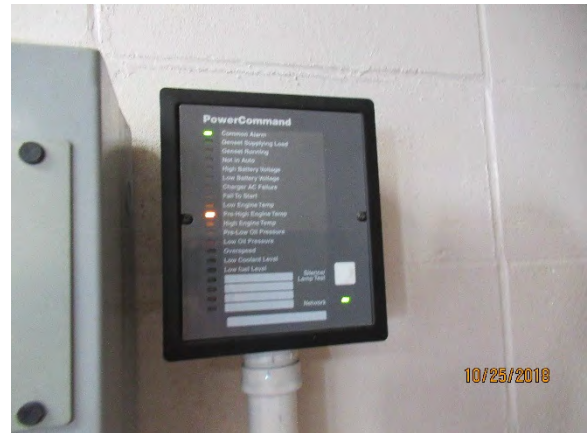
The above referenced on ramp is in good condition overall. Some landscaping around the bollards and propane tank is recommended (Figure 13 & Figure 14)

Figure 13 John Young Parkway Ramp On

Figure 14 John Young Parkway Ramp On

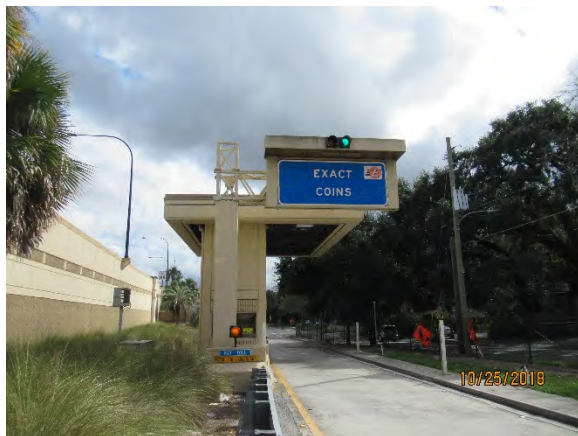
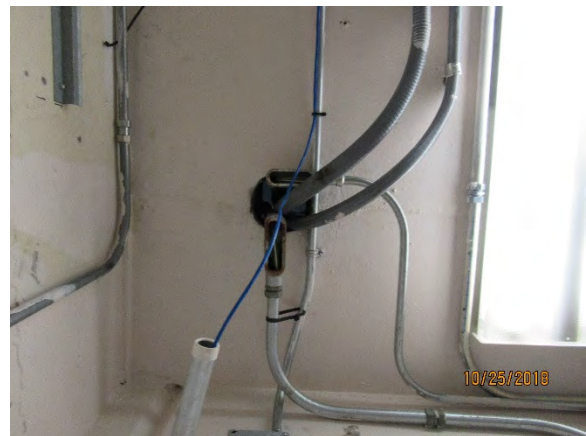
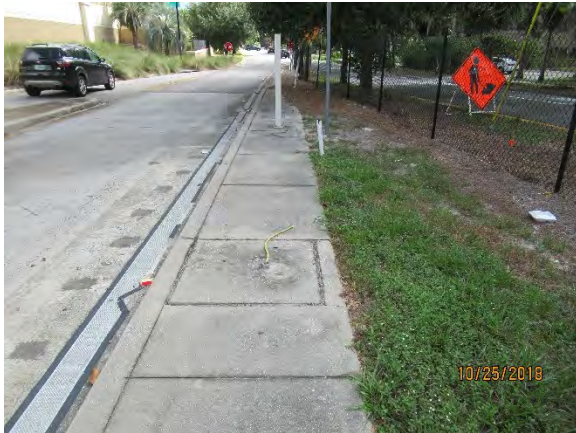
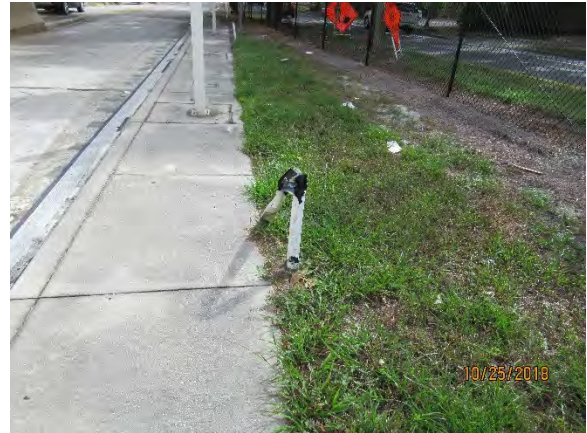
The above referenced on ramp is in good condition overall. Maintenance is recommended to properly fireproof ceiling penetrations and cap off communication wiring at grade.  
(Figure 23, Figure 24, Figure 25 & Figure 26)

Figure 23 Mills Ramp Off

Figure 24 Mills Ramp Off

*Figure 25 Mills Ramp Off*

*Figure 26 Mills Ramp Off*

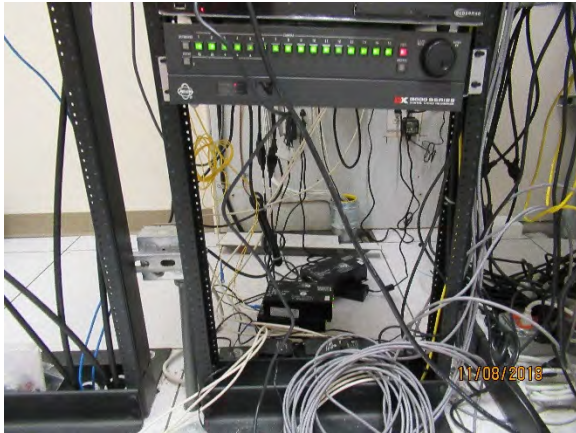
- EB Mainline computer room electrical wiring, power strips and equipment on floor under equipment rack. (Figure 1)
- EB Mainline entry appears to have a leak at the ceiling tile/vent location. (Figure 2)
- WB Mainline computer room electrical wiring, power strips and equipment on floor under equipment rack. (Figure 3)
- WB Mainline missing vent cover in computer room. (Figure 4)

Figure 1 Conway EB Mainline IT Room

- Recommend maintenance on of isolated wiring for computer room.
- Recommend HVAC contractor to ensure all vents are clear and have vent covers.
- Recommend maintenance on building façade to address separation from building.

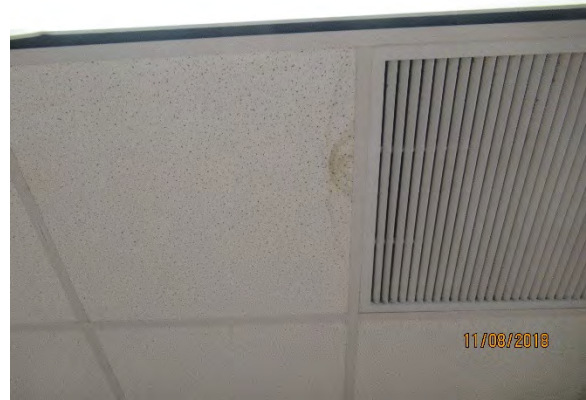
Figure 2 Conway EB Mainline Main Hall

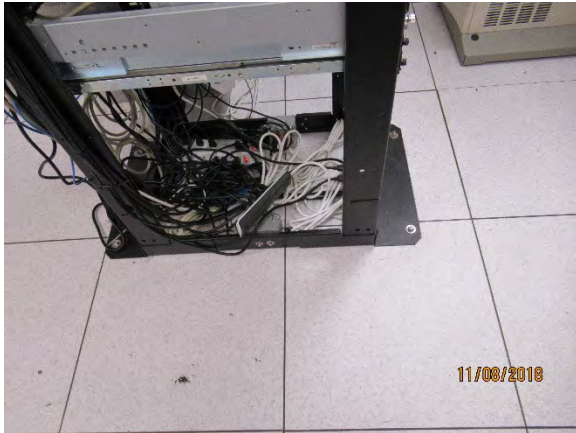
Figure 3 Conway WB Mainline

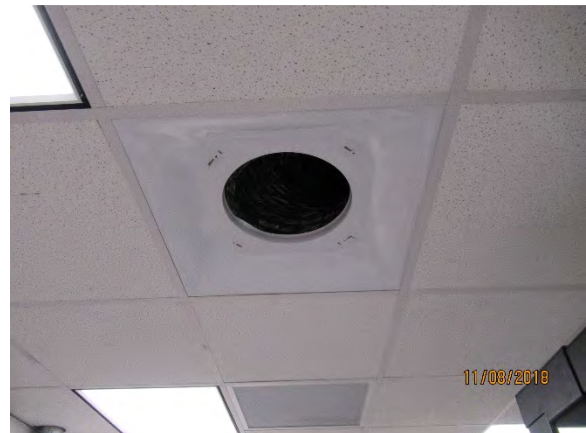
Figure 4 Conway WB Mainline

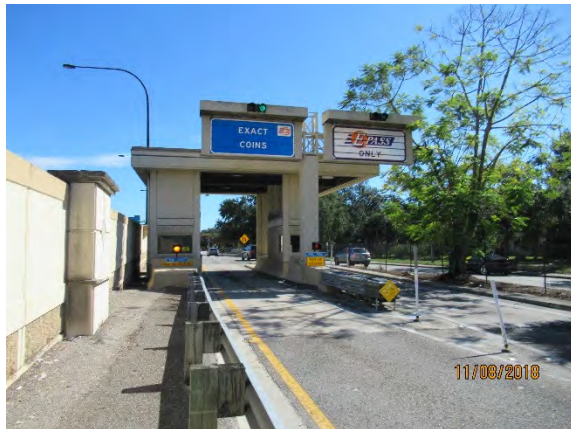
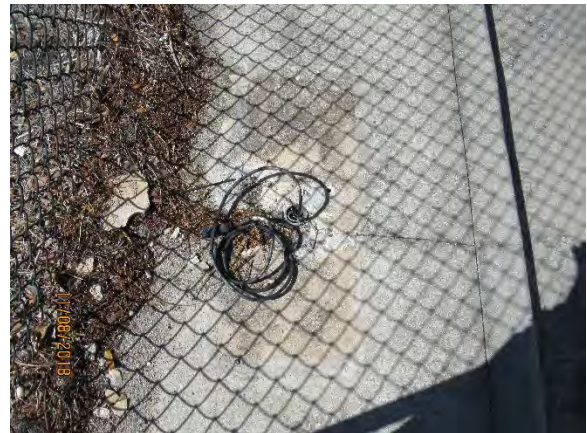
The above referenced on ramp is in good condition overall. Some maintenance to repair exterior pedestal wiring is recommended. (Figure 7 & Figure 8)

Figure 7 Bumby Ramp Off

Figure 8 Bumby Ramp Off

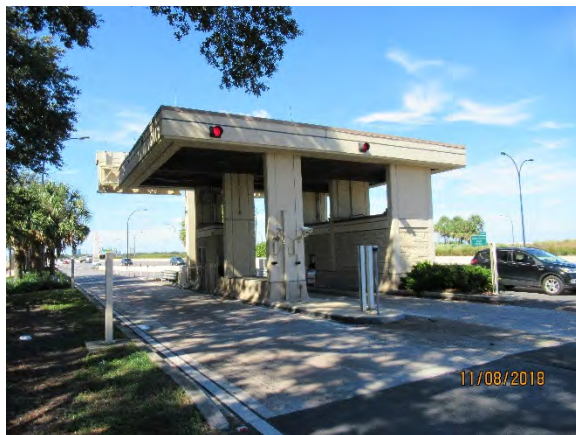
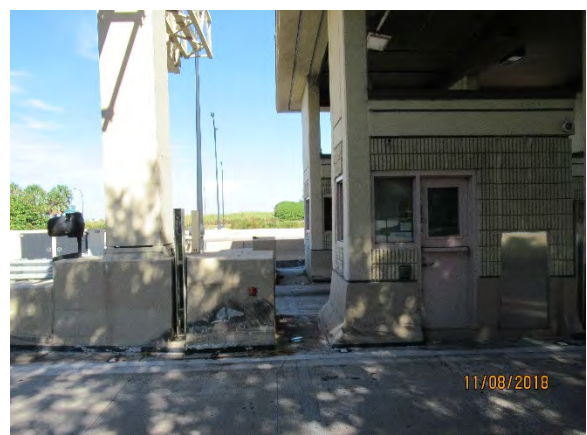
The above referenced on ramp is in good condition overall. Some maintenance is recommended to install trough cover and fasten 66 block securely to communications panel. (Figure 11, Figure 12, Figure 13 & Figure 14)

Figure 11 Conway Ramp Off

Figure 12 Conway Ramp Off

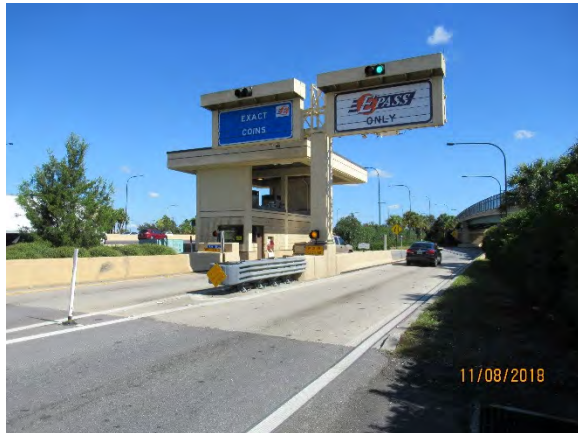
Figure 15 Andes Ave/LkUndehill/436 Ramp Off

The above referenced on ramp is in good condition overall. Some general maintenance of the exterior debris is recommended (Figure 15 & Figure 16)

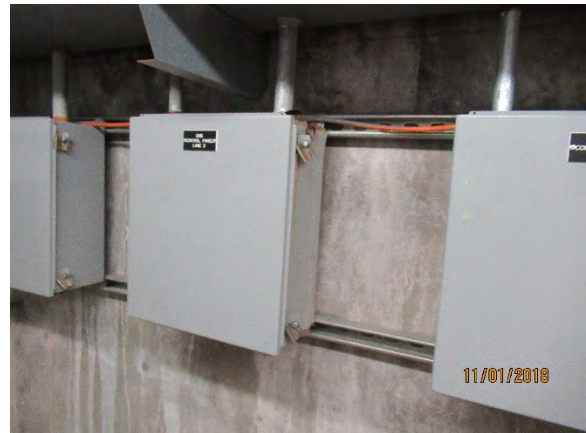
Figure 2 Dean Mainline

- Mainline tunnel CMS control panel Lane 1 & Lane 2 NEMA enclosures rusted out. (Figure 2, Figure 3 & Figure 4)
- Mainline tunnel seams are showing deterioration. (Figure 5 & Figure 6)
- Mainline tunnel overhead wire pathway is not properly secured. (Figure 7 & Figure 8)
- Mainline tunnel control panel NEMA enclosures beginning to rust. (Figure 9 & Figure 10)

- Recommend electrical contractor replace the rusted enclosure on the tunnel control panels.
- Recommend general maintenance to locate/address leaks in ceiling tile.
- Recommend general maintenance to fix ceiling seam in tunnel.

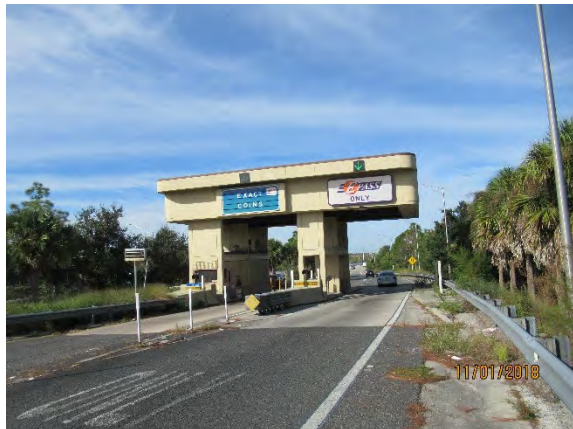
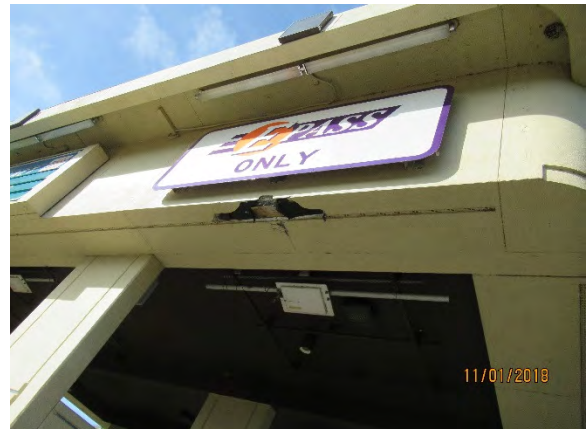
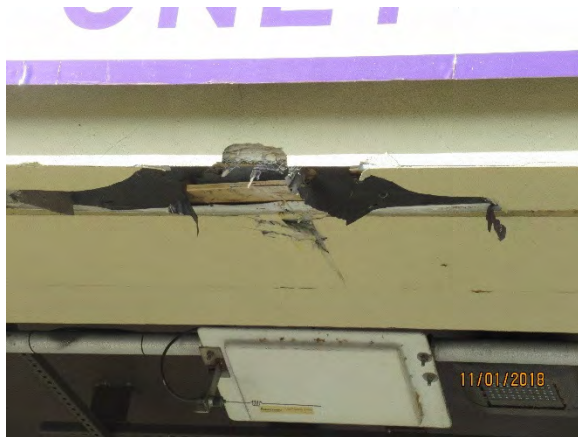
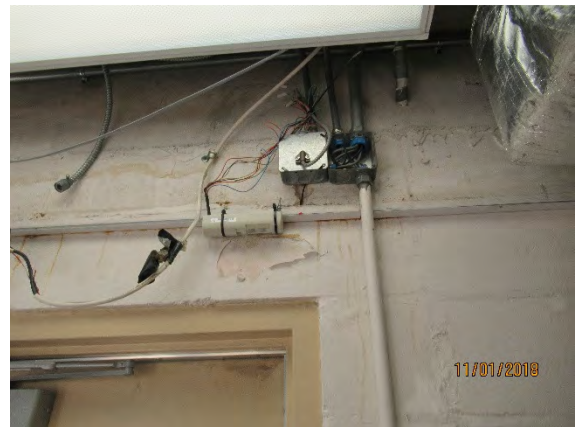
The above referenced on ramp is in good condition overall. Some maintenance is recommended on the damage to the building overhead E-pass lane and general electrical maintenance is recommended. (Figure 13, Figure 14, Figure 15 & Figure 16)

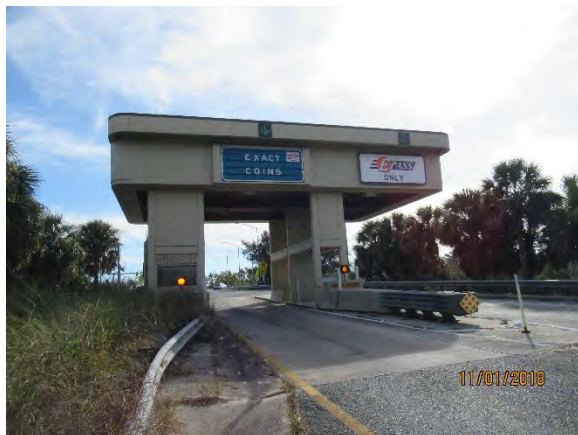
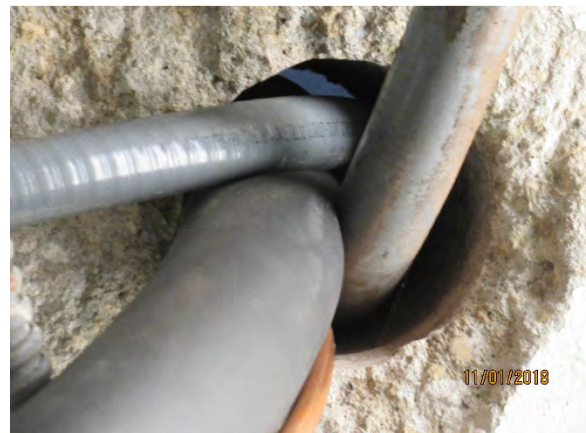
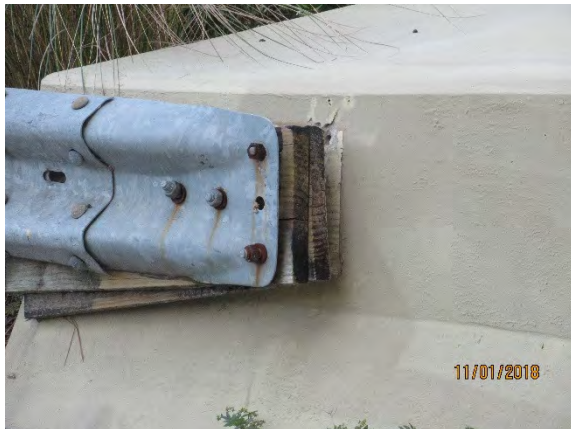
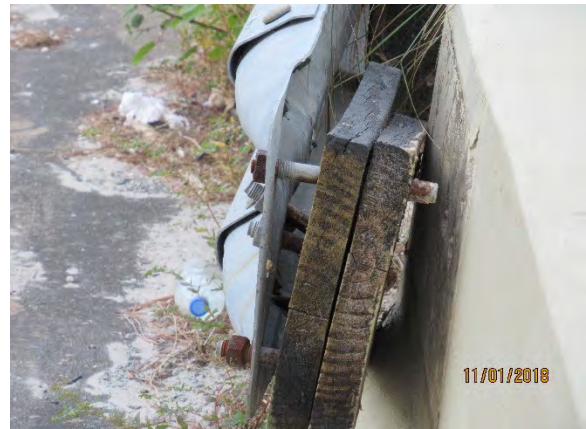
The above referenced on ramp is in good condition overall. Some maintenance to fireproof ceiling penetration and repairs to the separated guardrail is recommended.  
(Figure 17, Figure 18, Figure 19 & Figure 20)

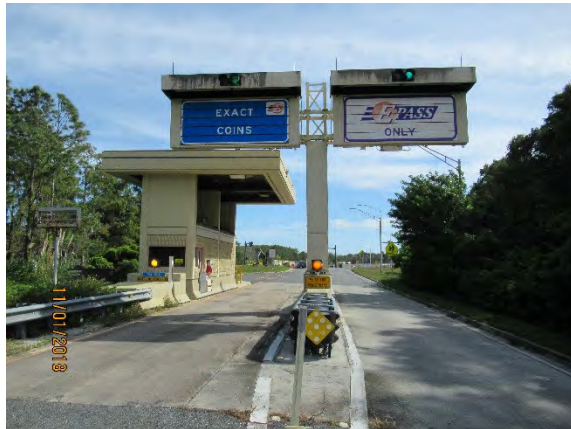
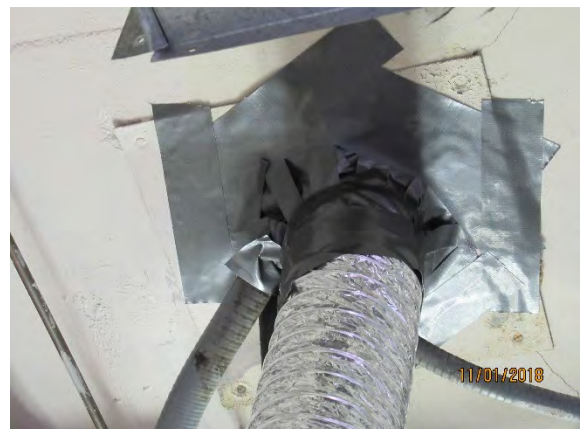
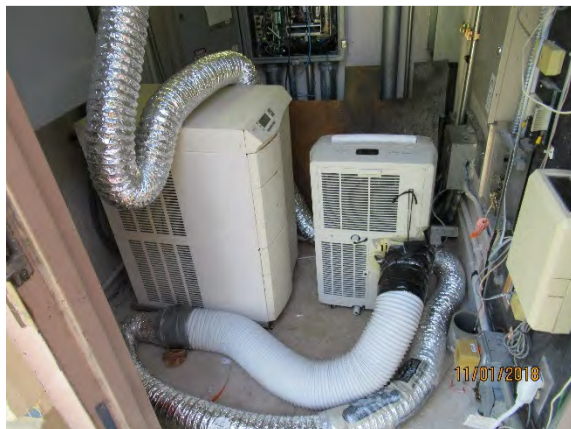
The above referenced on ramp is in good condition overall. Maintenance is recommended on the HVAC duct work that is attached to the ceiling and air conditioning units with duct tape.  
(Figure 21, Figure 22, Figure 23 & Figure 24)

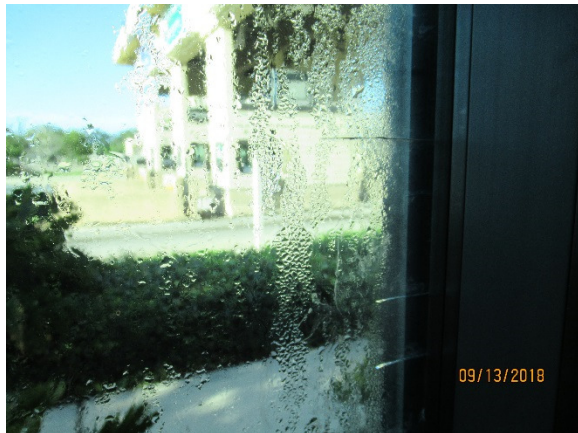
Figure 1 Coral Hills Mainline

- Mainline has cracks in the glass windows in the manager's office and break room. (Figure 1, Figure 3 & Figure 4)
- Mainline computer room missing vent cover. (Figure 2)
- Mainline has potential leak above ceiling tile in computer room, men's restroom and recording room. (Figure 5, Figure 6 & Figure 7)

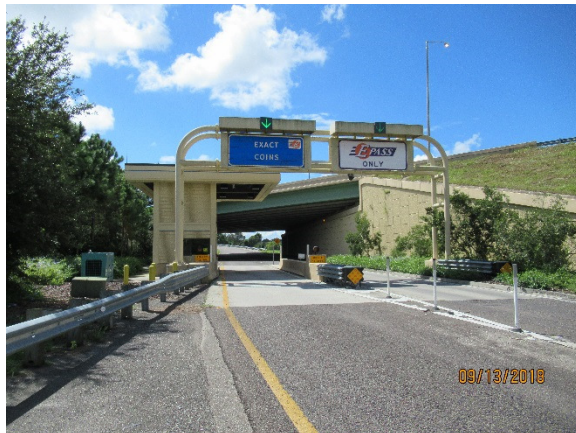
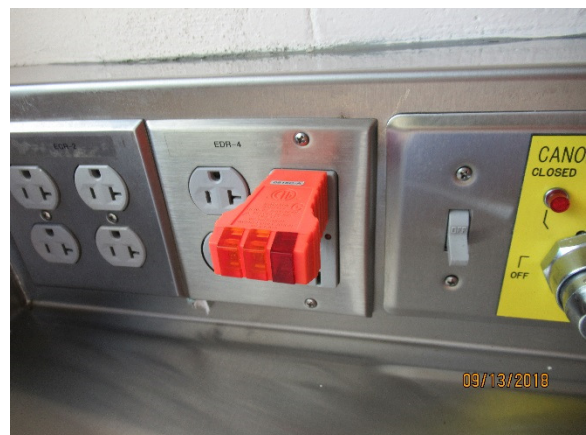
The above referenced on ramp is in good condition overall. Some maintenance on the electrical wiring for the circuits without power is recommended. (Figure 11 & Figure 12)

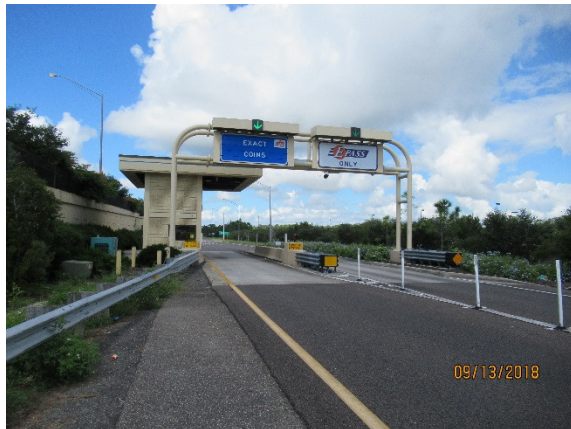
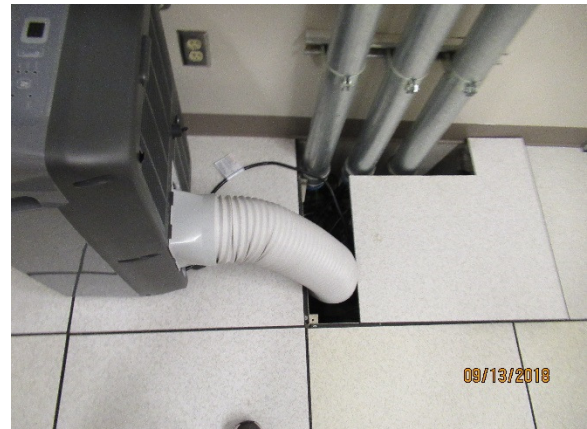
The above referenced on ramp is in good condition overall. Maintenance on ventilation system is recommended. (Figure 13 & Figure 14)

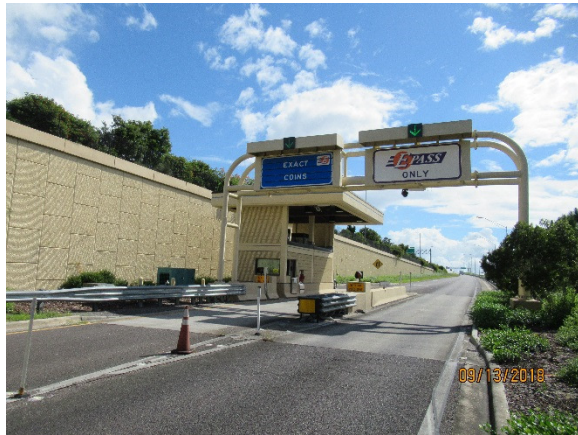
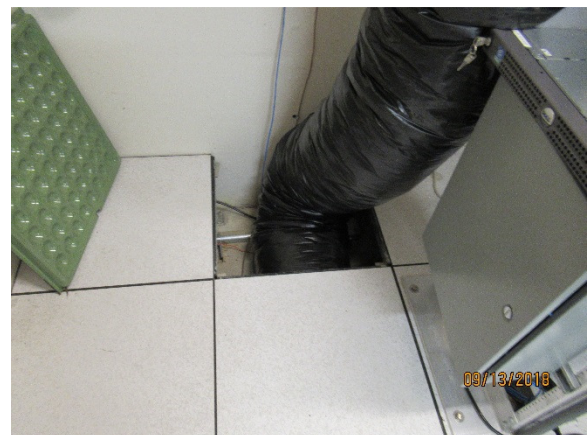
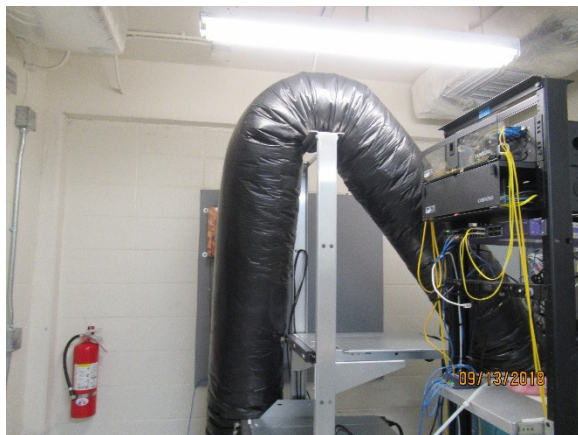
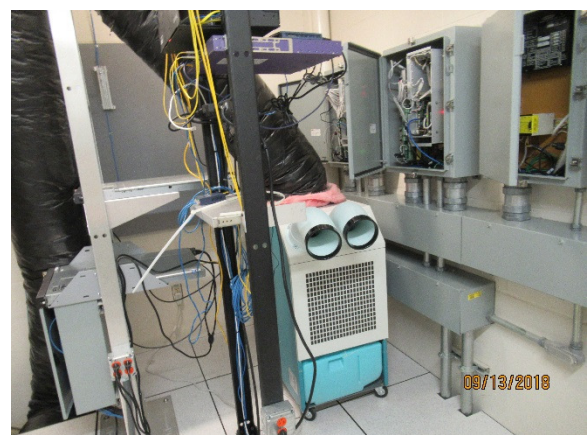
The above referenced on ramp is in good condition overall. Maintenance on ventilation system is recommended. (Figure 15, Figure 16, Figure 17 & Figure 18)

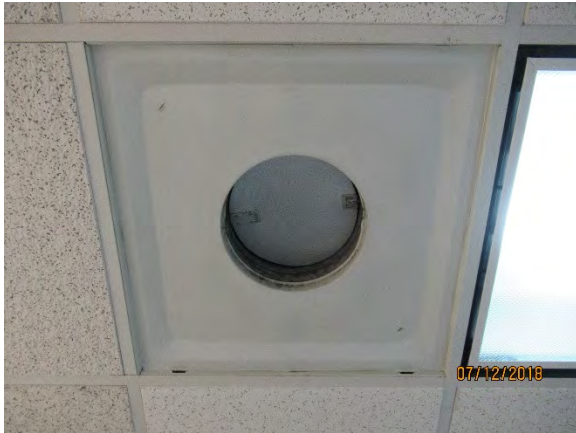
Figure 1 John Young Pkwy Mainline IT Room

- Overhead vent missing vent cover in IT room. (Figure 1)

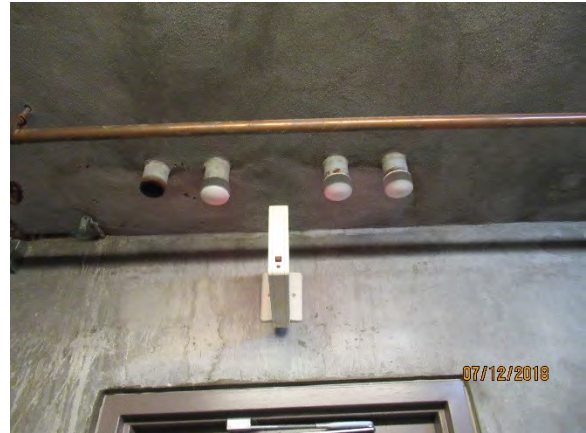
Figure 2 John Young Pkwy Mainline Tunnel Conduit

- Tunnel overhead conduit missing end cap. (Figure 2)

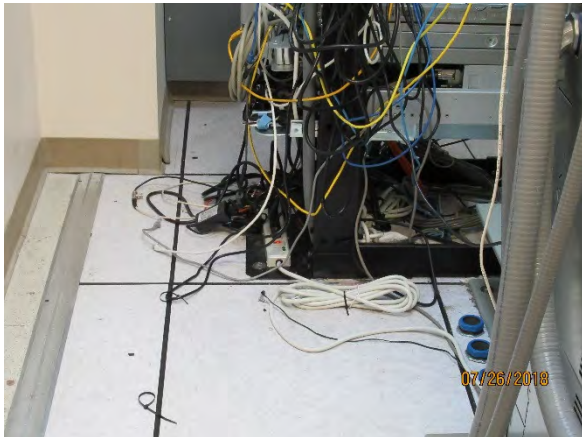
*Figure 1 Boggy Creek Mainline*

- Computer Room wiring under equipment rack. (Figure 1)
- Potential leak from HVAC equipment (Figure 2)
- Ceiling tiles showing potential roof leaks (Figure 3 & Figure 4)

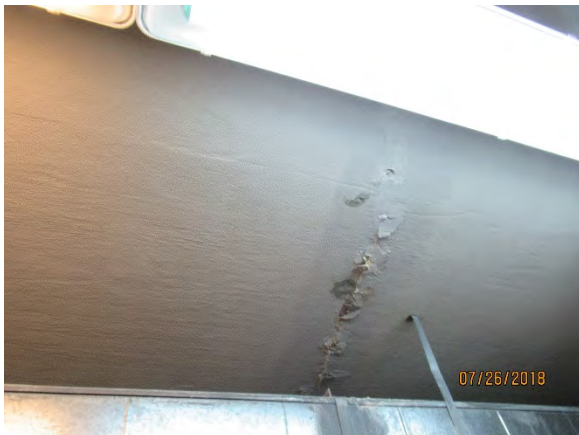
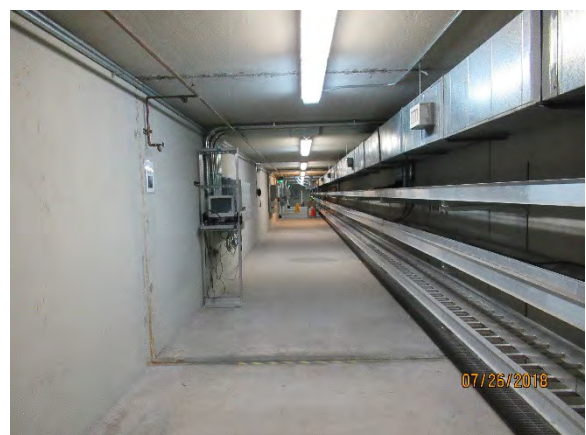
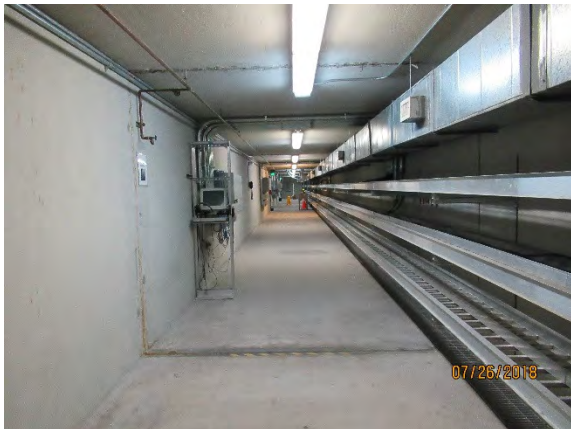
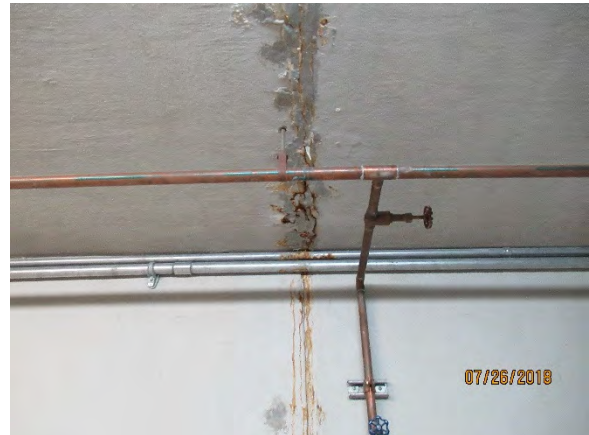
- Mainline tunnel seams are showing deterioration.  
(Figure 5 Figure 6, Figure 7 & Figure 8)

- Recommend maintenance on building façade to address separation from building.
- Recommend testing on HVAC to ensure unit is working properly.
- Recommend examination of roof to locate any potential leaks.
- Recommend general maintenance in tunnel to repair noted deficiencies.

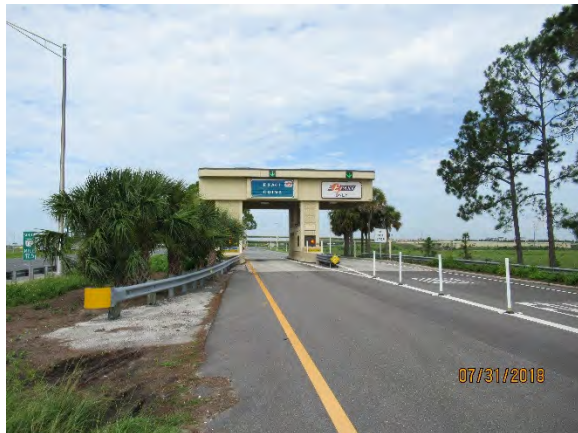
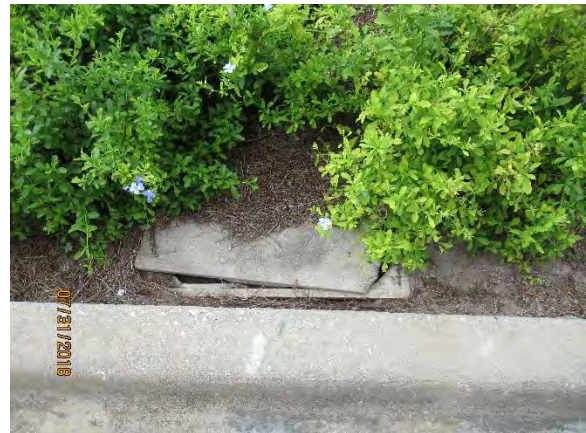
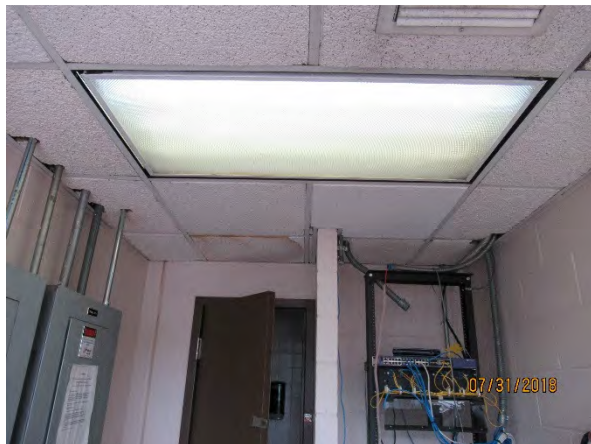
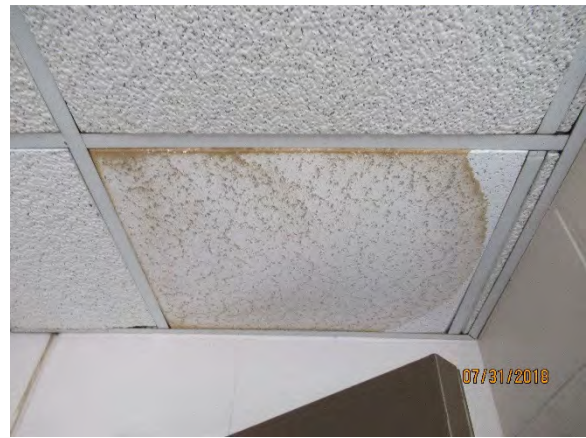
The above referenced on ramp is in good condition overall. Maintenance to ensure exterior equipment covers are secured properly is recommended. Maintenance is recommended on some ceiling tiles and potential leaks need to be addressed.  
(Figure 13, Figure 14, Figure 15 & Figure 16)

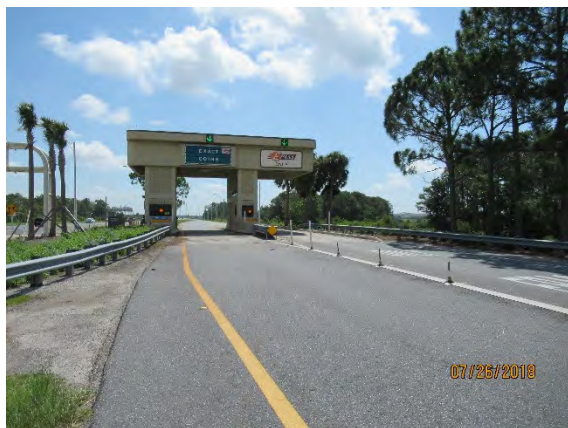
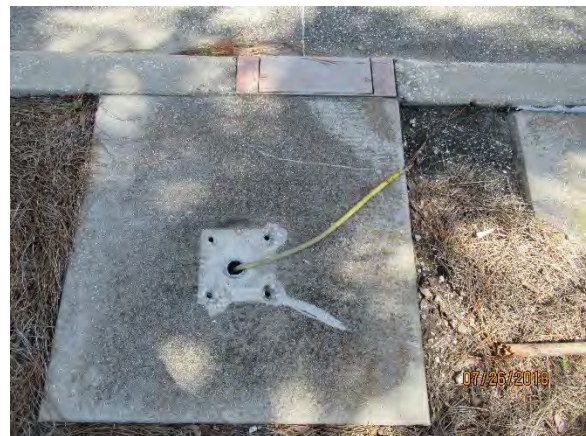
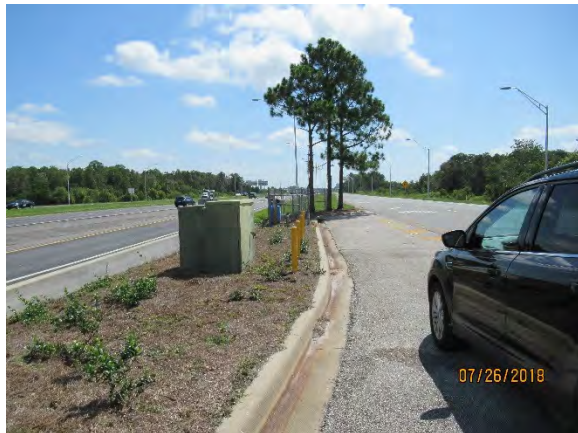
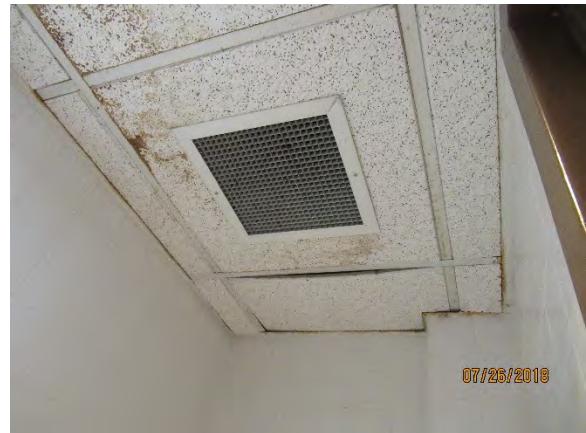
The above referenced on ramp is in good condition overall. Some maintenance on the exterior pedestal, ceiling tiles and potential leaks is recommended. Recommend installation of bollards to protect generator location. (Figure 17, Figure 18, Figure 19 & Figure 20)

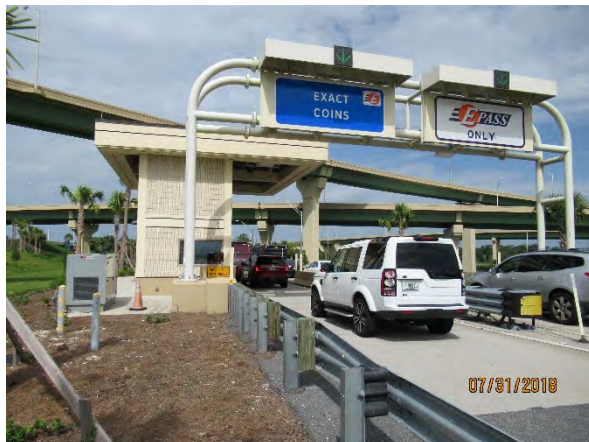
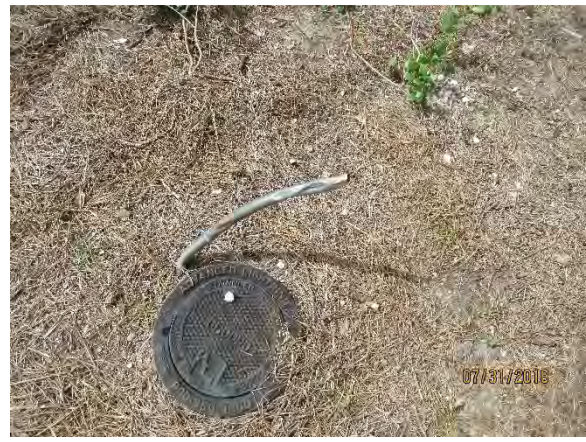
The above referenced on ramp is in good condition overall. Maintenance of the potential trip hazard is recommended. (Figure 21 & Figure 22)

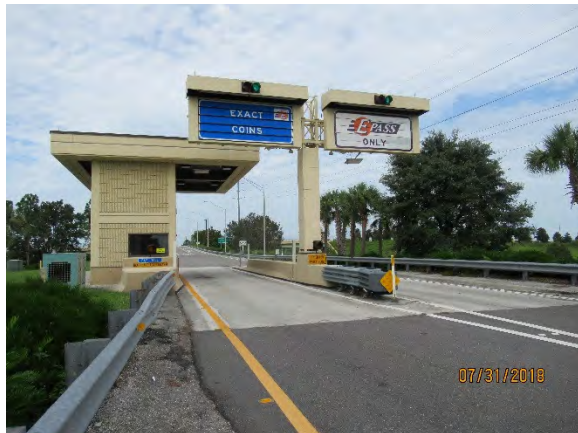
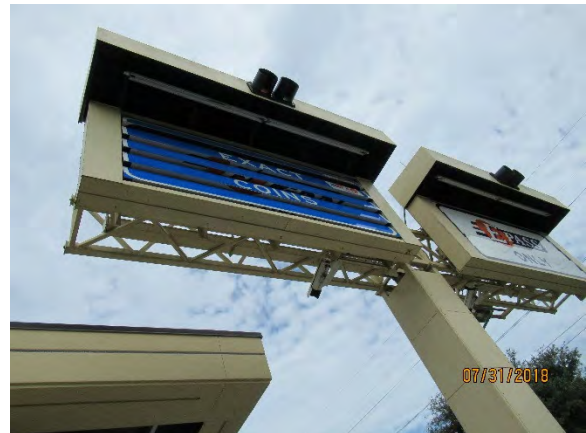
Figure 25 Lake Nona Ramp Off

The above referenced on ramp is in good condition overall. Some maintenance of isolated wiring on the outlet missing power is recommended. (Figure 25 & Figure 26)

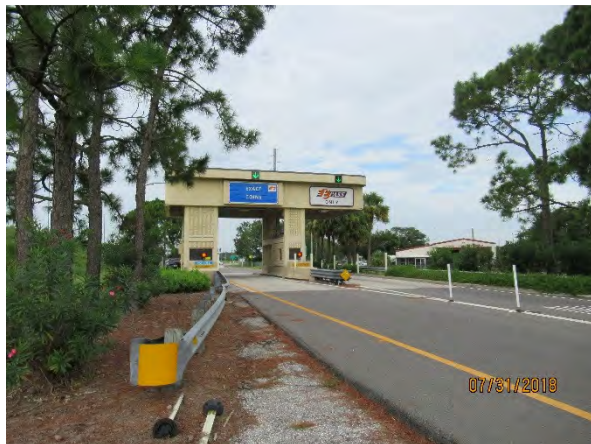
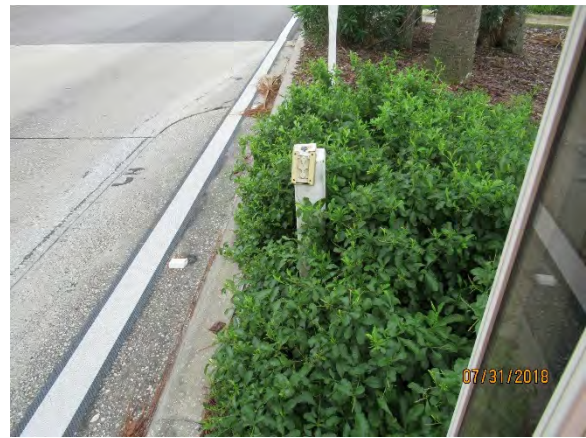
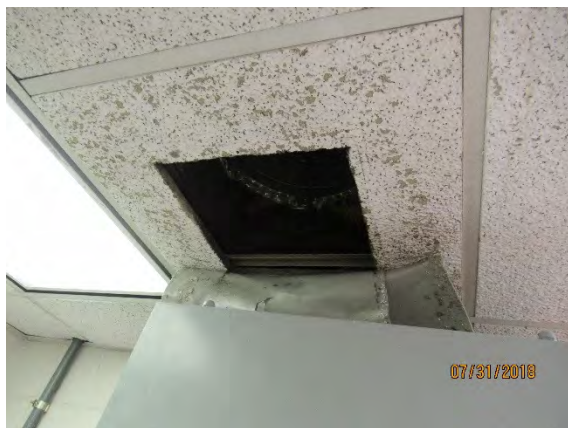
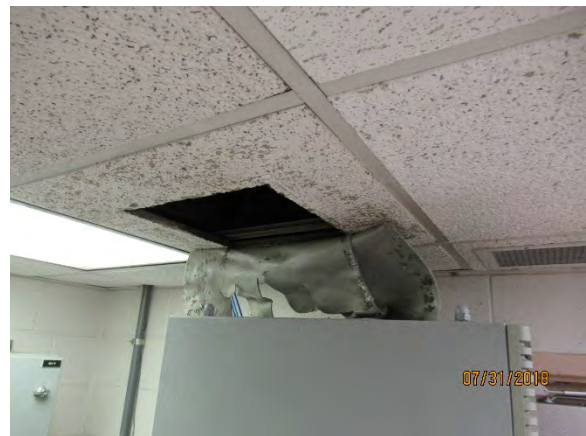
Figure 27 Narcoossee Ramp Off

The above referenced on ramp is in good condition overall. Minor maintenance to attach the loose pedestal cover and replace the vent cover is recommended.  
(Figure 27, Figure 28, Figure 29 & Figure 30)

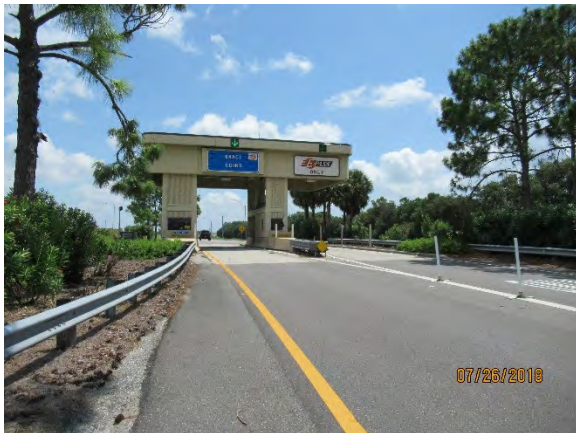
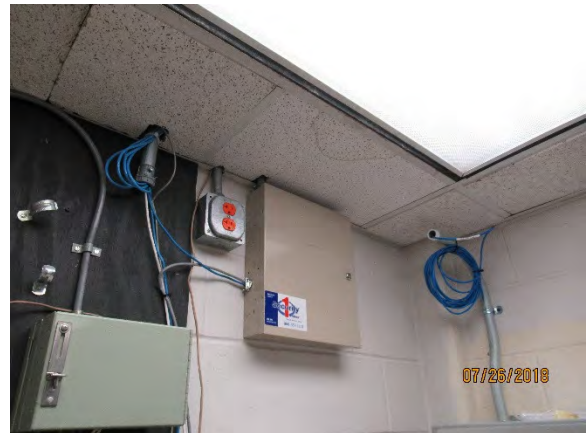
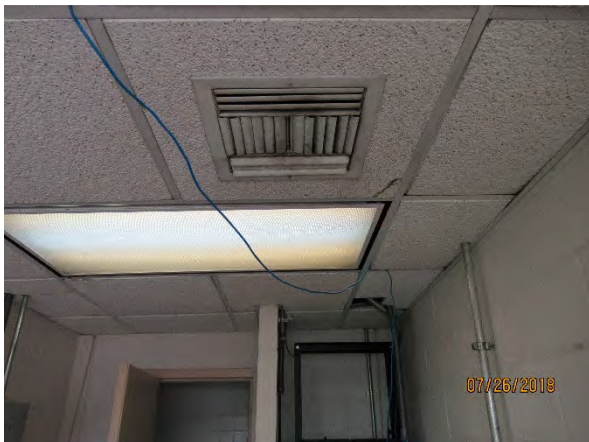
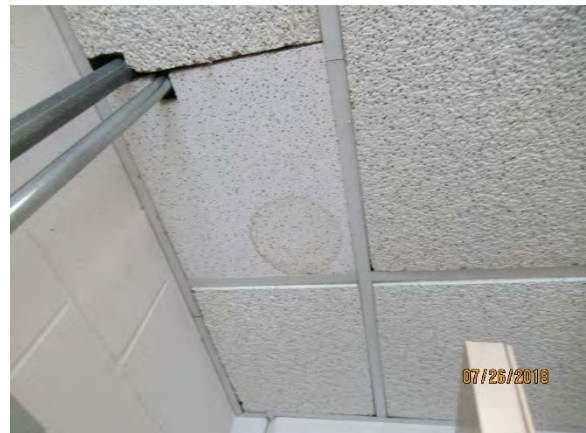
Figure 31 Narcoossee Ramp On

The above referenced on ramp is in good condition overall. Some maintenance of the installation of the wiring across ceiling tiles to the equipment rack, ceiling tiles and potential leaks is recommended. (Figure 31, Figure 32, Figure 33 & Figure 34)

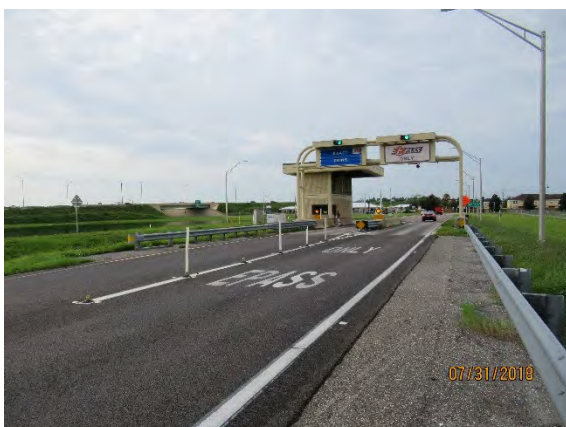
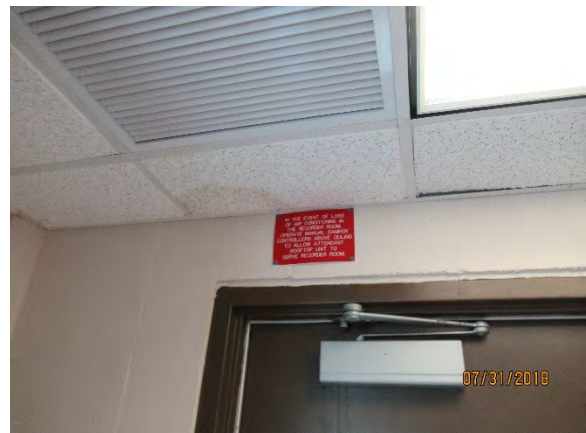
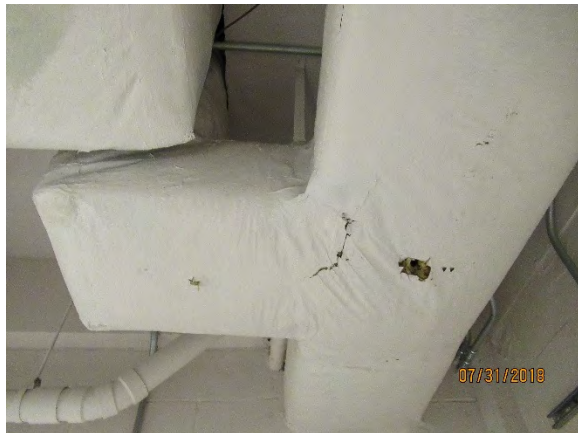
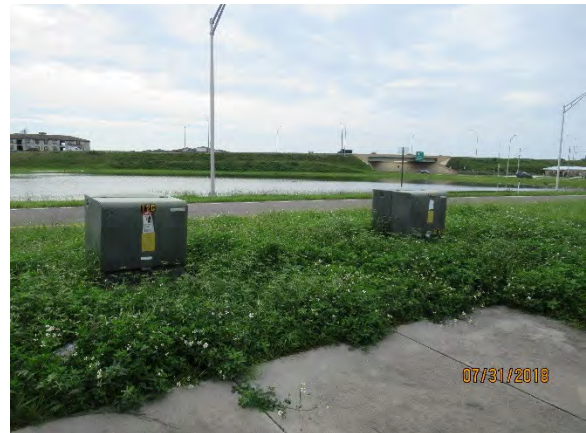
Figure 35 Moss Park Ramp Off

The above referenced on ramp is in good condition overall. Some maintenance to patch the tears in the ductwork, ceiling tiles and potential leaks need to be addressed. Recommend installation of bollards to protect generator location. (Figure 35, Figure 36, Figure 37 & Figure 38)

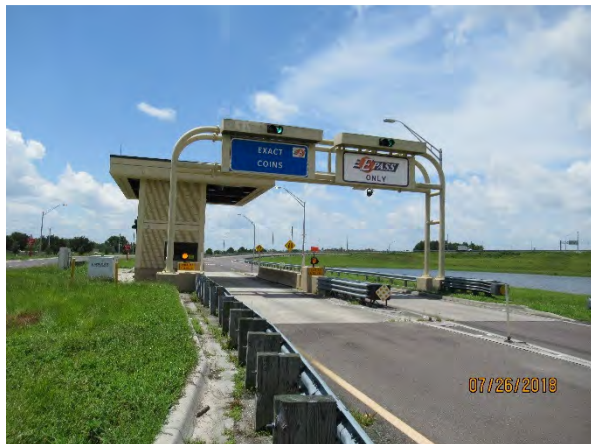
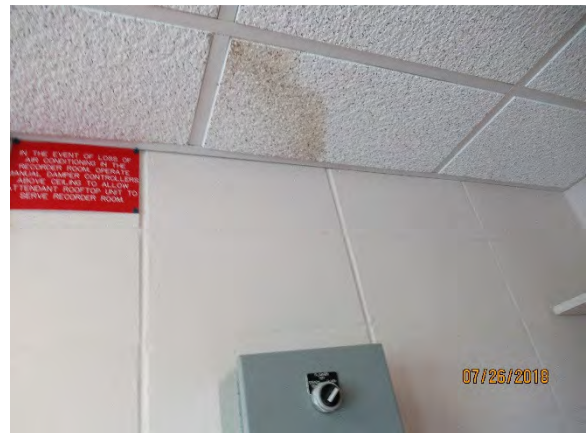
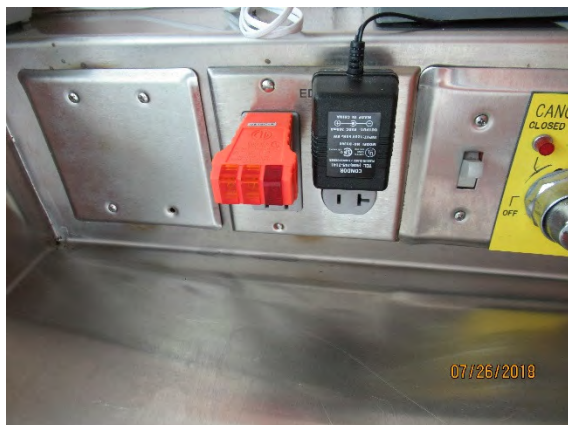
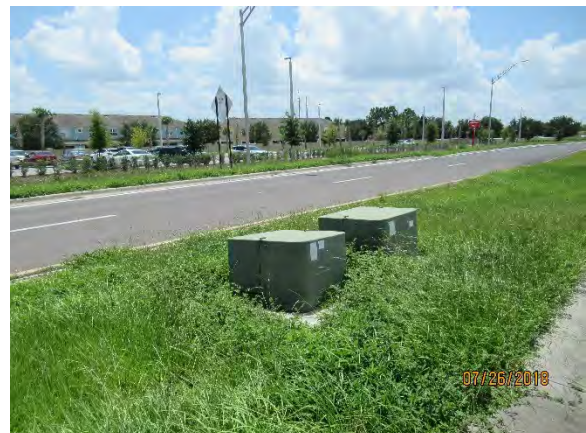
Figure 39 Moss Park Ramp On

The above referenced on ramp is in good condition overall. Some maintenance of isolated wiring on the outlet missing power, ceiling tiles and potential leaks is recommended. Recommend installation of bollards to protect generator location is recommended.  
(Figure 39, Figure 40, Figure 41 & Figure 42)

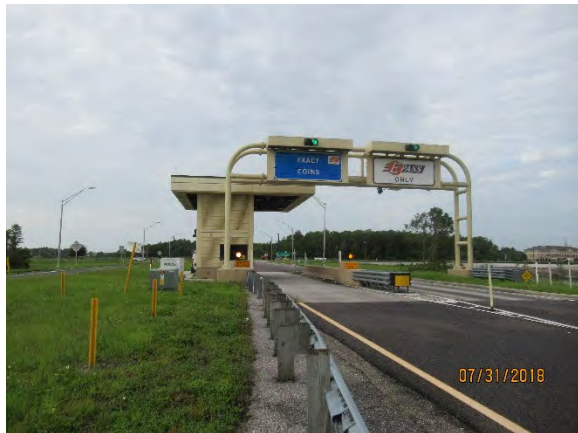
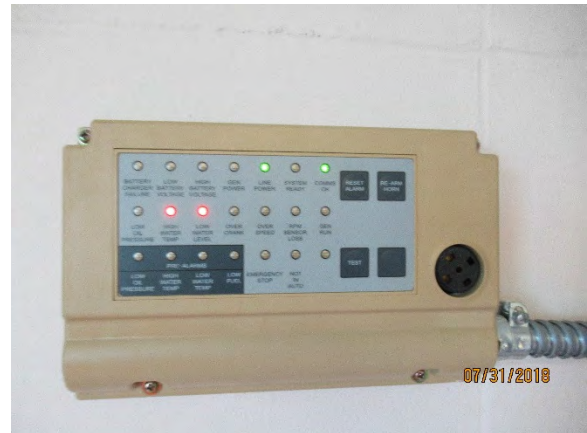
Figure 43 Innovation Ramp Off

The above referenced on ramp is in good condition overall. Some Maintenance to check the generator set is recommended. (Figure 43 & Figure 44)

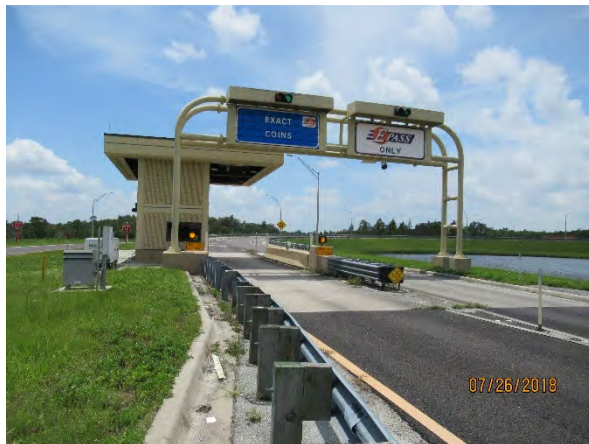
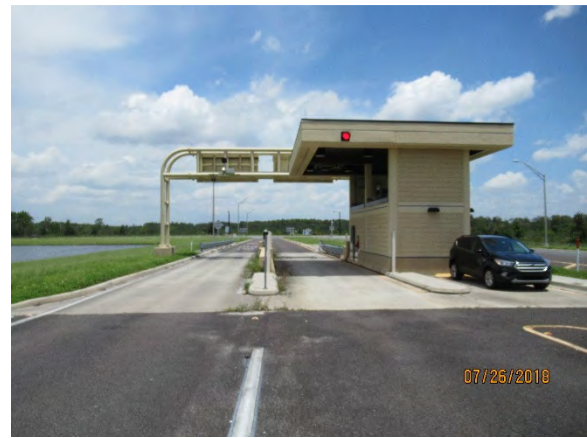
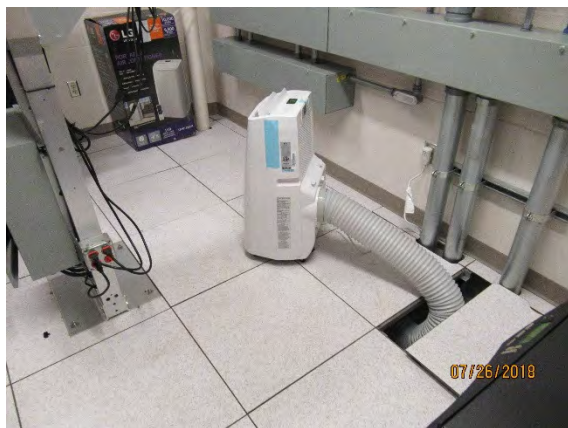
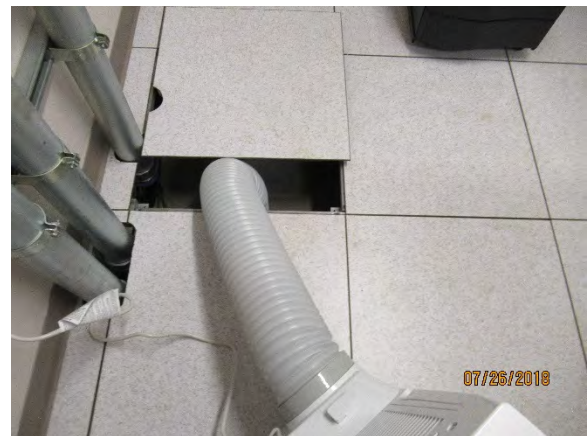
Figure 45 Innovation Way Ramp On

The above referenced on ramp is in good condition overall. Some maintenance to test and balance the HVAC system is recommended.  
(Figure 45, Figure 46, Figure 47 & Figure 48)

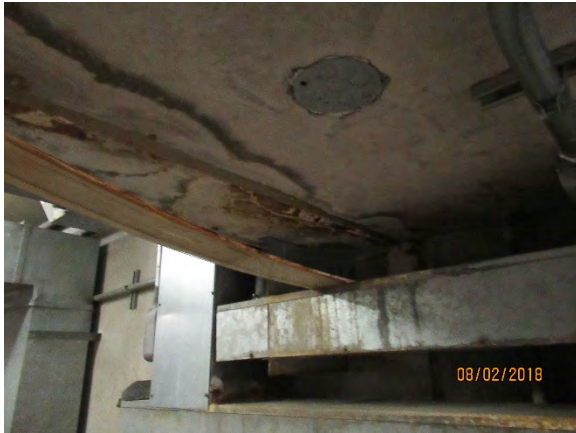
Figure 3 Curry Ford Mainline Tunnel

- Main Plaza tunnel ceiling seam/wood separation from ceiling. (Figure 3)
- Main Plaza tunnel has significant water leaking throughout the tunnel. (Figure 4 & Figure 5)

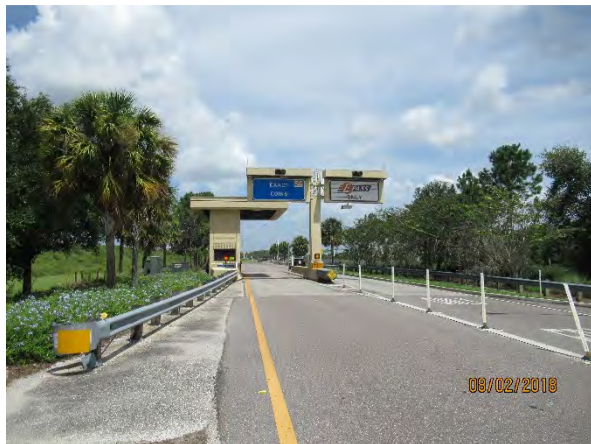
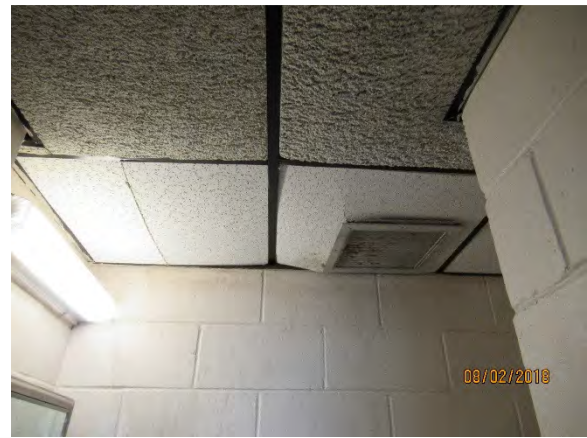
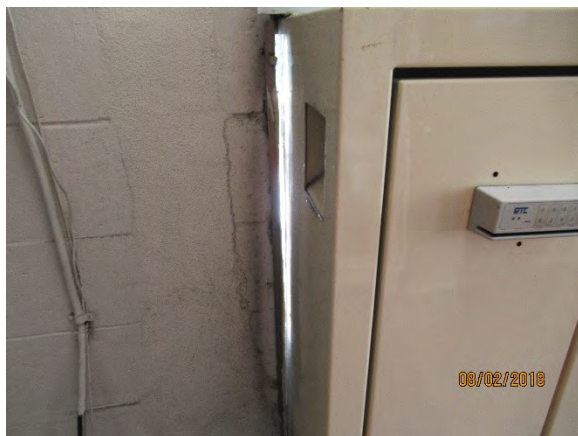
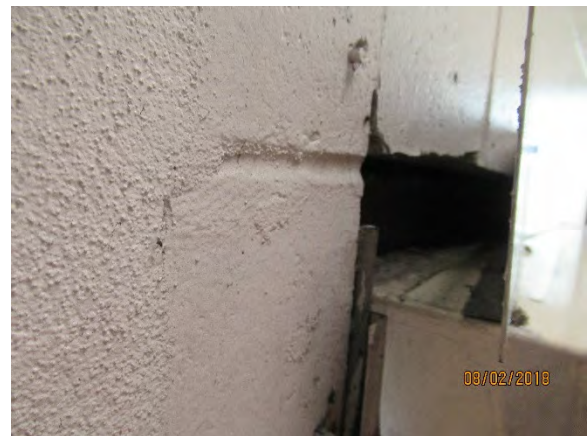
The above referenced on ramp is in good condition overall. Maintenance to repair counting machine separation from wall is recommended. (Figure 15, Figure 16, Figure 17 & Figure 18)

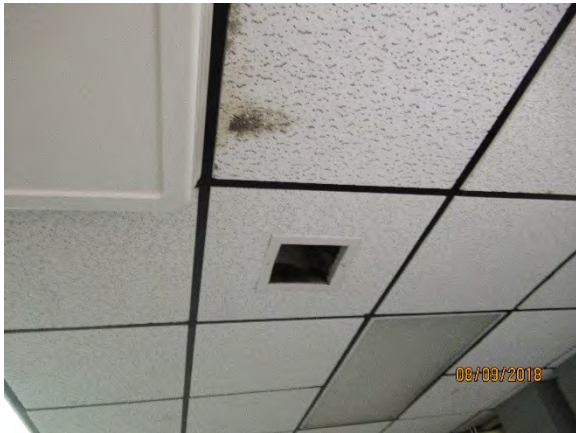
Figure 1 University Mainline IT Room

- Ceiling vent missing cover in computer room. (Figure 1)
- Manager office outlet and wiring separated from wall. (Figure 2)
