2018

# Annual Inspection Report

Re: 2018 Annual Inspection Report

2018 Annual Inspection Report  
CENTRAL FLORIDA EXPRESSWAY AUTHORITY

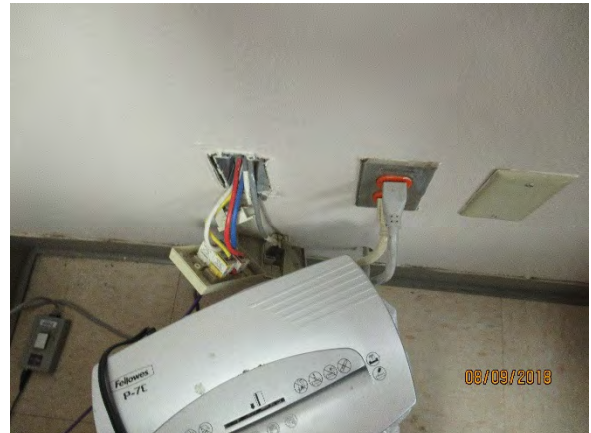
Figure 2 University Mainline Manager's Office

- Ceiling vent missing cover in computer room. (Figure 1)
- Manager office outlet and wiring separated from wall. (Figure 2)

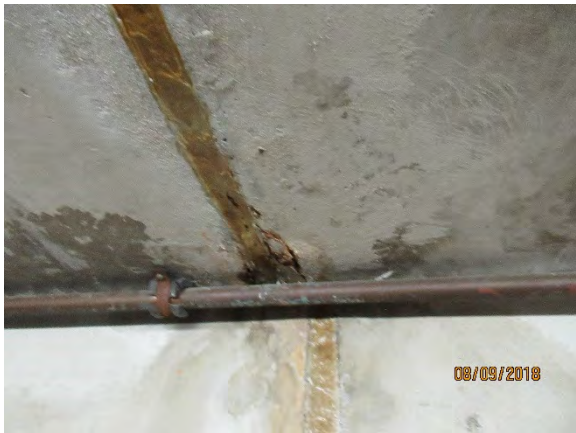
Figure 3 University Mainline Tunnel Seam

- Mainline tunnel seams are showing deterioration. (Figure 3)
- Mainline tunnel ductwork showing separation (Figure 4)

- Recommend maintenance on building façade to address separation from building.
- Recommend examination of roof to locate any potential leaks.
- Recommend general maintenance in tunnel to repair noted deficiencies.

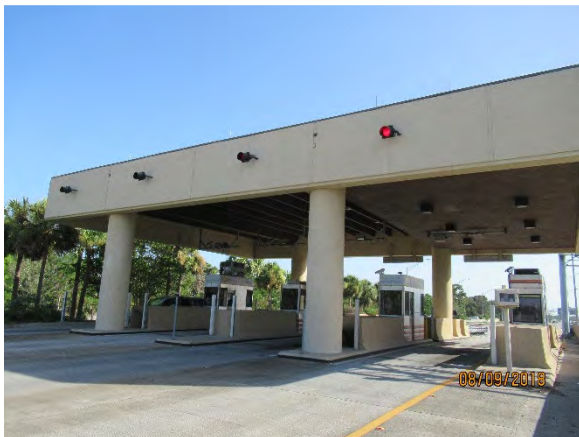
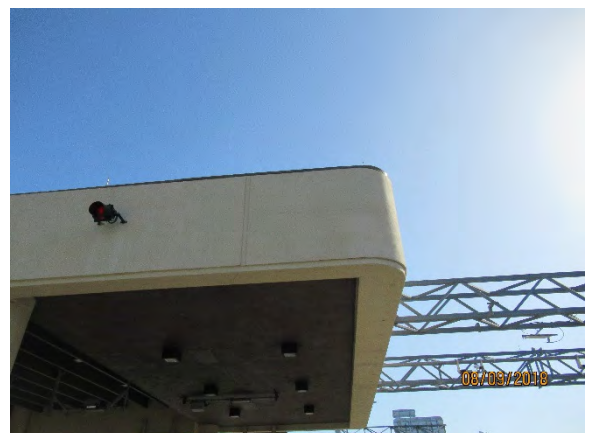
- Building façade showing cracks and minor separation from building. (Figure 5 & Figure 6)

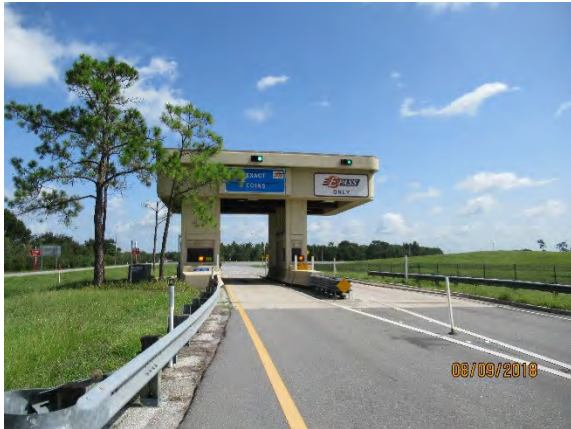
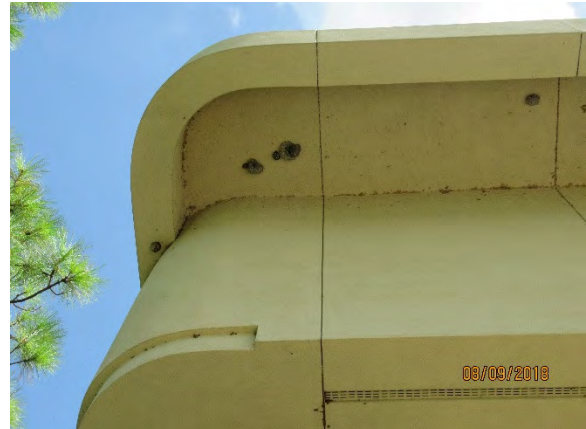
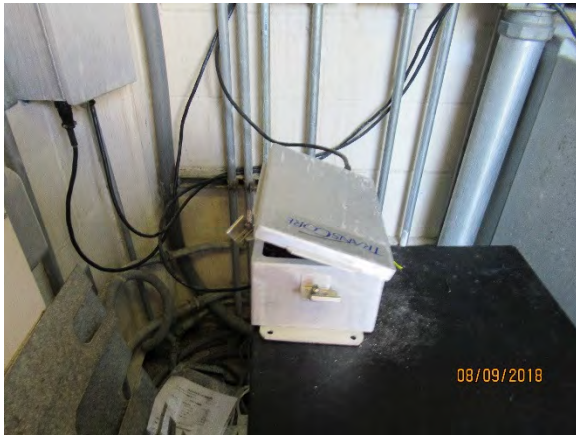
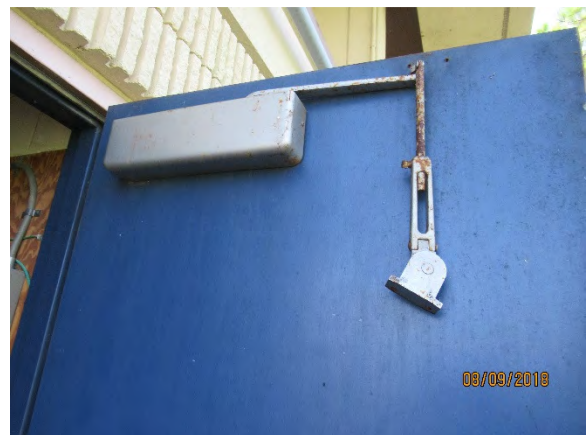
The above referenced on ramp is in good condition overall. Pest control is recommended to address the wasp nests on building façade. Maintenance to repair door latch and attach Trans Core enclosure to wall is also recommended. (Figure 7, Figure 8, Figure 9 & Figure 10)

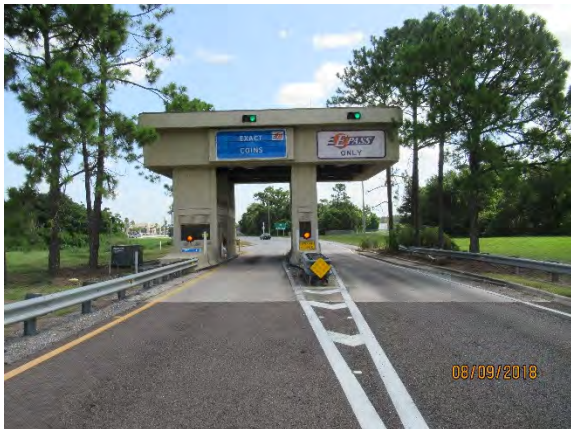
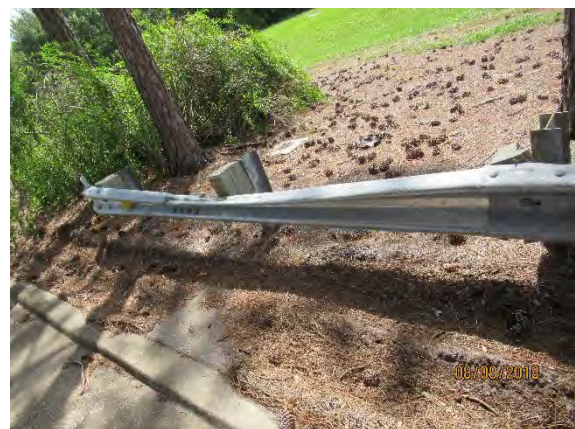
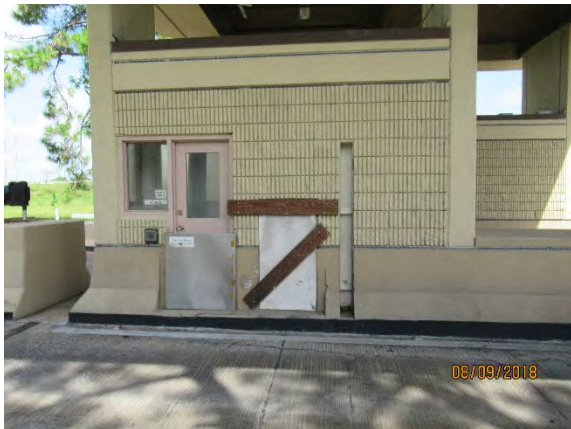
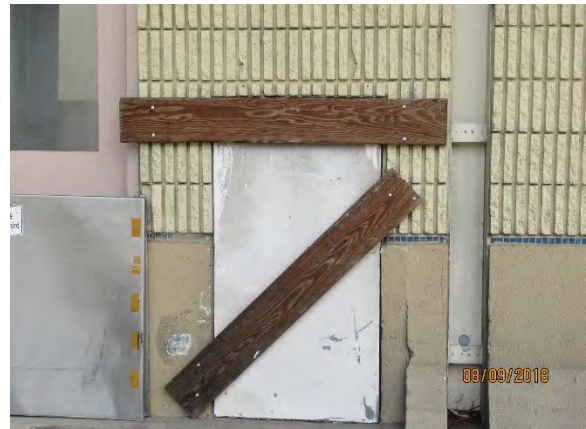
The above referenced on ramp is in good condition overall. Some maintenance on damaged guard rail and a permanent solution to the E-Pass lane is recommended.  
(Figure 11, Figure 12, Figure 13 & Figure 14)

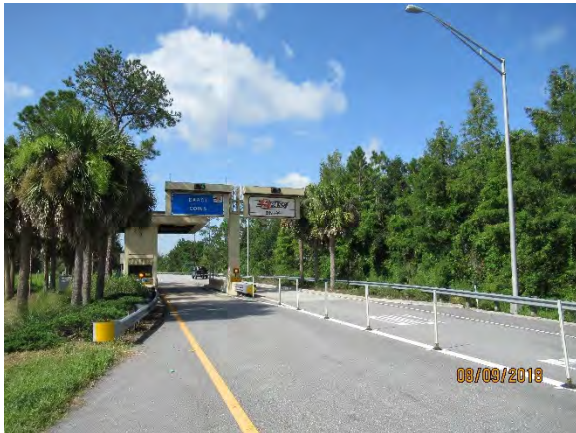
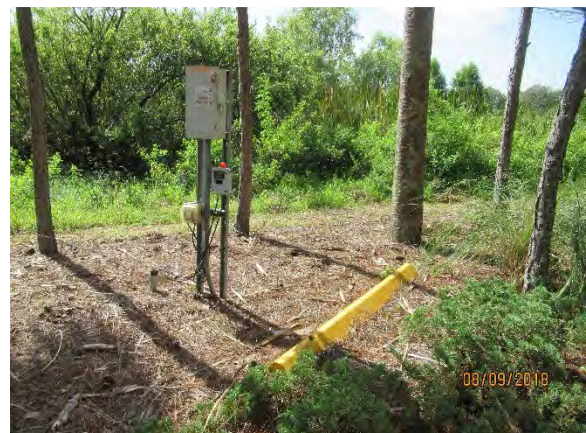
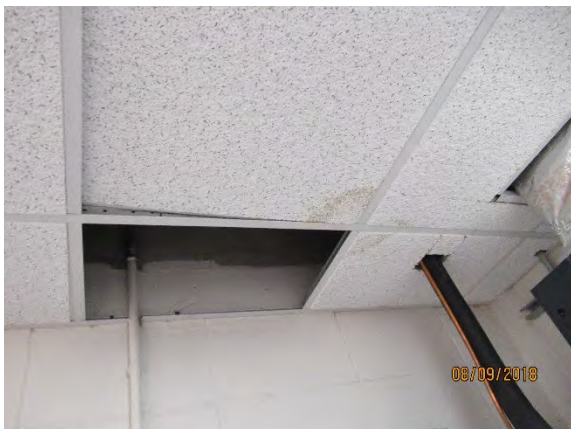
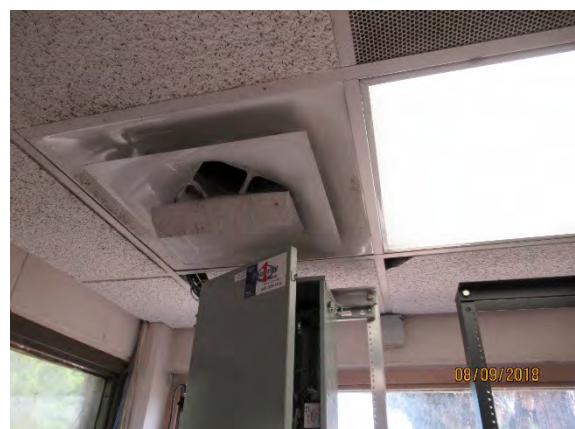
The above referenced on ramp is in good condition overall. Some maintenance to install missing ceiling tiles, repair leaks in ceiling and remove parking stop from landscape is recommended.  
(Figure 15, Figure 16, Figure 17 & Figure 18)

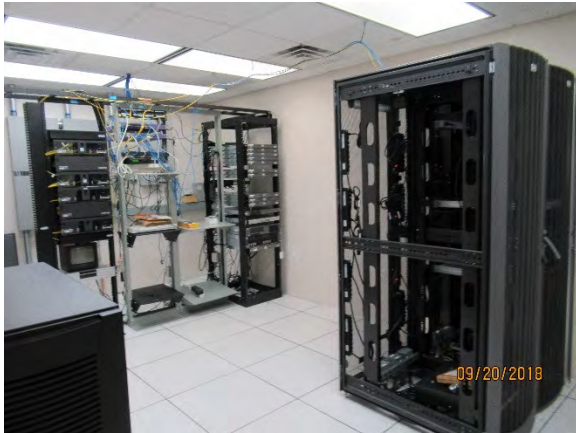
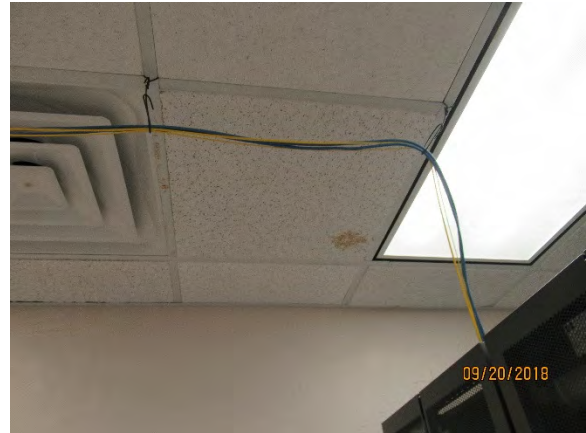
- Mainline computer room has isolated wiring hanging across the room. (Figure 1 & Figure 2)
- Mainline computer room is missing vent cover. (Figure 3)
- Mainline ductwork has tear and potential leak. (Figure 4)

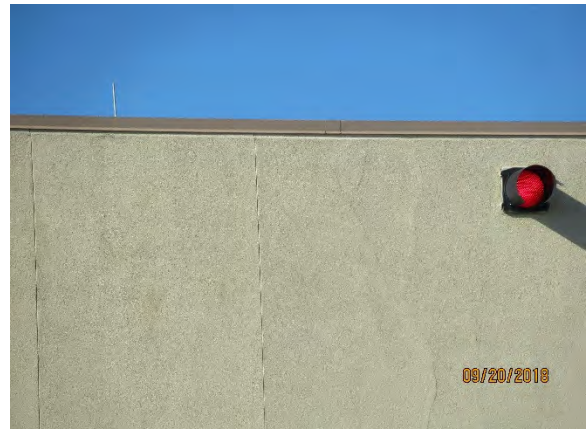
Figure 8 Independence Mainline

- Building façade showing cracks and minor separation from building. (Figure 8)

- Recommend pressure wash overpass area.
- Recommend maintenance on building façade to address separation from building.
- Recommend examination of roof to locate any potential leaks.

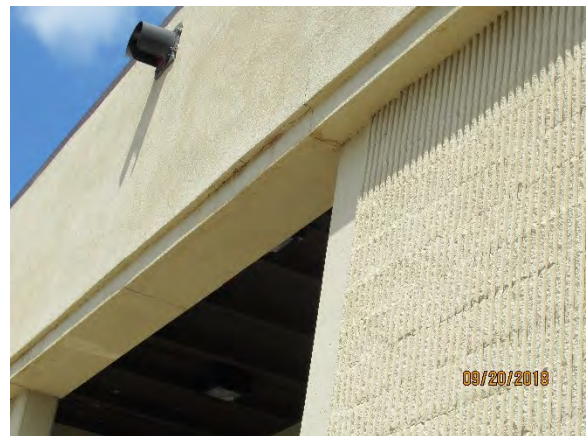
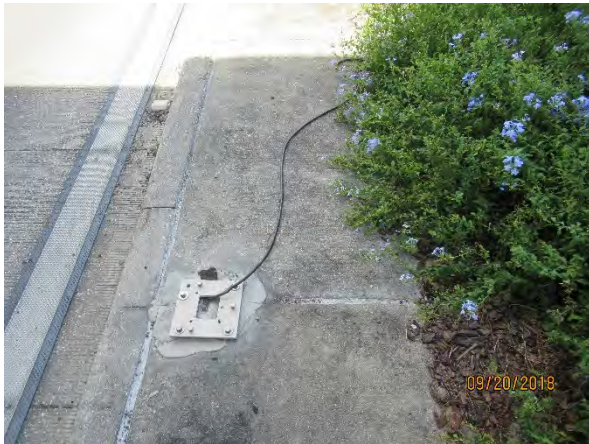
The above referenced on ramp is in good condition overall. Maintenance to repair building façade showing separation from building and pedestal wiring is recommended.  
(Figure 23, Figure 24, Figure 25 & Figure 26)

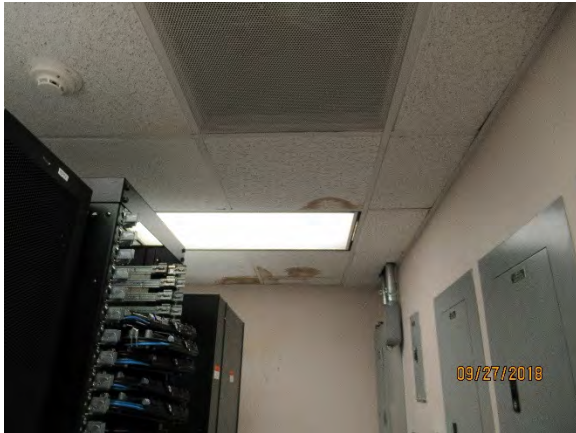
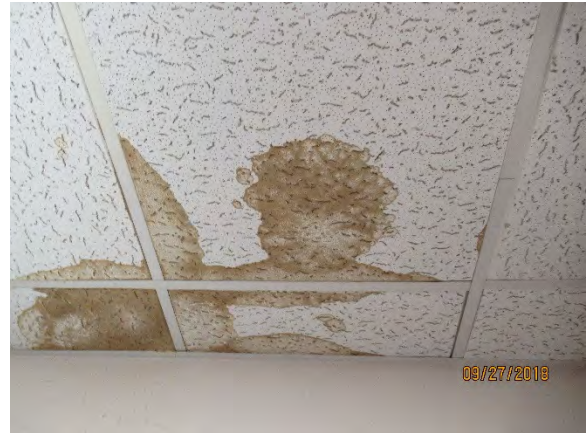
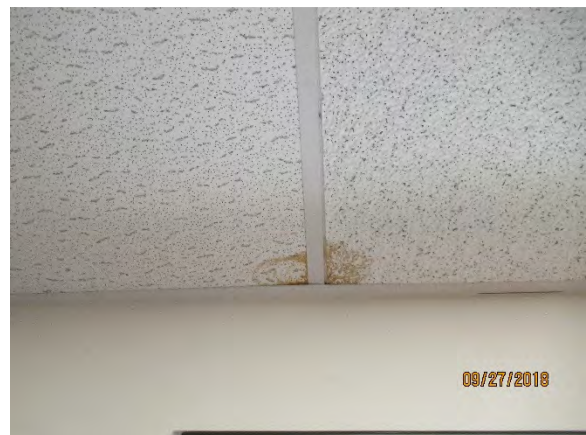
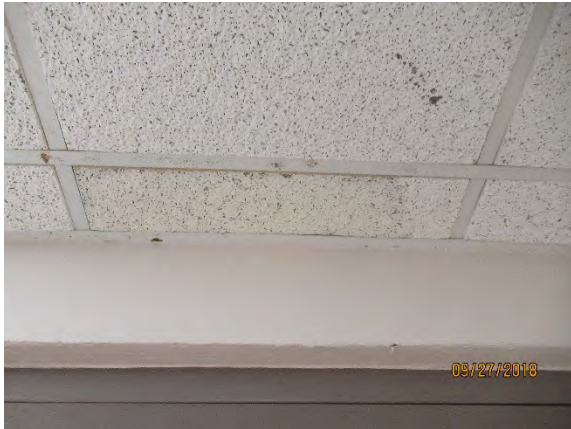
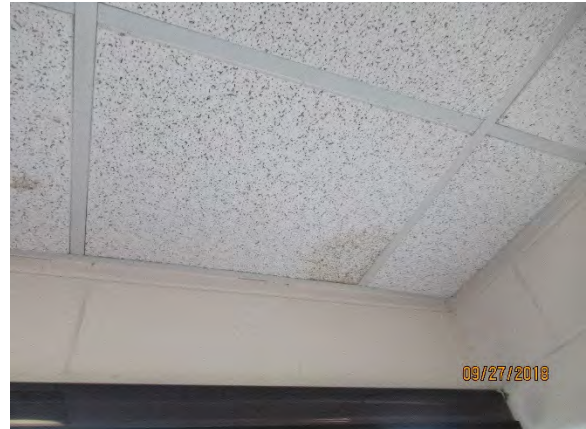
- Mainline has identified leaks above ceiling tile in computer room, break room and recording room. (Figure 1, Figure 2, Figure 4, Figure 7 & Figure 8)
- Mainline computer room is missing vent cover above equipment racks. (Figure 3)

- Recommend maintenance on building façade to address separation from building
- Recommend maintenance on overpass to restore and repaint identified area in need of repair.
- Recommend maintenance to determine the cause of the leaks in the ceiling tiles.

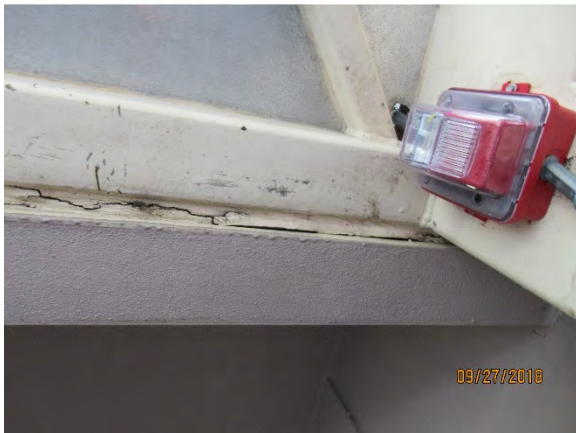
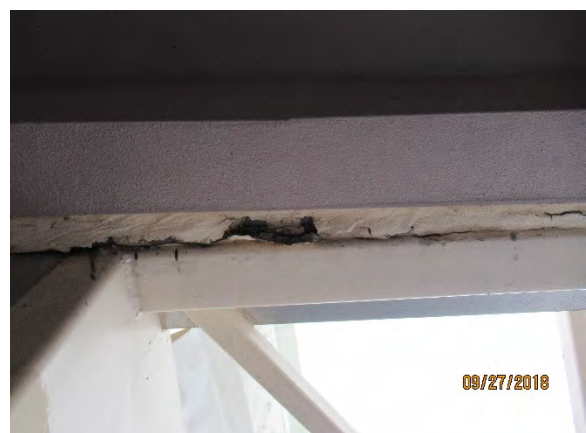
- Overpass has some recommended areas of repair in seam as shown in inspection photos. (Figure 5 & Figure 6)

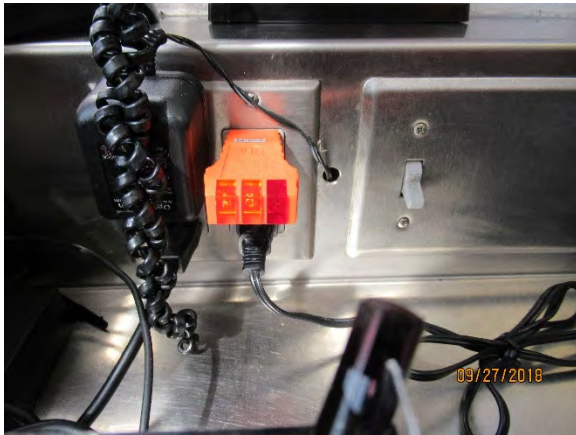
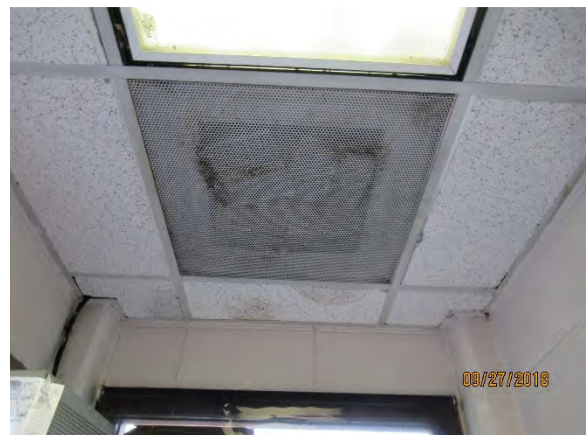
- Exterior toll booths have some isolated wiring issues identified and missing power outlets. (Figure 9 & Figure 10)
- Building façade showing separation from building. (Figure 11 & Figure 12)

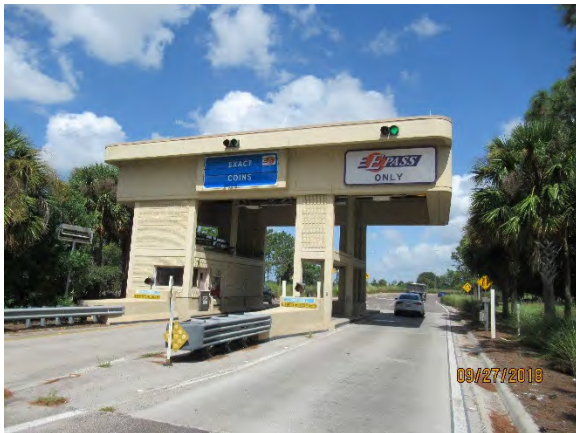
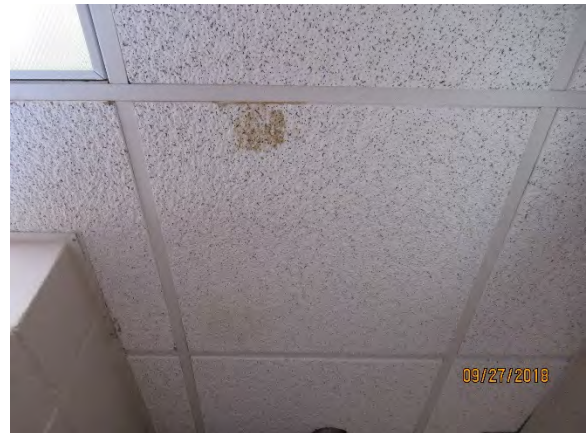
The above referenced on ramp is in good condition overall. Maintenance to locate potential ceiling leaks is recommended (Figure 13 & Figure 14)

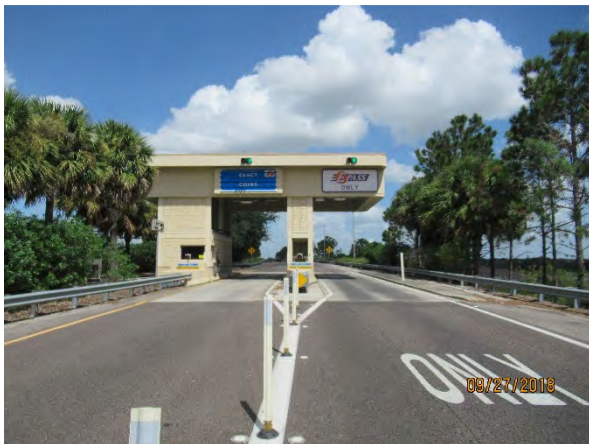
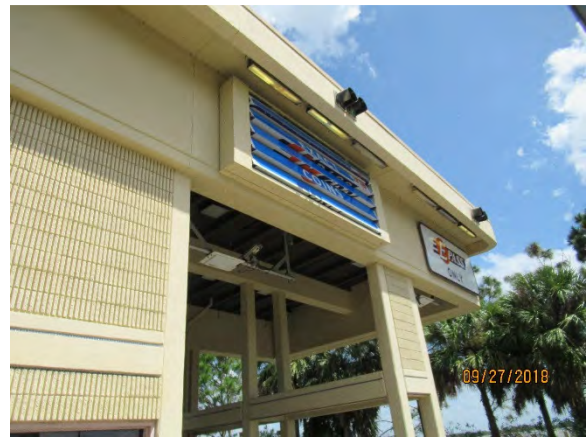
The above referenced on ramp is in good condition overall. Some maintenance to test the overpass sign is recommended. (Figure 15 & Figure 16)

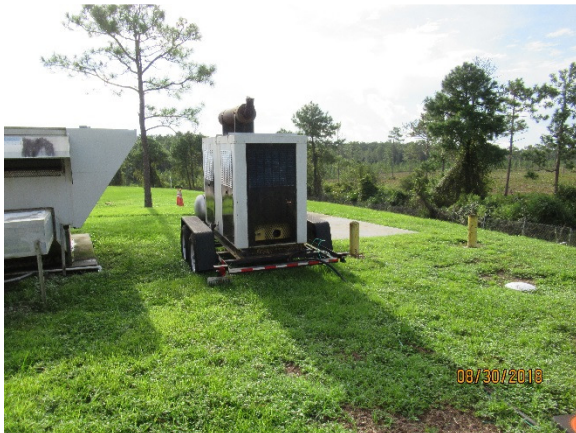
Figure 5 Beachline Mainline

- Exterior building is in good condition overall.
- Portable generator located behind mainline building. (Figure 5 & Figure 6)

- Recommend maintenance on of isolated wiring for computer room.
- Recommend electrical contractor determine computer room wiring can be addressed.
- Recommend determining solution to alleviate need for portable generator.

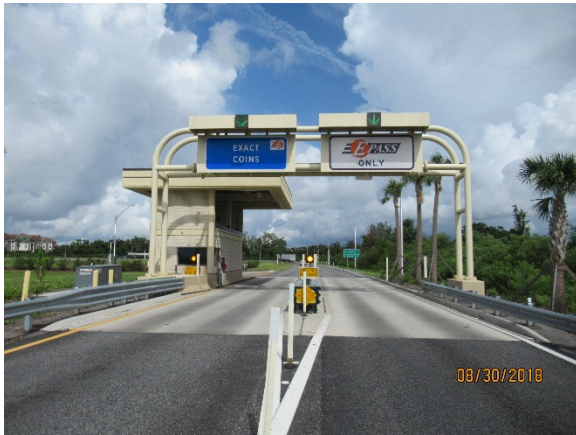
Figure 9 McCoy Road Ramp Off

The above referenced off ramp is in good condition overall. (Figure 9 & Figure 10)

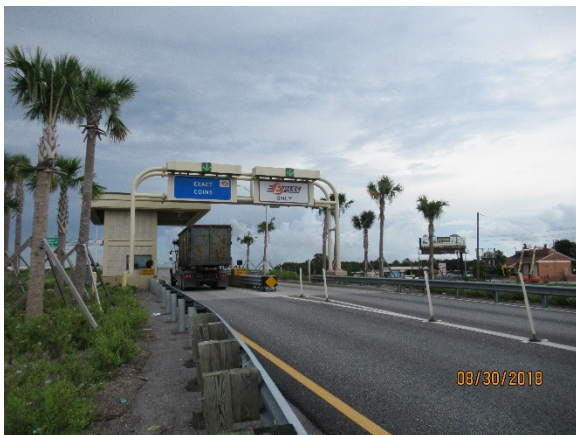
Figure 11 Jetport Ramp On

The above referenced on ramp is in good condition overall. (Figure 11 & Figure 12)

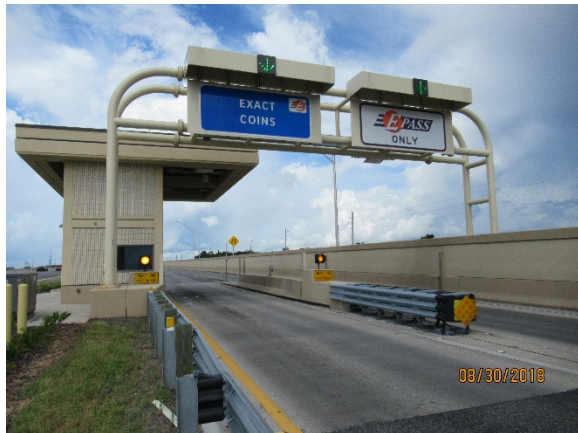
*Figure 13 Conway Ramp On*

The above referenced off ramp is in good condition overall. Maintenance to ensure underground propane tank cover is securely fastened. (Figure 13 & Figure 14)

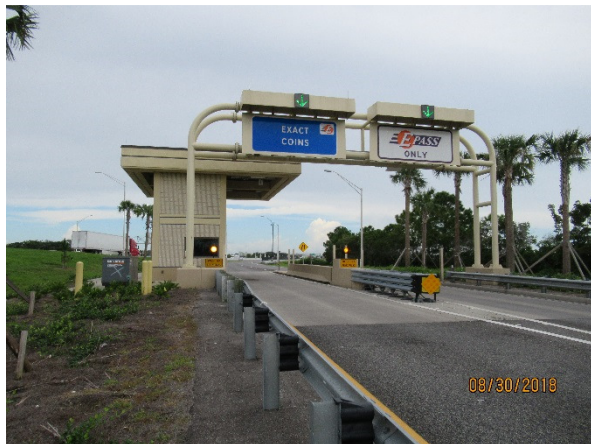
*Figure 15 Tradeport Ramp On*

The above referenced on ramp is in good condition overall. Maintenance is recommended on ceiling tiles and potential leaks need to be addressed. (Figure 15 & Figure 16)

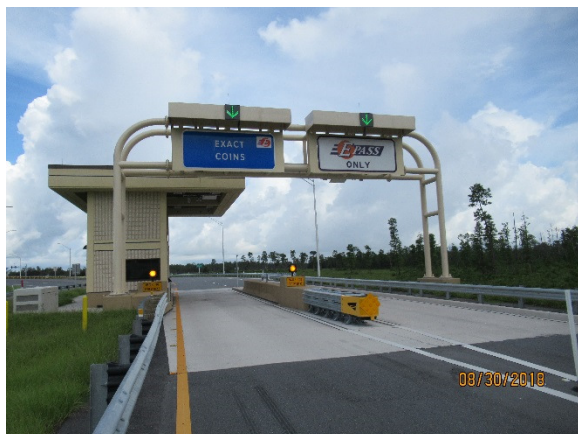
*Figure 17 ICP Ramp Off*

The above referenced on ramp is in good condition overall. (Figure 17 & Figure 18)

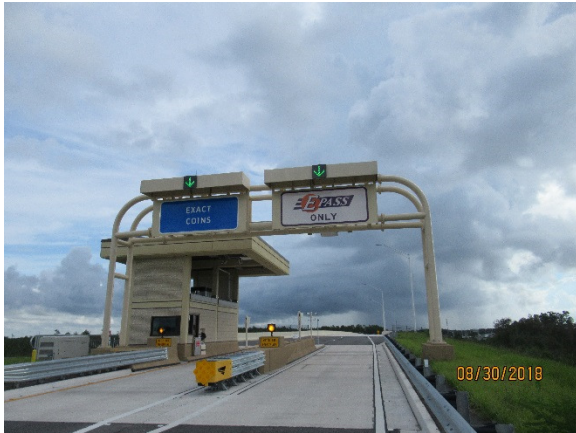
*Figure 19 ICP Ramp On*

The above referenced on ramp is in good condition overall. (Figure 19 & Figure 20)

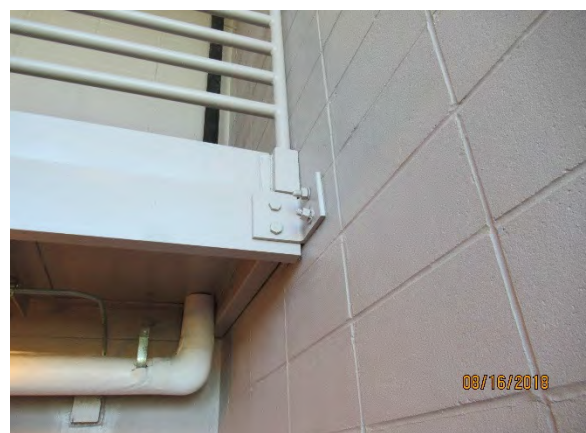
Figure 5 Dallas Mainline

- Mainline conference room ceiling tile has potential leak. (Figure 1)
- Mainline computer room has isolated wiring bundles with multiple power strips on floor below equipment racks. (Figure 2)
- Stairwell hardware is showing separation from interior wall. (Figure 5 & Figure 6)

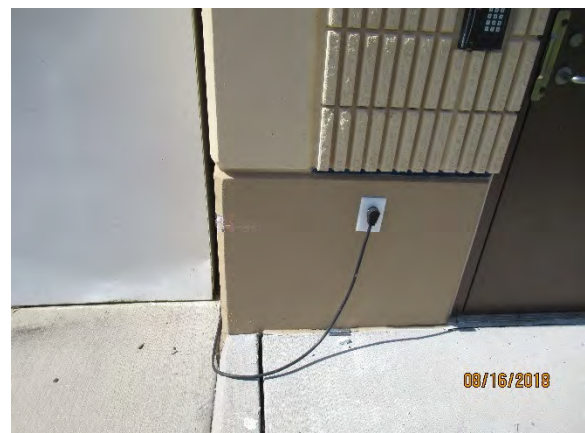
Figure 11 Dallas Ramp Off

The above referenced on ramp is in good condition overall. Action ice machine using ramp power source. (Figure 11 & Figure 12)

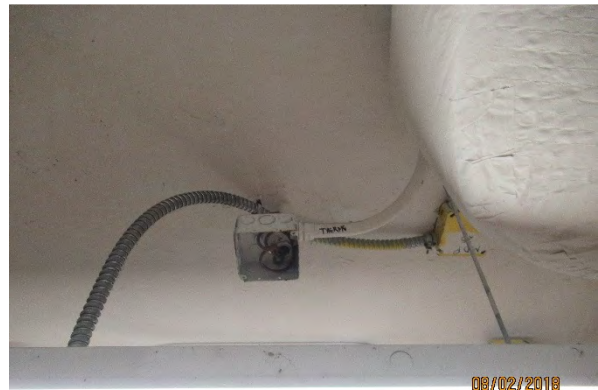
*Figure 2 Goldenrod Main Plaza*

- Mainline computer room has electrical outlet missing power and electrical box missing cover.  
(Figure 2 & Figure 3)

- Recommend electrical contractor provide general repair and replace missing outlet cover.
