# 2019

# Annual Inspection Report

Mr. Glenn Pressimone, P.E.  
Chief of Infrastructure  
Central Florida Expressway Authority  
4974 ORL Tower Road  
Orlando, Florida 32807

Re: 2019 Annual Inspection Report

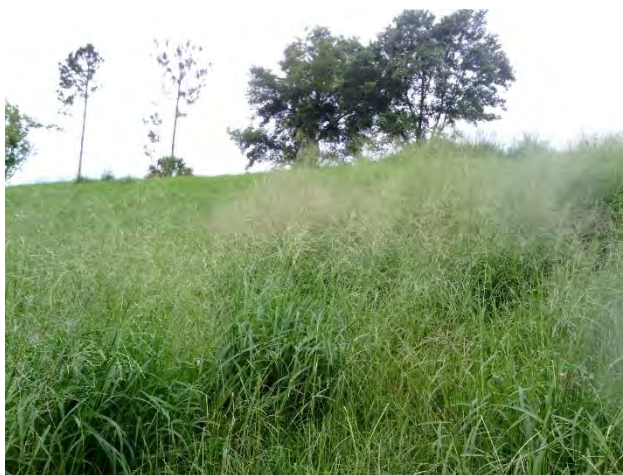
SR 451 roadway observations consisted of overgrown drainage structures with moderate erosion and overgrown front and back slopes.

**Figure 16:** Overgrown front slope along SR 451.

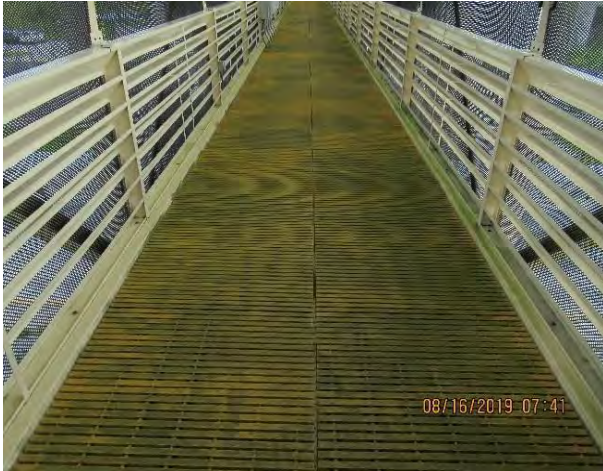
**Figure 19:** Dallas Mainline Pedestrian Bridge minor mold growth.

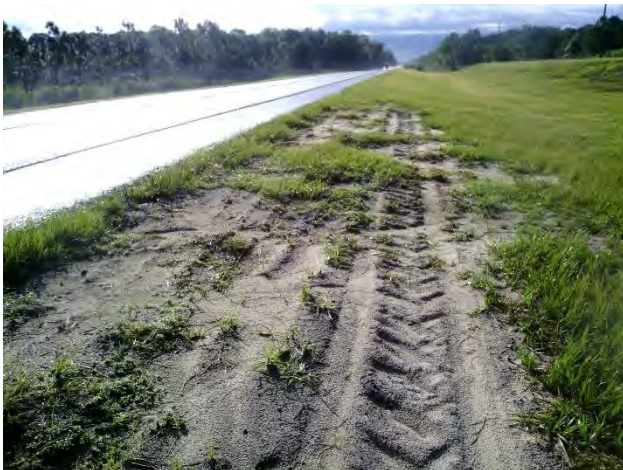
SR 538 observations consisted of minor overgrown drainage structures and minor roadside erosion.

**Figure 20:** SR 538 (Poinciana Parkway) minor roadside erosion.

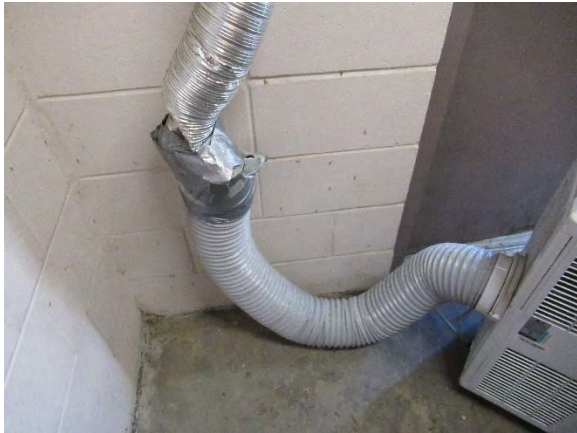
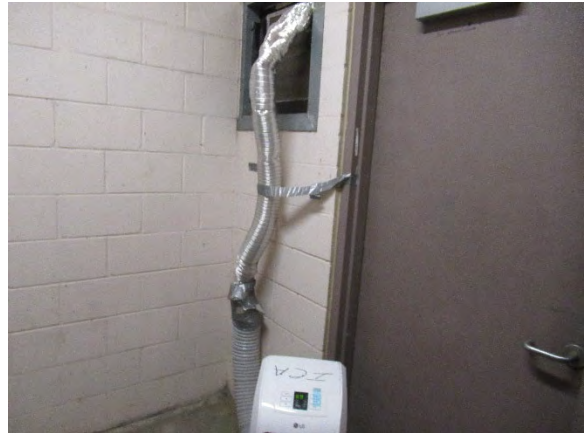
- Mainline elevator machine room has portable HVAC. (Figure 1 & Figure 2)
- Mainline computer room is missing HVAC vent covers. (Figure 3 & Figure 4)

- Recommend HVAC contractor to ensure that all vents have covers installed.
- Recommend repairs to ventilation system in elevator machine room.
- Recommend routine maintenance on overpass.
- Recommend attenuators are installed in guardrails.

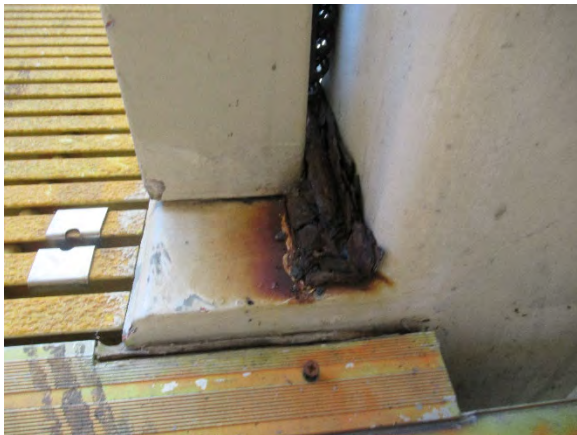
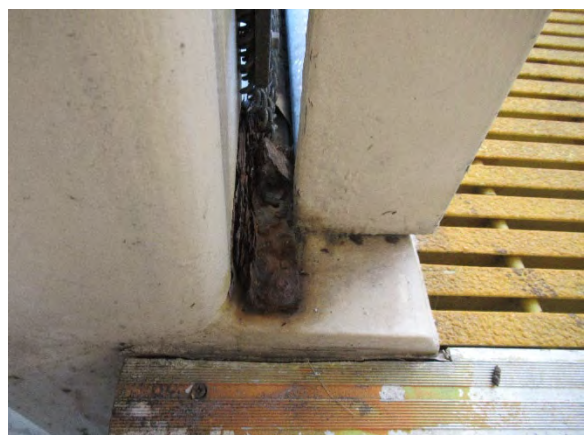
- The above referenced overpass has rusted members identified. (Figure 5 & Figure 6)

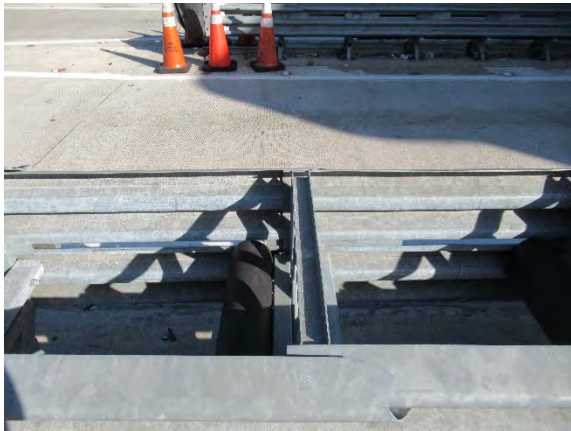
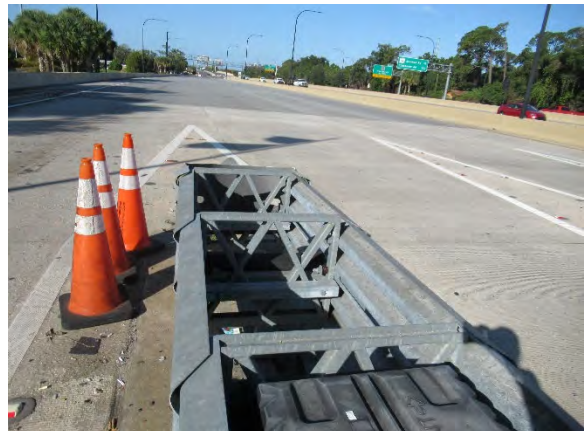
- Guardrail missing attenuators. (Figure 7 & Figure 8)

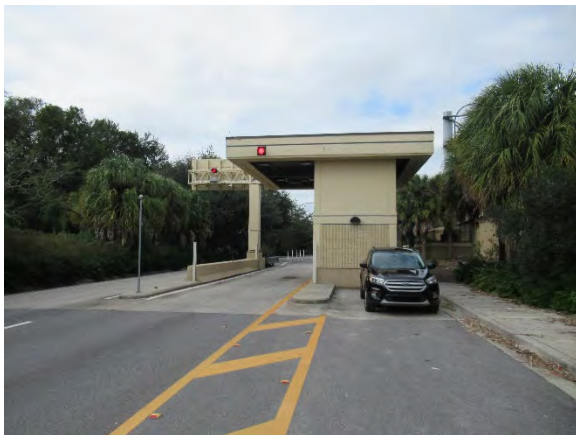
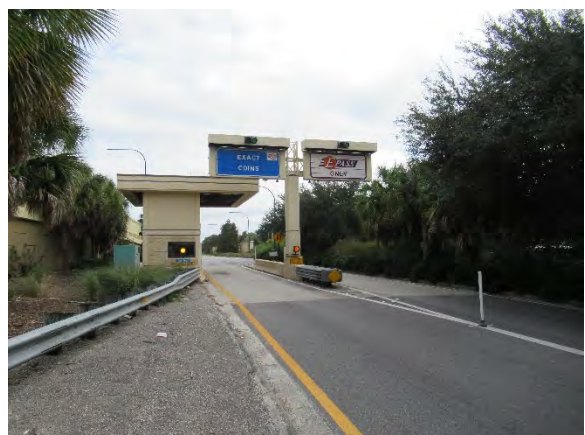
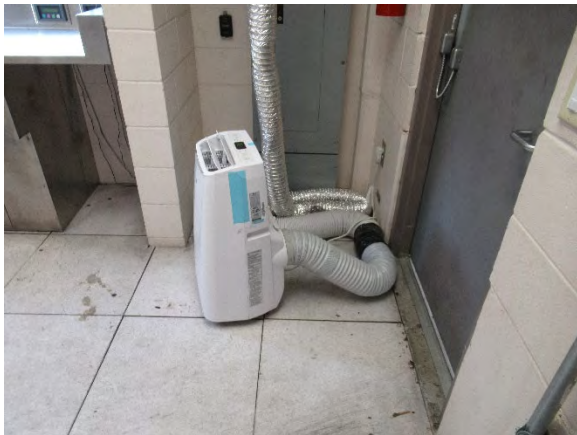
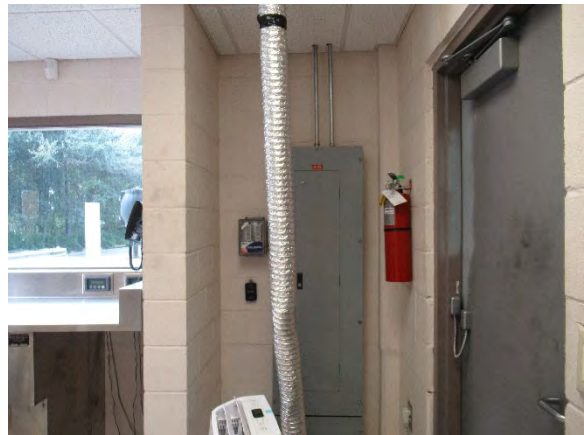
The above referenced on ramp is in good condition overall. Maintenance is recommended to test and balance HVAC. (Figure 11, Figure 12, Figure 13 & Figure 14)

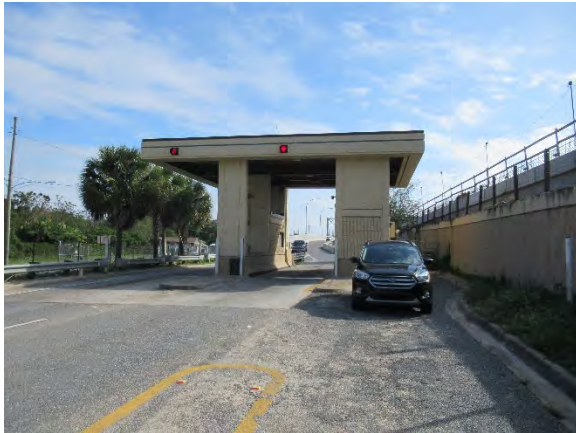
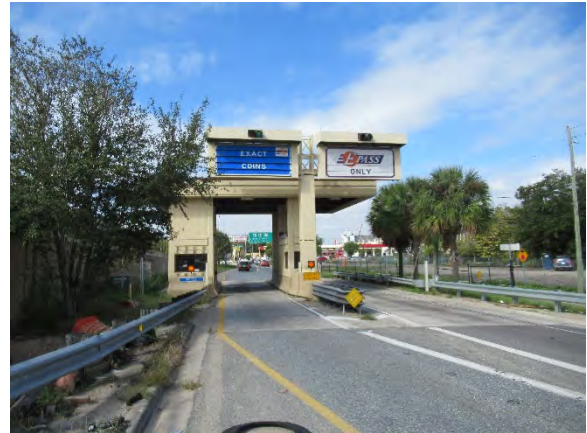
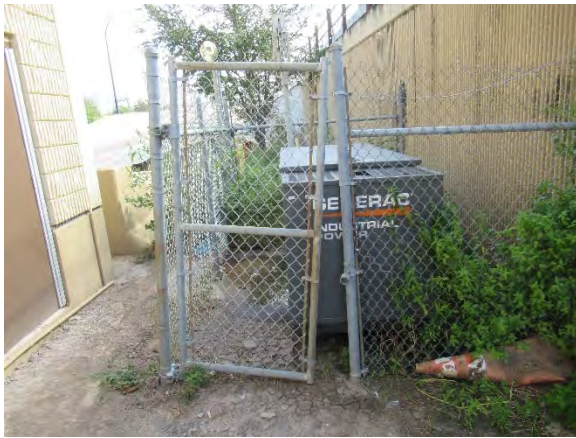
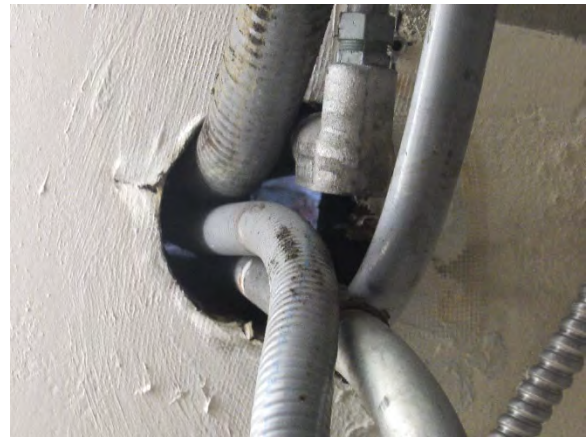
The above referenced on ramp is in good condition overall. Some maintenance to fix broken generator fence gate and fireproof ceiling penetration exposed to outside is recommended. (Figure 19, Figure 20, Figure 21 & Figure 22)

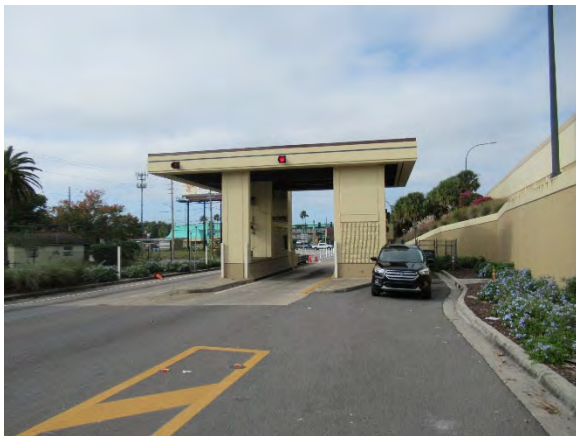
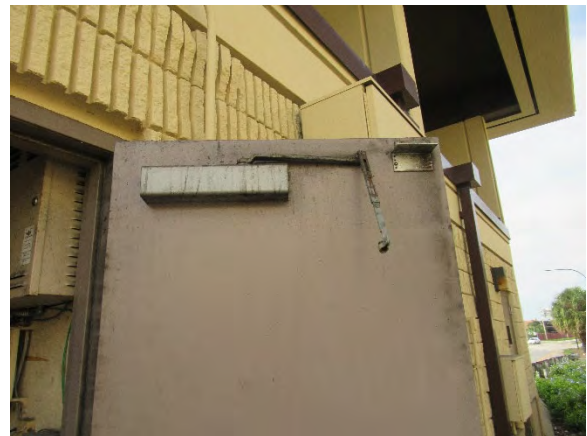
The above referenced on ramp is in good condition overall. Maintenance to repair broken door latch is recommended. (Figure 23 & Figure 24)

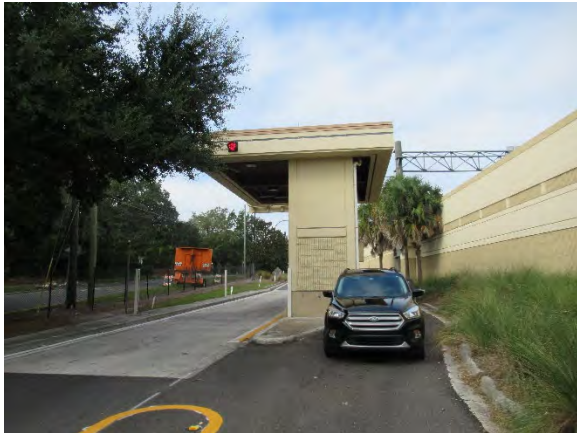
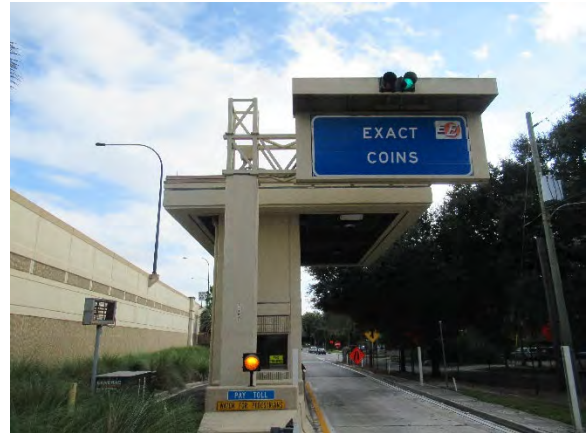
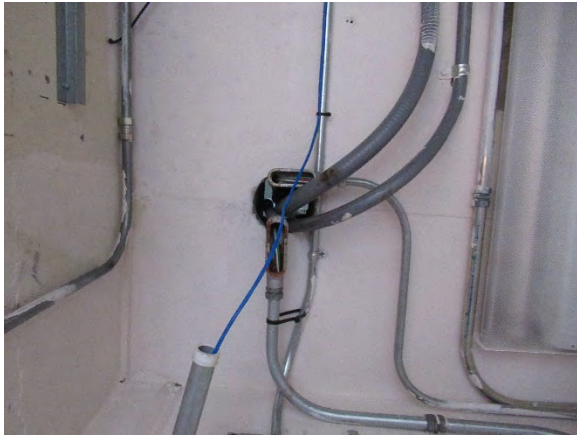
The above referenced on ramp is in good condition overall. Some maintenance to fireproof ceiling penetration exposed to outside is recommended. (Figure 25, Figure 26 & Figure 27)

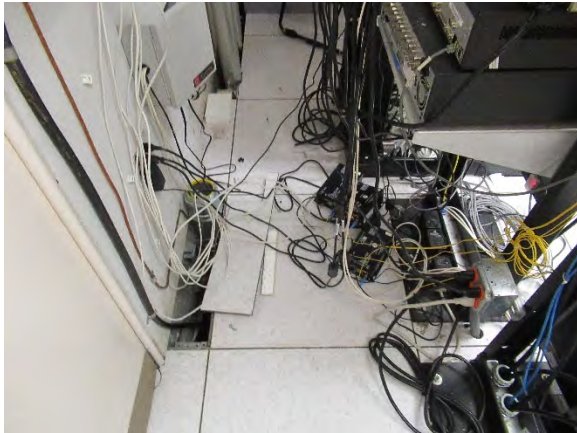
Figure 1 Conway EB Mainline

- EB Mainline computer room electrical wiring, power strips and equipment on floor under equipment rack. (Figure 1)
- EB Mainline counting room appears to have a leak above ceiling tile. (Figure 2)
- WB Mainline computer room temporary duct issue identified. (Figure 3 & Figure 4)

- Recommend maintenance on of isolated wiring for computer room.
- Recommend HVAC contractor to test and balance Mainline.
- Recommend maintenance on building façade to address separation from building.

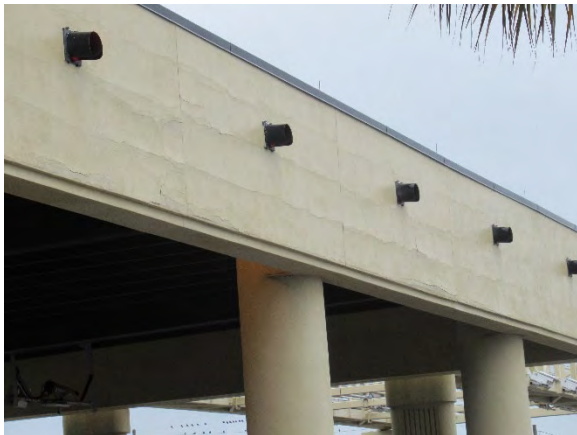
Figure 5 Conway WB Mainline

- EB Exterior is in good condition overall with no identified deficiencies
- WB Exterior façade separating from building with visible cracks. (Figure 5)

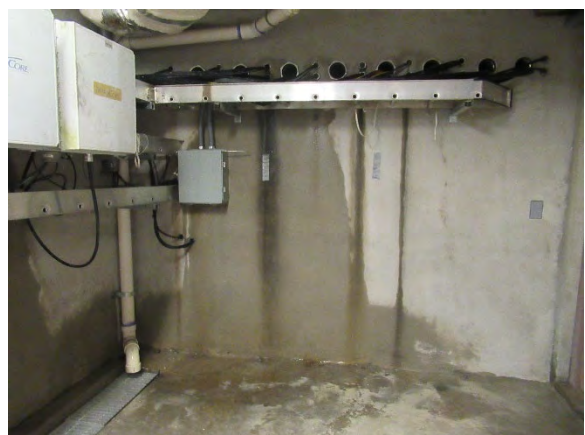
Figure 6 Conway WB Mainline

- EB Tunnel is in good condition overall with no identified deficiencies.
- WB Tunnel is in good condition overall with no identified deficiencies. During a storm, the tunnel has large leaks inside tunnel. (Figure 6)

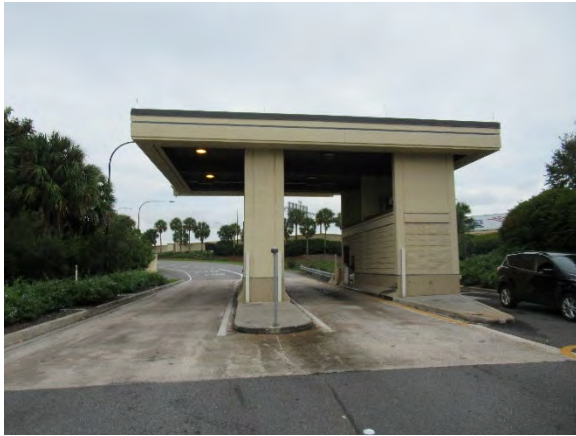
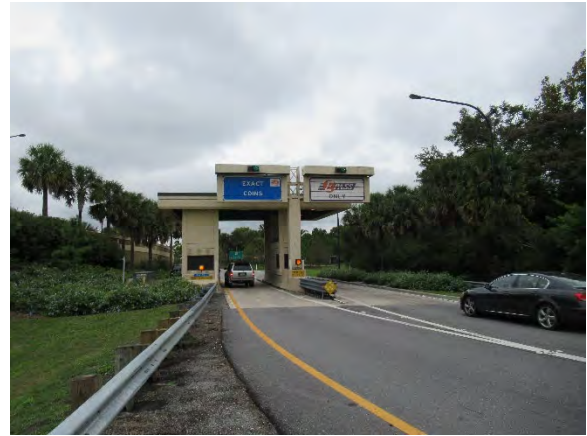
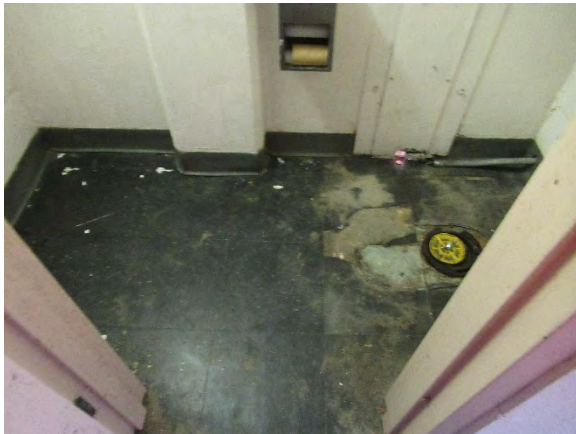
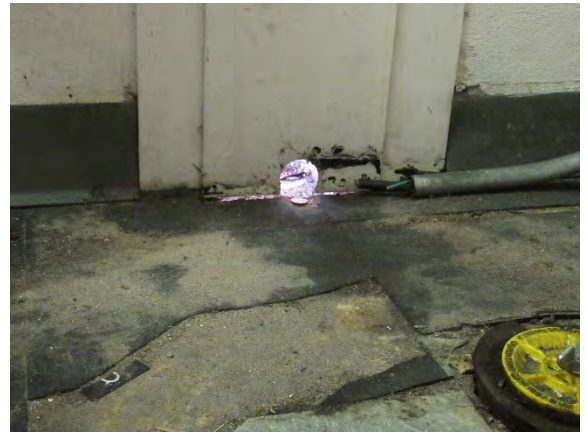
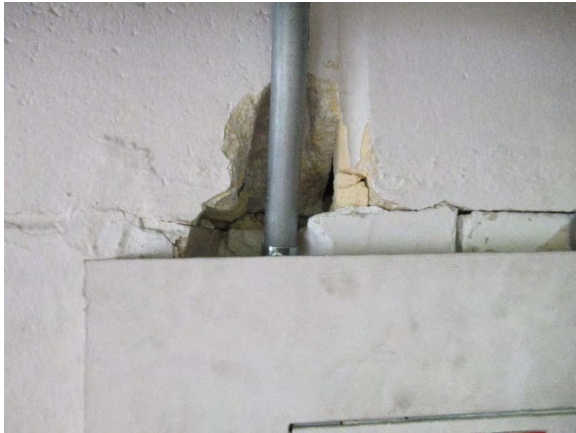
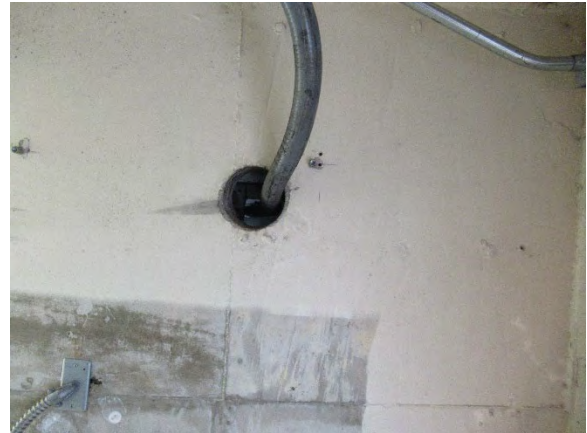
The above referenced on ramp is in good condition overall. Some maintenance to repair exposed exterior wall and fireproof ceiling penetration exposed to outside is recommended.  
(Figure 21, Figure 22, Figure 23, Figure 24, Figure 25 & Figure 26)

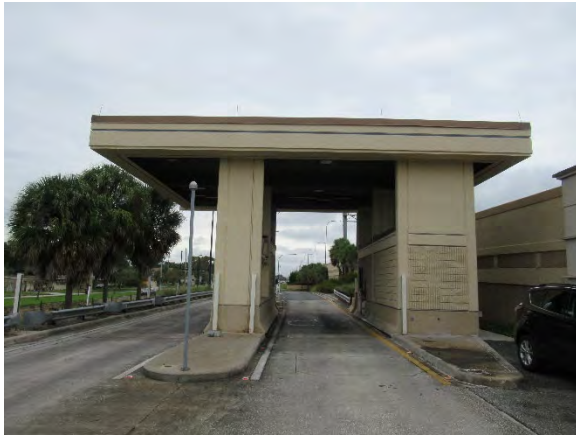
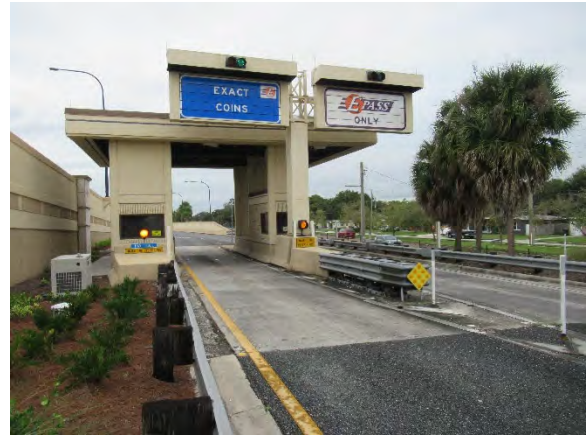
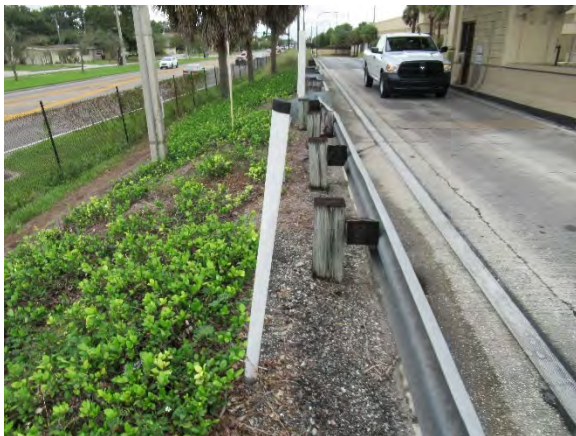
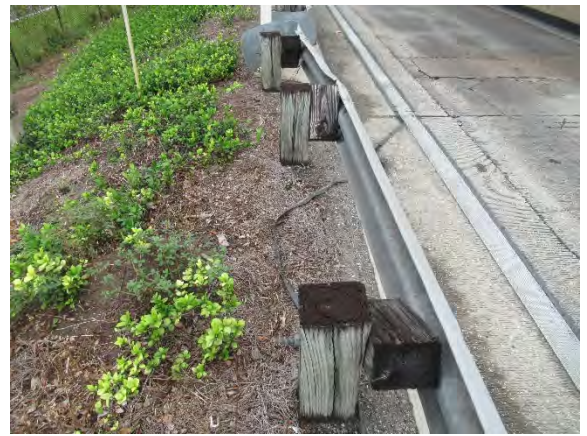
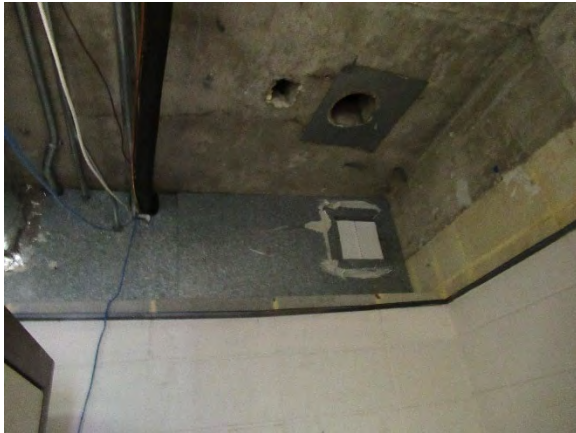
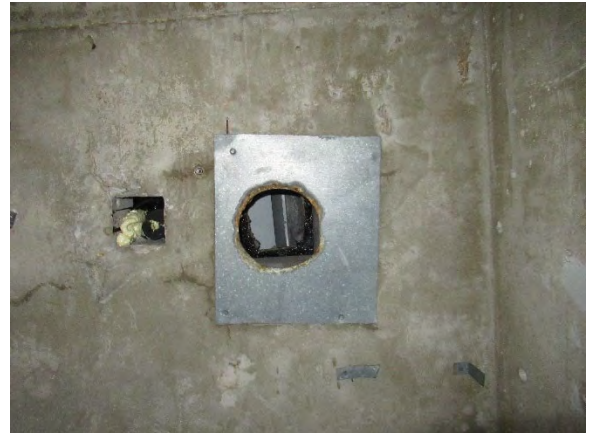
The above referenced on ramp is in good condition overall. Some maintenance to repair guardrail and fireproof ceiling penetration exposed to outside is recommended.  
(Figure 27, Figure 28, Figure 29, Figure 30, Figure 31 & Figure 32)

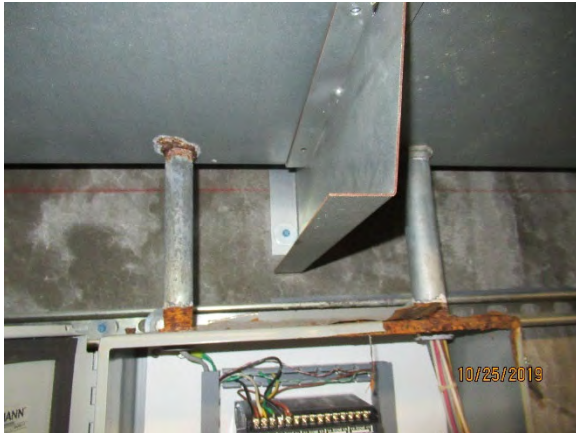
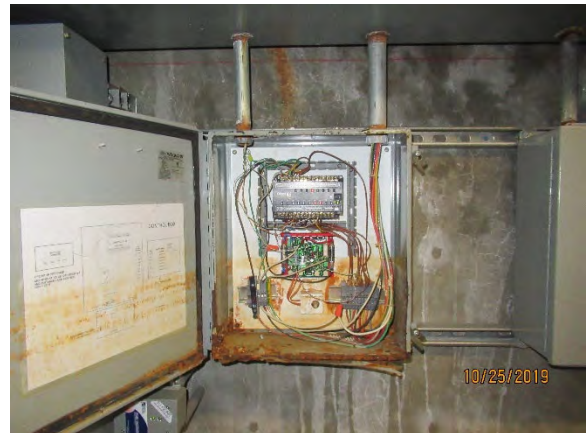
- Mainline tunnel control panel NEMA enclosures are rusted out. (Figure 3 & Figure 4)

- Recommend electrical contractor replace the rusted enclosure on the tunnel control panels.
- Recommend general maintenance to address exposed pipes and equipment located behind mainline building.

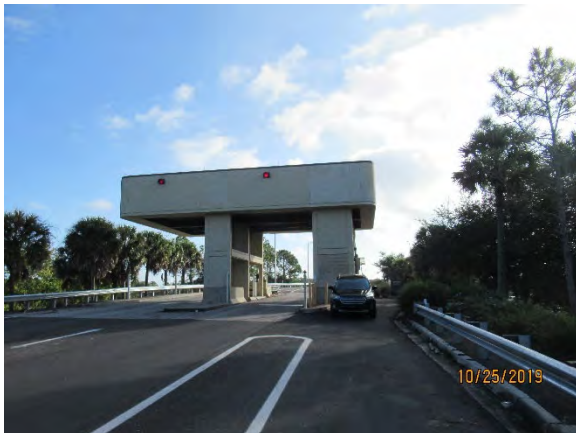
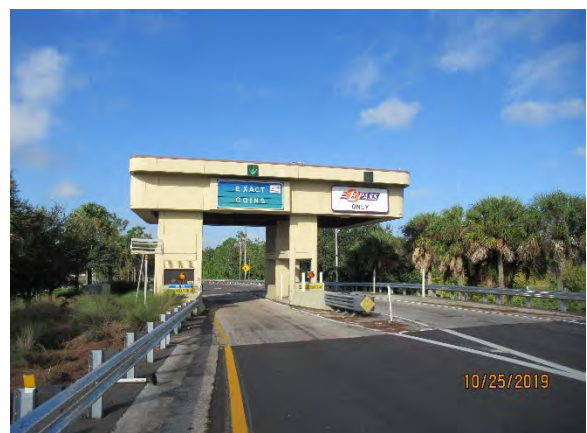
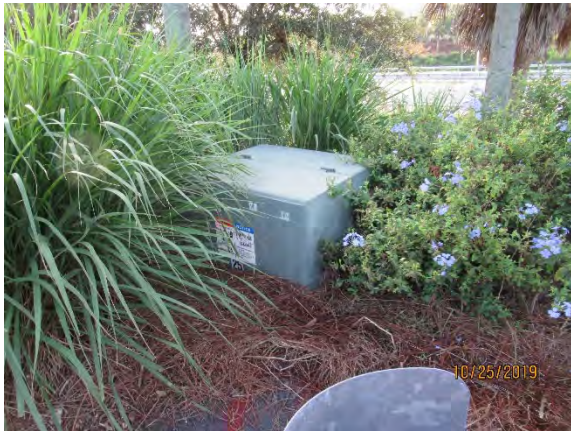
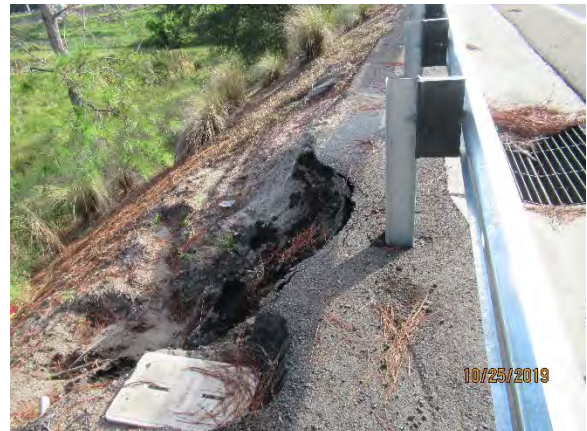
The above referenced on ramp is in good condition overall. Some maintenance is recommended on the identified erosion area and general landscaping maintenance is recommended. (Figure 5, Figure 6, Figure 7 & Figure 8)

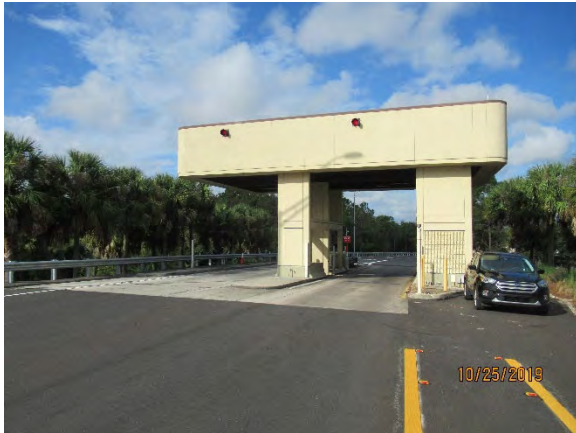
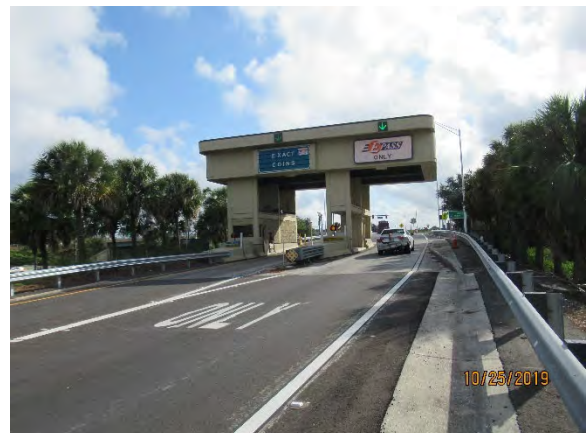
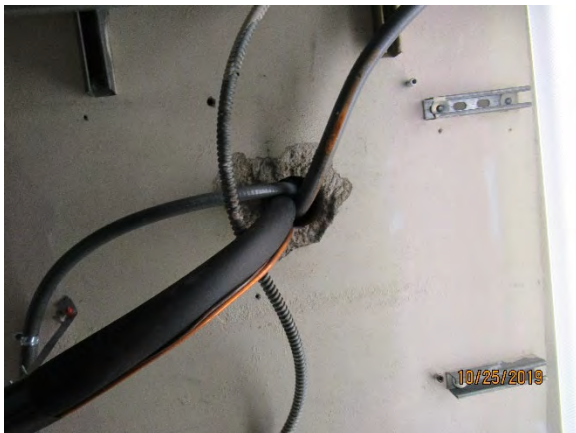
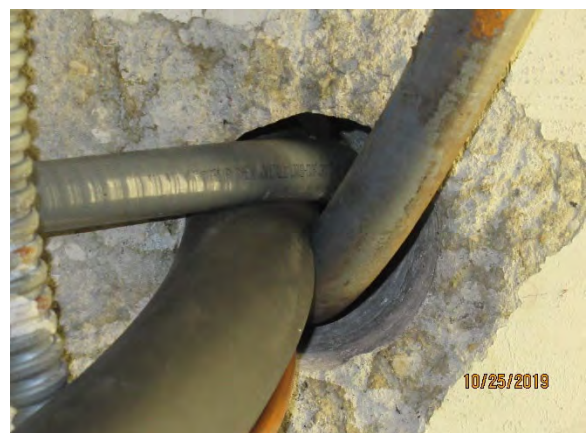
The above referenced on ramp is in good condition overall. Some maintenance to fireproof ceiling penetration is recommended. (Figure 9, Figure 10, Figure 11 & Figure 12)

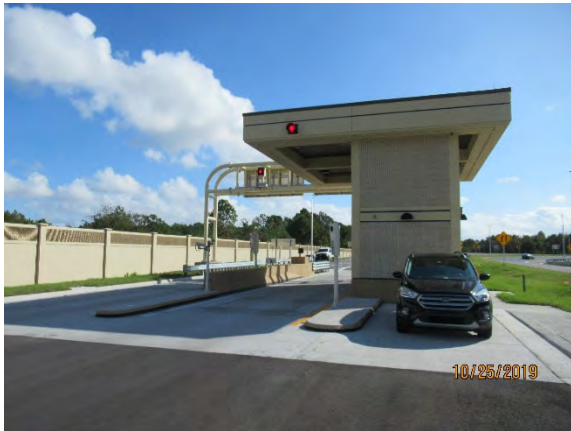
Figure 13 Rouse Road Ramp Off

The above referenced on ramp is in good condition overall. (Figure 13 & Figure 14)

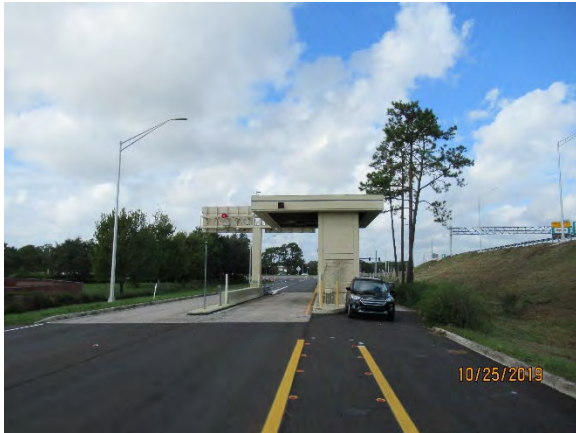
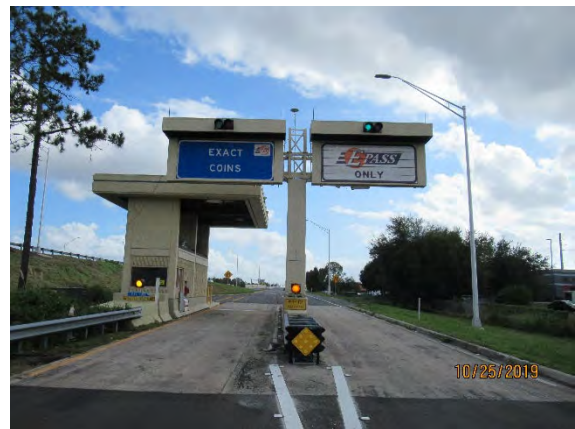
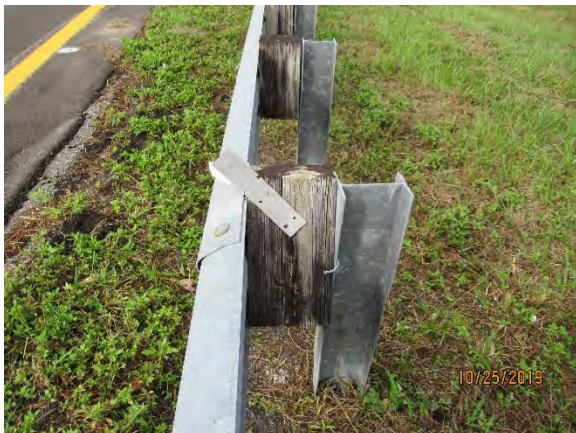
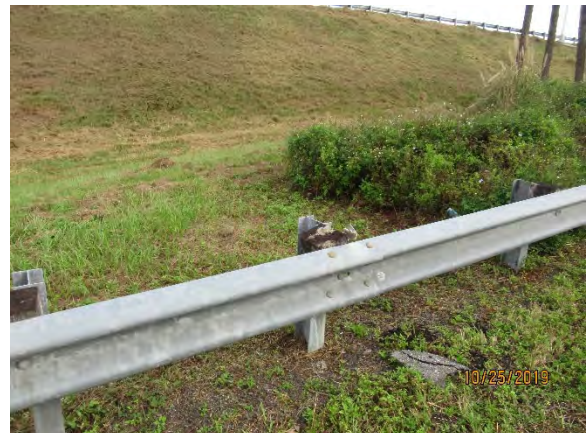
The above referenced on ramp is in good condition overall. Some maintenance to repair the guardrail is recommended. (Figure 15, Figure 16, Figure 17 & Figure 18)

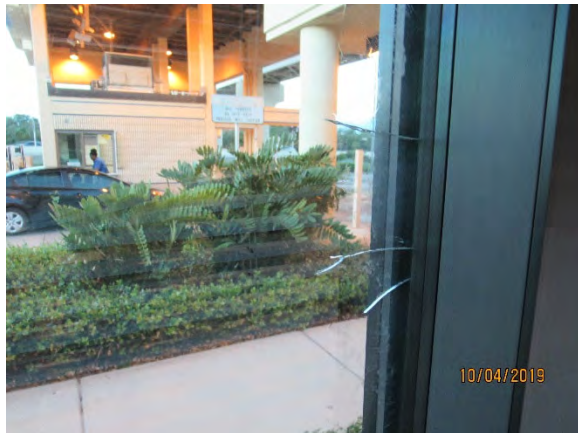
Figure 1 Coral Hills Mainline

- Mainline has cracks in the glass windows in the manager's office and break room. (Figure 1)
- Mainline has potential leak above ceiling tile in computer room. (Figure 2)
- Mainline has potential leak above ceiling tile in computer room on EB facility location. (Figure 3 & Figure 4)

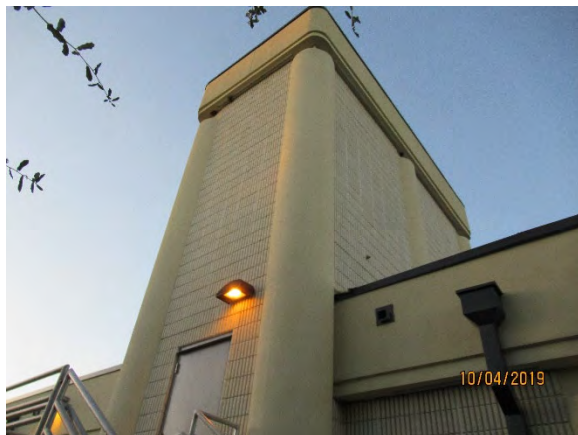
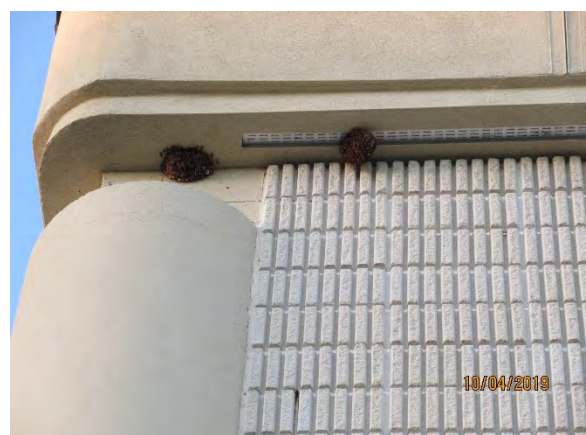
- Exterior building has a number of wasp nests on building façade. (Figure 5 & Figure 6)
- Exterior light fixture is in need of repair (Figure 7 & Figure 8)

- Recommend maintenance to locate any potential leaks.
- Recommend maintenance to repair exterior light fixture.
- Recommend routine pest control to remove wasp nests on building exterior.

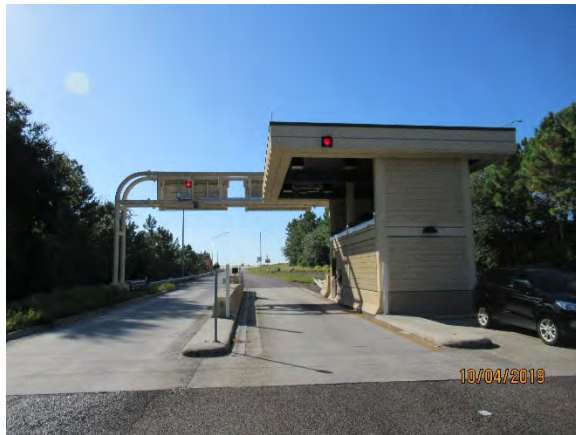
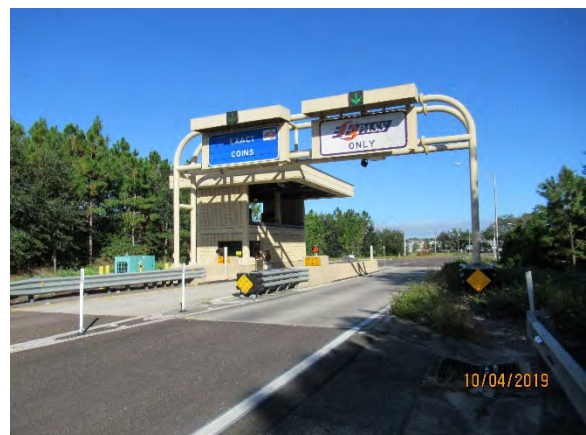
The above referenced on ramp is in good condition overall. (Figure 9 & Figure 10)

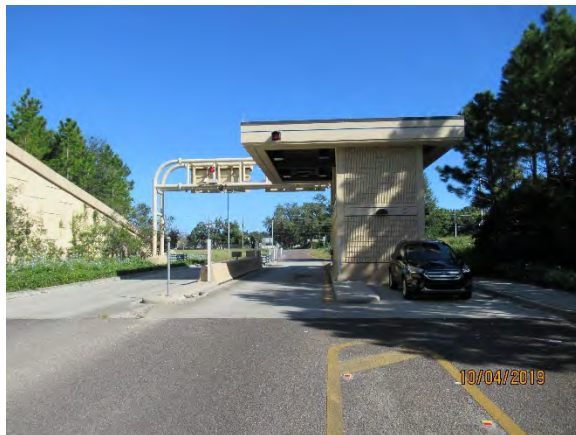
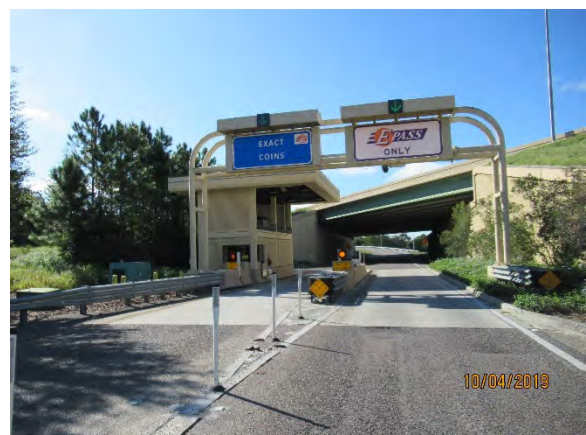
The above referenced on ramp is in good condition overall. (Figure 11 & Figure 12)

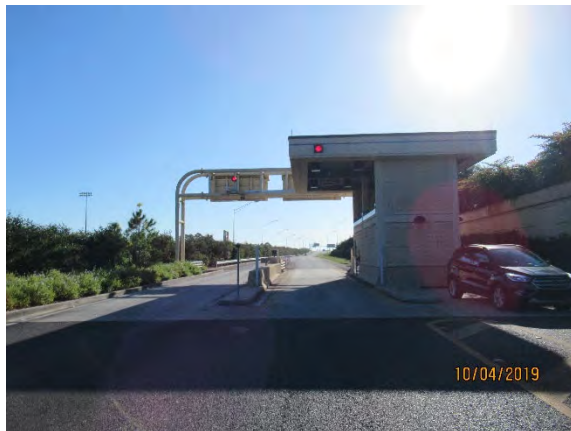
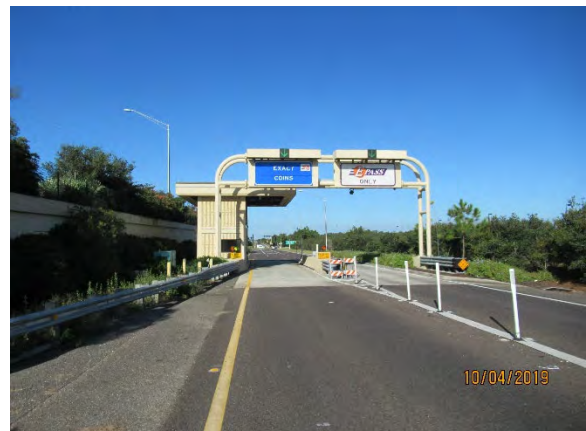
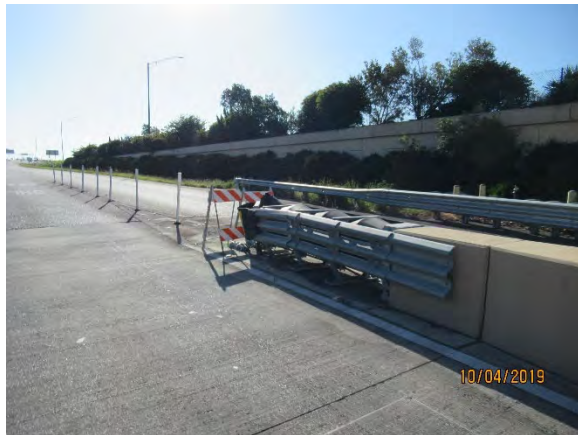
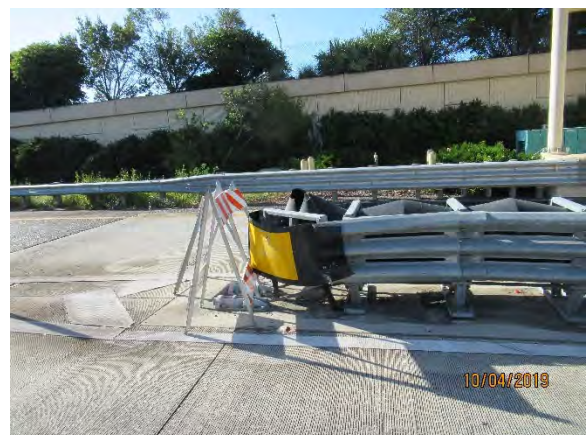
The above referenced on ramp is in good condition overall. Maintenance on guardrail safety is recommended. (Figure 13, Figure 14, Figure 15 & Figure 16)

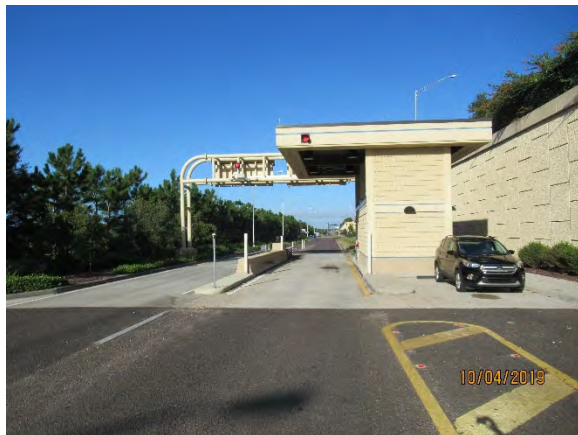
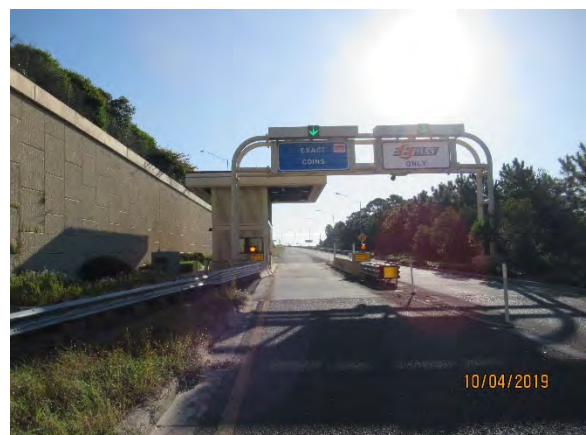
The above referenced on ramp is in good condition overall. (Figure 17 & Figure 18)

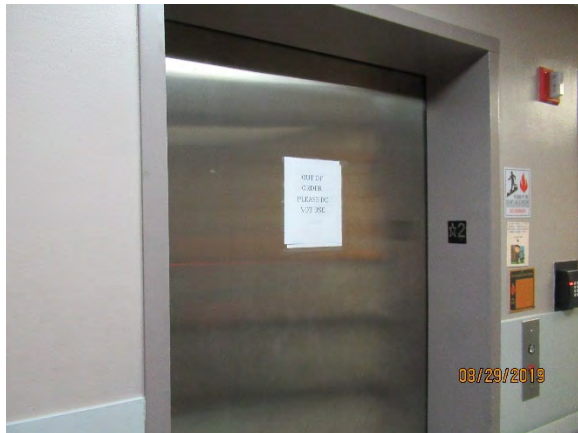
Figure 1 John Young Pkwy Mainline

- Main Plaza elevator is out of service. (Figure 1)
- Main Plaza stairwell has potential leak above ceiling tile. (Figure 2)

- Recommend elevator contractor repair out of service elevator.
- Recommend examination of roof to locate any potential leaks.
- Recommend general maintenance to repair exterior erosion areas near utility poles.

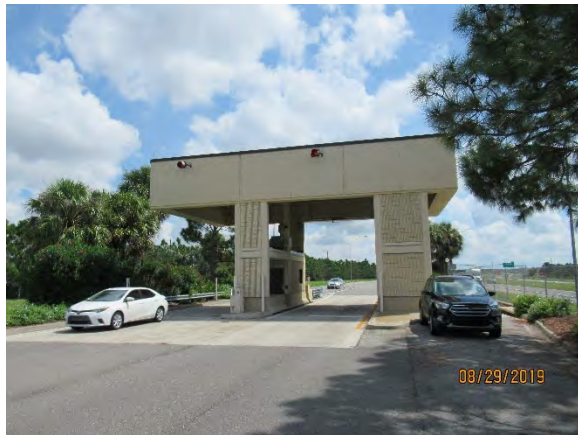
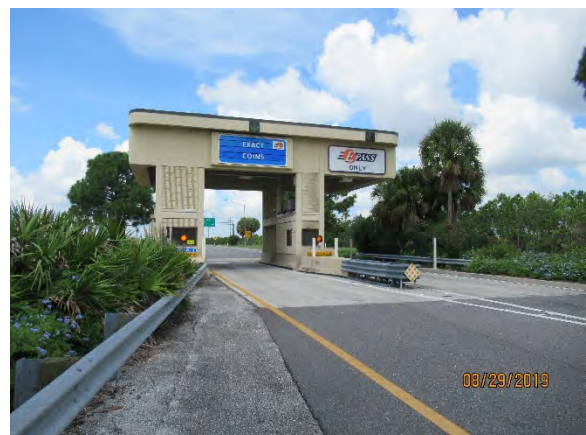
The above referenced on ramp is in good condition overall. (Figure 9 & Figure 10)

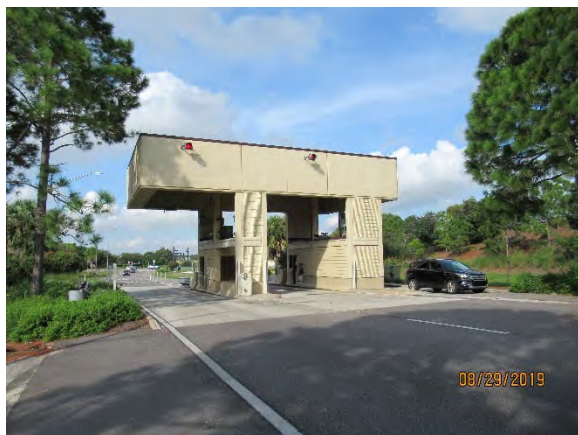
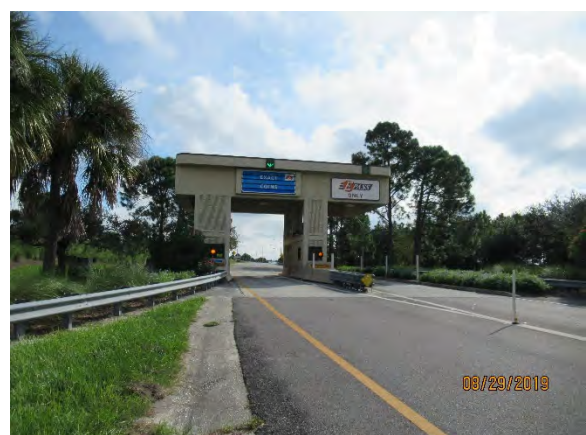
The above referenced on ramp is in good condition overall. (Figure 11 & Figure 12)

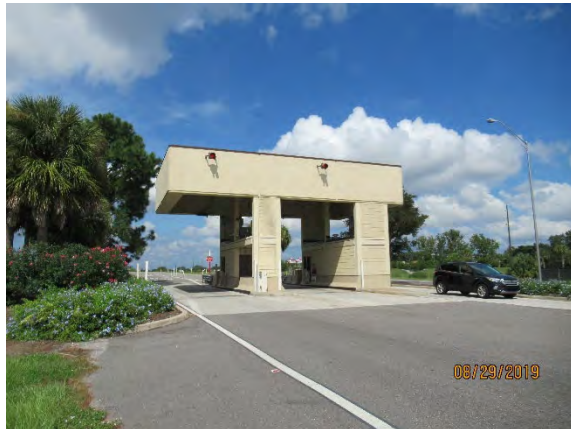
Figure 13 US-441 Ramp Off

The above referenced on ramp is in good condition overall. General maintenance is recommended to fasten electrical box and unistrut on the camera equipment securely to the building. Maintenance is recommended to check above ceiling tiles for potential leaks. (Figure 13, Figure 14, Figure 15 & Figure 16)

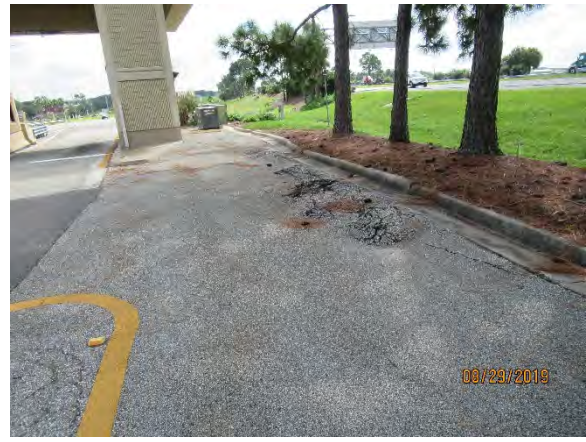
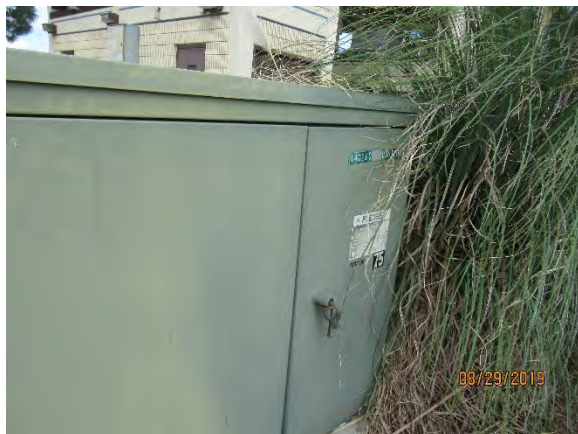
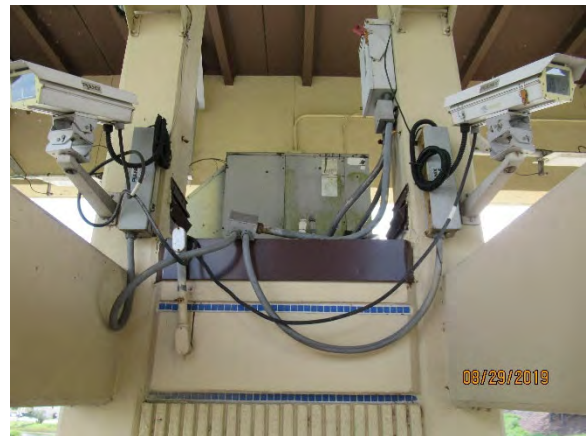
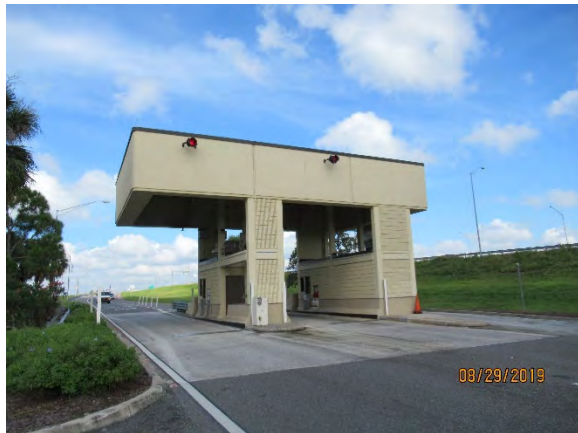
The above referenced on ramp is in good condition overall. Some maintenance of isolated wiring and uneven pavement is recommended. Some general landscaping is also recommended. (Figure 21, Figure 22, Figure 23 & Figure 24)

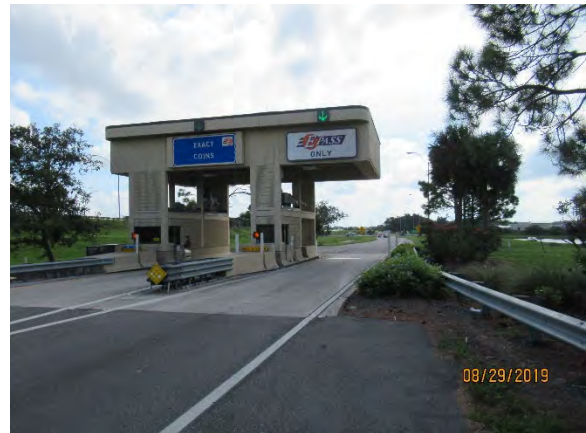
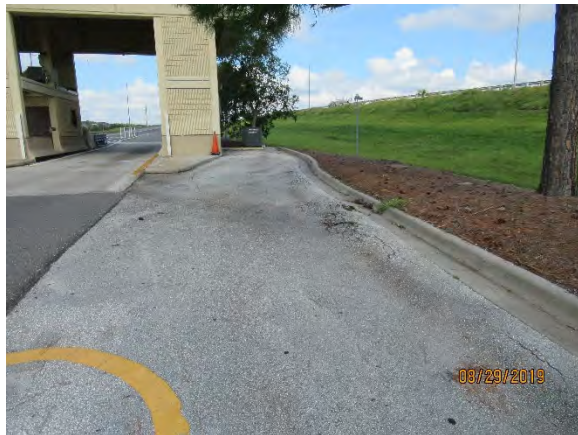
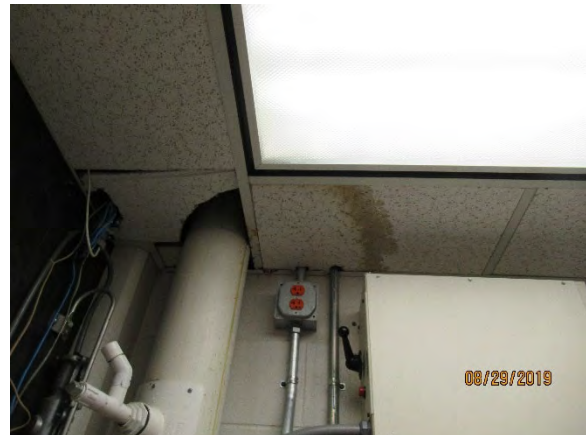
The above referenced on ramp is in good condition overall. Some maintenance on potential leaks above ceiling and uneven pavement is recommended. (Figure 25, Figure 26, Figure 27 & Figure 28)

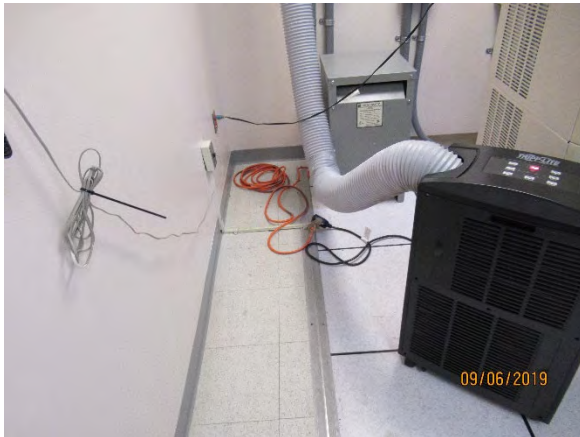
Figure 1 Boggy Creek Mainline

- Portable HVAC equipment in computer room and missing vent cover. (Figure 1 & Figure 2)
- Ceiling tiles showing potential roof leaks (Figure 3 & Figure 4)

- Recommend test and balance on HVAC system.
- Recommend examination of roof to locate any potential leaks.
- Recommend general maintenance in tunnel to repair noted deficiencies.
- Recommend general maintenance to repair exterior erosion areas near utility poles.

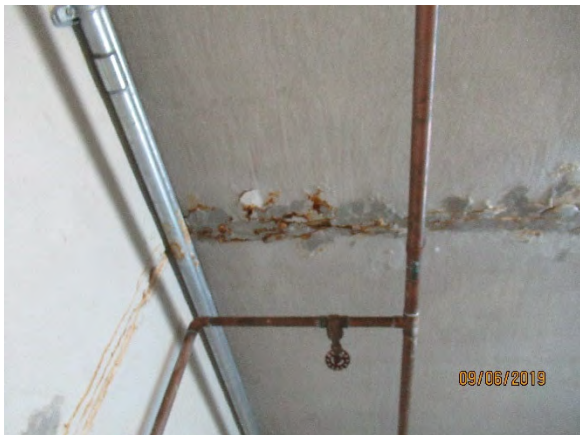
Figure 5 Boggy Creek Mainline Tunnel

- Mainline tunnel seams are showing deterioration. (Figure 5 & Figure 6)

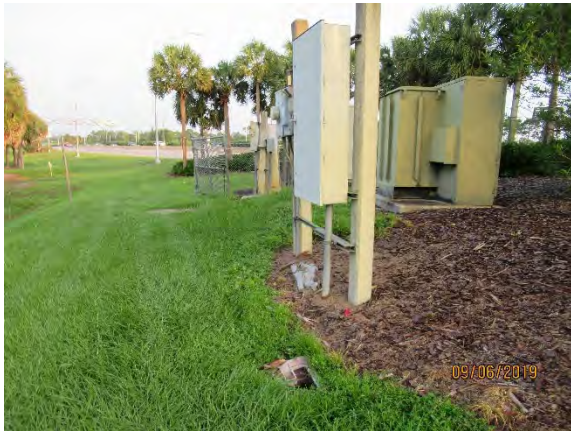
*Figure 7 Boggy Creek Mainline Exterior*

- Exterior handhole cover is missing behind main building. (Figure 7 & Figure 8)
- Exterior erosion surrounding utility poles located adjacent to toll lanes.  
(Figure 9, Figure 10, Figure 11 & Figure 12)
