# 2019

# Annual Inspection Report

Mr. Glenn Pressimone, P.E.  
Chief of Infrastructure  
Central Florida Expressway Authority  
4974 ORL Tower Road  
Orlando, Florida 32807

Re: 2019 Annual Inspection Report

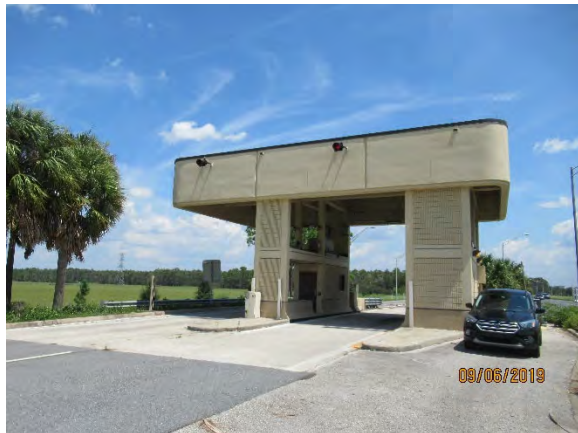
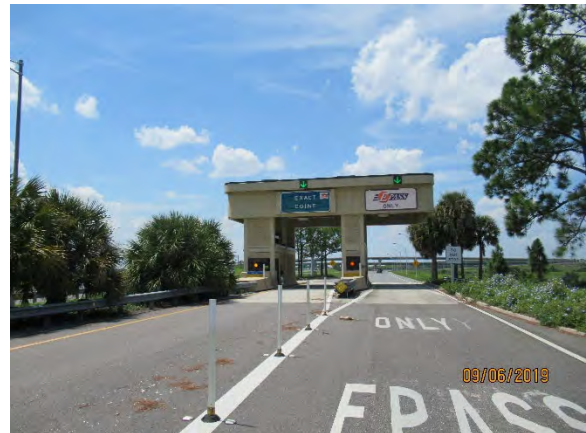
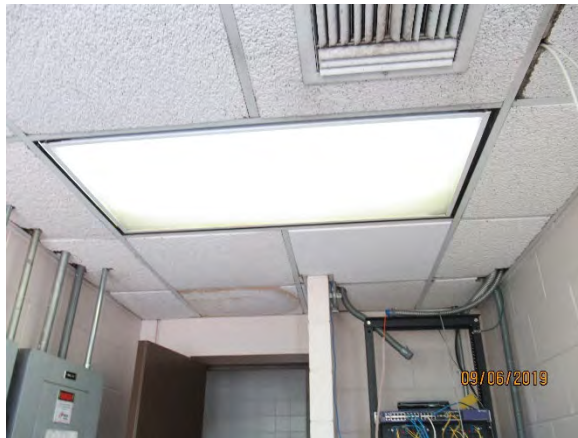
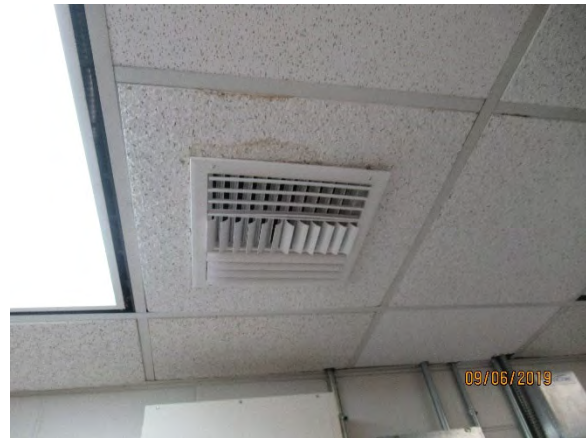
The above referenced on ramp is in good condition overall. Maintenance is recommended on some ceiling tiles and potential leaks need to be addressed.  
(Figure 13, Figure 14, Figure 15 & Figure 16)

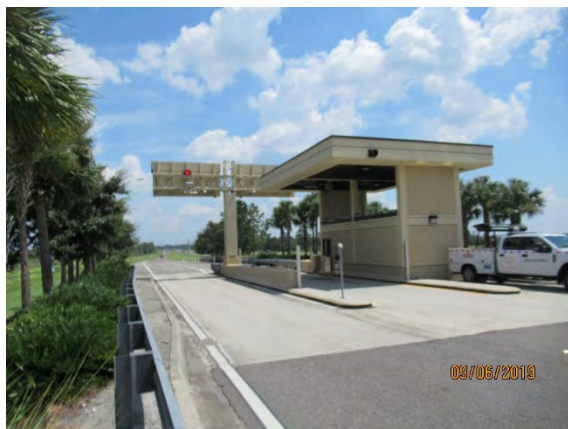
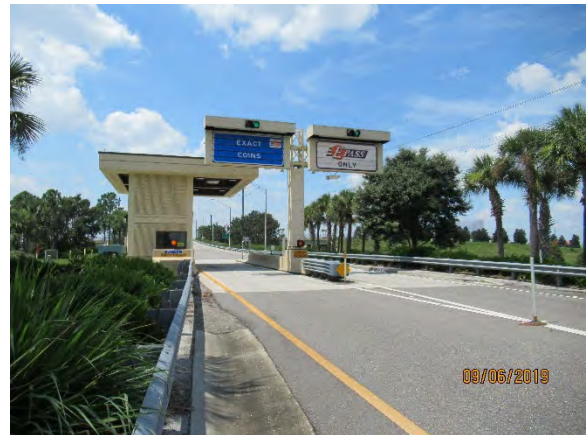
The above referenced on ramp is in good condition overall. General maintenance on the guardrail is recommended. (Figure 21, Figure 22, Figure 23 & Figure 24)

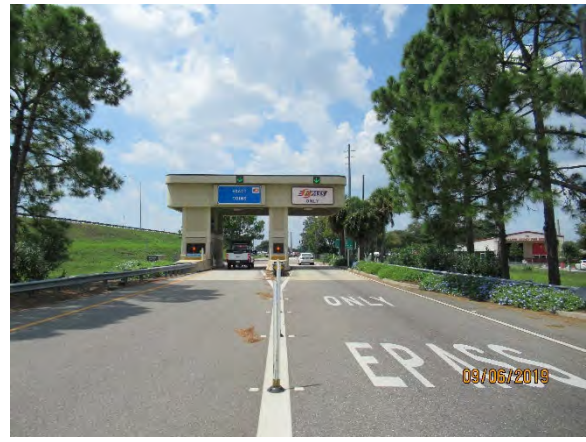
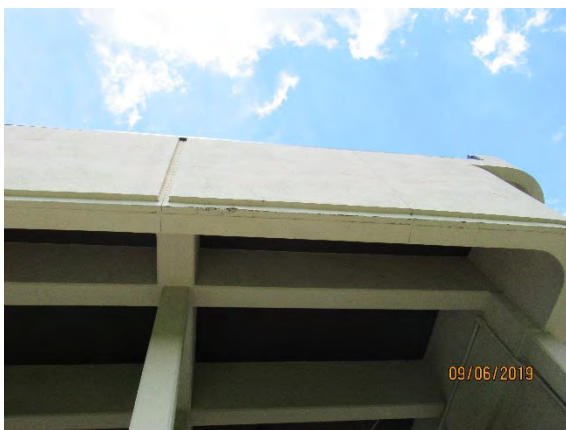
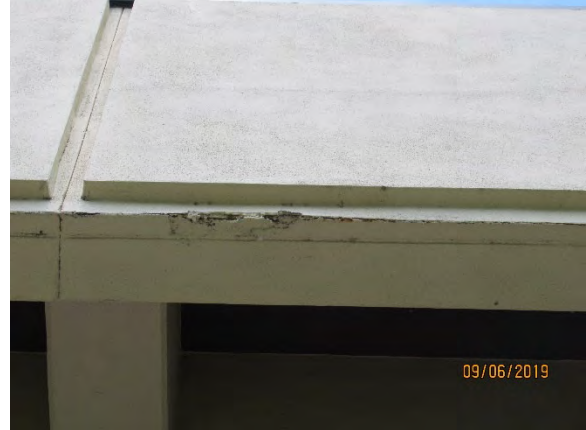
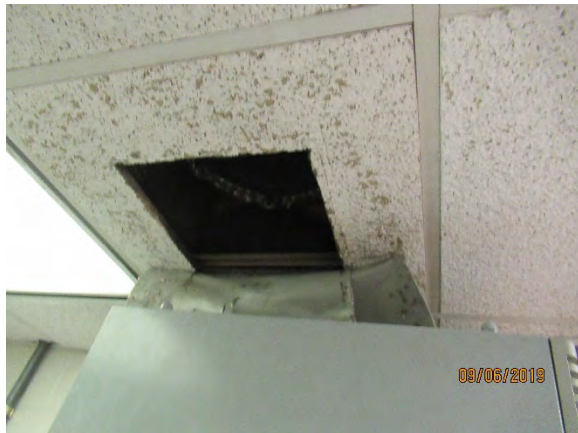
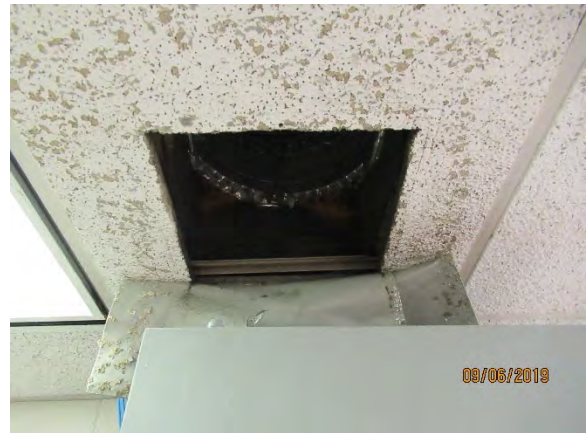
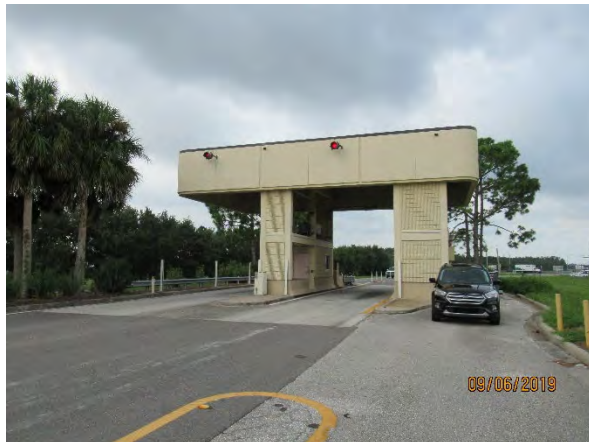
Figure 27 Narcoossee Ramp Off

The above referenced on ramp is in good condition overall. Maintenance on the building façade and vent is recommended. (Figure 27, Figure 28, Figure 29, Figure 30, Figure 31 & Figure 32)

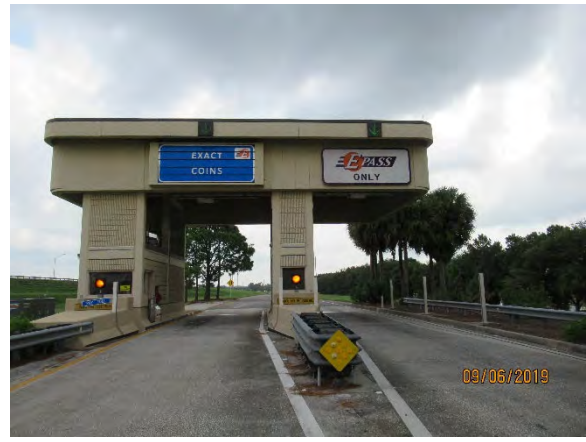
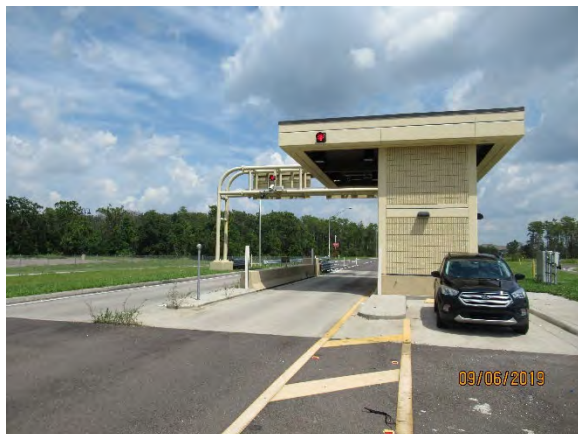
Figure 33 Narcoossee Ramp On

The above referenced on ramp is in good condition overall. (Figure 33 & Figure 34)

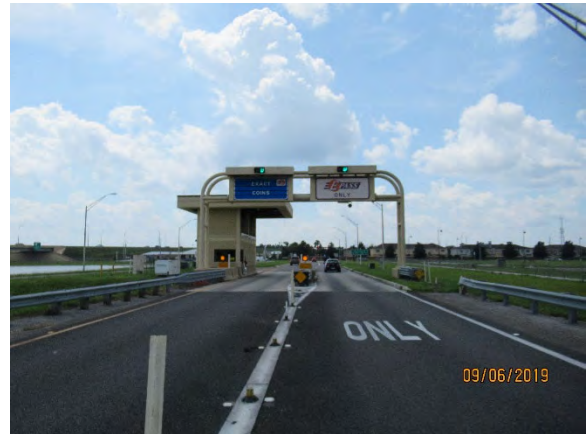
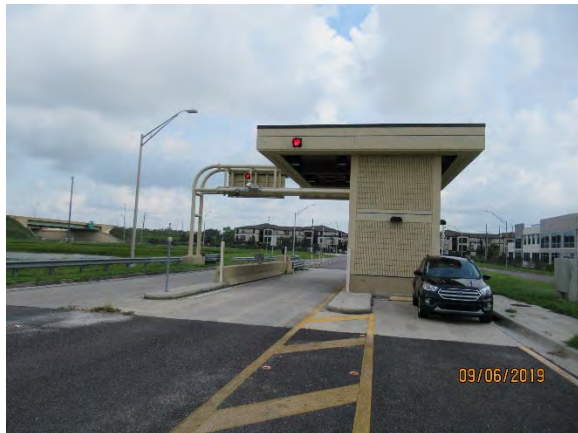
Figure 35 Moss Park Ramp Off

The above referenced on ramp is in good condition overall. (Figure 35 & Figure 36)

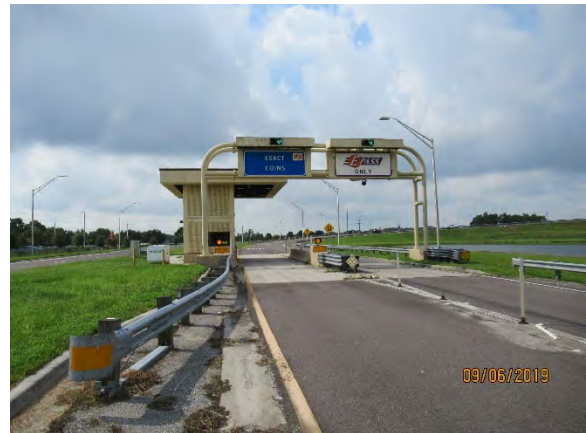
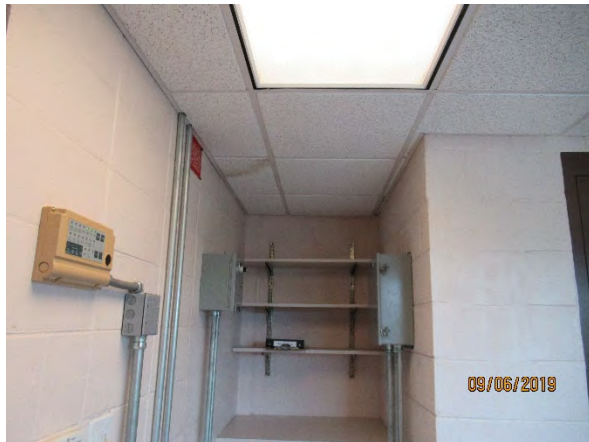
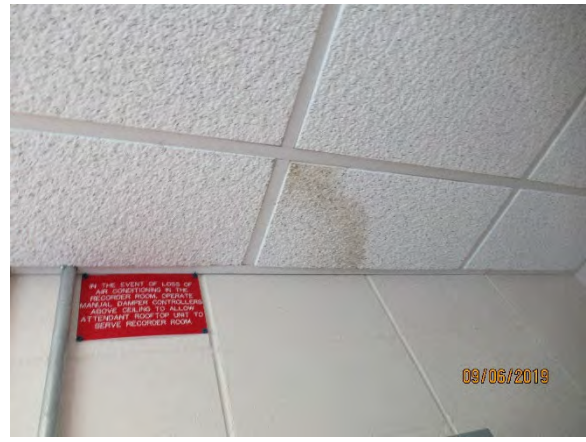
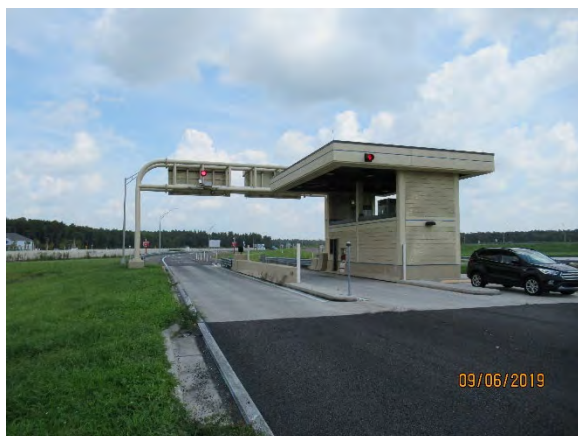
Figure 37 Moss Park Ramp On

The above referenced on ramp is in good condition overall. Some maintenance on potential leaks above ceiling tiles is recommended. (Figure 37, Figure 38, Figure 39 & Figure 40)

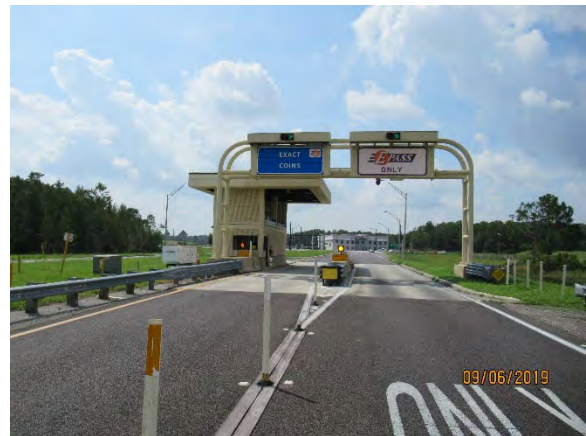
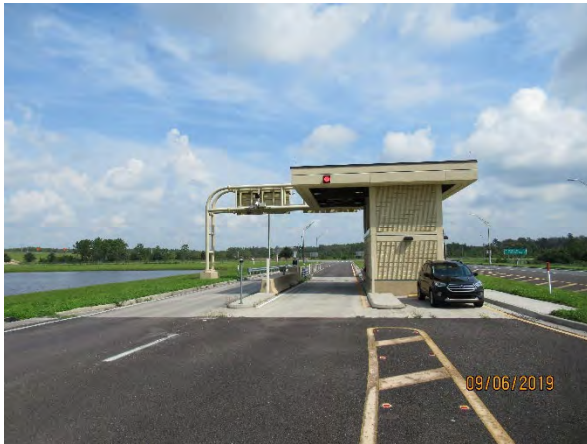
Figure 41 Innovation Ramp Off

The above referenced on ramp is in good condition overall. (Figure 41 & Figure 42)

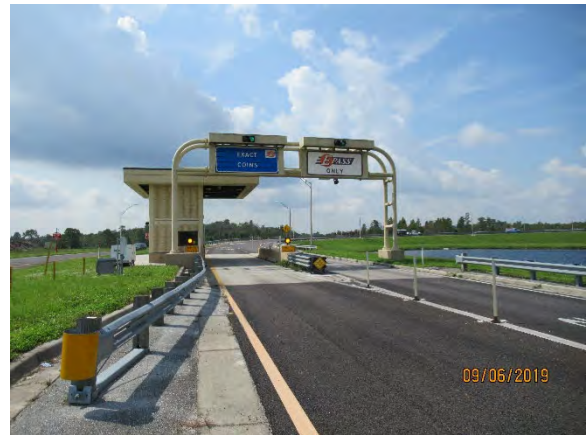
*Figure 43 Innovation Ramp On*

The above referenced on ramp is in good condition overall. (Figure 43 & Figure 44)

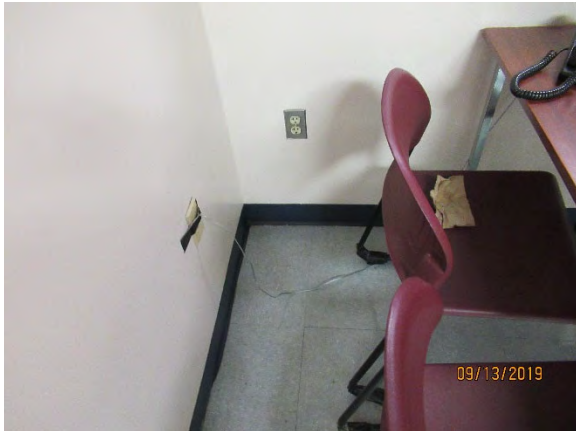
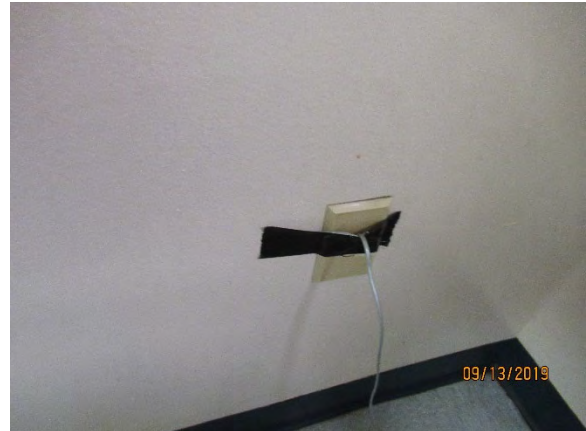
Figure 1 Curry Ford Mainline

- Main Plaza break room telephone line is connected with duct tape. (Figure 1 & Figure 2)
- Main Plaza locker area and hallway show potential leaks above ceiling tile. (Figure 3 & Figure 4)

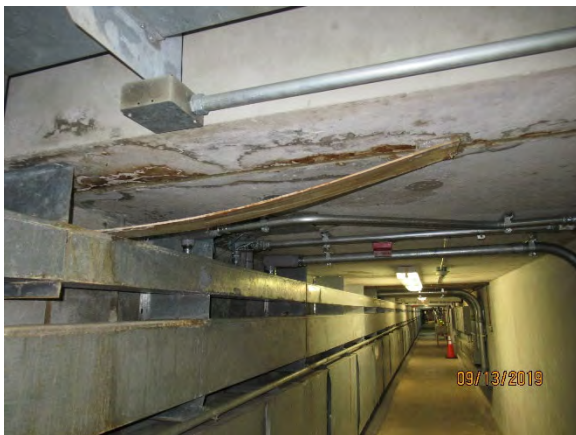
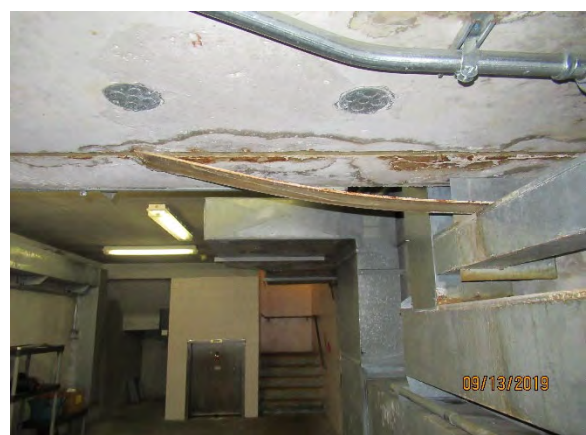
Figure 5 Curry Ford Mainline Tunnel

- Main Plaza tunnel ceiling seam/wood separation from ceiling. (Figure 5 & Figure 6)
- Main Plaza tunnel has water leaking through the tunnel. (Figure 7 & Figure 8)

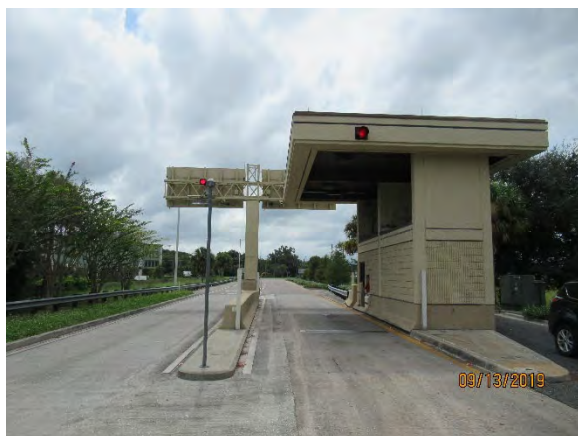
Figure 23 Curry Ford Ramp On

The above referenced on ramp is in good condition overall. (Figure 23 & Figure 24)

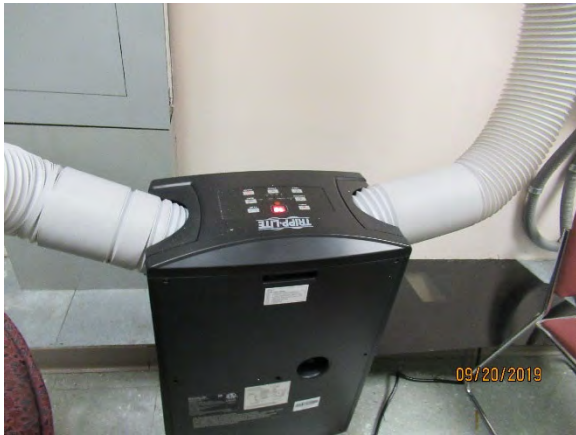
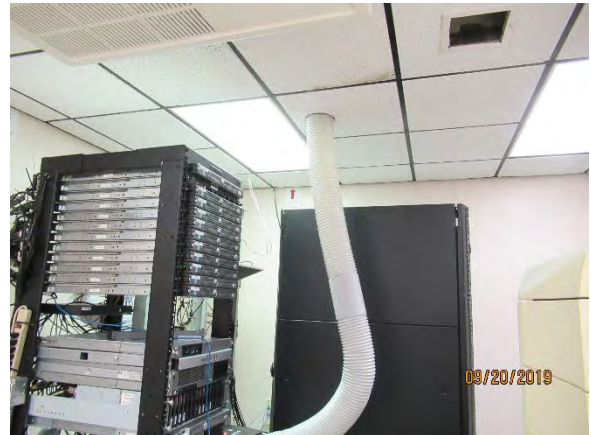
- Mainline computer room has portable HVAC equipment. (Figure 1 & Figure 2)
- Mainline restroom has opening in wall behind fixture. (Figure 3 & Figure 4)
- Mainline computer room has potential leak above ceiling tile. (Figure 5 & Figure 6)

- Recommend test and balance of HVAC system.
- Recommend examination of roof to locate any potential leaks.
- Recommend general maintenance in restroom to address noted deficiencies.

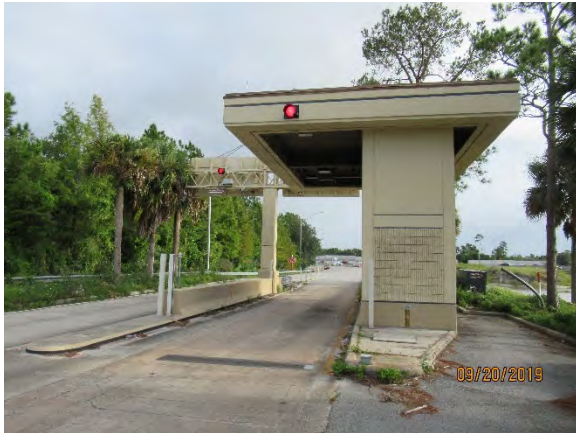
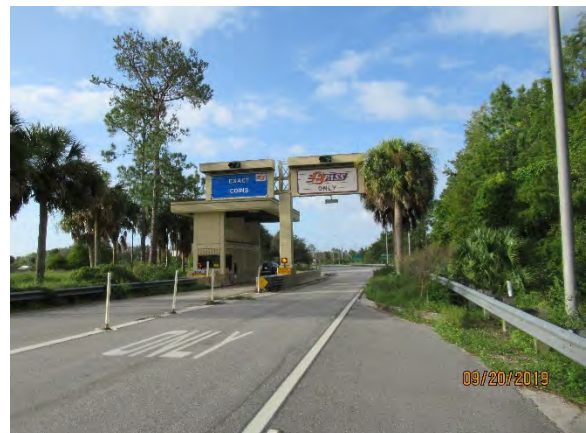
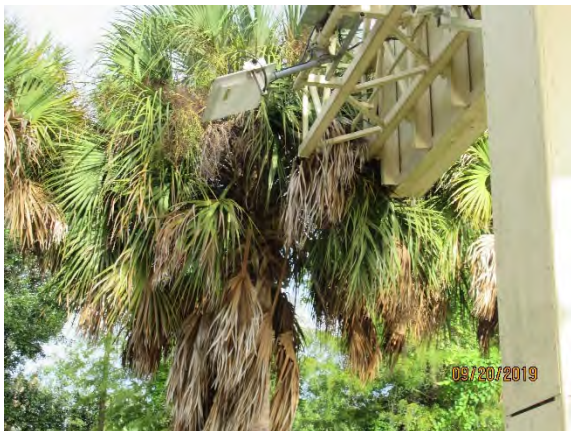
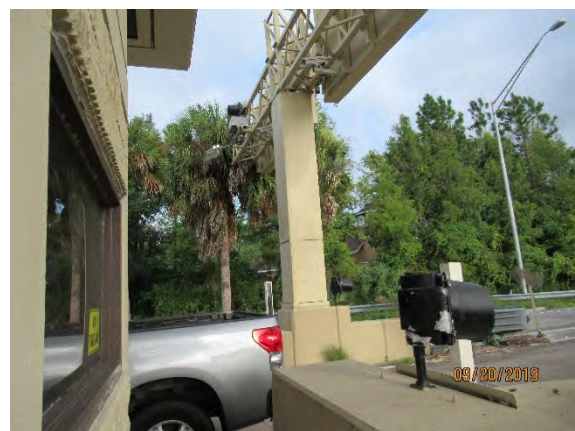
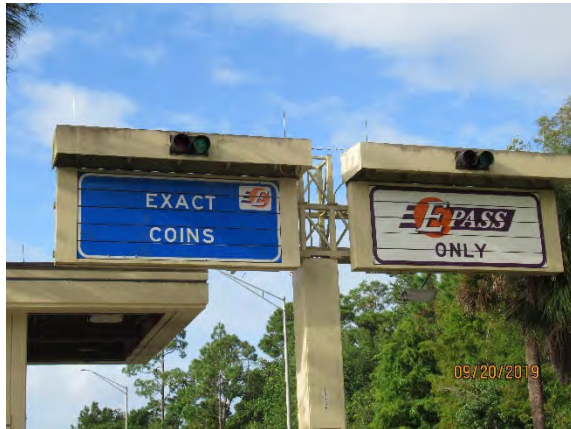
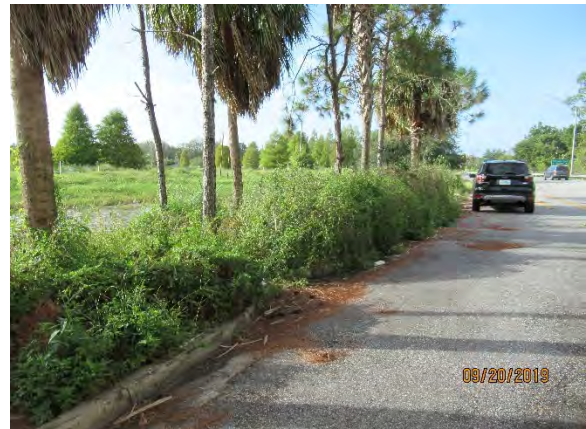
The above referenced on ramp is in good condition overall. General landscape maintenance is recommended. (Figure 15, Figure 16, Figure 17, Figure 18, Figure 19 & Figure 20)

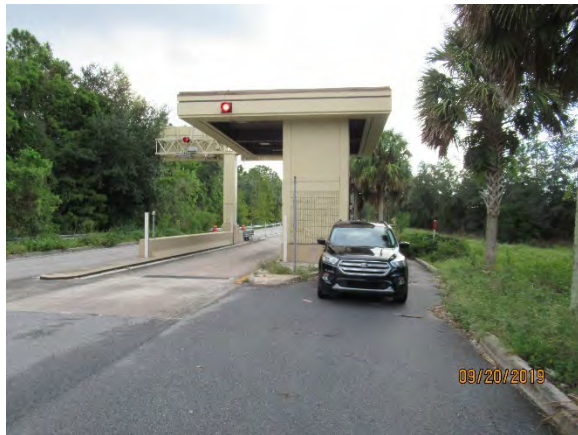
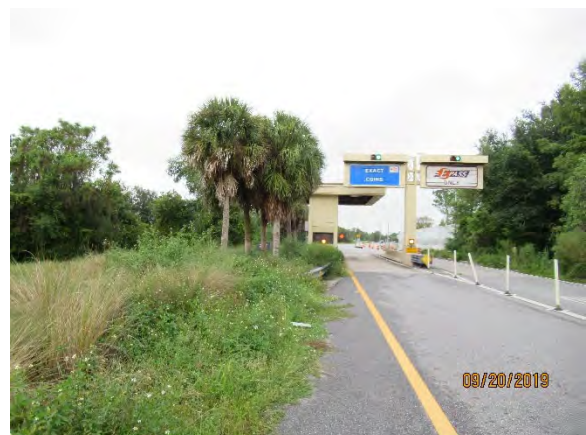
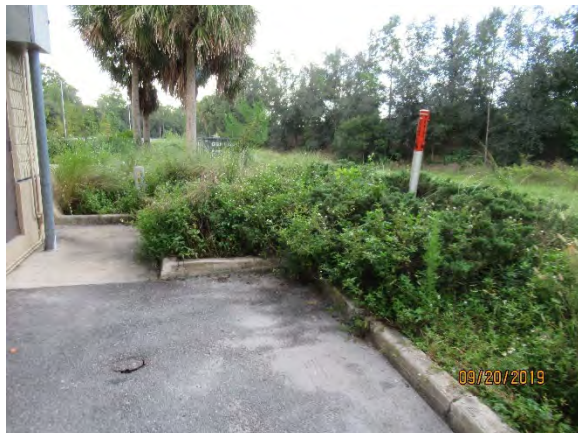
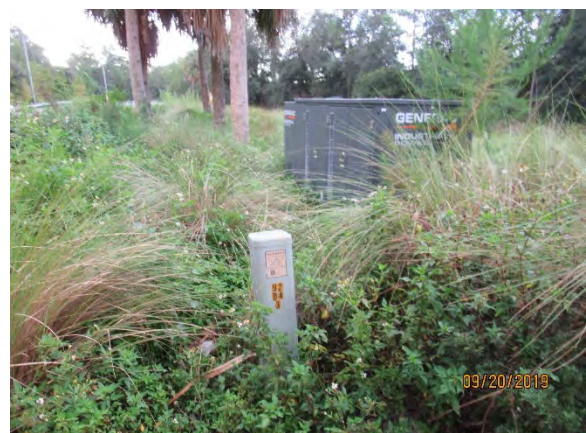
The above referenced on ramp is in good condition overall. General landscape maintenance is recommended. (Figure 21, Figure 22, Figure 23 & Figure 24)

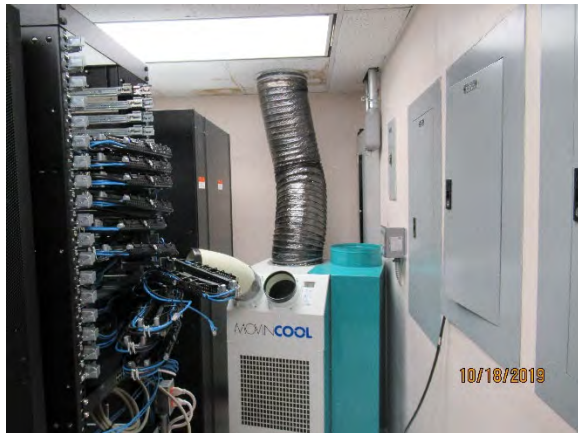
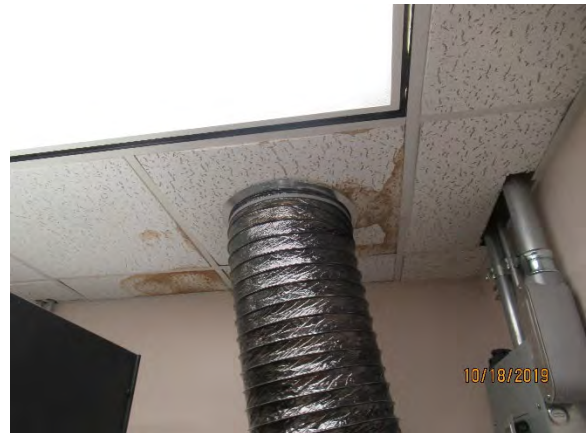
- Mainline has identified leaks above ceiling tile and temporary HVAC equipment in computer room. (Figure 1 & Figure 2)
- Mainline HVAC equipment paint is peeling off existing duct work. (Figure 7 & Figure 8)

- Recommend maintenance on building façade to address separation from building
- Recommend maintenance on overpass to restore and repaint identified area in need of repair.
- Recommend maintenance to determine the cause of the leaks in the ceiling tiles.

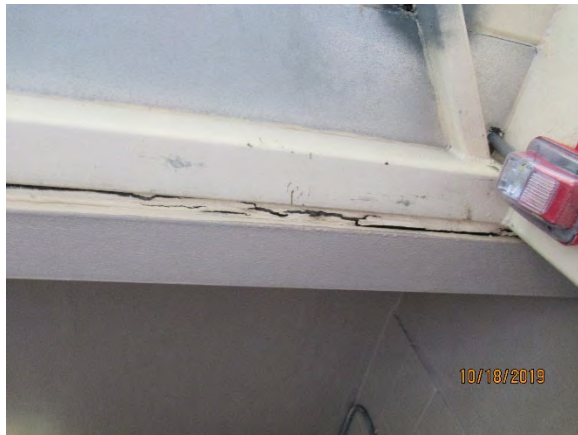
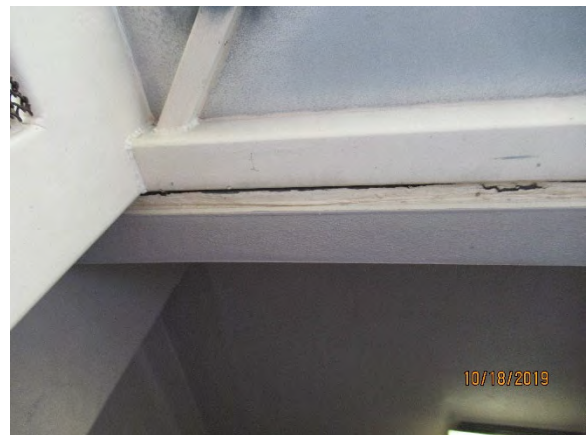
- Overpass has some recommended areas of repair in seam as shown in inspection photos. (Figure 3, Figure 4, Figure 9 & Figure 10)

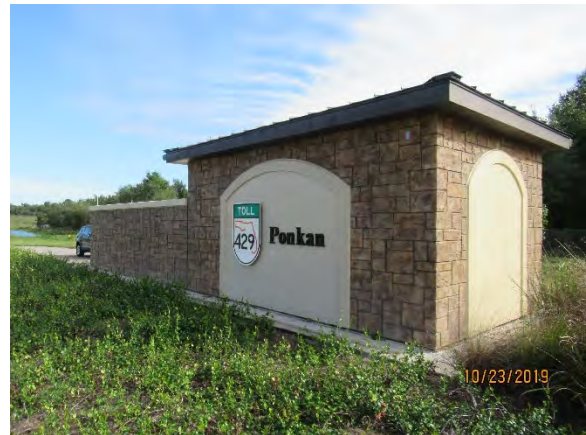
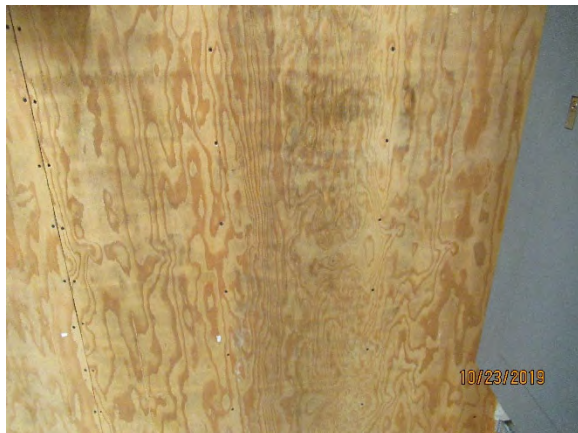
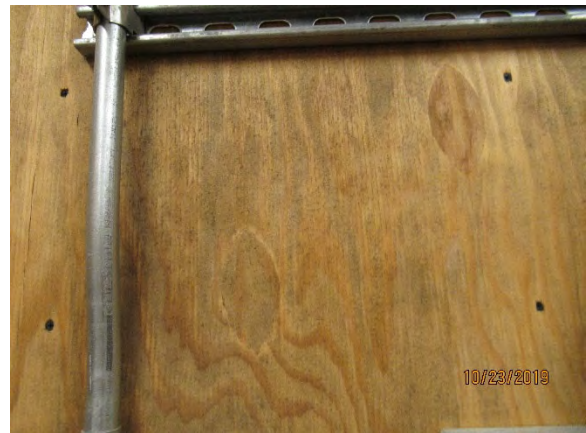
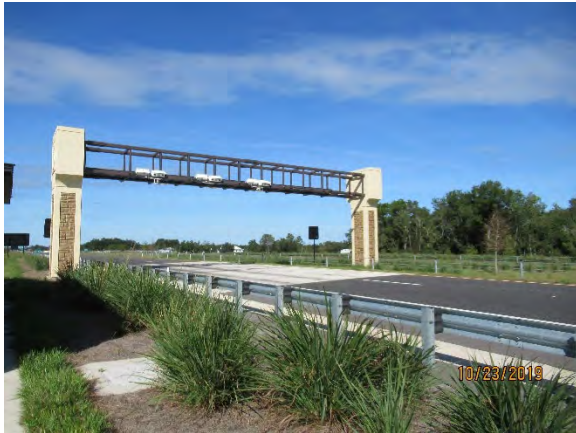
Figure 28 Ponkan Gantry

The above referenced on ramp is in good condition overall. General maintenance is recommended to address the condensation issue. (Figure 27, Figure 28, Figure 29 & Figure 30)

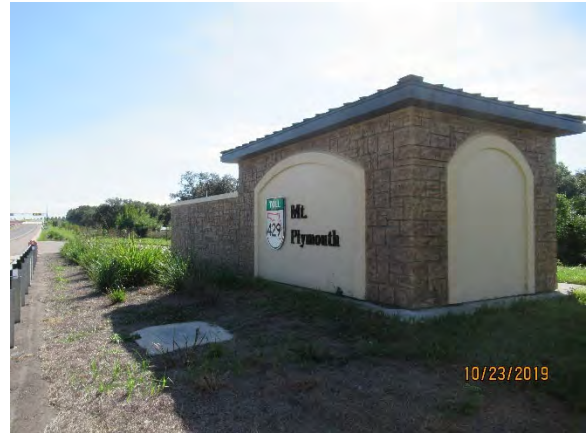
*Figure 32 Mt. Plymouth Gantry*

The above referenced on ramp is in good condition overall. General maintenance is recommended to address the condensation issue. (Figure 31 & Figure 32)

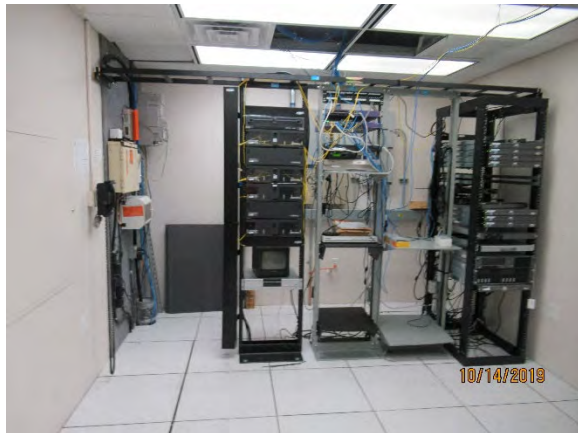
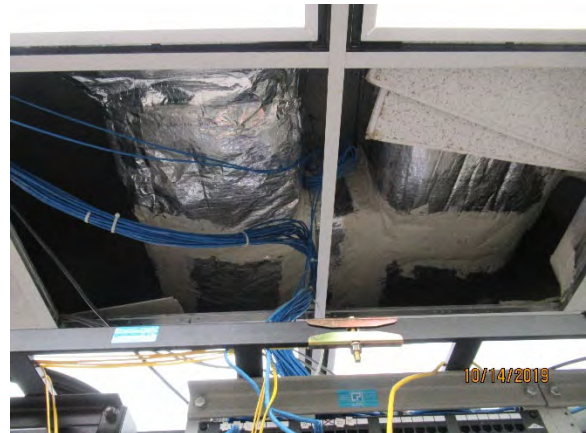
- Mainline computer room is missing ceiling tiles and has exposed duct work. (Figure 1 & Figure 2)

Figure 1 Independence Mainline IT Room

Figure 2 Independence Mainline IT Room

- Recommend pressure wash overpass area.
- Recommend test and balance of HVAC to ensure system is working properly.

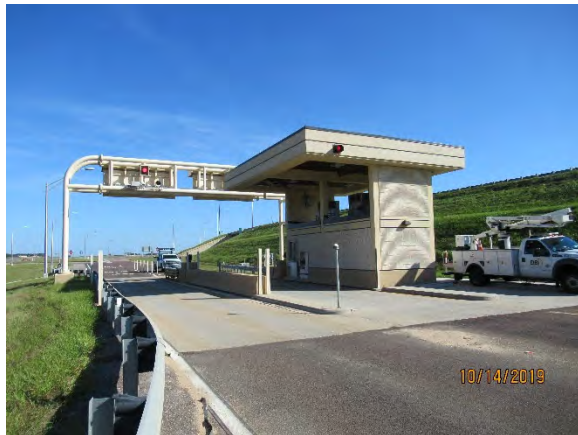
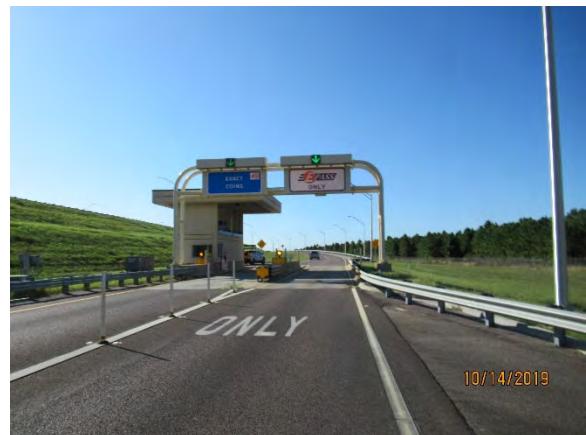
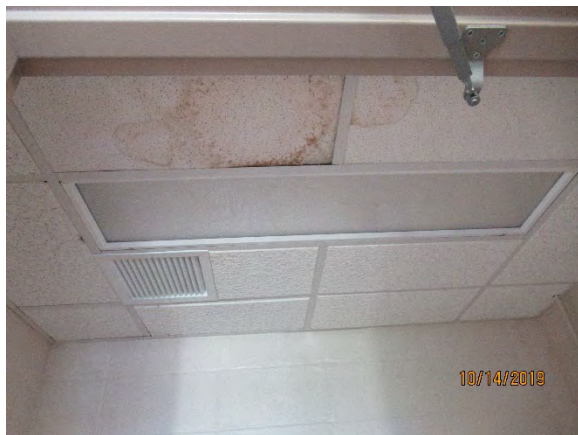
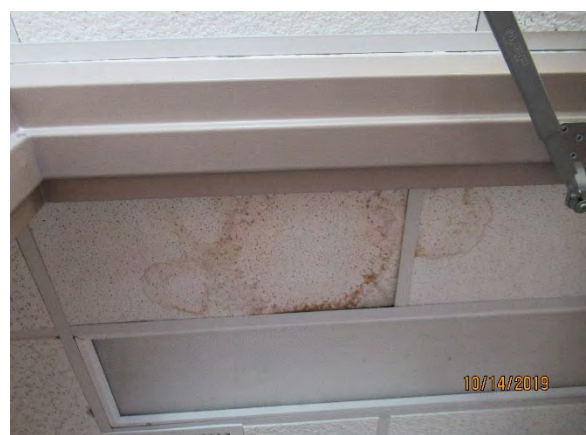
Figure 3 Schofield Ramp On

The above referenced on ramp is in good condition overall. Maintenance on ceiling tiles to locate potential is recommended. (Figure 3, Figure 4, Figure 5 & Figure 6)

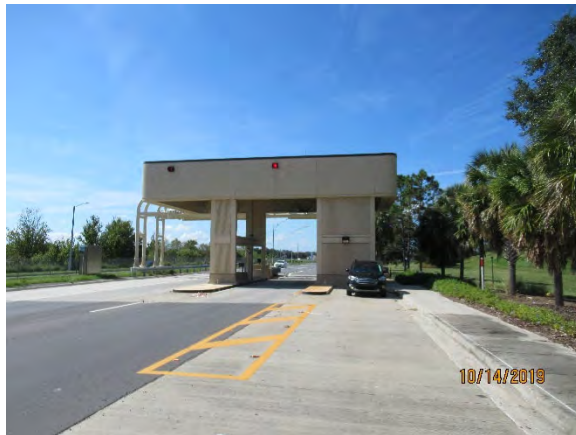
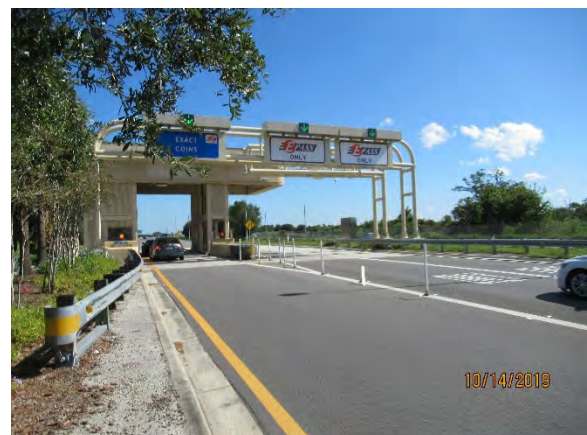
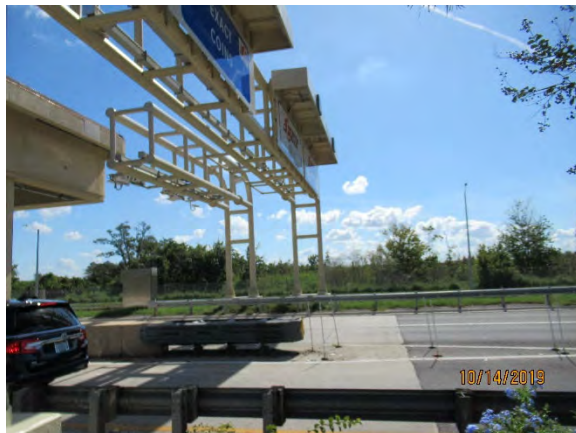
Figure 9 New Independence Ramp On

The above referenced on ramp is in good condition overall. General maintenance to repair/paint area where old signage used to be. (Figure 9, Figure 10, Figure 11 & Figure 12)

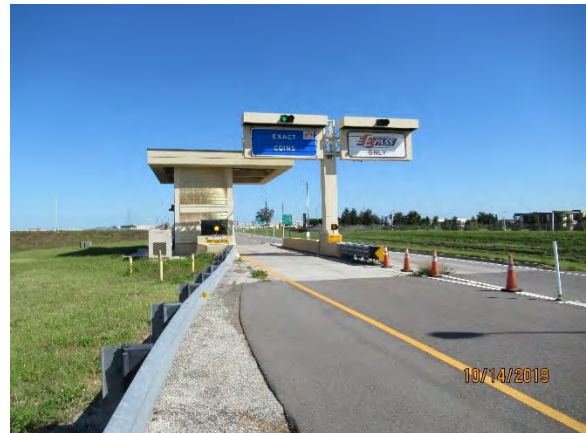
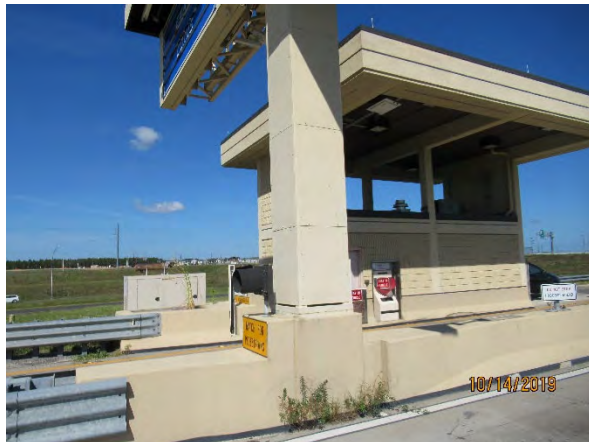
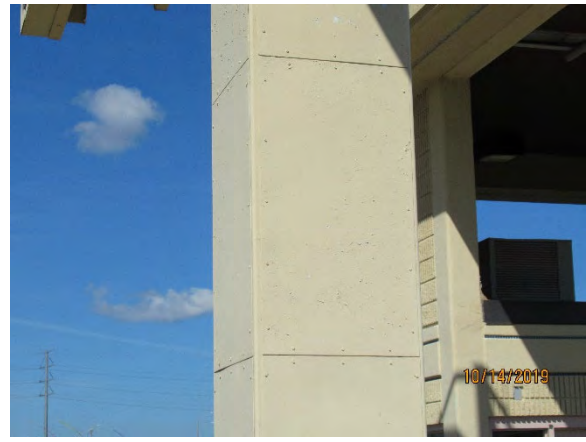
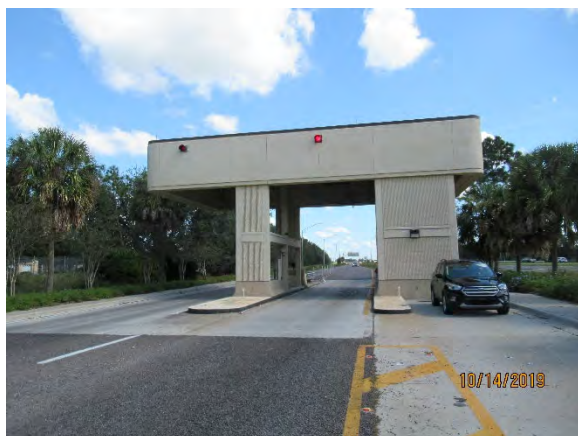
The above referenced on ramp is in good condition overall. Maintenance to address the peeling paint on the signage post is recommended. (Figure 13, Figure 14, Figure 15 & Figure 16)

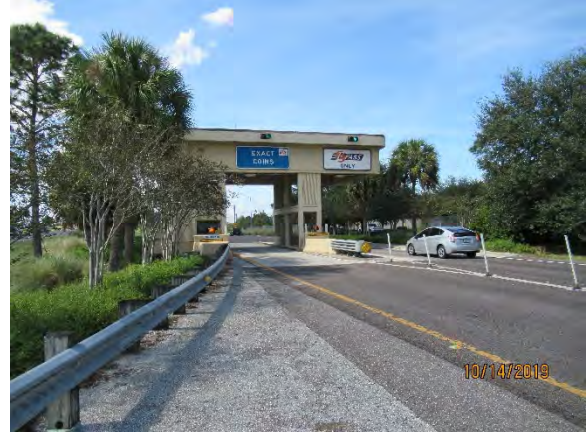
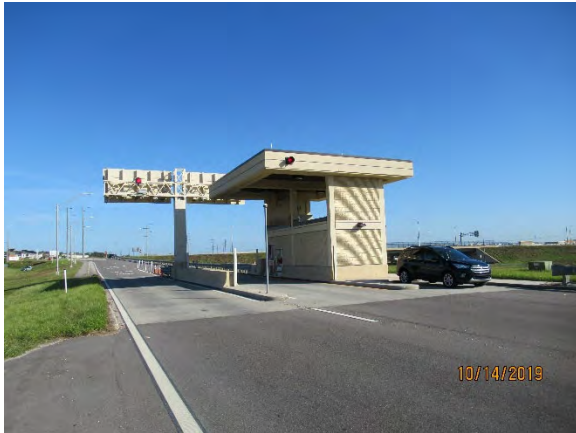
The above referenced on ramp is in good condition overall. (Figure 17 & Figure 18)

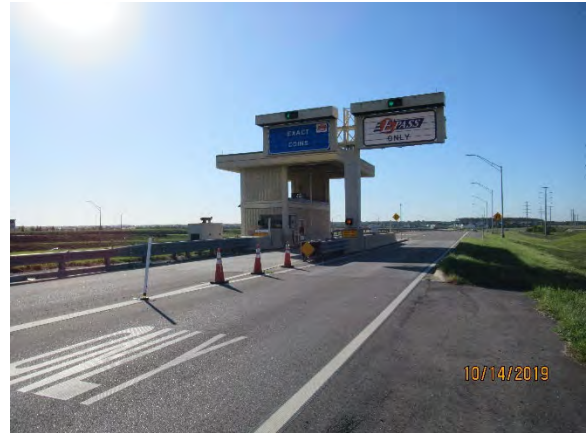
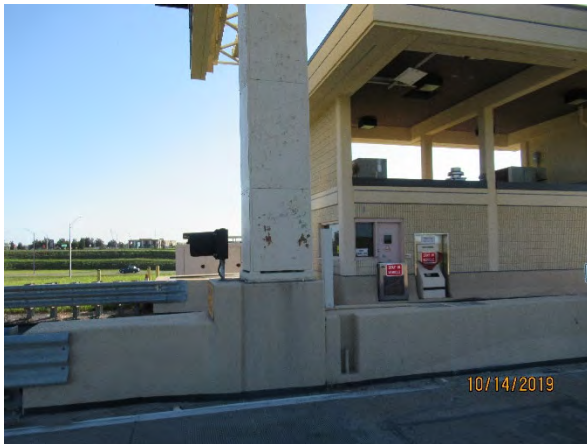
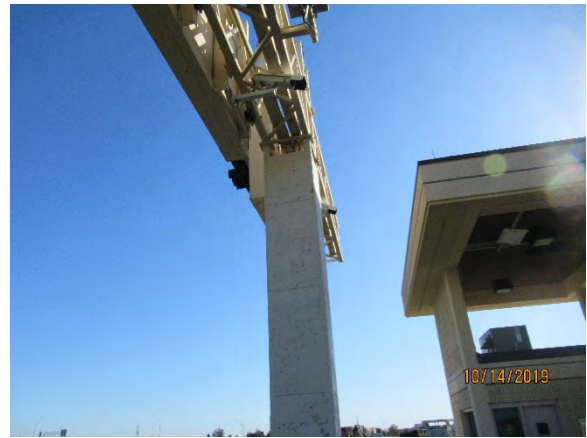
The above referenced on ramp is in good condition overall. Maintenance to address the peeling paint on the signage post is recommended. (Figure 19, Figure 20, Figure 21 & Figure 22)

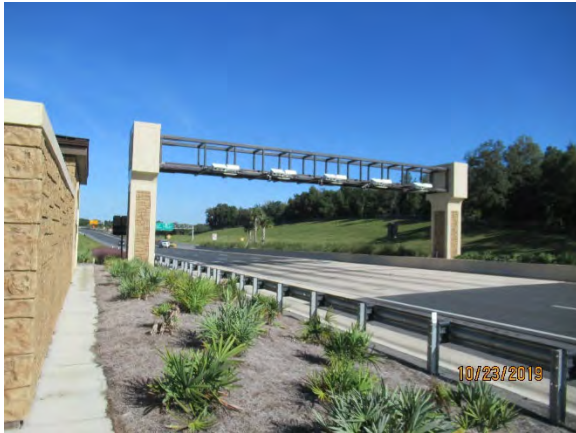
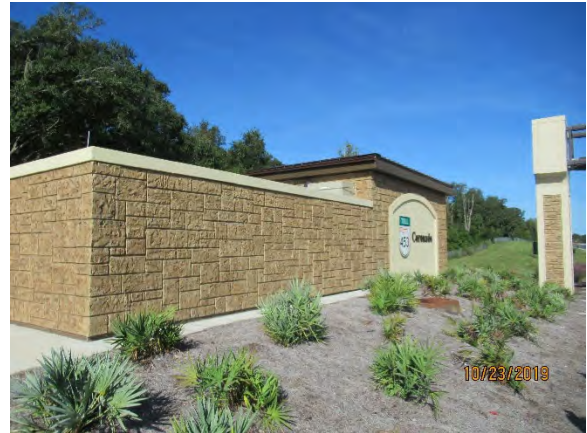
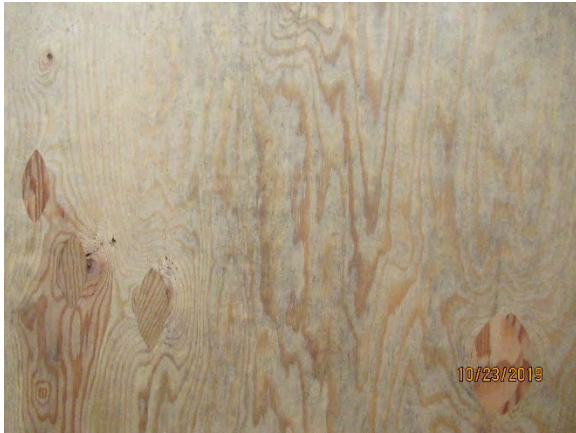
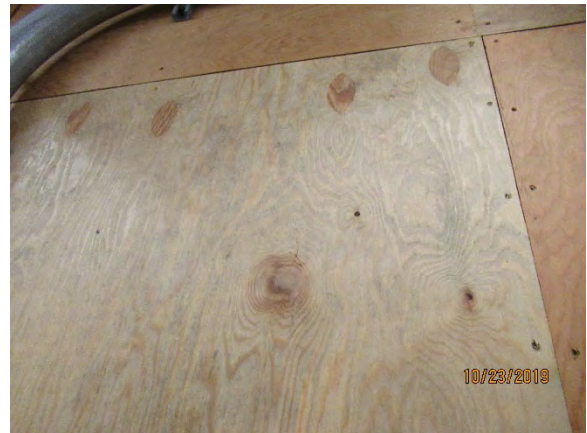
The above referenced gantry is in good condition overall. General maintenance is recommended to address the condensation issue. (Figure 1, Figure 2, Figure 3 & Figure 4)

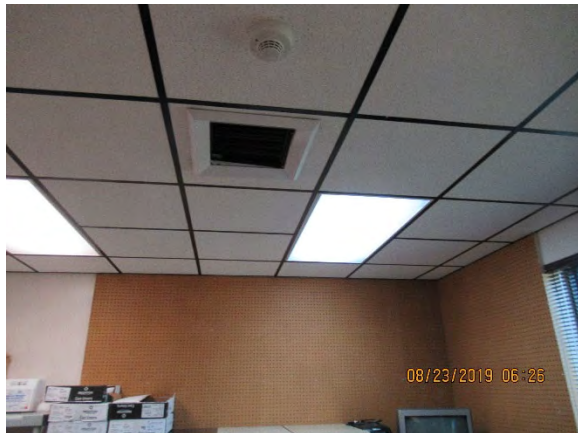
Figure 1 Beachline Mainline

- Mainline has isolated ceiling vent cover missing. (Figure 1)
- Mainline isolated wiring bundle is pulling from ceiling. (Figure 2)

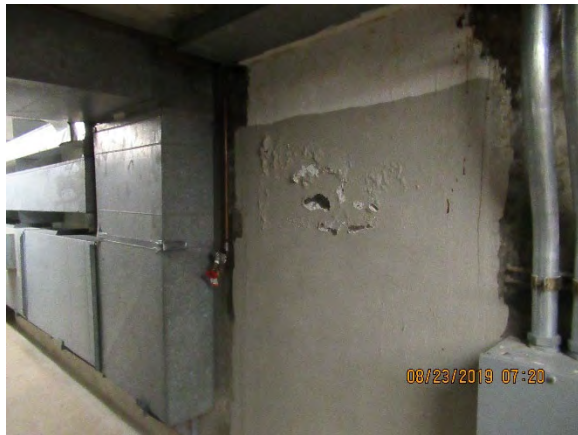
Figure 3 Beachline Mainline

- Interior tunnel wall has isolated deficiency. (Figure 3)

- Recommend maintenance on of isolated wiring in computer room.
- Recommend maintenance on interior tunnel wall.
- Recommend HVAC contractor inspect and address exterior condenser unit pipe corrosion.

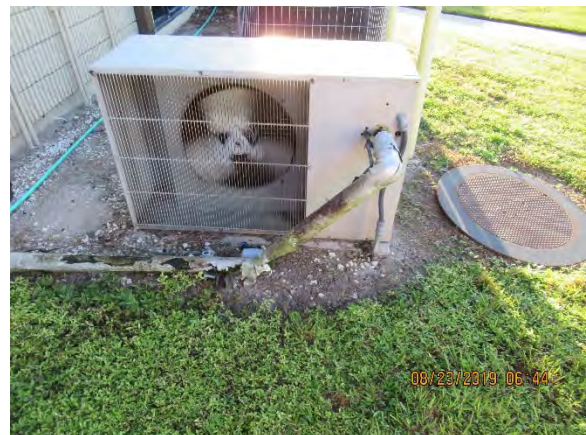
Figure 4 Beachline Mainline

- Exterior building is in good condition overall.
- Condenser unit located behind mainline building has pipe corrosion. (Figure 4)

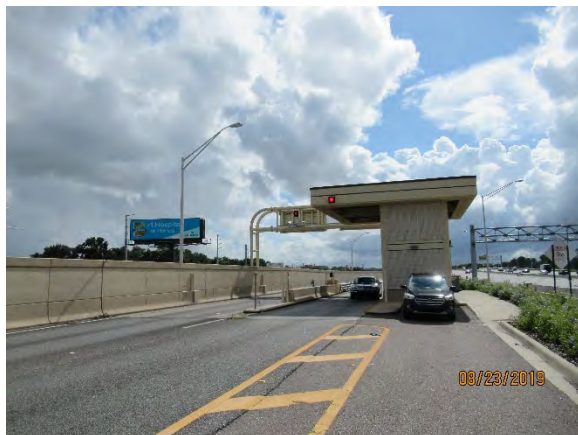
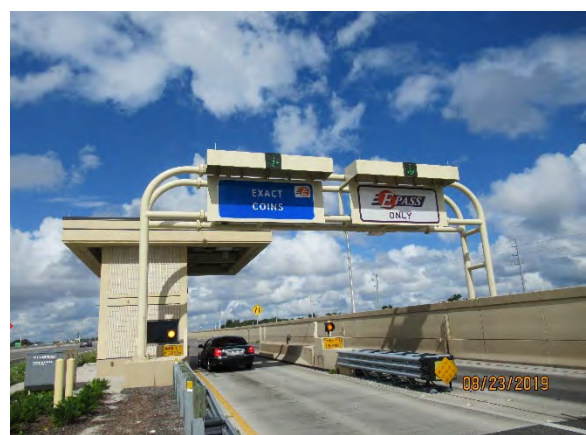
The above referenced off ramp is in good condition overall. (Figure 5 & Figure 6)

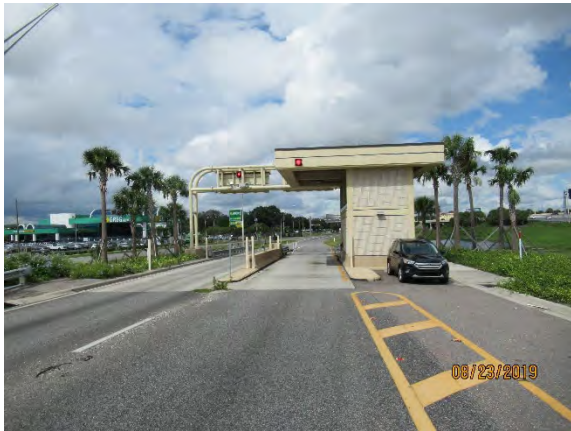
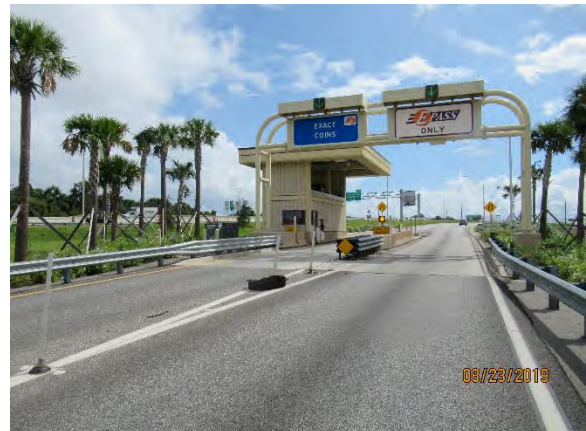
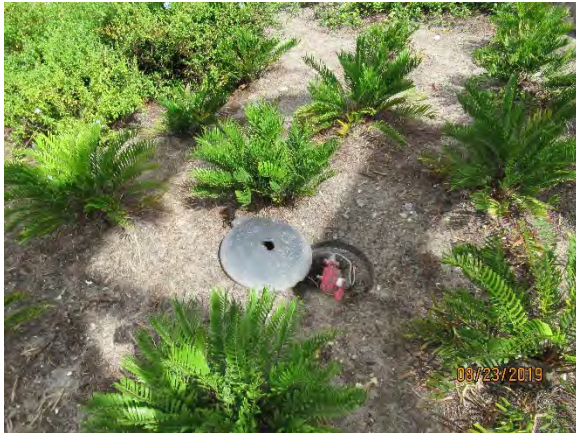
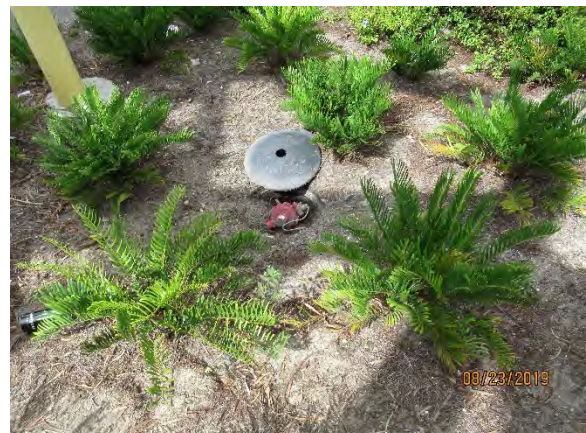
The above referenced on ramp is in good condition overall. Maintenance to ensure underground propane tank cover is securely fastened. (Figure 7, Figure 8, Figure 9 & Figure 10)

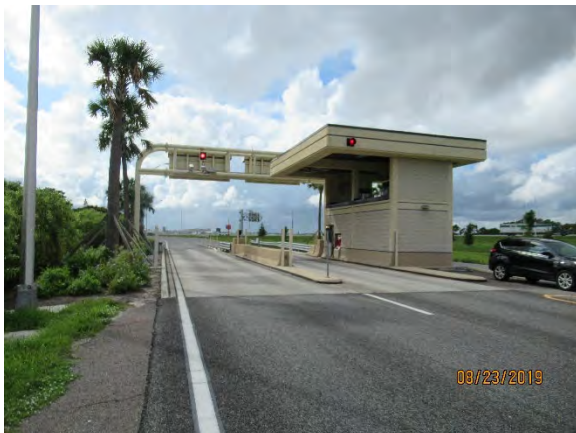
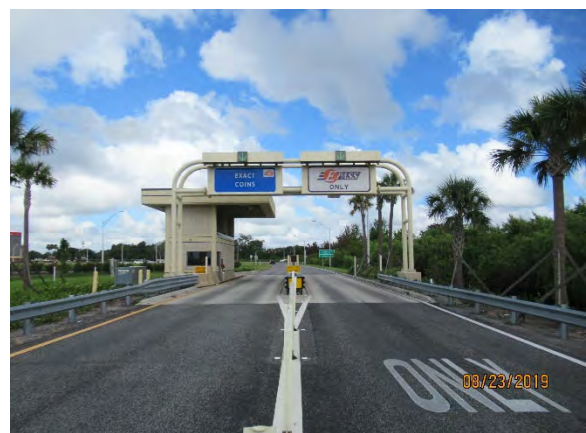
The above referenced off ramp is in good condition overall. (Figure 11 & Figure 12)
