# 2019

# Annual Inspection Report

Mr. Glenn Pressimone, P.E.  
Chief of Infrastructure  
Central Florida Expressway Authority  
4974 ORL Tower Road  
Orlando, Florida 32807

Re: 2019 Annual Inspection Report

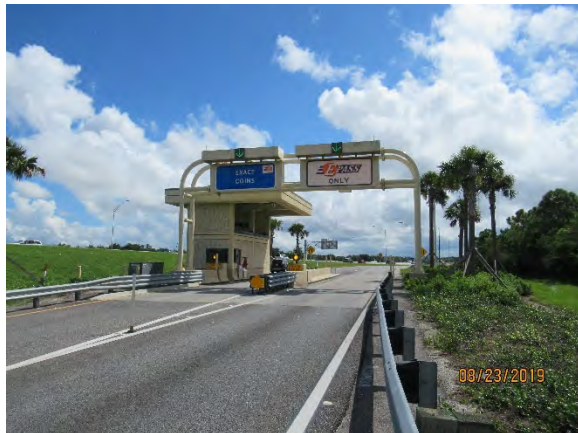
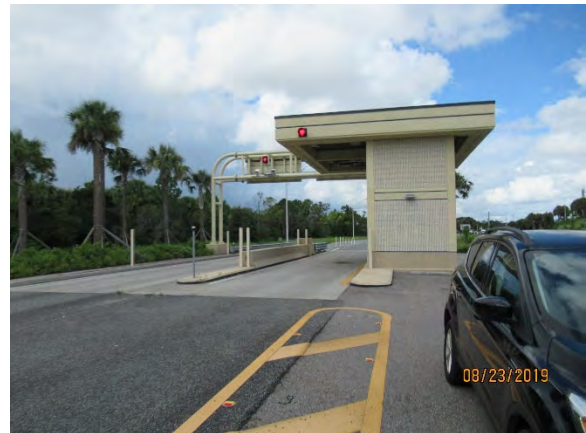
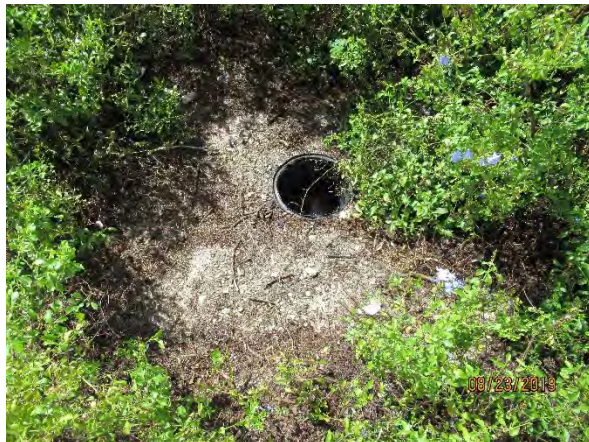
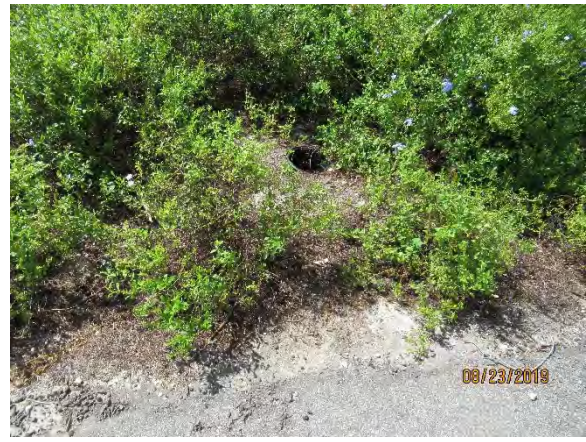
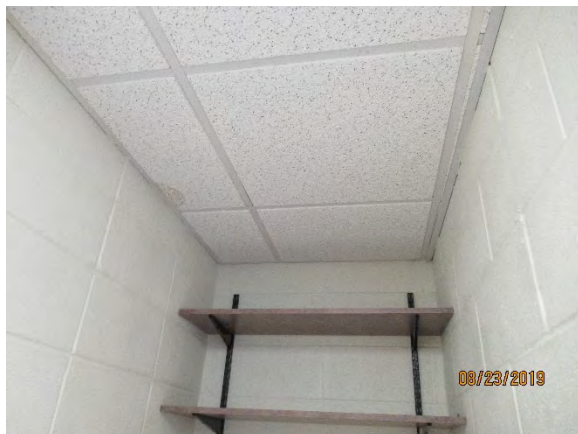
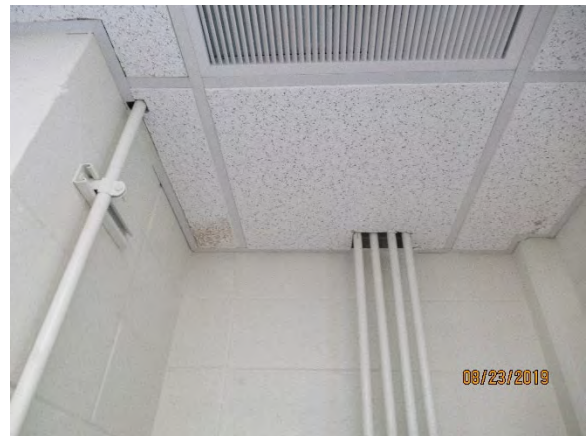
The above referenced on ramp is in good condition overall. Maintenance to ensure underground propane tank cover is securely fastened. Maintenance to verify potential leaks above ceiling tile. (Figure 13 & Figure 14, Figure 15, Figure 16, Figure 17 & Figure 18)

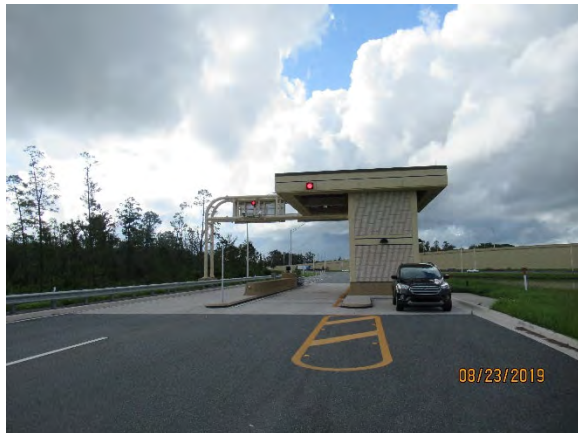
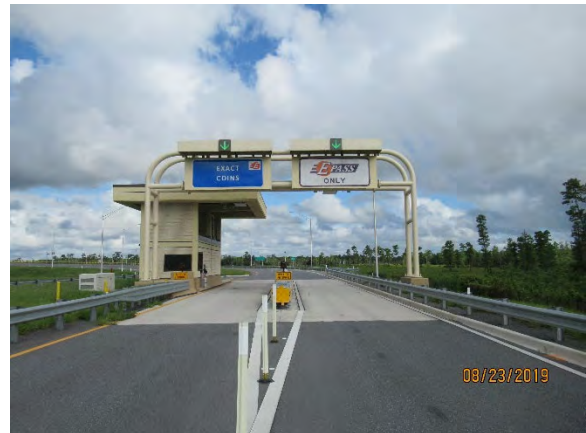
The above referenced on ramp is in good condition overall. (Figure 19 & Figure 20)

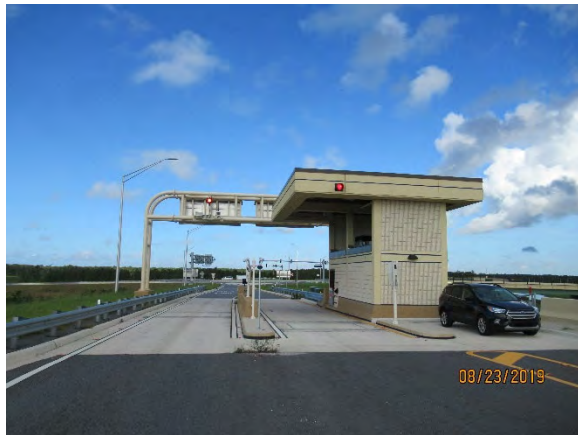
Figure 21 ICP Ramp On

The above referenced on ramp is in good condition overall. (Figure 21 & Figure 22)

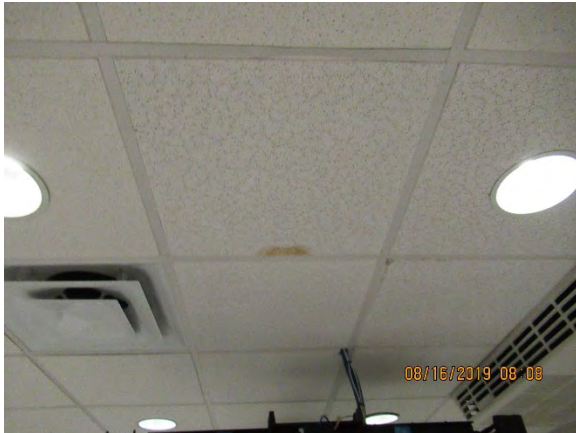
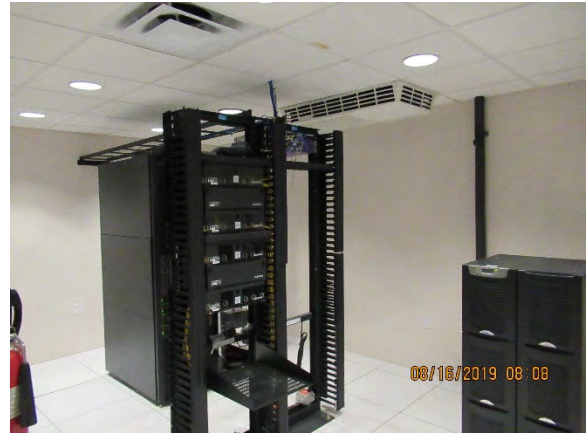
- Mainline computer room has potential leak in ceiling tile located above equipment rack. (Figure 1 & Figure 2)
- Mainline electrical junction box is missing cover. (Figure 3 & Figure 4)

Figure 1 Dallas Mainline IT Room

Figure 2 Dallas Mainline IT Room

- Recommend pressure wash for the building exterior and overpass.
- Recommend maintenance to locate/address leaks in ceiling tile.
- Recommend general maintenance to address erosion areas behind facility.

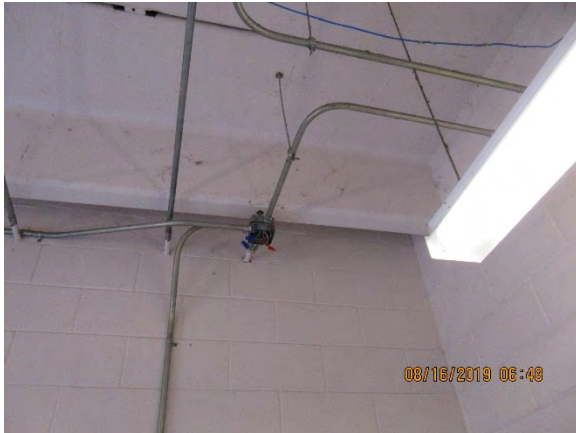
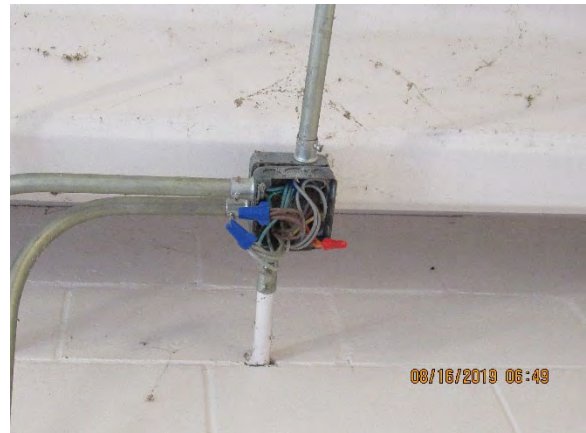
Figure 3 Dallas Mainline

Figure 4 Dallas Mainline

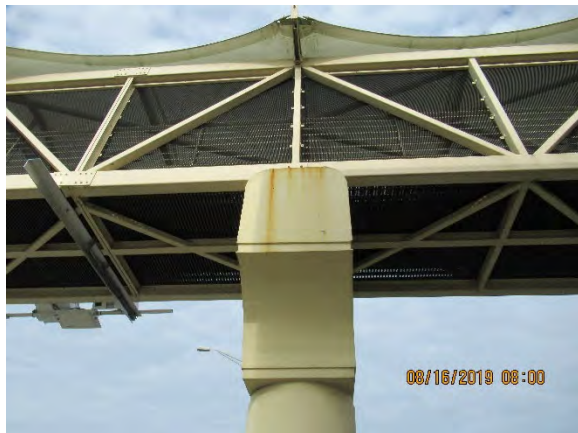
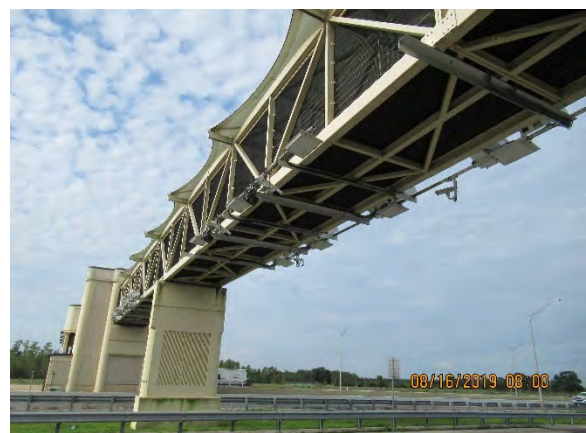
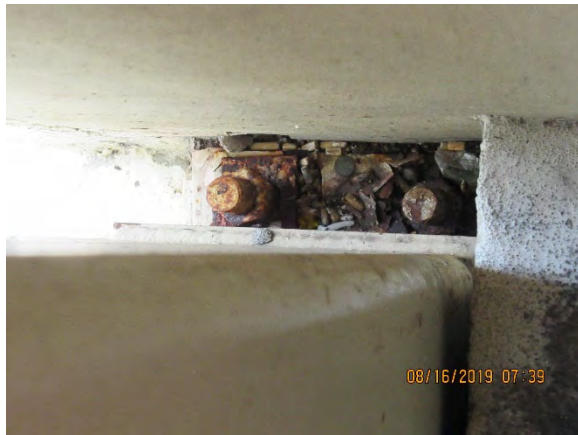
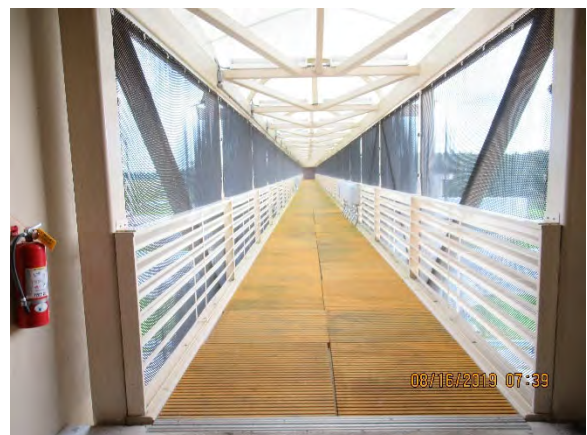
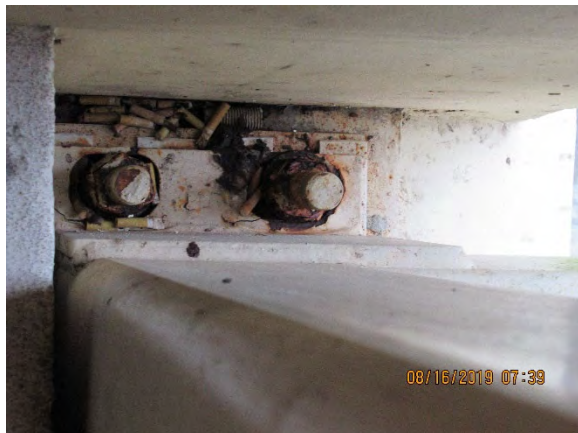
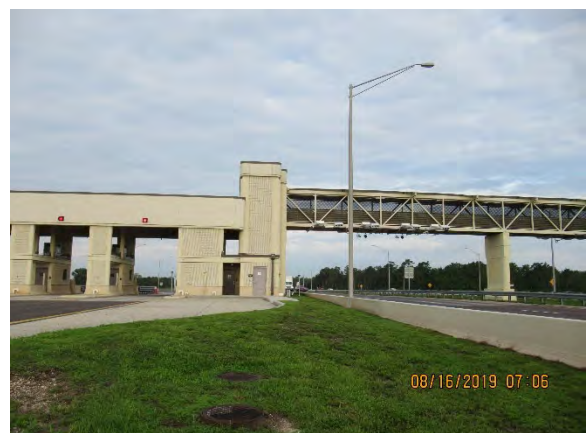
- Mainline overpass is in need of pressure wash. (Figure 13 & Figure 14)
- Mainline overpass connections are showing rusted hardware. (Figure 11, Figure 12, Figure 15, Figure 16, Figure 17 & Figure 18)

Figure 11 Dallas Mainline Overpass

Figure 12 Dallas Mainline Overpass

Figure 15 Dallas Mainline EB Overpass

Figure 16 Dallas Mainline EB Overpass

Figure 17 Dallas Mainline EB Overpass

Figure 18 Dallas Mainline EB

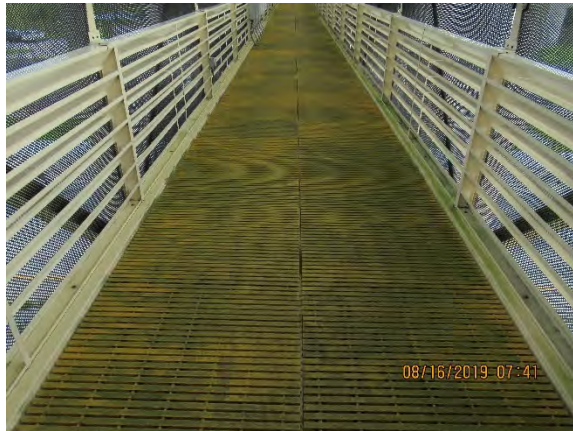
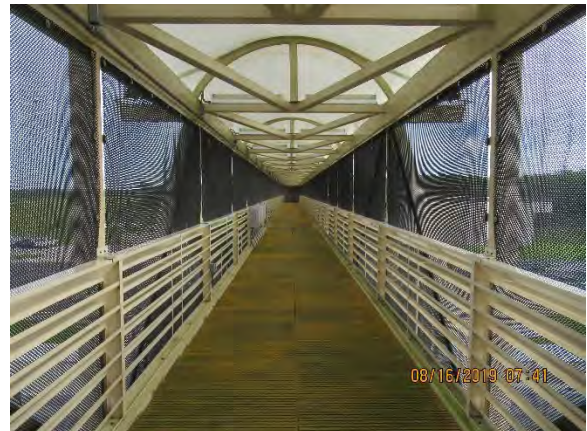
Figure 13 Dallas Mainline Overpass

Figure 14 Dallas Mainline Overpass

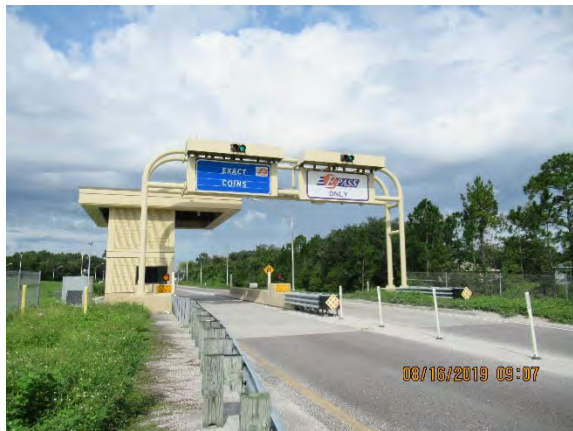
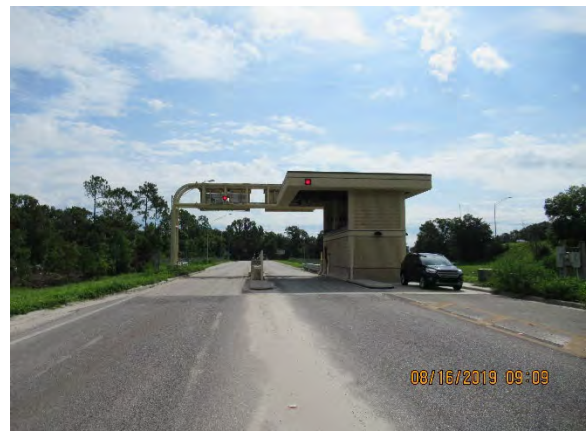
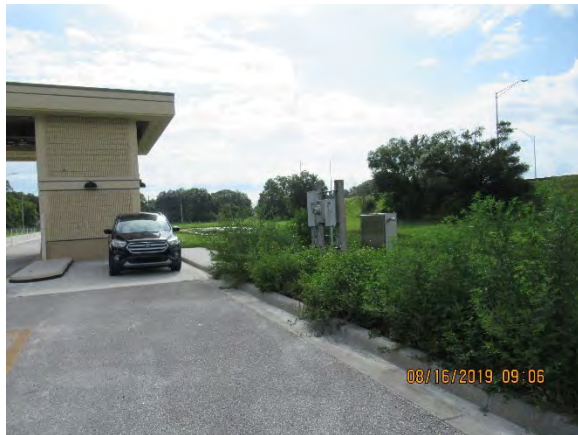
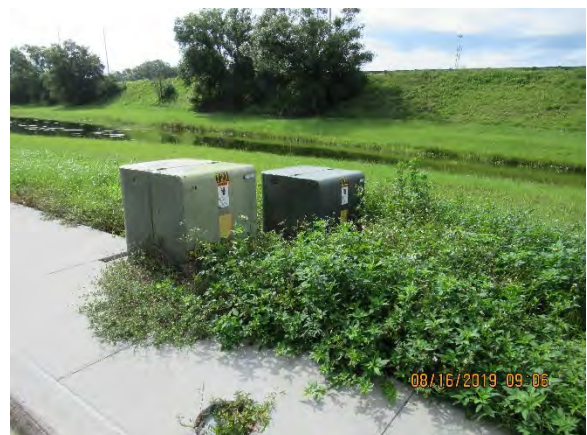
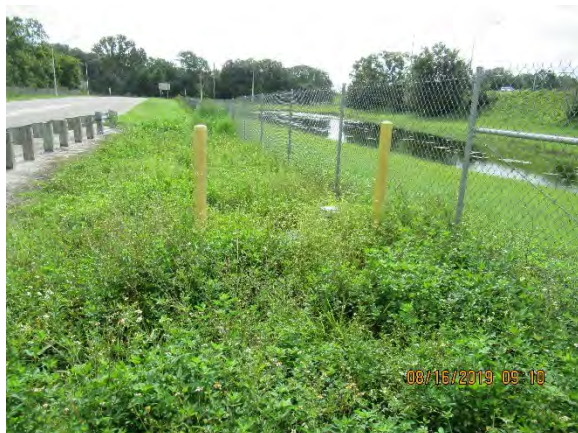
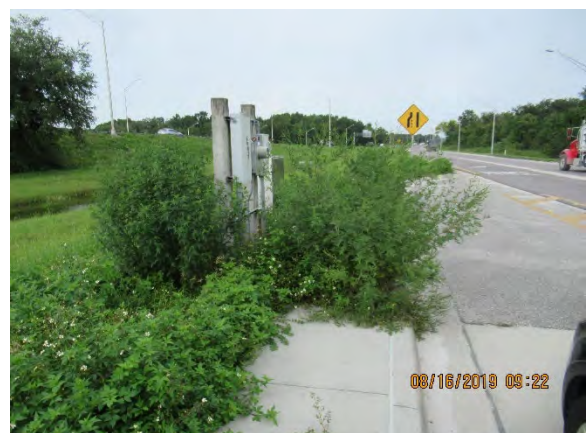
The above referenced on ramp is in good condition overall. Some general landscaping is recommended. (Figure 19, Figure 20, Figure 21, Figure 22, Figure 23 & Figure 24)

Figure 19 Dallas Ramp On

Figure 20 Dallas Ramp On

Figure 21 Dallas Ramp On

Figure 22 Dallas Ramp On

Figure 23 Dallas Ramp On

Figure 24 Dallas Ramp On

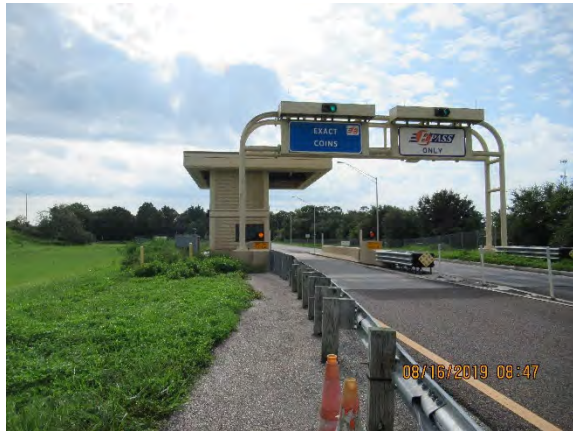
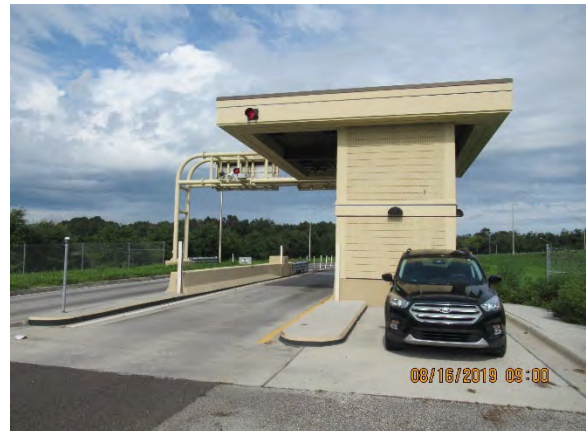
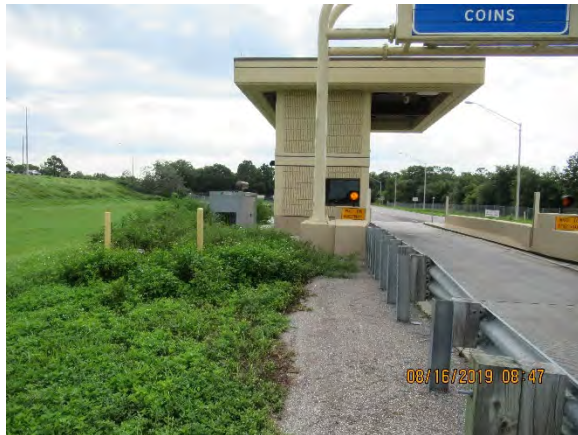
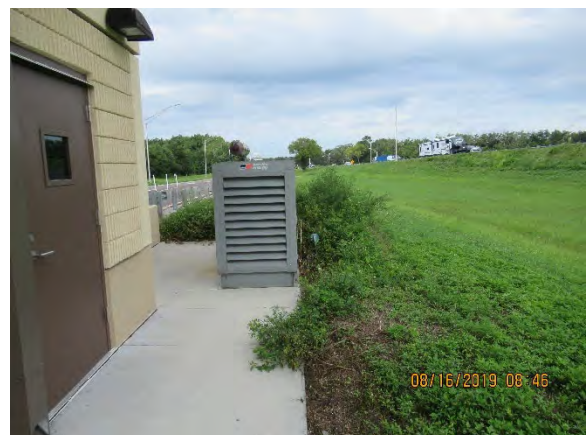
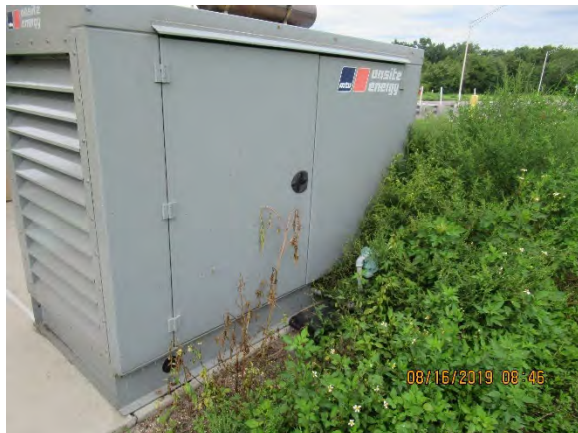
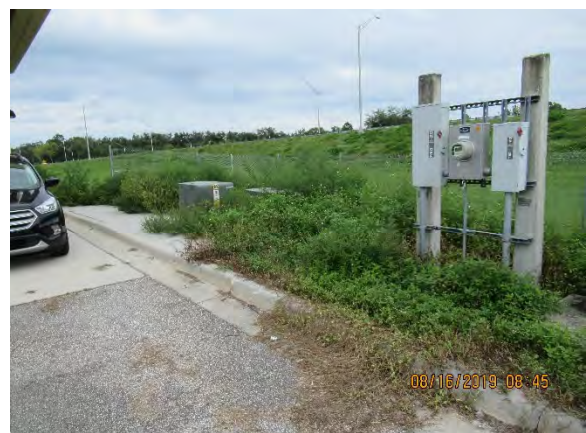
The above referenced on ramp is in good condition overall. Some general landscaping is recommended. (Figure 25, Figure 26, Figure 27, Figure 28, Figure 29 & Figure 30)

Figure 25 Dallas Ramp Off

Figure 26 Dallas Ramp Off

Figure 27 Dallas Ramp Off

Figure 28 Dallas Ramp Off

Figure 29 Dallas Ramp Off

Figure 30 Dallas Ramp Off

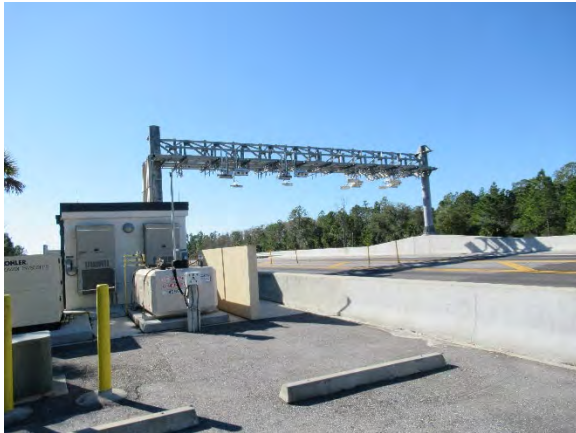
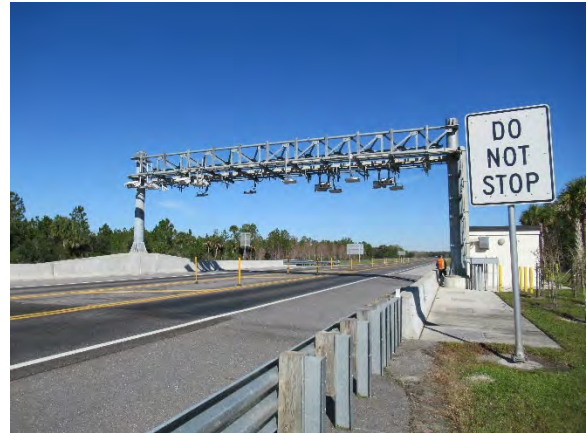
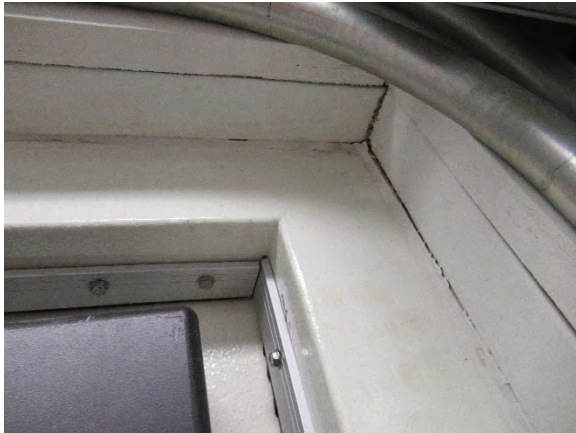
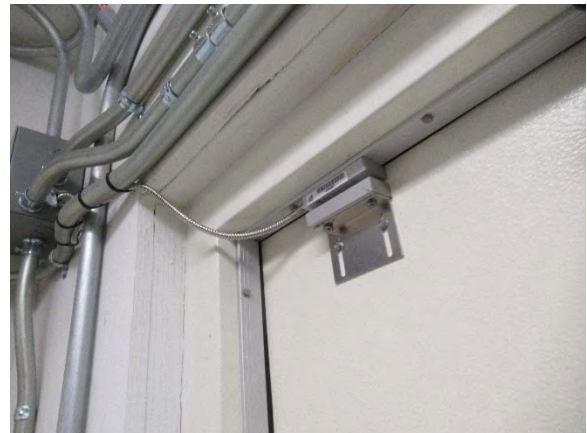
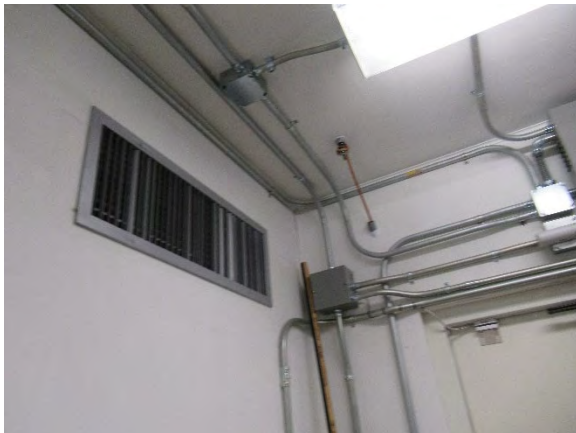
The above referenced plaza is in good condition overall. Some general maintenance to caulk/seal building framing is recommended.  
(Figure 1, Figure 2, Figure 3, Figure 4, Figure 5 & Figure 6)

*Figure 1 Marigold AET Toll Plaza*

*Figure 2 Marigold AET Toll Plaza*

*Figure 3 Marigold AET Toll Plaza*

*Figure 4 Marigold AET Toll Plaza*

*Figure 5 Marigold AET Toll Plaza*

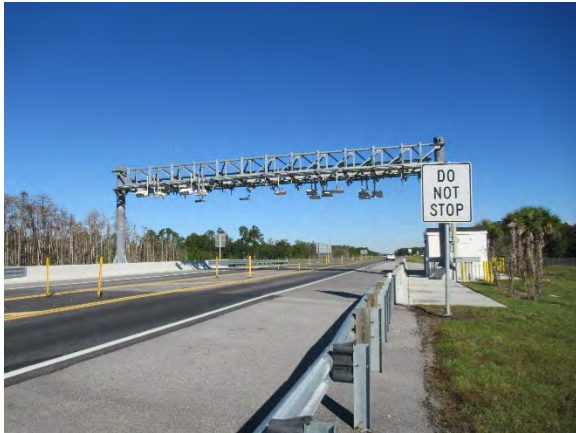
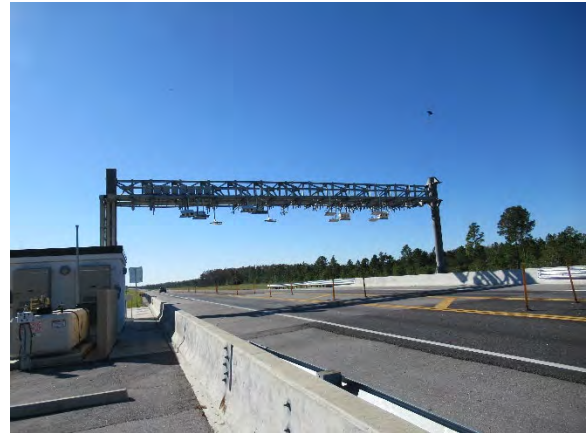
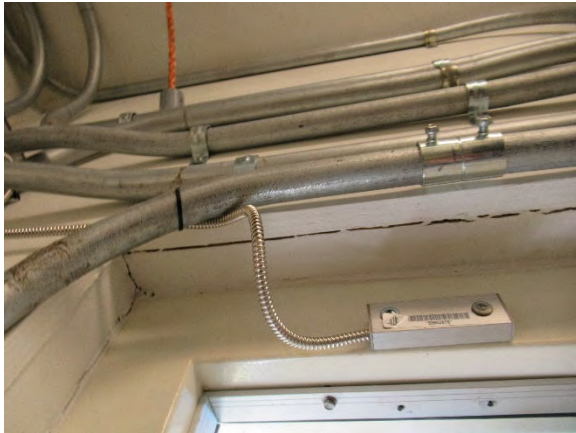
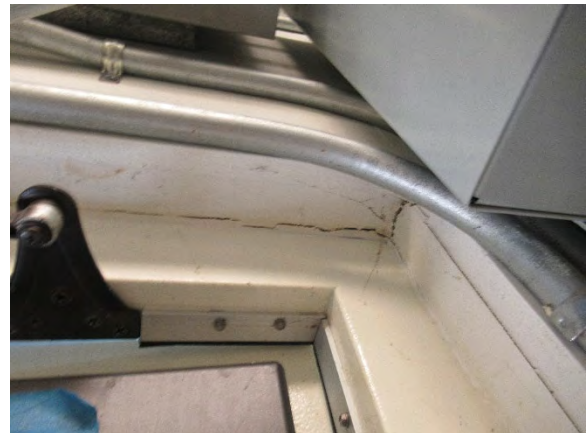
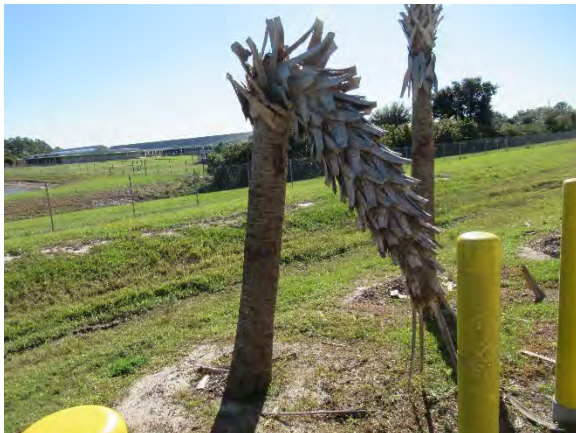
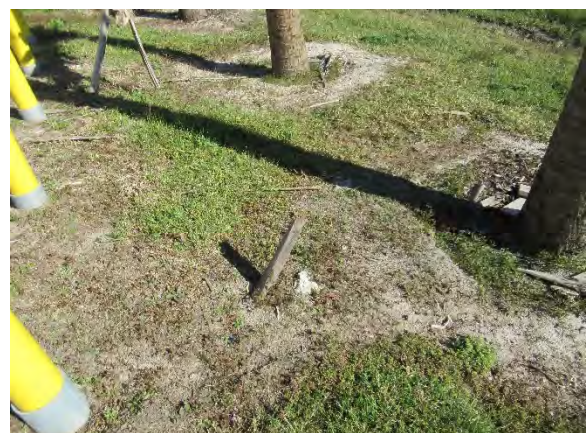
The above referenced plaza is in good condition overall. Some general maintenance to caulk/seal building framing and general landscaping is recommended.  
(Figure 7, Figure 8, Figure 9, Figure 10, Figure 11 & Figure 12)

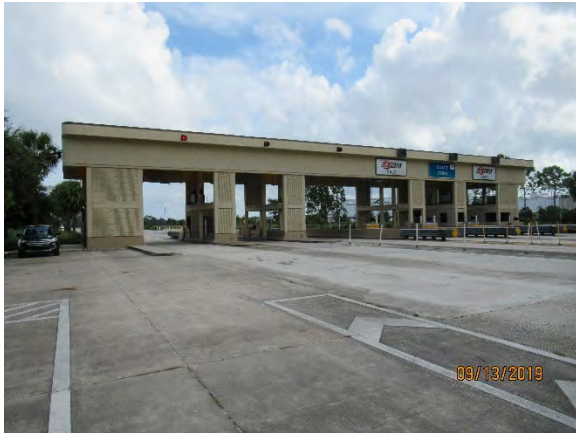
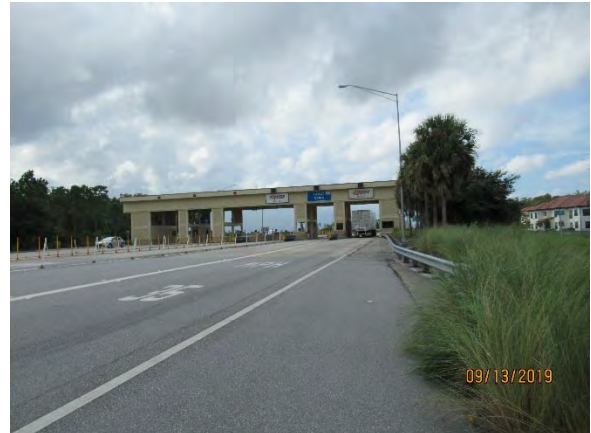
- The above referenced site is in good condition overall with no identified deficiencies. (Figure 1 & Figure 2)

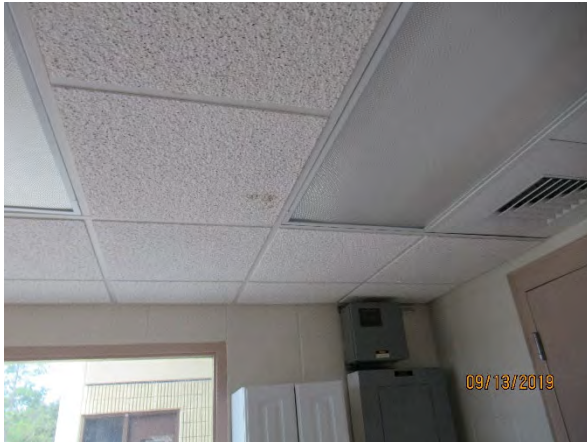
Figure 3 Goldenrod Main Plaza

- Mainline has potential leak above ceiling tile. (Figure 3 & Figure 4)

- Recommend maintenance to locate any potential leaks above ceiling tiles.

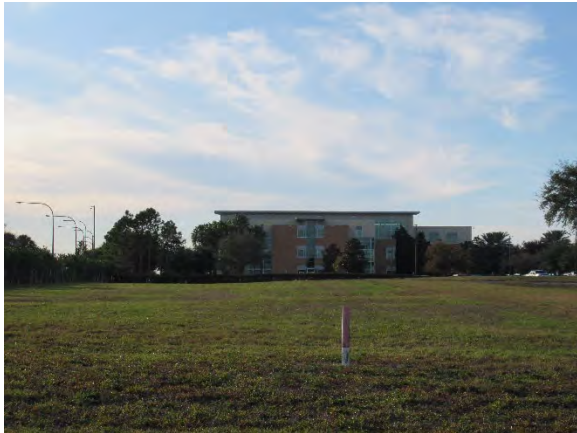
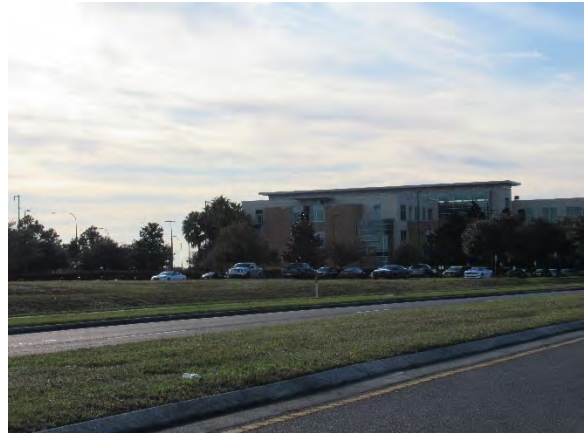
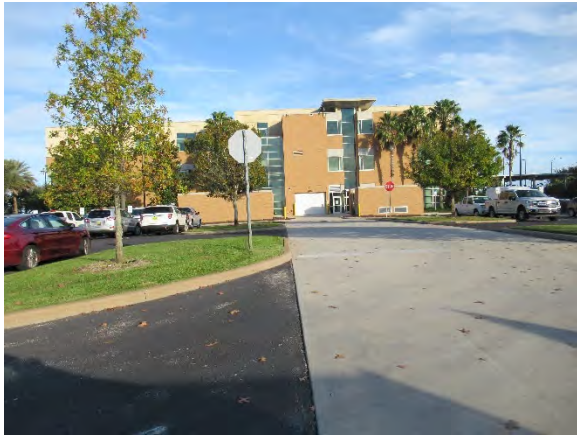
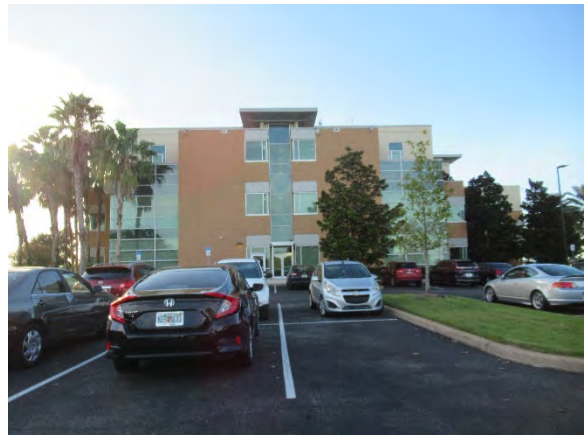
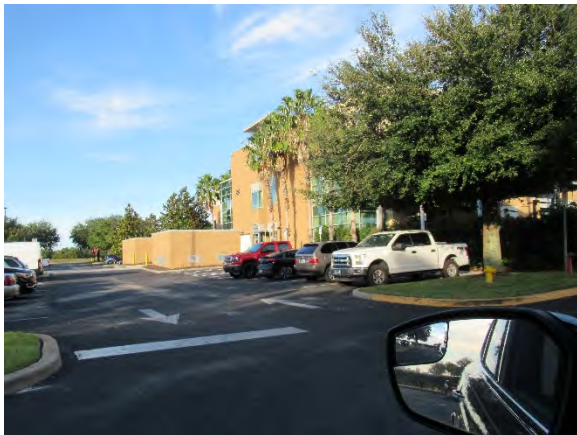
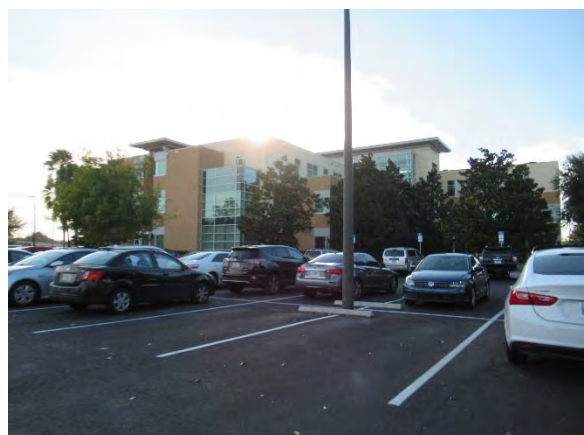
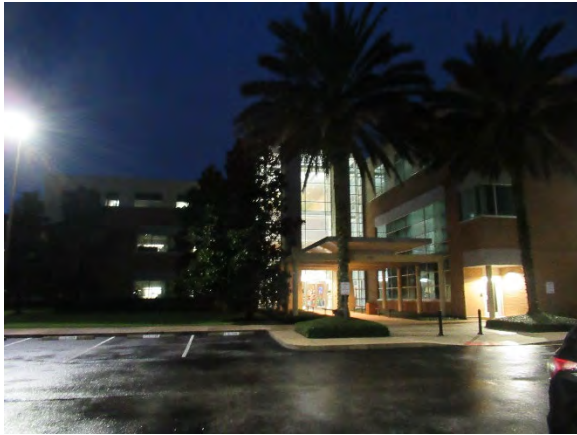
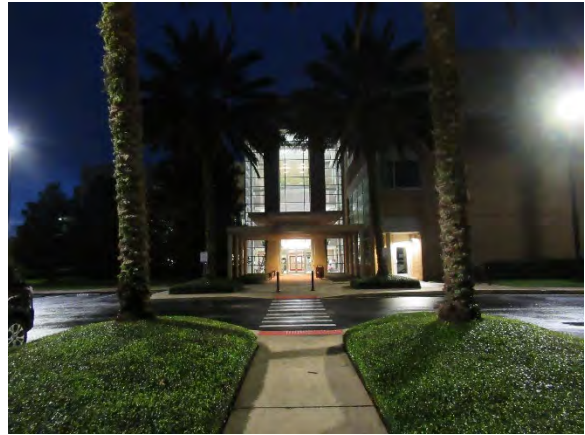
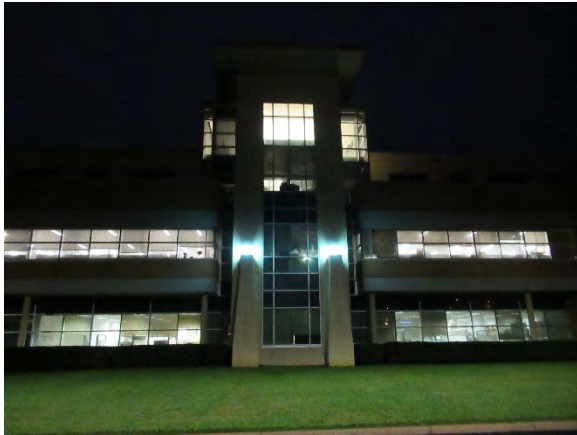
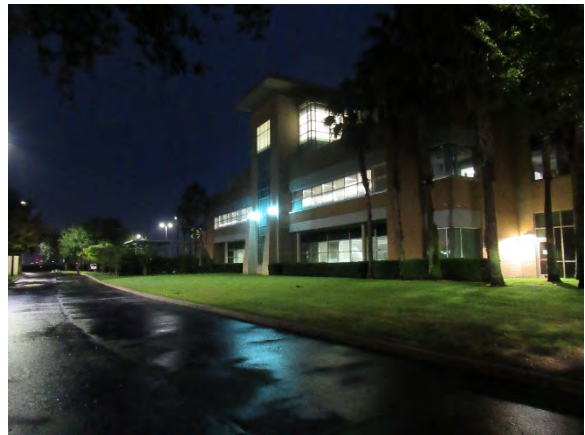
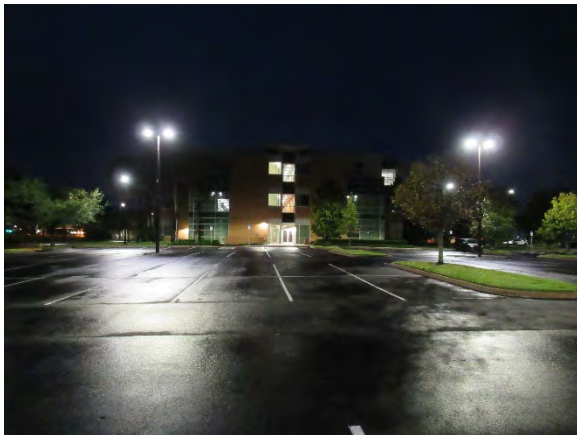
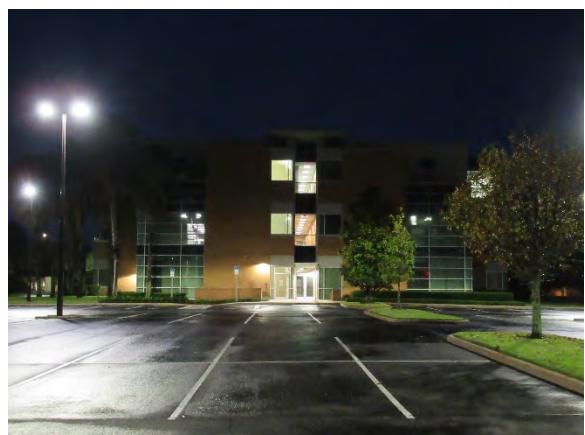
- Building exterior is in good condition overall with no identified deficiencies.  
(Figure 1 - Figure 12)

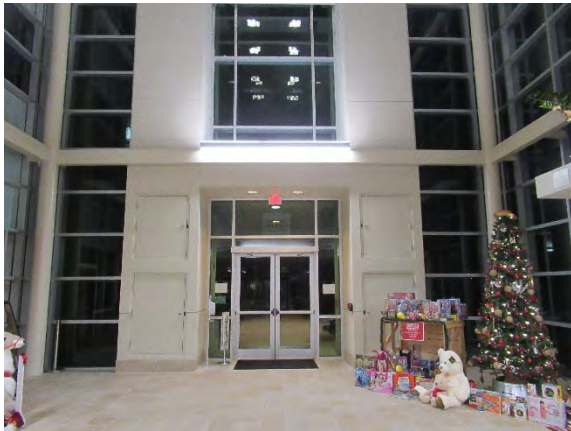
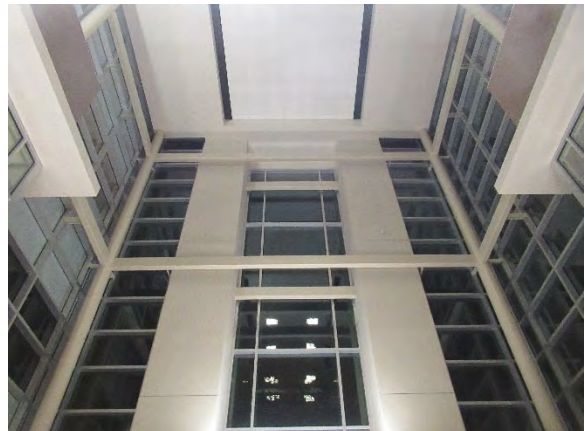
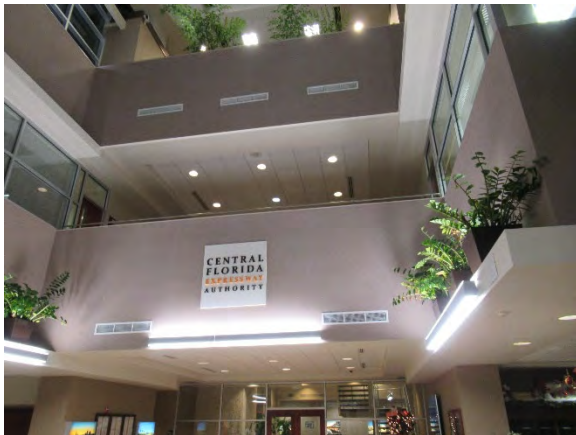
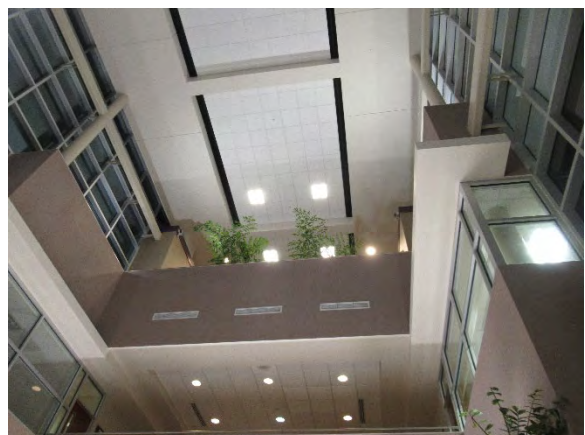
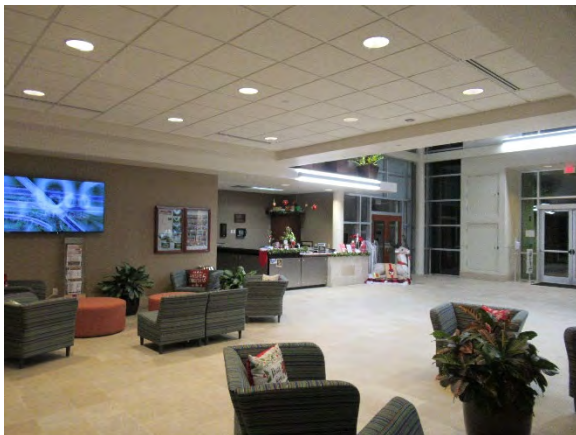
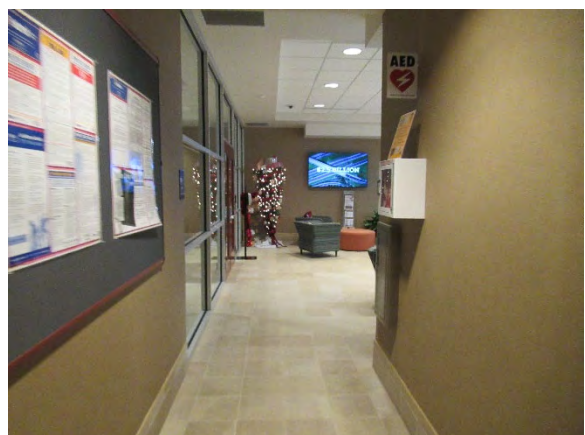
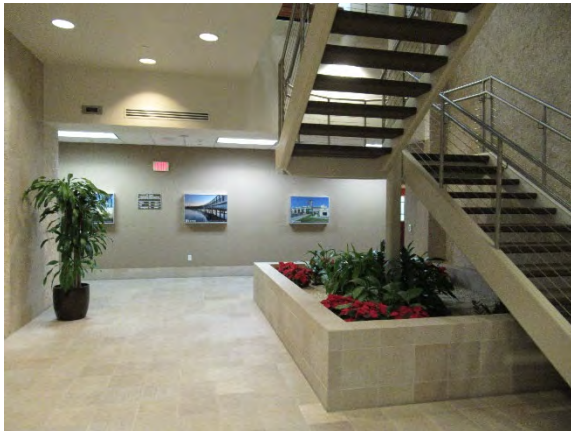
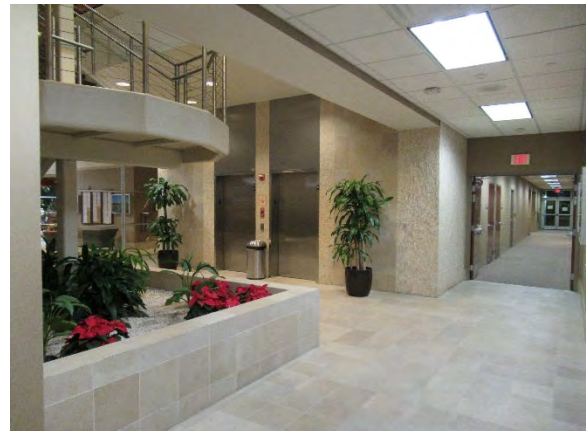
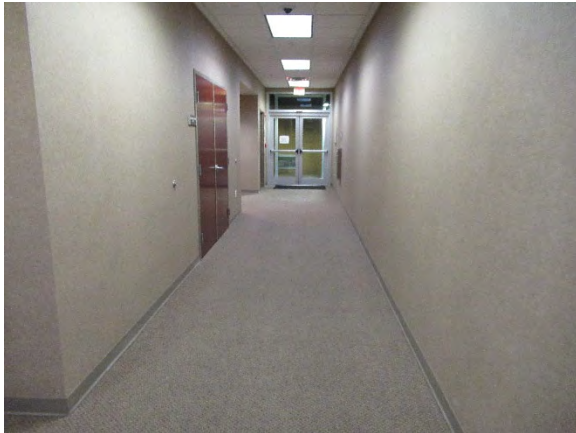
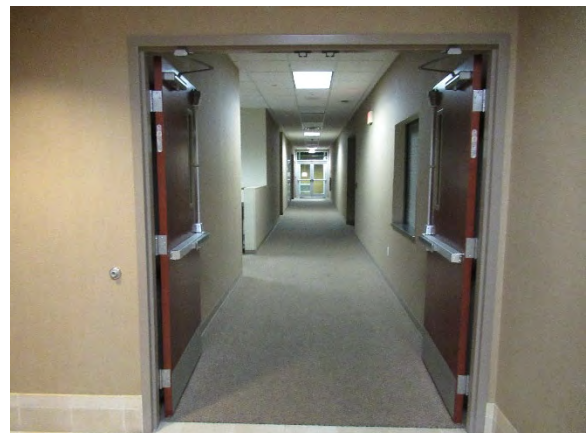
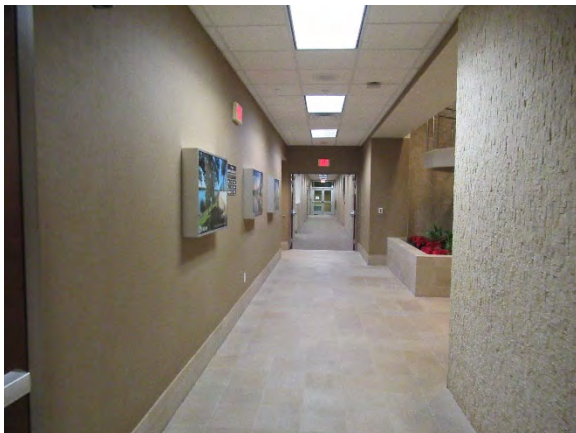
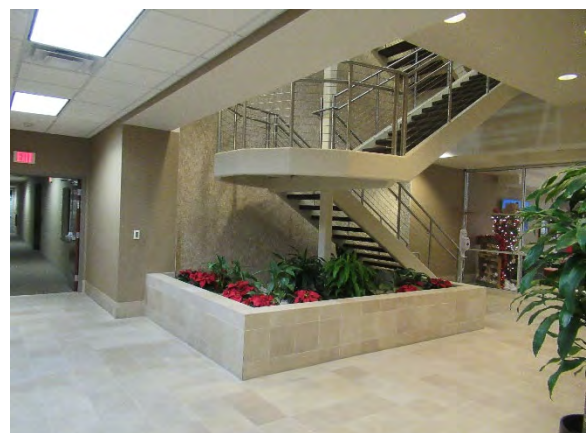
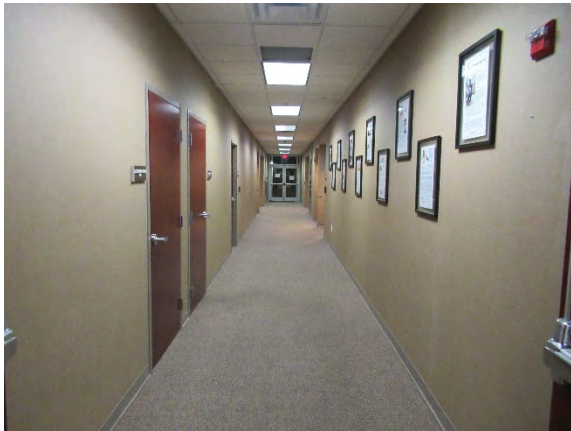
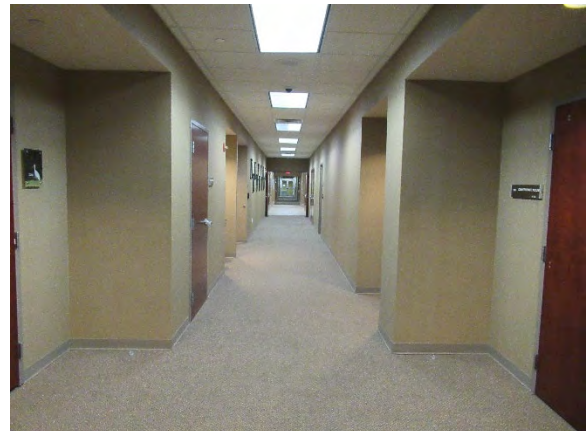
- Building interior is in good condition overall with no identified deficiencies.  
(Figure 13 - Figure 66)
