# 2019

# Annual Inspection Report

Mr. Glenn Pressimone, P.E.  
Chief of Infrastructure  
Central Florida Expressway Authority  
4974 ORL Tower Road  
Orlando, Florida 32807

Re: 2019 Annual Inspection Report

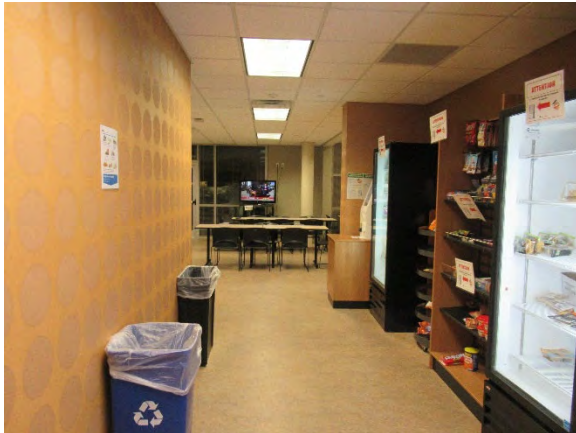
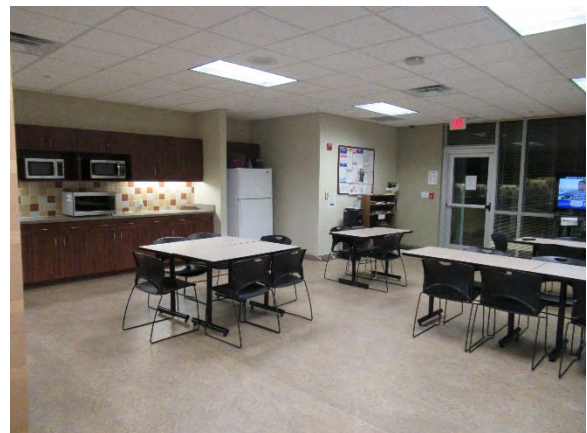
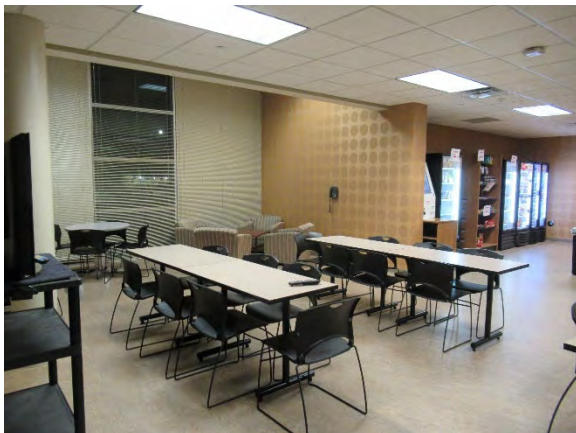
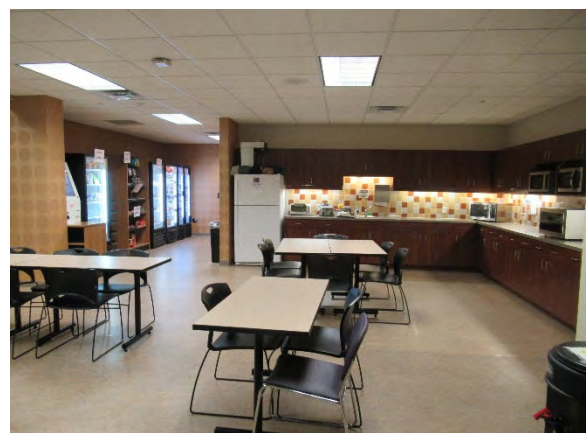
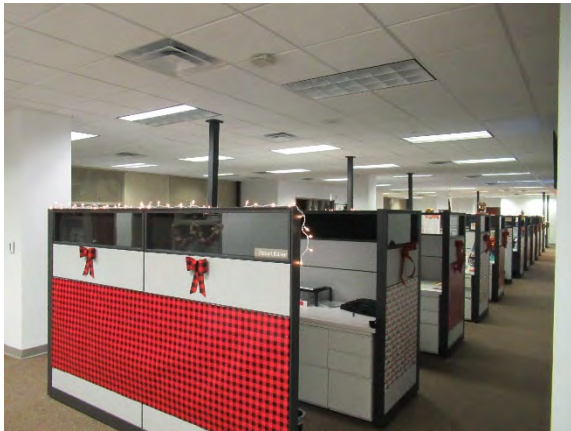
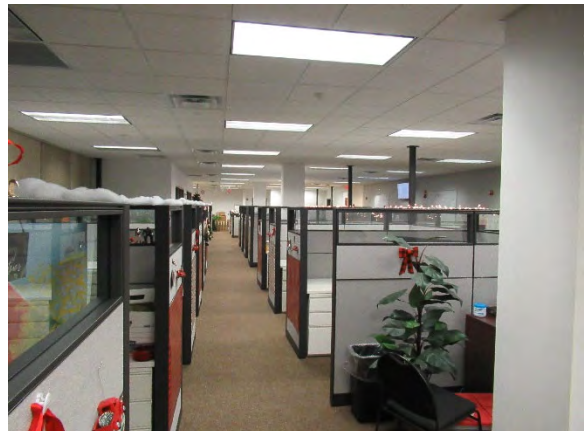
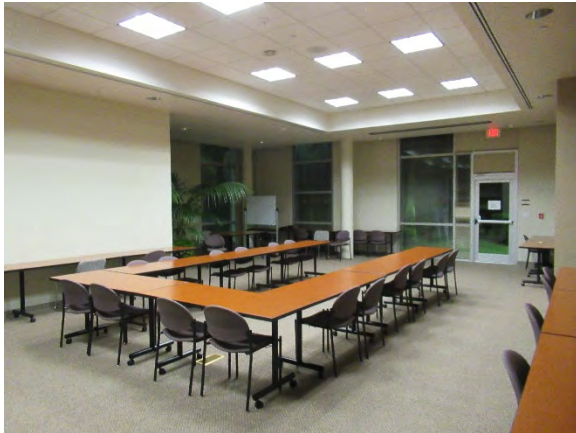
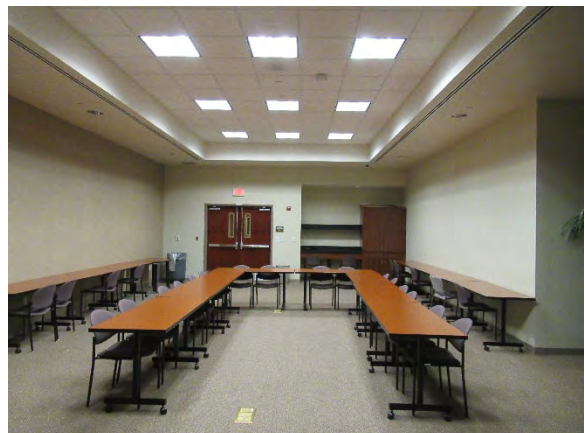
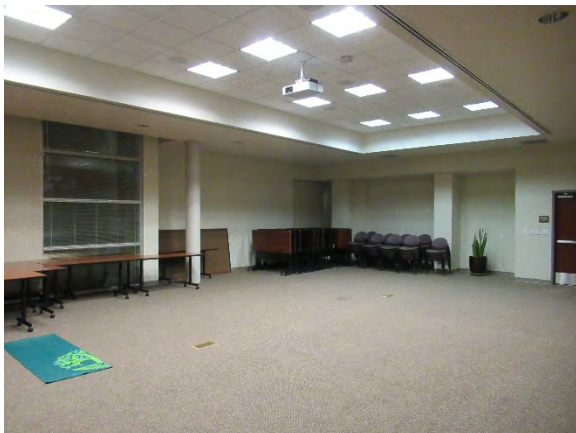
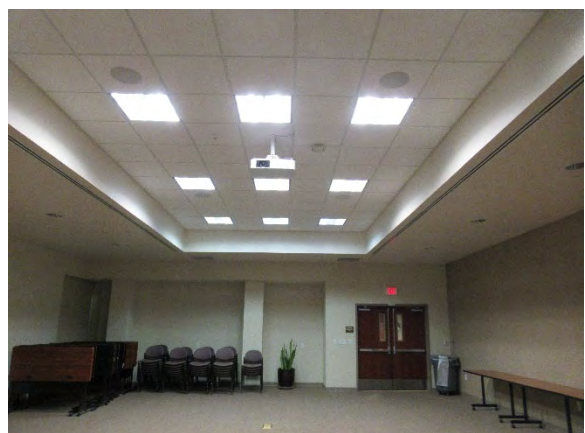
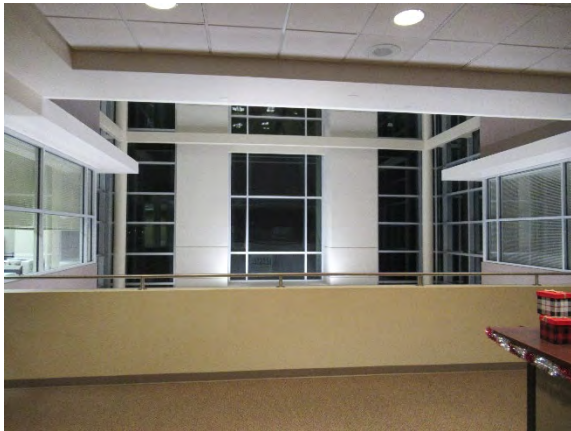
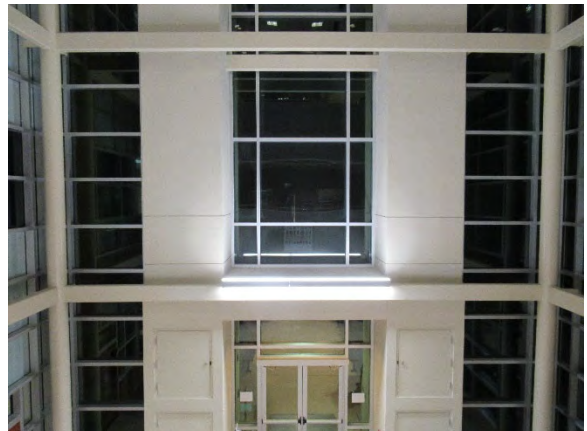
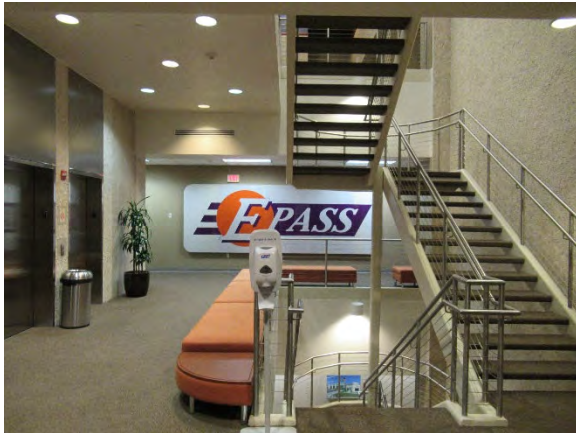
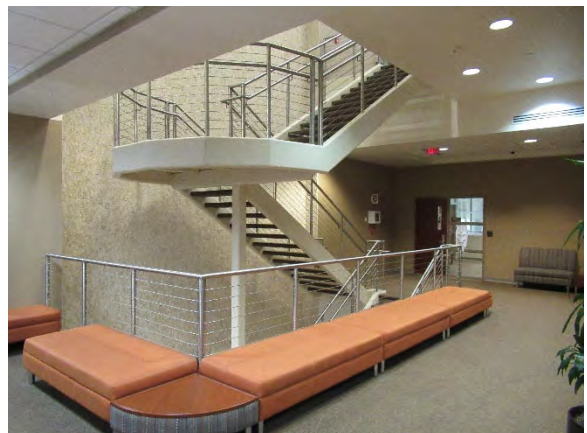
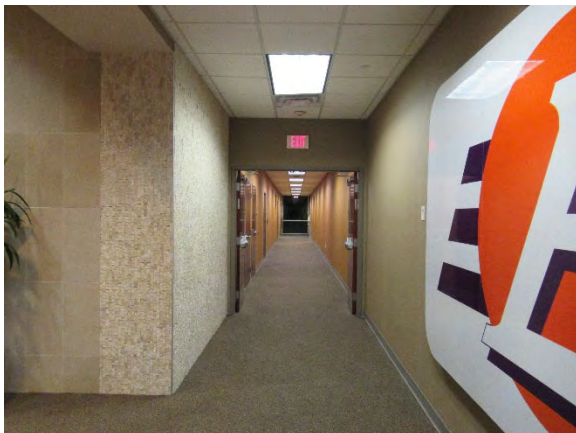
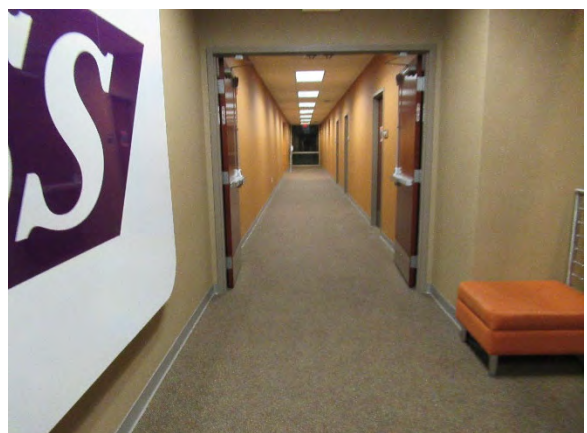
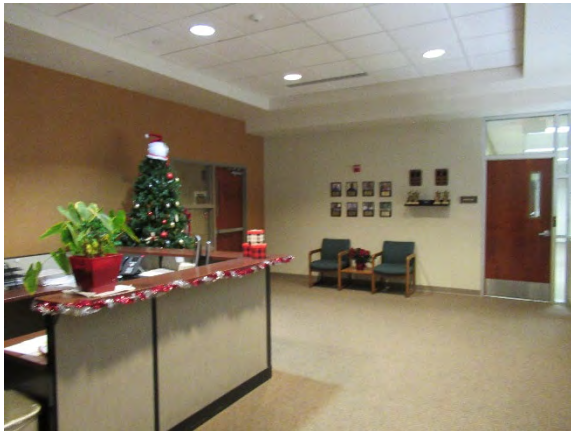
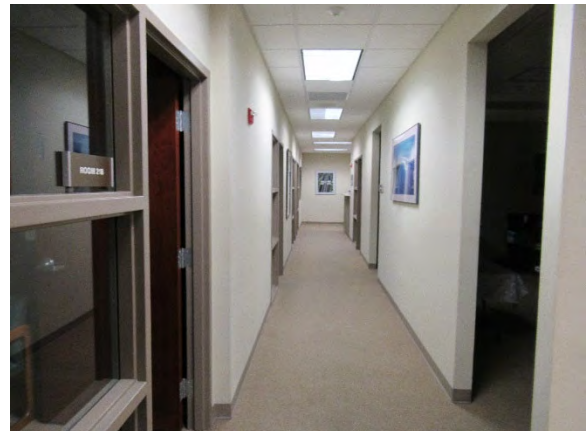
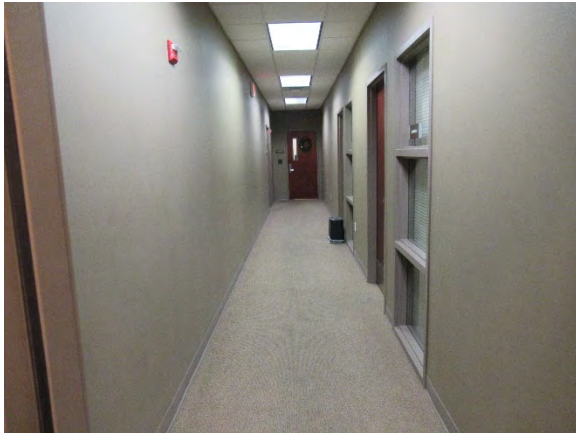
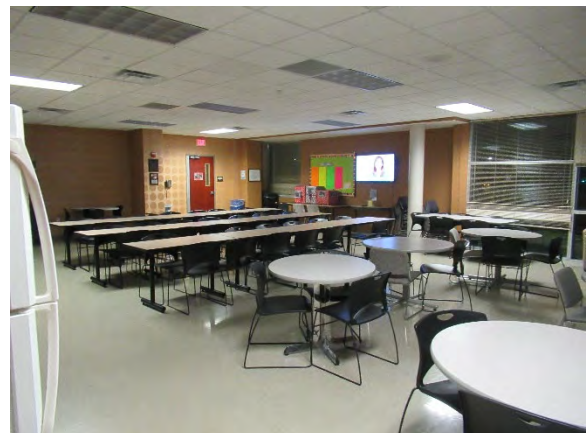
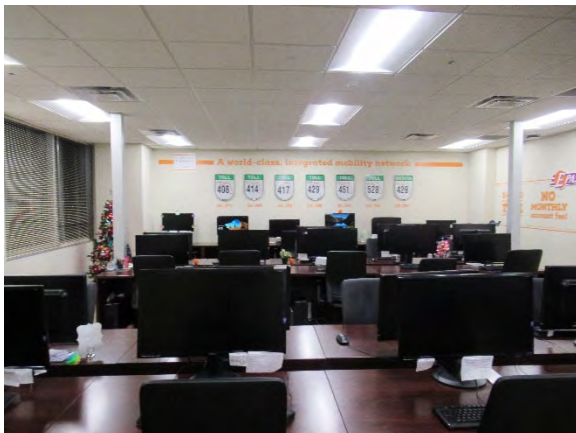
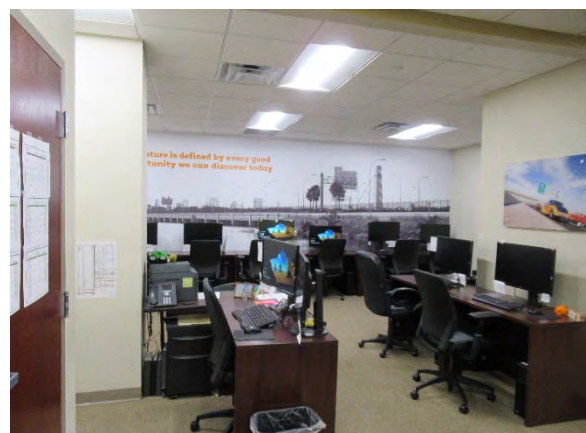
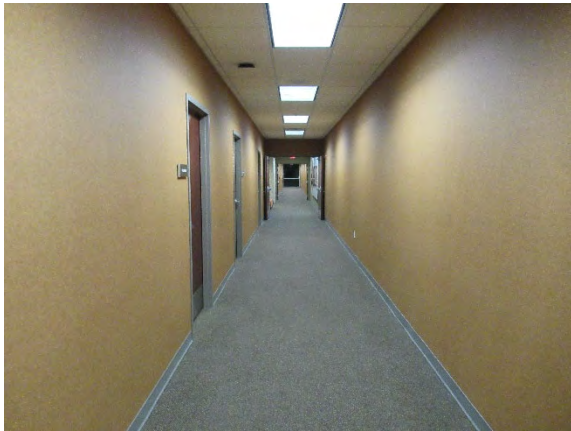
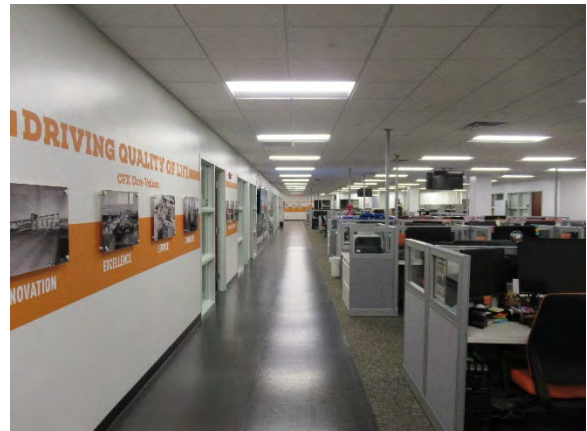
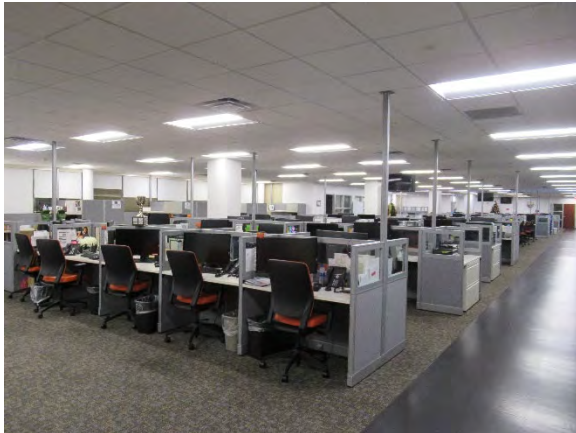
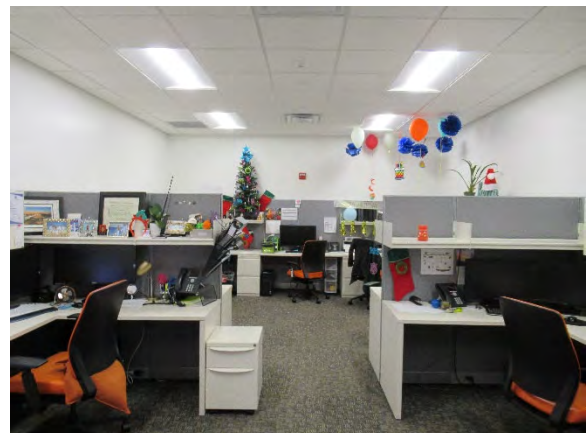
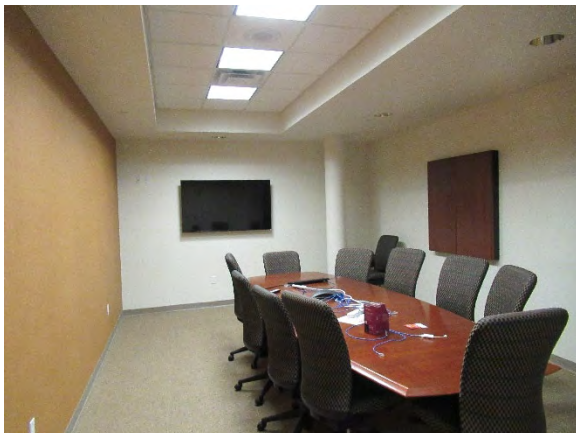
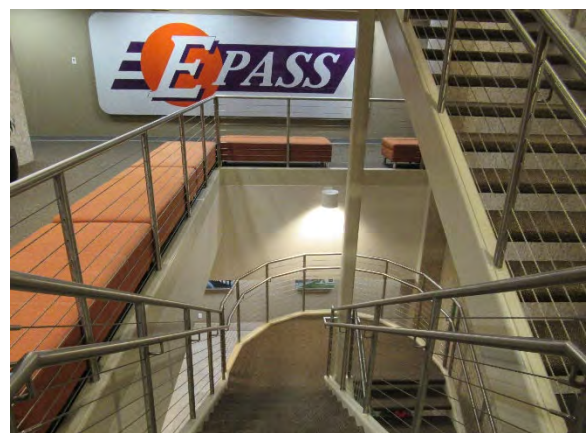
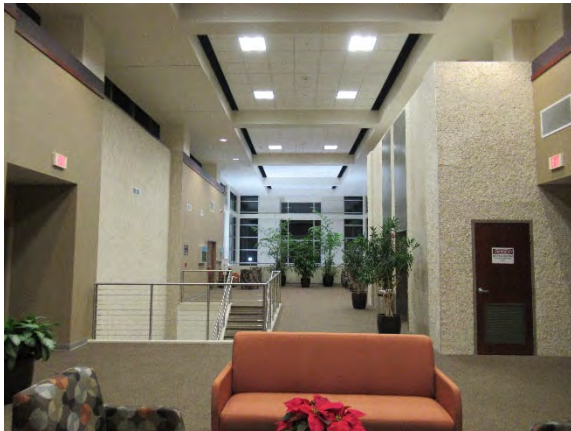
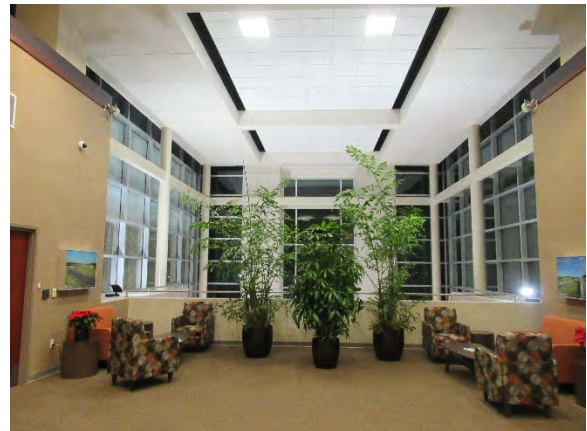
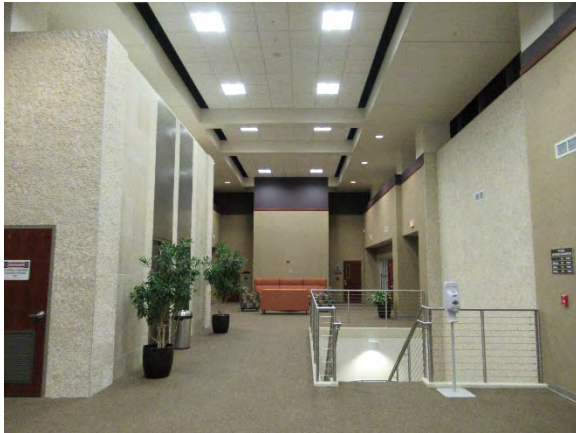
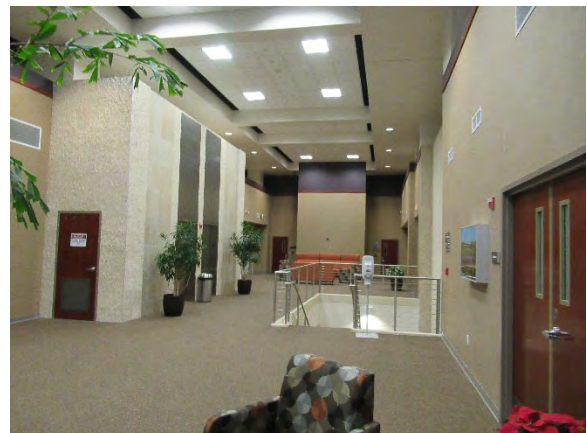
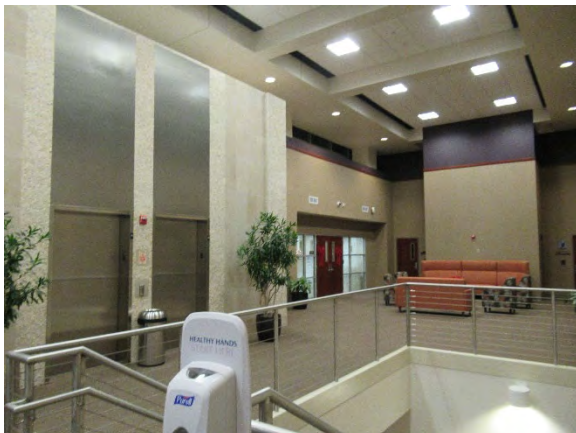
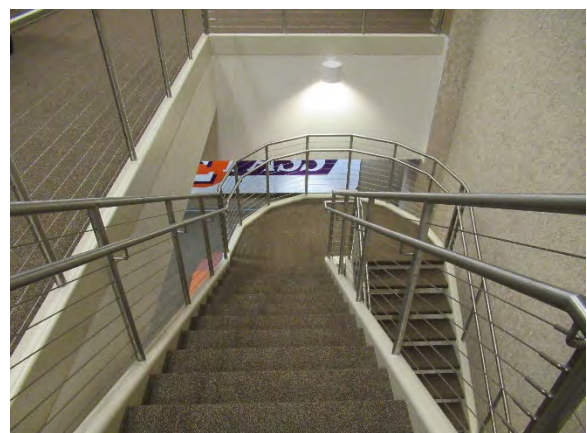
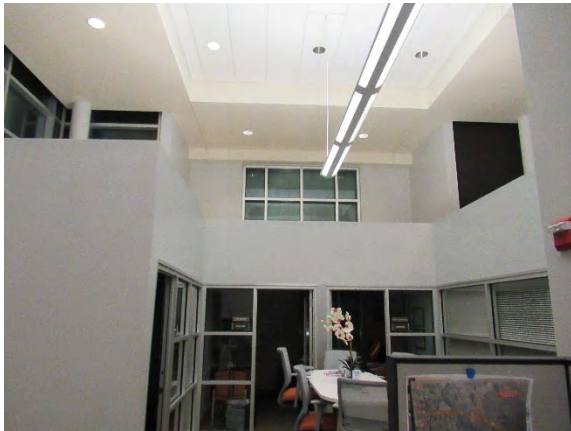
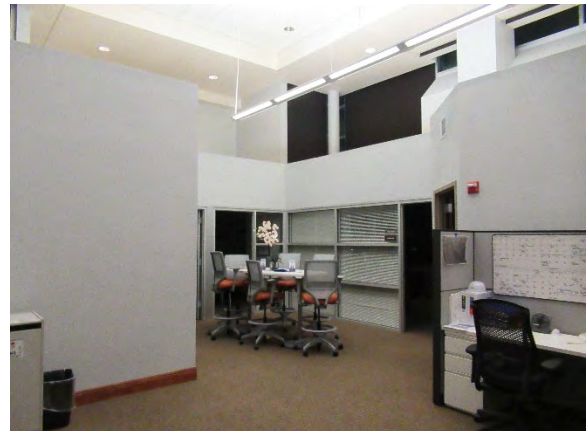
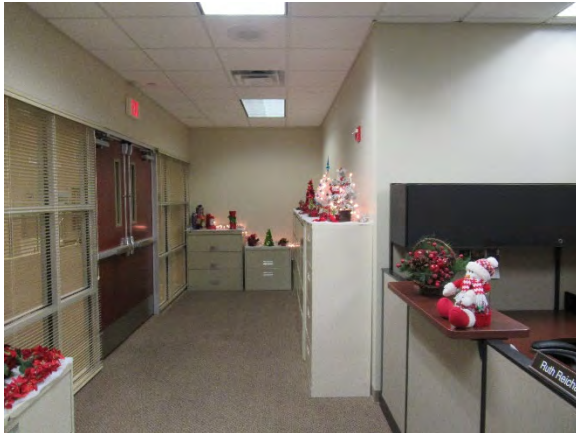
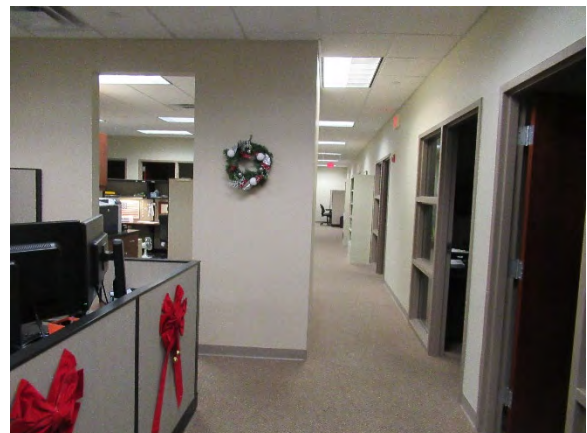
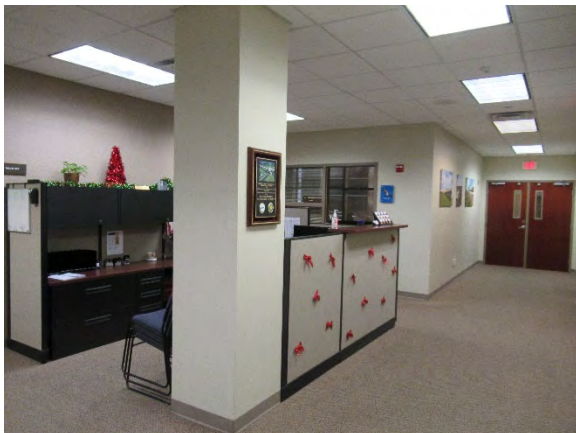
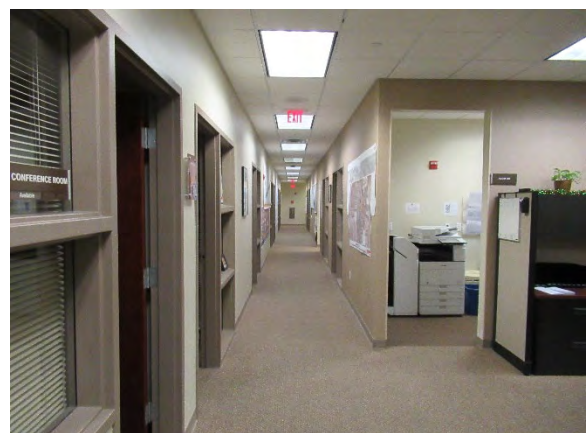
- Building interior is in good condition overall with no identified deficiencies.  
(Figure 13 - Figure 66)

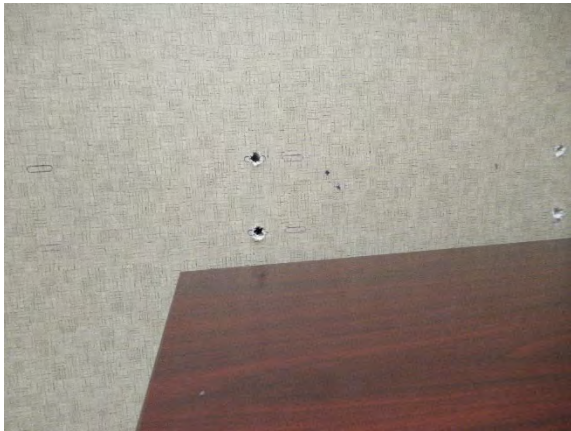
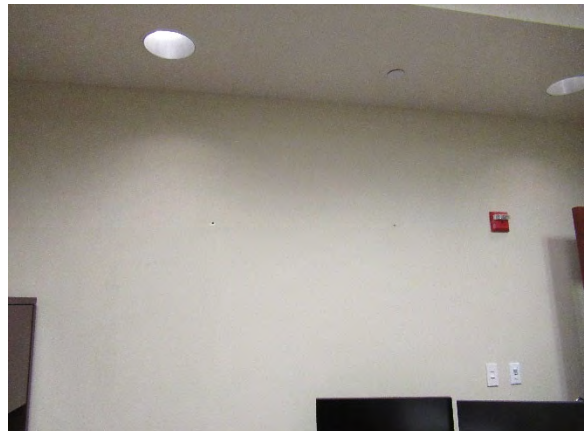
*Figure 67 Building Headquarters First Floor Room 147*

- Identified areas with potential leak above ceiling tile. (Figure 83 & Figure 84)
- Identified areas in need of patch and paint. (Figure 85, Figure 86, Figure 89 & Figure 90)

- Recommend general maintenance to locate potential leaks above ceiling.
- Recommend mechanical contractor inspect HVAC equipment for source of condensation.
- Recommend patch and paint in areas in need of touch up.

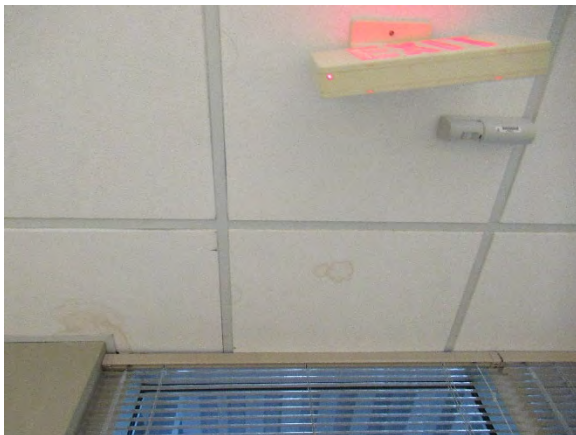
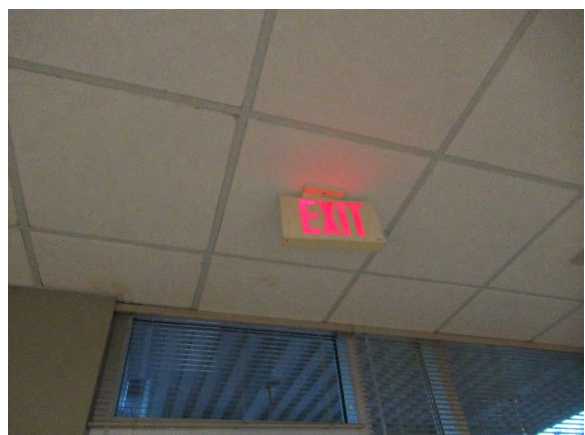
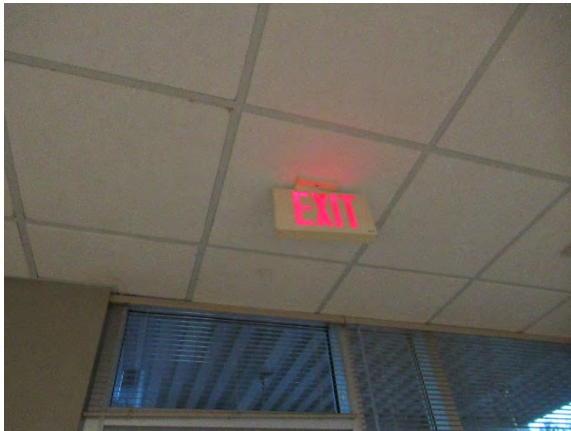
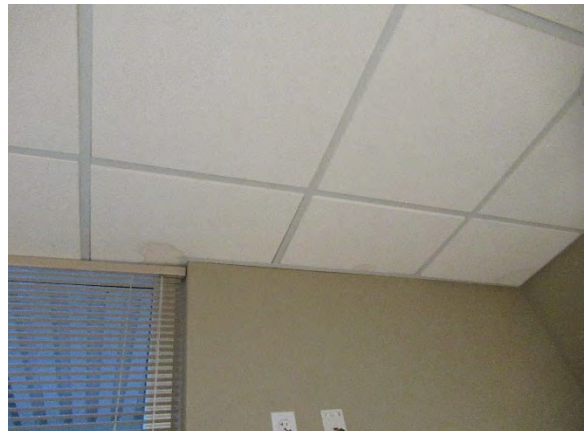
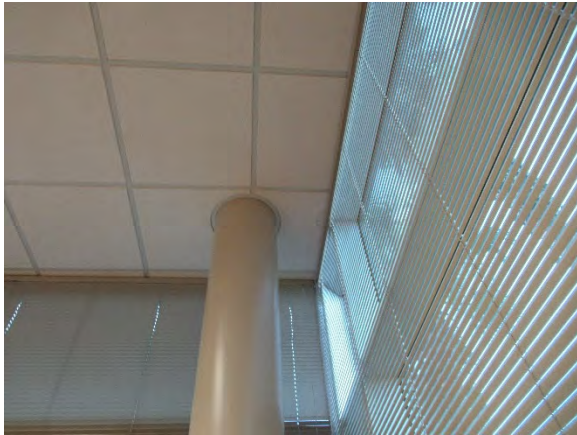
*Figure 71 Building Headquarters First Floor Room 135*

- Identified areas in need of patch and paint. (Figure 67 & Figure 68)
- Identified areas with potential leak above ceiling tile.  
(Figure 71, Figure 72, Figure 73, Figure 74 & Figure 75)

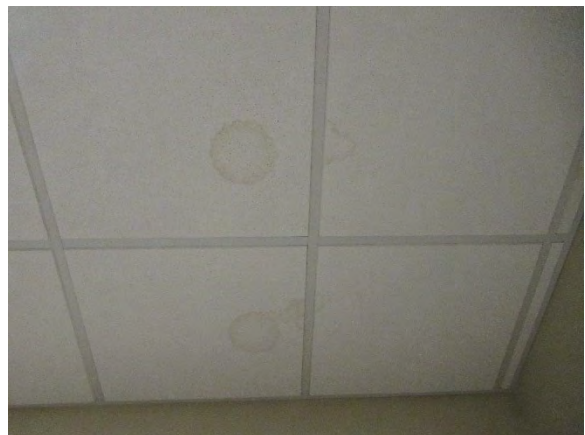
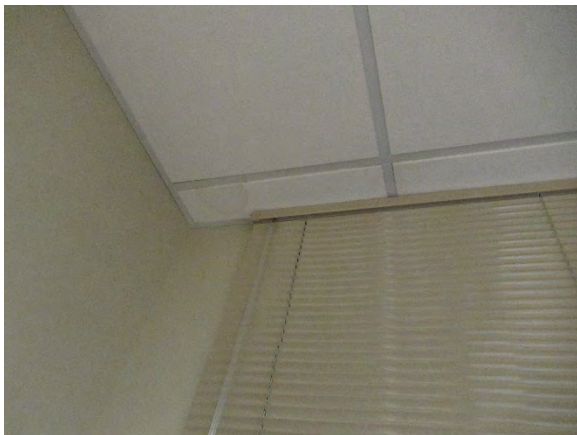
*Figure 76 Building Headquarters Second Floor Room 213*

- Identified areas with potential leak above ceiling tile. (Figure 76 & Figure 77)
- Identified condensation collecting under HVAC equipment in second floor mechanical room 232.  
(Figure 79, Figure 80, Figure 81 & Figure 82)

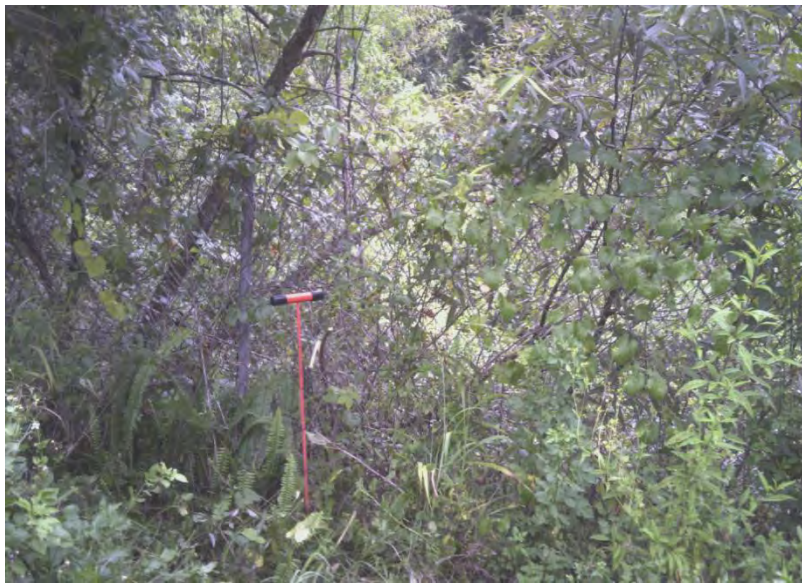
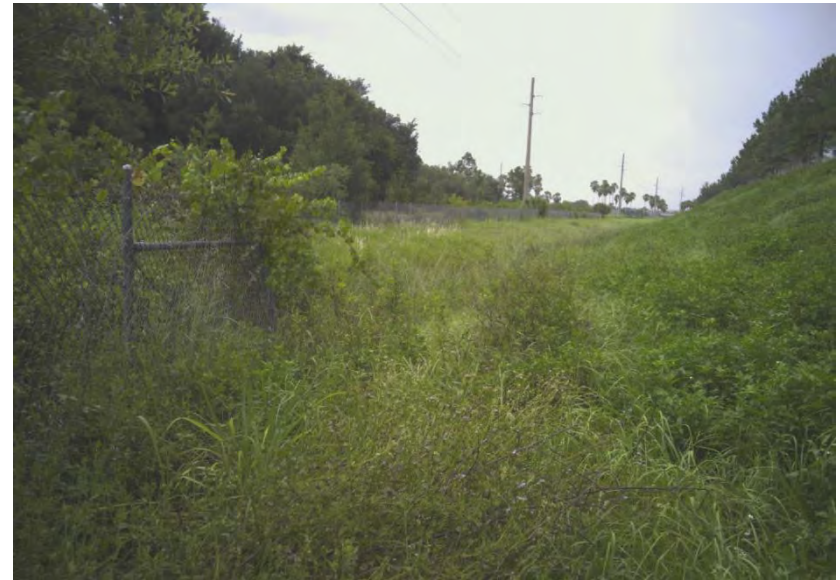
Structure No.	Station	Project No.	End Treatment Type	Pipe Size/Type	Maintenance Rating Level
C-4	950+00	654A	Straight Endwall	10' x 4' CBC	1

- Structure is beyond fence line
- Could not inspect

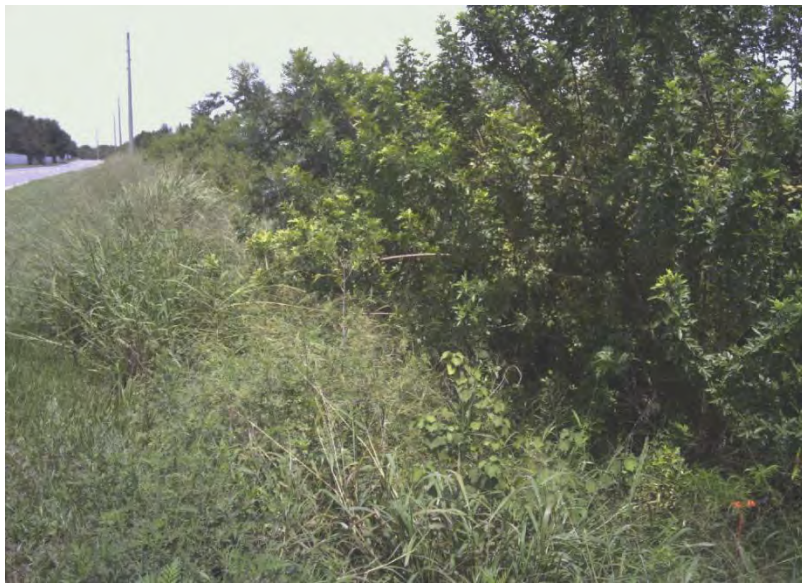
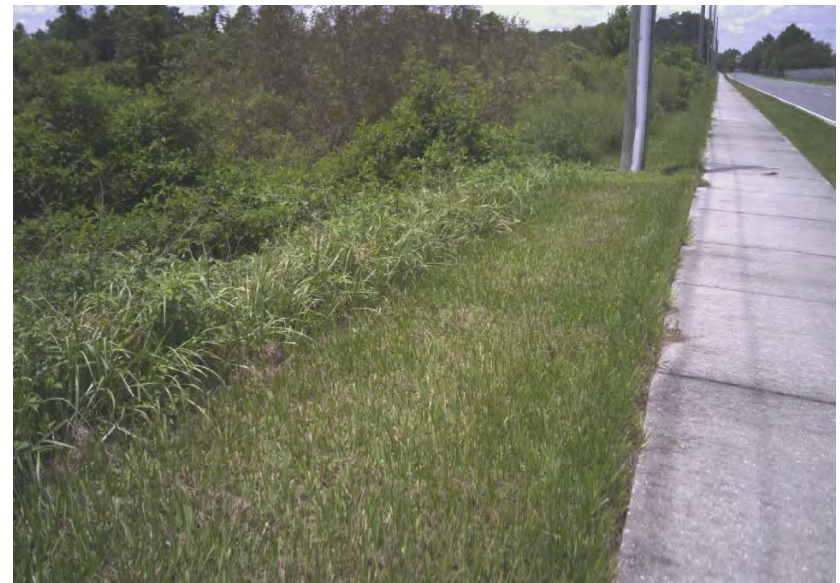
Structure No.	Station	Project No.	End Treatment Type	Pipe Size/Type	Maintenance Rating Level
C-5	996+62	654A	Straight Endwall	10' x 8' CBC	1

- Structure is beyond fence line, fence overgrown with vegetation
- Could not inspect

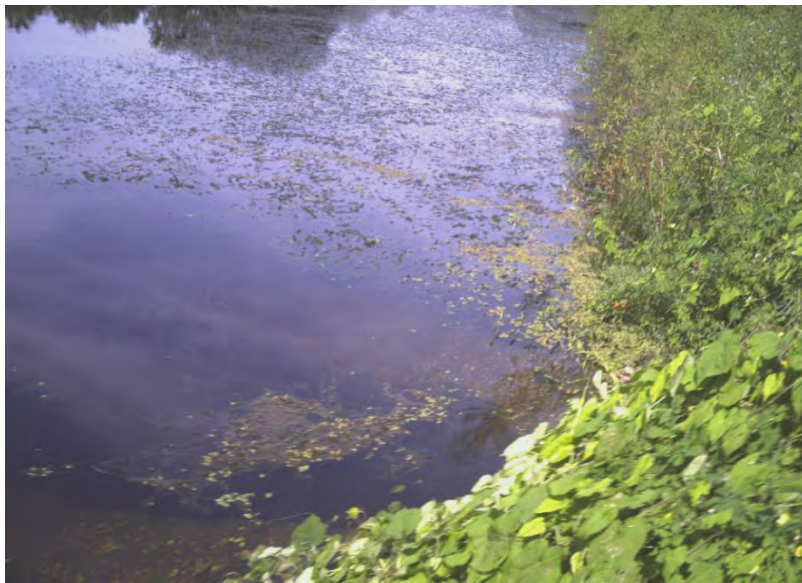
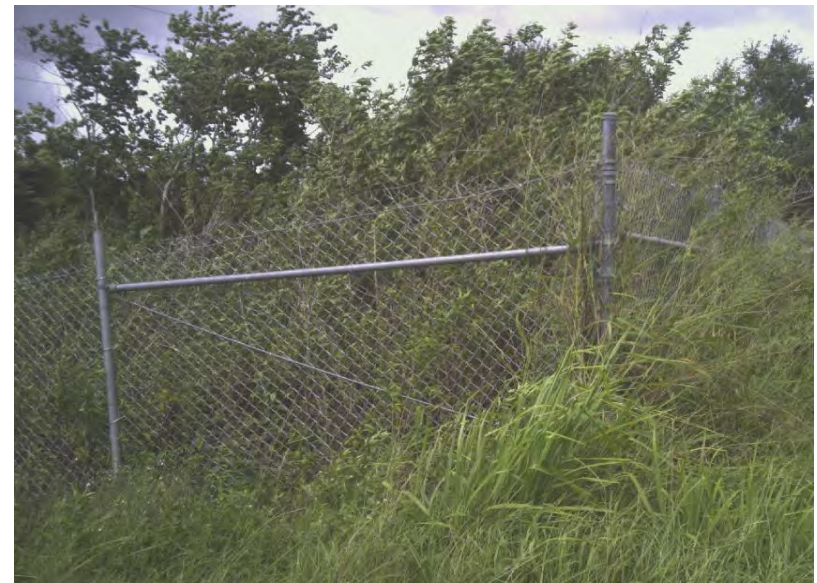
Structure No.	Station	Project No.	End Treatment Type	Pipe Size/Type	Maintenance Rating Level
S-13	1104+40	655	MES	60" RCP	1

- Left Structure is beyond fence line
- Could not inspect on Left side

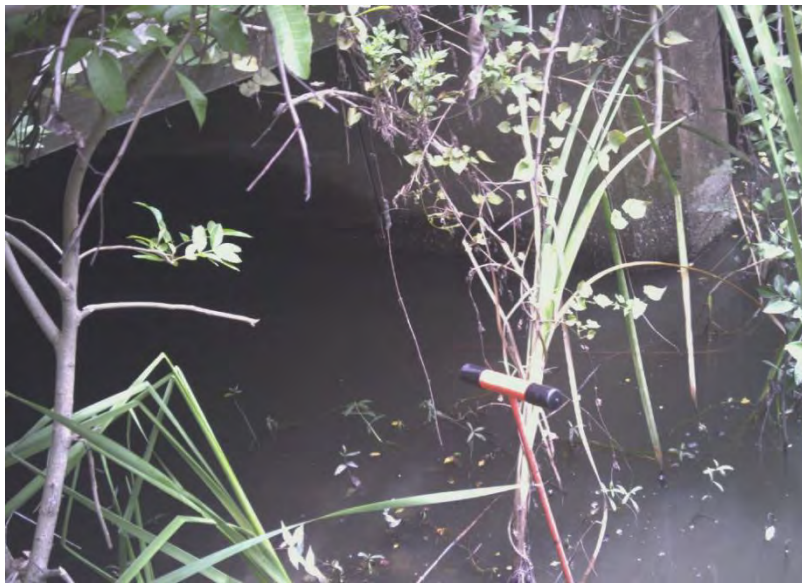
Structure No.	Station	Project No.	End Treatment Type	Pipe Size/Type	Maintenance Rating Level
OS-1	157+00	602	Straight Endwall	3 - 8' x 5' CBC	1

- Left Structure heavy vegetation. Right Structure beyond fence line
- Could not inspect Right structure
- Damage to fence

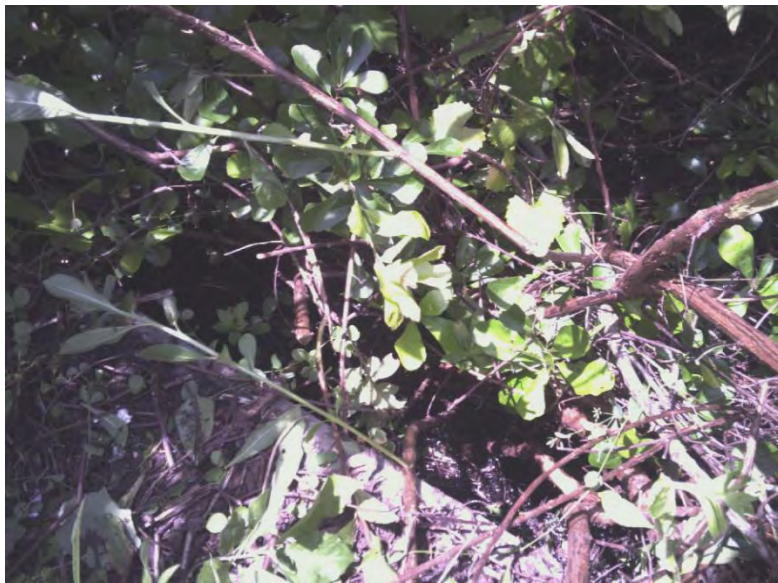
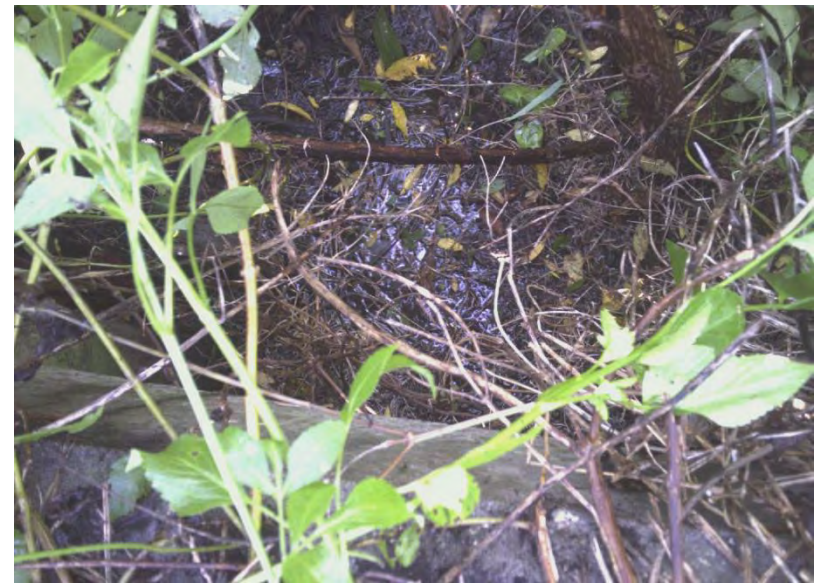
Structure No.	Station	Project No.	End Treatment Type	Pipe Size/Type	Maintenance Rating Level
OS-11	300+00	603	Straight Endwall	3 - 34" x 53" RCP	1

- Both ends covered in heavy vegetation

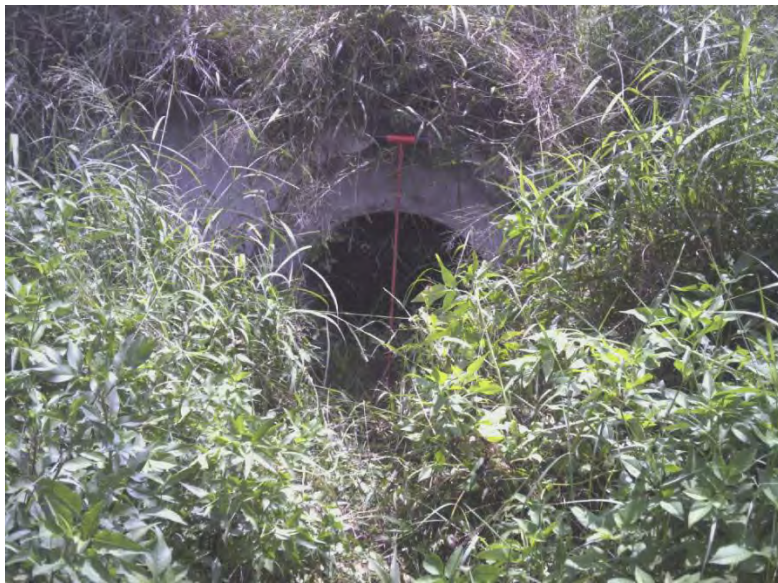
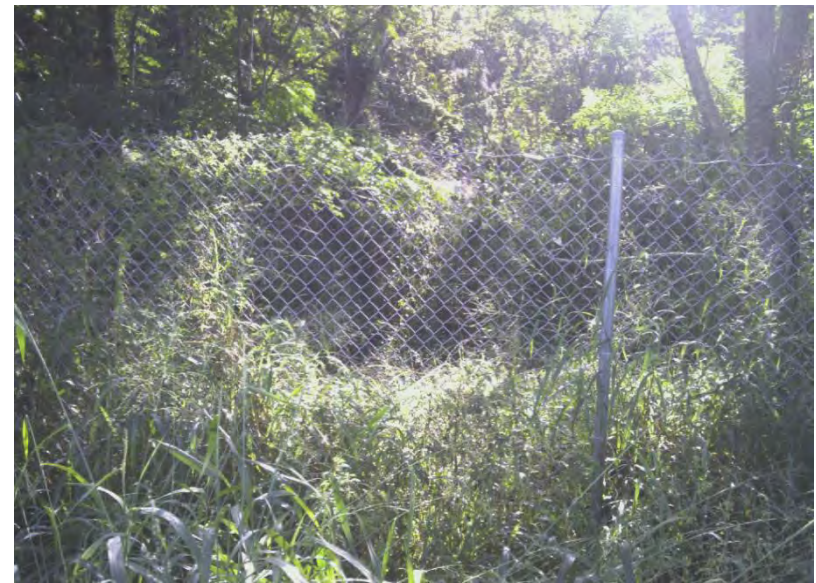
Structure No.	Station	Project No.	End Treatment Type	Pipe Size/Type	Maintenance Rating Level
CD-1	587+00	201	Straight Endwall	36" RCP	1

- Right Structure is beyond fence line, Left Structure heavy vegetation
- Could not inspect Right Structure

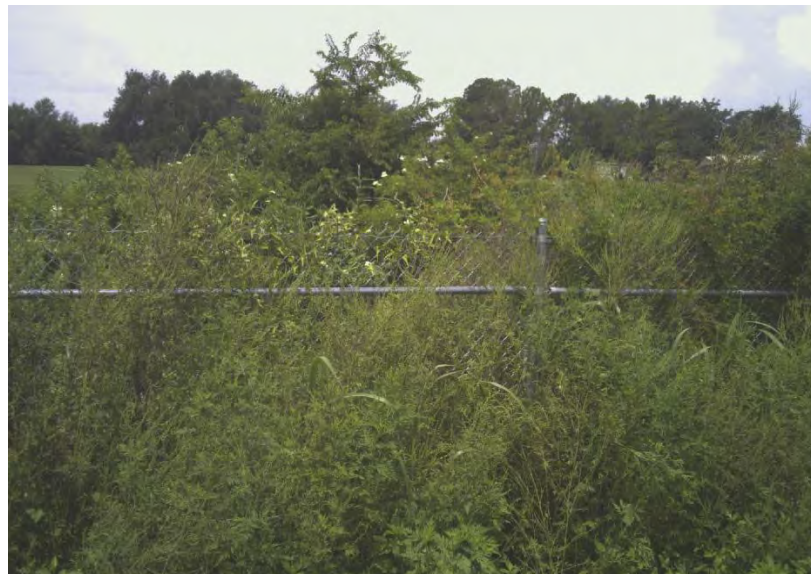
Structure No.	Station	Project No.	End Treatment Type	Pipe Size/Type	Maintenance Rating Level
CD-2	605+00	201	Straight Endwall	30" RCP	1

- Structure is beyond fence line
- Could not inspect

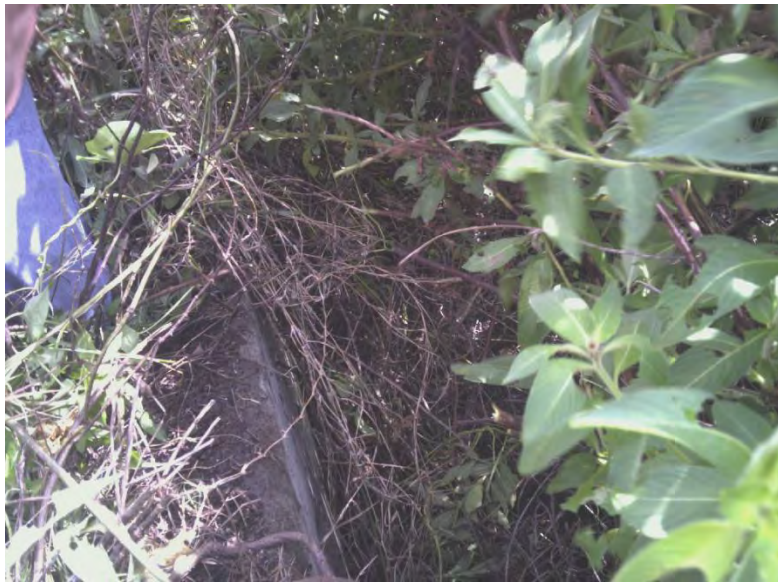
Structure No.	Station	Project No.	End Treatment Type	Pipe Size/Type	Maintenance Rating Level
CD-4	640+00	201	Straight Endwall	2 - 42" RCP	1

- Heavy vegetation surrounding structures
- 24" of sediment observed in 42" pipes

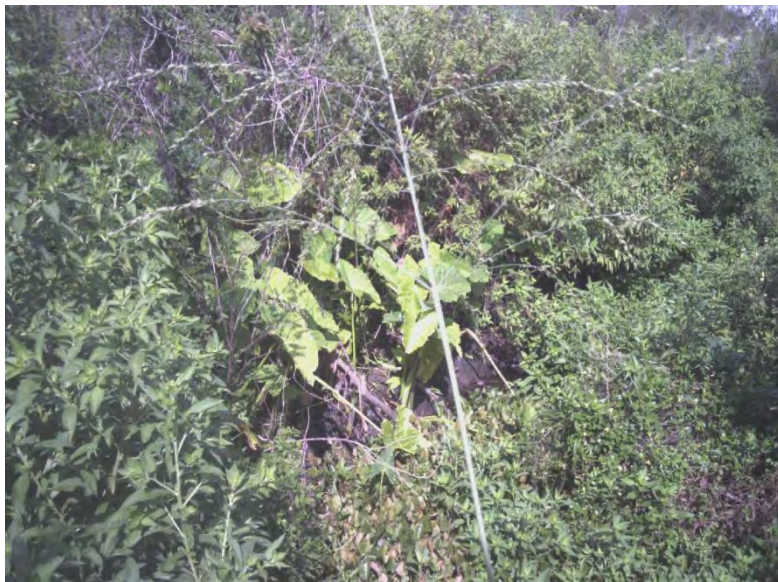
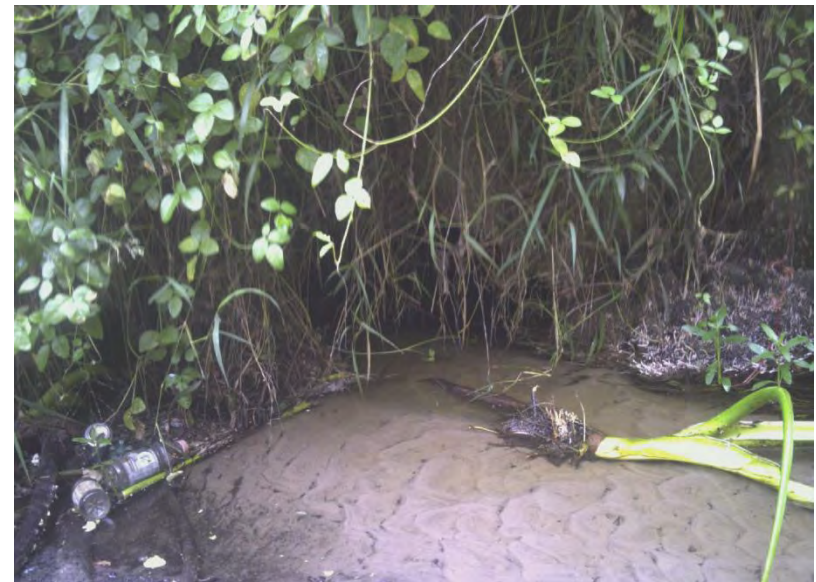
Structure No.	Station	Project No.	End Treatment Type	Pipe Size/Type	Maintenance Rating Level
S-5	621+92	451-604	Straight Endwall	84" RCP	1

- Heavy vegetation surrounding structures, Left structure beyond fence
- 60" of sediment measured in 84" pipe on Right structure

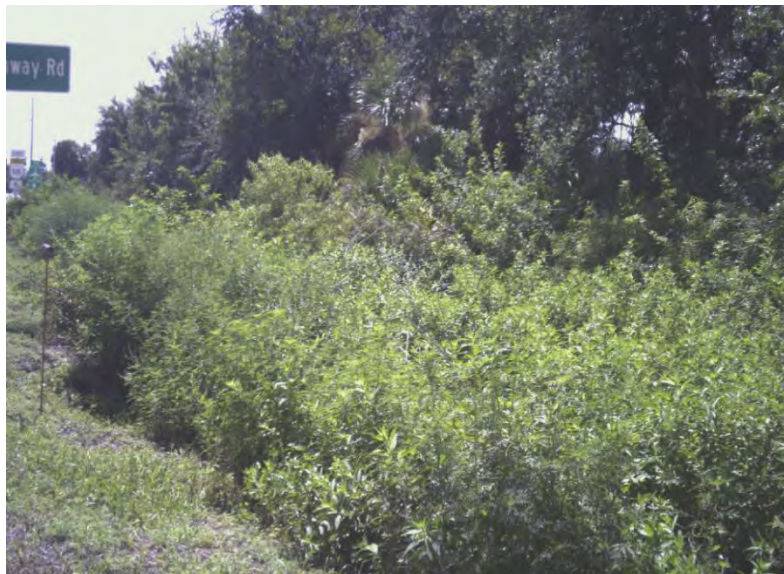
Structure No.	Station	Project No.	End Treatment Type	Pipe Size/Type	Maintenance Rating Level
N/A	684+00	405	Straight Endwall to DBI	N/A	1

- Structure overgrown with heavy vegetation

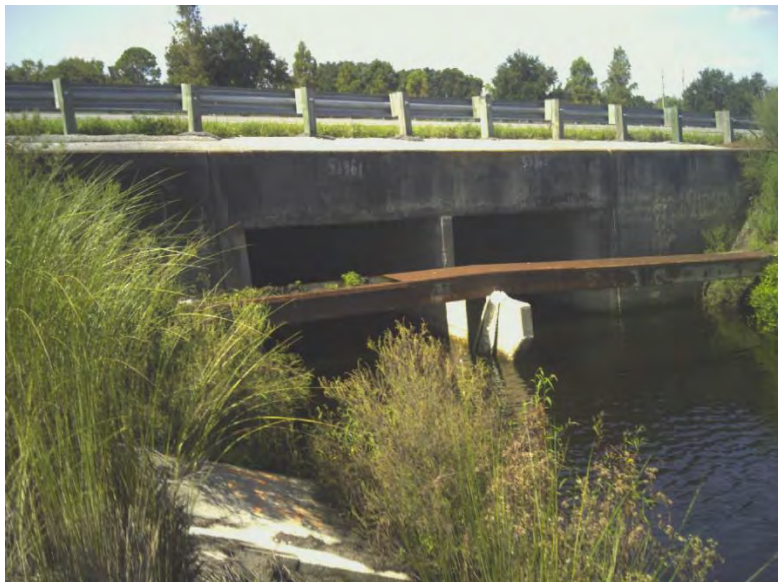
Structure No.	Station	Project No.	End Treatment Type	Pipe Size/Type	Maintenance Rating Level
CD-2	759+00	405	Straight Endwall	2 - 9' x 10' CBC	1

- Concrete flume near Right end damaged
- 6" of scour on Right structure

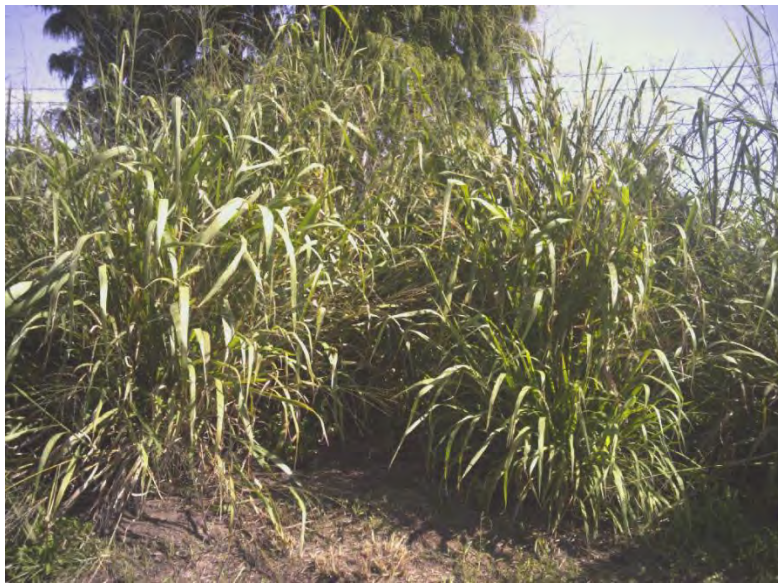
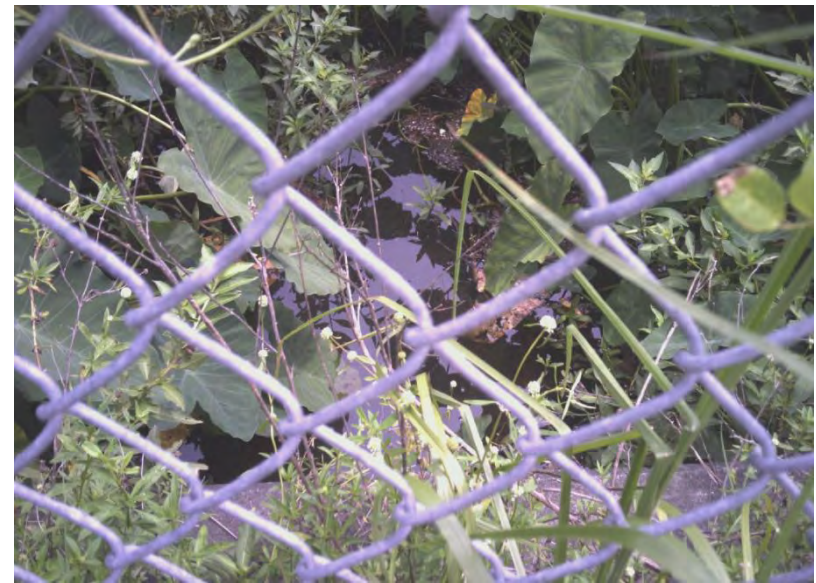
Structure No.	Station	Project No.	End Treatment Type	Pipe Size/Type	Maintenance Rating Level
S-1	898+50	900	Straight Endwall	2 - 4' x 6' CBC	1

- Both end structures behind R/W fence line
- Could not inspect

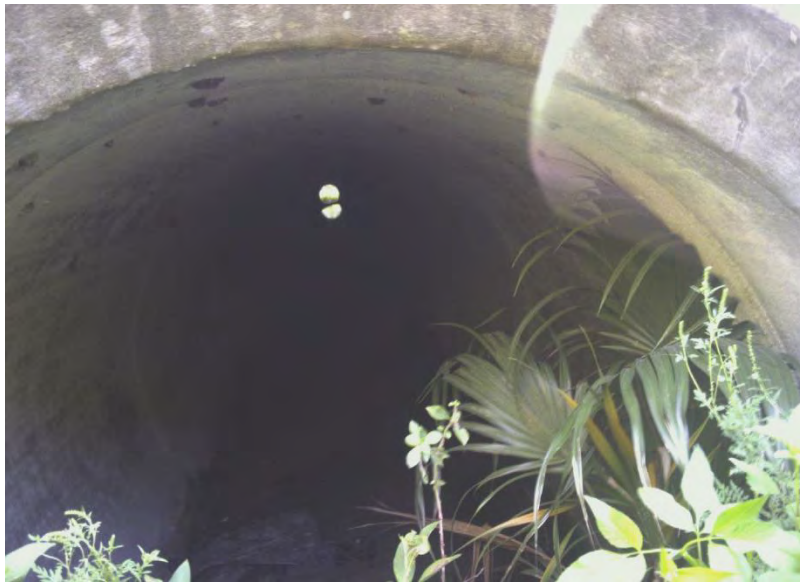
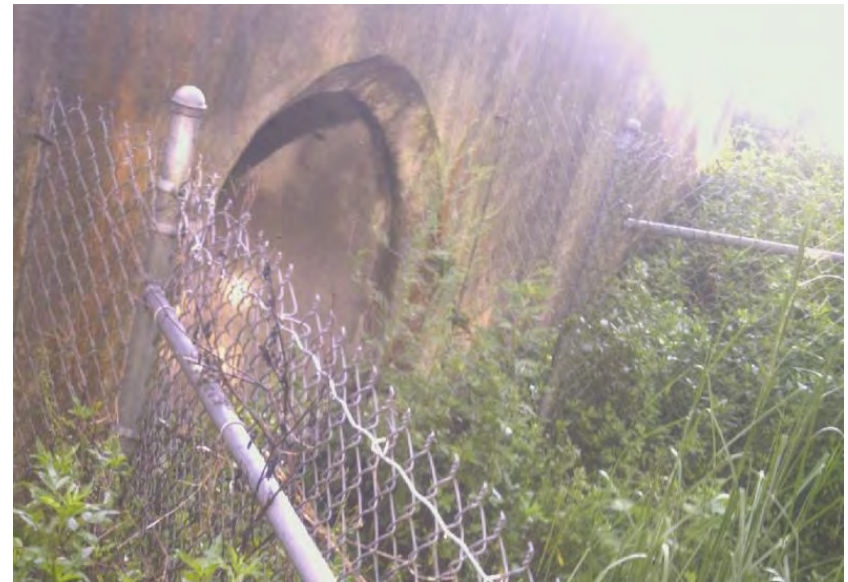
Structure No.	Station	Project No.	End Treatment Type	Pipe Size/Type	Maintenance Rating Level
S-27	433+50	450	Straight Endwall	72" RCP	1

- 12" of sediment measured on both ends
