# 2019

# Annual Inspection Report

Mr. Glenn Pressimone, P.E.  
Chief of Infrastructure  
Central Florida Expressway Authority  
4974 ORL Tower Road  
Orlando, Florida 32807

Re: 2019 Annual Inspection Report

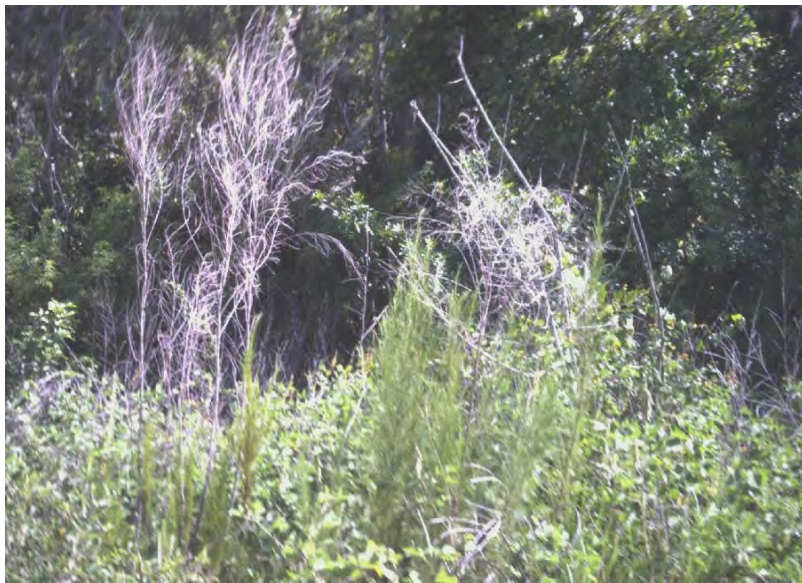
Structure No.	Station	Project No.	End Treatment Type	Pipe Size/Type	Maintenance Rating Level
S-5	685+00	451	Straight Endwall	2 - 9' x 3' CBC	1

- Right structure covered in heavy vegetation, structure not observed

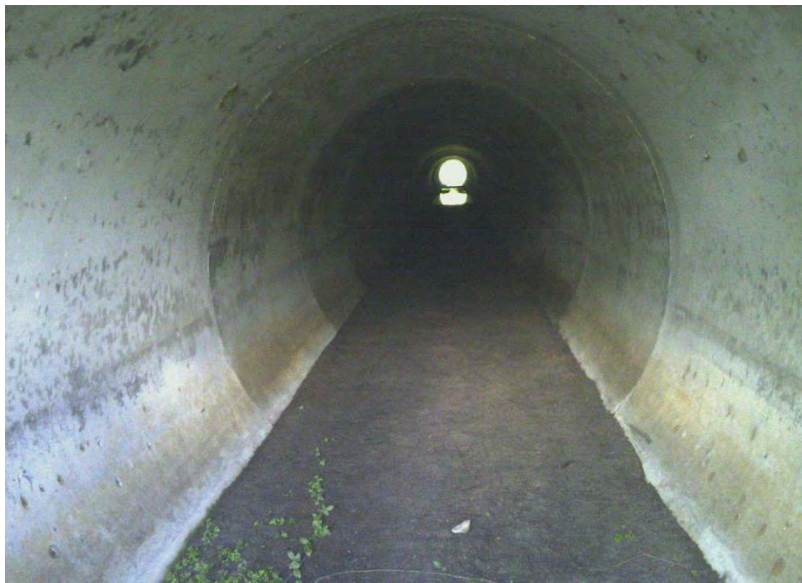
Structure No.	Station	Project No.	End Treatment Type	Pipe Size/Type	Maintenance Rating Level
B-30	687+50	451	Straight Endwall	84" RCP	1

- Left structure covered in heavy vegetation, structure not observed
- Left structure: 13" of sediment observed in 84" pipe

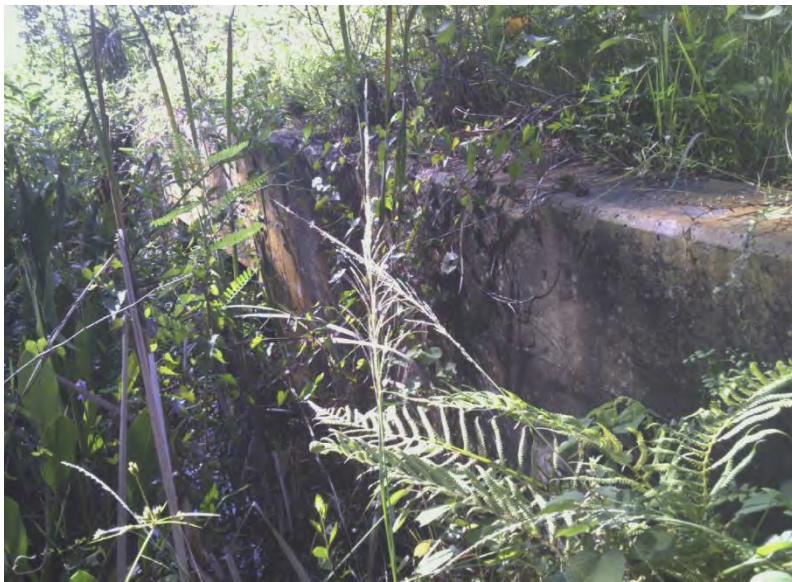
Structure No.	Station	Project No.	End Treatment Type	Pipe Size/Type	Maintenance Rating Level
S-6	692+40	451	Straight Endwall	8' x 3' CBC	1

- Up to 16" of sediment observed in 8' x 3' CBC
- Moderate vegetation around culvert openings

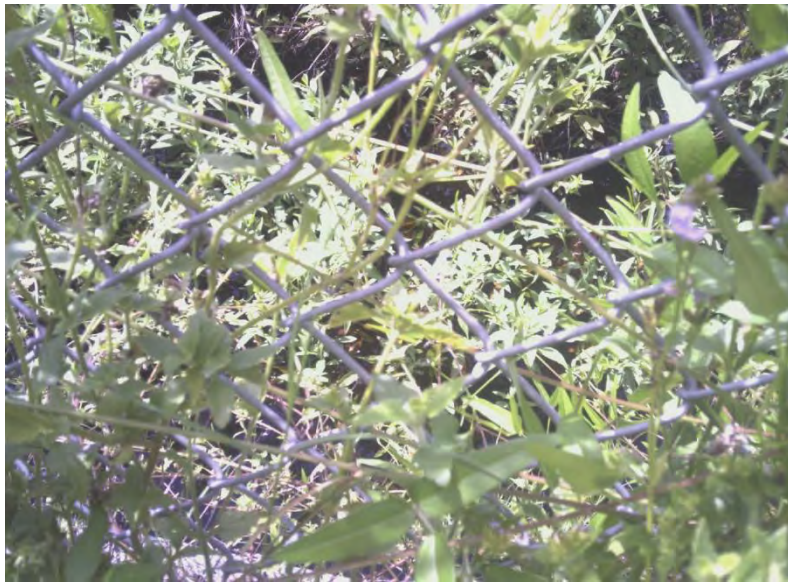
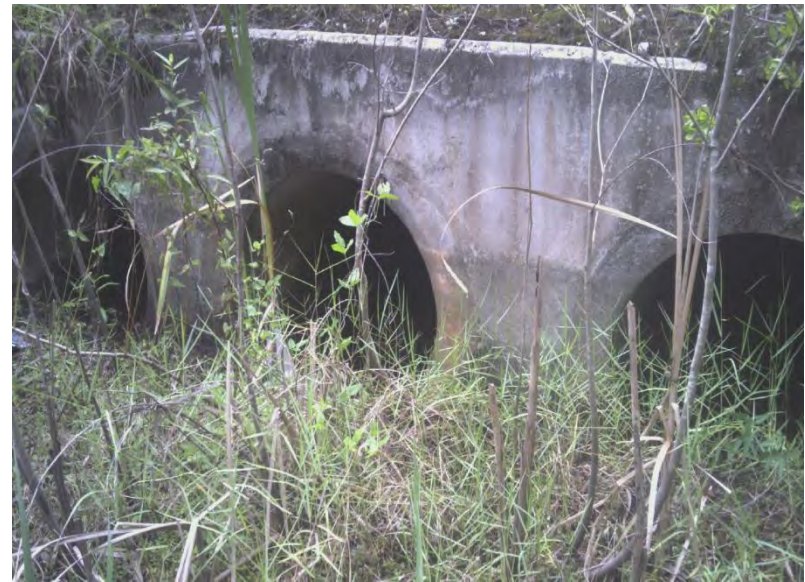
Structure No.	Station	Project No.	End Treatment Type	Pipe Size/Type	Maintenance Rating Level
S-8	747+00	451	Straight Endwall	4 - 36" RCP	1

- Right structure behind fence line
- Could not inspect Right structure

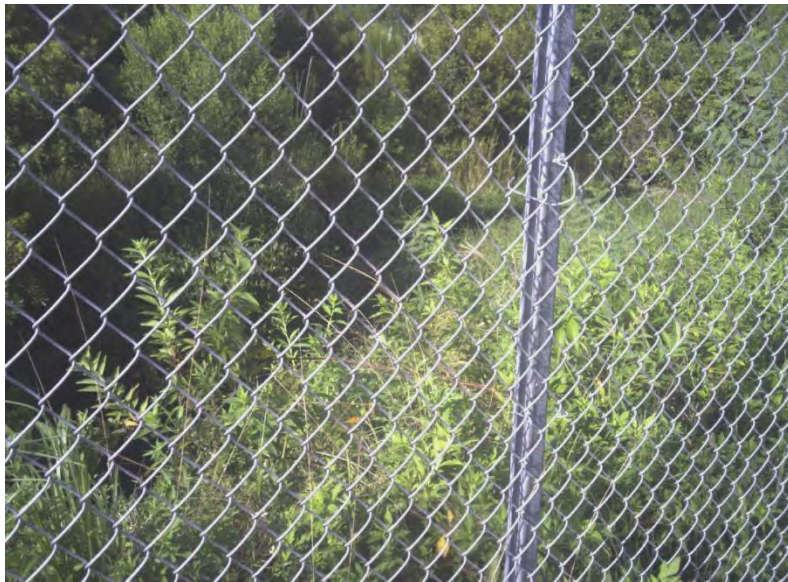
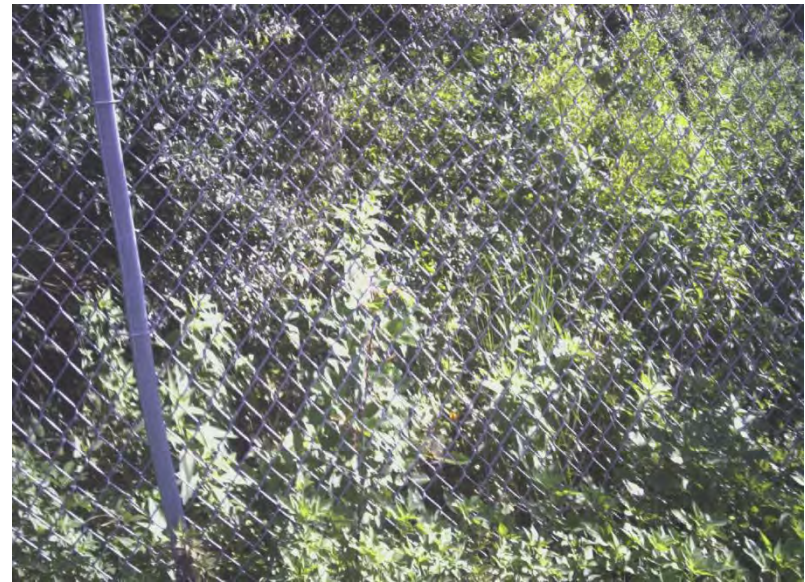
Structure No.	Station	Project No.	End Treatment Type	Pipe Size/Type	Maintenance Rating Level
S-63A	887+57	453	Straight Endwall	2 - 9' x 4' CBC	1

- Structures beyond fence line
- Could not inspect

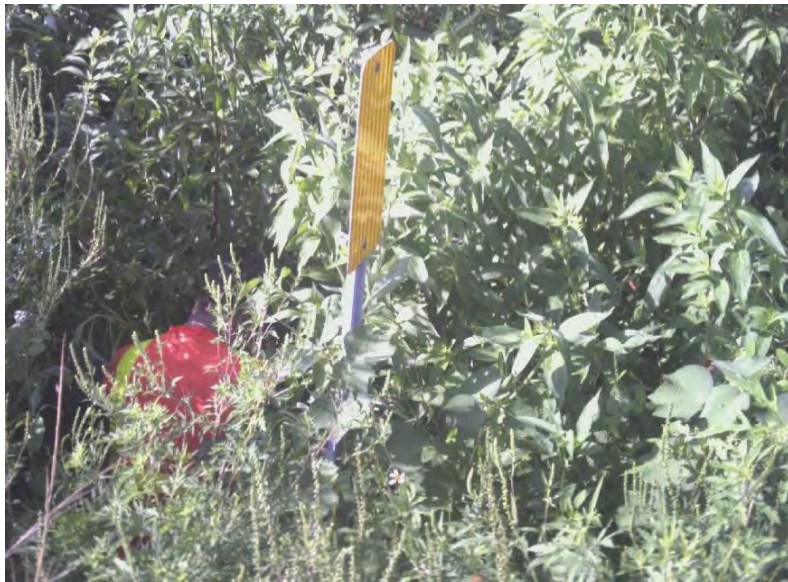
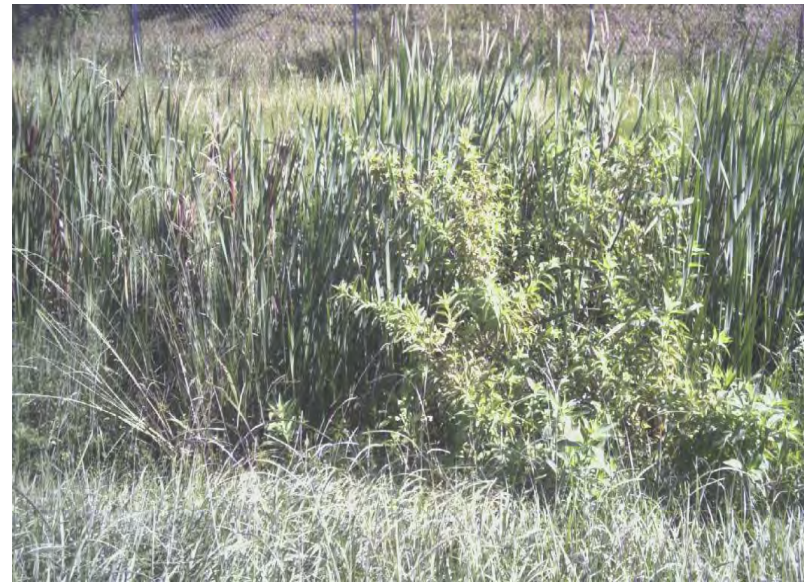
Structure No.	Station	Project No.	End Treatment Type	Pipe Size/Type	Maintenance Rating Level
S-73	923+25	453	MES	3 - 29" x 45" RCP	1

- Heavy vegetation surrounding structures
- Difficult access for maintenance

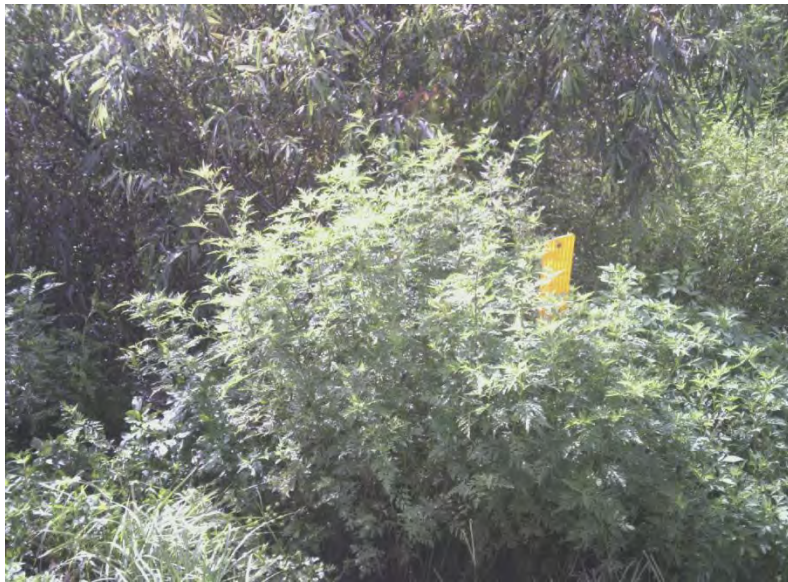
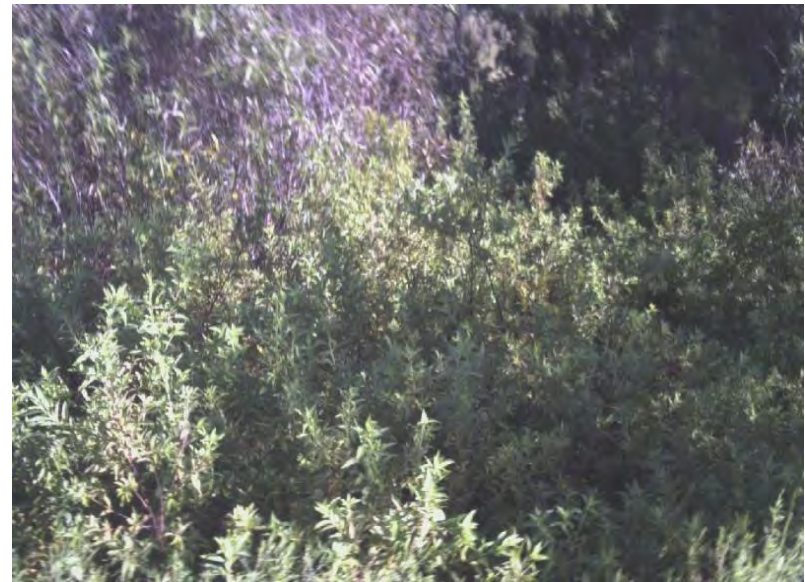
Structure No.	Station	Project No.	End Treatment Type	Pipe Size/Type	Maintenance Rating Level
S-520 to S-521	1021+15	454	MES	2 - 38" x 60" RCP	1

- Heavy vegetation surrounding structures, difficult access
- 16" Sediment measured

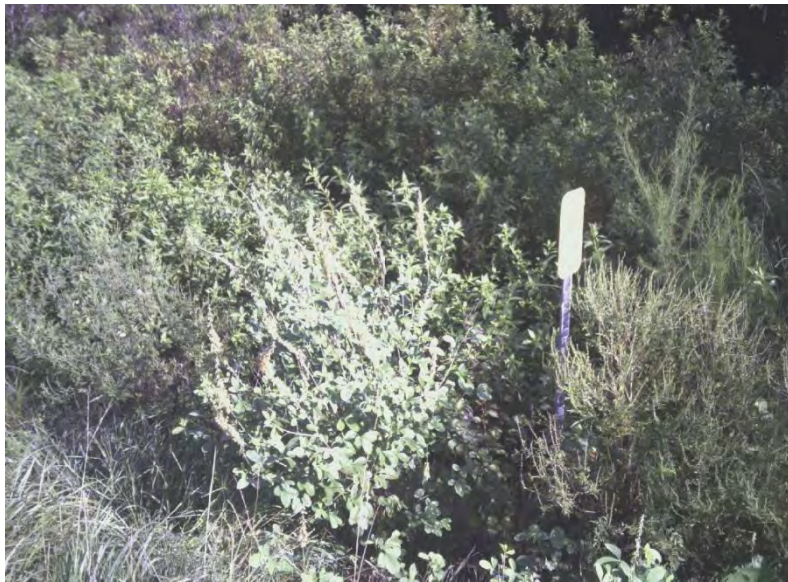
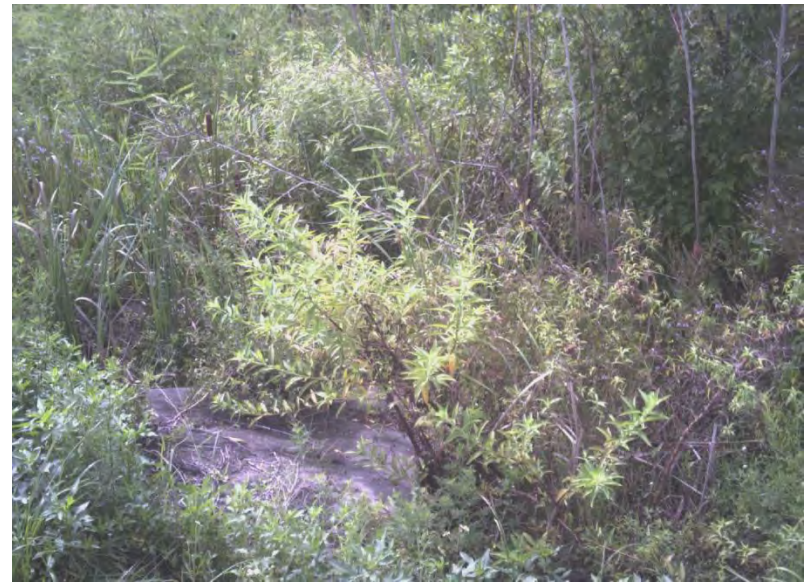
Structure No.	Station	Project No.	End Treatment Type	Pipe Size/Type	Maintenance Rating Level
S-523A to S-523B	1022+70	454	MES	2 - 38" x 60" RCP	1

- Heavy vegetation surrounding structures, difficult access
- 8" Sediment measured

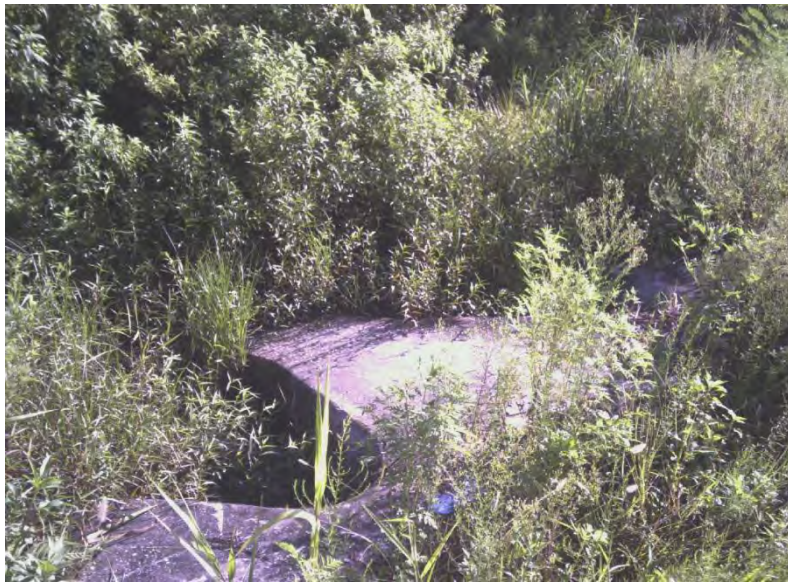
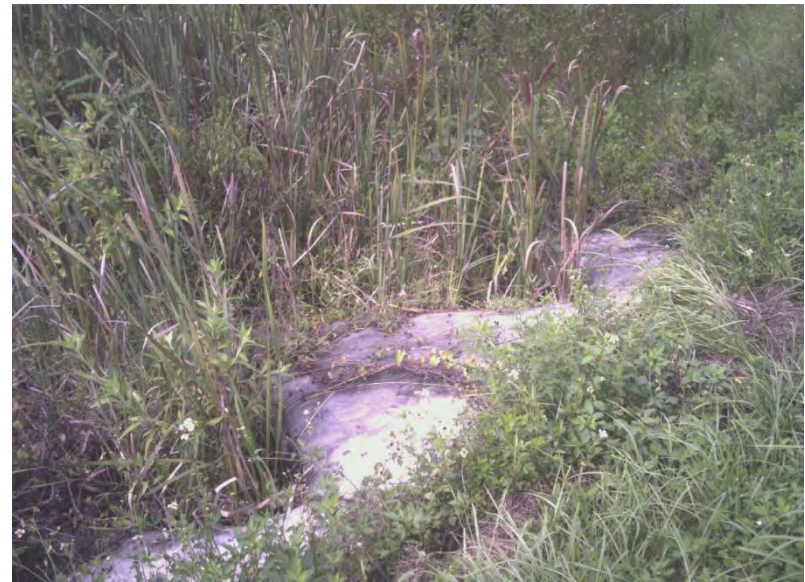
Structure No.	Station	Project No.	End Treatment Type	Pipe Size/Type	Maintenance Rating Level
S-523C to S-523D	1024+30	454	MES	2 - 38" x 60" RCP	1

- Heavy vegetation surrounding structures, difficult access
- 9" Sediment measured

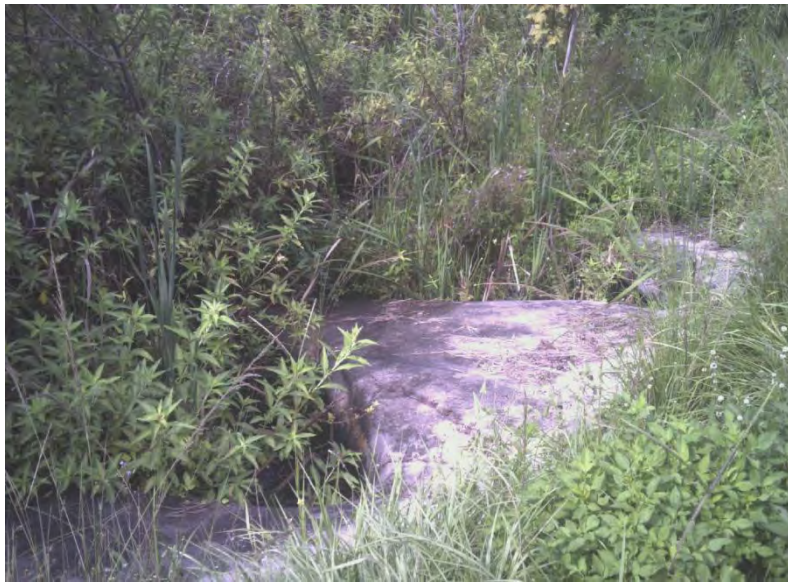
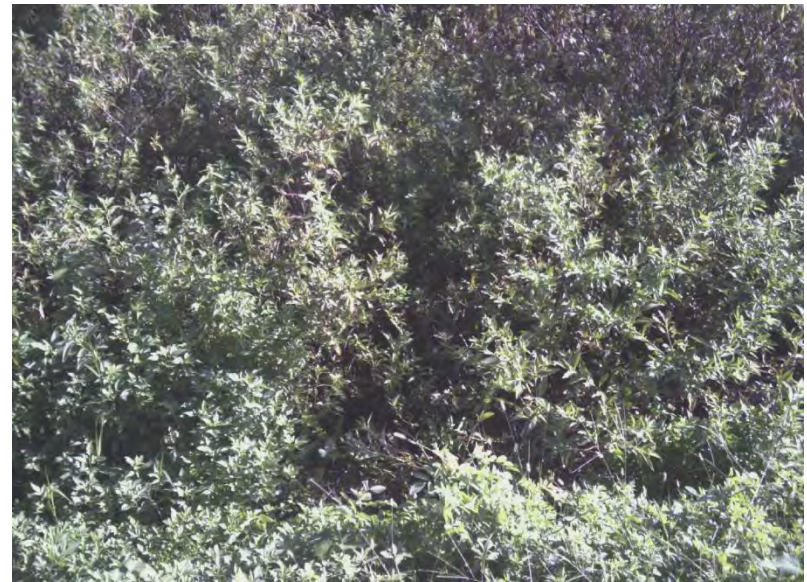
Structure No.	Station	Project No.	End Treatment Type	Pipe Size/Type	Maintenance Rating Level
S-525 to S-526	1025+85	454	MES	2 - 38" x 60" RCP	1

- Heavy vegetation surrounding structures, difficult access
- 9" Sediment measured

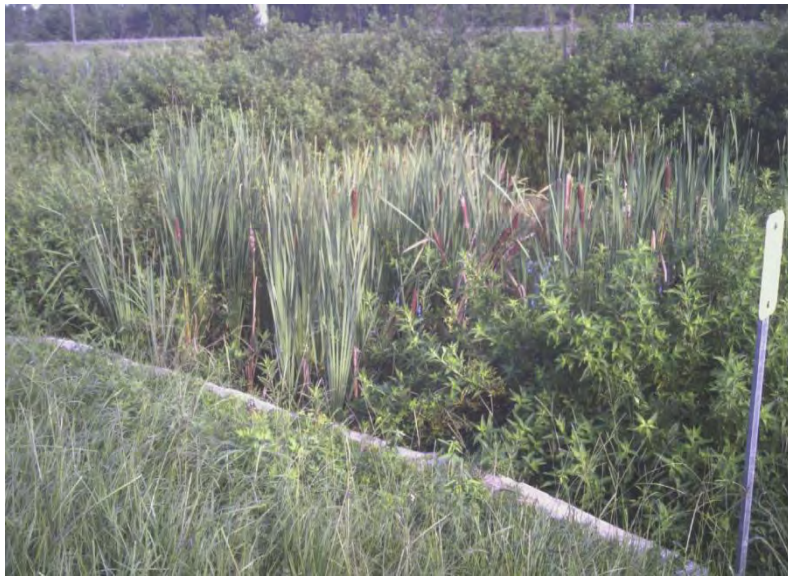
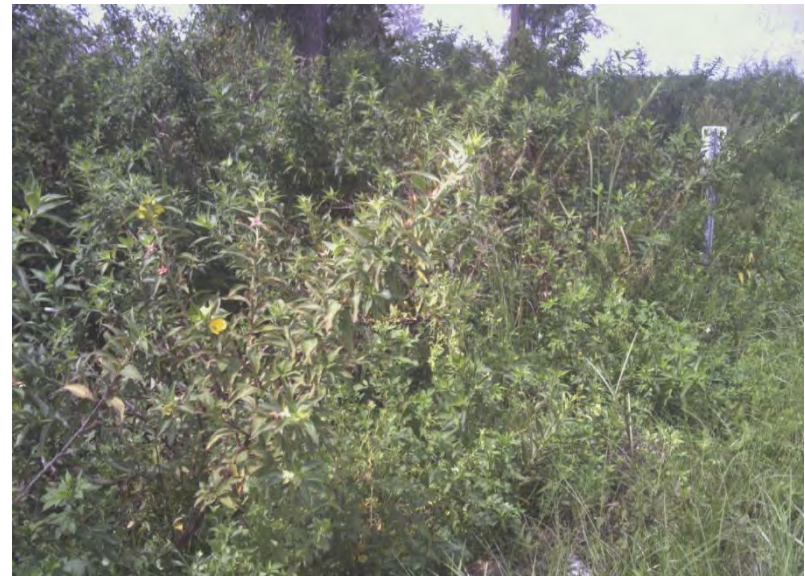
Structure No.	Station	Project No.	End Treatment Type	Pipe Size/Type	Maintenance Rating Level
S-7	1072+00	455	Straight Endwall	2 - 29" x 45"	1

- Heavy vegetation surrounding EB structure, difficult access

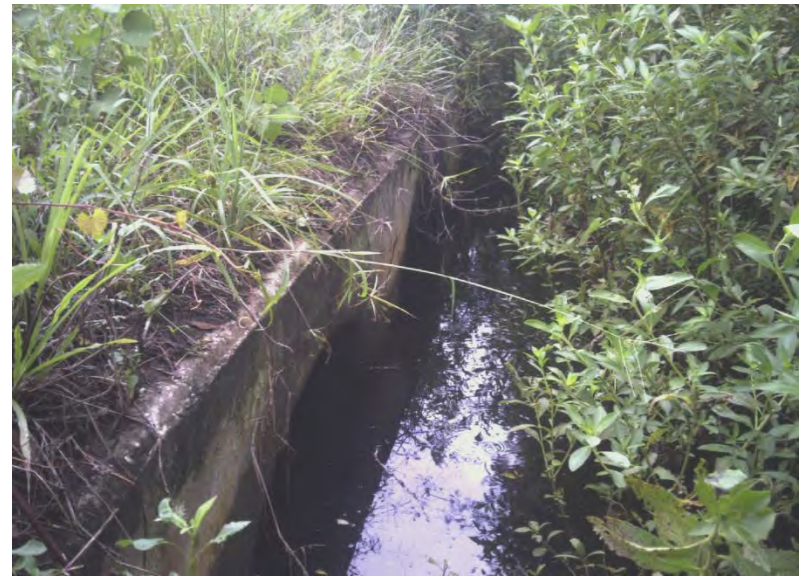
Right

- Heavy vegetation surrounding Left structure

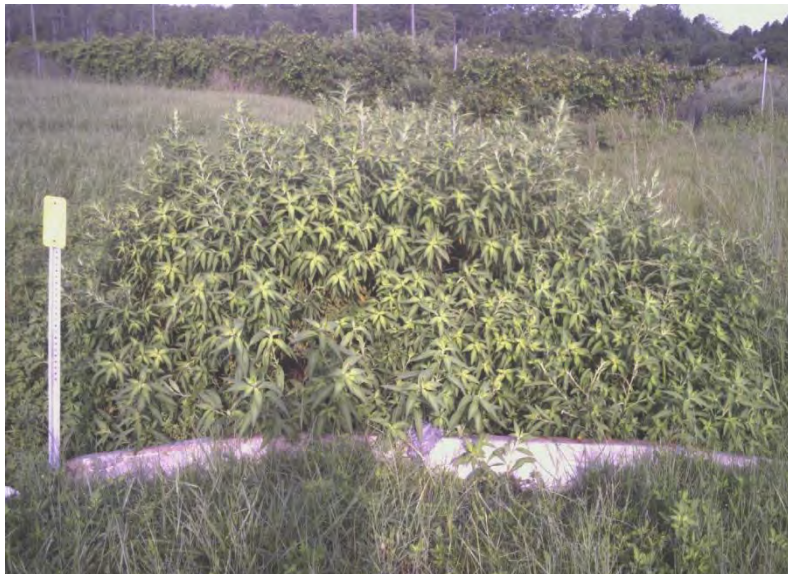
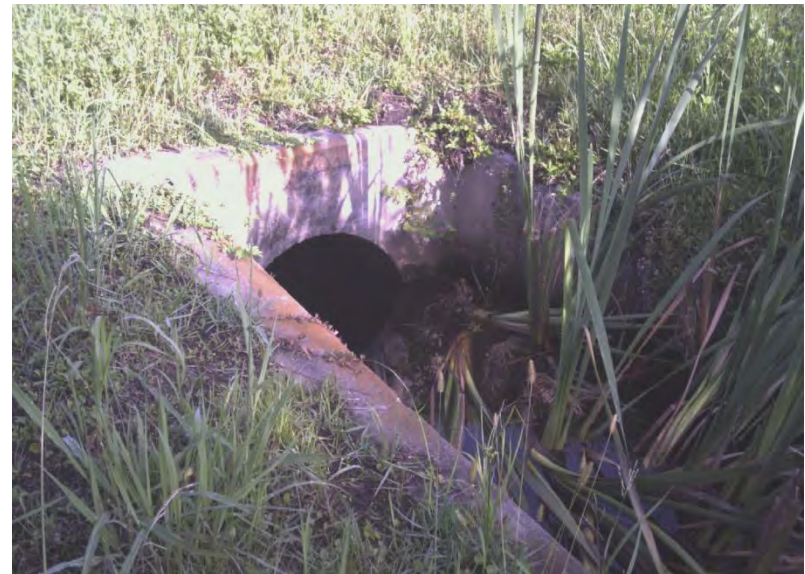
Structure No.	Station	Project No.	End Treatment Type	Pipe Size/Type	Maintenance Rating Level
S-34	1176+50	455	Straight Endwall to U-Endwall	30" RCP	1

- Heavy vegetation surrounding Left structure

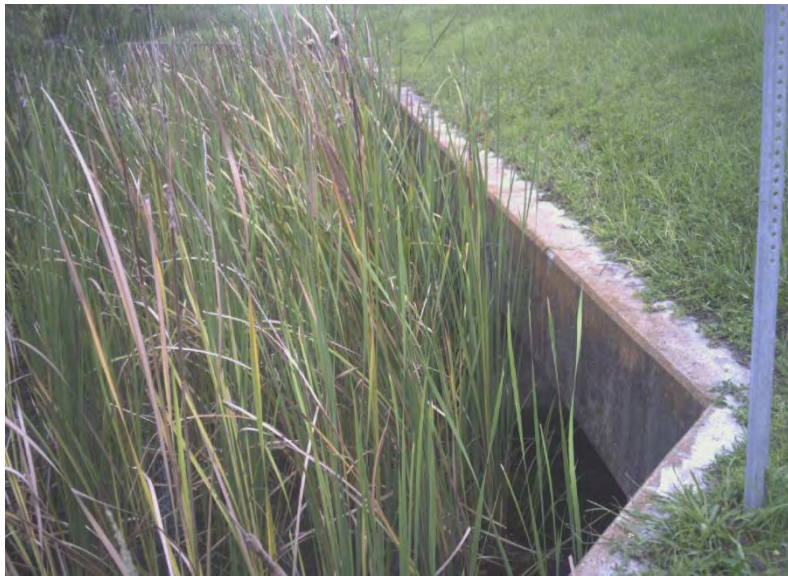
Structure No.	Station	Project No.	End Treatment Type	Pipe Size/Type	Maintenance Rating Level
S-3	1268+00	457	Wingwall	6 - 8' x 4' CBC	1

- 6" Sediment observed end of Right structure

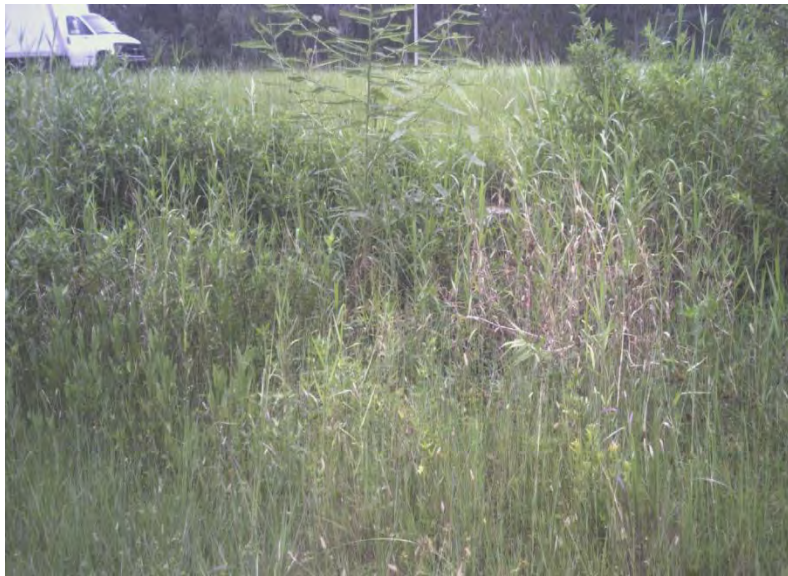
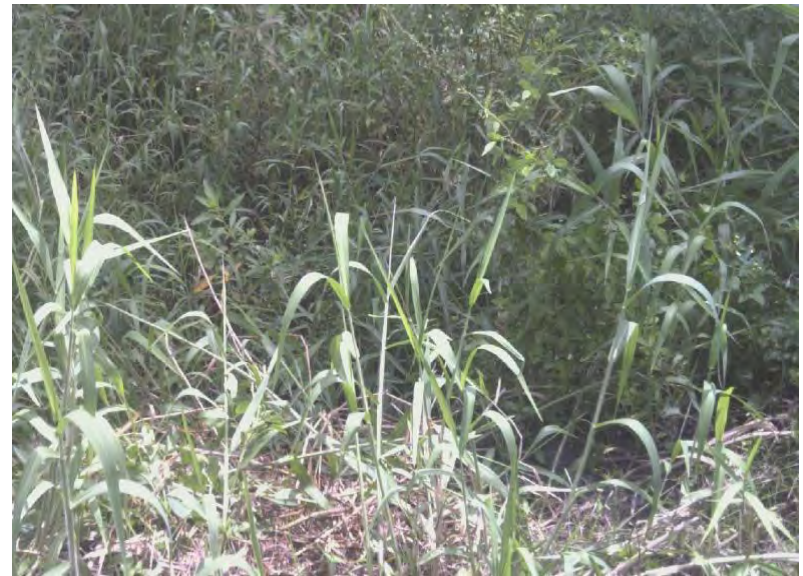
Structure No.	Station	Project No.	End Treatment Type	Pipe Size/Type	Maintenance Rating Level
B-9A	1324+00	457	Straight Endwall	4 - 34" x 53" RCP	1

- Heavy vegetation, difficult access

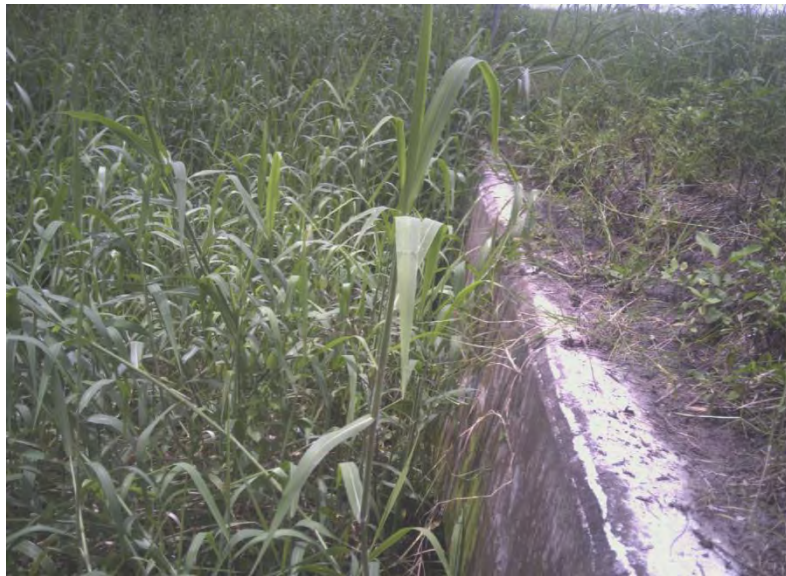
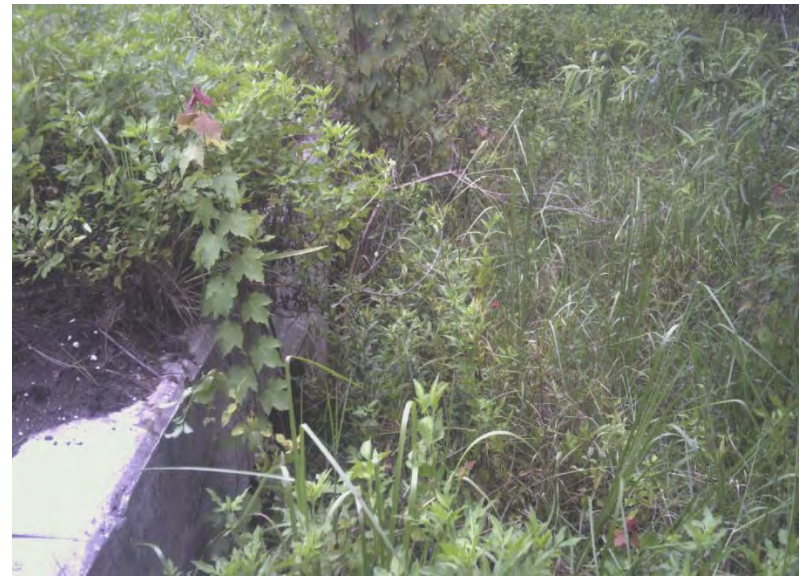
Structure No.	Station	Project No.	End Treatment Type	Pipe Size/Type	Maintenance Rating Level
B-9B	1326+00	457	Straight Endwall	3 - 29" x 45" RCP	1

- 8" Sediment measured

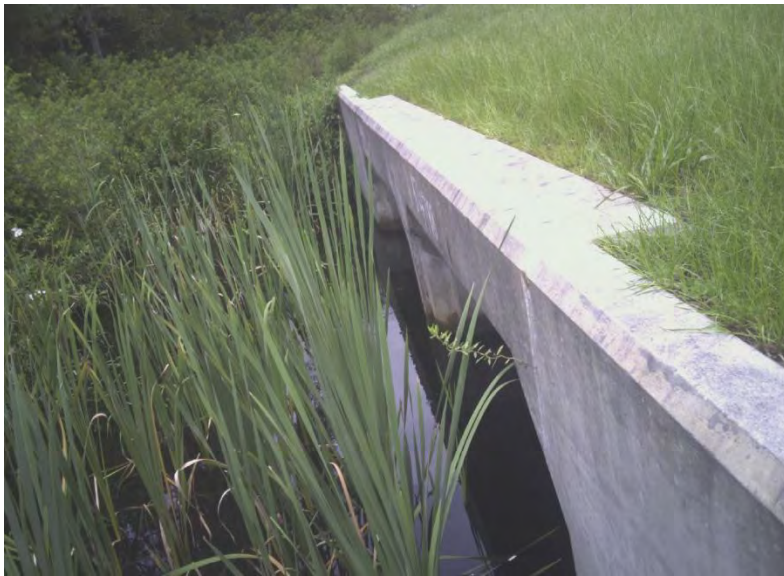
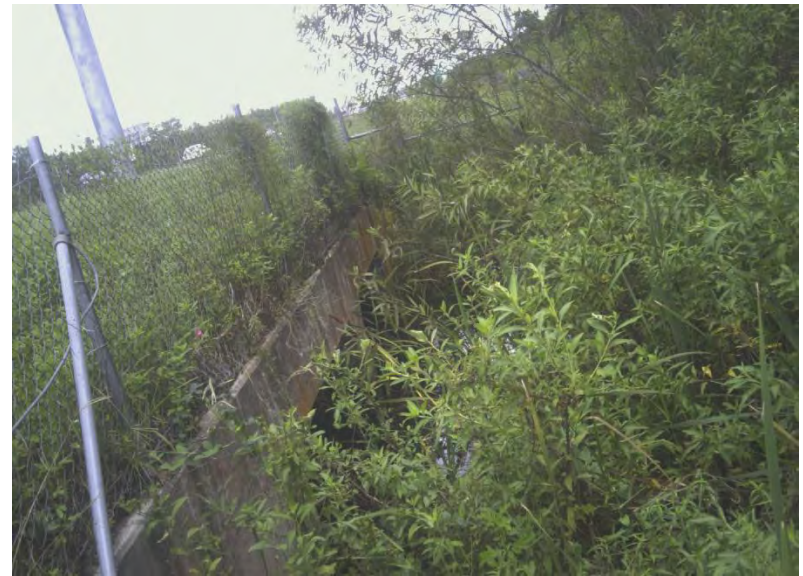
Structure No.	Station	Project No.	End Treatment Type	Pipe Size/Type	Maintenance Rating Level
D-1A	1377+60	457	Straight Endwall	2 - 9' x 4' CBC	1

- Left structure behind fence, no access
- Could not inspect

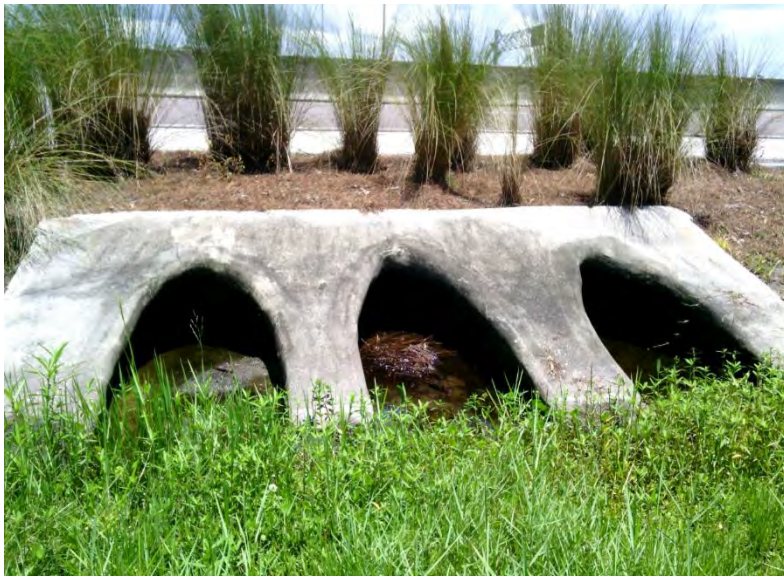
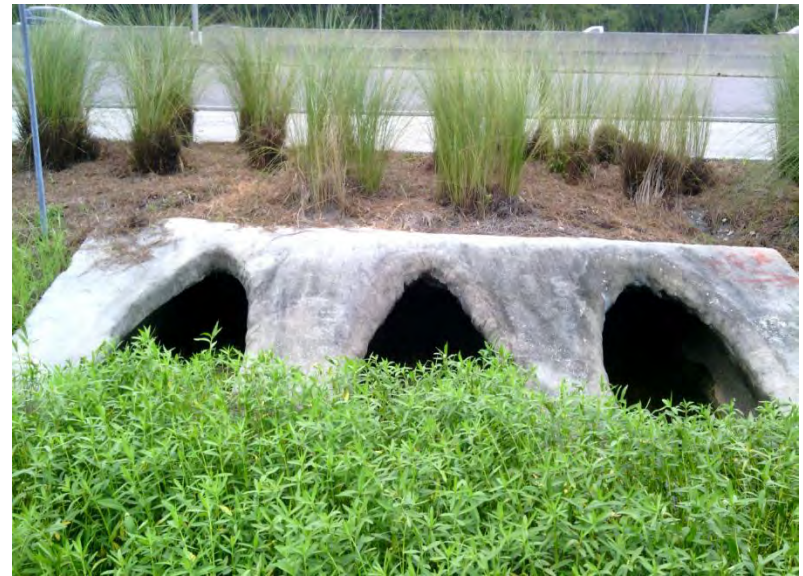
Structure No.	Station	Project No.	End Treatment Type	Pipe Size/Type	Maintenance Rating Level
S-14	235+00	402	MES	3 - 19" x 30" RCP	1

- 8" Sediment measured

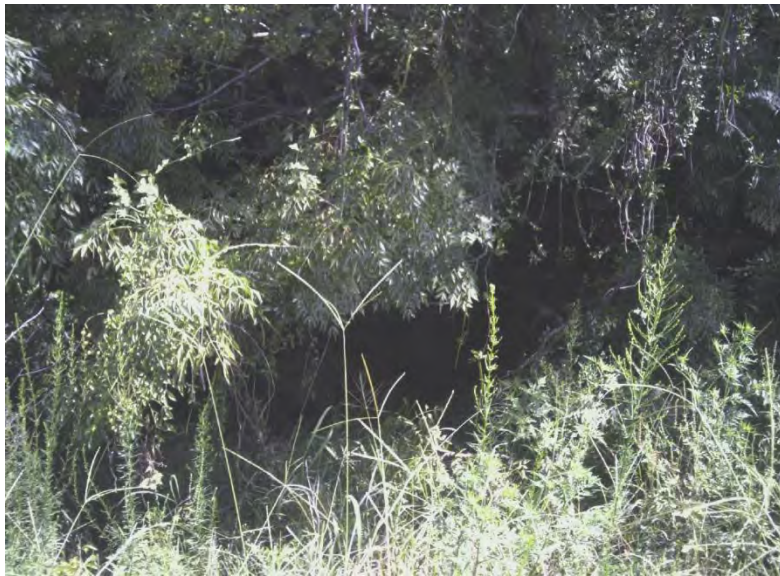
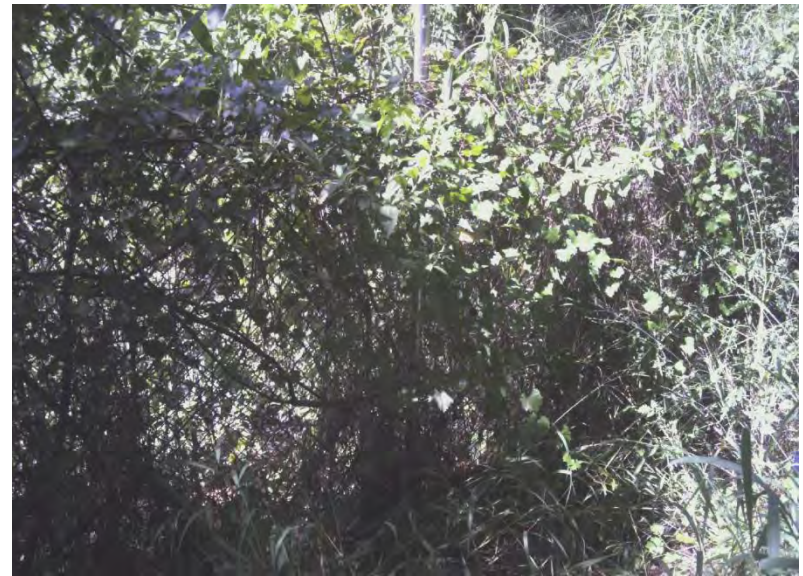
Structure No.	Station	Project No.	End Treatment Type	Pipe Size/Type	Maintenance Rating Level
S-4	165+57	502	Straight Endwall	10' x 6' CBC	1

- SB structure behind fence, no access
- Could not inspect

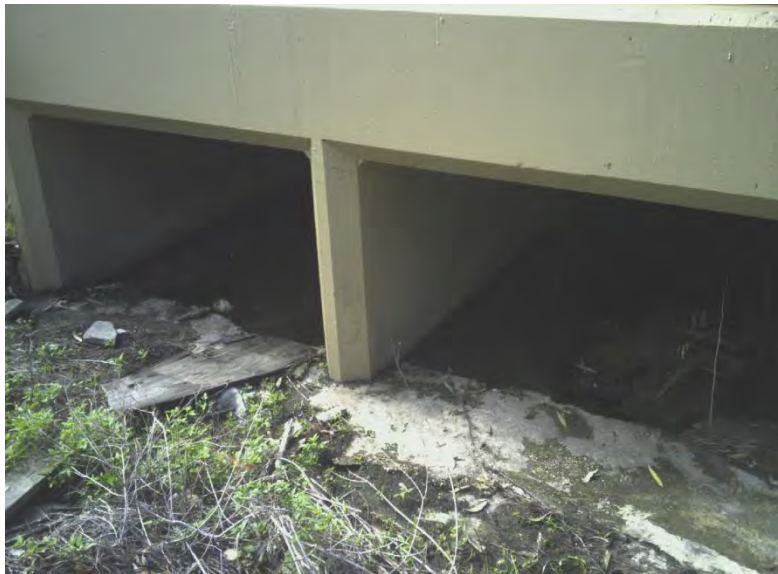
Structure No.	Station	Project No.	End Treatment Type	Pipe Size/Type	Maintenance Rating Level
S-99	500+50	1.1	Straight Endwall	2 - 7' x 3' CBC	1

- Piles of sediment up to 8" in depth
- Cracking in concrete around opening- 36" deep

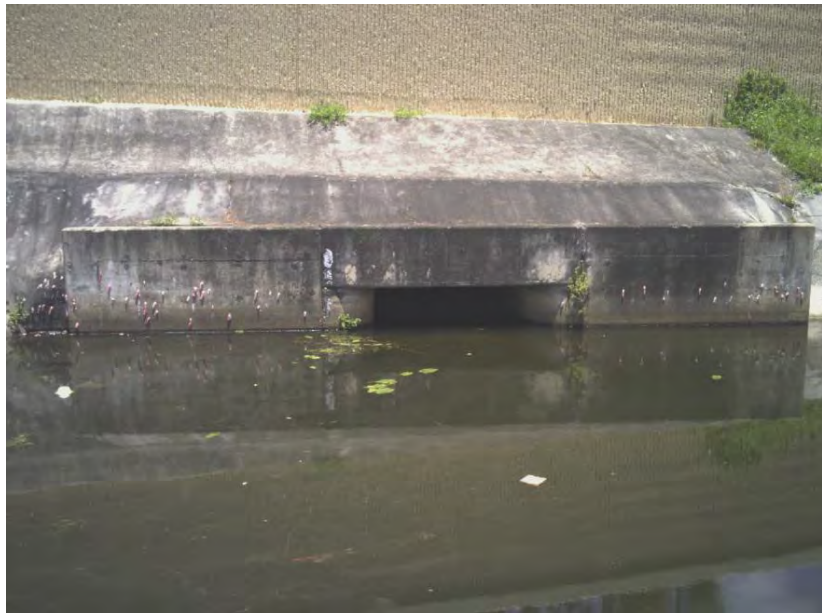
Structure No.	Station	Project No.	End Treatment Type	Pipe Size/Type	Maintenance Rating Level
C-1	582+37	252A	Straight Endwall	6' x 3' CBC	1

- WB structure behind fence line, no access
- Could not inspect

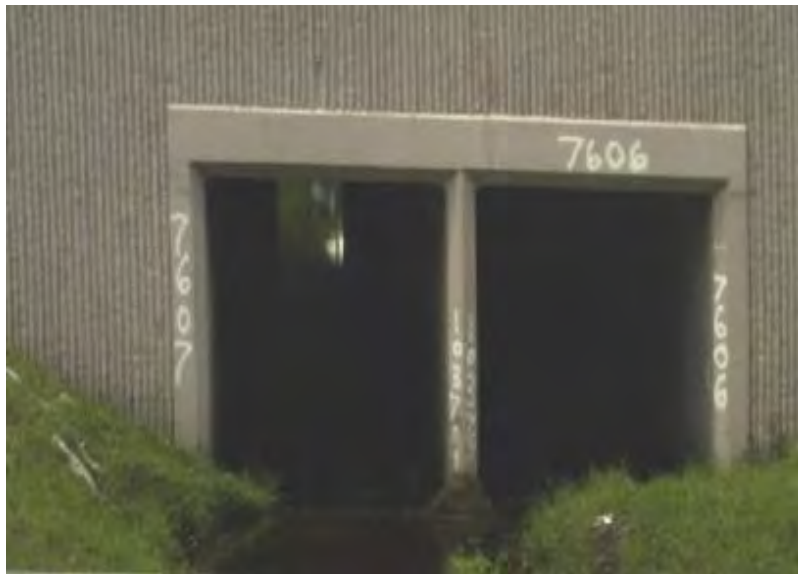
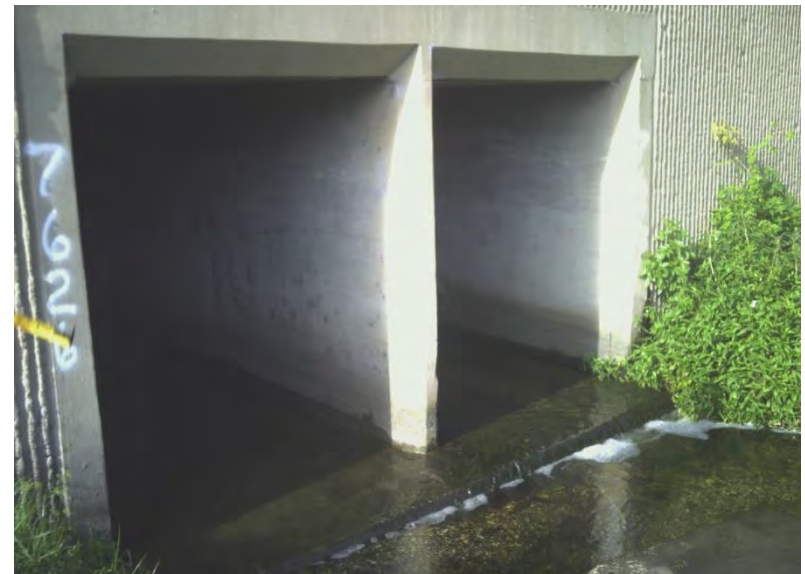
Structure No.	Station	Project No.	End Treatment Type	Pipe Size/Type	Maintenance Rating Level
A-9	1933+00	253D-D1	Straight Endwall	2 - 6' x 7' CBC	1

- 30" scour measured Right structure

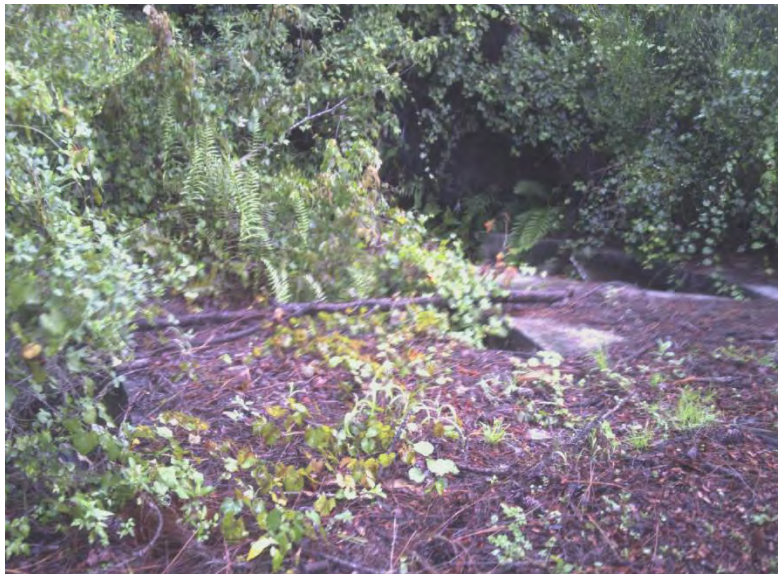
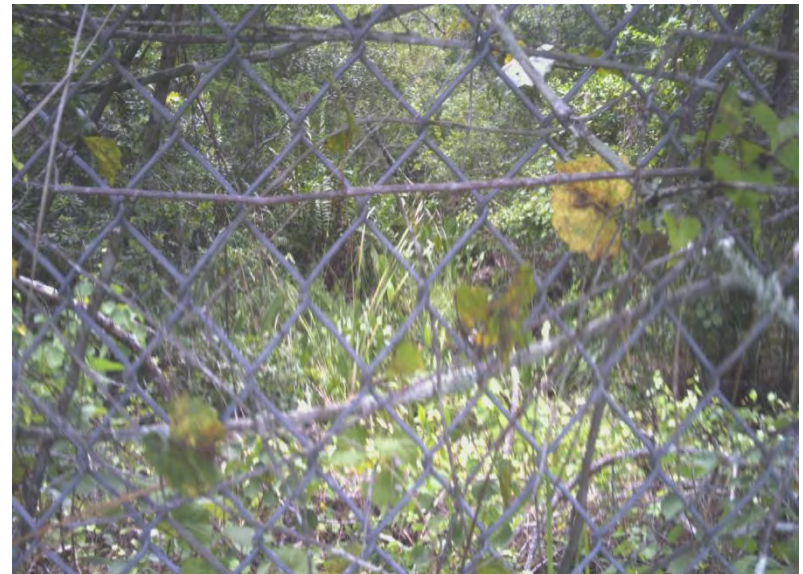
Structure No.	Station	Project No.	End Treatment Type	Pipe Size/Type	Maintenance Rating Level
S-9	408+85	113	MES	3 - 38" x 60" RCP	1

- Right structure behind fence line, no access
- Could not inspect

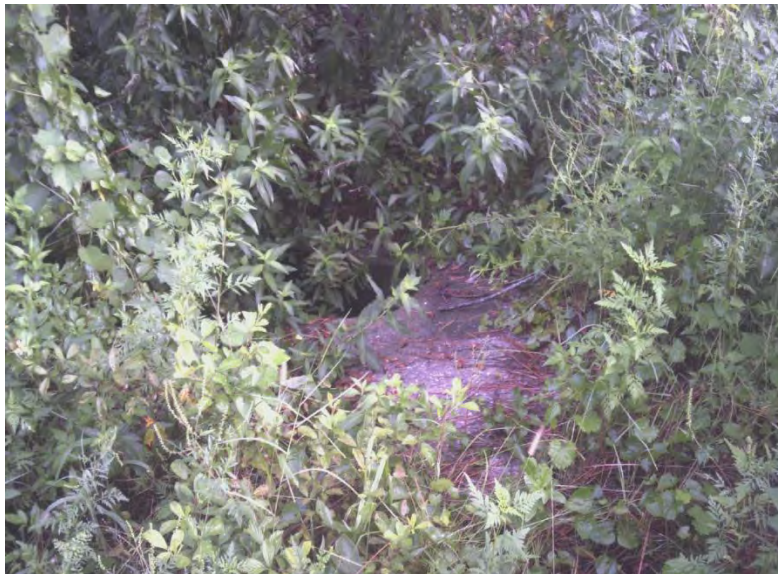
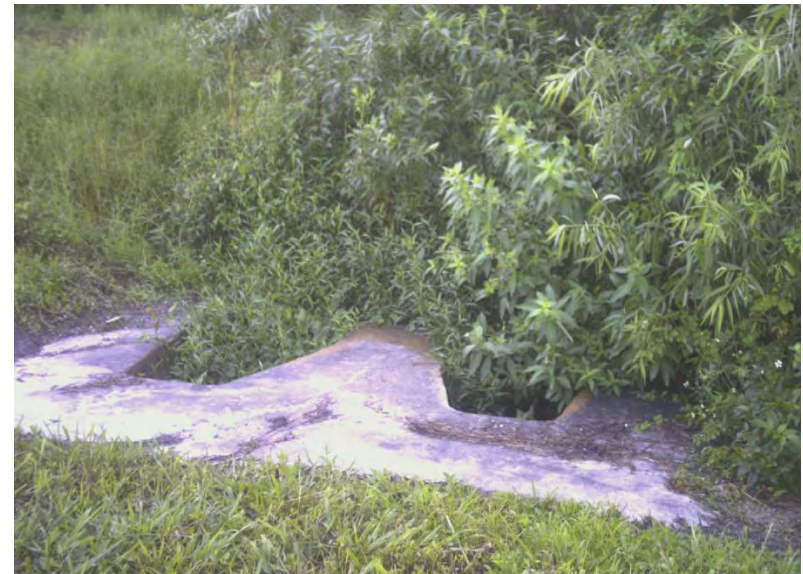
Structure No.	Station	Project No.	End Treatment Type	Pipe Size/Type	Maintenance Rating Level
S-14	416+00	113	MES	2 - 36" RCP	1

- Left structure covered in heavy vegetation
- Right structure moderate vegetation

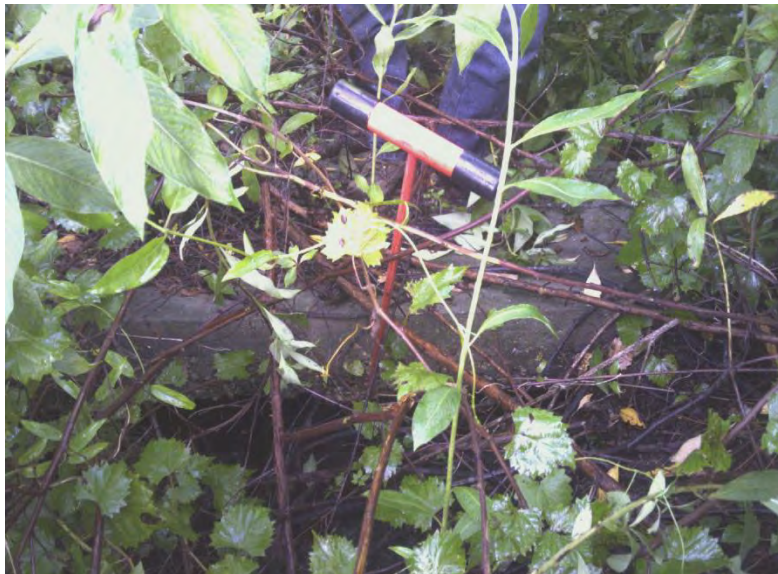
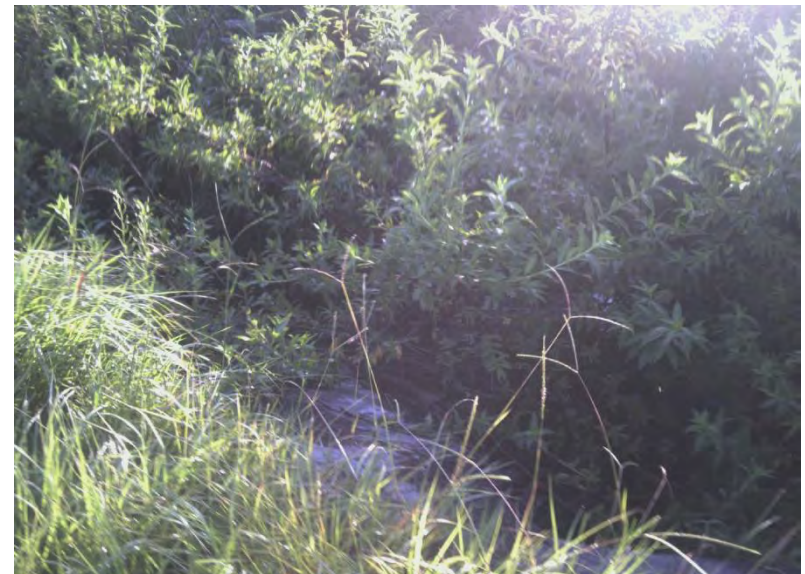
Structure No.	Station	Project No.	End Treatment Type	Pipe Size/Type	Maintenance Rating Level
S-17	426+00	113	MES	2 - 38" x 60" RCP	1

- Left structure covered in heavy vegetation
- Right structure moderate vegetation

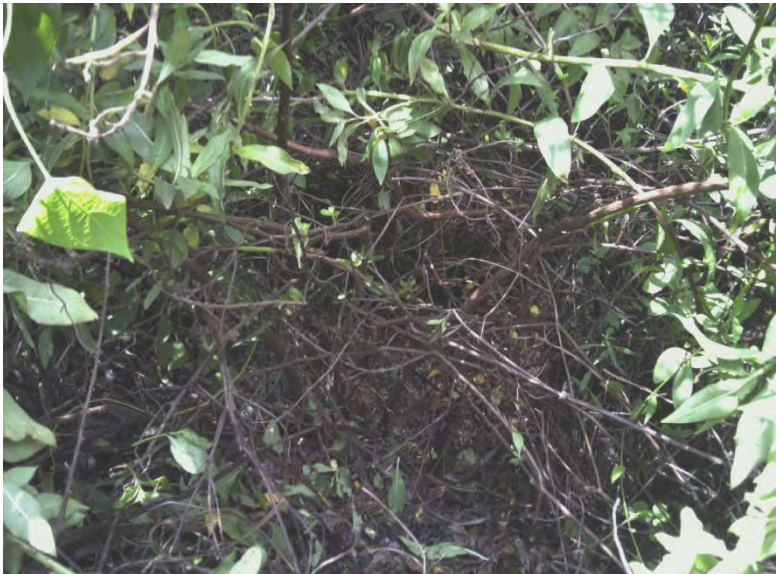
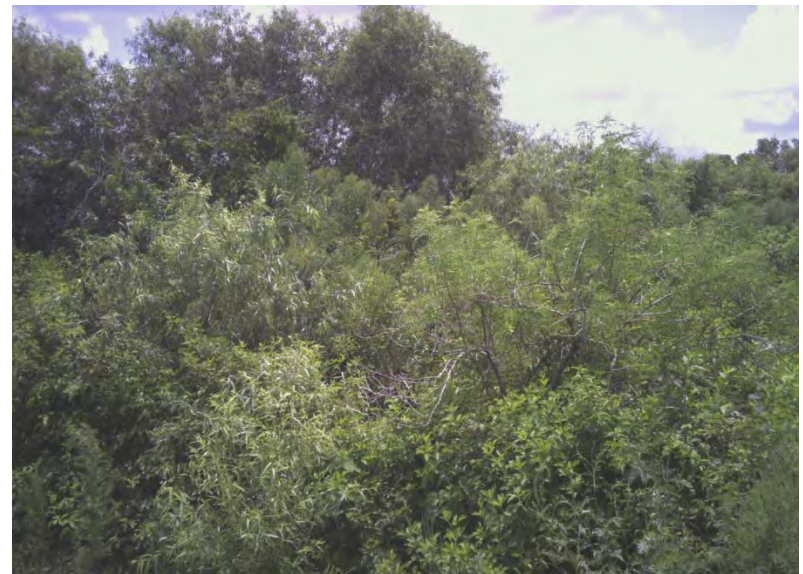
Structure No.	Station	Project No.	End Treatment Type	Pipe Size/Type	Maintenance Rating Level
S1-12	310+60	903	MES	3 - 29" x 45" RCP	1

- Both structures covered in heavy vegetation, pipes submerged

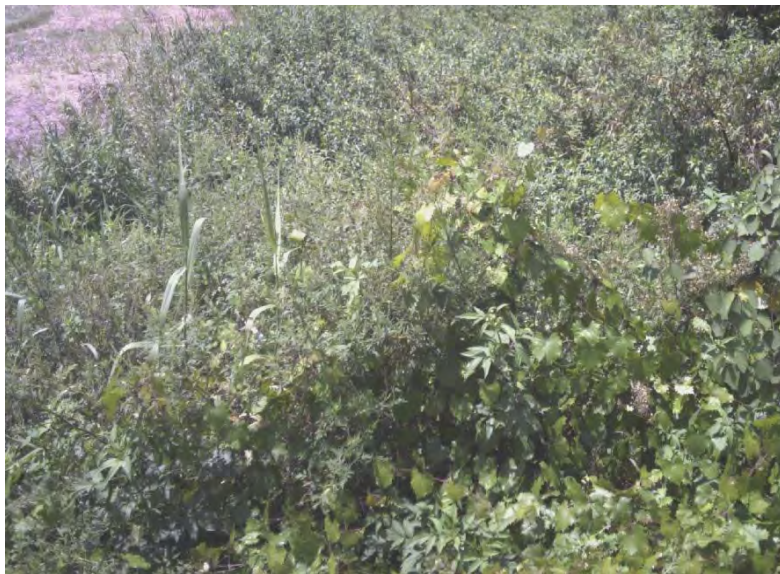
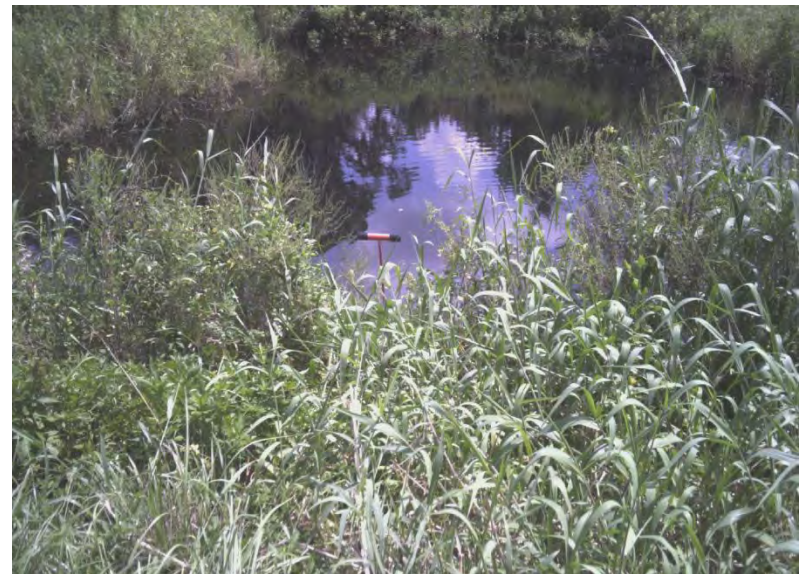
Structure No.	Station	Project No.	End Treatment Type	Pipe Size/Type	Maintenance Rating Level
S4-27	342+60	903B	Straight Endwall	3 - 48" RCP	1

- Left structure covered by heavy vegetation, inaccessible
