# 2019

# Annual Inspection Report

Mr. Glenn Pressimone, P.E.  
Chief of Infrastructure  
Central Florida Expressway Authority  
4974 ORL Tower Road  
Orlando, Florida 32807

Re: 2019 Annual Inspection Report

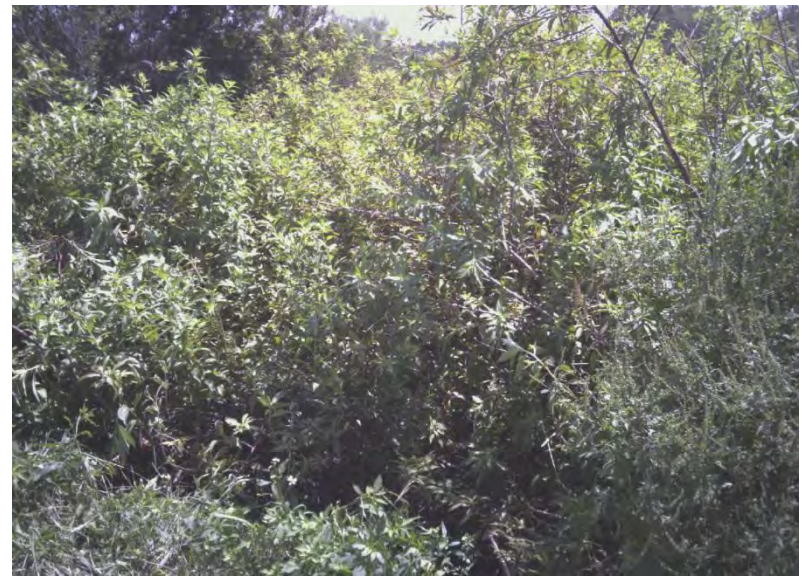
- Right structure covered by heavy vegetation

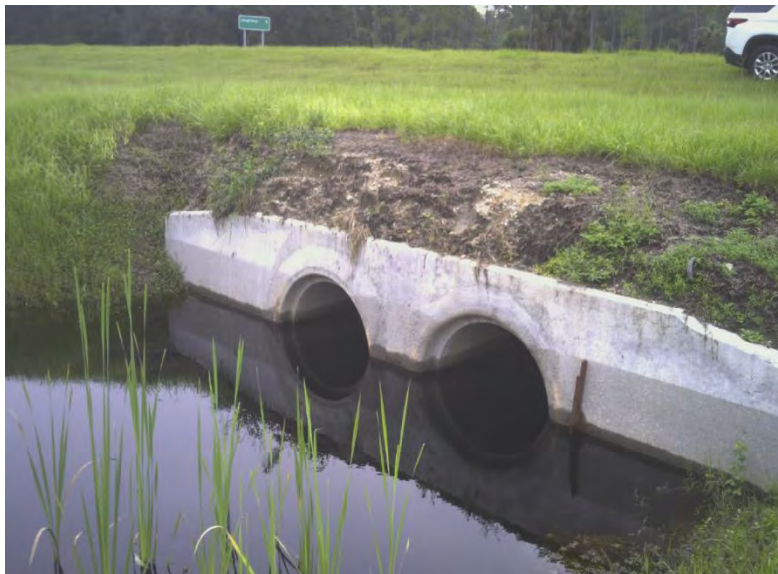
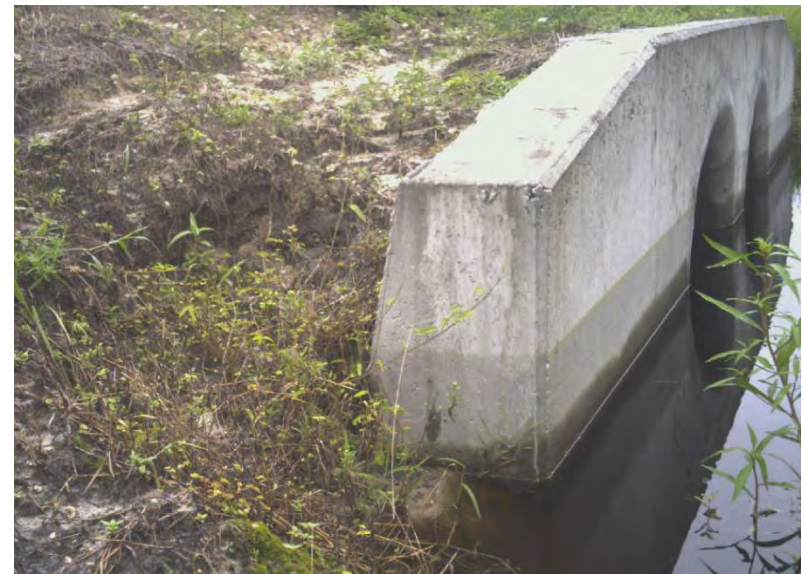
Structure No.	Station	Project No.	End Treatment Type	Pipe Size/Type	Maintenance Rating Level
CD-7	324+00	Segment 3	Straight Endwall	2 - 36" RCP	1

- 8" scour measured Right structure
- Washout around Right headwall

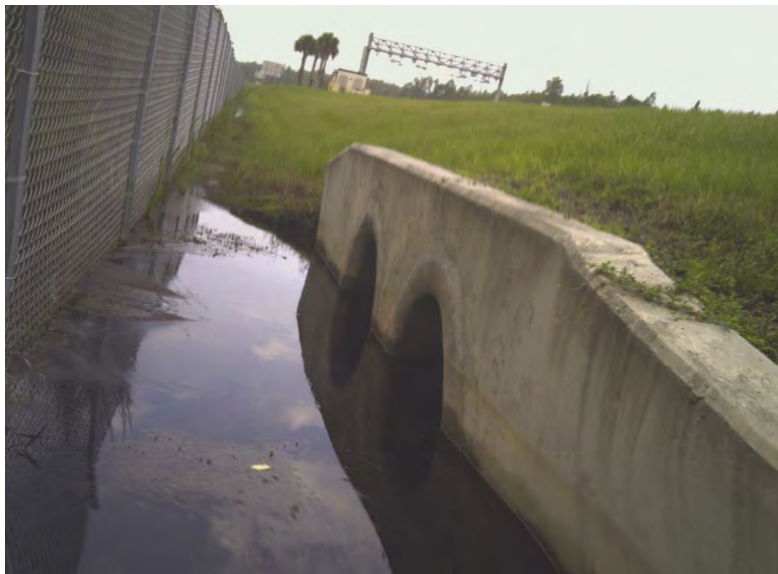
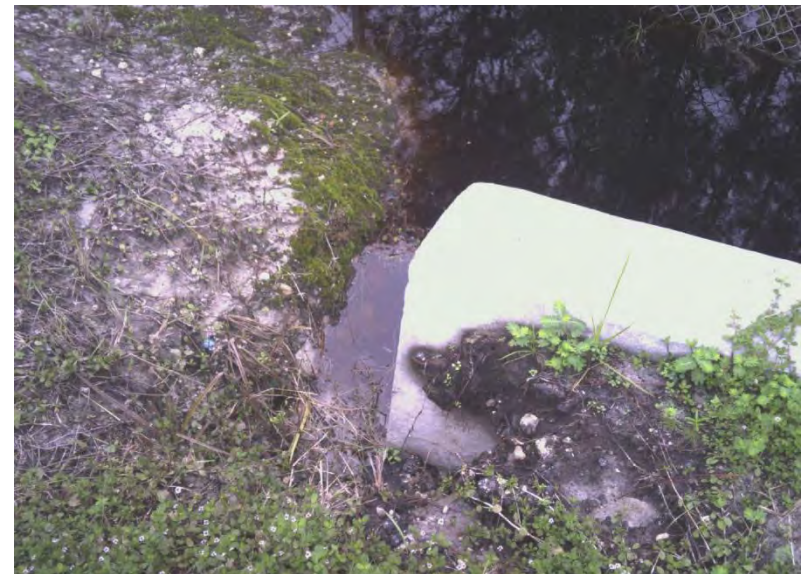
Structure No.	Station	Project No.	End Treatment Type	Pipe Size/Type	Maintenance Rating Level
CD-8	328+00	Segment 3	Straight Endwall	2 - 36" RCP	1

- 9" scour measured Right structure
- Washout around both headwalls

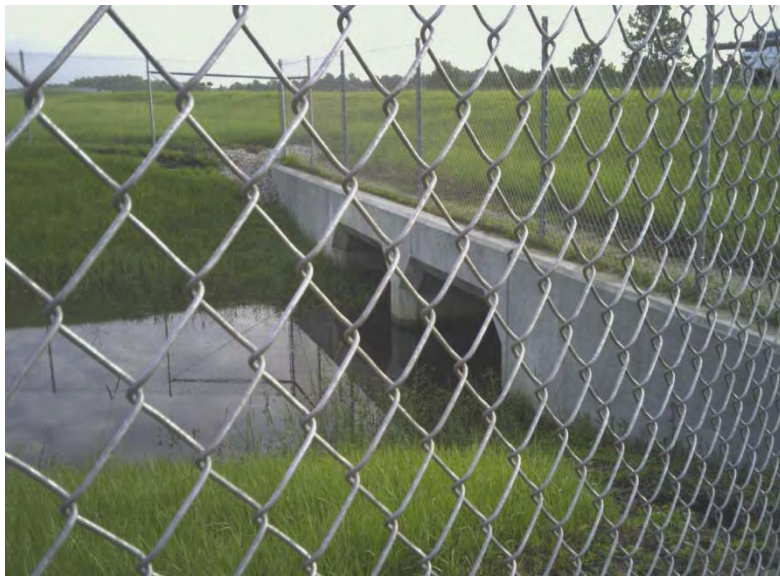
- Left structure behind fence
- No CFX lock on gate, no access
- Could not inspect

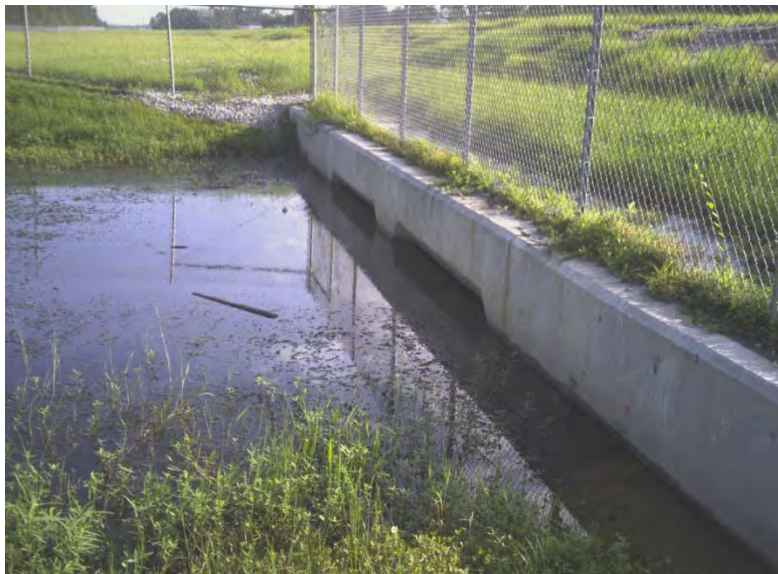
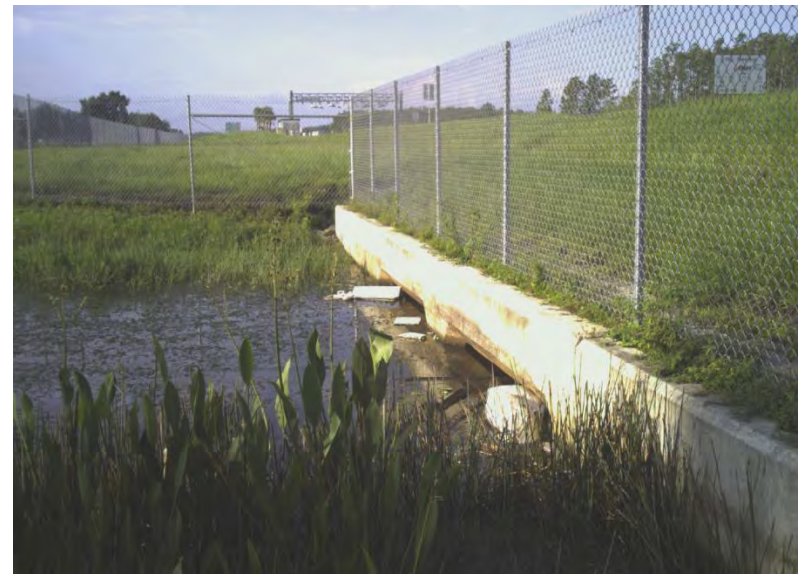
Structure No.	Station	Project No.	End Treatment Type	Pipe Size/Type	Maintenance Rating Level
N/A	551+25	Segment 4	Straight Endwall	2 - 10' x 4' CBC	1

- Both structures behind fence
- No CFX lock on gates, no access
- Could not inspect
