2020

Annual Inspection Report

Re: 2020 Annual Inspection Report

2020 Annual Inspection Report
CENTRAL FLORIDA EXPRESSWAY AUTHORITY

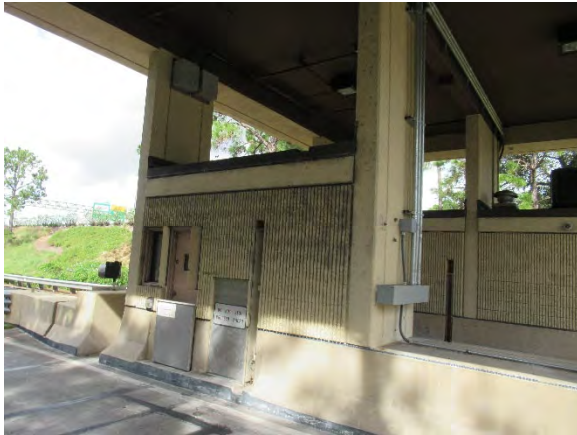
Figure 20 Hiawassee Ramp On

The above referenced ramp is in good condition overall. Some general maintenance to pressure wash plaza and cover electrical trough is recommended.
(Figure 19, Figure 20, Figure 21, Figure 22, Figure 23 & Figure 24)

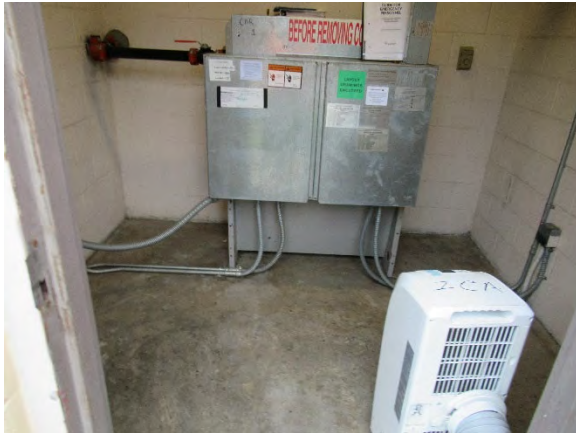
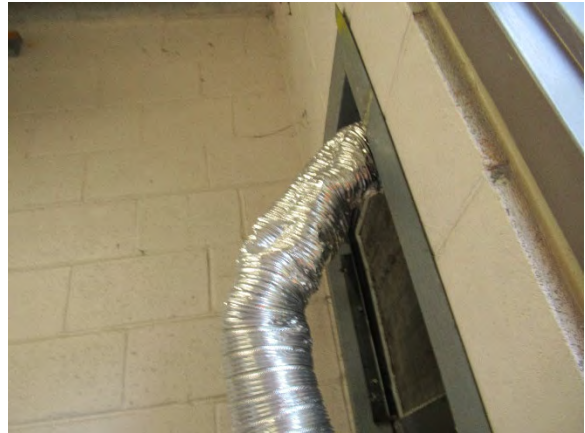
- Mainline elevator machine room has temporary HVAC equipment.
(Figure 1 & Figure 2)
- Mainline computer room has missing vent covers.
(Figure 3 & Figure 4)

- Recommend general maintenance to replace vent covers.
- Recommend general repairs to ventilation system in elevator machine room.
- Recommend routine maintenance to pressure wash and repaint overpass.
- Recommend general patch and repair of damage to base of toll plaza barrier.
- Recommend routine maintenance to address erosion under concrete pads located behind mainline building.

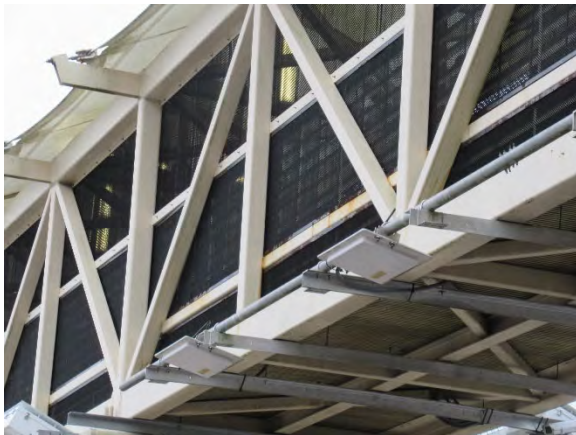
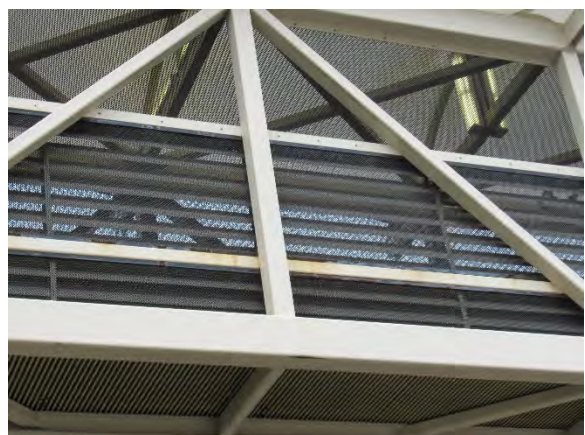
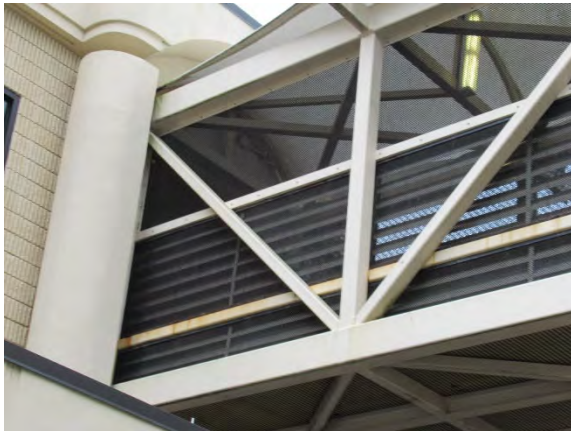
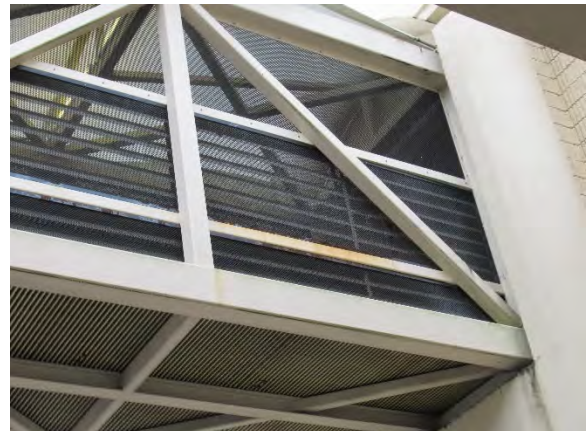
- The above referenced overpass has identified rusted members.
(Figure 5, Figure 6, Figure 7 & Figure 8)

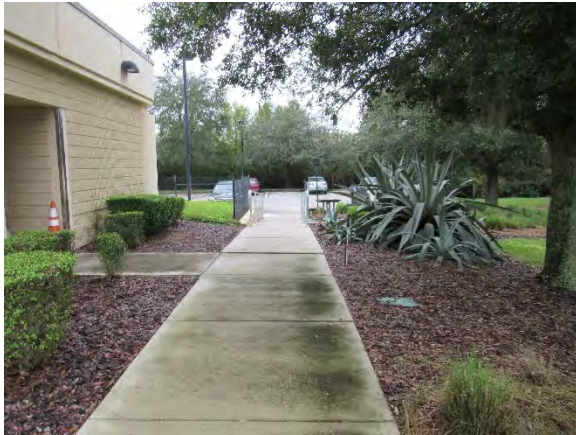
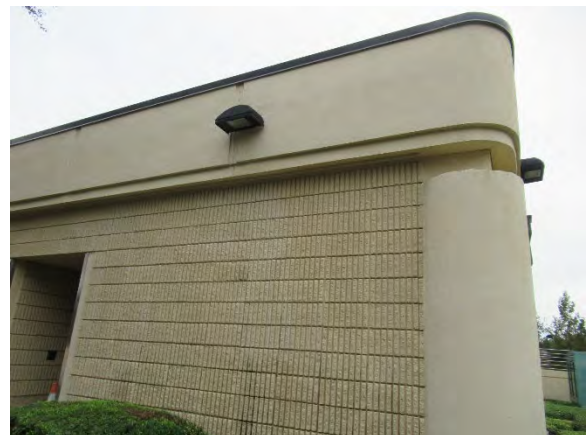
- Exterior mainline walkway and building façade in need of pressure wash.
(Figure 9 & Figure 10)
- Exterior erosion areas under concrete pads located behind mainline building.
(Figure 11 & Figure 12)
- Exterior concrete at toll plaza barrier has damage at base.
(Figure 13 & Figure 14)

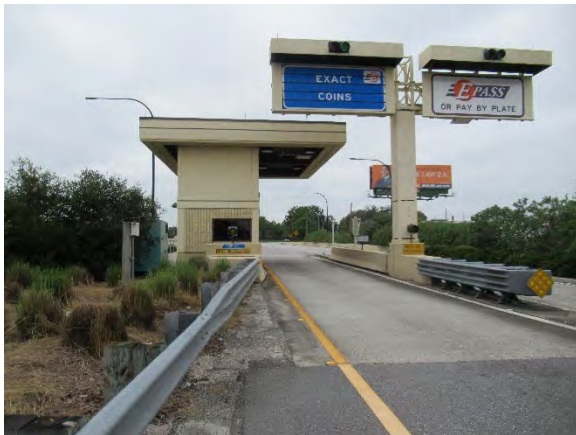
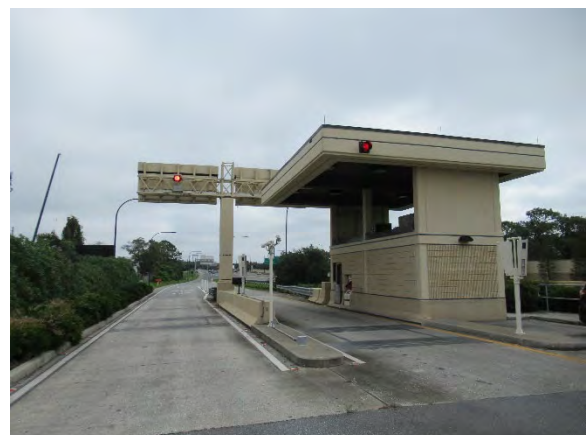
The above referenced ramp is in good condition overall.
(Figure 15 & Figure 16)

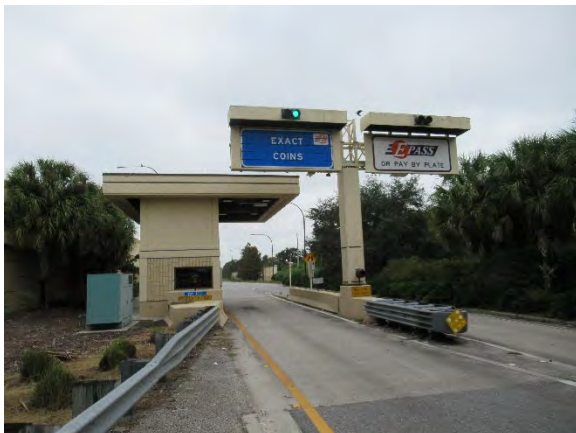
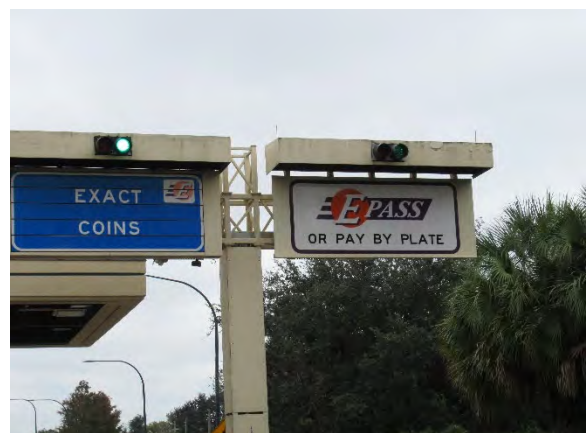
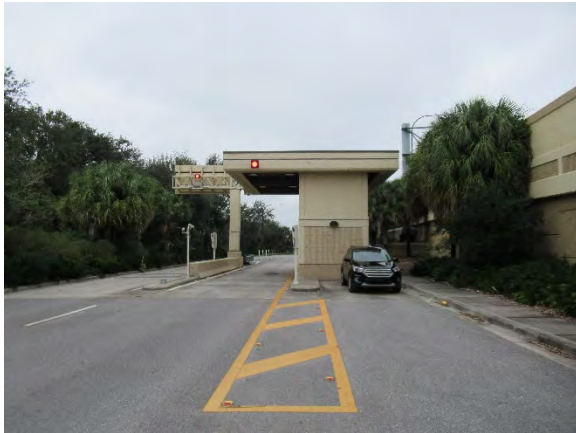
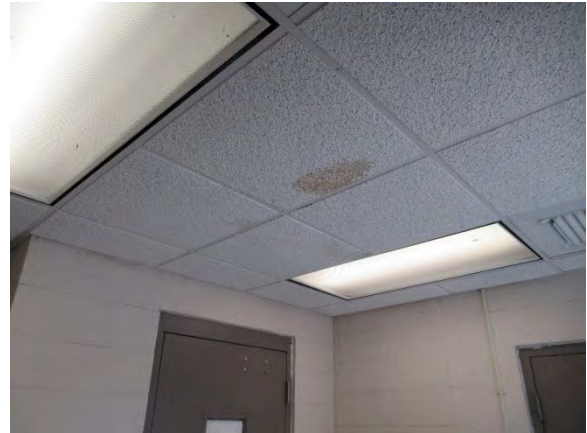
The above referenced ramp is in good condition overall. Some general maintenance to pressure wash plaza, overhead sign structure and repair potential leak above ceiling tile is recommended.
(Figure 17, Figure 18, Figure 19 & Figure 20)

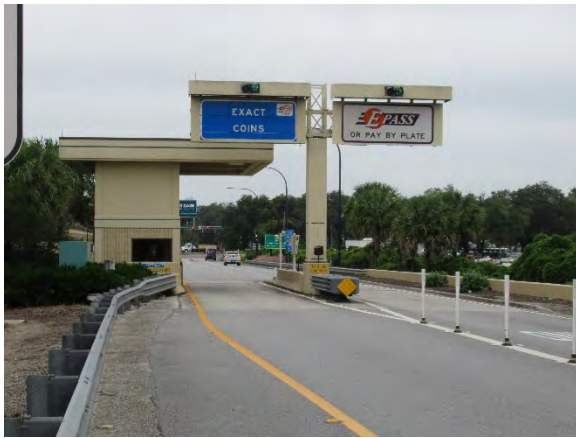
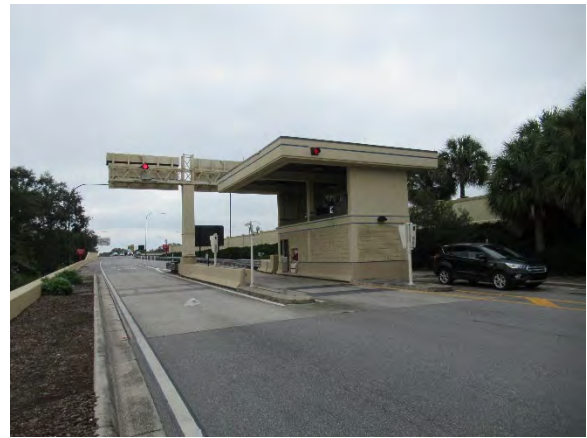
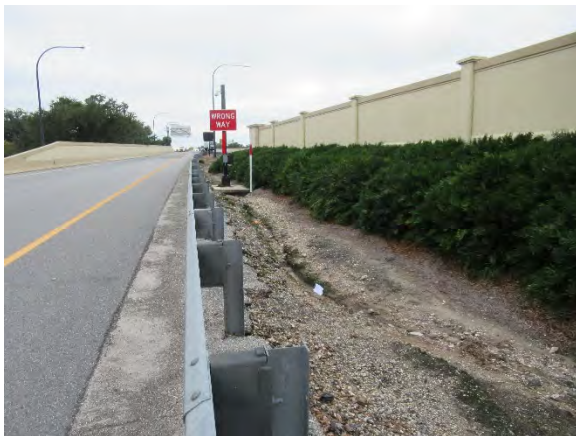
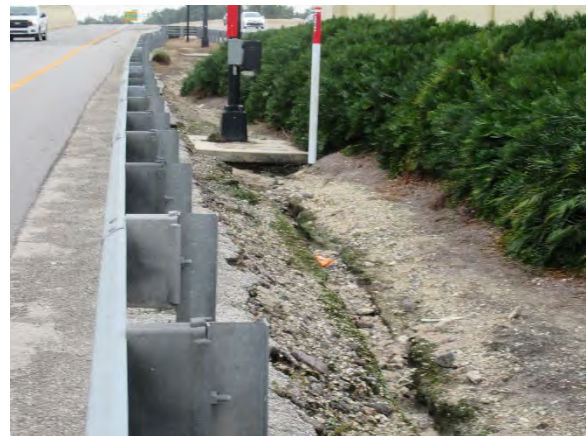
The above referenced ramp is in good condition overall. Some general maintenance to repair erosion area under wrong way sign structure is recommended.
(Figure 21, Figure 22, Figure 23 & Figure 24)

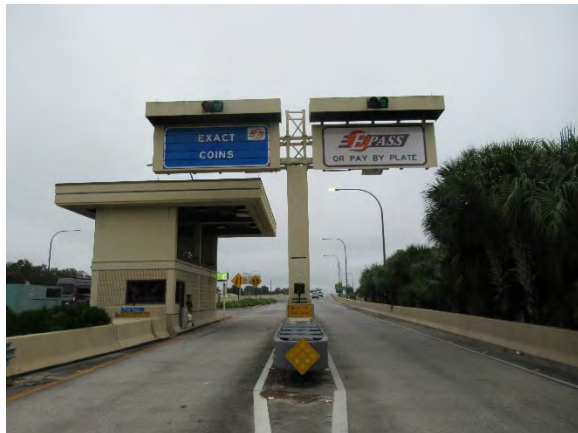
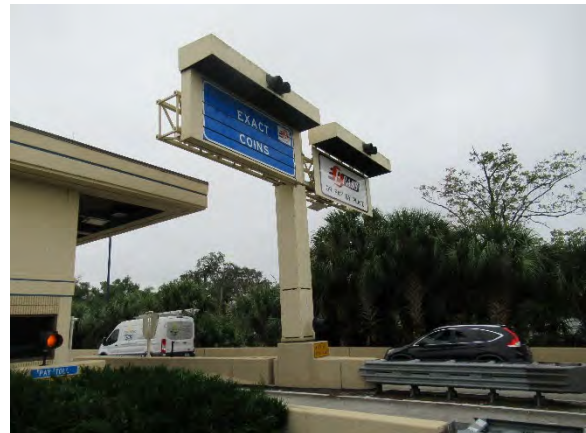
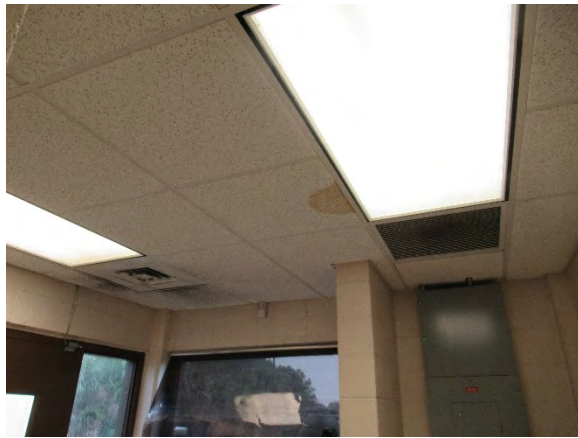
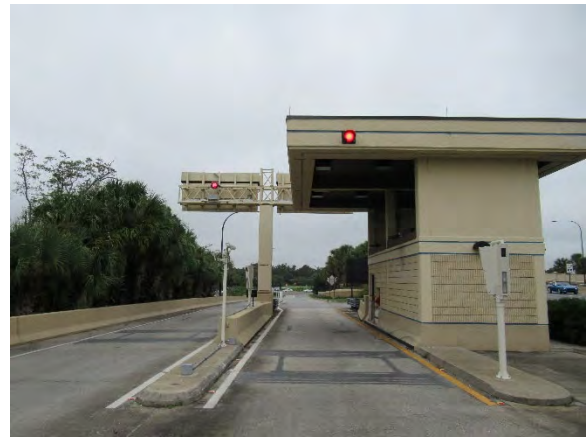
The above referenced ramp is in good condition overall. Some general maintenance to repair potential leak above ceiling tile is recommended.
(Figure 25, Figure 26, Figure 27 & Figure 28)

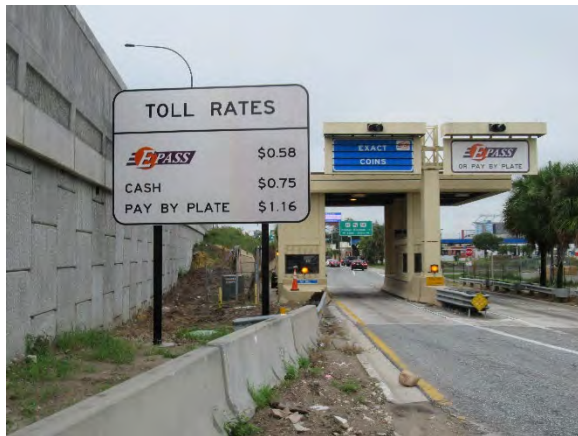
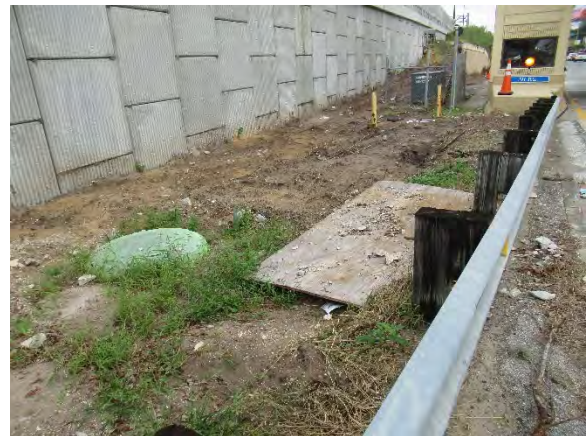
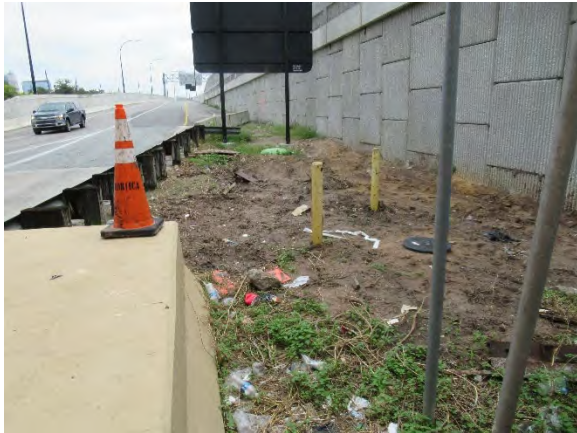
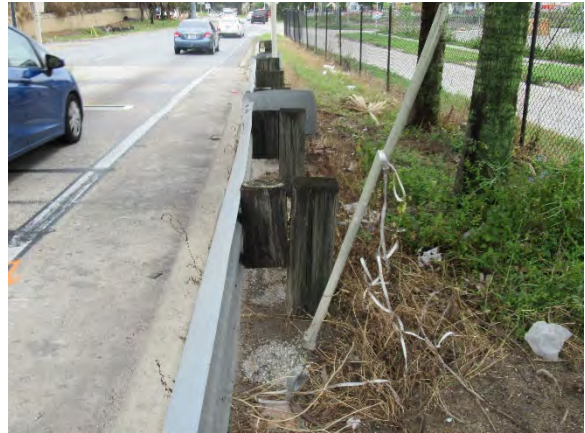
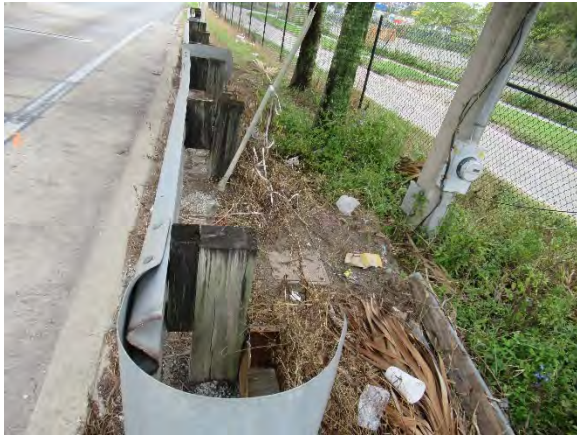
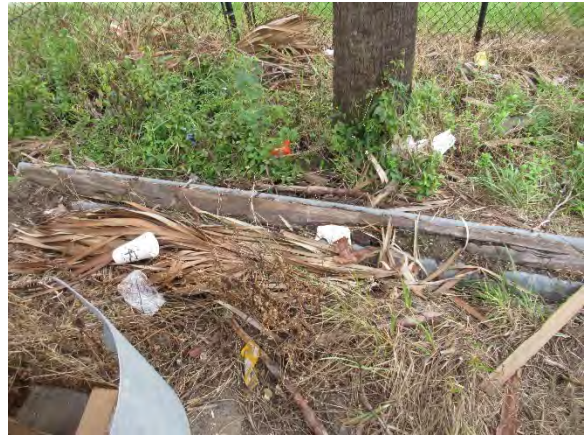
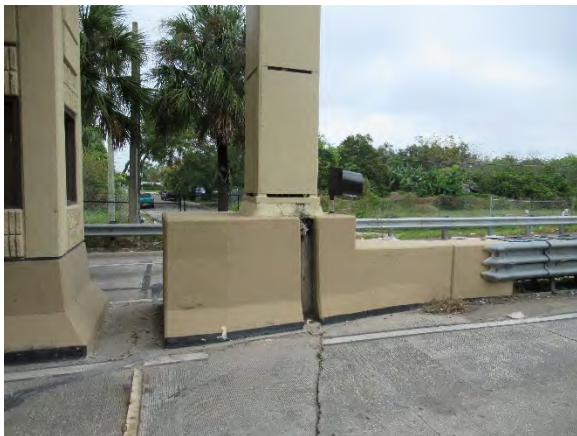
The above referenced ramp is in good condition overall. Some maintenance to remove debris surrounding plaza and patch and repair concrete at overhead sign structure is recommended.
(Figure 29, Figure 30, Figure 31, Figure 32, Figure 33, Figure 34, Figure 35 & Figure 36)

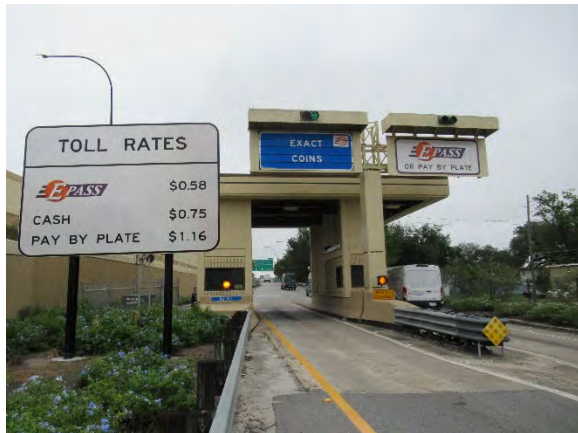
Figure 37 OBT Ramp On

The above referenced ramp is in good condition overall. Some general maintenance to pressure wash plaza, remove sign debris and patch and paint canopy is recommended.
(Figure 37, Figure 38, Figure 39, Figure 40, Figure 41 & Figure 42)

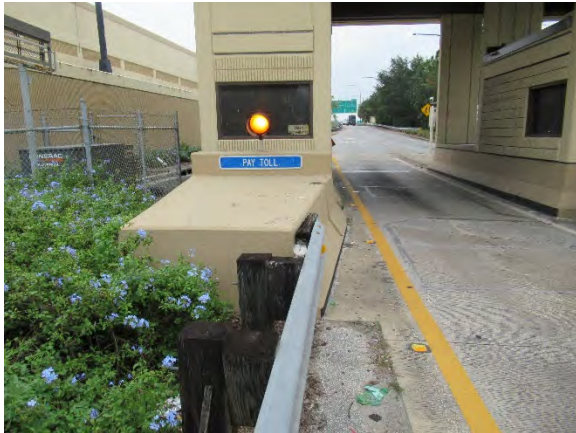
Figure 43 OBT Ramp On

The above referenced ramp is in good condition overall. Some general maintenance on guardrail, paint remainder of utility pole, repair potential leak above ceiling tile and fireproof ceiling penetration is recommended.
(Figure 43, Figure 44, Figure 45, Figure 46, Figure 47 & Figure 48)

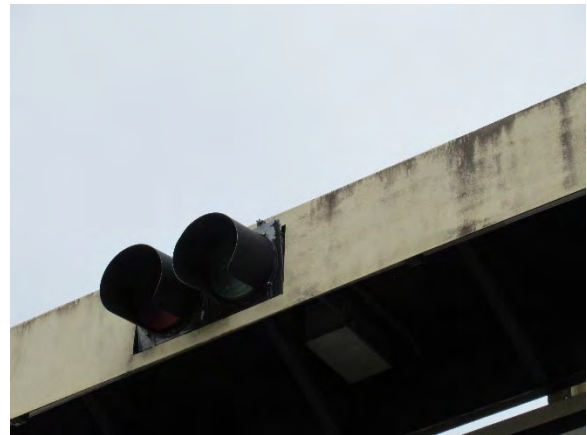
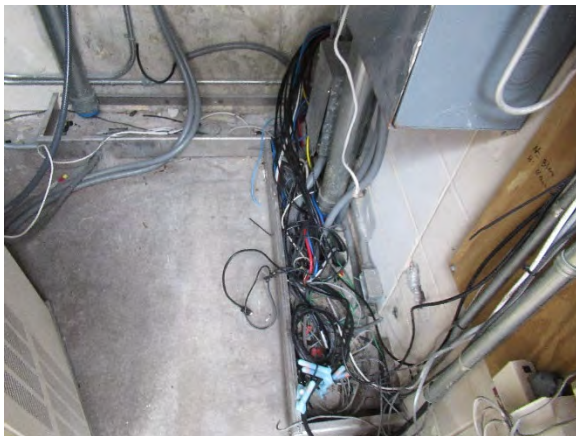
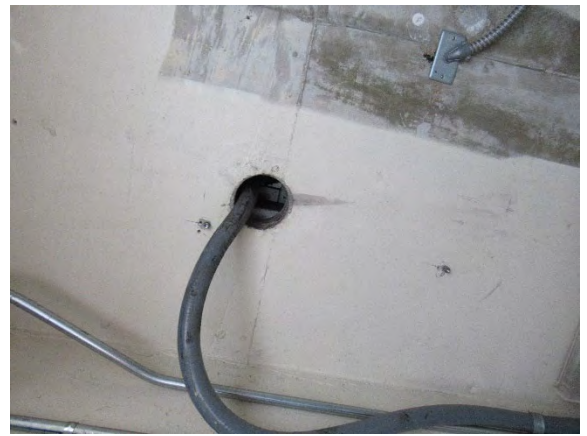
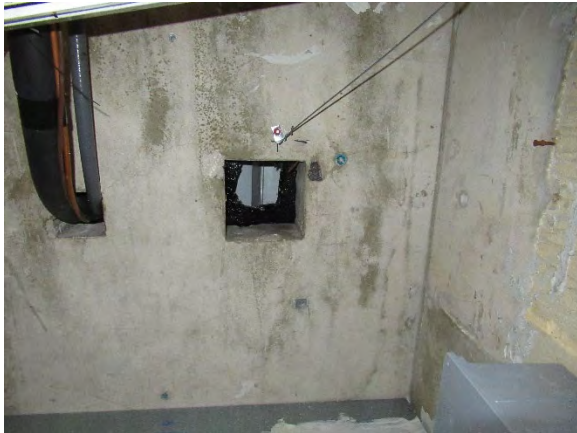
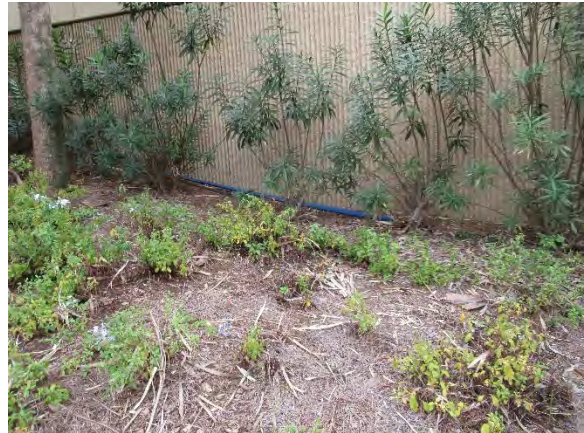
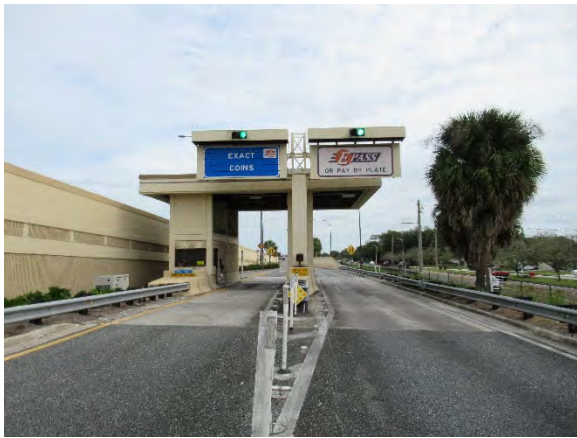
The above referenced ramp is in good condition overall. Some general maintenance to pressure wash plaza overhead sign structure, ensure wrong way detection lighting is secured properly, cover electrical trough and fireproof ceiling penetration is recommended.
(Figure 39, Figure 40, Figure 41, Figure 42, Figure 43 & Figure 44)

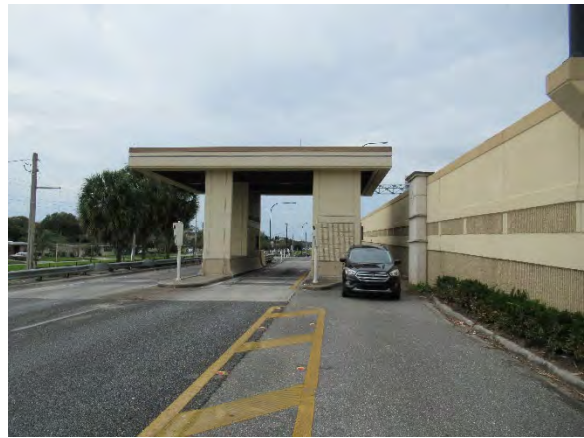
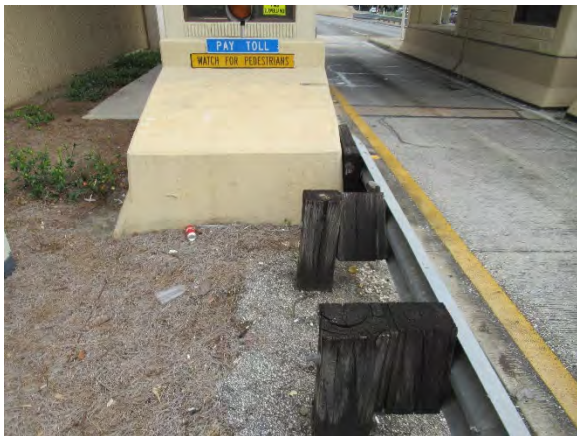
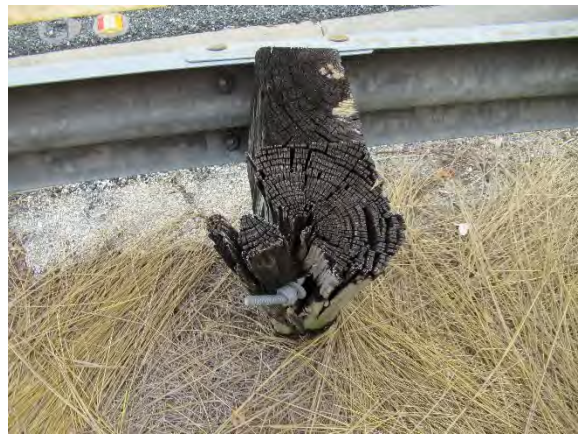
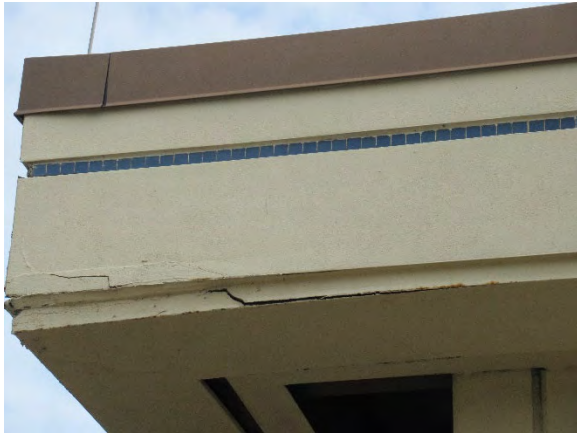
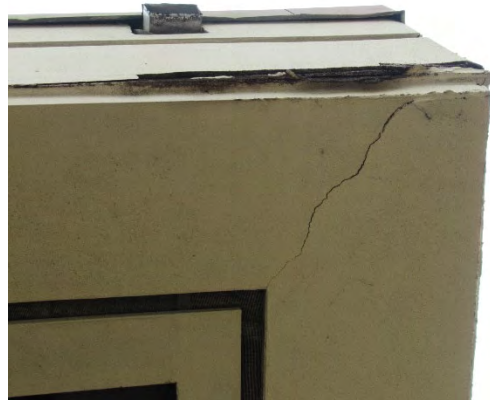
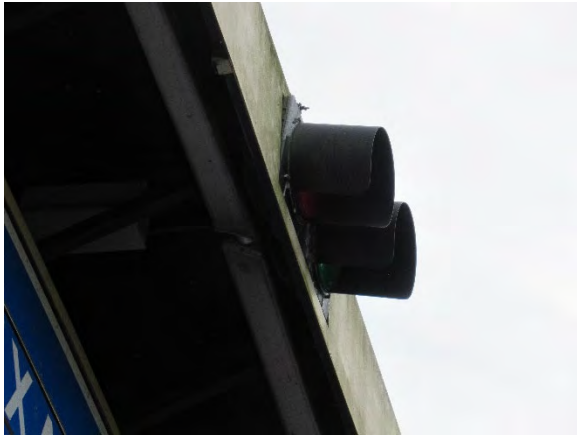
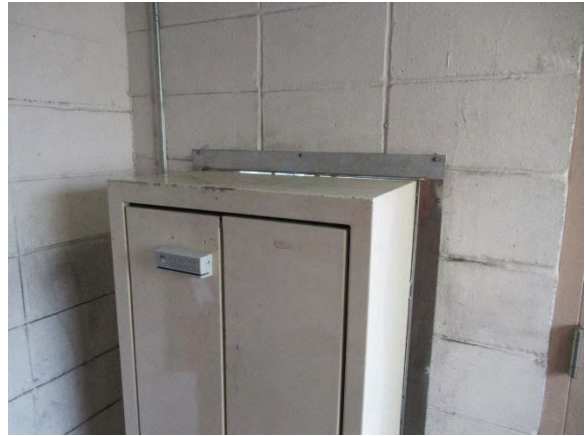
The above referenced ramp is in good condition overall. Some general maintenance to repair guardrail, ensure wrong way detection lighting is secured properly, cover electrical trough, weather seal interior joints at coin machine and patch and seal identified areas on building façade is recommended.
(Figure 45, Figure 46, Figure 47, Figure 48, Figure 49, Figure 50, Figure 51 & Figure 52)

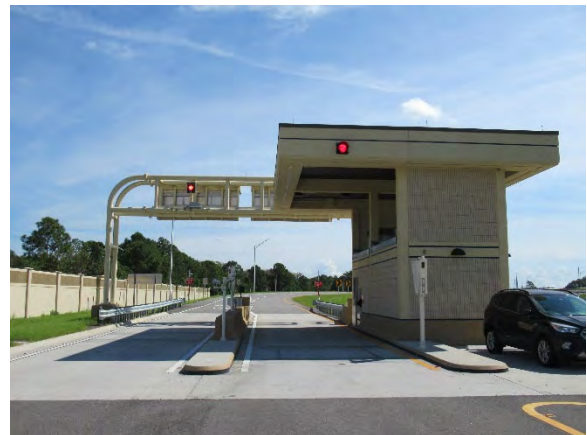
Figure 17 Rouse Road Ramp Off

The above referenced ramp is in good condition overall.
(Figure 17 & Figure 18)

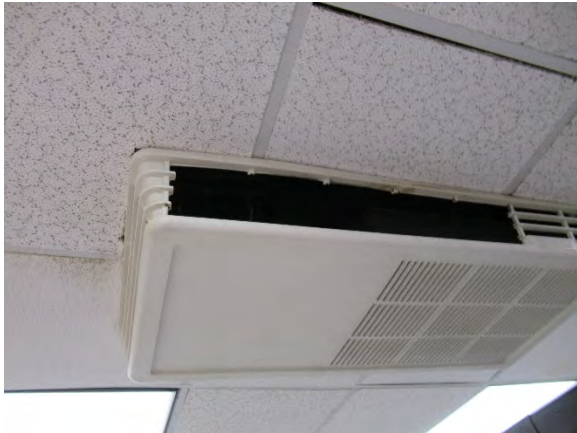
Figure 1 Coral Hills Mainline

- Mainline has leaks above ceiling tiles in multiple locations.
(Figure 1, Figure 2, Figure 3 & Figure 4)
- Mainline has cracks in the glass windows in the manager's office and break room.
(Figure 5 & Figure 6)

- Recommend maintenance to locate and repair any potential roof leaks.
- Recommend routine pest control to remove wasp nests under overpass and building exterior.
- Recommend routine maintenance to patch and seal cracks in building facade.

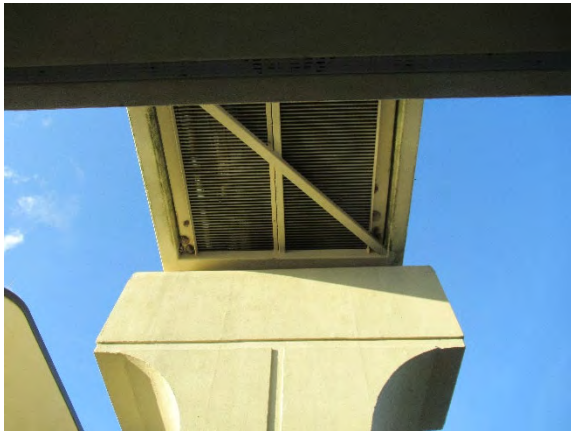
Figure 7 Coral Hills Mainline

- The above referenced overpass is in good condition overall with some identified wasp nests located on overpass underdeck.
(Figure 7 & Figure 8)

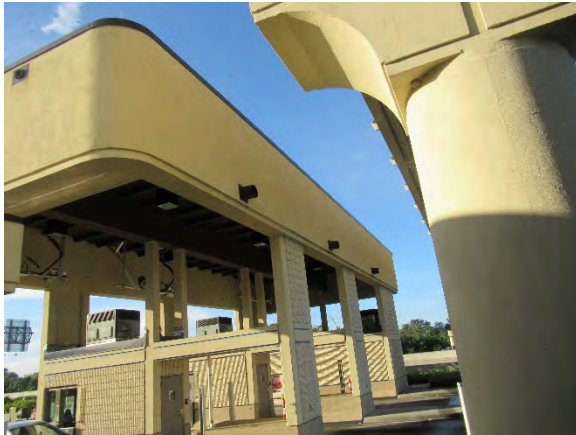
Figure 9 Coral Hills Mainline

- Exterior building has identified cracks in control joints on building façade and at plaza canopy wrong way detection lighting locations.
(Figure 9, Figure 10, Figure 11 & Figure 12)

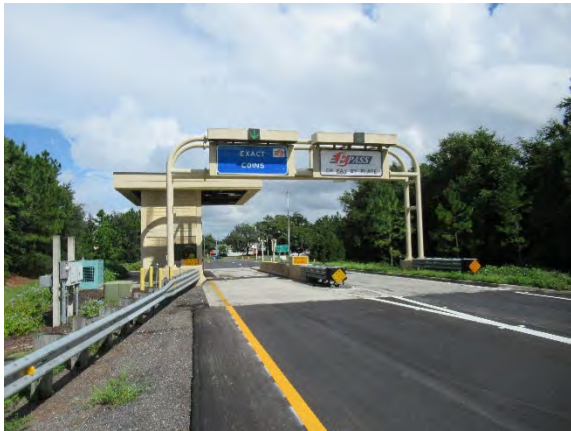
Figure 13 Keene Road Ramp Off

The above referenced ramp is in good condition overall. Some general maintenance to pressure wash plaza exterior and overhead sign structure is recommended.
(Figure 13 & Figure 14)

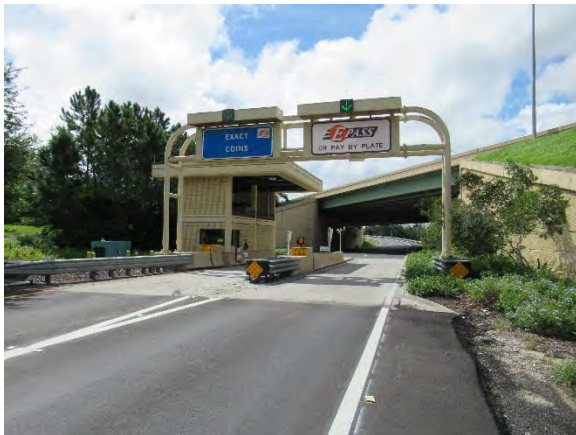
Figure 15 Keene Road Ramp On

The above referenced ramp is in good condition overall. Some general maintenance to weather seal interior joints at coin machine is recommended.
(Figure 15 & Figure 16)

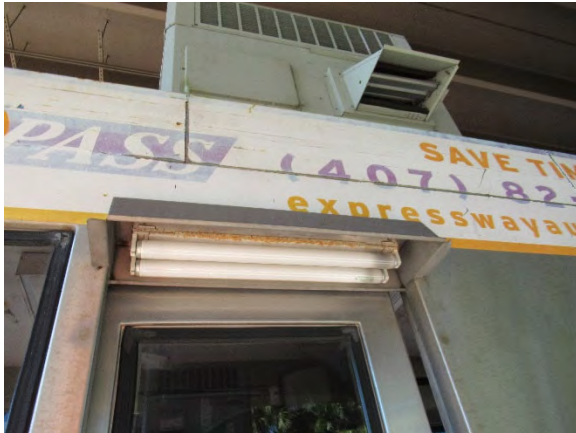
Figure 1 John Young Pkwy Mainline

- Exterior prefab toll booths have missing light covers.
(Figure 1 & Figure 2)
- Exterior erosion areas identified surrounding utility pole located adjacent to toll lanes.
(Figure 3, Figure 4 & Figure 5)
- Exterior palm trees are identified showing overgrowth into the overhead tolling structure.
(Figure 6)

- Recommend replacing missing light covers at prefab toll booths.
- Recommend general maintenance to repair exterior erosion areas near utility poles.
- Recommend general landscaping to trim palm trees away from overhead toll structure.

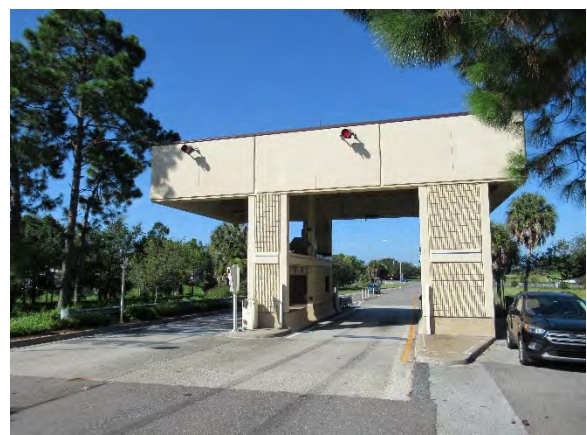
Figure 11 John Young Pkwy Ramp On

The above referenced ramp is in good condition overall.
(Figure 11 & Figure 12)

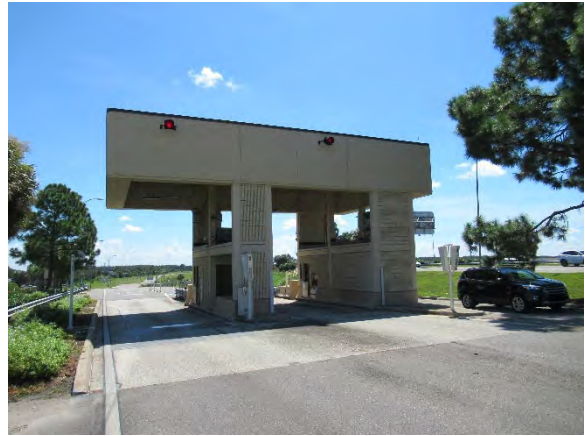
Figure 21 Landstar Ramp On

The above referenced ramp is in good condition overall.
(Figure 21, Figure 22, Figure 23 & Figure 24)

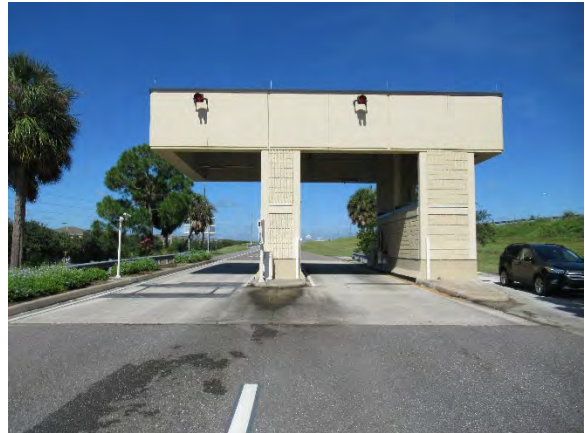
Figure 25 Landstar Ramp Off

The above referenced ramp is in good condition overall. Some general landscaping to replace ground cover erosion is recommended.
(Figure 25, Figure 26, Figure 27 & Figure 28)

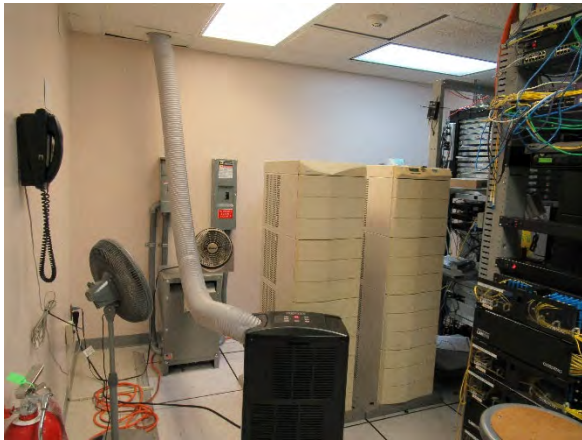
Figure 1 Boggy Creek Mainline

- Mainline interior has portable HVAC equipment in computer room and missing vent cover. (Figure 1, Figure 2, Figure 3 & Figure 4)
- Mainline interior has potential leaks above ceiling tiles in computer room and restrooms. (Figure 5 & Figure 6)

- Recommend general maintenance on HVAC system.
- Recommend maintenance to locate and repair any potential roof leaks.
- Recommend routine maintenance to patch and seal cracks in building facade.
- Recommend general maintenance to address exterior erosion areas near utility poles.

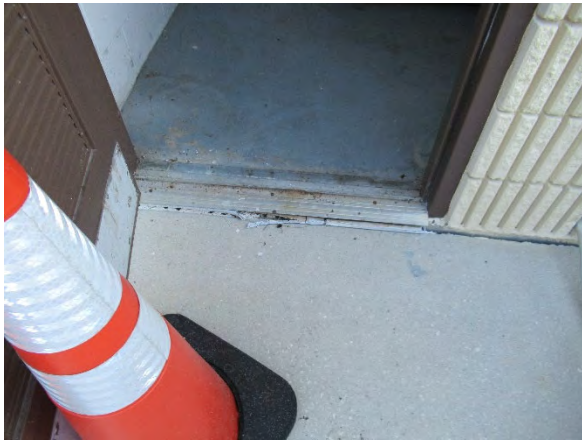
Figure 7 Boggy Creek Mainline

- Exterior elevator equipment room has identified deficiency in door threshold. (Figure 7)
- Exterior handhole cover is missing behind main building. (Figure 8)
- Exterior canopy has identified cracks in building façade. (Figure 9, Figure 10, Figure 11 & Figure 12)
- Exterior prefab toll booth lighting missing covers. (Figure 13 & Figure 14)
- Exterior erosion surrounding utility poles located adjacent to toll lanes. (Figure 15, Figure 16, Figure 17, Figure 18, Figure 19 & Figure 20)

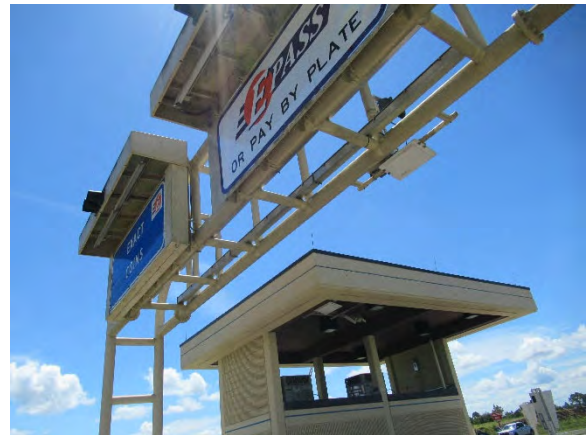
Figure 55 Innovation Ramp On

The above referenced ramp is in good condition overall. Some general maintenance to pressure wash plaza overhead sign structure, repair utility cover and general landscape is recommended.
(Figure 55, Figure 56, Figure 57, Figure 58, Figure 59 & Figure 60)

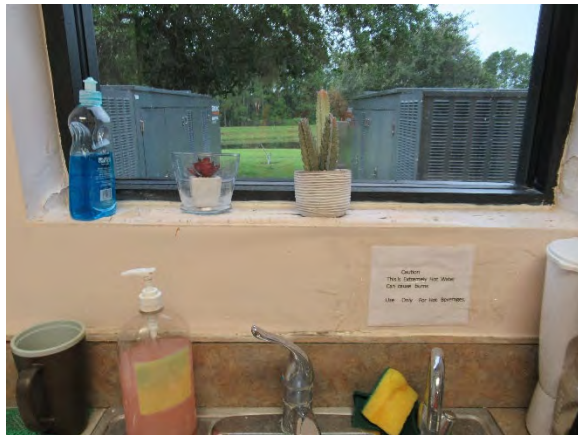
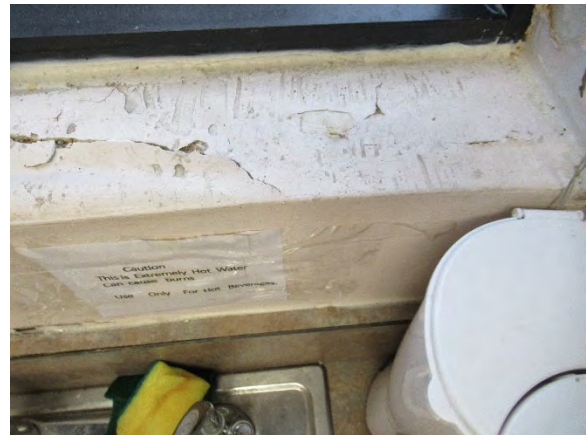
- Interior break room windowsill above sink area has identified cracks and paint peeling. (Figure 1 & Figure 2)
- Interior break room telephone jack is connected by duct tape. (Figure 3 & Figure 4)
- Interior locker area has potential leaks above ceiling tile. (Figure 5)
- Interior break room overhead lighting has crack (Figure 6)

Recommend general maintenance to locate and repair any potential roof leaks.
Recommend general maintenance to repair deficiencies in break room area.
Recommend general maintenance to pressure wash building exterior.

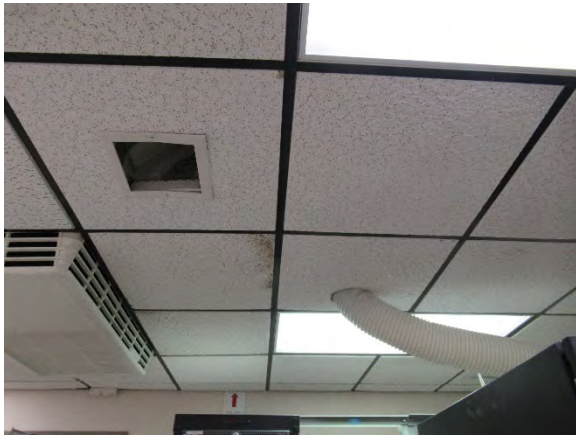
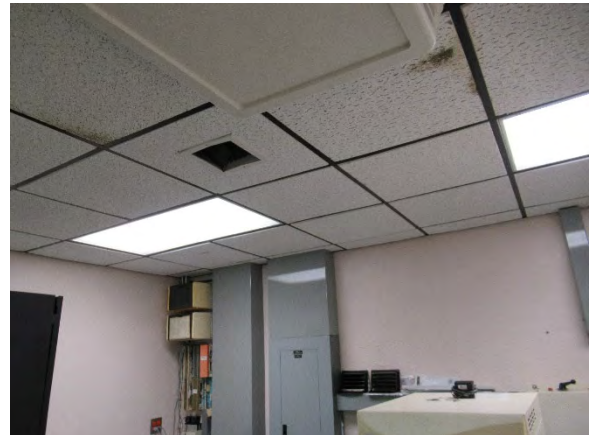
- Mainline interior has identified missing vent covers in computer room.
(Figure 1 & Figure 2)

- Recommend general maintenance on HVAC system to replace missing vent covers and ensure proper functionality.
- Recommend general maintenance to address exterior erosion areas located behind mainline building.
- Recommend general maintenance to pressure wash building exterior.

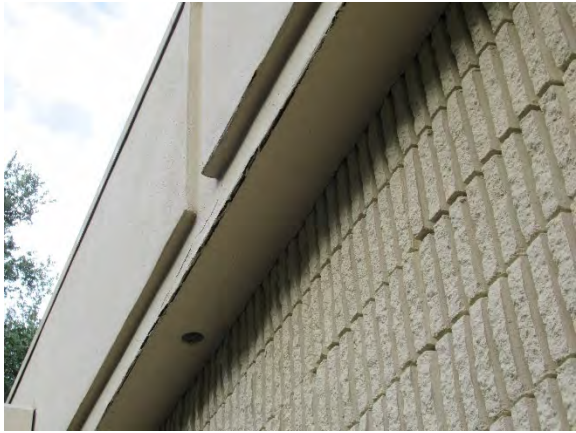
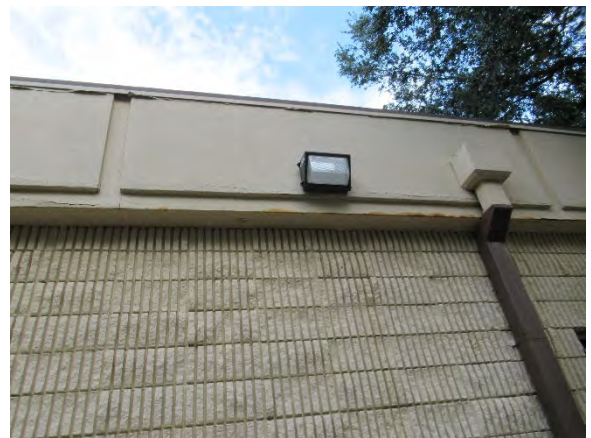
- Exterior building façade is in need of pressure wash and minor repairs.
(Figure 3 & Figure 4)
- Exterior maintenance shed located behind mainline facility has identified erosion located under concrete slab.
(Figure 5 & Figure 6)

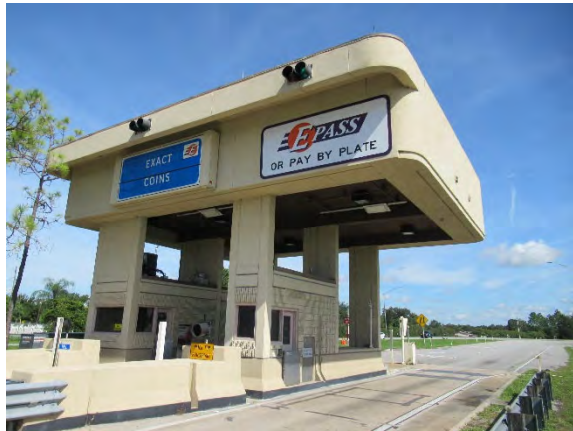
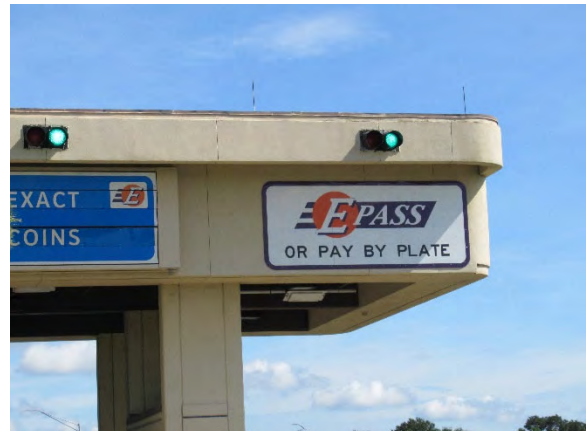
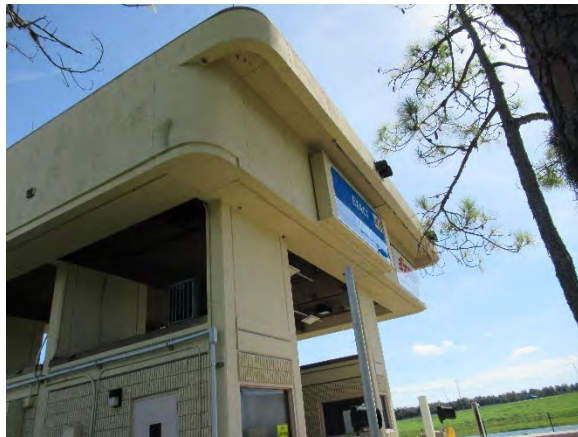
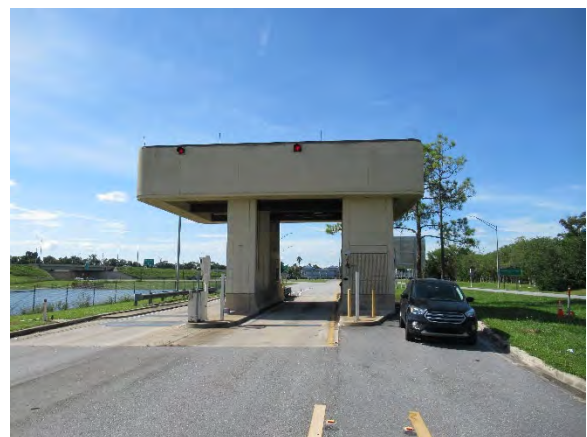
The above referenced ramp is in good condition overall. Some general maintenance to pressure wash plaza exterior and overhead sign structure is recommended.
(Figure 7, Figure 8, Figure 9 & Figure 10)

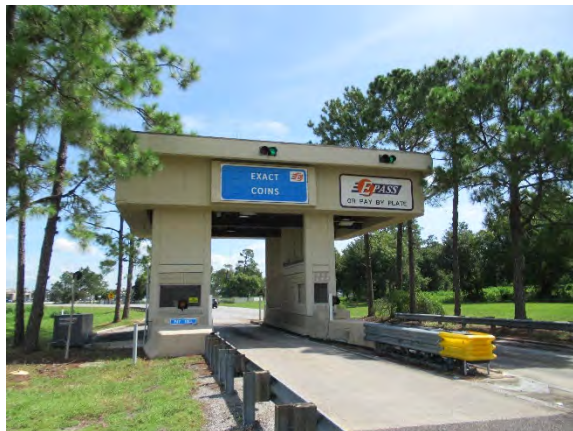
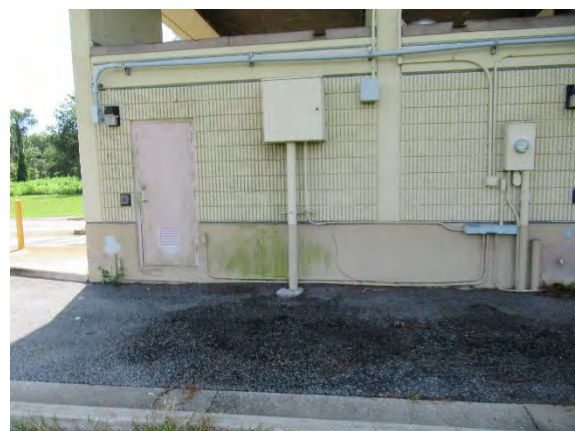
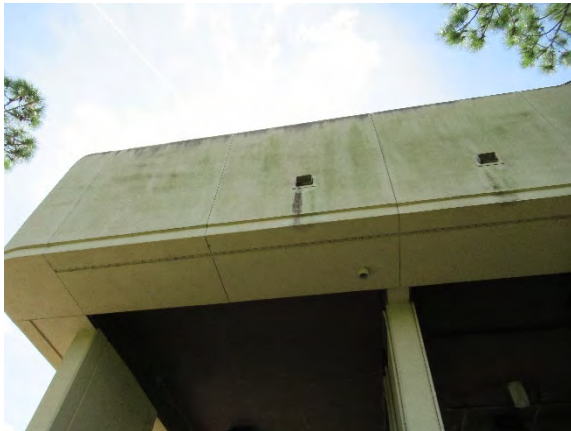
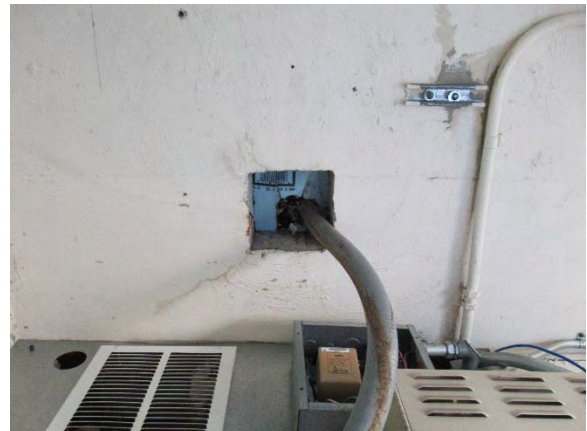
The above referenced ramp is in good condition overall. Some general maintenance to pressure wash plaza exterior, overhead sign structure and fireproof ceiling penetration is recommended.
(Figure 11, Figure 12, Figure 13 & Figure 14)

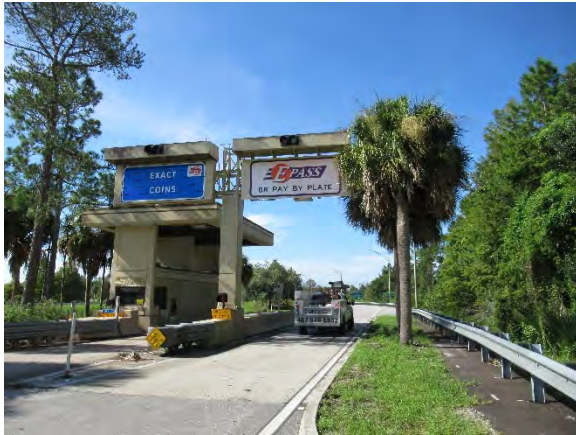
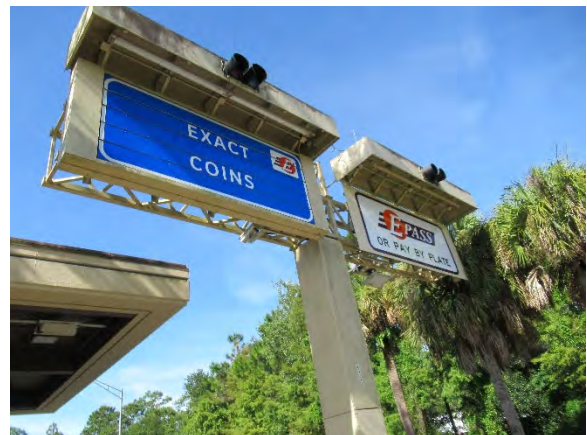
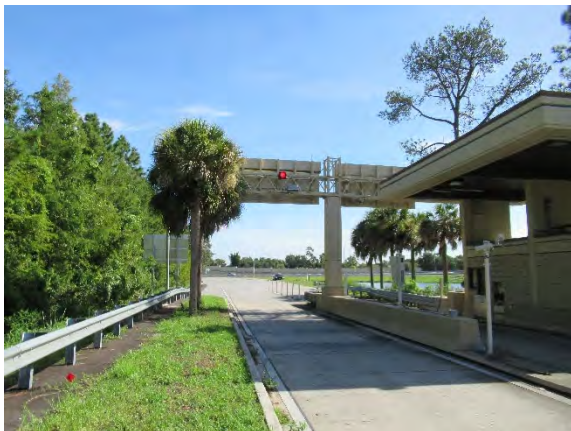
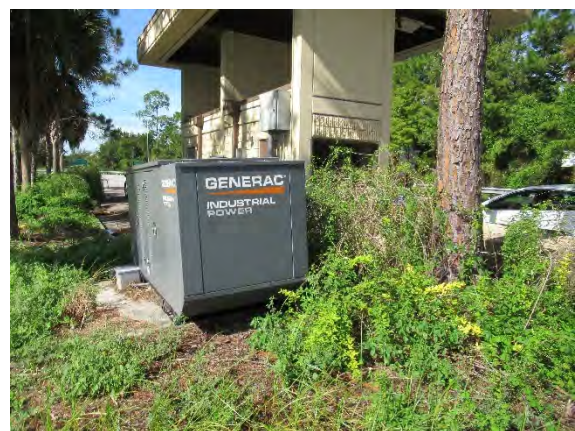
The above referenced ramp is in good condition overall. Some general maintenance to pressure wash plaza exterior, overhead sign structure and general landscape maintenance is recommended.
(Figure 15, Figure 16, Figure 17 & Figure 18)
