2020

Annual Inspection Report

Re: 2020 Annual Inspection Report

2020 Annual Inspection Report
CENTRAL FLORIDA EXPRESSWAY AUTHORITY

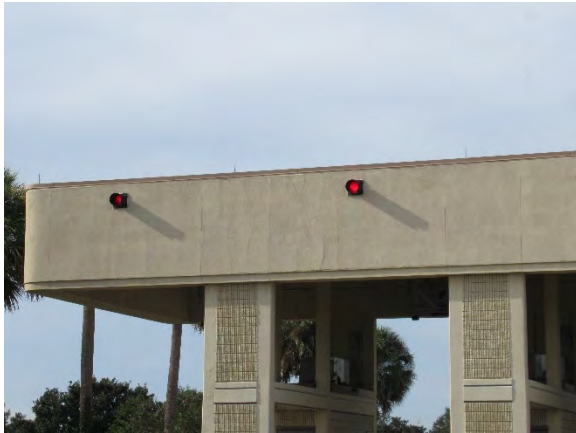
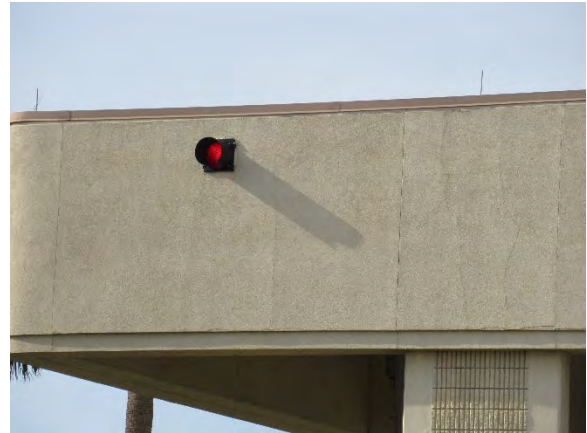
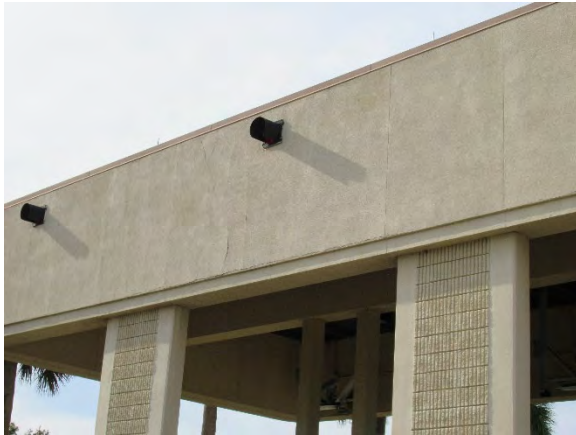
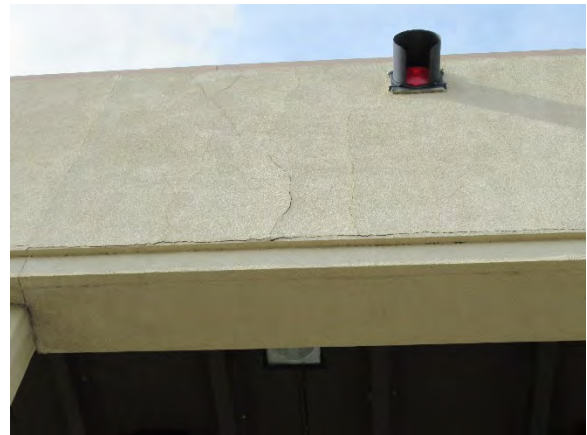
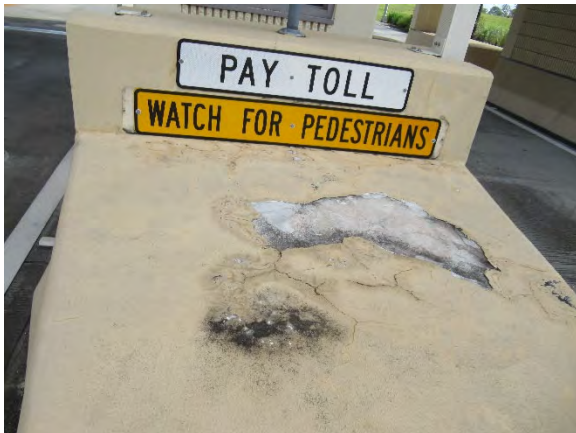
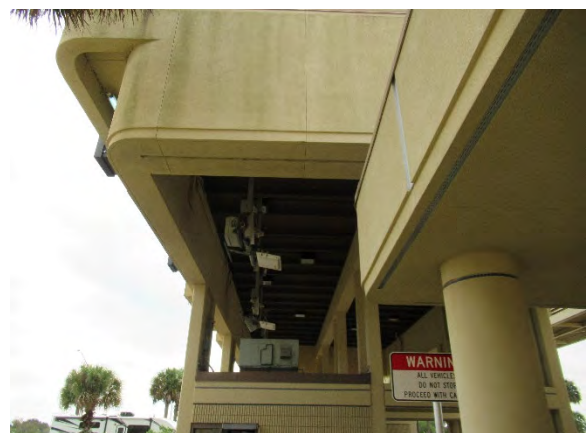
- Exterior building has identified cracks on building façade and at plaza canopy locations.
(Figure 7, Figure 8, Figure 9, Figure 10, Figure 11 & Figure 12)

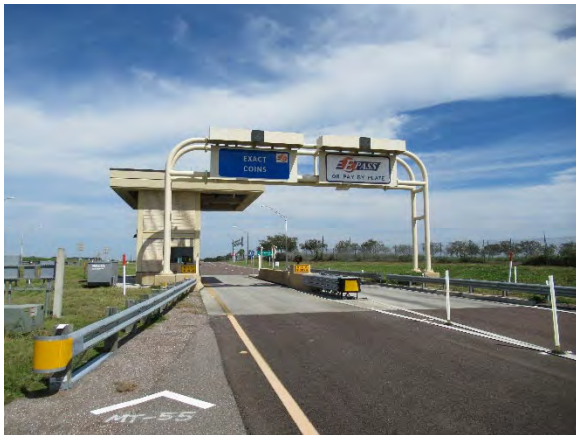
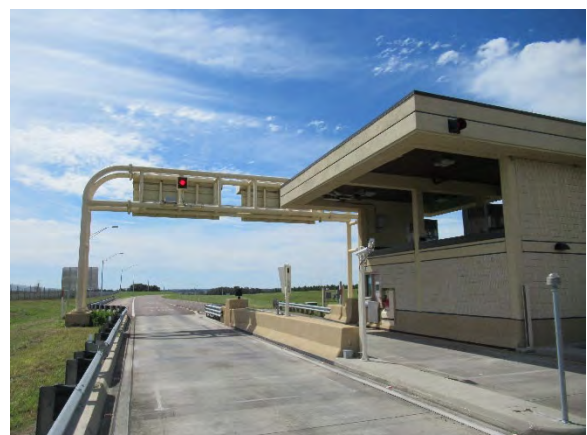
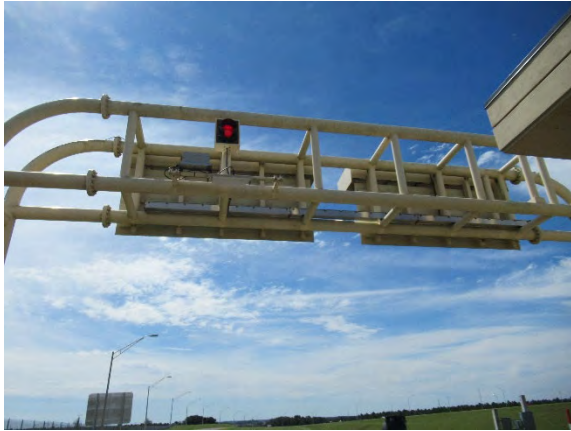
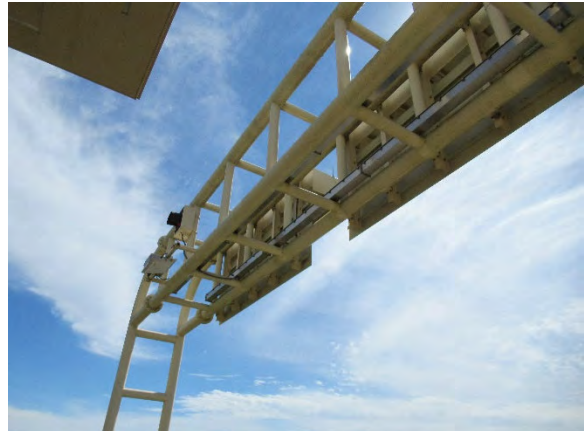
The above referenced ramp is in good condition overall. Some general maintenance to pressure wash plaza exterior and overhead sign structure is recommended.
(Figure 17, Figure 18, Figure 19 & Figure 20)

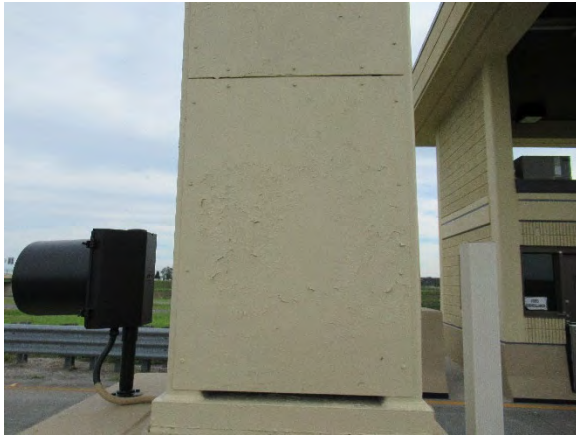
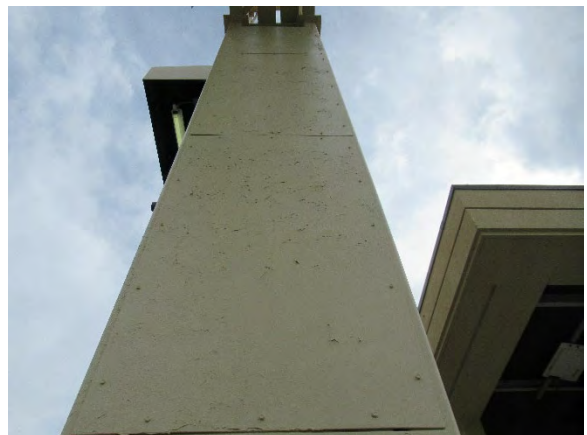
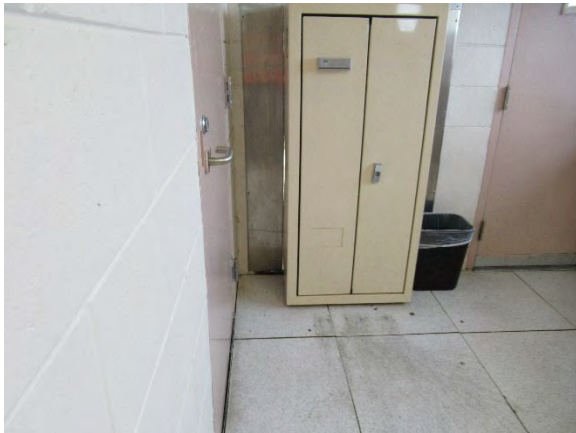
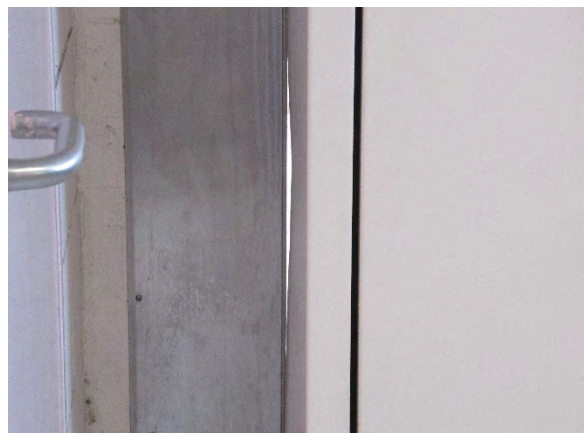
The above referenced ramp is in good condition overall. Some general maintenance to address the peeling paint on signage post and weather seal interior joints at coin machine is recommended.
(Figure 21, Figure 22, Figure 23 & Figure 24)

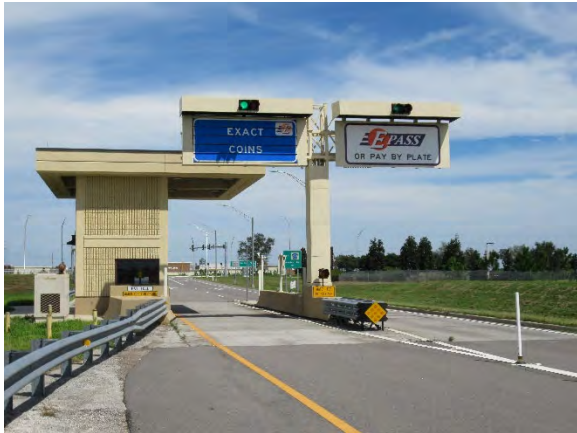
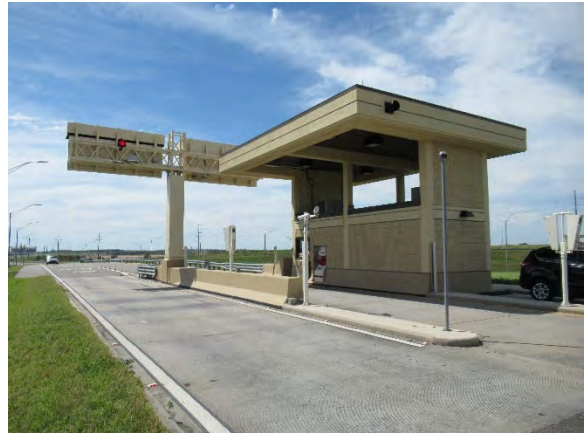
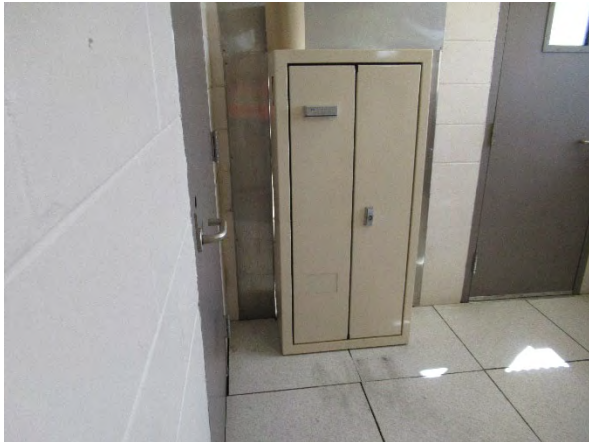
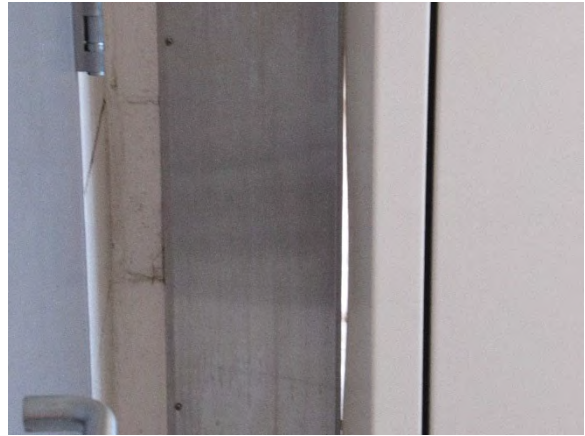
The above referenced ramp is in good condition overall. Some general maintenance to weather seal interior joints at coin machine is recommended.
(Figure 25, Figure 26, Figure 27 & Figure 28)

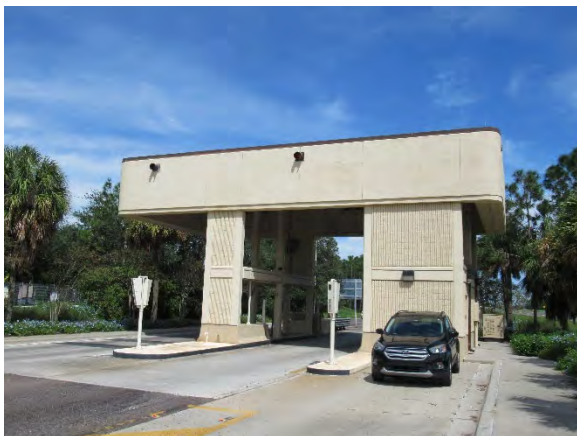
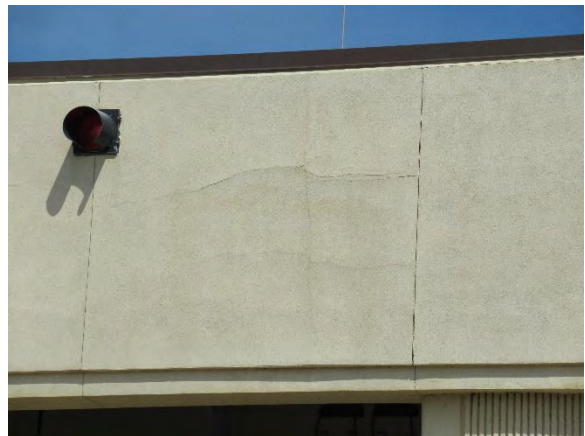
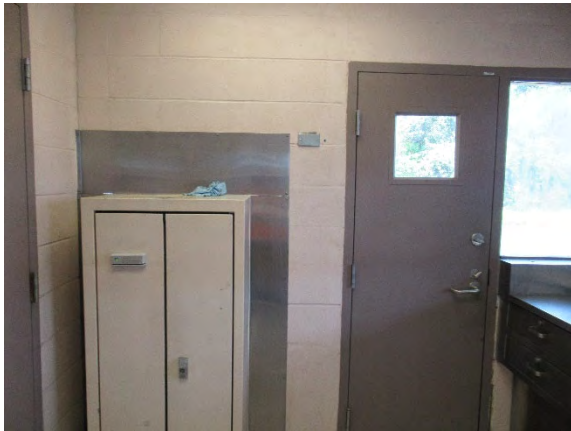
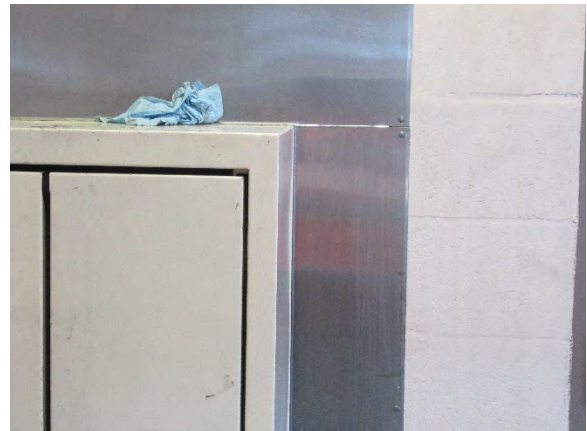
The above referenced ramp is in good condition overall. Some general maintenance to weather seal interior joints at coin machine and patch and seal cracks in building façade is recommended.
(Figure 29, Figure 30, Figure 31 & Figure 32)

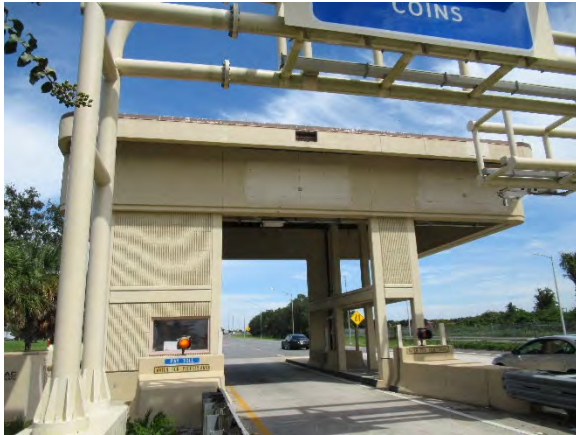
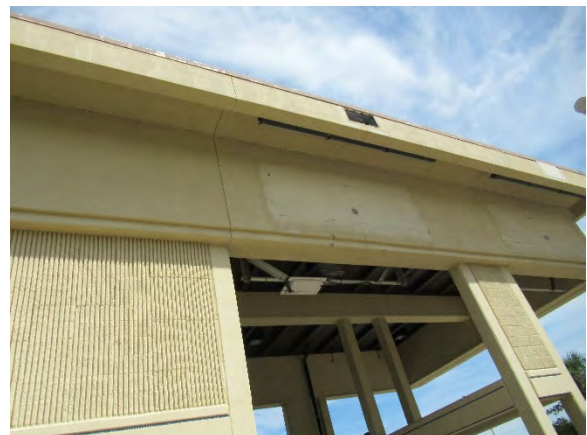
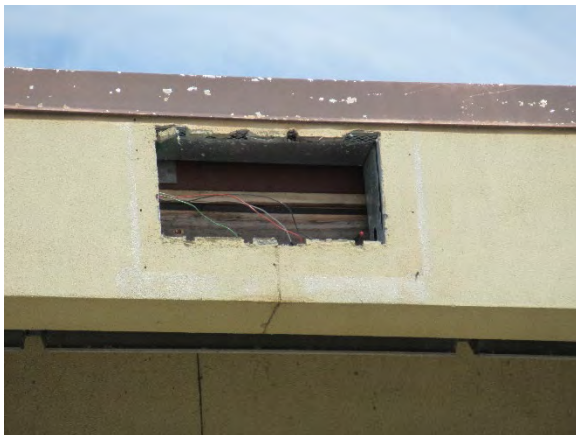
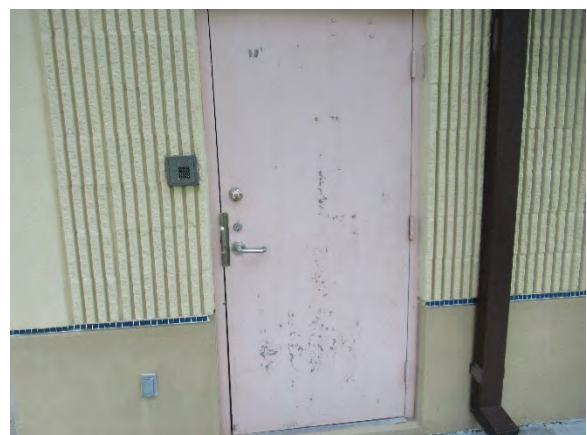
The above referenced ramp is in good condition overall. Some general maintenance to patch, seal and paint building façade at location of previous signage and paint door is recommended.
(Figure 33, Figure 34, Figure 35 & Figure 36)

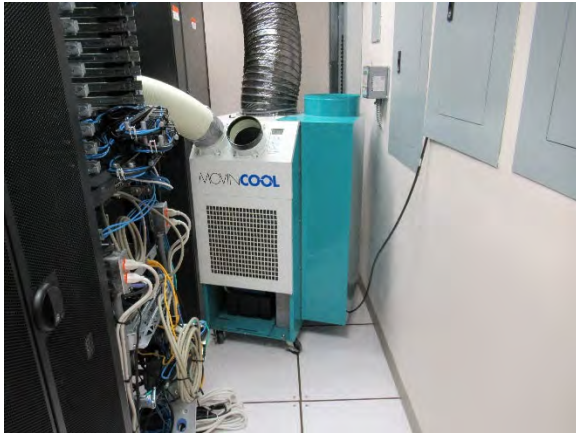
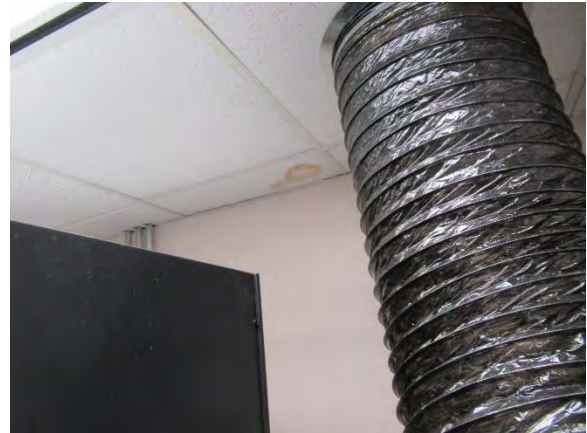
- Mainline interior has temporary HVAC equipment located in computer room.
(Figure 1 & Figure 2)
- Mainline interior has potential leaks above ceiling tile in computer room.
(Figure 3 & Figure 4)
- Elevator equipment room exterior door has identified rusting / corrosion at threshold.
(Figure 5 & Figure 6)

- Recommend general maintenance to locate and repair any potential roof leaks.
- Recommend general maintenance to ensure computer room HVAC is working properly.
- Recommend general maintenance to pressure wash overpass and building exterior.

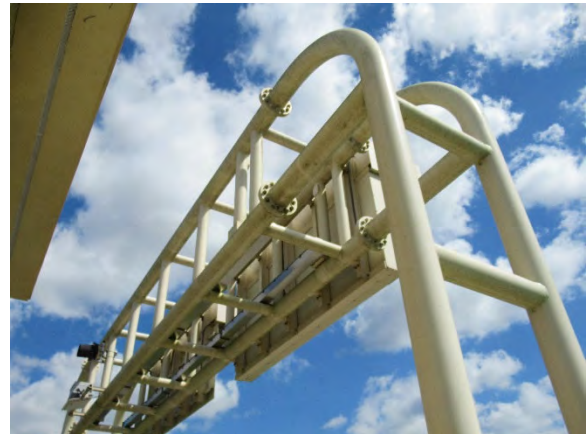
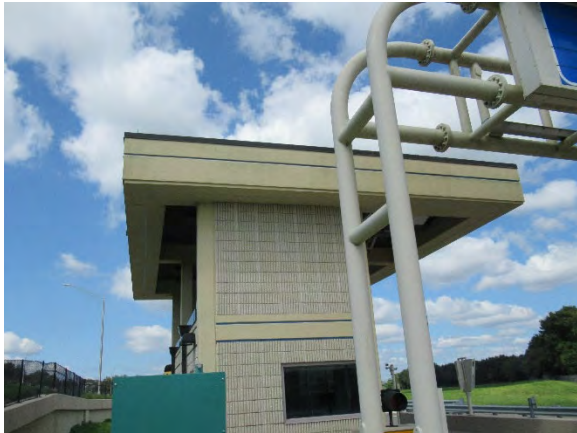
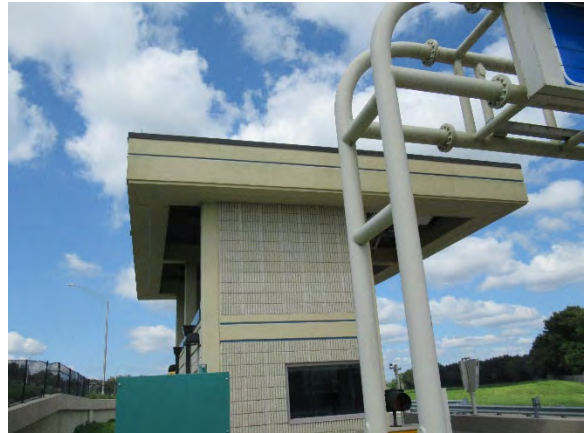
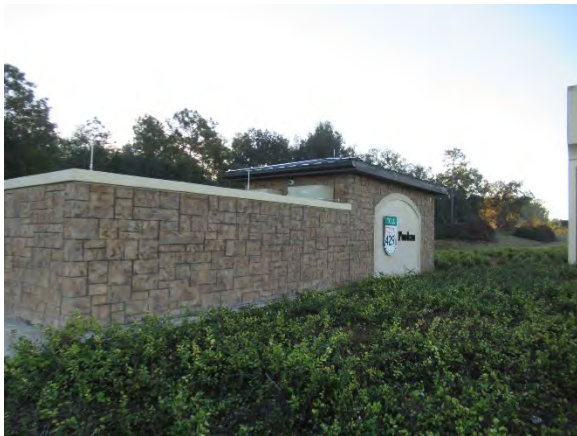
The above referenced ramp is in good condition overall. Some general maintenance to pressure wash plaza exterior and overhead sign structure is recommended.
(Figure 29, Figure 30, Figure 31 & Figure 32)

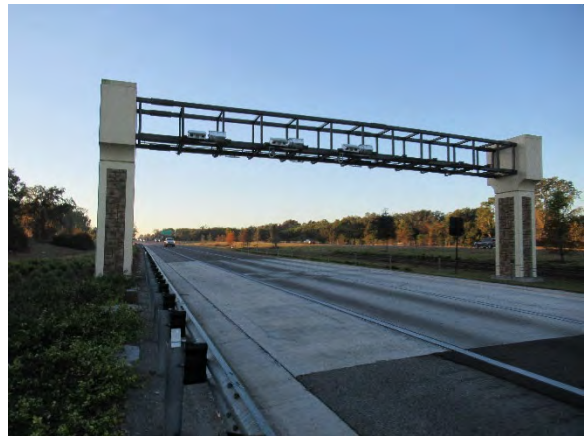
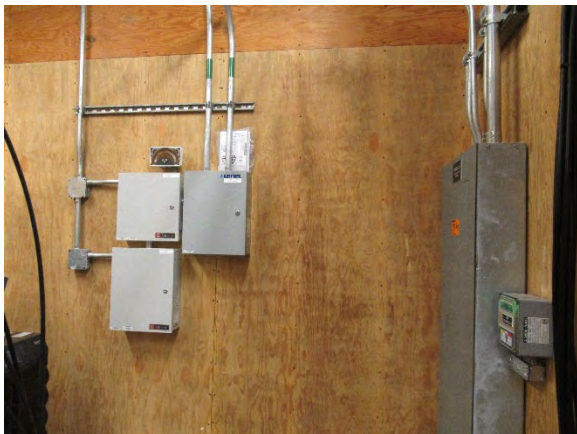
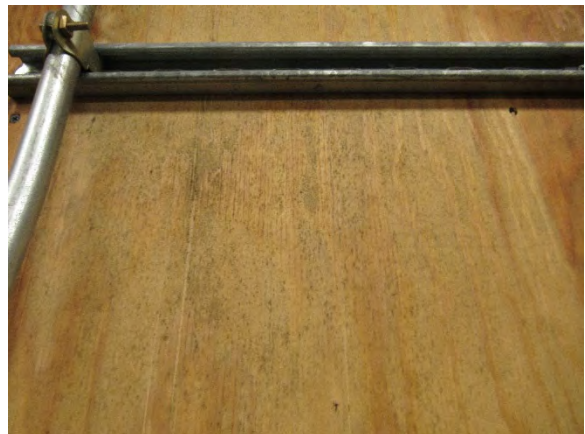
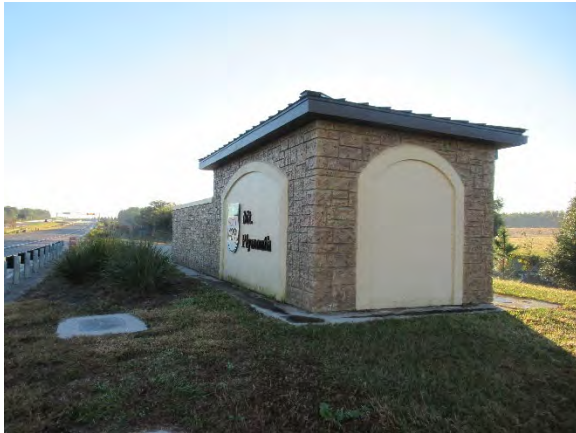
The above referenced ramp is in good condition overall. General maintenance is recommended to address interior condensation and general landscaping is recommended.
(Figure 33, Figure 34, Figure 35 & Figure 36)

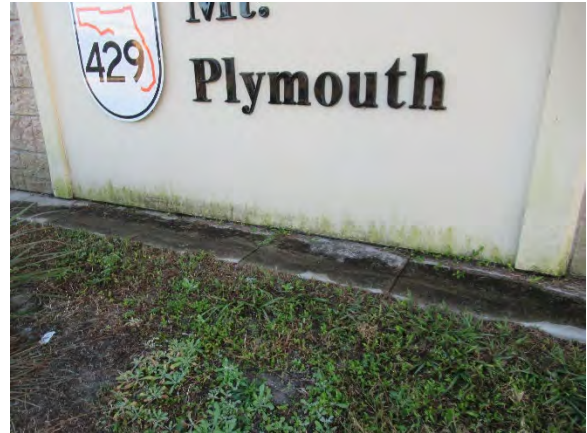
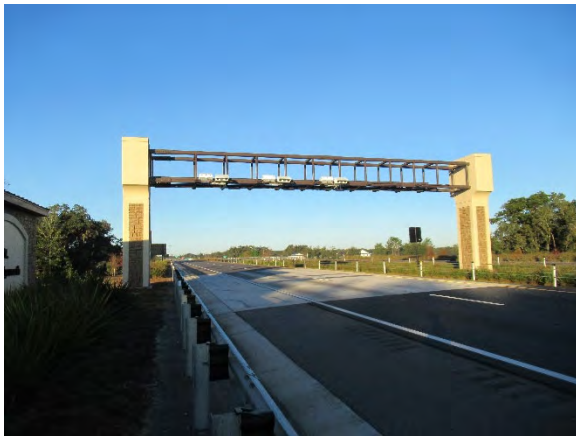
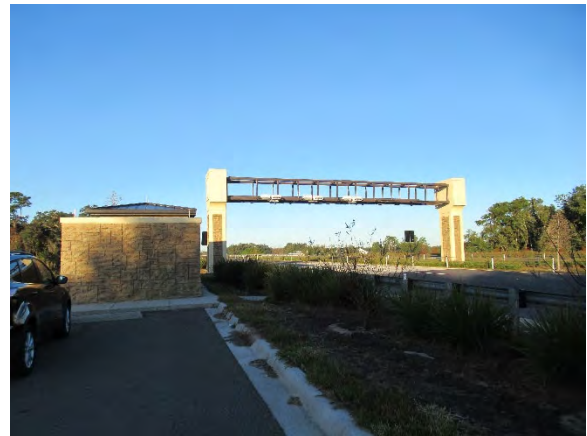
The above referenced ramp is in good condition overall. General maintenance is recommended to pressure wash building exterior.
(Figure 37, Figure 38, Figure 39 & Figure 40)

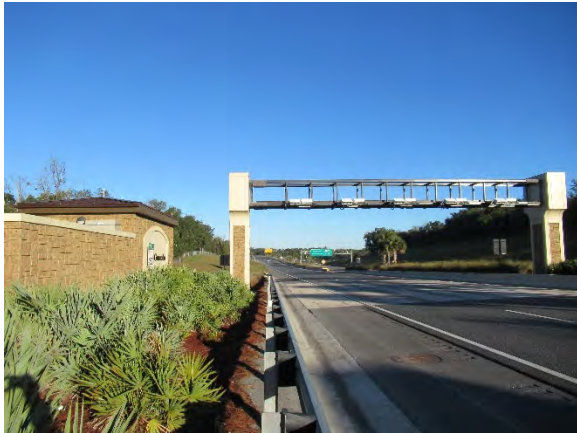
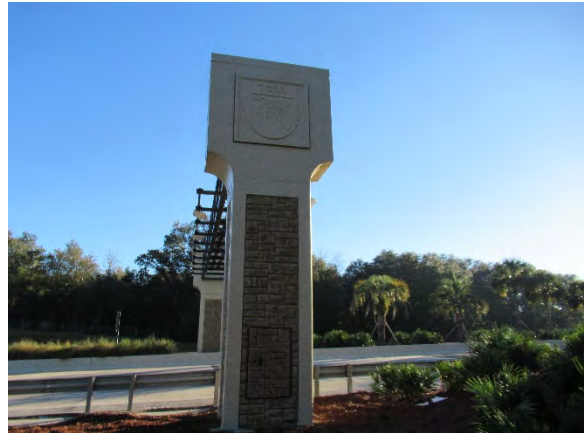
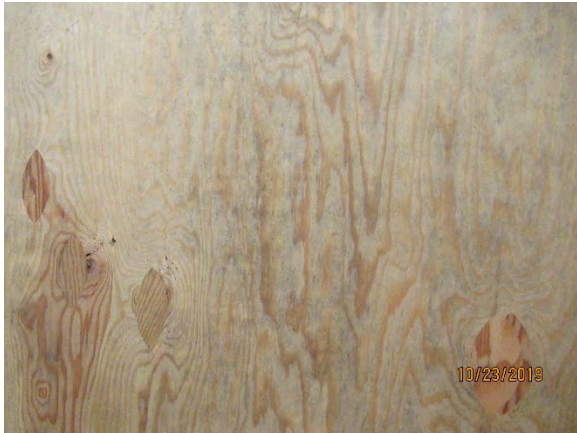
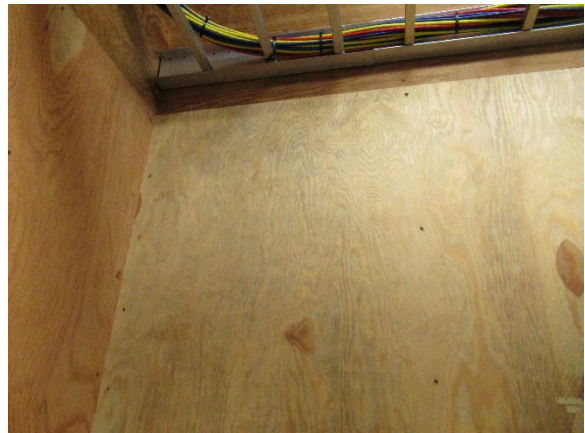
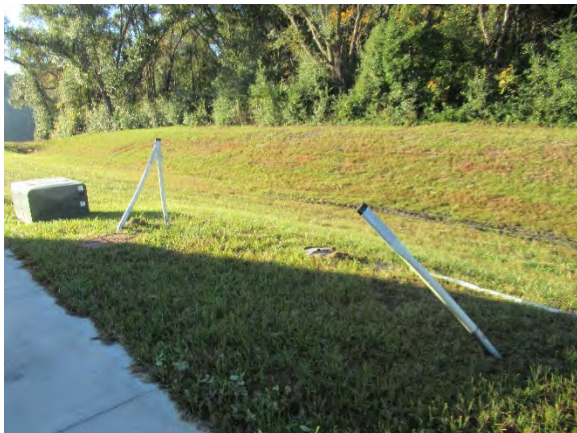
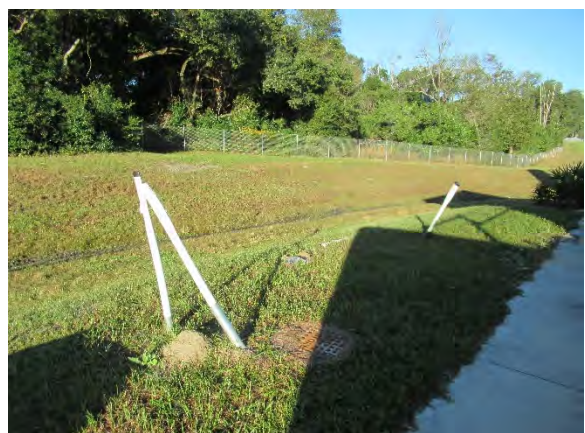
The above referenced ramp is in good condition overall. General maintenance is recommended to address interior condensation and replace delineator markings located around buried propane tank.

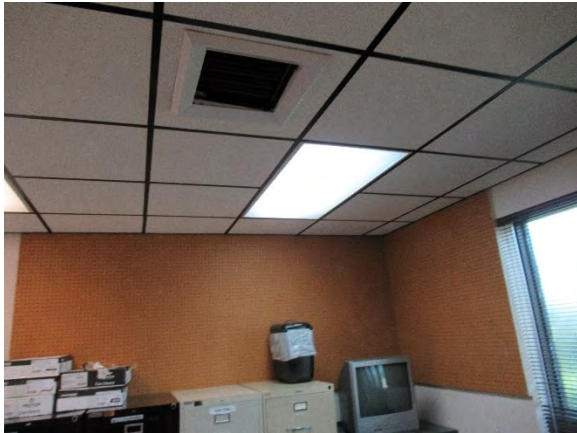
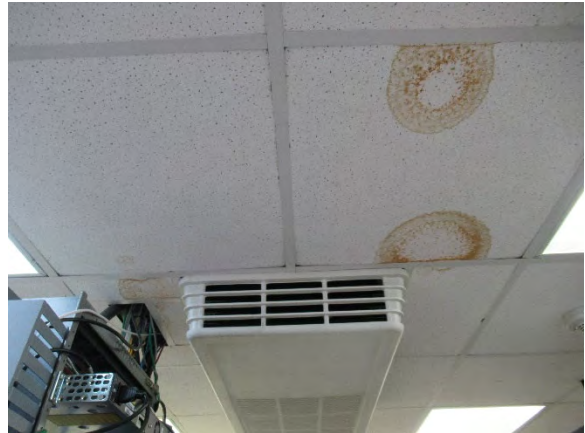
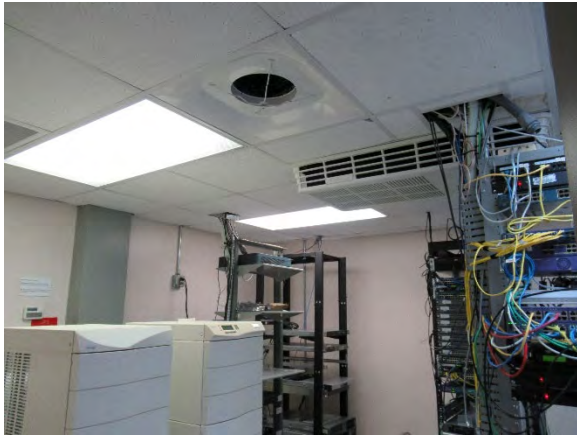
Figure 1 Beachline Mainline

- Mainline has isolated ceiling vent covers missing and potential leaks above ceiling tiles.
(Figure 1, Figure 2 & Figure 3)
- Mainline has isolated HVAC issue in computer room and is not working properly.
(Figure 4)
- Mainline electric room ceiling mounted smoke detector is identified as covered.
(Figure 5 & Figure 6)

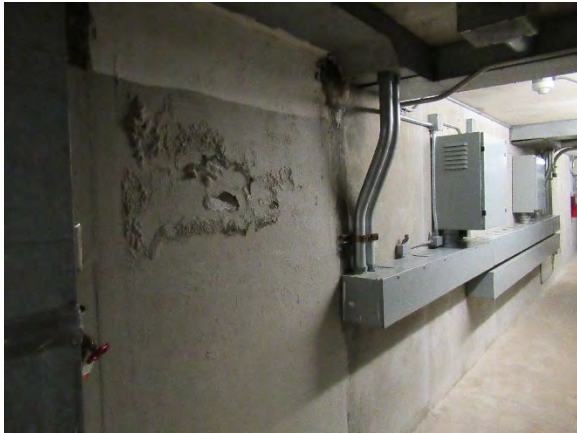
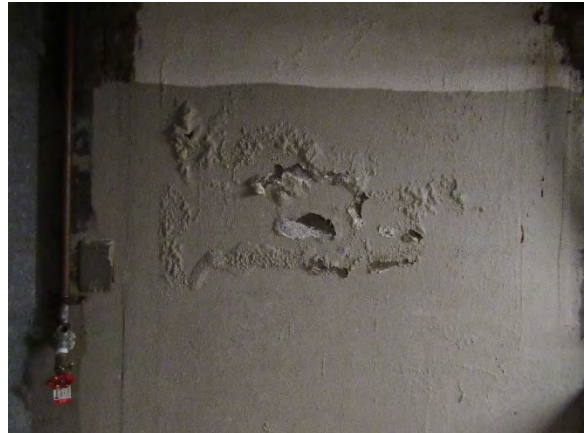
Figure 7 Beachline Mainline

- Interior tunnel wall has isolated deficiency. (Figure 7 & Figure 8)

- Recommend maintenance on electric room ceiling smoke detector to remove covering.
- Recommend maintenance on interior tunnel wall.
- Recommend general maintenance to ensure computer room HVAC is working properly.
- Recommend general landscaping and repair tear in fence located behind mainline facility.

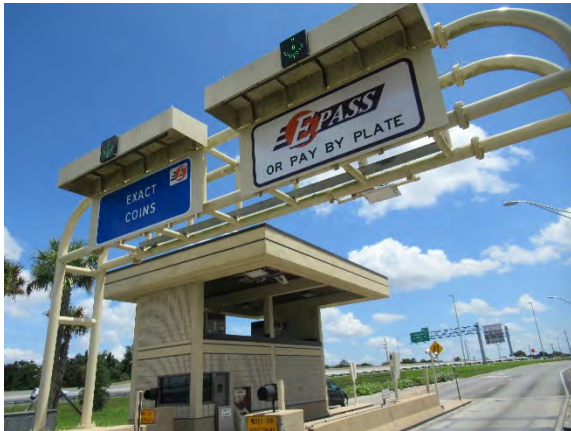
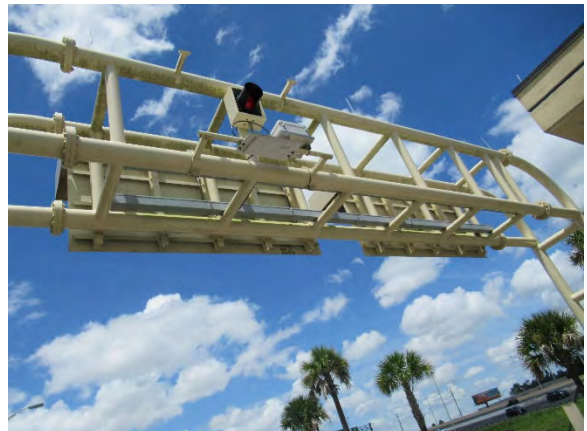
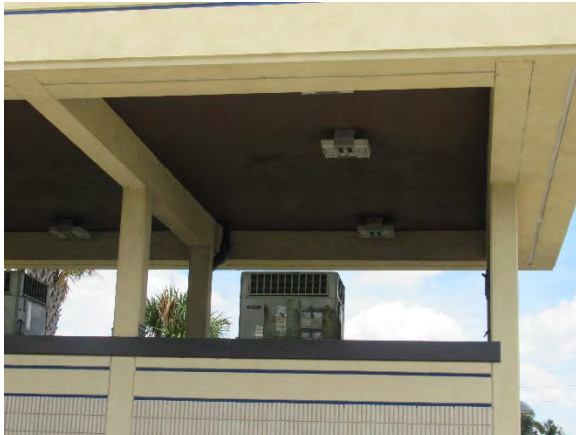
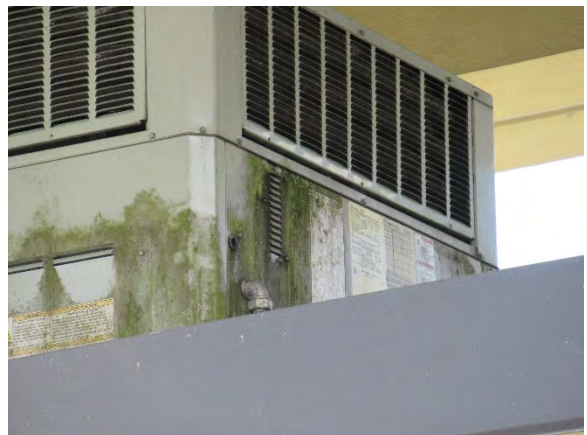
Figure 13 McCoy Road Ramp Off

The above referenced ramp is in good condition overall. Some general maintenance to pressure wash plaza exterior and overhead sign structure is recommended.
(Figure 13, Figure 14, Figure 15 & Figure 16)

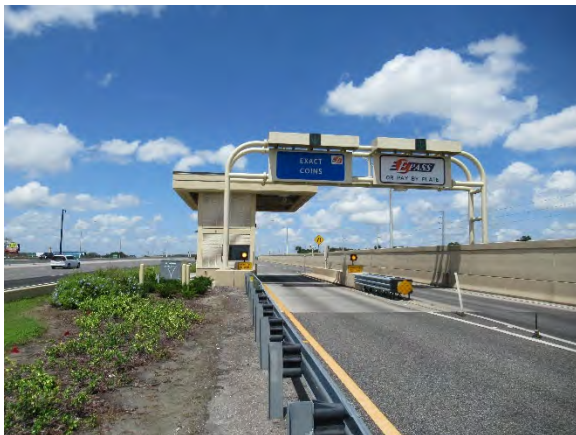
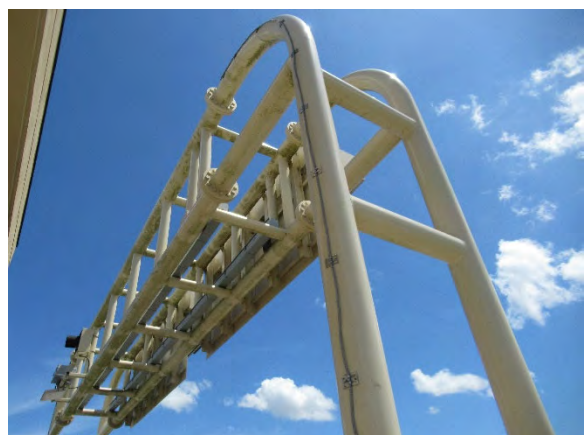
Figure 17 Jetport Ramp On

The above referenced ramp is in good condition overall. Some general maintenance to pressure overhead sign structure is recommended.
(Figure 17 & Figure 18)

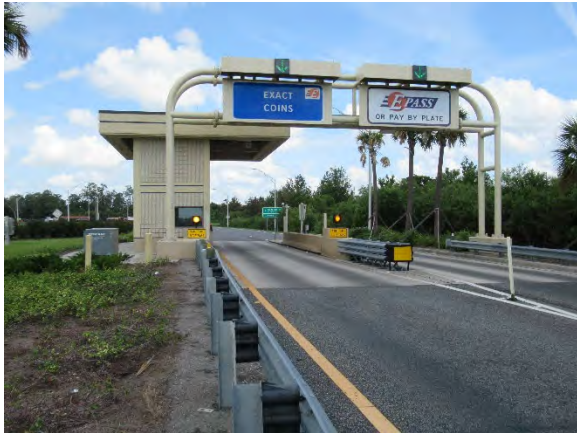
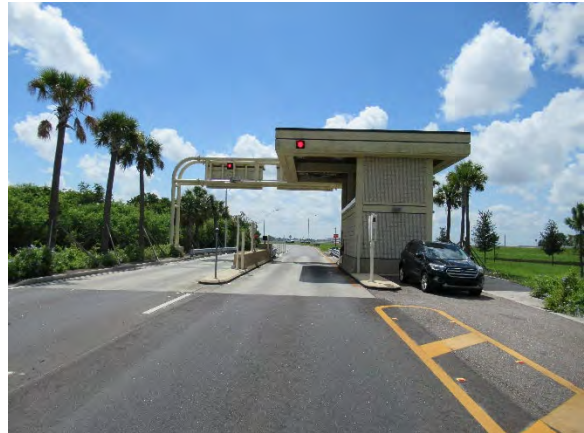
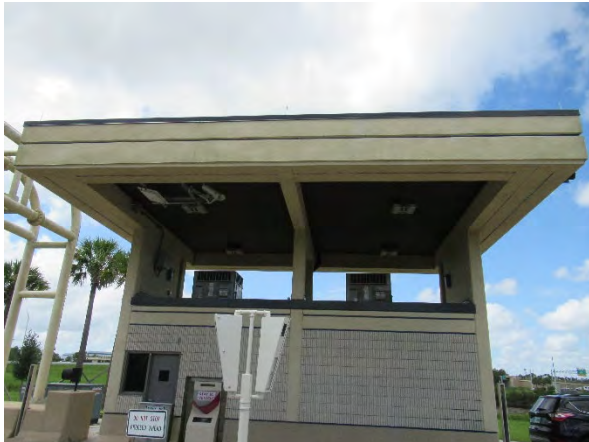
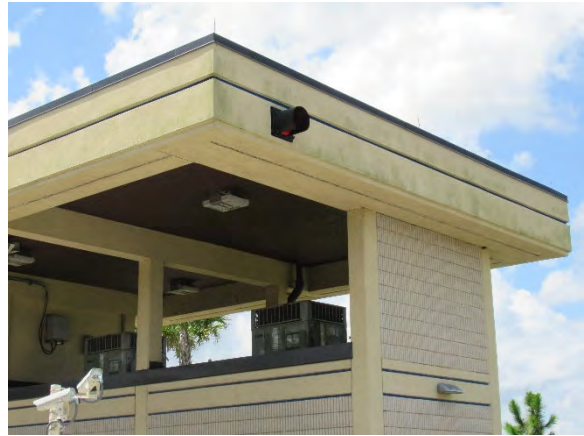
Figure 19 Conway Ramp On

The above referenced ramp is in good condition overall. Some general maintenance to pressure wash plaza exterior and overhead sign structure is recommended.
(Figure 19, Figure 20, Figure 21 & Figure 22)

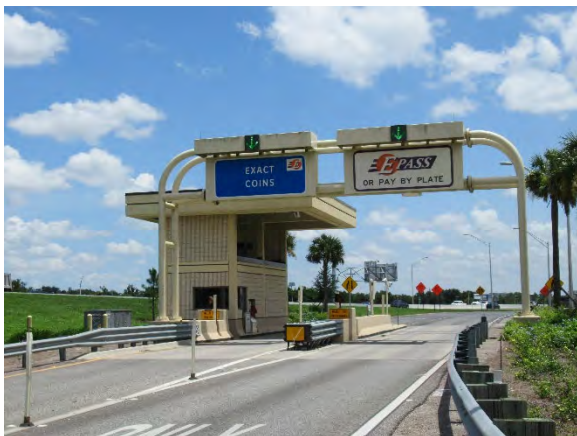
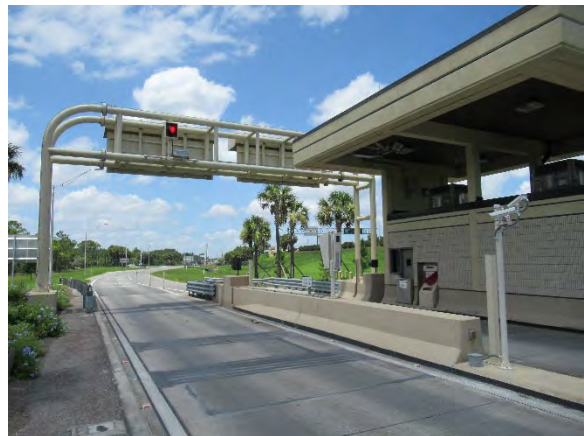
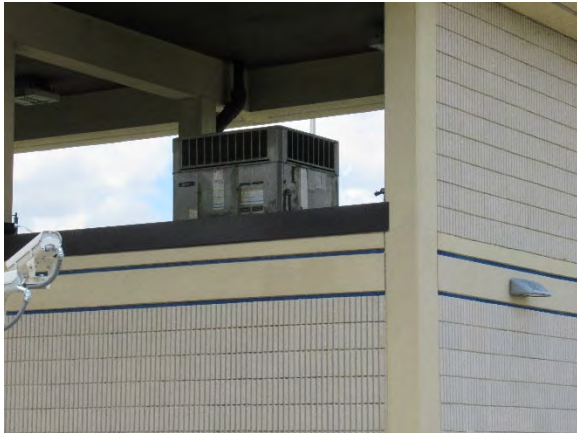
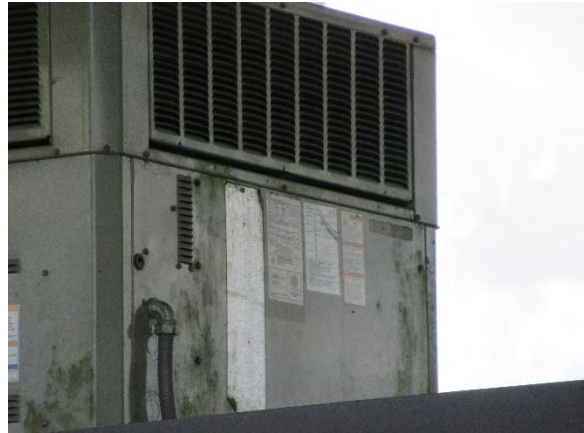
Figure 23 Tradeport Ramp On

The above referenced ramp is in good condition overall. Some general maintenance to pressure wash plaza exterior and overhead sign structure is recommended.
(Figure 23, Figure 24, Figure 25 & Figure 26)

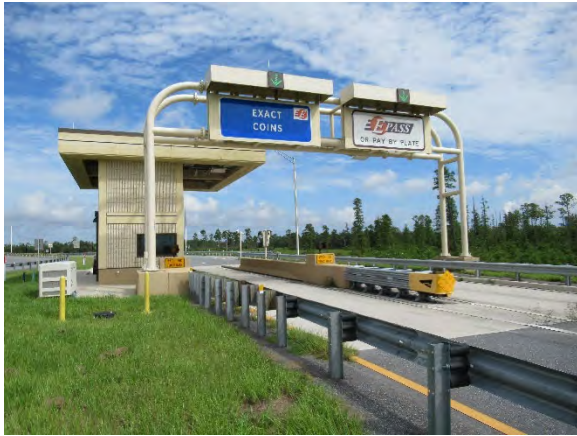
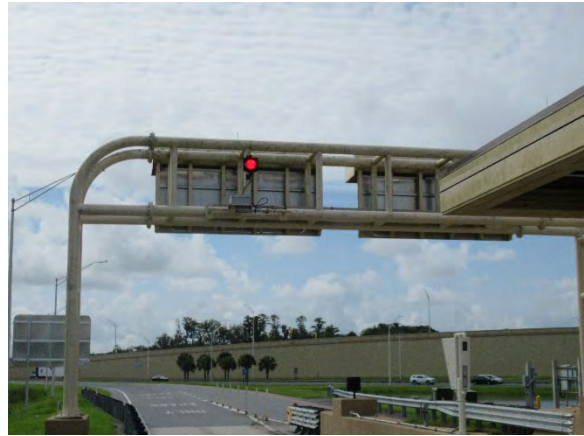
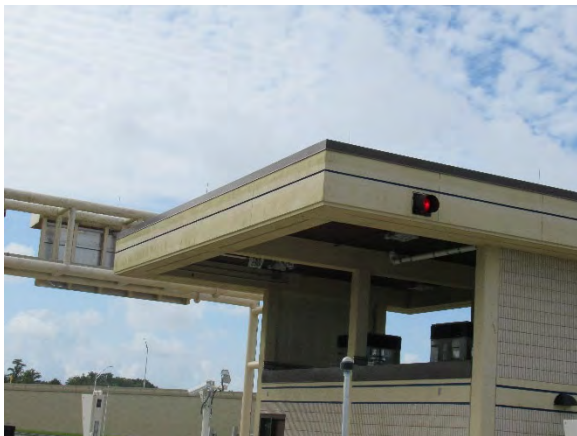
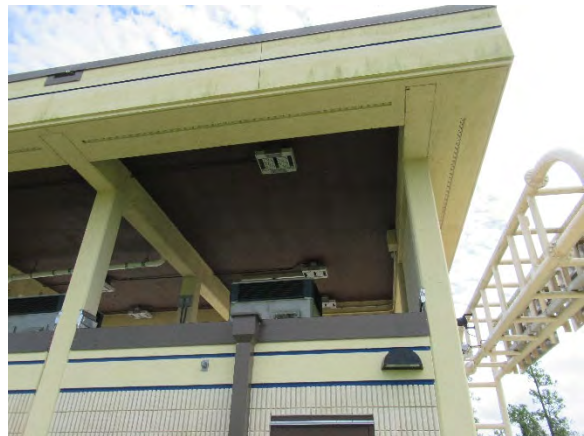
Figure 27 ICP Ramp Off

The above referenced ramp is in good condition overall. Some general maintenance to pressure wash plaza exterior and overhead sign structure is recommended.
(Figure 27, Figure 28, Figure 29 & Figure 30)

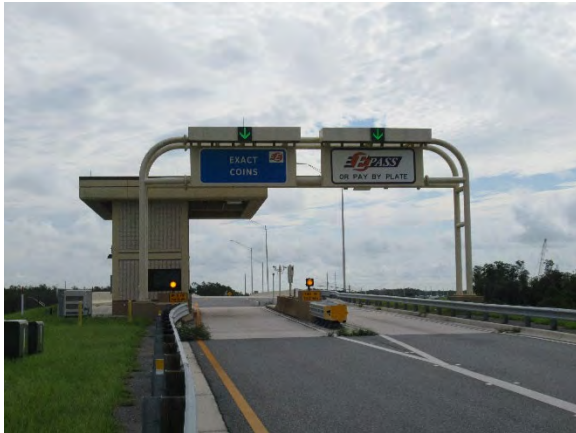
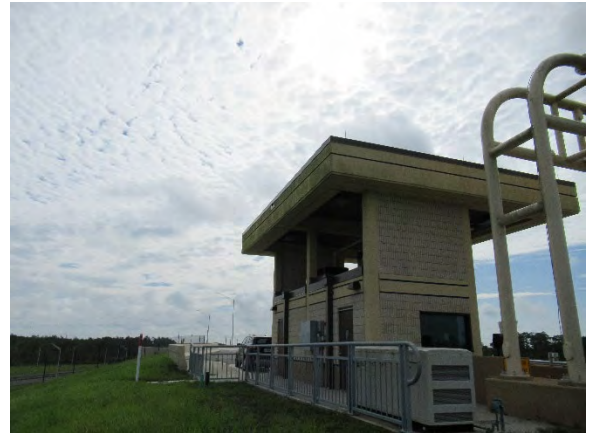
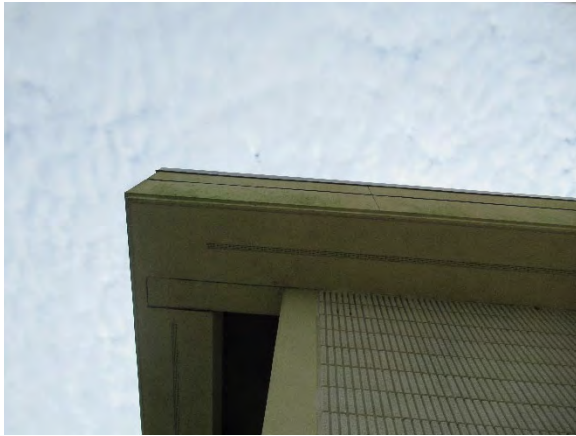
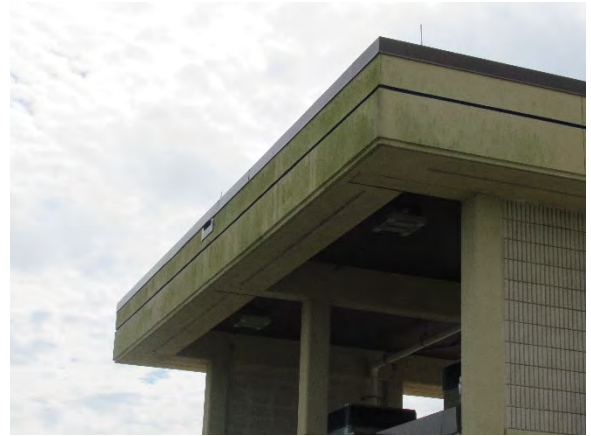
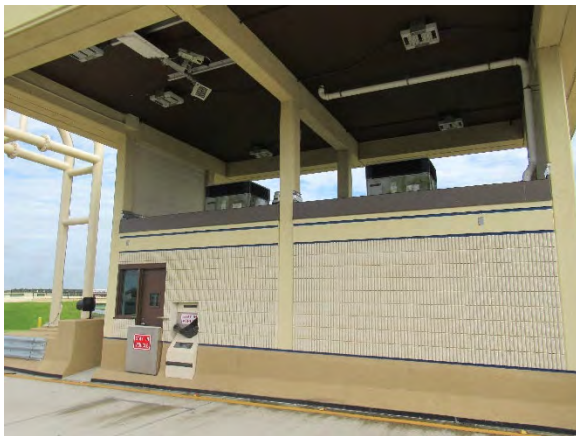
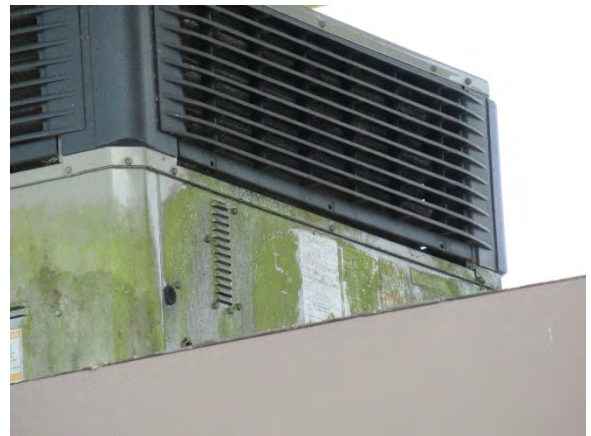
Figure 31 ICP Ramp On

The above referenced ramp is in good condition overall. Some general maintenance to pressure wash plaza exterior and overhead sign structure is recommended.
(Figure 31, Figure 32, Figure 33, Figure 34, Figure 35 & Figure 36)

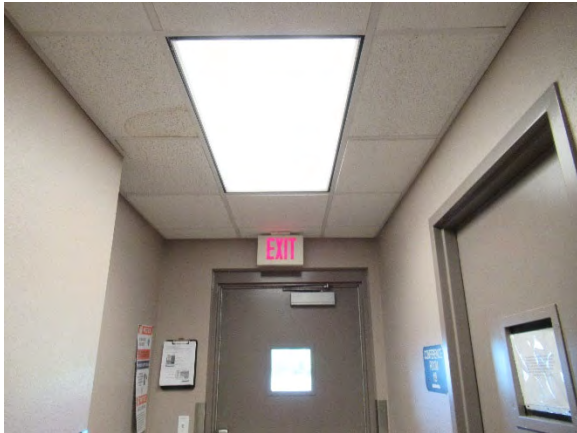
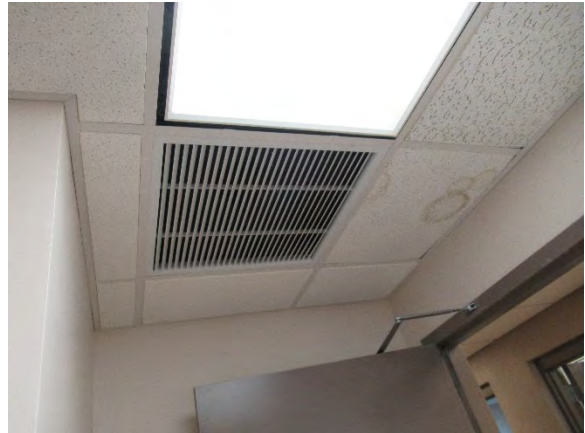
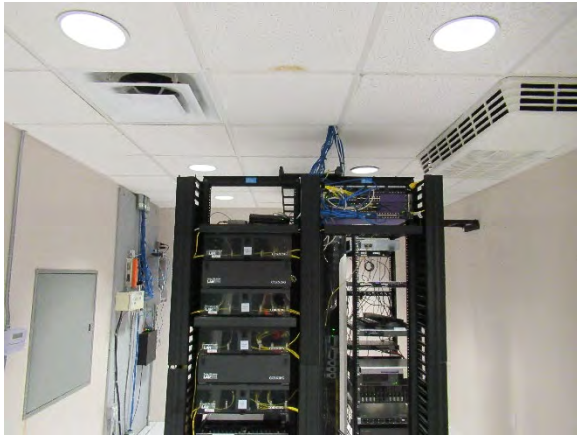
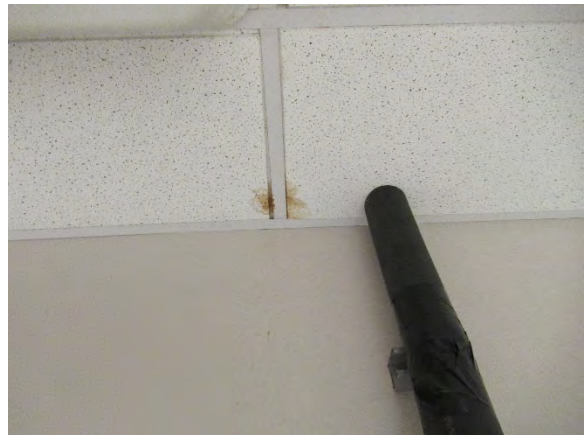
- Mainline has potential leaks above ceiling tiles located in main corridor and computer room.
(Figure 1, Figure 2, Figure 3 & Figure 4)

- Recommend repair of tear located in overpass canopy.
- Recommend pressure wash for the building exterior and overpass.
- Recommend maintenance to locate/address leaks in ceiling tile.
- Recommend general maintenance to address erosion areas behind facility.

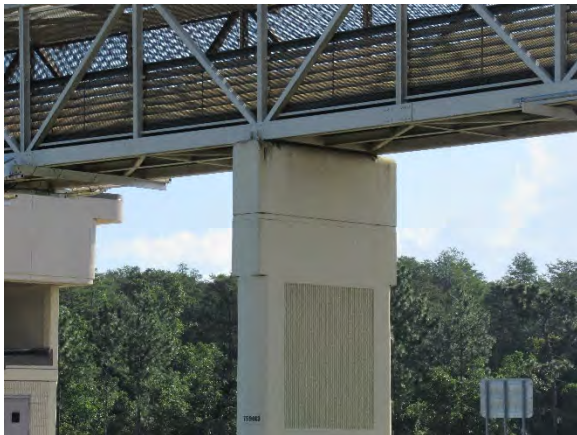
Figure 5 Dallas Mainline

- Mainline overpass is in need of pressure wash. (Figure 5)
- Mainline overpass canopy has tear and needs repair.
(Figure 7, Figure 8 & Figure 9)

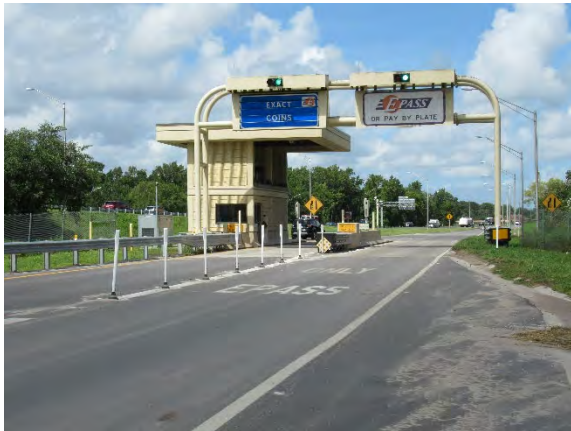
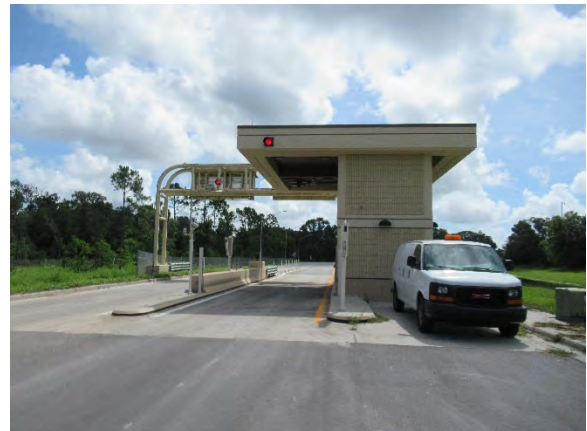
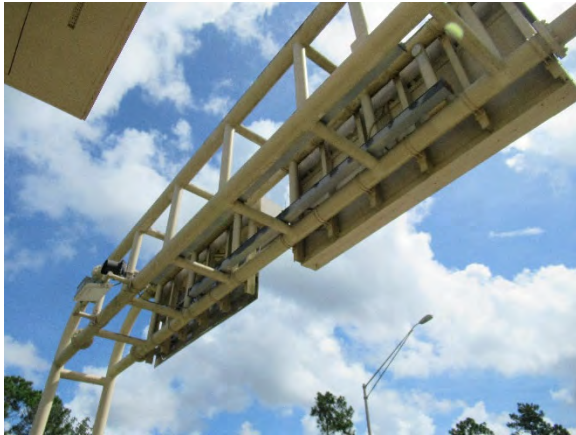
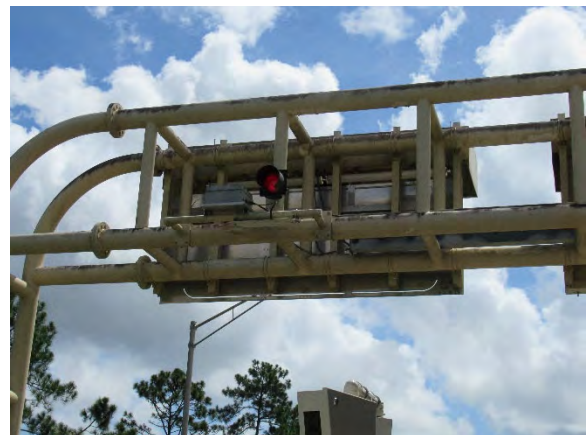
The above referenced ramp is in good condition overall. Some general maintenance to pressure wash plaza overhead sign structure is recommended.
(Figure 13, Figure 14, Figure 15 & Figure 16)
