2020

Annual Inspection Report

Re: 2020 Annual Inspection Report

2020 Annual Inspection Report
CENTRAL FLORIDA EXPRESSWAY AUTHORITY

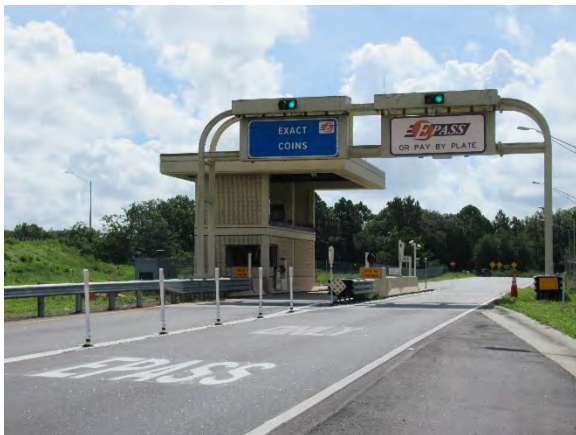
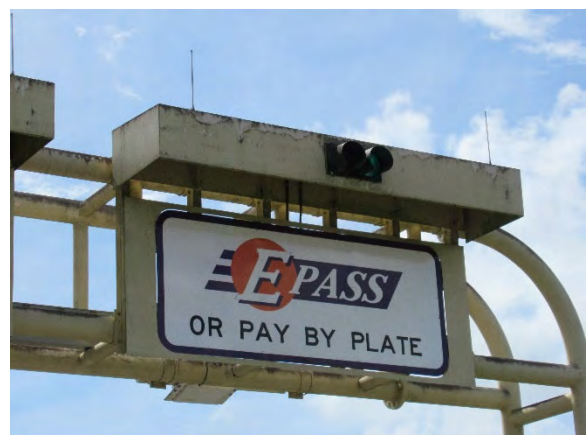
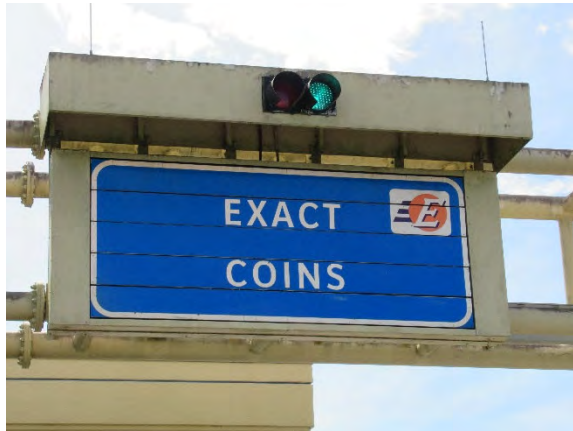
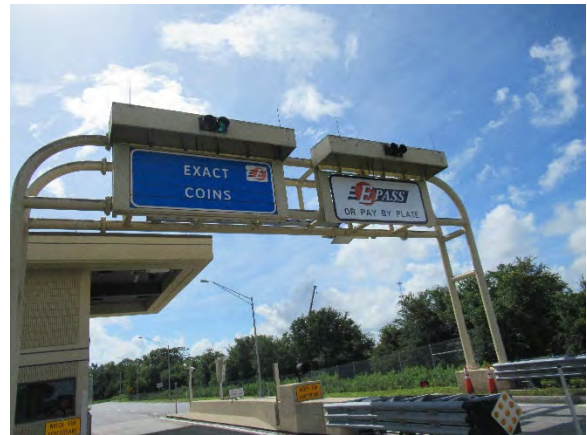
The above referenced ramp is in good condition overall. Some general maintenance to pressure wash plaza overhead sign structure is recommended.
(Figure 17, Figure 18, Figure 19 & Figure 20)

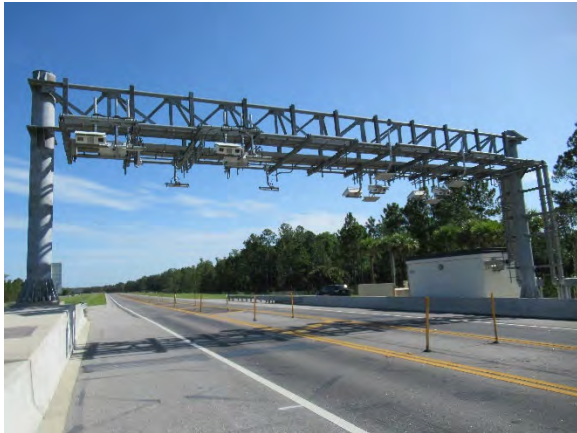
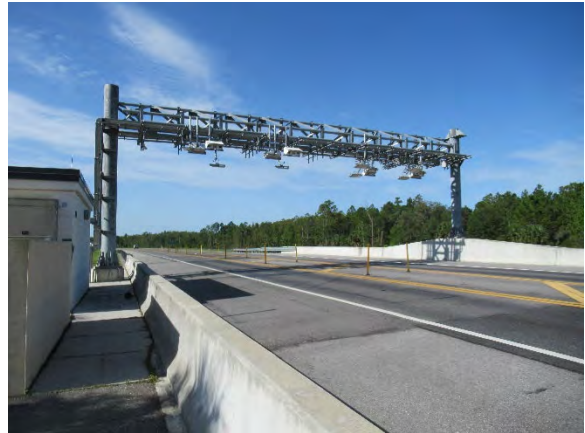
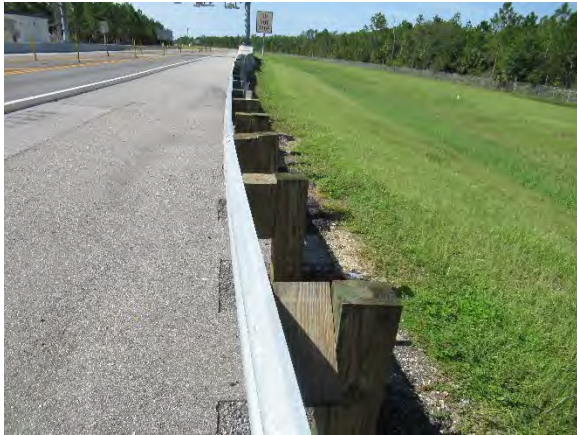
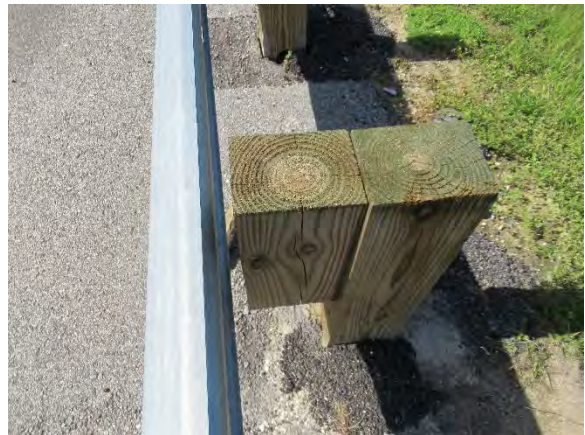
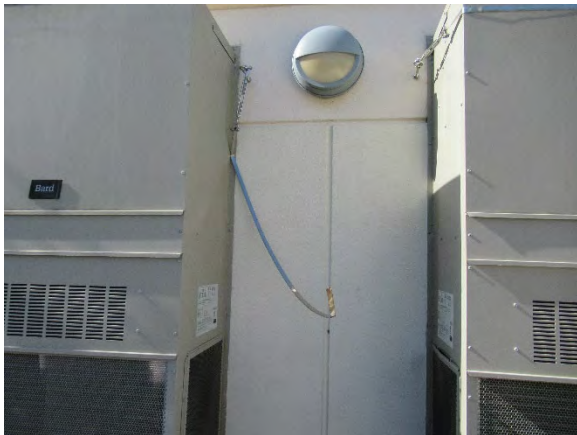
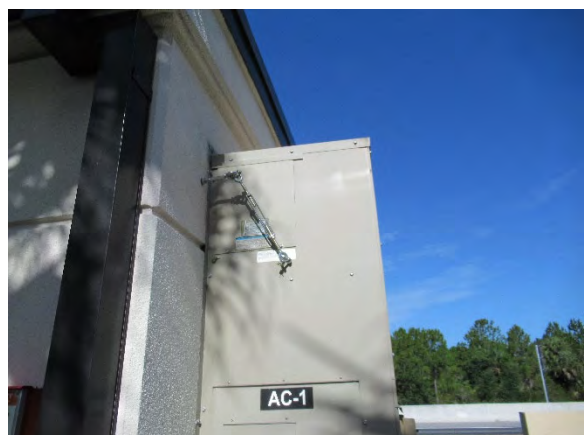
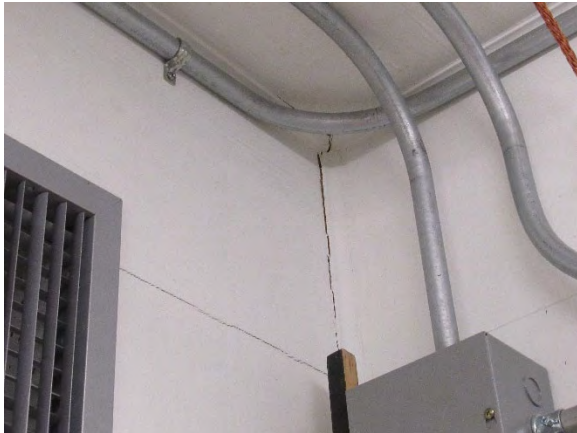
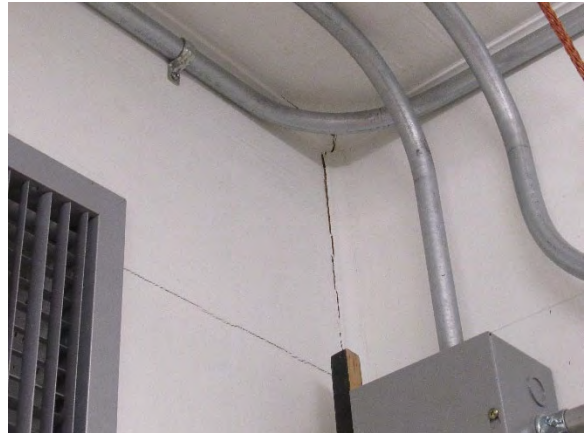
The above referenced plaza is in good condition overall. Some general maintenance to caulk/seal control joints, address any off-set blocks not fastened to guardrail and fasten HVAC strap to building exterior is recommended.
(Figure 1, Figure 2, Figure 3, Figure 4, Figure 5, Figure 6, Figure 7 & Figure 8)

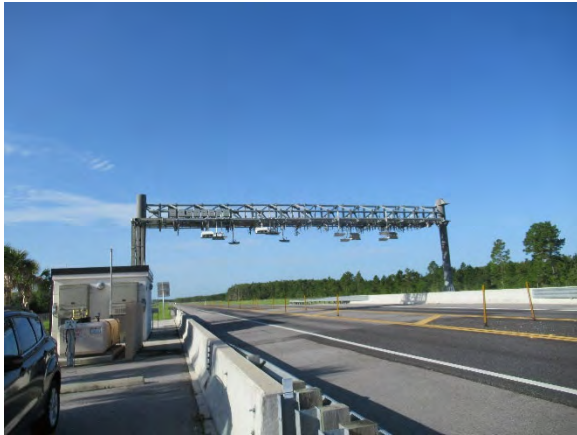
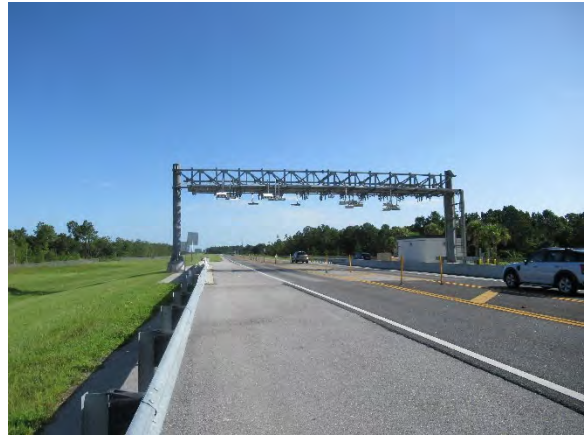
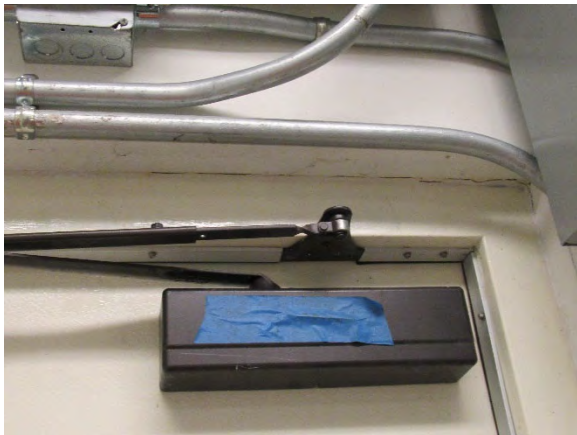
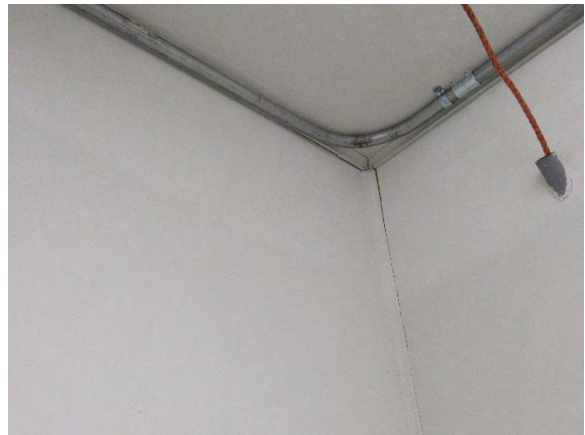
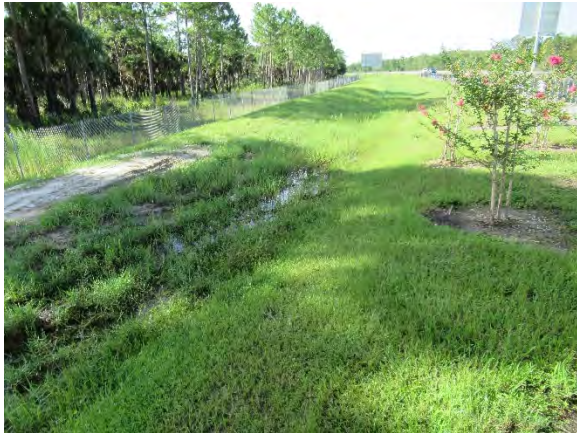
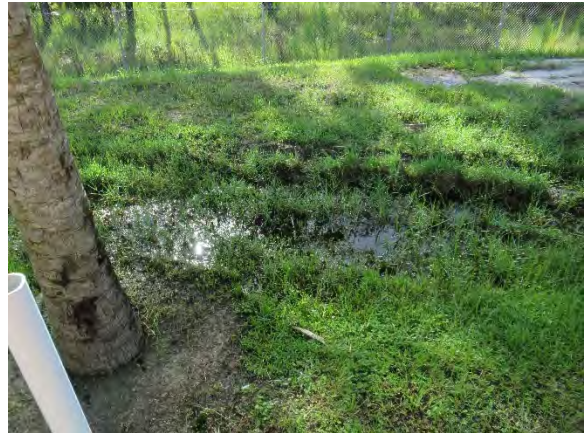
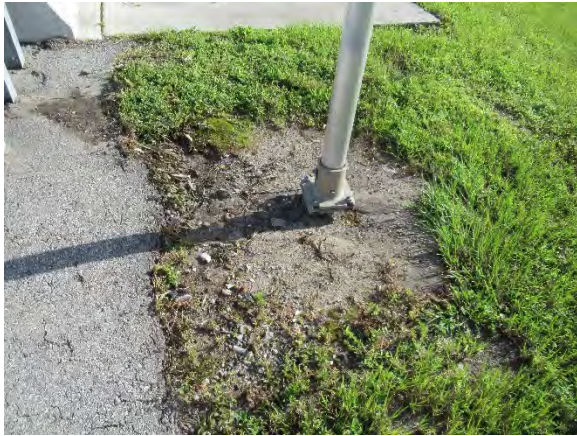
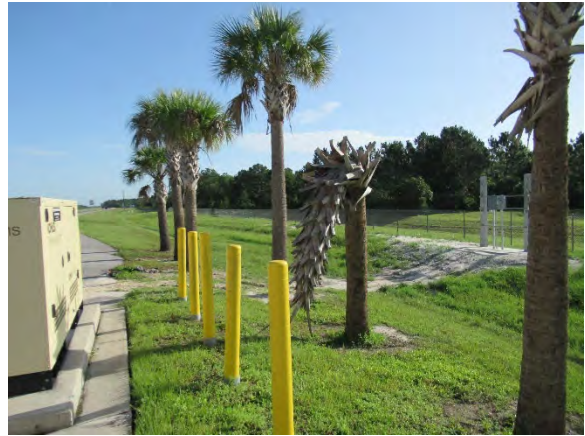
The above referenced plaza is in good condition overall. Some general maintenance to caulk/seal control joints and general landscaping to address ponding / erosion is recommended.
(Figure 9, Figure 10, Figure 11, Figure 12, Figure 13, Figure 14, Figure 15 & Figure 16)

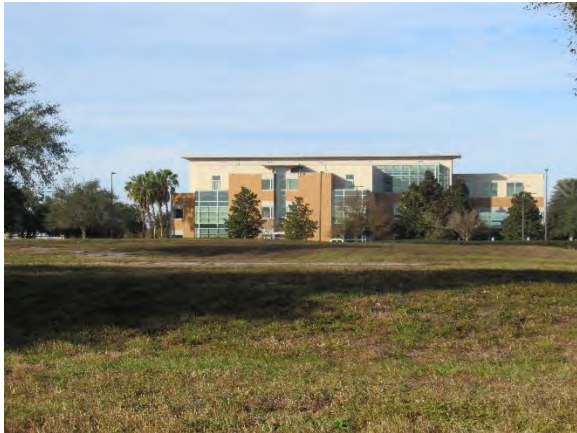
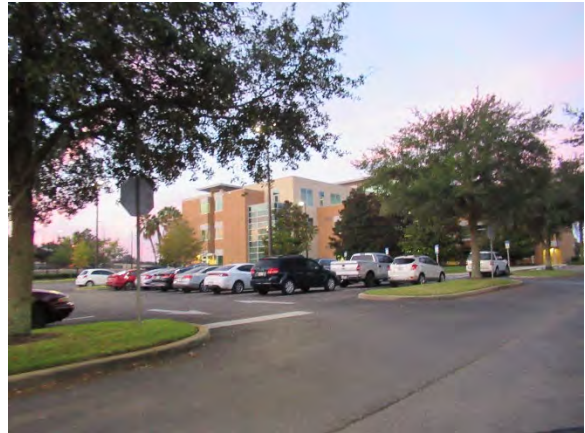
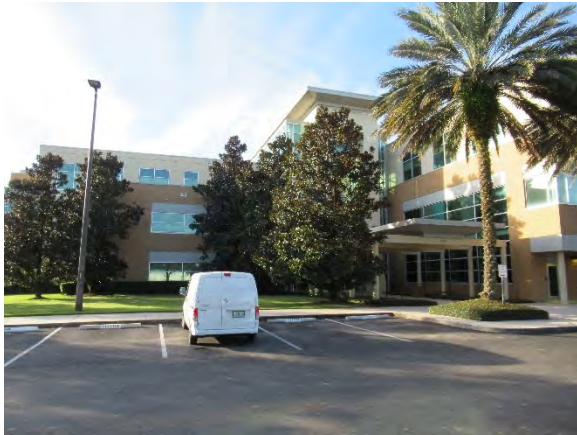
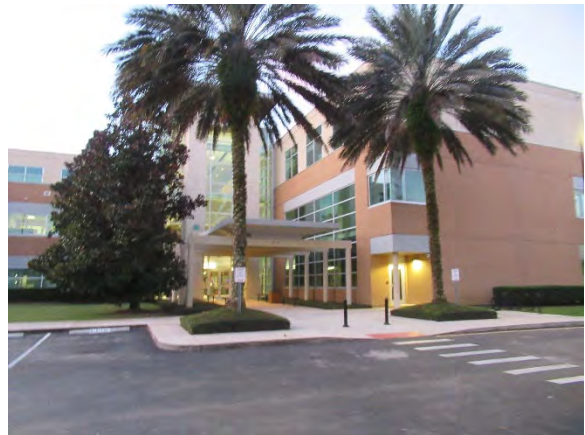
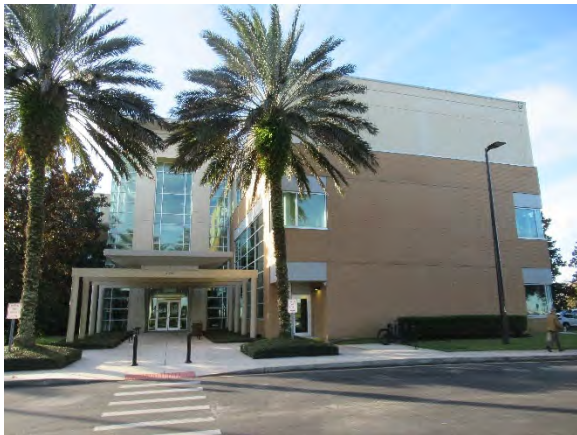
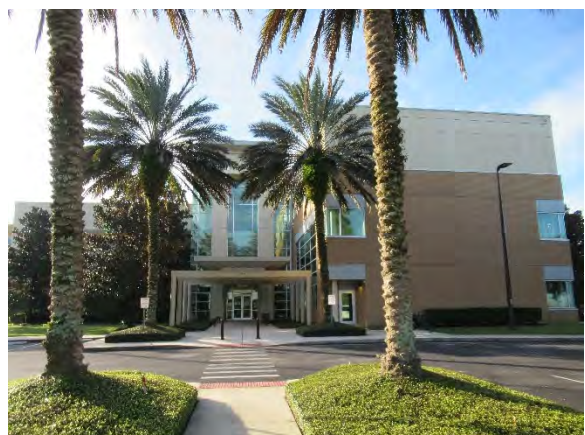
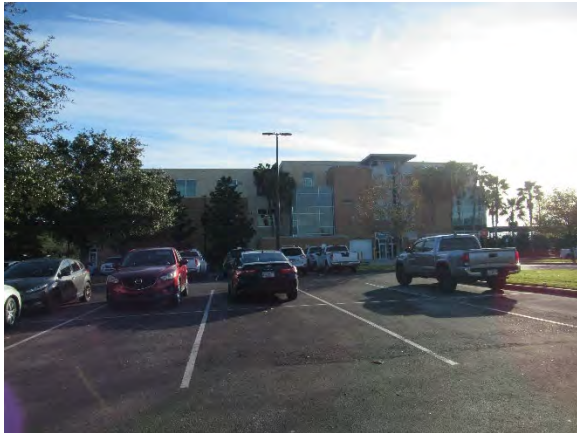
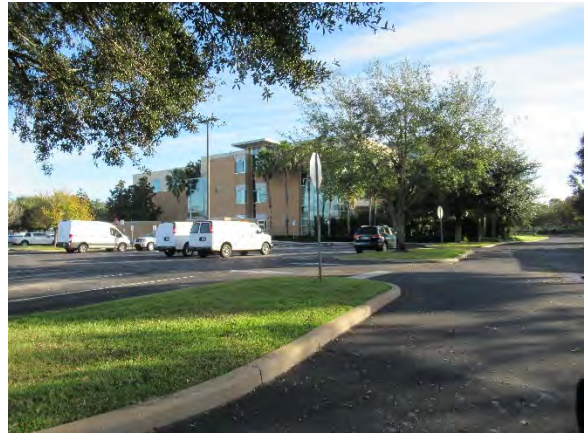
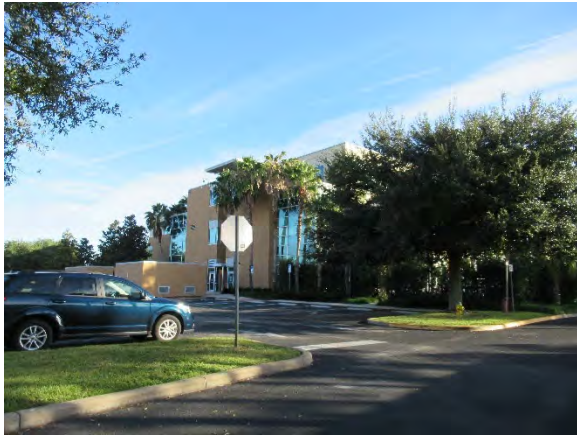
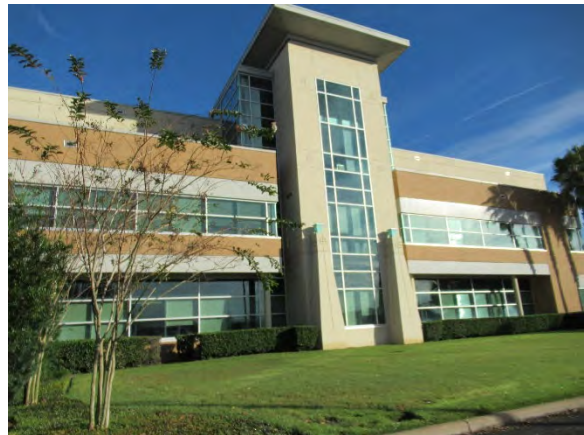
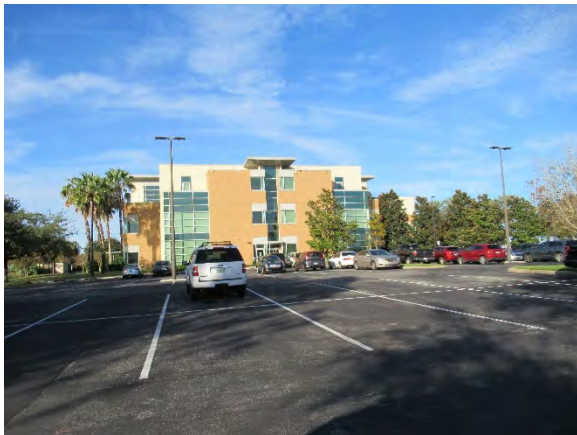
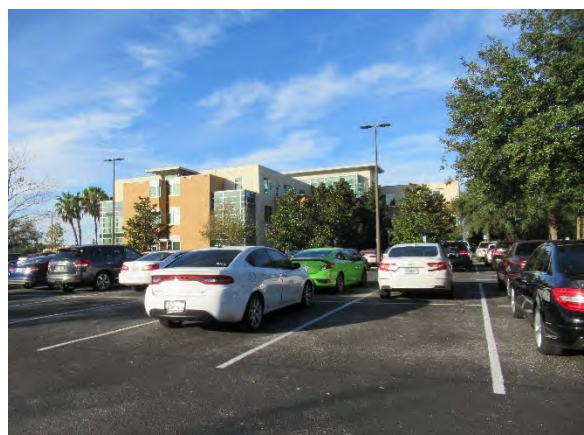
- Building exterior is in good condition overall with no identified deficiencies.
(Figure 1 - Figure 12)

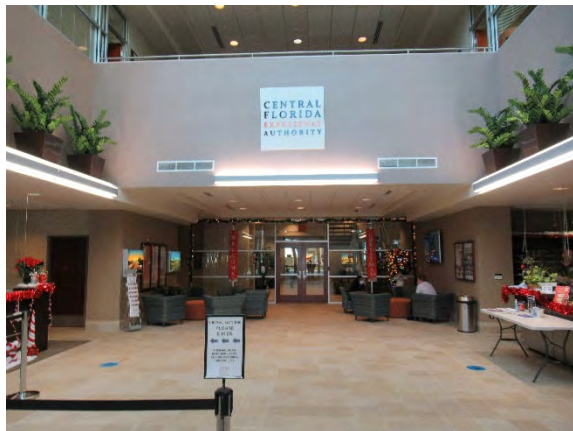
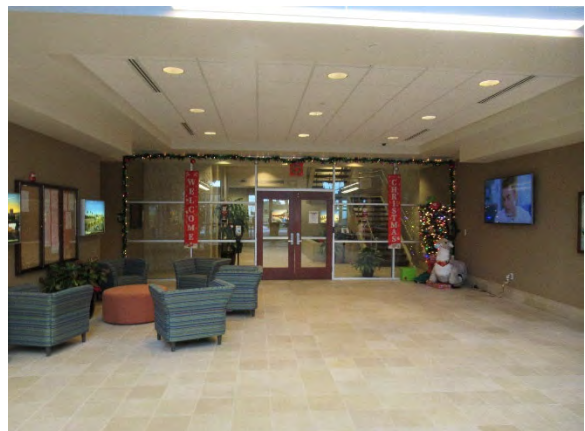
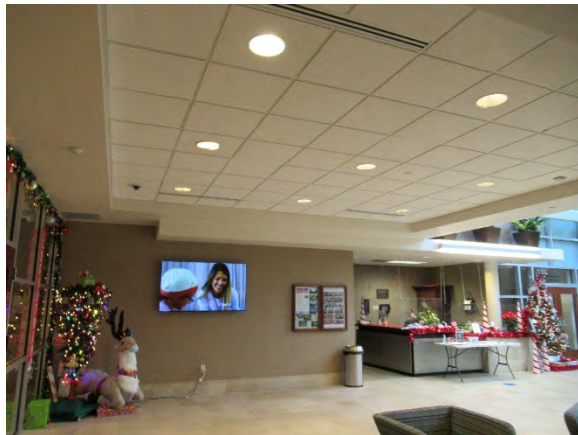
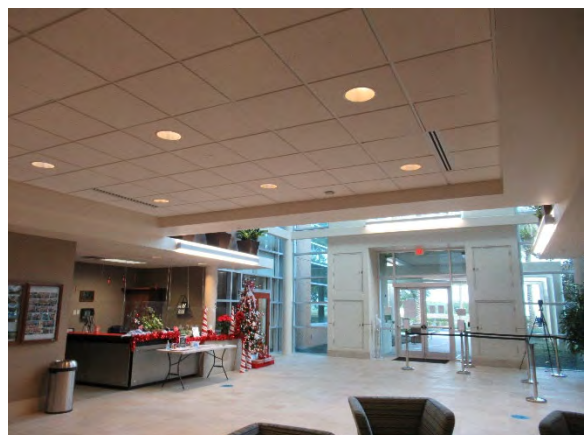
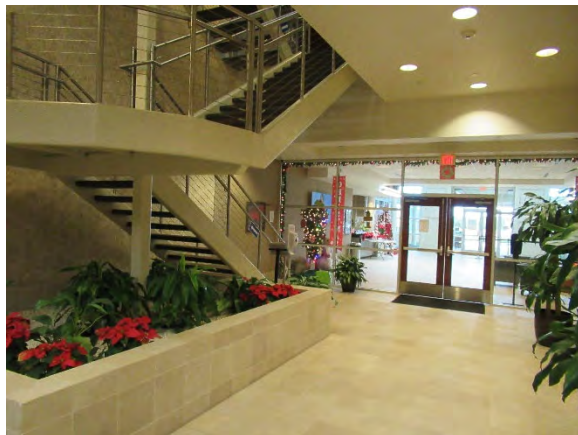
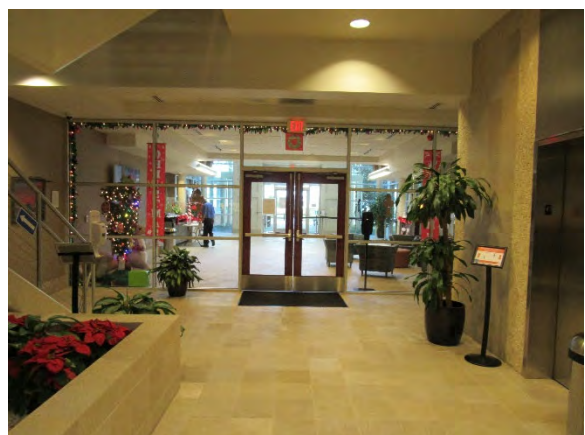
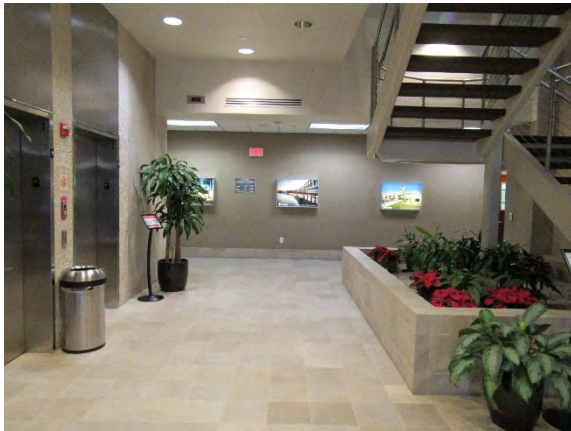
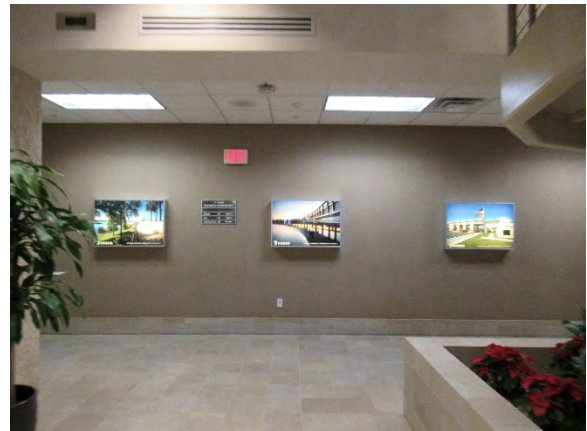
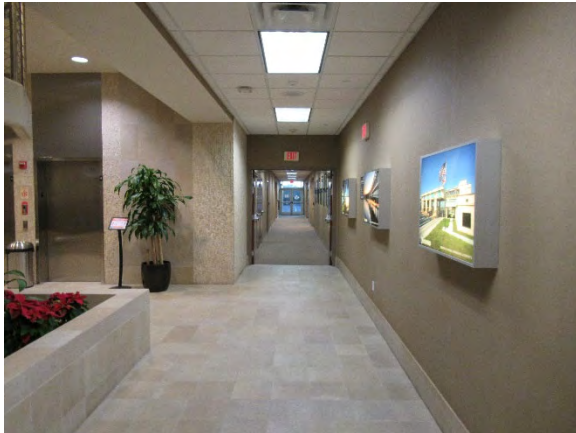
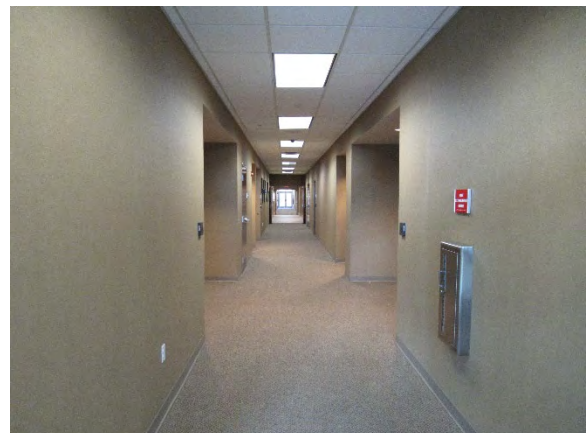
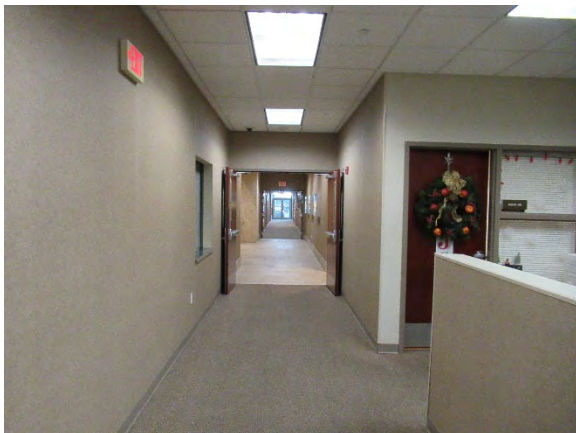
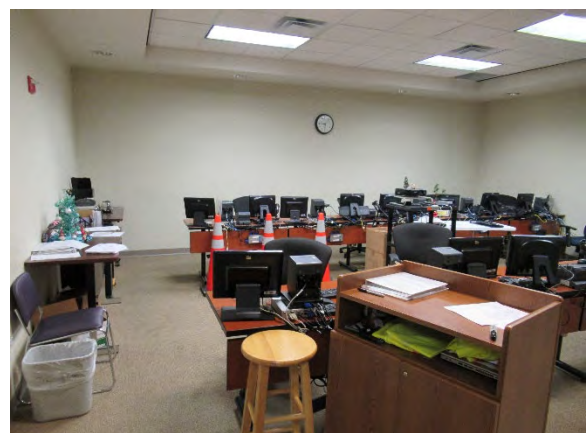
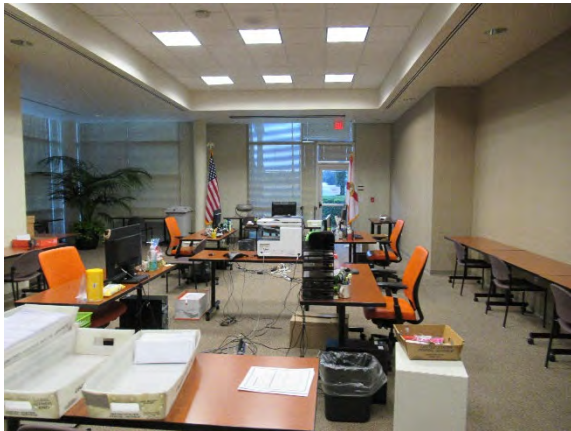
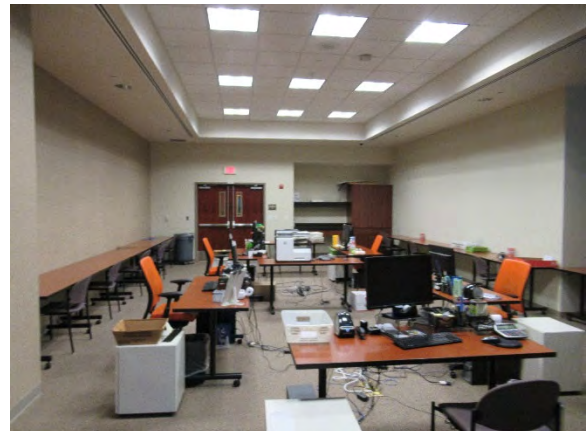
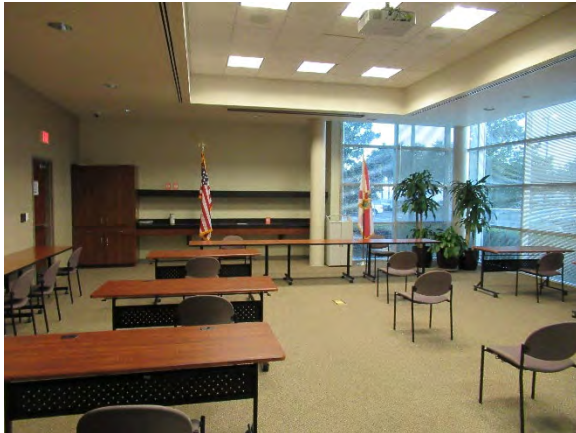
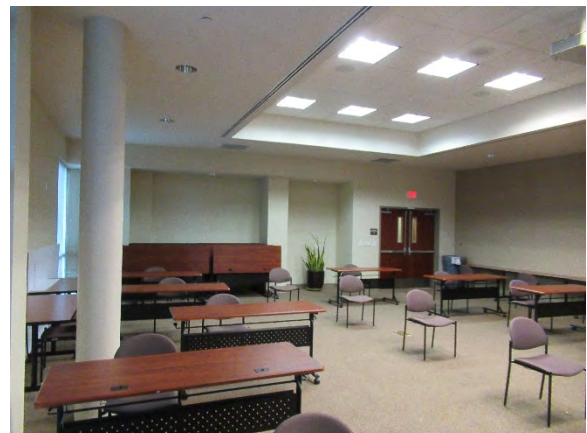
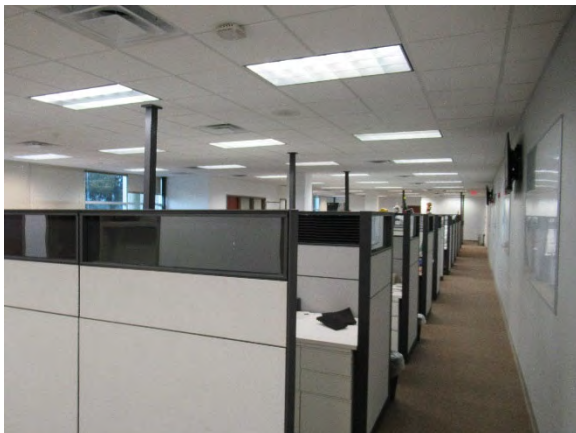
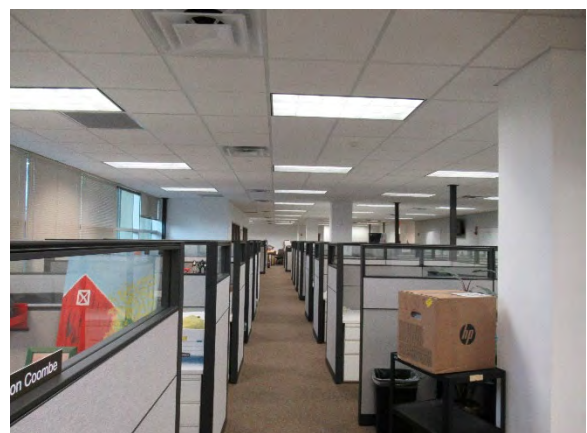
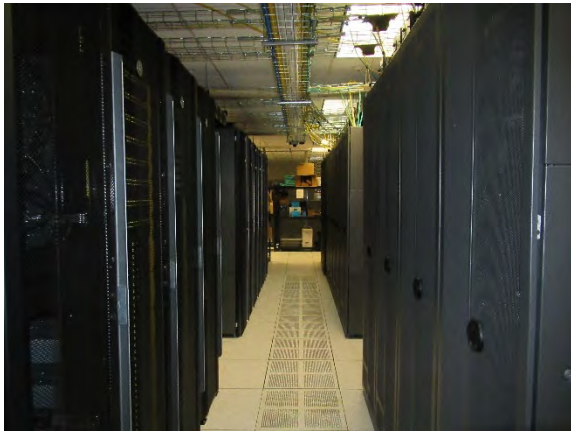
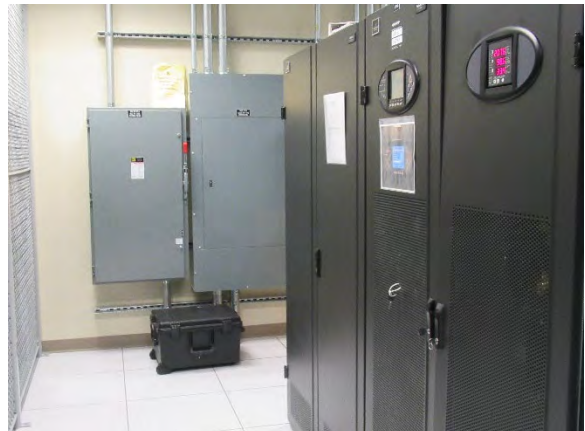
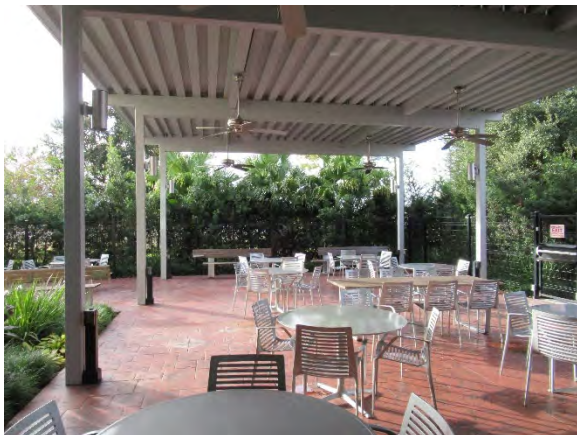
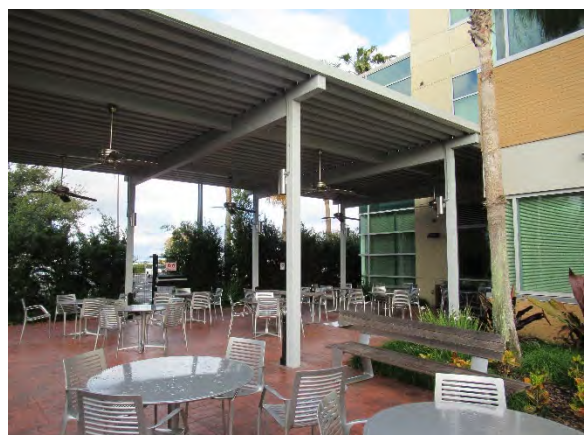
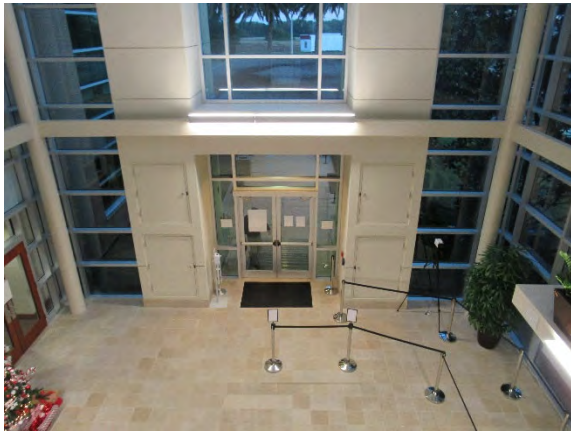
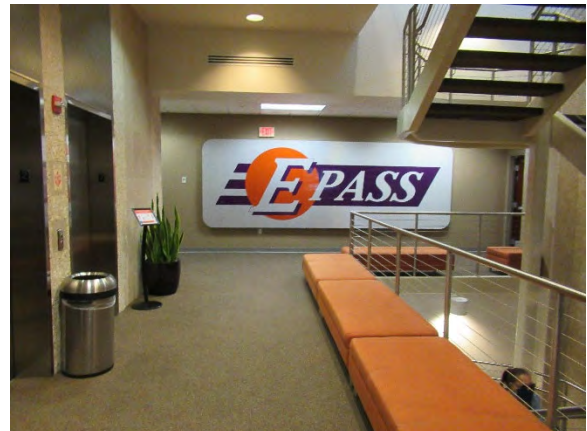
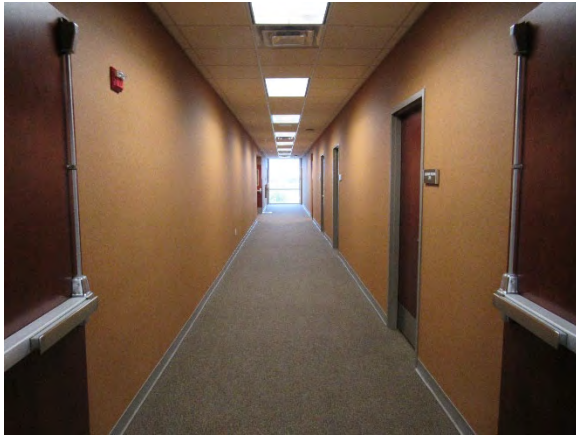
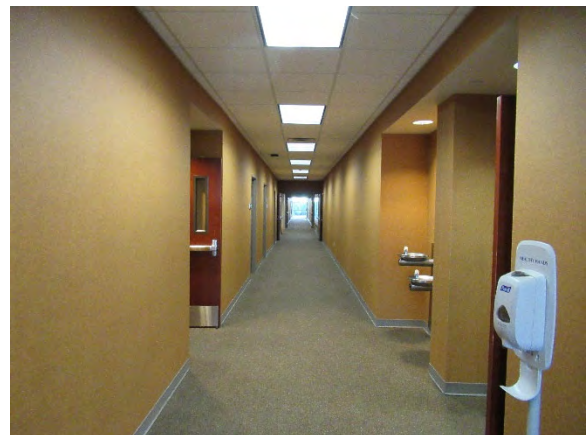
- Building interior is in good condition overall with no identified deficiencies.
(Figure 13 - Figure 96)

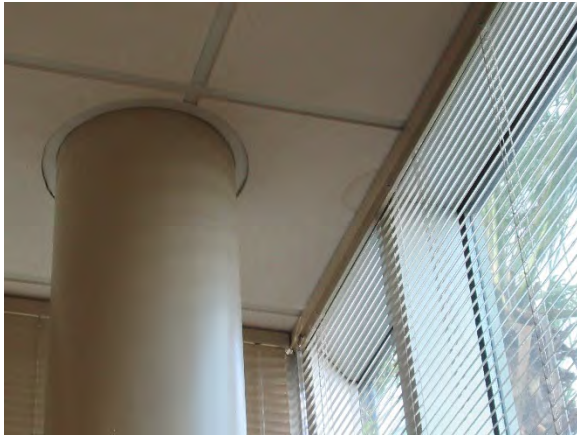
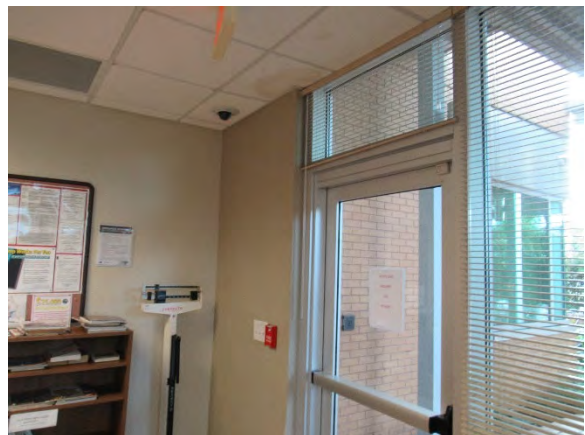
- Identified areas with potential leak above ceiling tile.
(Figure 33, Figure 34)

- Recommend general maintenance to locate potential leaks above ceiling.
- Recommend general maintenance to patch and paint areas in need of touch up.

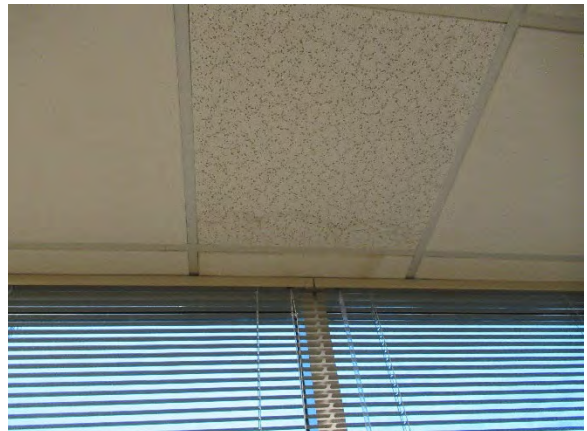
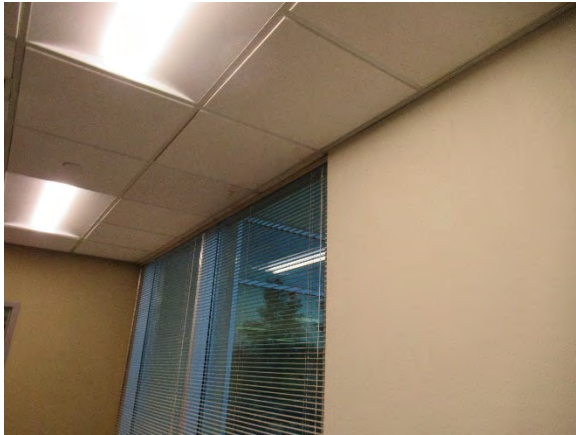
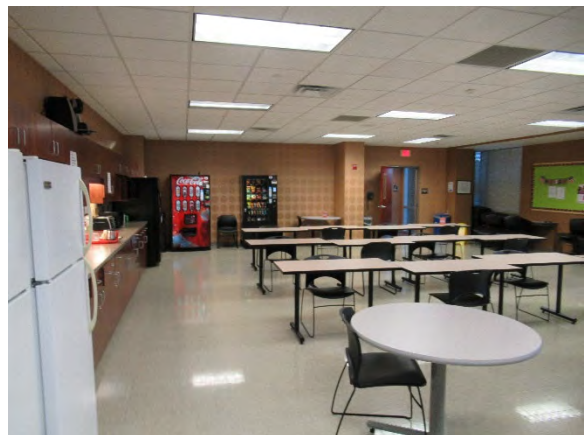
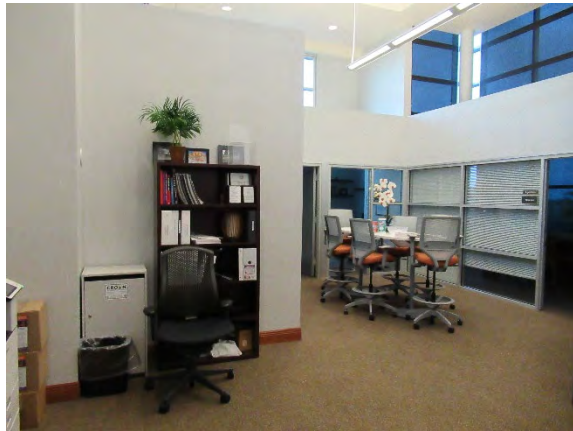
- Identified areas with potential leak above ceiling tile.
(Figure 55, Figure 56, Figure 57 & Figure 60)

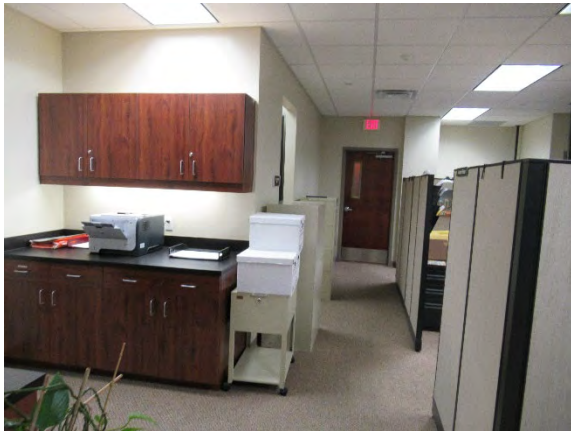
Figure 66 Building Headquarters Third Floor – Room 356

- Identified areas in need of patch and paint.
(Figure 66 & Figure 87)

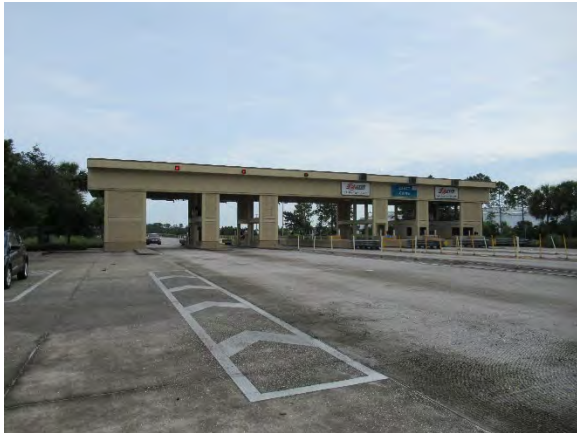
Figure 1 Goldenrod Main Plaza

- The above referenced site is in good condition overall with no identified deficiencies.
(Figure 1 & Figure 2)

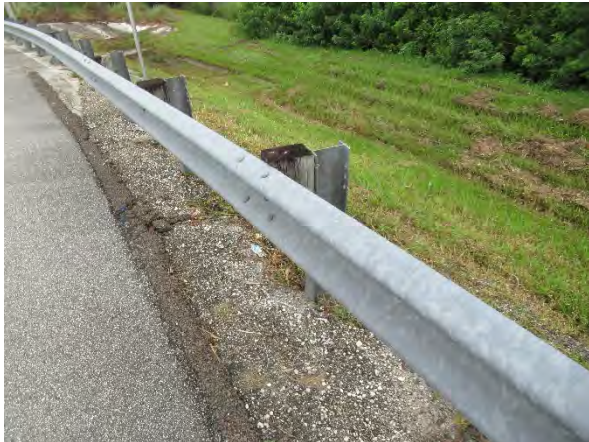
Figure 3 Goldenrod Main Plaza

- The above referenced site is in good condition overall with no identified deficiencies. Some general maintenance to the guardrail is recommended.
(Figure 3 & Figure 4)

- Recommend general maintenance to guardrail.
