2021

Annual Inspection Report

Re: 2021 Annual Inspection Report

2021 Annual Inspection Report
CENTRAL FLORIDA EXPRESSWAY AUTHORITY

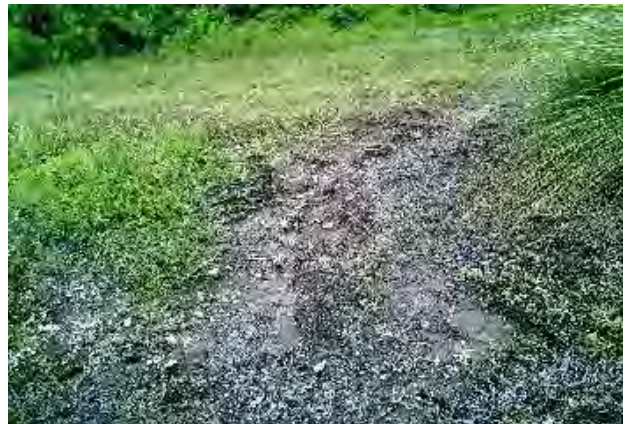
Figure 10: Minor bed erosion at International Drive

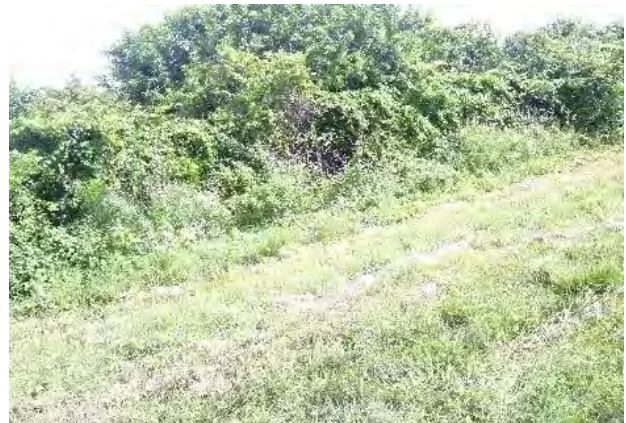
Figure 18: Overgrown fence line east of Narcoossee Road.

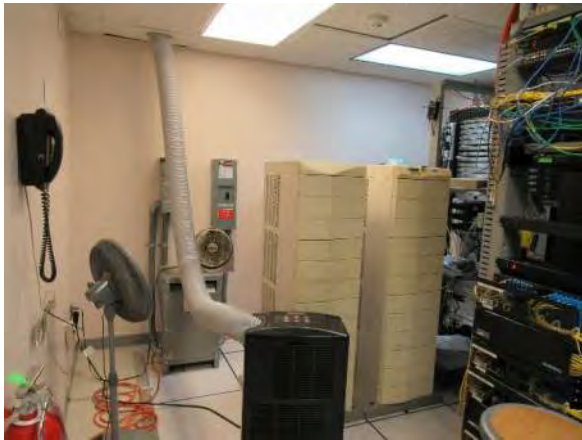
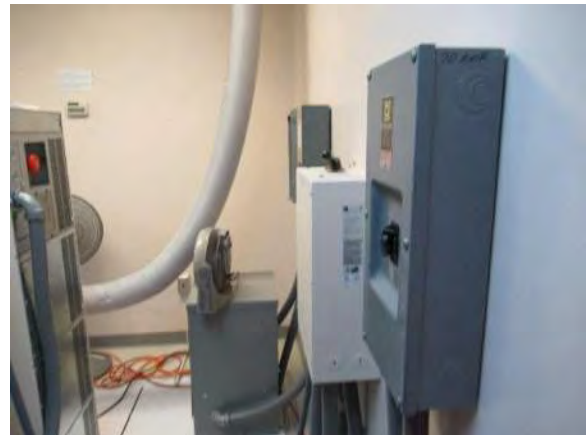
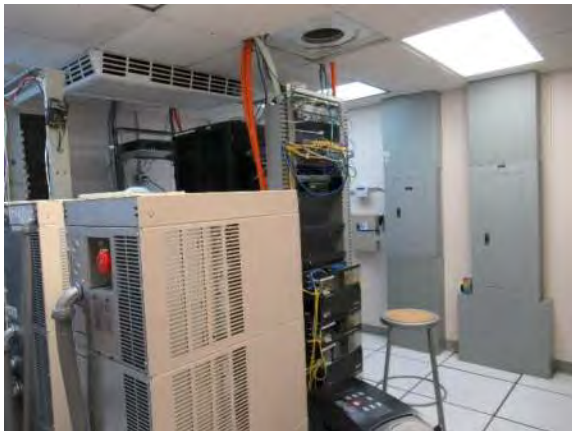
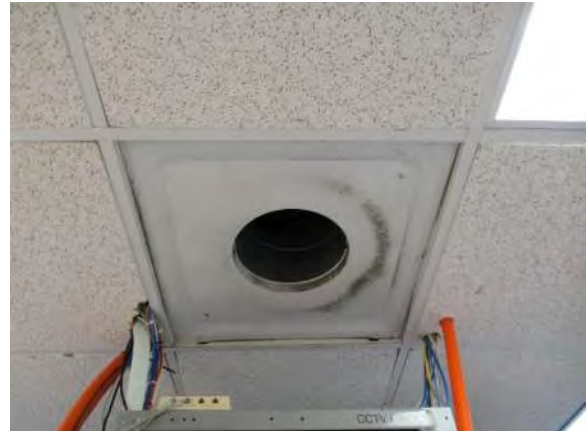
- Mainline interior has portable HVAC equipment in computer room and missing vent cover. (Figure 1, Figure 2, Figure 3 & Figure 4)
- Mainline interior has potential leaks above ceiling tiles in computer room, restrooms and locker room. (Figure 5 & Figure 6 & Figure 8)
- Lobby ceiling tile are falling out, potential leaks around the vent (Figure 9)

- Recommend general maintenance on HVAC system.
- Recommend maintenance to locate and repair any potential roof leaks.
- Recommend routine maintenance to patch and seal cracks in building facade.
- Recommend general maintenance to repair the bottom of the soffit.

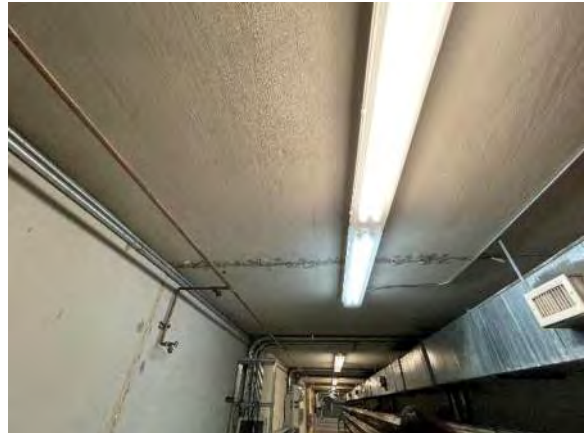
Figure 10 Boggy Creek Mainline

- The above referenced mainline tunnel is in good condition overall.
- The seal is coming out (Figure 10)

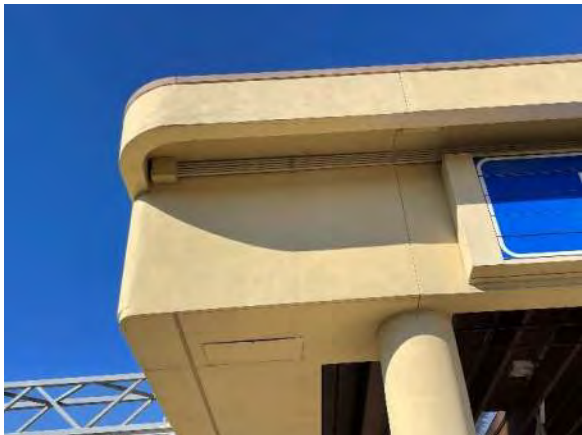
Figure 11 Boggy Creek Mainline

- Exterior canopy has visible cracks. (Figure 11 & Figure 13)
- Exterior pressure wash is recommended, remove wasp nests (Figure 14 & Figure 15)
- Bottom of soffit is falling out (Figure 16)

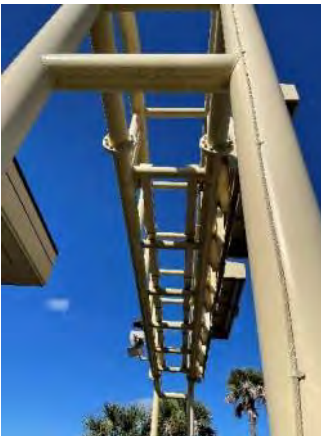
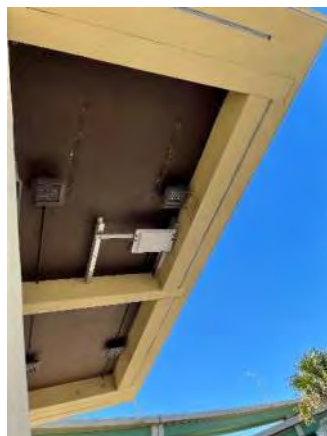
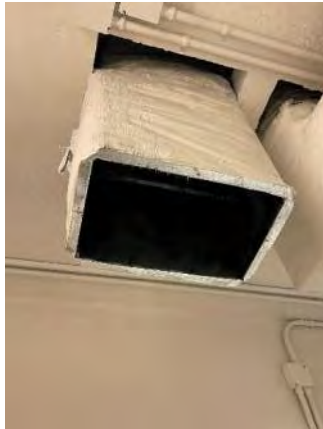
The above referenced ramp is in good condition overall. Some general maintenance to pressure wash plaza exterior and cover the vent is recommended.
(Figure 17, Figure 18 & Figure 19)

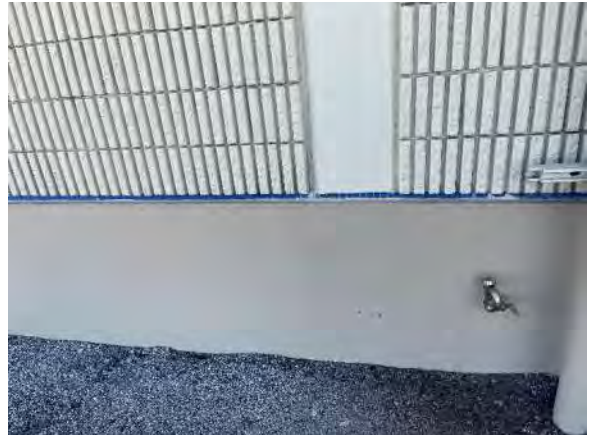
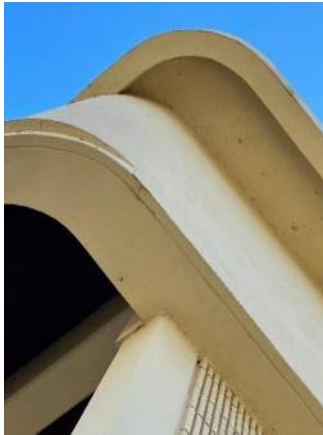
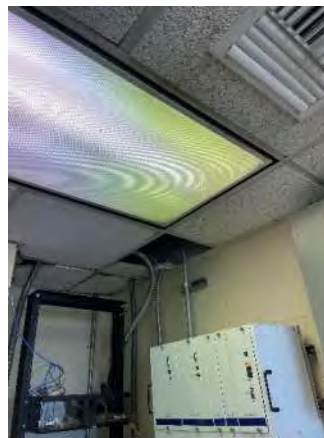
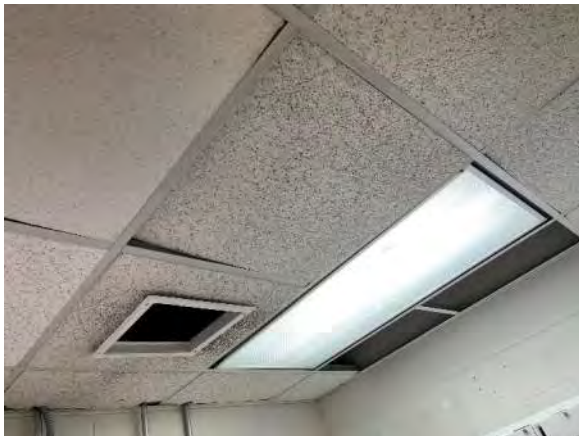
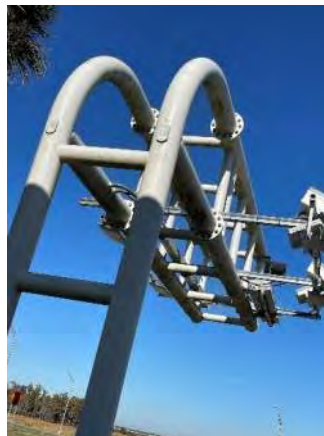
The above referenced ramp is in good condition overall. Some general maintenance to pressure wash plaza overhead sign structure is recommended. Exterior canopy and building facade have identified cracks. Missing ceiling tile.
(Figure 20 to Figure 24)

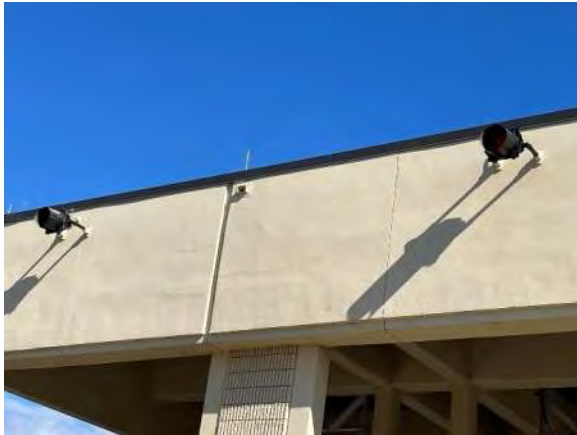
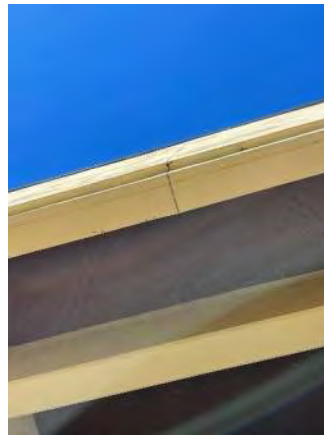
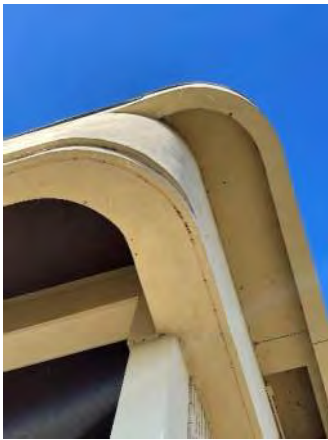
- Exterior canopy has visible cracks in front of the façade and corners
(Figure 25, Figure 26 & Figure 27)
- Exterior façade has visible cracks, repaint doors is recommended (Figure 28 & Figure 29)
- Cracking ceilings (Figure 30)
- Ceiling has potential leaks (Figure 31 & Figure 32)

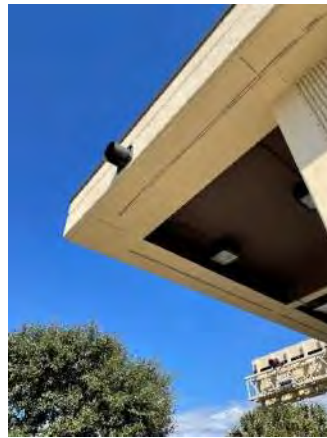
Figure 33 Lake Nona Ramp Off

- Exterior façade and bottom of the soffit have identified cracks.
(Figure 33, Figure 34 & Figure 35)
- Interior walls have paint shredding, potential leaks (Figure 36 & Figure 37)

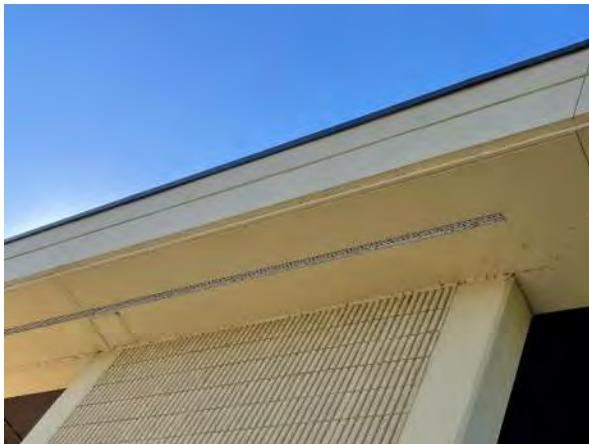
Figure 38 Lake Nona Ramp On

- The pipe is broken (Figure 38)
- Exterior façade, bottom of the soffit and the barriers have identified cracks.
(Figure 39 to Figure 44)
- Interior walls have paint shredding, potential leaks (Figure 45)

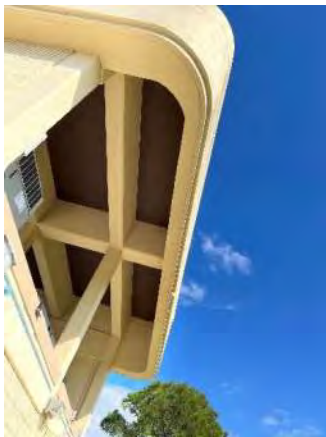
Figure 46 Narcoossee Ramp Off

- Exterior façade, bottom of the canopy and corner have visible cracks (Figure 46 to Figure 50)
- Interior ceilings have potential leaks, cover the vent is recommended (Figure 51 & Figure 52)

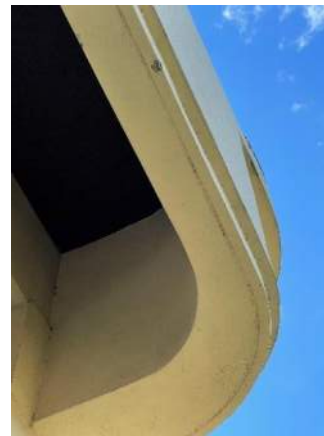
Figure 53 Narcoossee Ramp On

- Exterior façade, bottom of the canopy and corner have visible cracks (Figure 53 to Figure 56)
- Missing ceiling tile and wire is hanging out (Figure 56 to Figure 59)

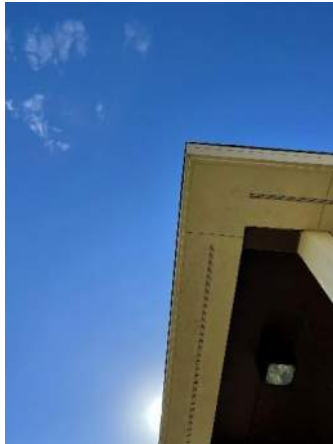
Figure 60 Moss Park Ramp Off

The above referenced ramp is in good condition overall. Some general maintenance to pressure wash plaza overhead sign structure is recommended. Corner of the canopy and column's foundation have visible cracks. The interior corner of the mechanical room has a visible crack.
(Figure 60 & Figure 64)

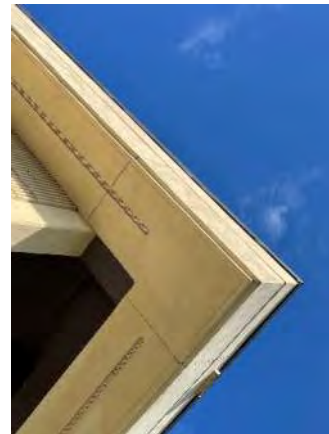
Figure 65 Moss Park Ramp On

The above referenced ramp is in good condition overall. Some general maintenance to pressure wash plaza overhead sign structure, locate potential leaks is recommended.
(Figure 65 to Figure 70)

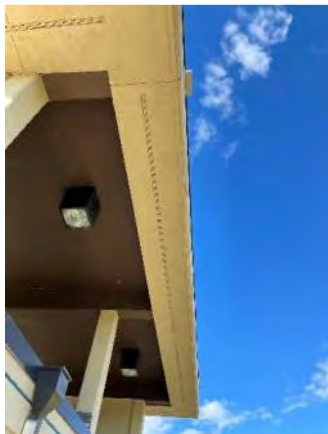
Figure 71 Innovation Way Ramp Off

The above referenced ramp is in good condition overall. Some general maintenance to pressure wash plaza overhead sign structure. (Figure 71 & Figure 72)

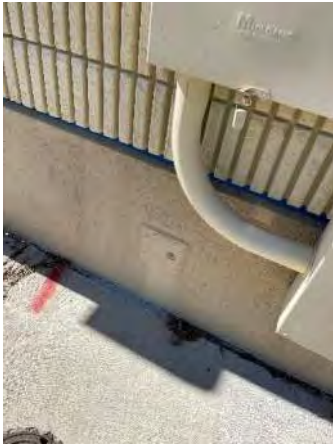
Figure 73 Innovation Way Ramp Off

- Exterior wall has a visible crack. (Figure 73)
- Ceiling tiles are falling out (Figure 74)
- Fire extinguisher needs to be refilled (Figure 75)
- Interior wall has visible crack. (Figure 76)

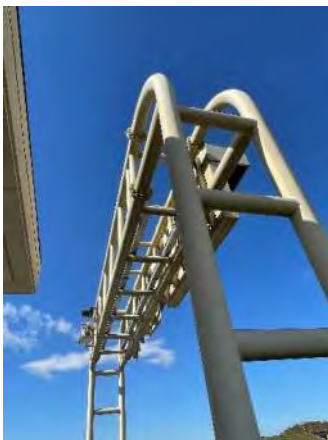
Figure 77 Innovation Way Ramp On

The above referenced ramp is in good condition overall. Some general maintenance to pressure wash plaza overhead sign structure. (Figure 77)

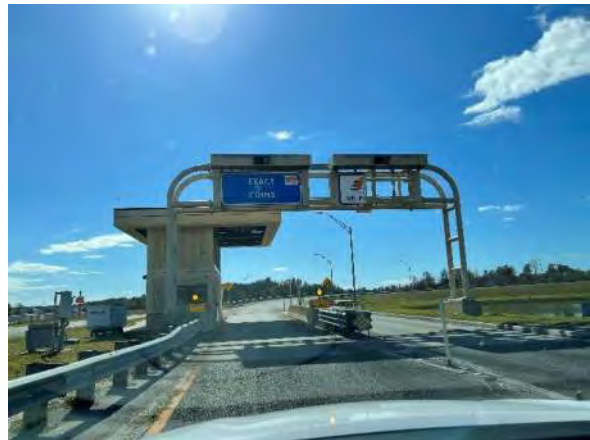
Figure 78 Innovation Way Ramp On

- Half of the sign is falling off (Figure 78)
- The edges underneath the canopy have visible cracks (Figure 79 & Figure 80)
- Exterior wall and interior wall have some visible cracks (Figure 81 & Figure 82)
- Ceiling has a potential leak (Figure 83)

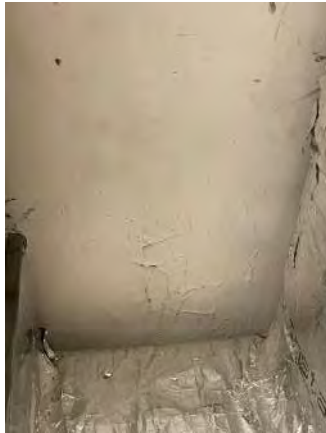
Figure 1 Curry Ford Mainline

- Ceiling cracked in mechanical room, possible leak. *(Figure 1)*
- Window sill cracked and paint peeling in lounge. *(Figure 2)*
- Ceiling tiles discolored and disheveled throughout plaza, possible leak in locker room. *(Figure 3 and 4)*
- Stairwell to tunnel has paint bubbling and peeling along lower level. Yellow grip on stairs peeling, creating trip hazard. *(Figure 5 and 6)*

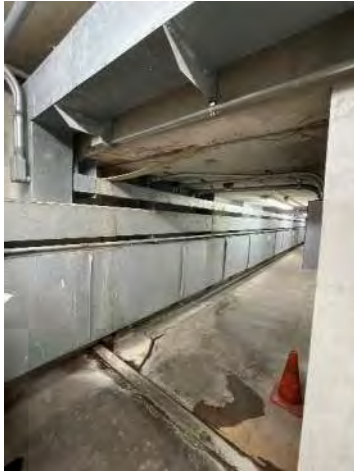
Figure 7 Curry Ford Mainline

- Severe leaks throughout tunnel. Leak appears to be behind panel, as well ceiling joint separated from wall. *(Figure 7, 8, and 9)*
- Several door frames to enter toll booths appear to be separating from wall. *(Figure 10)*

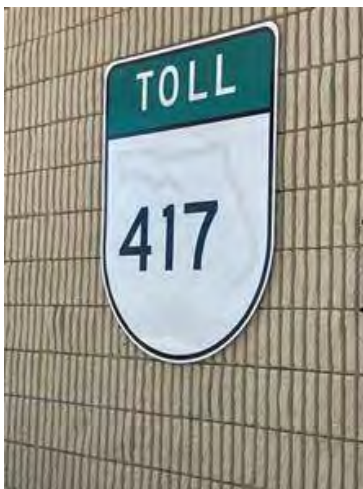
Figure 11 Curry Ford Mainline

- Sign is faded. *(Figure 11)*
- Doors have wall paint sprayed around borders, doors themselves require fresh paint. *(Figure 12)*
- Cracks along base of several columns supporting canopies. *(Figure 13 and 14)*

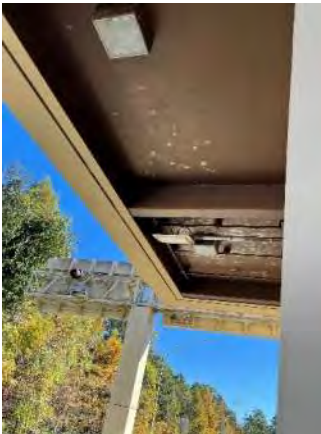
Figure 21 University Ramp On

- Cracks and gaps along canopy edge and soffit. *(Figure 19 and 20)*
- Exterior needs to be cleaned, stains of façade and debris underneath canopy. *(Figure 21 and 22)*

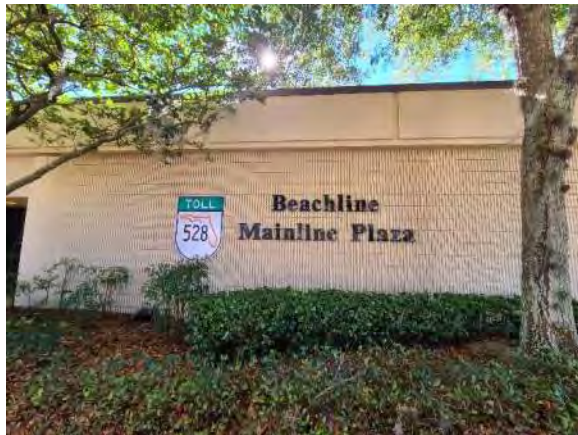
Figure 1 Beachline Mainline

- Overall exterior in good condition (*Figure 1*)
- Minor cracks in soffit (*Figure 2*)

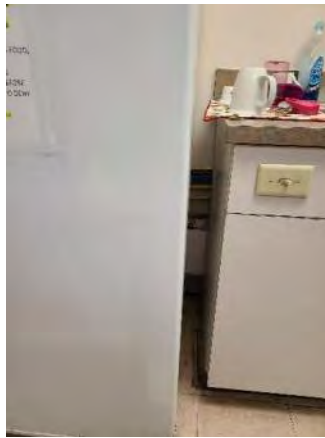
Figure 3 Beachline Mainline

- Cutout of wall behind refrigerator in breakroom, indicates previous repair (*Figure 3*)
- Baseboards peeling in multiple rooms (*Figure 4*)
- Possible leak in Recording room, Acoustic Ceiling Tile stained (*Figure 5*)
- Acoustic Ceiling Tile misplaced in Supply Room (*Figure 6*)

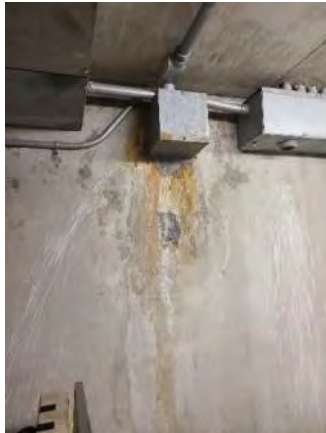
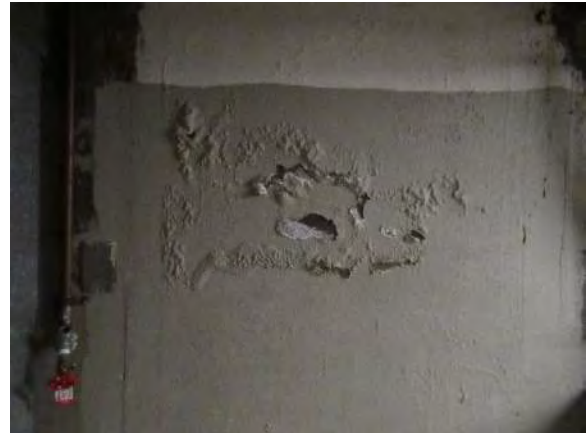
- Leaks and deterioration along tunnel walls (*Figure 7 and 8*)

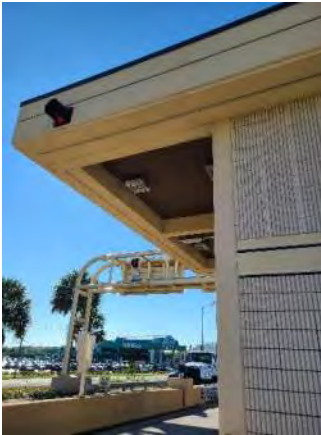
Figure 15 Jetport Ramp On

- Exterior needs to be cleaned, façade has large amounts of debris and mildew (*Figure 15 and 16*)
- Building elevation separating from foundation (*Figure 17*)
- Doors need to be repainted (*Figure 18*)

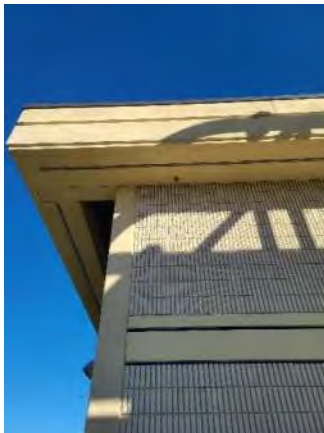
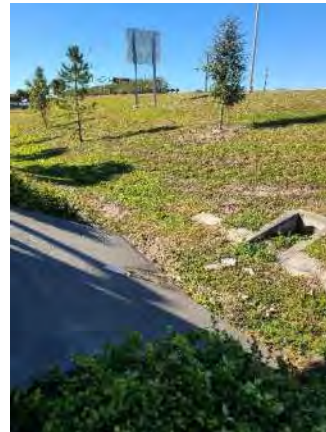
- Exterior façade and surrounding landscape need to be cleaned, wasp nests and debris present (*Figure 23 and 24*)
- Toll booth has possible leak towards back corner, Acoustic Ceiling Tile discolored. As well, equipment left in booth. (*Figure 25 and 26*)

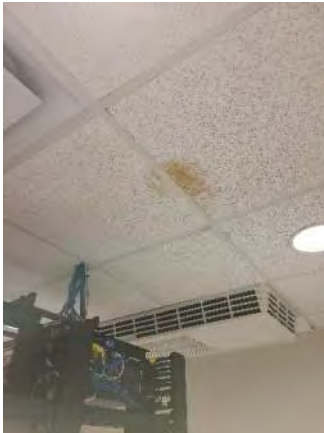
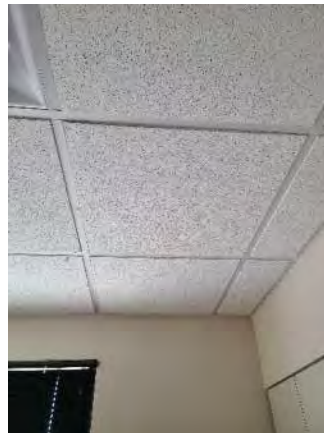
- Acoustic Ceiling Tile stains indicate leaking or condensation from interior air handling unit (*Figure 1 and 2*)
- Leaking from panel in recording room (*Figure 3*)
- Crack in wall guard along corridor (*Figure 4*)

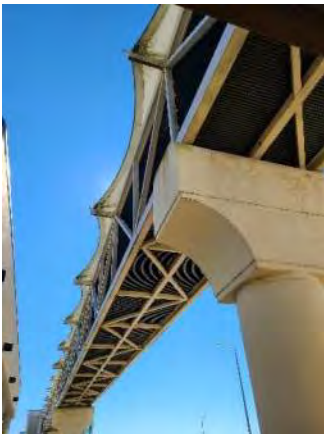
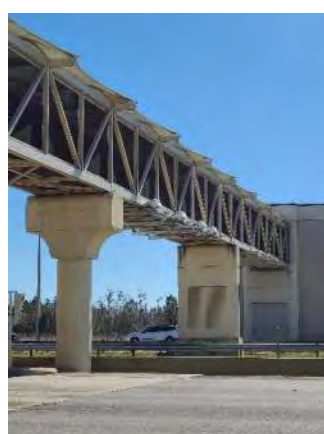
Small cracks along tops of supporting columns for overpass (*Figure 5 and 6*)
Entire façade of overpass and building need to be cleaned, build up of debris and mildew present (*Figure 7 and 8*)

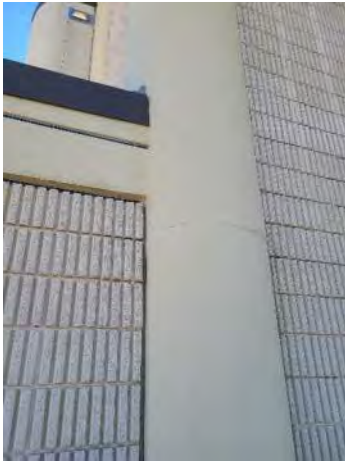
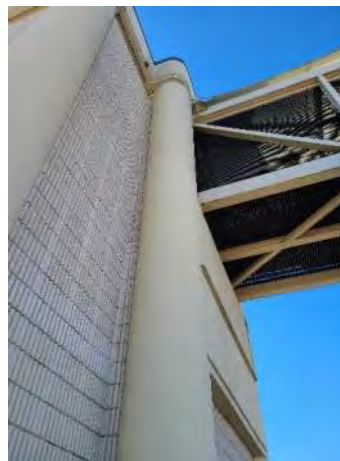
- Small cracks along columns and façade of secondary plaza building (*Figure 9 and 10*)
- Corner of back stairway cracked and deteriorated, stair railing is not secured properly to support required pressure per code. (*Figure 11*)
- Doors need to be repainted (*Figure 12*)

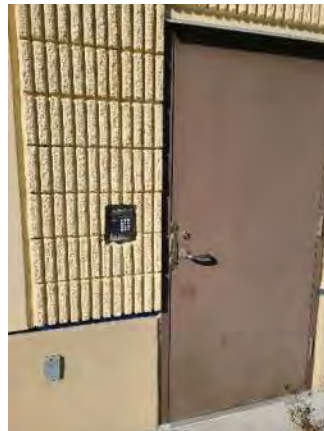
Figure 14 Dallas Ramp On

- Doors need to be repainted, difficult to open (Figure 14)
- Small cracks on corners of canopy (Figure 15 and 16)

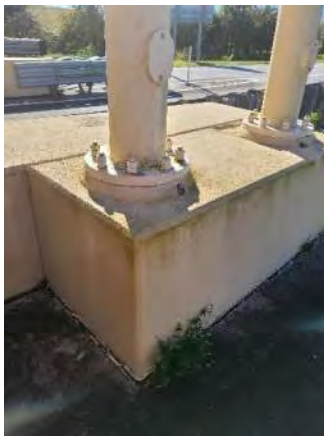
Figure 17 Dallas Ramp Off

- Façade needs to be cleaned (Figure 17)
- Possible leak by booth window (Figure 18)
- Rusting along flashing (Figure 19)
- Handle and lock on both doors have been tampered with, extremely difficult to open. Could not open Main Booth and data room have had strong odor. Main Plaza has been notified. (Figure 20)

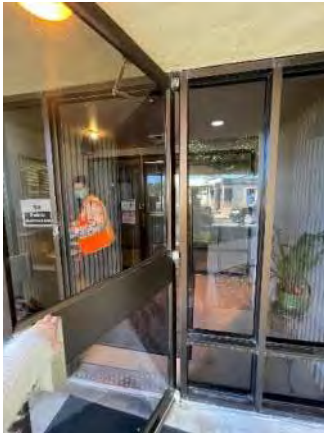
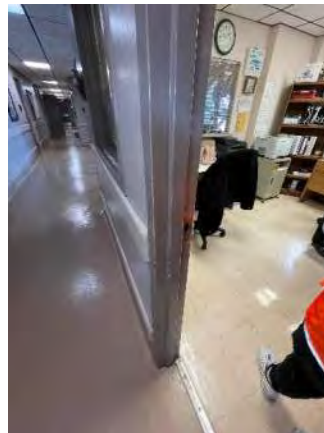
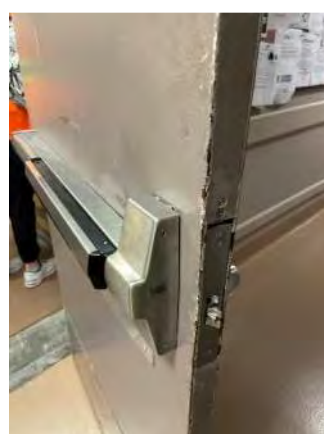
- The above referenced mainline interior is in good condition overall with no identified deficiencies.
- Repaint the front door mullions, interior door frames are recommended.
(Figure 1, Figure 2, & Figure 12)
- A better way to attach the lightings is recommended in mech room. (Figure 3)
- A hole with pipe in the ceiling in mech room, leaking potential. Light is broken and HVAC diffuser need to be repair. (Figure 4 to Figure 8)
- Fill up the holes in the dry walls (Figure 9 & Figure 10)
- Missing a ceiling tile in the janitor room (Figure 11)

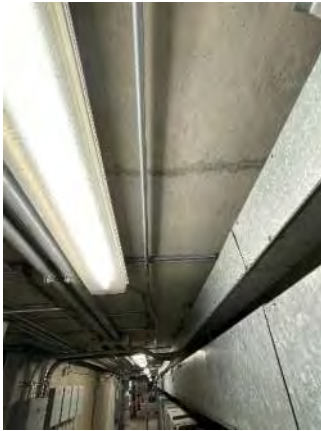
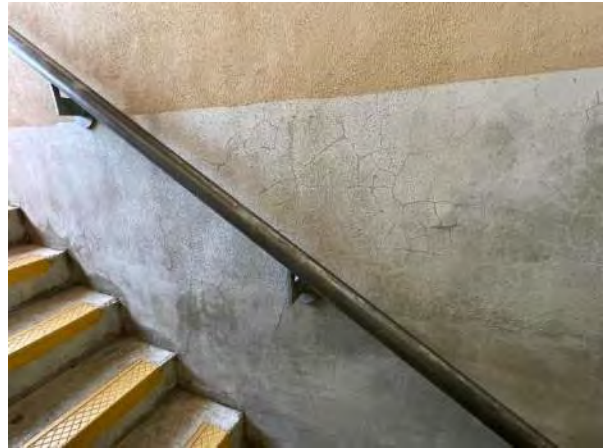
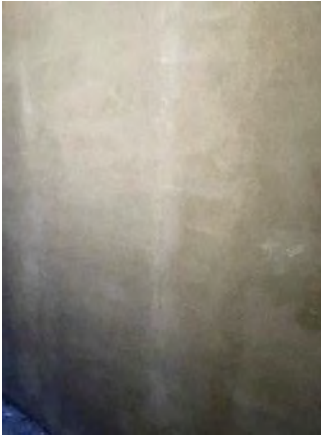
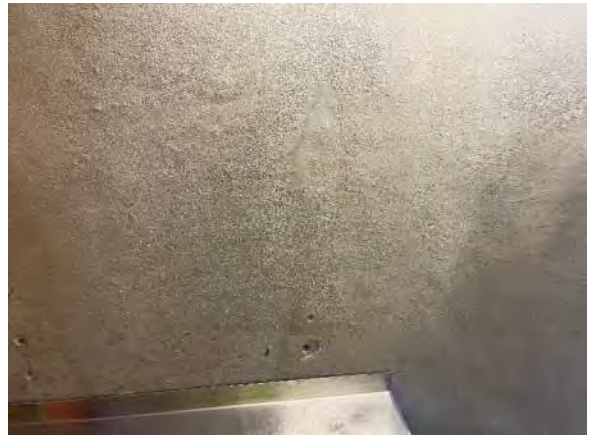
- The concrete walls and ceiling have visible cracks (Figure 13 to Figure 16)
- Concrete floor has potential leaking (Figure 17 & Figure 18)
- Holes into ceiling filled with paper (Figure 19)
- Incorrect way to attach the stair handrail (Figure 20)
- Column show visible leaking (Figure 21)
- Barriers have visible cracks (Figure 22 & Figure 23)
- Lane 21 has no light; outlets are not working.

- Recommend repairing the ceiling tiles and sealing the cracks.
- Recommend general maintenance to pressure wash building exterior.
- Recommend general maintenance to seal the holes above the ceilings both interior and the tunnel.

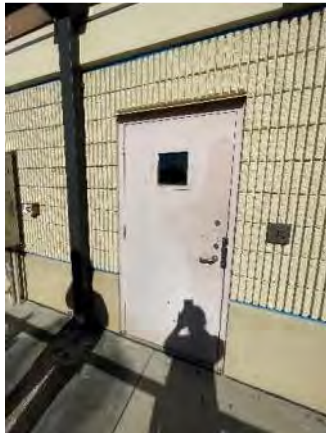
Figure 32 Good Homes Ramp On

- Curb has a visible crack (Figure 32)
- Repaint doors and windowsill are recommended (Figure 33 & Figure 34)
- New exterior lighting recommended (Figure 35)
- Barriers have visible cracks (Figure 36 & Figure 37)
- Paint is shredding, potential leaking (Figure 38)
- Wall has a visible crack (Figure 39)

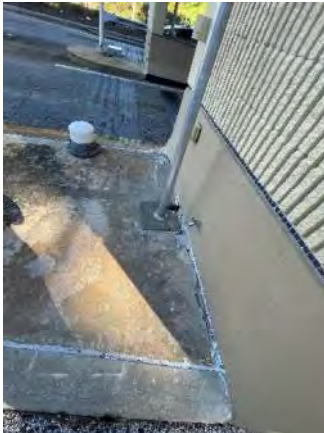
Figure 44 Hiawassee Ramp Off

- The above referenced ramp is in good condition overall. Some general maintenance to pressure wash plaza, general maintenance on bollard and cover electrical trough is recommended. (Figure 44 & Figure 45)
- Landscape cleaning (Figure 46)
- Cover the hole inside the wall (Figure 46)
- Paint is shredding, potential leaking (Figure 47 & Figure 48)
- Minor crack on the wall (Figure 49)

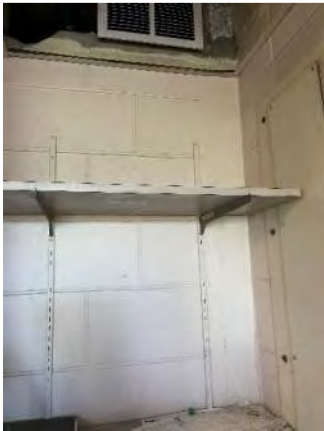
Figure 50 Hiawassee Ramp On

- The above referenced ramp is in good condition overall. Some general maintenance to pressure wash plaza and covers electrical trough is recommended.
- Landscape cleaning (Figure 50)
- Interior walls have visible cracks (Figure 51 & Figure 52)

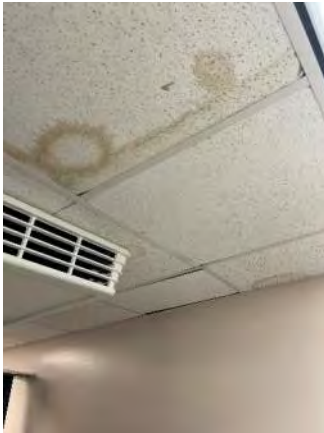
Figure 1 Conway EB Mainline

- WB and EB Interior mainline computer room have potential leaks above ceiling tiles. (Figure 1, Figure 36)
- Some of the ceiling tiles do not align with the grids. (Figure 2)
- The ceiling HVAC diffusers are missing. (Figure 3)
- The tiles were cut for wires (Figure 4)
- WB Interior mainline office has incorrect ceiling panel (Figure 5)
- Change the toilet seat is recommended (Figure 6)
- Stairway door color is fading (Figure 7)
- Floor has a visible crack, either the epoxy paint or the actual concrete slab (Figure 37)

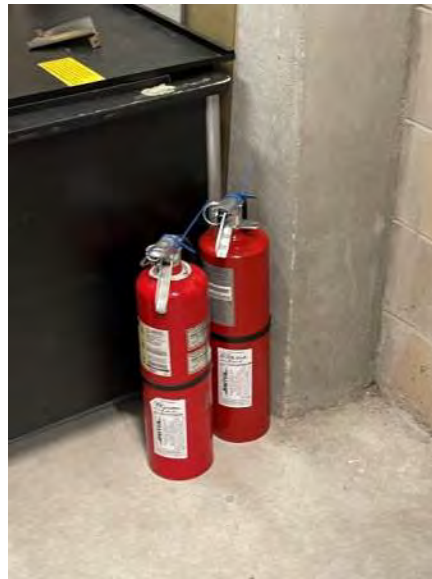
Figure 8 Conway EB Mainline

- The above referenced tunnel is in good condition overall.
- Signs need to be adjusted and secure (Figure 8)
- Incorrect FEC storage (Figure 9)
- Falling out/ unfinished work for electric panel (Figure 12)
- EB and WB walls have potential leaks and rusty electric panels (Figure 10, Figure 11, Figure 38, Figure 39 & Figure 40)
- EB floor has water leak (Figure 41)

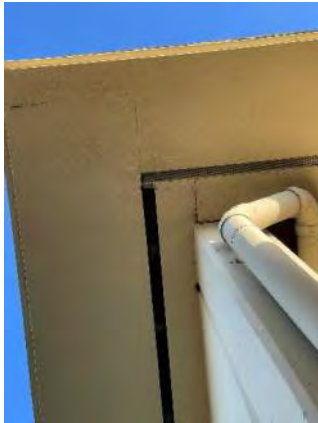
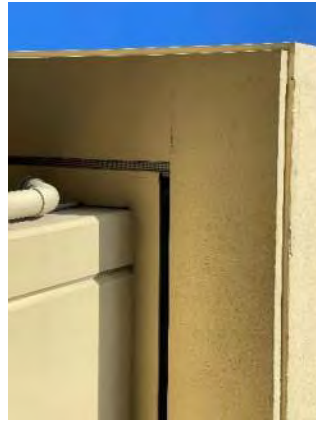
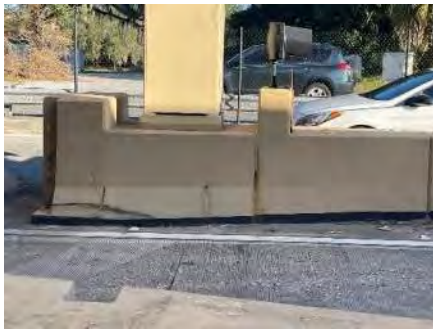
Figure 44 Bumby Ramp On

- There are two corners of the canopy and the barriers have visible cracks. The light of the toll booth doesn't turn on. Some general maintenance to pressure wash plaza, repaint for the 2 main doors and the barriers is recommended.
(Figure 44 to Figure 48)

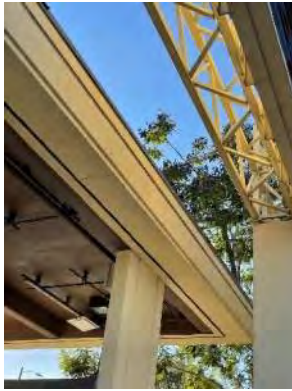
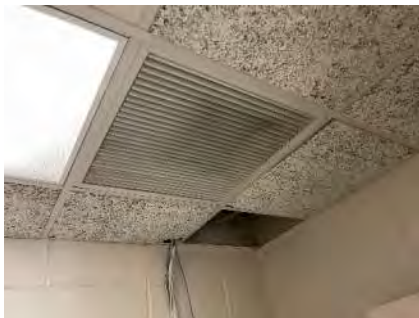
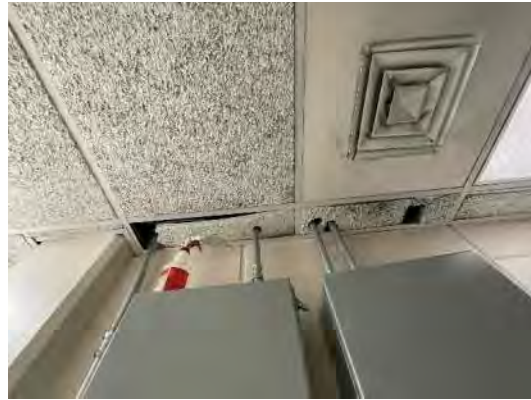
Figure 50 Bumby Ramp Off

- Corner of canopy has visible crack and paint peeling in front of the canopy, potential leaking. Barriers have visible cracks, scratches and repaint is recommended. Missing ceiling tiles and broken ceilings tiles. Filter is very dirty, replace HVAC filter is recommended. Oct 21 was the last fire extinguisher checked up. (Figure 49 to Figure 54)

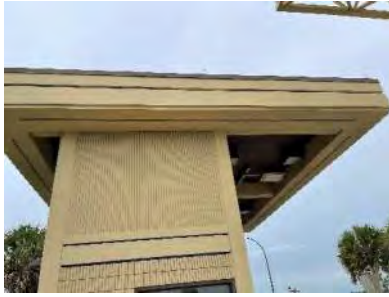
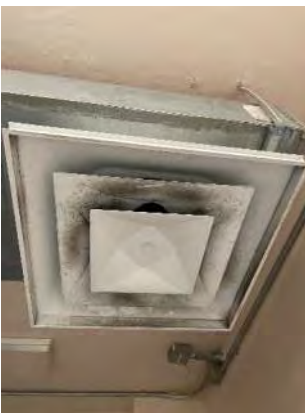
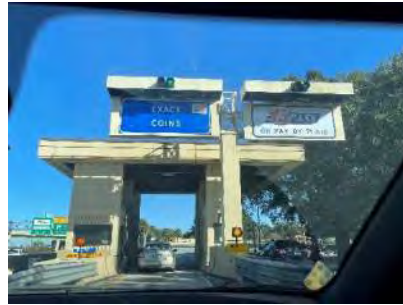
Figure 58 Conway Ramp On

- The above referenced ramp is in good condition overall. Some general maintenance to pressure wash canopy, air diffuser from HVAC unit, and enclose the big opening on the ground. From far away, the barrier has visible cracks. (Figure 55 to Figure 61)

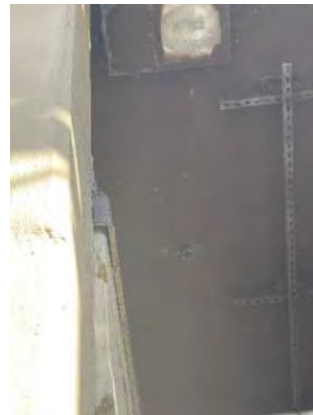
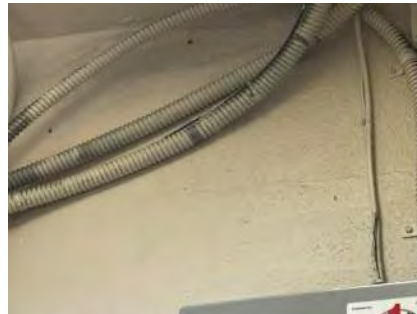
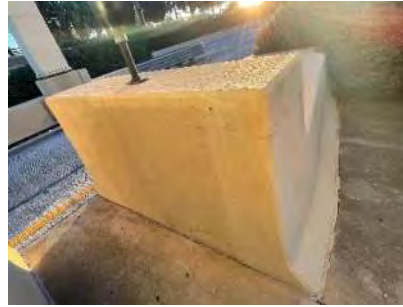
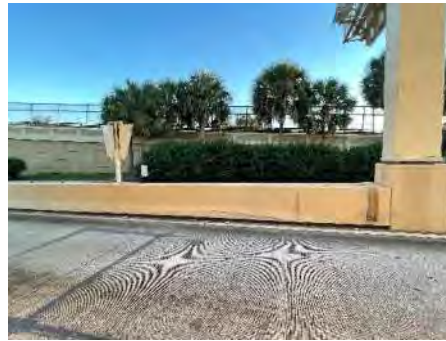
Figure 64 Conway Ramp Off

- Some general maintenance to pressure wash canopy. There is a hole in canopy above the toll booth. Wall and column in the mech room show visible cracks and black liquid leaking onto equipment. (Figure 62 to Figure 68)

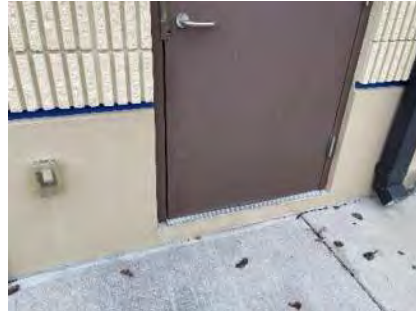
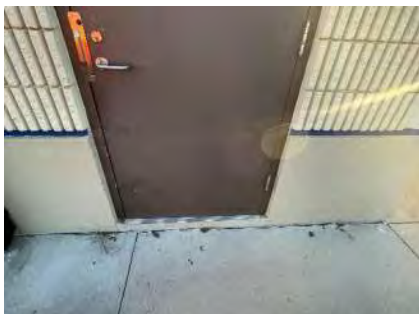
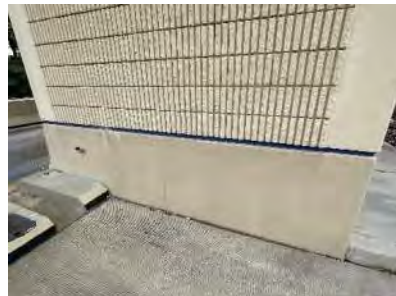
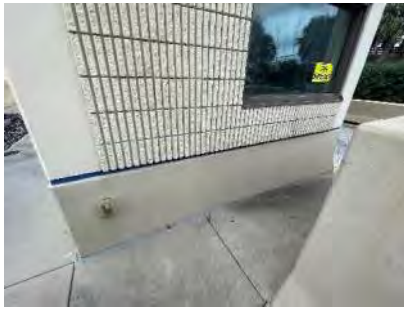
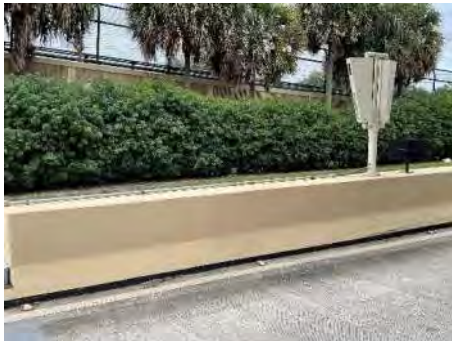
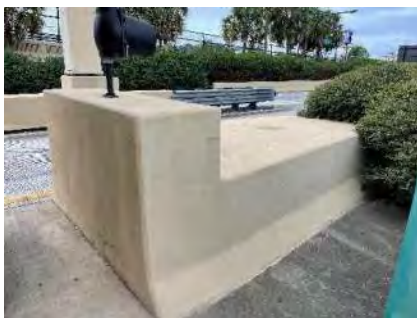
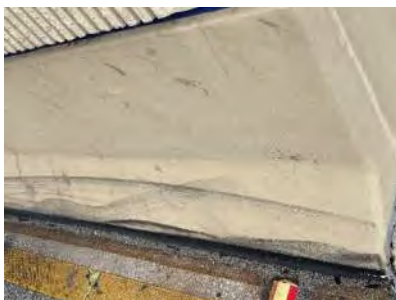
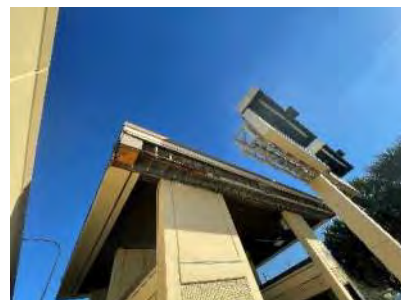
Figure 73 Semoran Ramp Off

- The above referenced ramp is in good condition overall. Some general maintenance to pressure wash plaza overhead sign structure. All walls of the building, step under both main doors, and the barriers have visible cracks. The sidewalk has a big visible crack. The coin collector did not work at the time of inspection. (Figure 72 to Figure 78)

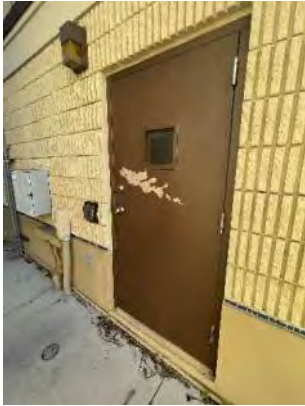
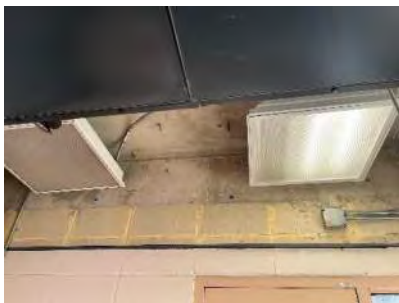
Figure 82 Yucatan Ramp On

- Exterior walls and corner of canopy have visible cracks. Fascia and soffit at canopy framing completely exposed. Needs complete repair/replacement of sheathing and finish cement plaster, "stucco" to properly enclose canopy. Color of the barrier is fading. Repaint doors and window sill are recommended. Black liquid is leaking onto equipment. (Figure 79 to Figure 86)

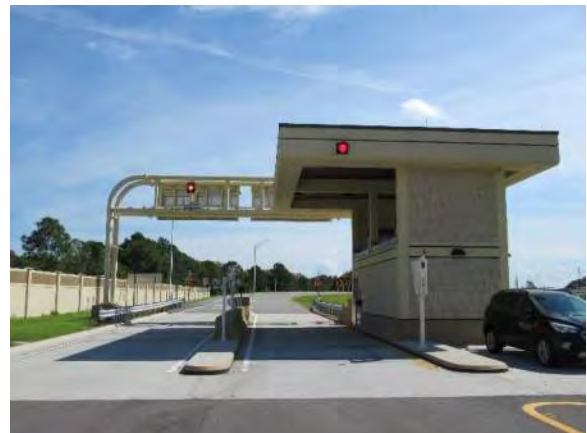
Figure 18 Rouse Road Ramp Off

The above referenced ramp is in good condition overall. (Figure 17 & Figure 18)

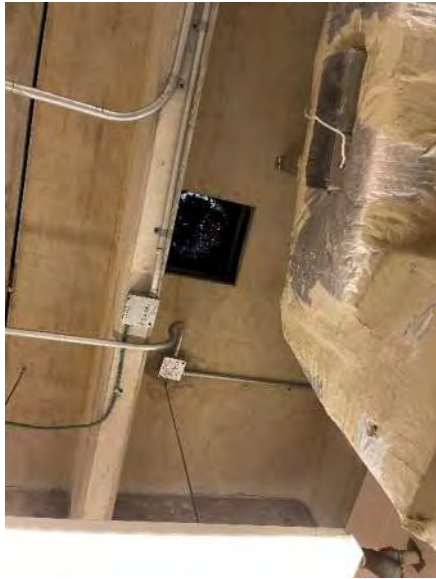
Figure 1 Coral Hills Mainline

- Mechanical room missing a cover for hole in ceiling exposed to exterior (*Figure 1*)
- Possible leaks throughout facility. Paint bubbling and peeling below windowsill in break room. As well leak stains along wall in data room, and Acoustic Ceiling Tile stained in supply room (*Figure 2, 3, and 4*)
- Windows cracked in manager's office and break room (*Figure 5 and 6*)

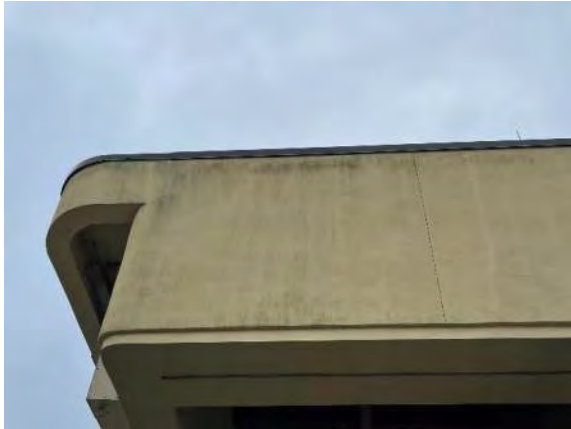
Figure 7 Coral Hills Mainline

- Exterior needs to be cleaned. Mildew buildup along façade of building and canopy, hornets in corners of building. (*Figure 7 and 8*)
- Cracks around facility. Most notable are underneath several lights of canopy, on the corners of the soffits, and a large crack running through the base of the loading dock. (*Figure 9, 10, 11, and 12*)

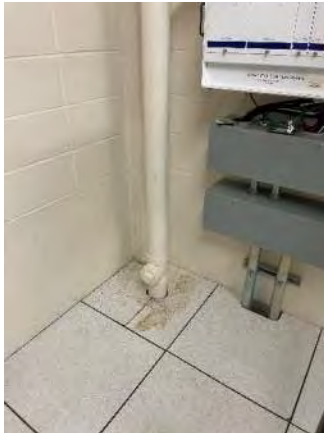
Figure 15 Keene Road Ramp On

- Possible leak in data room by pipe, floor is warped and stained (*Figure 15*)
- Small cracks in barriers (*Figure 16*)

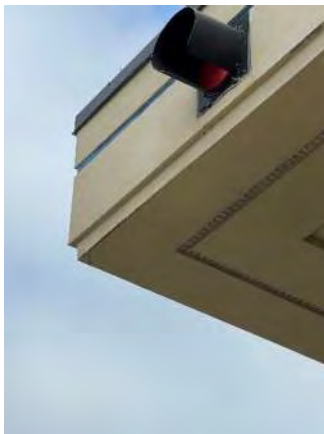
Figure 17 Hiawasse Ramp Off

- Small cracks at corners of canopies (*Figure 17 and 18*)

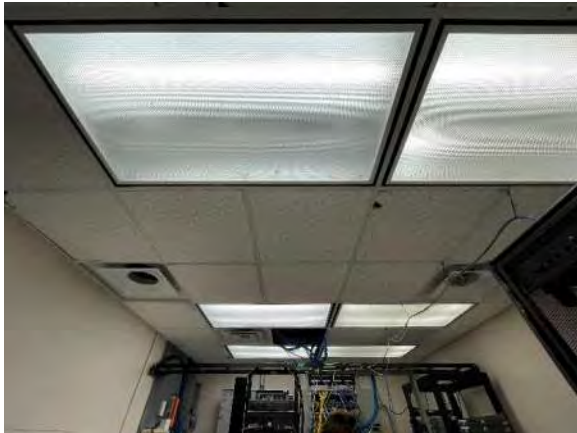
Figure 1 Independence Mainline

- Mainline has missing vent covers and potential leaks above ceiling tiles in multiple locations. (Figure 1, Figure 2, Figure 3, Figure 4 & Figure 5)

- Recommend maintenance to locate and repair any potential roof leaks.
- Recommend pressure wash, patch and paint as needed on building façade.
- Recommend routine maintenance to patch and seal cracks in building facade.

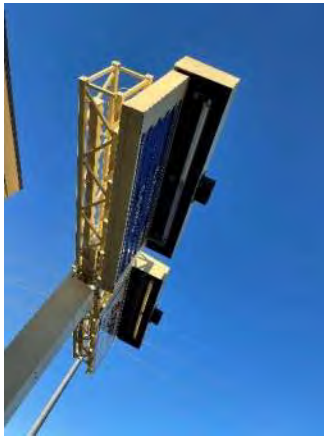
Figure 21 New Independence Ramp On

The above referenced ramp is in good condition overall. Some general maintenance to address the peeling paint on wall and weather seal interior joints at water pipe is recommended.
(Figure 21, Figure 22, Figure 23 & Figure 24)

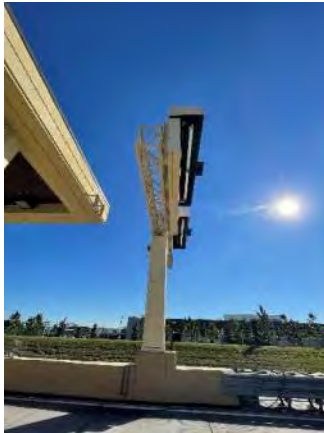
Figure 25 New Independence Ramp Off

The above referenced ramp is in good condition overall. Some general maintenance to address the water collecting on barrier is recommended. Light is not working properly on one side.
(Figure 25, Figure 26, Figure 27 & Figure 28)

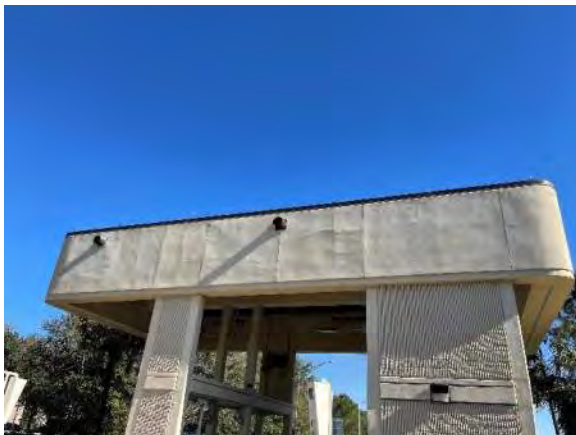
Figure 29 CR-535 Ramp Off

The above referenced ramp is in good condition overall. Some general maintenance to base boards, paint peeling on wall and patch and seal cracks in building façade is recommended.
(Figure 29, Figure 30, Figure 31 & Figure 32)

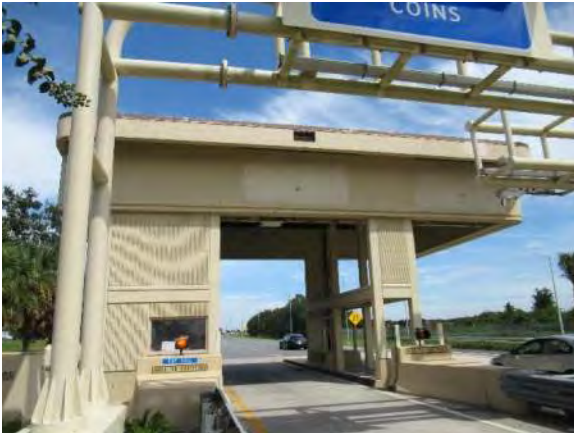
Figure 33 CR-535 Ramp On

The above referenced ramp is in good condition overall. Some general maintenance to patch, seal and paint building façade at location of previous signage and base boards, paint door is recommended.
(Figure 33, Figure 34, Figure 35 & Figure 36)

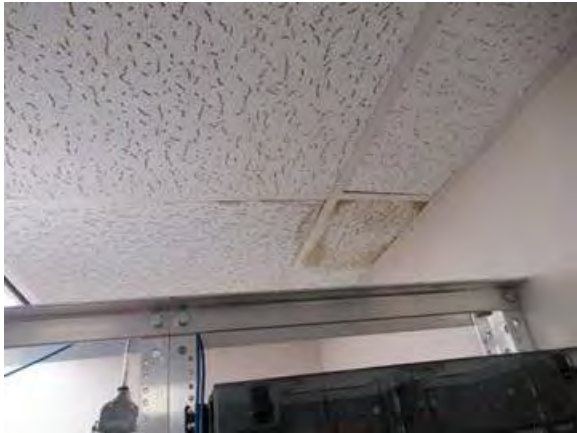
Figure 1 Forest Lake Mainline

- Leaks in ceilings of data room and recording room (*Figure 1 and 2*)

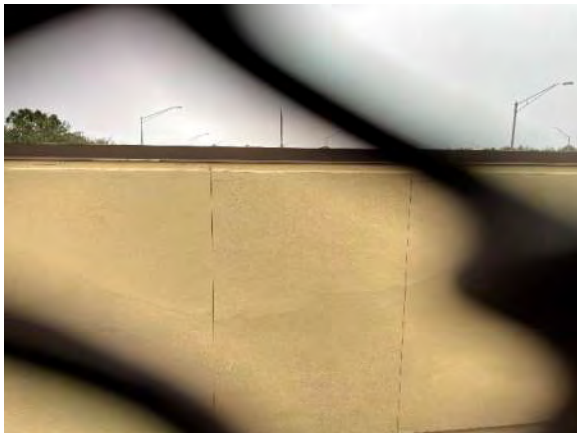
Figure 5 Forest Lake Mainline

- Cracks along canopies, and cracks throughout stairs of loading dock (*Figure 5 and 6*)
- Floor mats on side entrance of building are loose or entirely lifted (*Figure 7*)
- Elevator equipment door is deteriorating on bottom (*Figure 8*)
- Columns are peeling with small cracks throughout plaza (*Figure 9 and 10*)

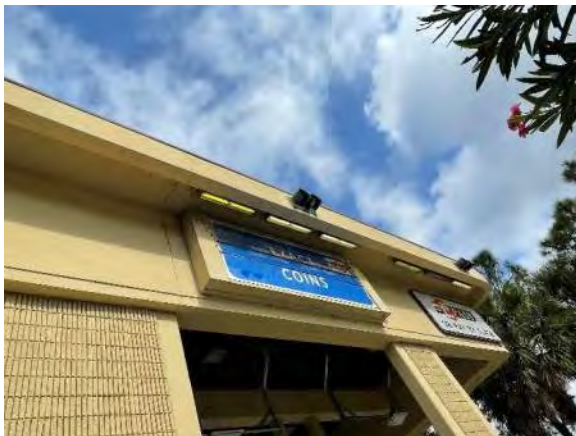
Figure 11 SR-438 Ramp On

- Façade needs to be cleaned and lights above signage replaced (*Figure 11*)
- Signage needs to be replaced (*Figure 12*)

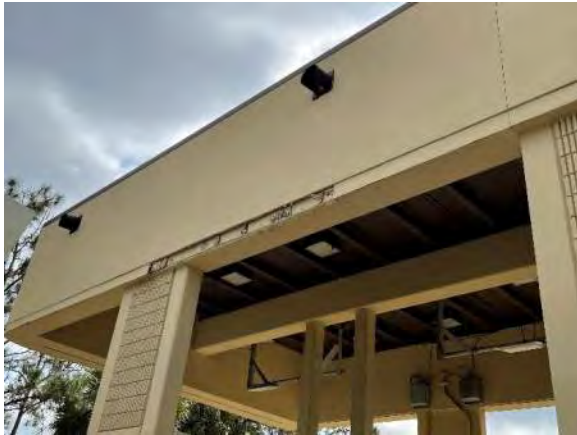
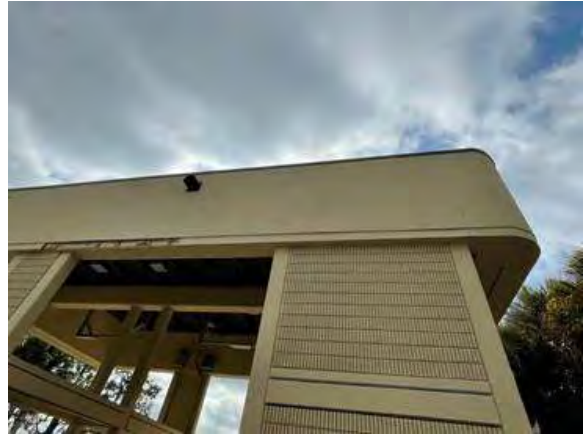
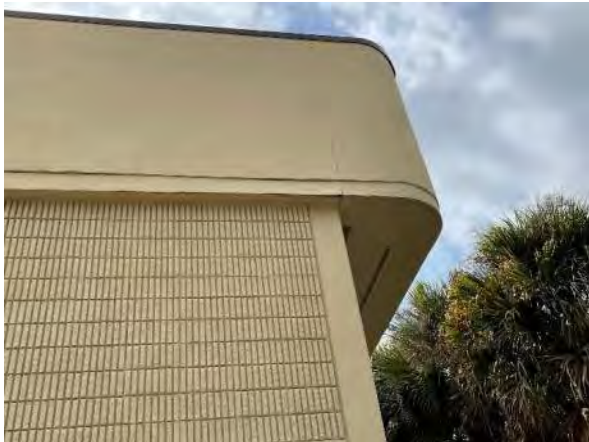
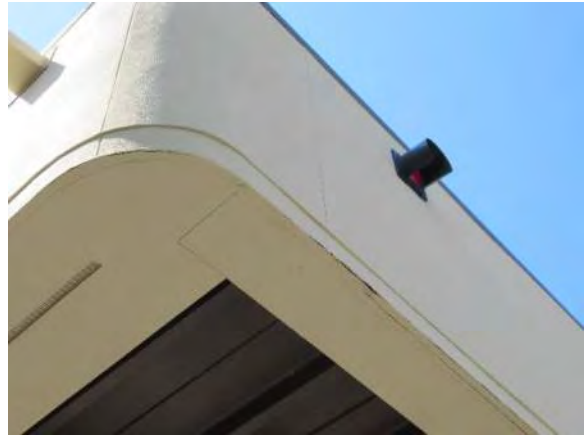
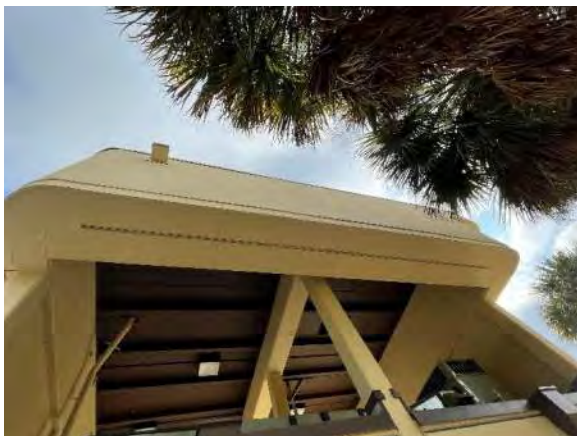
- Cracks along sides and undersides of canopy (*Figure 13, 14, 15, 16, and 17*)
- Lights for signage to be replaced (*Figure 18*)

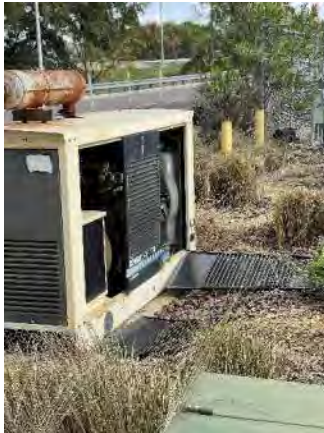
Figure 19 West Road Ramp On

- Machine equipment open (*Figure 19*)
- Lights for signage to be replaced (*Figure 20*)

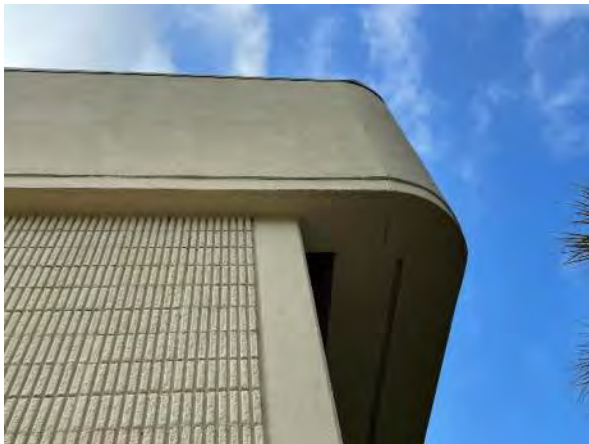
Figure 21 West Road Ramp Off

- Crack on corner of canopy (*Figure 21*)
- Interior of door to data room needs to be cleaned (*Figure 22*)
- Lights need to be replaced, exterior (*Figure 23 and 24*)
