2021

Annual Inspection Report

Re: 2021 Annual Inspection Report

2021 Annual Inspection Report
CENTRAL FLORIDA EXPRESSWAY AUTHORITY

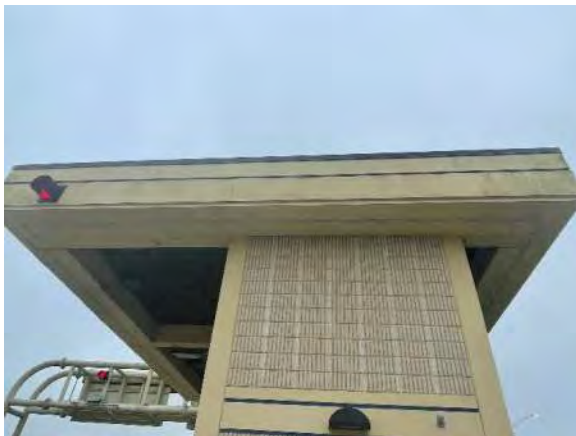
Figure 29 CR-437A Ramp On

- Building façade and canopy need to be cleaned (*Figure 29*)
- Doors need to be repainted (*Figure 30*)
- Cracks along base of building and barriers (*Figure 31 and 32*)

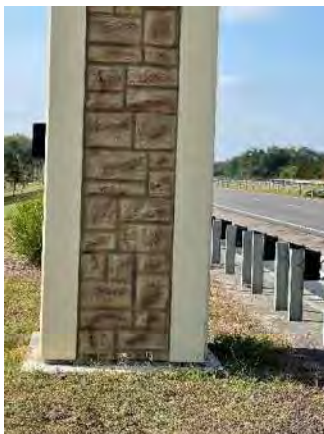
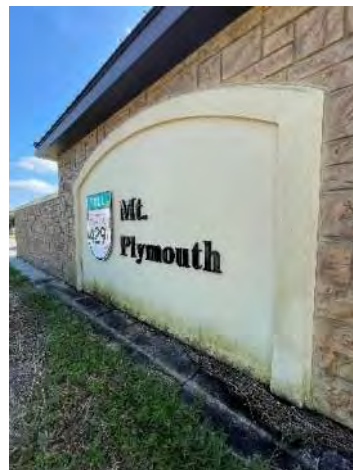
- Small cracks on exterior façade details, signage needs to be cleaned (*Figure 35 and 36*)

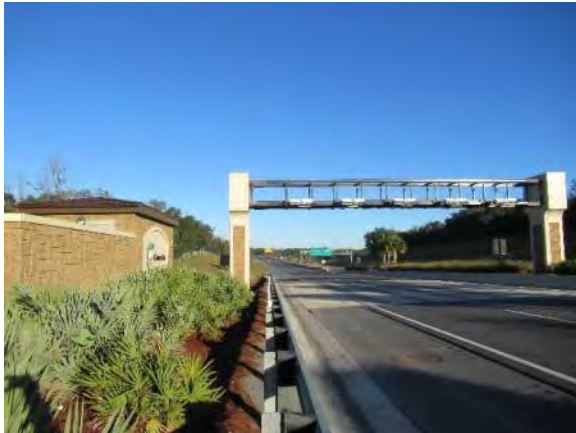
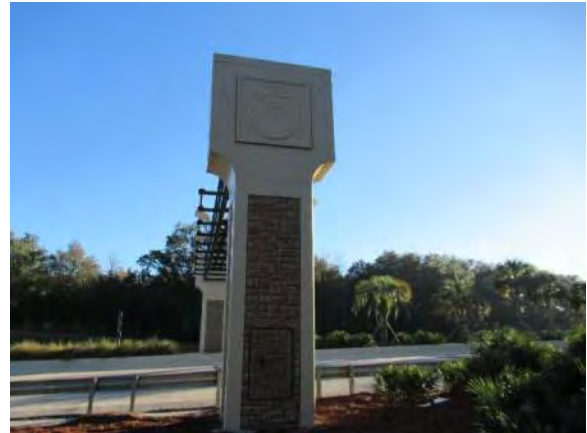
- The above referenced ramp is in good condition overall. Anthill through entrance, sand along interior. Needs to be cleaned (Figure 1 and 2)
- Exterior needs to be cleaned, crack in archway detail (Figure 3 and 4)

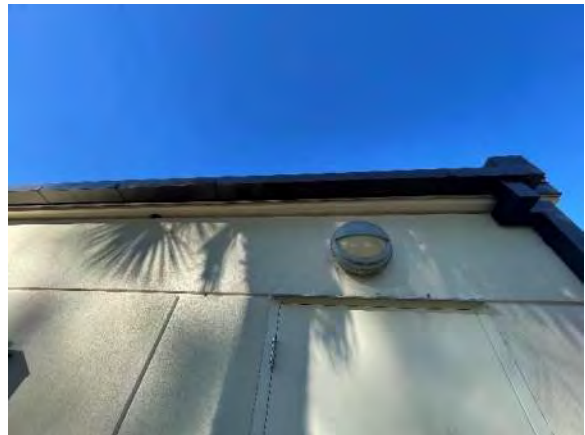
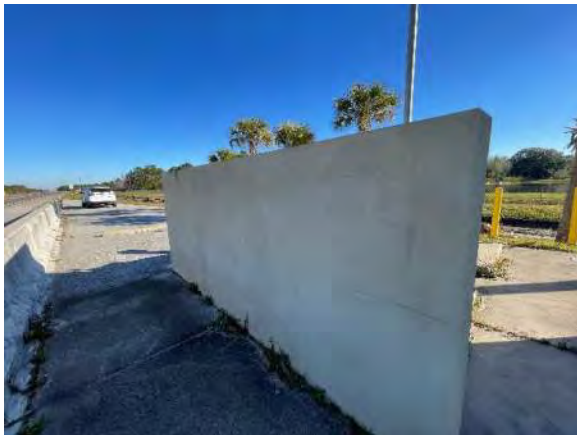
Figure 3 Marigold AET Toll Plaza

The above referenced plaza is in good condition overall. Some general maintenance to caulk/seal cracks to building exterior is recommended.
(Figure 3 & Figure 4)

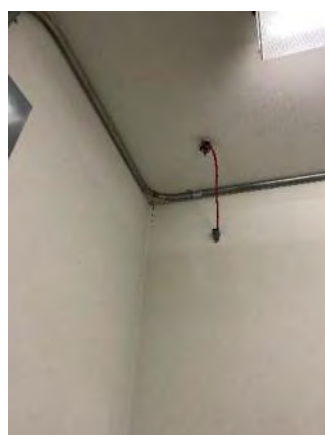
Figure 5 KOA AET Toll Plaza

The above referenced plaza is in good condition overall. Some general maintenance to caulk/seal control joints.
(Figure 5 & Figure 6)

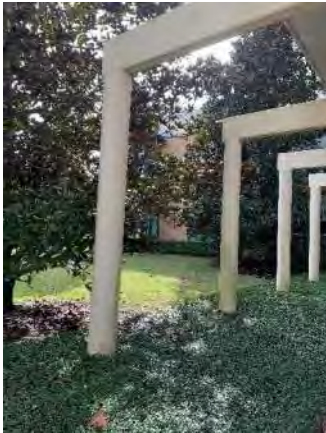
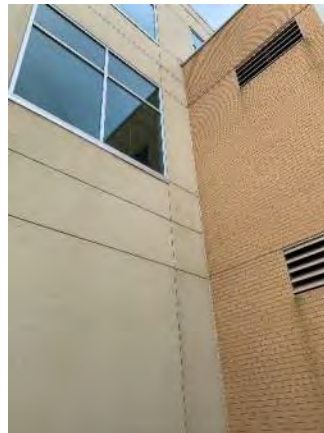
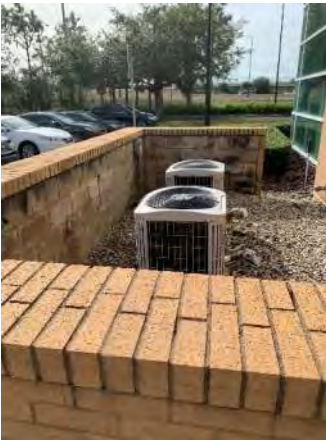
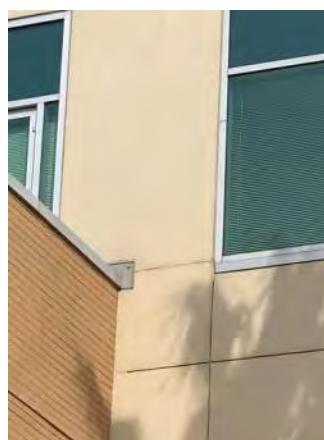
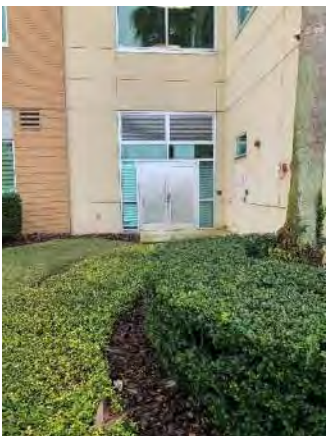
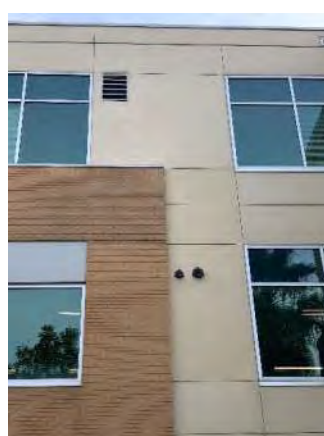
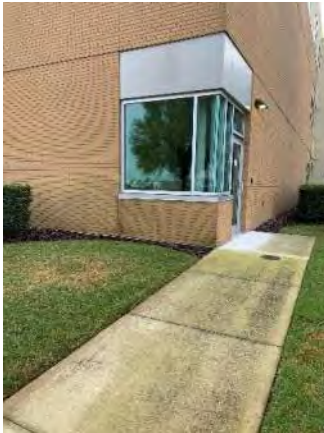
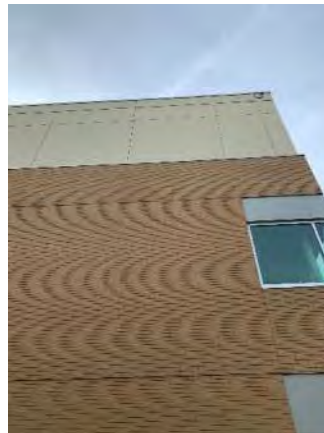
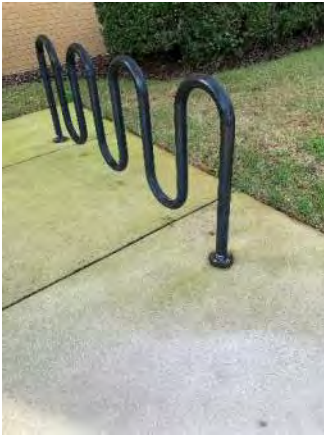
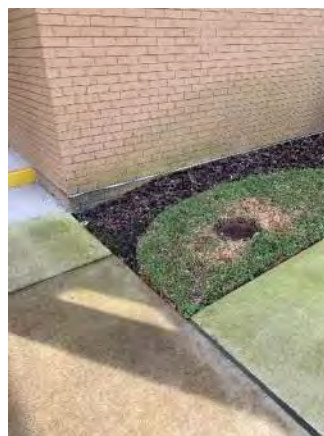
- Building exterior is in good condition overall with no identified deficiencies. Pressure wash is recommended for the sidewalk, corner of the building and main entrance.
(Figure 1 - Figure 10)

- Recommend general maintenance to locate potential leaks above ceiling.
- Recommend general maintenance to patch and paint areas in need of touch up.
- Recommend general maintenance to pressure wash exterior façade, sidewalk and main entrance.

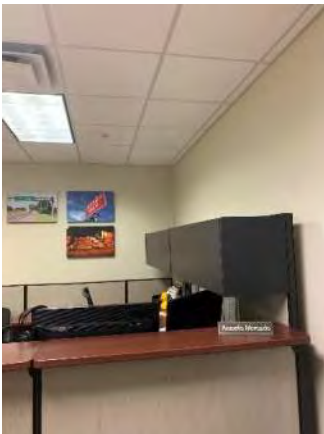
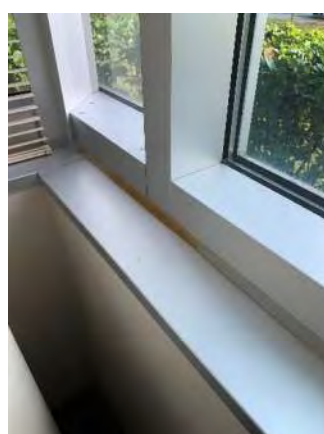
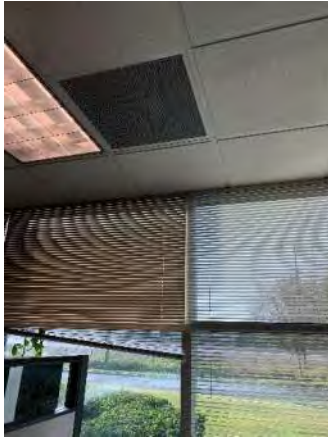
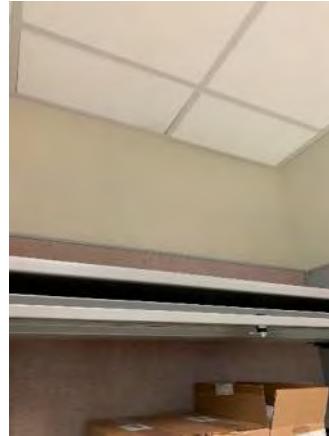
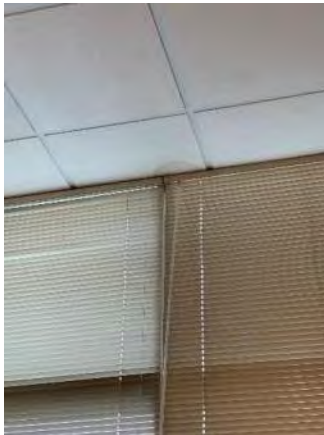
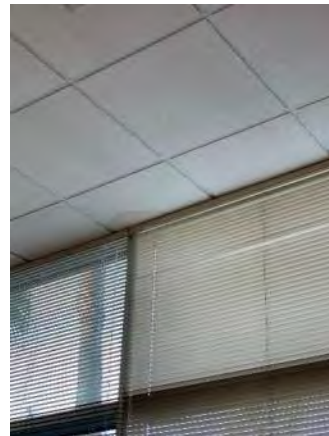
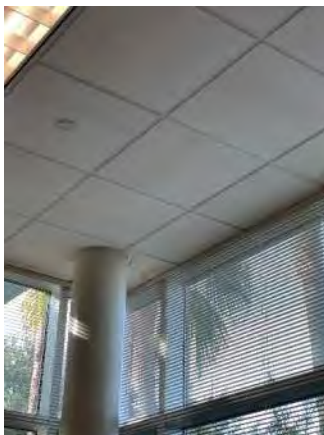
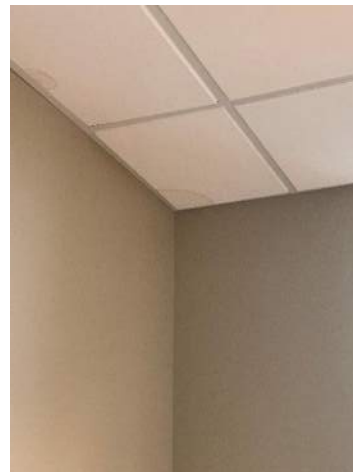
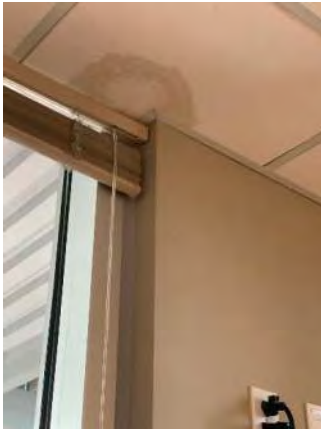
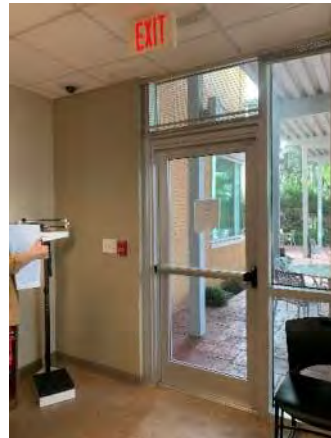
- Identified areas with potential leak above ceiling tile, potential leak at the window trim.
(Figure 11 to Figure 13, Figure 20 to Figure 27)
- Broken outlet cover (Figure 14)
- Visible hole above the ceiling tile – pest intrusion (Figure 15, Figure 16)
- Crack by the corner of the window trim (Figure 17)
- Dents on the corner (Figure 18)
- Light is not working (Figure 19)
- Broken fan (Figure 28)
- Code violation – empty space under stair is recommended (Figure 29)
- Broken exit sign (Figure 30)
- Visible crack line on tiled floor (Figure 31)
- Visible carpet buckling – moisture or delamination (Figure 32)

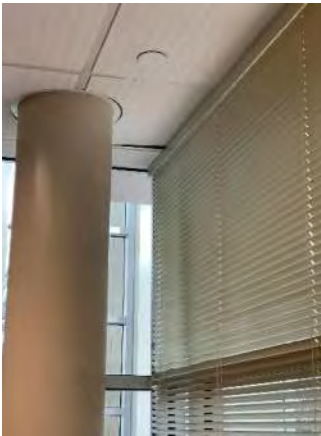
Figure 33 Building Headquarters Second Floor (Room 202)

- Identified areas with potential leak above ceiling tile.
(Figure 33 to Figure 46)

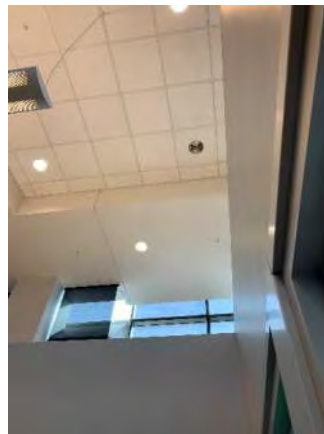
Figure 47 Building Headquarters Third Floor (Room 330)

- Code violation – empty space under stair is recommended (Figure 47)
- Light is not working (Figure 48)
- Identified areas with potential leak above ceiling tile (Figure 49)
- Broken tile board base (Figure 50)
