FY **2023** Annual Inspection Report

Mr. Glenn Pressimone, P.E.
Chief of Infrastructure
Central Florida Expressway Authority
4974 ORL Tower Road
Orlando, Florida 32807

Re: FY 2023 Annual Inspection Report

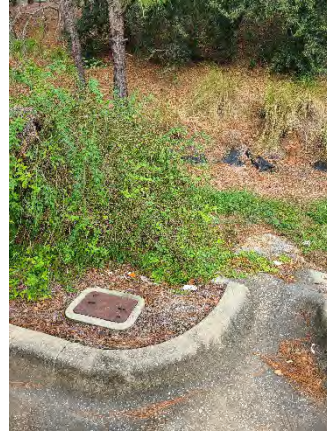
Figure 49 Hiawassee Ramp On

- General maintenance to pressure wash plaza and covers electrical trough is recommended. (*Figure 49*)
- Landscape cleaning. (*Figure 50*)
- Interior walls have visible cracks. (*Figure 51*)
- Door to data room damaged. (*Figure 52*)

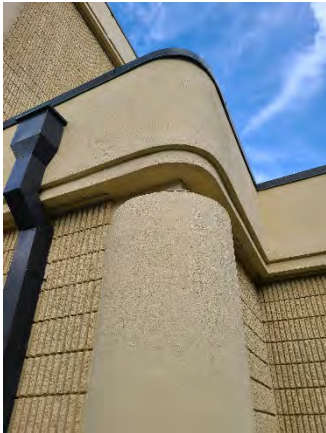
Figure 1 Pine Hills Mainline

- Concrete beginning to show wear along columns supporting canopy (*Figure 1*)
- Multiple cracks, and divots along soffit. (*Figure 2*)

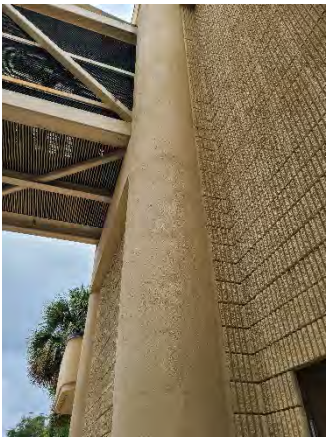
Figure 3 Pine Hills Mainline

- Overpass column shows bubbling and possible cracking. (*Figure 3*)
- Rusting along several components of overpass, interior and exterior. (*Figure 4*)

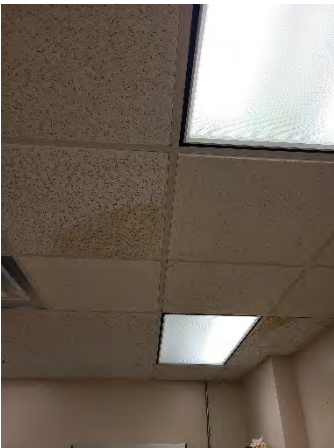
Figure 4 Pine Hills Mainline

- Several leaks throughout corridor ceiling. (*Figure 5, 6, 7, and 8*)
- Stairwell has cracking on the corner of stairs, as well 2 light fixtures nonresponsive to switch. (*Figure 9*)
- Wall corner of door dented and scuffed. (*Figure 10*)
- Storefront door had deep divots in glass, as well mullion does not match on storefront wall. (*Figure 11 and 12*)
- Women's restroom faucet leaking, as well water fountain not working. (*Figure 13 and 14*)

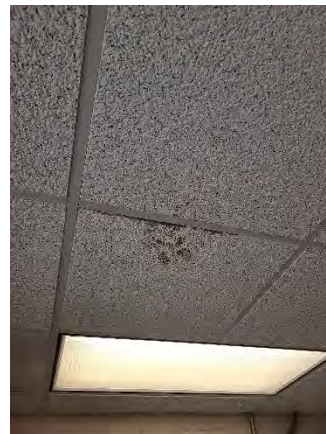
Figure 17 Old Winter Garden Ramp Off

- Needs to be cleaned.
- Discoloration and cracks along barriers. (Figure 19)
- Possible leak in ceiling, tile stained. (Figure 20)

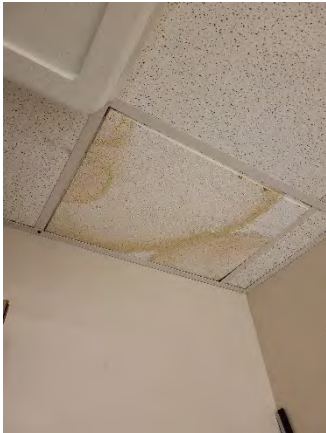
Figure 1 Conway EB Mainline

- EB Interior mainline computer room has potential leaks above ceiling tiles. Paint bubbling in stairway. *(Figure 1 and Figure 2)*
- WB Interior mainline computer room has potential leaks above ceiling tiles, misplaced ACT throughout facility. *(Figure 3 and Figure 4)*

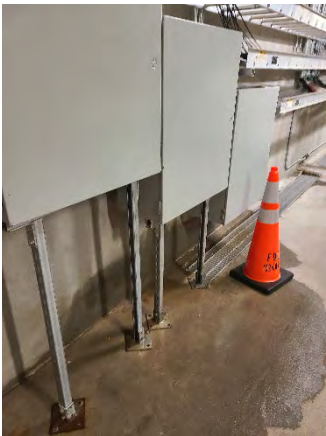
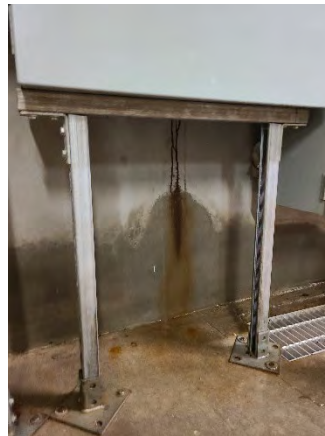
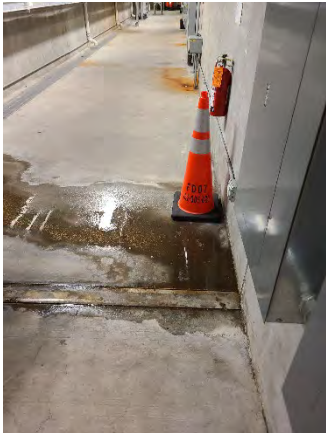
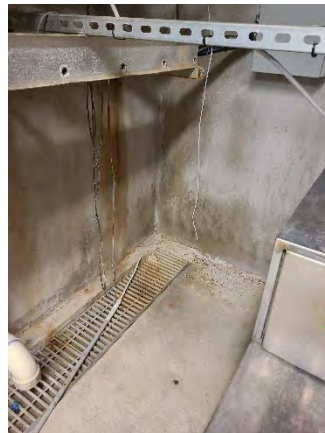
- EB Tunnel has multiple leaks, including active leak running behind electrical panel. Supervisor informed. *(Figure 5, Figure 6, Figure 7, and Figure 8)*
- WB Tunnel has multiple leaks, including pooling by floor grates. *(Figure 9, Figure 10, Figure 11 & Figure 12)*

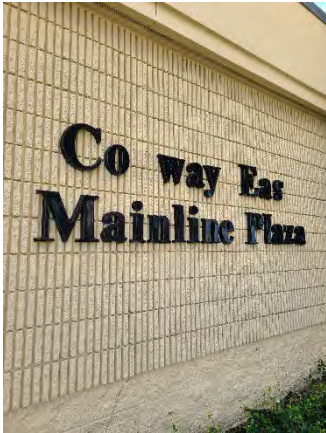
Figure 23 Conway EB Mainline

- WB Exterior light at toll booth entrance areas has identified paint shedding. *(Figure 13)*
- EB Exterior sign missing “n” and “t”. *(Figure 13)*
- EB Exterior cracking in foundation of loading dock and canopy façade. *(Figure 14 and Figure 15)*
- WB Exterior wall/columns/canopy have visible cracks. *(Figure 16, Figure 17, & Figure 18)*

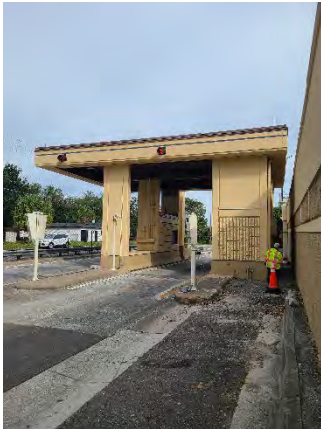
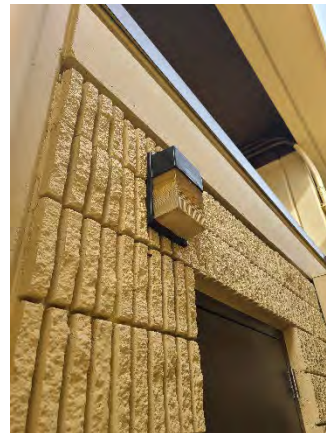
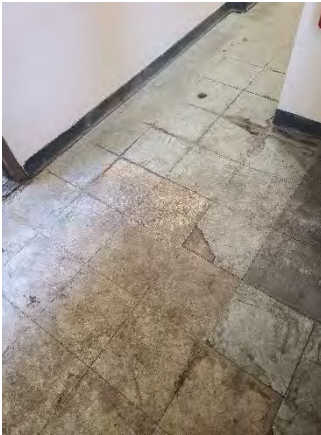
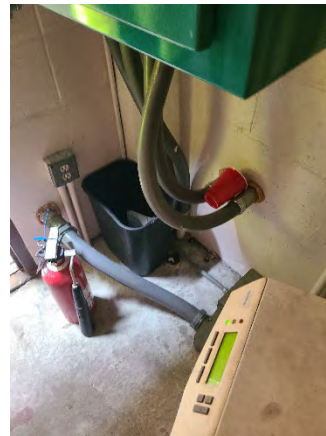
- The above referenced ramp is in good condition overall. Some general maintenance to pressure wash plaza, ensure lighting is functioning properly, cover electrical trough and fireproof ceiling penetration is recommended. *(Figure 19, Figure 20, Figure 21 & Figure 22)*

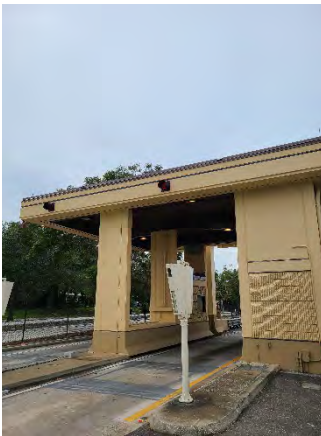
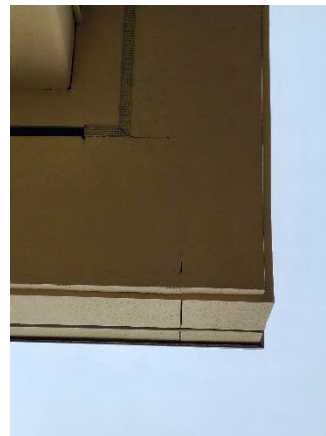
- The above referenced ramp is in good condition overall.
- Some general maintenance to pressure wash plaza, small cracks underneath canopy. *(Figure 23 and Figure 24)*
- Foundation separating from walls by door. *(Figure 25 and Figure 26)*
- ACT discolored and doorstop not working in data room. *(Figure 27 & Figure 28)*

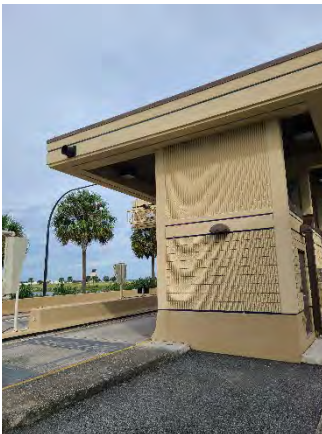
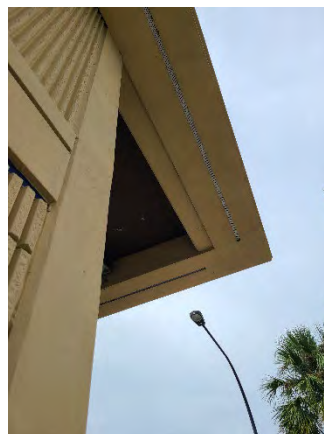
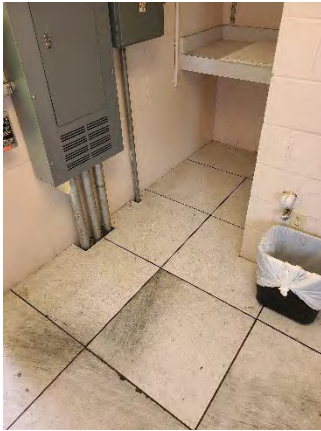
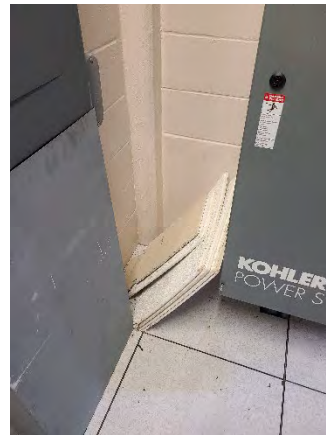
- The above referenced ramp is in good condition overall. Some general maintenance to remove debris around the landscaping is recommended. *(Figure 29, Figure 30, Figure 31 & Figure 32)*

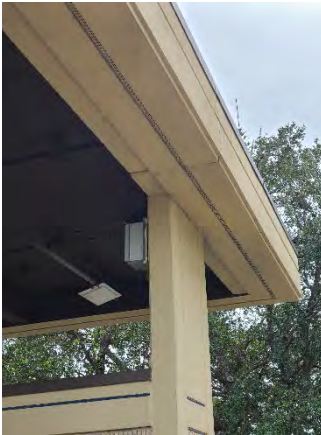
Figure 33 Conway Ramp Off

- The above referenced ramp is in good condition overall. Some general maintenance to remove debris around the landscaping and cover electrical trough is recommended. *(Figure 33)*
- Broken glass in back corner of booth. *(Figure 34)*
- Foundation separating in data room. *(Figure 35 & Figure 36)*

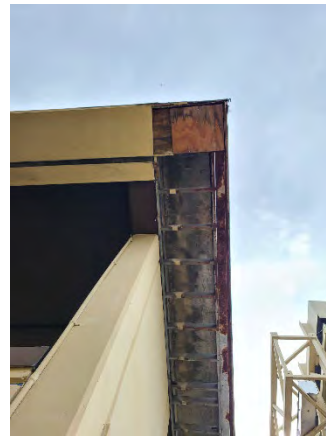
Figure 46 Yucatan Ramp On

- Canopy façade and undercarriage completely removed/missing. *(Figure 45, Figure 46, Figure 47, Figure 48)*
- Light does not work. *(Figure 49)*
- Presence of mold in booth. *(Figure 50)*
- Large crack running along wall separating booth and data room. *(Figure 51)*
- Leak in data room. *(Figure 52)*

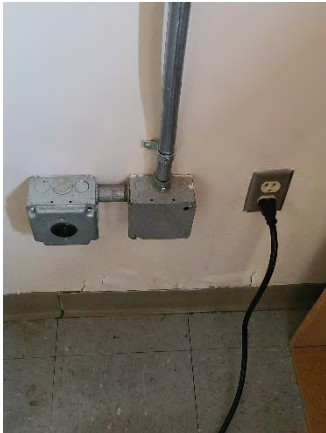
Figure 1 Dean Mainline

- The above referenced site is in good condition overall
- Water damage near base board in mech room and throughout facility. *(Figure 1 and Figure 2)*

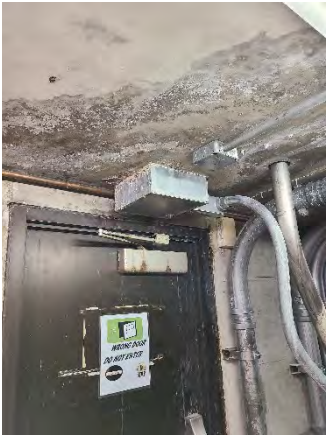
Figure 3 Dean Mainline

- Mainline tunnel control panel NEMA enclosures are rusted out.
- Water leaking along the walls.
- Dirty ceiling and cracked.
- Leaking above door.
(Figure 3 and Figure 4)

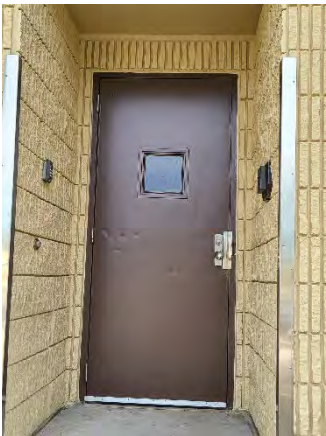
Figure 5 Dean Mainline

- Exterior maintenance to address ponding and exterior walls in need of pressure wash for the mainline building.
- Sign completely faded.
- Repaint stair and railing are recommended
- Top of the façade has a visible crack
- Door dented.
(Figure 5 & Figure 6)

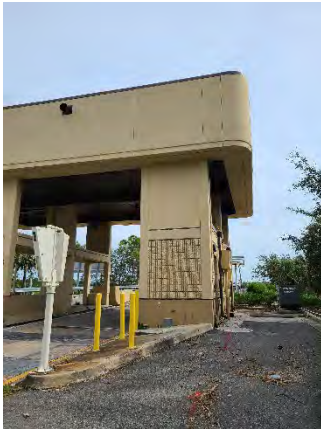
Figure 7 Dean Ramp On

- The above referenced ramp is in good condition overall. Need to be cleaned. *(Figure 7)*
- Paint rapidly peeling off interior walls. *(Figure 8, Figure 9 & Figure 10)*

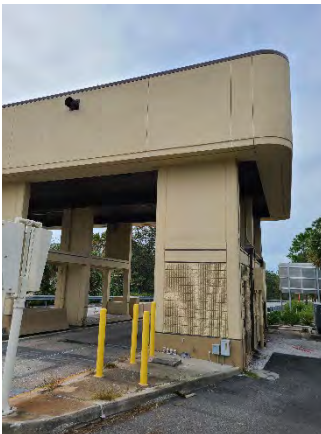
Figure 11 Dean Ramp Off

- The above referenced ramp is in good condition overall. Some general maintenance to patch and seal control joints. Light fixture does not work. *(Figure 11 and Figure 12)*
- Crack running along wall separating booth and data room. *(Figure 13 and Figure 14)*
- Paint rapidly peeling off interior walls. *(Figure 15 & Figure 16)*

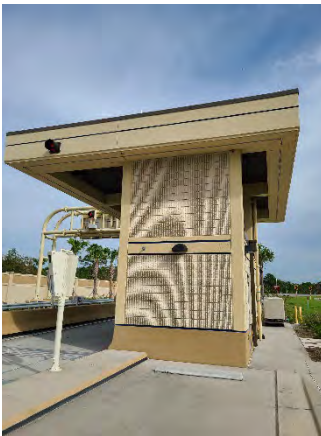
Figure 17 Rouse Road Ramp Off

- The above referenced ramp is in good condition overall. *(Figure 17 & Figure 18)*

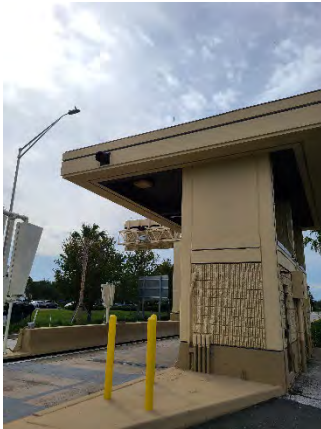
Figure 19 Rouse Road Ramp On

- The above referenced ramp is in good condition overall. Some general maintenance to ensure no debris. *(Figure 19)*
- Animal nesting in booth. *(Figure 20)*
- Paint rapidly peeling off interior walls. *(Figure 21 and Figure 22)*
- Crack running along wall separating booth and data room. *(Figure 23 & Figure 24)*

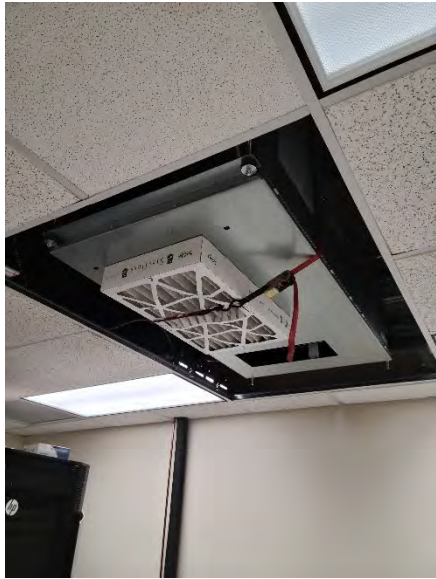
Figure 1 Coral Hills Mainline

- Data room missing a cover for filter, leaving ceiling exposed to vent (*Figure 1*)
- Possible leaks throughout facility. Paint bubbling and peeling below windowsill in break room. As well leak stains on floor of main stairwell. (*Figure 2 and 3*)
- Debris and supplies left in stairwell. (*Figure 4*)
- Multiple doors unable to close without excess effort, including restrooms, janitor's closet, and manager's office. (*Figure 5 and 6*)

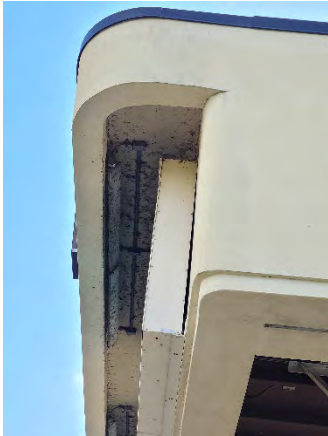
Figure 7 Coral Hills Mainline

- Exterior needs to be cleaned. Mildew buildup along façade of building and canopy, hornets in corners of building. (*Figure 7 and 8*)
- Cracks around facility. Most notable are underneath several lights of canopy, on the corners of the soffits, and small cracks running through columns. (*Figure 9, 10, 11, and 12*)

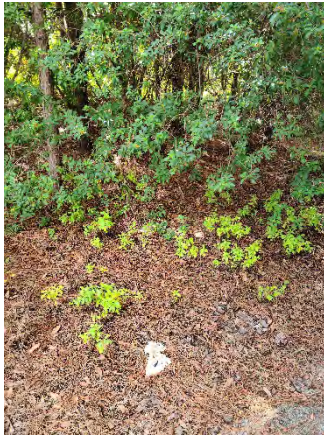
Figure 15 Keene Road Ramp On

- Debris surrounding ramp (*Figure 15*)
- Small cracks in barriers (*Figure 16*)

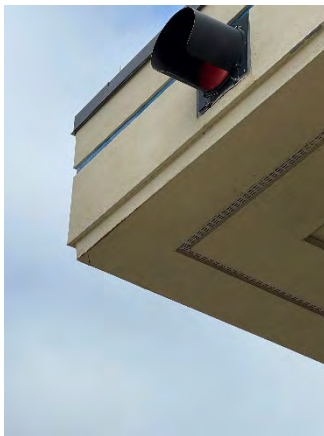
Figure 17 Hiawasse Ramp Off

- Small cracks at corners of canopies (*Figure 17*)
- Crack along wall of data room (*Figure 18*)

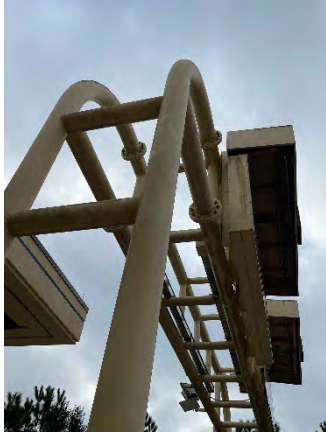
Figure 19 Hiawassee Ramp On

- Façade and sign need to be cleaned (*Figure 19*)
- Hinges on doors completely rusted (*Figure 20*)

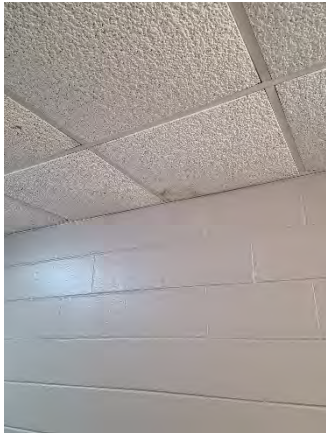
Figure 1 John Young Pkwy Mainline

- Acoustic Ceiling Tile slightly disheveled. Small stains could indicate minor leaking. *(Figure 1)*
- Floor panels lifted and stained. *(Figure 2)*

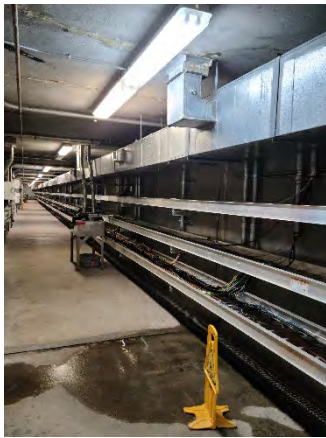
Figure 3 John Young Pkwy Mainline

- Various leaks throughout facility along walls and ceiling. Active leak in front of Island C. *(Figure 3 and 4)*

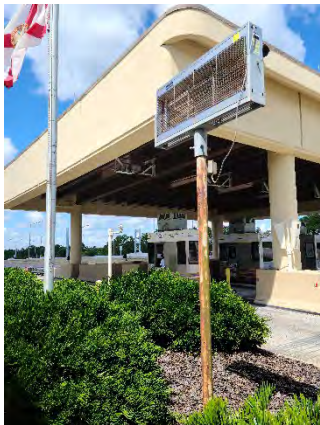
Figure 5 John Young Pkwy Mainline

- Pole completely rusted. *(Figure 5)*
- Small cracking and bubbling of paint on façade around vent. *(Figure 6)*

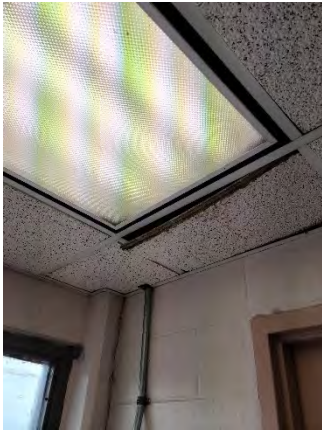
Figure 7 John Young Pkwy Ramp Off

- Acoustic Ceiling Tile displaced (*Figure 7*)
- Interior barrier appears to have been struck by vehicle (*Figure 8*)
- Overall unclean, with floor panels in poor condition. (*Figure 9 and 10*)
- *Fire extinguisher not dated.*

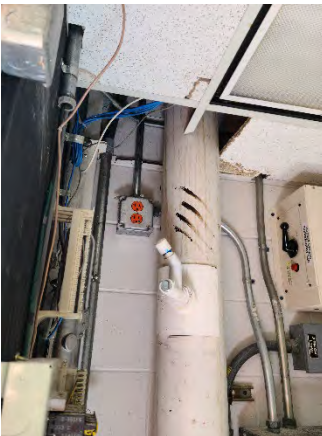
Figure 17 US-441 Ramp On

- Possible leak in data room (*Figure 17*)
- Light in main booth flickering. (*Figure 18*)
- Cracks along canopy façade, and around door frames (*Figure 19 and 20*)
- *Fire extinguisher not dated.*

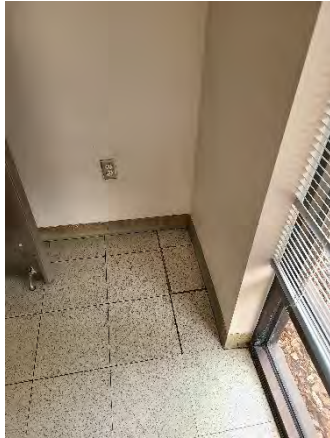
Figure 1 Boggy Creek Mainline

- Floor tiles raised and distressed in Technician Room. *(Figure 1)*
- Paint peeling in main corridor *(Figure 2)*
- Multiple ACT Tiles disheveled, damaged, or missing in Data room. ACT shows potential leaks, and vent is missing cover. *(Figure 3, Figure 4, Figure 5, & Figure 6)*
- Potential leaks above ceiling tiles in men's and women's restrooms and locker room. *(Figure 7 & Figure 8)*

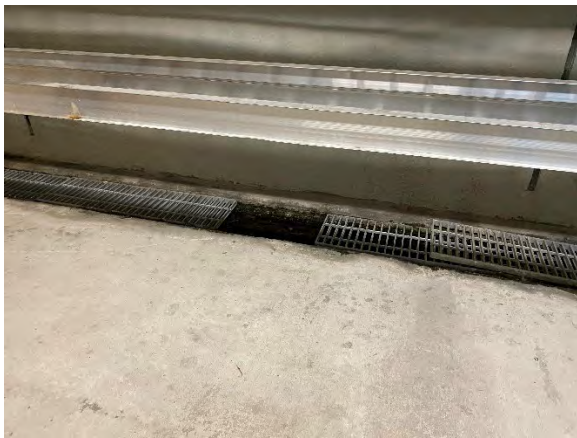
Figure 9 Boggy Creek Mainline

- The above referenced mainline tunnel is in good condition overall.
- Floor grates have been displaced, signs of overflowing/flooding. *(Figure 9)*
- Seal appears to be failing on expansion joint. *(Figure 10)*

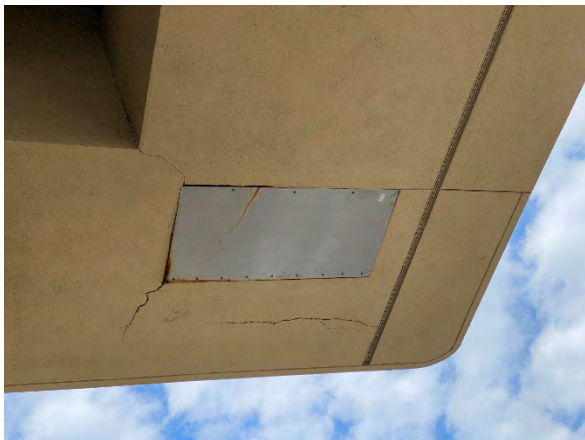
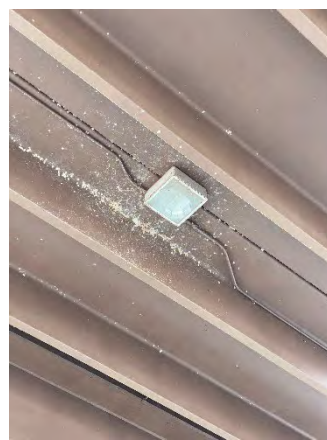
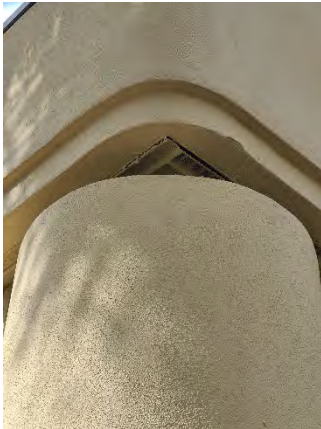
- Exterior canopy has visible cracks along corners, as well needs to be cleaned. *(Figure 11, Figure 12, & Figure 13)*
- Cracks and damage along soffit of main building, focused on North and South façade. *(Figure 14 & Figure 15)*
- Door needs to be repaired or replaced *(Figure 16)*

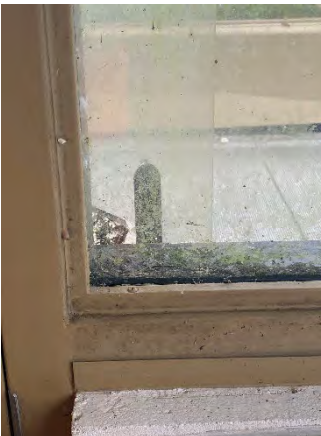
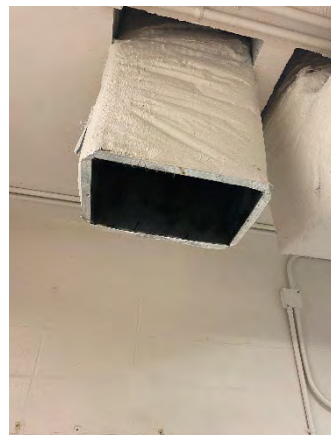
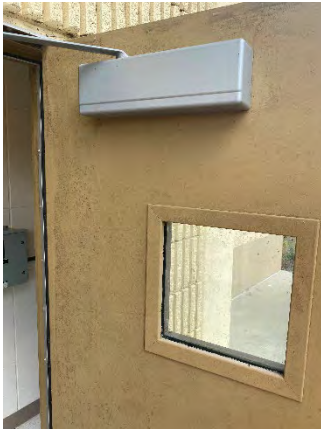
- Ramp shows evidence of mold cultivating inside booth, general maintenance to pressure wash plaza exterior and cover the vent is recommended. (Figure 17, Figure 18 & Figure 19)

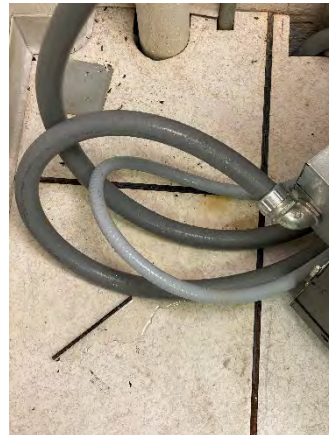
Figure 20 Boggy Creek Ramp On

- Active leak in data room, supervisor informed. (Figure 20)
- Exterior canopy and building facade have identified cracks. Missing ceiling tile. (Figure 21 and Figure 22)
- Multiple signs of leaking, discolored act tiles and peeling paint in booth. (Figure 23 and Figure 24)

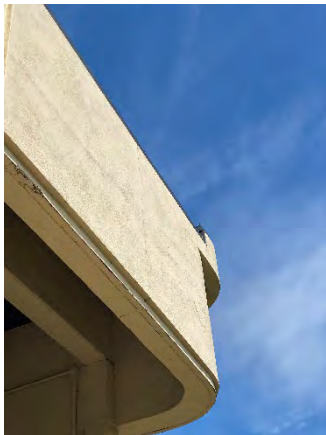
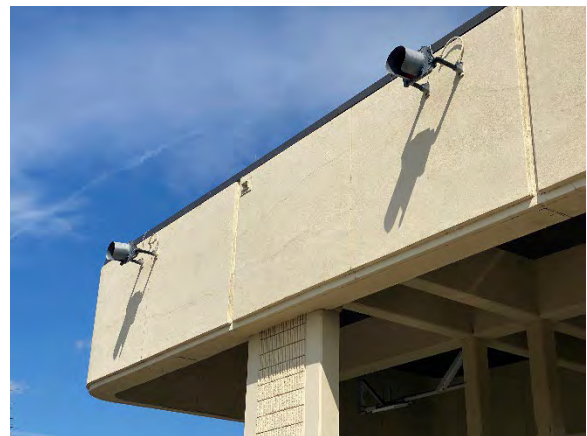
- Exterior façade, bottom of the canopy and corner have visible cracks (Figure 4 Figure 47, and Figure 48)
- Intrusion of debris and bugs into booth and data room. (Figure 49 and Figure 50)
- Interior ceilings have potential leaks, ACT tile fallen through, missing cover to the vent. (Figure 51 & Figure 52)

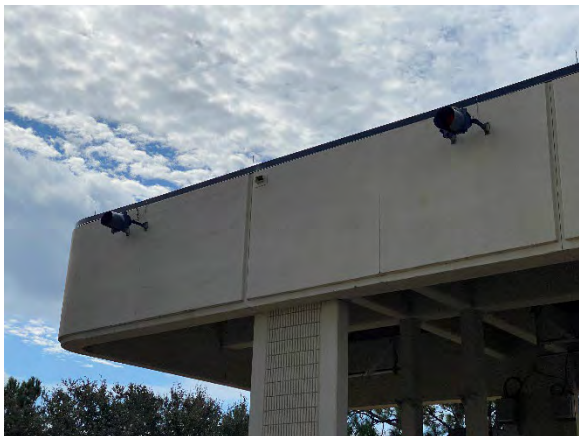
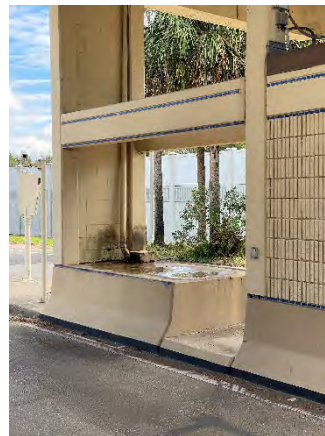
- Exterior façade, bottom of the canopy and corner have visible cracks. Water pooling at barrier. (Figure 53 and Figure 54)
- Door and windows need to be painted; seal is failing. (Figure 55 and Figure 56)
- Missing ceiling tile and wire is hanging out. Possible leak in data room. (Figure 57, Figure 58, and Figure 59)

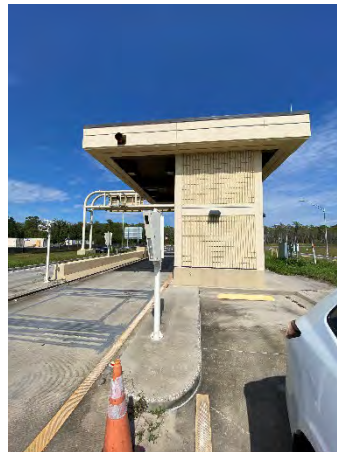
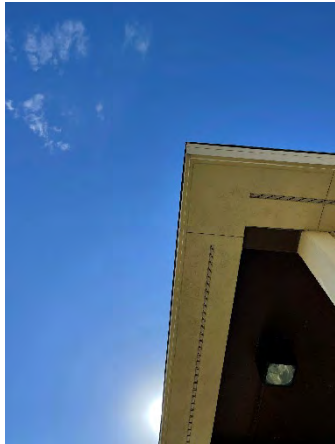
- The above referenced ramp is in good condition overall. Some general maintenance to pressure wash plaza overhead sign structure is recommended. (Figure 60 and Figure 61)
- The interior corner of the mechanical room has a visible crack. Possible leaks in ACT. (Figure 62, Figure 63, & Figure 64)

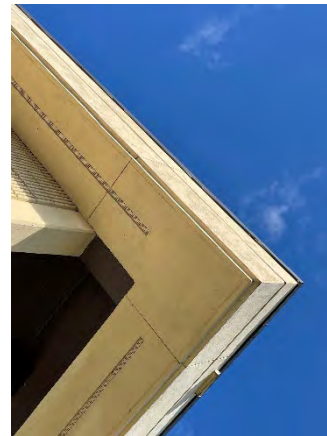
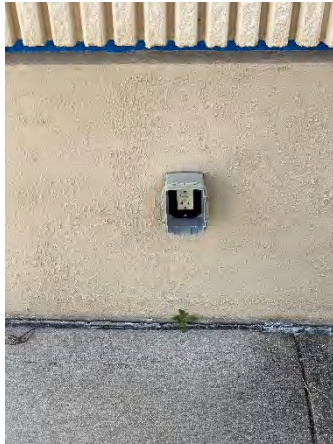
- The above referenced ramp is in good condition overall. Some general maintenance to pressure wash plaza overhead sign structure, locate potential leaks is recommended. *(Figure 65 to Figure 66)*
- Light cover missing, and window needs to be repainted. *(Figure 67 and Figure 68)*
- Possible leak in ACT, and debris left in data room. *(Figure 69 and Figure 70)*

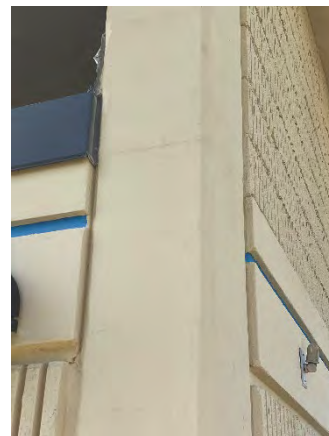
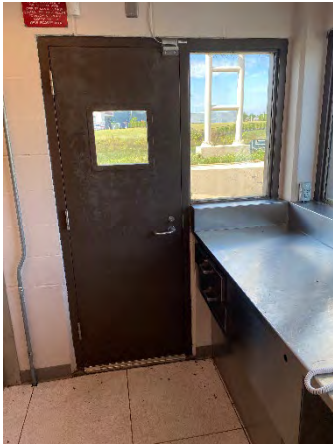
- The above referenced ramp is in good condition overall. Some general maintenance to pressure wash plaza overhead sign structure. Exterior wall has a visible crack. *(Figure 71 and Figure 72)*
- Sign of leaking in booth, mold, and mildew present. *(Figure 73, Figure 74, Figure 75, and Figure 76)*

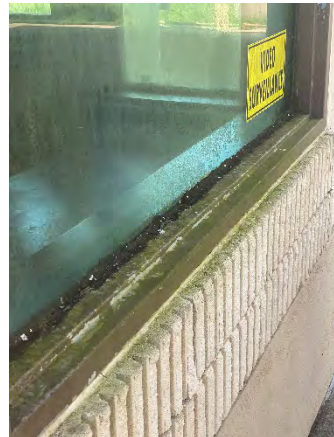
Figure 77 Innovation Way Ramp On

- The above referenced ramp is in good condition overall. Some general maintenance to pressure wash plaza overhead sign structure. *(Figure 77)*
- Mold and mildew along window, seal possibly failing. *(Figure 78)*
- Ceiling has a potential leak *(Figure 79, Figure 80, & Figure 81)*

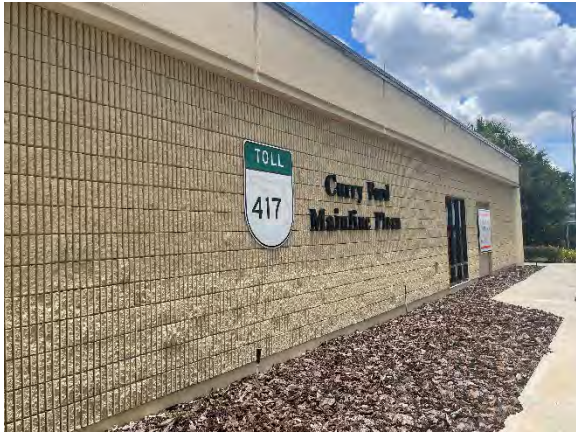
Figure 1 Curry Ford Mainline

- Sign is faded. (Figure 1)
- Cracks along base of several columns supporting canopies and under soffit (Figure 2 to figure 4)
- Doors have wall paint sprayed around borders, doors themselves require fresh paint (Figure 5 and figure 6)

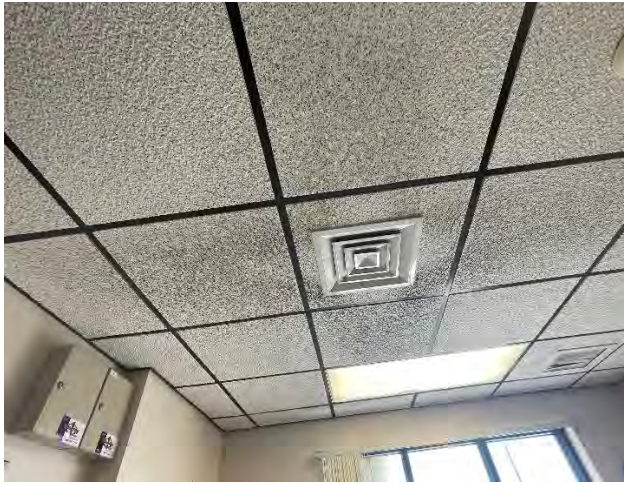
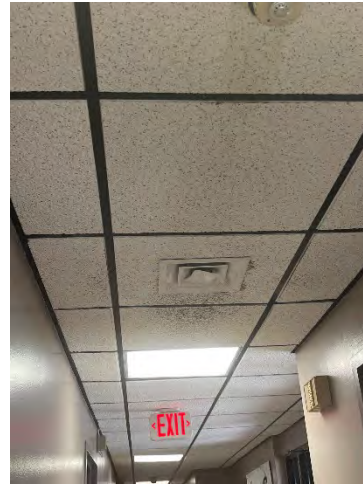
- Dirt build up around ventilation duct (Figure 7 and figure 8)
- Base board fall out along the wall (Figure 9)
- Ceiling cracked in mechanical room, possible leak. (Figure 10)
- Seat cover dispenser to be mount (Figure 11)
- Ceiling tiles discolored and disheveled throughout plaza, possible leak in locker room. (Figure 12)
- Windowsill cracked and paint peeling in lounge (Figure 13)

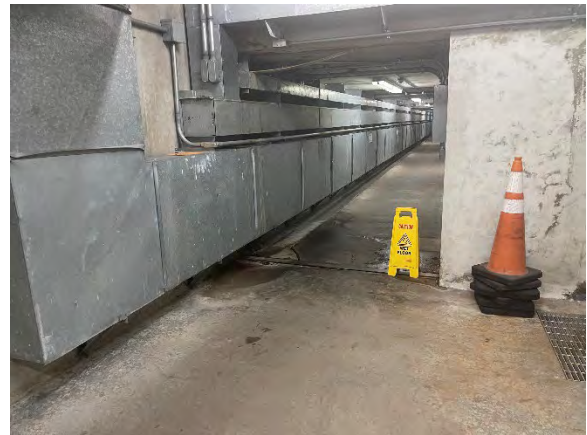
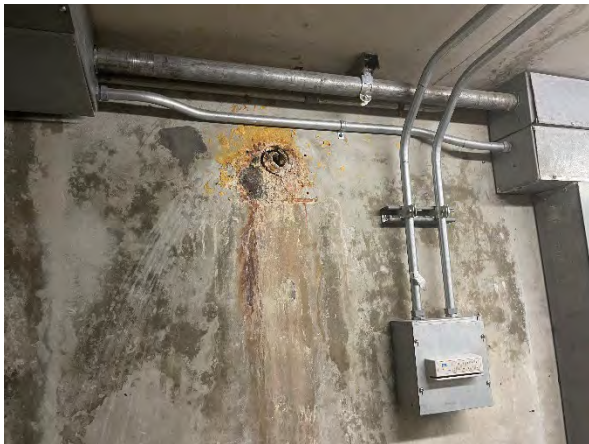
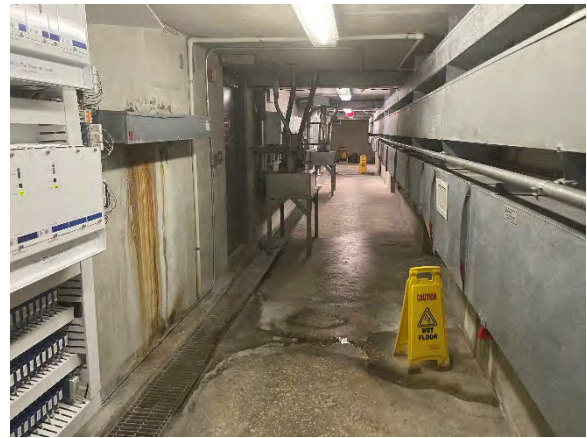
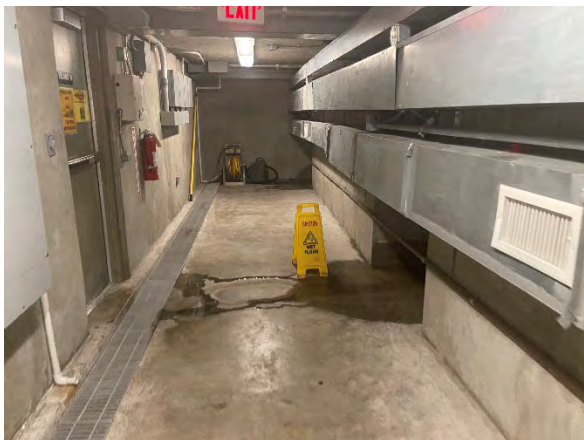
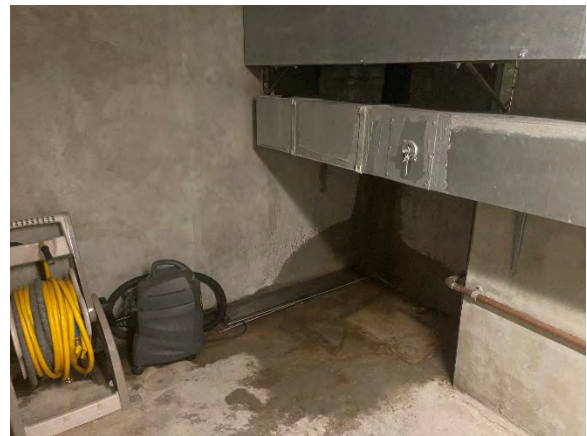
- Severe leaks throughout tunnel. Leak appears to be behind panel, as well ceiling joint separated from wall. (Figure 14 to figure 18)
- Several door frames to enter toll booths appear to be separating from wall. (Figure 20)
- Cracks along base of several columns supporting canopies (Figure 21 to figure 22)

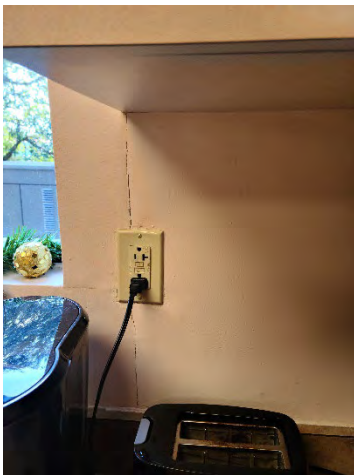
Figure 3 University Mainline

- Discolored Acoustic Ceiling Tile and possible leak in Men's Restroom (*Figure 1*)
- Multiple doors difficult to open, stuck in jamb. Room (*Figure 2*)
- Paint cracking and bubbling in several rooms of plaza. Possible leaks. (*Figure 3 and 4*)

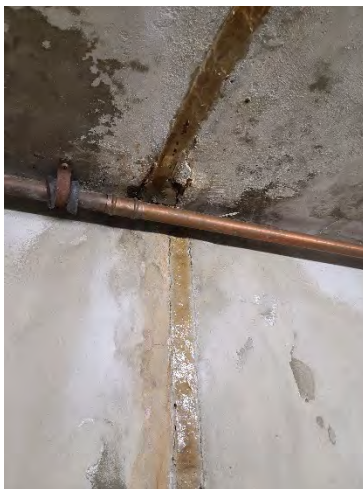
Figure 5 University Mainline

- Large joint appears to have been sealed and is again leaking, runs along wall and ceiling (*Figure 5*)

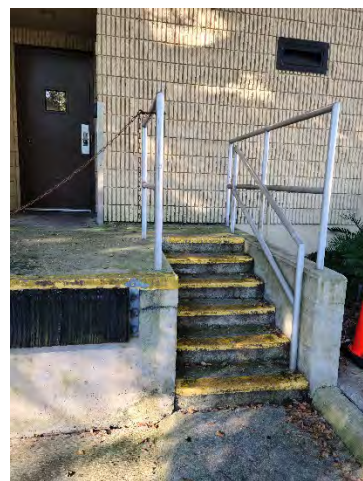
Figure 6 University Mainline

- Loading dock and attached stairway multiple cracks present with severe wear. (*Figure 6*)
- Exterior façade needs to be cleaned, paint bubbling at edge of canopy, and small cracks running along seam of soffit. (*Figure 7 and 8*)

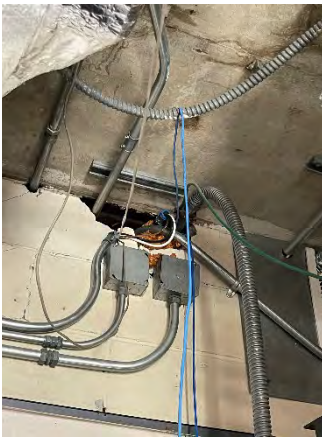
Figure 9 Colonial Ramp On

- Hole in wall at connection the ceiling, ceiling also proposes several small surface cracks. (*Figure 9*)
- Exterior needs to be cleaned.
- Parking stop dislodged. (*Figure 10*)

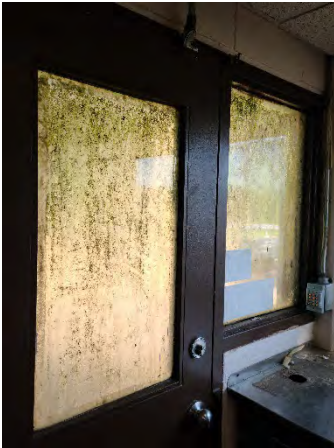
Figure 15 University Ramp Off

- Interior and exterior extremely unclean. (*Figure 15 and 16*)
- Acoustic Ceiling Tile cracked and misplaced in booth. (*Figure 17*)
- Floorboards raised and disheveled in data room. (*Figure 18*)

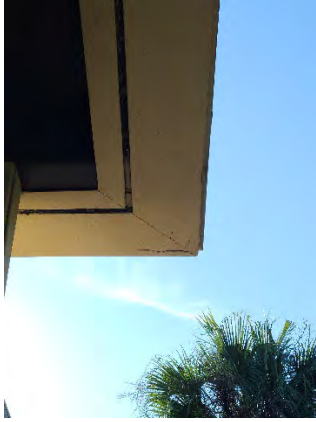
Figure 19 University Ramp On

- Cracks and gaps along canopy edge and soffit. Follow interior. (*Figure 19 and 20*)
- Exterior and interior need to be cleaned, stains on façade and debris underneath canopy. (*Figure 21 and 22*)

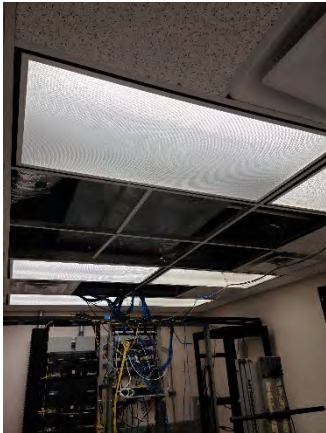
Figure 1 Independence Mainline

- Mainline has missing vent covers and potential leaks above ceiling tiles in multiple locations. Missing or damaged ceiling tiles throughout facility. (*Figure 1, Figure 2, Figure 3, & Figure 4*)
- Lights in corridor need to be cleaned, and light cover in break room needs to be replaced. (*Figure 5 and 6*)

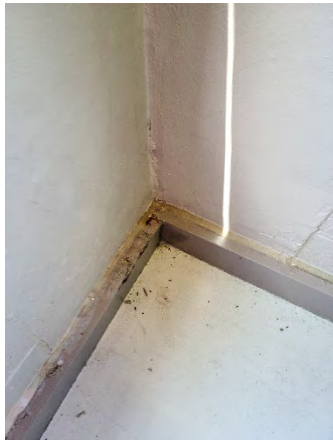
Figure 7 Independence Mainline

- Stairway to overpass shows cracking in corner of landing (*Figure 7 and 8*)
- Walkway of overpass is unsteady, and multiple clips between grates are loose or completely dislodged (*Figure 9*)

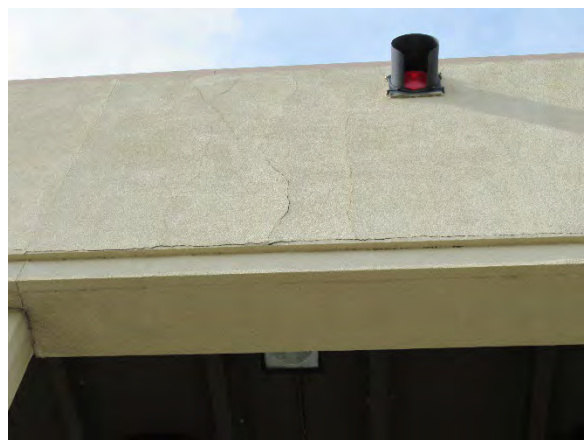
Figure 10 Independence Mainline

- Exterior building has identified cracks on building façade and at plaza canopy locations. Leak on façade (*Figure 10 and 11*)
- Large crack in sidewalks by column at entrance (*Figure 12*)

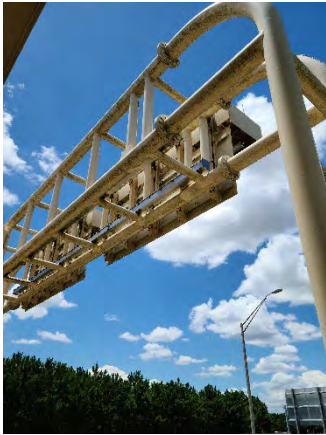
Figure 13 Schofield Ramp On

- Painted guardrail, doors, and pressure wash plaza overhead sign structure. (Figure 13)
- Rust spots on facade (Figure 14)
- Possible leak on interior, paint bubbles and discolored (Figure 15)
- Floor tile and baseboard damaged (Figure 16)

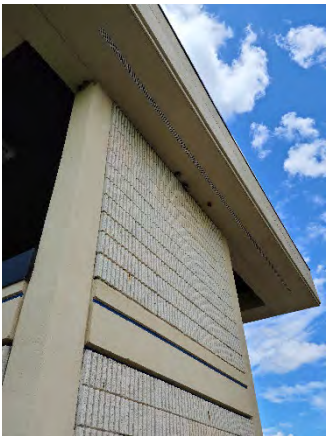
Figure 17 Schofield Ramp Off

- Pressure wash plaza exterior, overhead sign structure, and remove wasp nests (Figure 17 and 18)
- Possible leak on HVAC system in data room, room running hotter than normal (Figure 19 and 20)

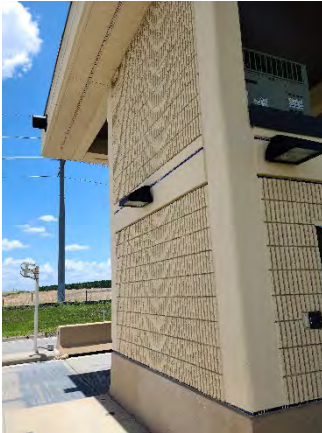
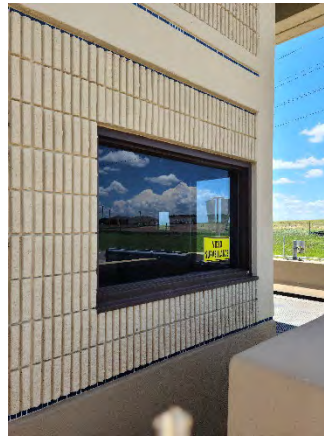
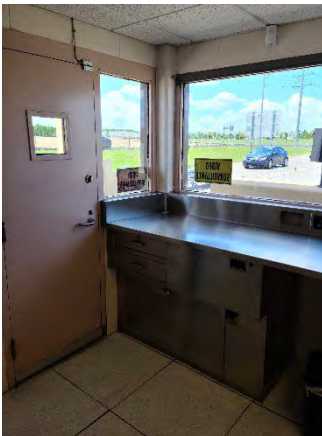
- The above referenced ramp is in good condition overall. Some general maintenance to address the peeling paint on wall and weather seal interior joints at water pipe. (Figure 21, 22, and 23)
- Data room very warm, possibly an issue with HVAC system (Figure 24)

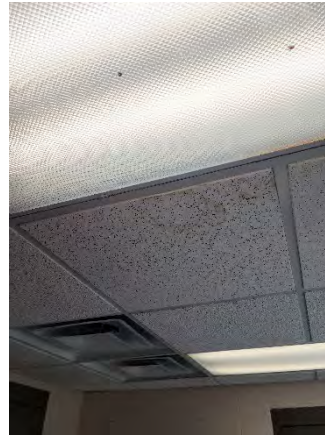
Figure 28 New Independence Ramp Off

- The above referenced ramp is in good condition overall. (Figure 25, 26, and 27)
- Possible leak on ACT interior (Figure 28)

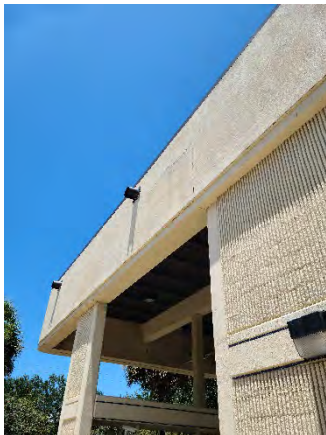
Figure 29 CR-535 Ramp Off

- Cracks in building façade (Figure 29)
- Possible leak under window (Figure 30)
- Cracking along connected walls on both rooms of interior (Figure 31 and 32)

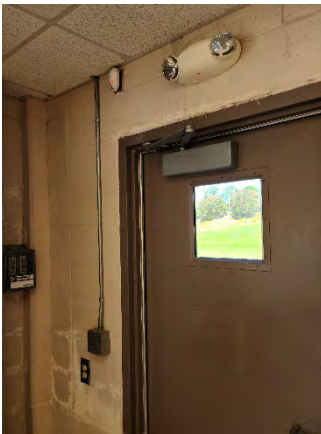
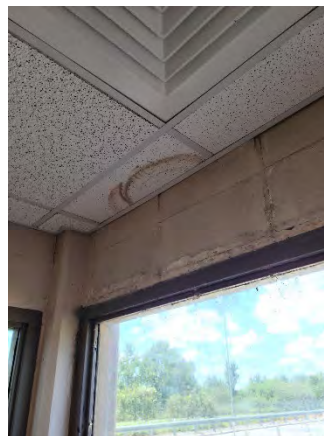
- Need to patch, seal and paint building façade at location of previous signage and base boards. Doors and window frames need to be repainted (Figure 33 and 34)
- Interior paint is peeling and bubbled, possible leak in main booth causing damage (Figure 35 and 36)

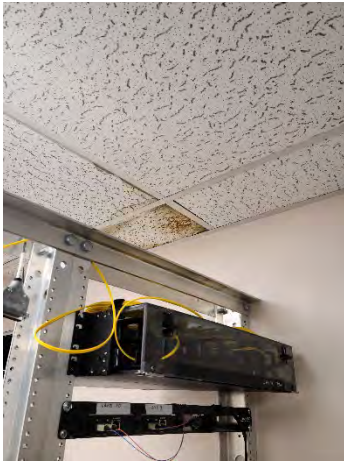
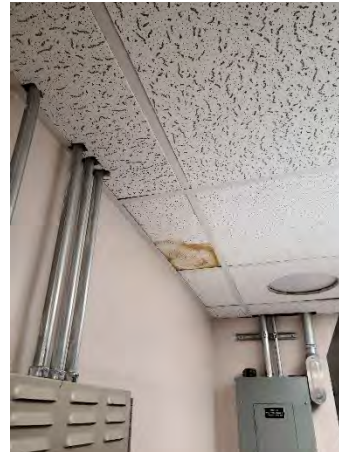
- Leaks in ceilings of data room and recording room (*Figure 1 and 2*)
- Slight cracking and tear in paint along corridor (*Figure 3 and 4*)

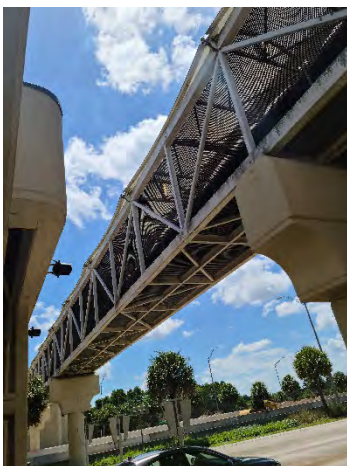
Figure 5 Forest Lake Mainline

- Exterior needs to be cleaned (*Figure 5*)
- Floors grates shift when stepped on, and with lack of railing it feels unsafe (*Figure 6*)

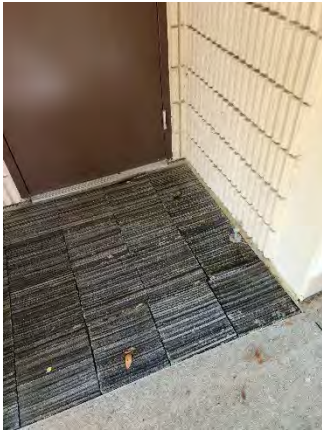
Figure 7 Forest Lake Mainline

- Floor mats on side entrance of building are loose or entirely lifted (*Figure 7*)
- Elevator equipment door is deteriorating on bottom (*Figure 8*)
- Columns are peeling with small cracks throughout plaza (*Figure 9 and 10*)

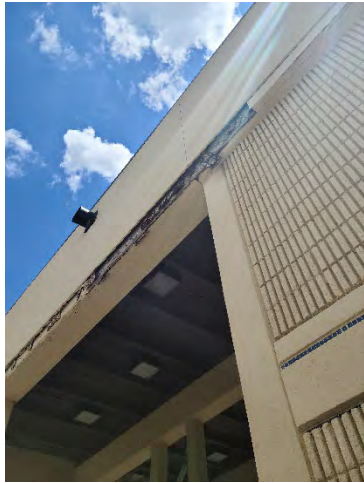
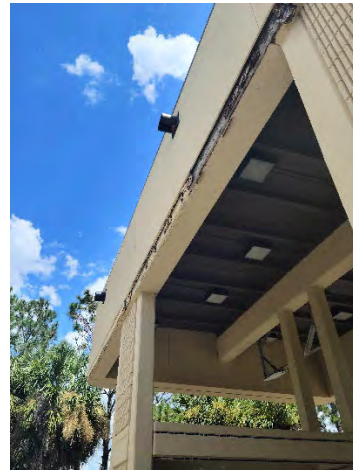
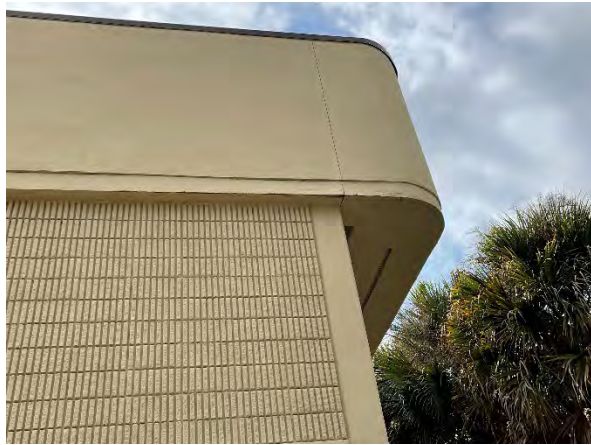
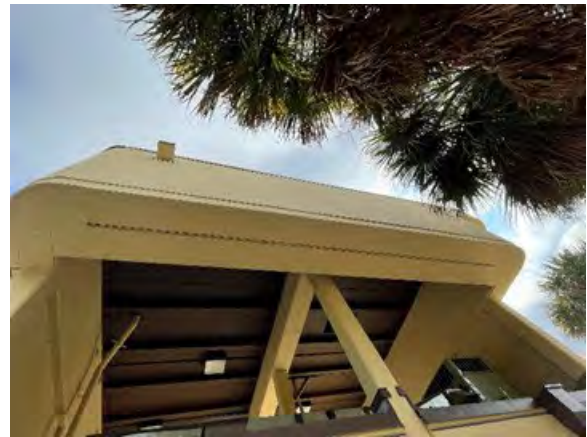
- Cracks along sides and undersides of canopy (*Figure 13, 14, 15, and 16*)
- Damage around door window (*Figure 17*)
- Barrier is damaged (*Figure 18*)

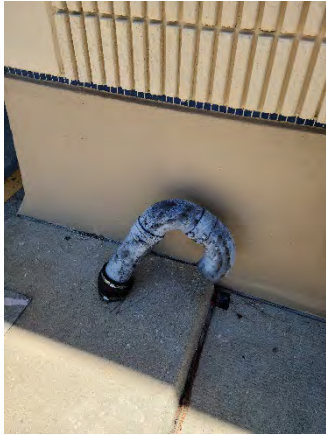
Figure 19 West Road Ramp On

- Pipe dislodged (*Figure 19*)
- Lights for signage to be replaced (*Figure 20*)

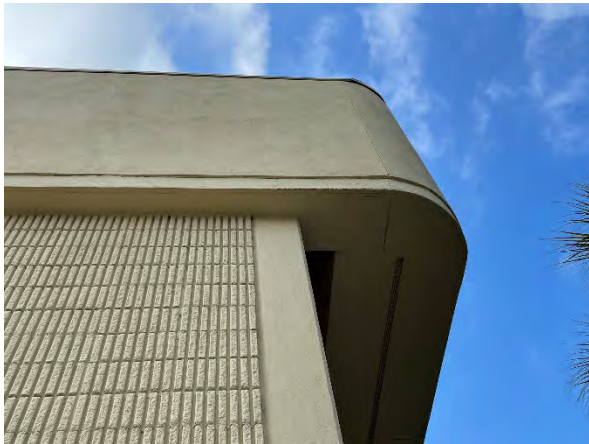
Figure 21 West Road Ramp Off

- Crack on corner of canopy (*Figure 21*)
- Interior of door to data room needs to be cleaned (*Figure 22 and 23*)
- Lights need to be replaced, exterior (*Figure 24*)

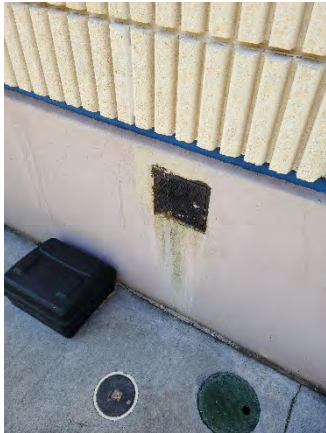
Figure 25 CR-437A Ramp Off

- Leaking (*Figure 25*)
- Signage and building façade need to be cleaned (*Figure 26, 27, and 28*)

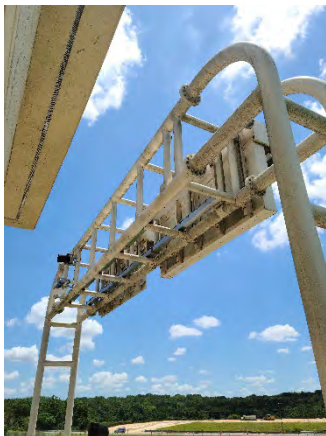
Figure 29 CR-437A Ramp On

- Building façade and canopy need to be cleaned (*Figure 29*)
- Possible leak in data room (*Figure 30*)
- Cracks along base of building and barriers (*Figure 31 and 32*)

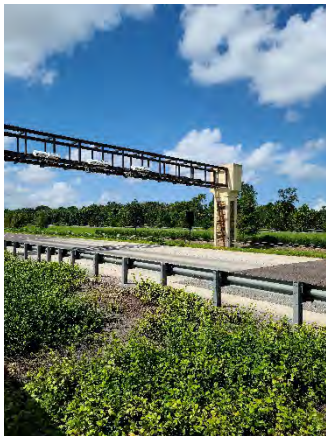
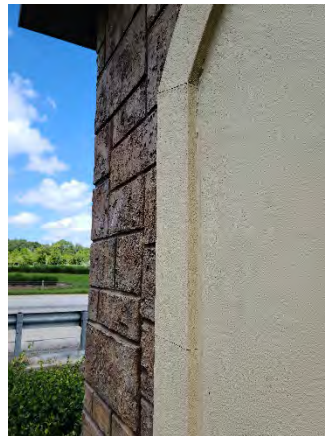
- Fire extinguisher not dated (*Not pictured*)
- Cracks in facade (*Figure 33 and 34*)

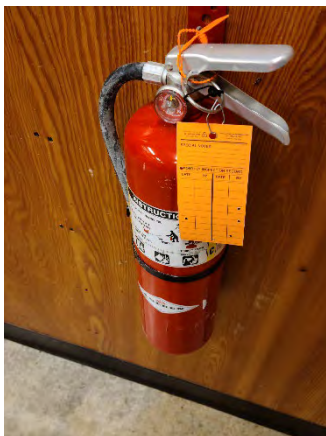
Figure 35 Mt. Plymouth Gantry

- Fire extinguisher not dated (*Figure 35*)
- Small cracks on exterior façade details, signage needs to be cleaned (*Figure 36*)

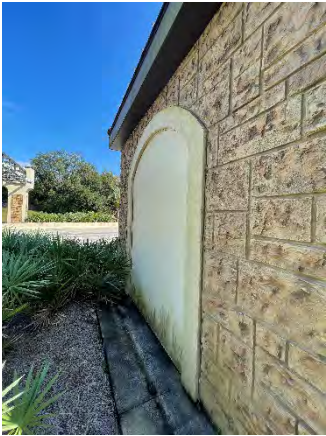
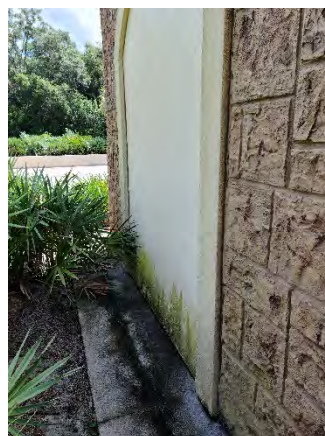
- The above referenced ramp is in good condition overall. (*Figure 1 and 2*)
- Exterior needs to be cleaned, crack in archway detail (*Figure 3 and 4*)
- Sand along perimeter of interior (*Figure 5*)
- Fire extinguisher not dated (*Figure 6*)

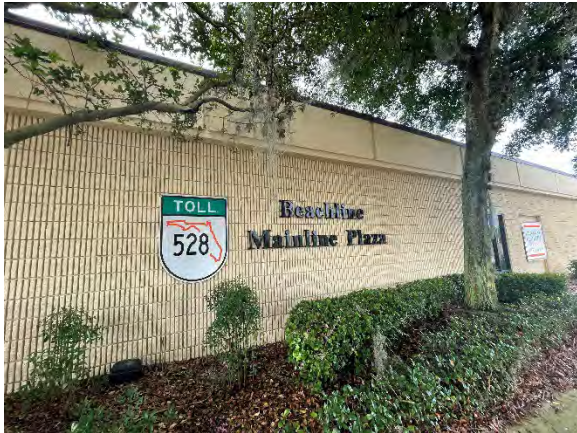
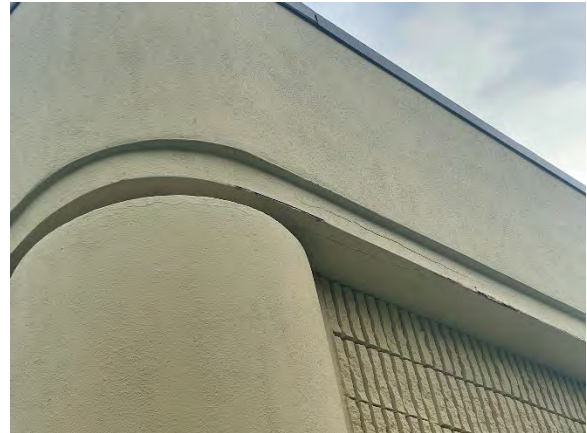
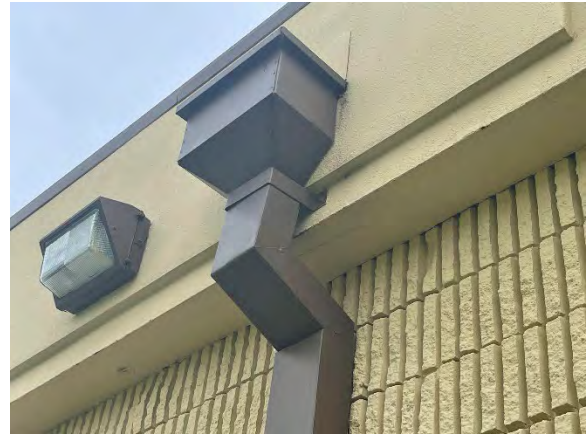
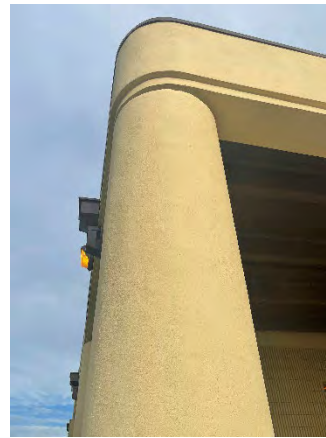
- Minor cracks in soffit and columns (Figure 1, Figure 2, Figure 8 and Figure 10)
- Rust/ possible mold on west wall door entrance (Figure 3, Figure 9, and Figure 13)
- Two of the exterior lighting fixtures stopped to work (Figure 4)
- Water damage and mold on the south wall by the downspouts (Figure 5 and 6)
- Unappropriated place to store the propane tanks (Figure 7)
- Remove wasp nests and pressure wash (Figure 12 and Figure 14)
- Loading dock is missing a guardrail (Figure 11)

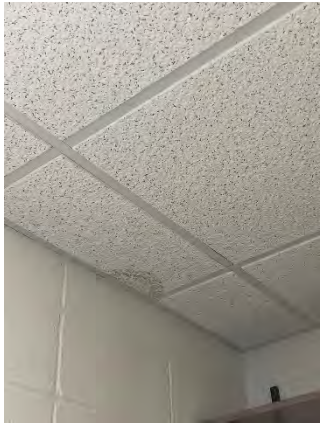
Figure 55 Tradeport Ramp On

- Exterior façade and surrounding landscape need to be cleaned, wasp nests and debris present (Figure 49 to Figure 53)
- Rusted mark along walls. (Figure 54)
- Possible leaking on tile (Figure 55)
- Light is out (Figure 56)
