FY **2023** Annual Inspection Report

Mr. Glenn Pressimone, P.E.
Chief of Infrastructure
Central Florida Expressway Authority
4974 ORL Tower Road
Orlando, Florida 32807

Re: FY 2023 Annual Inspection Report

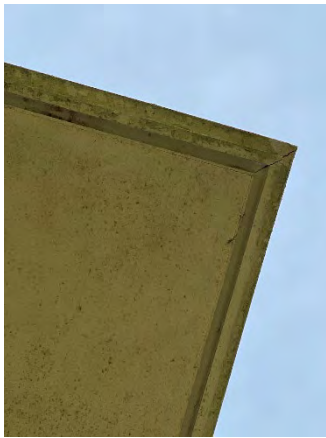
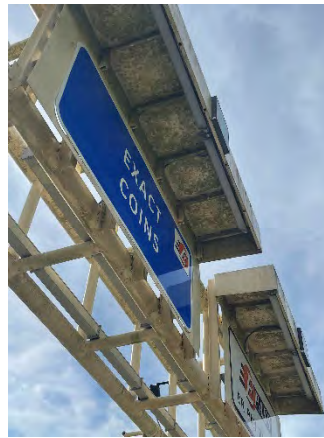
- Exterior needs to be cleaned, façade has large amounts of debris and mildew (Figure 57 and figure 58)
- Rusted mark on North wall (Figure 59)
- Door is moldy (Figure 60)

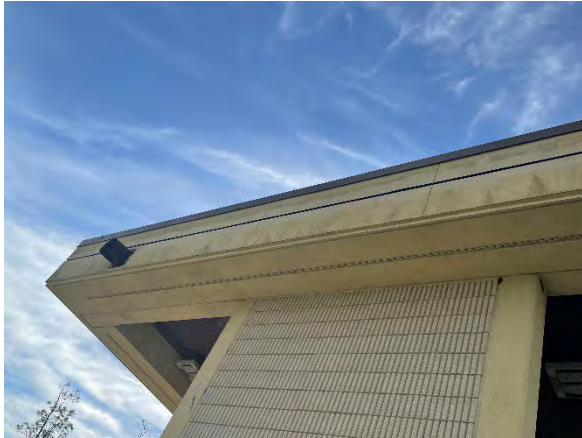
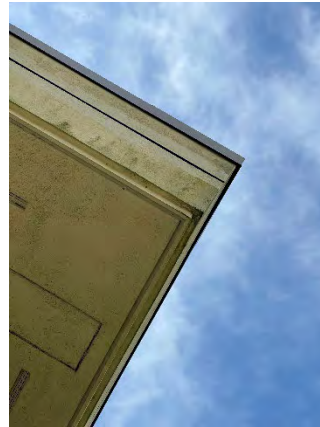
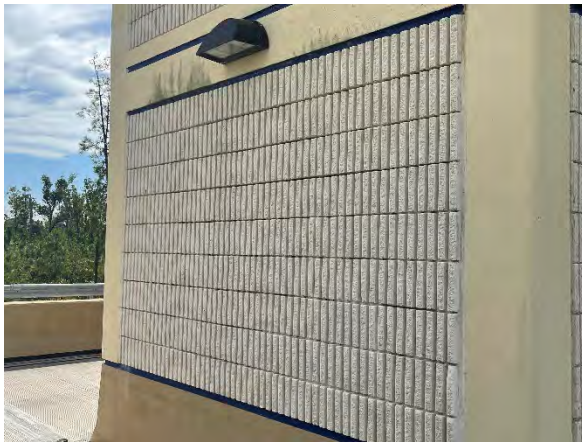
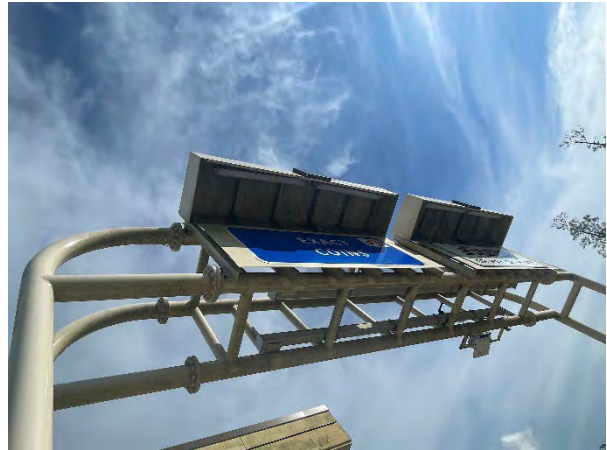
- Exterior needs to be cleaned, façade has large amounts of debris and algae (Figure 61 to figure 64)
- Possible leak residue on the wall (Figure 65)
- Rusted mark on North wall (Figure 66)

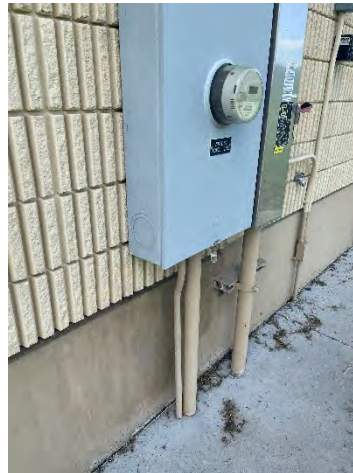
Figure 52 Dallas Ramp Off

- Small cracks along façades (Figure 51 and 52)
- Façade/ Canopy needs to be cleaned (Figure 53 and 54)

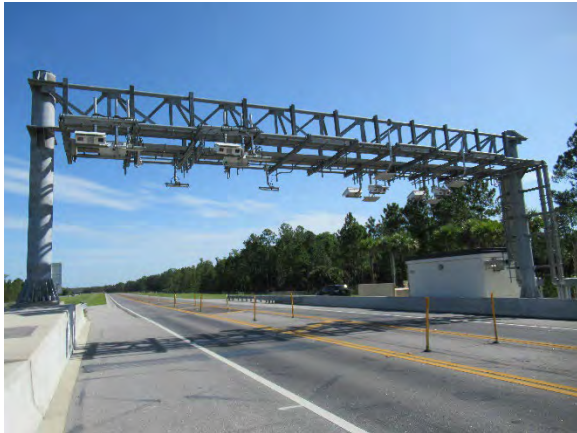
Figure 1 Marigold AET Toll Plaza

- The above referenced plaza is in good condition overall. Some general maintenance to caulk/seal cracks to building exterior is recommended. (*Figure 1, Figure 2, Figure 3, & Figure 4*)

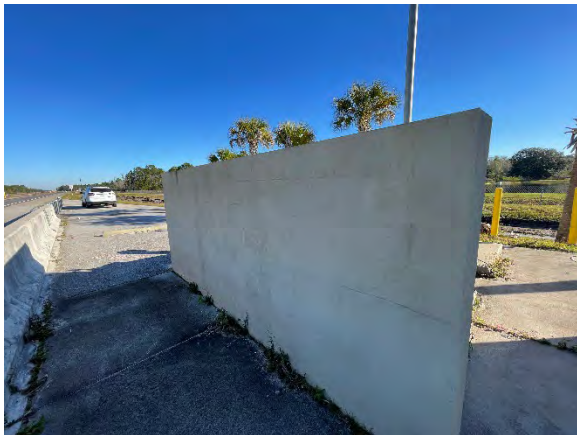
Figure 5 KOA AET Toll Plaza

- The above referenced plaza is in good condition overall. Some general maintenance to caulk/seal control joints. (*Figure 5 & Figure 6*)

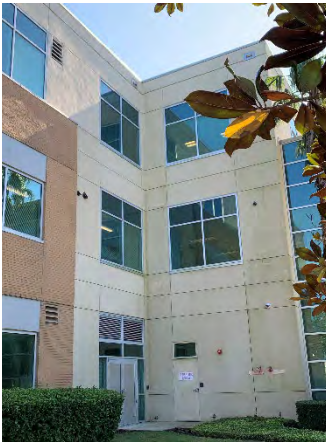
Figure 3 Building Headquarters

- Building exterior is in good condition overall with no identified deficiencies. Pressure wash is recommended for the sidewalk, corner of the building and main entrance. *(Figure 1 - Figure 4)*
- Paint and stucco showing signs of water damage. *(Figure 5 – Figure 7)*
- Cracking on sidewalk by main entrance. *(Figure 8)*
- Small openings that could be contributing to interior leaking. *(Figure 9 and Figure 10)*

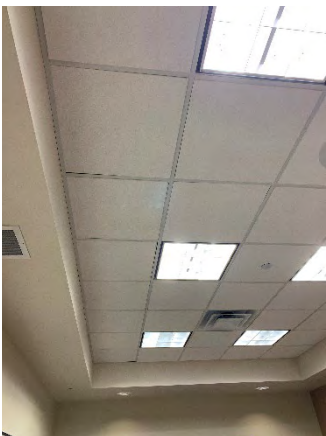
- Room 148 with potential leak above ceiling tile, potential leak at the window trim. *(Figure 11)*
- Room 160 with potential leak at the window trim. *(Figure 12 and Figure 13)*
- Room 142 with potential leak above ceiling tile at windows, potential leak at the window trim. *(Figure 14 - Figure 18)*
- Room 136 with cracked soffit at ACT. *(Figure 19)*
- Room 138 with scuffing and damage to wall. *(Figure 20)*
- Break room with potential leak above ceiling tile by windows and door. *(Figure 21 – Figure 24)*
- Break room with floor damage by patio entrance. *(Figure 25 and Figure 26)*
- Stair 133 and 157 Code violation – empty space under stair is recommended *(Figure 27 and Figure 28)*
- Board room missing threshold at exit and entrance doors. *(Figure 29 and Figure 30)*
- Board room show peeling and damage of wallpaper on north walk and half wall. *(Figure 31 and Figure 32)*

Figure 11 Building Headquarters First Floor
(Room 148)

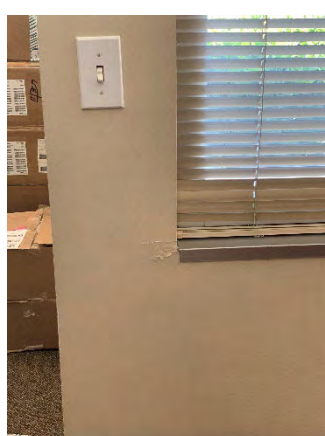
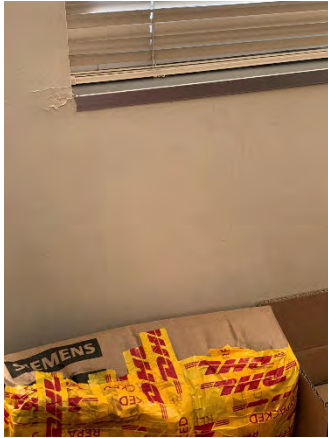
Figure 12 Building Headquarters (Room 160)

Figure 13 Building Headquarters First Floor (Room 160)

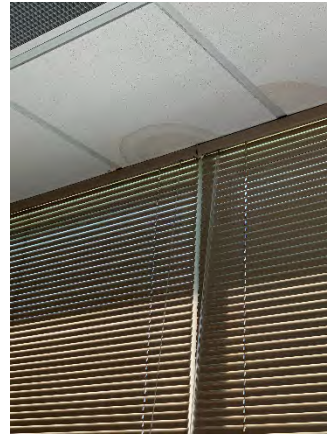
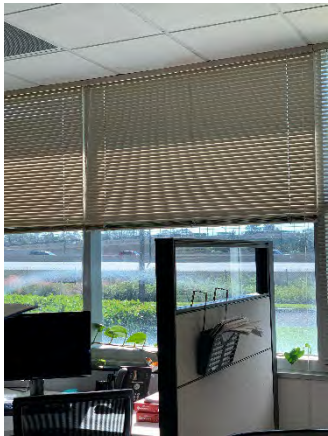
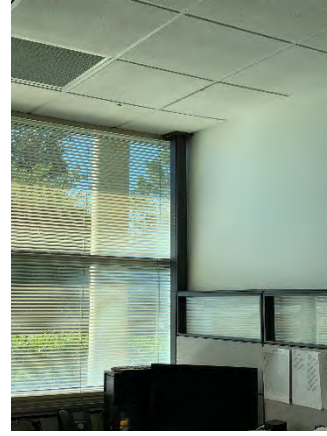
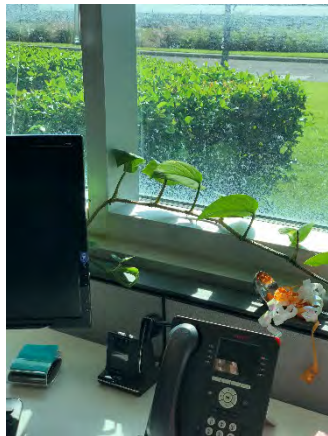
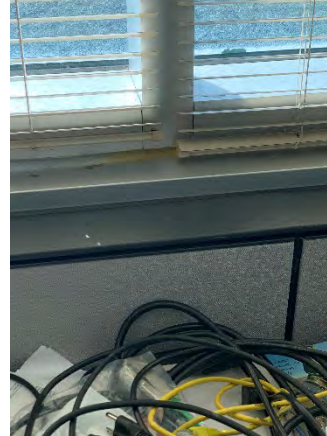
Figure 14 Building Headquarters First Floor (Room 142)

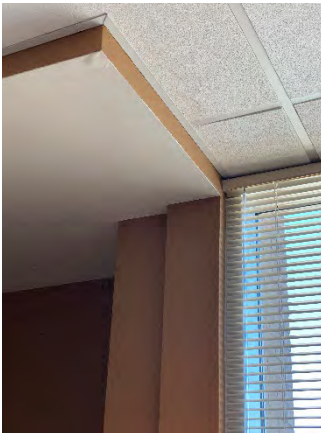
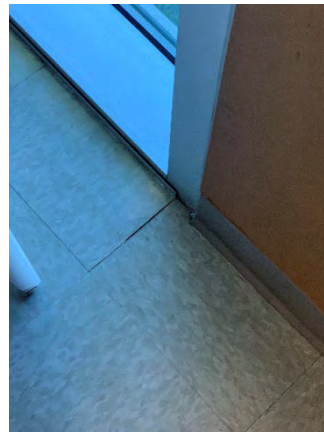
- Room 231 with potential leak above ceiling tile, and floor damage. *(Figure 33 and Figure 34)*
- Room 223 and adjacent corridor with mismatched and stained carpet. *(Figure 35 and Figure 36)*
- Room 252 with damaged flooring. *(Figure 37)*
- Room 233 with potential leak above ceiling tile. *(Figure 38)*
- Room 234 with potential leak above ceiling tile, and floor damage. *(Figure 39 and Figure 40)*
- Room 235 with potential leak above ceiling tile at column connection. *(Figure 41 and Figure 42)*

Figure 33 Building Headquarters Second Floor (Room 231)

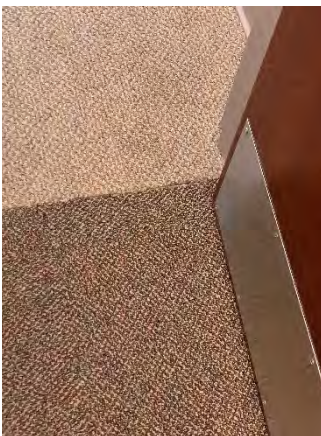
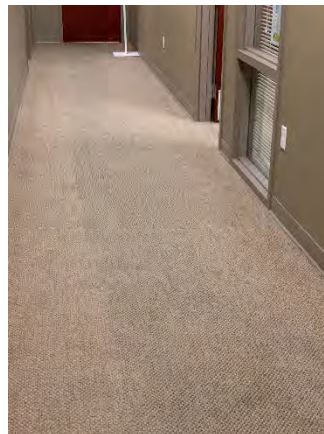
Figure 35 Building Headquarters Second Floor (Room 223)

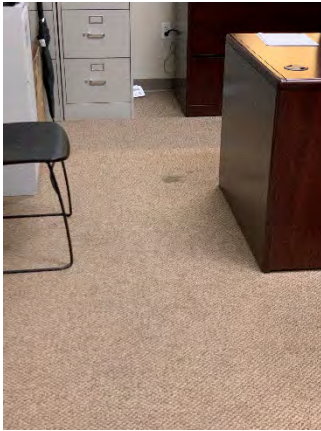
Figure 37 Building Headquarters Second Floor (Room 252)

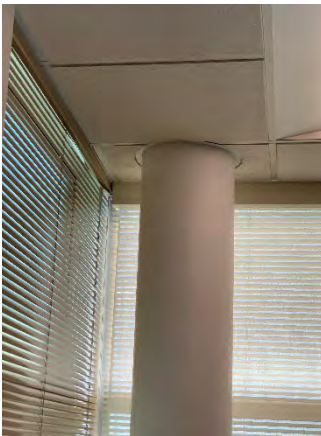
Figure 41 Building Headquarters Second Floor (Room 235)

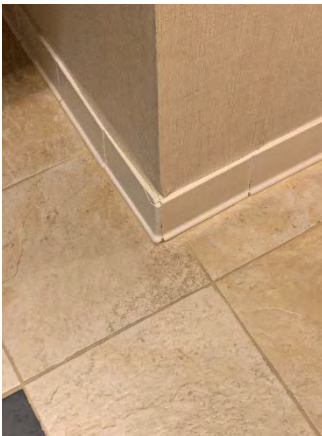
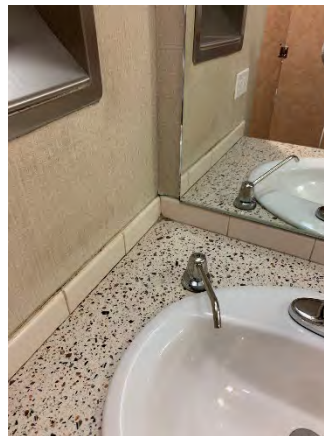
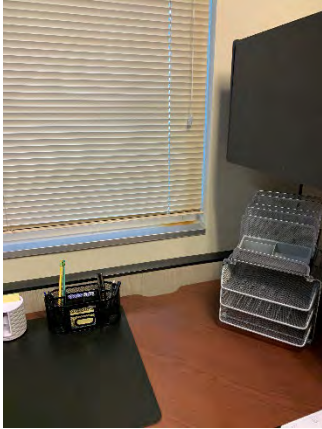
Figure 46 Building Headquarters Third Floor (Women's RR)

- Women's Restroom shows cracked tile at floor and sink, peeling wallpaper on entry wall and lavatory. *(Figure 46 – Figure 48)*
- Room 312 and adjacent corridor show potential leak at window, humidity on storefront glass. *(Figure 49 and Figure 50)*
- Room 356 shows cracked gyp wall at windows, potential leak. *(Figure 51 – Figure 53)*
- Room 323 shows potential leak at window. *(Figure 54 and Figure 55)*
- Open floor of Level 3 with identified areas with potential leak above ceiling at soffit. *(Figure 56 and Figure 57)*
- Room 352C shows potential leak, water stains present on wall. *(Figure 58)*
- Room 347 with potential leak at window. *(Figure 59 and Figure 60)*
