Central Florida Expressway Authority

ANNUAL INSPECTION REPORT

FY 2024

Re: Fiscal Year 2024 Annual Inspection Report

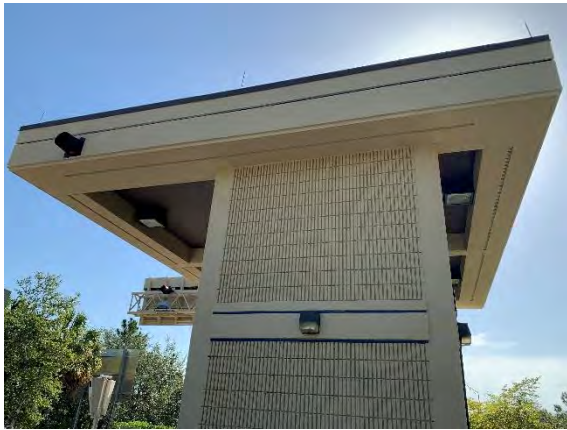
Figure 39 Good Homes Ramp Off

- The observed ramp is in overall good condition. *(Figure 39 and 40)*
- Interior has debris in bathroom, needs to be cleaned. *(Figure 41 and Figure 42)*
- Bag covering ACT or vent in main booth – needs to be addressed. *(Figure 43)*

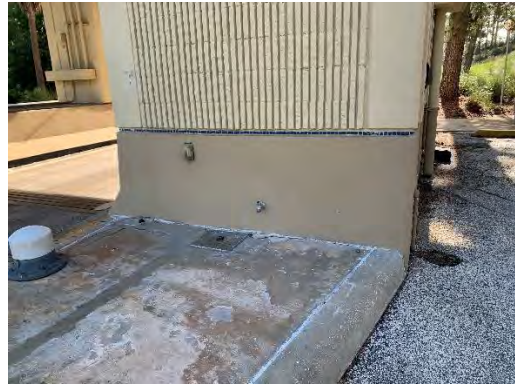
Figure 44 Hiawassee Ramp Off

- Exterior curb in poor condition. *(Figure 44)*
- Edge of soffit and underside of signage showing cracks and signs of water damage. *(Figure 45 and 46)*
- Signs of mold in bathroom, ACT in poor shape and mold along interior walls. *(Figure 47)*
- Paint is shredding and peeling in data room, potential leaking. *(Figure 48)*

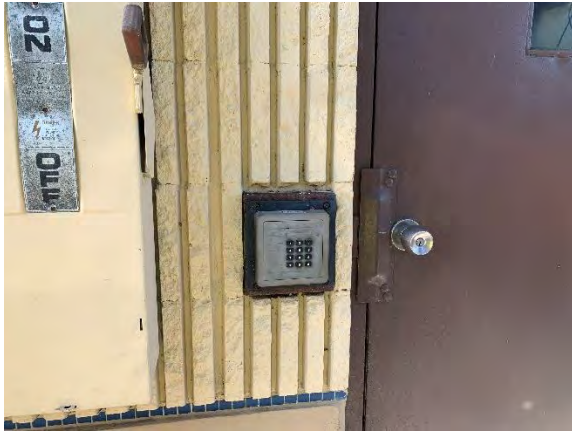
Figure 49 Hiawassee Ramp On

- Keypad security in poor condition. *(Figure 49)*
- Threshold of main booth torn, floor tiles need to be replaced. *(Figure 50)*
- ACT damaged and disheveled. *(Figure 51)*
- Door to data room damaged, signs of water by door close. *(Figure 52)*

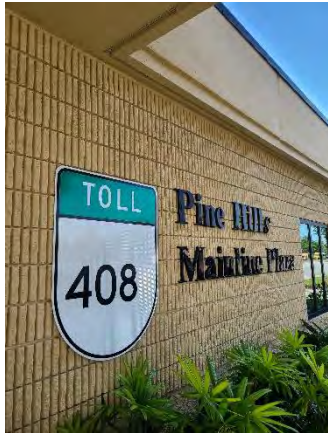
Figure 1 Pine Hills Mainline

- Signage faded on both North and South facilities. Florida symbol missing. *(Figure 1 and 2)*
- Window and louver seal failing. *(Figure 3 and 4)*
- Multiple cracks, and divots along soffit and columns of facility. Paint peeling on stairs. *(Figure 5, 6, 7, 8, 9, 10, and 11)*
- Downspout damaged on North facility. *(Figure 12)*

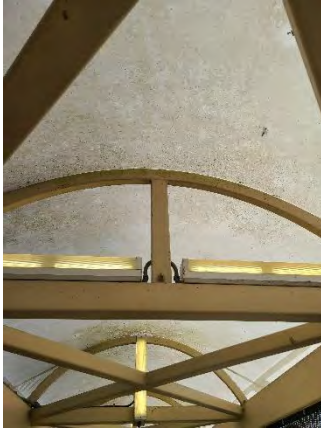
Figure 13 Pine Hills Mainline

- Overpass needs to be cleaned. *(Figure 13 and 14)*
- Rusting along several components of overpass, interior and exterior. *(Figure 15 and 16)*
- Overpass column shows bubbling and possible cracking. *(Figure 17 and 18)*

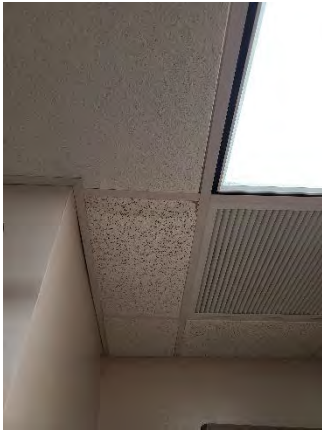
Figure 19 Pine Hills Mainline

- Several leaks throughout corridor ceiling, multiple ACT damaged throughout facility. *(Figure 19, 20, 21, 22, 23, and 24)*
- Walls are stained in North Facility, corner of supervisor room damaged. *(Figure 25 and 26)*
- ADA wall barrier in corridor broken, needs to be replaced. *(Figure 27 and 28)*
- Loading dock door seal in poor condition. *(Figure 29)*
- Wall of kitchenette shows water damage behind faucet. *(Figure 30)*
- Women's restroom faucet leaking, as well water fountain not working. *(Figure 31)*
- Soap dispenser improperly covered. *(Figure 32)*

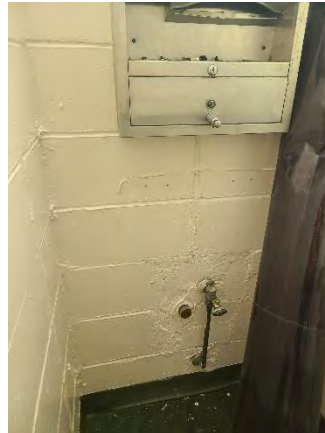
Figure 60 OBT Ramp On

- Soffit damaged, multiple holes throughout. (Figure 55, 56, and 57)
- Water pooling around exterior from poor drainage. (Figure 58)
- Damage to ceiling tile behind booth, as well peeling of ceiling in data room. (Figure 59)
- Paint bubbling and peeling in data room. (Figure 60)

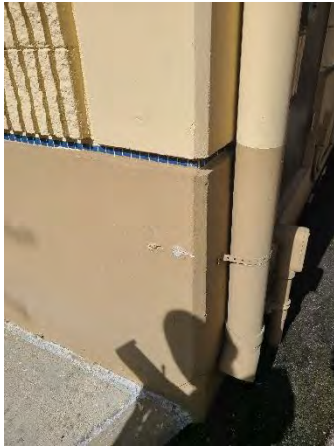
Figure 61 Mills Ramp Off

- Exterior needs to be cleaned. Paint chipped/peeling at corners of building. (Figure 61)
- Soffit damaged, multiple holes throughout. (Figure 62)
- ACT disheveled and stained, in very poor condition throughout booth. (Figure 63, 64, and 65)
- Cracks along wall separating booth and data room. (Figure 66)

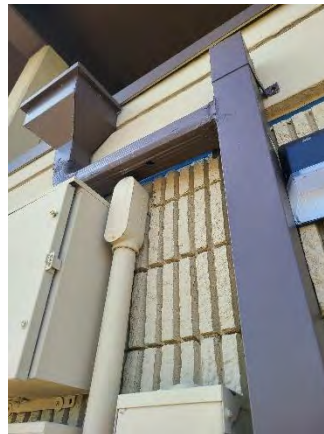
Figure 52 Conway Ramp Off

- The above referenced ramp is in good condition overall. Some general maintenance to remove debris around the landscaping and cover electrical trough is recommended. *(Figure 51)*
- Crack along underside of gutter. *(Figure 51)*
- Ceiling of main booth shows signs of water damage, paint peeling for panel. *(Figure 53 and 54)*
- Substance leaking from hole in ceiling of data room. *(Figure 55)*
- Small crack above doorway of data room. *(Figure 56)*

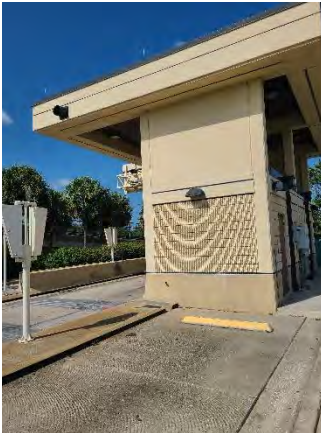
Figure 57 Conway Andes Ave/LkUndehill/436 Ramp Off

- The above referenced ramp is in good condition overall. Needs to be cleaned. *(Figure 57)*
- Small cracks around corners of canopy, signs of water damage around edge. *(Figure 58)*
- Signs of possible leak above ACT in main booth. *(Figure 59)*
- Bathroom needs to be cleaned. *(Figure 60)*
- Possible leak in corner of data room. *(Figure 61)*
- Paint bubbling/peeling along walls of data room. *(Figure 62)*

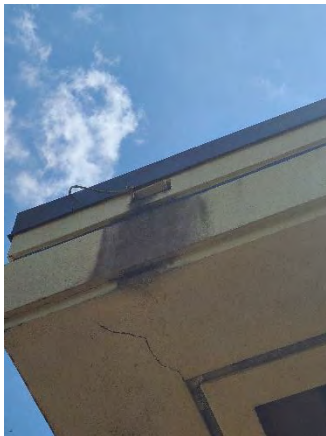
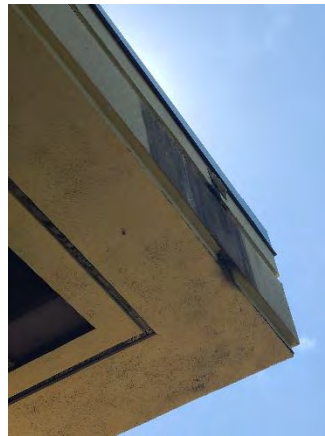
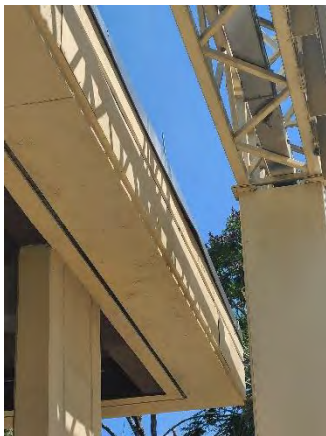
- Some general maintenance to pressure wash plaza overhead sign structure, visible cracks along corners of canopies. Dark staining along edges of canopy. *(Figure 63, 64, and 65)*
- Paint peeling and electric panels still protruding from wall in main booth. *(Figure 66)*
- Hole in wall at backend of main booth. *(Figure 67)*
- Door closer detached on door of data room. *(Figure 68)*

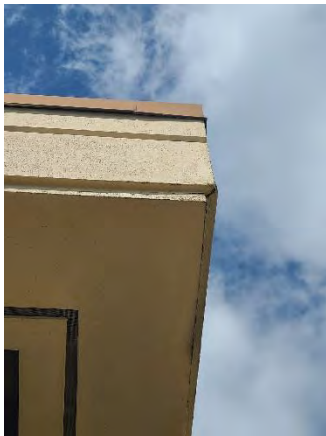
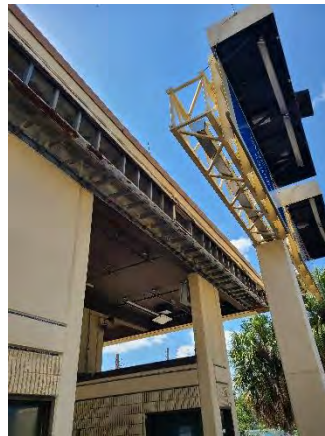
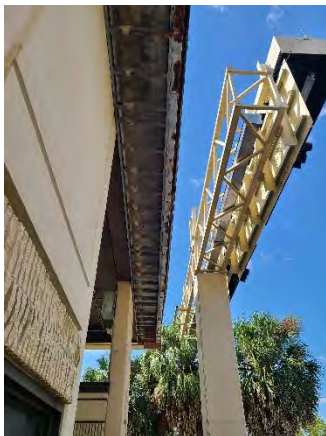
- Canopy façade and undercarriage completely removed/missing – cracks along corners of canopy. *(Figure 69, 70, and 71)*
- Light does not work at back of main booth, ceiling damaged throughout booth. *(Figure 72 and 73)*
- Substance leaking from hole in ceiling of data room. *(Figure 74)*
- Large crack running along wall separating booth and data room, with small cracks above data room doorway. *(Figure 75 and 76)*

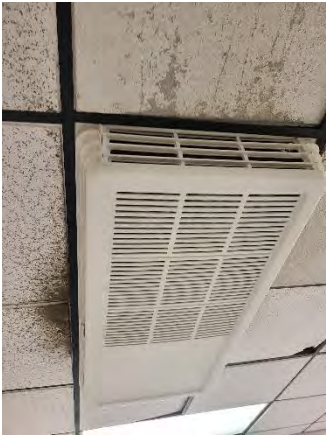
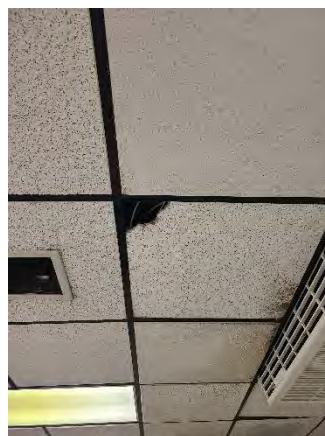
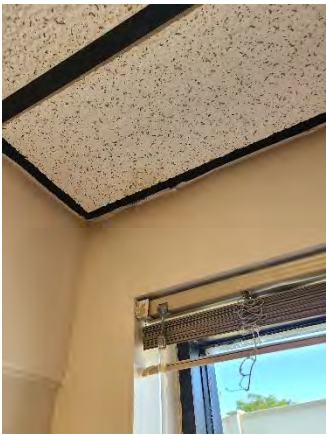
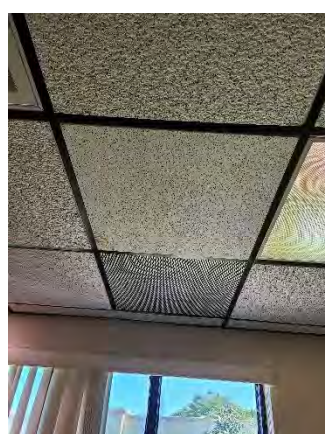
- The above referenced site is in good condition overall
- Water damage near base board in mech room and throughout facility. Multiple signs of paint bubbling and cracking in mechanical room, tech room, recording room, and break room. *(Figure 1, 2, 3, and 4)*
- Windowsill in breakroom has signs of leaking. *(Figure 5 and 6)*
- Windows/storefront system in managers office and tech room show signs of water intrusion. *(Figure 7 and 8)*
- ACT throughout the facility shows signs of leaking and water damage. Multiple ACT missing or damaged. *(Figure 9, 10, 11, and 12)*

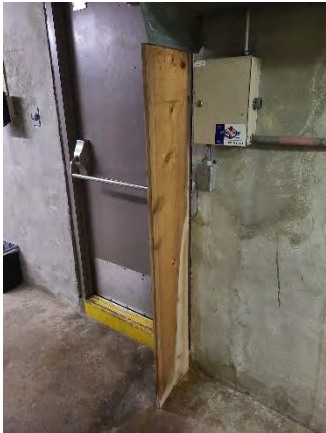
Figure 13 Dean Mainline

- Tunnel system being supported by piece of wood, needs to be properly repaired. *(Figure 13)*
- Water leaking along the walls, from ceiling, and surrounding majority of doors. *(Figure 14, 15, 16, and 17)*
- Expansion joints deteriorating. *(Figure 18)*

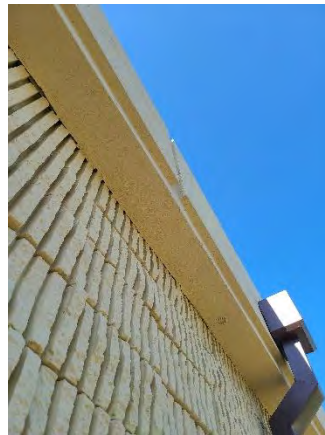
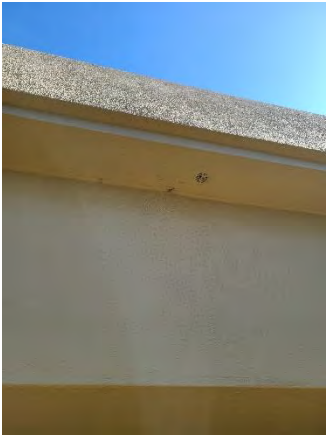
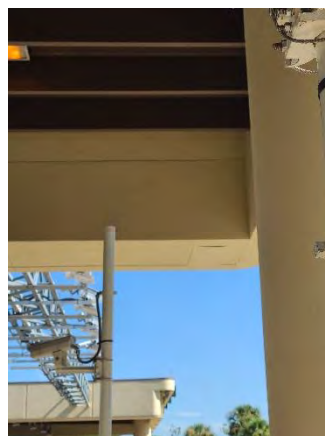
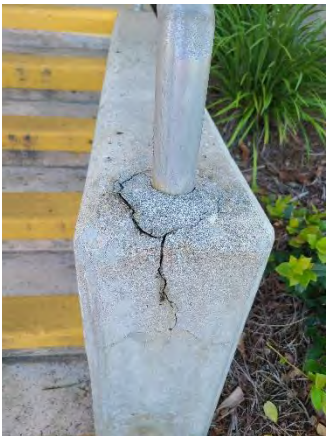
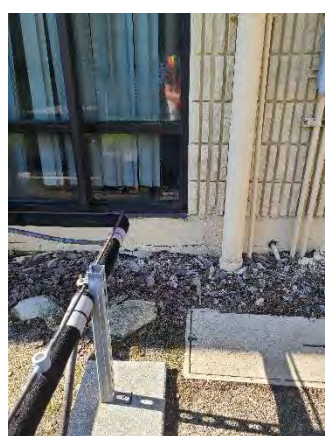
- Multiple cracks around exterior of building, including underside of canopy. *(Figure 19, 20, 21, 22, 23, and 24)*
- HVAC system runoff pooling around back of facility. Piping not properly protected at join. *(Figure 25 and 26)*
- Downspout damaged. *(Figure 27)*
- Sign completely faded, Florida symbol missing. *(Figure 28)*
- Light broken at far door of tunnel. *(Figure 29)*
- Underside of canopy needs to be cleaned. *(Figure 30)*

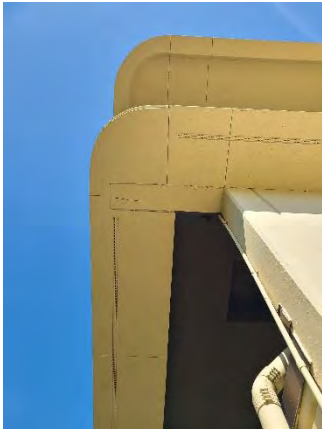
Figure 31 Dean Ramp On

- Cracking along corner of canopy. *(Figure 31)*
- Water pooling from poor drainage. *(Figure 32)*
- Insects and water in main booth, signs of poor building seal. *(Figure 33 and 34)*
- Paint bubbling and peeling in both main booth and data room. *(Figure 35 and 36)*

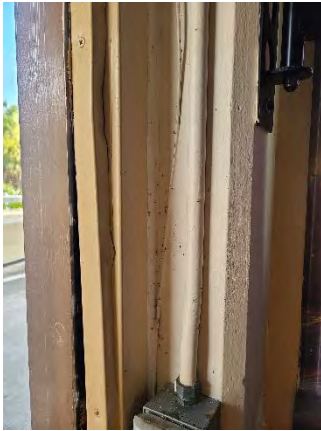
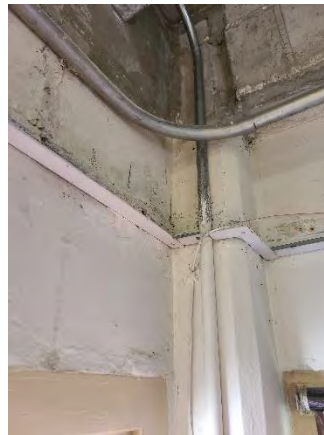
- Insects and mold present in main booth. Building seal in poor condition. *(Figure 37 and 38)*
- Seal around window failing. *(Figure 39 and 40)*
- Signs of leaking in data room. *(Figure 41)*
- Crack running along wall separating booth and data room, as well crack running along wall on both sides of restroom. Paint throughout in poor condition. *(Figure 42)*

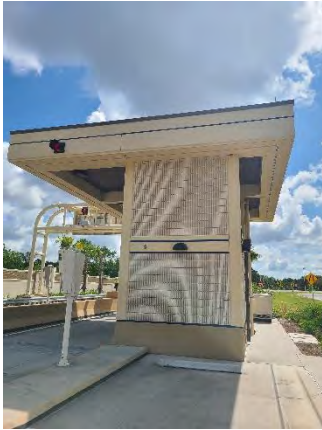
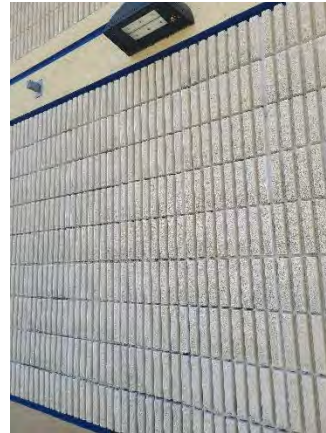
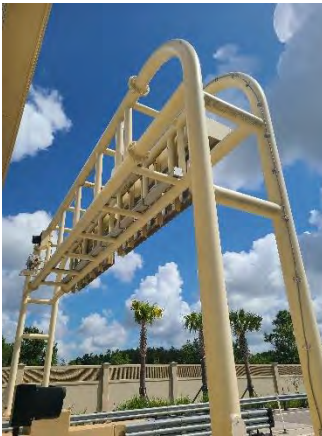
- The above referenced ramp is in good condition overall. *(Figure 43, 44, and 45)*
- Sign of leak at corner of windowsill. *(Figure 46)*
- Light not fully inserted into ceiling grid. *(Figure 47)*
- Threshold missing to data room. *(Figure 48)*

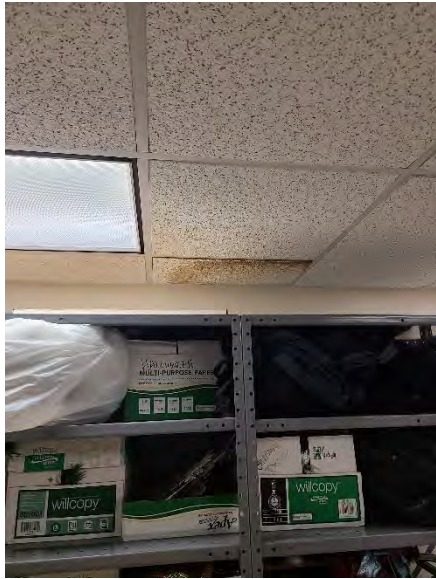
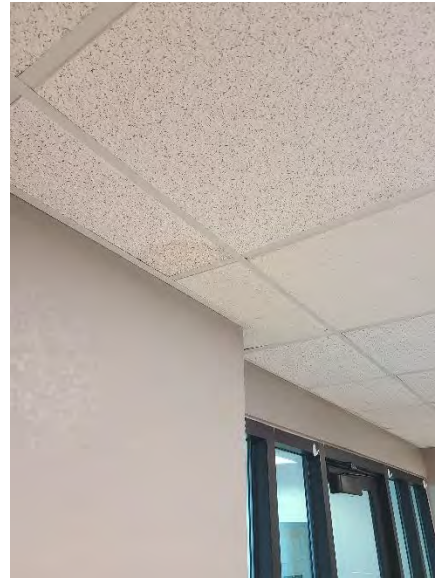
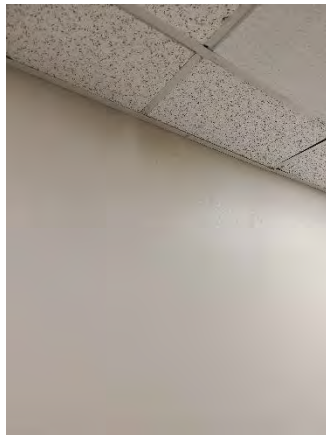
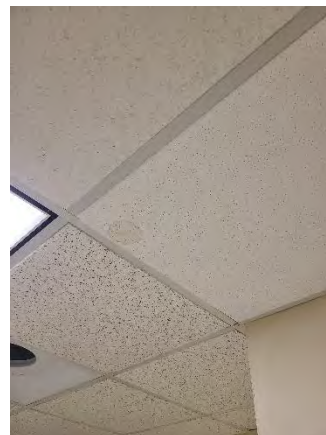
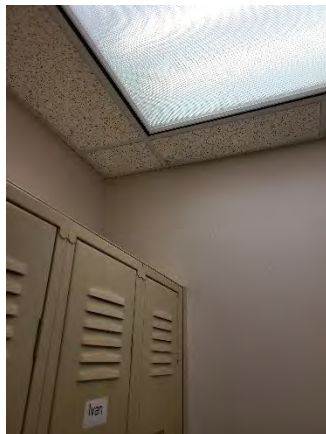
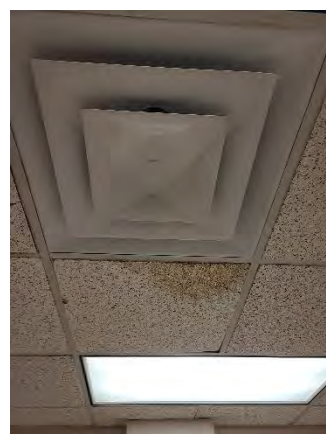
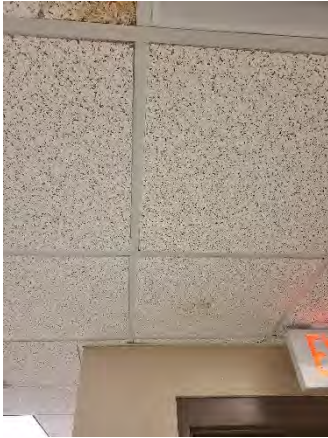
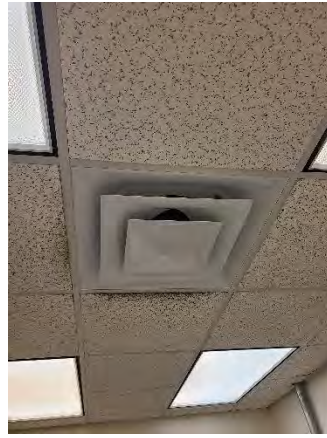
- Multiple ACT throughout North and South facility show signs of leaking. ACT damaged and disheveled. *(Figure 1, 2, 3, 4, 5, 6, 7, and 8)*
- Corner of manager office worn and damaged. *(Figure 9)*
- Multiple doors unable to close without excess effort, including restrooms, janitor's closet, and manager's office. Jamb in poor condition. *(Figure 10)*
- Possible leaks throughout facility. Paint bubbling and peeling below windowsill in break room. *(Figure 11 and 12)*
- Windows cracked in manager office and supervisor office. Supervisor has reported damage. *(Figure 13, 14, 15, and 16)*

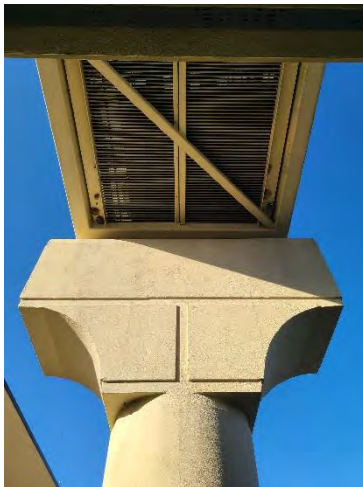
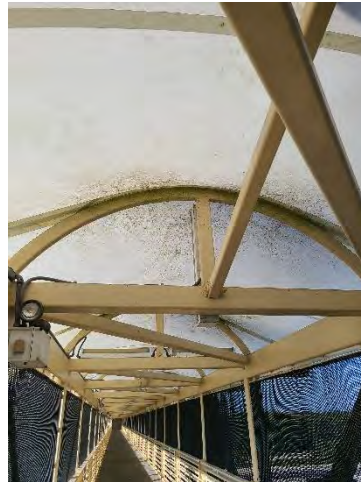
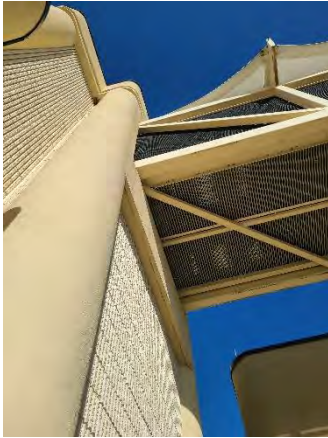
- Overall, overpass bridge is in good condition. Minor cracks on columns supporting overpass. Exterior needs to be cleaned. *(Figure 17, 18, 19, and 20)*

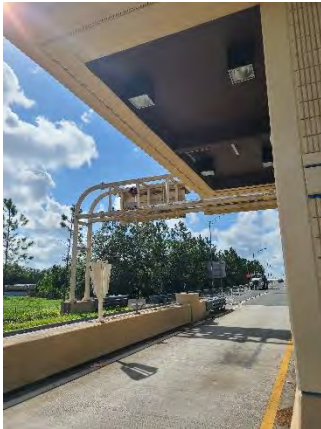
Figure 31 Keene Road Ramp Off

- Back of signage still needs to be cleaned, mold and dirt build up. *(Figure 31)*
- Cracks along underside of canopy, signs of water damage along edge. *(Figure 32 and 33)*
- ACT shows signs of leaking in main booth. *(Figure 34)*

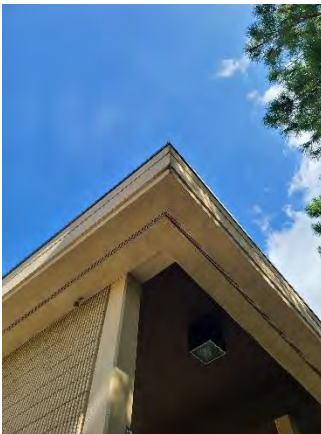
Figure 35 Keene Road Ramp On

- Corner of canopy shows signs of wear, small cracks along underside. *(Figure 35)*
- Hardware needs to be replaced on main booth door. *(Figure 36)*
- Back of signage still needs to be cleaned, mold and dirt build up. *(Figure 37)*
- Signs of water damage surrounding pipe in data room. *(Figure 38)*

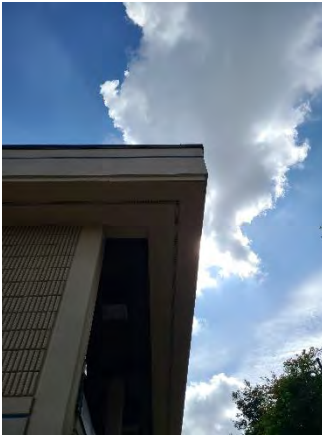
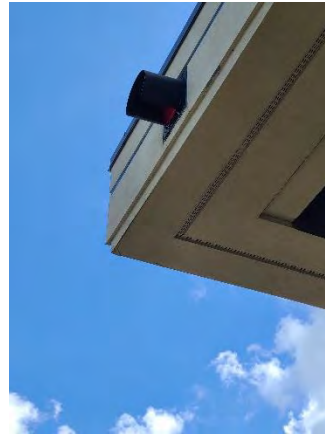
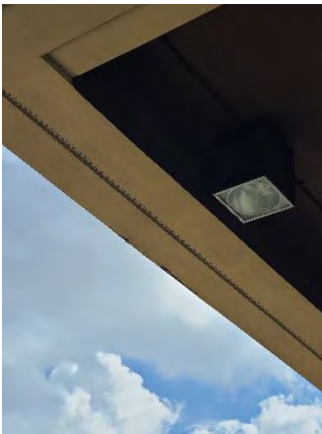
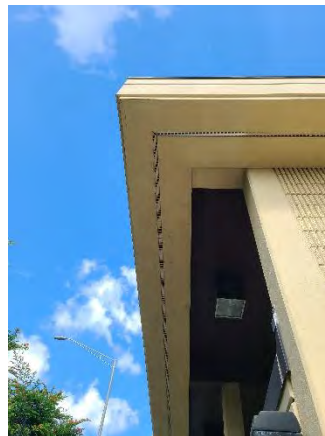
- Small cracks at corners of canopies, signs of water damage along edge. *(Figure 39, 40, 41, and 42)*
- Interior in overall good condition, needs to be cleaned.

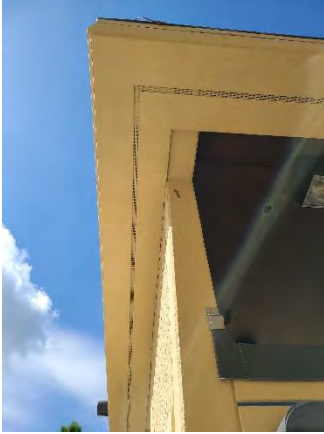
Figure 43 Hiawassee Ramp On

- Overspray of paint under canopy, blocking in soffit. *(Figure 43)*
- Water stain on exterior. *(Figure 44)*
- Interior in overall good condition, needs to be cleaned.

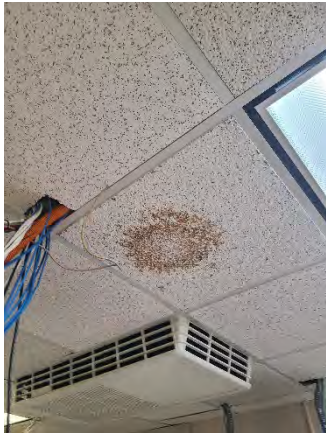
Figure 1 John Young Pkwy Mainline

- Acoustic Ceiling Tile slightly disheveled. Stains could indicate leaking. *(Figure 1)*
- Floor panels lifted and stained. *(Figure 2)*
- Left knob on women's bathroom is too tight. *(Figure 3)*
- Burn above thermostat. *(Figure 4)*
- Docking door missing sealant. *(Figure 5)*
- Panel above stair's exit presents cracking. *(Figure 6)*
- Vent cover missing *(Figure 7)*

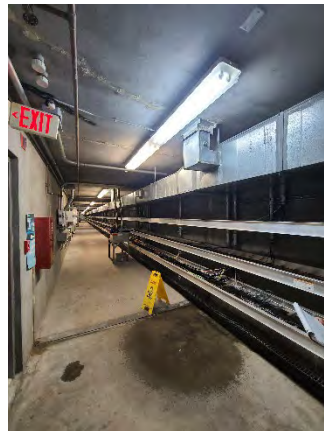
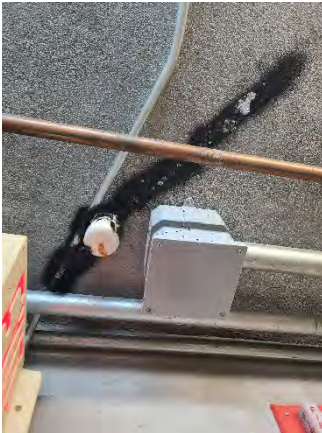
- Various leaks throughout facility along walls and ceiling. Active leak in front of Island C. *(Figure 8 and 9)*
- Expansion joint decaying *(Figure 10)*

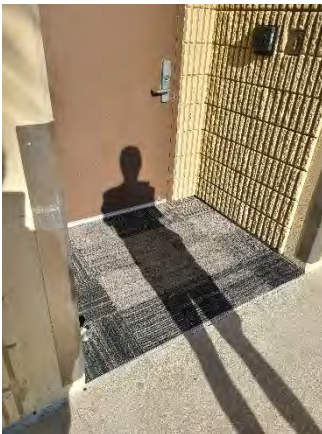
Figure 11 John Young Pkwy Mainline

- Slight dent on dock entrance floor. *(Figure 11)*
- Panel above entrance to tunnel shows rotting. *(Figure 12)*
- Sealant peeling off windows. *(Figure 13)*
- Stains on façade. *(Figure 14)*
- Dirt present under canopy. *(Figure 15)*

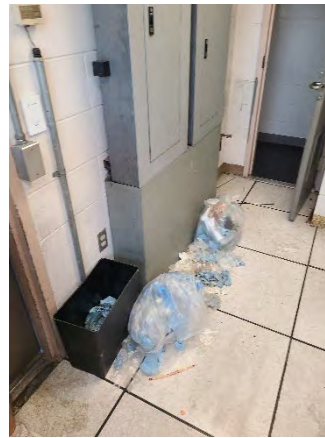
Figure 22 John Young Pkwy Ramp-On

- Both rooms very unclean. (Figure 22 and 23)
- Acoustic Ceiling Tile displaced. (Figure 24)
- Acoustic Ceiling Tile leaking. (Figure 25)
- Wasp nest found on building façade. (Figure 26)
- Dirt present under canopy. (Figure 27)
- Poor repair, seal deteriorating between fuse boxes. (Figure 28)

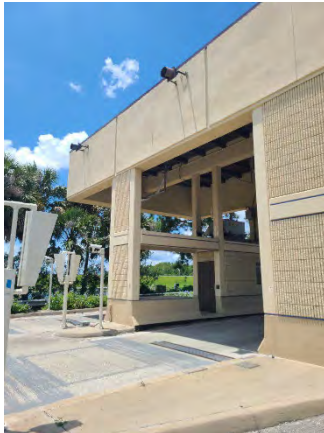
Figure 29 US-441 Ramp-Off

- Cracks along canopy, both in façade and underneath (Figure 29 and 30)
- Acoustic Ceiling Tile leaking. (Figure 31 and Figure 32)
- Acoustic Ceiling Tile displaced. (Figure 33)
- Unclean floor with tiles slightly tilting and moving when walked on. (Figure 34)

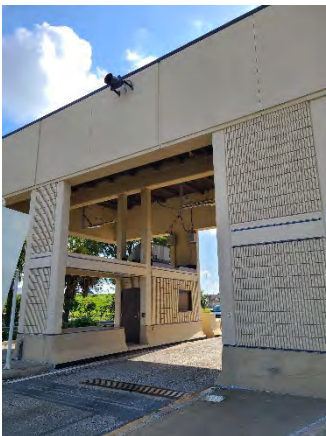
Figure 35 US-441 Ramp-On

- Cracks along canopy façade and foundation. (Figure 35 and 36)
- Acoustic Ceiling Tile leaking. Ceiling and floor tiles stained, disheveled, damaged. (Figure 37, 38, and 39)
- Exterior needs to be cleaned, signs of wasp nests around perimeter. (Figure 40)
- Fire extinguisher out of date. (Figure 41)

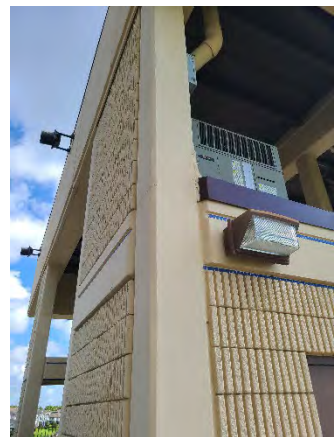
Figure 42 Landstar Ramp-On

- Cracks along canopy façade, and around corners of canopy and columns. (Figure 42, 43, and 44)
- Rusting around window frame exterior (Figure 45)
- ACT showing signs of possible leak. Ceiling and floor tiles damaged and displaced. (Figure 46, 47, and 48)

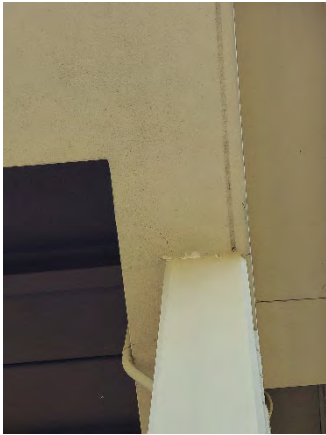
Figure 49 Landstar Ramp-Off

- Cracking along columns and shown at join of column to canopy. (Figure 49 and 50)
- Possible leak in data room from piping. Other signs of leaking are shown in ACT and door closer. (Figure 51, 52, 53 and 54)

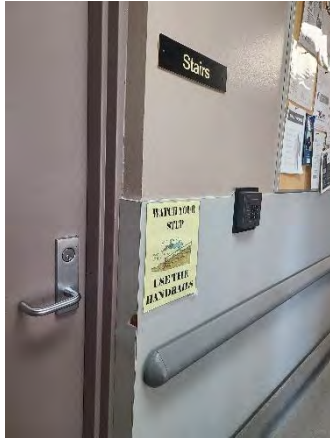
Figure 1 Boggy Creek Mainline

- Corner damaged in main corridor, creates sharp edge. *(Figure 1)*
- Door to women's restroom difficult to open, hardware shows damage. *(Figure 2)*
- Multiple ACT Tiles disheveled, damaged, or missing in Data room. ACT shows potential leaks, and vent is missing cover. *(Figure 3, 4, 5, and 6)*
- Potential leaks above act in men/women's restrooms and locker room. *(Figure 7 and 8)*

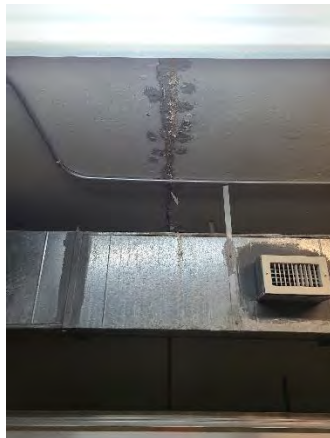
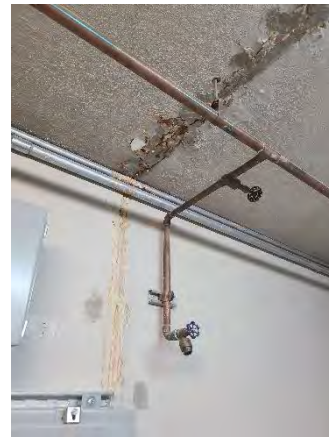
- The above referenced mainline tunnel is in good condition overall.
- Seal appears to be failing on expansion joint. *(Figure 9 and 10)*

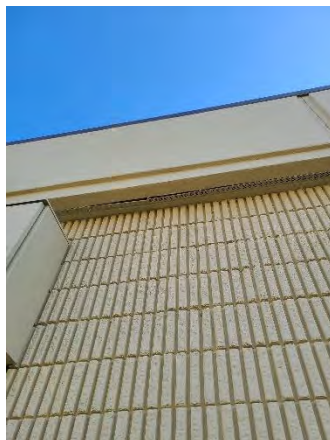
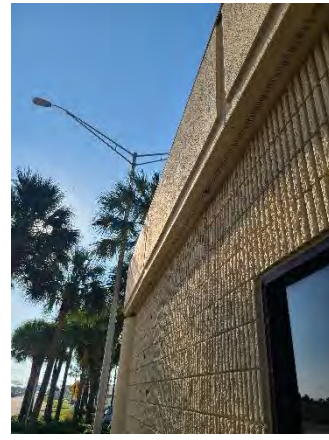
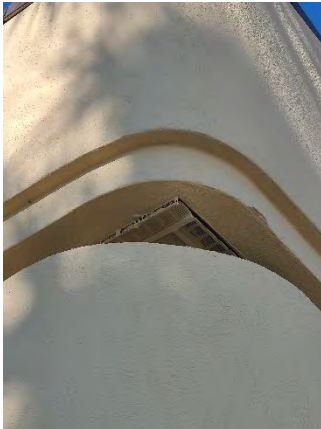
- Cracks and damage along soffit of main building, soffit removed from exterior at corners and South façade *(Figure 11, 12, and 13)*
- Poor drainage from HVAC unit as well as refrigerant structure in back of building. *(Figure 14 and 15)*
- Exterior canopy has visible cracks along corners, as well needs to be cleaned. Supervisor has previously reported damage. *(Figure 16)*

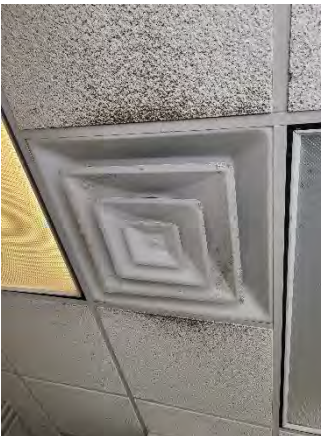
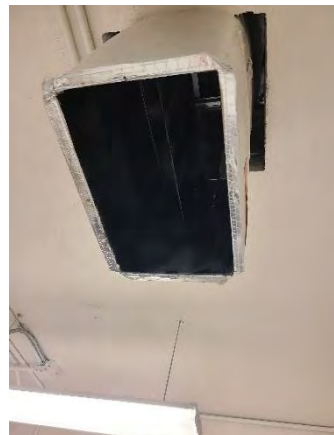
- Ramp shows evidence of mold cultivating inside booth, general maintenance to pressure wash plaza exterior and cover the vent is recommended. *(Figure 17 and 18)*
- Sun visor damaged, causing room to be above recommended temperature for equipment. *(Figure 19)*
- Floor panels damaged and disheveled in data room. *(Figure 20)*

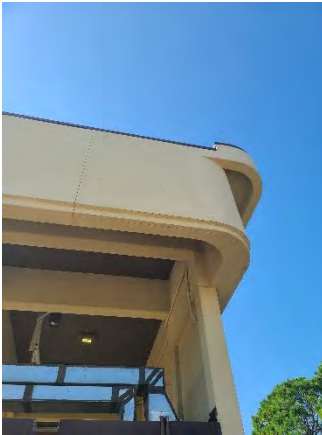
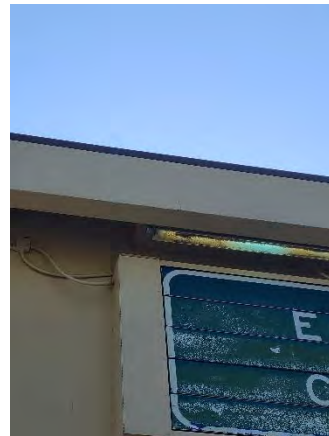
- Exterior canopy and building facade have identified cracks surrounding entire structure. *(Figure 21 and 22)*
- Multiple signs of leaking above ACT. Discolored, disheveled, and missing ACT throughout booth and data room. *(Figure 23, 24, and 25)*

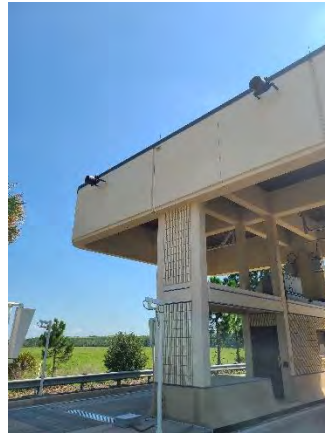
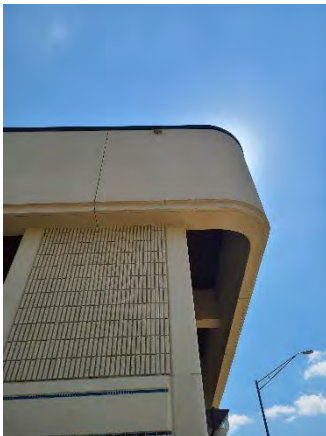
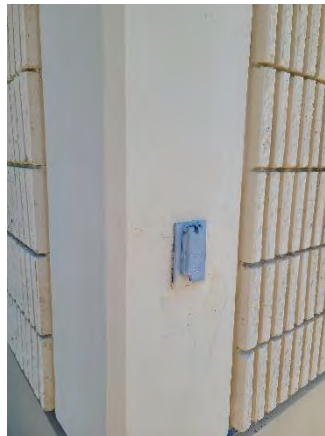
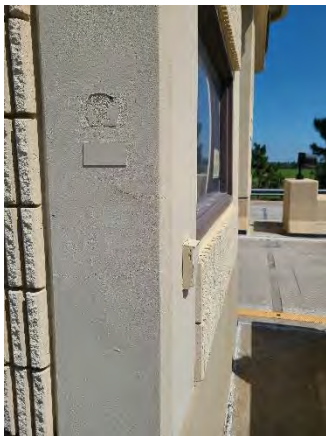
- Exterior canopy has visible cracks in front of the façade and corners – as does the building envelope. *(Figure 26, 27, 28, and 29)*
- Doors need to be repainted. *(Figure 30)*
- ACT shows potential leaks and damage. Floor and ceiling tiles are discolored and disheveled throughout booth and data room. *(Figure 31, 32, and 33)*

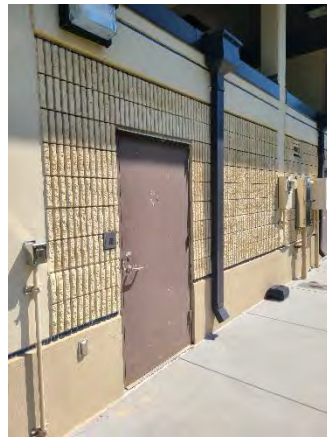
Figure 34 Lake Nona Ramp Off

- Doors need to be repainted. *(Figure 34)*
- Floor tiles stained and disheveled. *(Figure 35)*
- Interior walls have paint shredding, potential leaks. *(Figure 36 and 37)*

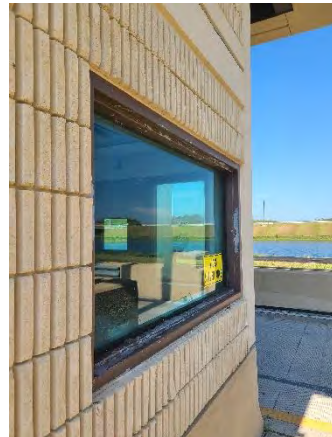
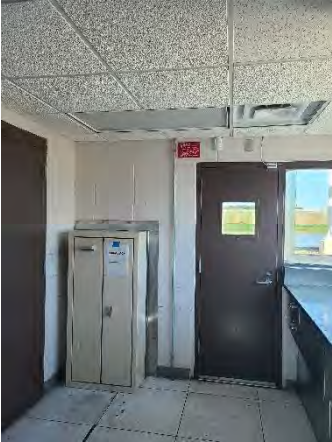
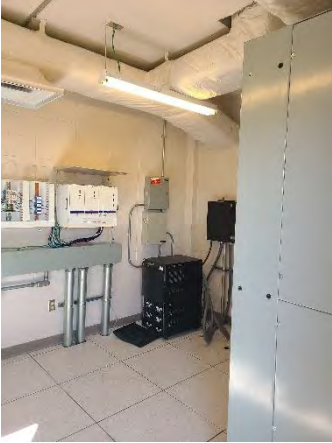
- The above referenced ramp is in good condition overall. Some general maintenance to pressure wash plaza overhead sign structure. (Figure 77, 78, 79, and 80)

Figure 77 Innovation Way Ramp On

Figure 78 Innovation Way Ramp On

Figure 79 Innovation Way Ramp Off

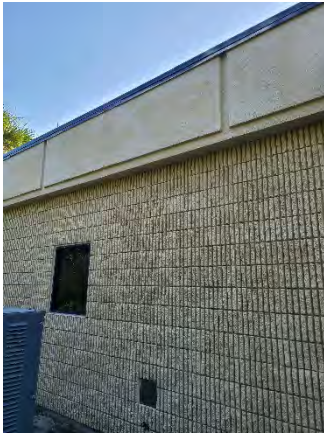
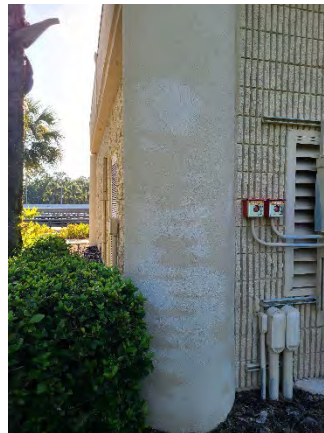
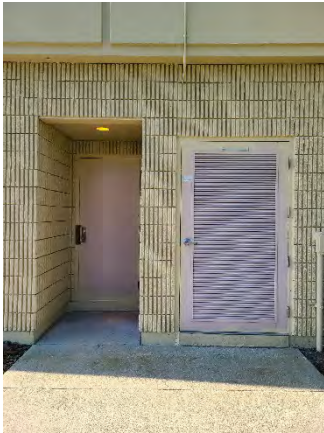
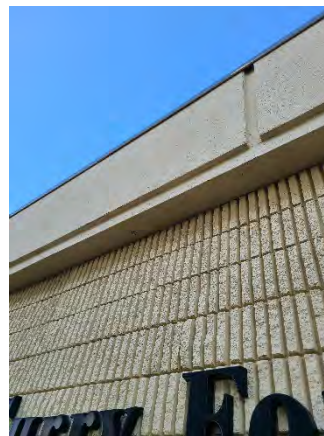
- Cracks along base of several columns supporting canopies and under soffit, with signs of water damage. Overall, poor paint job around building, with areas such as columns and doors in need for further painting. *(Figure 1, 2, 3, and 4)*
- Large crack about tunnel door, Island B *(Figure 5)*
- Cracking and peeling at underside perimeter of canopy. *(Figure 6)*
- Cracking along columns of canopy above toll lanes. *(Figure 7 and 8)*

Figure 1 Curry Ford Mainline

Figure 2 Curry Ford Mainline

Figure 3 Curry Ford Mainline

Figure 4 Curry Ford Mainline

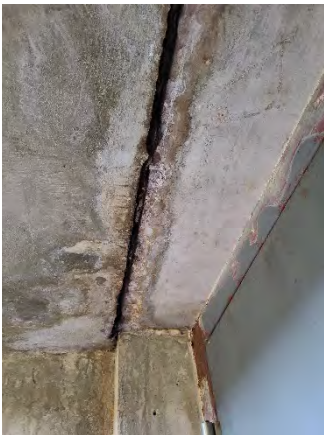
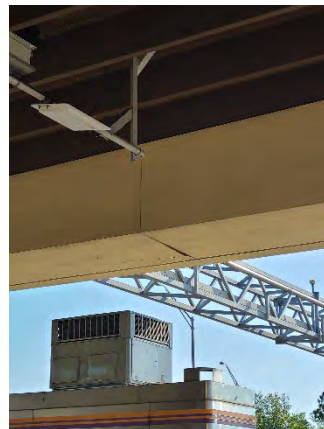
Figure 5 Curry Ford Mainline

Figure 6 Curry Ford Mainline

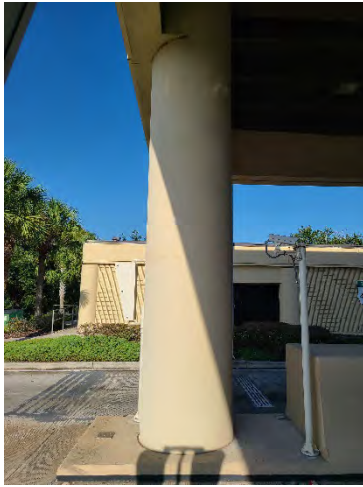
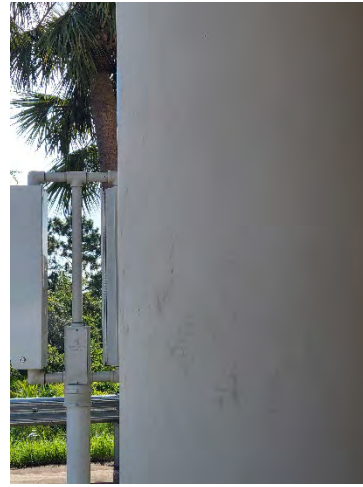
Figure 7 Curry Ford Mainline

Figure 8 Curry Ford Mainline

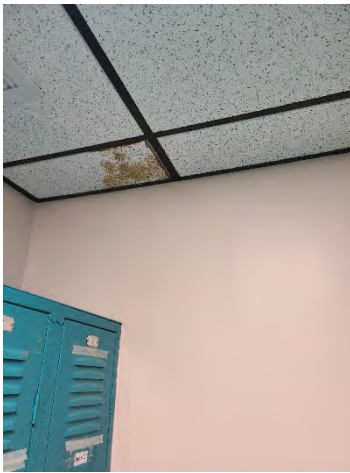
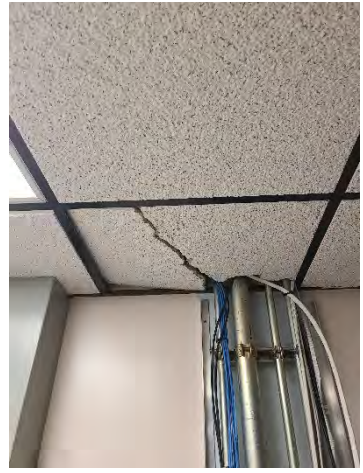
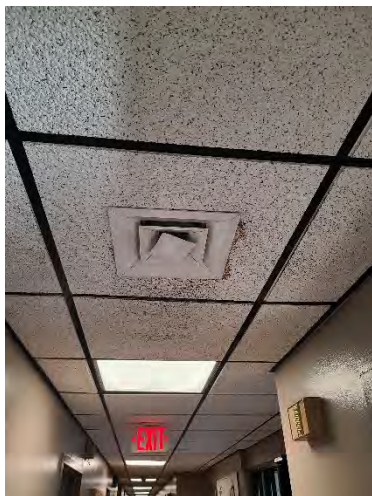
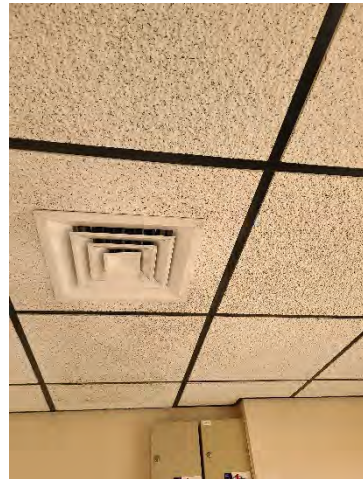
- Ceiling tiles discolored and disheveled throughout plaza, possible leak in locker room. *(Figure 9, 10, 11, and 12)*
- Paint bubbling and cracking in mechanical room. *(Figure 13)*
- Possible leak at base of storefront window in manager's room. *(Figure 14)*
- Windowsill damaged, signs of water intrusion, and paint peeling in lounge. Leak in windowsill shows below cabinet. *(Figure 15 and 16)*

Figure 9 Curry Ford Mainline

Figure 10 Curry Ford Mainline

Figure 11 Curry Ford Mainline

Figure 12 Curry Ford Mainline

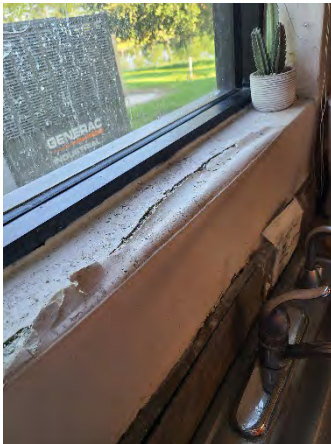
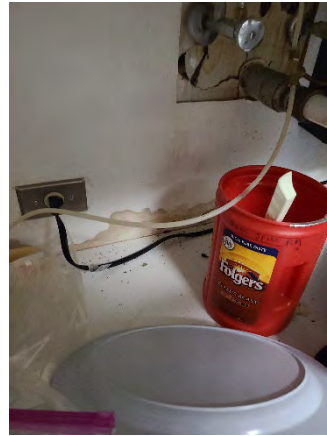
Figure 15 Lee Vista Ramp On

Figure 16 Lee Vista Ramp On

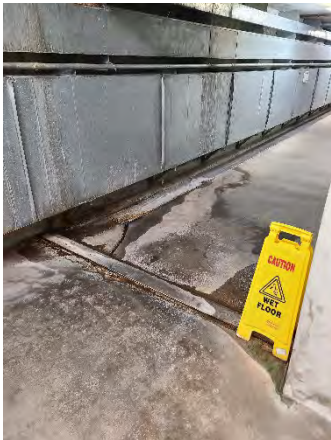
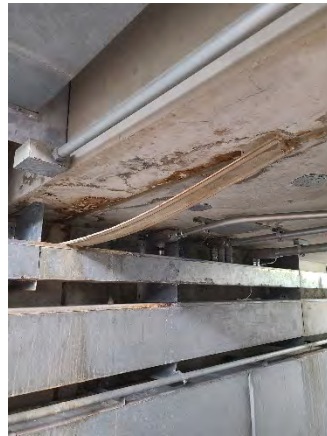
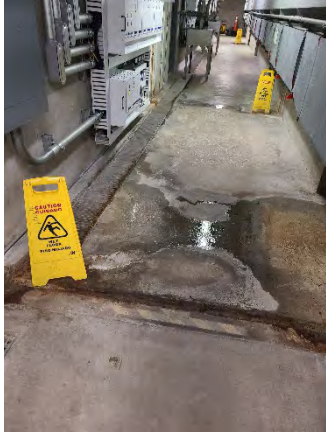
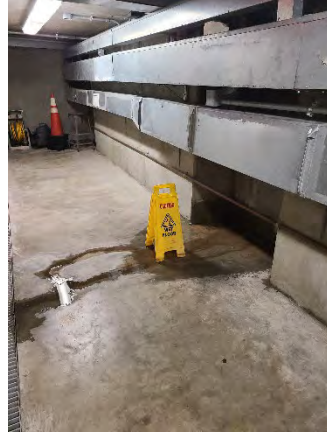
- Severe leaks throughout tunnel. Leak appears to be behind panel, as well ceiling joint separated from wall with poor repair. *(Figure 17, 18, 19, and 20)*
- Staining behind several panels; indicates leaking along tunnel walls. *(Figure 21)*
- Paint bubbling and peeling along interior of tunnel stairwell. *(Figure 22)*

Figure 17 Lee Vista Ramp On

Figure 18 Lee Vista Ramp On

Figure 19 Curry Ford Mainline

Figure 20 Curry Ford Mainline

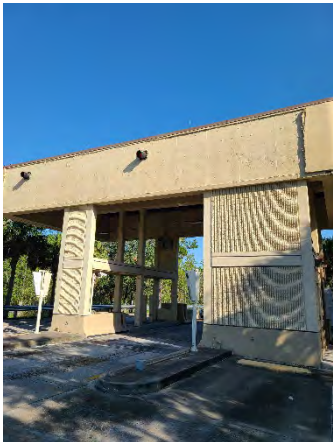
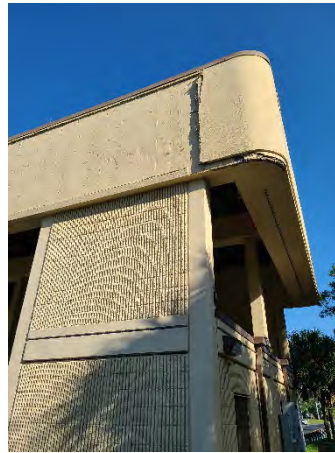
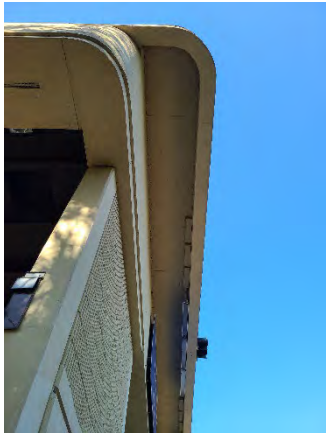
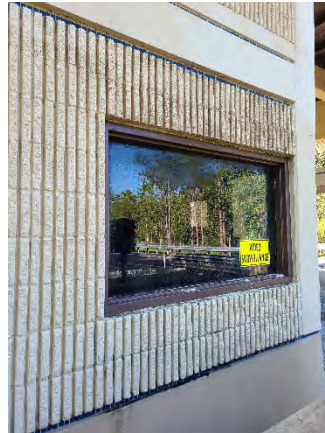
- Back cover of canopy has been removed/damaged, with multiple cracks along corner of canopy. Exterior needs to be cleaned. *(Figure 23, 24, 25, and 26)*
- Multiple signs of mold/mildew throughout interior of booth and data room. *(Figure 27 and 28)*
- Crack along wall join of booth and data room. *(Figure 29)*

Figure 23 Lee Vista Ramp On

Figure 24 Lee Vista Ramp On

Figure 25 Lee Vista Ramp On

Figure 26 Lee Vista Ramp On

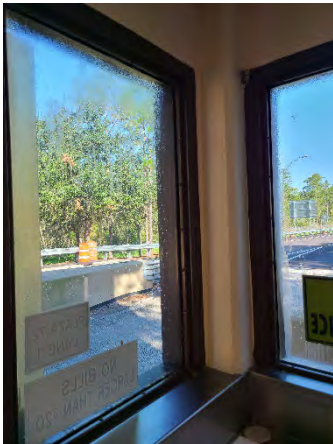
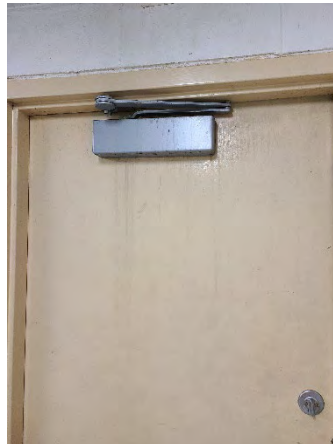
Figure 27 Lee Vista Ramp On

Figure 28 Lee Vista Ramp On

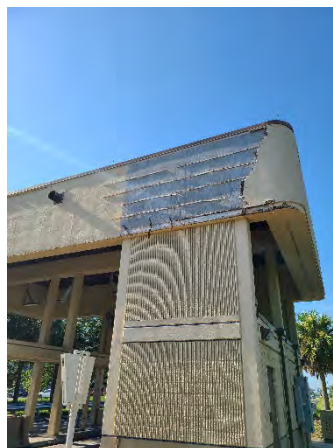
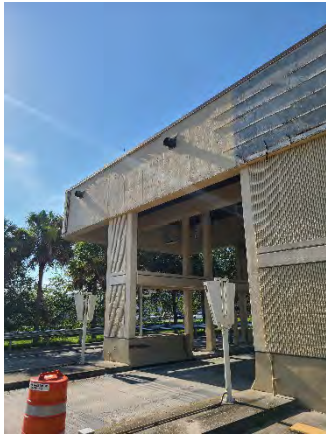
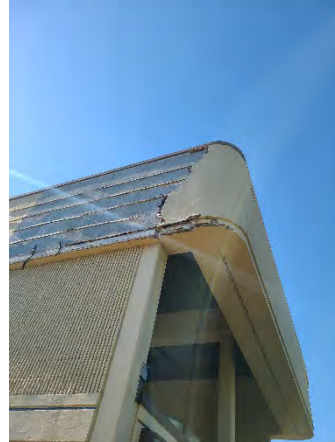
- Cracking and missing components of façade around canopy. *(Figure 30, 31, and 32)*
- Door to main booth damaged, robbery reported 8/8/23. Window of door and machine need to be replaced/repaired. *(Figure 33, 34, and 35)*
- Crack along wall join of booth and data room. *(Figure 36)*

Figure 30 Lee Vista Ramp Off

Figure 31 Lee Vista Ramp Off

Figure 32 Lee Vista Ramp Off

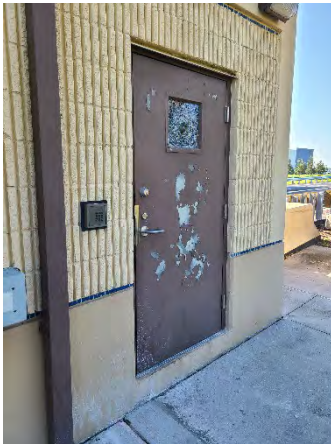
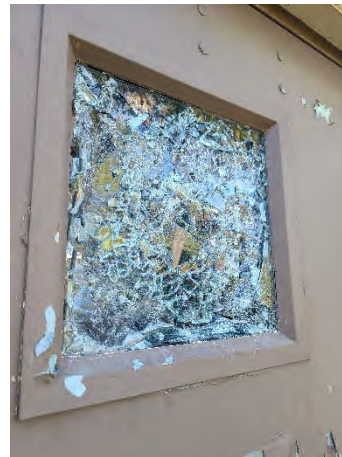
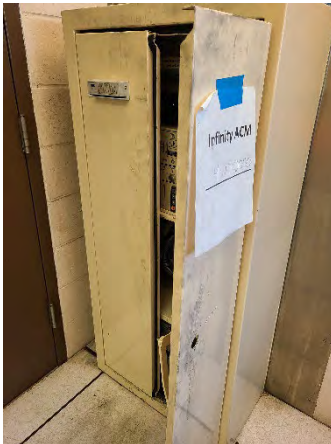
Figure 33 Lee Vista Ramp Off

Figure 34 Lee Vista Ramp Off

Figure 35 Lee Vista Ramp Off

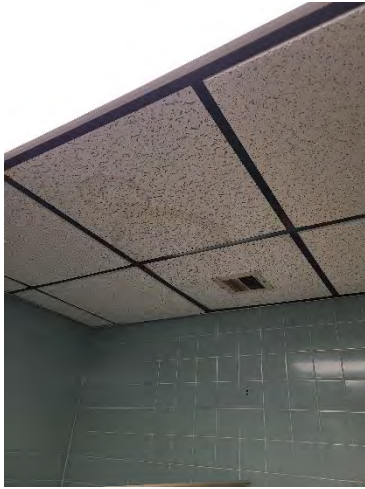
Figure 1 University Mainline

- Discolored and damaged ACT throughout facility, ACT shows signs of possible leak in Men's Restroom (*Figure 1,2, and 3*)
- Paint cracking and bubbling in several rooms of plaza. Paint peeling from wall in corridor to Men's restroom. (*Figure 4, 5, and 6*)
- Windowsill of breakroom shows signs of leaking, water damage along wall of sink. (*Figure 7 and 8*)

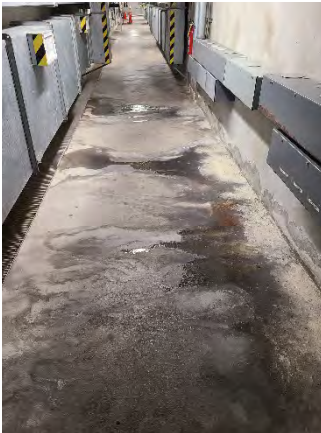
Figure 9 University Mainline

- Tunnel is in overall good condition with the exception of multiple signs of leaking. Active leak on equipment at back end of tunnel. (*Figure 9, 10, 11, and 12*)

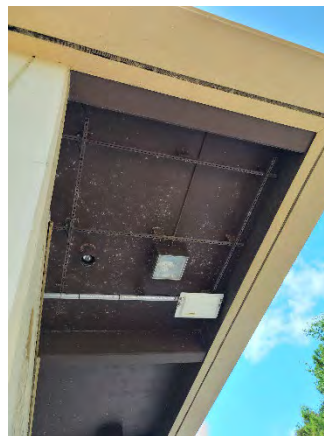
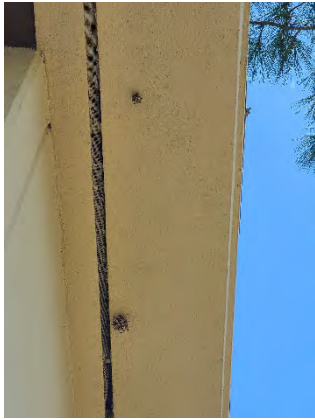
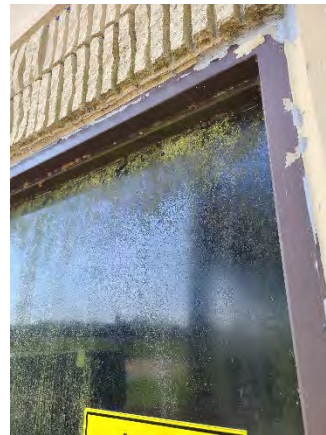
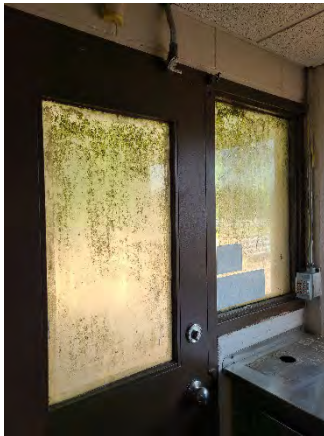
- Interior and exterior extremely unclean.
- Exterior needs to be cleaned. Signs of mildew/mold, debris, and wasp nests present. *(Figure 35, 36, 37, and 38)*
- Interior needs to be addressed and cleaned. Mold/mildew/algae coating interior windows. Signs of mold and debris throughout booth and data room. *(Figure 39, 40, and 41)*
- ACT cracked and damaged in booth. *(Figure 42)*

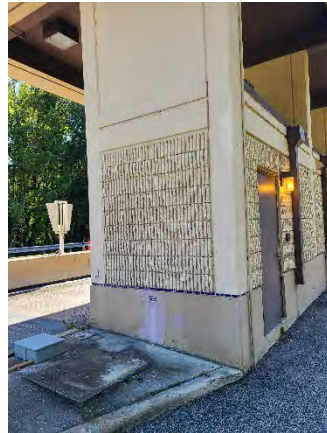
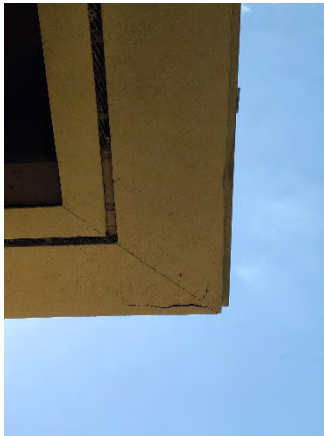
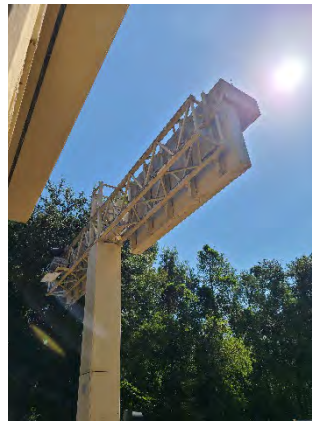
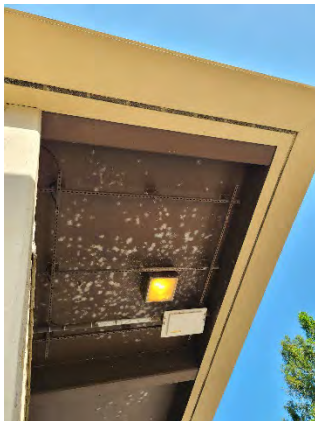
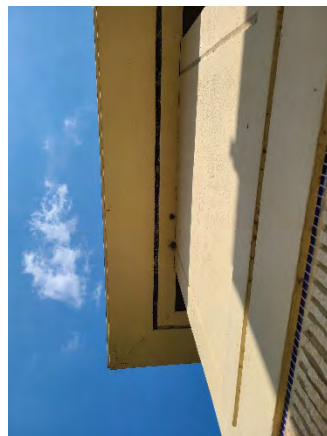
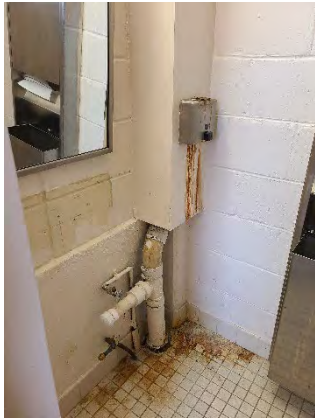
- Exterior needs to be cleaned. Signs of mildew/mold, debris, and wasp nests present. Cracks and gaps along canopy edge and soffit. *(Figure 43, 44, 45, 46, 47, and 48)*
- Interior needs to be cleaned. Stains on walls and floors, and signs of damage above window. *(Figure 49 and 50)*
- Missing and damaged ACT throughout booth and data room. Wire exposed through missing ACT. *(Figure 51 and 52)*

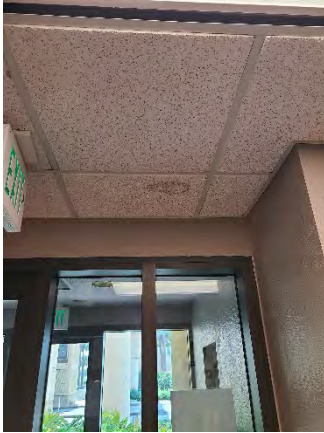
Figure 1 Independence Mainline

- Facility has missing vent covers and potential leaks above ceiling tiles in multiple locations. Missing or damaged ceiling tiles throughout facility. Small cracks and peeling paint along ceiling of North facility. *(Figure 1, 2, 3, 4, 5, and 6)*
- Wall throughout facility show signs of leaking with multiple stains and paint defects. Corner of walls show signs of damage. *(Figure 7, 8, 9, 10, 11, and 12)*
- Floor tiles throughout facility are damaged/disheveled. *(Figure 13, 14, and 15)*
- Possible leak beneath sink in break room. *(Figure 16)*
- Signs of mold/mildew on interior of associate booth door. *(Figure 17)*
- Sink separating from wall in associate booth bathroom. *(Figure 18)*
