Central Florida Expressway Authority

ANNUAL INSPECTION REPORT

FY 2024

Re: Fiscal Year 2024 Annual Inspection Report

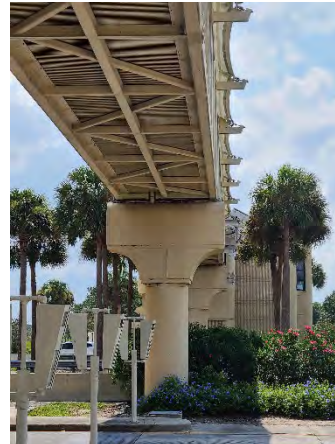
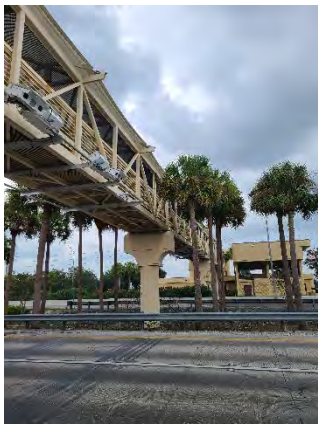
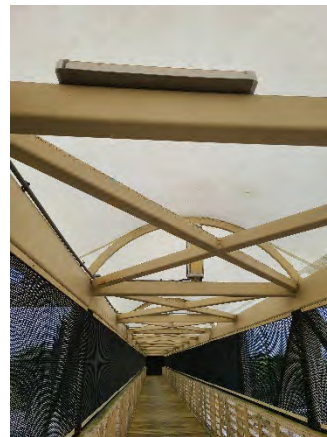
- Overpass in overall good condition. Minor cracks along underside of columns supporting bridge. *(Figure 19, 20, and 21)*
- Walkway of overpass is unsteady, and multiple clips between grates are loose or completely dislodged. Interior needs to be cleaned and repainted. *(Figure 22, 23, 24, and 25)*
- Small crack above entrance to overpass bridge. *(Figure 26)*
- Seal failing on exterior windows of North stairwell. *(Figure 27 and 28)*
- Multiple leaks along walls and doorways of stairs. *(Figure 29 and 30)*

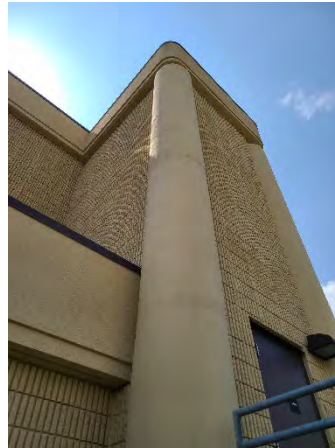
Figure 31 Independence Mainline

- Rusting around stair railing connection to pavement. *(Figure 31)*
- Cracking and peeling paint on building façade and columns. *(Figure 32 and 33)*
- Plaza canopy shows signs of leaking. Façade cracked. *(Figure 34 and 35)*
- Dents in walls around entrance. *(Figure 36)*

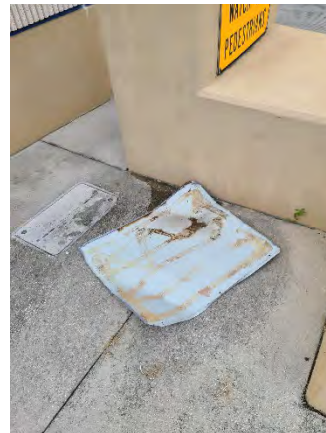
Figure 37 Schofield Ramp On

- Recommend pressure wash ramp and overhead sign structure – water stains on façade. (Figure 37)
- Sign removed and discarded on walkway. (Figure 38)
- Possible leak on interior, ACT discolored or missing. Light fixture damaged. (Figure 39 and 40)

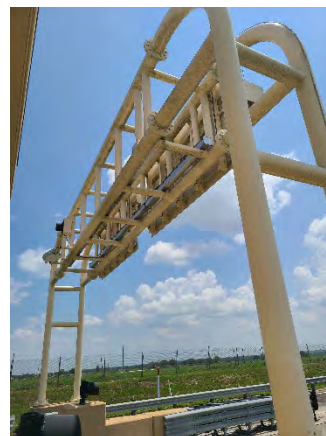
Figure 41 Schofield Ramp Off

- Pressure wash plaza exterior, overhead sign structure, and remove wasp nests. (Figure 41 and 42)
- Small leak above ACT in main booth. (Figure 43)
- Possible leak on HVAC system in data room, paint bubbling and peeling in corner. (Figure 44)

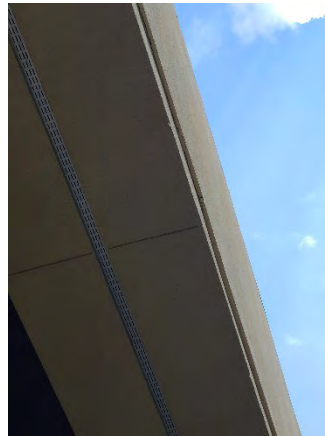
Figure 54 CR-535 Ramp Off

- Cracks in building façade, signs of water damage along underside of canopy. (Figure 53 and 54)
- Signs of mold/mildew along interior walls. (Figure 55)
- Cracking along connected walls on both rooms of interior. Large crack along data room wall. (Figure 56)

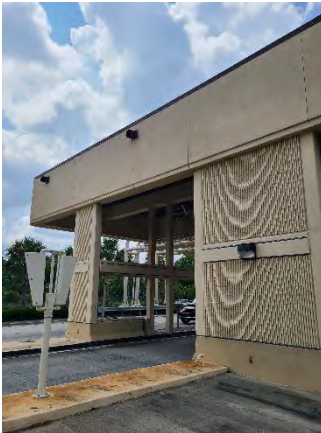
Figure 57 CR-535 Ramp On

- Cracking along façade of canopy. (Figure 57 and 58)
- Doors and window frames need to be repainted. Both main door and window covered in mold/mildew. (Figure 59 and 60)
- Interior paint is peeling and bubbled, possible leak in main booth causing damage. Signs of water damage around door and window. (Figure 61, 62, 63, 64, and 65)
- Large crack along wall in data room. (Figure 66)

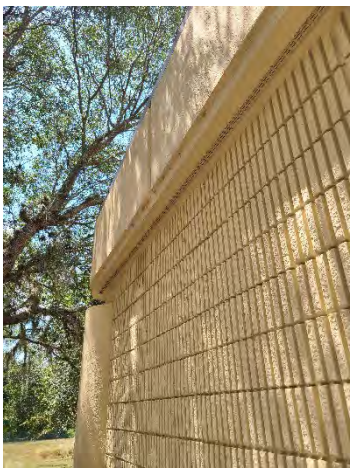
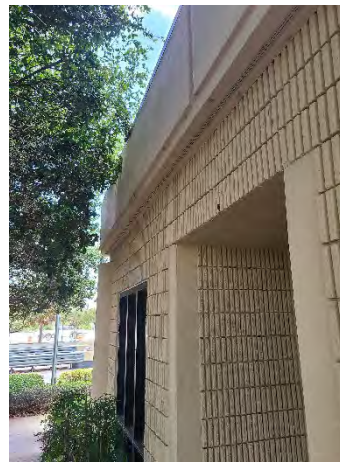
- Exterior overall in good condition – needs to be cleaned. *(Figure 17 and 18)*
- Columns show signs of damage, paint peeling from exterior with small cracks present. *(Figure 19 and 20)*
- Windows and storefront around exterior show signs of water damage – seal showing signs of damage. *(Figure 20, 21, 22, 23, and 24)*
- Canopy façade cracking and peeling, with signs of water damage underneath. *(Figure 25, 26, 27, 28, 29, and 30)*

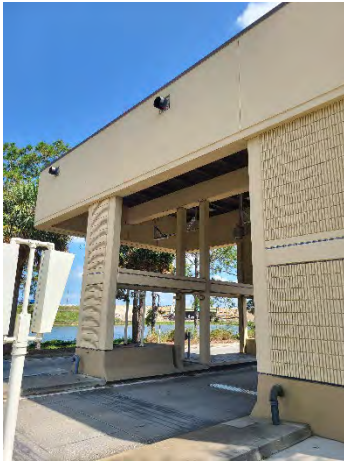
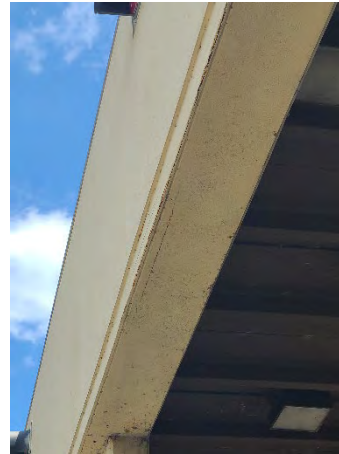
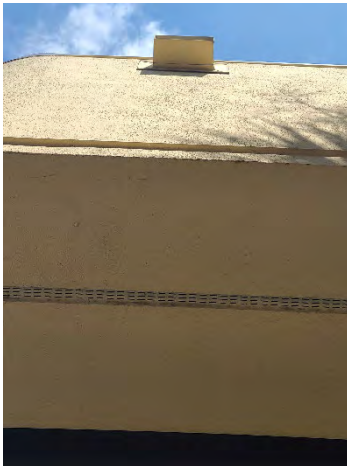
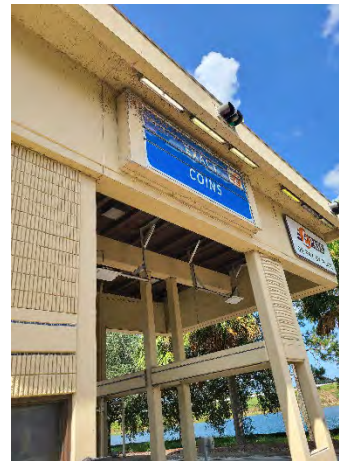
- Façade and below canopy need to be cleaned. Signs of water damage along underside of canopy. (Figure 31, 32, 33, and 34)
- Possible leak above ACT in main booth, signs of mold/mildew on interior of windows. (Figure 35 and 36)

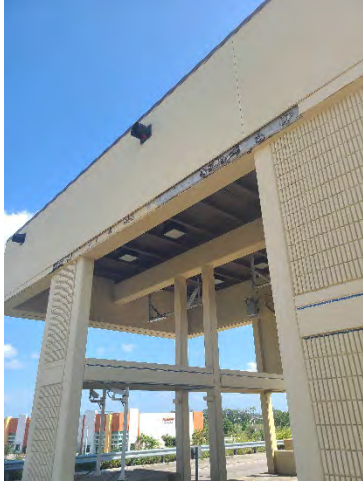
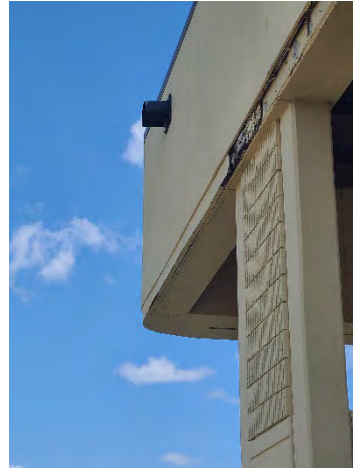
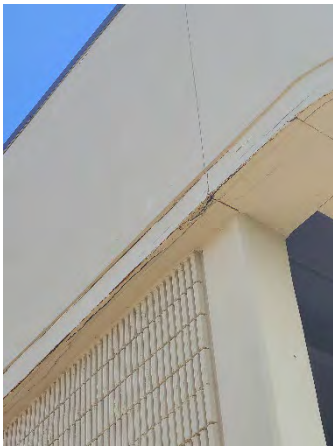
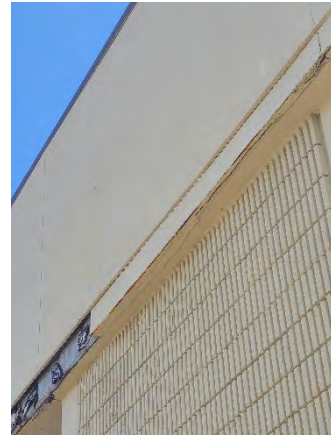
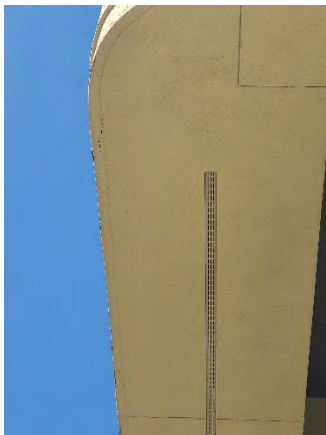
- Cracks along sides and undersides of canopy. Entire bottom of soffit removed/missing. Signs of water damage. (Figure 37, 38, 39, 40, and 41)
- Interior in overall good condition. (Figure 42)

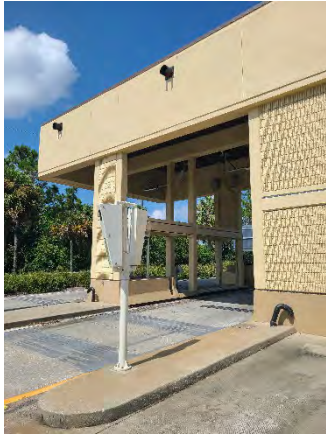
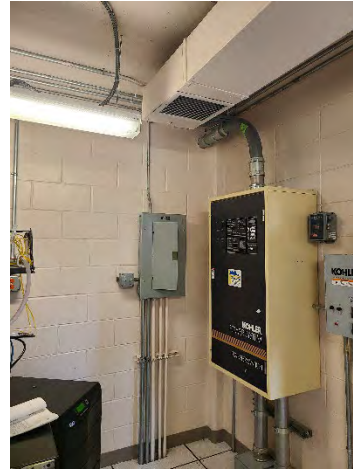
- Ramp is overall in good condition – would recommend cleaning exterior. (Figure 43 and 44)

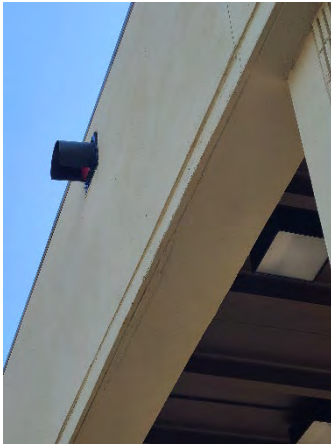
Figure 45 West Road Ramp Off

- Cracking along underside of canopy. (Figure 45)
- Interior of door to data room needs to be cleaned. Insect infestation around exterior of ramp with signs of insect intrusion into rooms. Signs of mold/mildew. (Figure 46, 47, and 48)

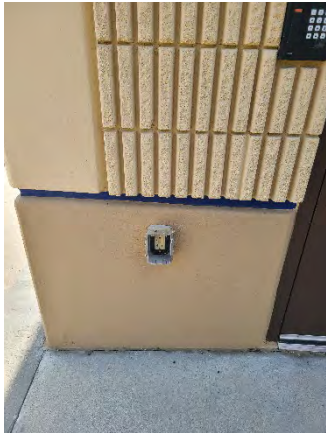
Figure 49 CR-437A Ramp Off

- Outlet cover missing. (Figure 49)
- Downspout damaged. (Figure 50)
- Possible leak above ACT in main booth and along walls of data room. (Figure 51 and 52)

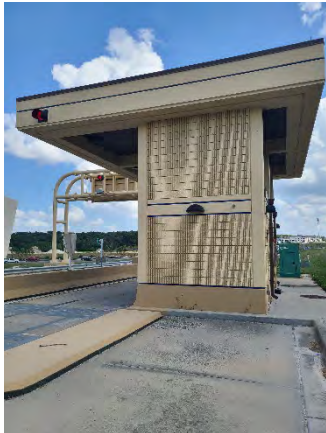
Figure 53 CR-437A Ramp On

- Building façade and canopy need to be cleaned (Figure 53)
- Poor drainage. (Figure 54)
- Possible leak above ACT in main booth. (Figure 55)
- Baseboard peeling in data room. (Figure 56)

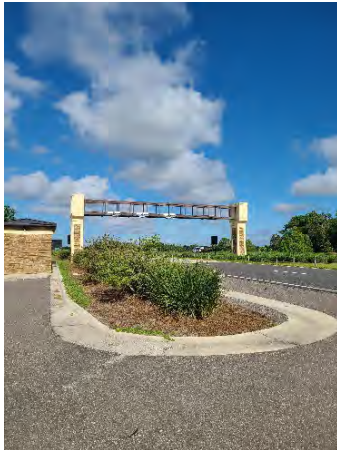
Figure 61 Mt. Plymouth Gantry

- Gantry overall in good condition – would recommend cleaning exterior. (Figure 61 and 62)
- Small cracks in façade by signage. (Figure 63 and 64)
- Insects at corners of interior – would recommend cleaning/reviewing seals. (Figure 65 and 66)

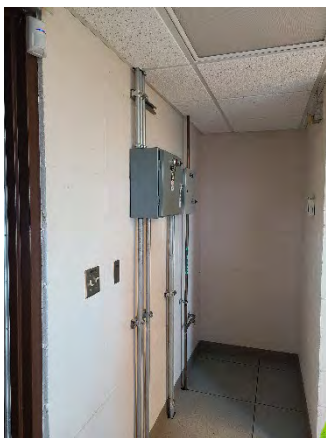
Figure 59 ICP Ramp On

- Exterior in good condition, mild water marks (*Figure 57, 58*)
- Interior in good condition (*Figure 59*)
- Door to main booth easily stuck (*Figure 60*)

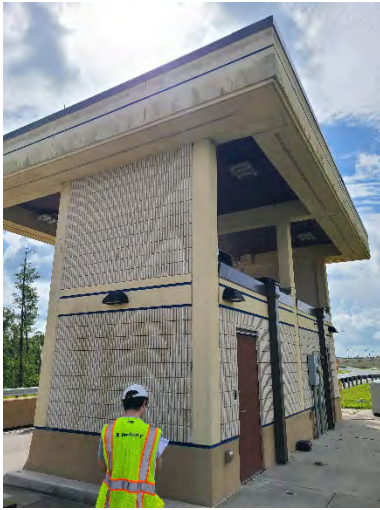
Figure 61 ICP Ramp Off

- Exterior in good condition, mild water marks – minor cracks along foundation (*Figure 61, 62, 63*)
- Interior in good condition (*Figure 64*)

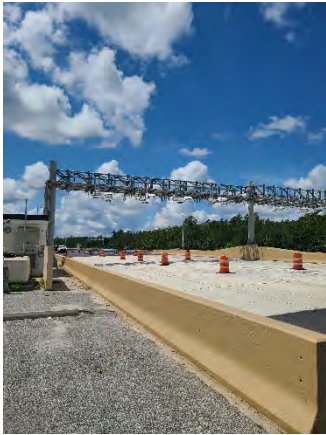
Figure 1 Marigold AET Toll Plaza

- The above referenced plaza is in good condition overall. Some general maintenance to caulk/seal cracks to building exterior is recommended. (*Figure 1, Figure 2, Figure 3, & Figure 4*)
- One of the gutters presented a dent on it. (*Figure 5*)
- Interior presented cracks on corners and edge of the ceiling. (*Figure 6 & Figure 7*)
- Door presented heavy staining. (*Figure 8*)

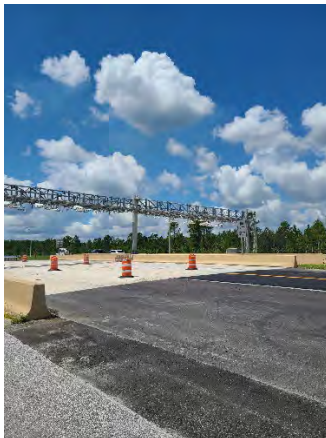
Figure 9 KOA AET Toll Plaza

- The above referenced plaza is in good condition overall. Some general maintenance to caulk/seal control joints. (*Figure 9 & Figure 10*)
- Interior presented cracks on corners and edge of the ceiling. (*Figure 11 & Figure 12*)

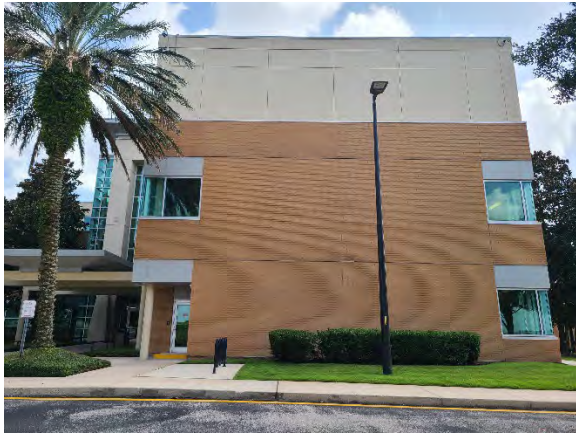
Figure 1 Building Headquarters

- Building exterior is in good condition overall with no identified deficiencies. Pressure wash is recommended for the sidewalk, corner of the building and main entrance. *(Figure 1 – Figure 12)*
- Signs of water intrusion through storefront surrounding northwest stairwell. *(Figure 13 and 14)*
- Signs of water intrusion at second level of storefront, southeast corner of facility. Glazing appears to be damp on the interior. *(Figure 15 and 16)*
- Fans in poor condition under pavilion of employee breakroom. *(Figure 17, 18, and 19)*
- Signs of water intrusion throughout exterior of employee breakroom. Multiple leaks and examples of paint bubbling/peeling from surface. *(Figure 20- Figure 24)*

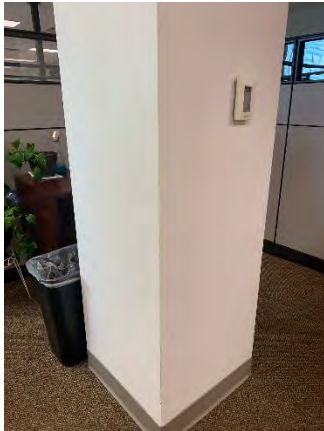
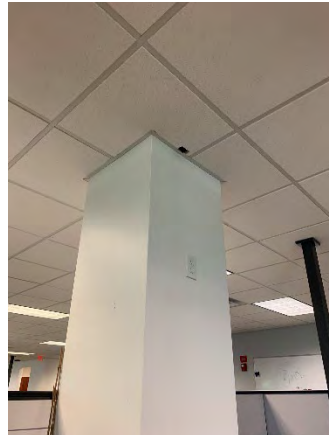
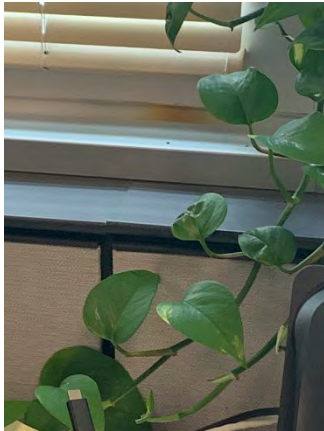
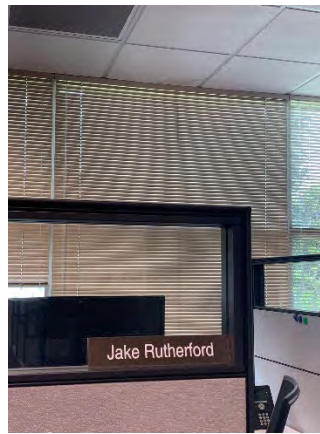
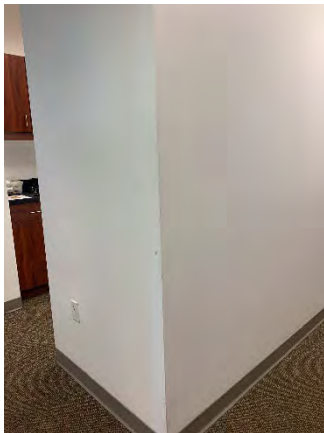
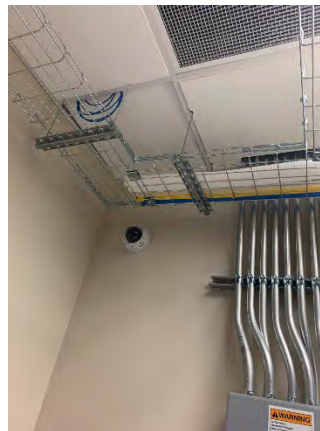
- Room 142 with ACT damaged in several places. Open office area shows signs of leaking above ACT surrounding curtain windows, with water damage on windows themselves. Office area also contains damage on walls and columns throughout space. (Figure 54-Figure 59)

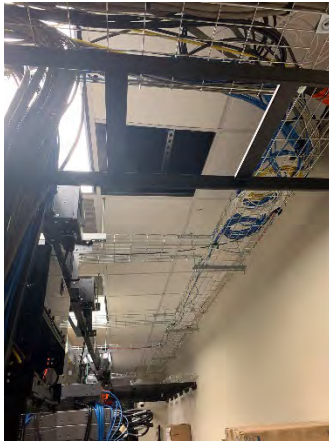
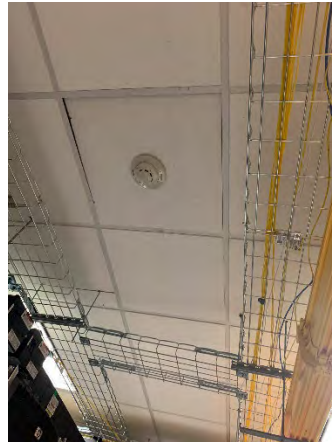
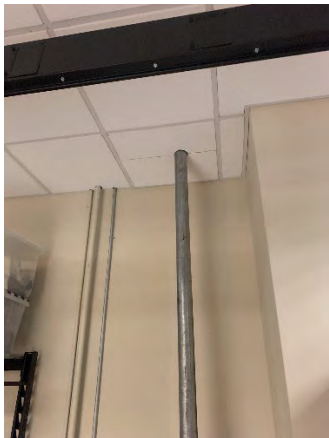
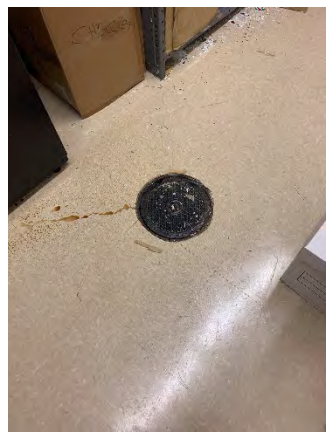
- Room 144 with damaged/missing ACT – negative environment for equipment in room. (Figure 60, 61, 62, and 63)
- Room 149 with uneven floor surrounding drain – possible trip hazard. (Figure 64)

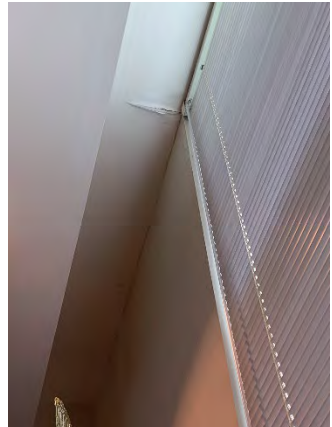
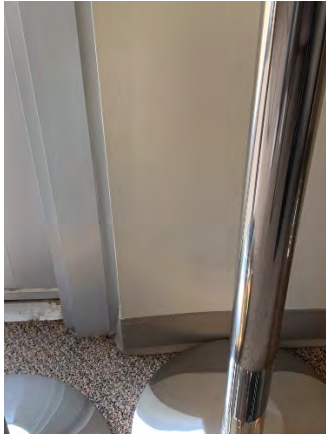
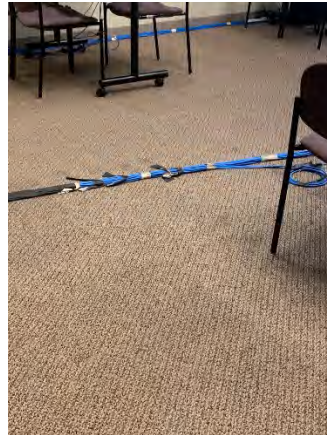
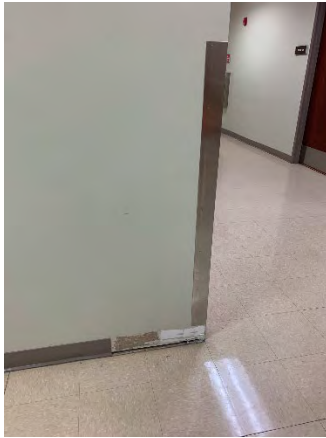
- Room 150 with possible leak above curtain window. Bottom pane of window shattered from exterior – supervisor aware. Trip hazard with cable management. (Figure 65, 66, 67, and 68)

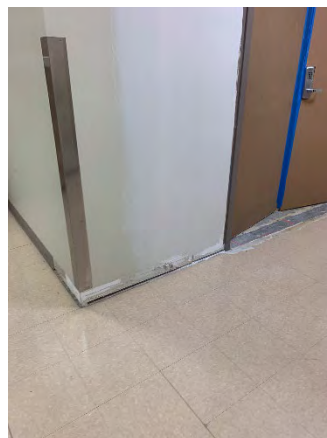
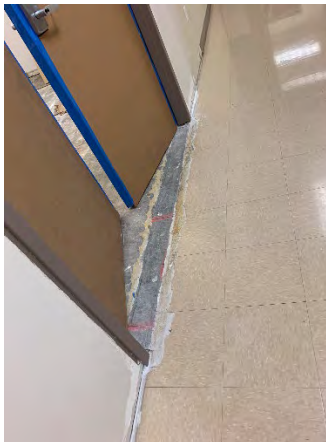
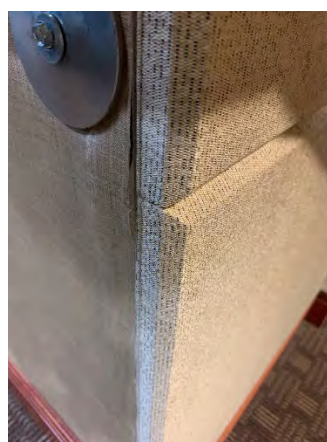
- Corridor 152 with baseboard and portion of flooring removed – this portion of facility is under construction. (Figure 69, 70, and 71)
- Room 156 with wallpaper peeling from several locations around boardroom. Curtain wall shows signs of multiple leaks. (Figure 72- Figure 79)

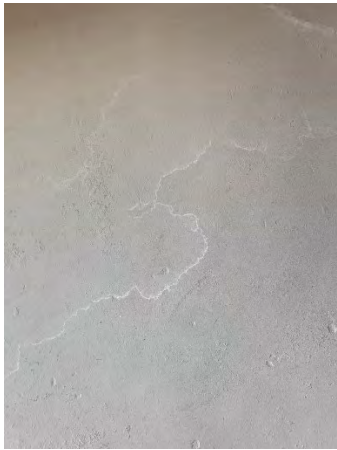
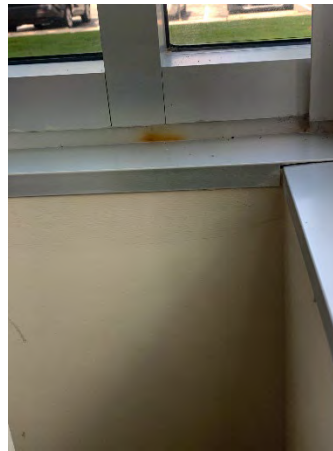
- Stair 157 with signs of leaking along walls and around door/window system. (Figure 80, 81, and 82)
- Room 160 with potential leak at the window trim. (Figure 83 and 84)

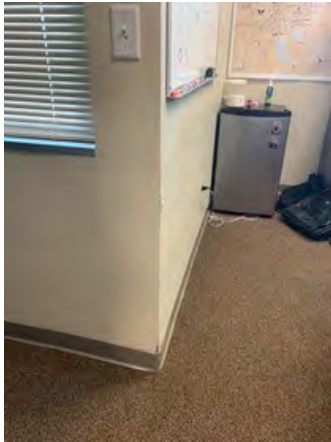
Figure 85 Building Headquarters First Floor (Room 161)

- Room 161 with potential leak at window trim and damage to corner of wall. (Figure 86 and 86)
- Corridor 165 with wallpaper peeling throughout, and damage to several wall corners, and wall faces. (Figure 87, 88, 89, and 90)

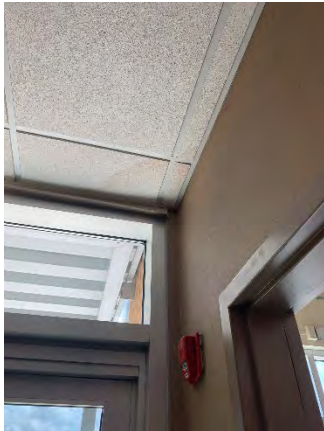
Figure 91 Building Headquarters First Floor (Corr. 166)

- Corridor 166 with signs of leaking above ACT and exit door. (Figure 91 and 92)
- Lobby 117 with scratched on several columns – this portion of facility is under construction. (Figure 93 and 94)

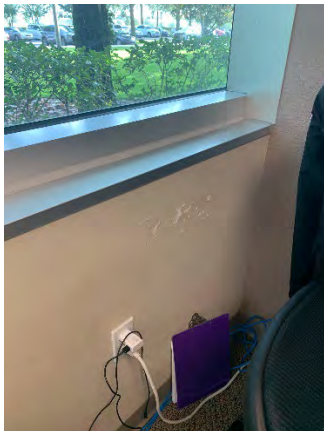
Figure 95 Building Headquarters First Floor (Sec. 117)

- Security 117 with damage to wall. (Figure 95)
- Women's restroom 100 with damage to corner of wall and peeling wallpaper. (Figure 96 and 97)
- Men's restroom 101 with damage to mirror. (Figure 98)

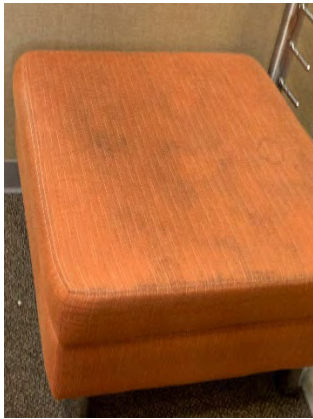
Figure 99 Building Headquarters Second Floor (Room 203)

- Room 203 with all seating available stained. (Figure 99)
- Room 205 with signs of water damage along walls. (Figure 100 and 101)
- Room 209 with signs of water damage at corner of window. (Figure 102)

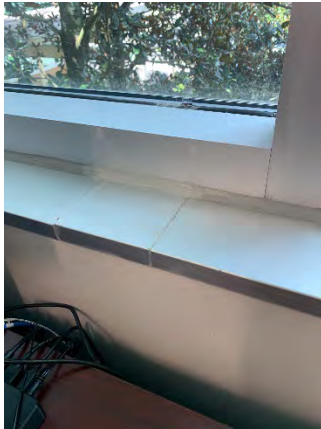
Figure 103 Building Headquarters Second Floor (Room 219)

- Room 219 with signs of water damage around window and present on ACT. Door scratched. Sticker above door notes room "215". (Figure 103-108)
- Room 221 with damage ACT grid – section missing/above partition. (Figure 109)

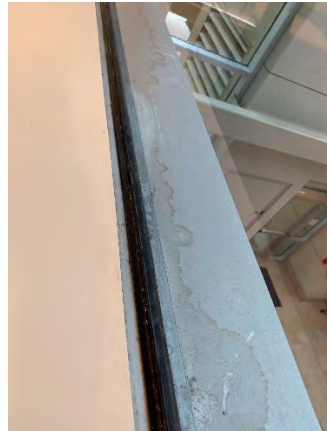
Figure 110 Building Headquarters Second Floor (Room 222)

- Room 222 with signs of water damage around storefront. Missing ACT. (Figure 11 and 111)
- Room 228 with damage to door frame. (Figure 112)
- Room 230 with damage to door frame and walls. (Figure 113 – Figure 116)

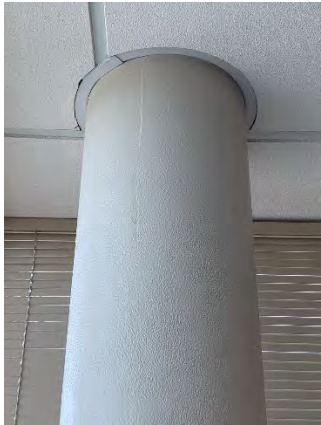
Figure 117 Building Headquarters Second Floor (Room 231)

- Room 231 with signs of water damage above ACT, surrounding windows, and around columns. Grout missing at kitchenette. (Figure 117, 118, 119, and 120)

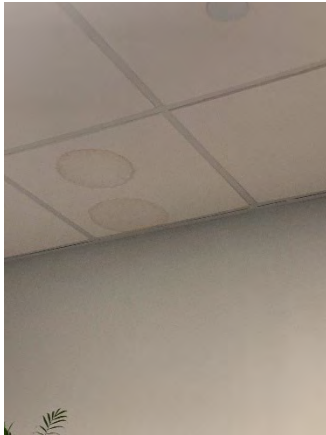
Figure 121 Building Headquarters Second Floor (Room 233)

- Room 233 with signs of water damage above ACT, and damage to walls. (Figure 121 and 122)
- Stair 234 with signs of water damage around windows. (Figure 123 and 124)

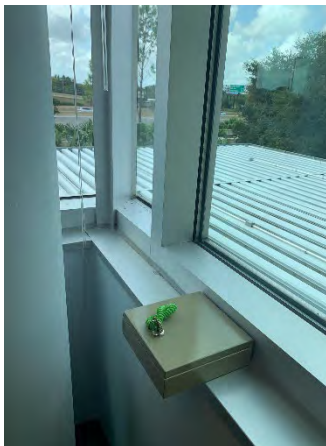
Figure 125 Building Headquarters Second Floor (Room 235)

- Room 235 with signs of water damage around windows, and above ACT surrounding column. (Figure 125 and 126)
- Room 237 with damage to door. (Figure 127)

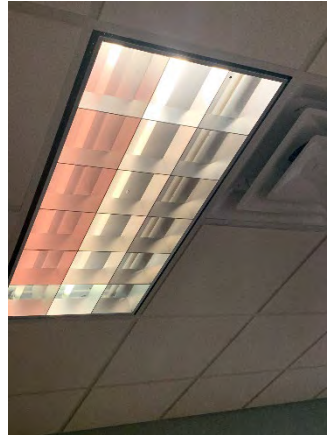
Figure 128 Building Headquarters Second Floor (Room 238)

- Room 238 with light damaged. (Figure 128)
- Room 239 with damage to ACT. Open Office space has multiple signs of water damage above ACT and above windows – pieces of ACT do not match. (Figure 129, 130, 131, and 132)

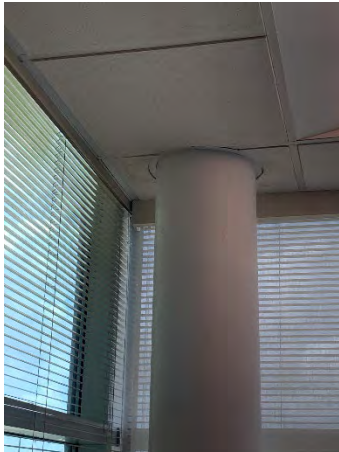
Figure 133 Building Headquarters Second Floor (Room 241)

- Room 241 with signs of water damage above ACT. (Figure 133)
- Room 242 with damage to door frame. (Figure 134)
- Room 243 with damage to corner of wall. (Figure 135)

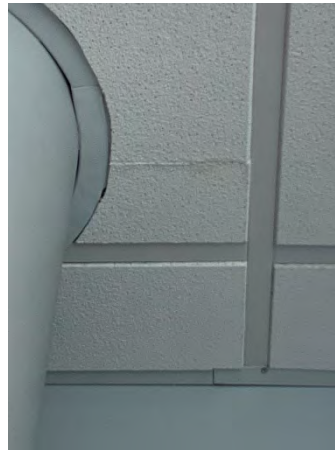
Figure 136 Building Headquarters Second Floor (Room 246)

- Room 246 with damage to ACT and ceiling grid. (Figure 136 and 137)

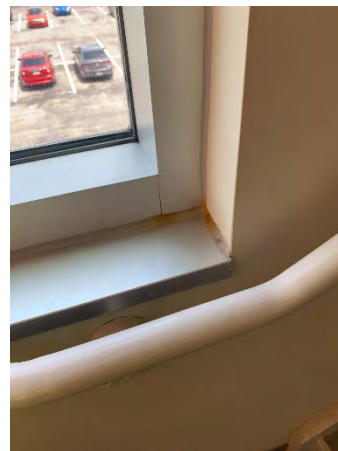
Figure 138 Building Headquarters Second Floor (Stair 248)

- Stair 248 with signs of water damage around window, and large scratch along West wall. (Figure 138, 139, 140, and 141)
- Room 252 with missing baseboard and ACT - this portion of facility is under construction. (Figure 142 and 143)
- Corridor 256 with damaged carpet. The carpet has been removed far beyond baseboard and is stained - this portion of facility is under construction. (Figure 144, 145, and 146)
- Women's Restroom 200 with missing paint on corner of wall. (Figure 147)
- Men's Restroom 201 with peeling wallpaper. (Figure 148)

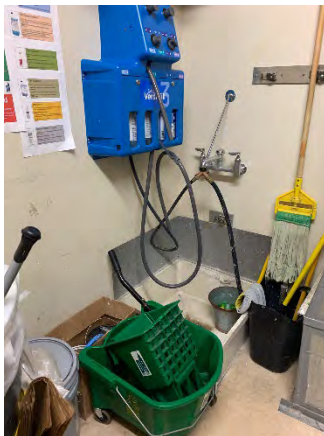
Figure 149 Building Headquarters Third Floor (Room 304)

- Room 304 with signs of water damage along walls. (Figure 149)
- Room 310 with signs of water damage at corner of window and ACT. (Figure 150 and 151)
- Room 311 with signs of water damage around window. (Figure 152, 153, 154, and 155)

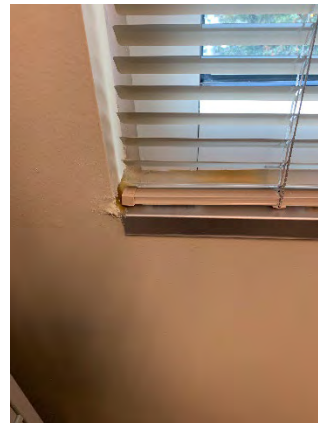
Figure 156 Building Headquarters Third Floor (Room 322)

- Room 322 with signs of water damage around window. (Figure 156 and 157)
- Room 323 with signs of water damage round window, corner of wall damaged, and wallpaper peeling. (Figure 158, 159, 160, and 161)

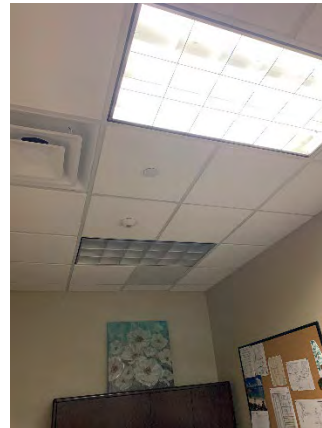
Figure 162 Building Headquarters Third Floor (Room 325B)

- Room 325B with light damage. (Figure 162)
- Room 331 with crack at corner of window, and signs of water damage above ACT. (Figure 163 and 164)
- Room 333 with signs of water damage above ACT. (Figure 165)

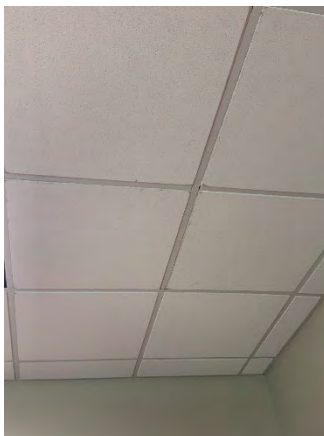
Figure 166 Building Headquarters Third Floor (Room 335)

- Room 335 with signs of water damage above ACT. (Figure 166 and 167)
- Room 337 with signs of water damage at window and wall below window. (Figure 168, 169, 170, and 171)

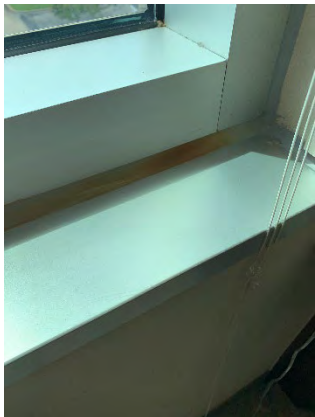
Figure 172 Building Headquarters Third Floor (Room 339)

- Room 339 with signs of water damage along all windows and above ACT throughout breakroom. (Figure 172- Figure 176)
- Room 342 with poor patch in wall. (Figure 177)

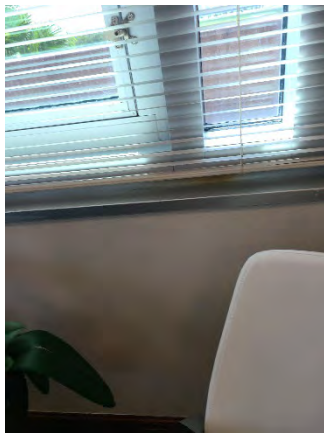
Figure 178 Building Headquarters Third Floor (Room 343)

- Room 343 with signs of water damage at window. (Figure 178, 179, and 180)
- Room 345 with signs of water damage at window and wall below window. (Figure 181, 182, 183, and 184)

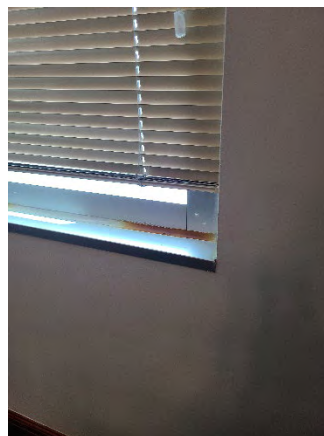
Figure 185 Building Headquarters Third Floor (Room 346)

- Room 346 with signs of water damage at window. (Figure 185, 186, 187, and 188)
- Room 347 with signs of water damage at window. (Figure 189)
- Room 351 with ACT and ceiling grid disheveled. (Figure 190)

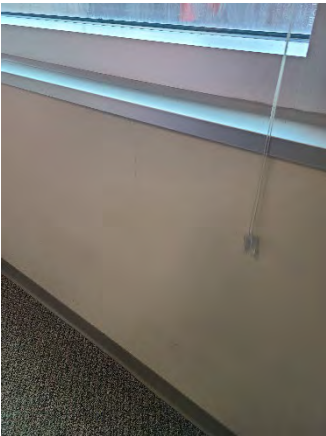
Figure 200 Building Headquarters Third Floor (Room 355)

- Room 355 with signs of water damage at windows and insects throughout room. (Figure 200, 201, 202, and 203)
- Room 356 with signs of water damage at windows and insects throughout room. Strong odor in room. (Figure 204, 205, 206, and 207)

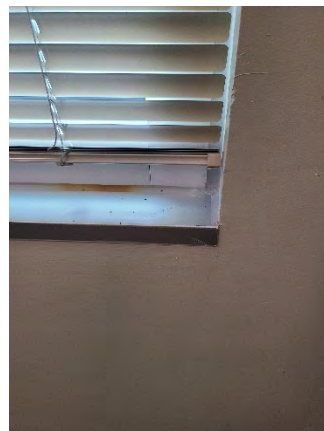
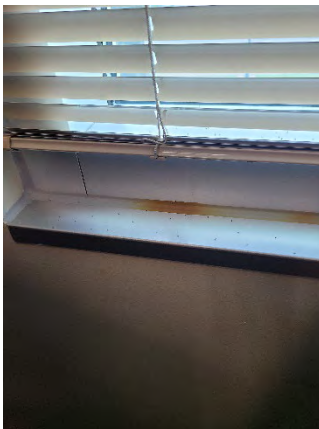
- Room 357 with signs of water damage at window. (Figure 208 and 209)
- Room 358 with signs of water damage at window. (Figure 210)
- Room 302 with signs of water damage along ceiling. Lobby shows multiple points of bubbling/peeling from surface, (Figure 211 – Figure 216)
