Central Florida Expressway Authority

ANNUAL INSPECTION REPORT

FY 2025

Re: FY 2025 Annual Inspection Report

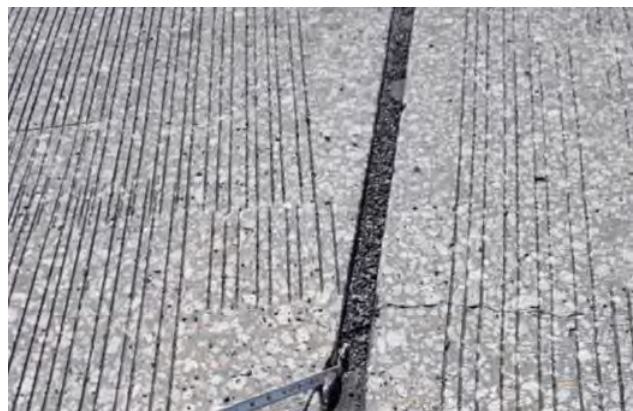
FIGURE 7: Adhesion loss at abutment joint bridge over CR437A

along the barriers and some loss of adhesion at the abutment joints

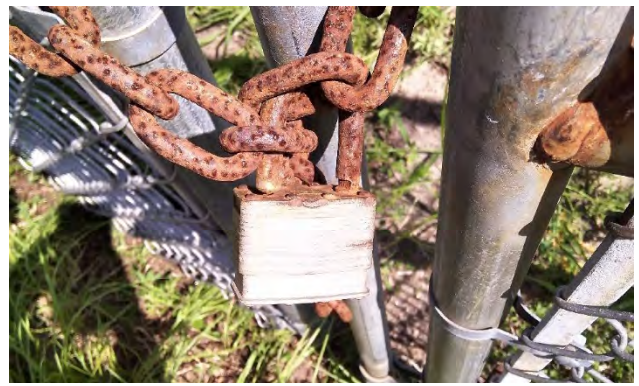
FIGURE 14: Inoperable gate lock SR 451

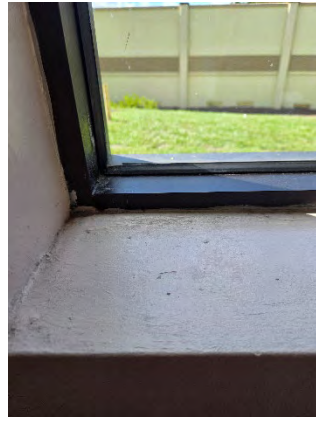
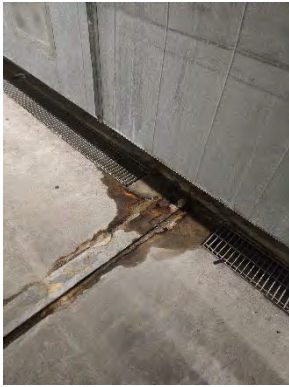
- Doors, door frames and hardware throughout facility show scratches and damage. *(Figure 11, 12, 13, 14, 15, 16, 17, 18, 19, and 20)*
- Vent cover and light fixture cover not properly secured. *(Figure 21 and 22)*
- Multiple holes and dents in walls. Paint cracking and bubbling in recording room. *(Figure 23, 24, 25, 26, 27, and 28)*
- Missing and damaged ACT throughout facility. *(Figure 29 and 30)*
- Signs of rust and leakage in the restrooms. *(Figure 31, 32, and 33)*
- Cabinet under sink in kitchen in very poor condition. *(Figure 34)*
- Multiple parts of floor cracked, scratched or stained. *(Figure 35, 36, 37, and 38)*
- Hardware buildup in tech room. *(Figure 39)*
- Exposed cables. *(Figure 40)*
- Seal behind kitchen sink deteriorating. Joint between window frame and wall cracking. *(Figure 41 and 42)*

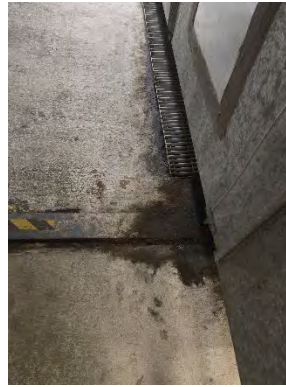
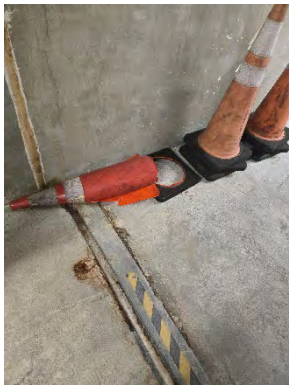
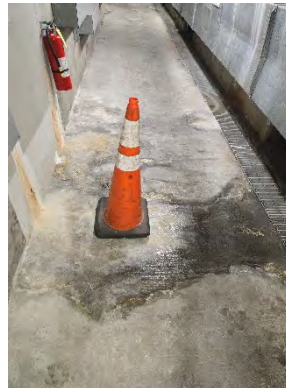
- Expansion joints in poor condition. *(Figure 43, 44, and 45)*
- Leaking and water pooling throughout tunnel. *(Figure 46, 47, 48, and 49)*
- The concrete walls have visible cracks and show signs of leaking. Clear water intrusion throughout tunnel with metal system dented at multiple points. *(Figure 50, 51, 52, and 53)*

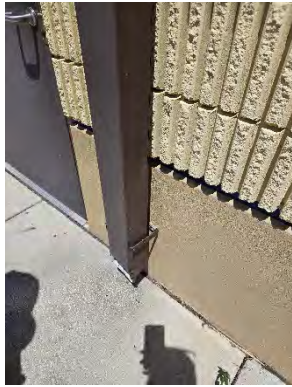
Figure 54 Good Homes Ramp On

- The observed ramp is in overall good condition. Some minor dirt stains under canopy (*Figure 54*)
- Downspout dented. Drainage problem creating dirt buildup and plant growth. (*Figure 55 and 56*)
- Water buildup in light fixture. (*Figure 57*)
- Barrier cracked. (*Figure 58*)
- Walls stained and damaged. (*Figure 59, 60, 61, 62, and 63*)
- HVAC system off. (*Figure 64*)
- Floor tiles cracked or stained. (*Figure 65, 66, and 67*)
- Sign of mold on walls and vent. (*Figure 68 and 69*)

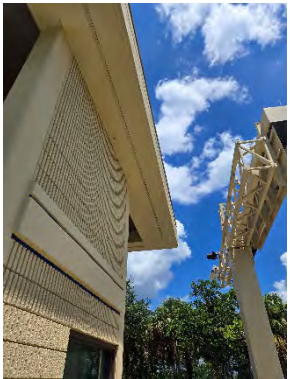
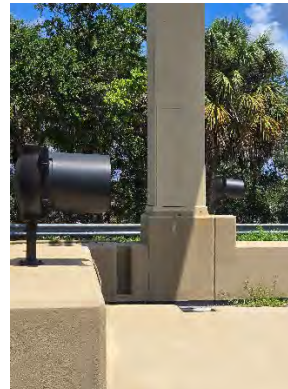
- The observed ramp is in overall good condition. Some minor dirt stains under canopy as well as the presence of one wasp nest. (*Figure 70 and 71*)
- Some cracks on the barrier. (*Figure 72*)
- Interior has minor debris in bathroom, needs to be cleaned. (*Figure 73*)
- Bag covering ACT or vent in main booth. (*Figure 74*)
- Paint peeling off walls. Parts of wall stained and dirty. (*Figure 75, 76 and 77*)
- Door and door plate damaged. (*Figure 78*)

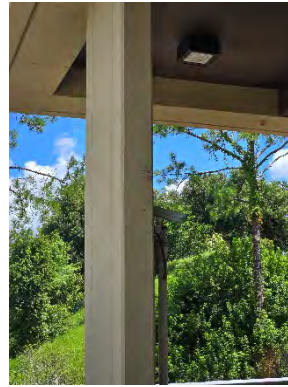
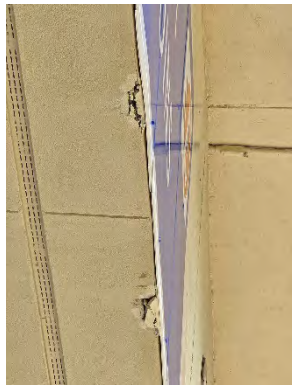
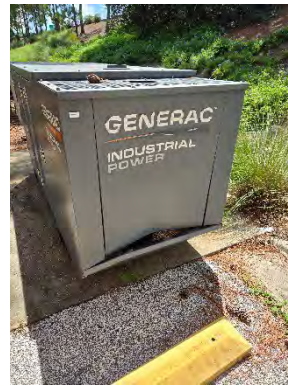
- Stains in parts of the façade. Cracks under toll sign on canopy. (*Figure 79, 80, and 81*)
- Electric equipment dented. (*Figure 82*)
- Drainage problem with active leakage. (*Figure 83*)
- Signs of mold in bathroom, ACT in poor shape and mold along interior walls. (*Figure 84, 85, and 86*)
- Paint is shredding and peeling in data room, potential leaking. (*Figure 87 and 88*)
- CMU Unit broken. Potential hazard. (*Figure 89 and 90*)
- Floor tiles scratched, stain, or cracked. (*Figure 91 and 92*)
- Wall to window frame joint in poor condition. (*Figure 93*)

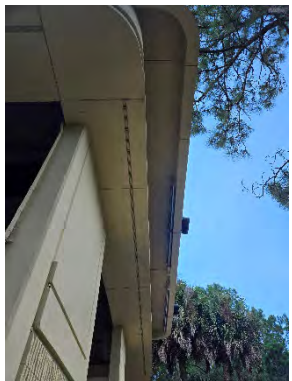
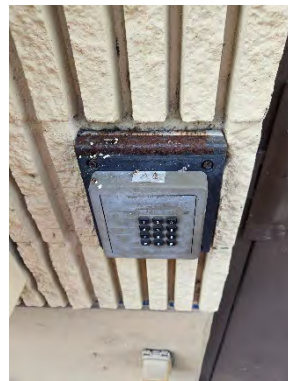
- Stains and dirt buildup on façade and under the canopy. (*Figure 94 and 95*)
- Keypad security in poor condition. (*Figure 96*)
- Shrub buildup next to drainage area. (*Figure 97*)
- Signs of dirt, mold, and stain on doors. (*Figure 98, 99, and 100*)
- ACT damaged and disheveled. (*Figure 101*)
- Floor in poor condition. Parts missing, stained, or cracked. (*Figure 102, 103, and 104*)
- Walls stained, cracked, or peeling off. (*Figure 105, 106, 107, and 108*)
- Equipment dented. (*Figure 109*)

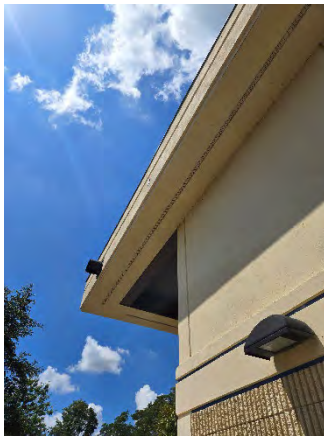
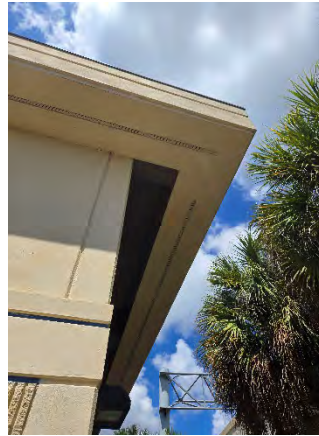
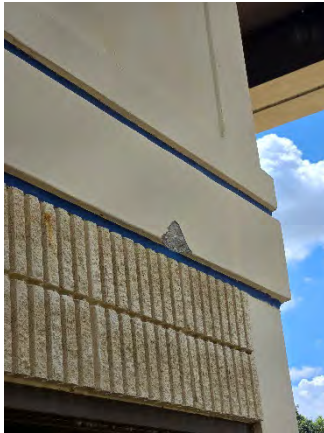
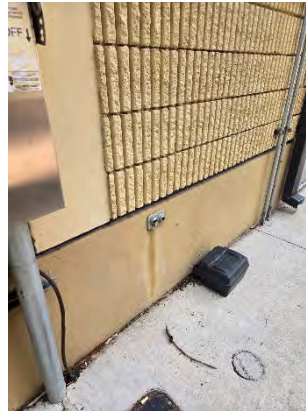
Figure 46 Ortman Mercy Drive Ramp On

- Cracks along façade and debris buildup under the canopy. (*Figure 46, 47, 48, and 49*)
- Signs on leakage along base of wall. (*Figure 50*)
- Barrier cracked. (*Figure 51*)
- Tape from repaint not removed - slowly peeling off. (*Figure 52*)
- ACT stained, possible leak. (*Figure 53*)
- Floor scratched, stained, and dirty. (*Figure 54, 55, 56, 57, and 58*)
- Door shows signs of mold. (*Figure 59*)

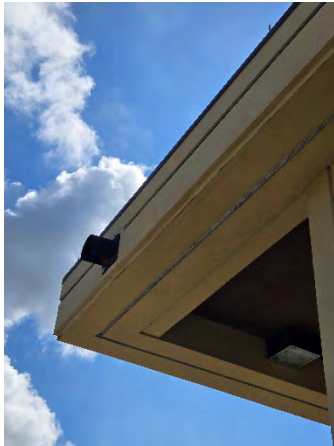
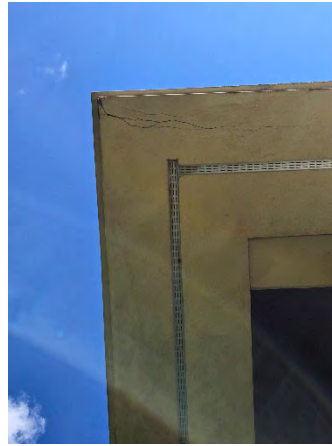
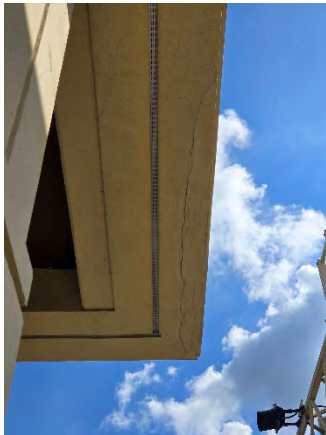
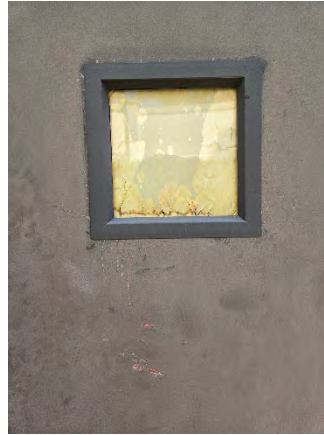
Figure 60 John Young Parkway Ramp Off

- Large cracks along underside of canopy, focused on corners. (*Figure 60, 61, 62, and 63*)
- Film cracking behind door window panel. (*Figure 64*)
- Cables/wires coming off wall. (*Figure 65*)
- Vent cover and ACT stained. (*Figure 66*)
- Floor scratched, stained, and dirty. (*Figure 67, 68, 69, and 70*)
- Crack along wall. (*Figure 71*)

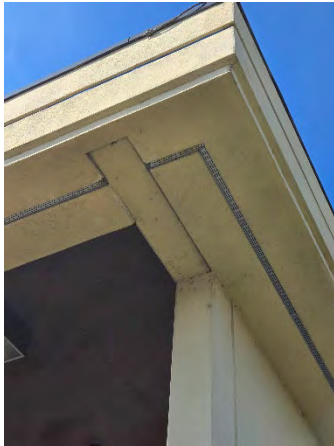
Figure 72 John Young Parkway Ramp On

- Cracks and leak signs along the façade. Canopy shows signs of wear and poor paint jobs. (*Figure 72, 73, 74, and 75*)
- Cracks on barrier. (*Figure 76*)
- Vent cover and ACT stained. (*Figure 77*)
- Floor scratched, stained, and dirty. Some tiles slightly disheveled. (*Figure 78, 79, 80, 81, 82, and 83*)
- Cracks along wall. Wall discolored (*Figure 84 and 85*)

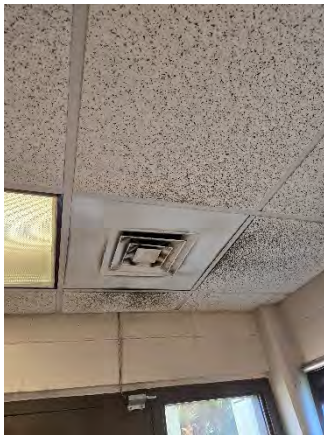
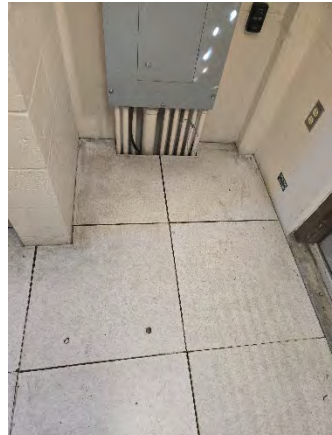
- Some water leak damage present on the façade as well as some cracks found on the barriers. *(Figure 77 and 78)*
- Exposed wires. *(Figure 79)*
- Floor tiles are damaged with some parts missing. *(Figure 80 and 81)*
- Substance on window frame. *(Figure 82)*
- Crack on bathroom wall. *(Figure 83)*
- Extinguisher out of date. *(Figure 84)*
- Crack above entry door. *(Figure 85)*

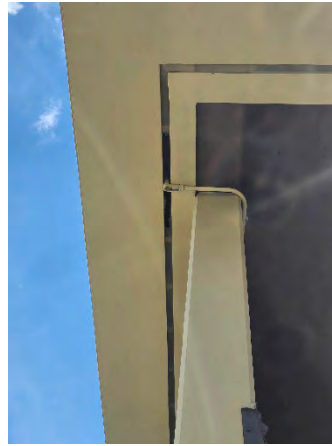
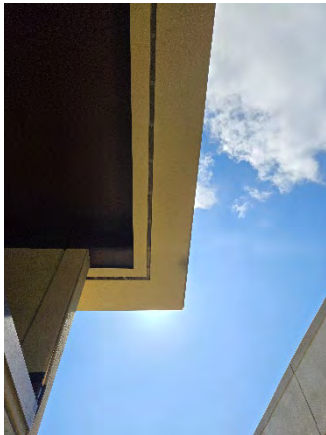
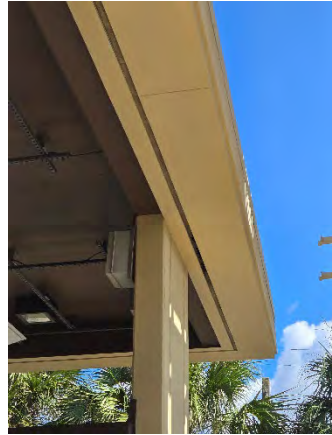
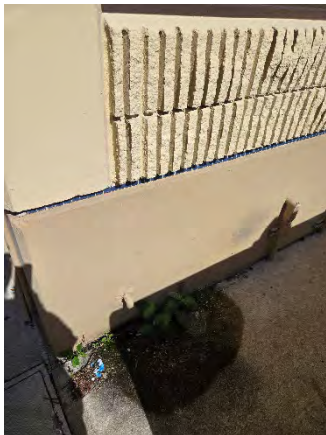
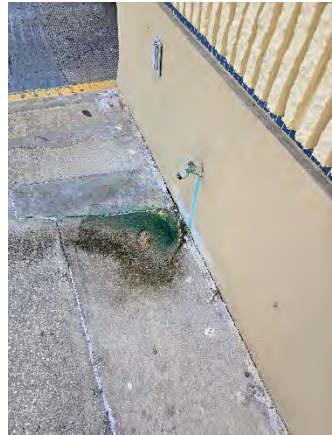
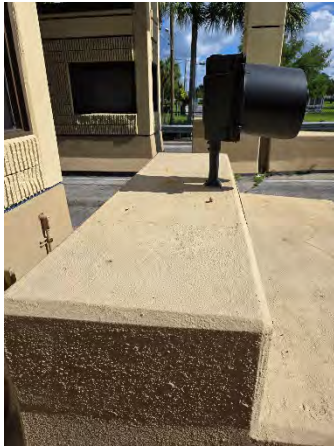
- The façade shows cracks at the base and columns and the canopy shows cracks around the soffit. Signs of damage along barriers as well. *(Figure 86, 87, 88, 89, 90, and 91)*
- Downspout dented. *(Figure 92)*
- Floor tiles in poor condition. *(Figure 93, 94, 95, 96, and 97)*
- Stains and paint bubbling/peeling along walls. *(Figure 98, 99, 100, 101, and 102)*

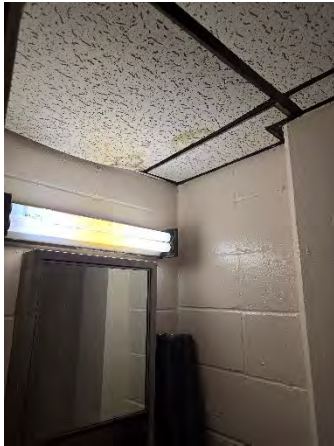
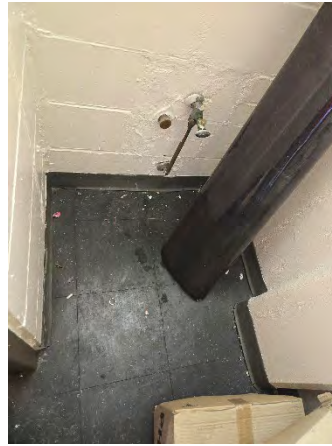
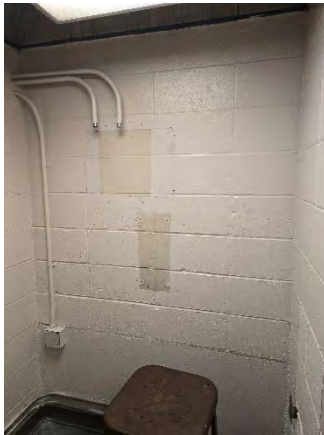
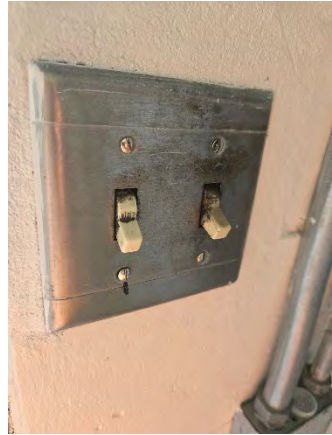
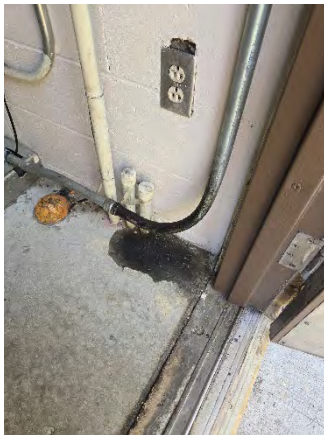
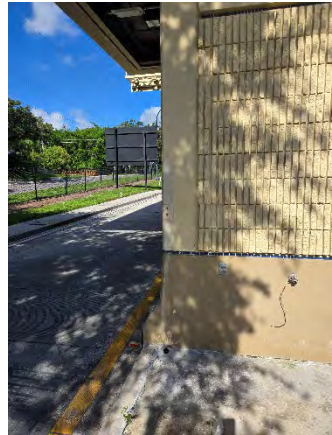
- The façade and canopy show cracks and overall poor condition on multiple areas. Wasp nests present in the canopy. Scupper missing. *(Figure 103, 104, 105, 106, 107, and 108)*
- Floor tiles in poor condition. *(Figure 109, 110, and 111)*
- Walls cracked, stained and paint peeling. *(Figure 112, 113, 114, 115, 116, 117, and 118)*
- ACT sinking. *(Figure 119)*
- Dented door hardware. *(Figure 120)*
- Damaged equipment. *(Figure 121)*

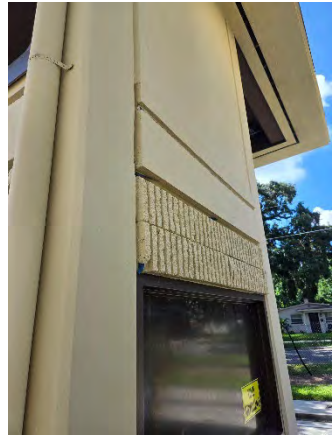
Figure 114 Mills Ramp Off

- Canopy façade and undercarriage completely removed/missing – cracks along corners of canopy and barriers. *(Figure 122, 123, 124, and 125)*
- Poor water drainage conditions. *(Figure 126)*
- Rusty electric lock mount. *(Figure 127)*
- Cracks and stains along walls with signs of mold. *(Figure 128, 129, 130, and 131)*
- Floor tiles cracked, stained, or missing. *(Figure 132, 133, 134, and 135)*

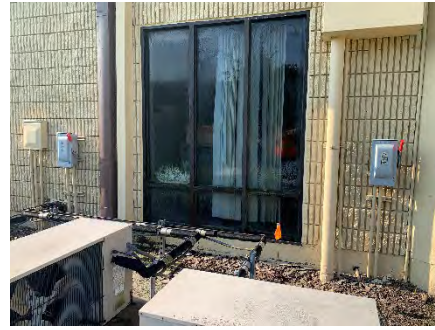
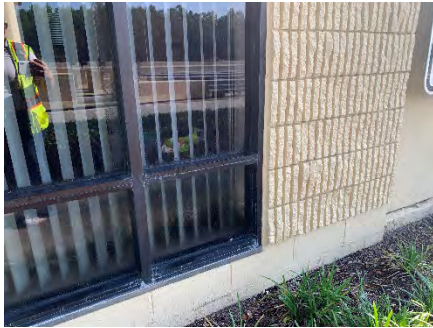
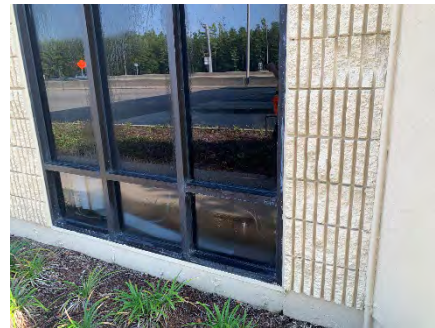
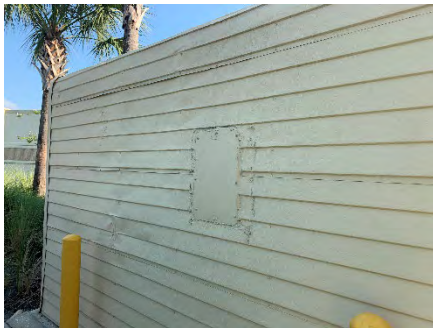
- Multiple cracks around exterior of building, including underside of canopy. *(Figure 1, 2, 3, 4, and 5)*
- HVAC system runoff pooling around back of facility. Piping not properly protected at join. *(Figure 6, 7, 8, and 9)*
- Downspout damaged. *(Figure 10 and 11)*
- Sign fading, Florida symbol missing. *(Figure 12)*
- Condensation on glass panels at entrance and windows. Some windows show algae. Signs of damaged sealant. *(Figure 13, 14, 15, and 16)*
- Hole patched on shed. *(Figure 17)*

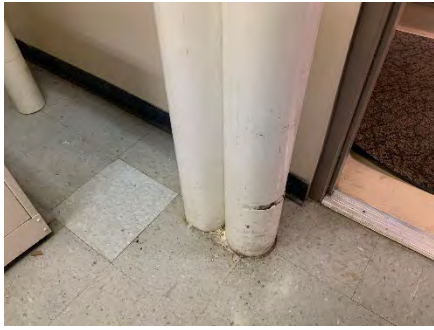
Figure 18 Dean Mainline

- Water damage near base board in mech room. Signs of paint bubbling and cracking in mechanical room. *(Figure 18)*
- Pipe cracked. *(Figure 19)*
- ACT throughout the facility shows signs of leaking and water damage. Multiple ACT missing or damaged. *(Figure 20, 21, 22, 23, and 24)*
- Wall, floors epoxy, and baseboards throughout facility damaged and dirty. *(Figure 25, 26, 27, 28, 29, 30, 31, and 32)*
- Film on window peeling off and taped up. Joint between window frame and wall damaged. *(Figure 33, 34, 35, and 36)*
- Water fountain not working. *(Figure 37)*
- Cover plate unscrewed. *(Figure 38)*
- Backsplash in kitchen separating from wall, signs of water damage. *(Figure 39 and 42)*
- Cracks through multiple walls and finishes in the facility. *(Figure 40 and 41)*

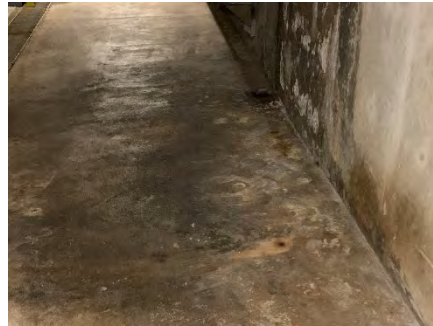
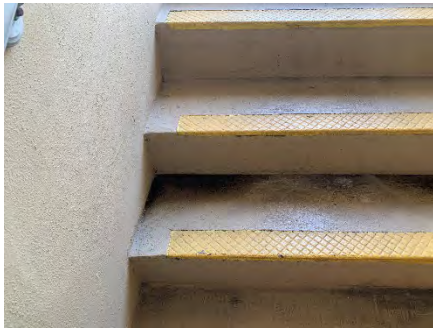
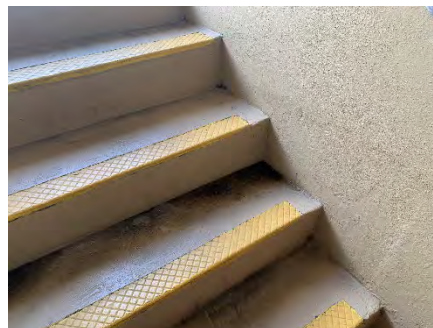
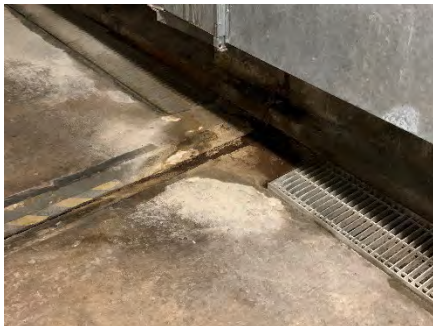
- Water pooling at multiple points of the tunnel. *(Figure 43, 44, 45, and 46)*
- Expansion joints deteriorating. *(Figure 47, 48, and 49)*

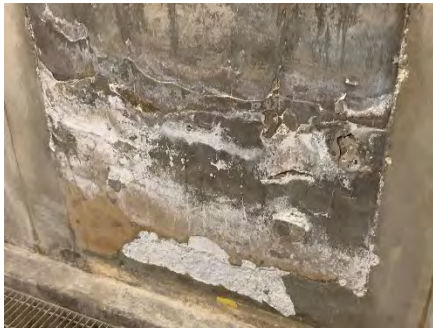
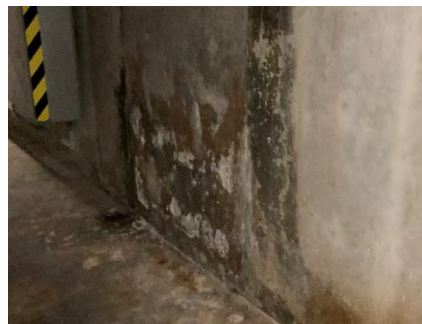
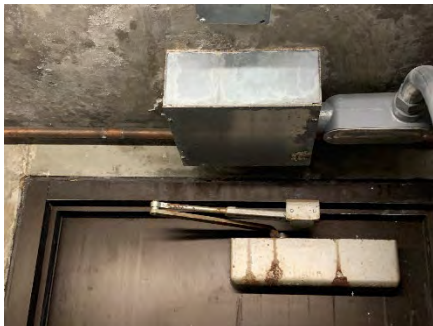
- Water leaking along the walls, from ceiling, and surrounding majority of doors. (*Figure 50, 51, 52, and 53*)
- Part of equipment cover unscrewing. (*Figure 54*)
- Cracked light. (*Figure 55*)
- Rusted equipment. (*Figure 56 and 57*)

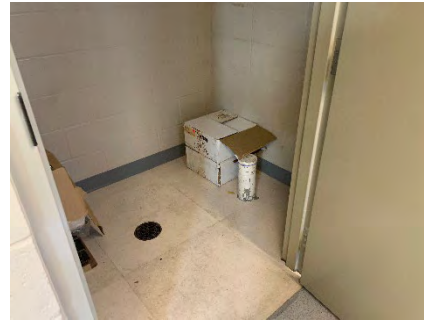
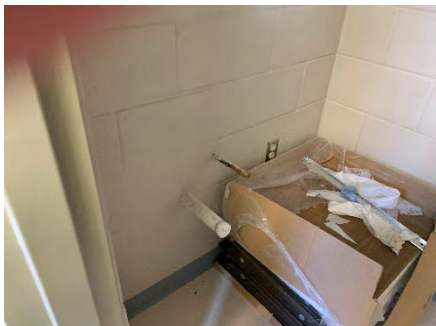
- The above referenced ramp is in good condition overall. (*Figure 91, 92, and 93*)
- Boxes with supplies in bathroom. (*Figure 94 and 95*)
- Light panel not fully inserted into ceiling grid. (*Figure 96*)
- Minor stains and scratches on floor, threshold missing. (*Figure 97 and 98*)
- Data room in overall good condition. (*Figure 99 and 100*)

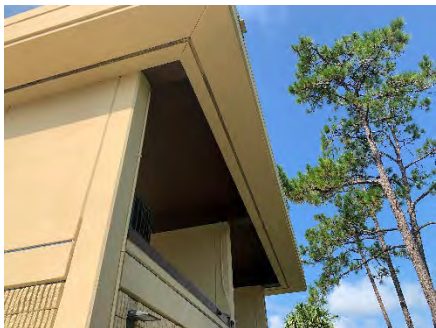
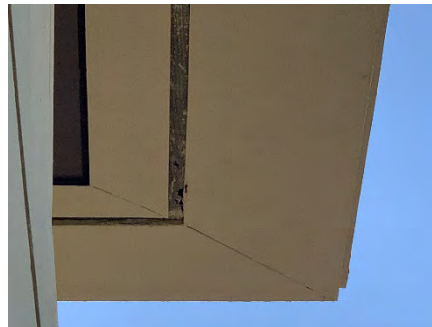
- Overall good exterior conditions. Soffit shows signs of damage. (*Figure 101 and 102*)
- Water pooling on exterior. Poor draining system. (*Figure 103*)
- Rusted keypad holder. (*Figure 104*)
- Paint bubbling and peeling on walls. Some cracks on walls as well. (*Figure 105, 106, 107, 108, and 109*)
- ACT in poor condition in restroom of main booth. (*Figure 110*)
- Equipment dented. (*Figure 111*)
- Floor tile broken and missing. (*Figure 112*)

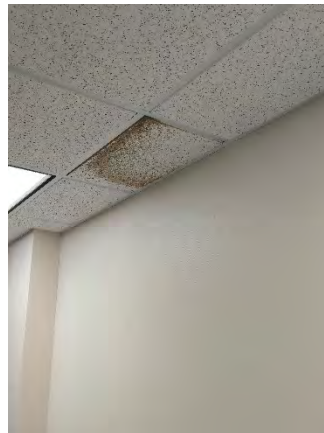
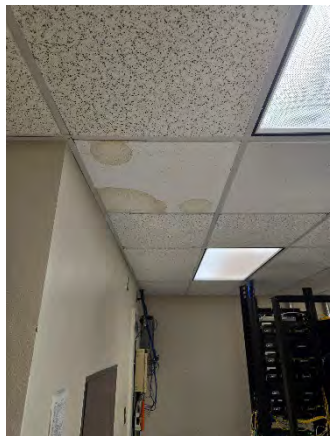
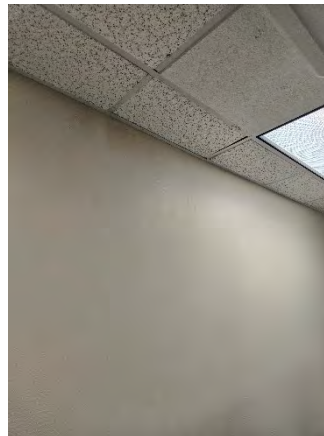
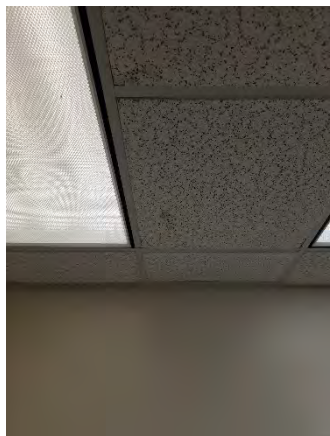
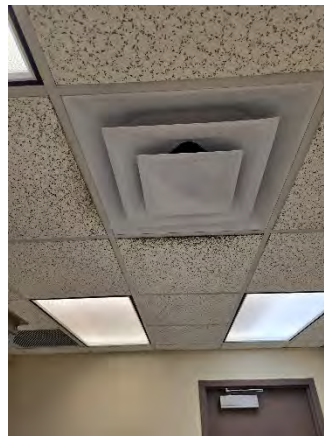
- Multiple ACT throughout North and South facility show signs of leaking. ACT damaged and disheveled. *(Figure 20, 21, 22, 23, and 24)*
- Paint peeling/missing on walls - some areas show signs of leakage or cracks. Plaster work on kitchen windows not sufficient - need to repair water damaged at windowsill. *(Figure 25, 26, 27, 28, 29, and 30)*
- Window cracked in supervisor room. Reported in previous years. *(Figure 31)*
- Backsplash behind sink in kitchen starting to separate from wall. *(Figure 32)*
- Toilet seats stained and in poor condition. *(Figure 33 and 34)*
- Floor in men's restroom separating from foundation in center of room. *(Figure 35)*
- Some doors throughout the facility show signs of damage and scratches. *(Figure 36 and 37)*
- One of the extinguishers is out of date. *(Figure 38)*

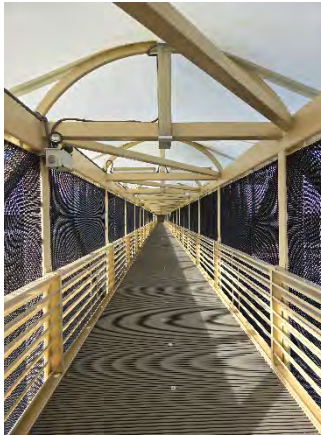
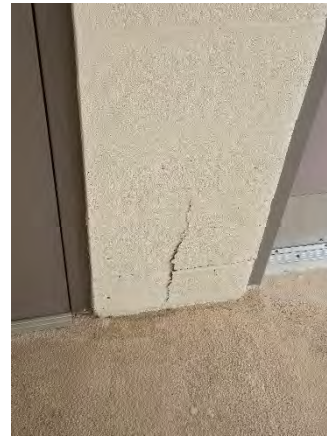
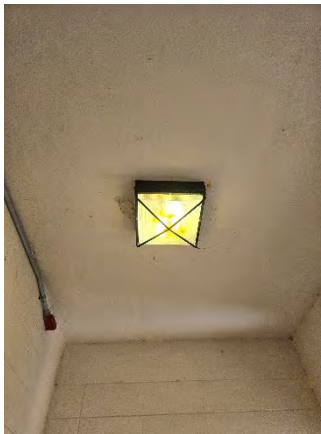
- Overall, overpass bridge is in good condition. Exterior and some parts within the interior needs to be cleaned. One crack showing on wall as you enter the overpass. *(Figure 39, 40, and 41)*

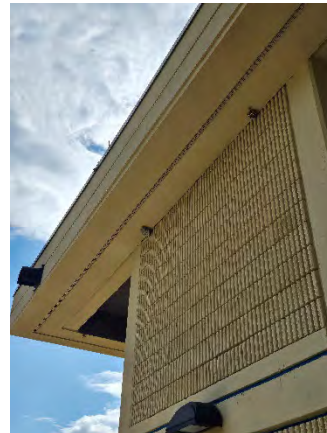
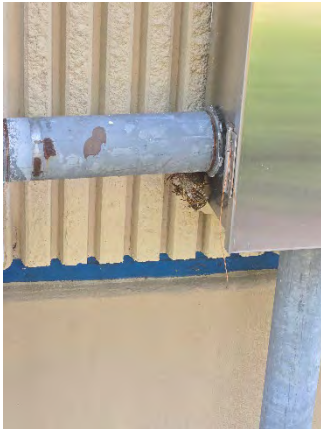
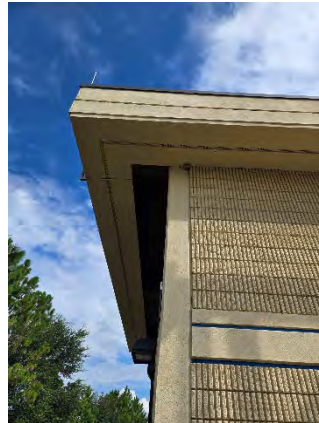
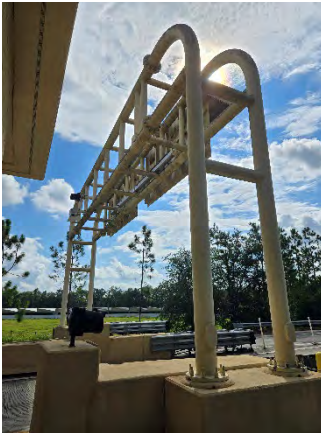
- Small cracks along underside of canopy, signs of water damage along edge. Wasp nests and insects surround exterior of facility. *(Figure 42, 43, and 44)*
- Back of signage still needs to be cleaned, mold and dirt build up. *(Figure 45)*
- Door scratched and stained. *(Figure 46)*
- ACT shows signs of leaking in main booth. *(Figure 47)*
- Floor tiles scratched and stained. *(Figure 48)*
- Boxes of equipment in data room. Maintenance present on site. *(Figure 49 and 50)*

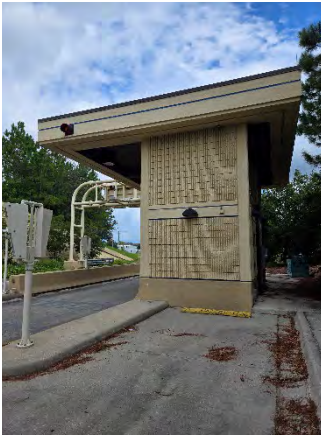
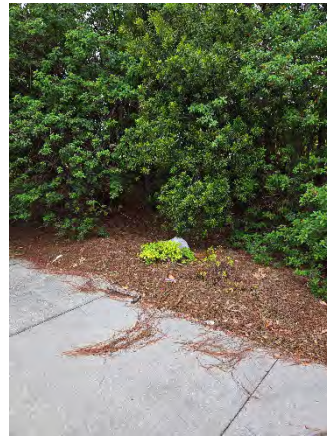
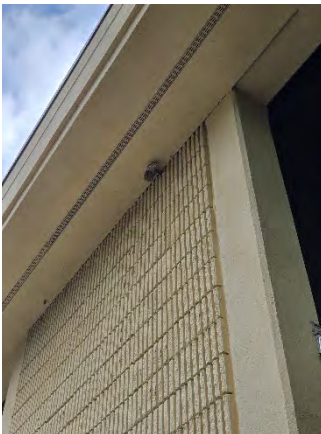
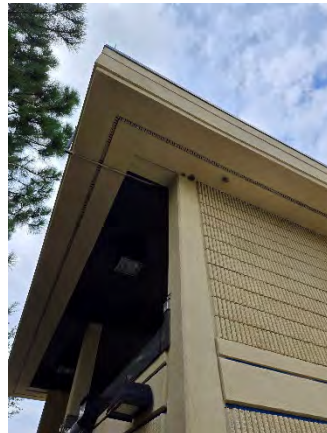
- Small debris buildup on site. *(Figure 51 and 52)*
- Corner of canopy shows signs of wear, small cracks along underside. Wasp nests and insects along underside of canopy. *(Figure 51, 52, 53, and 54)*
- Signs of leakage along façade under window. *(Figure 55)*
- Back of signage still needs to be cleaned, mold and dirt build up. *(Figure 56)*
- Dented downspout. *(Figure 57)*
- Some floor tiles stained and scratched. *(Figure 58 and 59)*

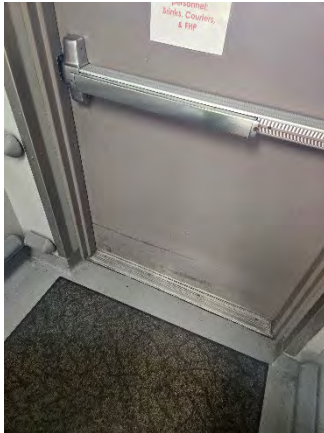
Figure 1 John Young Pkwy Mainline

- Exit door missing kick-plate. *(Figure 1)*
- Wall in Technicians rooms show signs of water damage along base. *(Figure 2)*
- ACT throughout facility slightly disheveled and dated. ACT stain in data room could indicate leaking. Vents in both men's and women's restroom displaced with sagging ACT. *(Figure 3, 4, and 5)*
- Window in locker room shows signs of water damage -wallpaper peeling from wall above window. *(Figure 6 and 7)*

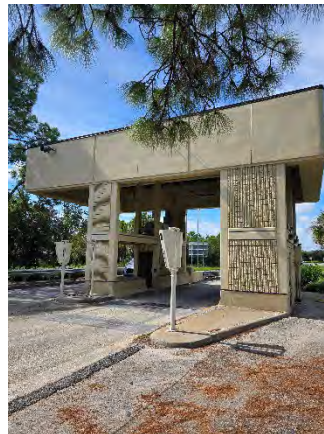
Figure 16 John Young Pkwy Ramp-Off

- Exterior in overall good condition – needs to be cleaned of debris and staining. *(Figure 16)*
- ACT throughout interior stained and disheveled. *(Figure 17)*
- Interior of main booth and data room very unclean, with floor panels in poor condition. Walls stained with signs of leaking around piping. *(Figure 18 - 21)*

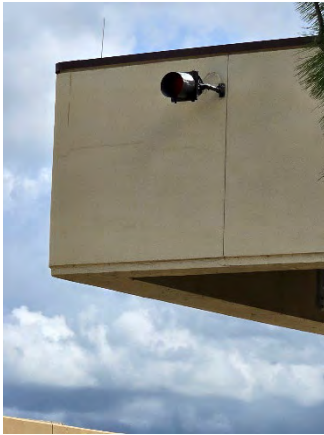
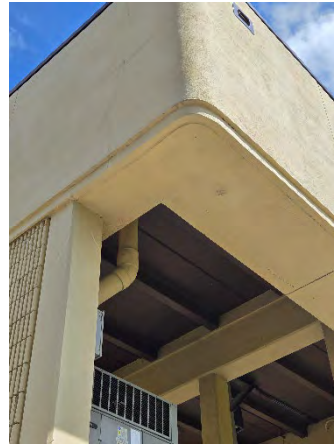
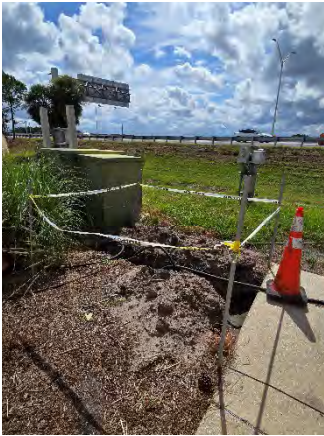
Figure 42 Landstar Ramp-On

- Cracks remain along canopy façade, and around corners of canopy and columns. *(Figure 42, 43, and 44)*
- Construction on site near generator. *(Figure 45)*
- Rusting remains around window frame exterior. *(Figure 46 and 47)*
- ACT showing signs of possible leaking in both main booth and data room. Ceiling and floor tiles damaged and displaced. *(Figure 48, 49, and 50)*

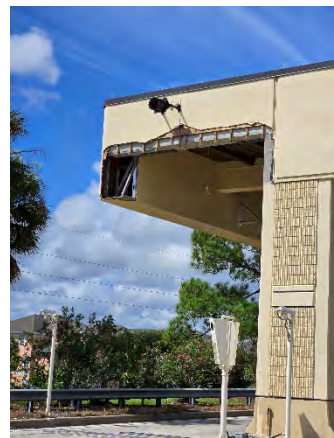
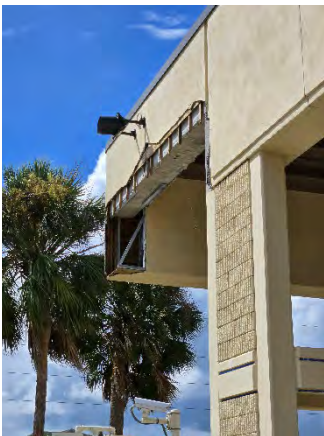
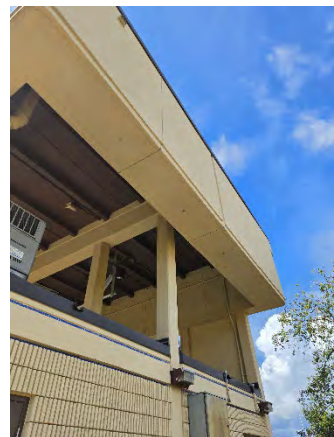
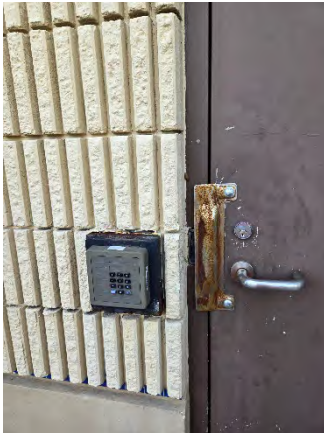
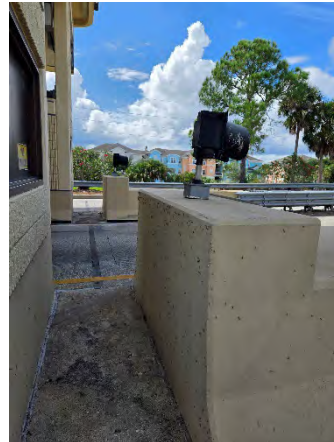
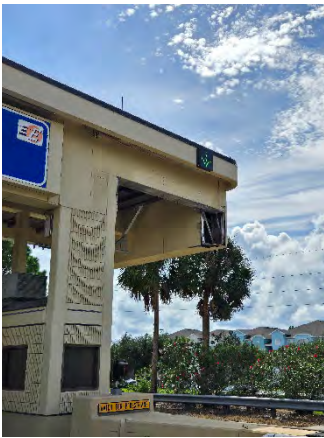
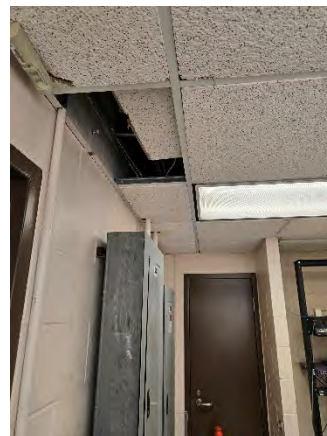
Figure 51 Landstar Ramp-Off

- Cracking remains along columns, with debris along exterior. Extensive damage from reported accident along canopy. *(Figure 51 - 57)*
- ACT disheveled and damaged in main booth. *(Figure 58)*
- Signs of leaking and rust along window. *(Figure 59)*
- Signs of leaking above ACT and along piping in data room. *(Figure 60)*

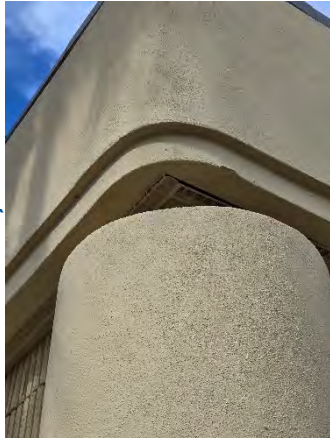
Figure 1 Boggy Creek Mainline

- Cracks and damage along soffit of main building, soffit separating from exterior at corners and South façade (*Figure 1, 2, and 3*)
- Wall of shed deteriorating along bottom. (*Figure 4*)
- Poor drainage from HVAC unit as well as refrigerant structure behind building. (*Figure 5*)
- Exterior mount has a dent. (*Figure 6*)
- Exterior window joint sealant is in poor condition. (*Figure 7*)
- Change in elevation at entrance carpet. (*Figure 8*)

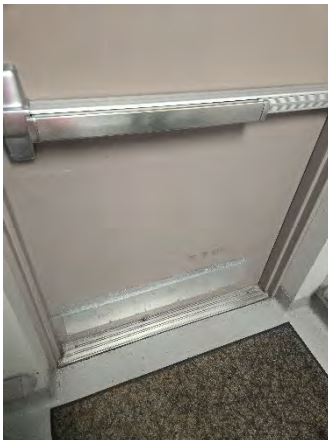
Figure 9 Boggy Creek Mainline

- Kickplate damaged. (*Figure 9*)
- Multiple ACT Tiles disheveled, damaged or with potential leaks, and vent is missing cover. (*Figure 10, 11, 12, 13, 14, 15, and 16*)
- Multiple vent covers are rusted. (*Figure 17 and 18*)
- Potential leaks at urinals. (*Figure 19*)
- Fridge in the break room is rusted. (*Figure 20*)
- Baseboards in bad conditions. (*Figure 21 and 22*)
- Small part of hall wall missing finish. (*Figure 23*)

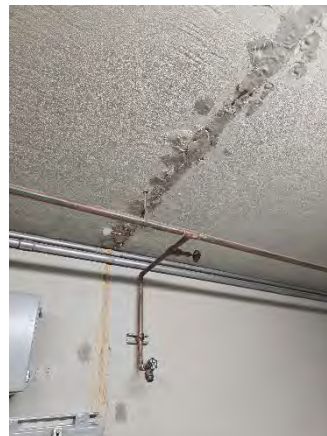
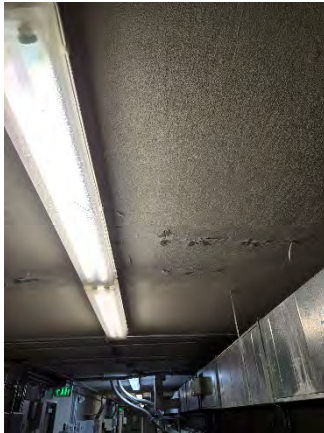
- Seal appears to be failing on expansion joint. (*Figure 24 and 25*)
- Cracks along tunnel floor. (*Figure 26*)

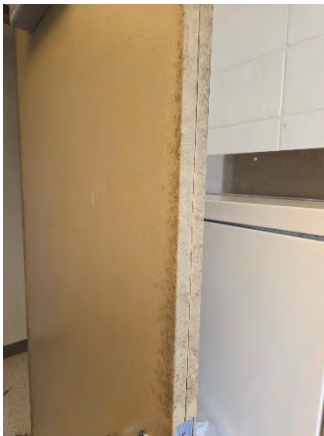
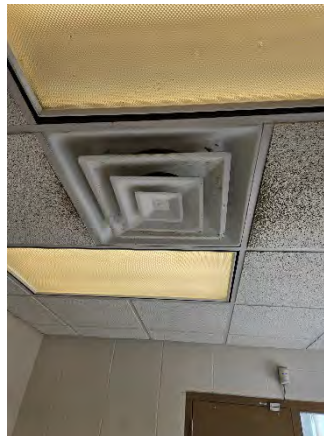
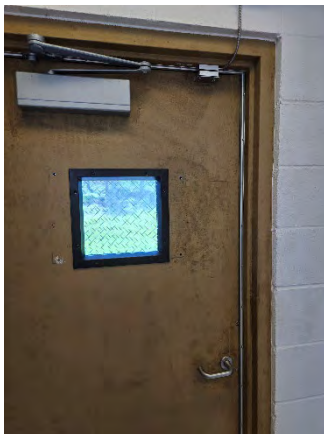
- Ramp shows evidence of mold cultivating inside booth, general maintenance to pressure wash plaza exterior and cover the vent is recommended. *(Figure 27, 28, and 29)*
- Sun visor damaged, causing room to be above recommended temperature for equipment. *(Figure 30)*
- Floor panels damaged and disheveled in data room as well as missing vent. *(Figure 31)*

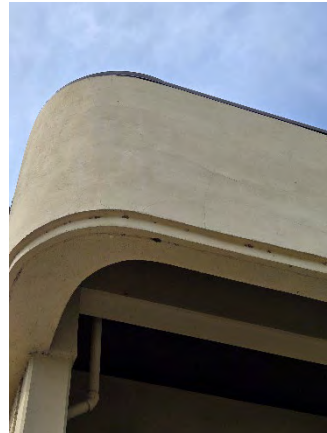
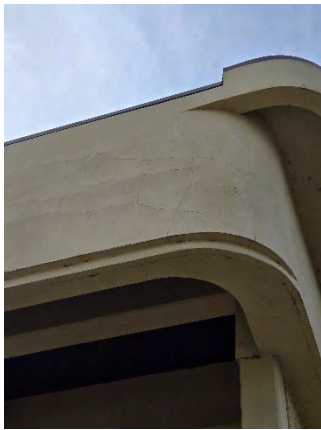
- Exterior canopy and building facade have identified cracks surrounding entire structure. *(Figure 32 and 33)*
- Rusty control panel to open door. *(Figure 34)*
- Multiple signs of leaking above ACT. Discolored, disheveled, misplaced, and missing ACT throughout booth and data room. *(Figure 35, 36, 37, 38, 39, and 40)*

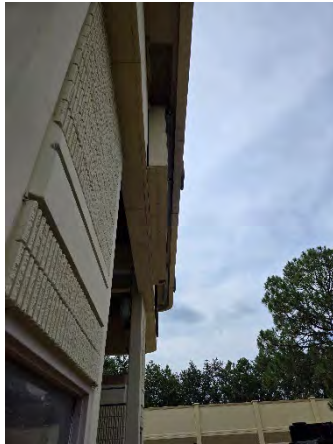
Figure 78 Narcoossee Ramp On

- Exterior façade, bottom of the canopy and corner have visible cracks. *(Figure 76, 77, 78, and 79)*
- Window seal in poor condition - needs to be painted; exterior needs to be pressure washed. *(Figure 80 and 81)*

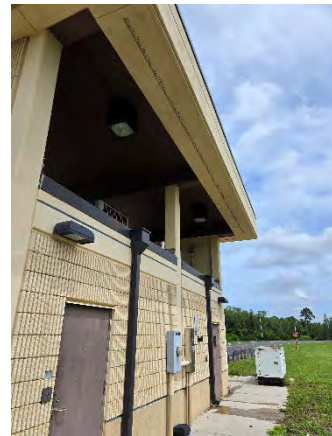
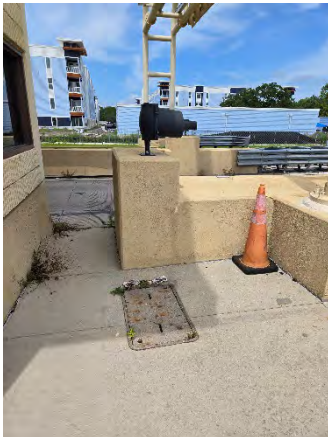
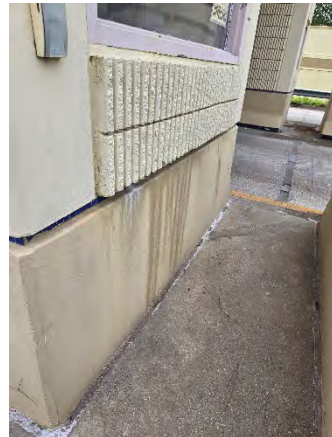
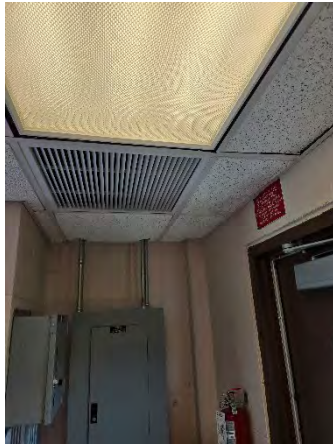
Figure 88 Moss Park Ramp Off

- Exterior façade and bottom of the canopy have visible cracks and water damage. Some general maintenance to pressure wash plaza overhead sign structure is recommended. *(Figure 87, 88, 89, and 90)*
- Possible leaks in several ACT. *(Figure 91 and 92)*
- Floor tiles stained, disheveled and dirty. *(Figure 93, 94, and 95)*
- HVAC Punctured *(Figure 96)*
- Temperature not suitable for equipment – supervisor reported on day of inspection.

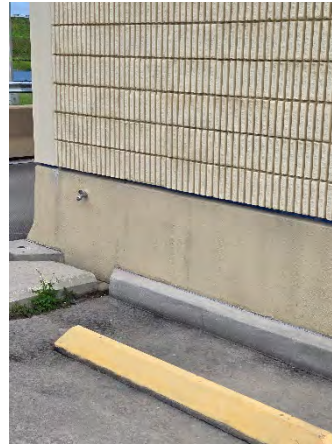
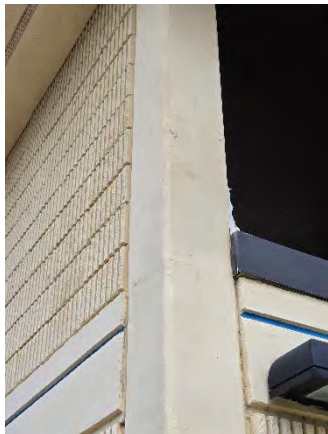
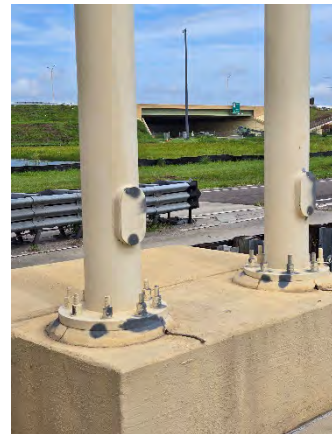
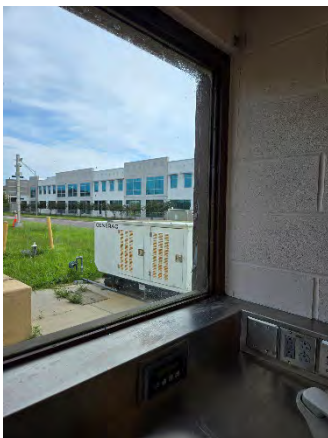
Figure 98 Moss Park Ramp On

- Exterior façade and canopy have visible cracks. Some general maintenance to pressure wash plaza. *(Figure 97, 98, 99, and 100)*
- Moisture on windows and signs of mold. *(Figure 101 and 102)*
- Possible leak in ACT, and debris left in data room. *(103, 104, 105, and 106)*
- Stains and damage on walls. *(Figure 107, 108, and 109)*
- Temperature not suitable for equipment – supervisor reported.

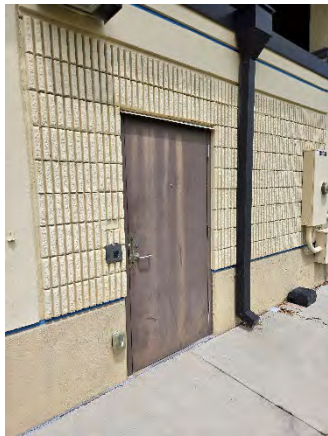
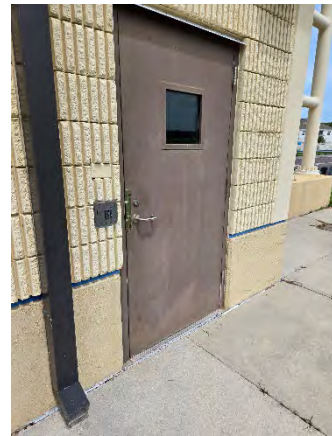
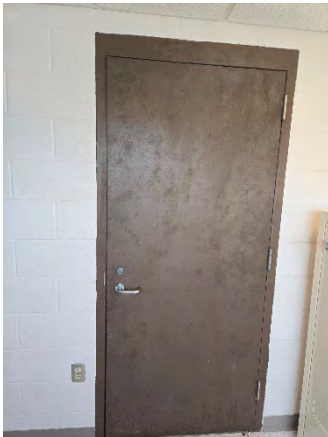
Figure 111 Innovation Way Ramp Off

- The above referenced ramp is in good condition overall. Façade has some slight cracks and doors need to be painted. Some general maintenance to pressure wash plaza overhead sign structure. *(Figure 110, 111, and 112)*
- Mold present on door inside booth. *(Figure 113 and 114)*
- ACT show signs of leaking, mold, and mildew. *(Figure 103, 104, and 105)*

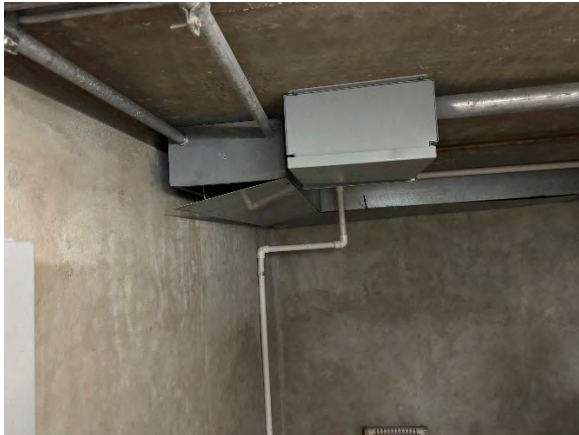
Figure 30 Curry Ford Mainline

- Expansion joint in poor condition. *(Figure 23)*
- Severe leaks throughout tunnel. Leak appears to be behind panel, as well ceiling joint falling apart. *(Figure 24, 25, and 26)*
- Water pooling at different areas. Poor drainage. *(Figure 27, 28, 29, and 30)*
- Equipment on ceiling not secured as well as stains on door frame. *(Figure 31 and 32)*

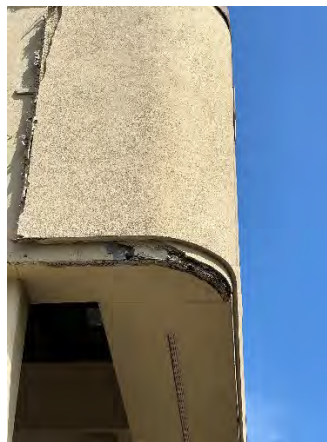
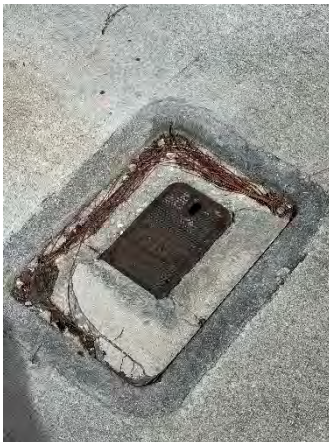
Figure 33 Lee Vista Ramp On

- Back cover of canopy has been removed/damaged, with multiple cracks along corner of canopy. *(Figure 33 and 34)*
- Cracks along floor. Tripping hazard. *(Figure 35 and 36)*
- Breaker tripped. *(Figure 37)*
- Signs of leakage along façade. *(Figure 38)*
- Door damaged. *(Figure 39)*
- Walls stained and cracks showing above frame of window. *(Figure 40 and 41)*
- Misplaced items through the room. *(Figure 42, 43, and 44)*
- Stained floor tiles. *(Figure 45)*

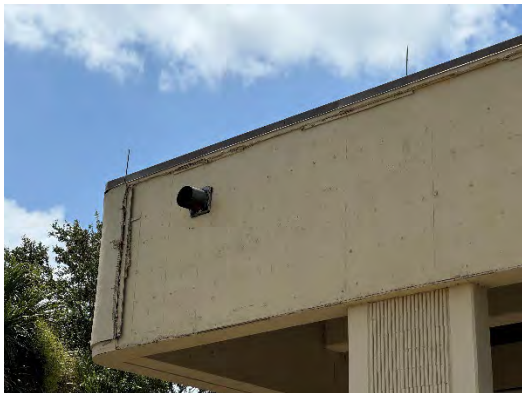
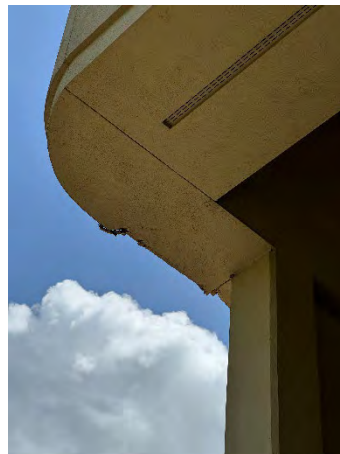
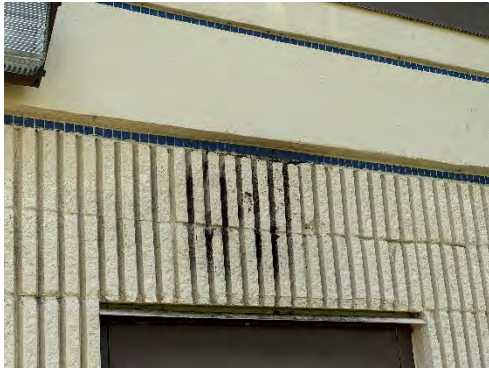
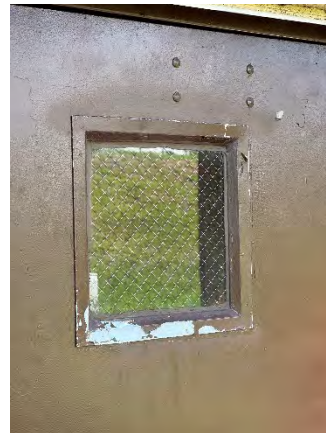
Figure 46 Lee Vista Ramp Off

- Cracking and missing components of façade around canopy. Stains on façade. *(46, 47, 48, and 49)*
- Door to main booth damaged. *(Figure 50 and 51)*
- Breaker tripped. *(Figure 52)*
- Crack on floor. Tripping hazard. *(Figure 53)*
- Damaged barrier. Misplaced keys on it. *(Figure 54 and 55)*
- Misplaced items throughout booths. *(Figure 56, 57, and 58)*
- ACT caving out and showing slight signs of leakage. *(Figure 59 and 60)*
- Pipe connection fixed with a kind of tape. Paint peeling from pipes. *(Figure 61 and 62)*
- Cracks along the walls. *(Figure 63, 64 and 65)*
- HVAC vent cover missing. *(Figure 66)*

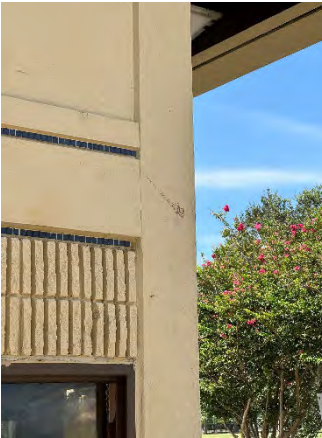
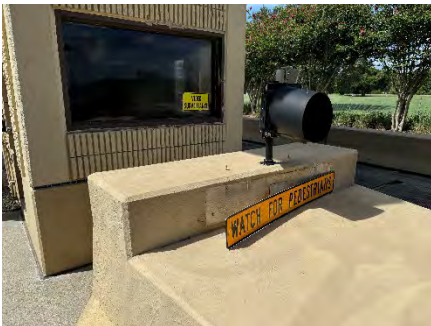
Figure 67 Curry Ford Ramp Off

- Cracking and damage along soffits of entire canopy perimeter. Facade shows cracks and some stains. *(Figure 67, 68, 69, and 70)*
- Sign unscrewed. *(Figure 71)*
- Electrical equipment unit dented. *(Figure 72)*
- Door and door frame show signs of leaks and damage. *(Figure 73 and 74)*
- Window frame in poor condition. *(Figure 75)*
- ACT in very poor condition. *(Figure 76 and 77)*
- Cracks, stains, leaks, and mold along the walls. *(Figure 78, 79, 80, 81, 82, and 83)*

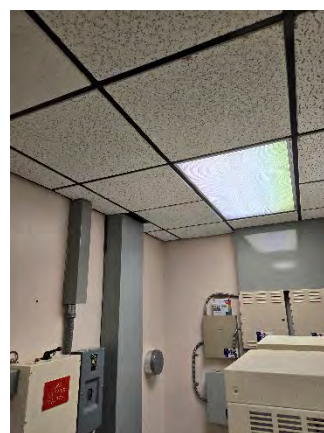
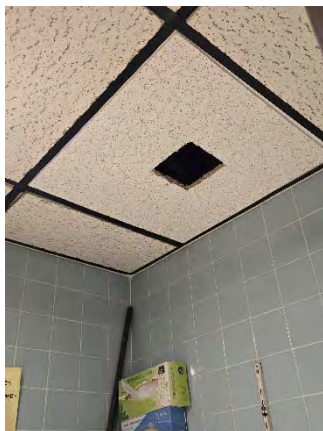
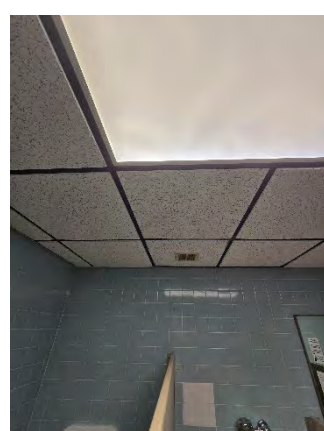
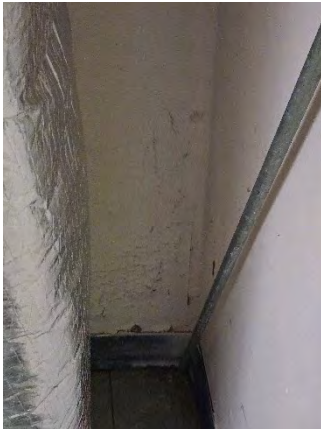
Figure 9 University Mainline

- Exposed equipment. *(Figure 7)*
- Discolored and damaged ACT throughout facility, ACT shows signs of possible leak in Men's Restroom *(Figure 8, 9, 10, 11, and 12)*
- Paint and finishes peeling off at multiple areas. *(Figure 13, 14, 15, 16, 17, and 18)*
- Windowsill of breakroom shows signs of leaking, water damage along wall of sink. *(Figure 19 and 20)*
- Window sealant peeling off. *(Figure 21)*

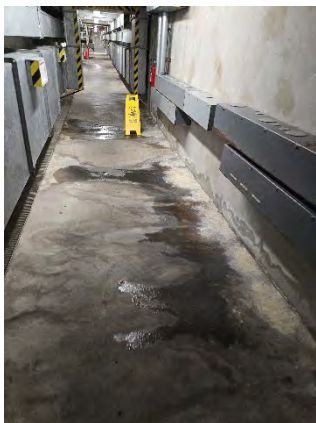
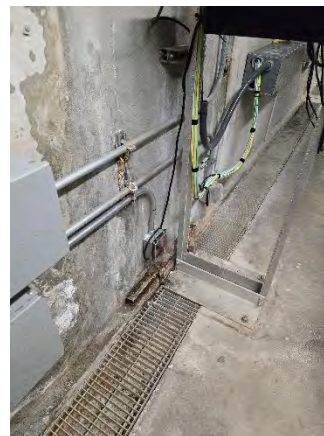
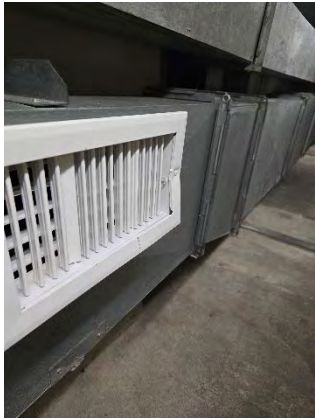
Figure 22 University Mainline

- Tunnel shows multiple signs of leaking. Active leak on equipment at back end of tunnel. *(Figure 22, 23, and 24)*
- Some vents are dented. *(Figure 25 and 26)*
- Equipment covered in black tarp. *(Figure 27)*

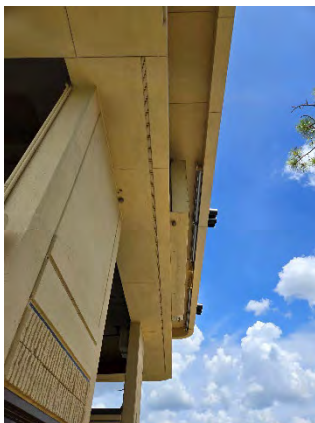
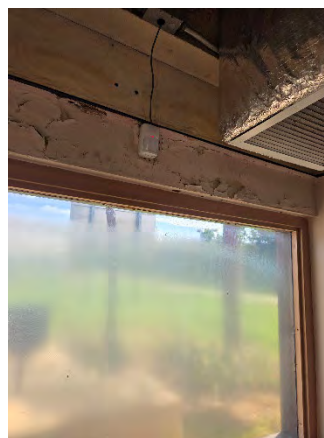
Figure 28 Colonial Ramp On

- Overall good exterior condition with the presence of some small cracks and wasp nests. *(Figure 28 and 29)*
- Multiple cracks and damages on walls and floor tiles. *(Figure 30, 31, 32, 33, 34, 35, and 36)*
- Door is missing seal. *(Figure 37)*
- ACT shows signs of leaking in restroom. *(Figure 38)*
