Central Florida Expressway Authority

ANNUAL INSPECTION REPORT

FY 2025

Re: FY 2025 Annual Inspection Report

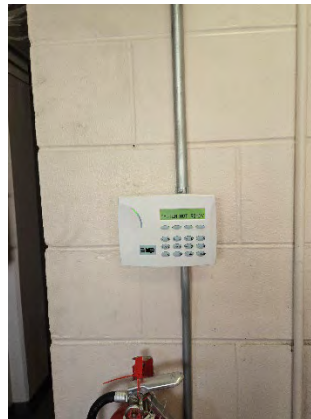
Figure 39 Colonial Ramp Off

- Overall good exterior condition. Pressure washing is recommended to clean some of the exterior. *(Figure 39)*
- New alarm system, old system still installed. *(Figure 40 and 41)*
- Hole that creates exposure to exterior. *(Figure 42)*
- ACT damaged, ceiling shows multiple signs of leaking throughout booth and data room. *(Figure 43, and 44)*
- Multiple cracks throughout booth and data room, most prominent in restroom and ceiling of data room. *(Figure 45, 46, and 47)*
- Misplaced equipment. *(Figure 48 and 49)*

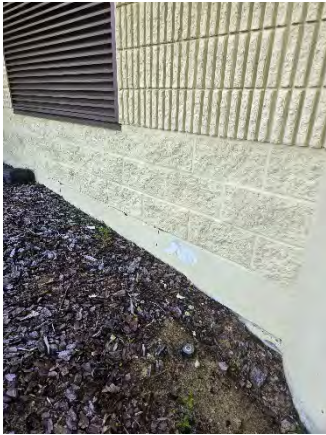
Figure 1 Independence Mainline

- Cracking and peeling paint on building façade and columns. *(Figure 1, 2, 3, and 4)*
- Plaza canopy shows signs of leaking. Façade cracked. *(Figure 5, 6, 7, and 8)*
- Rusting around stair railing connection to pavement. *(Figure 9 and 10)*
- Loose items/tripping hazards. *(Figure 11 and 12)*
- Water damage/intrusion at base of column and wall joint. *(Figure 13)*
- Hornets' nest at soffit. *(Figure 14)*
- Station sign has faded. *(Figure 15)*
- Counter finish missing at transaction desk. *(Figure 16)*
- Poorly sealed door. *(Figure 17 and 18)*
- Louver to be painted. *(Figure 19)*

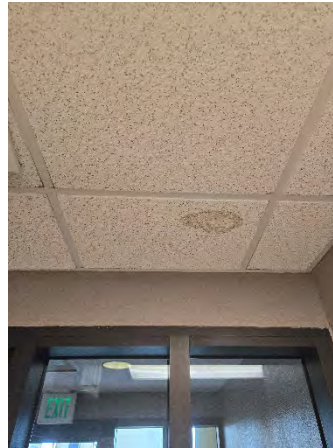
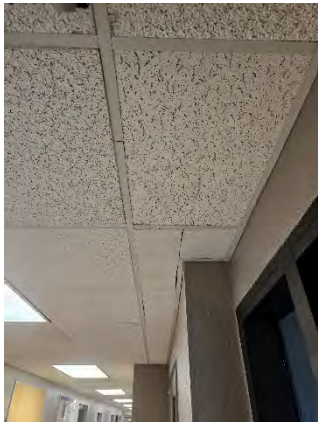
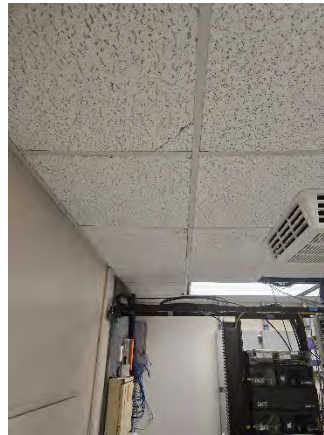
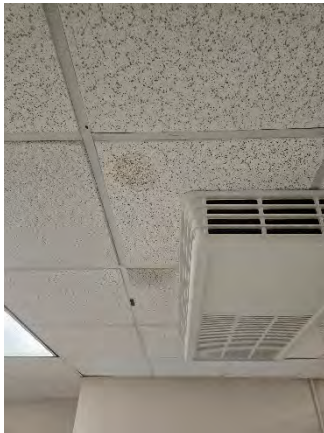
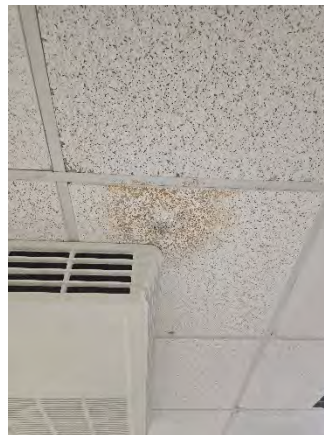
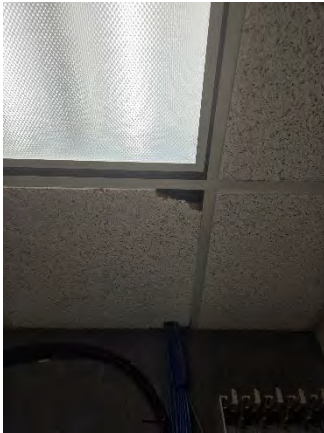
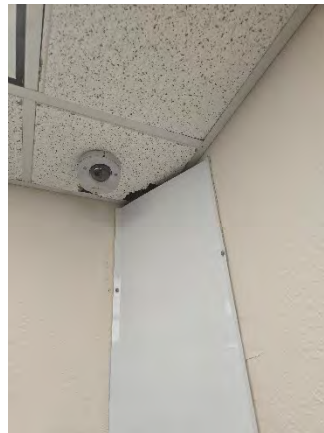
- Facility has damaged ceiling tiles with signs of leakage throughout facility. *(Figure 20, 21, 22, 23, 24, 25, and 26)*
- Air vents rusted and disheveled. *(Figure 27, 28, 29, and 30)*
- Floor tiles throughout facility are stained and dirty. *(Figure 31, 32, 33, 34, 35, 36, and 37)*
- Ceiling laminate missing. *(Figure 38)*
- Door and corner of walls show signs of damage. *(Figure 39 and 40)*
- Access panel found open. *(Figure 41)*
- Fridge in breakroom has a rusted door. *(Figure 42)*
- Seals of window are coming off. *(Figure 43 and 44)*
- The attendant booth has stains on walls, water damage, mold and cracks. *(45, 46, 47, 48, and 49)*
- Leaks on walls and cracks on ceiling in stairwell. *(Figure 50, 51, and 52)*
- Note that there was a strong smell coming from both the men's and women's restroom. *(Not photographed)*

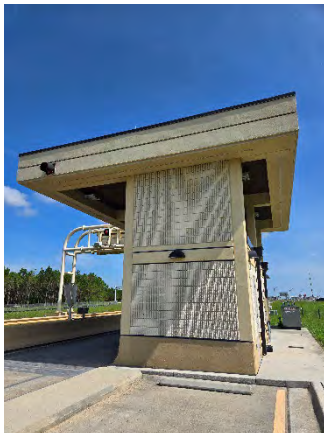
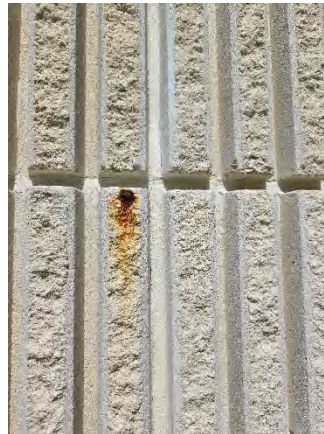
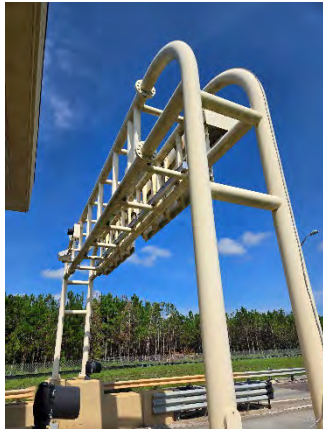
- Water and dirt stains on façade and signage structure. *(Figure 53, 54, and 55)*
- Possible leak on interior, ACT discolored and missing. *(Figure 56)*

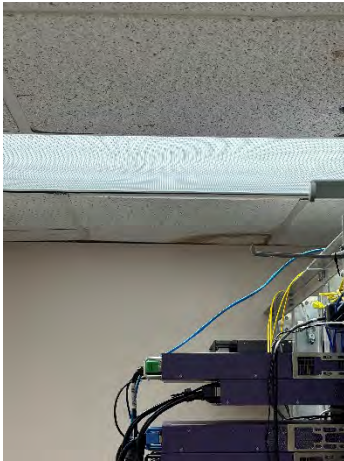
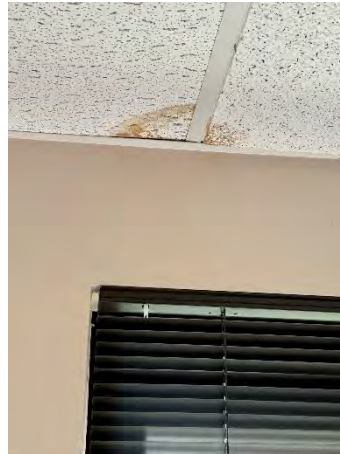
Figure 1 Forest Lake Mainline

- Signs remain of leaking above ACT in data room and recording room – stains larger than last year's inspection (*Figure 1, 2*)
- Water damage remains surrounding windows in breakroom and manager office (*Figure 3 - 5*)
- Sealant along sinks in break room and men's restroom failing – signs of water damage along backsplash (*Figure 6, 7*)
- Room name/sign missing (*Figure 8*)
- Crash guards disconnected from wall and missing end caps (*Figure 9*)
- Counting Room door still in poor condition (*Figure 10*)

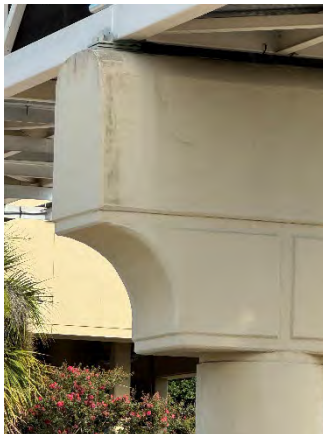
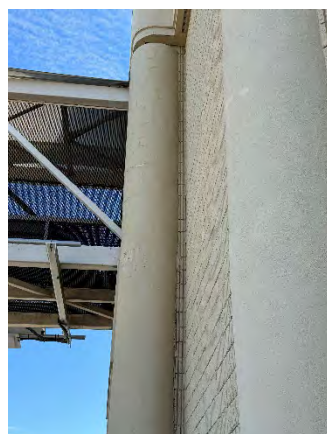
Figure 11 Forest Lake Mainline

- Small cracks remain surrounding bridge support, paint peeling off overpass columns with multiple cracks (*Figure 11, 12*)
- Walkway of overpass is still unsteady, and multiple clips between grates remain loose or completely dislodged - no handrails or guards on sides (*Figure 13, 14*)
- Debris along underside of canvas cover and within light boxes (*Figure 15, 16*)

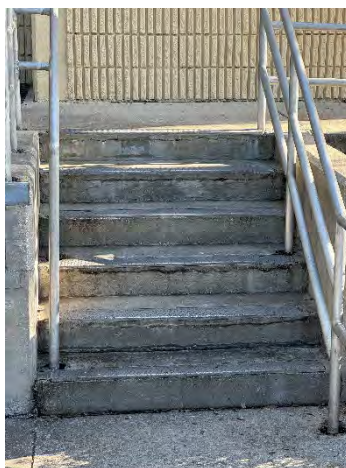
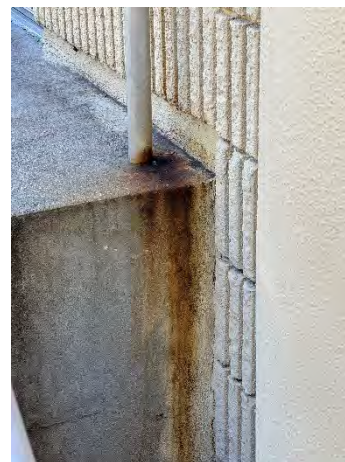
Figure 17 Forest Lake Mainline

- Stairs at loading dock and back exit show signs of wear and rust staining around rail (*Figure 17, 18*)
- Columns still show signs of damage, paint peeling from exterior with small cracks present (*Figure 19, 20*)
- Debris and wasp nests along exterior (*Figure 21, 22*)
- Exterior carpet lifting from floor (*Figure 23*)
- Canopy façade still cracking and peeling, with signs of water damage underneath. (*Figure 24 - 27*)
- Multiple cracks and signs of wear along exterior of East facility – dent in exterior above booth entry (*Figure 28 - 30*)

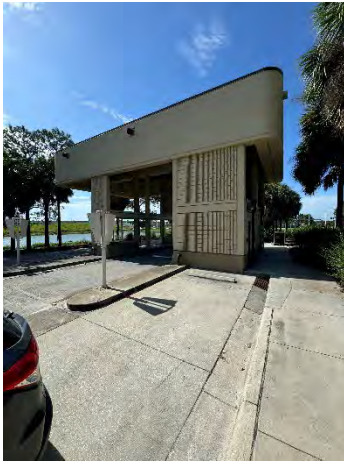
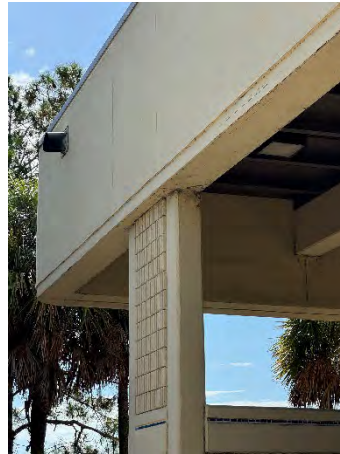
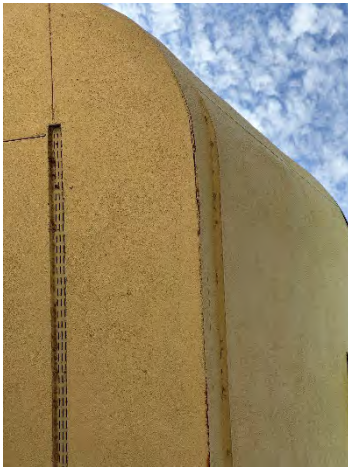
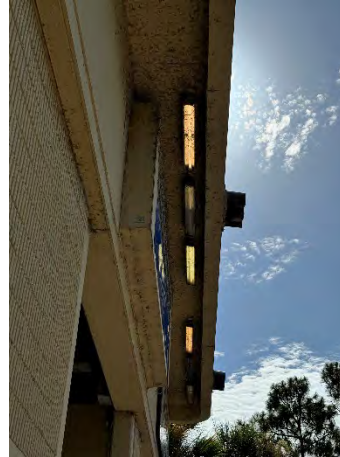
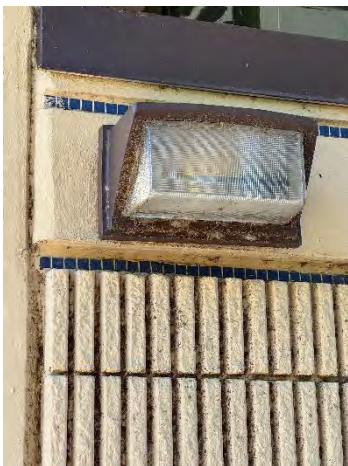
Figure 31 SR-438 Ramp On

- Façade and below canopy still need to be cleaned. Signs of water damage/rusting along underside and edge of canopy (*Figure 31 - 35*)
- Mildew present on exterior of windows (*Figure 36, 37*)
- Debris in restroom (*Figure 38*)
- Possible leak above ACT in main booth (*Figure 39*)
- Flooring in data room disheveled, otherwise room in overall good condition (*Figure 40*)

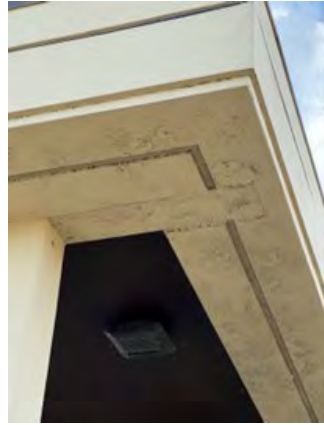
Figure 53 CR-437A Ramp On

- Exterior in overall good condition, signs of debris along underside of canopy (*Figure 53, 54*)
- Poor drainage from downspout – pooling on roof of structure. (*Figure 55*)
- Baseboard still peeling in data room – worse condition than reported last year (*Figure 56*)

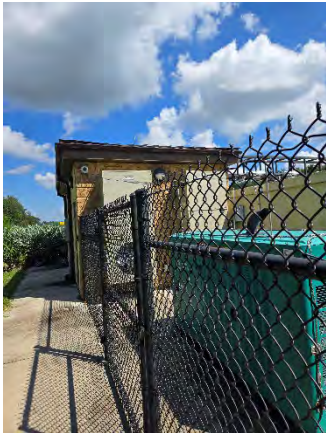
Figure 1 Coronado Gantry

- Equipment fastener unscrewed on one end. (*Figure 1*)
- Signs of drainage issue with stained floors. (*Figure 2*)
- Exterior needs to be cleaned, crack/damage still on columns. Overgrown landscaping to be addressed. (*Figure 3, 4, and 5*)
- Non-specified date of the month for fire extinguisher. (*Figure 6*)
- Sand buildup at the edges inside the building. (*Figure 7, 8, and 9*)

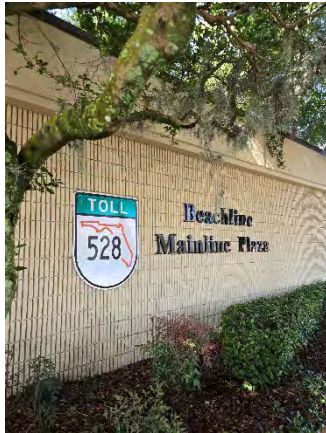
Figure 1 Beachline Mainline

- Sign has crooked letters; “i” and “e” not aligned (*Figure 1*)
- Railing at loading dock bent (*Figure 2*)
- Cracking along columns and exterior wall (*Figure 3, 4*)
- Water pooling from HVAC drainage (*Figure 5*)
- Rust and cracking along soffit, rust staining along exterior at weephole (*Figure 6 - 8*)
- Carpet missing at exterior door (*Figure 9*)
- Debris collected under canopy (*Figure 10*)

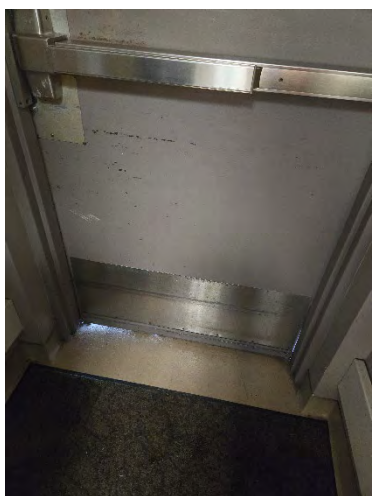
Figure 11 Beachline Mainline

- Seal on exit doors deteriorated (*Figure 11*)
- Transaction window peeling (*Figure 12*)
- Floor tile damaged throughout facility; concentrated in mechanical room (*Figure 13, 14*)
- Water damage around window in breakroom (*Figure 15*)
- Possible leak above ACT (*Figure 16*)
- Several doors damaged; counting room door missing paint, restroom door easily jammed and difficult to open (*Figure 17, 18*)
- Sinks in restrooms and breakroom show signs of water damage (*Figure 19, 20*)
- Doorstop impacted in front of vault, damage to wall (*Figure 21*)
- Stain/moisture along wall of supervisor office (*Figure 22*)

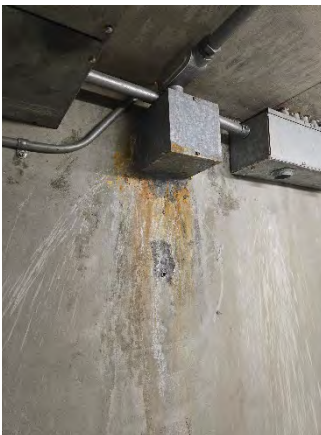
Figure 23 Beachline Mainline

- Signs of leaking/water damage in tunnel – present in same locations as reported in previous years (*Figure 23 - 25*)
- Expansion joints showing signs of water damage, cover midway through tunnel lifting from ground (*Figure 26, 27*)
- Insulation/barrier surrounding HVAC torn (*Figure 28*)
- Small crack along underside of canopy (*Figure 29*)
- Paint peeling/bubbling along interior of tunnel stairway and exterior of islands (*Figure 30*)

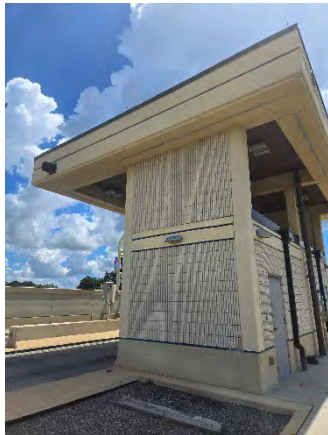
Figure 31 McCoy Ramp Off

- Water marks and staining along exterior facade (*Figure 31, 32*)
- Doors recommended to be repainted, booth door hard to open with scuff marks along frame and door (*Figure 33, 34*)
- Flooring in booth stained (*Figure 35*)
- Data room in overall good condition (*Figure 36*)

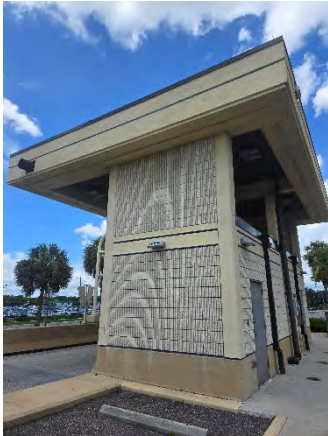
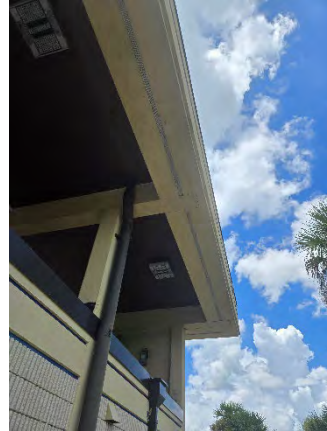
- Small cracks remain along corners of canopies, mild staining along exterior (*Figure 37, 38*)
- Doors recommended to be repainted, rust on hinges – algae present below downspout (*Figure 39*)
- ACT missing/disheveled throughout booth, possibly effecting HVAC system – room very warm and supervisor noted day of inspection (*Figure 40 - 42*)

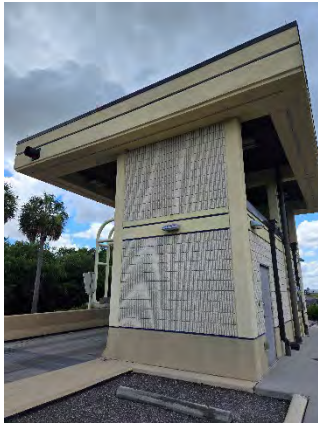
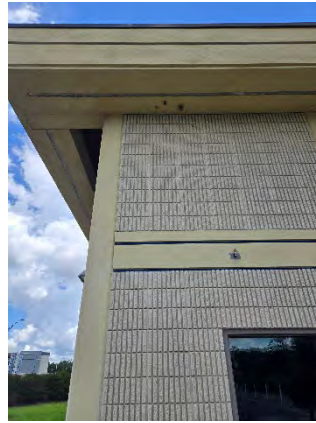
- Mild water marks, debris, and hornet's nests present along exterior (*Figure 43, 44*)
- Doors recommended to be repainted, door to booth and data room easily stuck and difficult to open (*Figure 45*)
- Barriers scratched and damaged, shows signs in impact (*Figure 46*)
- Water stain at corner of window exterior – no damage noted at window interior (*Figure 47*)
- Interior in overall good condition - coin machine making loud noise, supervisor noted on day of inspection (*Figure 48*)

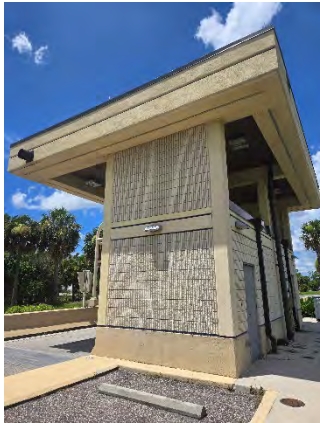
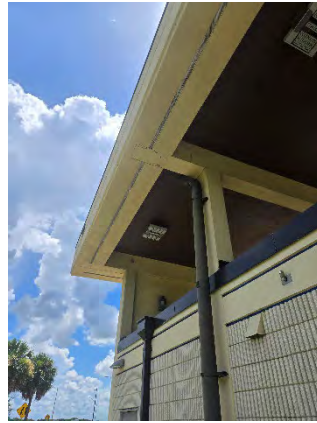
- Small cracks remain along corners of canopies, debris along exterior (*Figure 49, 50*)
- Water stain/algae still present below downspout. (*Figure 51*)
- Signs of water damage/leaking above ACT in booth (*Figure 52, 53*)
- Doors need to be repainted; scuff marks along frame and door (*Figure 54*)
- HVAC System in data room making noise – supervisor notified on day of inspection (*Not Photographed*)

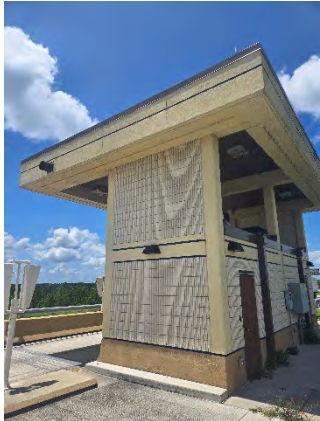
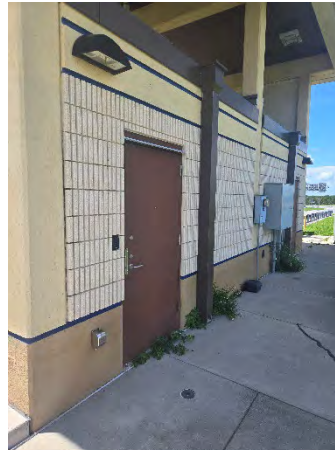
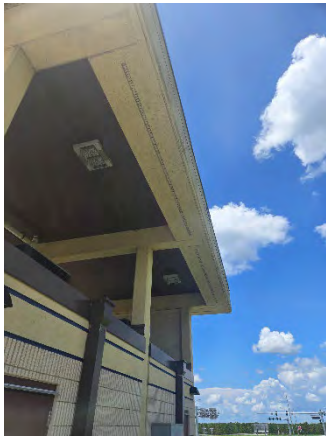
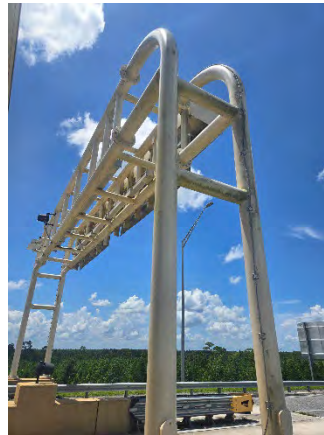
- Mild water marks and debris along exterior façade and signage. Vegetation growing along foundation. (*Figure 55 - 58*)
- Debris throughout interior of main booth (*Figure 59*)
- Door to main booth remains easily stuck – issue when locking/unlocking hardware (*Figure 60*)

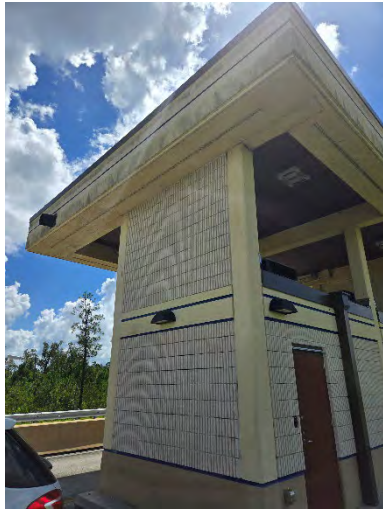
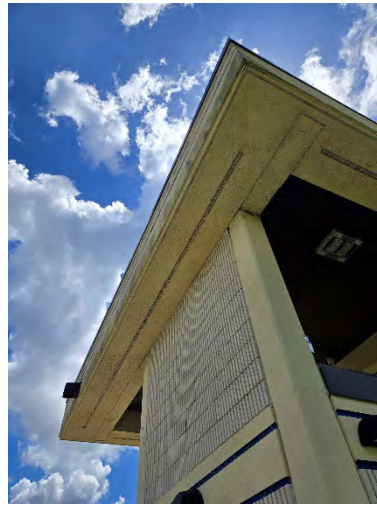
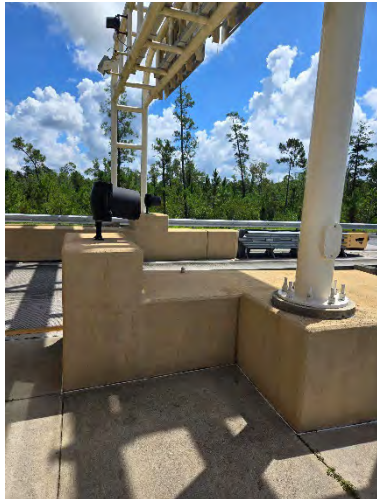
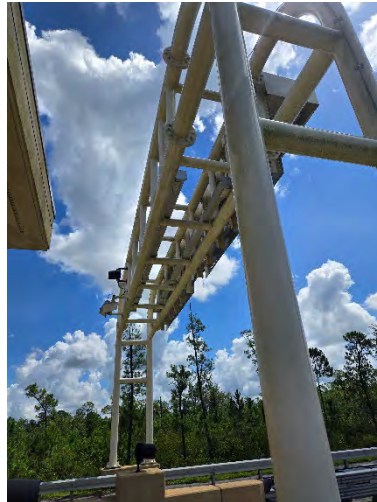
- Mild water marks and debris along exterior façade and signage – minor cracks remain along foundation (*Figure 61 - 64*)
- Interior in overall good condition (*Not Photographed*)

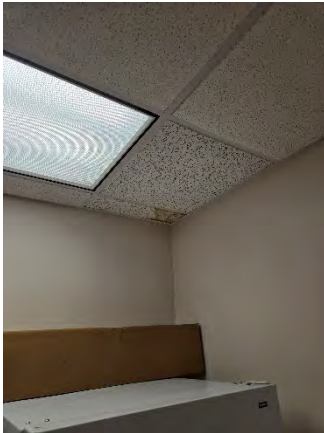
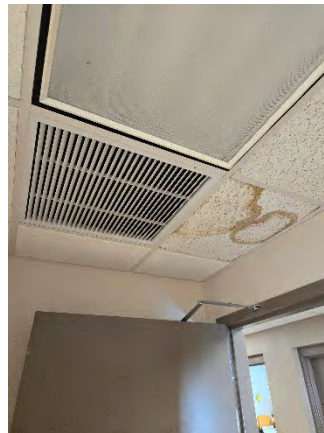
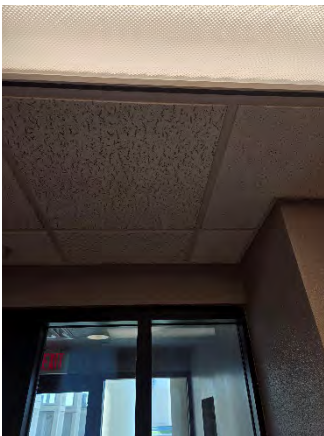
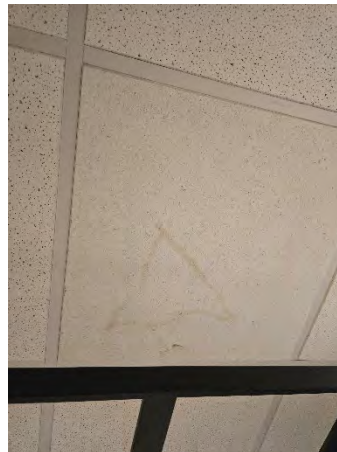
- ACT disheveled, shows signs of leaking above storage room, recording room, and corridor (*Figure 1-4*)
- Signs of water damage at corner of windows in break room and office (*Figure 5, 6*)
- Water contaminated; supervisor aware (*Figure 7-10*)
- Backsplash and counter show signs of water damage in break room (*Figure 11*)
- Door to counting room dented and scratched (*Figure 12*)
- Panel in recording room shows signs of leaking/damage at bottom corners (*Figure 13*)
- Crash barrier patched in corridor (*Figure 14*)

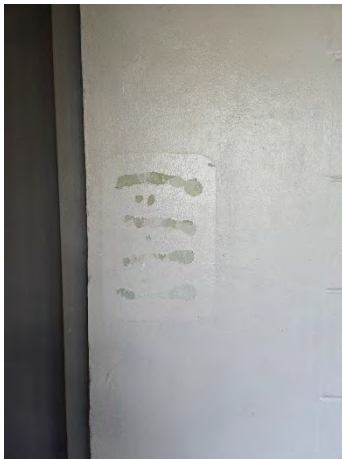
Figure 15 Dallas Mainline

- Stair sign missing at bridge level of main facility building (*Figure 15*)
- Bridge in overall good condition, paint missing and debris present (*Figure 16, 17, 18*)
- Signs of intrusion, debris in recording room of adjacent facility building (*Figure 19*)
- Rust along floor of restroom in attendant booth (*Figure 20*)
- Paint peeling/bubbling in both stairwells (*Figure 21, 22*)
- Cracks along overhead canopies and columns supporting bridge and stair tower, water damage/staining along canopy façade (*Figure 23-32*)

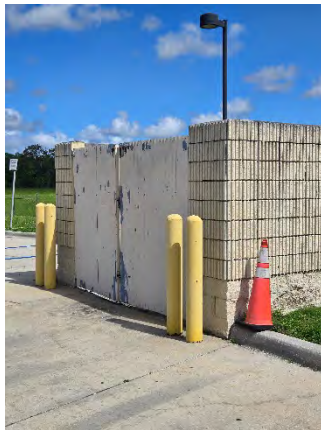
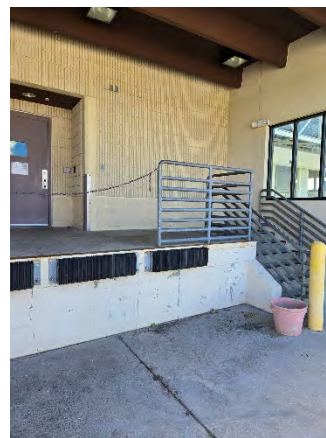
- Paint peeling/missing along loading dock and dumpsters enclosure (*Figure 33, 34*)
- Cracks in columns surrounding main plaza (*Figure 35, 36*)
- Small cracks along soffit (*Figure 37, 38*)
- Cracking and paint missing along back exterior stairs, rust staining stairs from railing (*Figure 39, 40*)
- Debris collected along underside of canopies and roof structures (*Figure 41, 42*)

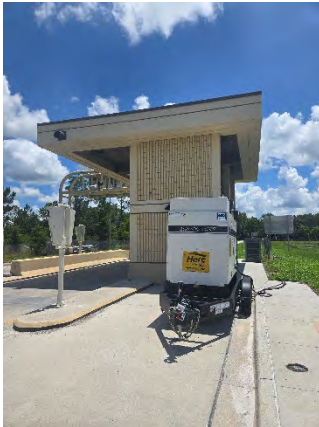
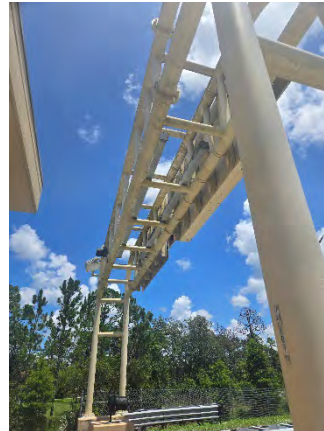
- Exterior in overall good conditions, debris and staining along exterior and gantry (*Figure 43, 44*)
- Mold/milder present along doors and windows of attendant booth (*Figure 45 - 47*)
- External power source fed into Data room (*Figure 48*)

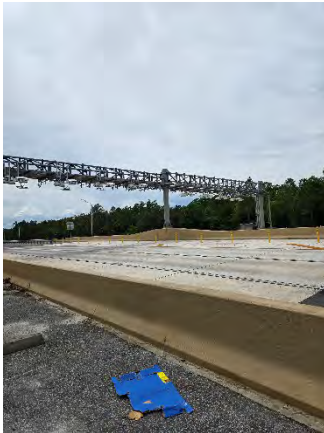
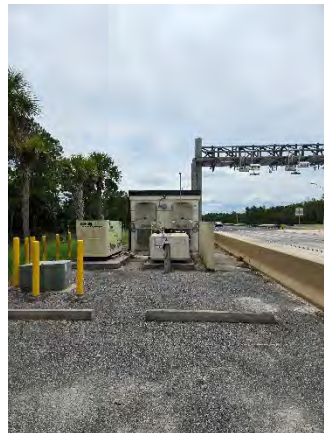
- The above referenced plaza is in good condition overall. Some general maintenance to caulk/seal cracks to building exterior is recommended. (*Figure 1 and 2*)
- Door stained along exterior. (*Figure 3*)
- Insects and weeds present along exterior. (*Figure 4, 5, and 6*)
- Interior still shows cracks on corners and edge of the ceiling. (*Figure 7 and 8*)

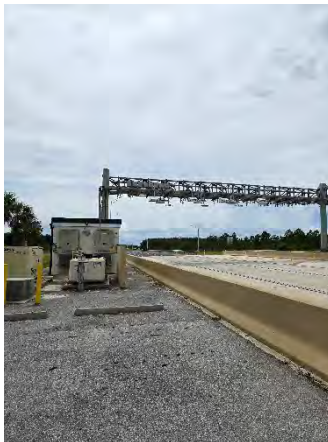
Figure 9 KOA AET Toll Plaza

- The above referenced plaza is in good condition overall. Some general maintenance to caulk/seal control joints. (*Figure 9*)
- Door and exterior walls stained. (*Figure 10 and 11*)
- Interior still shows cracks on corners and edge of the ceiling. (*Figure 12*)

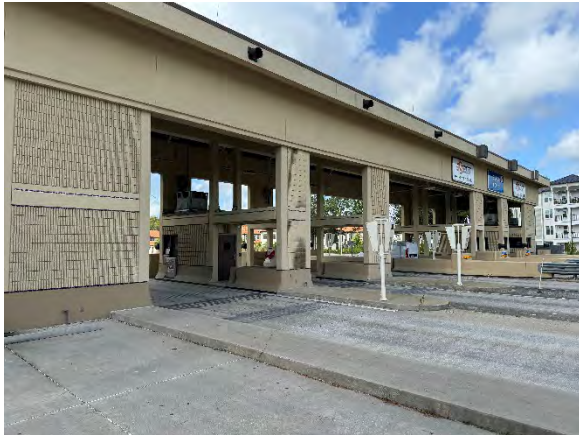
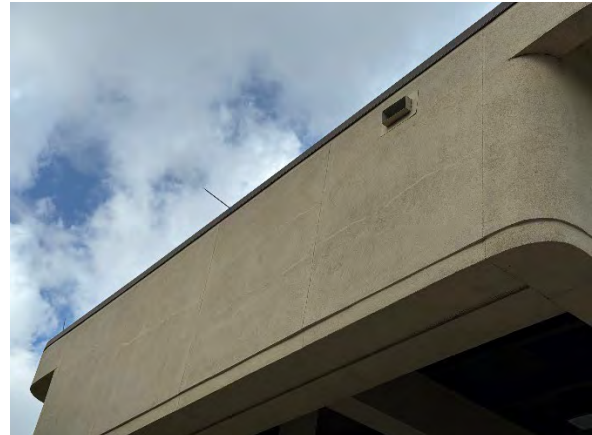
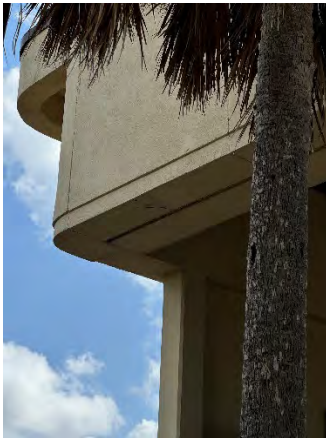
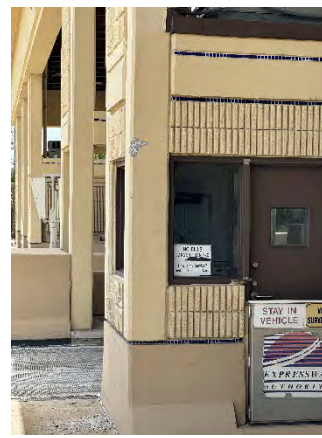
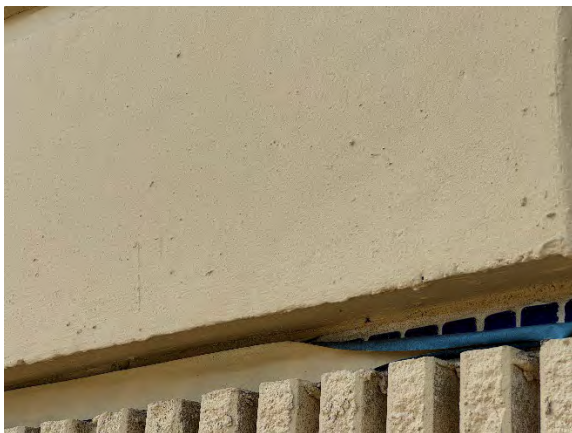
- Barriers, columns and canopy show signs of cracking and damage. (*Figure 1, 2, 3, 4, and 5*)
- Water draining and pooling in front of booth door in two separate places. One staining the base of the façade. Other one has the downspout dented (*Figure 6 and 7*)

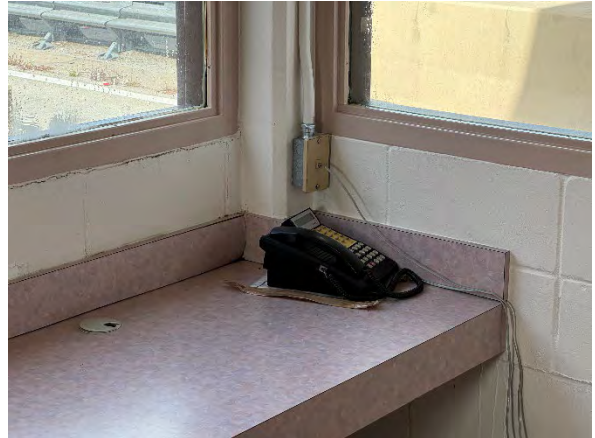
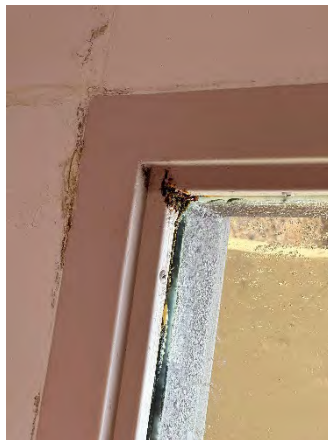
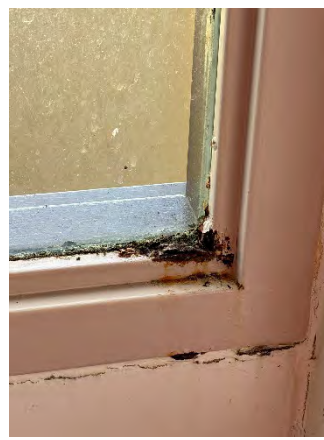
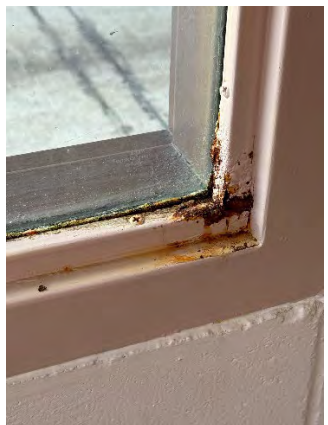
- Wall cracking inside booth between window frame joint. Several window frame corners in bad condition (*Figure 8, 9, 10, and 11*)
- Outdated printed sign. (*Figure 12*)
- Bathroom areas need some slight cleaning done to the toilets. (*Figure 13 and 14*)
- Floor tiles disheveled and coming out of place. (*Figure 15 and 16*)
- HVAC vents show some discoloring. Needs some cleaning done. (*Figure 17 and 18*)

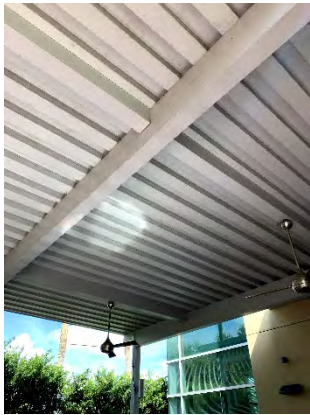
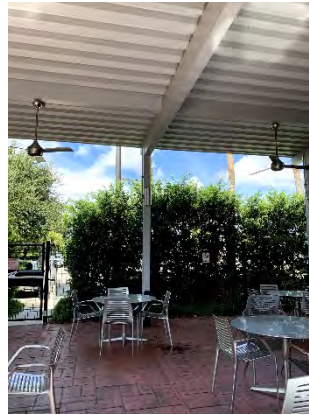
- Building exterior is in good condition overall with no identified deficiencies. Pressure wash is recommended for the sidewalk, corner of the building and main entrance. Signs of water intrusion in several areas of stucco façade. *(Figure 1 – Figure 16)*
- Column at northwest stairwell missing paint. *(Figure 17)*
- Signs of water intrusion throughout exterior of employee breakroom. Multiple leaks and examples still present of paint bubbling/peeling from surface. *(Figure 19 and 20)*
- Signs of pooling water and leaking along underside of pavilion of employee breakroom. *(Figure 21 and 22)*

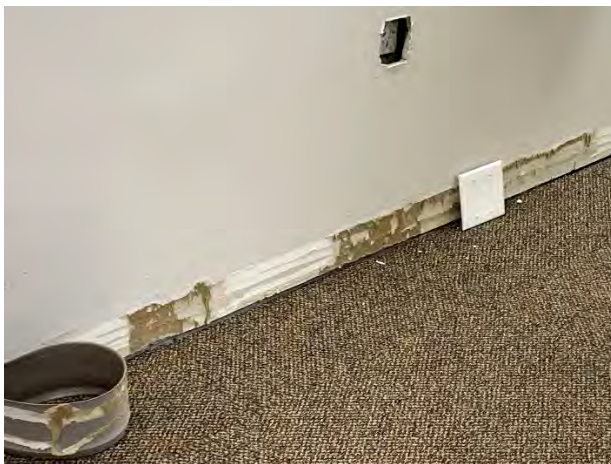
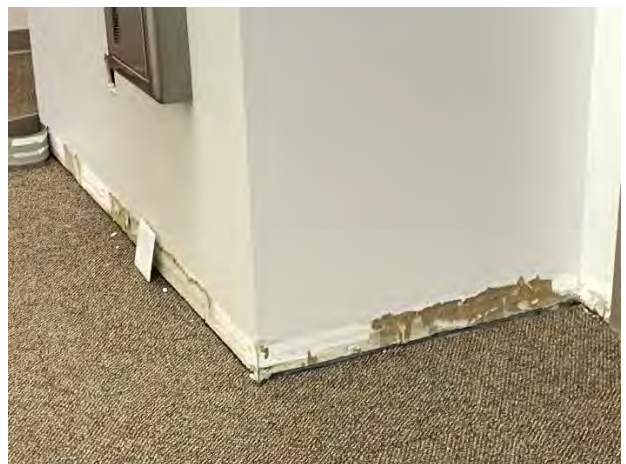
- Corridor 109 with water damage to wall, base boards peeling from moisture. *(Figure 23 and 24)*
- Room 107 with wallpaper and baseboard peeling from wall. *(Figure 25)*

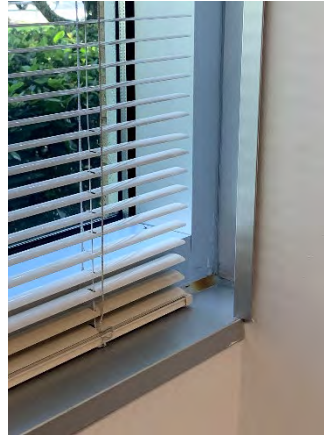
Figure 26 Building Headquarters First Floor (Room 112)

- Room 112 with signs of leaking at corner of window. *(Figure 26)*
- Room 116 with signs of leaking along window. *(Figure 27)*
- Room 126 with damage to corner of door. *(Figure 28)*

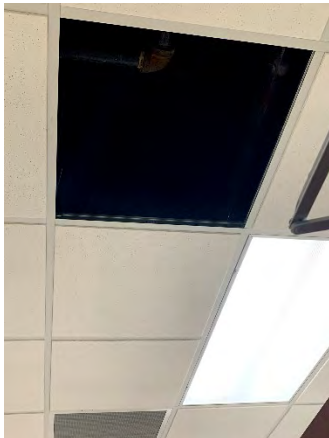
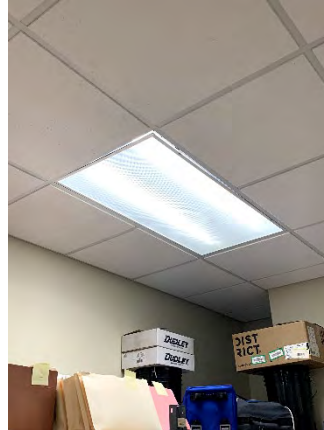
- Room 127 with missing/damaged ACT and light displaced. *(Figure 29 and 30)*
- Room 127 with damage to walls. *(Figure 31)*
- Room 129 with damage to walls and floor in poor condition. *(Figure 32 and 33)*

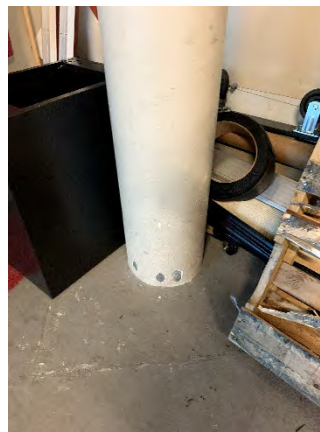
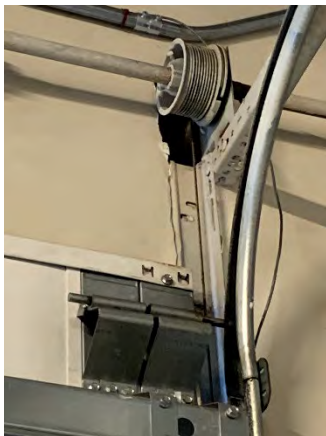
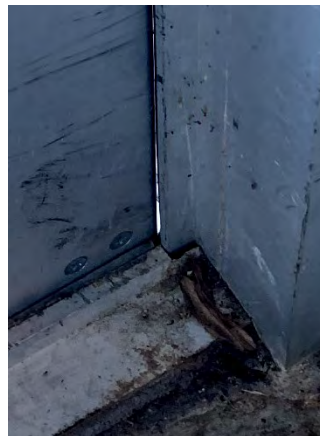
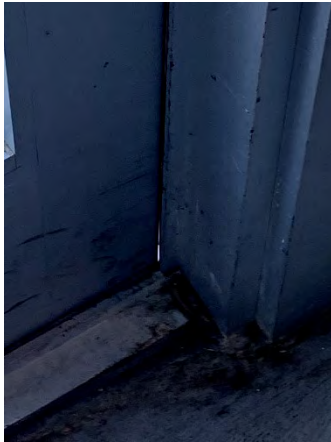
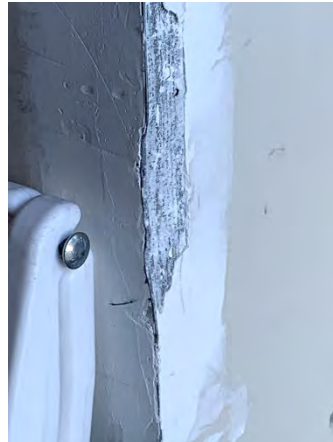
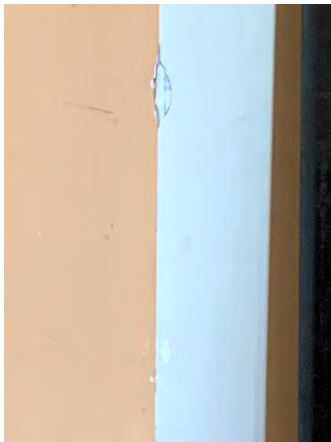
- Room 132 with corner of wall, and wall of garage door dented/damaged. Door at corner has weak seal, and multiple gaps along seal of garage door. *(Figure 34 - 39)*

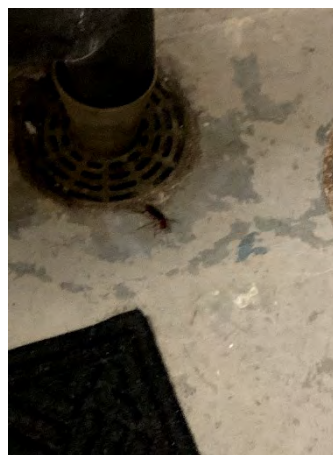
Figure 40 Building Headquarters First Floor (Room 134)

- Room 134 with insects present in room. *(Figure 40)*
- Room 135 with signs of leaking above ACT surrounding curtain wall. *(Figure 41 - 46)*
- Room 136 with damage to walls and ceiling. ACT and soffit not aligned with wires exposed. *(Figure 47, 48, and 49)*

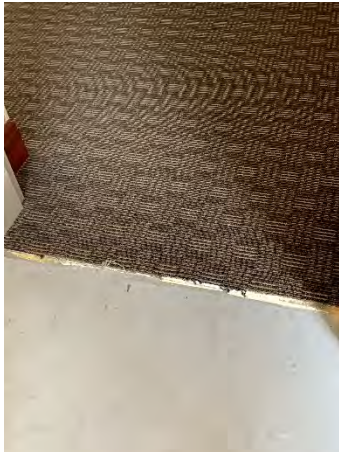
Figure 78 Building Headquarters First Floor (Stair 157)

- Stair 157 with chairs obstructing egress/refugee space, and threshold missing. *(Figure 78 and 79)*
- Stair 157 with signs of leaking along walls and around door/window system. Cover plate unscrewed. *(Figure 80, 81, and 82)*

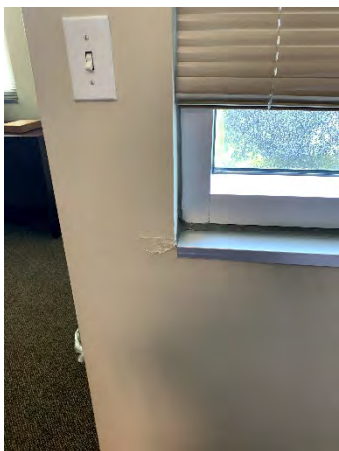
Figure 83 Building Headquarters First Floor (Room 160)

- Room 160 with potential leak at the window trim. *(Figure 83 and 84)*
- Room 161 with potential leak at window trim and seal peeling from windowpane. *(Figure 85 and 86)*

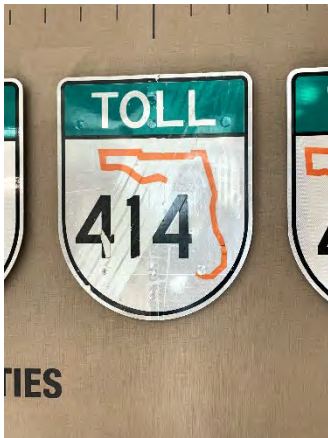
Figure 87 Building Headquarters First Floor (Room 161)

- Room 161 with entry door scratched and sign in poor condition. *(Figure 87 and 88)*
- Corridor 165 with wallpaper scratched, and corner guard peeling. *(Figure 89 and 90)*

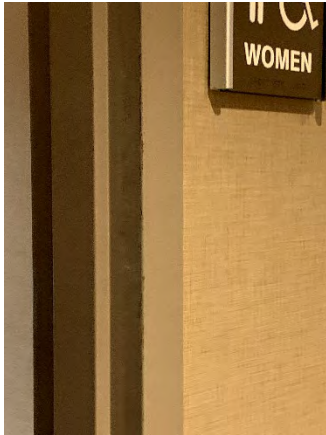
Figure 98 Building Headquarters First Floor (R.R. 100)

- Women's restroom 100 with damage to corner of wall/tiles at base and peeling wallpaper. Sinks are missing plumbing shield. *(Figure 98, 99, and 100)*

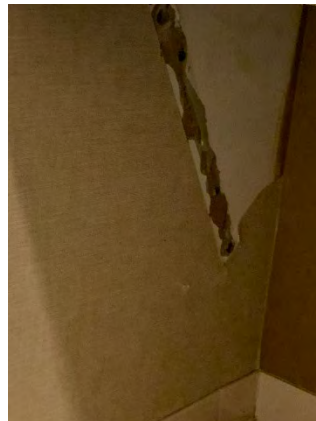
Figure 101 Building Headquarters First Floor (R.R. 101)

- Men's restroom 101 with missing plumbing shield and torn wallpaper. *(Figure 101 and 102)*

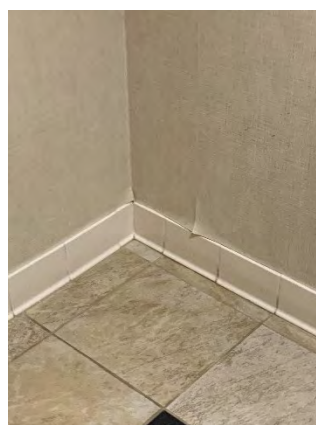
Figure 103 Building Headquarters Second Floor (Room 203)

- Room 203 with stones missing from wall cover and all seating available still stained. *(Figure 103 and 104)*
- Room 206 with sealant missing. Room warm. *(Figure 105 and 106)*

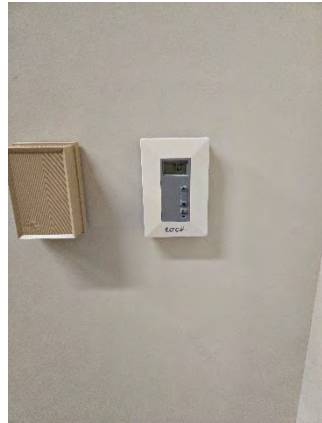
Figure 107 Building Headquarters Second Floor (Room 208)

- Room 208 with damage to walls. *(Figure 107 and 108)*
- Room 211 with signs of leaking above ACT. *(Figure 109 and 110)*
- Room 212 with signs of water damage around window. *(Figure 111 and 112)*

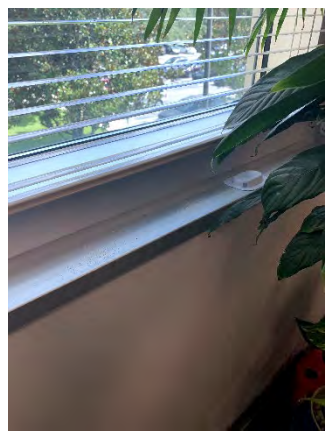
Figure 113 Building Headquarters Second Floor (Room 213)

- Room 213 with signs of water damage around window. *(Figure 113 and 114)*
- Room 215 with signs of leaking above ACT. *(Figure 115)*
- Room 218 with signs of leaking above ACT. *(Figure 116)*

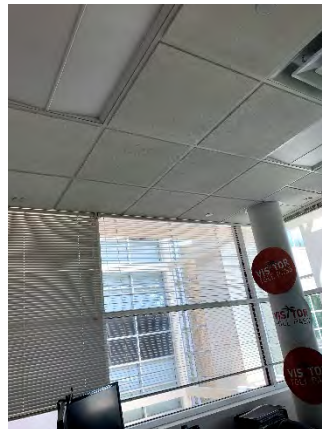
Figure 117 Building Headquarters Second Floor (Room 219)

- Room 219 with signs of leaking above ACT. *(Figure 117)*
- Room 222A with signs of leaking above ACT. *(Figure 118 and 119)*
- Room 228 with damage to door frame and ACT disheveled. *(Figure 120 and 121)*

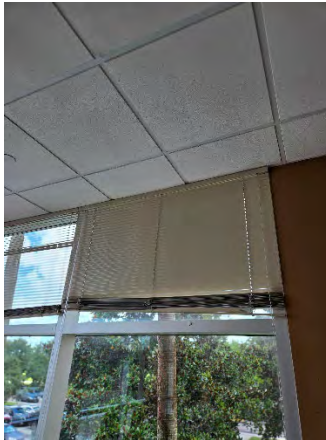
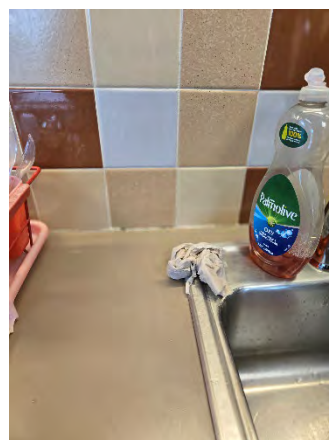
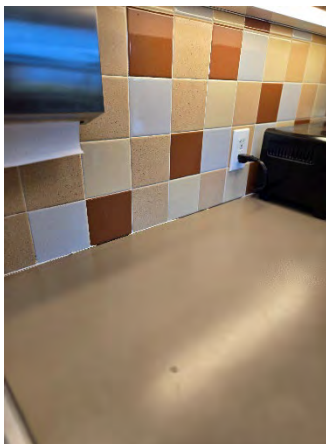
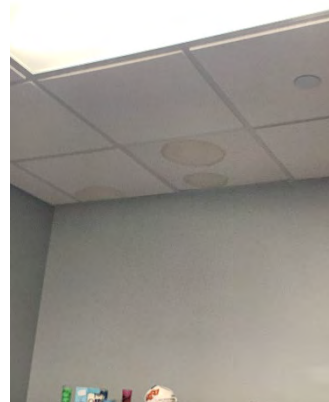
Figure 122 Building Headquarters Second Floor (Room 231)

- Room 231 with signs of water damage above ACT, surrounding windows, and around columns. Grout missing at kitchenette. *(Figure 122 - 125)*
- Room 233 with signs of water damage above ACT. *(Figure 126)*

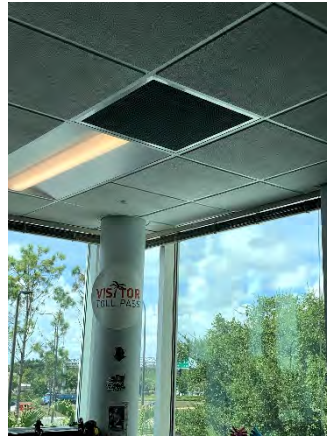
Figure 127 Building Headquarters Second Floor (Stair 234)

- Stair 234 with signs of water damage around windows. *(Figure 127)*

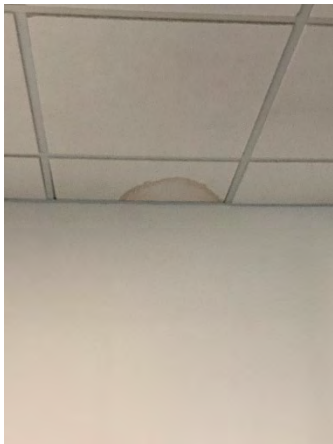
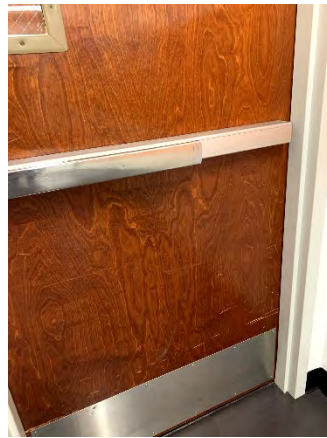
Figure 128 Building Headquarters Second Floor (Room 235)

- Room 235 with signs of water damage around windows, and above ACT surrounding column. *(Figure 128 and 129)*
- Room 239 with damage to East entry door and adjacent wall. *(Figure 130 and 131)*

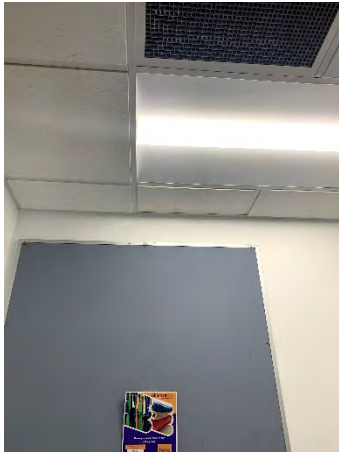
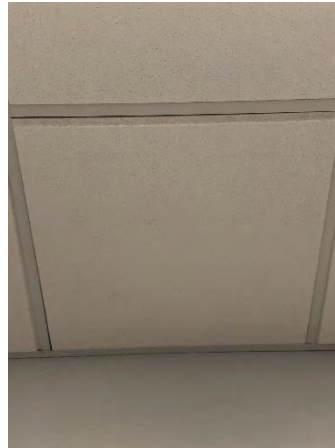
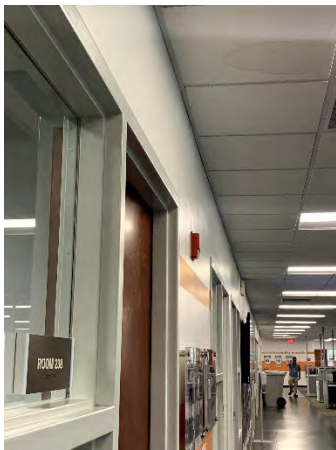
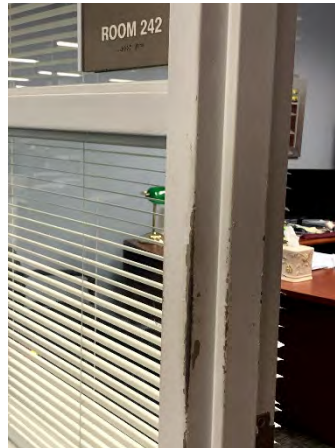
Figure 132 Building Headquarters Second Floor (Room 239)

- Room 239 with damage to ACT. Open Office space has multiple signs of water damage above ACT and above windows – pieces of ACT still do not match. *(Figure 132 - 135)*

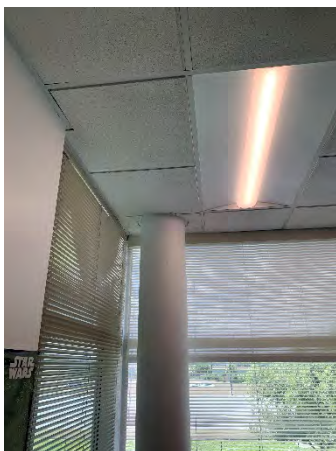
Figure 136 Building Headquarters Second Floor (Room 242)

- Room 242 with damage to door frame. *(Figure 136)*
- Room 243 with signs of leaking above ACT. *(Figure 137 and 138)*
- Stair 248 with signs of water damage around window, and large scratch along West wall. *(Figure 139, 140, and 141)*

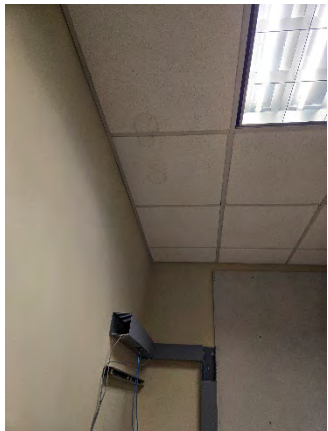
Figure 142 Building Headquarters Second Floor (Room 251)

- Room 251 with signs of leaking above ACT. *(Figure 142)*
- Room 252 with signs of leaking above ACT. *(Figure 143)*
- Corridor 253 with baseboard separating from wall at corner of East corridor window. *(Figure 144)*

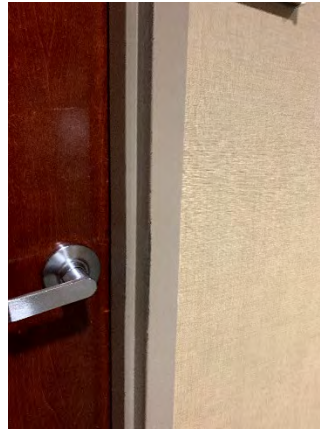
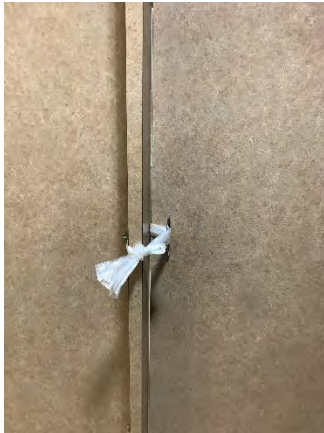
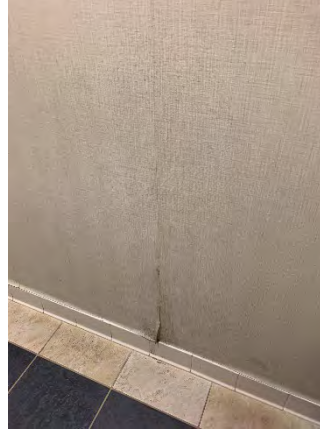
Figure 145 Building Headquarters Second Floor (R.R. 200)

- Women's Restroom 200 with damage to entry door and one stall out of commission. *(Figure 145, 146, and 147)*
- Men's Restroom 201 with peeling wallpaper. *(Figure 148)*

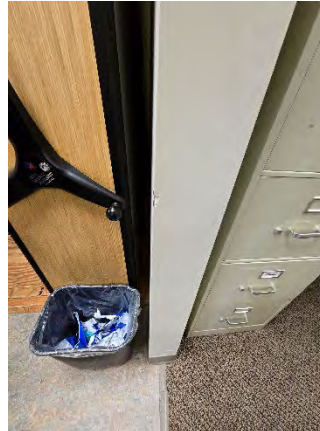
Figure 149 Building Headquarters Third Floor (Room 305)

- Room 304 with signs of water damage along walls. *(Figure 149)*
- Room 310 with signs of water damage at corner of window and ACT. *(Figure 150 and 151)*

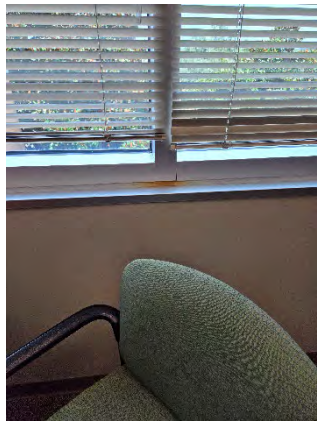
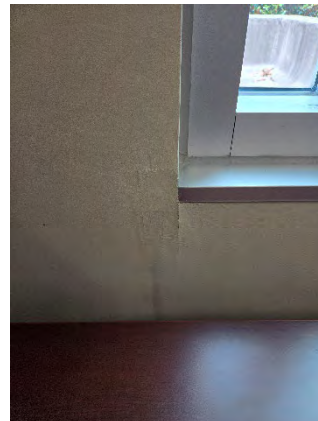
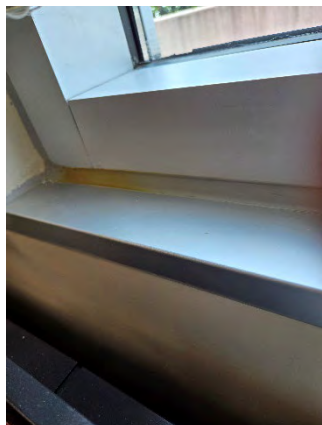
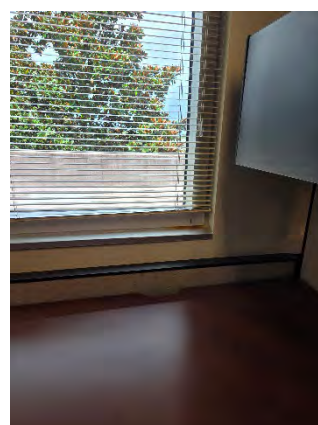
Figure 152 Building Headquarters Third Floor (Room 311)

- Room 311 with signs of water damage around window. *(Figure 152, 153, 154, and 155)*
- Room 322 with signs of water damage around window. *(Figure 156 and 157)*

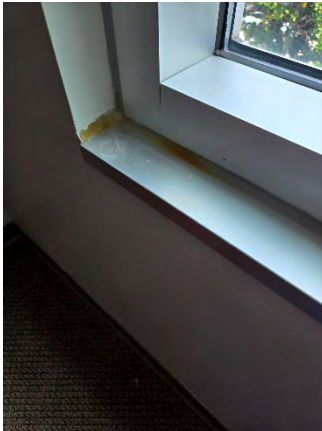
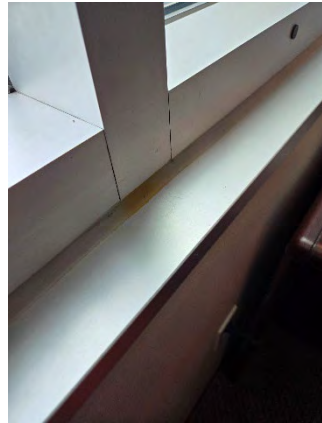
Figure 158 Building Headquarters Third Floor (Room 312)

- Room 323 with signs of water damage round window, corner of wall damaged, and wallpaper peeling. *(Figure 158, 159, 160, and 161)*
- Room 325B with light damage. *(Figure 162)*

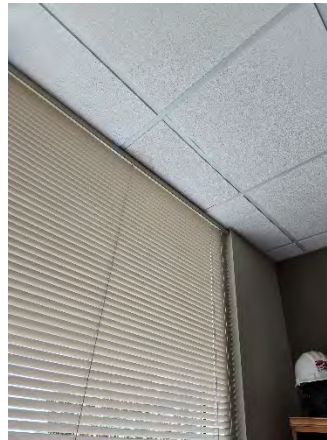
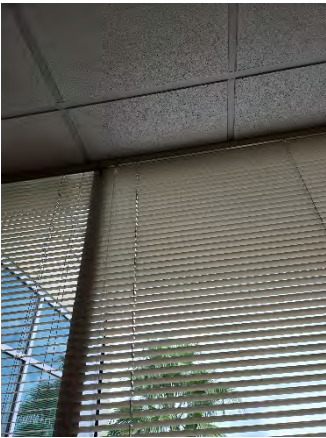
- Room 331 with crack at corner of window, and signs of water damage above ACT. *(Figure 163 and 164)*
- Room 333 with signs of water damage above ACT. *(Figure 165)*

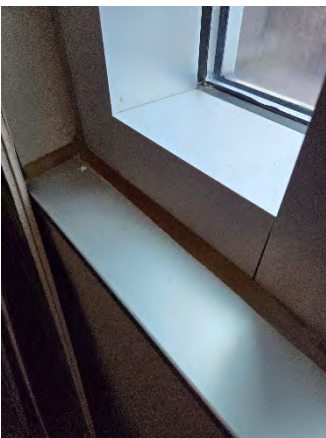
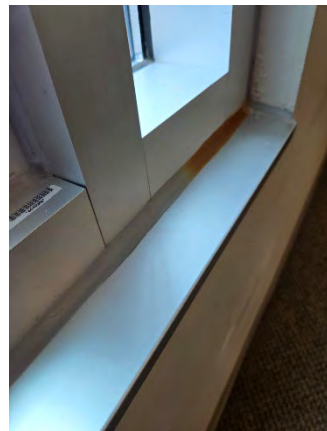
- Room 335 with signs of water damage above ACT. *(Figure 166 and 167)*
- Room 337 with signs of water damage at window and wall below window. *(Figure 168, 169, 170, and 171)*

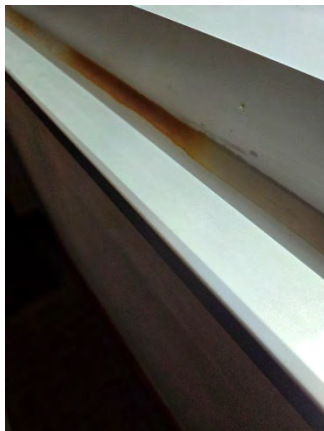
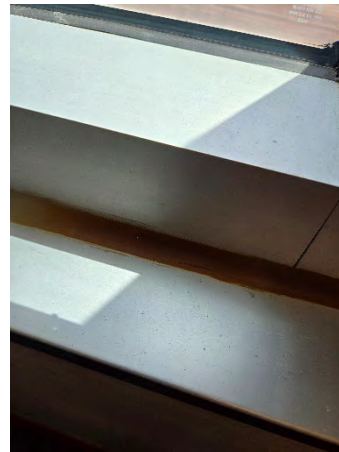
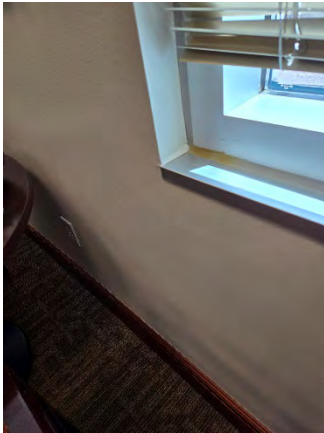
- Room 343 with signs of water damage at window. *(Figure 178, 179, and 180)*
- Room 345 with signs of water damage at window and wall below window. *(Figure 181, 182, 183, and 184)*
