Central Florida Expressway Authority

ANNUAL INSPECTION REPORT

FY 2025

Re: FY 2025 Annual Inspection Report

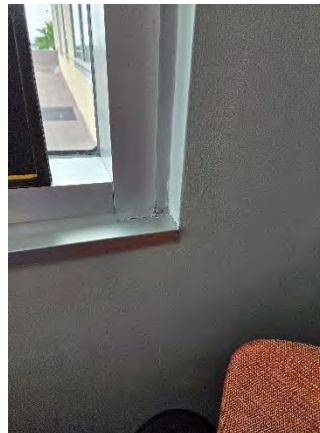
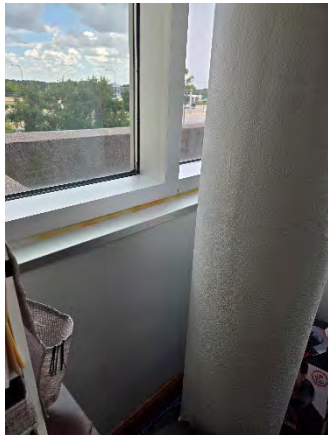
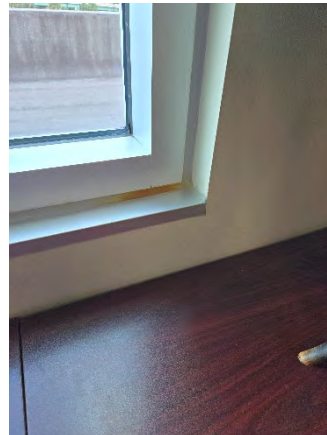
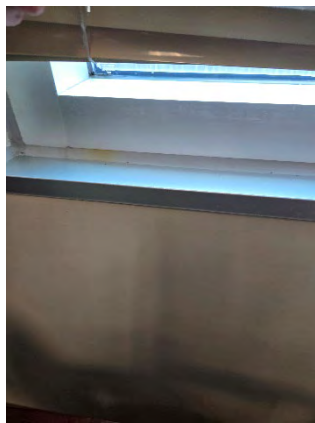
- Room 346 with signs of water damage at window. *(Figure 185, 186, 187, and 188)*
- Room 347 with signs of water damage at window. *(Figure 189)*
- Room 351 with ACT and ceiling grid disheveled. *(Figure 190)*

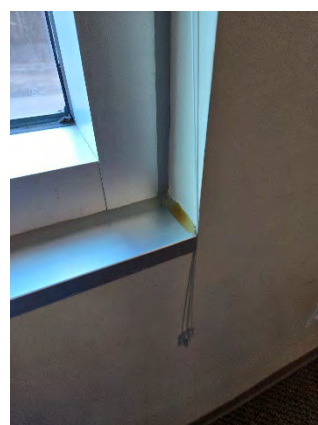
Figure 191 Building Headquarters Third Floor (Room 354)

- Room 352 with damage to ceiling. Signs of water damage with paint bubbling/peeling off surface. *(Figure 191)*
- Room 352B with signs of water damage at window and along ceiling. *(Figure 192, 193, 194, and 195)*

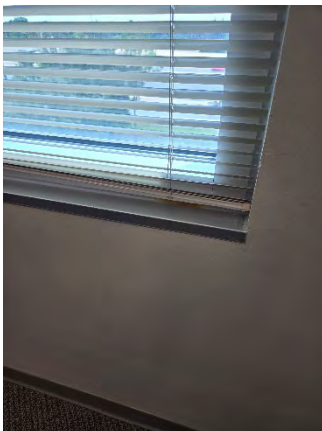
Figure 196 Building Headquarters Third Floor (Room 356)

- Room 352D with transitional strip missing between curtain wall and carpet. *(Figure 196)*
- Room 353 with signs of water damage at window. *(Figure 197)*

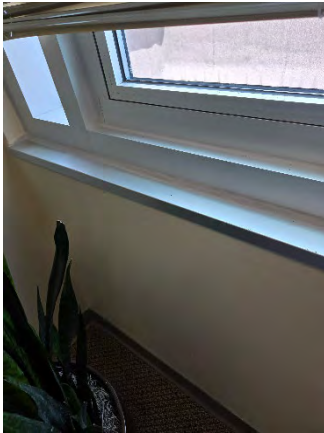
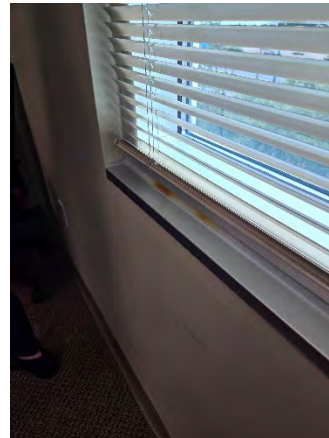
- Room 354 with signs of water damage at window. *(Figure 198 and 199)*
- Room 355 with signs of water damage at windows and insects throughout room. *(Figure 200, 201, 202, and 203)*

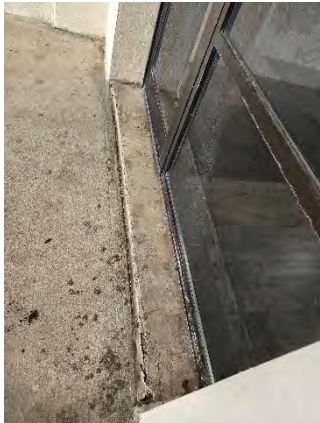
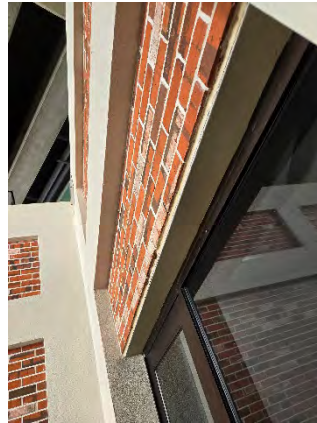
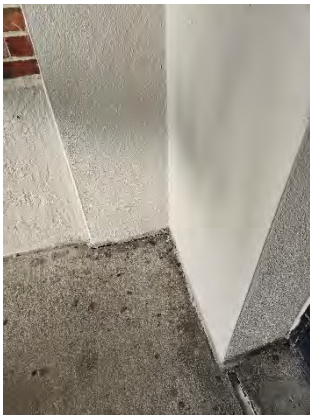
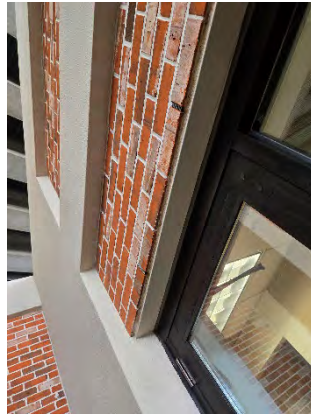
- Building exterior is in good condition overall with no identified deficiencies. Pressure wash is recommended for the sidewalk and exterior of building. Signs of water intrusion in several areas of stucco façade and above windows. *(Figure 1 – Figure 4)*
- East facade shows multiple signs of water damage and stucco façade peeling. Damage concentrated around windows and southeast corner of building. *(Figure 5 – Figure 8)*
- South façade shows signs of water damage concentrated above windows – brick veneer separating from wall. *(Figure 9 – Figure 14)*
- Door at West façade shows signs of water intrusion from exterior – cracks along foundation and damage to door glass. *(Figure 15 – Figure 18)*
- North façade shows signs of water damage above windows and at side entrance – door shows signs of water intrusion. *(Figure 19 - Figure 22)*

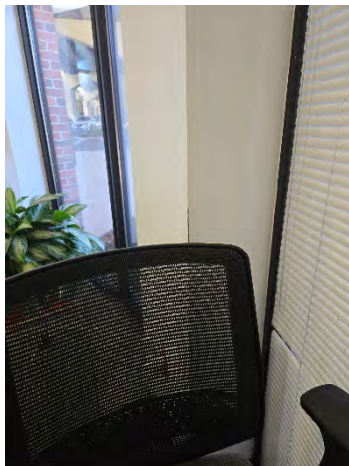
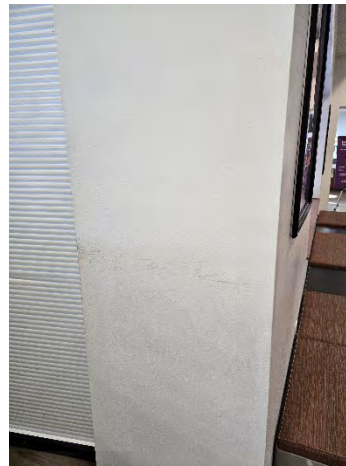
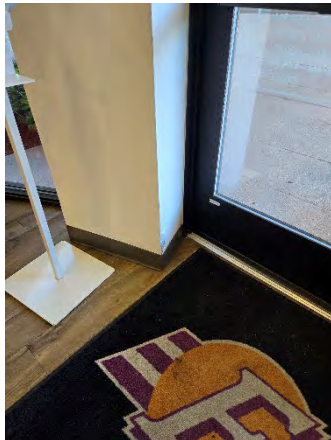
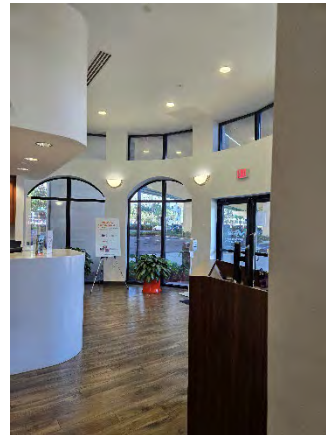
- Building interior is in good condition overall with no identified deficiencies. West portion of building under construction with limited access.
- Room 100 in overall good condition – minor scuffs and damage to walls. *(Figure 23 – Figure 26)*

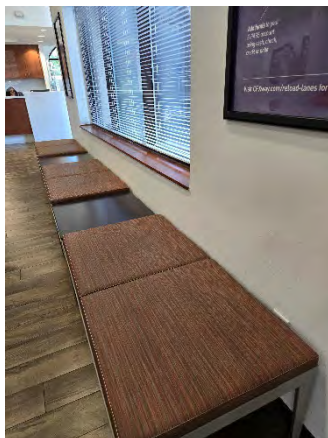
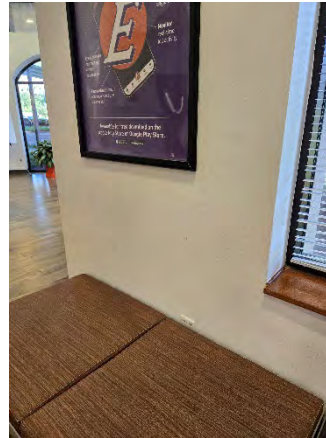
- Room 101 in overall good condition, minor scuffs and damage to walls behind furniture. *(Figure 27 and 28)*
- Room 102 in overall good condition – scuffs and damage to corners of columns by transaction windows. *(Figure 29 – Figure 32)*

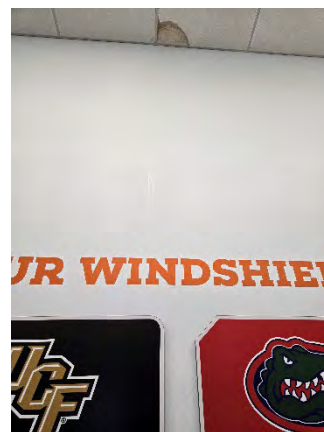
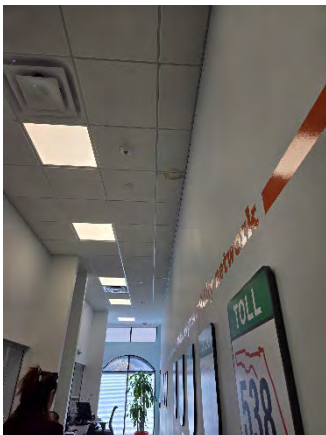
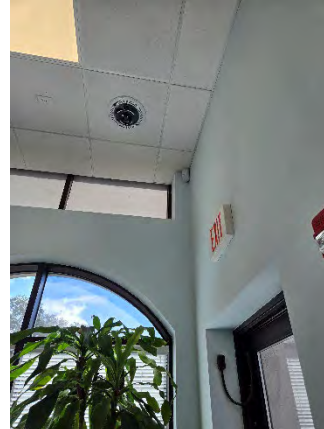
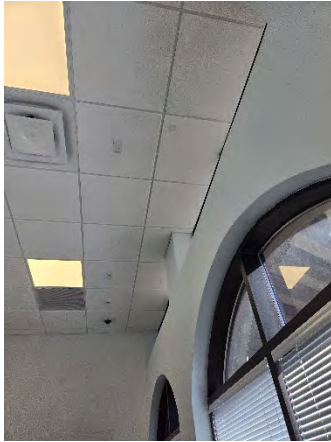
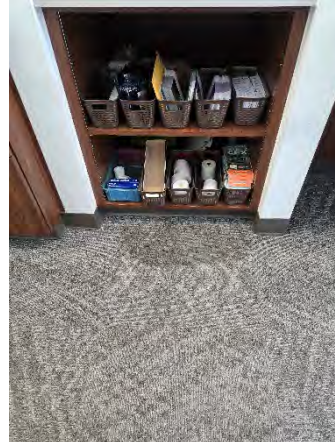
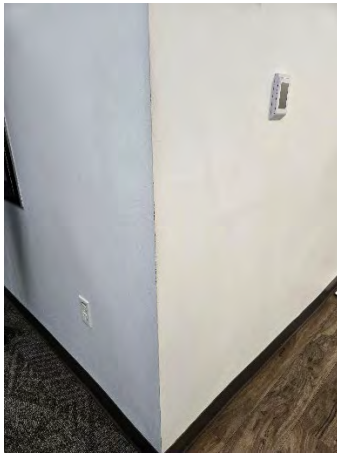
- Room 104 with multiple signs of leaking above ACT, most present at Southeast corner of building. Carpet tile stained by millwork. *(Figure 33 – Figure 38)*

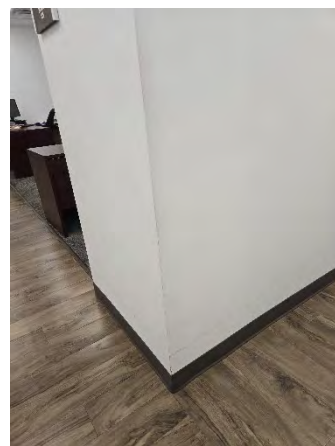
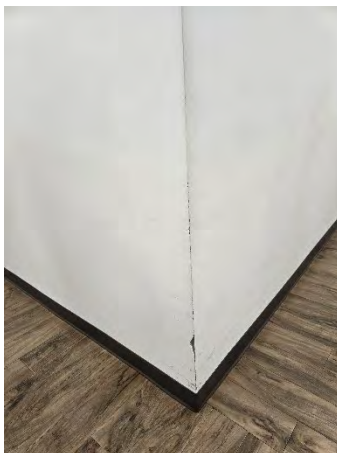
- Corridor 110 with several scratches along walls, most damage prominent on corners. *(Figure 39 – Figure 40)*
- Corridor 110 missing electrical plate cover. *(Figure 43)*

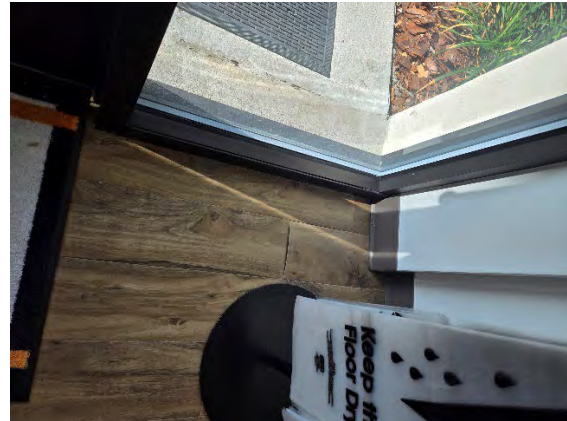
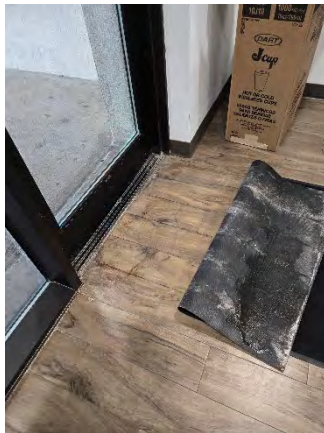
- Corridor 127 with possible water damage to entrance door. *(Figure 49 and 50)*
- Corridor 133 with water intrusion at both exit door and break area door. Water pooling under mats and damaging floor below – maintenance notified on day of inspection. *(Figure 51 and 52)*

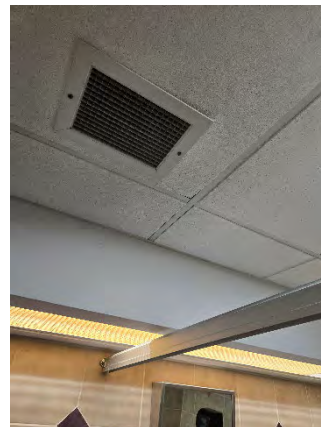
Figure 53 E-Pass Service Center (Room 135)

- Room 135 with displaced ACT. *(Figure 153)*
- Room 136 with displaced ACT, and damaged millwork. *(Figure 54 and 55)*
- Room 137 with mop sink missing caulking. *(Figure 56)*

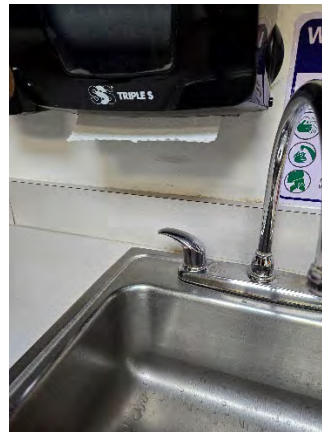
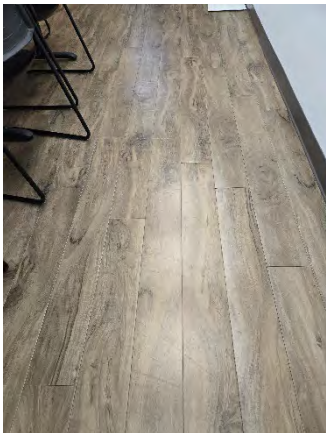
- Room 138 with signs of leaking above ACT at entrance, and minor water damage to backsplash behind sink. *(Figure 57 and 58)*
- Room 139 with damage to floor – scratched around table and lifting by window. *(Figure 59 and 60)*

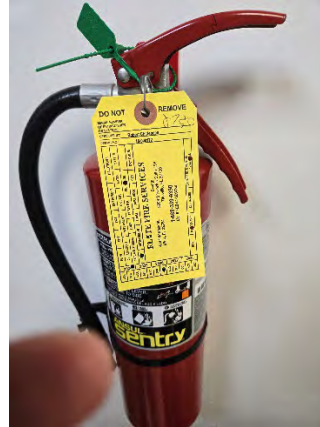
Figure 62 E-Pass Service Center (Room 139)

- Room 139 with scratch to wall. *(Figure 61)*
- Room 139 with outdated fire extinguisher. *(Figure 62)*
- Room 100 WEST with slight damage to floor – possible water intrusion at door. *(Figure 63)*
