2020

Annual Inspection Report

Appendix 3: SR 408

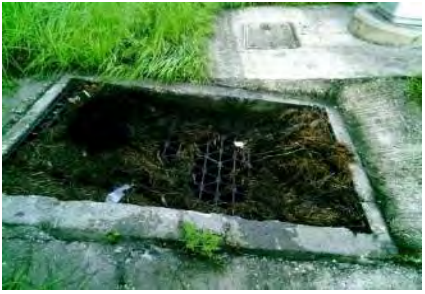
Drainage	Drainage Structure	3	inlet grate damaged	23
1

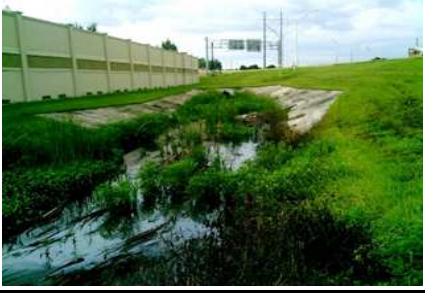
Drainage	Flume/ Concrete Apron	3	sediment / overgrown vegetation in flume	24
2

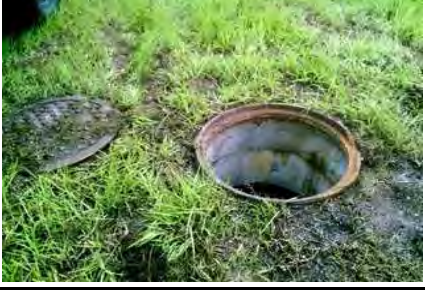
Drainage	Drainage Structure	1	manhole cover not secured	24
3

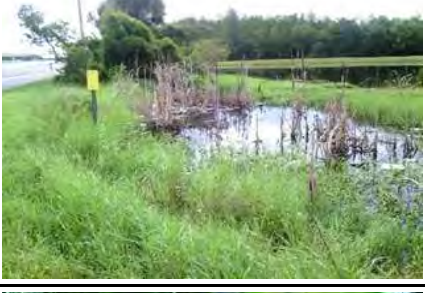
Drainage	Drainage Structure	2	no access to structure / standing water around	25
4

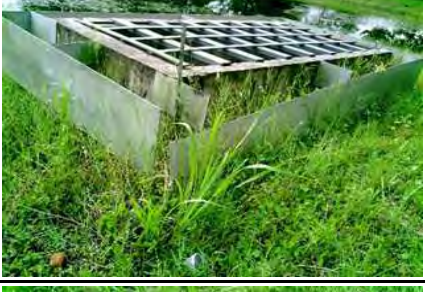
Drainage	Drainage Structure	3	control structure skimmer damaged	26
5

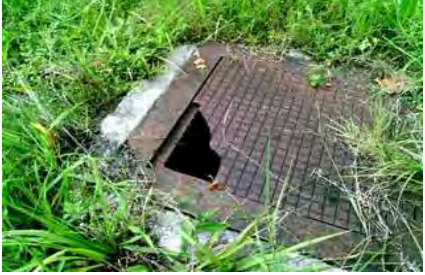
Drainage	Drainage Structure	1	manhole cover broken	26

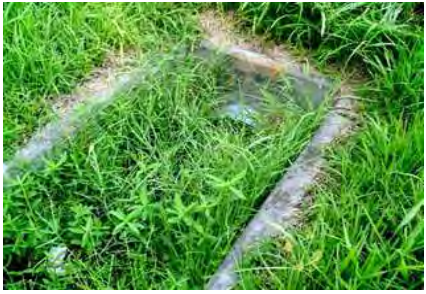
Drainage	Drainage Structure	3	outfall half full sediment	27
7

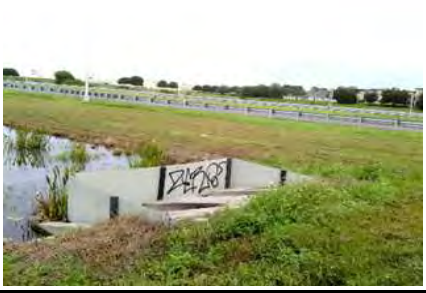
Drainage	Drainage Structure	3	graffiti on skimmer	29
8

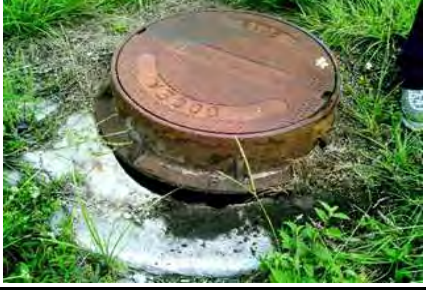
Drainage	Drainage Structure	3	manhole slightly exposed	29
9

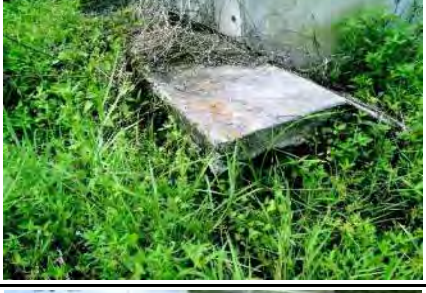
Drainage	Drainage Structure	2	erosion around control structure	29
10

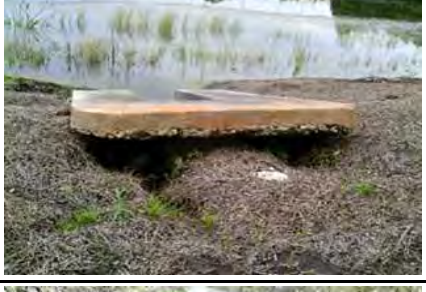
Drainage	Drainage Structure	2	erosion underneath the mes around the pond	31
11

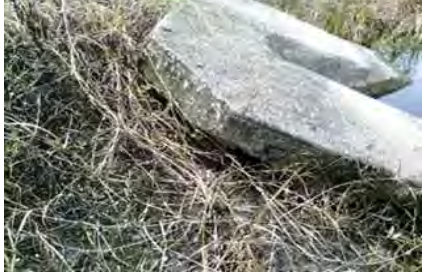
Drainage	Drainage Structure	3	erosion undermining mes	31

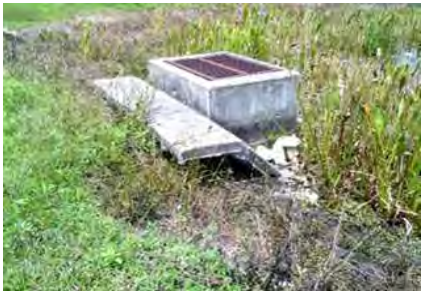
Drainage	Drainage Structure	2	erosion underneath control structure	30
13

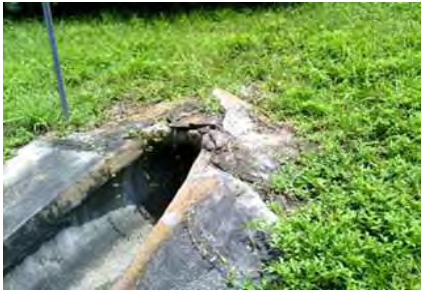
Drainage	Drainage Structure	2	mes broken	29
14

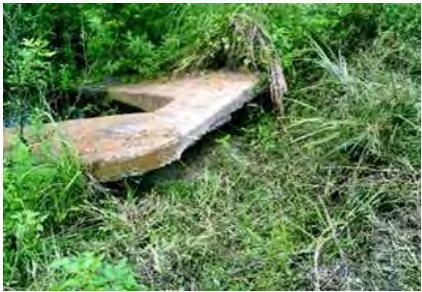
Drainage	Drainage Structure	2	erosion undermining mes around the pond	25
15

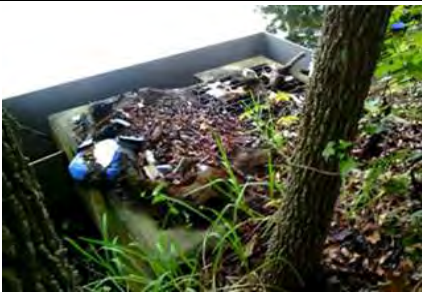
Drainage	Drainage Structure	3	control structure grate covered with debris	25
16

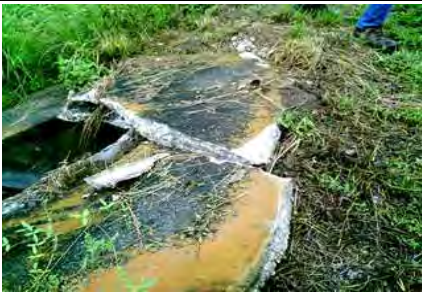
Drainage	Drainage Structure	1	mes broken	24
17

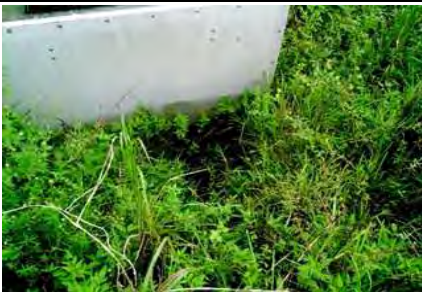
Drainage	Drainage Structure	2	erosion around control structure	24

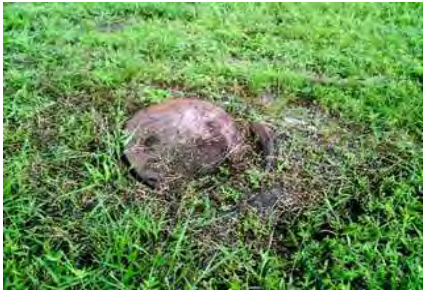
Drainage	Drainage Structure	2	manhole broken	22
19

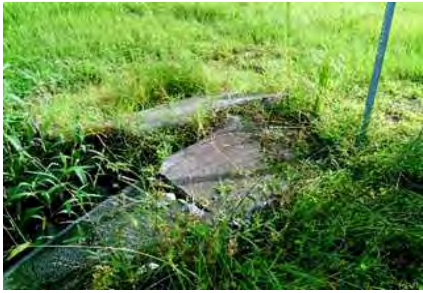
Drainage	Drainage Structure	1	mes broken	22
20

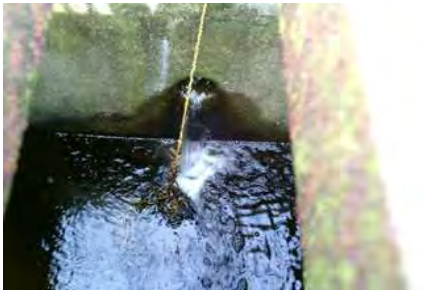
Drainage	Drainage Structure	3	remove rope and debris	22
21

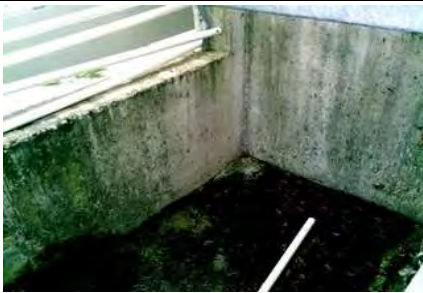
Drainage	Drainage Structure	3	filter pvc in control structure damaged	20
22

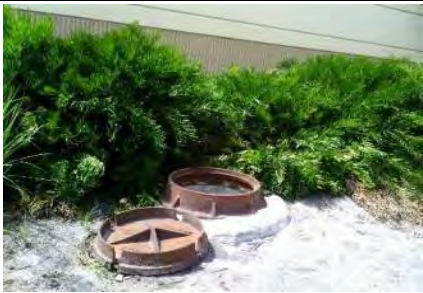
Drainage	Drainage Structure	2	manhole cover off	16
23

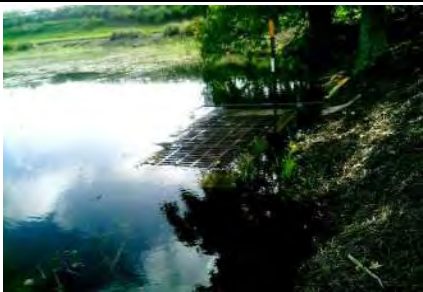
Drainage	Drainage Structure	1	control structure non functional - orifice blocked / no water flow at the outfall	31

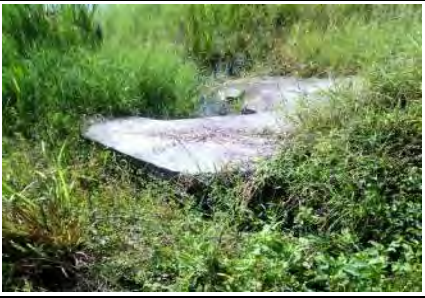
Drainage	Drainage Structure	2	erosion around the mes	31
25

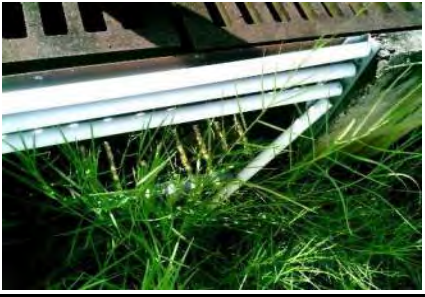
Drainage	Drainage Structure	3	fish excluder damaged	30
26

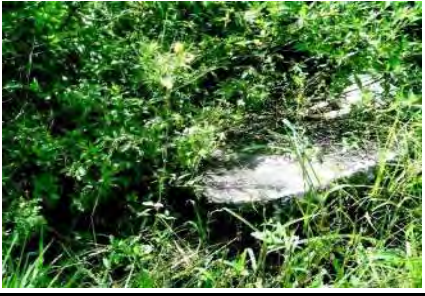
Drainage	Drainage Structure	3	erosion around mes	30
27

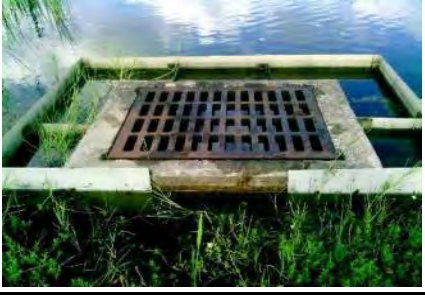
Drainage	Drainage Structure	1	control structure non functional / outfall clogged	28
28

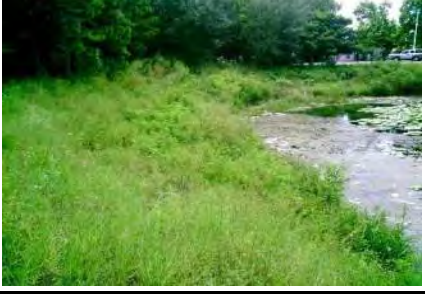
Drainage	Pond/ Ditch/ Canal	2	pond maintenance berm not maintained - overgrown vegetation	18
29

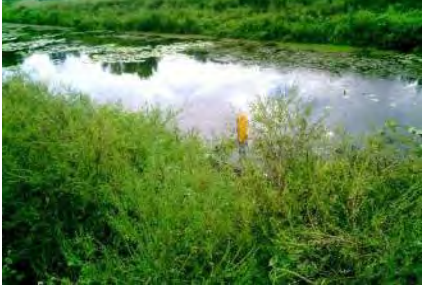
Drainage	Pond/ Ditch/ Canal	2	no access to control structure - overgrown vegetation	18

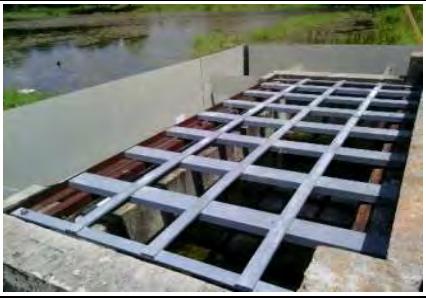
Drainage	Drainage Structure	2	no orifice - pond not draining	21
31

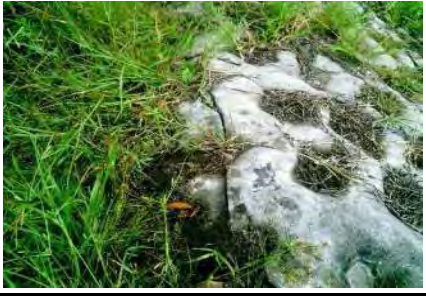
Drainage	Rip Rap	3	fabric rip rap damaged	27
33

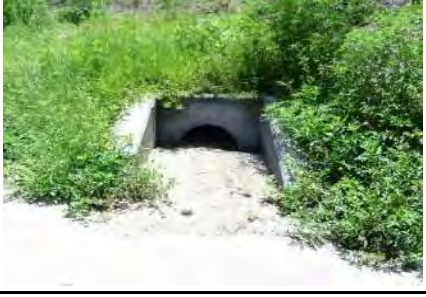
Drainage	Drainage Structure	2	sediment in pipe	5
35

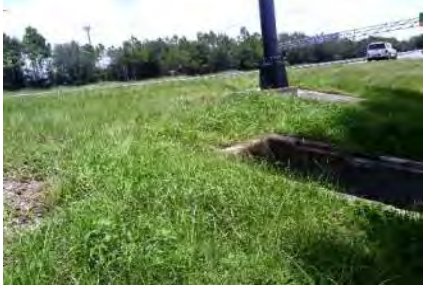
Drainage	Drainage Structure	1	end wall 23 foot from the travel lane - grate missing	6

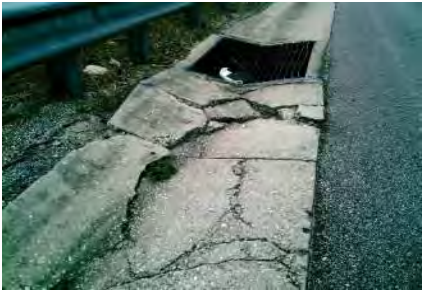
Drainage	Other	2	broken shoulder gutter	9
37

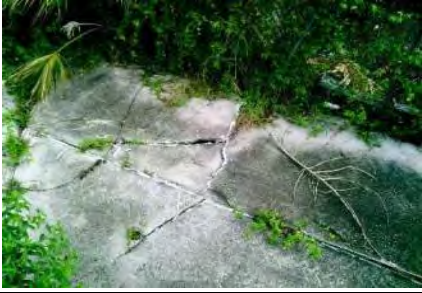
Drainage	Flume/ Concrete Apron	2	concrete ditch damaged / debris around	9
38

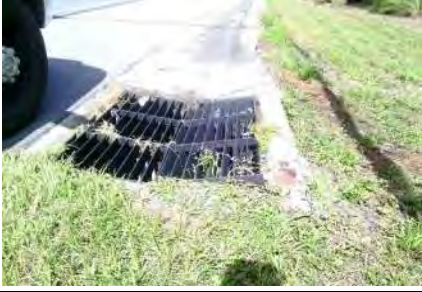
Drainage	Other	2	shoulder gutter damaged / erosion underneath	7
39

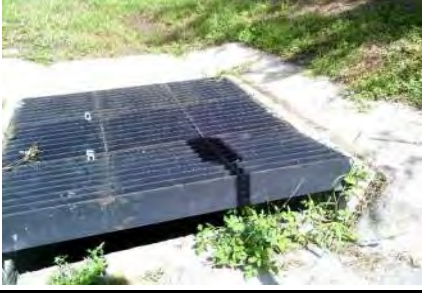
Drainage	Drainage Structure	3	dbi damaged - grate out of place	7
40

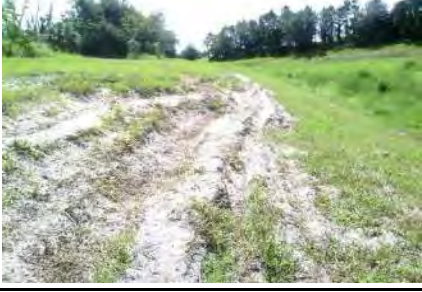
Drainage	Pond/ Ditch/ Canal	2	erosion around the pond	6
41

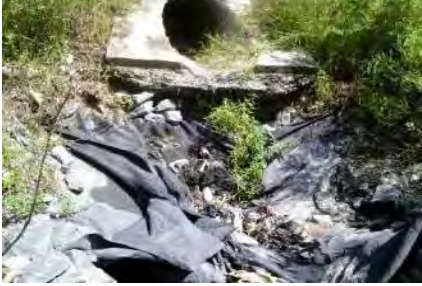
Drainage	Drainage Structure	1	erosion around the mes - rip rap failure	6

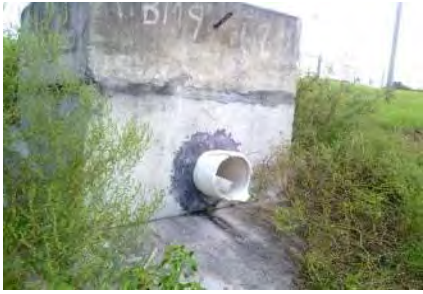
Drainage	Drainage Structure	3	control structure pipe damaged	6
43

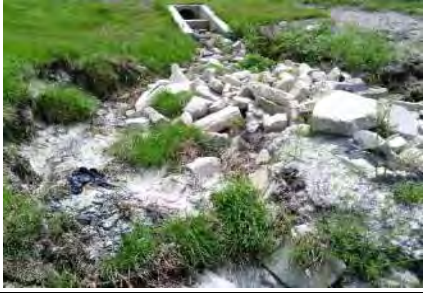
Drainage	Drainage Structure	2	rip rap failure - wash out at toe of endwall	3
44

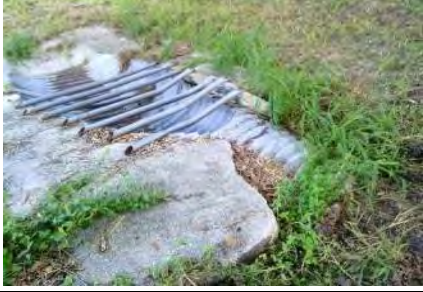
Drainage	Drainage Structure	2	structure broken - pipe exposed / grate pipes damaged	1
45

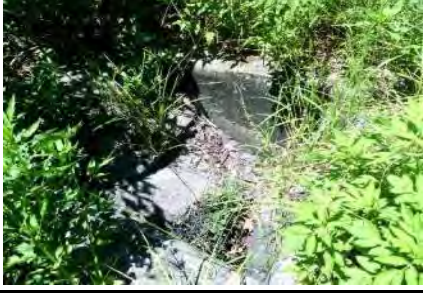
Drainage	Drainage Structure	2	obstructed endwall	3
46

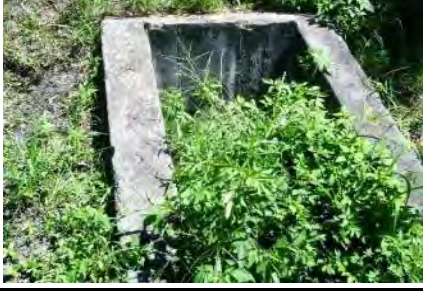
Drainage	Drainage Structure	2	2 endwalls obstructed - sediment in pipe	3
47

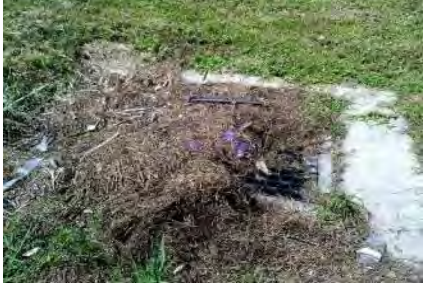
Drainage	Drainage Structure	3	dbi grate covered with debris	4

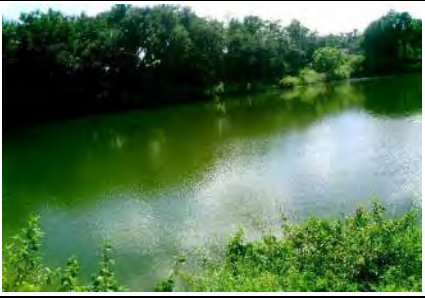
Drainage	Pond/ Ditch/ Canal	2	no access to control structure	7
49

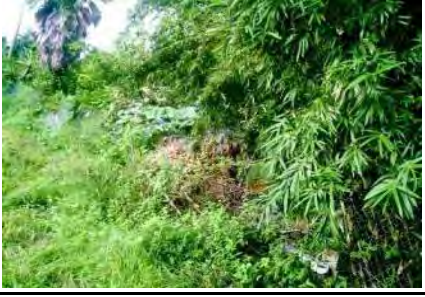
Roadside	Fence	3	fence damaged	23
50

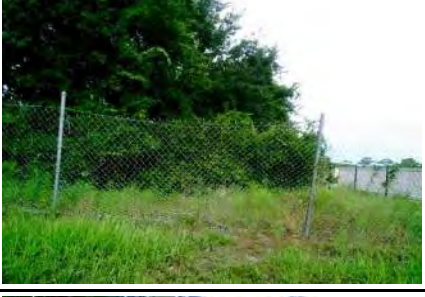
Roadside	Fence	3	fence damaged	23
51

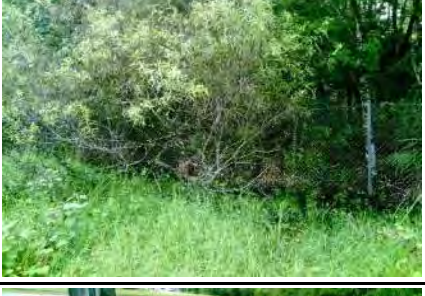
Roadside	Fence	3	fence damaged by tree	25
53

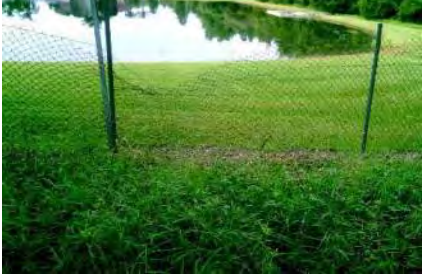
Roadside	Fence	2	fence damaged	26

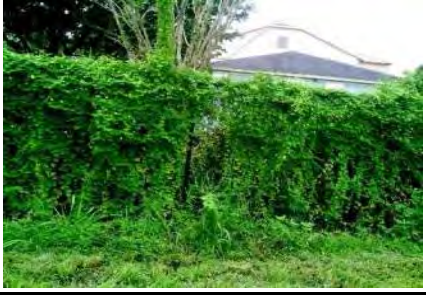
Roadside	Fence	2	hole in the fence	28
56

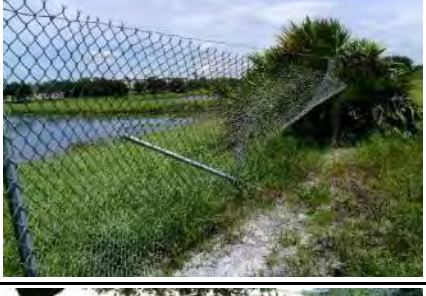
Roadside	Fence	2	fence damaged	28
59

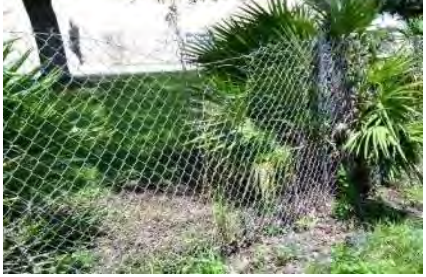
Roadside	Fence	2	fence damaged at multiple spots	28

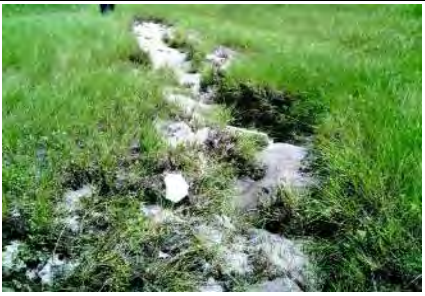
Roadside	Erosion	2		28
61

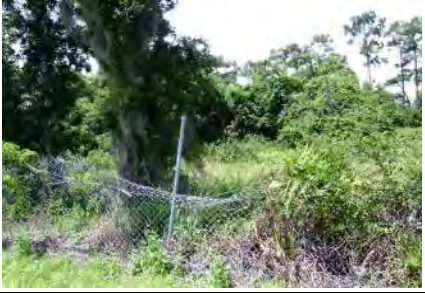
Roadside	Fence	2	fence damaged	27
62

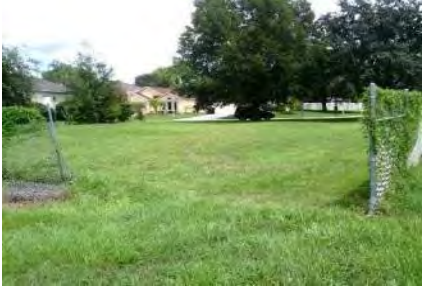
Roadside	Fence	1	fence gap wide open	25
63

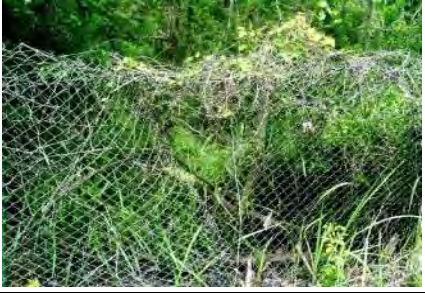
Roadside	Fence	2	fence damaged	25
64

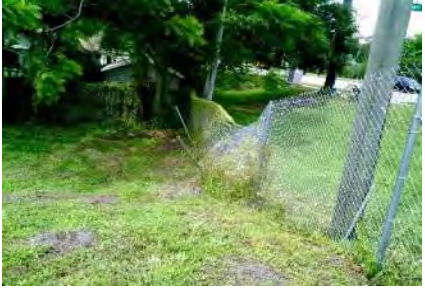
Roadside	Fence	2	fence damaged around the pond	25
65

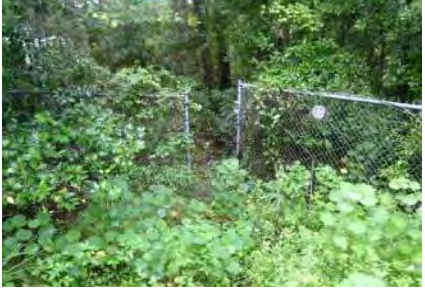
Roadside	Fence	1	open gate with no lock	25

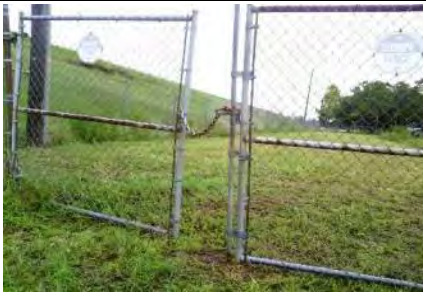
Roadside	Fence	2	no lock for gate	24
67

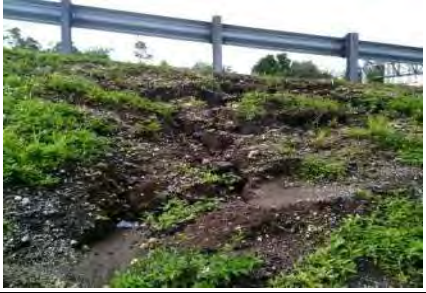
Roadside	Fence	3	erosion by the shoulder	22
68

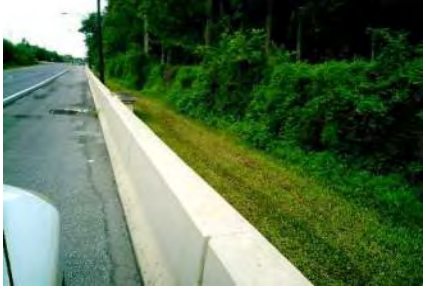
Roadside	Fence	3	overgrown vegetation on fence	21
69

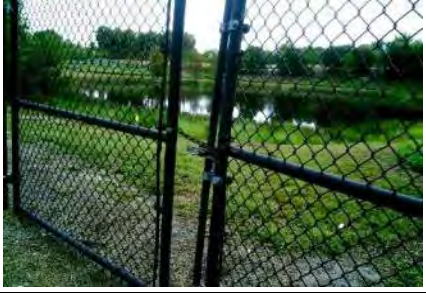
Roadside	Fence	3	no lock pond gate	19
70

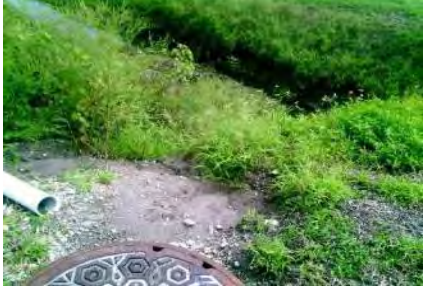
Roadside	Erosion	3	erosion by head walls around the pond	17
71

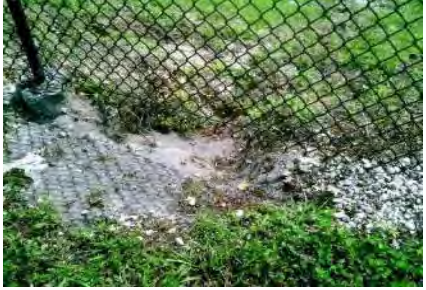
Roadside	Erosion	2	wash out	17

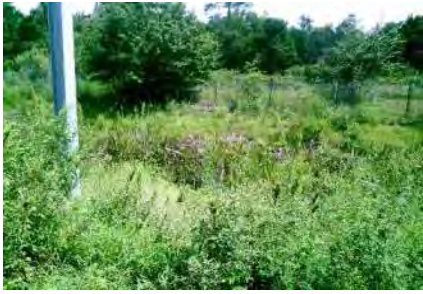
Roadside	Fence	3	fence damaged / overgrown vegetation at this location not maintained	22
79

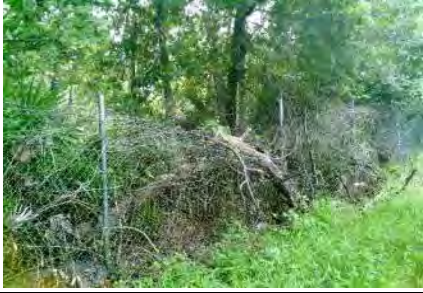
Roadside	Fence	3	fence damaged / overgrown vegetation not maintained	22
80

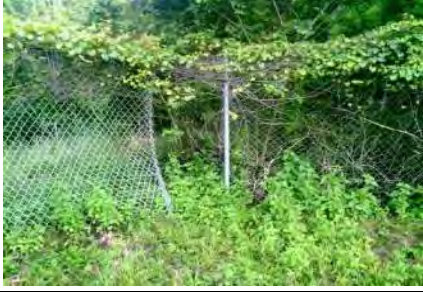
Roadside	Fence	1	fence cut open	27
81

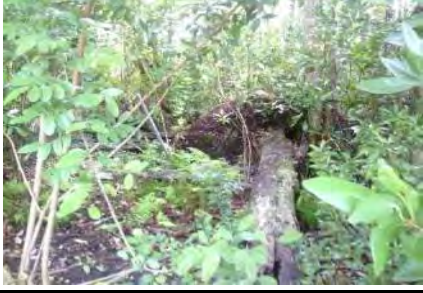
Roadside	Fence	1	fence downed	27
82

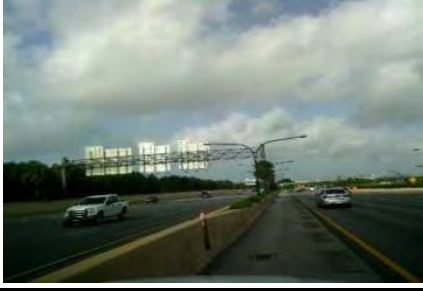
Roadside	Lighting	1	missing light post	18
83

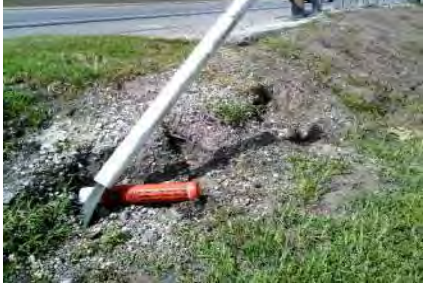
Roadside	Erosion	3		7

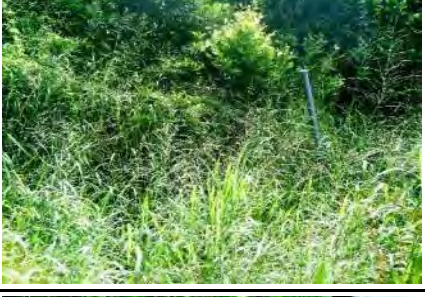
Roadside	Fence	1	fence posts damaged / fence downed	1
87

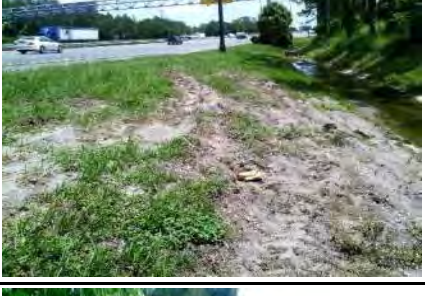
Roadside	Erosion	3		6
89

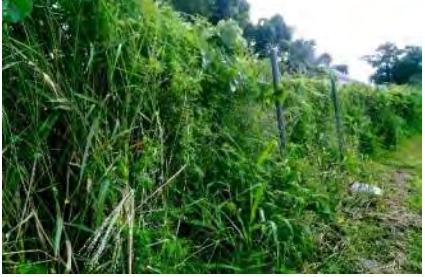
Roadside	Erosion	2	erosion by the shoulder	10

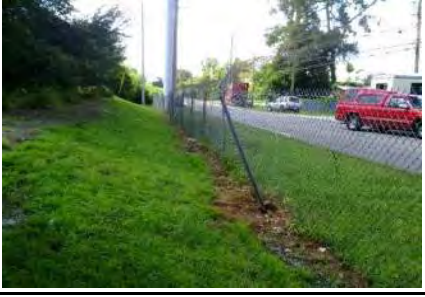
Roadside	Fence	3	fence damaged	8
92

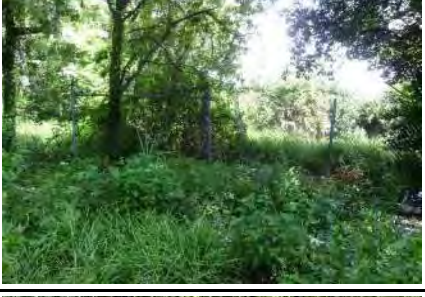
Roadside	Fence	1	hole in the fence - homeless encampment behind	7
93

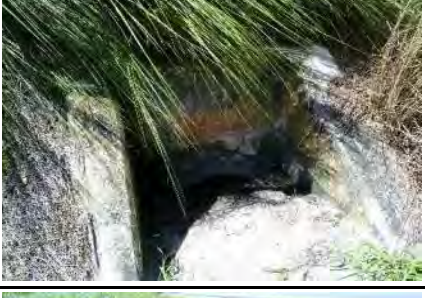
Roadside	Other	2	sediment in pipe	6
94

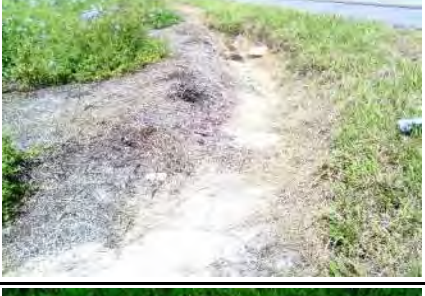
Roadside	Erosion	2	erosion by the shoulder	6
95

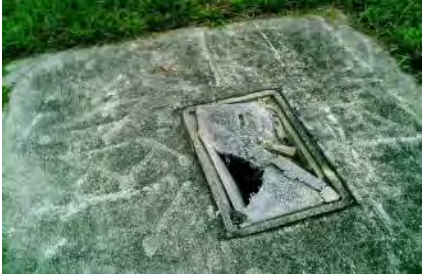
Roadside	Lighting	2	electrical pull box lid broken	6

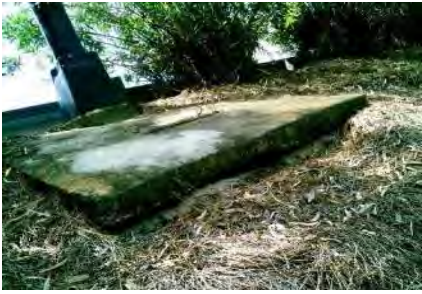
Roadside	Erosion	3		5
97

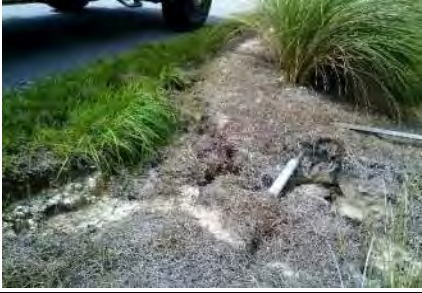
Roadside	Erosion	2	erosion by the shoulder - conduit exposed	5
98

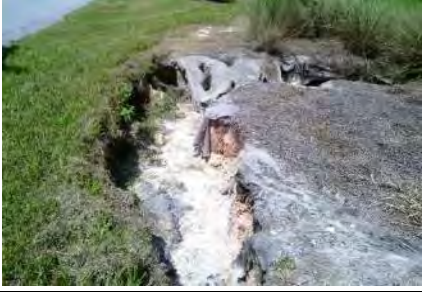
Roadside	Erosion	2	erosion by the shoulder - conduit exposed	5
99

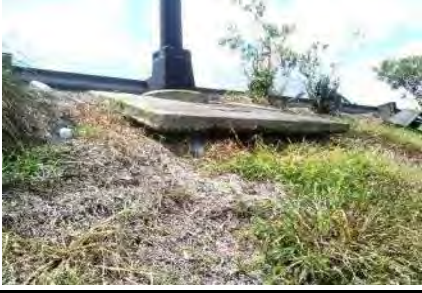
Roadside	Erosion	3	erosion around light pole apron	5
100

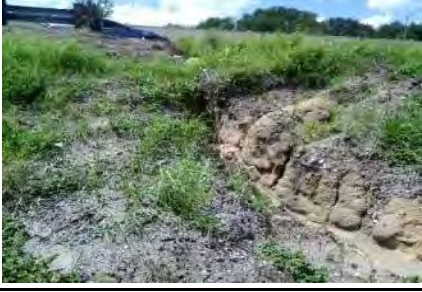
Roadside	Erosion	2	slope erosion	5
101

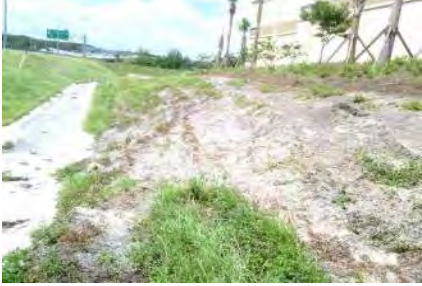
Roadside	Erosion	3	slope erosion also decipators for flume damaged	3

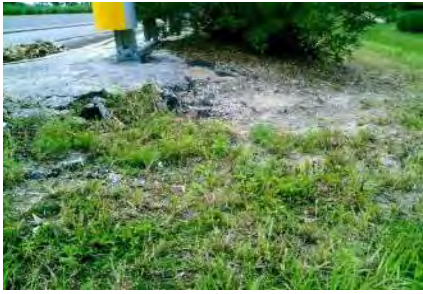
Roadside	Erosion	3	erosion undermining the miscellaneous asphalt	2
103

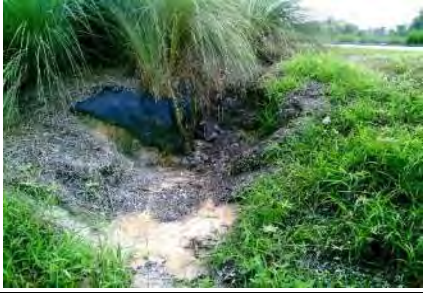
Roadside	Erosion	2		1
104

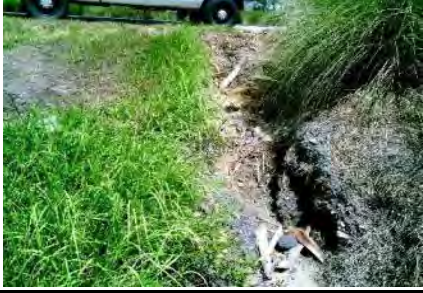
Roadside	Erosion	2	slope erosion	2
106

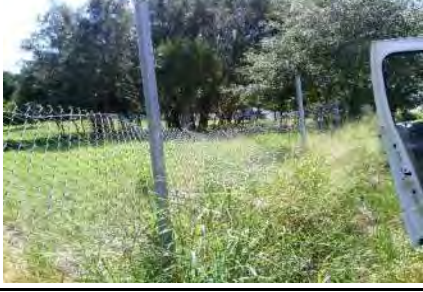
Roadside	Fence	2	fence damaged	4
107

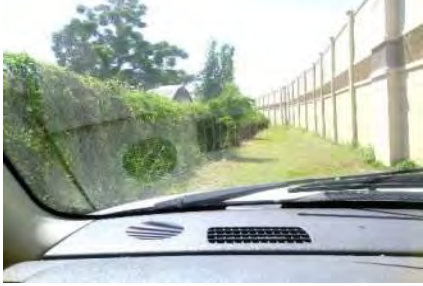
Roadside	Fence	3	overgrown vegetation	4

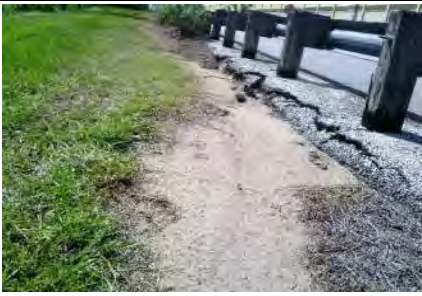
ID No.	Image	Category	Issue Type	Rating (1, 2, or 3)	Comments	Map Sht No.
108

Roadside	Erosion	2	erosion by the shoulder	5
109

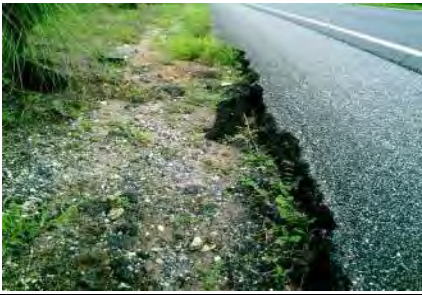
Roadside	Other	2	damaged by erosion	31
110

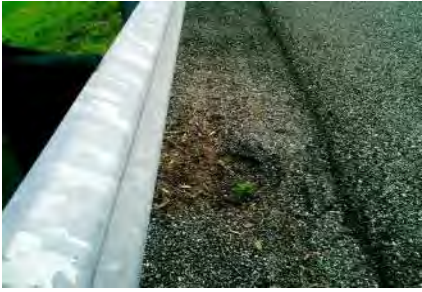
Pavement	Pothole	3	pothole forming	22
111

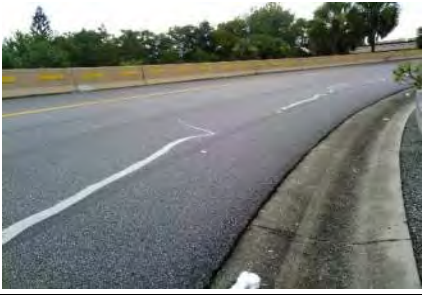
Pavement	Striping or Pavement Marking	2	striping on on ramp	19
112

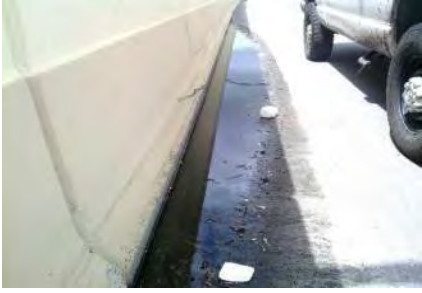
Pavement	Other	3	water ponding on the shoulder	18
113

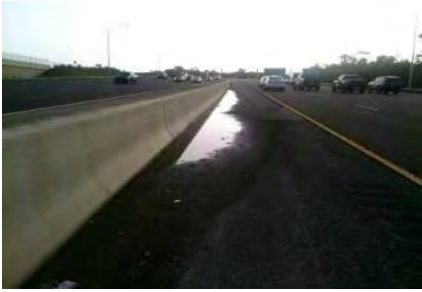
Pavement	Other	2	standing water on paved shoulder	22

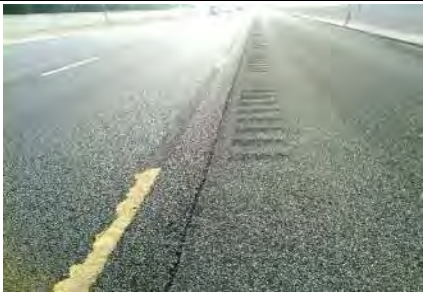
ID No.	Image	Category	Issue Type	Rating (1, 2, or 3)	Comments	Map Sht No.
114

Pavement	Striping or Pavement Marking	2	striping missing	23
115

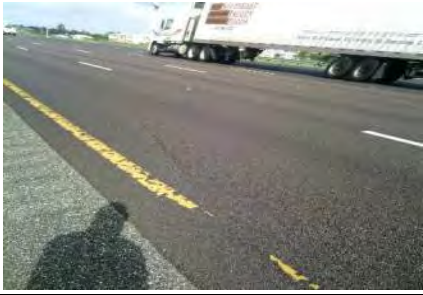
Pavement	Other	3	mainline asphalt damaged	22
116

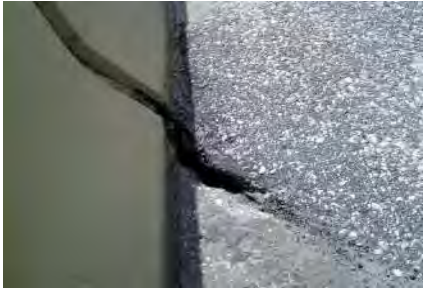
Pavement	Other	1	hole in approach slab - bridge connection	11
117

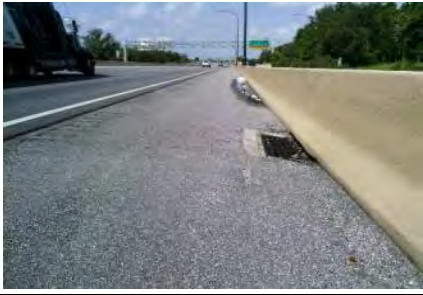
Pavement	Other	2	standing water - not draining into the inlet	8
118

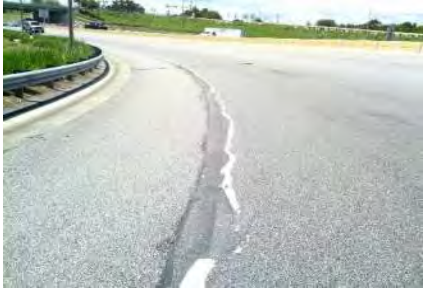
Pavement	Striping or Pavement Marking	2	striping damaged	3
119

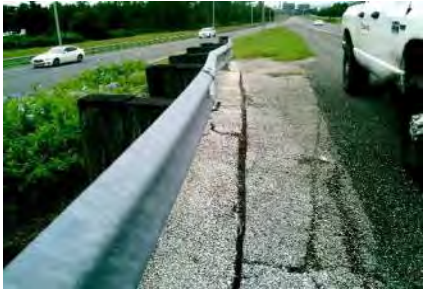
Walls or Barriers	Guardrail	2	guard rail smashed	30

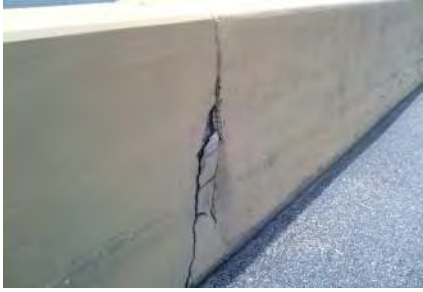
Walls or Barriers	Barrier Wall	2	barrier wall damaged	18
128

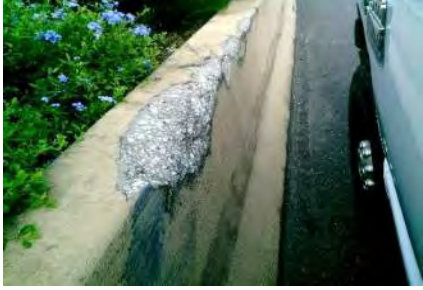
Walls or Barriers	Barrier Wall	2	barrier wall damaged	15
129

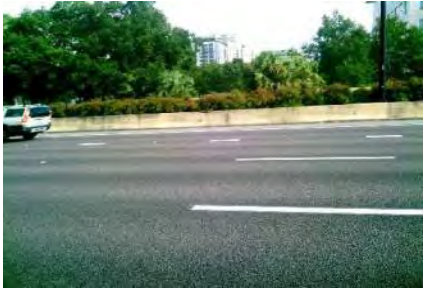
Walls or Barriers	Barrier Wall	2	barrier wall damaged outside shoulder	14
130

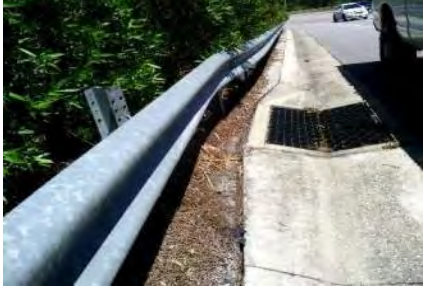
Walls or Barriers	Guardrail	2	smashed	3
131

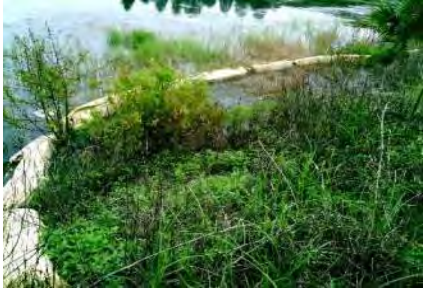
Other Issue	Other	1	turbidity barrier in pond	31

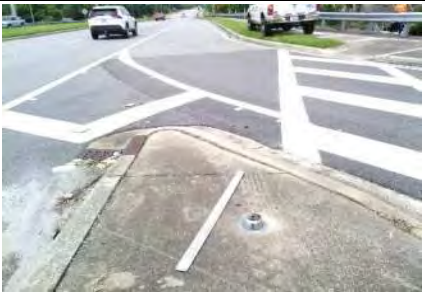
ID No.	Image	Category	Issue Type	Rating (1, 2, or 3)	Comments	Map Sht No.
132

Other Issue	Other	2	missing sign	25
133

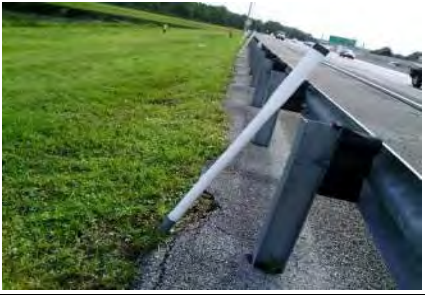
Other Issue	Other	3	delineators tilted	22
134

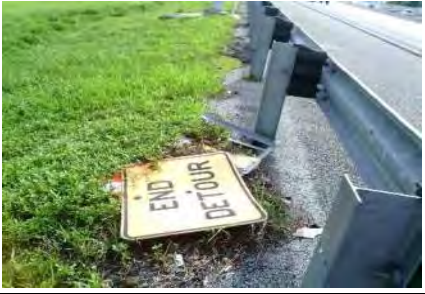
Other Issue	Other	3	work sign not removed	22
135

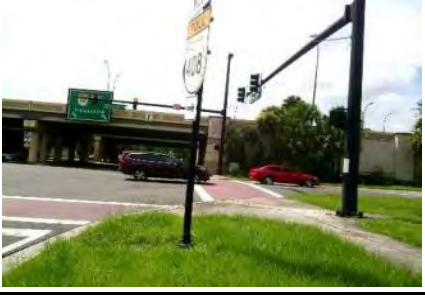
Other Issue	Other	2	sign turned and pointing wrong direction	16
136

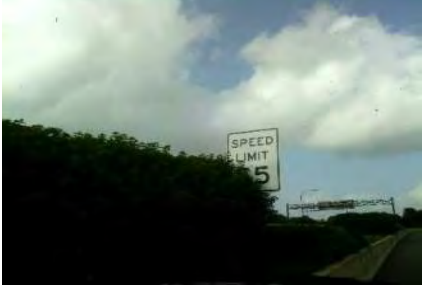
Other Issue	Other	2	sign covered by landscaping	15

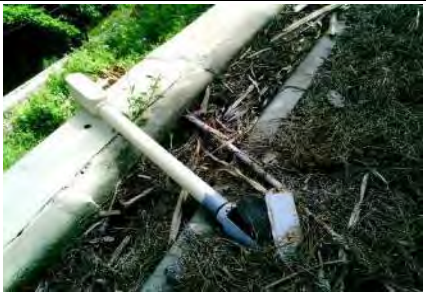
ID No.	Image	Category	Issue Type	Rating (1, 2, or 3)	Comments	Map Sht No.
138

Other Issue	Other	2	ITS wire exposed	10
139

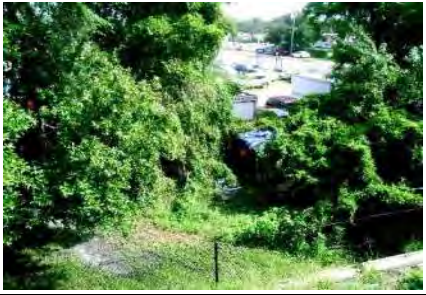
Other Issue	Other	1	homeless camp in ROW	10
140

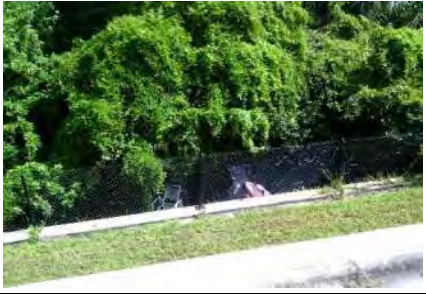
Other Issue	Other	1	homeless camp in ROW	9
141

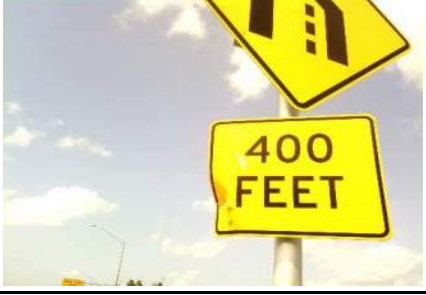
Other Issue	Other	3	sign damaged / old base not removed	2
143

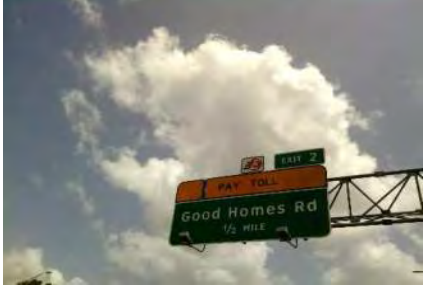
Other Issue	Other	3	yellow reflective material not consistent behind Pay Toll message	2

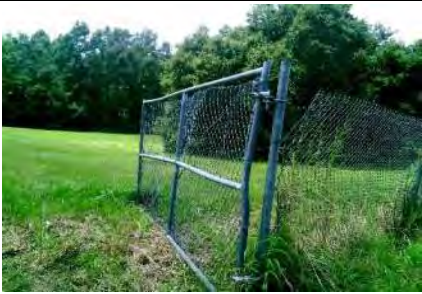
ID No.	Image	Category	Issue Type	Rating (1, 2, or 3)	Comments	Map Sht No.
144

Other Issue	Other	1	gate damaged	2
145

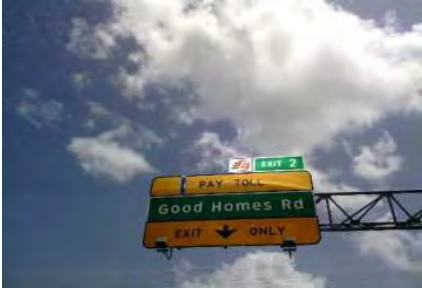
Other Issue	Other	3	yellow reflective material behind the Pay Toll message not consistent	2
146

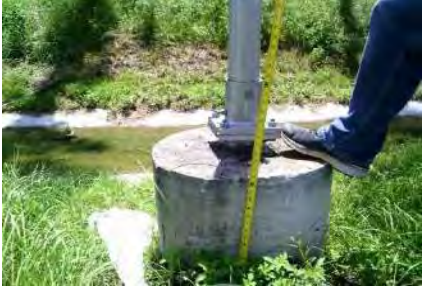
Other Issue	Other	3	sign base exposed - 12 inches	6
147

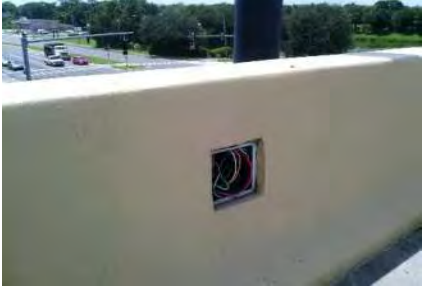
Other Issue	Other	2	hand hole cover missing	7
148

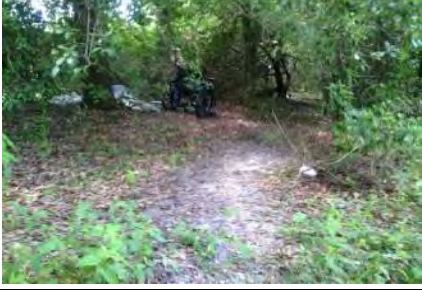
Other Issue	Other	1	homeless encampment	10
149

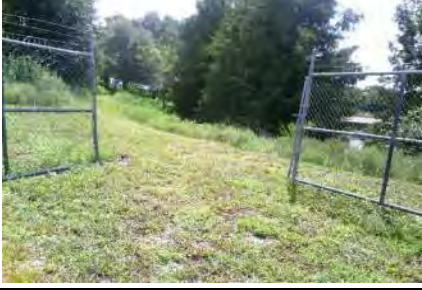
Other Issue	Other	1	gate lock missing	7

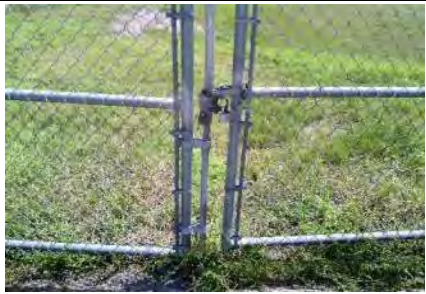
ID No.	Image	Category	Issue Type	Rating (1, 2, or 3)	Comments	Map Sht No.
150

Other Issue	Other	2	no access to pond - numeric code lock	5

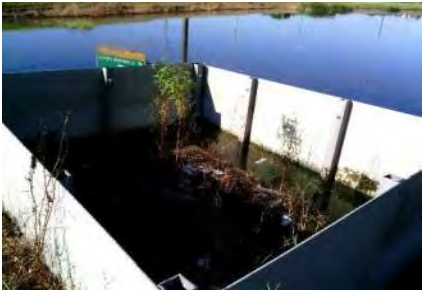
Drainage	Drainage Structure	2	grate top fully covered with debris	9
1

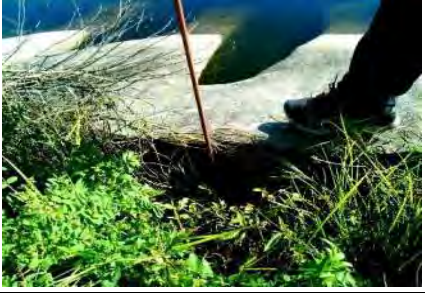
Drainage	Drainage Structure	3	erosion at back of triple mes	9
2

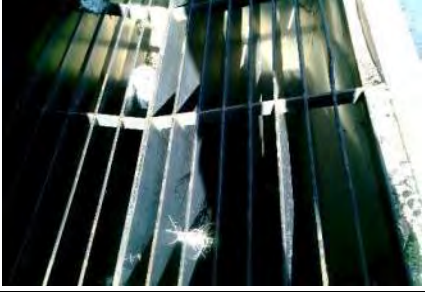
Drainage	Drainage Structure	2	three shoulder gutter inlets at this area - pipes fully covered with sediment / debris	8
3

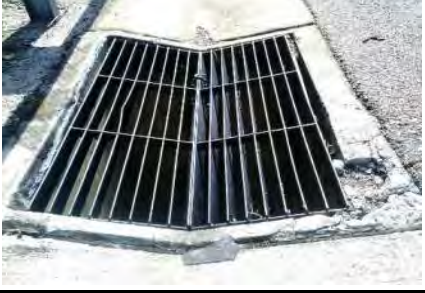
Drainage	Drainage Structure	3	shoulder gutter inlet damaged	6
4

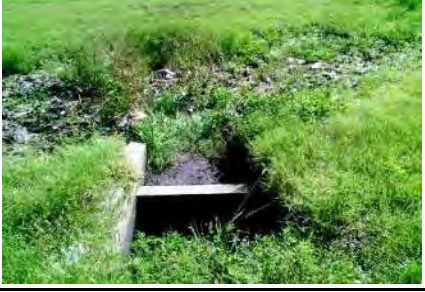
Drainage	Drainage Structure	3	u type endwall obstructed / not maintained	6
5

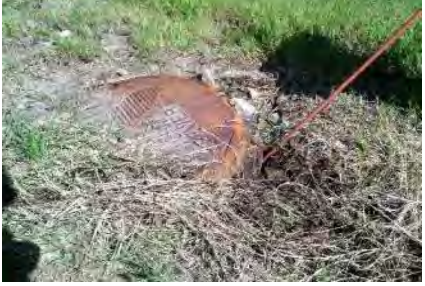
Drainage	Drainage Structure	3	manhole damaged	6

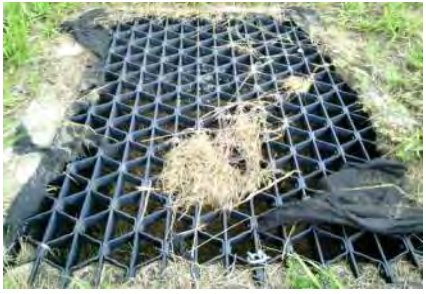
Drainage	Drainage Structure	3	inlet protection fabric still in place / no active construction	2
7

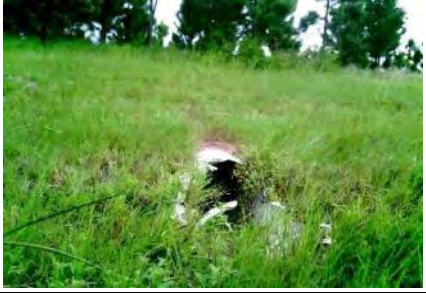
Drainage	Drainage Structure	3	protruding pipe damaged	2
8

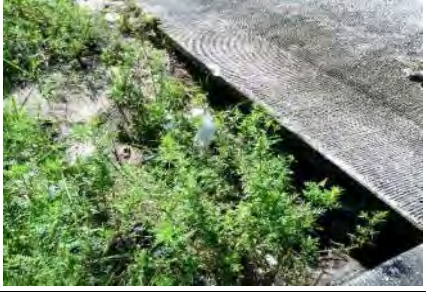
Drainage	Flume/ Concrete Apron	2	erosion underneath	6
9

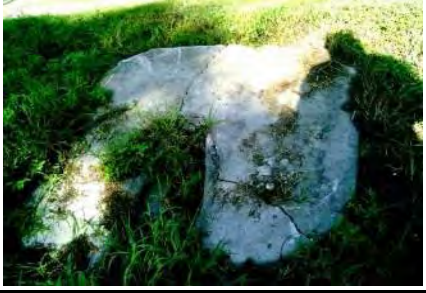
Drainage	Drainage Structure	2	mes damaged	8
10

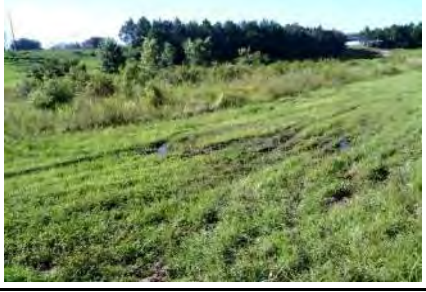
Drainage	Pond/ Ditch/ Canal	3	dry pond appears to be wet with overgrown vegetation	7
11

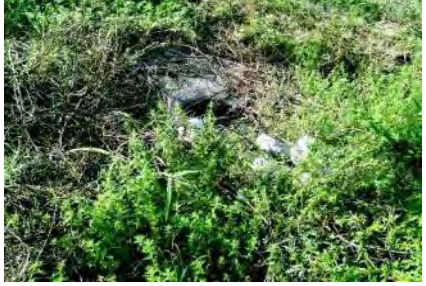
Drainage	Drainage Structure	2	mes 3/4 full sediment and undermined	6

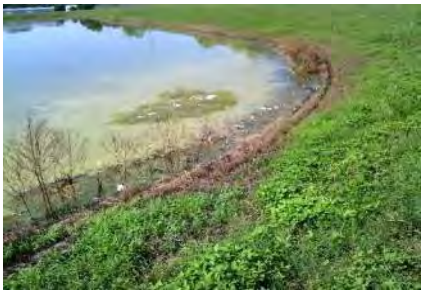
Drainage	Pond/ Ditch/ Canal	2	pond turbid also debris not cleaned	5
13

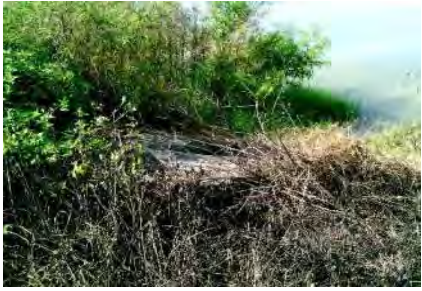
Drainage	Drainage Structure	2	erosion underneath the 2 mes at this pond	5
14

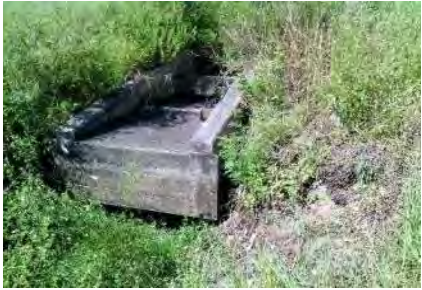
Drainage	Drainage Structure	2	erosion underneath the endwall	4
15

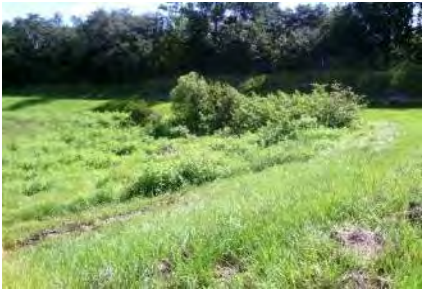
Drainage	Pond/ Ditch/ Canal	3	wet area in a dry pond with overgrown vegetation	4
16

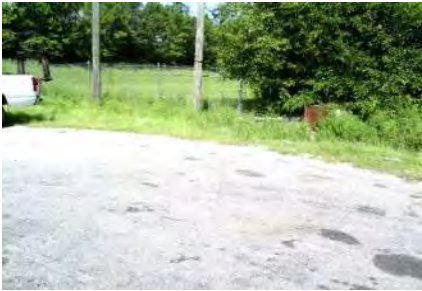
Drainage	Pond/ Ditch/ Canal	2	access gate needed for dry ponds by toll plaza	4
17

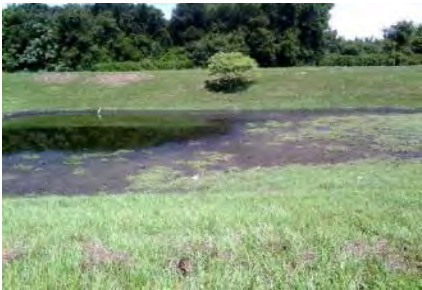
Drainage	Pond/ Ditch/ Canal	2	wet area in a dry pond	1

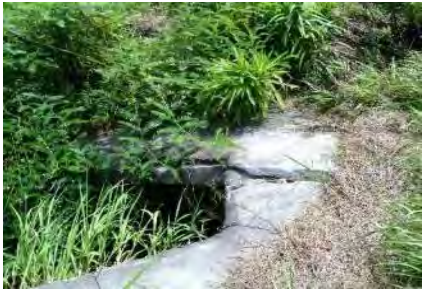
Drainage	Drainage Structure	2	broken mes	1
19

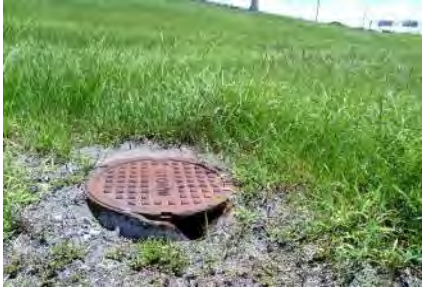
Drainage	Drainage Structure	1	manhole damaged	2
20

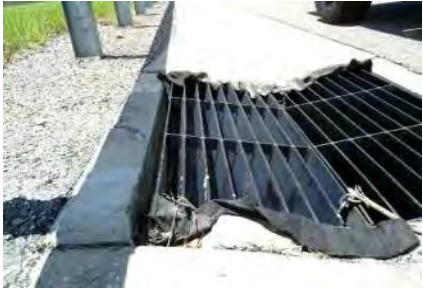
Drainage	Drainage Structure	3	shoulder gutter inlet damaged	4
21

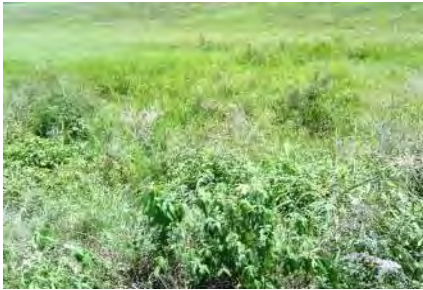
Drainage	Drainage Structure	2	no access to mes / overgrown vegetation	2
22

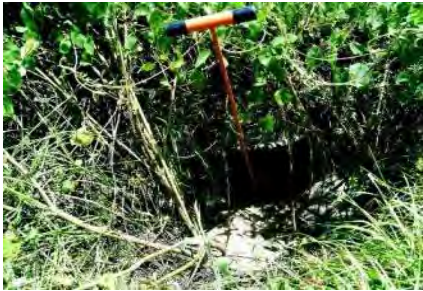
Drainage	Drainage Structure	2	erosion underneath the mes	3
23

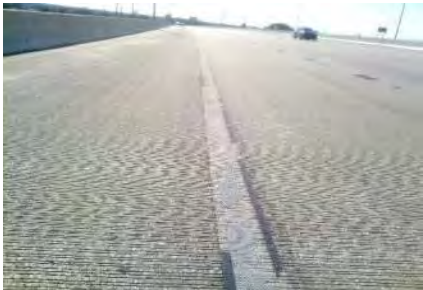
Pavement	Striping or Pavement Marking	2	striping peeling away all along the bridge	8

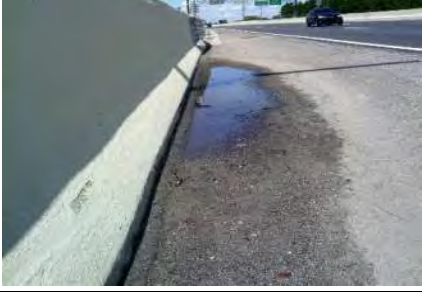
Pavement	Other	2	water ponding on shoulder	5
27

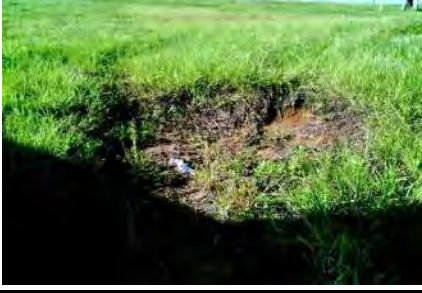
Roadside	Erosion	3	erosion around pond	9
28

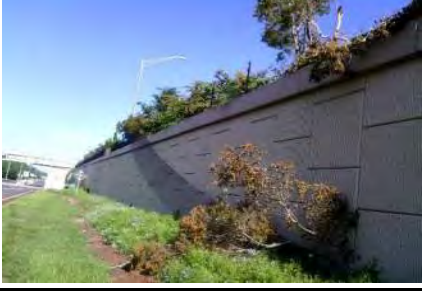
Roadside	Fence	1	fence over mse wall knocked down / coping damaged	7
29

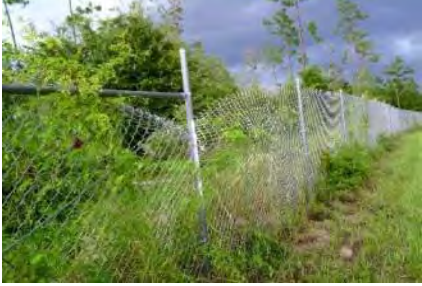
Roadside	Fence	3	fence damaged	2

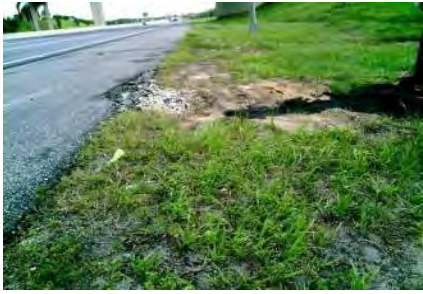
Roadside	Erosion	2	erosion by the shoulder undermining pavement	2
31

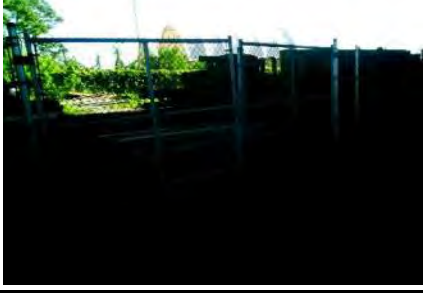
Roadside	Fence	3	gate to railroad broken under bridge	8
33

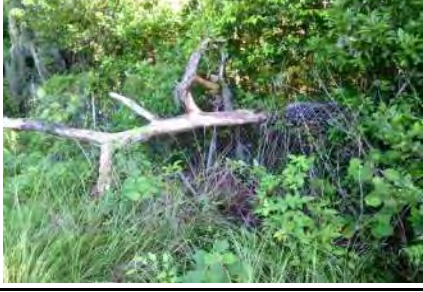
Roadside	Fence	3	gate to railroad under bridge blocked with debris / posts down along fence	8
34

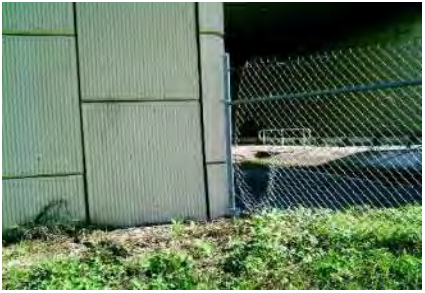
Roadside	Fence	3	fence damaged / leaning	7
37

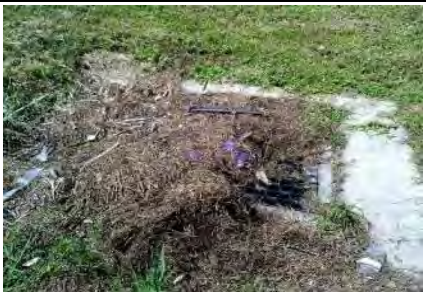
Other Issue	Other	2	solid asphalt on grass	2
47

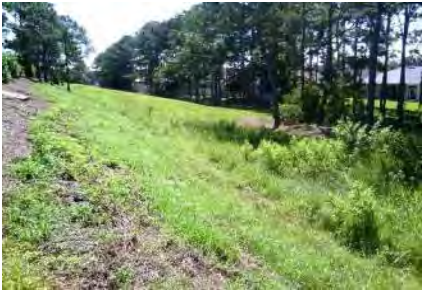
Drainage	Drainage Structure	2	overgrown vegetation in ditch / no access to mes	3
1

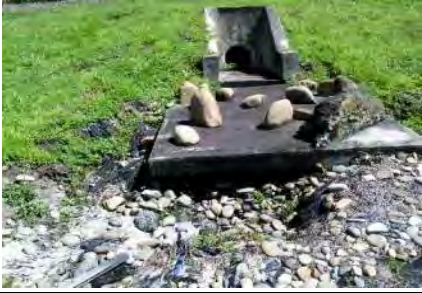
Drainage	Drainage Structure	2	erosion at toe of endwall	1
2

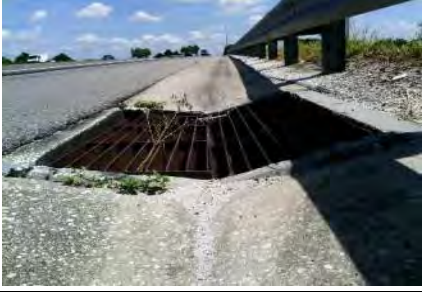
Drainage	Drainage Structure	3	shoulder gutter inlet damaged grate exposed	5
3

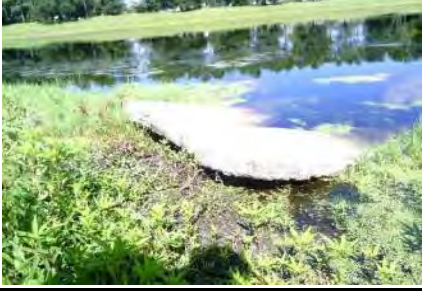
Drainage	Drainage Structure	2	multiple mes around pond undermined	7
5

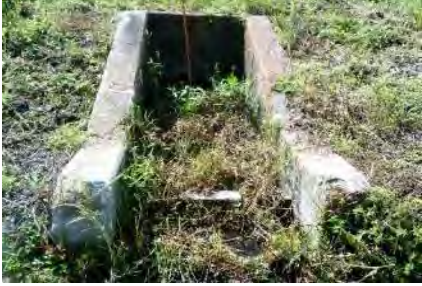
Drainage	Drainage Structure	3	end wall obstructed - 6 inch sediment in pipe / dbi not maintained	7
