2020

Annual Inspection Report

Appendix 3: SR 408

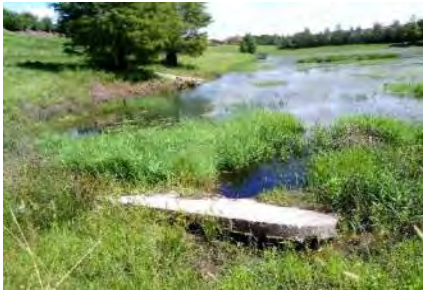
Drainage	Drainage Structure	2	erosion around the mes / mes damaged	6
7

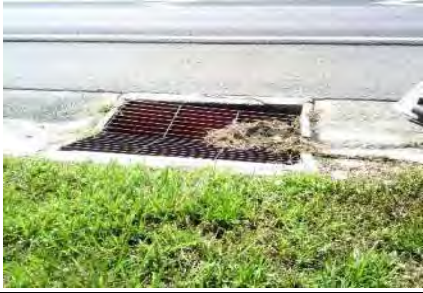
Drainage	Drainage Structure	2	grate needs to be reset	6
8

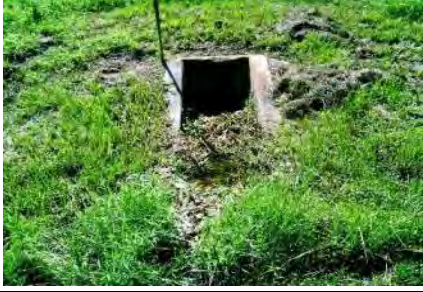
Drainage	Drainage Structure	3	endwall obstructed - 6 inch sediment in pipe	6
9

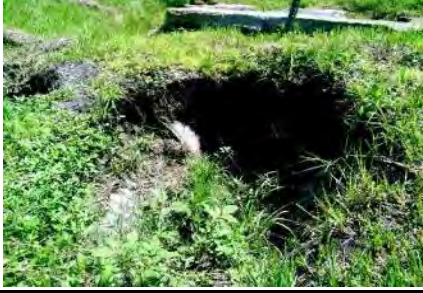
Drainage	Drainage Structure	1	erosion exposing pipe - structure several damaged	5
10

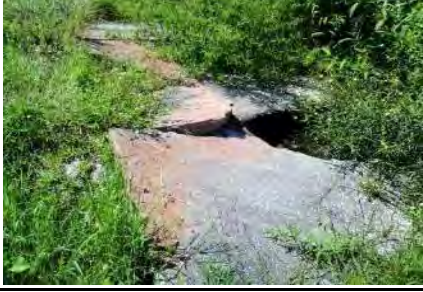
Drainage	Drainage Structure	1	2 mes around the pond broken	5
11

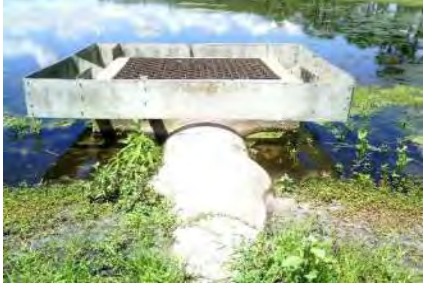
Drainage	Drainage Structure	3	pipe exposed	4

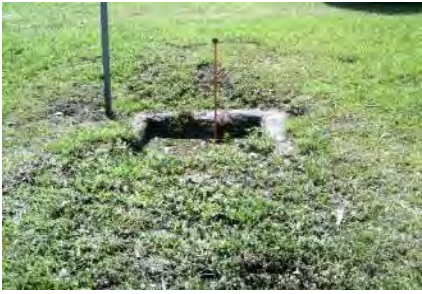
Drainage	Drainage Structure	2	endwall obstructed - 9 inch sediment	3
13

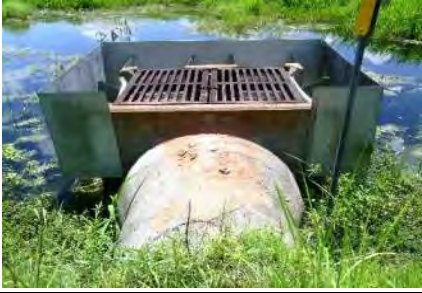
Drainage	Drainage Structure	2	pipe exposed	2
14

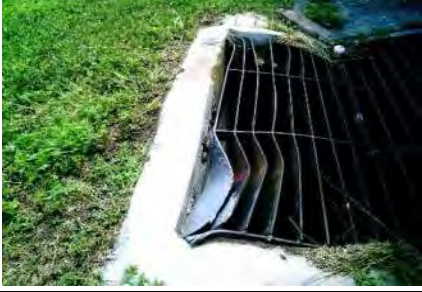
Drainage	Drainage Structure	3	shoulder gutter inlet grate damaged	2
15

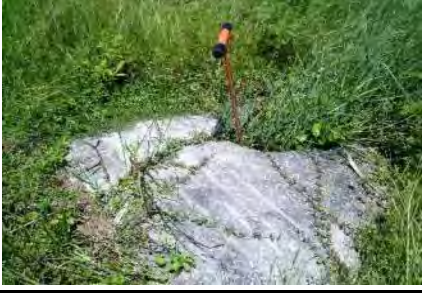
Drainage	Drainage Structure	2	mes broken	2
16

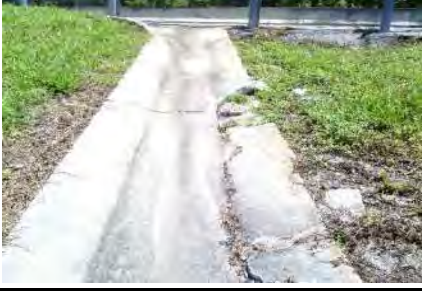
Drainage	Flume/ Concrete Apron	3	flume damaged also miscellaneous asphalt settled at several spots at this location	4
17

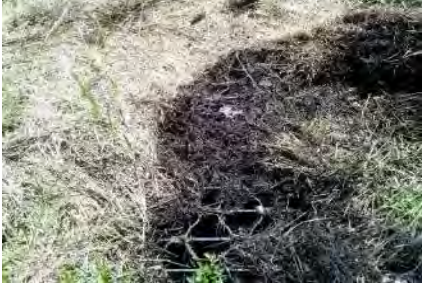
Drainage	Drainage Structure	2	dbi grate completely obstructed	6

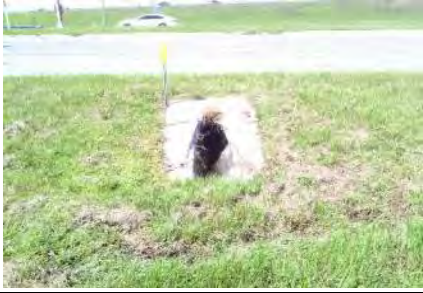
Drainage	Drainage Structure	3	mes damaged	8
20

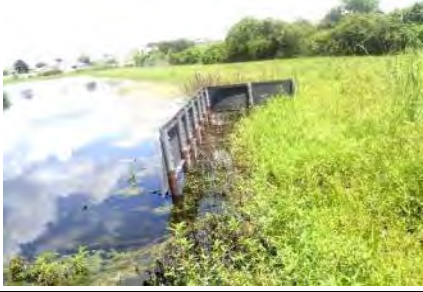
Drainage	Other	2	broken skimmer / overgrown vegetation on fabric rip rap	11
21

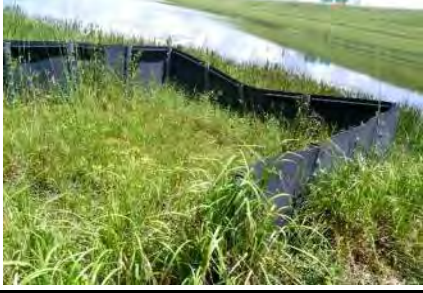
Drainage	Other	2	broken skimmer / overgrown vegetation on fabric rip rap	9
22

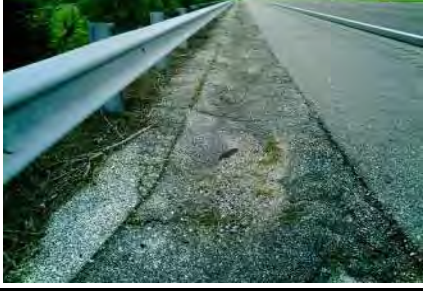
Drainage	Other	2	shoulder gutter damaged	12
23

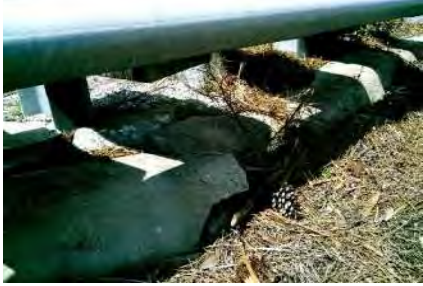
Drainage	Other	3	shoulder curb damaged	12

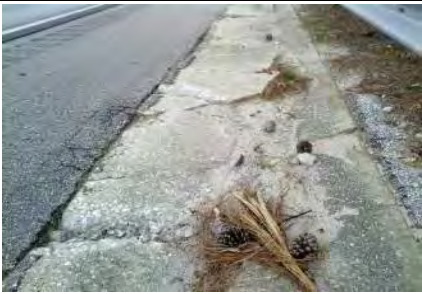
Drainage	Other	2	shoulder gutter damaged	11
25

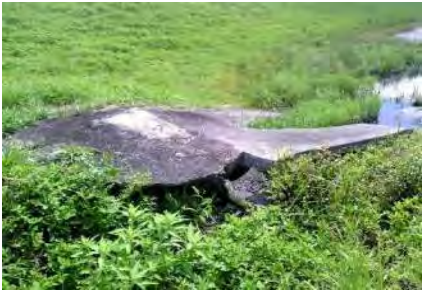
Drainage	Drainage Structure	2	erosion around mes"	12
26

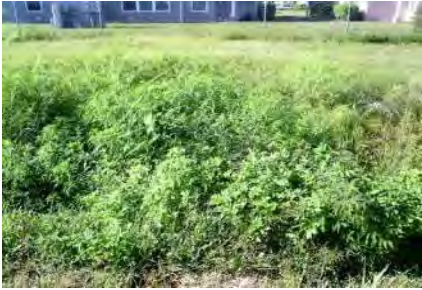
Drainage	Drainage Structure	3	no access to outfall of control structure	13
27

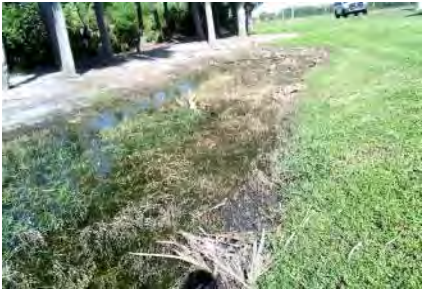
Drainage	Pond/ Ditch/ Canal	2	mes missing	14
28

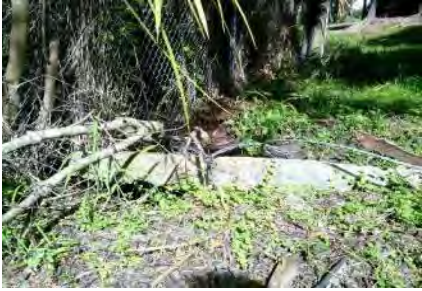
Drainage	Drainage Structure	3	erosion around mes / 6 inch sediment in pipe	14
29

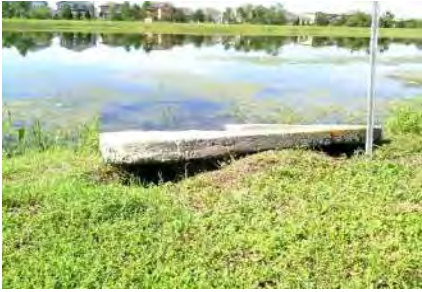
Drainage	Drainage Structure	2	erosion around the mes	14

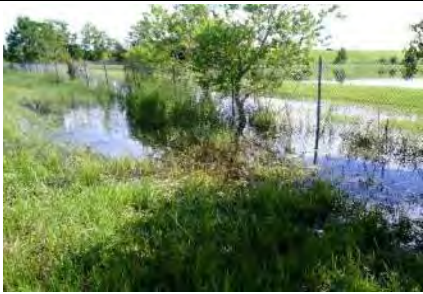
Drainage	Pond/ Ditch/ Canal	3	water ponding by the berm	15
31

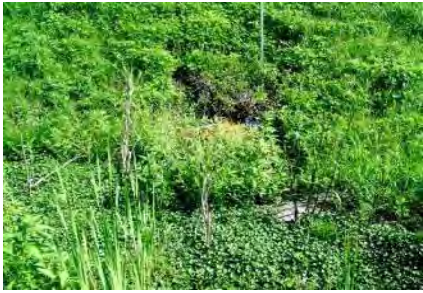
Drainage	Drainage Structure	3	veg and debris mes	15
32

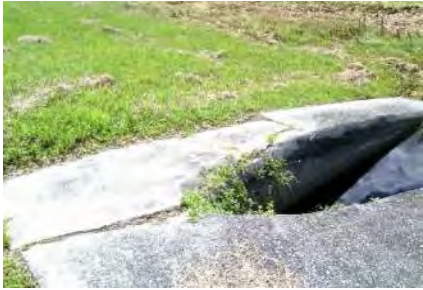
Drainage	Drainage Structure	3	mes damaged	17
33

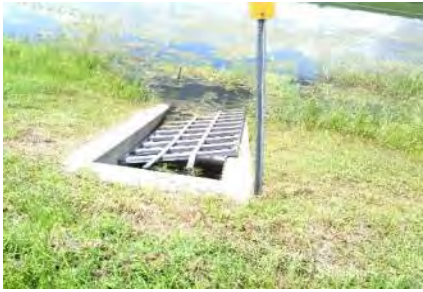
Drainage	Drainage Structure	3	grate damaged	18
34

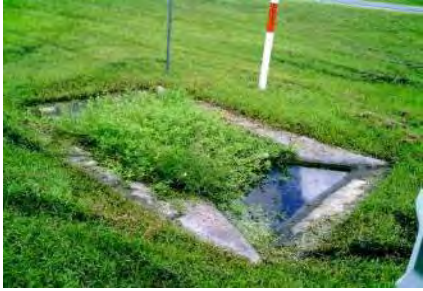
Drainage	Drainage Structure	2	dbi grate obstructed	19
35

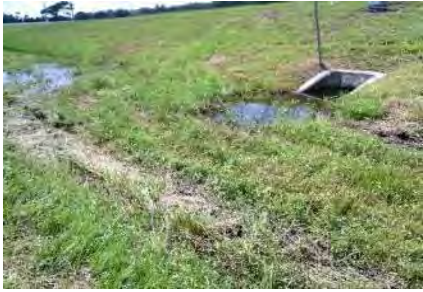
Drainage	Drainage Structure	2	endwall obstructed	22

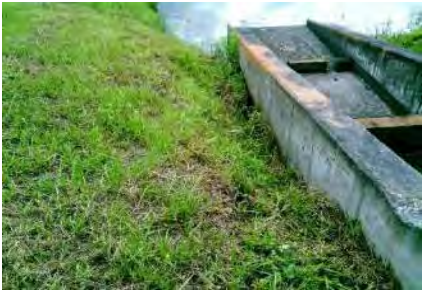
Drainage	Drainage Structure	3	erosion around the endwall	22
37

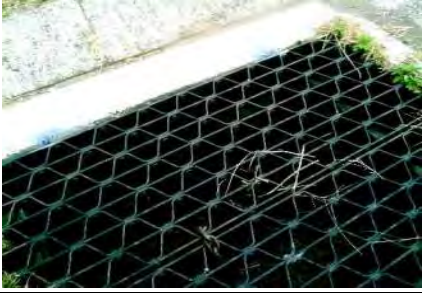
Drainage	Drainage Structure	3	sediment in inlet	19
38

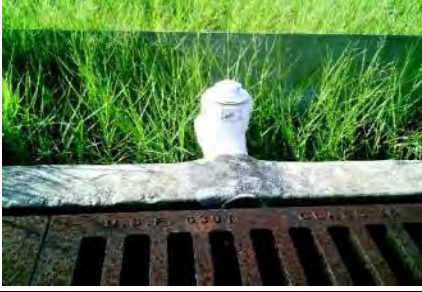
Drainage	Drainage Structure	3	trash in orifice / flow obstructed	24
39

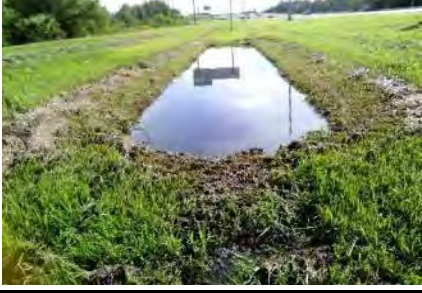
Drainage	Pond/ Ditch/ Canal	2	ditch water ponding / cross drain pipe located underneath	23
40

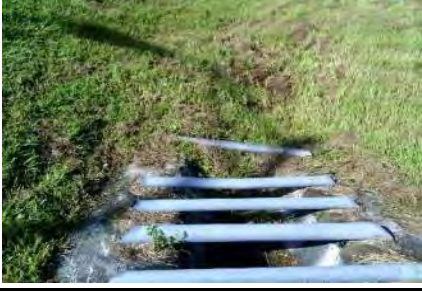
Drainage	Drainage Structure	3	broken grate	23
41

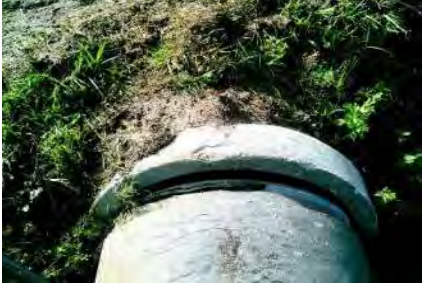
Drainage	Drainage Structure	1	pipe joint separation - control structure	22

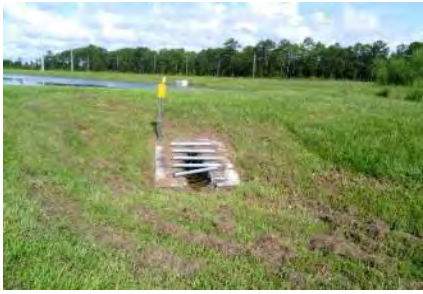
Drainage	Drainage Structure	3	grate damaged	20
43

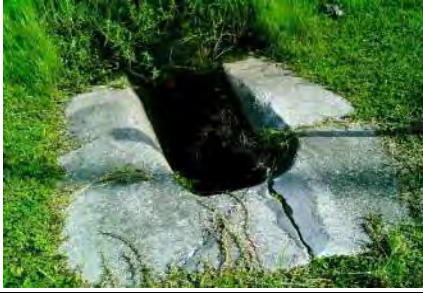
Drainage	Drainage Structure	2	mes damaged	17
44

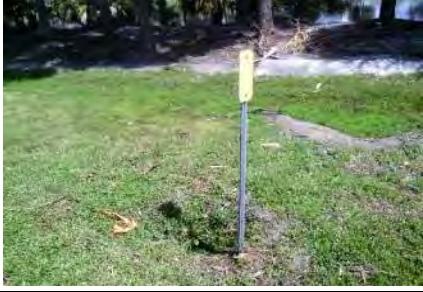
Drainage	Drainage Structure	2	structure submerged	14
45

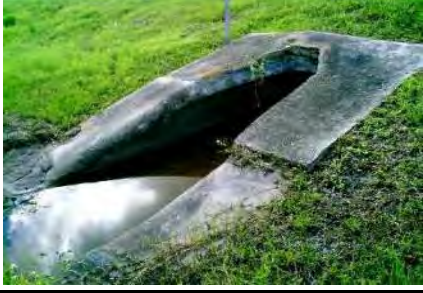
Drainage	Drainage Structure	2	mes broken	14
46

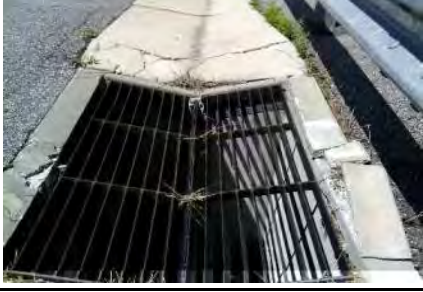
Drainage	Other	2	shoulder gutter damaged	16
47

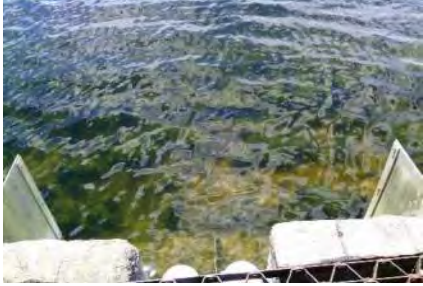
Drainage	Drainage Structure	2	skimmer missing	19

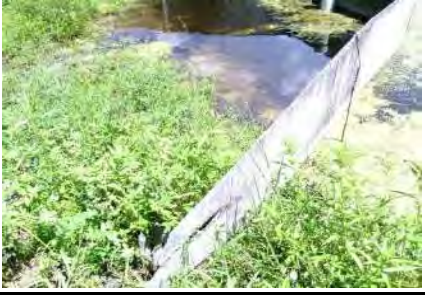
Drainage	Drainage Structure	3	skimmer bent and damaged	24
50

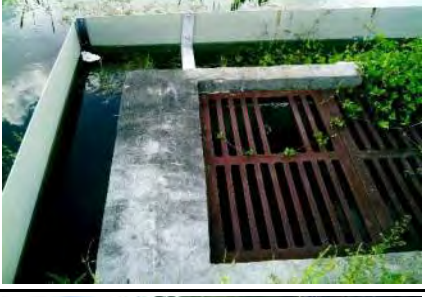
Drainage	Drainage Structure	3	grate damaged	25
51

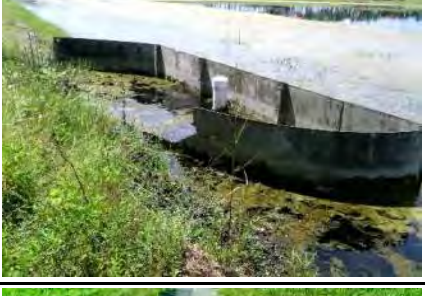
Drainage	Drainage Structure	2	skimmer damaged / control structure non functional	27
53

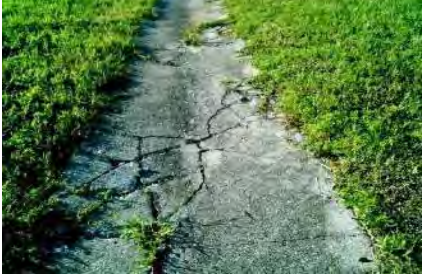
Drainage	Flume/ Concrete Apron	3	flume damaged	24

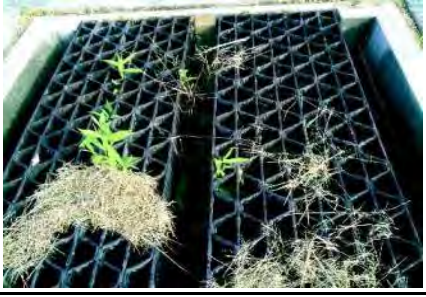
Drainage	Drainage Structure	3	dbi filled with sediment	23
56

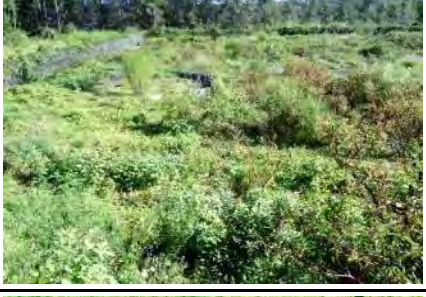
Drainage	Pond/ Ditch/ Canal	2	overgrown vegetation around the pond no access / skimmer damaged	45
57

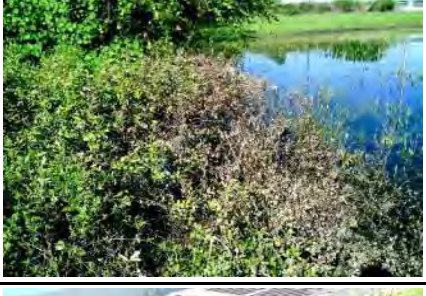
Drainage	Drainage Structure	2	control structure skimmer damaged by overgrown vegetation / fabric rip rap gbroken	28
59

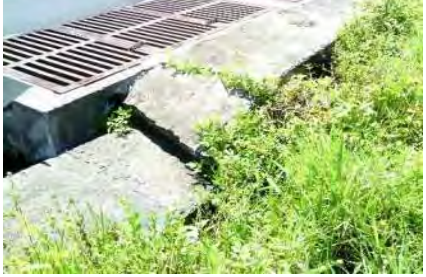
Drainage	Drainage Structure	2	control structure damaged / undermined by erosion	30

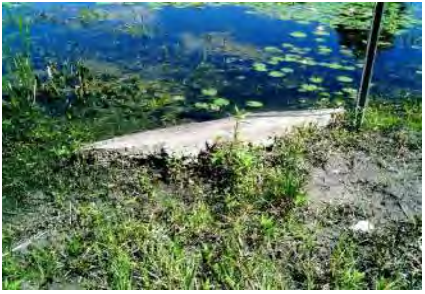
Drainage	Drainage Structure	2	erosion - 2 mes around mes around the pond	30
61

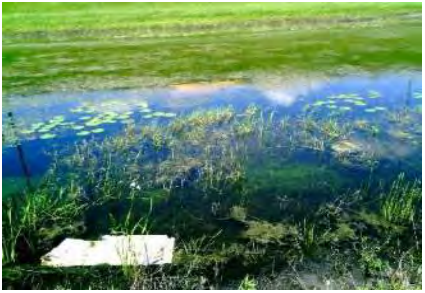
Drainage	Pond/ Ditch/ Canal	3	trash in pond	30
62

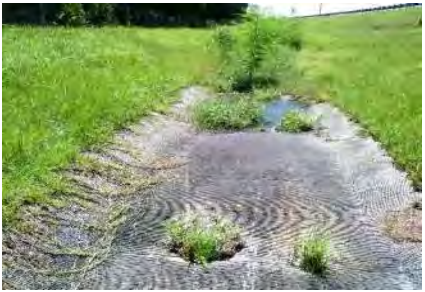
Drainage	Flume/ Concrete Apron	3	overgrown vegetation - flume	33
63

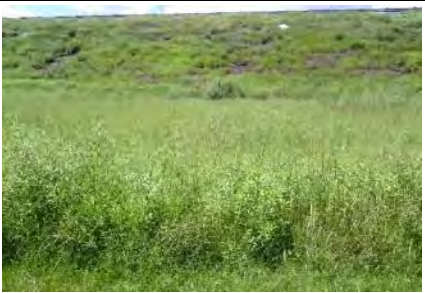
Drainage	Drainage Structure	2	overgrown vegetation end wall obstructed / control structure non functional	33
64

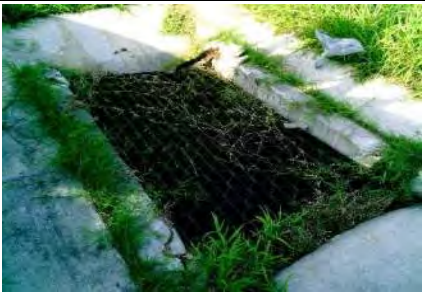
Drainage	Drainage Structure	2	inlet grate smashed	35
65

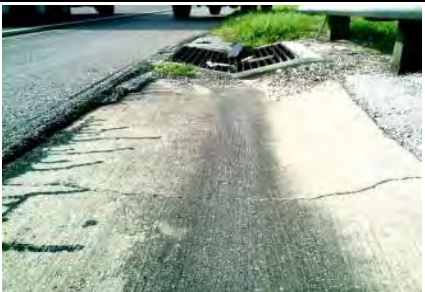
Drainage	Other	3	shoulder gutter cracked / settled	34

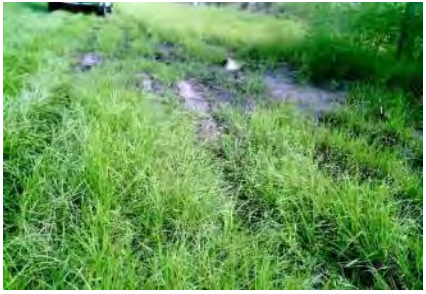
Drainage	Pond/ Ditch/ Canal	3	standing water in ditch	33
67

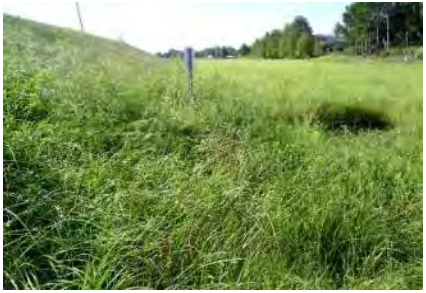
Drainage	Drainage Structure	3	overgrown vegetation around end wall / no access	33
68

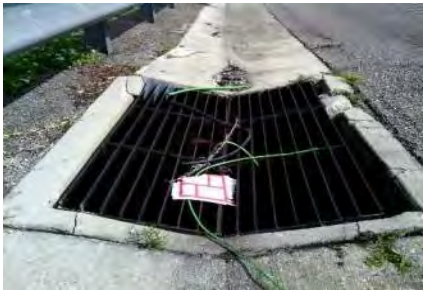
Drainage	Drainage Structure	3	damaged inlet	33
69

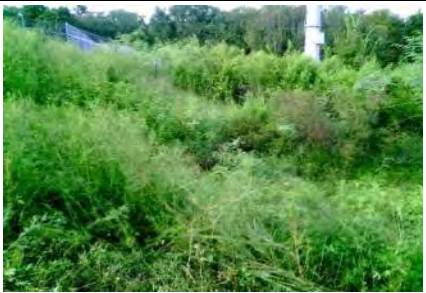
Drainage	Drainage Structure	2	vegetation overgrown and erosion around head wall	32
70

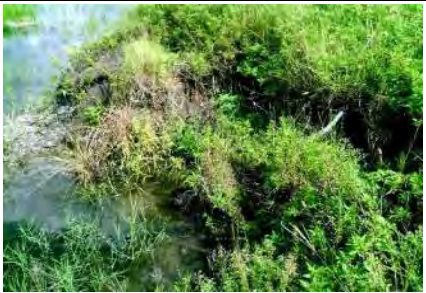
Drainage	Pond/ Ditch/ Canal	1	pond erosion	31
71

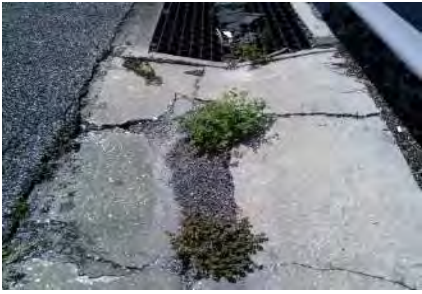
Drainage	Other	3	shoulder gutter damaged	30
73

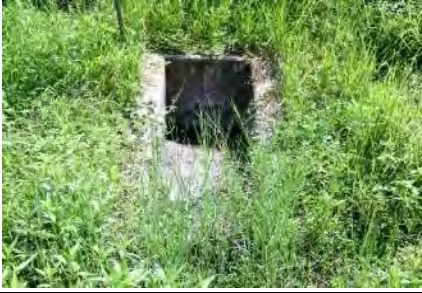
Drainage	Drainage Structure	2	pipe covered with sediment	30
74

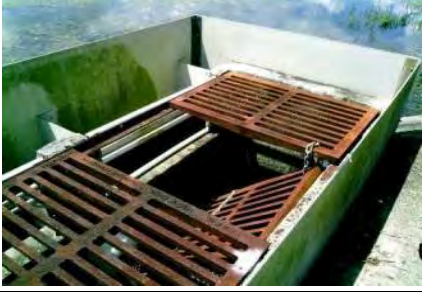
Drainage	Drainage Structure	2	grate and erosion around control structure	29
75

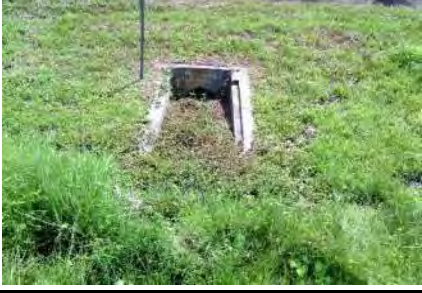
Drainage	Drainage Structure	2	sediment in pipe in this area	28
76

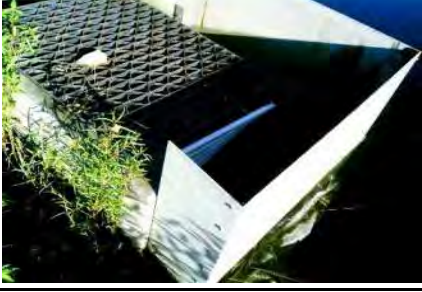
Drainage	Drainage Structure	2	filter pvc damaged/ debris and high water elevation	33
77

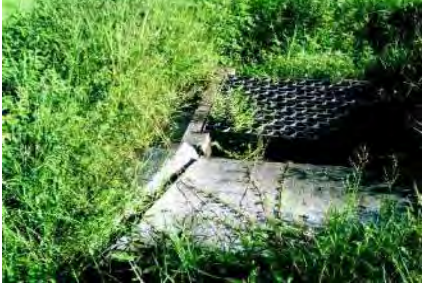
Drainage	Drainage Structure	1	inlet structure damaged	34

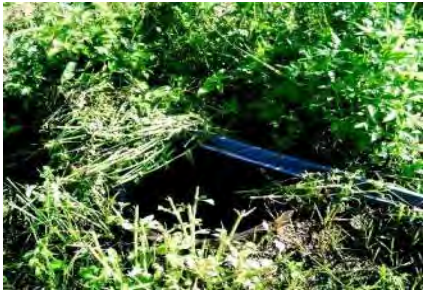
Drainage	Drainage Structure	1	delineator down and manhole with no cover	34
79

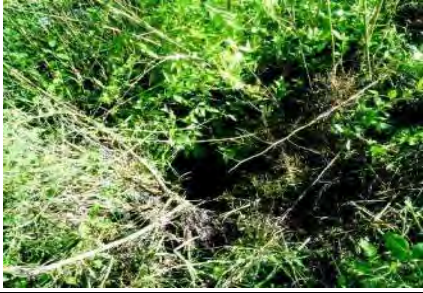
Drainage	Drainage Structure	2	erosion around control structure	35
80

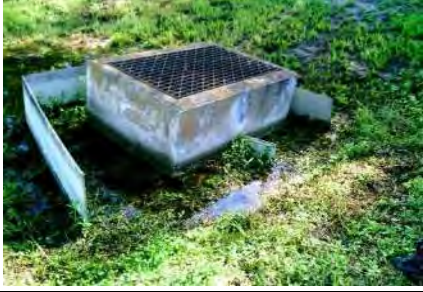
Drainage	Drainage Structure	2	skimmer broken	40
81

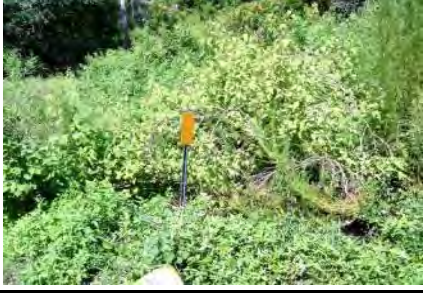
Drainage	Drainage Structure	2	overgrown vegetation	40
82

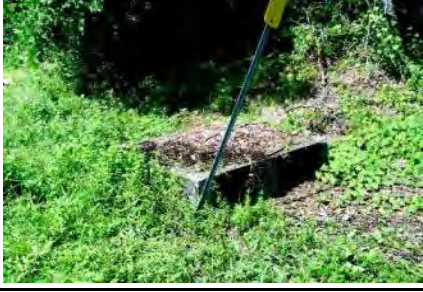
Drainage	Drainage Structure	2	erosion around inlet / grate fully covered with debris	40
83

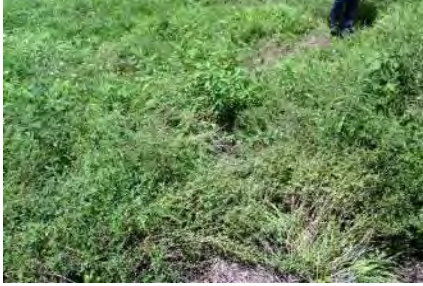
Drainage	Drainage Structure	2	overgrown vegetation / obstructed inlet	38

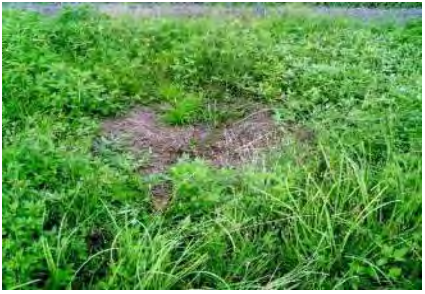
Drainage	Drainage Structure	2	pipe joint relief sucken area	38
85

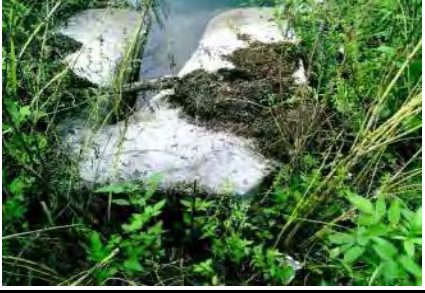
Drainage	Drainage Structure	2	erosion around the mes	38
86

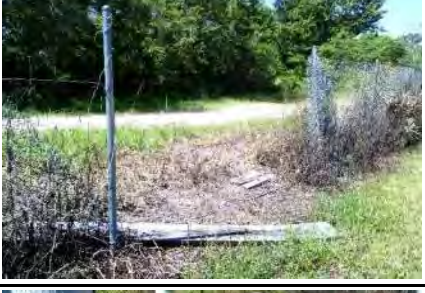
Roadside	Fence	1	fence missing	1
88

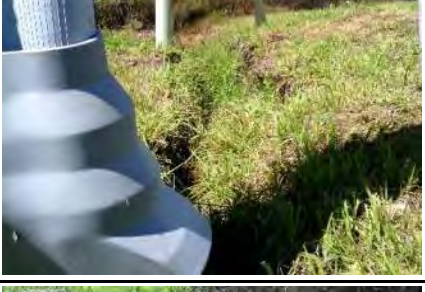
Roadside	Erosion	3	erosion	1
89

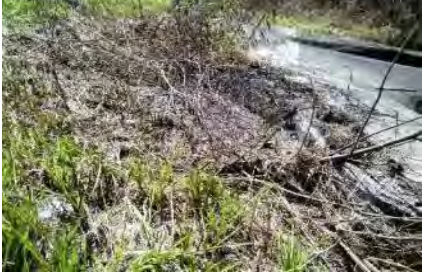
Roadside	Erosion	3	erosion around the mes	2

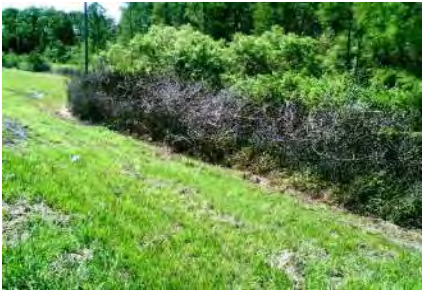
Roadside	Fence	3	overgrown vegetation on fence line at this location	2
91

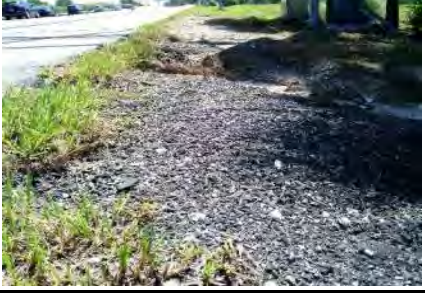
Roadside	Erosion	2	erosion by the shoulder at the landscaped areas	3
92

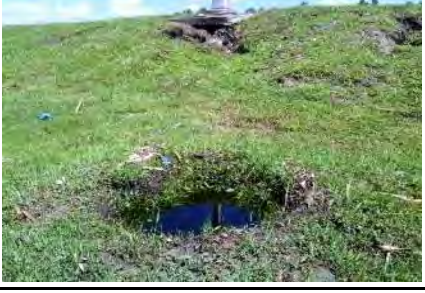
Roadside	Erosion	1	erosion underneath the light pole	3
93

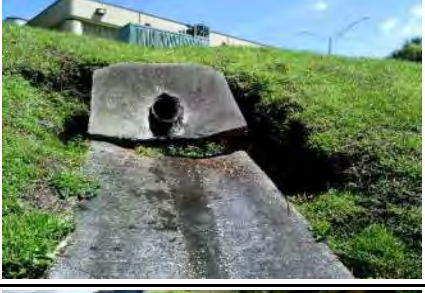
Roadside	Erosion	1	structure and flume undermined by erosion	3
94

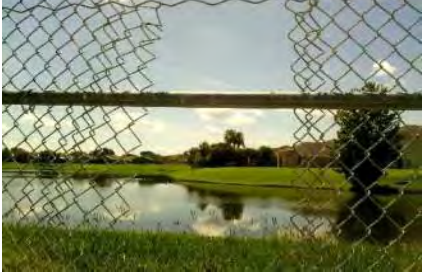
Roadside	Fence	1	hole in the fence	5

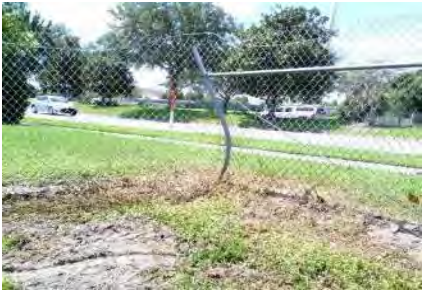
Roadside	Fence	3	fence post damaged	6
97

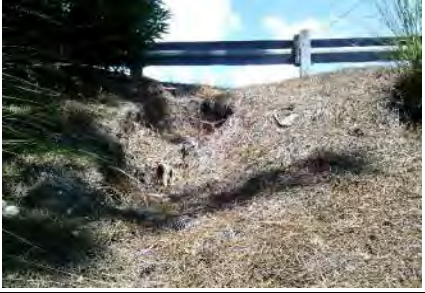
Roadside	Erosion	2	erosion by the shoulder	6
98

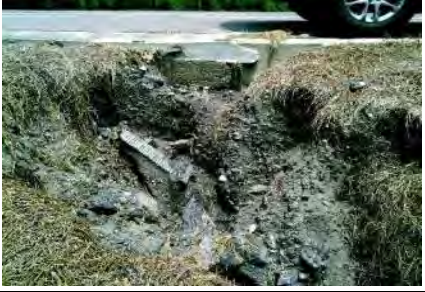
Roadside	Erosion	2	erosion by the shoulder	6
99

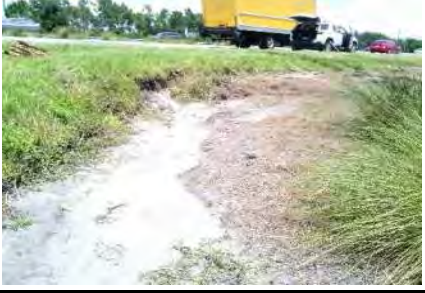
Roadside	Erosion	3	erosion around landscaping	7
100

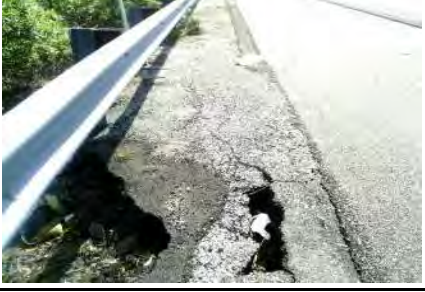
Roadside	Erosion	1	erosion undermining shoulder pavement and miscellaneous asphalt	7
101

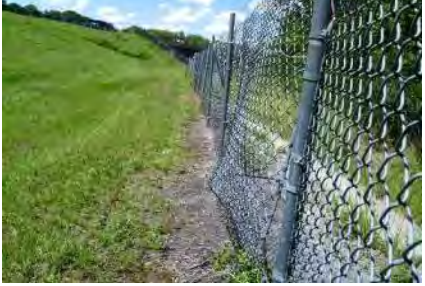
Roadside	Fence	3	fence line needs repair	4

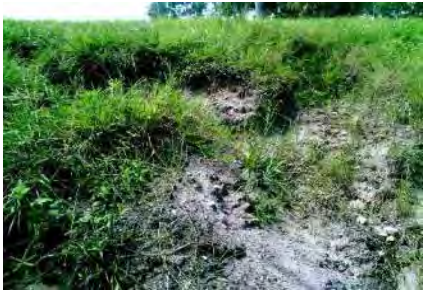
Roadside	Erosion	2	slope erosion at several spots	3
103

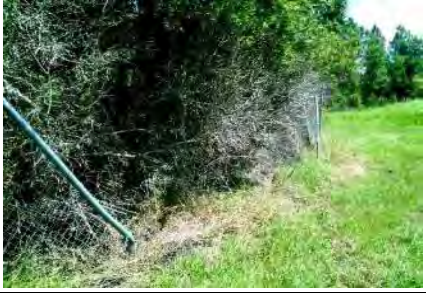
Roadside	Fence	1	fence damaged / missing	2
104

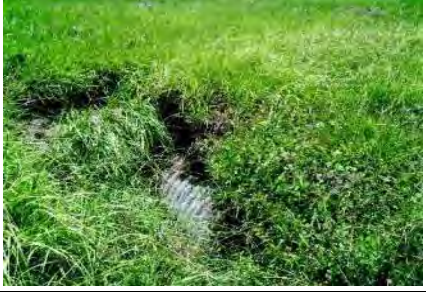
Roadside	Erosion	2	big hole in the berm exposing pipe	2
105

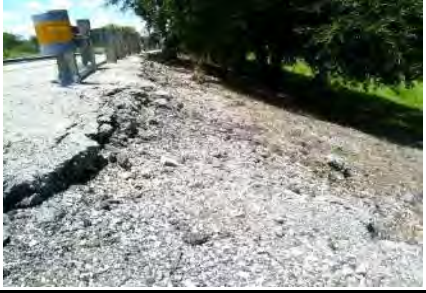
Roadside	Erosion	2	slope erosion	1
106

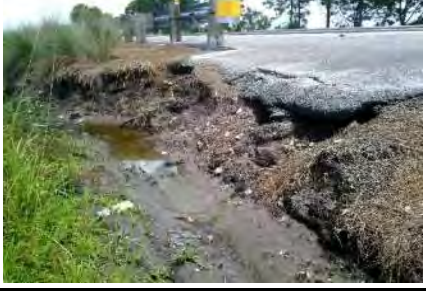
Roadside	Erosion	1	erosion undermining the miscellaneous asphalt	6
107

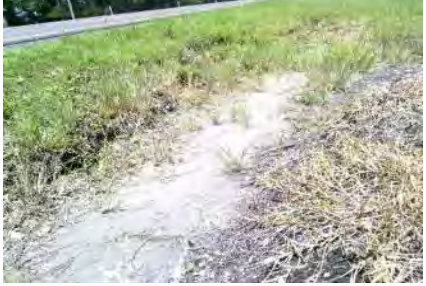
Roadside	Erosion	3	erosion by the shoulder	7

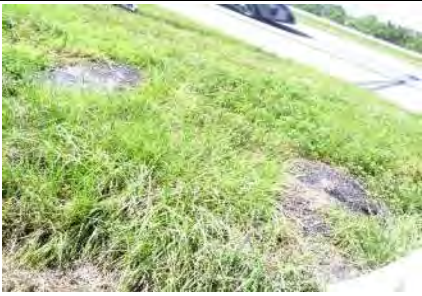
Roadside	Other	3	asphalt dumped roadside	8
109

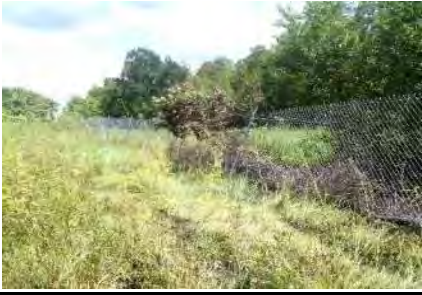
Roadside	Fence	3	fence damaged	8
110

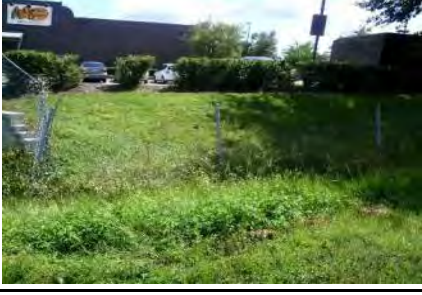
Roadside	Fence	2	fence damaged	8
111

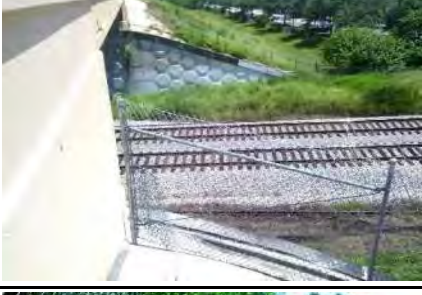
Roadside	Fence	2	fence damaged / downed by overgrown vegetation	11
112

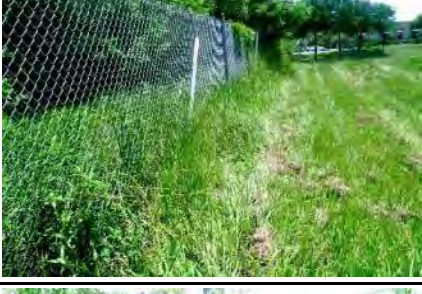
Roadside	Fence	3	fence post damaged	11
113

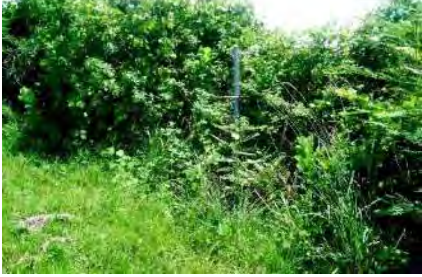
Roadside	Fence	1	fence downed by overgrown vegetation at several spots around the pond	11

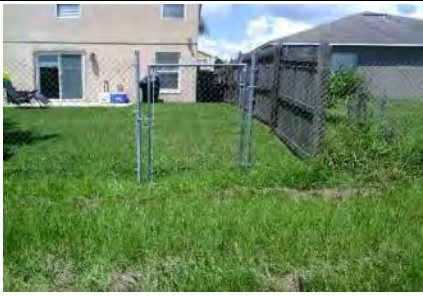
Roadside	Fence	1	unofficial fence gate to pond / hole in fence	9
115

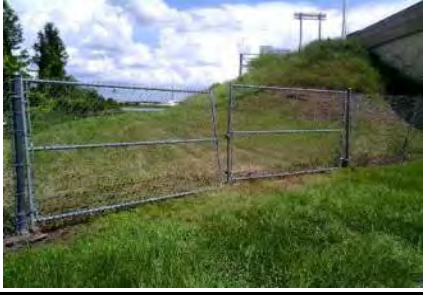
Roadside	Fence	2	all 4 adjacent gates broken or inaccessible	9
116

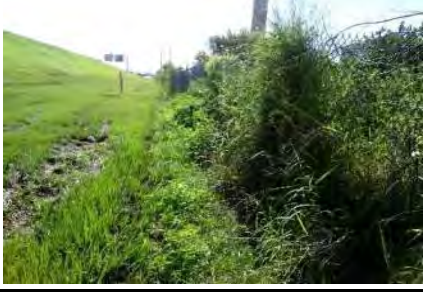
Roadside	Fence	3	overgrown vegetation on fence / posts damaged	13
117

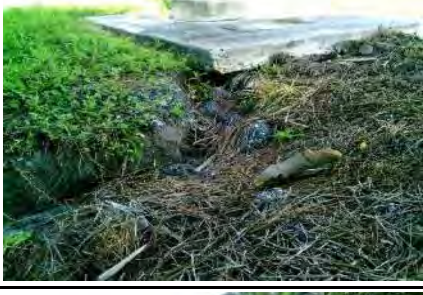
Roadside	Erosion	3	erosion underneath the light pole / by the shoulder	14
118

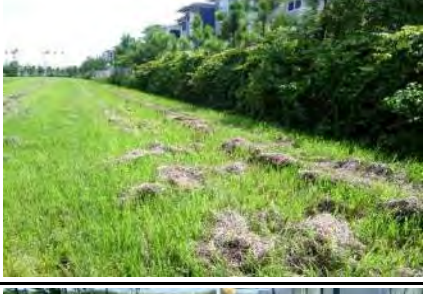
Roadside	Fence	3	veg and posts	-
119

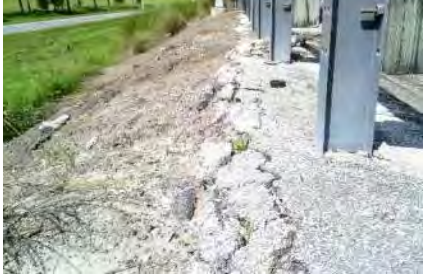
Roadside	Erosion	2	erosion by the shoulder undermining the miscellaneous asphalt	16

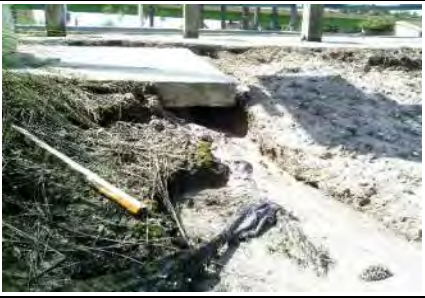
Roadside	Erosion	2	erosion	16
121

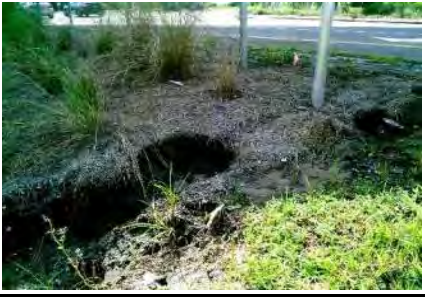
Roadside	Erosion	2	erosion	16
122

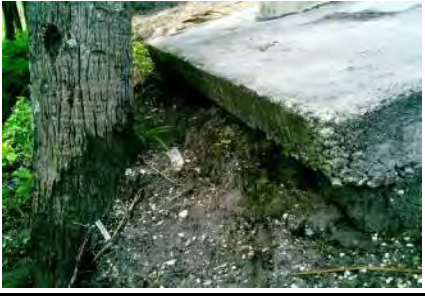
Roadside	Erosion	2	erosion underneath the light pole	16
123

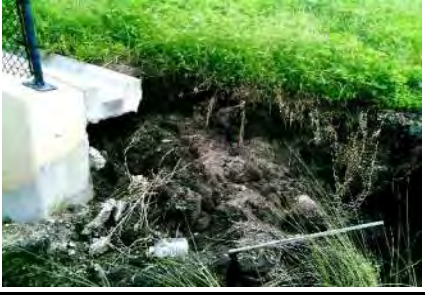
Roadside	Erosion	2	erosion at toe coping gutter / erosion around the pond	16
124

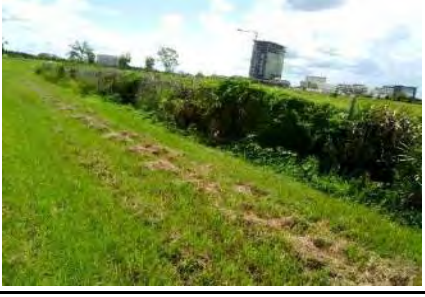
Roadside	Fence	3	overgrown vegetation on fence	18
125

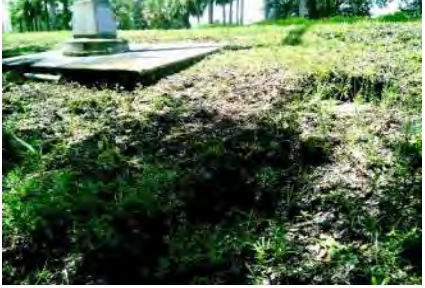
Roadside	Erosion	3	erosion around the light pole / old sign pole base not removed	19

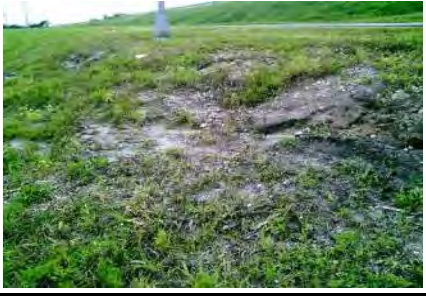
Roadside	Erosion	3	slope erosion	22
129	 	Roadside	Erosion	3	erosion on both sides of the cross drain	26
130

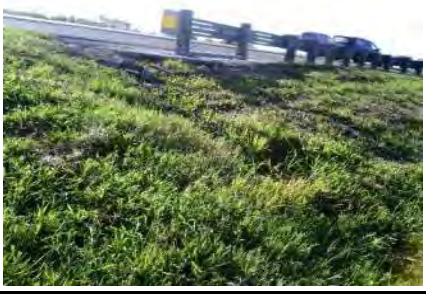
Roadside	Erosion	2	erosion undermining the miscellaneous asphalt	26
131	 	Roadside	Erosion	2	erosion by the shoulder at multiple spots along the ramp	25

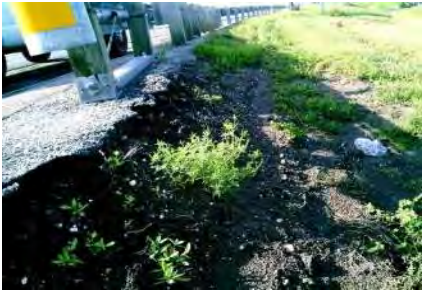
Roadside	Erosion	3	erosion behind the guard rail	24
133

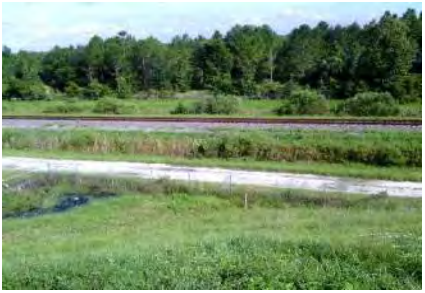
Roadside	Fence	1	fence missing	24
134

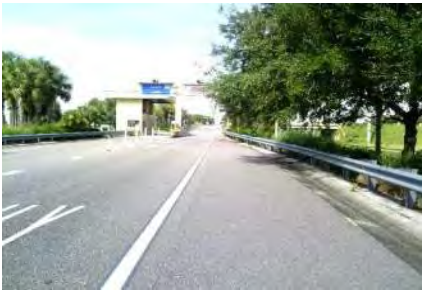
Roadside	Other	2	tree leaning onto the travel lane	19
135

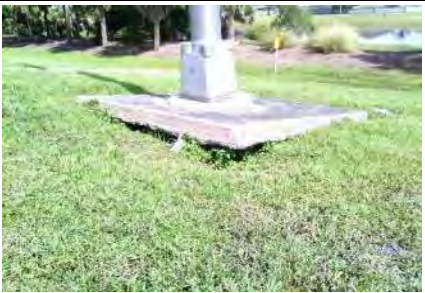
Roadside	Erosion	2	erosion underneath the light pole base	14
136

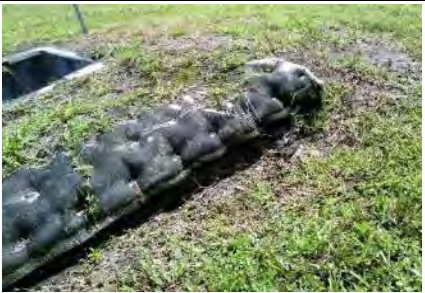
Roadside	Erosion	3	erosion by the fabric rip rap	24
137

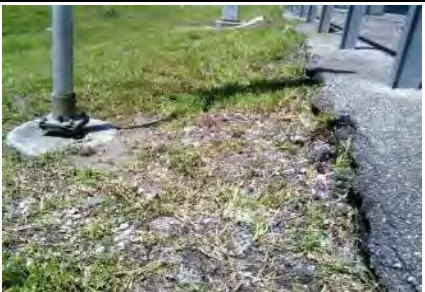
Roadside	Erosion	3	erosion behind the guard rail	24

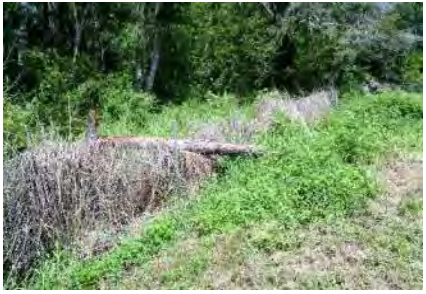
Roadside	Fence	2	fence damaged by downed tree	24
139

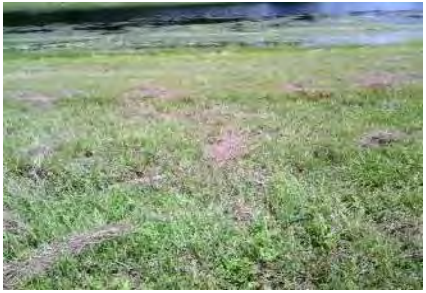
Roadside	Other	2	depression in the berm - pipe joint failure	26
140

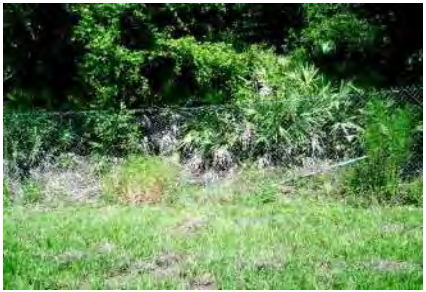
Roadside	Fence	2	fence downed / damaged	27
141

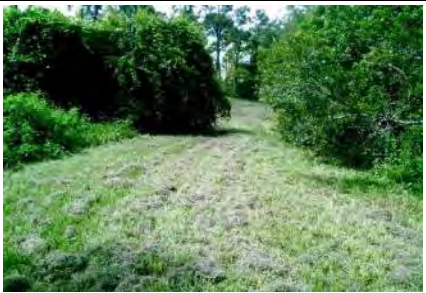
Roadside	Other	3	overgrown vegetation in berm blocking access	28
142

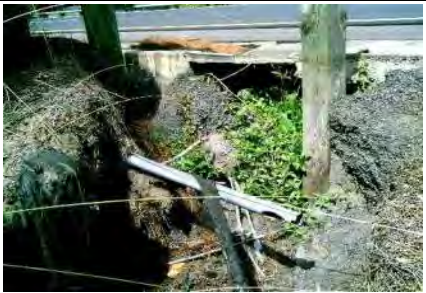
Roadside	Erosion	1	erosion - miscellaneous asphalt / base material under shoulder gutter undermined	28
143

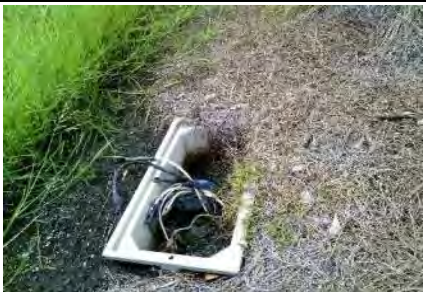
Roadside	Lighting	2	pull box lid missing	28

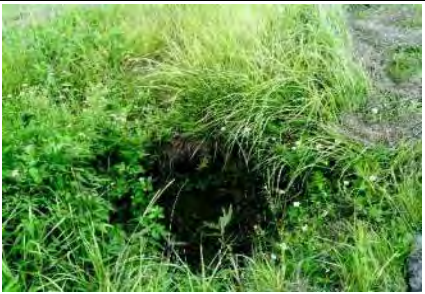
Roadside	Other	2	hole in the berm	28
145

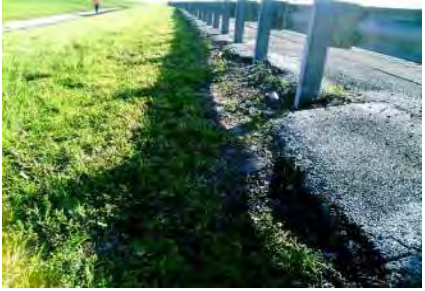
Roadside	Erosion	2	erosion undermining the miscellaneous asphalt / guard rail smashed	24
146

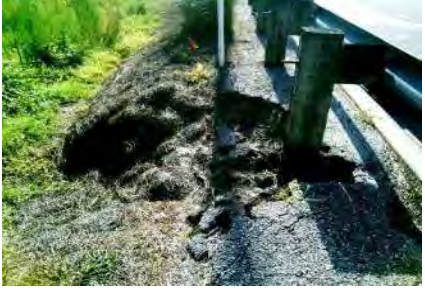
Roadside	Erosion	1	erosion undermining the miscellaneous asphalt / guard rail smashed	45
147

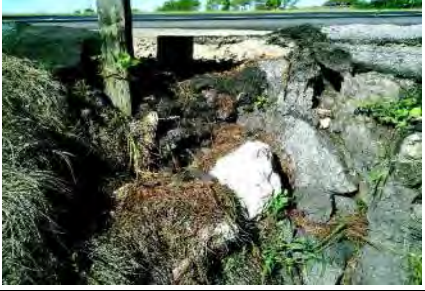
Roadside	Erosion	1	erosion undermining the miscellaneous asphalt all along this area at multiple spots	28
148

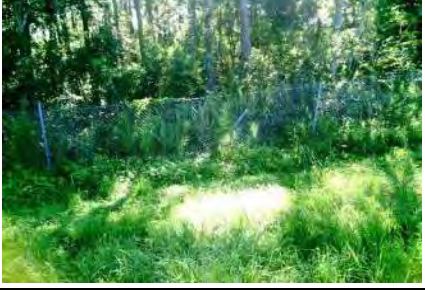
Roadside	Fence	3	fence post damaged / fence leaning	28
149

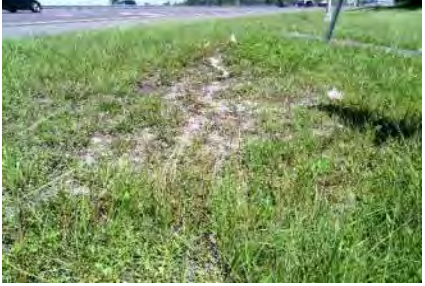
Roadside	Erosion	3	slope erosion	29

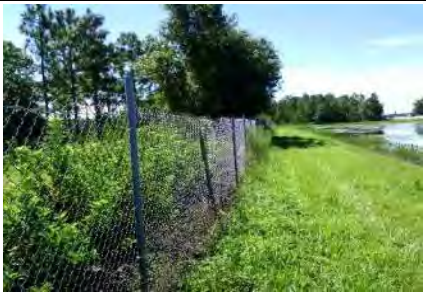
Roadside	Fence	3	fence posts damaged around the pond	30
151

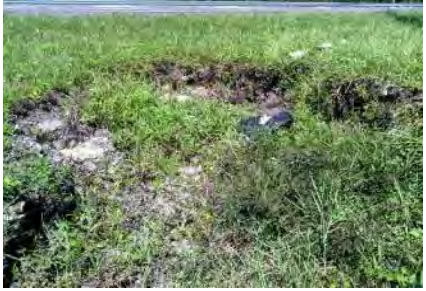
Roadside	Erosion	2	erosion	30
152

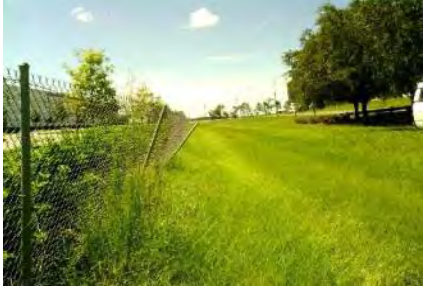
Roadside	Fence	2	fence downed	30
153

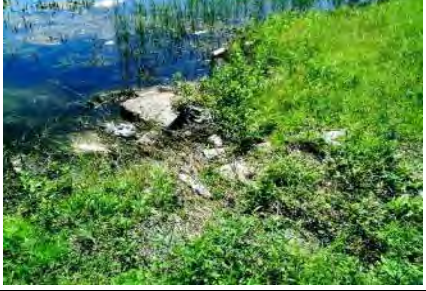
Roadside	Erosion	3	erosion undermining rip rap	30
154

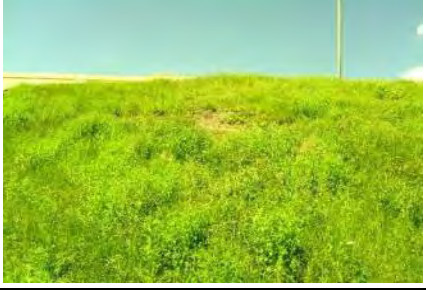
Roadside	Erosion	3	slope erosion	30
155

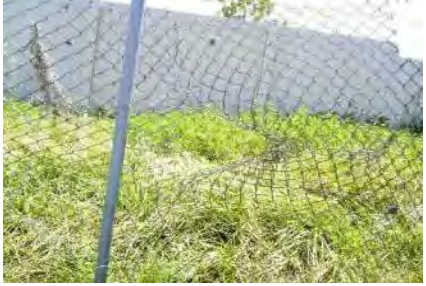
Roadside	Fence	2	hole in fence	30

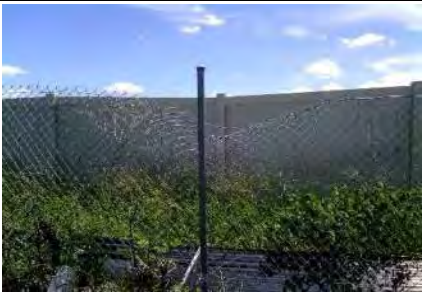
Roadside	Fence	3	fence damaged	31
157

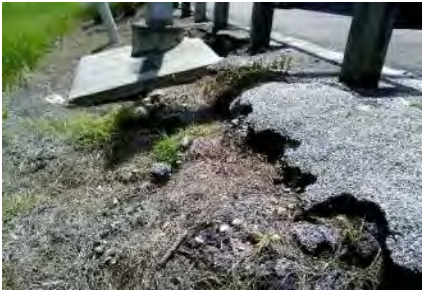
Roadside	Erosion	1	erosion all along behind the guard rail undermining miscellaneous asphalt / light pole aprons	33
158

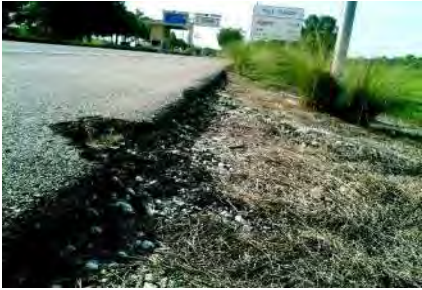
Roadside	Erosion	2	erosion along the shoulder of the exit ramp	33
159

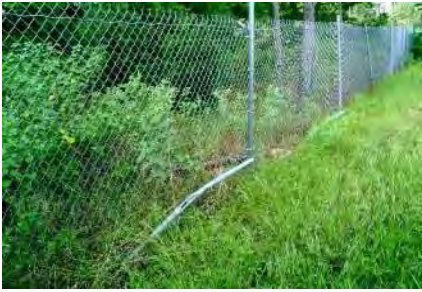
Roadside	Fence	3	fence posts damaged	33
160

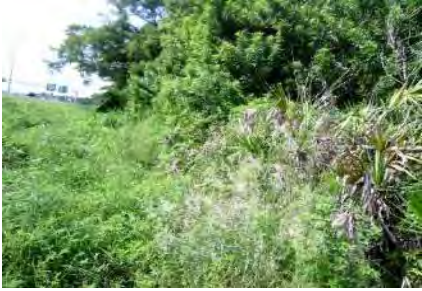
Roadside	Fence	3	vegetation overgrown entire fence line	32
161

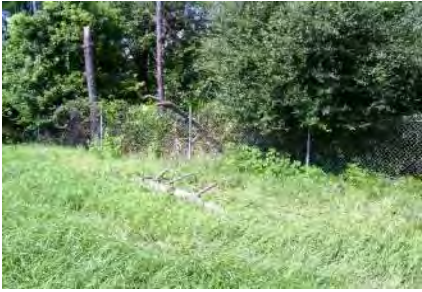
Roadside	Fence	3	trees fell on fence / gaps	31

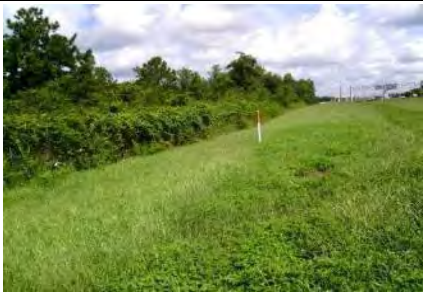
Roadside	Fence	3	vegetation overgrown	31
163

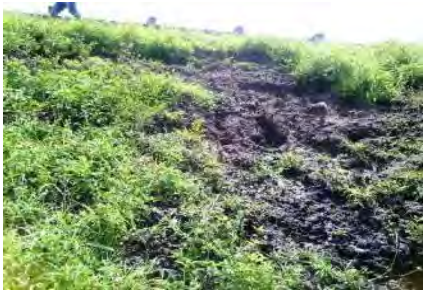
Roadside	Erosion	3	slope erosion at multiple spots	30
164

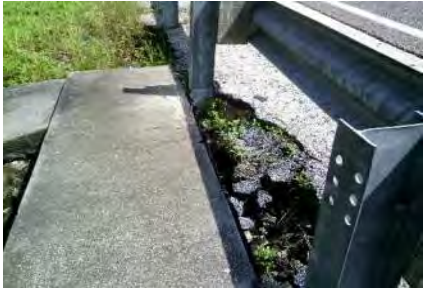
Roadside	Erosion	1	erosion undermining miscellaneous asphalt	30
165

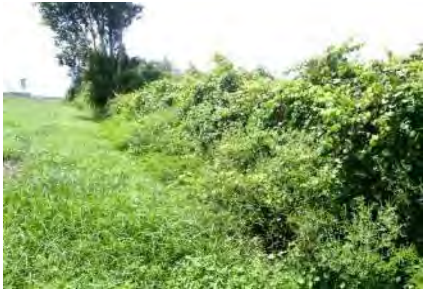
Roadside	Fence	3	vegetation overgrown	30
166

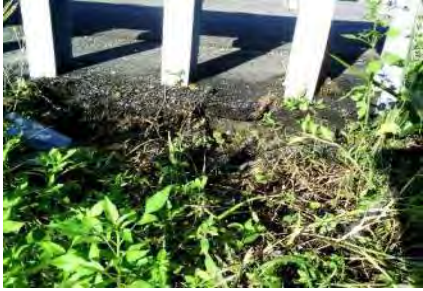
Roadside	Erosion	3	erosion by guard rail	33
167

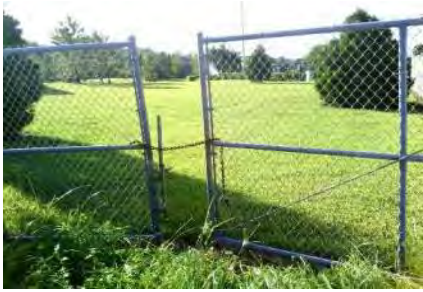
Roadside	Fence	2	fence gate no lock	33

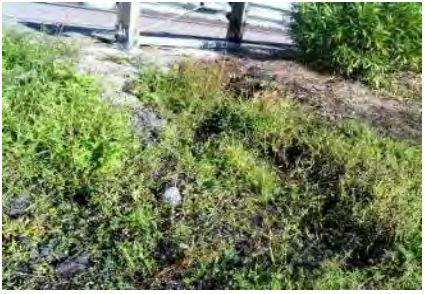
Roadside	Fence	2	erosion end of guard rail / undermining light pole	34
169

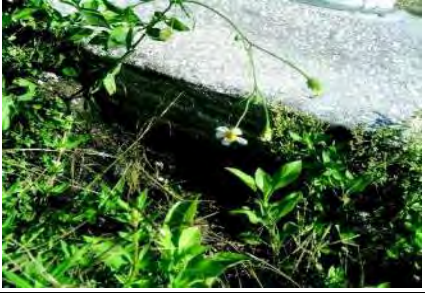
Roadside	Erosion	3	undermining light pole	35
170

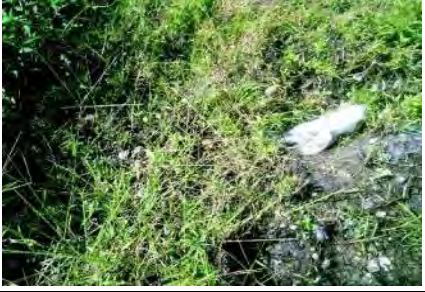
Roadside	Erosion	2	moderate to severe erosion around pond	35
171

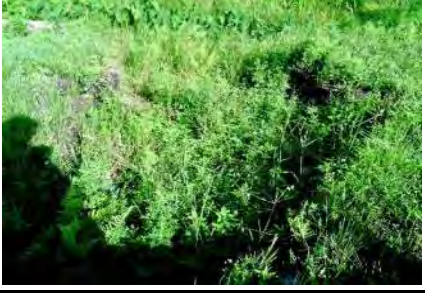
Roadside	Erosion	1	erosion right side of head wall	39
172

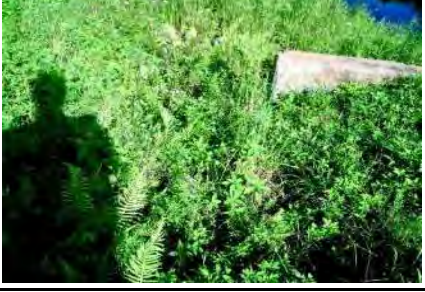
Roadside	Erosion	2	erosion left side of head wall	39
173

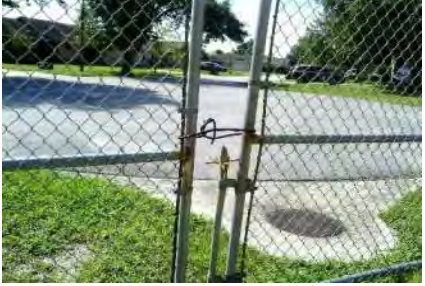
Roadside	Fence	2	gate no lock	42

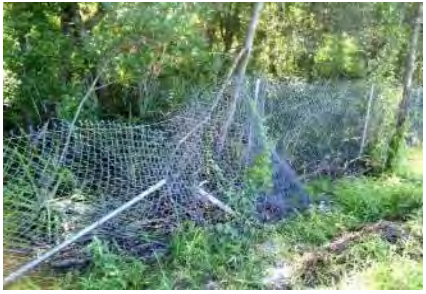
Roadside	Fence	3	damaged	43
175

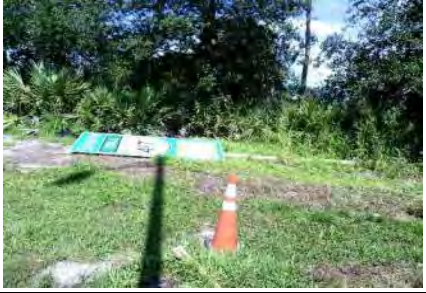
Roadside	Other	3	sign knocked down	41
176

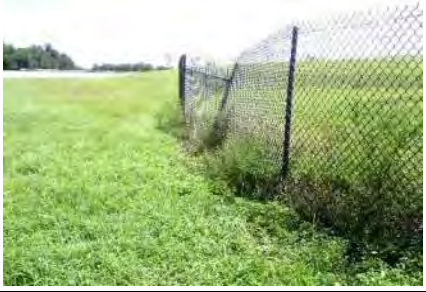
Roadside	Fence	3	fence post damaged	39
177

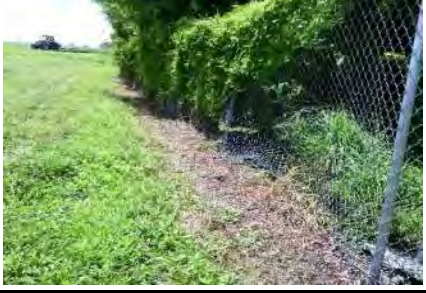
Roadside	Fence	3	fence damaged / overgrown vegetation on fence	38
178

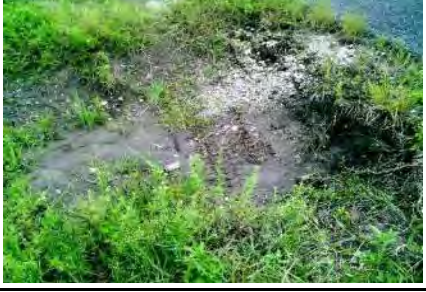
Roadside	Erosion	2	shoulder erosion	37
179

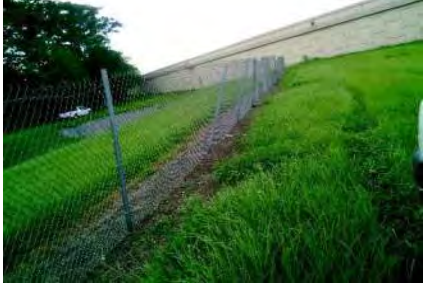
Roadside	Fence	3	fence not connected to posts	38

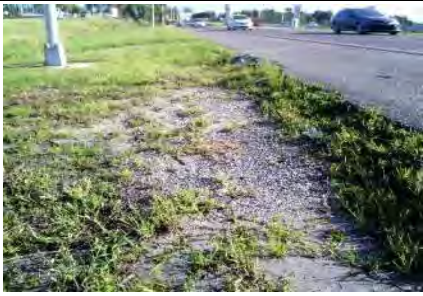
Pavement	Edge Ravel	3	paved shoulder damaged	27
187
