2020

Annual Inspection Report

Appendix 3: SR 408

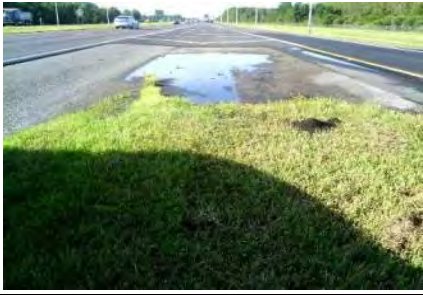
Pavement	Other	2	standing water - gore area	27
188

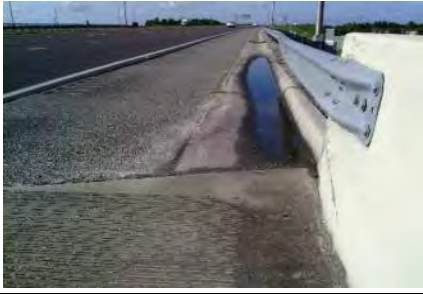
Pavement	Other	2	standing water - gutter	24
189

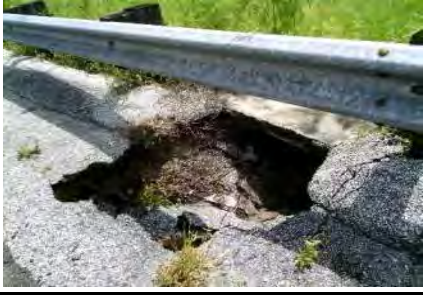
Pavement	Pothole	1	miscellaneous asphalt undermined	28
190

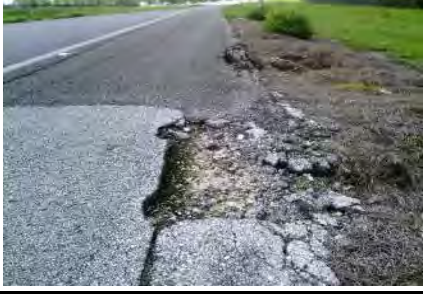
Pavement	Edge Ravel	1	paved shoulder undermining all along the ramp	30
191

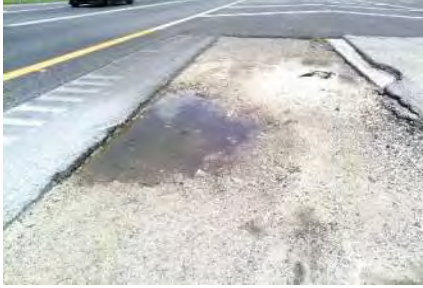
Pavement	Edge Ravel	2	erosion by paved shoulder	28

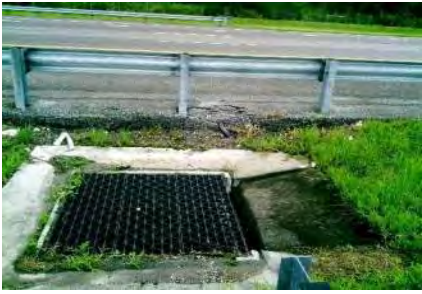
Pavement	Cracking	3	miscellaneous asphalt cracking around inlets in this area	30
193

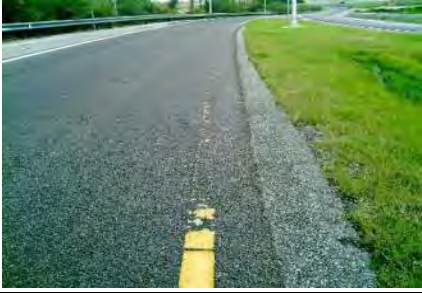
Pavement	Striping or Pavement Marking	2	striping missing	37
194

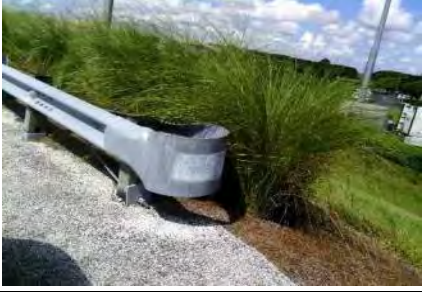
Walls or Barriers	Guardrail	2	yellow reflector missing	7
195

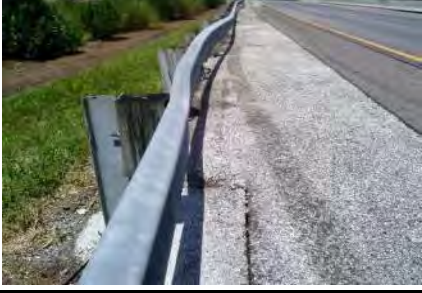
Walls or Barriers	Guardrail	1	guard rail smashed	6
196

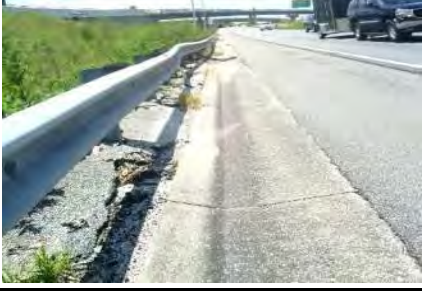
Walls or Barriers	Guardrail	1	guard rail smashed	10
197

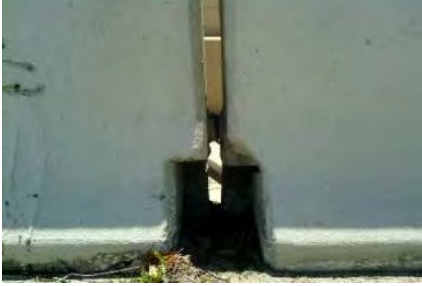
Walls or Barriers	Barrier Wall	2	open joint seal missing	10

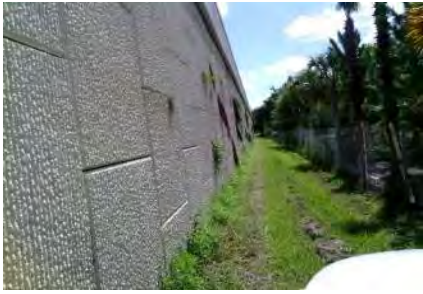
Walls or Barriers	Retaining Wall	3	overgrown vegetation on mse wall	16
199

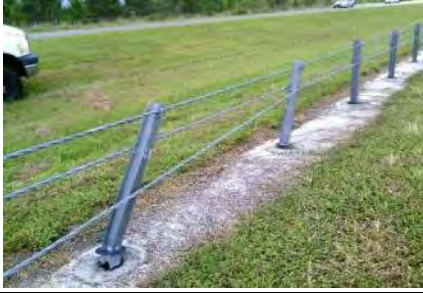
Walls or Barriers	Other	3	cable rail posts damaged	20
200

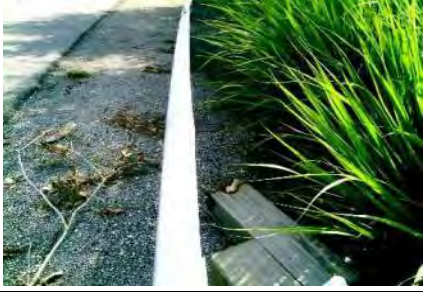
Walls or Barriers	Guardrail	2	guard rail post not secured	19
201

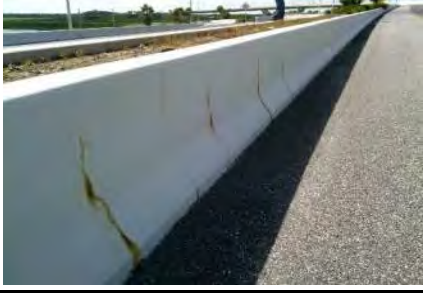
Walls or Barriers	Barrier Wall	3	cracking along barrier wall	-
202

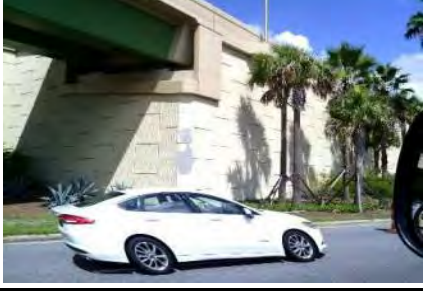
Walls or Barriers	Retaining Wall	2	finish coat peeling	16
203

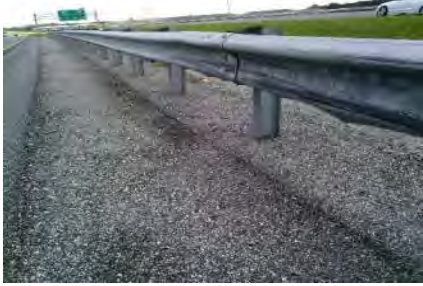
Walls or Barriers	Guardrail	2	crashed	15

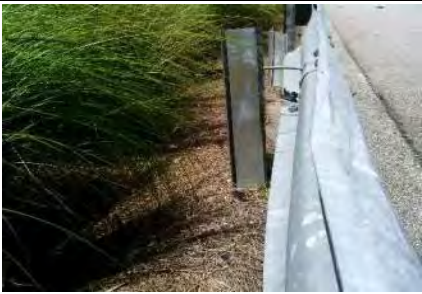
Walls or Barriers	Guardrail	2	crashed	14
205

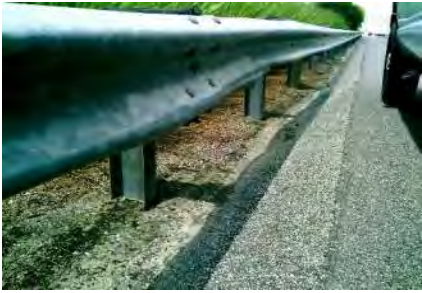
Walls or Barriers	Guardrail	2	crashed	14
206

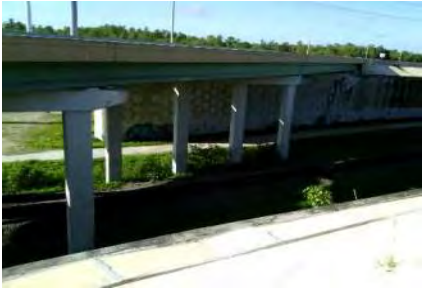
Walls or Barriers	Retaining Wall	2	graffiti on mse wall	24
207

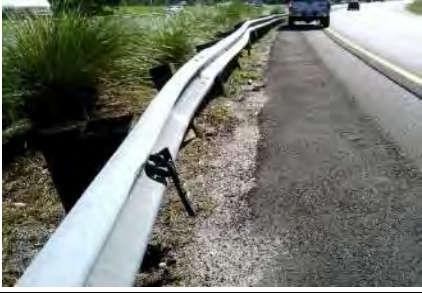
Walls or Barriers	Guardrail	1	guard rail smashed	45
208

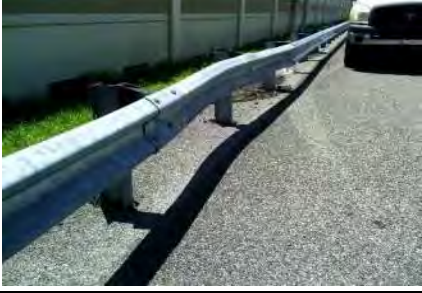
Walls or Barriers	Guardrail	2	guard rail smashed	32
209

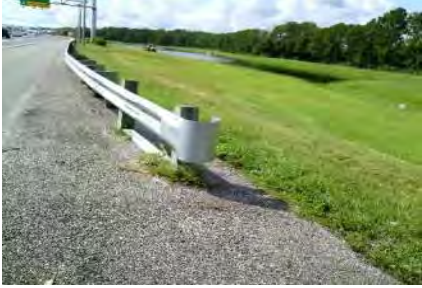
Walls or Barriers	Attenuator (Crash Cushion)	2	yellow reflector missing	31

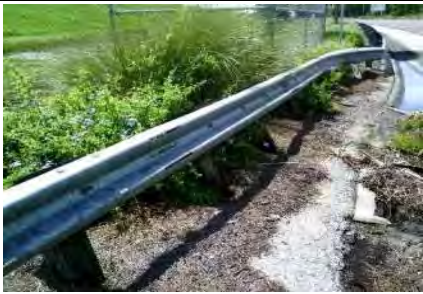
Walls or Barriers	Guardrail	1	guard rail smashed	30
211

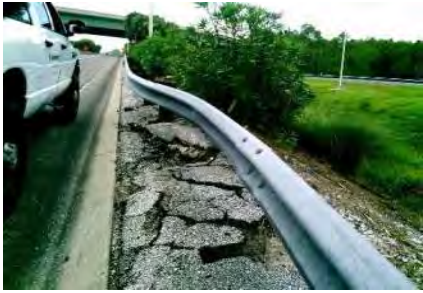
Walls or Barriers	Guardrail	1	guard rail smashed	27
212

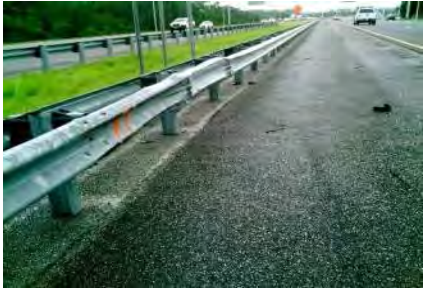
Walls or Barriers	Guardrail	2	guard rail smashed	29
213

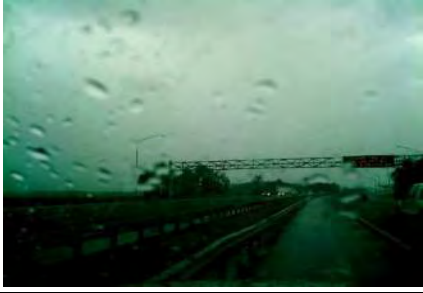
Walls or Barriers	Guardrail	3	guard rail smashed	29
214

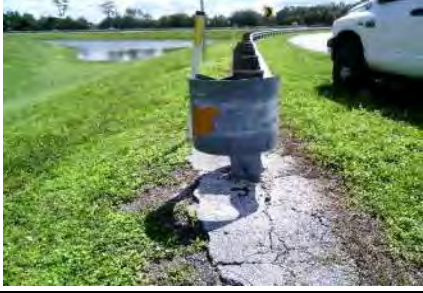
Walls or Barriers	Guardrail	3	yellow reflector missing	39
215

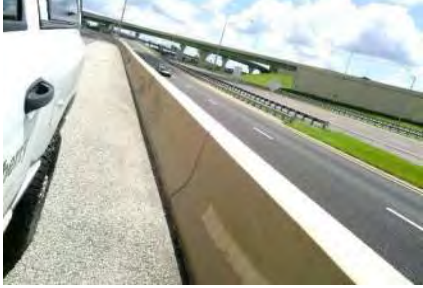
Walls or Barriers	Barrier Wall	3	barrier wall smashed / finish coat peeling	-

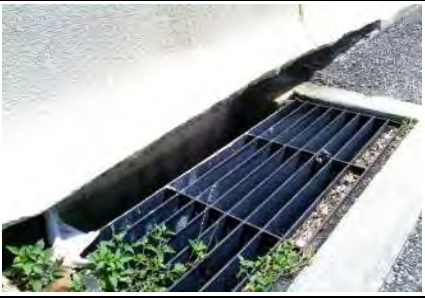
Walls or Barriers	Barrier Wall	3	barrier wall smashed	38
217

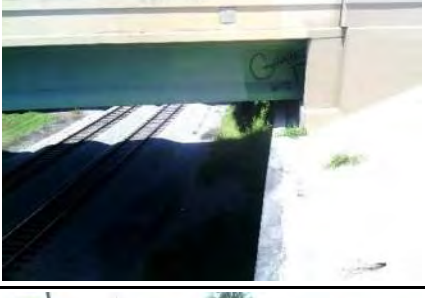
Other Issue	Other	2	graffiti on mse wall / beam	11
220

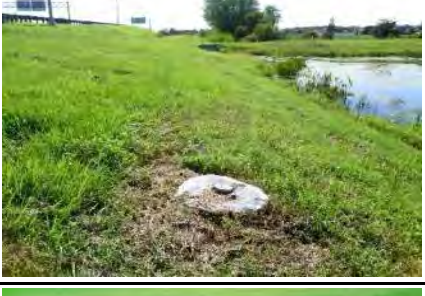
Other Issue	Other	2	sign base not removed	15
221

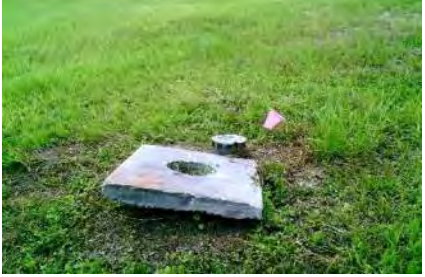
Other Issue	Other	2	sewer pipe apron damaged	19

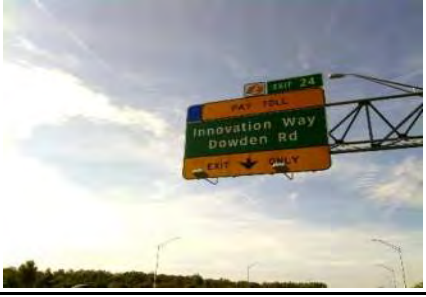
Other Issue	Other	3	sign panel - yellow reflector missing all the way through	26
224

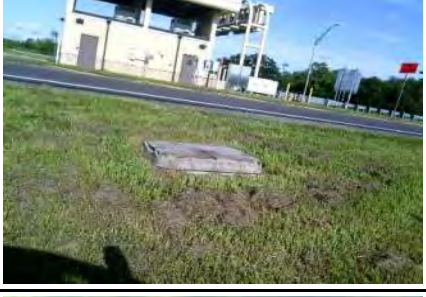
Other Issue	Other	2	broken its box	24
225

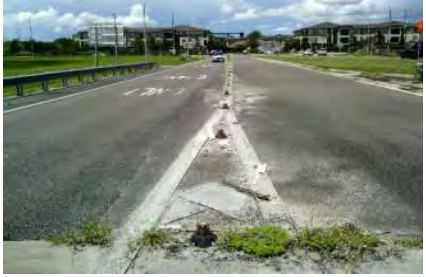
Other Issue	Other	3	flexible delineators damaged	24

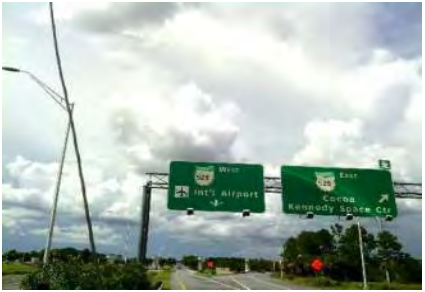
Other Issue	Other	3	faded sign	27
230

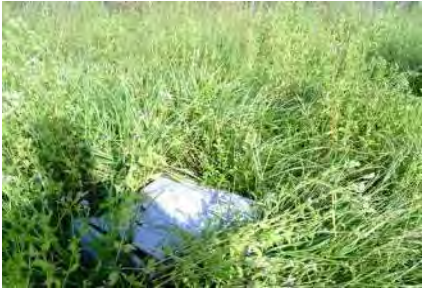
Other Issue	Other	2	electrical box run over	35
231

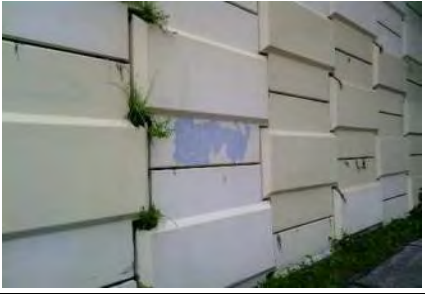
Other Issue	Other	3	finish coat peeling	30
232

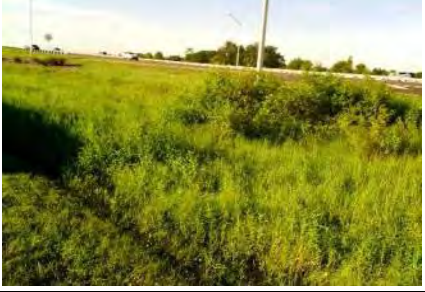
Other Issue	Other	2	ditch vegetation overgrown invasive species	33
233

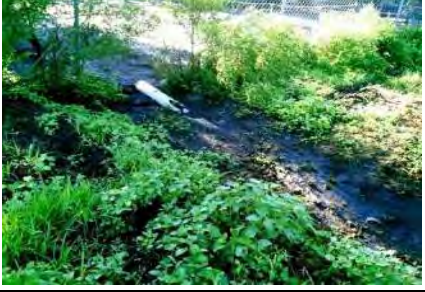
Other Issue	Other	3	horse waste on cfx property	34

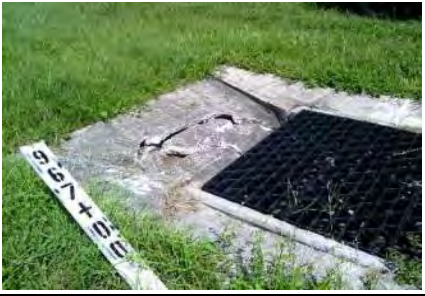
ID No.	Image	Category	Issue Type	Rating (1, 2, or 3)	Comments	Map Sht No.
D1

Drainage	Drainage Structure	1	cracked structure	10
D2

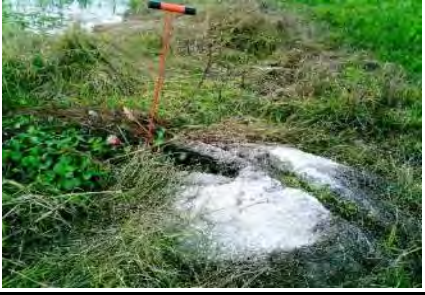
Drainage	Drainage Structure	1	broken structure	9
D3

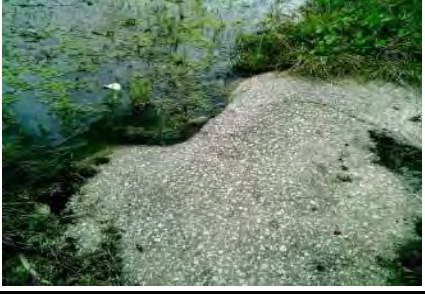
Drainage	Drainage Structure	1	fully submerged structure (3ft<)	9
D4

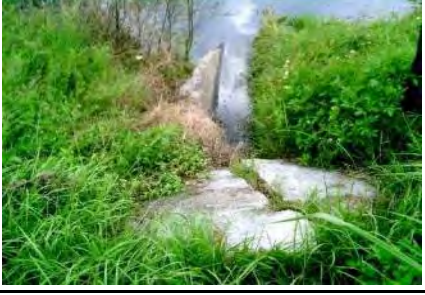
Drainage	Drainage Structure	1	broken mes / 1 foot erosion around	10
D5

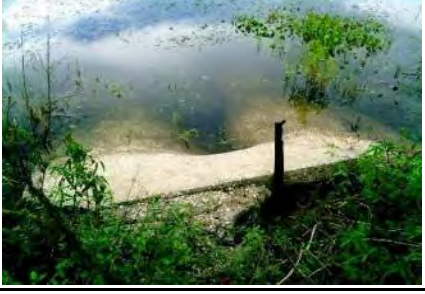
Drainage	Drainage Structure	1	broken mes	12
D6

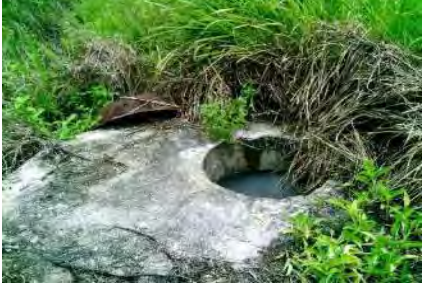
Drainage	Drainage Structure	1	manhole lid missing	13

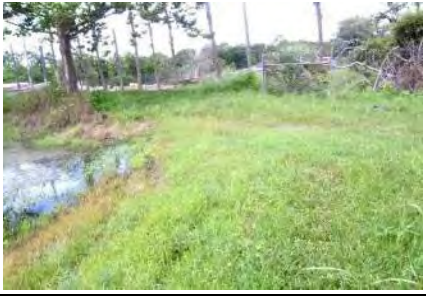
Drainage	Pond/ Ditch/ Canal	1	berm overtopping	13
D8

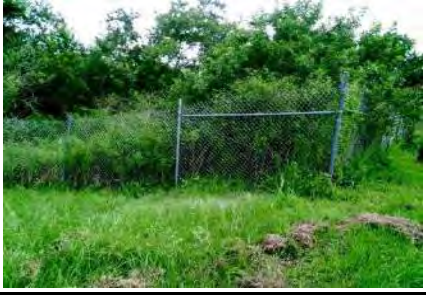
Drainage	Drainage Structure	1	no access to cross drain	14
D9

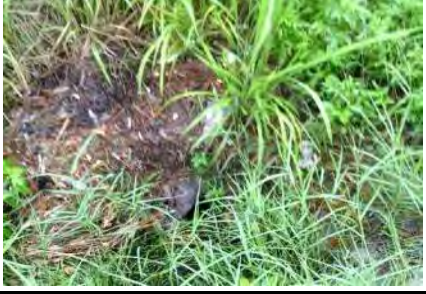
Drainage	Drainage Structure	1	buried mes	13
D10

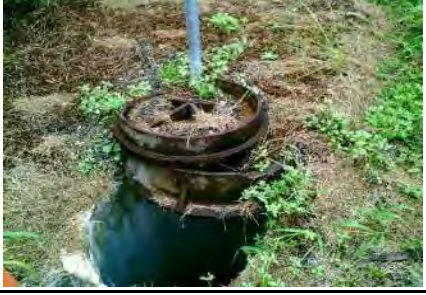
Drainage	Drainage Structure	1	manhole lid not secured	16
D11

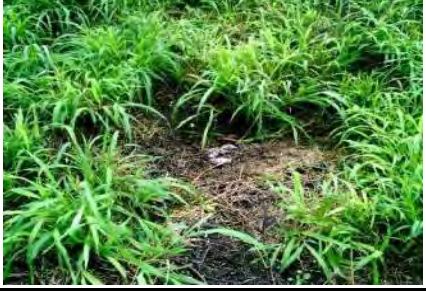
Drainage	Drainage Structure	1	covered inlet / dirt from embankment	16
D12

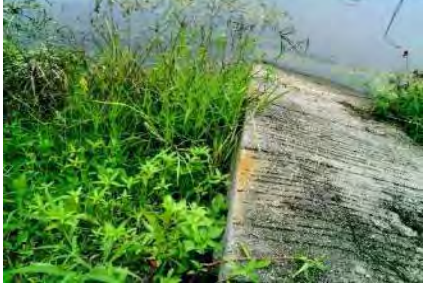
Drainage	Drainage Structure	1	settlement and erosion	16

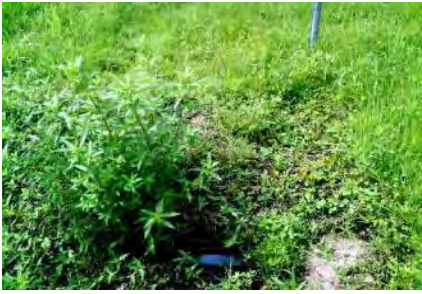
Drainage	Drainage Structure	1	clogged inlet	18
D14

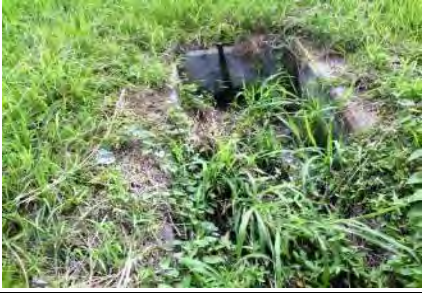
Drainage	Drainage Structure	1	clogged concrete endwall u type	18
D15

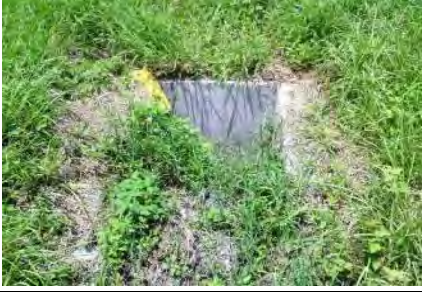
Drainage	Drainage Structure	1	completely obstructed concrete endwall u type	18
D16

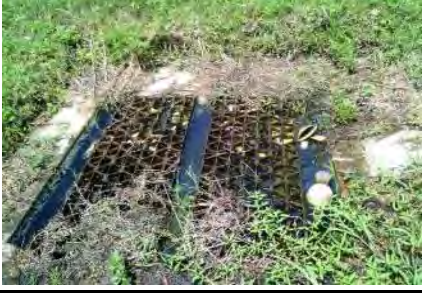
Drainage	Drainage Structure	1	inlet clogged	18
D17

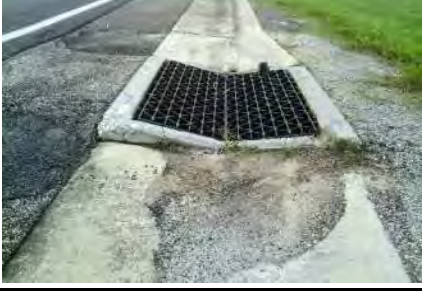
Drainage	Drainage Structure	1	top of grate above gutter line	21
D18

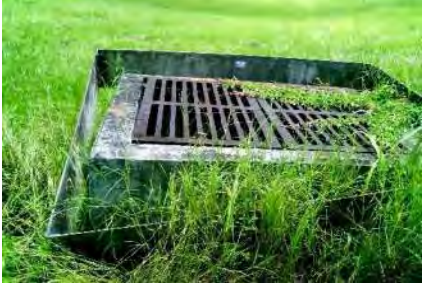
Drainage	Drainage Structure	1	skimmer damaged	25

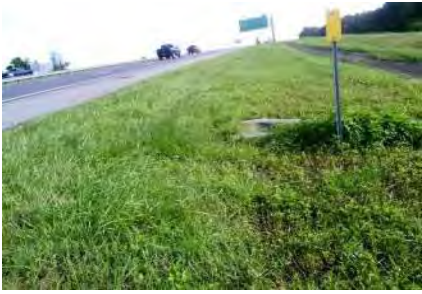
Drainage	Drainage Structure	1	u type endwall within clear zone 22' feet from edge of travel lanes / grate missing	29
D20

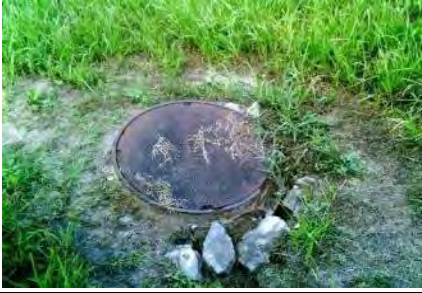
Drainage	Drainage Structure	1	Manhole severely damaged	30
D21

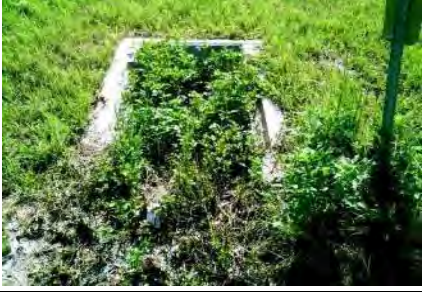
Drainage	Drainage Structure	1	grate needed / mes within clear zone i.e. 24' from edge of travel lane / not maintained	32
D22

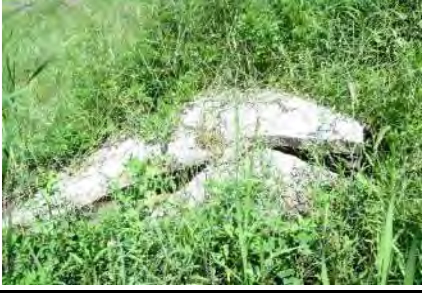
Drainage	Drainage Structure	1	mes broken	35
D23

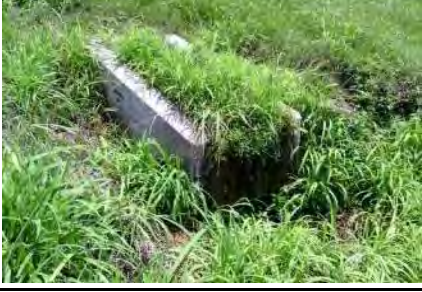
Drainage	Drainage Structure	1	undermined fully	18
D24

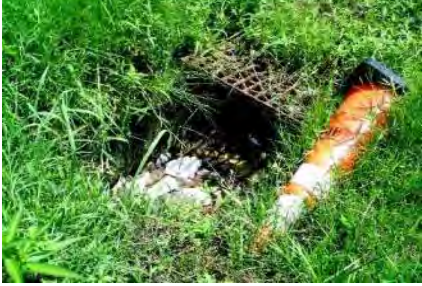
Drainage	Drainage Structure	1	full and grate off/manhole damaged	16

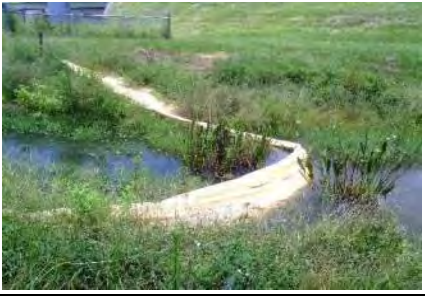
Drainage	Pond/ Ditch/ Canal	2	turb barrier	2
D26

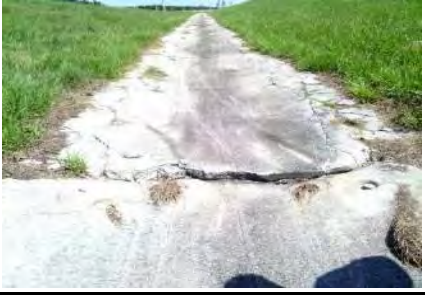
Drainage	Flume/ Concrete Apron	2	flume repair	3
D27

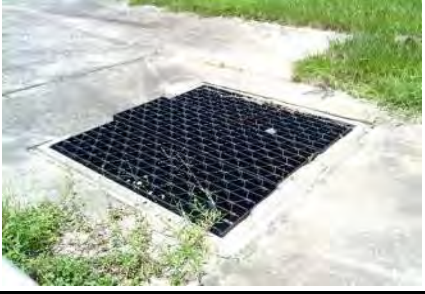
Drainage	Drainage Structure	2	reset grate top	4
D28

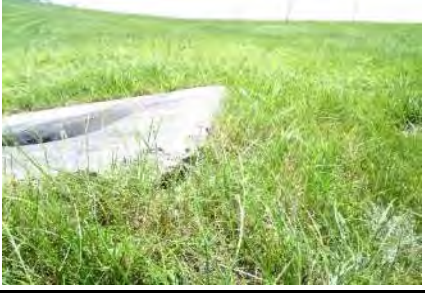
Drainage	Drainage Structure	2	grade issue top of drain structure	4
D29

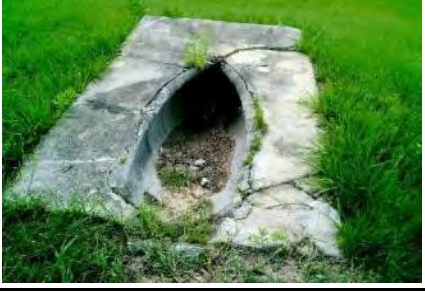
Drainage	Drainage Structure	2	cracked /grade issue	3
D30

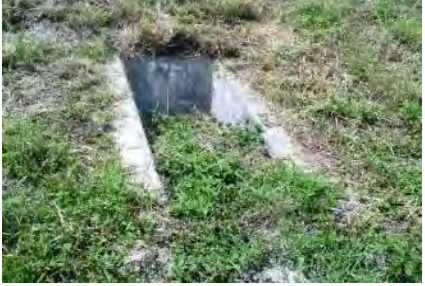
Drainage	Drainage Structure	2	vegetation	6

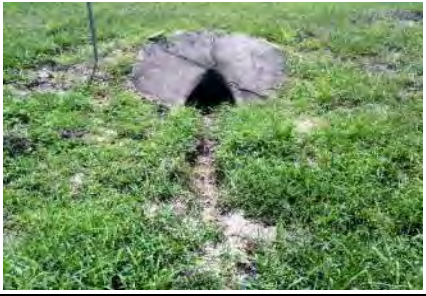
Drainage	Drainage Structure	2	cracking and grade issue	8
D32

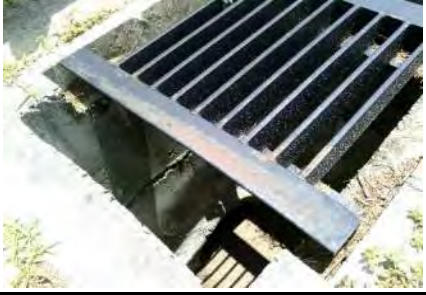
Drainage	Drainage Structure	2	approx. half of the pipe covered with sediment	8
D33

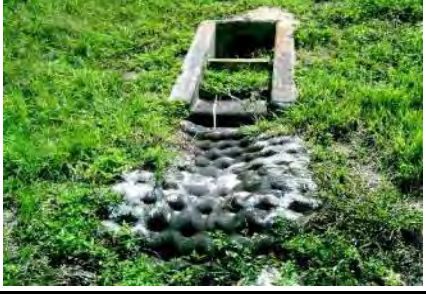
Drainage	Drainage Structure	2	fiber foam undermined and washout	6
D34

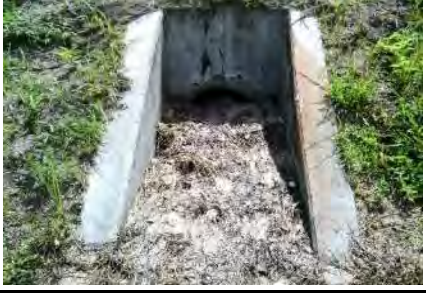
Drainage	Drainage Structure	2	obstructed structure / 14 inch sediment	6
D35

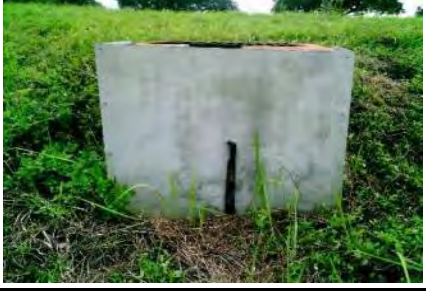
Drainage	Drainage Structure	2	sediment and debris blocking skimmer	8
D36

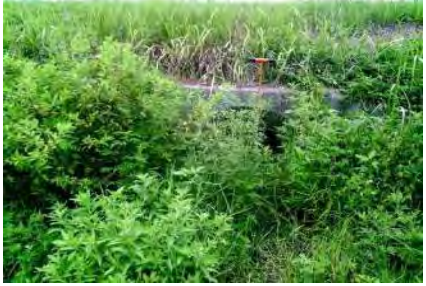
Drainage	Drainage Structure	2	4 x 24 inch cross drain excessive vegetation	9

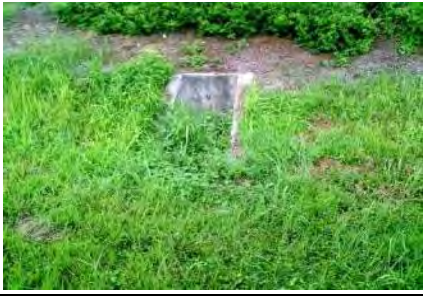
Drainage	Drainage Structure	2	obstructed / overgrown vegetation	12
D44

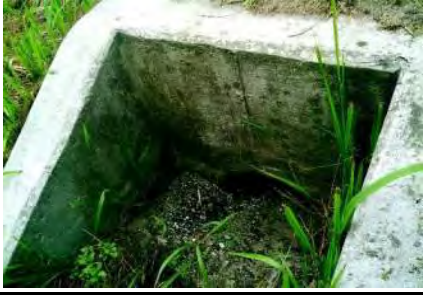
Drainage	Drainage Structure	2	8 inch sediment	12
D45

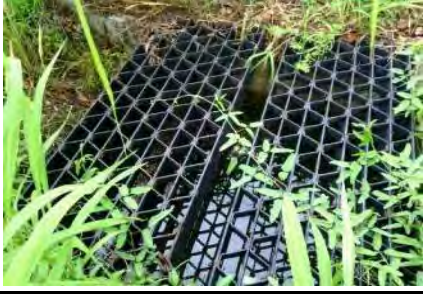
Drainage	Drainage Structure	2	submerged / maintenance	11
D46

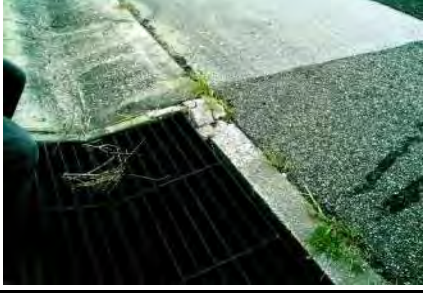
Drainage	Drainage Structure	2	cracked	16
D47

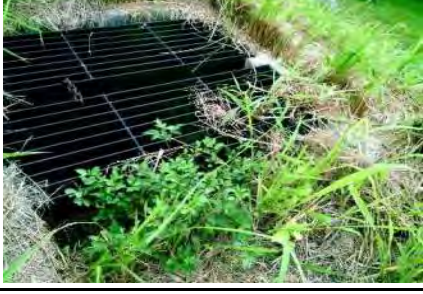
Drainage	Drainage Structure	2	inlet clogged and resulting washout	16
D48

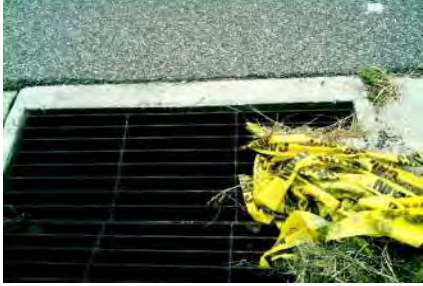
Drainage	Drainage Structure	2	inlet / pipe blocked with trash	15

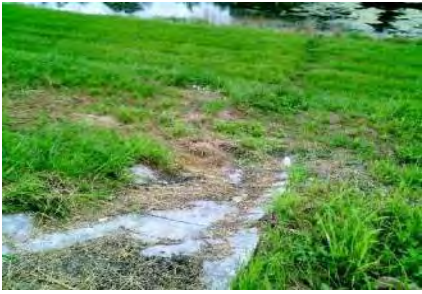
Drainage	Flume/ Concrete Apron	2	debris	15
D50

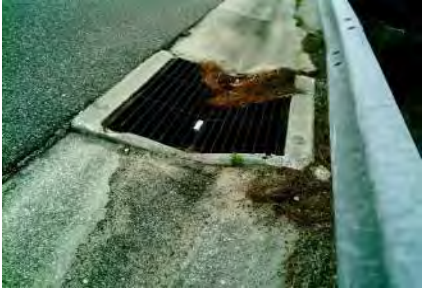
Drainage	Drainage Structure	2	inlet lip	15
D51

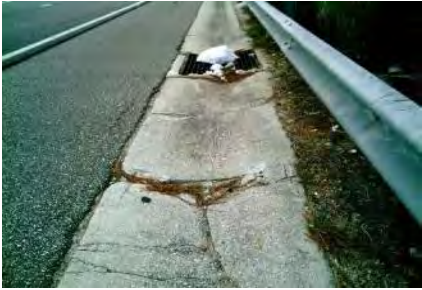
Drainage	Drainage Structure	2	broken shoulder gutter / inlet chipped	15
D52

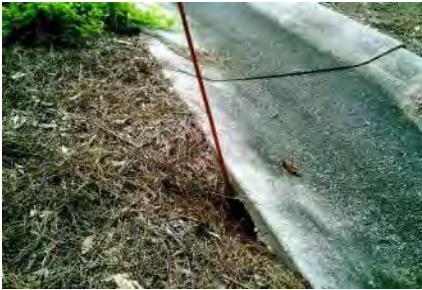
Drainage	Flume/ Concrete Apron	2	cracked flume top/undermined	15
D53

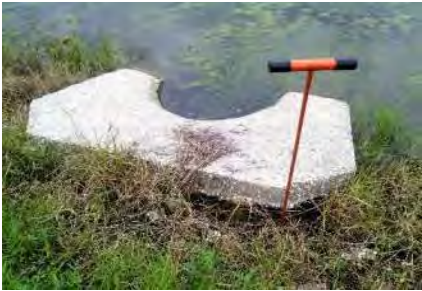
Drainage	Drainage Structure	2	mes erosion	15
D54

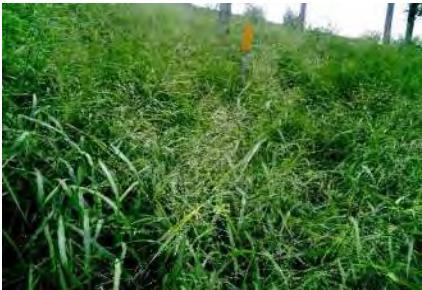
Drainage	Drainage Structure	2	vegetation overgrown	15

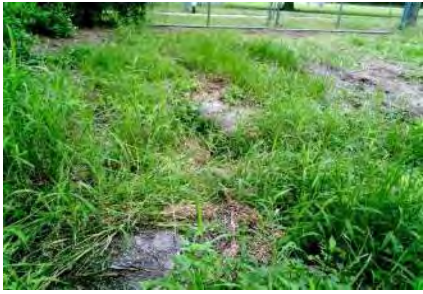
Drainage	Drainage Structure	2	vegetation overgrown/obstruction	15
D56

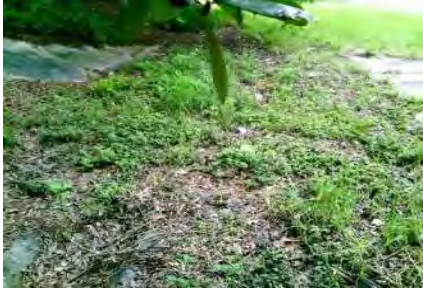
Drainage	Drainage Structure	2	debris blocking ditch from washout	15
D57

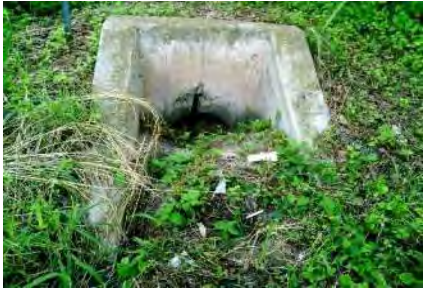
Drainage	Drainage Structure	2	1ft sediment	13
D58

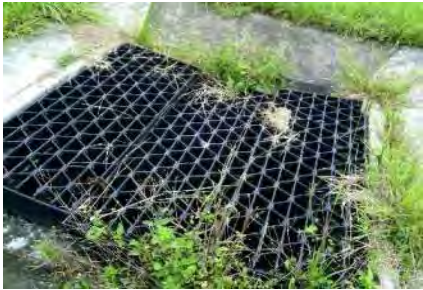
Drainage	Drainage Structure	2	grate issue	0
D59

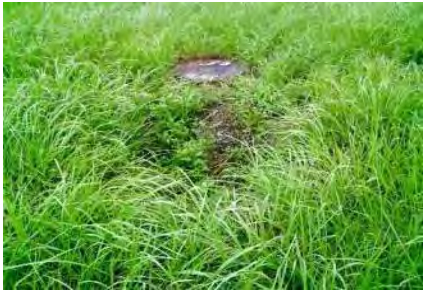
Drainage	Drainage Structure	2	dropoff before manhole	13
D60

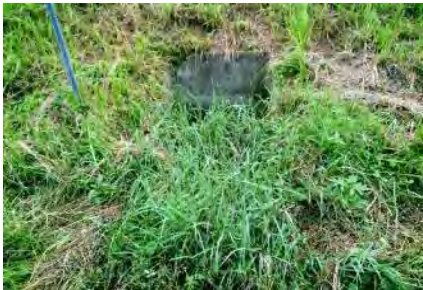
Drainage	Drainage Structure	2	mes maintenance	16

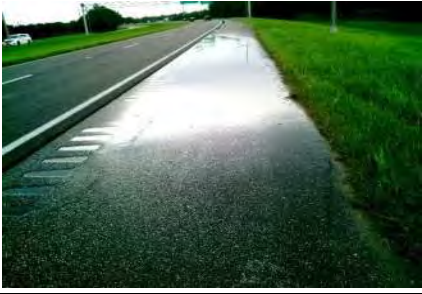
Drainage	Other	2	water ponding on paved shoulder	14
D64	 	Drainage	Other	2	water ponding on paved shoulder	14
D65	 	Drainage	Drainage Structure	2	inlet damaged / grates out of place	15
D66

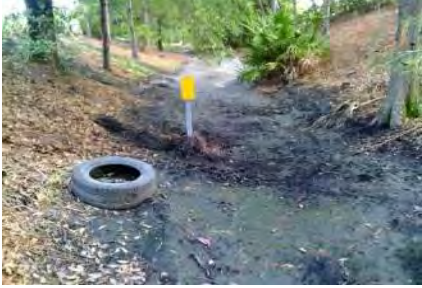
Drainage	Pond/ Ditch/ Canal	2	ditch grade issue / inlet covered by dirt	16

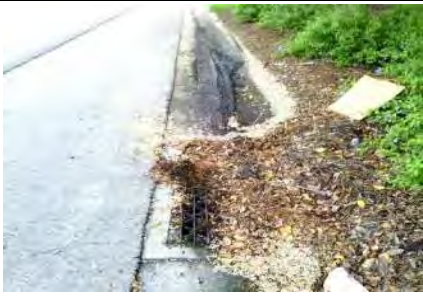
Drainage	Drainage Structure	2	shoulder gutter inlet not maintained	16
D68

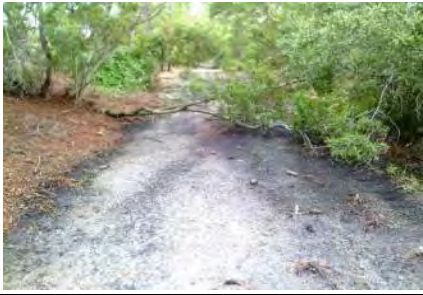
Drainage	Pond/ Ditch/ Canal	2	ditch grade issue / debris blocking	16
D69

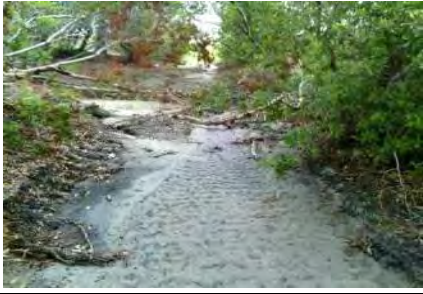
Drainage	Pond/ Ditch/ Canal	2	ditch issue	16
D70

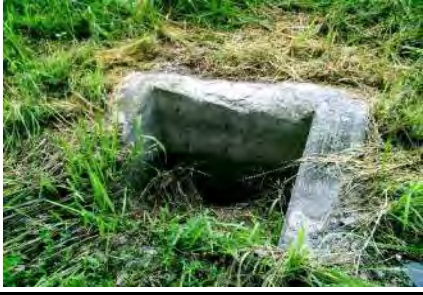
Drainage	Drainage Structure	2	silt build up in pipe	16
D71

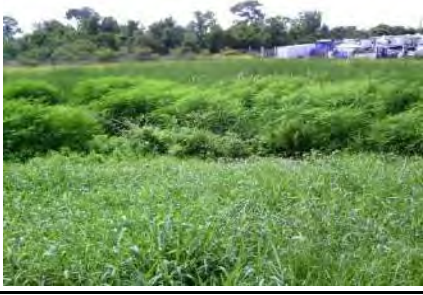
Drainage	Drainage Structure	2	no access to outfall	17
D72

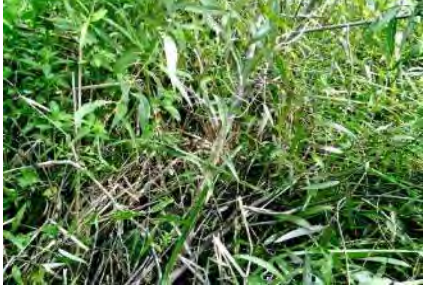
Drainage	Drainage Structure	2	overgrown vegetation	18

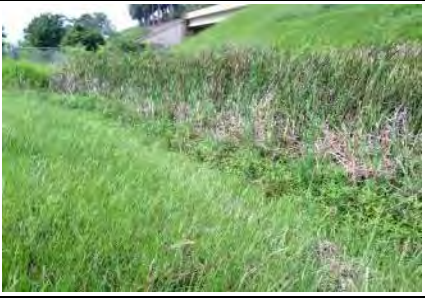
Drainage	Pond/ Ditch/ Canal	2	overgrown vegetation swale	18
D74

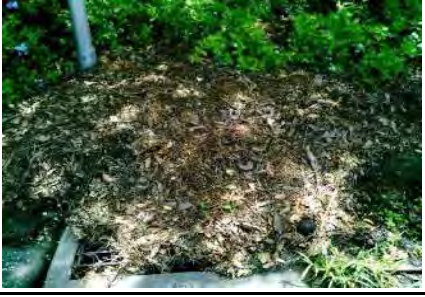
Drainage	Drainage Structure	2	flume / shoulder gutter inlet not maintained	16
D75

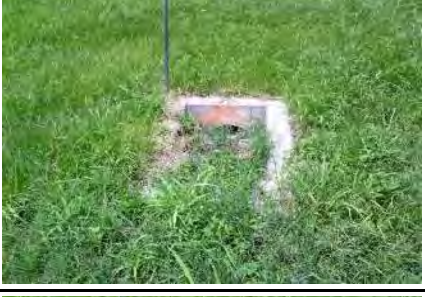
Drainage	Drainage Structure	2	clogged concrete endwall u type	18
D76

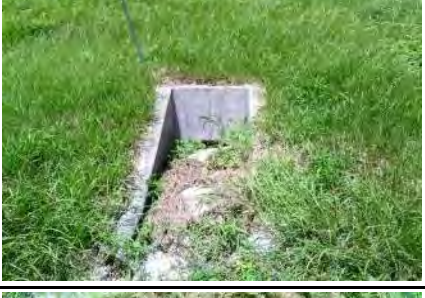
Drainage	Drainage Structure	2	clogged concrete endwall u type	18
D77

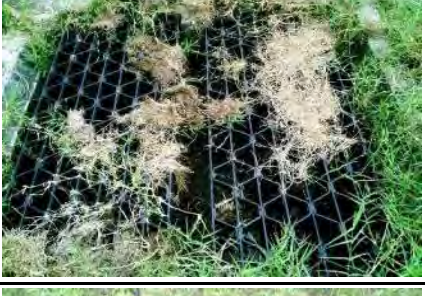
Drainage	Drainage Structure	2	clogged dbi / pipe silted	18
D78

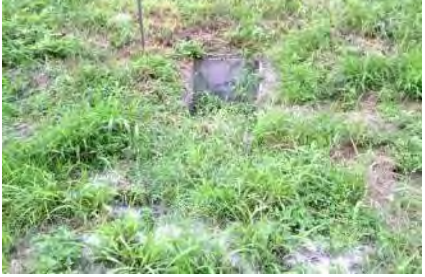
Drainage	Drainage Structure	2	maintenance	19

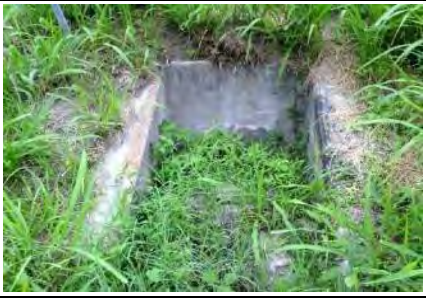
Drainage	Drainage Structure	2	obstructed u type endwall	19
D80

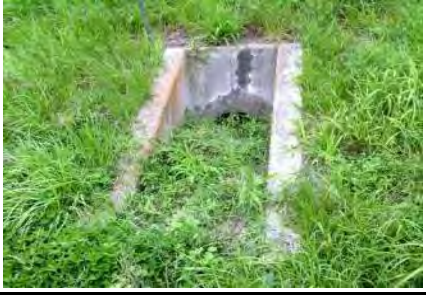
Drainage	Drainage Structure	2	obstructed u type endwall	19
D81

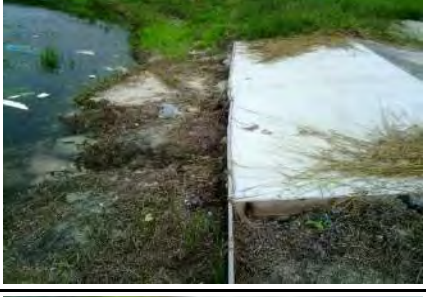
Drainage	Drainage Structure	2	form work not removed / erosion around	20
D82

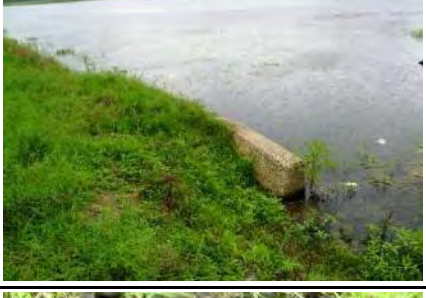
Drainage	Drainage Structure	2	erosion around the headwall	19
D83

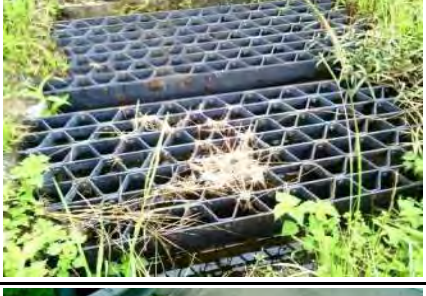
Drainage	Drainage Structure	2	heavy sediment \clogged	20
D84

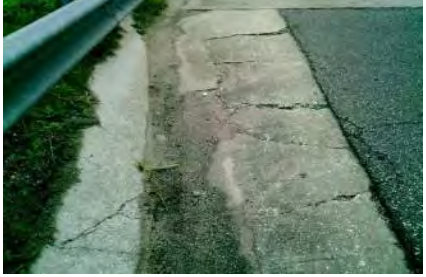
Drainage	Other	2	shoulder gutter damaged	20

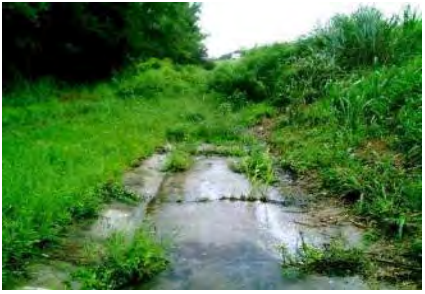
Drainage	Flume/ Concrete Apron	2	path obstructed / overgrown vegetation	20
D86

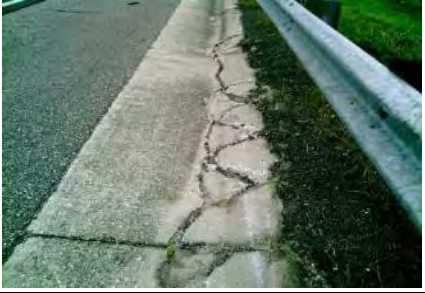
Drainage	Other	2	shoulder gutter damaged	20
D87	 	Drainage	Drainage Structure	2	frame / filter pipes damaged	21
D88

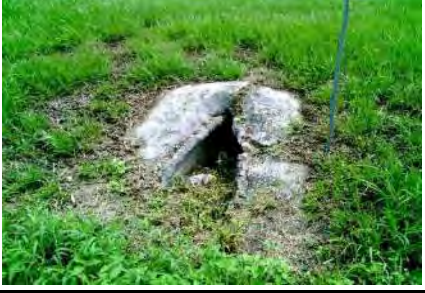
Drainage	Drainage Structure	2	damaged mes	24
D89	 	Drainage	Drainage Structure	2	heavy sediment clog	25
D90

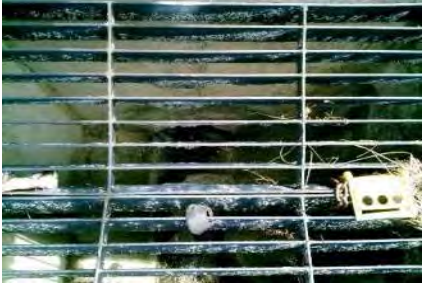
Drainage	Drainage Structure	2	concrete in inlet	25

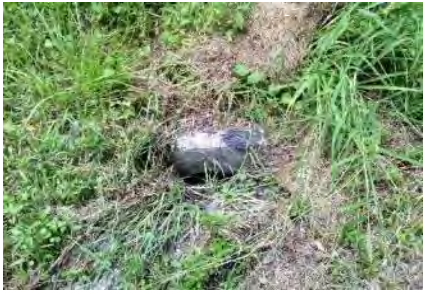
Drainage	Drainage Structure	2	heavy sediment clog	25
D92

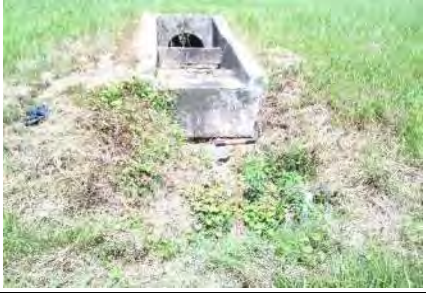
Drainage	Drainage Structure	2	erosion around u-type endwall	24
D93

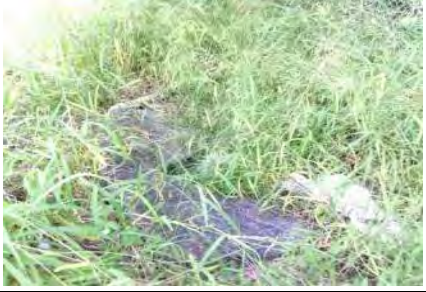
Drainage	Drainage Structure	2	overgrown vegetation obstructed mes	24
D94

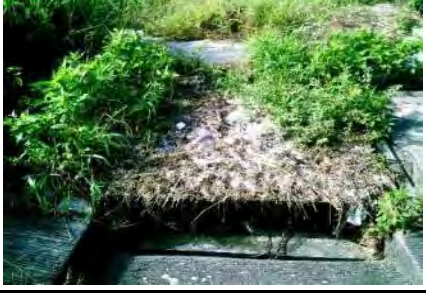
Drainage	Drainage Structure	2	DBI obstructed / not maintained	29
D95

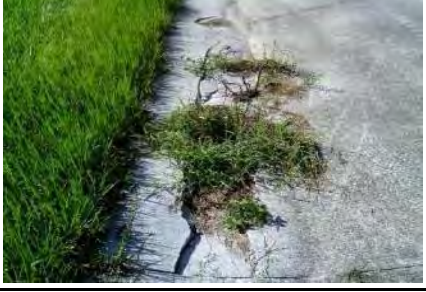
Drainage	Flume/ Concrete Apron	2	flume damaged	32
D96

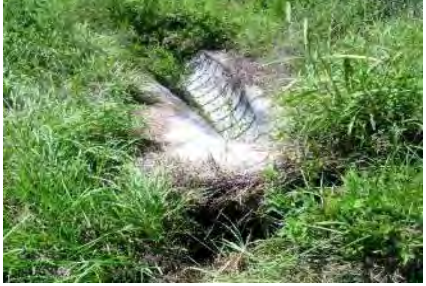
Drainage	Drainage Structure	2	erosion around the mes / overgrown vegetation	33

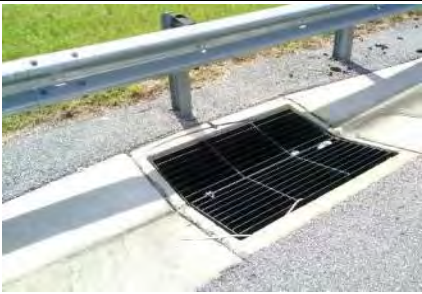
Drainage	Drainage Structure	2	shoulder gutter inlet damaged	36
D98

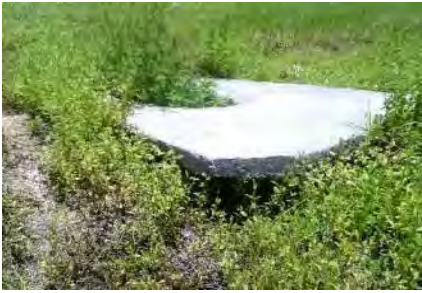
Drainage	Drainage Structure	2	erosion around the mes	37
D99

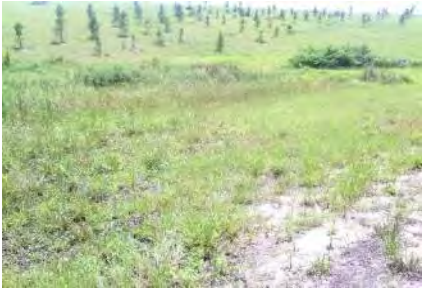
Drainage	Pond/ Ditch/ Canal	2	wet area in a dry pond vegetation overgrown	40
D100

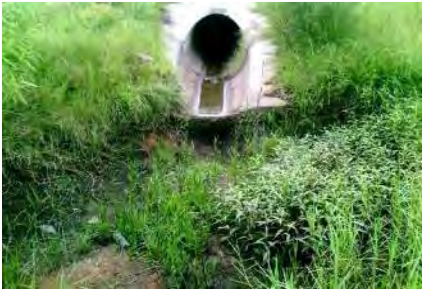
Drainage	Drainage Structure	2	erosion at toe of mes	36
D101

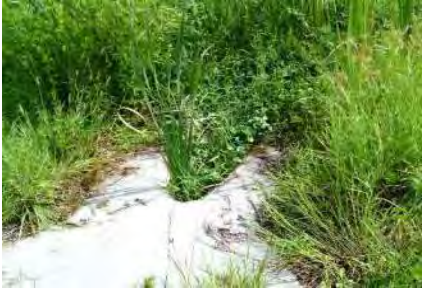
Drainage	Drainage Structure	2	overgrown vegetation / mes cracked	36
D102

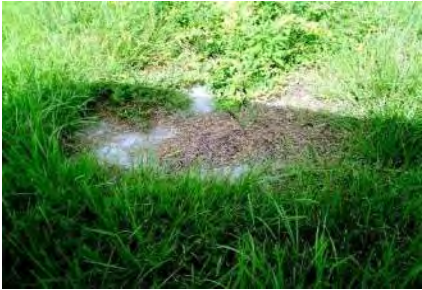
Drainage	Drainage Structure	2	overgrown vegetation / mes cracked	36

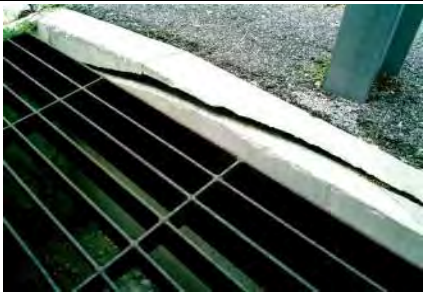
Drainage	Drainage Structure	2	shoulder gutter inlet damaged	36
D104

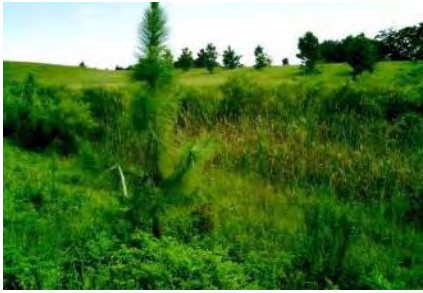
Drainage	Drainage Structure	2	no access to outfall overgrown vegetation	34
D105

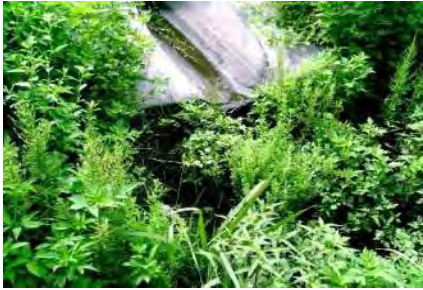
Drainage	Drainage Structure	2	erosion at mes toe	34
D106

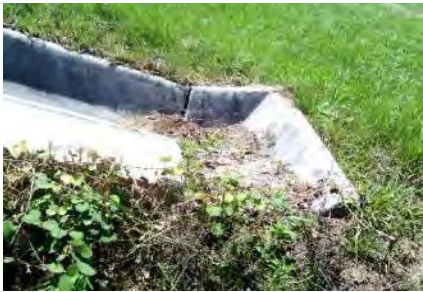
Drainage	Drainage Structure	2	cracked bridge gutter	30
D107

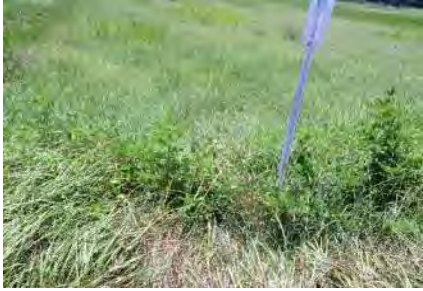
Drainage	Drainage Structure	2	mes fully obstructed overgrown vegetation	27
D108

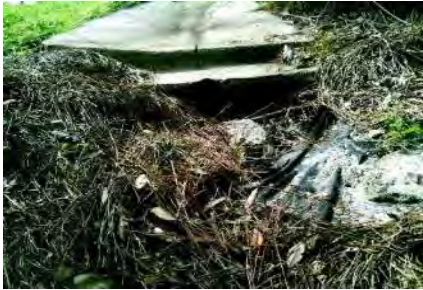
Drainage	Flume/ Concrete Apron	2	erosion at toe of the flume	23

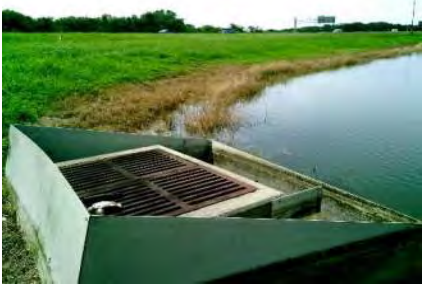
Drainage	Drainage Structure	2	skimmer	20
D110

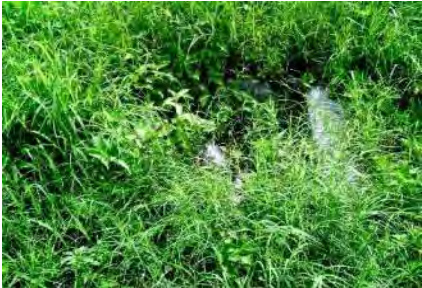
Drainage	Drainage Structure	2	u type endwall obstructed / pipe covered with sediment	19
D111

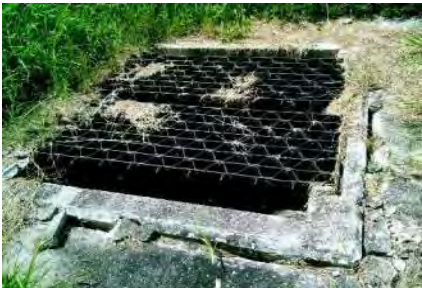
Drainage	Drainage Structure	2	dbi damaged	18
D112

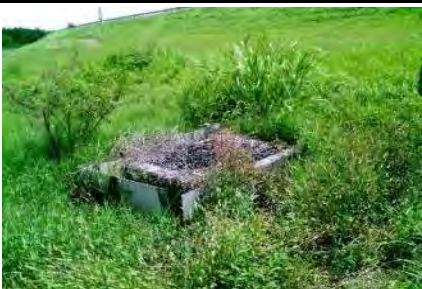
Drainage	Drainage Structure	2	skimmer broken/vegetation /clogged pipe	20
D113

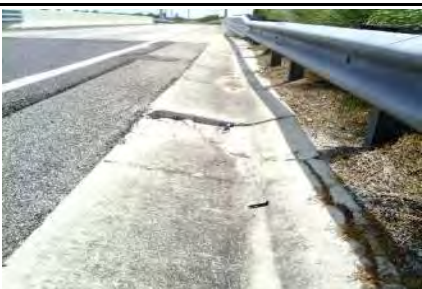
Drainage	Drainage Structure	2	shoulder gutter damaged	17
D114

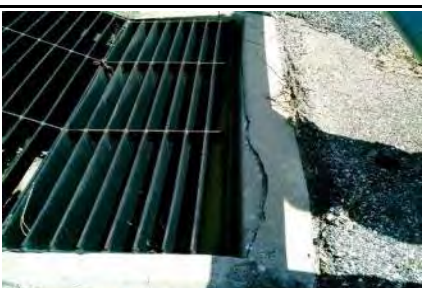
Drainage	Flume/ Concrete Apron	3	shoulder gutter inlet cracked	1

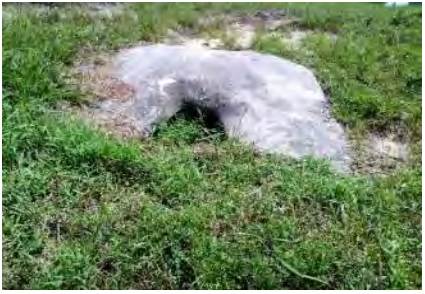
Drainage	Drainage Structure	3	sediment/silt in pipes and erosion	7
D122

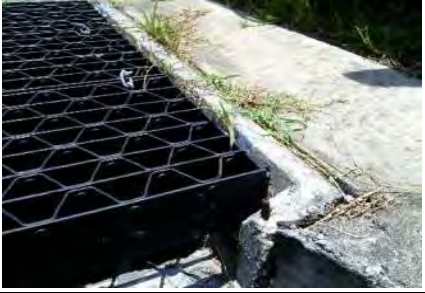
Drainage	Drainage Structure	3	Rebar exposed	7
D123

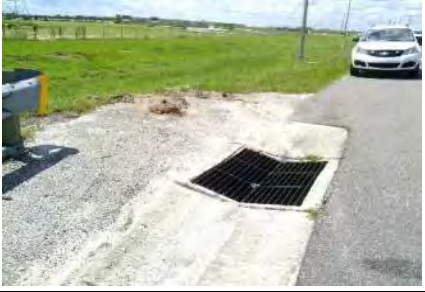
Drainage	Other	3	water by passing the inlet and cause erosion	6
D124

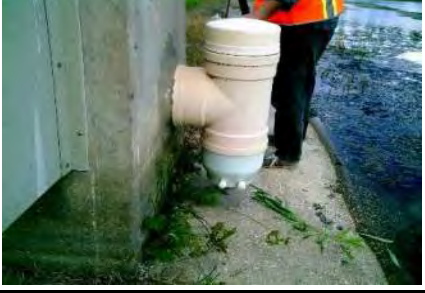
Drainage	Drainage Structure	3	fish excluder	9
D125

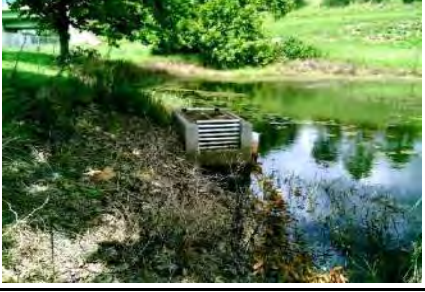
Drainage	Drainage Structure	3	fish extrude good	10
D126

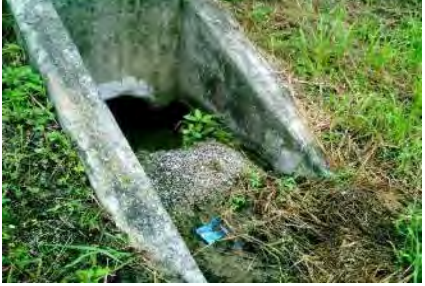
Drainage	Drainage Structure	3	sediment	11

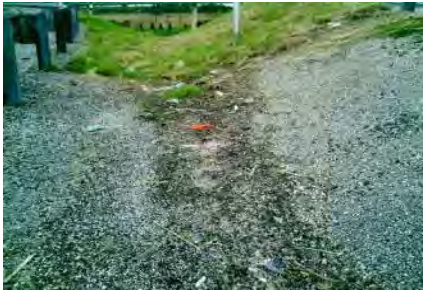
Drainage	Pond/ Ditch/ Canal	3	debris in ditch	16
D128

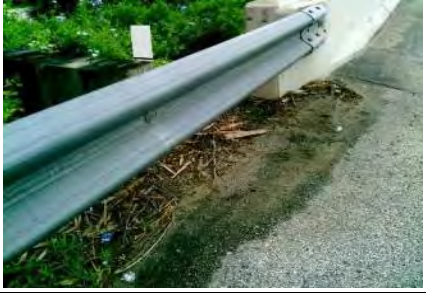
Drainage	Other	3	gutter transistion for future design	15
D129

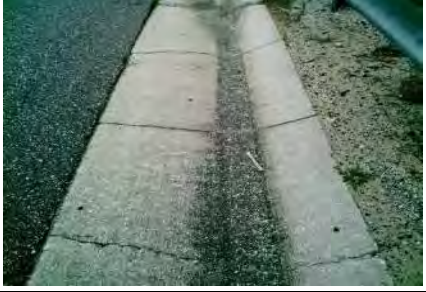
Drainage	Other	3	shoulder gutter damaged	15
D130

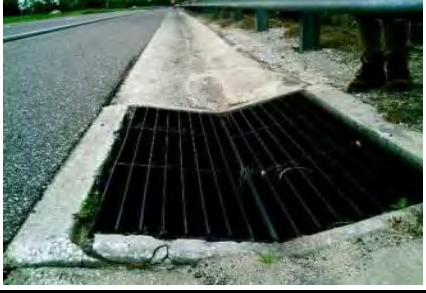
Drainage	Drainage Structure	3	inlet chipped	15
D131

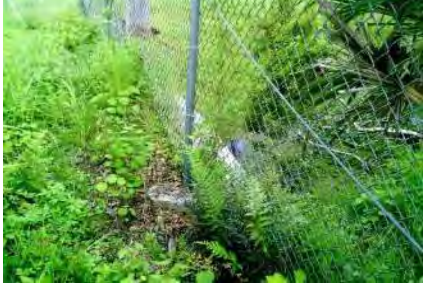
Drainage	Drainage Structure	3	no access to outfall	13

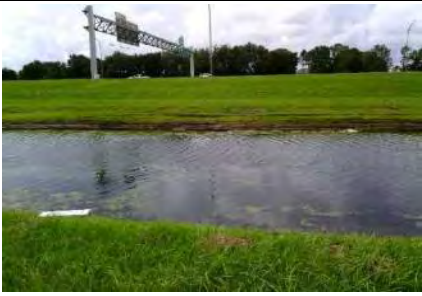
Drainage	Pond/ Ditch/ Canal	3	debris	14
D134

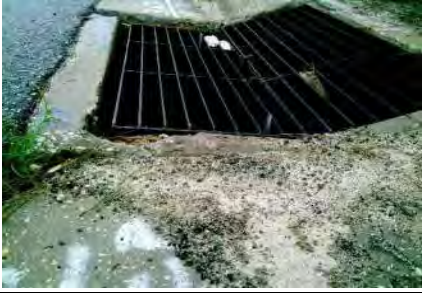
Drainage	Drainage Structure	3	inlet chipped	13
D135

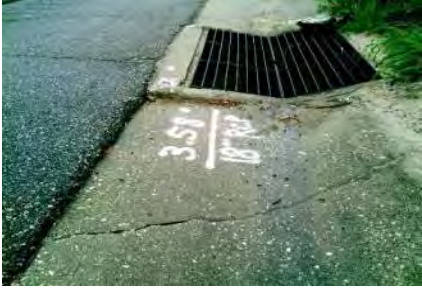
Drainage	Drainage Structure	3	inlet chipped / shoulder gutter cracked	13
D136

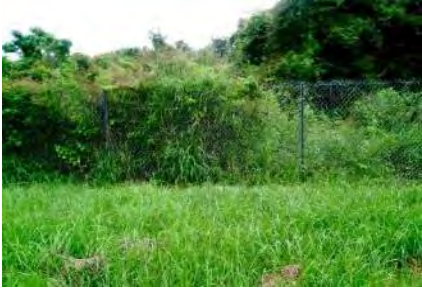
Drainage	Drainage Structure	3	no access to pond outfall	14
D137

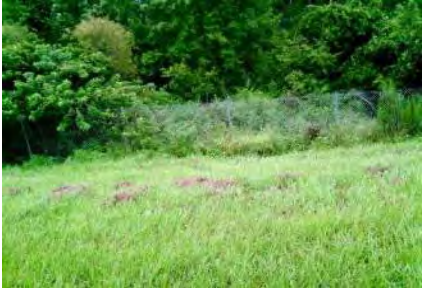
Drainage	Drainage Structure	3	no access to cross drain	14
D138

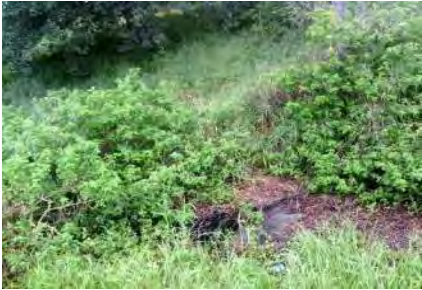
Drainage	Drainage Structure	3	DBI maintenance	15

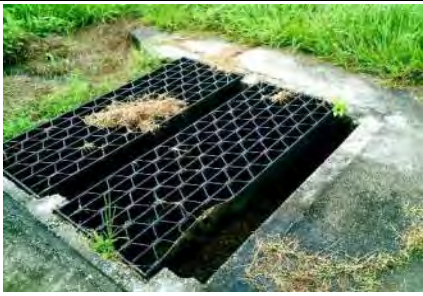
Drainage	Drainage Structure	3	grate damaged / chain not secured	15
D140

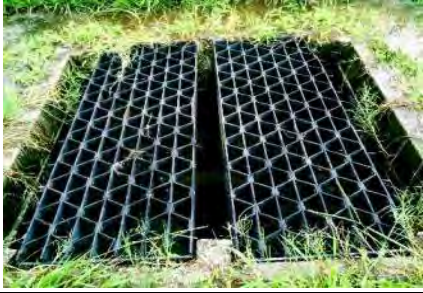
Drainage	Drainage Structure	3	inlet and grate damaged	17
D141
