2020

Annual Inspection Report

Appendix 3: SR 408

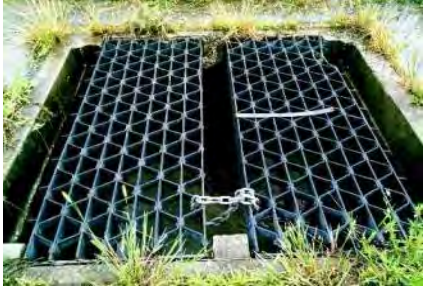
Drainage	Drainage Structure	3	inlet damaged	17
D142

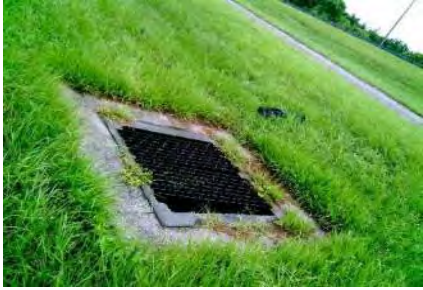
Drainage	Drainage Structure	3	inlet damaged	21
D143

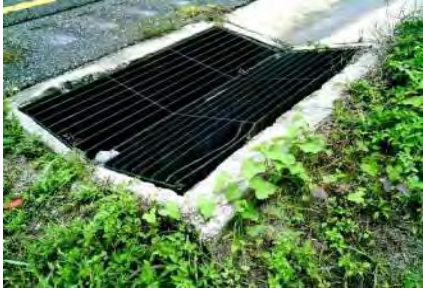
Drainage	Drainage Structure	3	inlet / grate damaged	23
D144

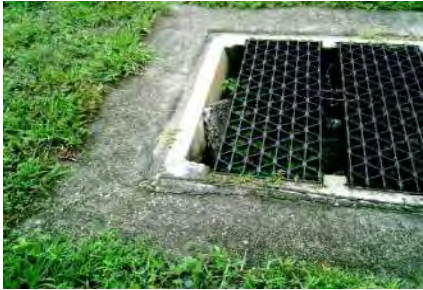
Drainage	Drainage Structure	3	debris in inlet	24

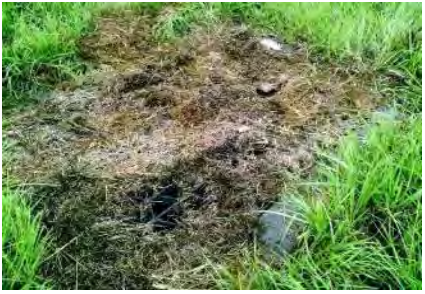
Drainage	Drainage Structure	3	debris covering inlet	27
D146

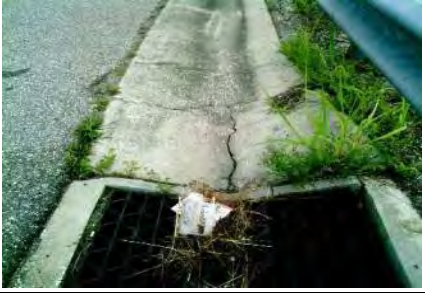
Drainage	Other	3	shoulder gutter cracked	17
D147

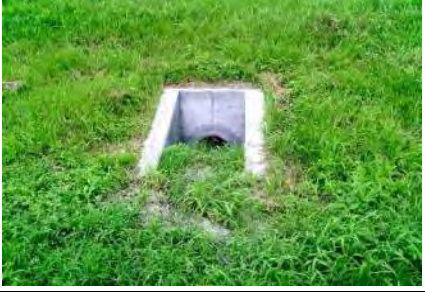
Drainage	Drainage Structure	3	maintenance	19
D148

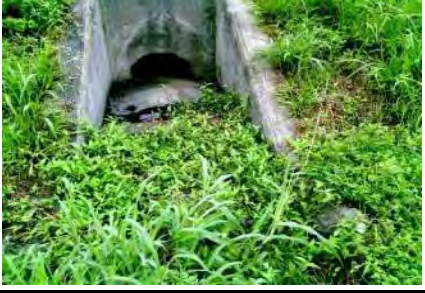
Drainage	Drainage Structure	3	sediment mes	20
D149

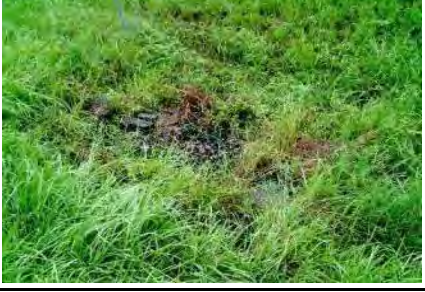
Drainage	Drainage Structure	3	vegetation overgrown	20
D150

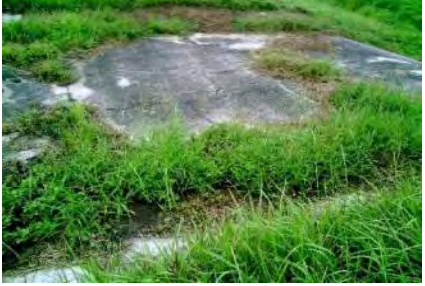
Drainage	Drainage Structure	3	trap weir / fence vegetation overgrown	21

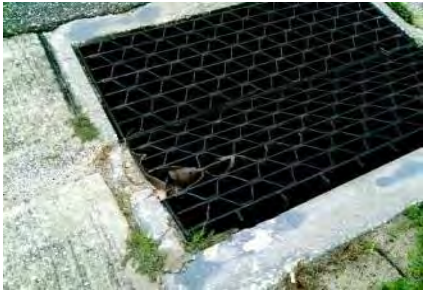
Drainage	Drainage Structure	3	inlet grate damaged	21
D152

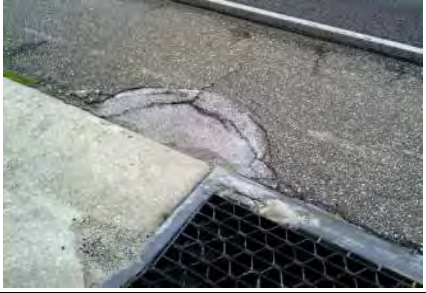
Drainage	Drainage Structure	3	top of grate damaged \ pothole	21
D153

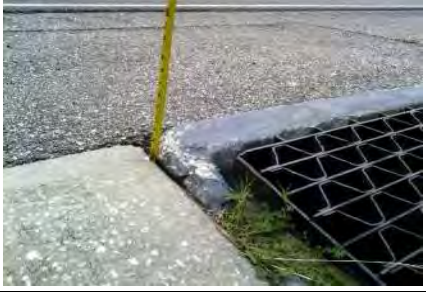
Drainage	Drainage Structure	3	inlet damaged grate exposed	22
D154

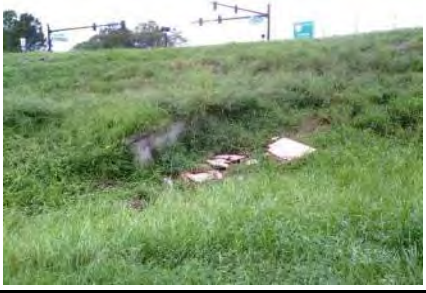
Drainage	Drainage Structure	3	head wall vegetation and debris	21
D155

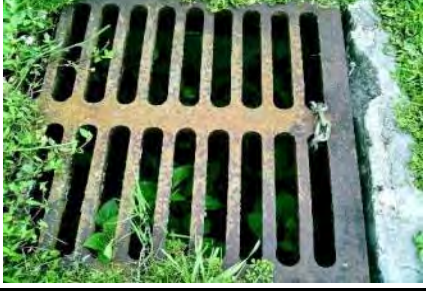
Drainage	Drainage Structure	3	inlet with veg inside	23
D156

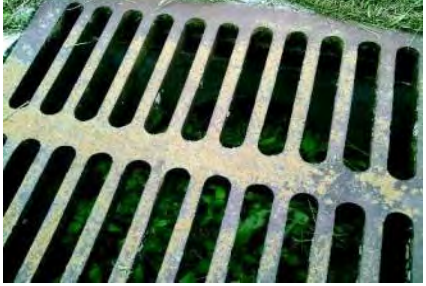
Drainage	Drainage Structure	3	inlet with veg inside	23

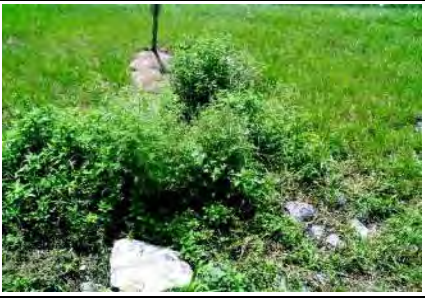
Drainage	Drainage Structure	3	maintenance mes	25
D158

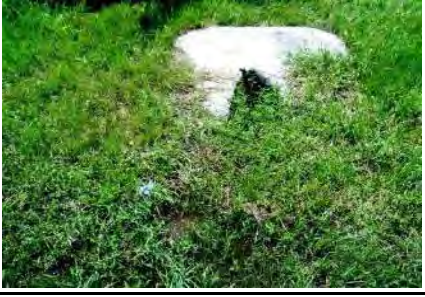
Drainage	Drainage Structure	3	maintenance / 6 inch sediment	25
D159

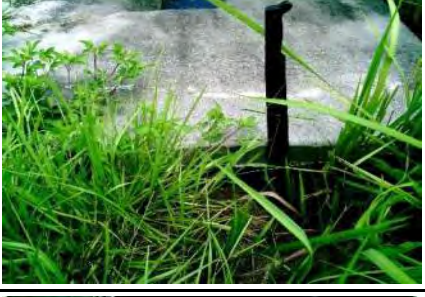
Drainage	Drainage Structure	3	erosion	26
D160

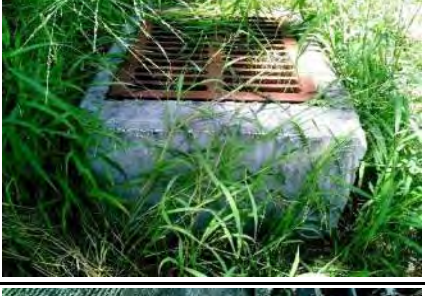
Drainage	Drainage Structure	3	control structure sediment build up/not leveled	25
D162

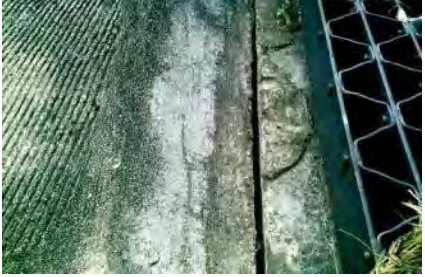
Drainage	Drainage Structure	3	joint seal missing between dbi and flume	29

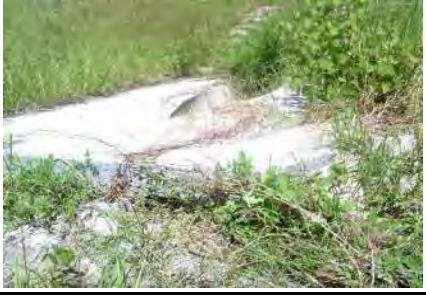
Drainage	Drainage Structure	3	erosion	36
D165

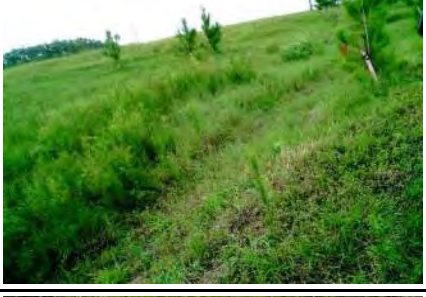
Drainage	Other	3	overgrown vegetation in swale	38
D166

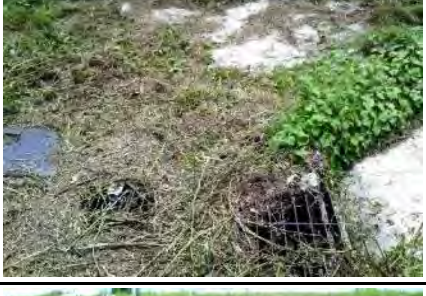
Drainage	Drainage Structure	3	dbi maintenance	31
D168

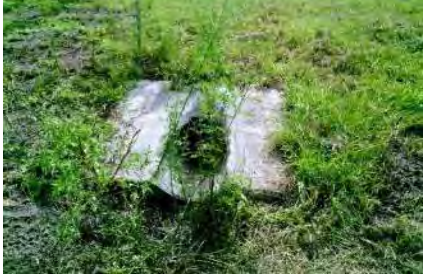
Drainage	Drainage Structure	3	mes slightly undermined	31

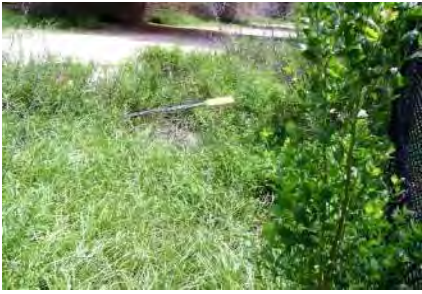
Drainage	Drainage Structure	3	mes vegetation	31
D170

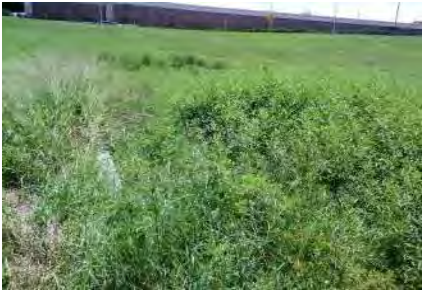
Drainage	Drainage Structure	3	all pond outfalls vegetation overgrown	31
D171

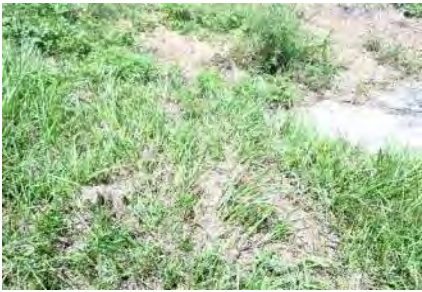
Drainage	Drainage Structure	3	inlet not visible	29
D172

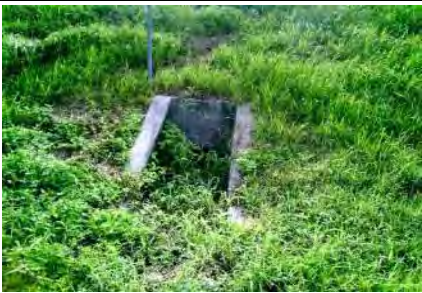
Drainage	Drainage Structure	3	sediment in pipes in this area	24
D173

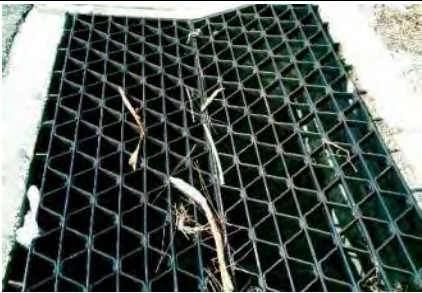
Drainage	Drainage Structure	3	pipe covered with sediment	22
D174

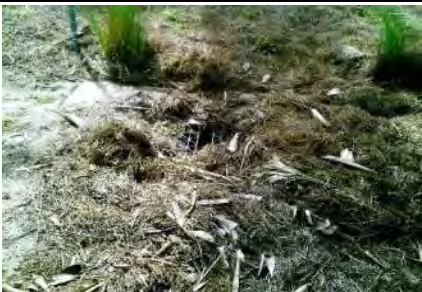
Drainage	Drainage Structure	3	inlet obstructed	22

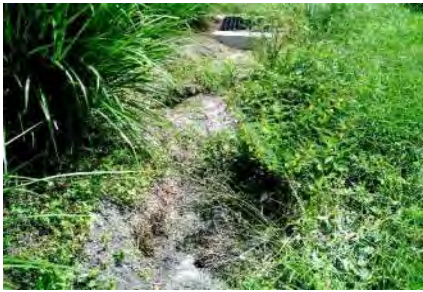
Drainage	Drainage Structure	3	erosion around the dbi	17
OI2

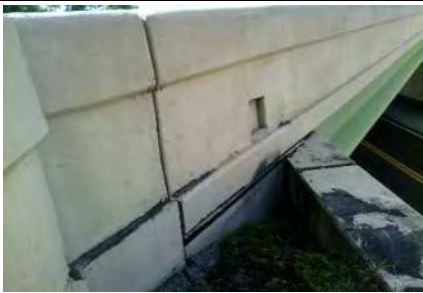
Other Issue		1	open joint need to be sealed / slopped pavement settled	9
OI1

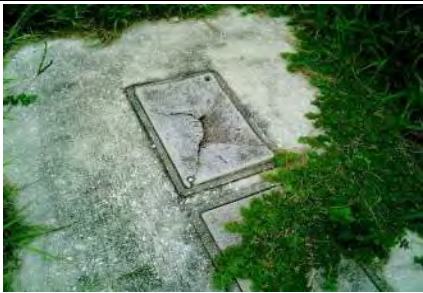
Other Issue		1	electrical box top damaged	11
OI3	 	Other Issue		1	bridge is cracking	34

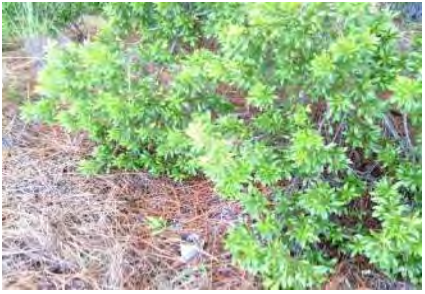
Other Issue		1	missing signage	16
OI5

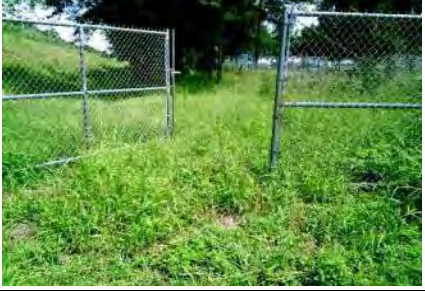
Other Issue		1	lock missing	16
OI6

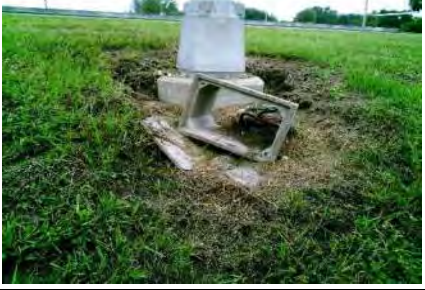
Other Issue		1	electrical box out of place	23
OI7

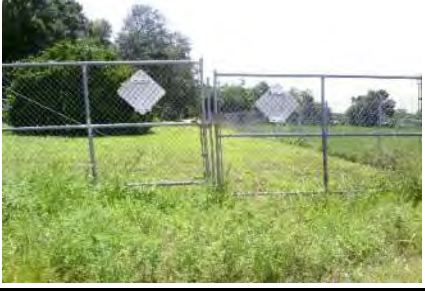
Other Issue		1	gate lock missing	24
OI8

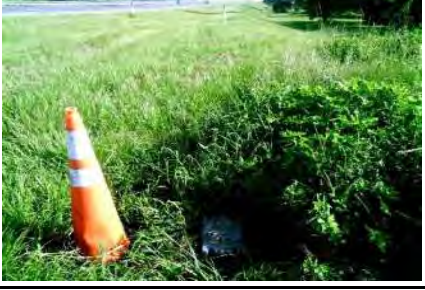
Other Issue		1	sign missing	29
OI9

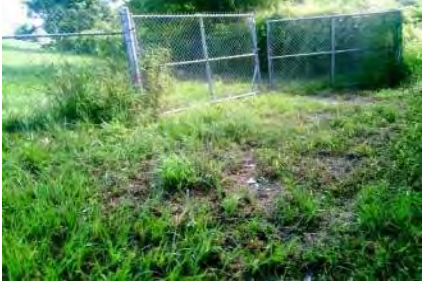
Other Issue		1	gate lock missing / damaged	30

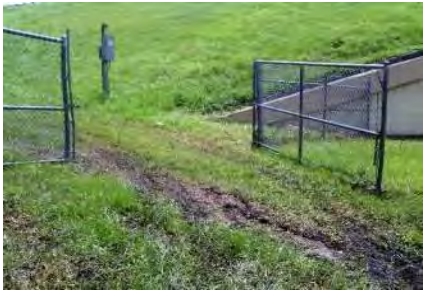
Other Issue		1	gate lock missing	20
OI11

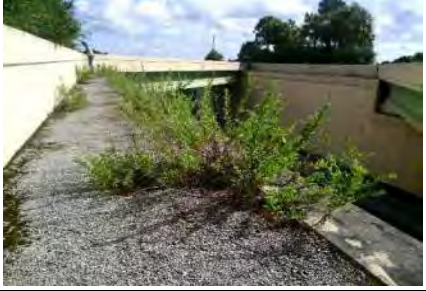
Other Issue		2	veg on bridge	9
OI12

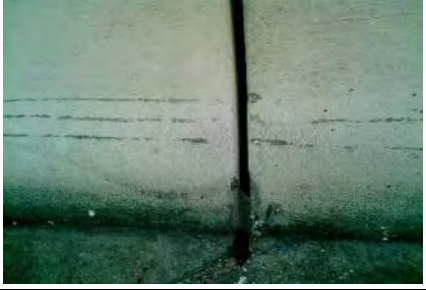
Other Issue		2	slopped pavement settled	9
OI13

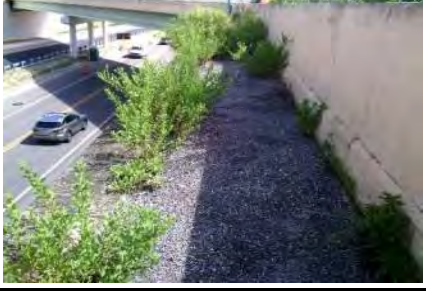
Other Issue		2	veg on bridge	2
OI14

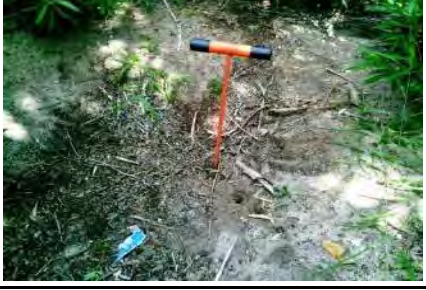
Other Issue		2	settlement /void	2
OI15

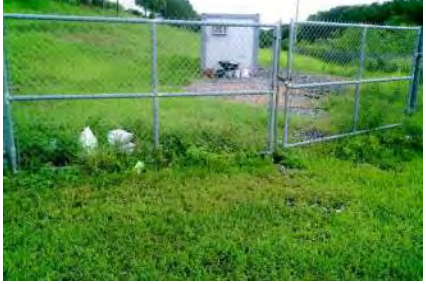
Other Issue		2	no access	10

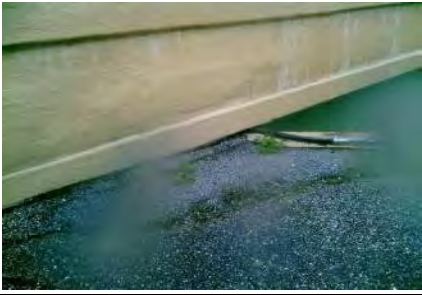
Other Issue		2	cracking sloped pavement	20
OI18

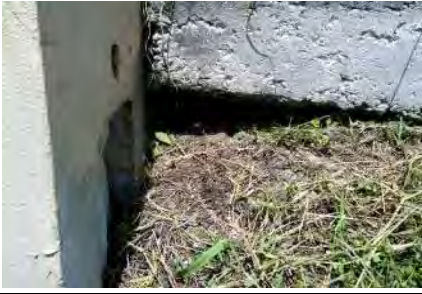
Other Issue		2	undermining of gutter by toll	25
OI19

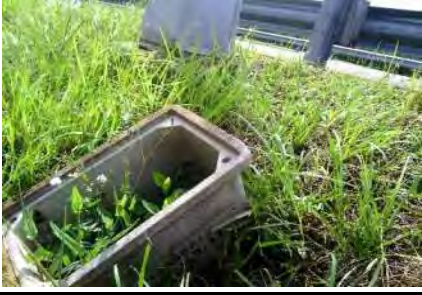
Other Issue		2	electrical pull box damaged	22
OI20

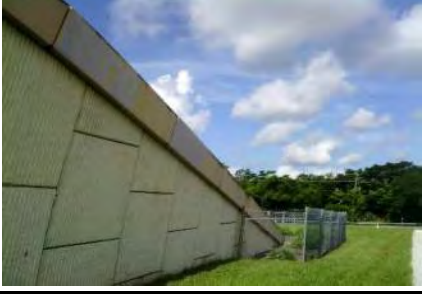
Other Issue		3	paint on bridge	5
OI21

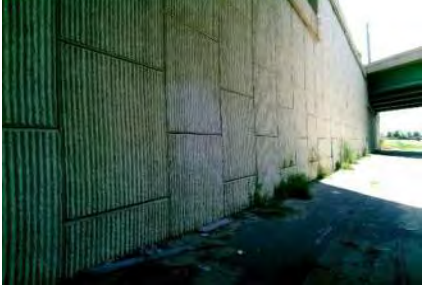
Other Issue		3	inside bridge paint [avalon road]	2

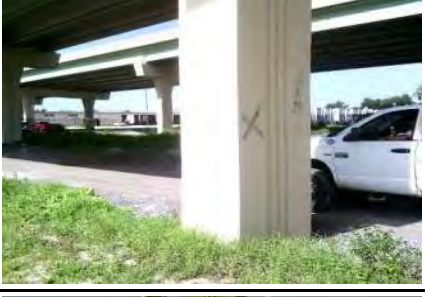
Other Issue		3	graffiti under bridge	30
OI31

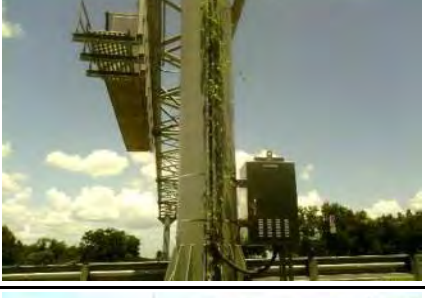
Other Issue		3	vegetation on sign upright	40
P1

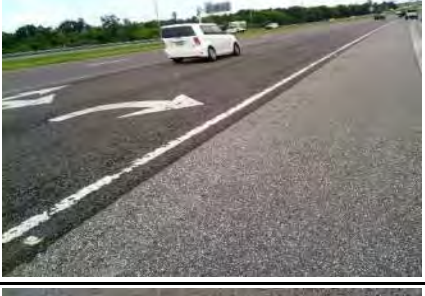
Pavement	Striping or Pavement Marking	1	missing striping	17
P2

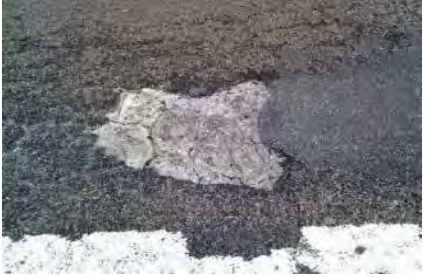
Pavement	Pothole	1	pothole	17

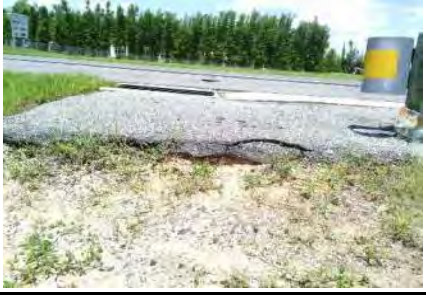
Pavement	Cracking	2	undermine	1
P5	 	Pavement	Other	2	eroded away	4
P6

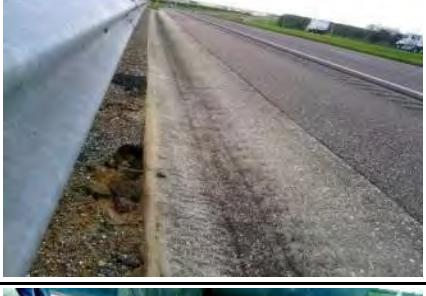
Pavement	Cracking	2	chipping away	4
P8

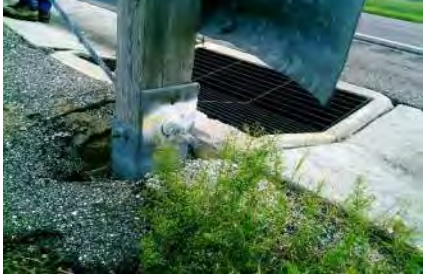
Pavement	Cracking	2	chipping away	3

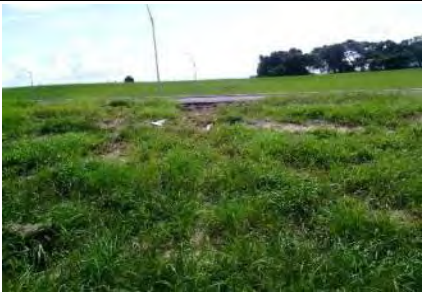
Pavement	Cracking	2	chipping away	3
P10

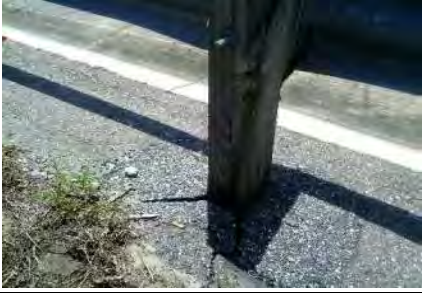
Pavement	Cracking	2	cracked Around railing	3
P11

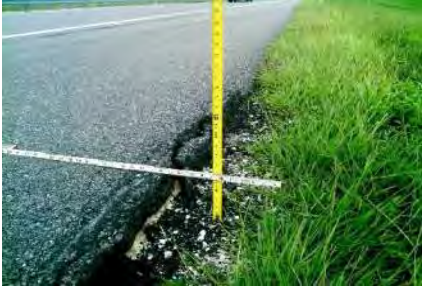
Pavement	Edge Ravel	2	edge damaged / shoulder dropoff	6
P12

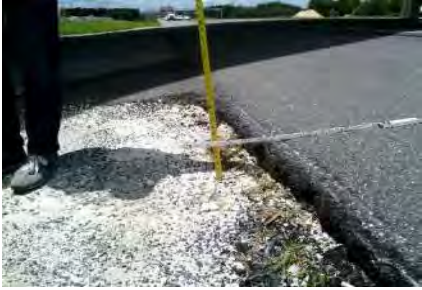
Pavement	Other	2	shoulder dropoff 6 inch	7
P13

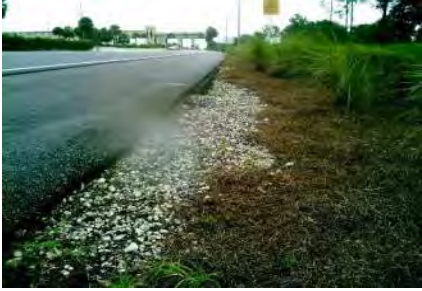
Pavement	Other	2	shoulder dropoff	8
P14

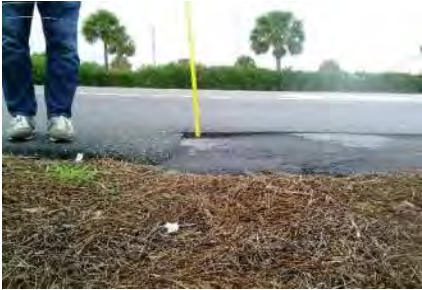
Pavement	Depression	2	1.5 inch dropoff	9

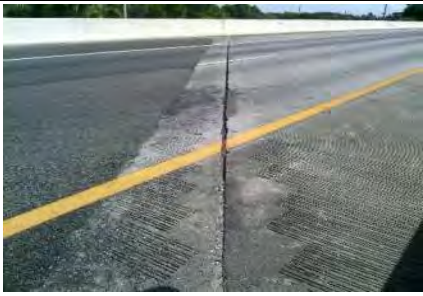
Pavement	Other	2	joint seal damaged	9
P16

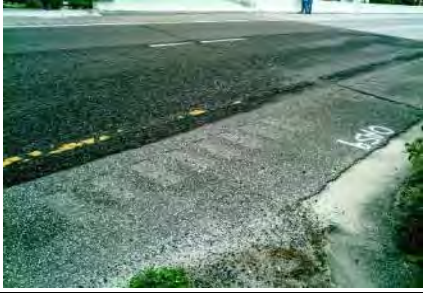
Pavement	Striping or Pavement Marking	2	worn out line	12
P17

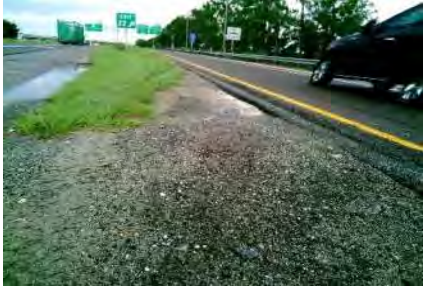
Pavement	Other	2	dropoff	15
P18

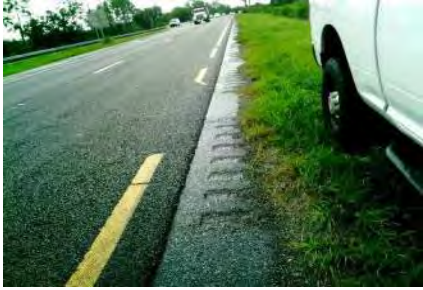
Pavement	Striping or Pavement Marking	2	striping missing	15
P19

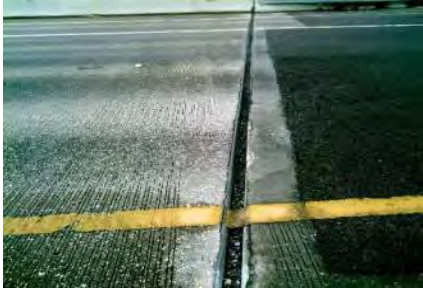
Pavement	Other	2	joint seal missing	16
P20

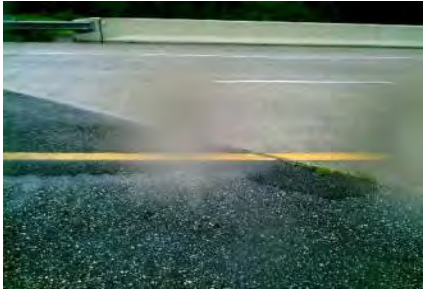
Pavement	Pothole	2	pot hole	20

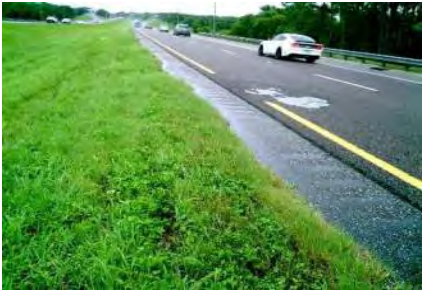
Pavement	Striping or Pavement Marking	2	striping missing	20
P22

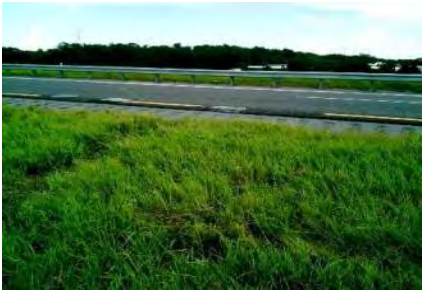
Pavement	Striping or Pavement Marking	2	striping missing	36
P23

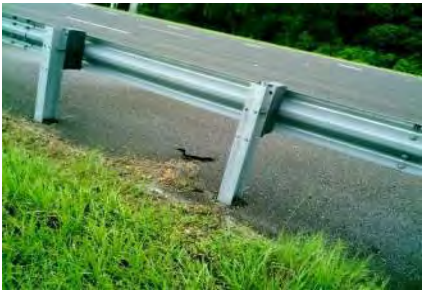
Pavement	Cracking	2	cracking	37
P24

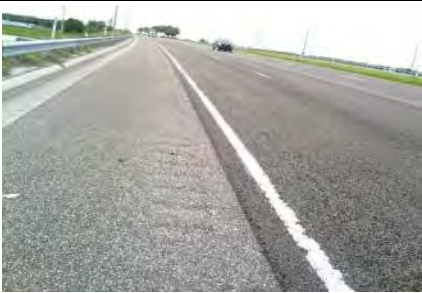
Pavement	Striping or Pavement Marking	2	striping faded	17
P25

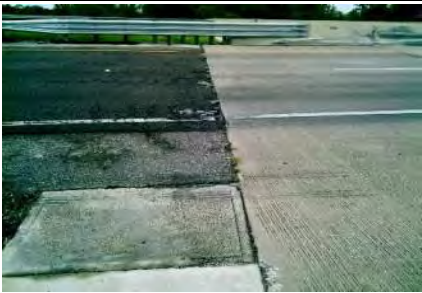
Pavement	Pothole	2	pothole at bridge connection	20
P26

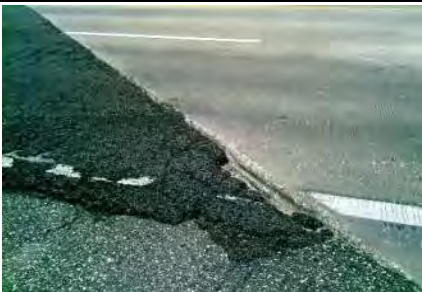
Pavement	Pothole	2	pothole	20

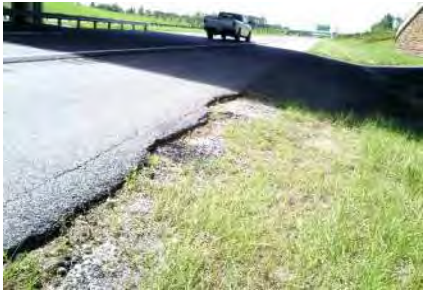
Pavement	Other	2	drop off	32
P28

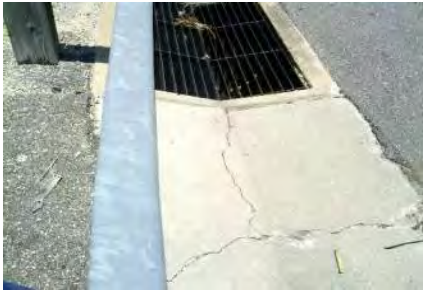
Pavement	Cracking	3	curb crack	2
P29

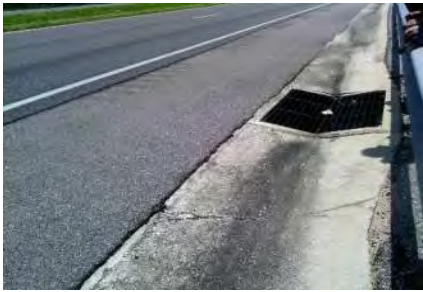
Pavement	Cracking	3	curb crack	2
P30

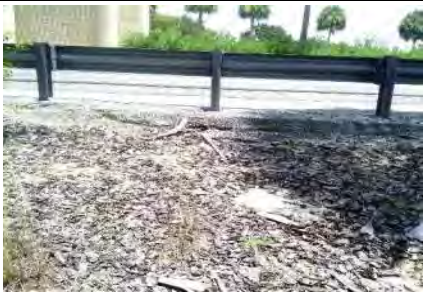
Pavement	Other	3	erosion	8
P31

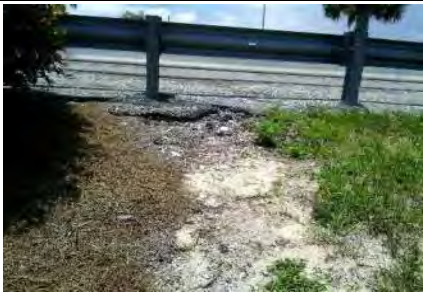
Pavement	Other	3	erosion	9
P32

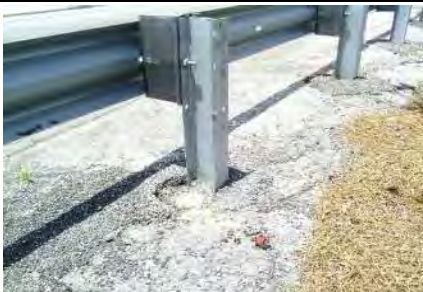
Pavement	Other	3	monitoring guard rail post base	8

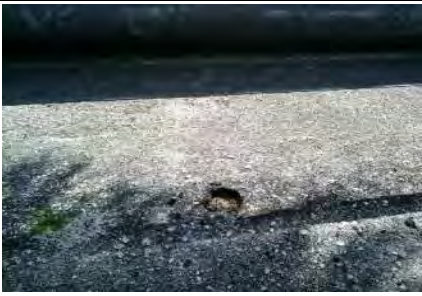
Pavement	Other	3	hole	8
P34

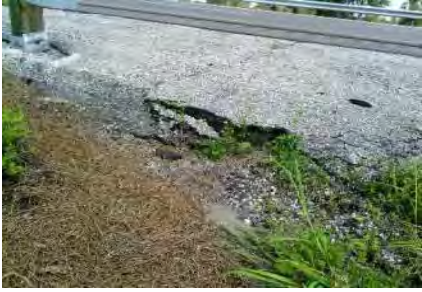
Pavement	Other	3	slopped pavement cracked	10
P35

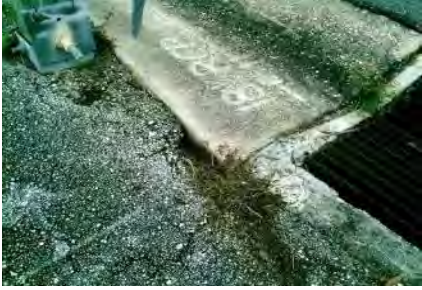
Pavement	Cracking	3	cracked	11
P36

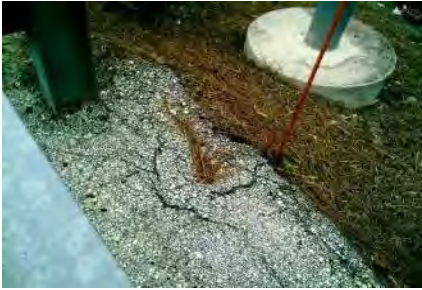
Pavement	Other	3	erosion	15
P37

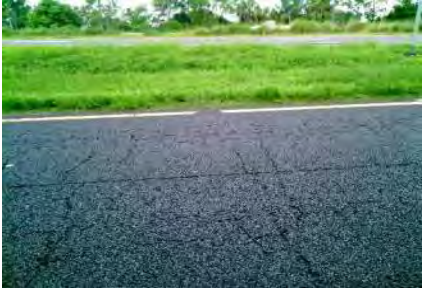
Pavement	Striping or Pavement Marking	3	missing striping	16
P38

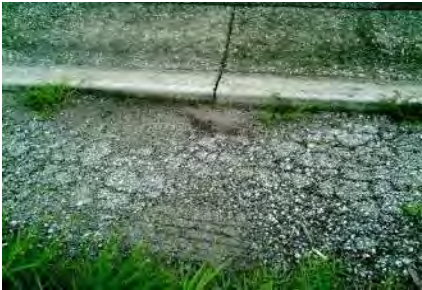
Pavement	Other	3	miscellaneous asphalt settlement	21

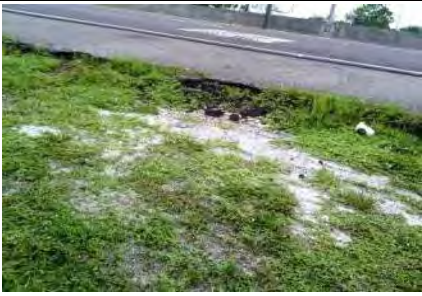
Pavement	Other	3	erosion	23
P40

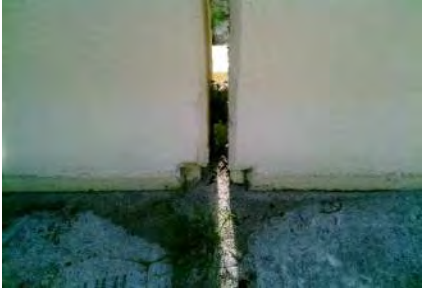
Pavement	Other	3	open joint seal missing	31
P41

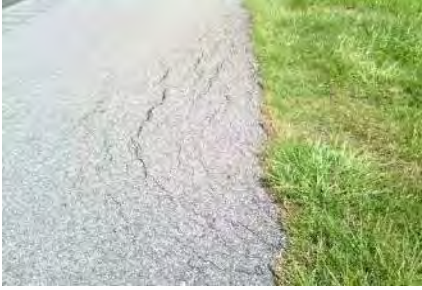
Pavement	Depression	3	cracking / settlement	32
P42

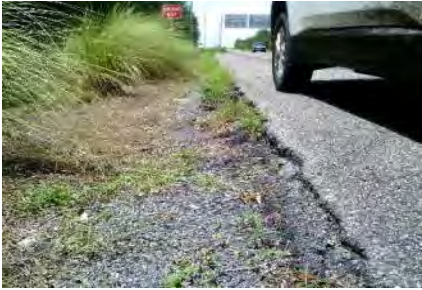
Pavement	Edge Ravel	3	erosion by the shoulder / dropoff	16
R1

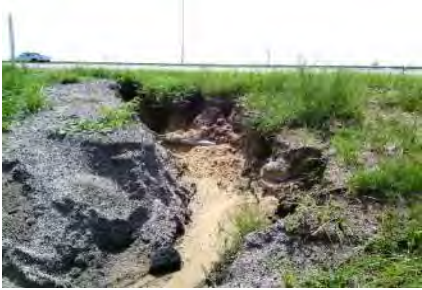
Roadway	Erosion	1	erosion / washout	4
R2

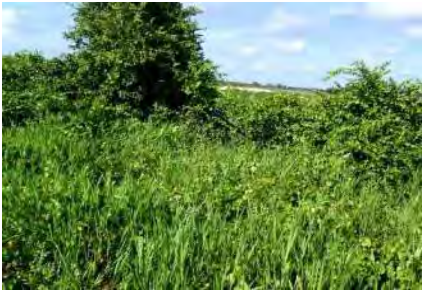
Roadway	Fence	1	vegetation and fence damaged	5

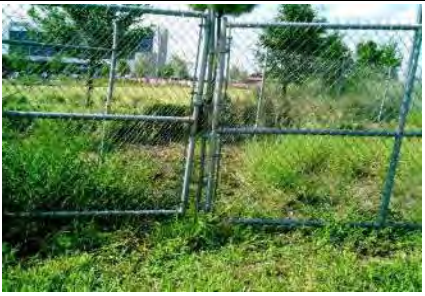
Roadway	Fence	1	missing lock	5
R4

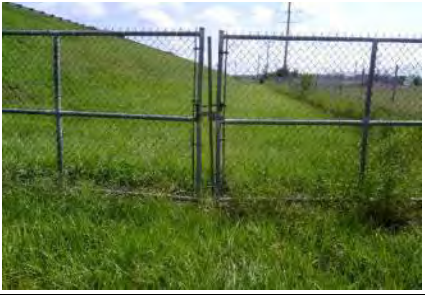
Roadway	Fence	1	missing lock	4
R5

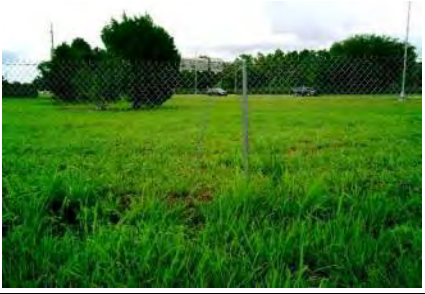
Roadway	Fence	1	fence line cut	12
R6

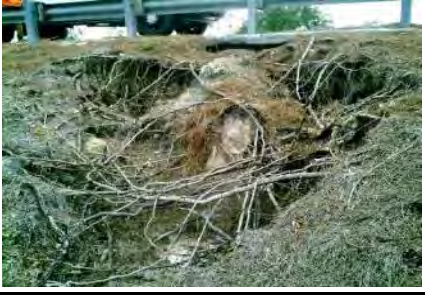
Roadway	Erosion	1	erosion by the shoulder / miscellaneous asphalt undermined	15
R7

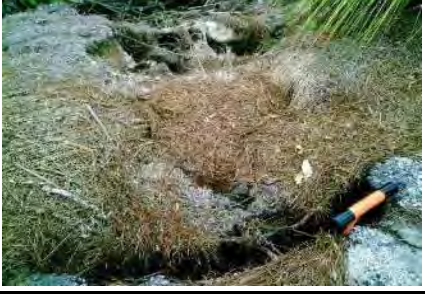
Roadway	Erosion	1	erosion by the shoulder / miscellaneous asphalt undermined	15
R8

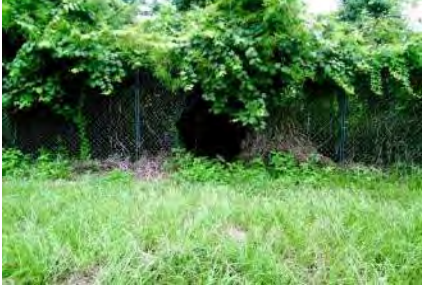
Roadway	Fence	1	large gap	14

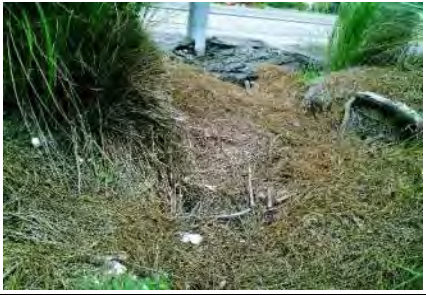
Roadway	Erosion	1	undermining and guard rail asphalt cracked	12
R11

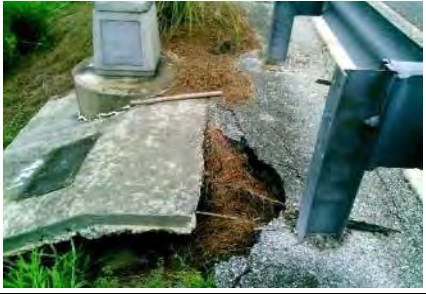
Roadway	Erosion	1	light post base / miscellaneous asphalt undermined	12
R12	 	Roadway	Fence	1	fence gate broken / heavy erosion	15
R13

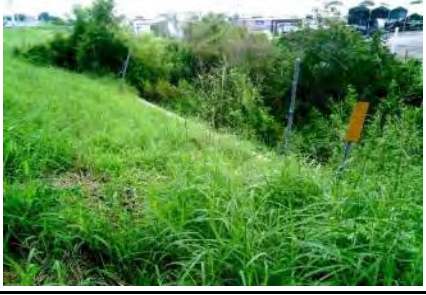
Roadway	Fence	1	fence missing	17
R14

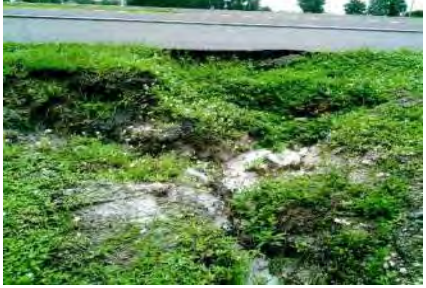
Roadway	Erosion	1	washout	23

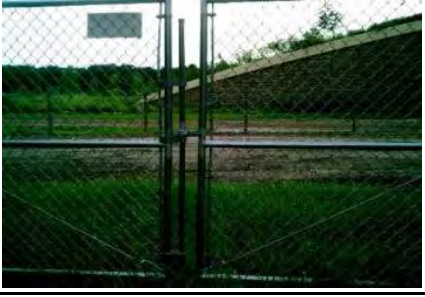
Roadway	Fence	1	no chain or lock	39
R17

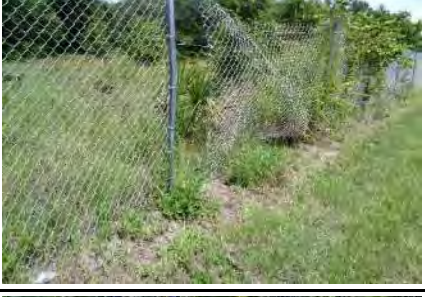
Roadway	Fence	1	fence missing	31
R18

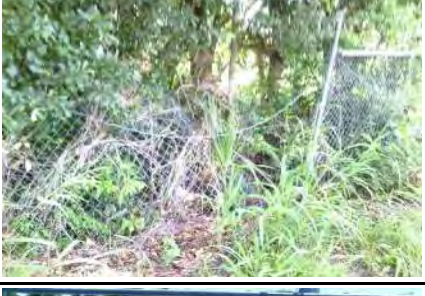
Roadway	Fence	1	fence missing / fence posts damaged around the pond	17
R20

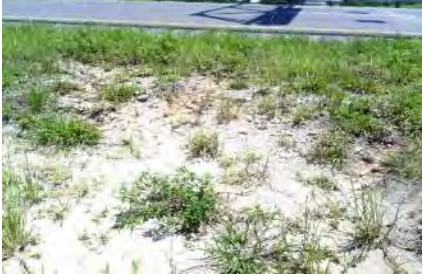
Roadway	Erosion	2	erosion	2

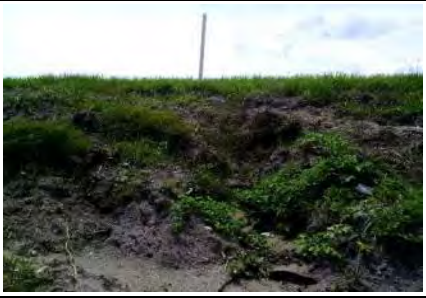
Roadway	Erosion	2	erosion / washout	4
R22

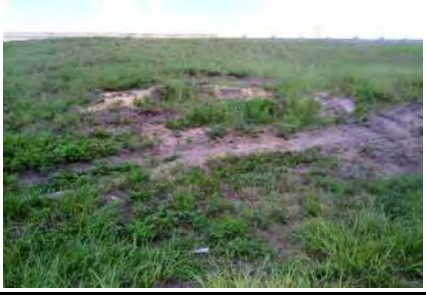
Roadway	Erosion	2	erosin from mower	1
R23

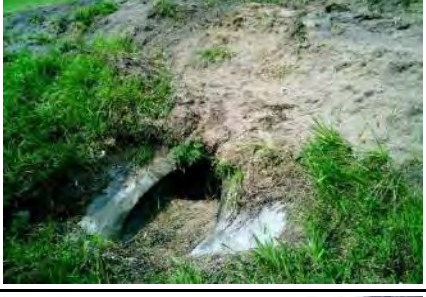
Roadway	Erosion	2	erosion at mes from mowing	1
R24

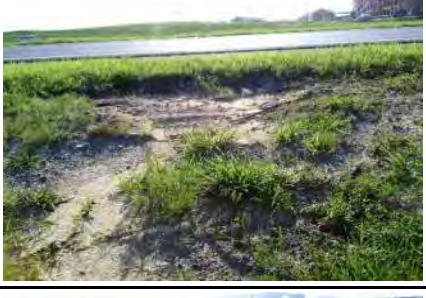
Roadway	Erosion	2	erosion	5
R25

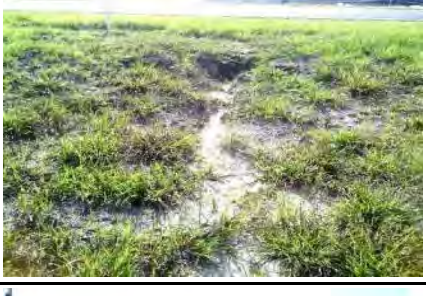
Roadway	Erosion	2	erosion	5
R26

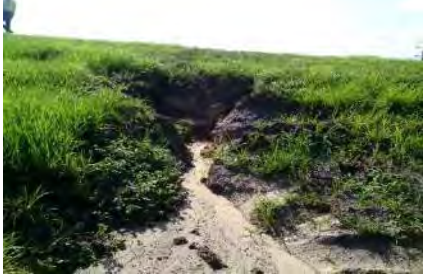
Roadway	Erosion	2	erosion	5

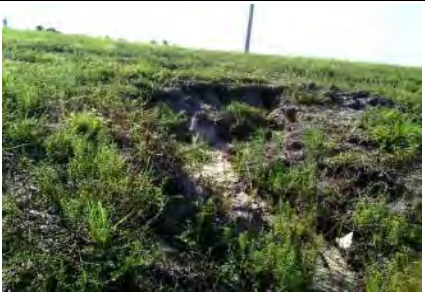
Roadway	Erosion	2	erosion	5
R28

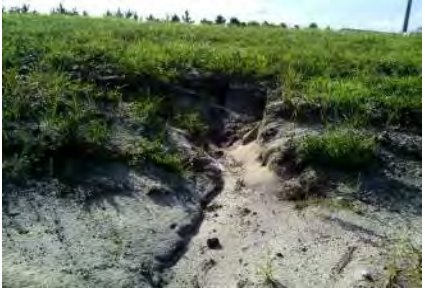
Roadway	Erosion	2	erosion	5
R29

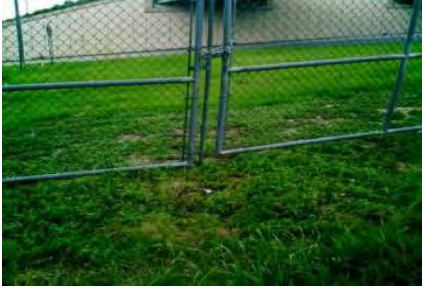
Roadway	Fence	2	lock malfunction	4
R30

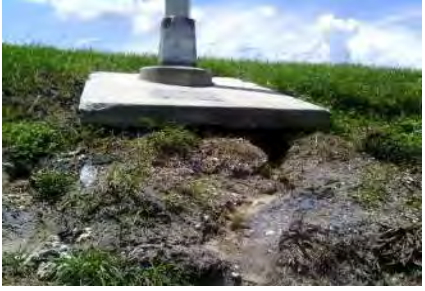
Roadway	Lighting	2	undermining light post	4
R31

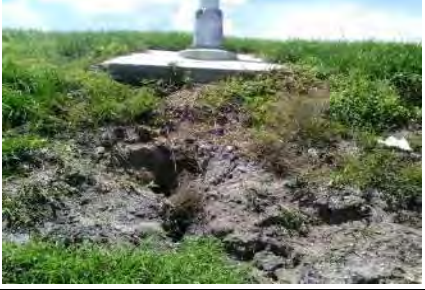
Roadway	Lighting	2	undermining light post	4
R32

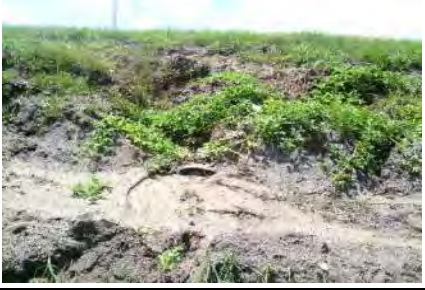
Roadway	Erosion	2	erosion	4

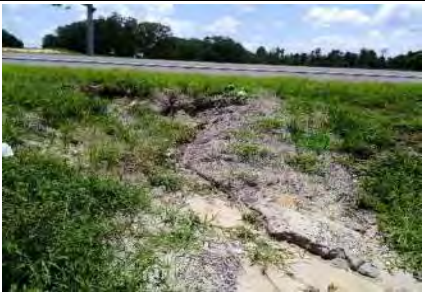
Roadway	Erosion	2	erosion	7
R34

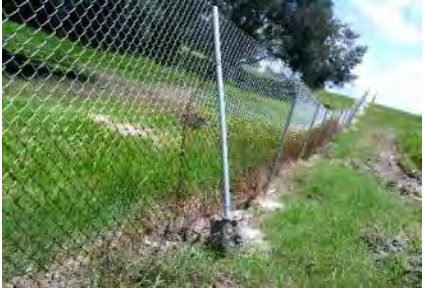
Roadway	Fence	2	fence post and erosion	7
R35

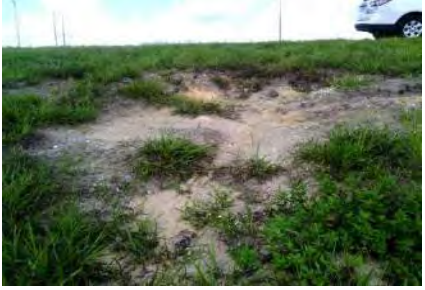
Roadway	Erosion	2	slope erosion	6
R36

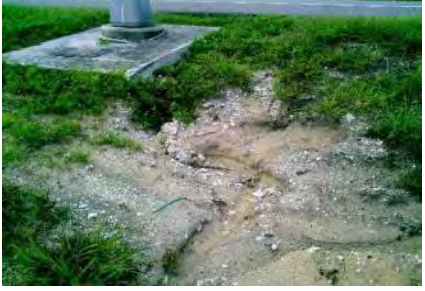
Roadway	Erosion	2	slope erosion by the pole base	6
R37

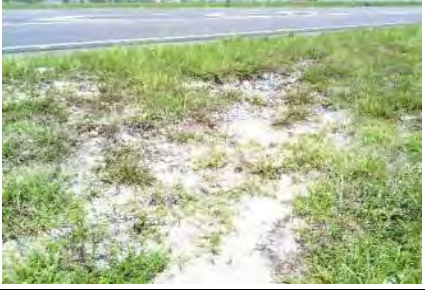
Roadway	Erosion	2	erosion by the shoulder	6
R38

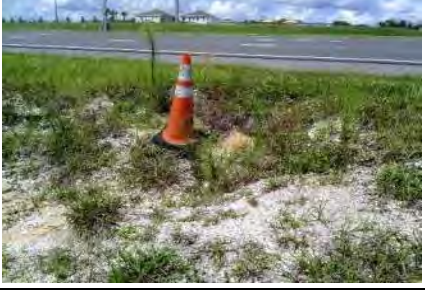
Roadway	Erosion	2	erosion by the shoulder	6

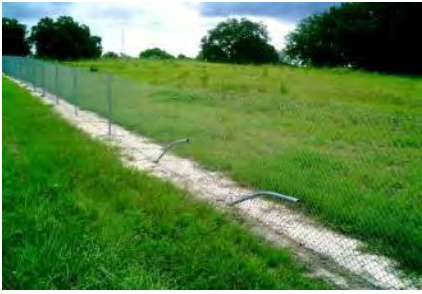
Roadway	Fence	2	fence post damaged	8
R40

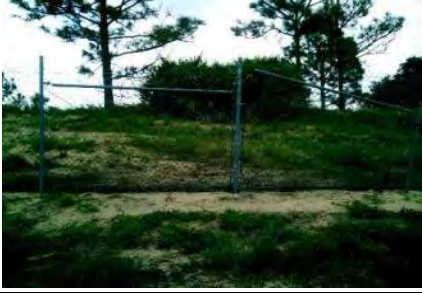
Roadway	Fence	2	fence post damaged	8
R41

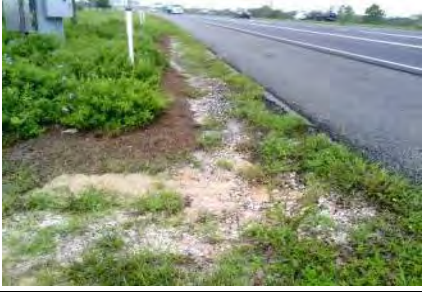
Roadway	Erosion	2	erosion by the shoulder	8
R42

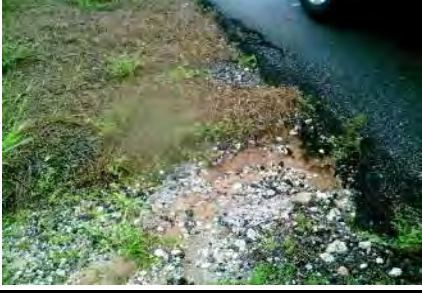
Roadway	Erosion	2	erosion by the shoulder 12 inch	8
R43

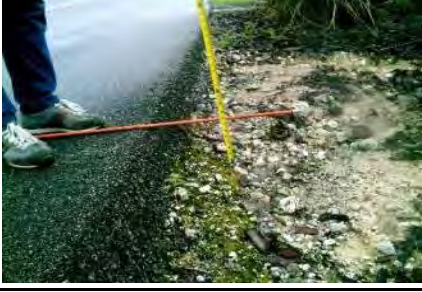
Roadway	Erosion	2	erosion by the shoulder 8 inch dropoff	9
R44

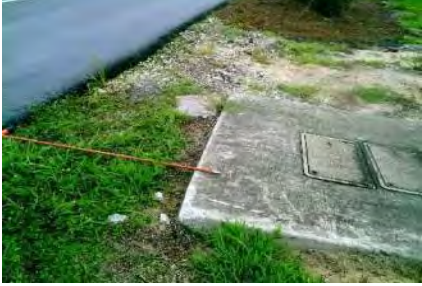
Roadway	Erosion	2	erosion by the shoulder 7 inch dropoff	9

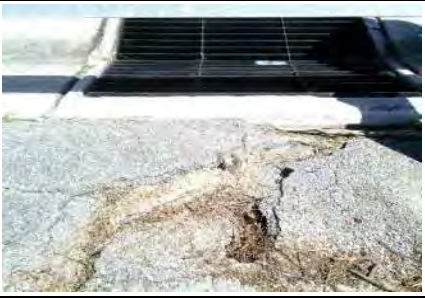
Roadway	Erosion	2	erosion / miscellaneous asphalt undermined	10
R52

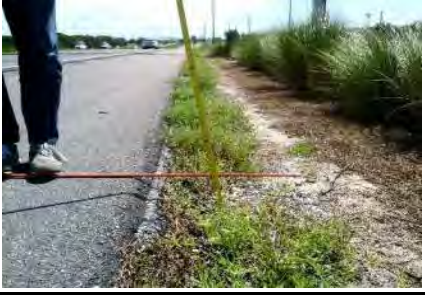
Roadway	Erosion	2	erosion / 7 inch dropoff	9
R53

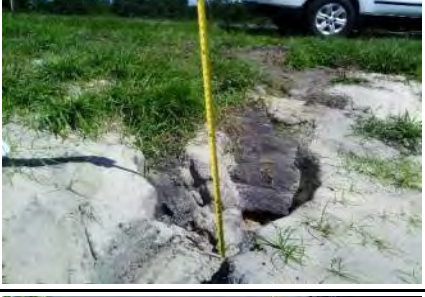
Roadway	Erosion	2	erosion by the sign foundation	9
R54

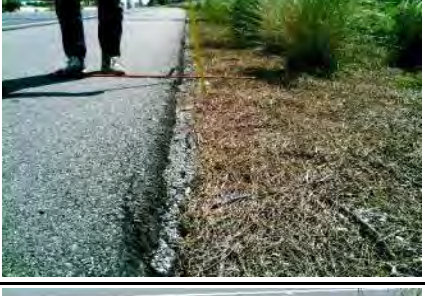
Roadway	Erosion	2	erosion by the shoulder / 5 inch dropoff	9
R56

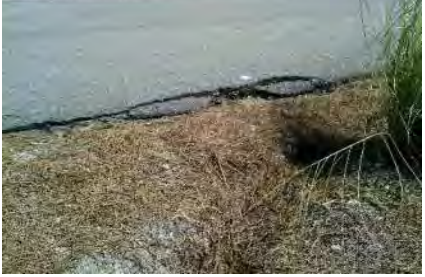
Roadway	Erosion	2	erosion by the shoulder undermining pvmt	8

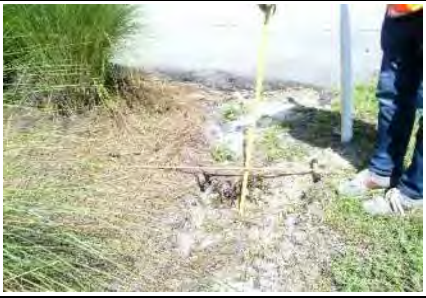
Roadway	Erosion	2	erosion by the shoulder undermining pvmt	8
R58

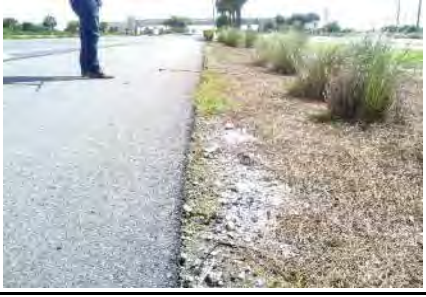
Roadway	Erosion	2	erosion by the shoulder / 5 inch dropoff	9
R59

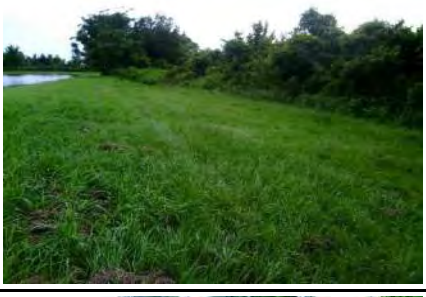
Roadway	Fence	2	overgrown vegetation on fence lines	12
R60

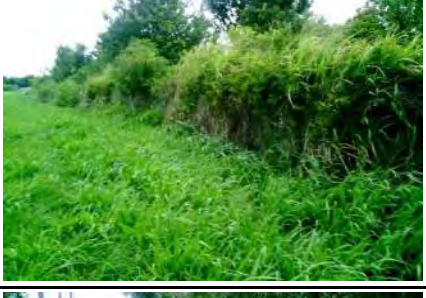
Roadway	Fence	2	overgrown vegetation on fence lines	0
R61

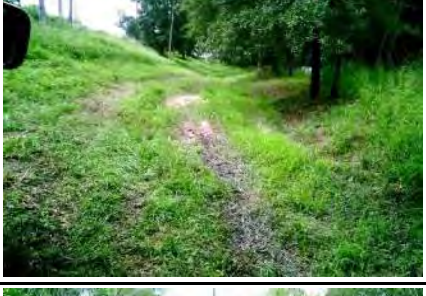
Roadway	Erosion	2	sediment from washout blocking ditch	15
R62

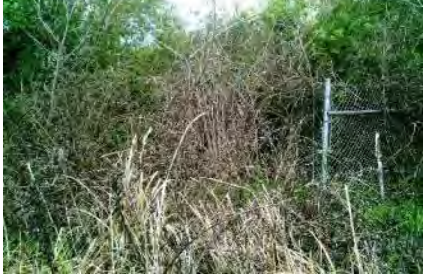
Roadway	Fence	2	fence line downed by excessive vegetation	13

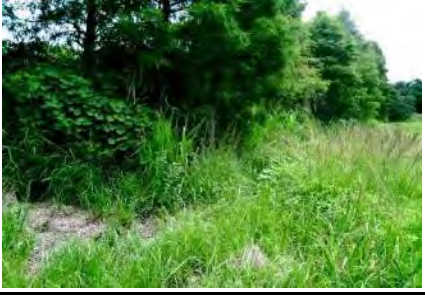
Roadway	Other	2	no maintenance / no access	14
R65

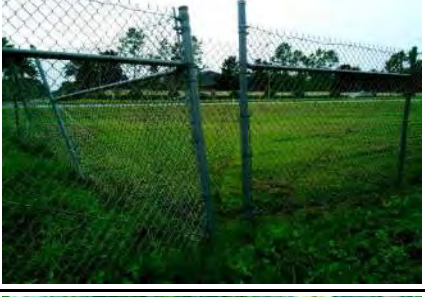
Roadway	Fence	2	fence line not secured	13
R66

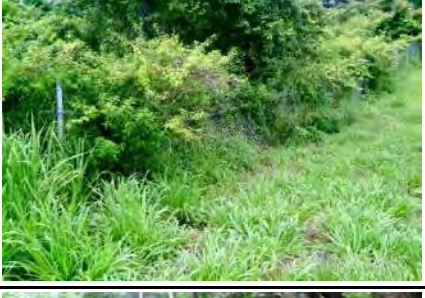
Roadway	Fence	2	overgrown vegetation on fence line	14
R67

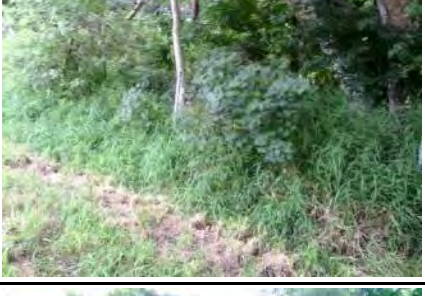
Roadway	Fence	2	fence damaged /vegetation overgrown maintenance	16
R68

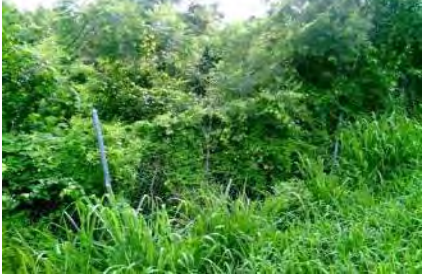
Roadway	Fence	2	fence damaged	12

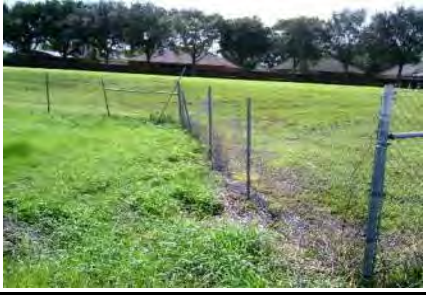
Roadway	Fence	2	damaged	15
R71

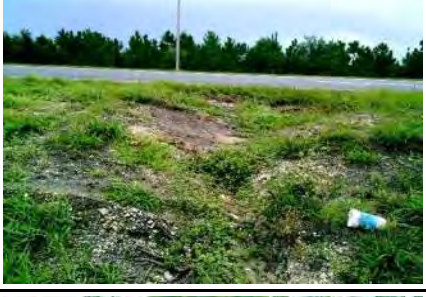
Roadway	Erosion	2	erosion	26
R72

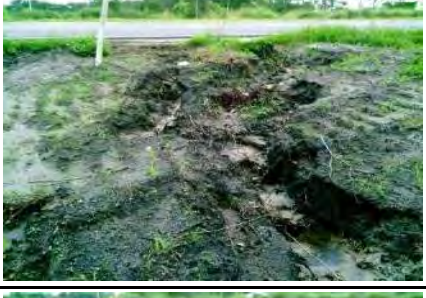
Roadway	Erosion	2	washout	16
R73

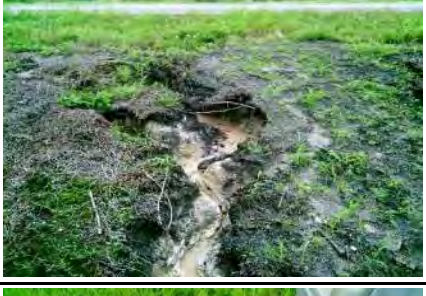
Roadway	Erosion	2	washout	17
R74

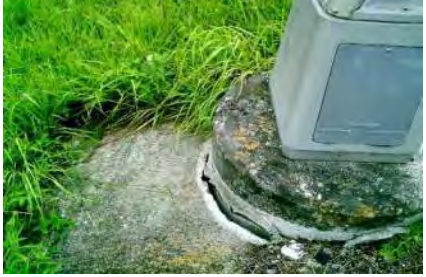
Roadway	Lighting	2	joint seal damaged / apron not secured to light pole	16

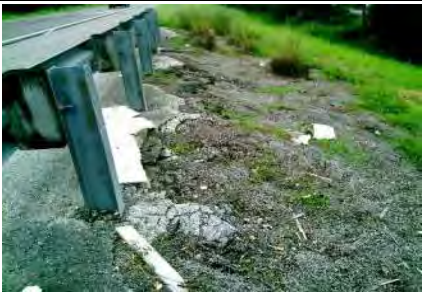
Roadway	Erosion	2	erosion / miscellaneous asphalt undermined	16
R76

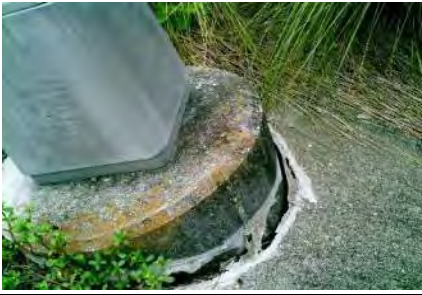
Roadway	Lighting	2	joint seal damaged	16
R77

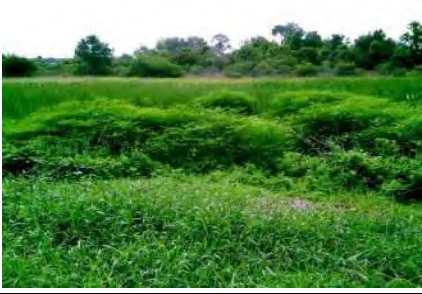
Roadway	Other	2	overgrown vegetation	17
R78

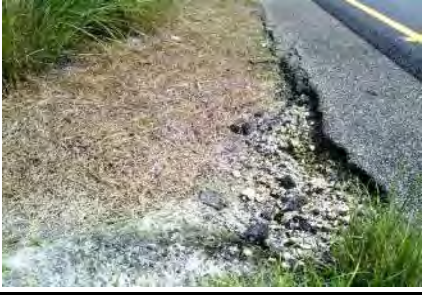
Roadway	Erosion	2	dropoff	18
R79

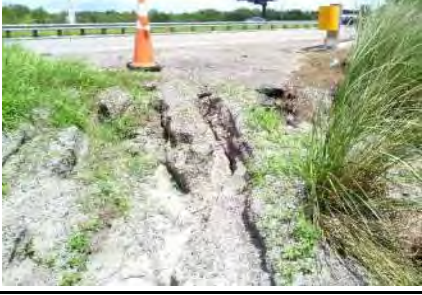
Roadway	Erosion	2	erosion / miscellaneous asphalt undermined	18
R80

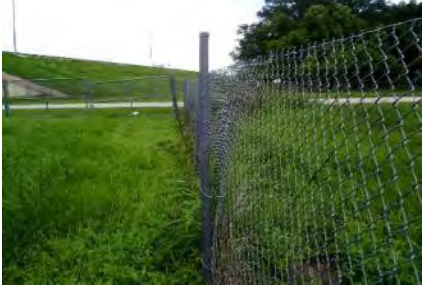
Roadway	Fence	2	fence post damaged	19

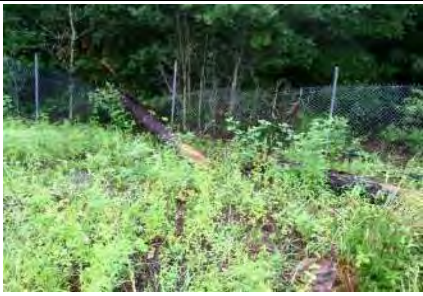
Roadway	Fence	2	fence damaged tree fell	20
R82

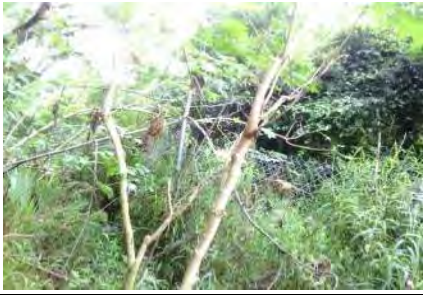
Roadway	Fence	2	vegetation overgrown/fence damaged	22
R83

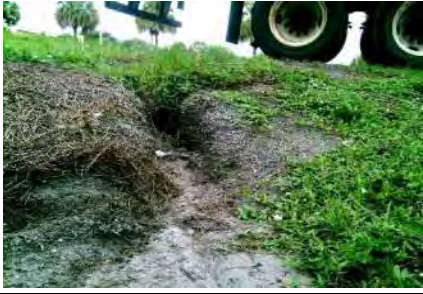
Roadway	Erosion	2	erosion by the shoulder	23
R84

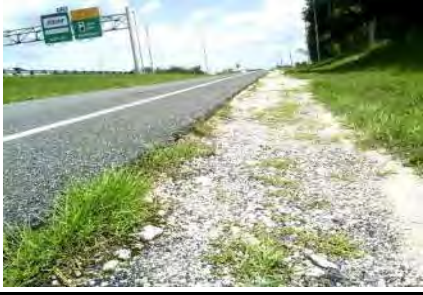
Roadway	Erosion	2	erosion by the shoulder / dropoff	0
R85

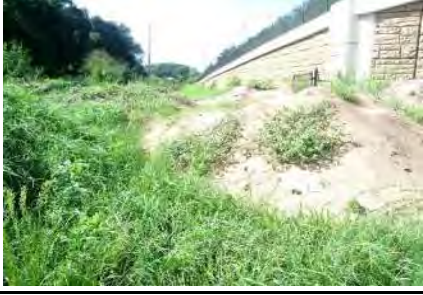
Roadway	Other	2	access blocked	31
R86

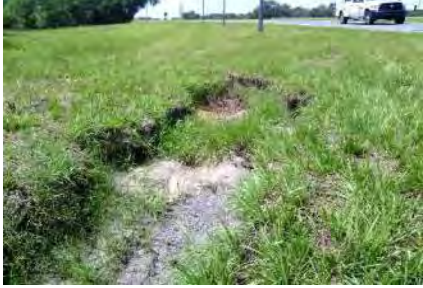
Roadway	Erosion	2	swale washout	36

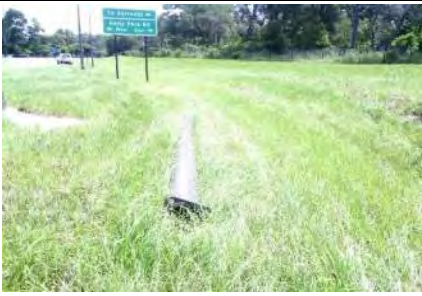
Roadway	Lighting	2	old pole not hauled offsite	36
R88

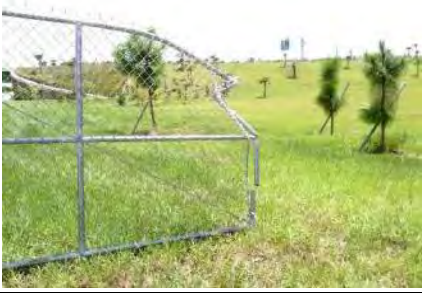
Roadway	Fence	2	fence gate damaged	41
R89
